5. LIQUEFACTION EFFECTS AND ASSOCIATED DAMAGE AT THE PORT OF WELLINGTON

5.1 Introduction

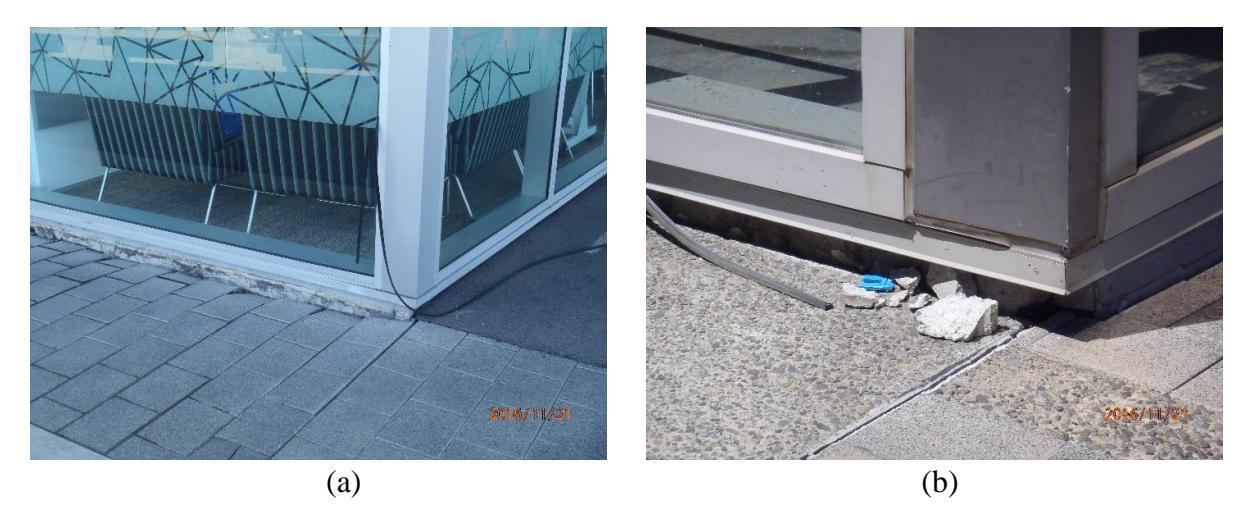
The B building is supported on piles with stone column ground improvement performed over the southeastern (seaward) half of the building footprint. The surrounding ground settled approximately 50 to 90 mm uniformly relative to the building (Figure 5.83). No other significant movements were observed.

Figure 5.83: Ground settlement relative to the pile-supported B building at: (a) the southwest corner of the building with ground improvement (S41.279767°, E174.782100°), and (b) northwest corner of the building without ground improvement (S41.279419°, E174.781443°). (taken at 1350 hrs on 21NOV16)
