6. GEOTECHNICAL EFFECTS ON CRITICAL STRUCTURES DURING THE MARCH 5TH FLOOD EVENT

Bridge scour

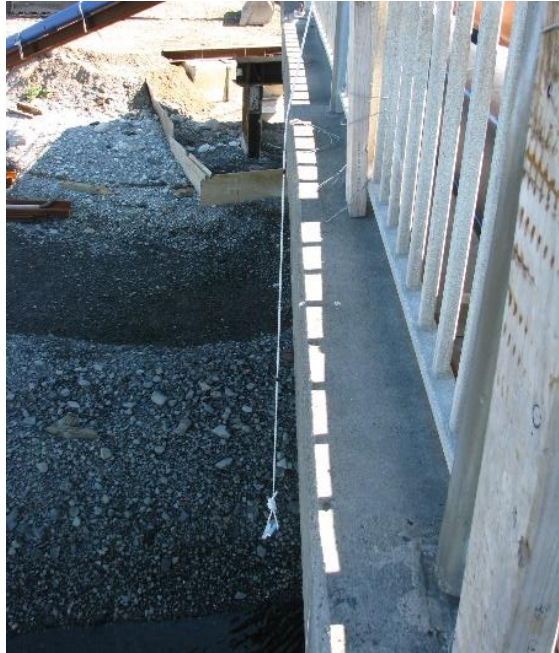
Figure 6-6 Sounding at South Brighton Bridge with construction work in the background on 19 March 2014.

With the original river bed level (Figure 6-5), scour would correspond to the octagonal columns, probably reaching the pile caps and making them a scour protection. With full exposure of the pile caps, scour would be expected to develop in a different shape, in response to the sharp pile cap edges. However, destabilization of the bridge due to scour is very unlikely, because of the support provided by the concrete piles. Surveying was limited due to construction work (Figure 6-6, Figure 6-7, and Figure 6-8). Figure 6-8 shows the soundings generally indicating a deepening towards the east in the channel, and the downstream side was generally deeper by ~30-40 cm. An irregularity was found at a distance of 24-26 m from the western lightpost which served as datum. Due to the limited soundings, it cannot be determined if the shoaling or the deepening represents the irregularity, or if this might be related to scour processes and/or an increase of erosion during the flood. A shoaling could be related to a gravel bank deployed around the piers for a remediation of the pier pile caps. A more detailed investigation after the conclusion of the construction work would answer this question.

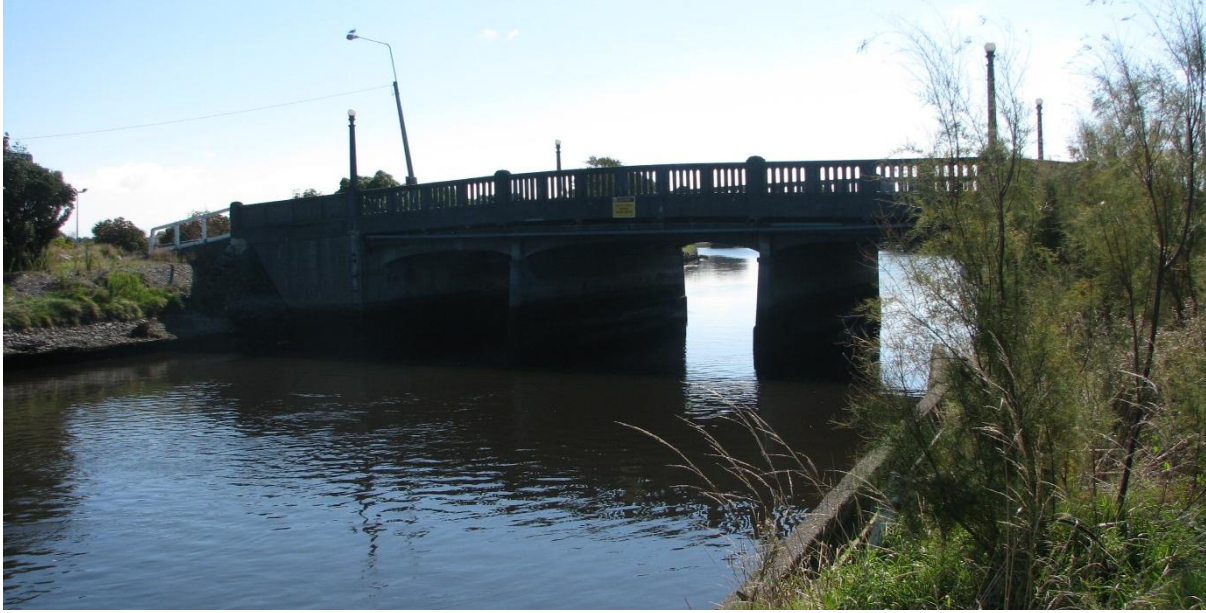
Figure 6-11 Pages Road Bridge on 19 March 2014.

The deck is supported by two concrete wall piers, with the superstructure fully built into these and the abutments (Figure 6-11). Both piers and abutments are supported by 350 mm wide octagonal reinforced concrete piles, each 7.3 m long. Each pier has 14 vertical piles, while each abutment has eight piles supporting the backwall and two piles supporting each wing-wall.

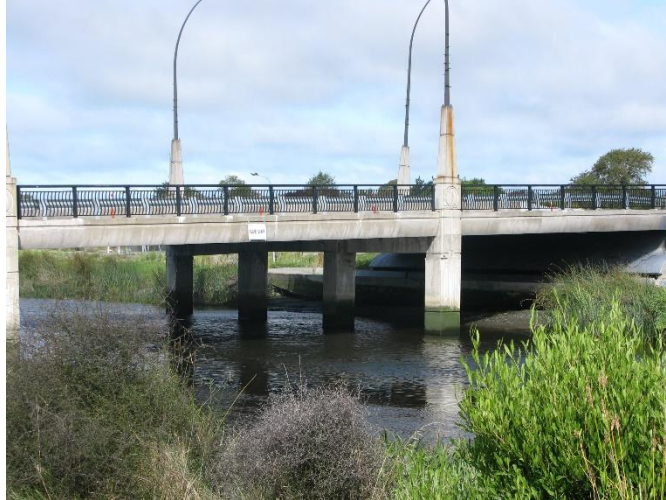
Figure 6-14 Anzac Drive Bridge on 19 April 2014.

Following the Christchurch earthquake, both pier frames suffered extensive cracking of the concrete columns and beams as well as the beam-column joint regions of the pier cap. Spalling of the concrete cover appears to be primarily as a result of interaction between the transverse motion of the bridge and the rotation of the piers due to lateral spreading. There was no serious damage to the bridge superstructure.

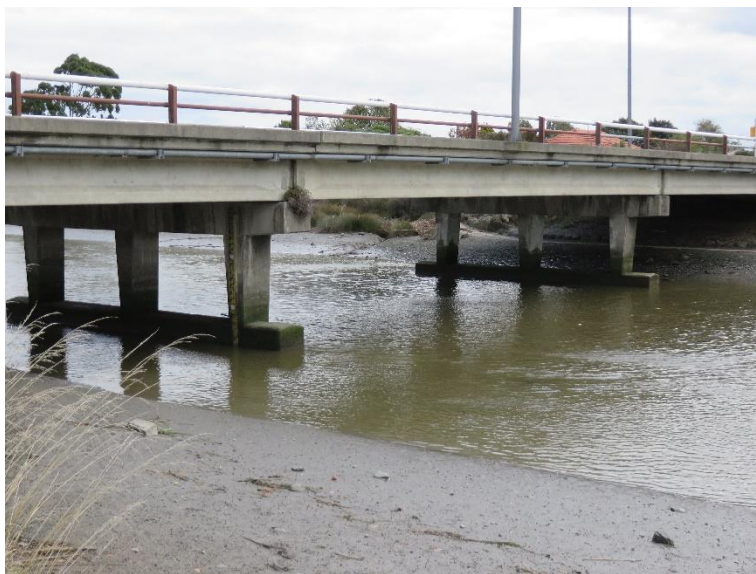
Figure 6-18 Heathcote River Bridge on 20 March 2014.

The bridge was undamaged during the Darfield earthquake. During the Christchurch earthquake there was a significant amount of lateral spreading and cracking of the approach soils and approach settlement. There was approximately 1° of back rotation of the north abutment towards the river.

The soundings at Heathcote River Bridge are shown in Figure 6-19 and indicated that most of the flow is going between the two pile groups. No significant water depth variations were noted at the foundations, while downstream a slight deepening in the center of the channel by ~ 0.2 m was observed, likely eroded due to compression of streamlines between the piers.

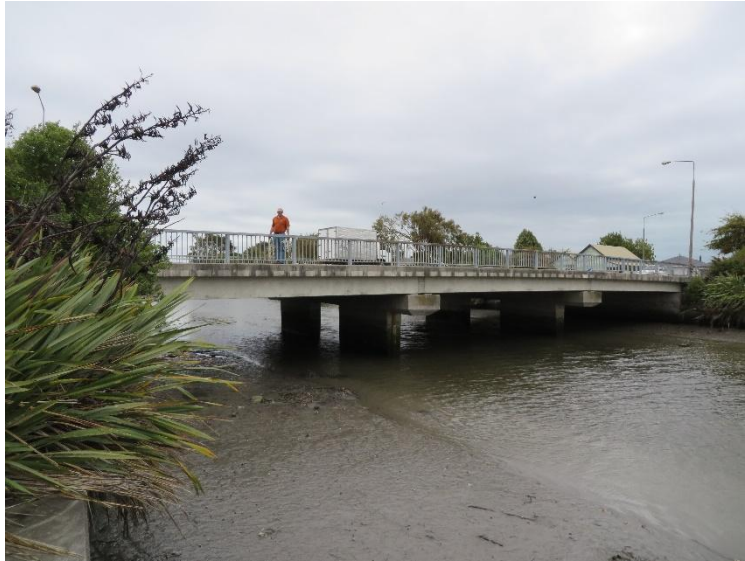
Figure 6-20 Rutherford Street Bridge on 20 March 2014.

The bridge was undamaged during the Darfield earthquake. During the Christchurch earthquake the high abutment walls rotated and displaced horizontally, closing the abutment joint gaps, and the approach had settled by approximately 0.1 m. Lateral spreading may have been a factor causing this damage.

The soundings shown in Figure 6-21 highlighted that flow is funneled through the two pier structures, but no indicators for scour were observed.
