8. POST-EARTHQUAKE SEQUENCE FLOODING IMPACTS ON THE BUILT-ENVIRONMENT

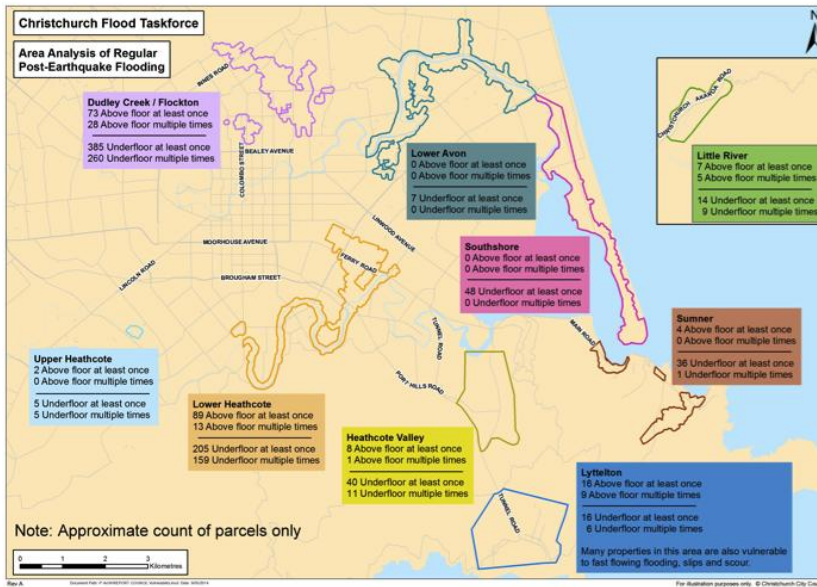
Figure 8-1 Areas of investigation by the 2014 Mayoral Flood Taskforce (CCC Task Force, 2014a): (a) Summary map of Christchurch outlining investigation areas; (b) Avon River area of investigation; (c) Heathcote River area of investigation.
