Seismological and Engineering Effects of the M 7.0 Samos Island (Aegean Sea) Earthquake

Hellenic Association of Earthquake Engineering: Report 2020/02

Geotechnical Extreme Events Reconnaissance Association: Report GEER-069

December 31, 2020

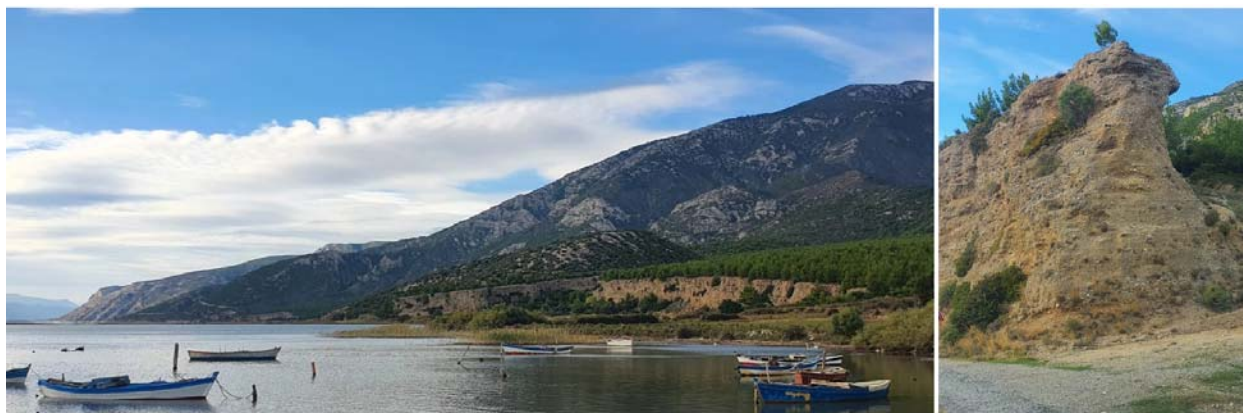
In the southern side of the Dilek Peninsula, young uplifted terraces are detected in the coast supporting a rapid tectonic uplift associated with active normal faulting (Figure 1.28). This location is near the Karina Lagoon, where different intercalations were deposited during tsunamis. To identify any coseismic ground deformation, in the Turkish side, the NE-SW oriented strike-slip Tuzla and Seferihisar, E-W oriented normal faults near Kuşadası, Gümüldür, Selçuk, Söke and Dilek Peninsula, were visited (Figure 1.27).

Figure 1.28. Photos taken at the southern side of Dilek Peninsula showing uplifted terrace deposits.

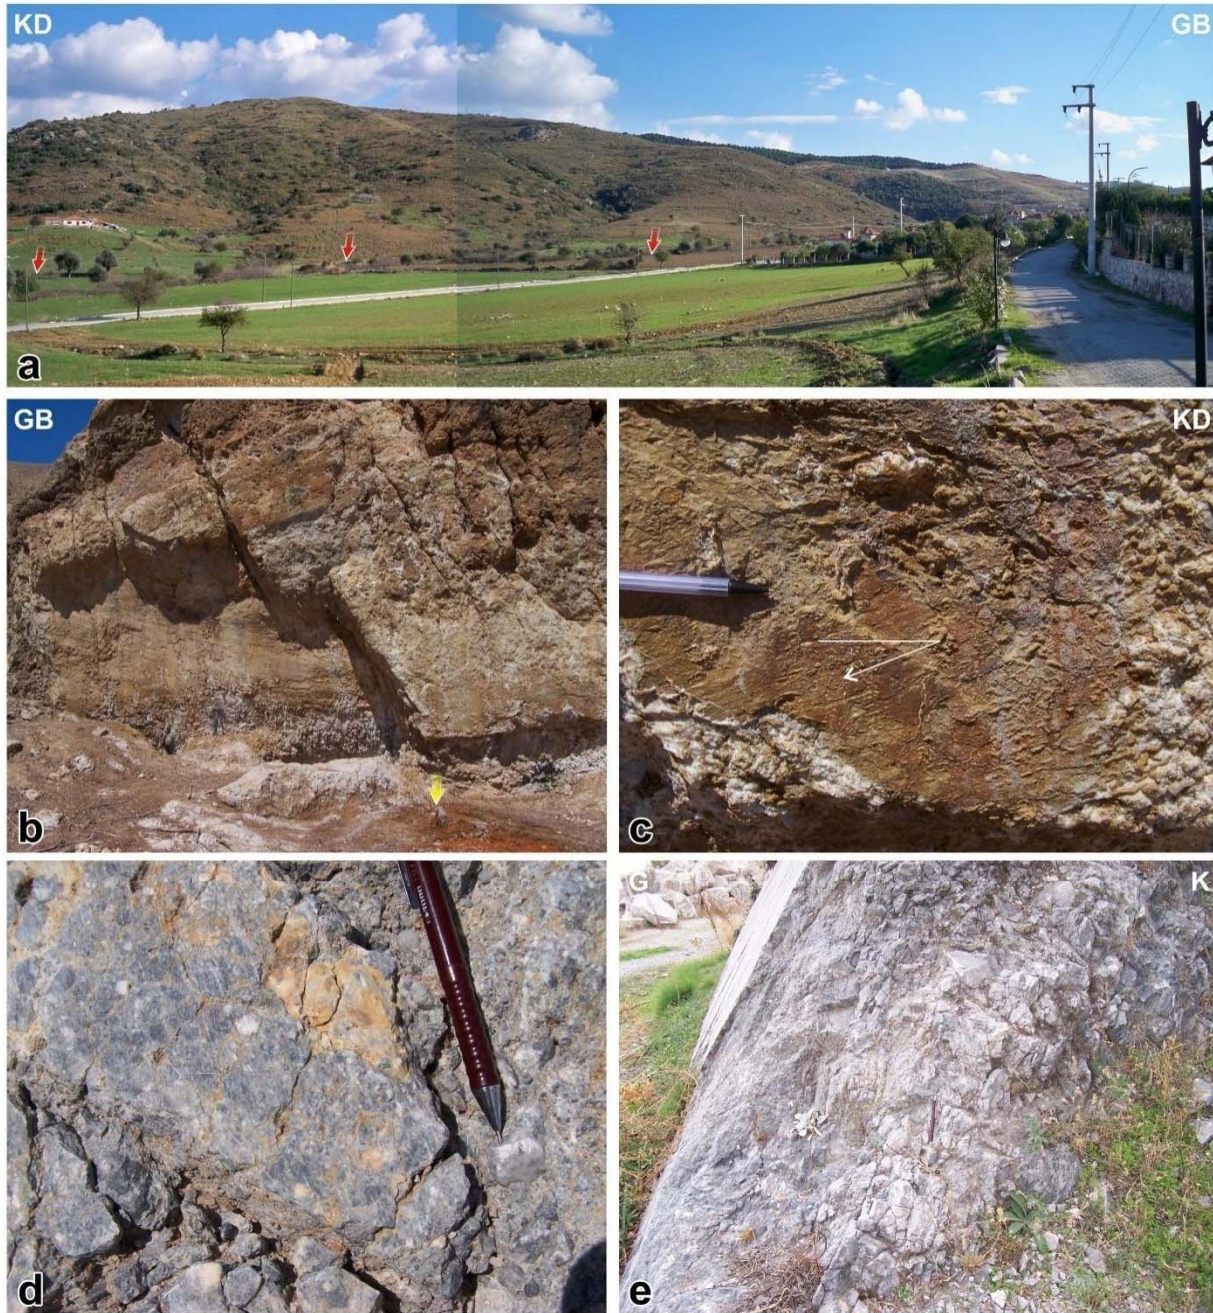
Figure 1.29 (a-e) shows the morphology of active Seferihisar strike-slip fault on land. At the Tuzla Fault site, geothermal alterations implying fault activity were detected. Moreover, the preserved striations identified on the fault scarp of the Tuzla fault revealed right lateral strike-slip motion, with a minor normal component (Figure 1.29c).

Figure 1.29. Photos of Seferihisar (a), Tuzla (b, c) strike-slip faults and Söke (d, e) normal fault. Red arrows show the fault trace, while the yellow arrow points out to geothermal fluids coming from the fault zone.

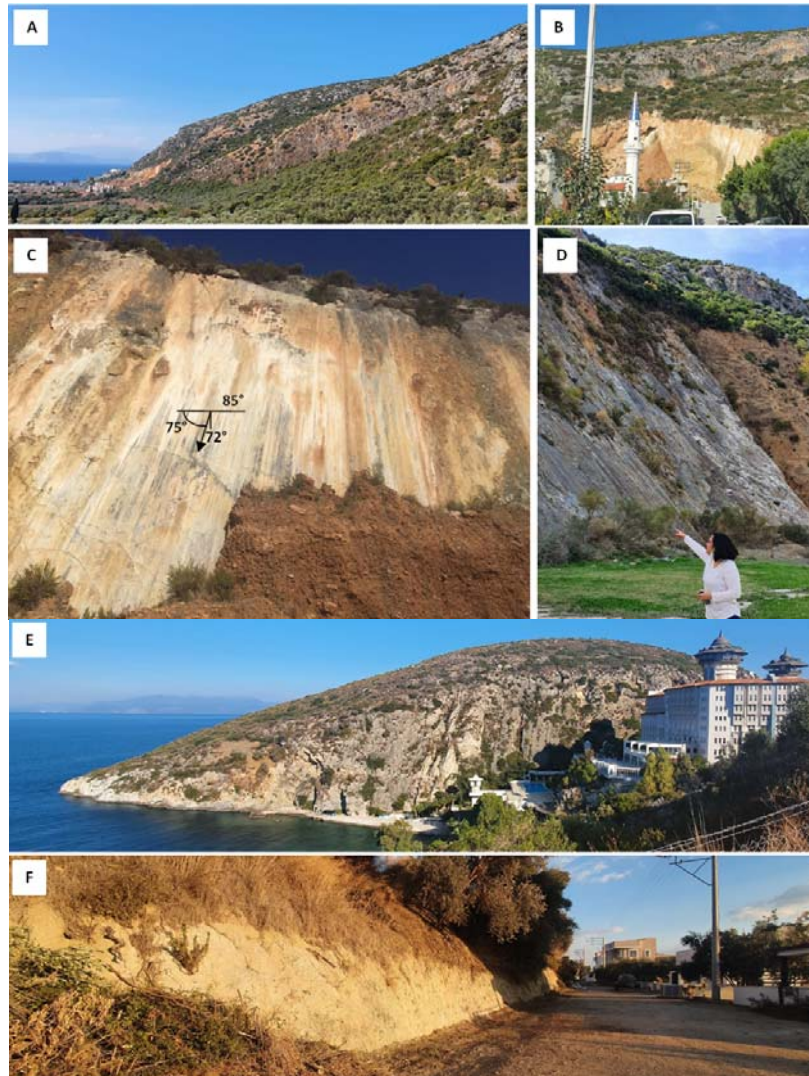
Figure 1.30. Active fault observations. Photos of south dipping normal faults near Kuşadası are given in **a**, **b**, **c** and **e**; Ephesus fault is in **d** and Gümüldür fault in **f**.

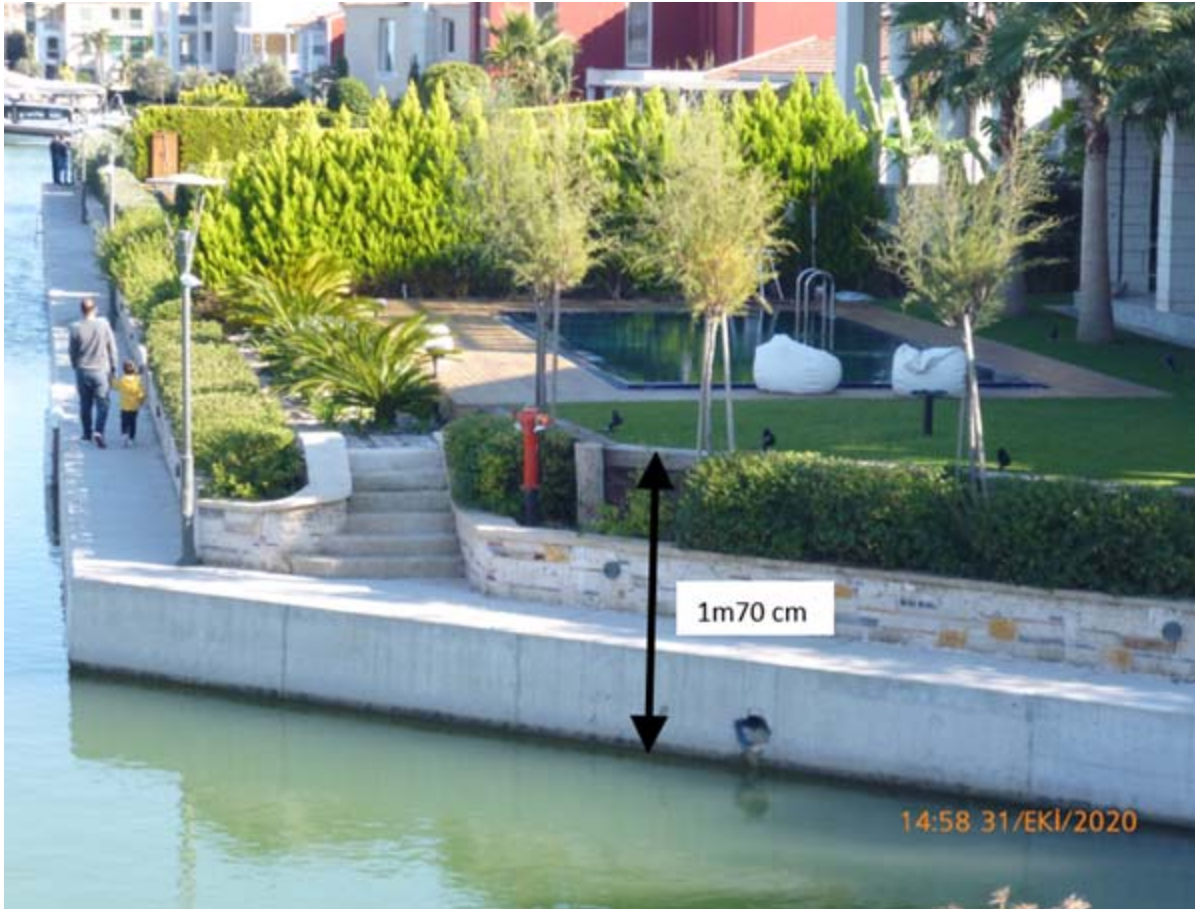
The water level increased and overtopped the garden wall of Port Alacati Houses up to 1.70 m (38.26346N 26.37304E and 38.26320N 26.37654E) (Figure 2.4). Here, the sea receded up to a depth of 1.5 m, 28 minutes after the earthquake, as seen in a security video recording.

Figure 2.4. Water level rise at the garden wall of Alacati Port Houses according to the house owner (38.26370N 26.37427E).

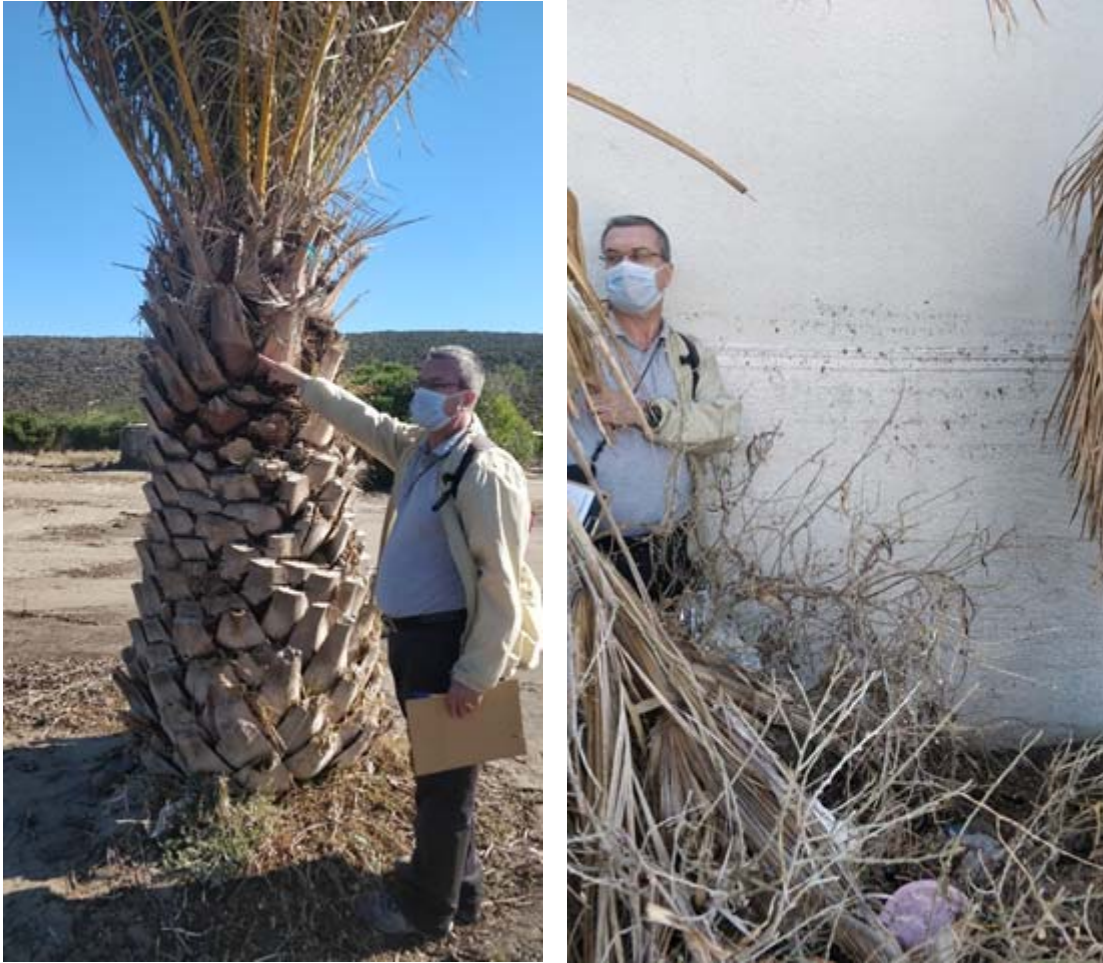
A 1.9m flow depth was measured on the palm trees, about 50 m away from the coastline (38.19600N 26.48859E and 38.19602N 26.48936E), and from debris materials accumulated at the outer wall of a house (38.19587N 26.49027E) (Figure 2.7). The abandoned summer houses along the shore were severely damaged, and debris materials accumulated on both outer walls and inside them. Additionally, tsunami boulders of concrete material (30x50x300 cm), weighing approximately 1 ton, were found transported 20-25 m inland.

Figure 2.7. (Left) Wave traces on the palm tree (1.90 m) near the coastline (38.19600N 26.48859E), and (Right) trace of debris materials accumulated at the outer wall (1.50 m) of a house (38.19587N 26.49027E).

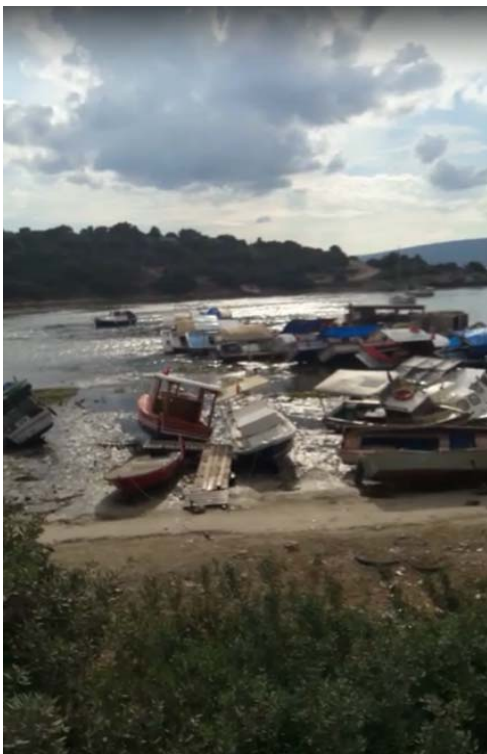
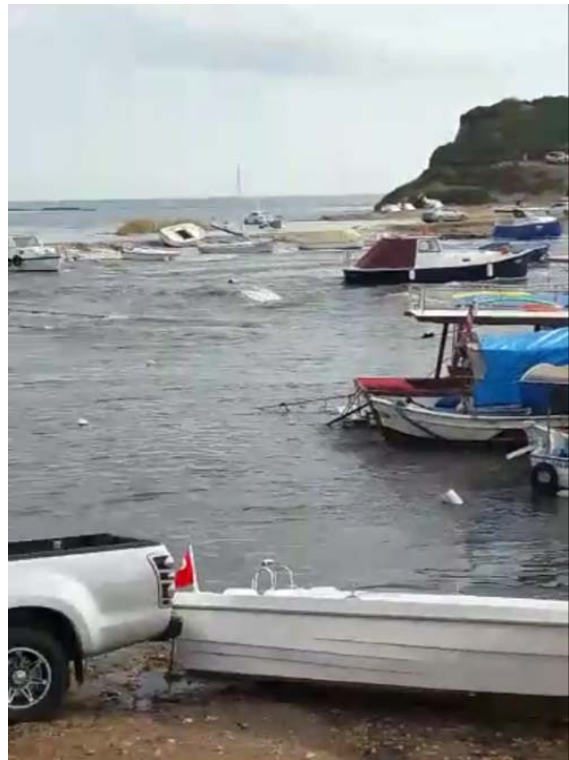
In the Demircili locality, 45m inundation was measured at the beach (38.211628N 26.676901E) on the northwestern side of the bay (Figure 2.8). However, significant damage was observed by the local people and fishermen in a narrow beach site in the southeastern part of the bay (Figure 2.9, 38.207508N 26.686378E). According to the eyewitness statements, the sea receded almost 20 min after the earthquake, and came back in 3-4 minutes. They observed this cycle of ebb and tide for about five hours. A boat moored at a depth of 1.8 m was grounded when the sea receded during the leading-depression wave (Tadepalli and Synolakis, 1994). The water level increased more than 1 m inside the local fishery port.

Figure 2.9. Highly damaged boats in a small fishery port in the Demircili locality.

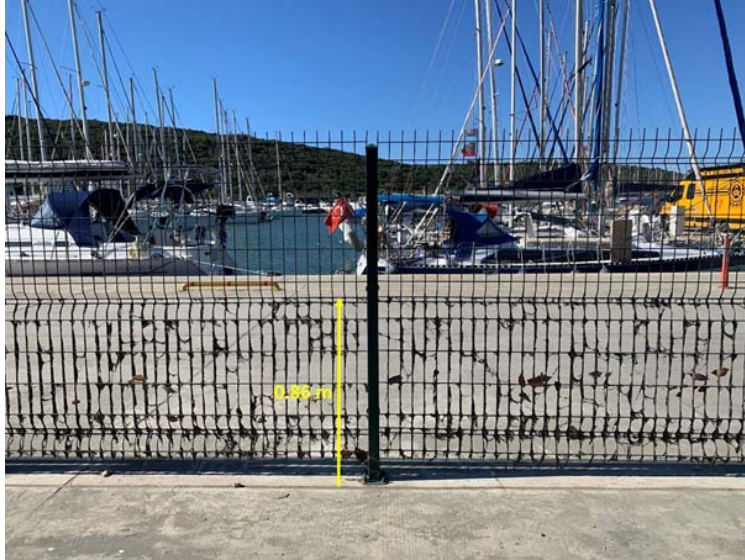
Figure 2.13. Tsunami traces on the garden fence of Teos Marina corresponding to a flow depth of 0.86 m. Classic presentation of debris “escalator” showing maximum flow depth.

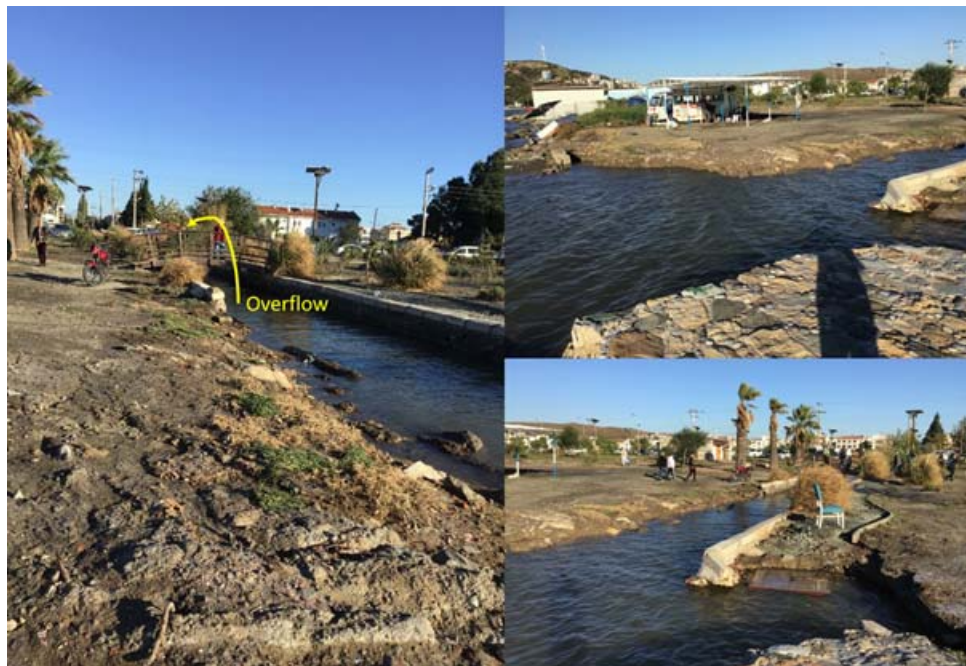
Figure 2.14. Azmak river in the East direction from Teos Marina where the tsunami overflowed the small bridge.

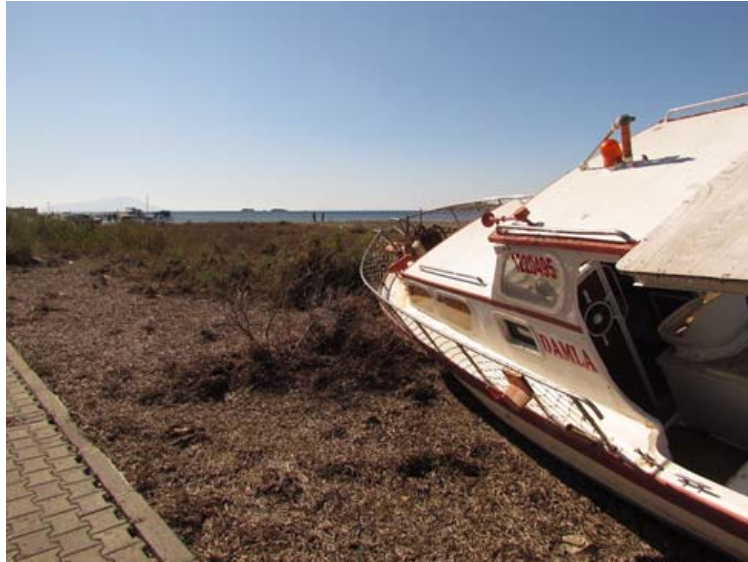
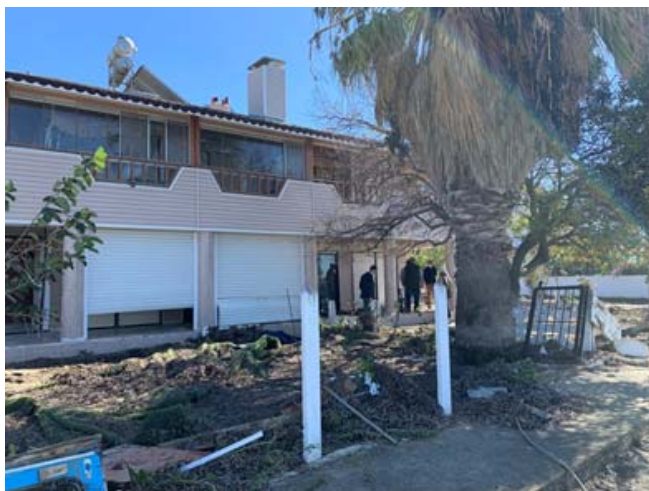
Figure 2.16. A boat dragged 90 m from the shoreline.

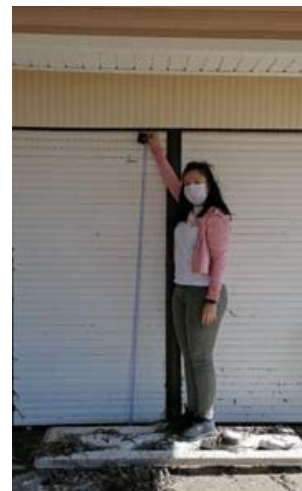
Akarca Locality. The coast in the Akarca region from 38.171062N 26.803827E to 38.168131N 26.811287E was highly impacted by the tsunami, whereas a significant reduction of impact was observed in the region after the small V shape cape in the northwestern direction. In a small fishery port in the small cape (38.164666N, 26.814649E), 20 boats sank. A boat was dragged inland by the strong currents 90 m from the shoreline (Figure 2.16). A water storage tank (half full) and a car were also dragged towards land at 38.164526N 26.814808E. A 1.9 m splash height was measured on a vertical wall of a house located just near the shore (38.164666N 26.8146490E, Figure 2.17).

Figure 2.17. A damaged house located just near the shoreline where a 1.9 m splash height was measured in Akarca.

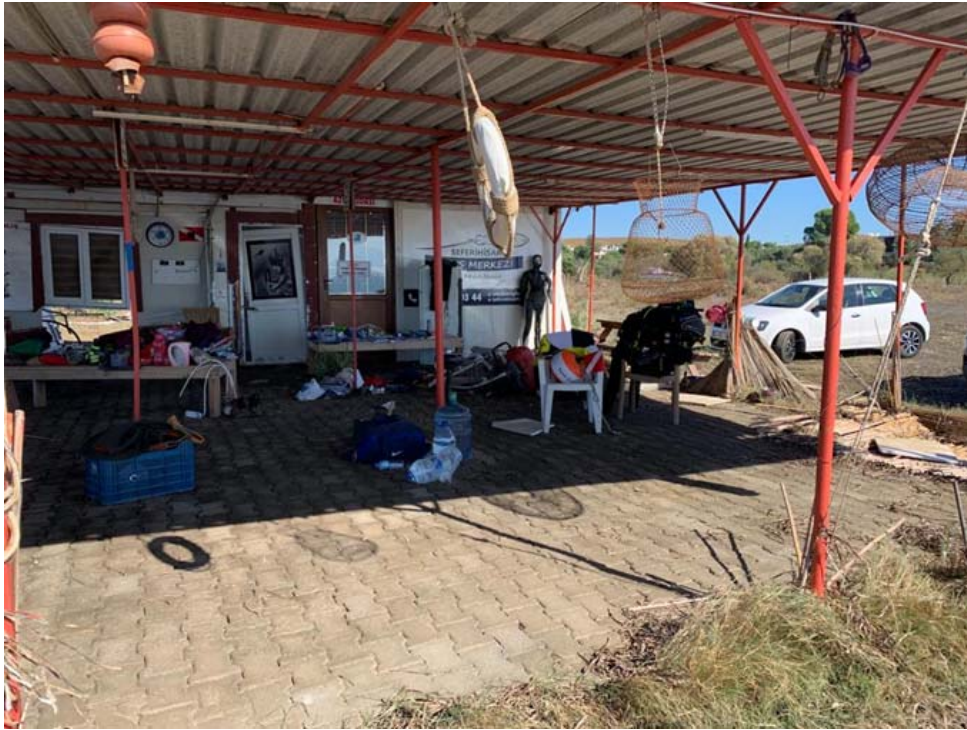
In Seferihisar Diving Center (Figure 2.18, 38.165560N 26.813708E), located in Akarca, the sea receded up to a depth of 4m and ~180m in the horizontal direction, 10 minutes after the earthquake, according to the owner of the center, Mr. Aydın Tunca. He observed the first wave arrival between 10-15 minutes. He stated that he jumped on a sofa and drifted ~200-250 m inland on the sofa until the foot of the sofa was locked on the land. He observed 4-5 waves, about 8-10 minutes apart. The inundation distance measured was 279 m and the flow depth 2.19 m.

Figure 2.18. Tsunami damage on Seferihisar Diving Center (38.165683N 26.813717E).

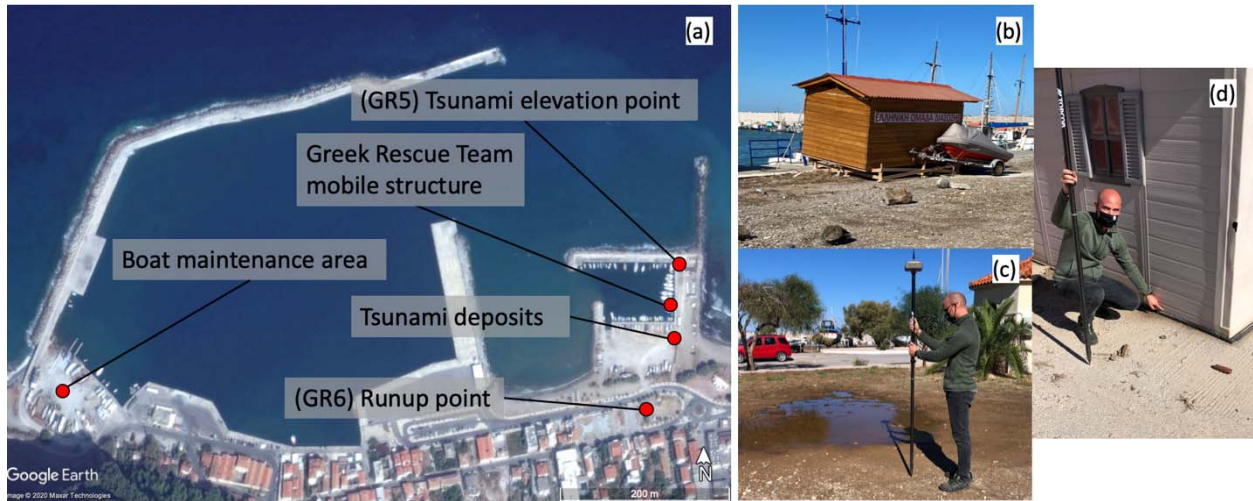
Karlovasi - Ag. Nikolaos. Karlovasi is a coastal town located on the NW side of the island, and therefore very close to the upper dip edge of the fault ruptured by the earthquake on October 30th, 2020. The tsunami reached Karlovasi within minutes after the earthquake. An eyewitness video from the area posted on Facebook live (reliable time information) shows that the sea level in the port of Karlovasi had already dropped significantly by 11:55 UTC and had begun rising again. At 11:57 UTC (~ 6 minutes after the earthquake), the risen sea level had reached the boat maintenance area (Figure 2.21a) on the western part of the harbor. At 11:59 UTC, the sea level had dropped again below the height of the quay. On the eastern part of the harbor, where the small craft marina is located, the flow depth over the quay, although not significant (of the order of 5-20 cm), was enough to suspend a mobile structure of the Greek Rescue Team and displace it from its base (Figure 2.21b). An eyewitness indicated that tsunami inundation reached an empty lot south of the marina and past the coastal road, where a water pond had formed (Figure 2.21c). This point corresponds to a wave runup of 1.84 m and 100 m of horizontal inundation.

Figure 2.21. (a) Google Earth satellite picture of the harbor of Karlovasi and the locations of tsunami observations. (b) The mobile structure of the Greek Rescue team that was displaced by the tsunami. (c) The maximum runup point location. (d) The flow depth mark on the side of a structure where tsunami elevation was measured.

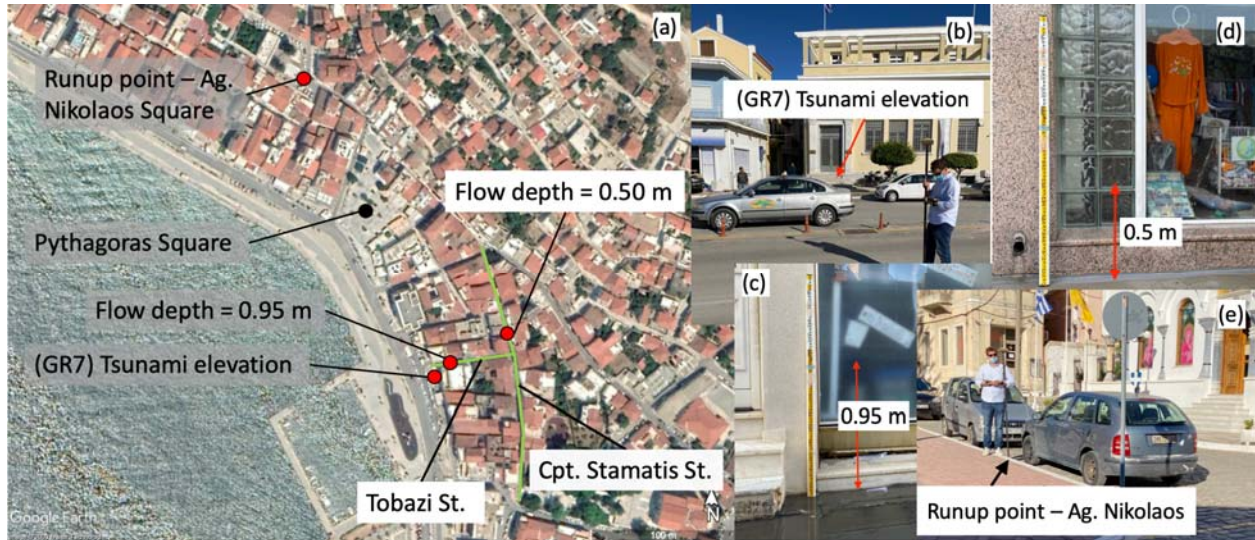
Field measurements focused on the area landward from the marina of Vathi and Pythagoras Square (Figure 2.23). An eyewitness indicated the maximum level the water reached at the entrance steps to the Bank of Greece branch, which was confirmed through videos shared on social media. This datapoint, located 62 m inland from the marina (Figure 2.23b), corresponds to a tsunami overland flow depth of 1.0 m and 1.7 m tsunami height. A flow depth of 0.95 m was measured along Tobazis St. at the side of the Bank of Greece branch that runs normal to the shoreline (Figure 2.23c). The inundating water traveled through the narrow street and

reached the commercial street of Cpt. Stamatis, where a flow depth of 0.5 m was observed (Figure 2.23d). The water entered the stores and flooded the basements of the buildings. Further north, the inundating water traveled through Pythagoras Square and reached the pavement next to Ag. Nikolaos Square (Figure 2.23e).

Figure 2.23. (a) Google Earth satellite picture of Vathi and the locations of tsunami observations. (b) The steps at the entrance to the Bank of Greece branch where tsunami elevation was measured. (c-d) Flow depth marks on store windows along Tobazi. (c) and Cpt. Stamatis (d) streets. (e) The runup location at Ag. Nikolaos Square.

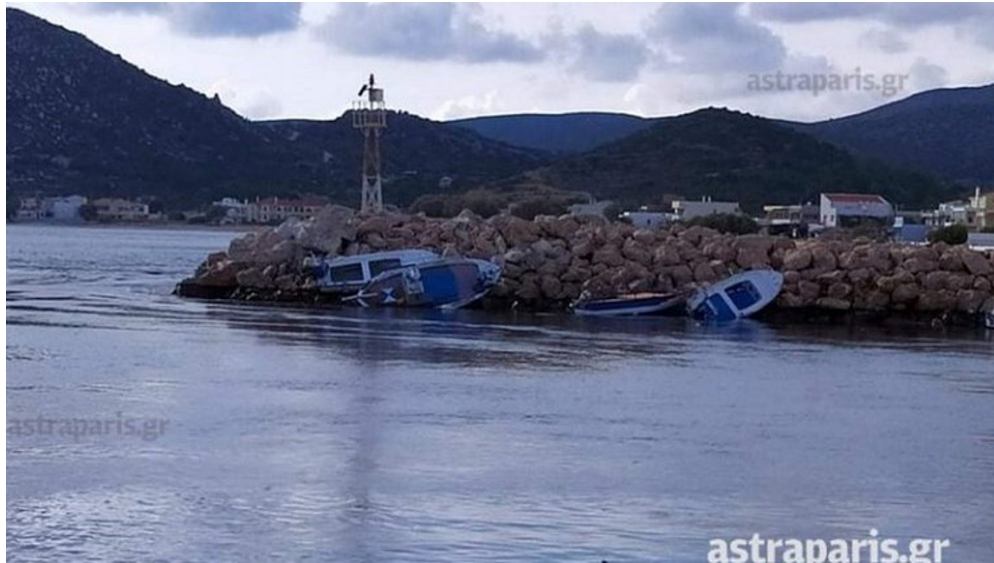
About 3 minutes later, the water level started rising again, and about an hour after the arrival of the first wave, the water level rose to ~1.10 m. above mean sea level. The water level fluctuations were intense for about 3 hours after the 1st wave arrival. Small boats that were docked in the small harbor of Komi were swept ashore along the breakwater (Figure 2.24). The eyewitness estimated the maximum horizontal inundation at the beach to be ~20 m.

Figure 2.24. Small boats were swept away and put ashore along the breakwater of the harbor of Komi, Chios (<https://15minutes.gr/>).

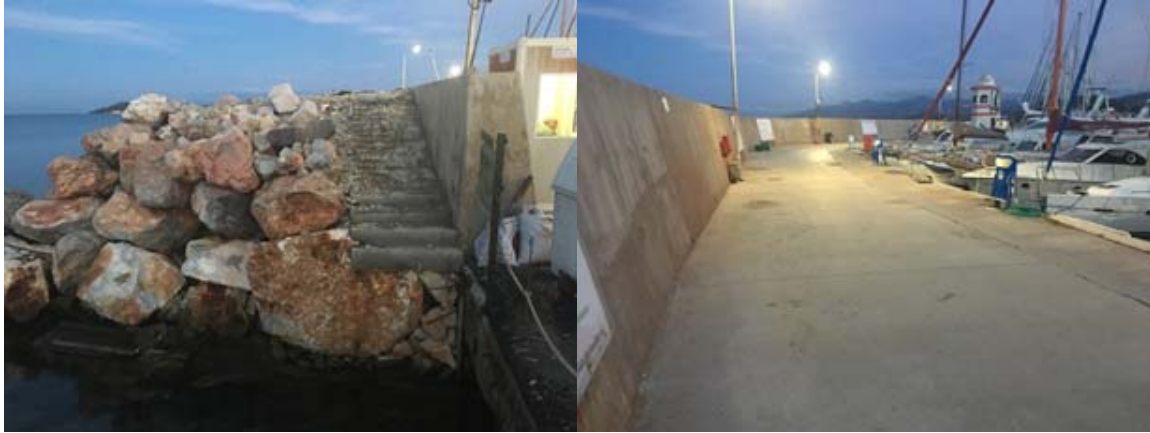
During the post-earthquake survey, no damage on the rubble mound breakwaters, i.e., settlement or damage on the armor layer of any rubble mound protection, was observed (Figures 2.25 and 2.26).

Figure 2.25. Rubble Mound Breakwater with the crown wall in Urla Fishery Harbor.

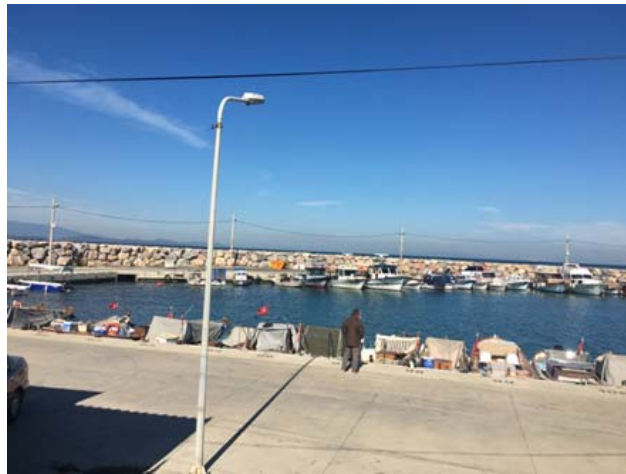
Figure 2.26. Rubble Mound Breakwater without crown wall in Guzelbahce Fishery Harbor.

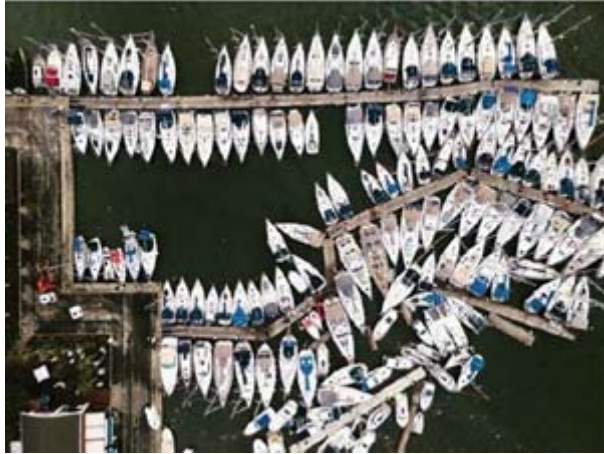
Contrary to the concrete block type, piers composed of floating pontoons in Teos Marina were the most damaged mooring structures. The damage was not due to the earthquake shaking but entirely due to tsunami hydrodynamic forces. Two dramatic photos of the floating piers shared on social media are shown in Figures 2.27 and 2.28.

Figure 2.27. Floating Piers in Teos Marina after tsunami attack.

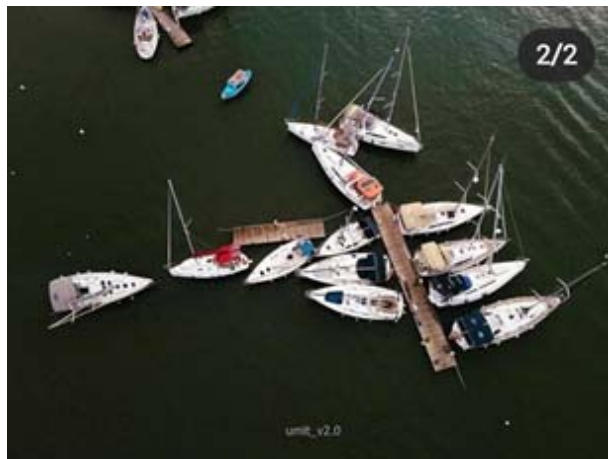
Figure 2.28. Drift of floating piers in Teos Marina after tsunami attack.

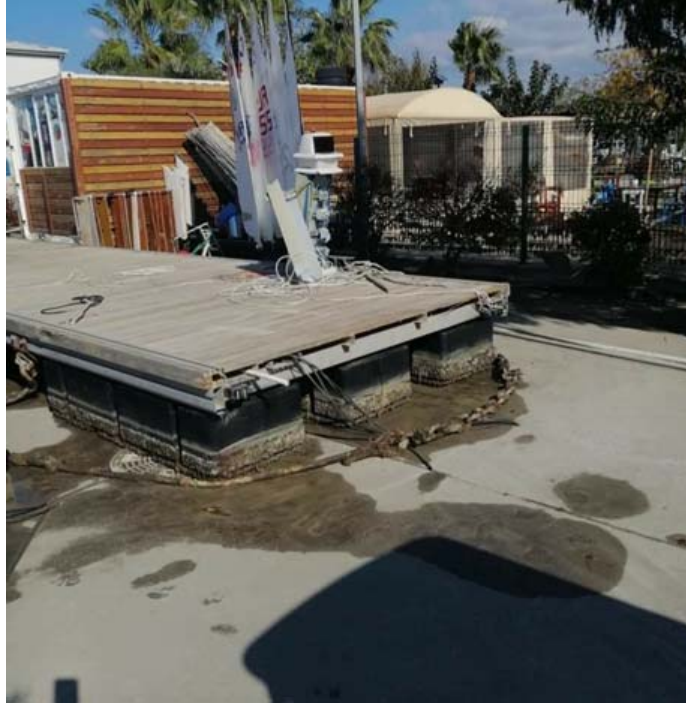
The pontoons of Teos Marina were constructed using floaters under an aluminum frame (Figure 2.29). The pontoon length and width were 20 and 2.5 m, respectively. The pontoons were connected to the gravity type anchorage at the seafloor by both steel chains and ropes. Apparently, strong tsunami currents broke the moorings, and the pontoons were dragged and detached. Moreover, aluminum pontoons and the moored ships were damaged. During the survey, the detached pontoons were moored to another location, as can be seen in Figure 2.30; these photos also show buckling in the rings at the fairlead. The ropes and the chains were broken off. In contrast to the aluminum pontoons, the concrete floating pontoon was not damaged (Figure 2.31).

Figure 2.29. One of the pontoons used in Teos Marina (floaters are at the bottom).

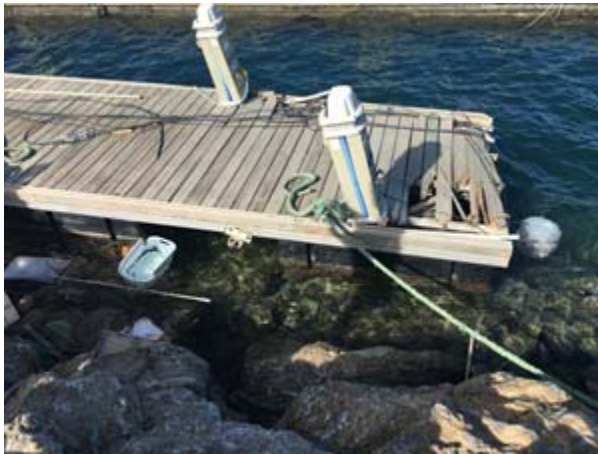
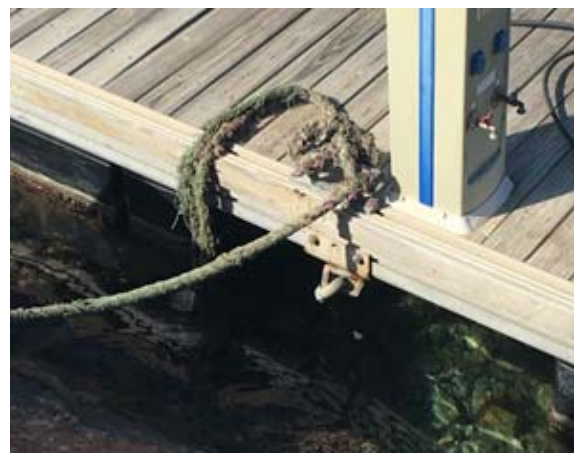
Figure 2.30. Damages in the pontoons and rings at the fairleads.

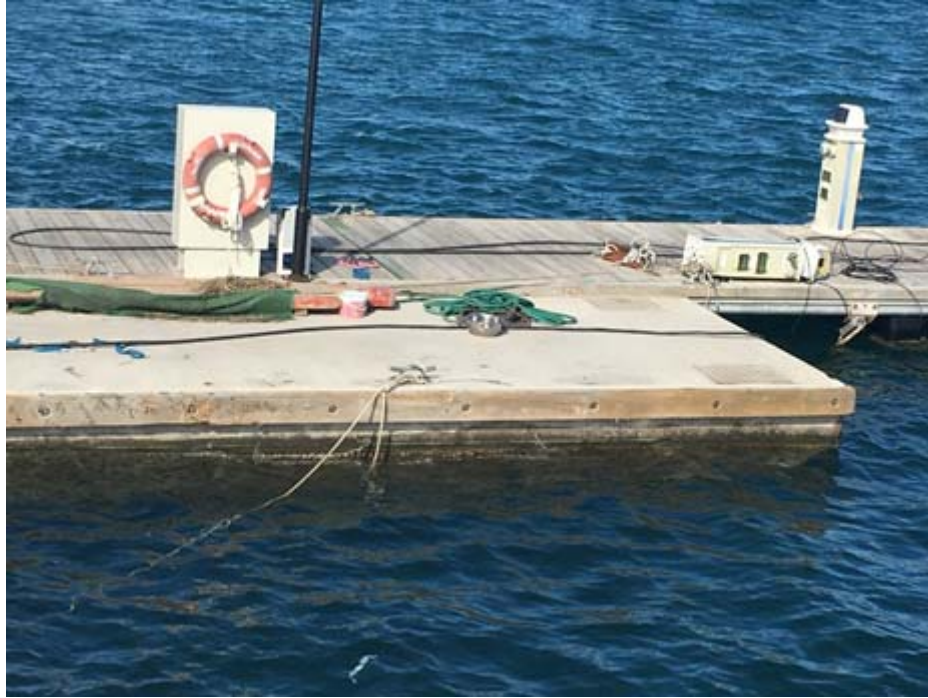
Figure 2.31. Undamaged concrete pontoon in Teos Marina.

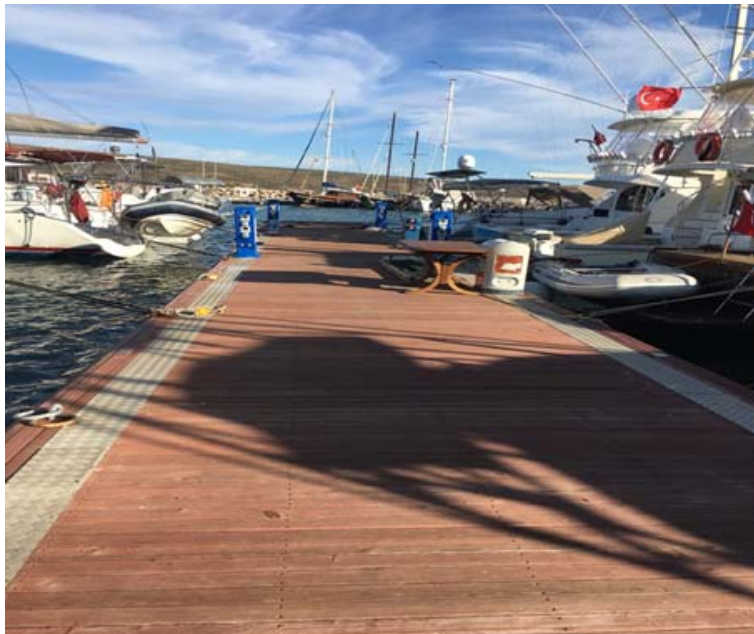
Similar observations were made for concrete pontoons in other marinas. For example, in Alacati Marina, the sea level rose by 1.5-2 m, but the pontoons sustained no damage (Figure 2.32).

Figure 2.32. Concrete Pontoons in Alacati Marina.

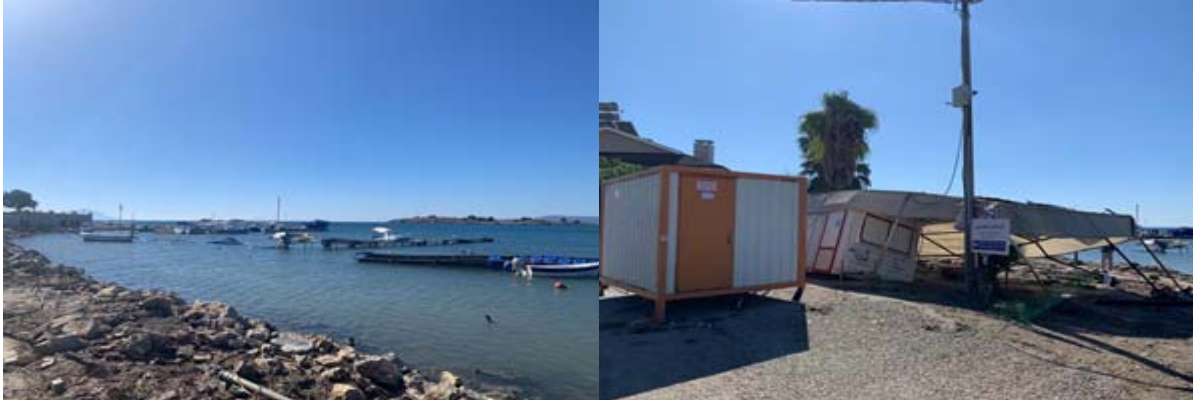
In addition to the ports and harbors previously described, the small fishery port in Akarca locality also suffered substantial damage, as all of the floating piers used for berthing and

mooring, including other seafront port facilities, were destroyed or became unusable (Figure 2.33). More than 20 boats sunk in this location, as reported by the president of Seferihisar fishery cooperative (Mr. Mustafa Gul).

Figure 2.33. Observed damage in the floating piers used for berthing and mooring and the seafront harbor facilities in Akarca fishery shelter.

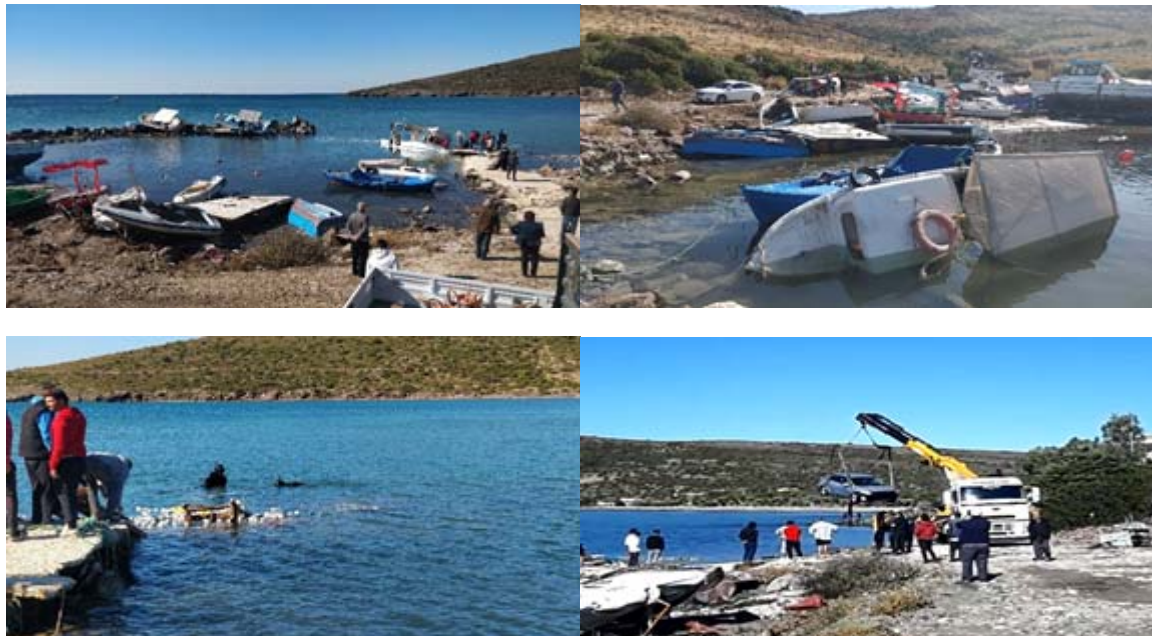
We also examined serious tsunami damage in another small fishery shelter in the Zeytineli locality (Figure 2.34). The non-engineered mooring and berthing structures and all boats in the shelter were destroyed, requiring a reconstruction. The parked cars on the shore drifted to the sea and the boats that sank also required rescue operations.

Figure 2.34. Photos showing the heavy damage and rescue operation of a car which was dragged into the water by the tsunami in Zeytineli fishery shelter (38.19336N 26.49233E); all of the boats and mooring facilities were unusable after the tsunami.

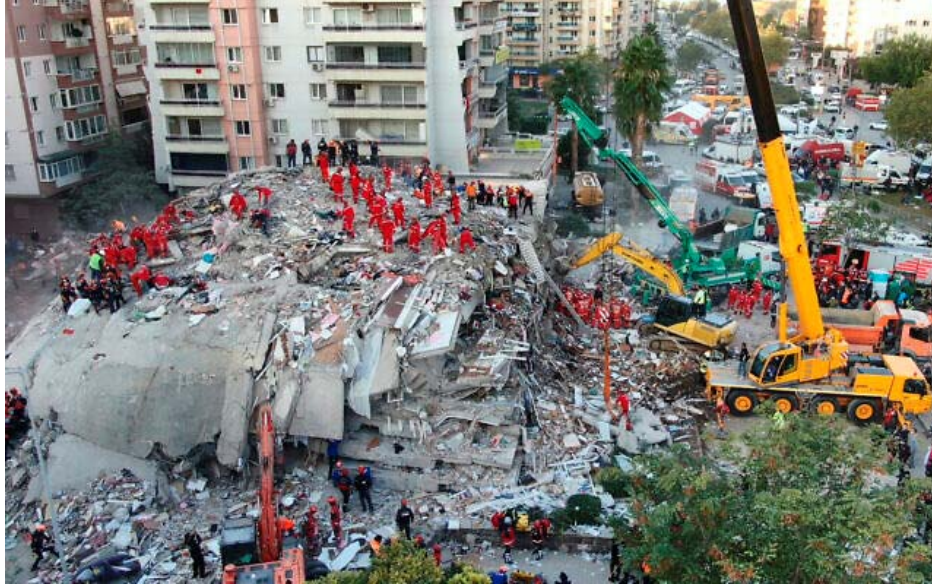
However, even these unusually amplified and prolonged seismic demand, was below the design basis response spectra. The recent event is not classified as a design basis event, but more of a 72 year return period event, and is not expected to cause structural damage, not to mention hundreds of collapsed or heavily damaged buildings, one of which is shown in Figure 4.15. There, poor structural design and detailing, along with construction practices come into the picture, which are discussed thoroughly in Chapter 7.

Figure 4.15. Doganlar residential building, fully collapsed after the event (courtesy of Ali Aksoyer)

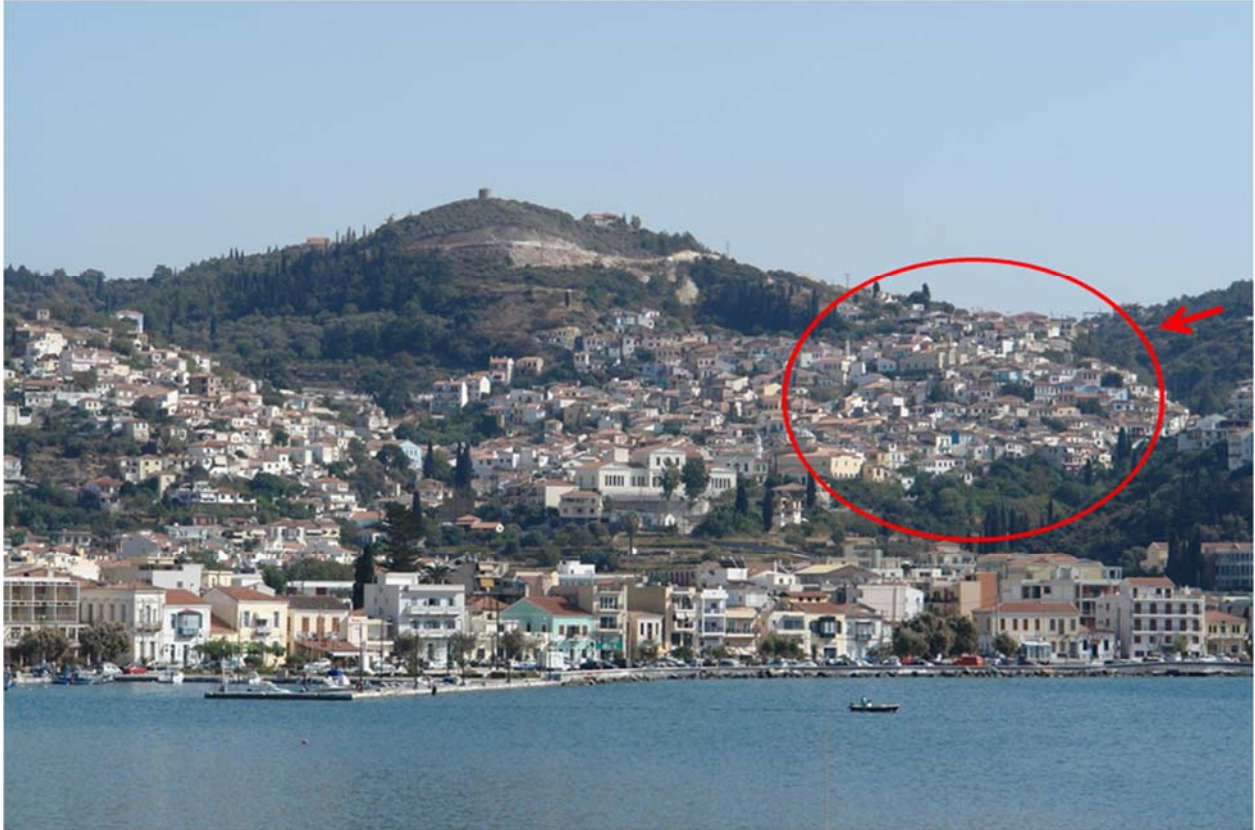
Although located only about 10 km from the ruptured area (22 km away from the epicenter), in the near fault zone, the seaside town of Vathy (Figure 4.16, from Google Earth) at the northeastern part of the island was rather lightly affected by the earthquake. Despite the tragic death of 2 high school students in Vathy, the collapsed or heavily damaged buildings were relatively few considering the magnitude of the event and the proximity to the source. Figure 4.17 shows the area of concentrated damage in the Ano Vathy district.

Figure 4.17. Ano Vathy hill (at the southeastern side of Vathy) highlighting the area of potential topographic and valley effects (Photo by Christos Giarlelis, HAEE Team).

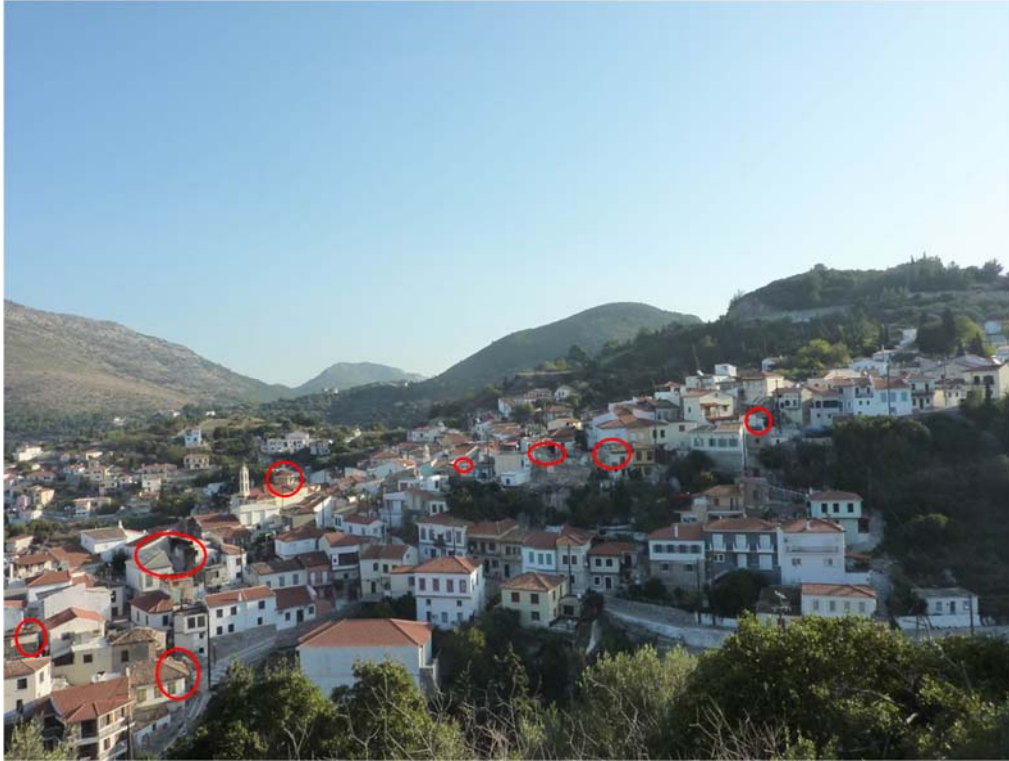
The reconnaissance efforts in the greater area of Vathy depicted a concentration of damage in the low-rise buildings of Ano Vathy, an area of about 0.1 km² resting in the southeastern side of Vathy (at a distance of 600 to 1000 m from the coastline), at an elevated location (altitude ranging from 50 to 120 m). The building stock includes several structures dating from the 19th (possibly even the 18th) century, built at a high elevation to protect the inhabitants from pirates. Examples of the observed damage are depicted in Figure 4.21 and Figure 4.22.

Figure 4.21. Ano Vathy hill: Red circles denote damaged buildings. (Photo by Christos Giarlelis, HAEE/ETAM Team).

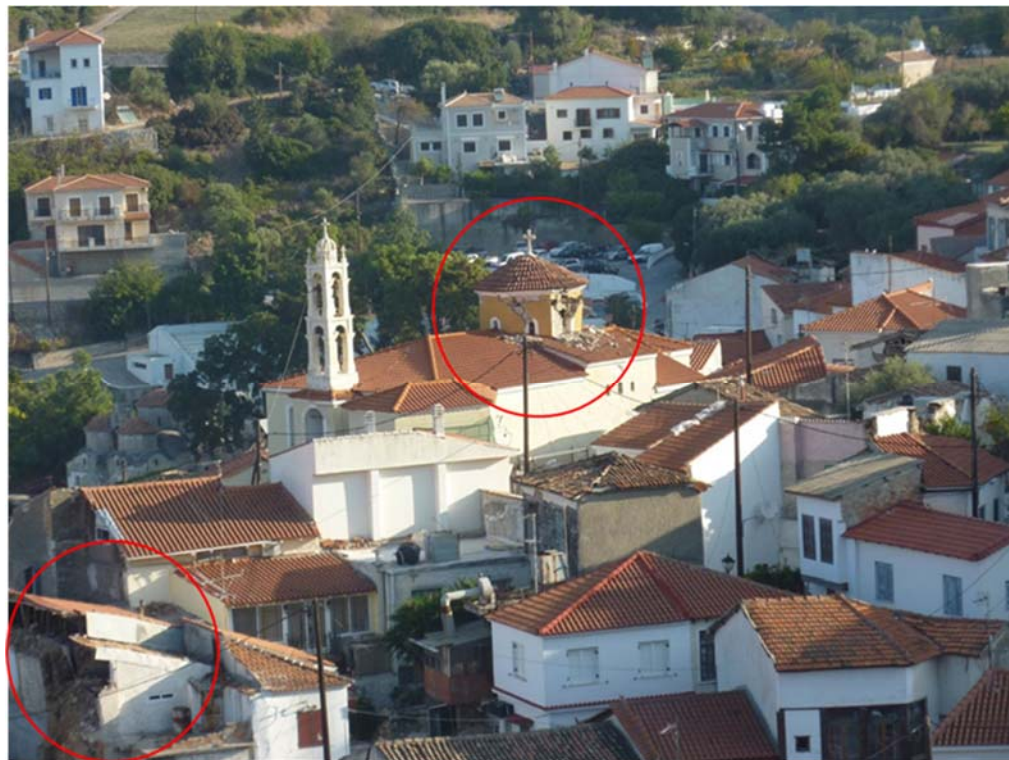
Figure 4.22. Ano Vathy: Close view of the damaged dome of the Church of Metamorphosi Sotiros and neighboring building. (Photo by Christos Giarlelis, HAEE/ETAM Team).
