Seismological and Engineering Effects of the M 7.0 Samos Island (Aegean Sea) Earthquake

Hellenic Association of Earthquake Engineering: Report 2020/02

Geotechnical Extreme Events Reconnaissance Association: Report GEER-069

December 31, 2020

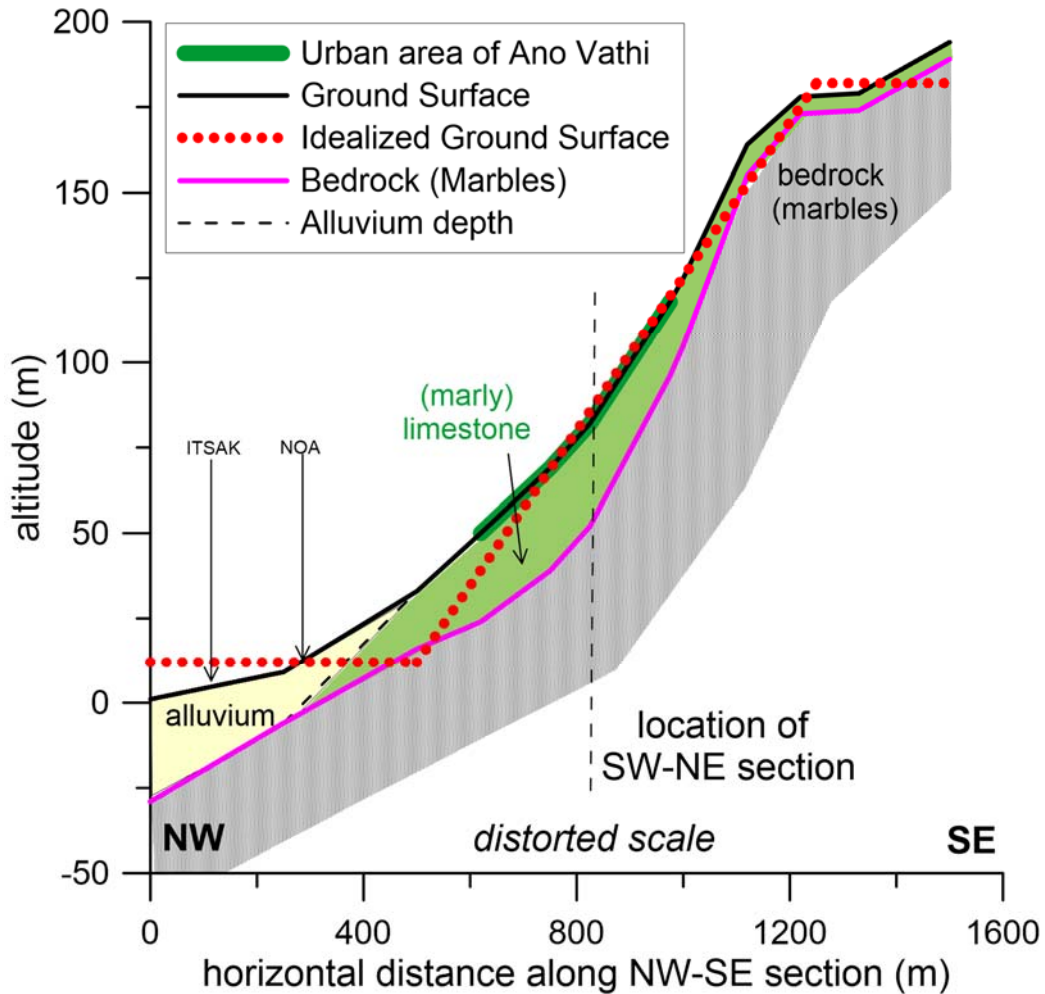
This type of ground surface topography may be marginally considered a cause of increased seismic ground motion at Ano Vathy. Specifically, according to EC8, this is possible for slopes having a height $H > 30$ m, as that shown in Figure 4.25. However, the same code prescribes that topography effects may be neglected if the inclination angle is $i < 15^\circ$. Disregarding this notion, EC8 also mentions that for ridges with crest width significantly less than the base width, a

topography factor $S > 1.2$ should be used near the top of the slopes with angles $i < 30^\circ$ (as this one). Furthermore, this S factor may be assumed to decrease as a linear function of height above the base of the cliff or ridge, and to become unity at the base. Hence, for the Ano Vathy area a factor of $S = 1.1$ may be assumed, as the average of $S = 1.2$ at $H = 170$ m and $S = 1$ at the base, given that it is located at mid-height of the slope.

Figure 4.25. Ground surface elevation and approximate geological cross section along the NW-SE section running through the damaged area of Ano Vathy. Average (idealized) inclination is 13° .

From another point of view, one may estimate the topographic amplification on the basis of the approximate relations of Bouckovalas and Papadimitriou (2005). Considering the seismic excitation as having a predominant period of $T_e = 0.5$ sec (on the basis of the 2 recordings at Vathy), and by assuming that the inclined ground has an average shear wave velocity of V_s (m/s) = 500 (near the weathered surface of the marly limestone) to significantly more than 800 (marble bedrock) but a relatively small damping ratio ($\xi = 2\%$), the idealized cross section with $H = 170$ m and $i = 13^\circ$ shown in Figure 4.25 is expected to be characterized by $S = 1.16$ at its crest. Therefore, for the Ano Vathy area that lies at the mid-height of the slope, the $S = 1.08$, on average, which is

in good agreement with the EC8 provision. On top of this, Bouckovalas and Papadimitriou (2005) prescribe parasitic vertical accelerations whose peak values are in the order of 14-20% of the horizontal acceleration. This vertical acceleration has the low-frequency content of the horizontal motion and is considered additionally to the vertical acceleration of the earthquake itself, which has a high frequency content (predominant period of 0.1 s). This parasitic vertical acceleration is disregarded by EC8.

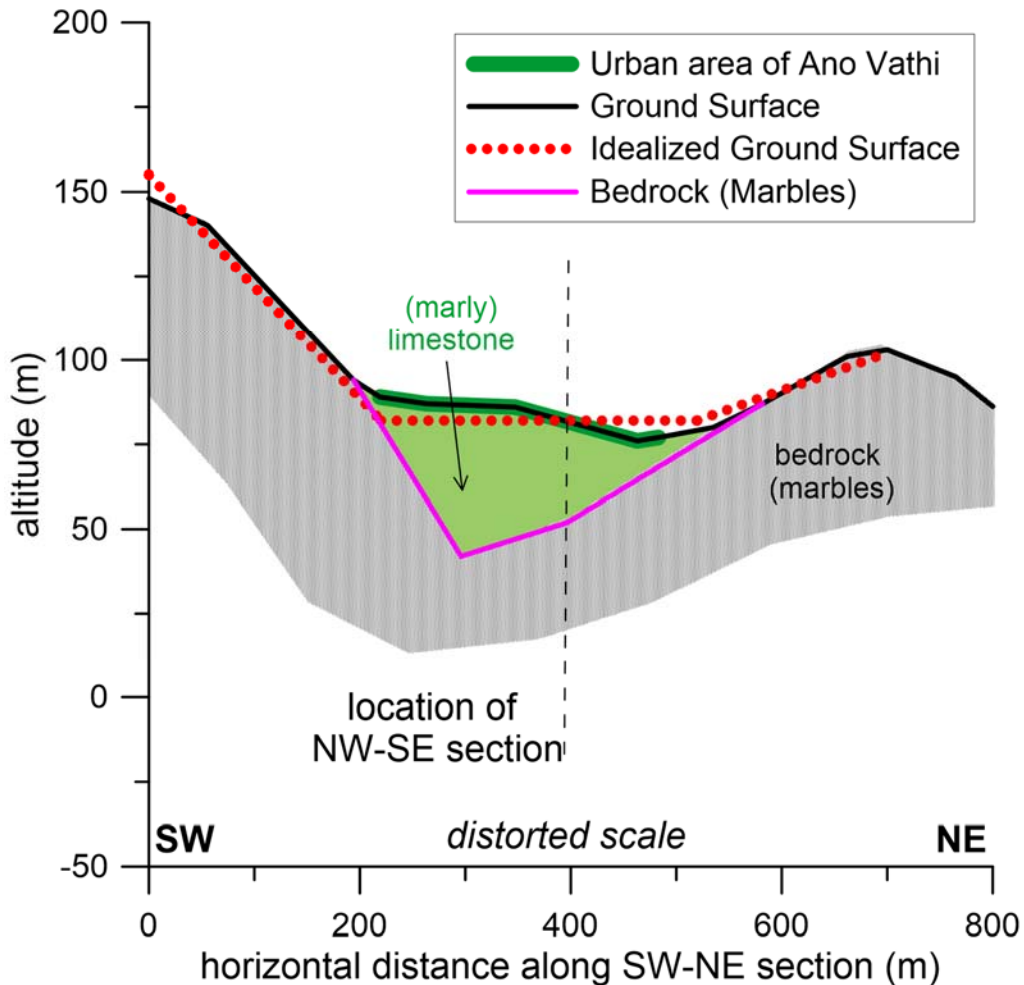
Figure 4.26. Ground surface elevation and approximate geological cross section along the SW-NE section running through the damaged area of Ano Vathy.

Figure 4.26 shows the ground surface elevation as well as the (approximate) geological layers that are to be found along the SW-NE cross section running through the urban area of Ano Vathy (see location in Figure 24). This figure also includes an idealization of the ground surface, which shows that Ano Vathy sits roughly at the top of an (approximately triangular) valley with surface width $B = 300$ m and maximum thickness $H = 40$ m at the location where the probable or covered geological fault (with a NNW-SSE direction) lies (see also Figure 4.24) at the western side of Ano Vathy. This western side of Ano Vathy exhibits the steepest bedrock inclination ($i = 28^\circ$) and

In this cross section, (ground surface) topography effects alone give negligible amplification at Ano Vathy, since it lies at the base of the canyon shaped topography where seismic strong motion is generally not significantly amplified (Papadimitriou 2019). However, the valley-shaped stratigraphy of the underlying layers may be considered a cause of increased seismic ground motion at Ano Vathy, concurrently with that due to surface topography effects that was depicted along the NW-SE direction (see Figure 4.25). It may be assumed here that the role of “soft” soil should be attributed to the marly limestone with a $V_s > 500$ m/s, that overlies the bedrock (marbles with $V_s > 800$ m/s), and consequently this valley-shaped structure is not expected to have an intense impedance contrast. Unfortunately, there are no code provisions for valley effects on seismic ground motion and any approximate estimation may only be based on the literature. For example, according to Vessia et al. (2011), this valley has a thickness over half-width shape ratio $SR = 40/(300/2) = 0.27$ (intermediate-depth valley), leading to an amplification of at least 35%, on top of ordinary 1D soil amplification. In this case, this value should be considered an upper limit, since the valley material is not soft alluvium and the horizontal acceleration has a low frequency content (predominant period 0.5 sec), thus increasing the predominant shear wavelength to values comparable with the valley width and much larger than the valley thickness (Papadimitriou 2019). However, the aforementioned 35% amplification may be considered an appropriate value if one also considers any 1D soil amplification (Ground Category B as per EC8), as well as the enhanced amplification effect due to the outcropping bedrock slopes (Papadimitriou 2019). This is especially so at its western side where the bedrock slopes are relatively tall (73m). In addition, this valley configuration may have also created low frequency (predominant period 0.5 sec) parasitic vertical accelerations, that should be in the order of 10% of the horizontal acceleration (Papadimitriou et al. 2018).

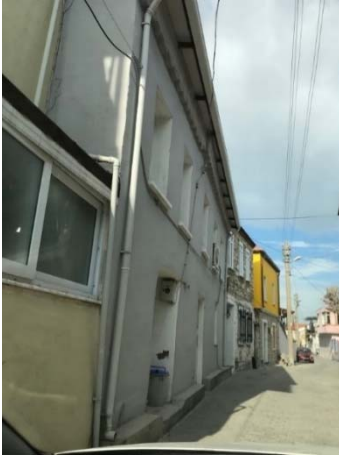
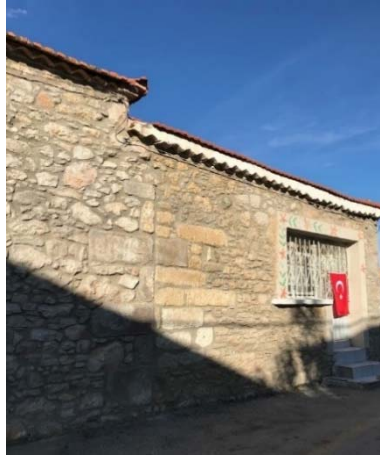
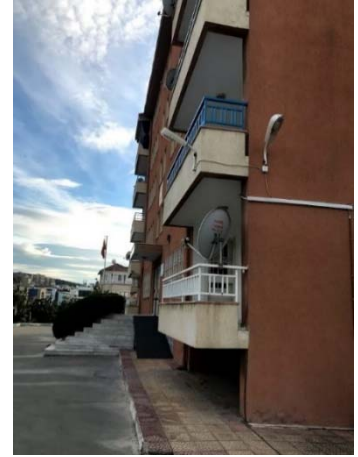
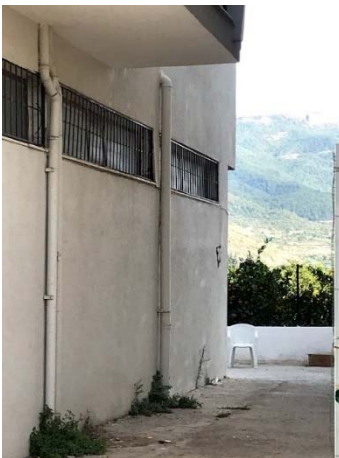
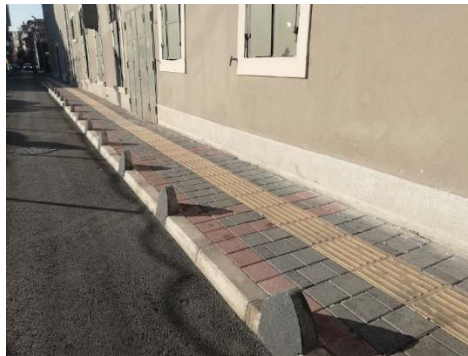
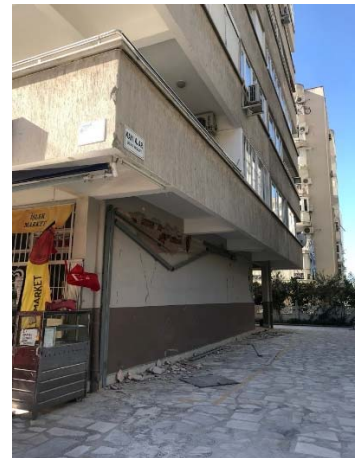
Many residential buildings have been investigated in the center of Urla, Cesme, Kusadasi, Gumuldur, Izmir-Konak, Izmir-Bayrakli regions, which are further detailed in Chapter 7. In this chapter, the foundation performances of these residential structures will be discussed. Among them, no foundation-induced failures, evident by excessive total or differential settlement or tilting, or bearing capacity exceedance, were mapped. A sample set of pictures illustrating these satisfactory foundation performances, is shown in Figures 5.2 (a) through (f).

Figure 5.2. Illustrative pictures of satisfactory foundation performances after the event

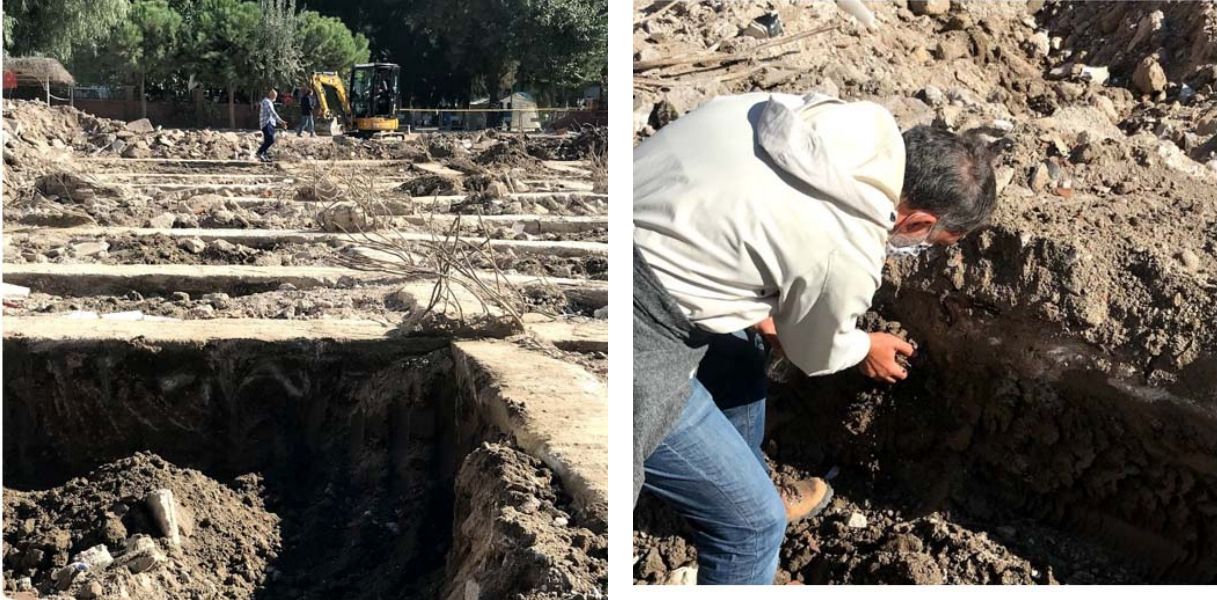
Moreover, no foundation-induced structural failure mechanisms were observed or reported for the collapsed or heavily damaged buildings in Bayrakli and Bornova districts. For residential structures up to 7-9 stories, foundation systems were mostly selected as two-way combined footings or individual footings with strap beams. Mat foundations are not very commonly used

Figure 5.3. Two-way combined footing system of a heavily damaged building in Bayrakli

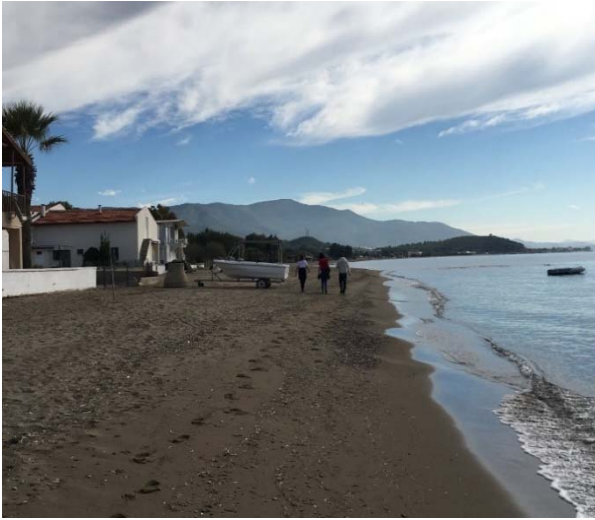
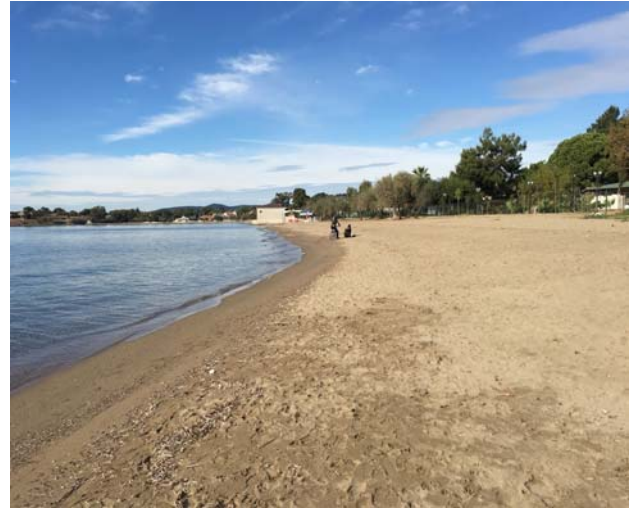
Figure 5.7. No seismically-induced soil liquefaction manifestation was observed at the shores of Gumuldur city ($38^{\circ}04'30.9''\text{N}$ $26^{\circ}58'32.7''\text{E}$ / November 3rd 2020/ 11:03)

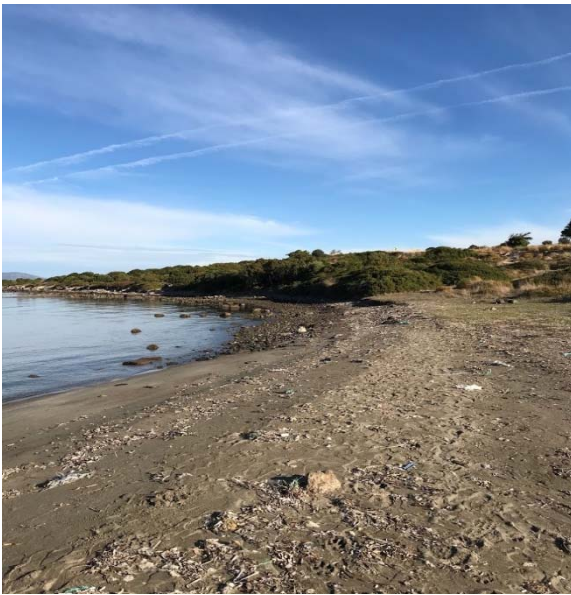
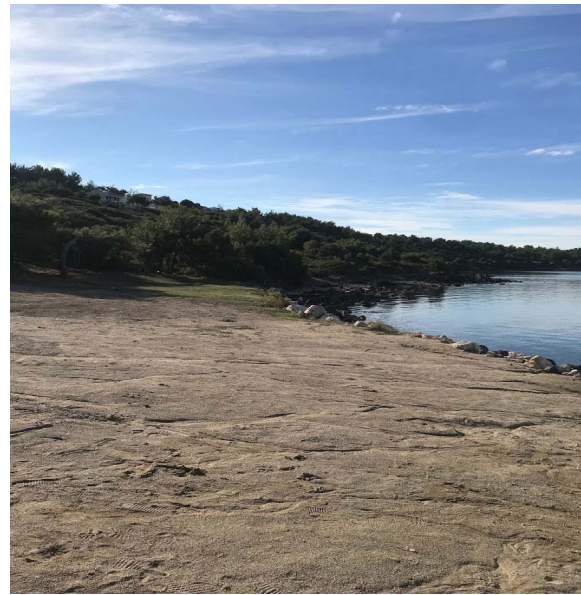
Figure 5.8. No seismically-induced soil liquefaction manifestation was observed at the shores of Cesme ($38^{\circ}20'54.5''\text{N}$ $26^{\circ}27'07.6''\text{E}$ / November 3rd 2020 / 09:54)

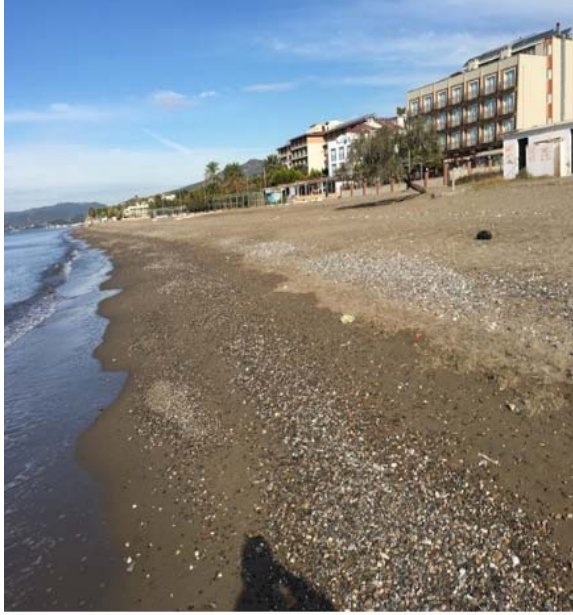
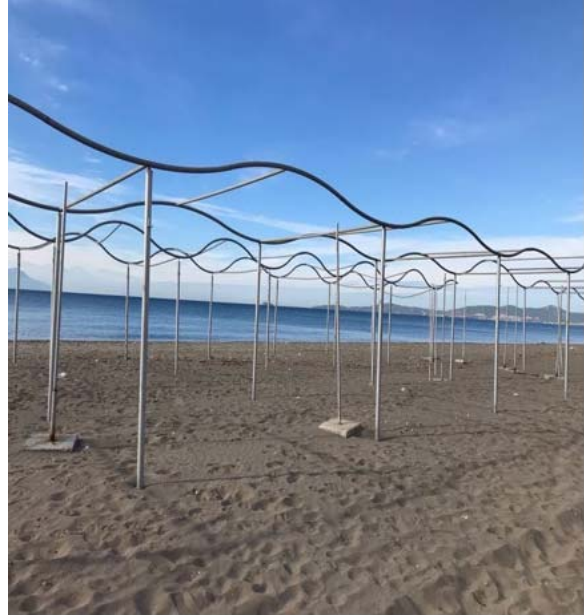
Figure 5.9. No ground failure was observed at the shores of Gumuldur city ($38^{\circ}03'30.6''\text{N } 27^{\circ}00'38.3''\text{E}$ / November 3rd 2020/ 10:30)

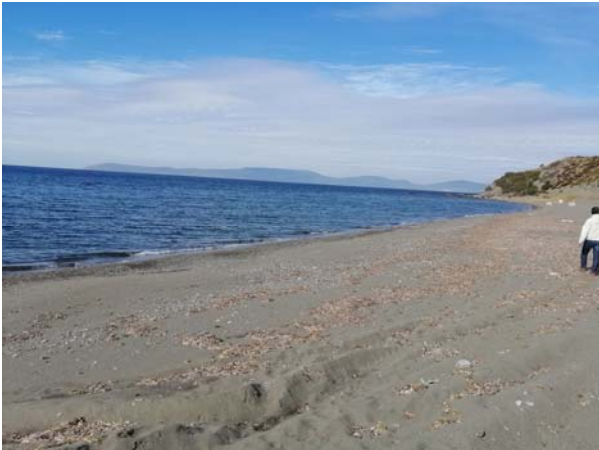
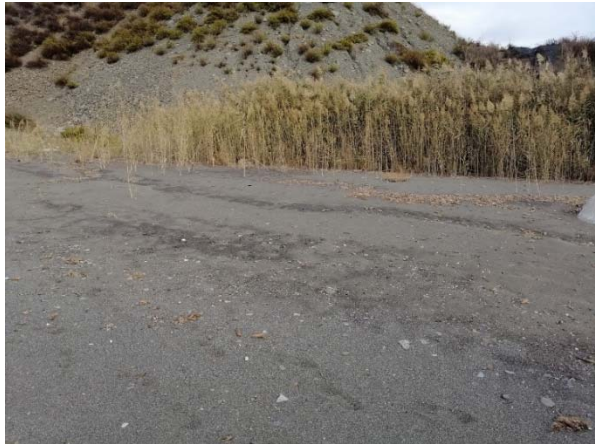
Figure 5.10. No liquefaction manifestation was observed on the shore of the Seferihisar district ($38^{\circ}05'11.5''\text{N } 26^{\circ}51'39.7''\text{E}$ / November 3rd 2020/ 11:31)

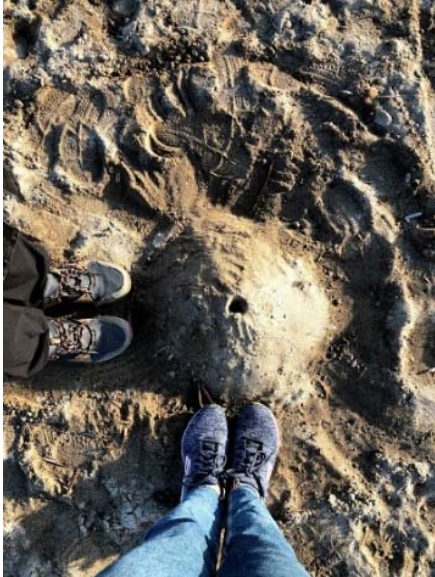
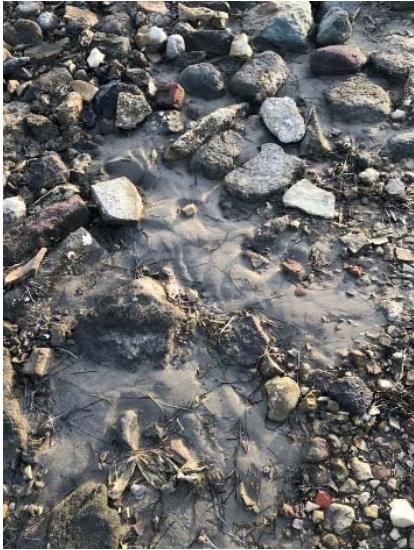
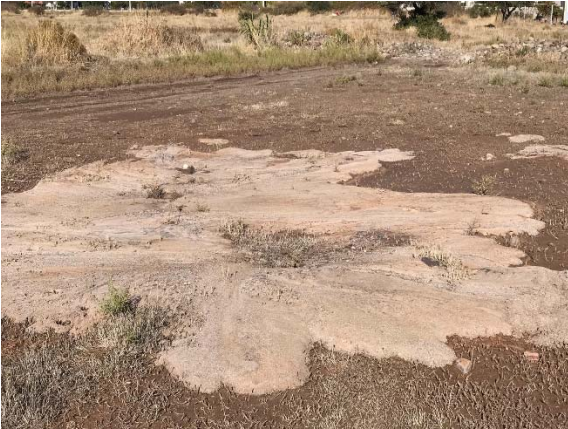
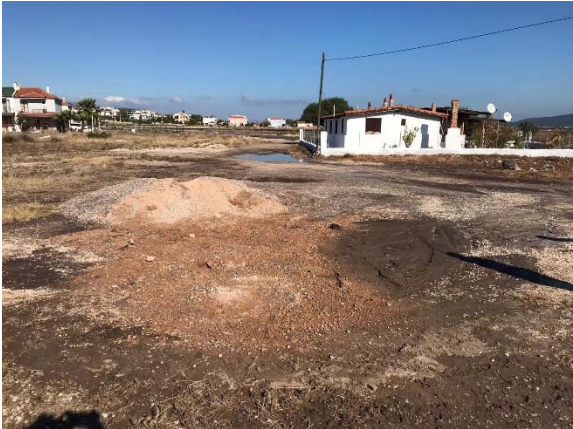
Consistent with USGS predictions, at 45-50 km away from the rupture, along the shores of Icmeler and Gulbahce districts, sand boils were observed, as shown in Figure 5.11 (a) through (d). These sites were close to Gulbahce fault zone, and artesian pressures along with hot water springs are known to be present, which are also believed to have contributed to the observed

Figure 5.11. Surface manifestations of earthquake-induced soil liquefaction in the form of sand boils at a) $38^{\circ}20'18.4''N$ $26^{\circ}38'51.0''E$ and b) $38^{\circ}18'37.3''N$ $26^{\circ}40'47.1''E$, c) and d) 38.338088 N, $26.647763E$

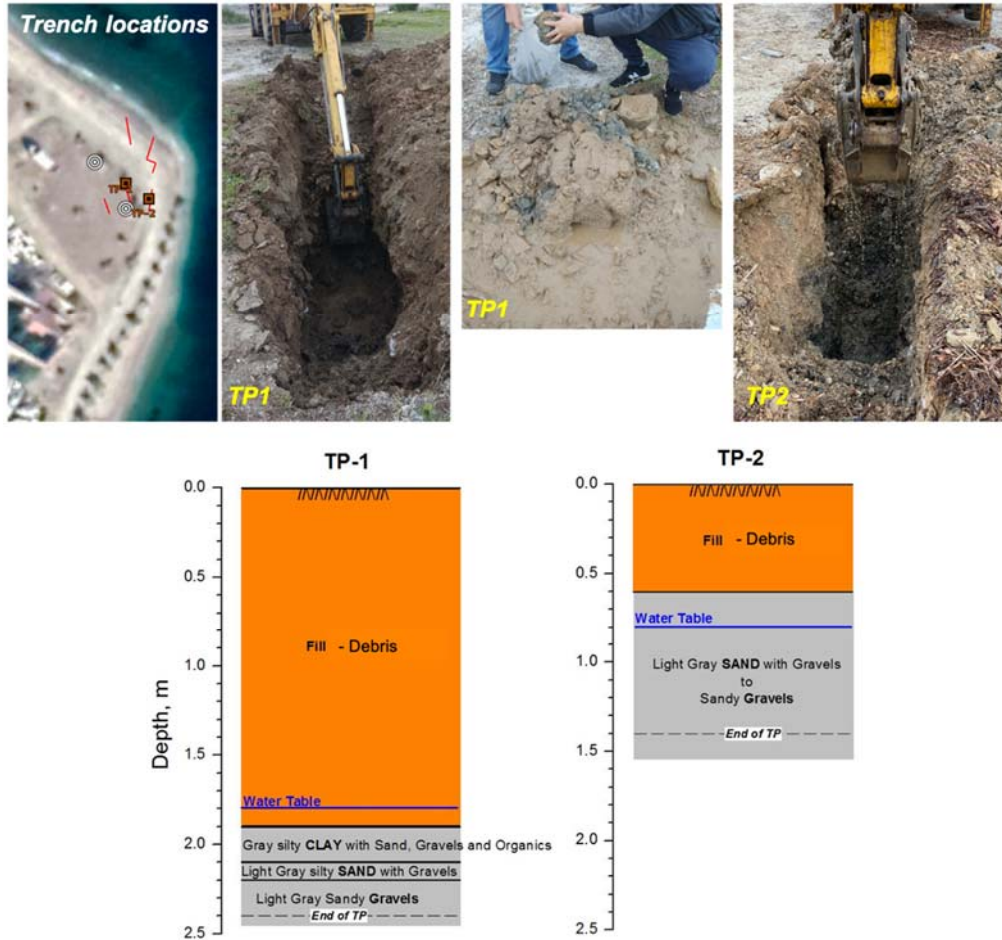
Professor Panagiotis Pelekis performed trenching and soil sampling at two locations at the Malagari site, which yielded two rough cross-sections and three grain size distributions for samples at three distinct depth intervals at the site illustrated in Figures 5.15 and 5.16 respectively. The fines portion in all three samples was found to be non-plastic.

Figure 5.15. Trenching at the Malagari liquefaction site and rough stratigraphy resulting from it (courtesy of Professor P. Pelekis).

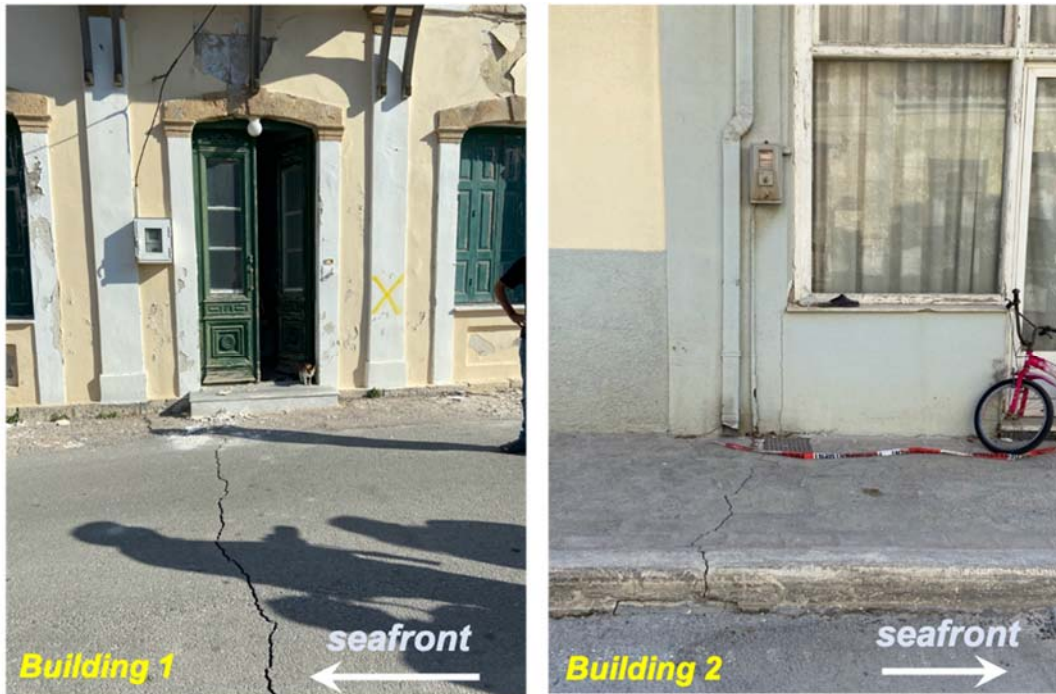
Structural damages at some nearshore locations were compatible with a lateral spreading failure mechanism. Specifically, Figures 5.18 and 5.19 illustrate three buildings and their location close to the north shore of the island, in the neighborhood Vyrsolepsia in Karlovasi. No surface manifestation of liquefaction was identified nearby, but the ground cracking crossing the street pavement and running through the buildings (the two in Figure 5.18 are about 70 m inland and the one in Figure 5.19 is about 20 m inland), in combination with the level/mildly sloping ground, the shallow water table, and the free face to the sea are all compatible with the hypothesis of lateral spreading.

Figure 5.20. Buildings likely affected by lateral spreading towards the seafrent in the neighborhood of Vyrsopepsia in Karlovasi (left: $37^{\circ}47'57.6''N$ $26^{\circ}42'12.5''E$ and right: $37^{\circ}47'59.3''N$ $26^{\circ}42'20.0''E$) [photos taken by the HAEE reconnaissance team]

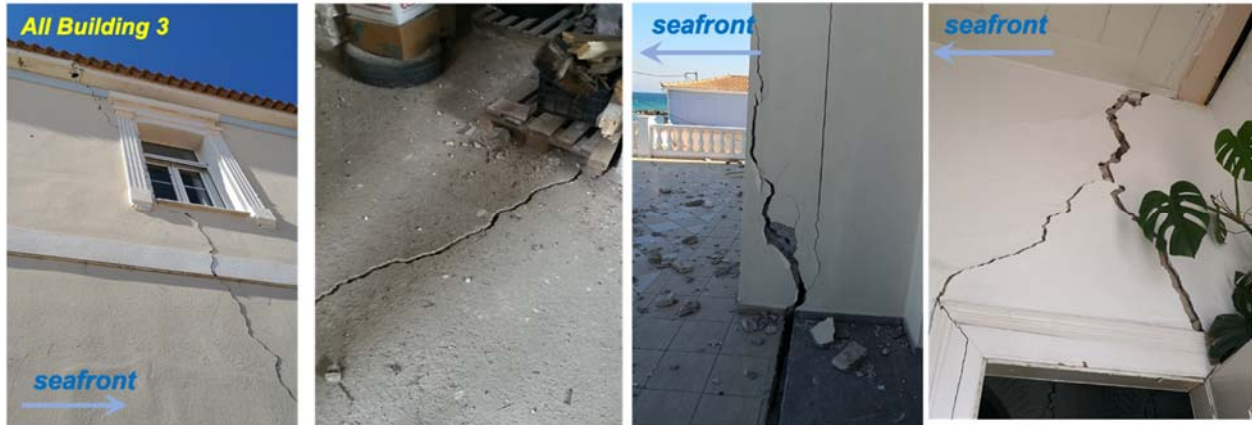
Figure 5.21. Building affected by lateral spreading towards the seafront in the neighborhood of Vyrsopepsia in Karlovasi ($37^{\circ}48'01.1''\text{N}$ $26^{\circ}42'20.6''\text{E}$). The cracks observed running across the building indicate 3-5cm of movement. [Photos courtesy of Prof. K. Antonopoulos]

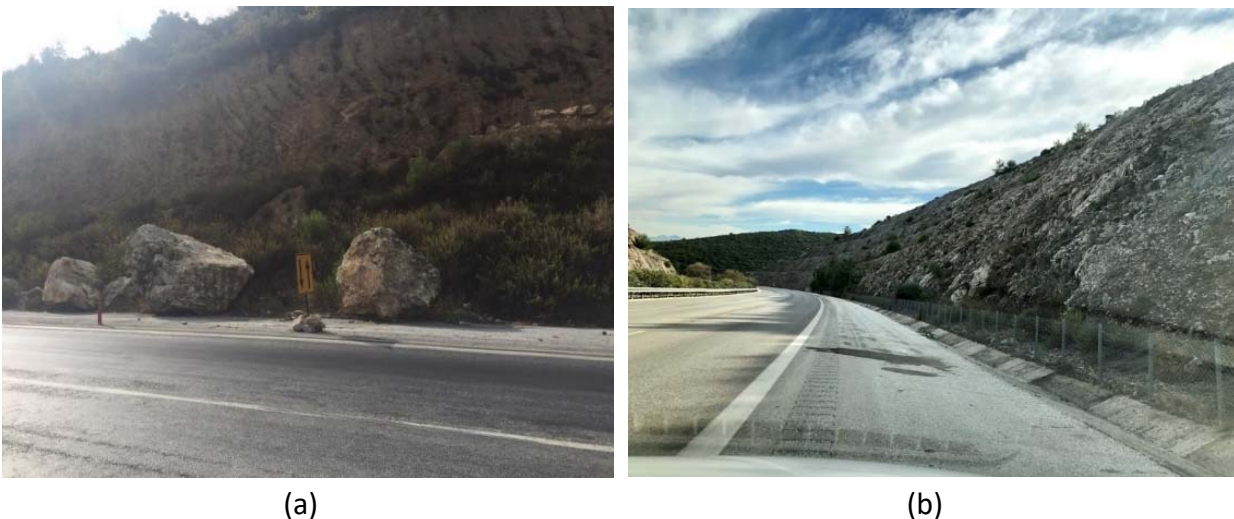
A limited number of rockfalls were observed by the benches of highways, one of which is illustrated in Figure 5.22. Some potential and existing landslide sites were also visited, but no signs of seismically induced movements were documented, one of which is shown in Figure 5.22 (b).

Figure 5.22. a) Fallen rock blocks ($37^{\circ}53'50.4''\text{N}$ $27^{\circ}22'06.2''\text{E}$, b) A view from a highway cut with potential for slope instability ($38^{\circ}17'31.6''\text{N}$ $26^{\circ}40'14.6''\text{E}$)

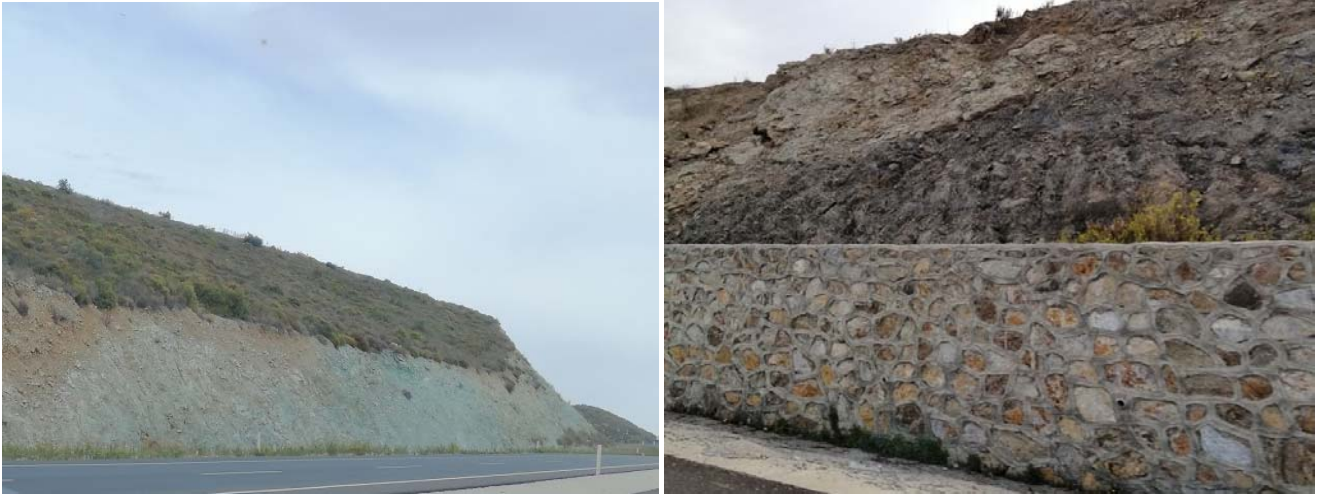
The highways were also investigated; no proof of any seismically induced damage both on the highways or on the shoulder slopes was found, as shown in Figure 5.23.

Figure 5.23. Views from a highway cuts with no signs of slope instability ($38^{\circ}17'31.6''N$ $26^{\circ}40'14.6''E$)

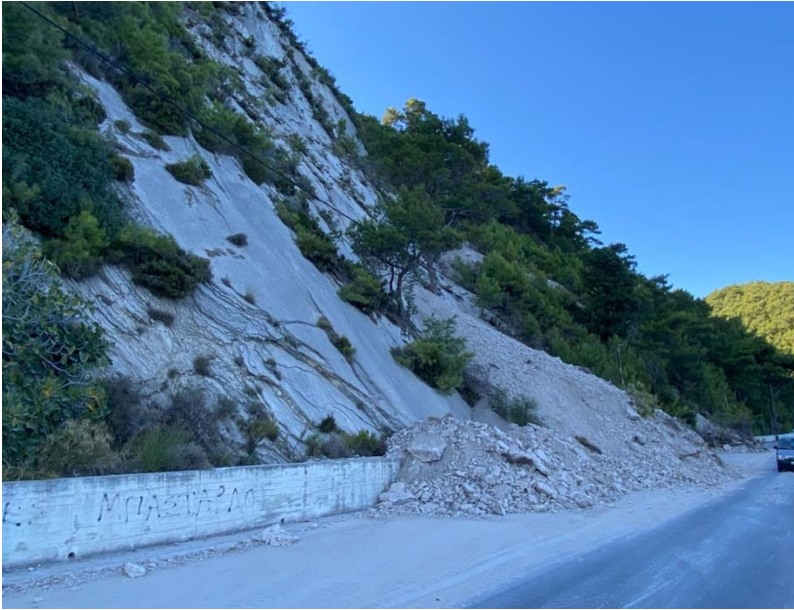
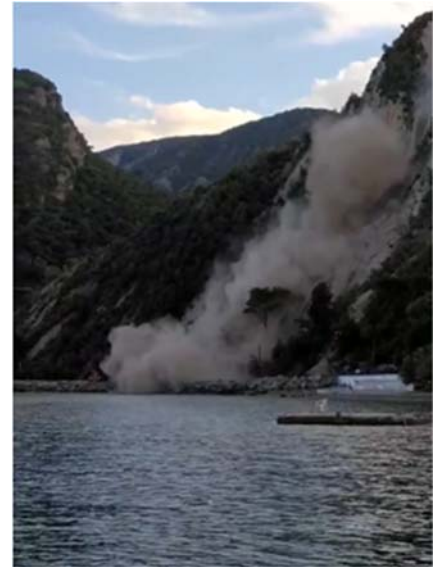
A weathered rock slide was recorded at a steep slope close to Avlakia region (Figure 5.25), which caused a temporary closure of the road. It is reiterated that the main geological formations in the above area are marbles with intercalations of schist (see Chapter 4). However, the road access was quickly recovered after a few days by temporary restraining measures with large concrete blocks placed at the slope toe (Lekkas et al. 2020). Detachments of sandy marls and marly limestones were recorded very close to a residential building in Kokkari region (Figure 5.26), while lighter failures referring to rockfalls and detachments of limestones, were observed close to the villages Potami (Figure 5.27 – left) and Koumeika (Figure 5.27 – right). Slope failures of similarly low intensity were also recorded by other reconnaissance teams. These include limestone segments falls at the area of Remataki (next to Pythagorio – Figure 5.28) or rockfalls close to the village Stavrinides (Figure 5.29).

Figure 5.25. Up: A rock slide close to Avlakia region (aerial photograph courtesy of I.N. Spyrou and Prof. K. Ziotopoulou – *to not be reproduced without permission from Prof. Ziotopoulou, 37°47'48.0"N, 26°51'27.7"E*), Bottom – left: a closer view of the above rockslide reported illustrating the rock formation more clearly (picture by HAEE reconnaissance team), Bottom – right: Snapshot from a video recorded during the failure (source: <https://www.cnn.gr/ellada/story/240726/seismos-samos-vinteo-apo-katolisthisi-sta-aylakia>)

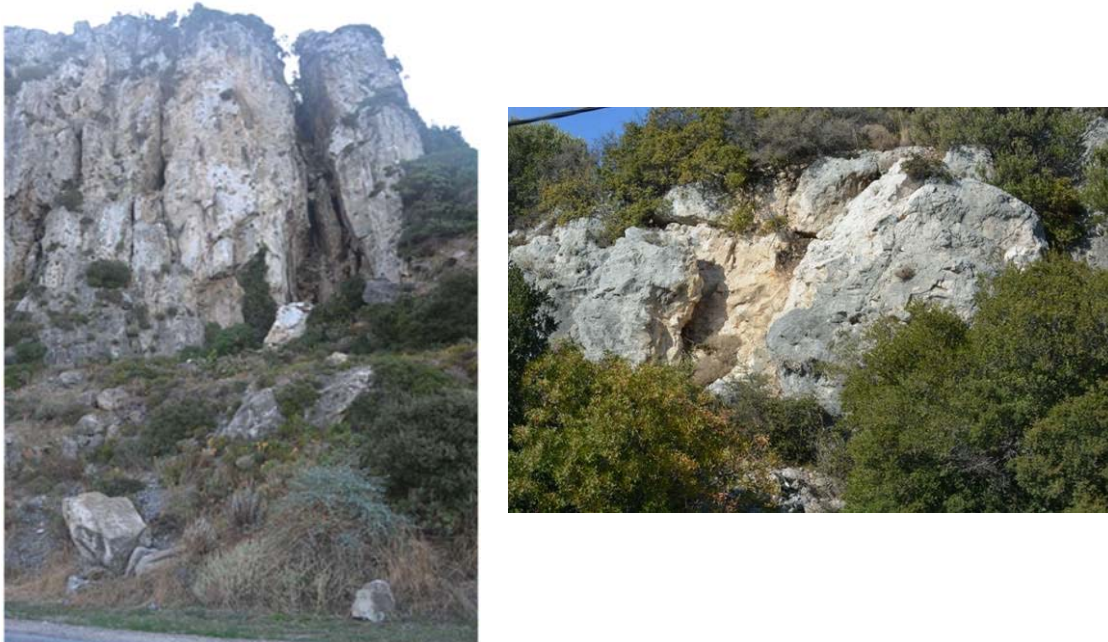
Figure 5.27. Left: Rockfalls recorded at the road network close to the village Potami ($37^{\circ}47'17.6''\text{N}$, $26^{\circ}40'00.5''\text{E}$), Right: Detachment of limestone segments close to the village Koumeika (photos taken by the HAAE reconnaissance team, $37^{\circ}42'33.7''\text{N}$, $26^{\circ}44'52.9''\text{E}$).

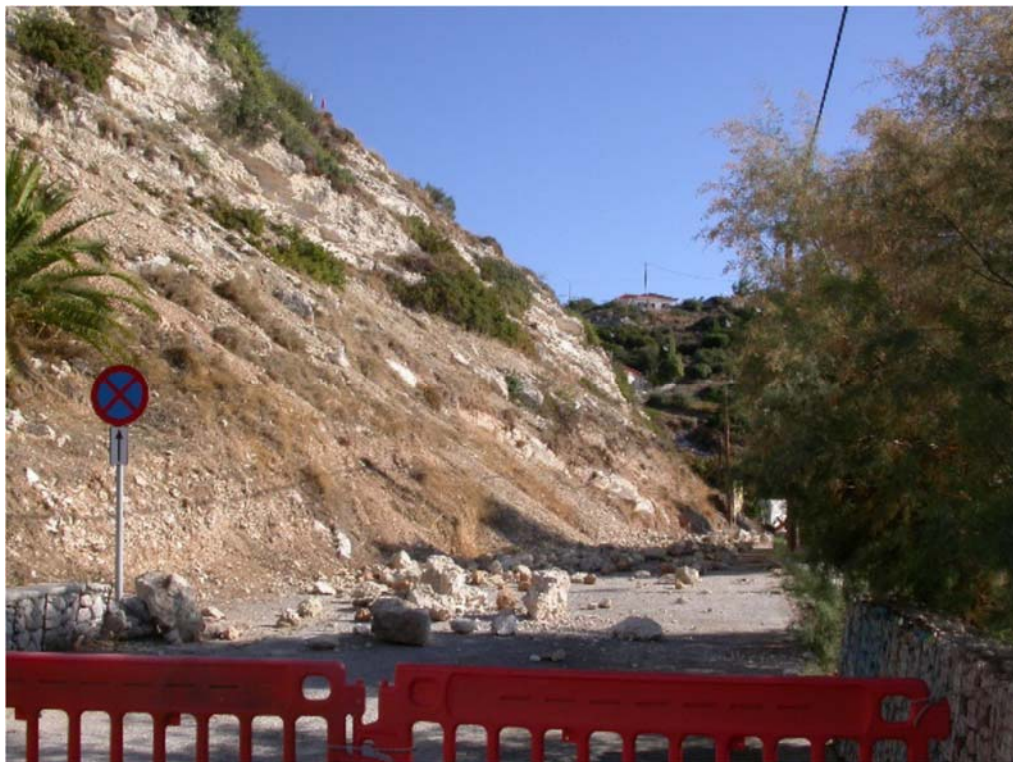
Figure 5.28. Limestone segments falls to a provincial road in Remataki region (photo reported in Lekkas et al. 2020).

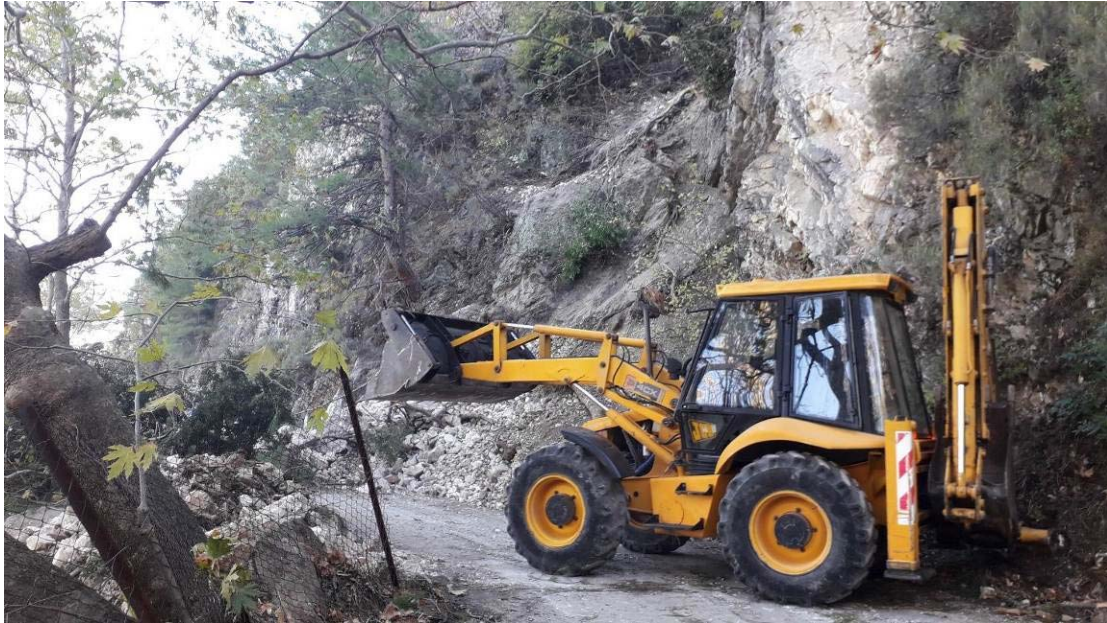
Figure 5.29. Slope failures close to the village Stavrinides (photo reported in HSGME 2020).

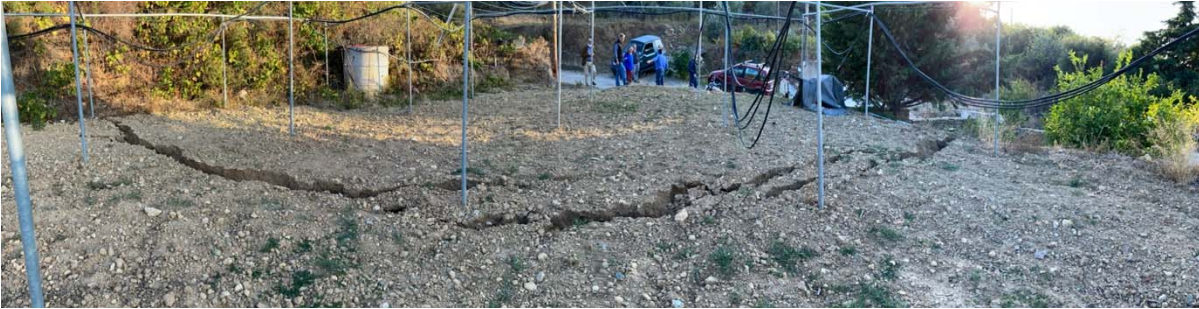
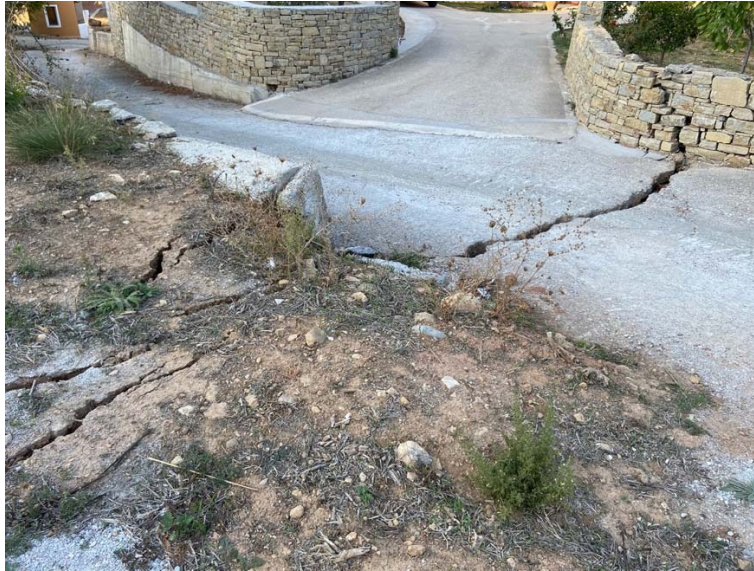
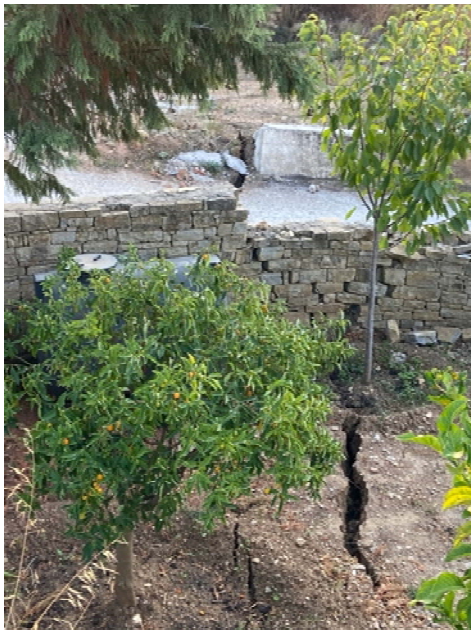
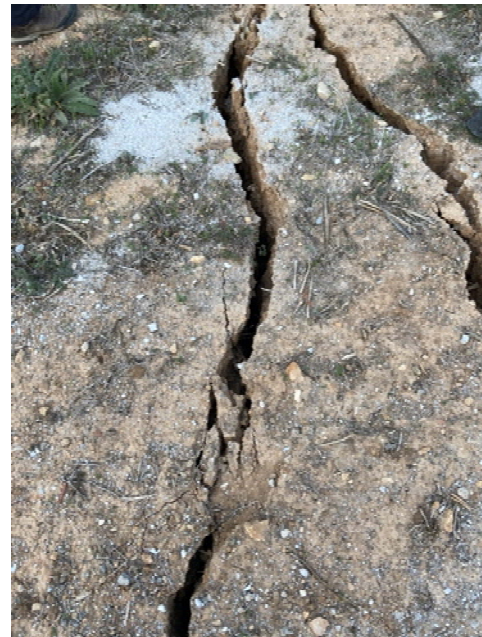
In the village of Kontakeika, extended ground cracks (openings of about 10 – 20 cm) were observed that were compatible with the mobilization of a larger, albeit very mild, slope or could be more broadly characterized as seismically-induced secondary ground failures. The HAEE team did not locate other similar indications of ground cracking in the near or extended vicinity of Kontakeika so it is hard to draw conclusions regarding the nature of this observation. (According to local engineers, the Municipality of Samos had repaired the pavement in that particular location several times in the past, which suggests a pre-existing creeping landslide that got reactivated by the earthquake.) The cracks were extending from soft soil formations, crossing the street and extending to soil formations across.

Figure 5.30. Ground and pavement cracks in the village of Kontakeika (Samos), indicative of the mobilization of an extended but mild slope or more broadly characterized as seismically-induced secondary ground failures. The cracks extended on both sides of the street through soft soil formations.

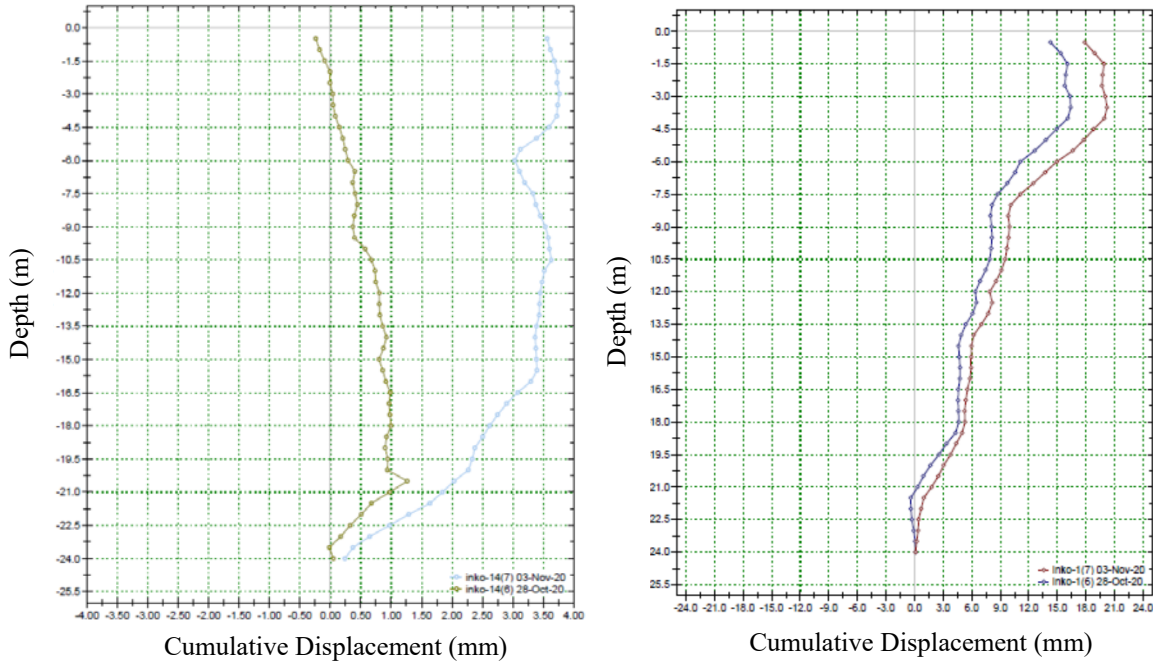
In the sedimentary district, two well-monitored deep excavation systems, which were under construction in the last three months before the earthquake, were shaken. Both of these systems reached a depth of about 9 m; their (satisfactory) performance was recorded by instruments. (Fig. 5.31). No failure or relaxation of pre-stressing loads on anchors was measured/observed. These observations are also supported by inclinometer measurements taken before and after the earthquake. The measurements suggest that the lateral displacements accumulated during the earthquake are less than 2 mm. These displacements are illustrated in Fig. 5.32.

Figure 5.32. Inclinometer data covering the period of earthquake shaking, at a 9m-deep excavation, supported by diaphragm walls.

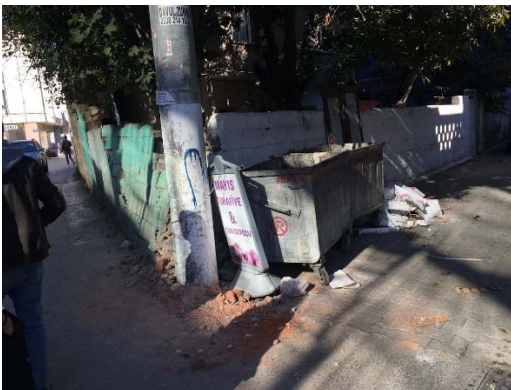
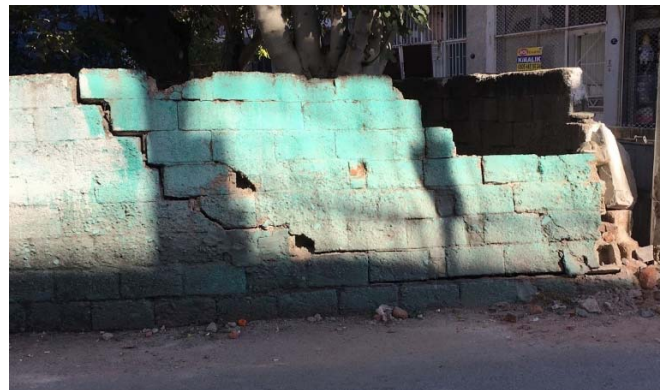
There are no reported failures of engineered retaining structures in Turkey. During the reconnaissance studies, a limited number of tilted and/or partially collapsed safety walls were observed, as documented in Figures 5.33 through 5.35.

Figure 5.33. No signs of soil liquefaction. Tilted and partially collapsed very poor safety walls (38°27'24.6"N 27°10'53.1"E/ 11:10/ 04.11.2020).

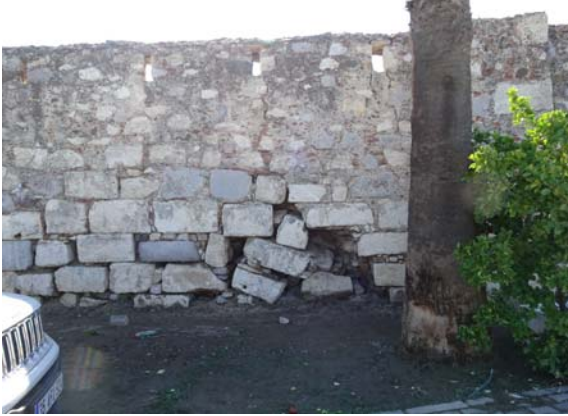
Figure 5.34. Deformed and cracked safety wall $38^{\circ}11'40.93''\text{N } 26^{\circ}47'3.47''\text{E} / 14:16 / 31.10.2020$

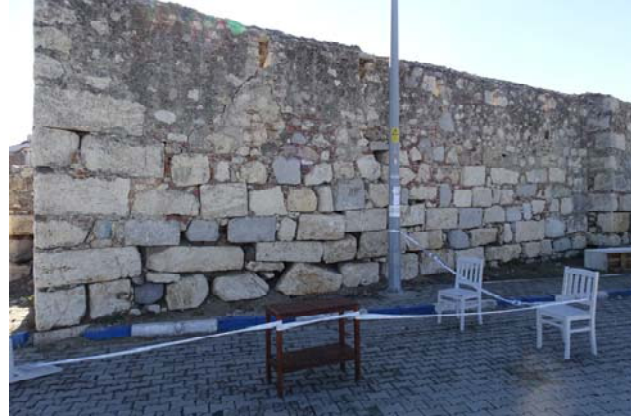
Figure 5.35. Deformed and cracked safety wall $38^{\circ}11'40.34''\text{N } 26^{\circ}47'3.22''\text{E} / 14:22 / 31.10.2020$

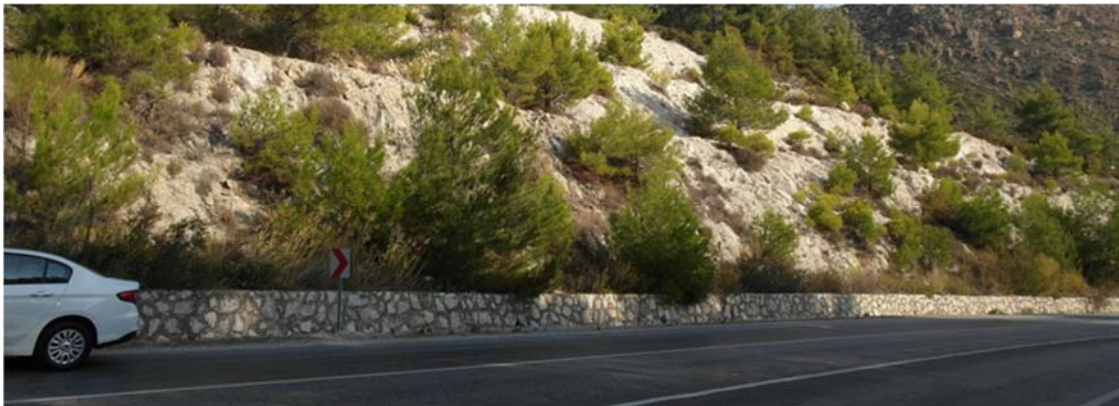
Additionally, no damage on retaining walls due to seismic shaking was likewise encountered during the reconnaissance inspections of the sites in the south of İzmir province, as shown in Figure 5.36. These stone walls are generally used to provide a buffer area between the cut slopes and highway to obstruct or retard the shallow failures to reach the highway. Regardless of the height of these stone walls, no seismically-induced deformations or failure was observed on the highway connecting Menderes to Gumuldur.

Figure 5.36. Short, stoned retaining walls on the toe of the highway cuts between Menderes and Gumuldur in the south of İzmir city center.

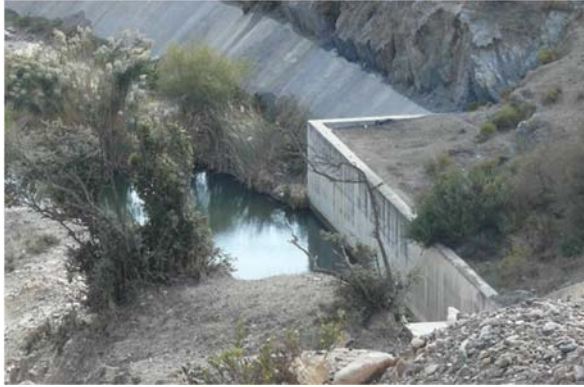
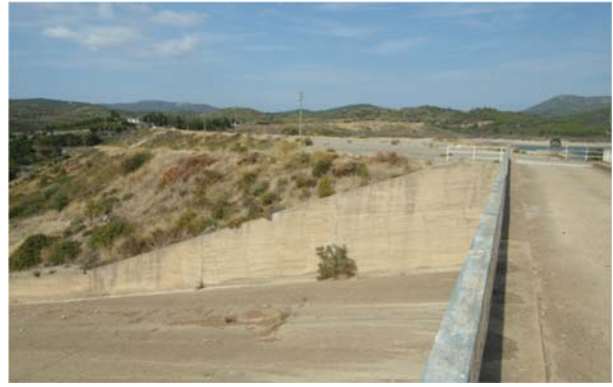
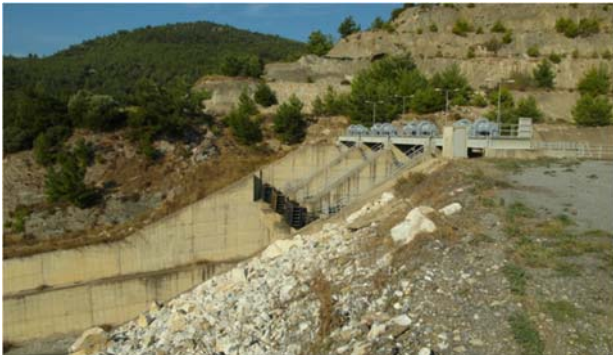
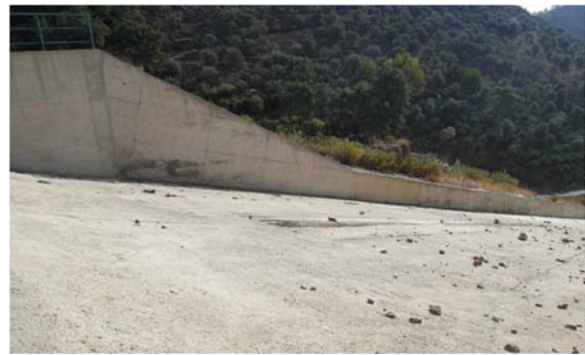
Figure 5.37 shows the sides of the spillway channels of the dams in the region. No sign of any structural damage was likewise observed on these walls.

Figure 5.37. (a) Wall on the end of spillway chute of Kavakdere Dam, and side walls of spillways of (b) Urkmez Dam, (c) Tahtalı Dam, and (d) Gumuldur Dam
