Seismological and Engineering Effects of the M 7.0 Samos Island (Aegean Sea) Earthquake

Hellenic Association of Earthquake Engineering: Report 2020/02

Geotechnical Extreme Events Reconnaissance Association: Report GEER-069

December 31, 2020

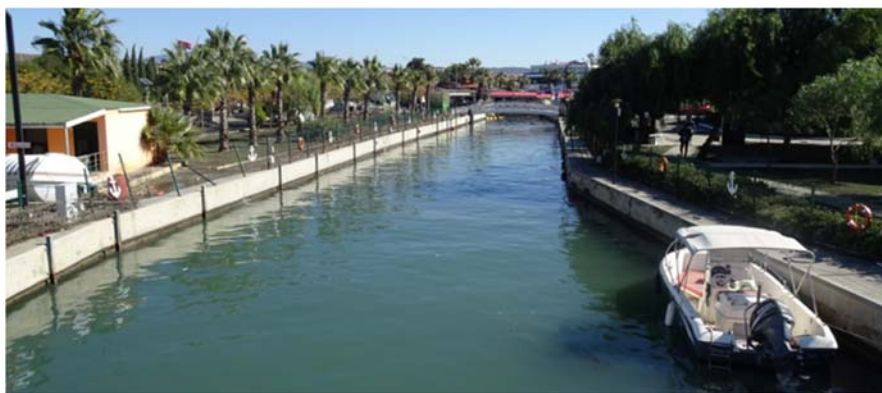
Figure 5.38 shows the sidewalls of the river canal in Sığacık Marina, hit by the tsunami after the earthquake. No structural distress can be observed on these walls, which suggests that the severity of shaking was modest despite its proximity to the rupture. Additionally, no signs of liquefaction or permanent deformations were reported.

Figure 5.38. Sidewalls of the river canal in the Sığacık Marina (Photo: Courtesy of Gurel Özdemir). (38°11'33.86"N 26°47'4.07"E 14:16 / 31.10.2020)

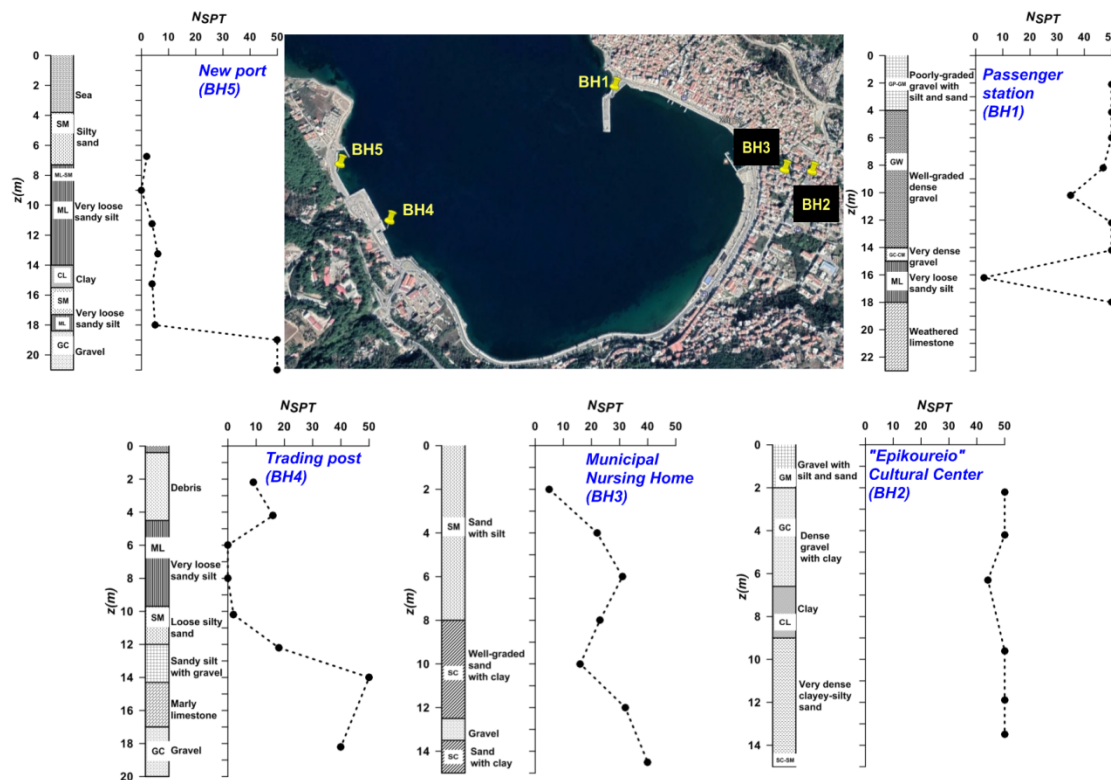
Although all boreholes have been drilled through the same alluvial deposits, there is a clear pattern that can be observed as one moves alongshore, from east (BH 1) to west (BH 4 and BH 5): If continuous, the layer of sandy silt or silty sand (ML-SM) emerges at shallower depths and also gets thicker (Fig. 5.41). However, given the distance between Vathy and Malagari as well as the relative depth and thickness of the ML-SM layer in each location, it is also possible that this is not the same layer across the sites. The associated SPT blow counts are extremely low (essentially zero), which indicates very low strength and high compliance. As the associated materials are non-plastic and saturated, this provides evidence of susceptibility to liquefaction.

Figure 5.41. Four geotechnical borehole logs (BH1, BH2, BH3, BH4) alongshore from the eastern (old) port to the western (new) port at Vathy (courtesy of G. Milionis – modified by Em. Rovithis). One offshore borehole (BH5) at the NW edge of the new port (kindly provided by the Ministry for the Environment, Physical Planning and Public Works of Greece – modified by Em. Rovithis).

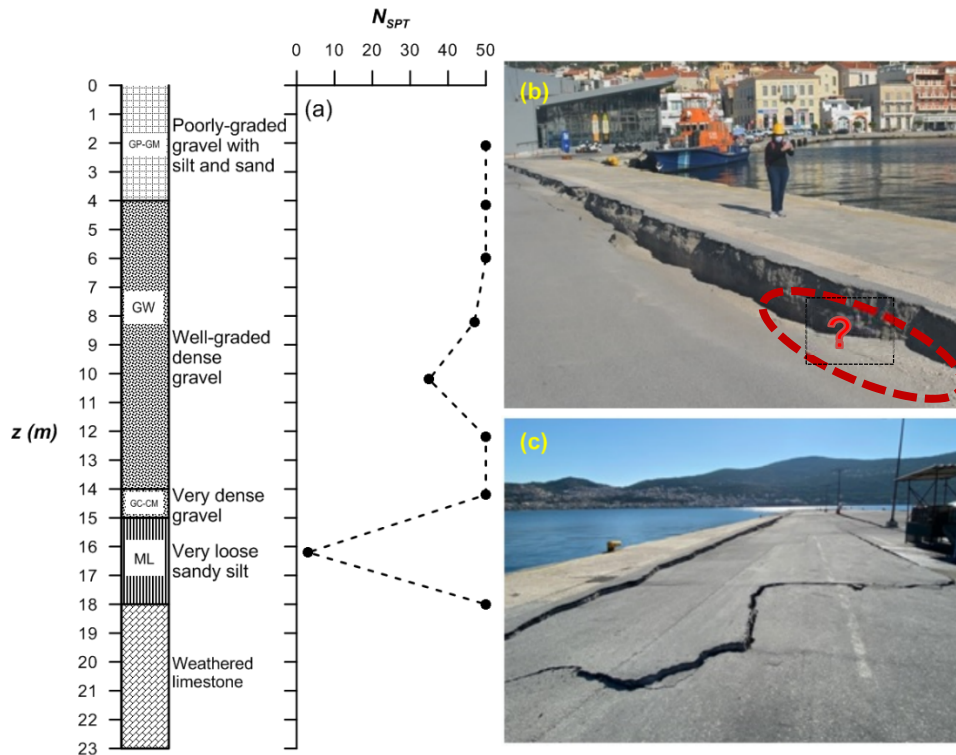
The jetty of the eastern (old) port experienced extensive longitudinal and transverse open cracks - several centimeters wide - whilst the backfill behind the quay wall experienced a subsidence that locally exceeded 50 to 60 cm (Fig 5.42). In the upper part of the figure, traces of gravels and sand are visible behind the quay wall. These might be remnants of ejecta partially washed out by the tsunami. The presence of ejecta could be the result of liquefaction of a very loose sandy silt layer located 15 to 18 m deep, right beneath the backfill material (Fig. 5.42). Similar observations of ejecta behind quay walls have been made in many previous earthquakes (Professor G. Bouckovalas – *personal communication*), even in the absence of any native liquefiable soil layer. As such, any observed ejecta may be due to liquefaction and wash out of a loosely deposited fine silty-sand phase which fills the voids of a typically much coarser backfill gravel skeleton that does not participate in the load-carrying capacity of the wall (Professor G. Bouckovalas – *personal communication*). This could explain the lack of excessive displacements and rotations of the wall towards the sea. Construction records from the said ports and further investigations can elucidate this further.

Figure 5.42. Top right (b): subsidence of backfill material behind the quay wall at the eastern (old) port, measuring up to 60 cm. Down right (c): 10 – 15 cm wide longitudinal and transversal open cracks, located on the pavement over the backfill material, in contact with the quay wall. Left part: a crude log of borehole S-1 located at the jetty of the old port where the liquefiable layer of the very loose sandy silt layer is located at a depth of 15 m (*borehole kindly provided by G. Millionis - elaboration by Em. Rovithis*)

On the basis of the above data, it is possible that the upper 15 m of borehole BH1 is material that has been superimposed over the layer of very loose sandy silt, which most likely is the preexisting natural layer (often found in ports and bays). This material appears highly deformable, with very low bearing capacity, so that cracks and deformations might have already existed. Discussions with the local port engineers, revealed that the pavement was mildly cracked prior to the earthquake (pers. communication with Mrs. Sechioti). If this is indeed the case, then most probably the cracks might have simply further opened/intensified after the earthquake. Also, it

needs to be verified whether the traces of sand and gravel shown in Fig. 5.42 are 1) ejecta from a distinct layer that liquefied, 2) ejects from a finer sand portion in the coarser skeleton of the backfill, or 3) just a natural product of friction and bouncing between the backfill material and the quay wall following their detachment. Given the preliminary observations and the experience for other earthquakes in the broader area and their effects on similar infrastructure, it is more likely that the latter two explanations are the most plausible ones.

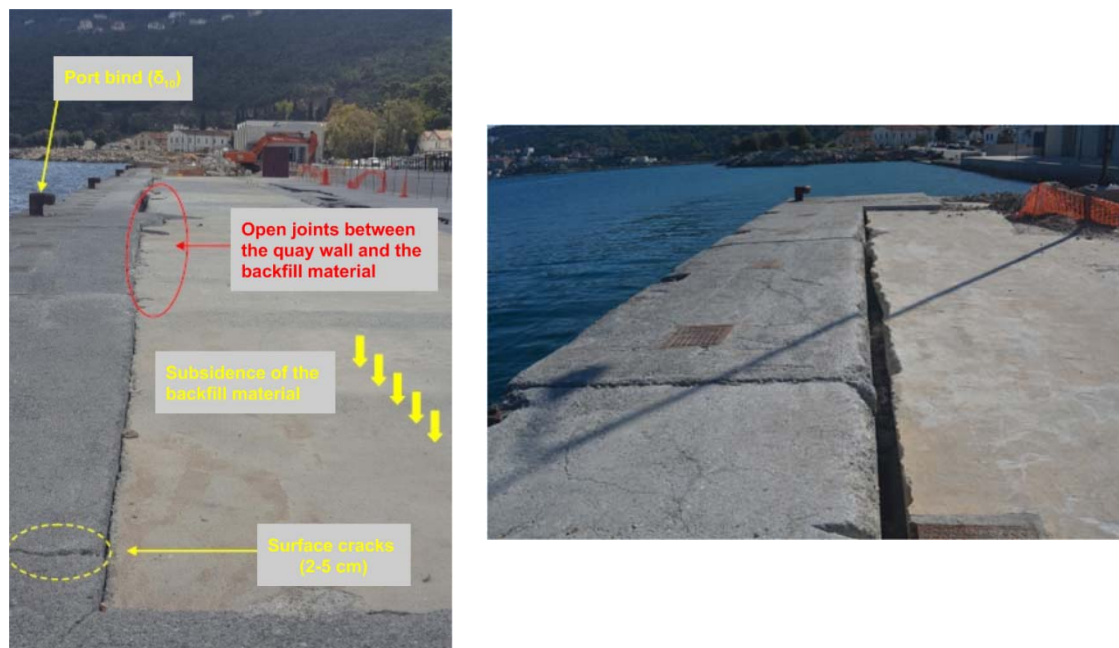
Figure 5.45 illustrates (a) a view of the pre-existing open joints between the quay wall and the backfill material and the subsidence of the backfill material behind the quay wall about 3 years ago (Triton, 2017), and its comparison to (b) its condition immediately after the earthquake (HAEE reconnaissance report, 2020). Interestingly, the earthquake damage observed are quite similar but most probably intensified by the earthquake. At the time the site was visited by the HAEE team, the construction operations in response to the Triton (2017) study were ongoing.

Hauled construction materials did allow the team to delineate between those and any potential liquefaction-induced ejecta at the site. Nevertheless, given the geotechnical data (see Fig. 5.41) liquefaction might have taken place on a rather limited scale and probably worsened the already existing damages. In addition, the quay walls at this particular site are massive and consequently subject to large inertia forces mostly due to their own mass and not due to seismic earth pressures from the backfill. Consequently, it is likely that the quay walls at the Malagari port rotated somewhat outwards during the earthquake, thus widening any pre-existing gaps (Triton 2017) and also leading to some settlement of the backfill next to the wall. As such, it is rather unlikely that the present picture of the quay wall damages can be attributed entirely to liquefaction and dynamic settlement.

Figure 5.45. View of the quay wall at new (Malagari) port, Vathy, from NW to SE direction: (left) photo taken 3 years before the earthquake (Triton, 2017); (right) photo taken a few days after the earthquake (HAEE reconnaissance report, 2020)

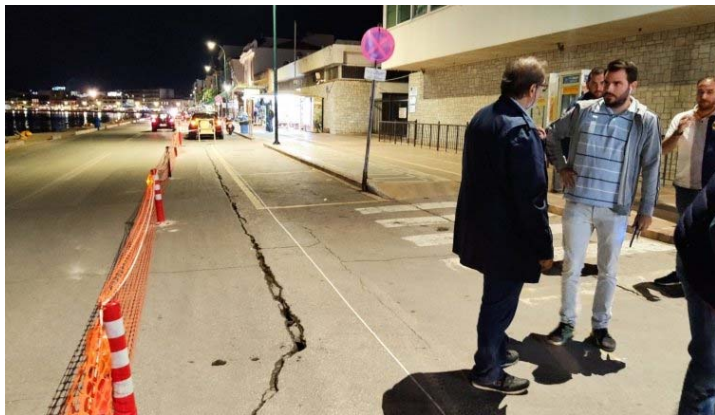
Port of Chios Island. Earthquake-induced failures were observed in the port of Chios island, situated approximately 80 km from fault, referring mainly to surface cracks of considerable width and depth (Fig. 5.50a), as reported in the post-earthquake preliminary report by Pelekis and Roumelioti (2020). At specific locations these cracks were about 10-15 cm wide and about 40 cm deep (Fig. 5.50b). Such type of failures in the port of Chios may indicate soil liquefaction that was marginally triggered during the earthquake, and ensuing lateral spreading effects towards the shoreline, as suggested by Pelekis and Roumelioti (2020). The existence of inclined strata below the filling material of the quay walls and pre-earthquake damage due to gravity loads (e.g. scour of its foundation) should be considered when interpreting the observed seismic behavior.

Figure 5.50. (a) Earthquake-induced surface cracks parallel to the quay wall front in the port of Chios; (b) Close view of 10-15 cm wide and 40 cm deep surface cracks.

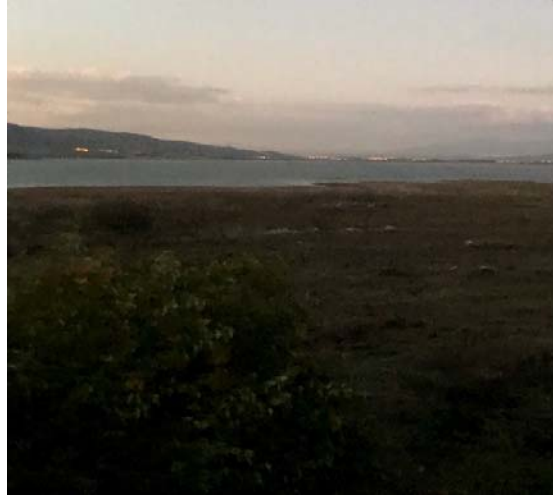
(a)

Figure 6.11. Tahtali Dam a) reservoir site, no damage observed ($38^{\circ}07'48.7''N$ $27^{\circ}06'13.3''E$ / 18:34/ 04.11.2020) b) crest and spillway view on November 6

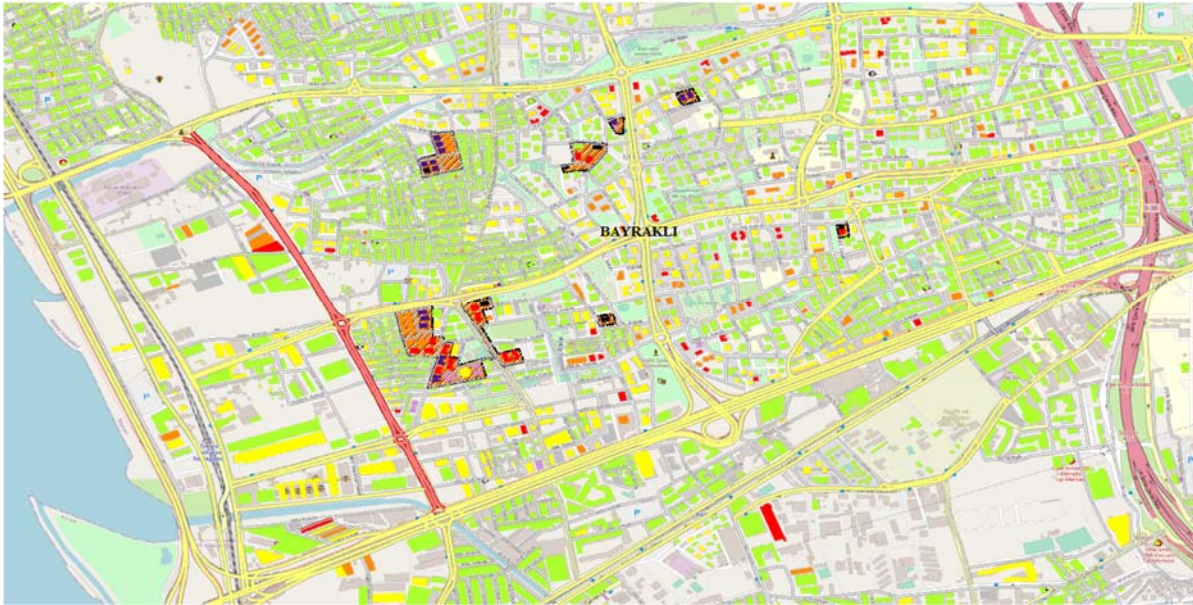
The structural damage was mostly concentrated in the Bayraklı, Bornova, Karşıyaka and Konak Districts of İzmir. These are among the most densely populated, central regions of the city. The distribution of damage in these districts as obtained from AFAD and the Ministry of Environment and Urbanization are shown in map form in Figures 7.4-7.7. It should be noted that green, yellow,

Figure 7.4. Damage distribution in the Bayraklı district of Izmir (green, yellow, orange and red colors indicate buildings with no, slight, moderate and heavy damages, respectively. The black and pink indicators show the buildings that have totally or partially collapsed during the earthquake)

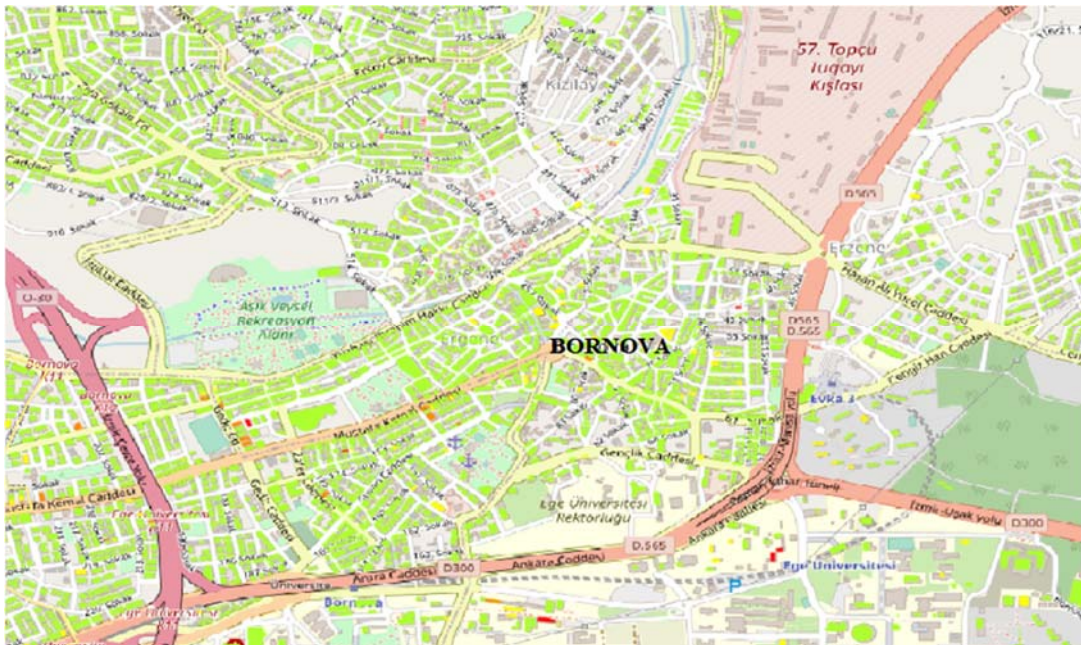
Figure 7.5. Damage distribution in the Bornova district of Izmir

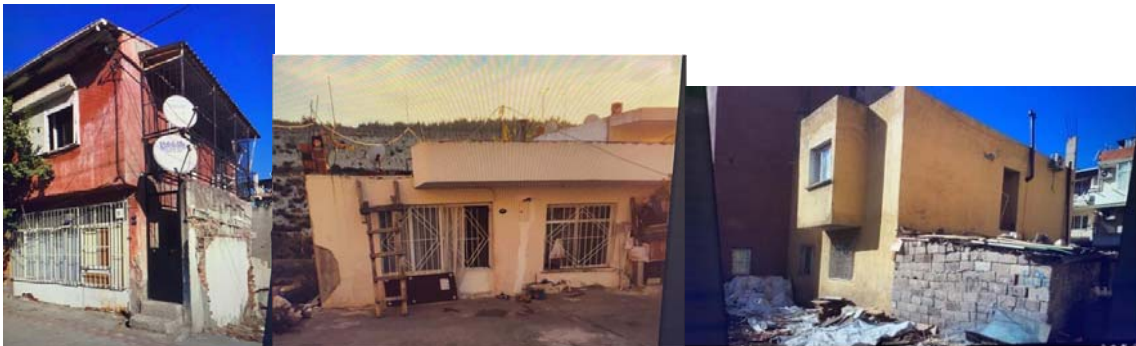
Figure 7.10. Examples of one- and two-story buildings designated as heavily damaged even though the damages due to earthquake are not severe

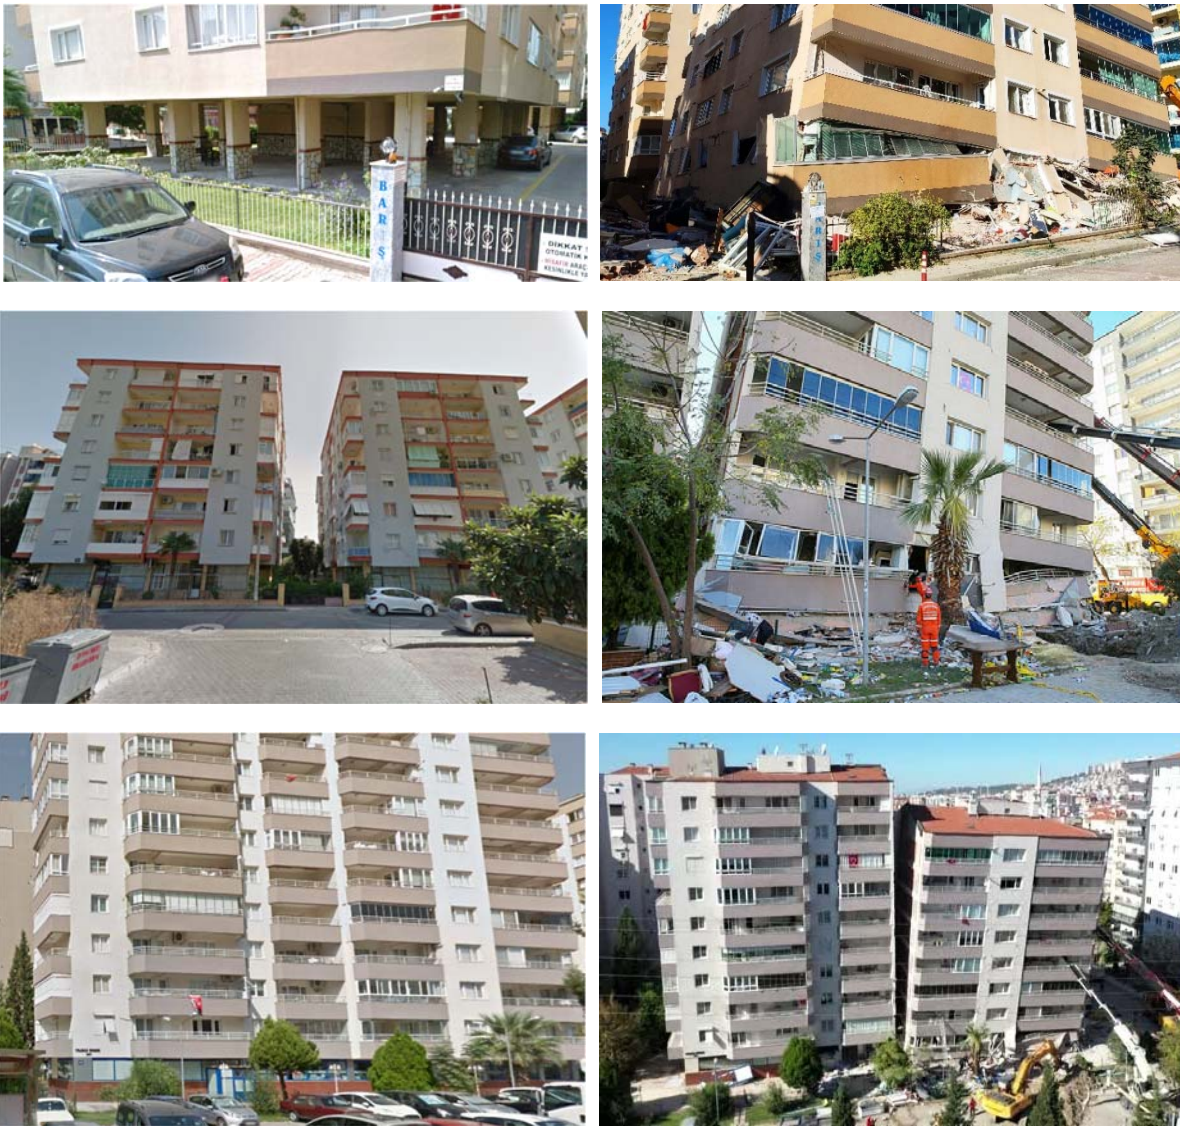
Soft / Weak Story Damage. A number of buildings have suffered damage or partial collapse at their first stories. A typical feature of the buildings in Turkish city centers is the presence of shops at the ground levels. In order to create wider space, infill walls are generally removed in those stories where the seismic demands are maximum (Figure 7.11). In addition, poor beam-column connections and the presence of weak columns are the key reasons for the development of soft-story mechanisms. Due to the soft/weak stories, building collapses occur partially in the ground story in some cases, whereas total collapse was observed in some other buildings.

Figure 7.11. Soft / weak story failure (without infill walls)

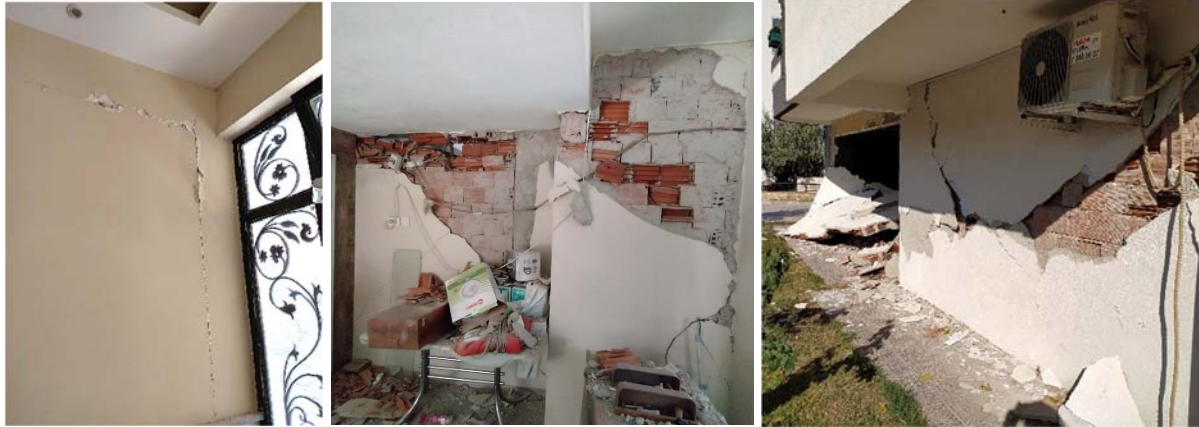
Infill Wall Damage. The most widespread damage type observed in İzmir is infill wall damage. The most common infill material was hollow-core clay bricks in the Bayraklı Region. Infill wall damage consisted of interface cracking at frame-boundary interfaces, diagonal cracking, and crushing (Figure 7.12). The structural benefits and weaknesses of the infill walls were similar to those observed in previous earthquakes such as Kocaeli 1999, Bingöl 2002, Van 2011, and Elazığ 2020. In some buildings, the infill walls appeared to stiffen the building and reduce the lateral deformation demands. In one of the eight-story apartment complexes comprised of four buildings, the benefit of infill walls was clearly observed. In one of those buildings, there were extensive infill walls in the first story (Figure 7.13). In the other buildings, this floor had no infill walls at all (Figure 7.11, top row). Three of the buildings without infill walls were either heavily damaged or collapsed, resulting in nine fatalities. The one with the infill walls in the first story, on the other hand, experienced moderate infill wall damage without any significant structural damage (Figure 7.13). It can be viewed as a striking example of the “unintended” benefit of infill walls contributing to lateral stiffness, strength, and axial capacities. Our assessments revealed that the presence of infill walls and the difference in the quality of construction might have increased the building base shear capacity, also reducing soft/weak story irregularity. The past observation on the effect of infill walls to help the buildings survive small to medium-sized earthquakes by contributing to their lateral load-carrying capacity was confirmed.

Figure 7.12. Infill wall damages

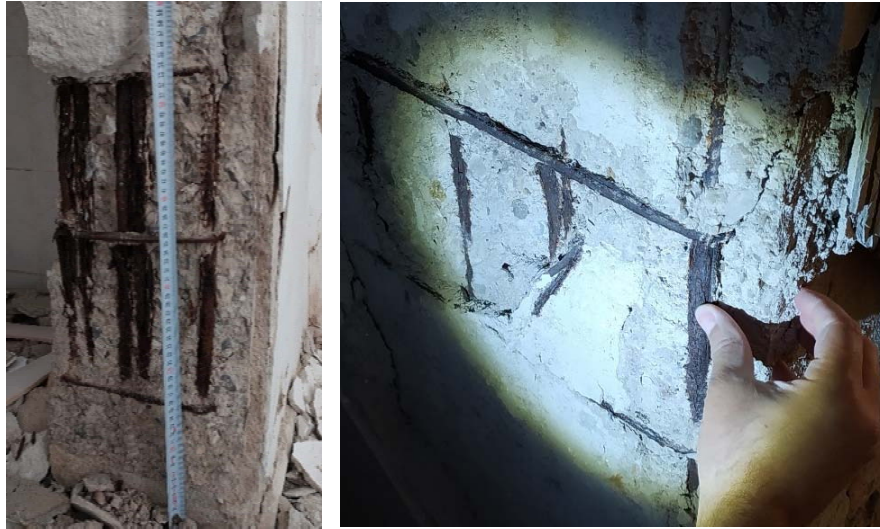
Corrosion induced damage. Our investigations showed that corrosion in reinforcement is a widespread problem in İzmir (Figure 7.16). Excessive corrosion was especially observed at the bottom of columns in the basement or ground floors. The loss in the cross-sectional area of reinforcement due to corrosion was significant in some instances, reaching ratios of 25 to 65 percent. The critical problems associated with corrosion in building columns are reduced moment and shear capacities, loss of bond strength, and concrete spalling leading to premature rebar buckling. Hence, addressing problems related to corrosion detection and protection remains critical for seismic risk reduction.

Figure 7.16. Corrosion damages

- 7- Excessive corrosion was observed in the bottom ends of columns located at the basement and ground floors of the examined buildings in Bayraklı, İzmir (similar effects are anticipated elsewhere). Corrosion levels accelerate the loss of bond, cover spalling and deformation capacity of RC columns.

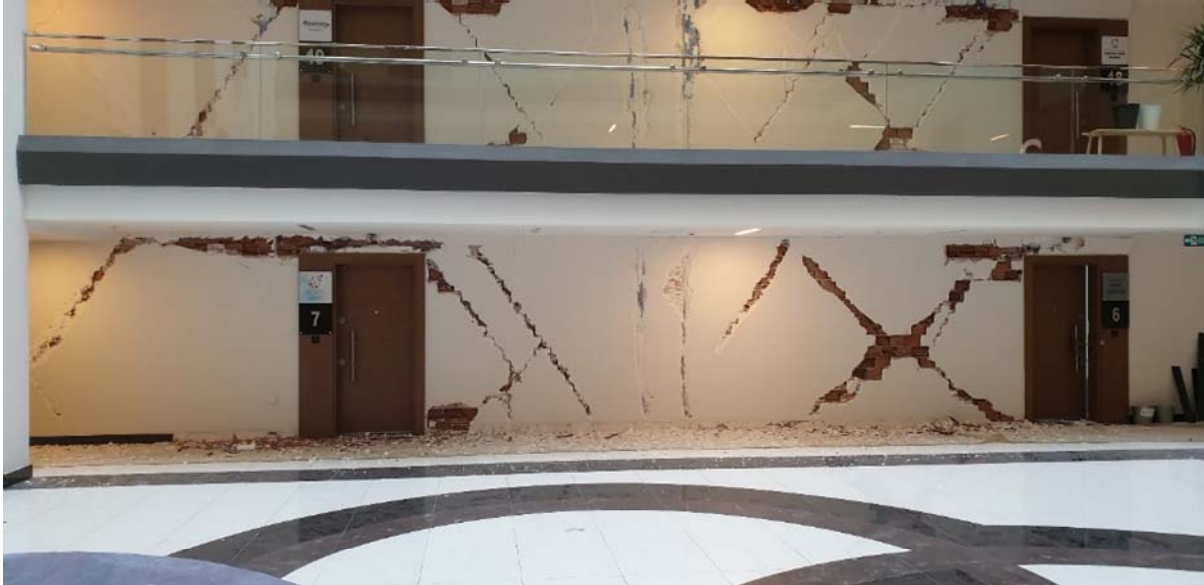
Design Problems. The aforementioned damage occurred mainly in buildings constructed in the 1990's, before the publication of TEC 1997 (CSCDA 1997) and before the Kocaeli and Düzce Earthquakes (1999), which increased awareness of the importance of construction quality and control. However, some examples of design errors leading to heavier non-structural damage than expected were encountered. The widespread non-structural damages that were observed in a recently constructed commercial center reveals some noteworthy design mistakes. Figure 7.17 shows a 10-story commercial center with a shear wall core and a large opening in the center of the slab. All offices are located around the opening. Although no damage was observed in the shear wall, wide shear cracks were observed in the infill walls. It is surprising to see such heavy infill wall damage in a recently constructed building under an earthquake ground motion with intensity well below the design earthquake level. It is believed that due to the lack of diaphragm action, the core wall was unable to limit the inter-story drifts. It appears that improper modeling due to lack of diaphragm action and poor design led to excessive drift of office areas, and the infill walls around offices suffered heavy damage. This observation emphasizes the importance of slab openings (slab discontinuity) and ways for developing proper load transfer mechanisms to the shear walls.

Figure 7.17. Non-structural damage due to large openings in slabs

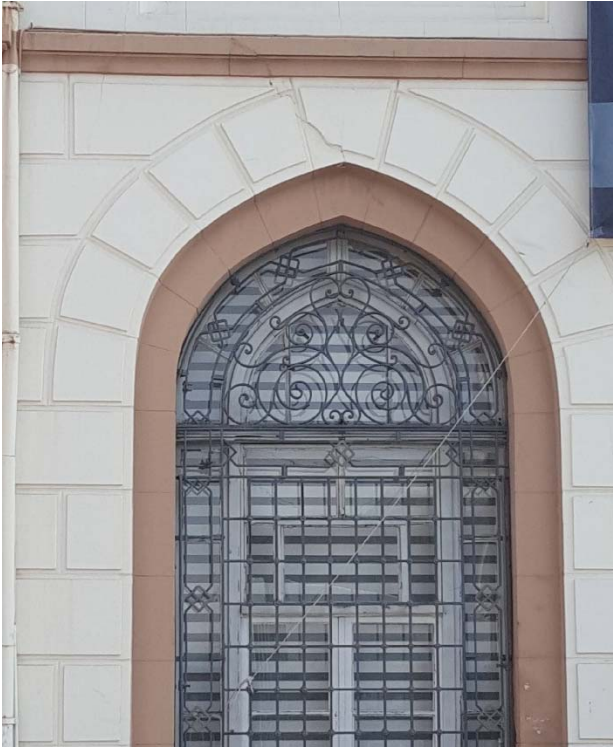
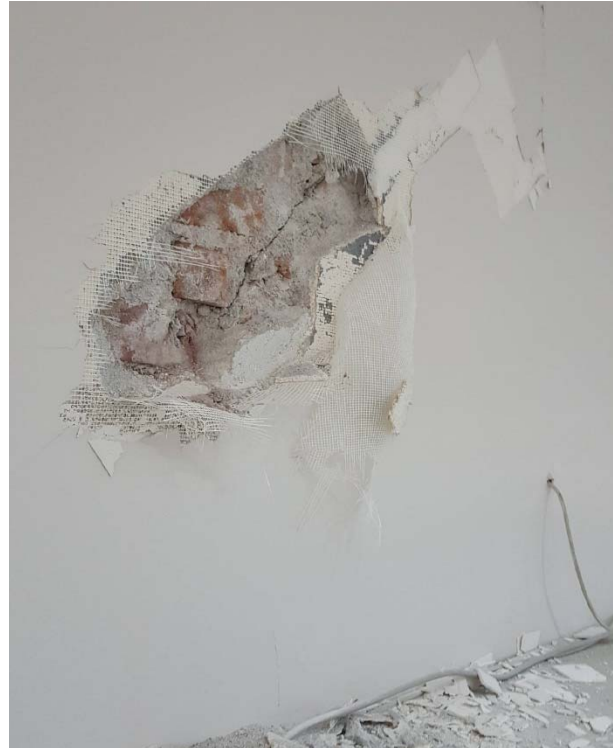
The building suffered both structural and nonstructural damage. It is reported that the disruption of the original frame due to the partial stories added by dividing the stories with high headspace inside the building is the root cause of the damage. The plan of the ground story is presented in Figure 7.21. Some structural damage observed in the structure is presented in Figures 7.22 and 7.23.

Figure 7.22. İzmir Commerce Building, observed damages; both outside and inside

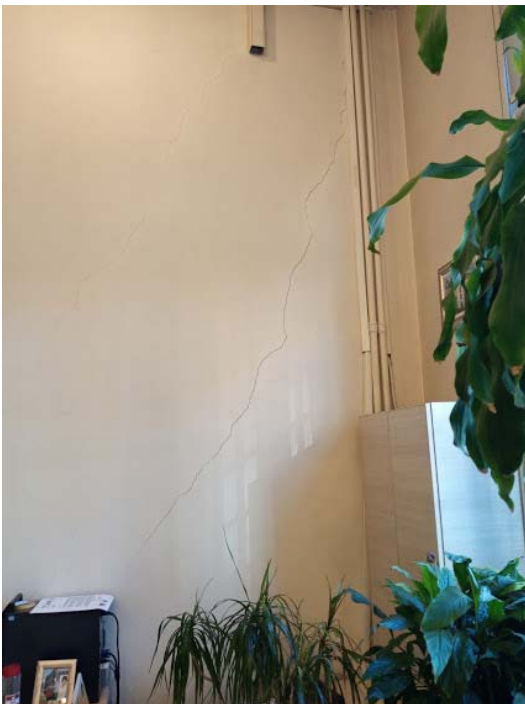
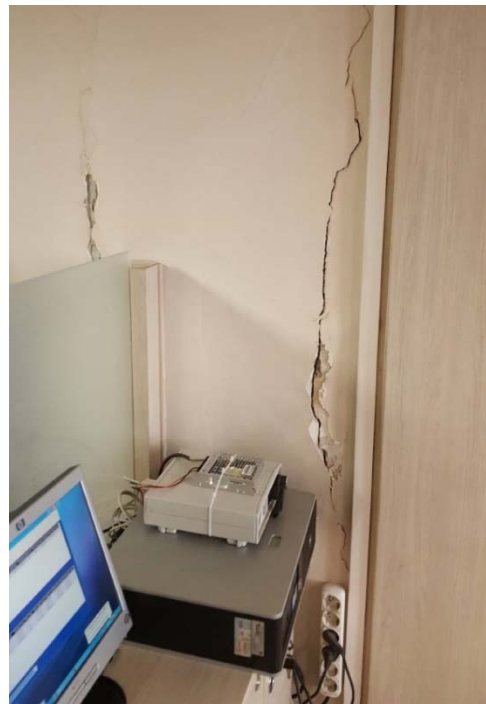
Figure 7.23. İzmir Commerce Building. Observed damages from inside the structure

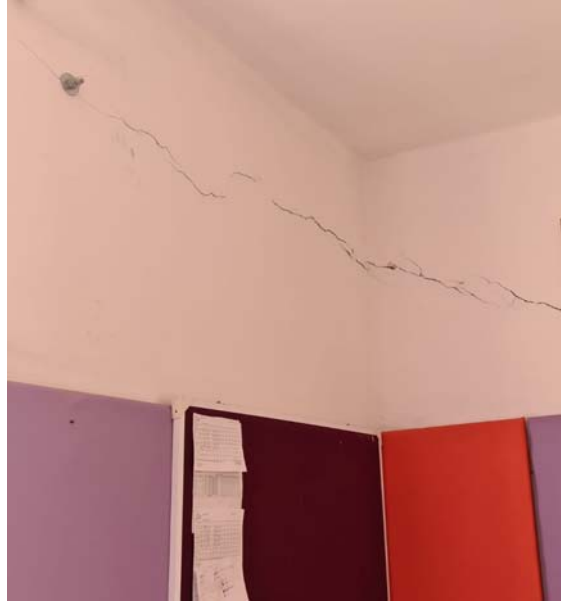
Another example in the Konak district is a school building. It is a two-story masonry structure. Detailed information about the structure is not available yet. The observed damages clearly show that the structure reached its capacity levels, as evidenced in Figures 7.24 and 7.25.

Figure 7.25. Interior wall damages in the school building

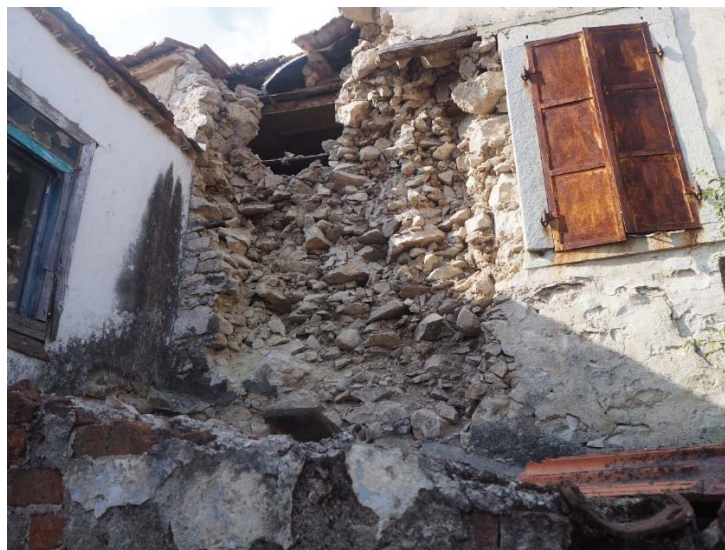
Figure 7.28. Collapsed portion of a wall

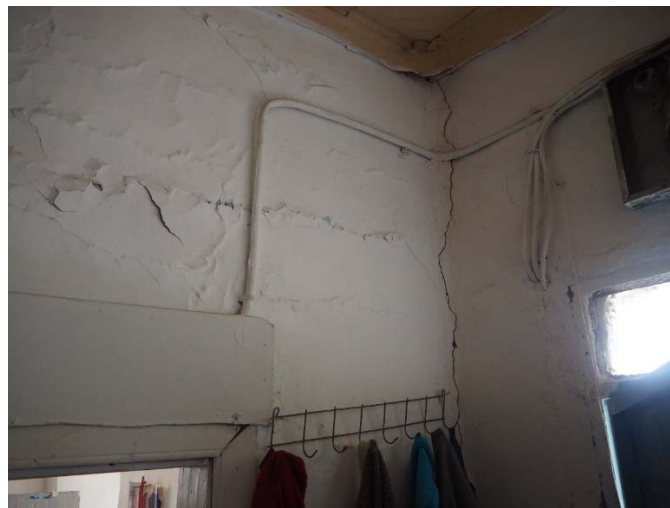
Wall damage developed as separations at the wall-to-wall connections (Figure 7.29), cracks in wall bodies (Figure 7.30), and at the window/door openings (Figure 7.31). Due to cracking, the

Figure 7.29. Separation at a wall-to-wall connection

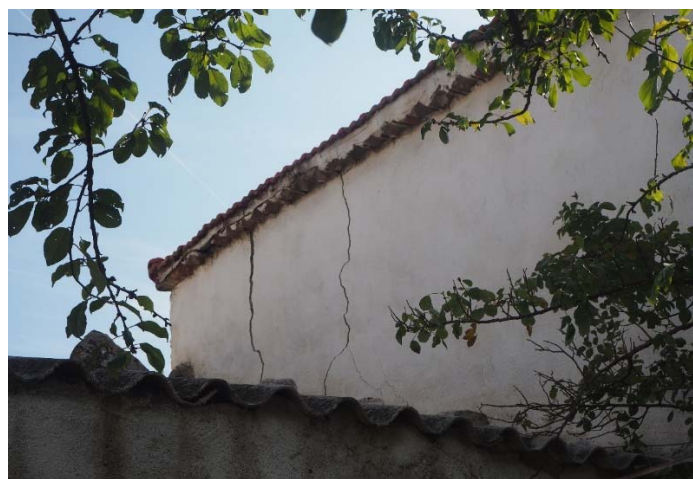
Figure 7.30. Cracking in the body of a wall

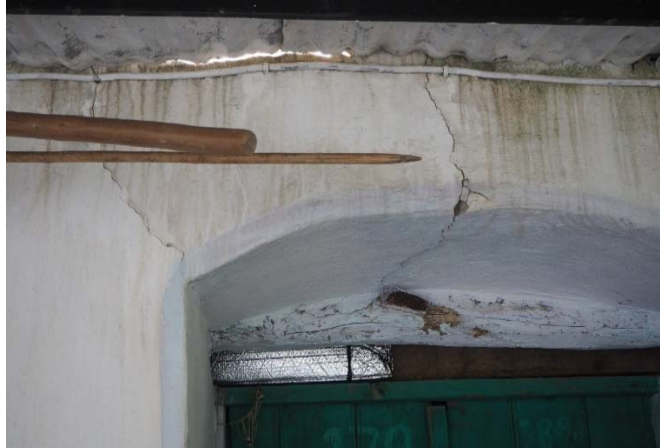
Figure 7.31. Cracking at the door opening

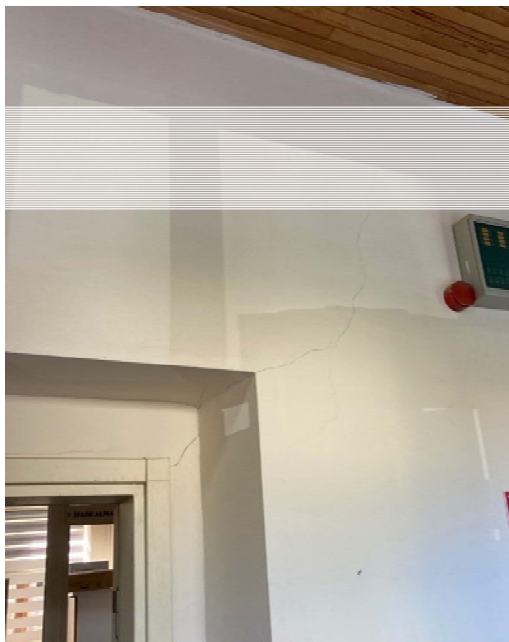
There are individual masonry structures that sustained damage during the earthquake. There is a police station building in the Alaçatı neighborhood of Çeşme. The building is about 55 km away from the epicenter, and about 2 km to Alaçatı strong motion station of AFAD. It is again a two-story structure with a wooden floor and roof framing. Walls are composed of two layers of stone with rubble infill. Soft Alaçatı stone is the wall material. This structure was originally constructed as a mill, later converted to a school, and finally became a police station. It is estimated as 70-80 years old. It suffered shear cracks in the interior and exterior wall bodies (Figures 7.32 and 7.33).

Figure 7.32. Cracking at the door opening

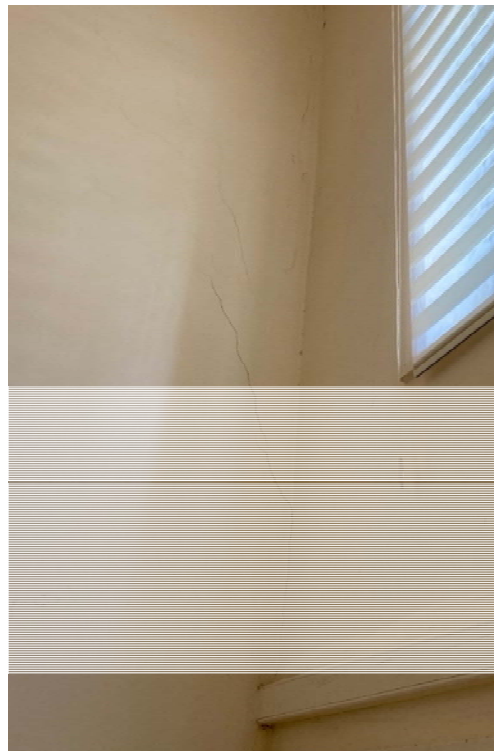
Figure 7.33. Interior to exterior wall connection

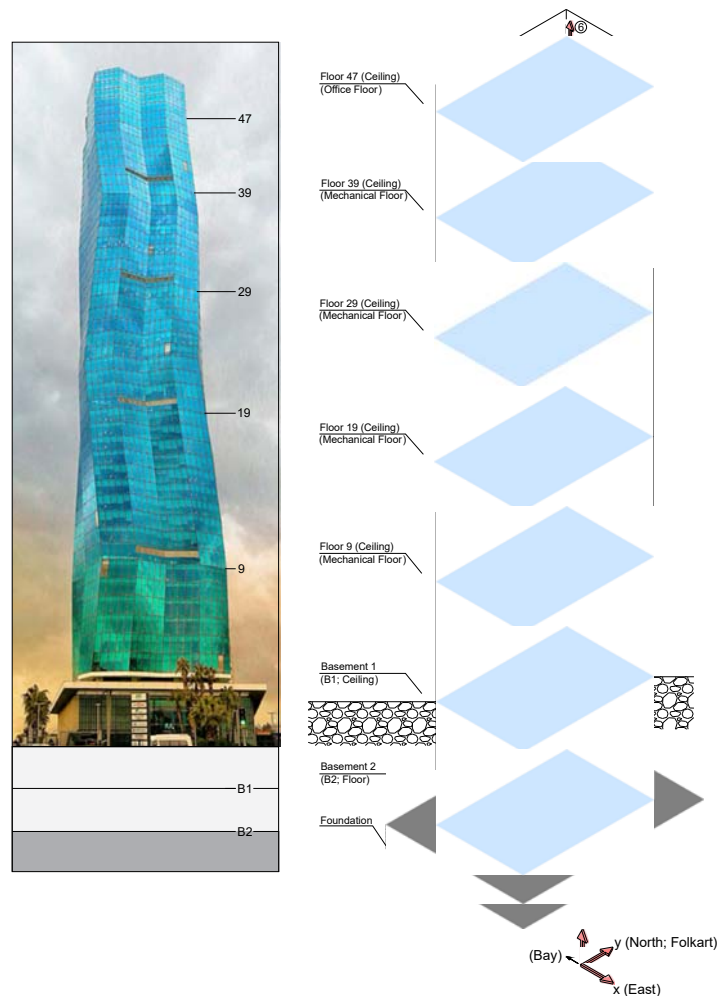
Figure 7.44. The instrumentation scheme

The tallest building in Izmir, the 216 m tall 48-story Mistral Izmir Office Tower in the Konak district, has been monitored since January 27, 2019 within the scope of a research project entitled “Guidelines for Structural Health Monitoring Systems on Tall Buildings and a Case Study”. The project is undertaken by METU and funded by the Disaster and Emergency Management Presidency of Turkey (AFAD) under its National Earthquake Research Program. The building was permanently instrumented with a 27-channel structural health monitoring system (Figure 7.44) and vibration records from the building and seven AFAD strong motion stations in the vicinity of the building have been streamed in real time to METU (Gumus and Celik, 2019). Recorded floor accelerations and calculated floor displacements during the mainshock are presented in Figure 7.45. The maximum floor acceleration is 0.28 g at the 48th floor and 0.11 g at the second basement while the maximum displacement is 16 cm at the 48th floor. No damage was reported, and the building is in continued use following the earthquake.

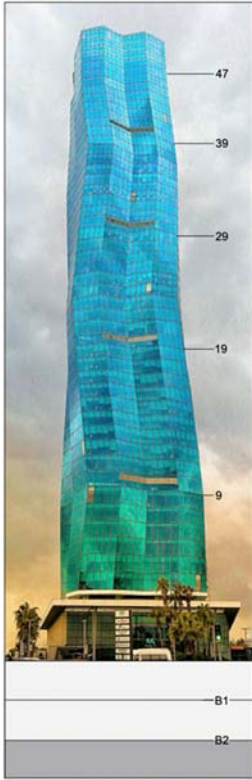
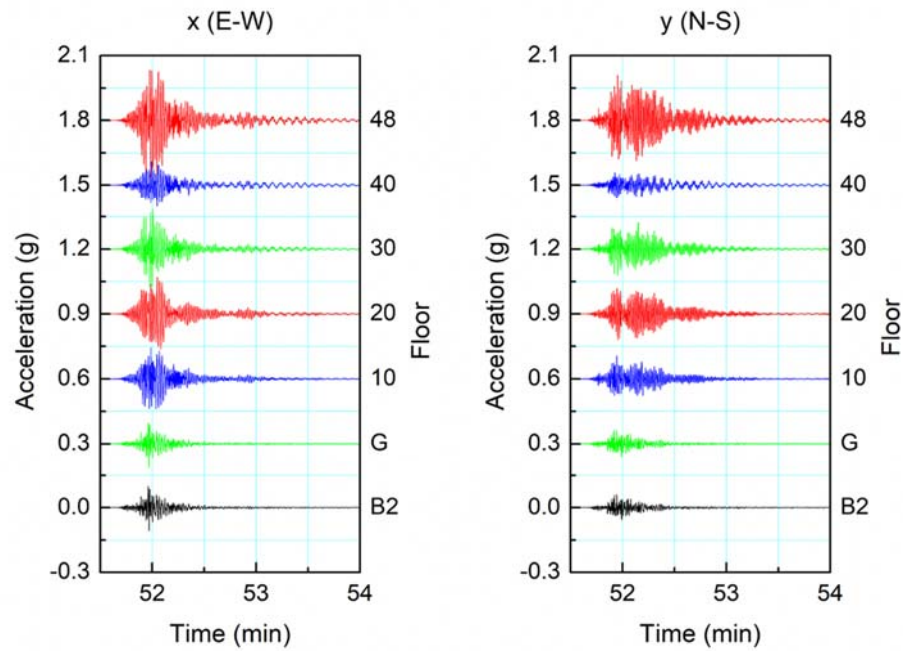
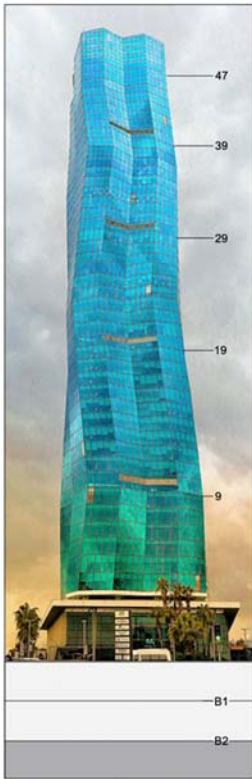
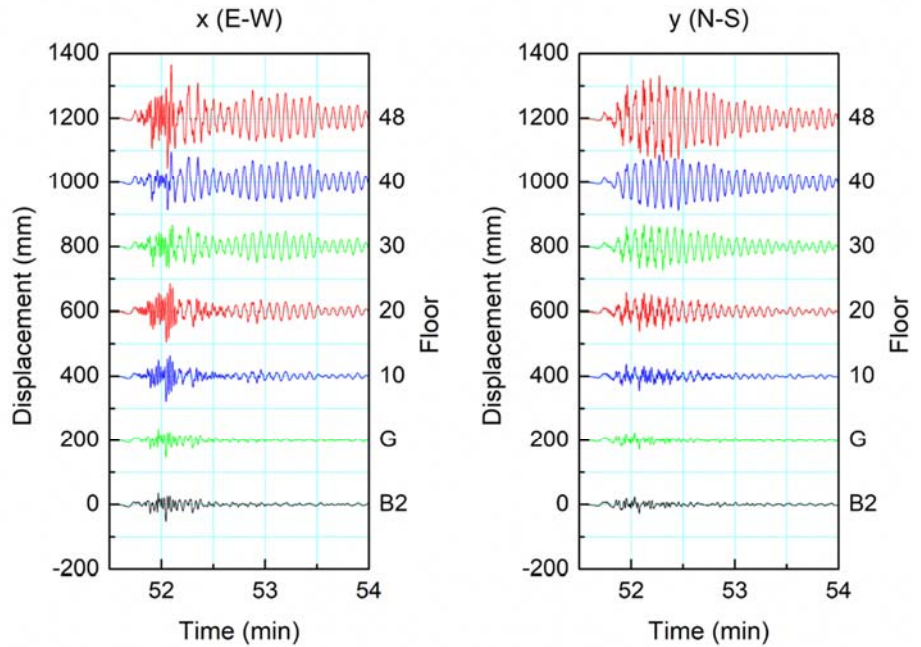
Figure 7.45. Floor accelerations and displacements

Max acceleration: 0.28 g (48th floor), 0.11 g (2nd basement)

Max displacement: 16 cm (48th floor)

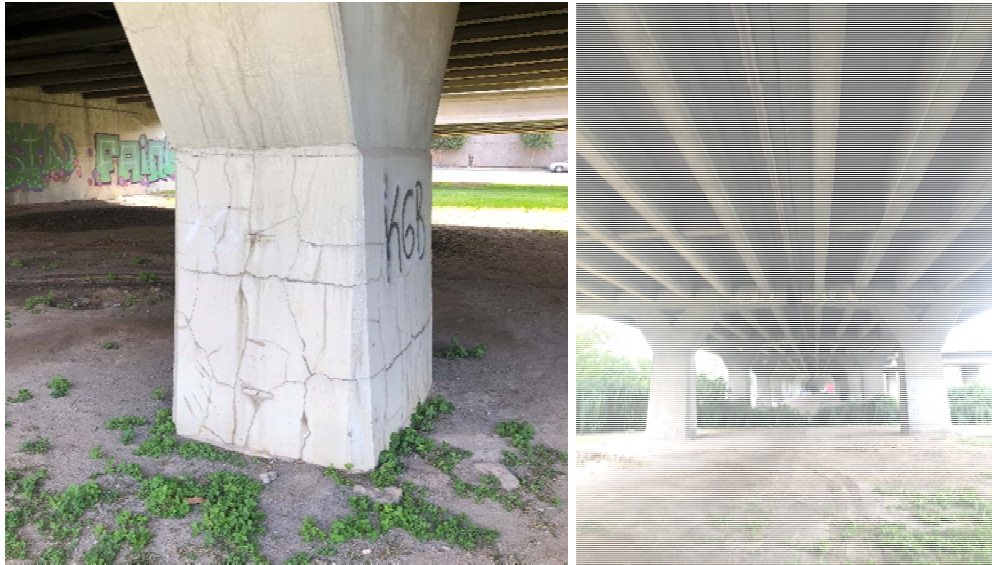
The structural history of the bridges cannot be traced after the transfer of ownership from KGM to İzmir municipality. Mürselpaşa-Zafer Payzın highway line rehabilitation project began in September 2019, and includes the maintenance, repair and identification of seismic performance of the bridges, highway, connection and roads. Improvement and strengthening studies continue within the scope of the strengthening projects. Most of the cracks observed since the beginning of the project were caused by rainwater and are ASR (Alkali-Silica Reaction) cracks, which are the result of a chemical reaction that occurred years ago in the bridge elements. These chemical

cracks did not grow after the earthquake. The repair of these cracks will be carried out within the scope of the related project (Figure 7.50).

Figure 7.50. ASR based cracks (non-seismic) and general view

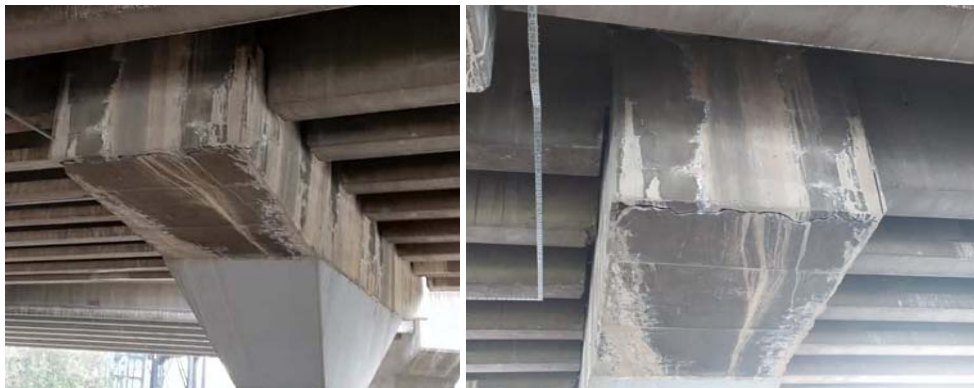
Bridges were available for use right after the earthquake. As a result, it was determined that bridges that performed successfully during the earthquake were serviceable without a need of emergency intervention (Figure 7.51).

Figure 7.51. A typical before-and-after earthquake photo (December 2019 and November 2020)

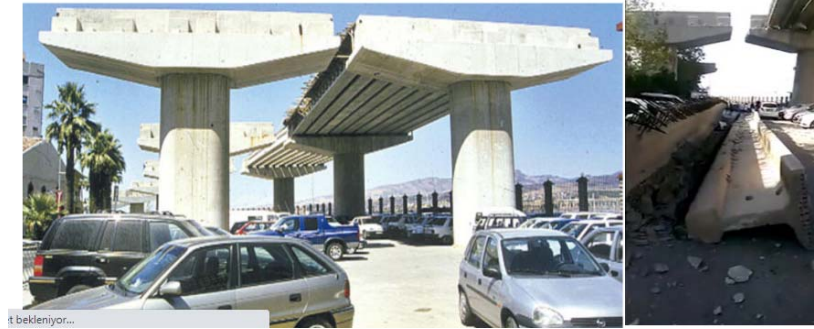
Bridge girders, which were started to be built 20 years ago and discontinued because of a plan change, fell during the earthquake because their lateral stability has not been provided for the last 20 years (Figure 7.52). These bridges were not on the highway line for service.

Figure 7.52. An incomplete bridge construction 20 years ago without providing a lateral girder stability at the site (10 years ago and now)
