Seismological and Engineering Effects of the M 7.0 Samos Island (Aegean Sea) Earthquake

Hellenic Association of Earthquake Engineering: Report 2020/02

Geotechnical Extreme Events Reconnaissance Association: Report GEER-069

December 31, 2020

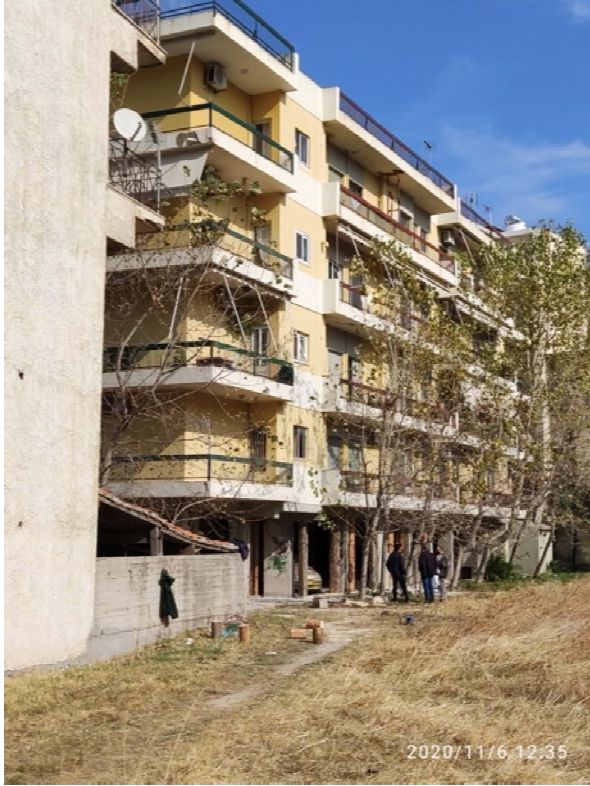
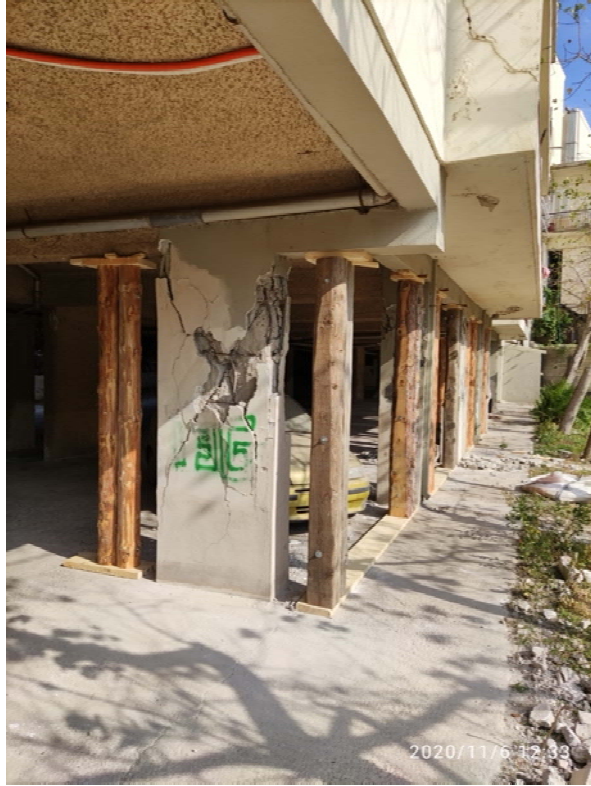
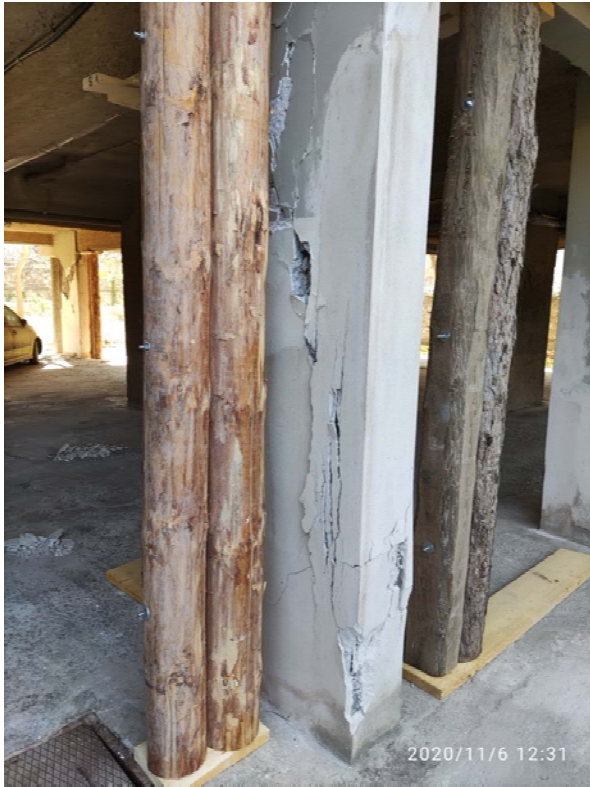
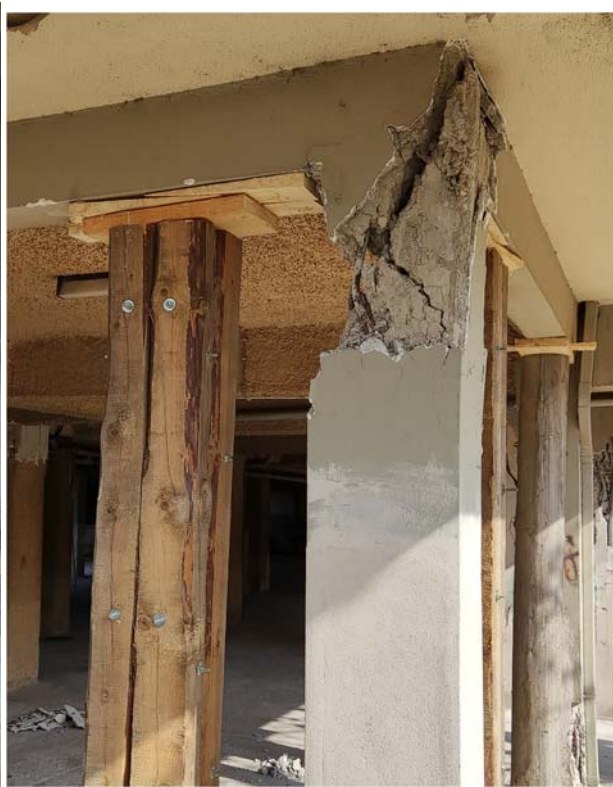
As already reported, the damage observed in RC buildings was rather limited, and no collapse occurred. Typical damage was related to soft (open) ground floors, in buildings designed and constructed before 1985. The lack of adequate stiffness at the ground floor, combined with scarcity of shear reinforcement, led to shear failures of columns, walls and beam-column joints, as shown in Figure 7.59, where buckling of longitudinal reinforcement is also visible. Short column failures were also observed (e.g., Figure 7.60), while diagonal cracking of shear walls occurred, especially in soft stories (Figure 7.61). The tallest RC building on the island, a seven-story residential building, did not experience any damage, despite its irregularities (Figure 7.62). Quite common was the damage in non-structural elements, mainly in infill walls made of brickwork (Figure 7.63). The most common types of damage observed was: (a) separation of the infill wall from the concrete frame and in some cases overturning, (b) out-of-plane movement and cracking due to out-of-plane bending (Figure 7.64).

Figure 7.59. Soft-story failure of a five-story residential building in Karlovasi.

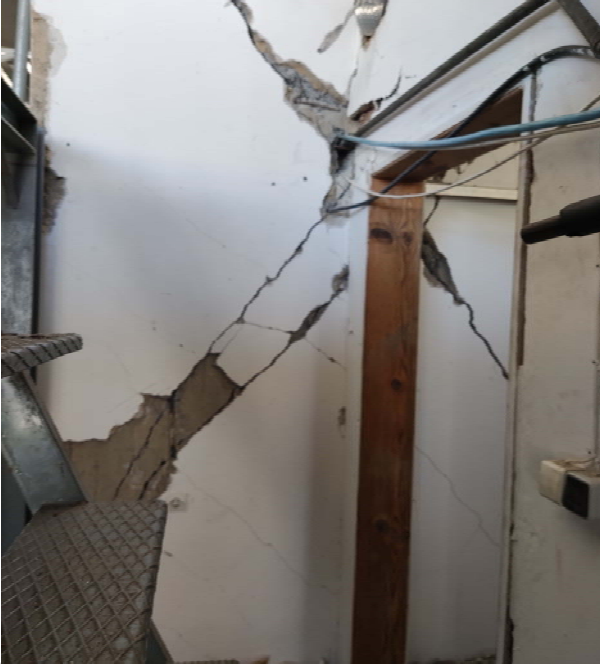
Figure 7.61. Shear failure of a shear wall in a soft story.

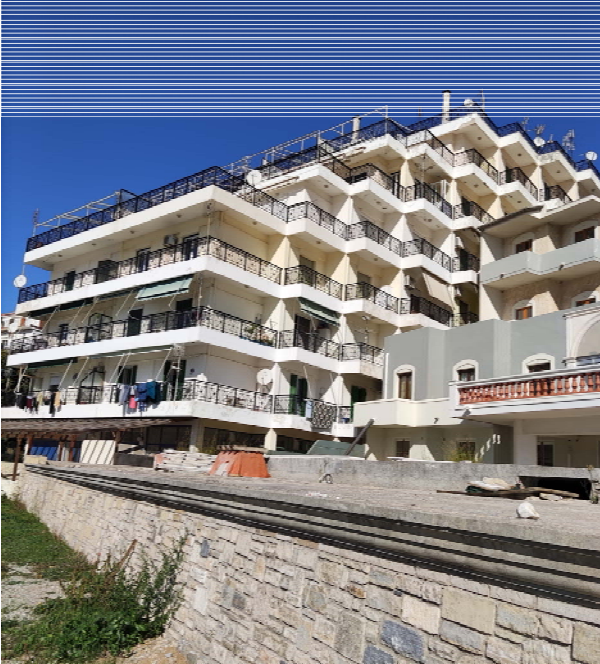
Figure 7.62. Irregular 7-story residential building without any damage.

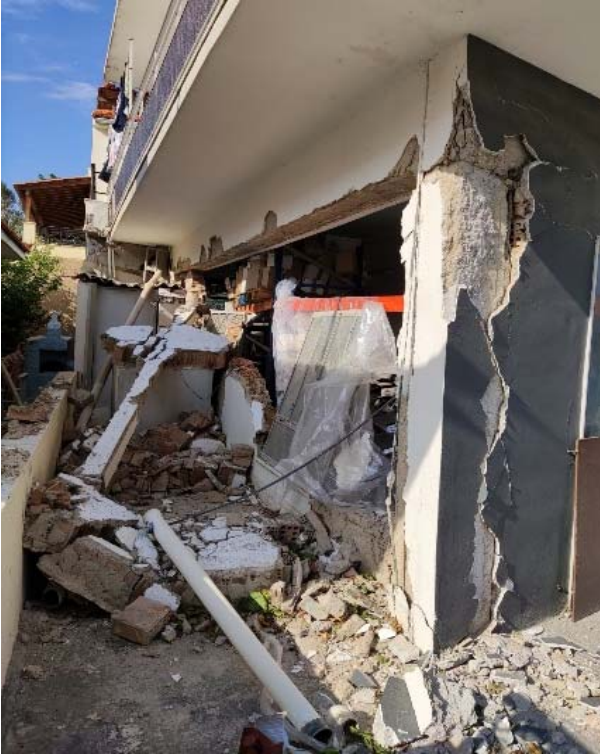
Figure 7.63. Separation and overturning of infill walls.

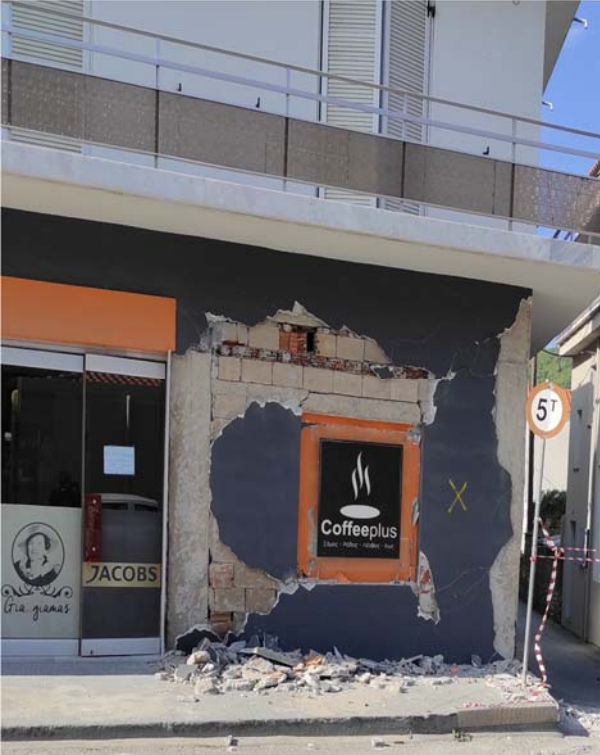
Figure 7.64. Cracking of infill walls due to out-of-plane bending.

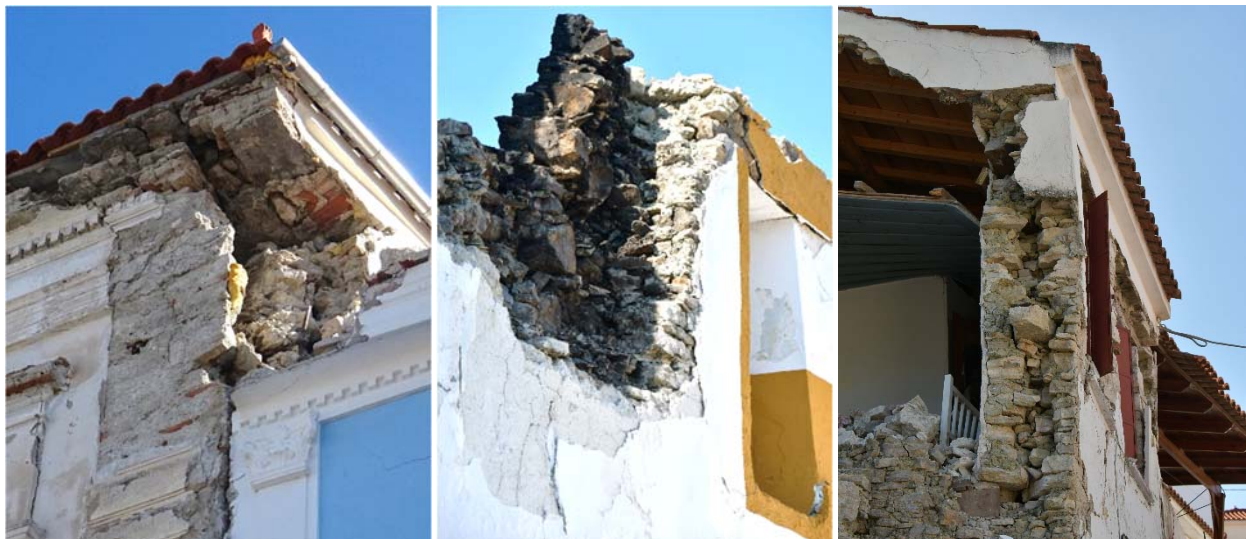
Residential Buildings. They are single or, more frequently, two-story buildings made of poor-quality (two- or three-leaf) rubble stone masonry. In some cases, three-story buildings were also found.

Figure 7.65. Poor-quality, three-leaf stone masonry building.

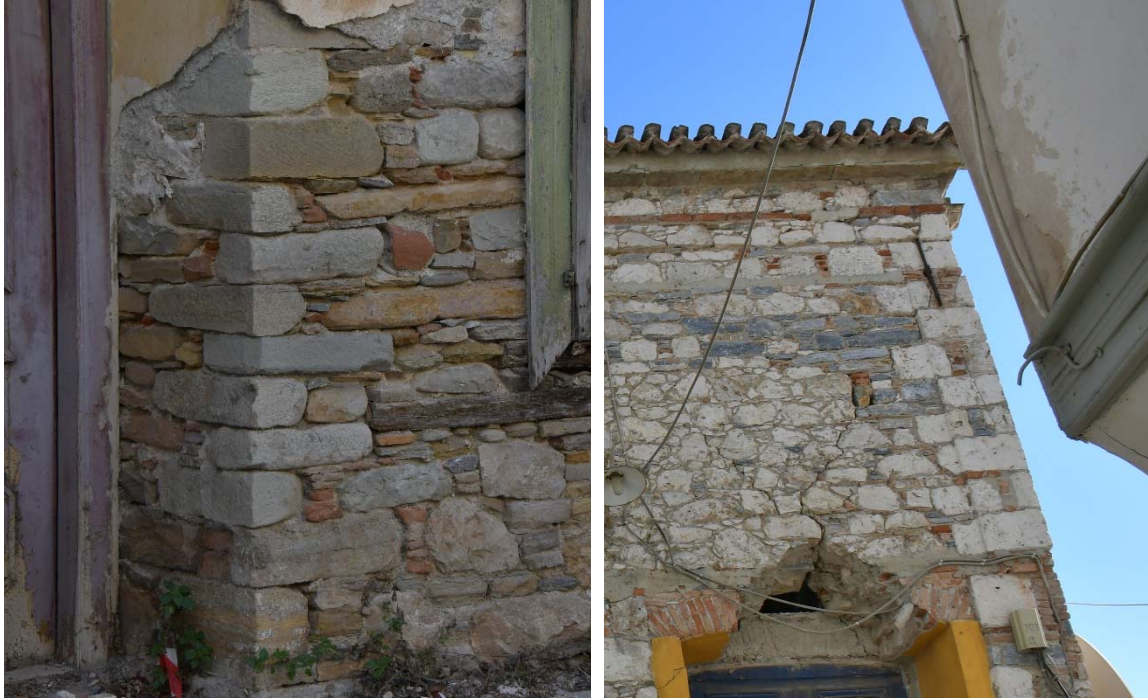
An important detail in the construction of masonry structures is the corners, and we encountered different construction styles and different levels of performance (Figure 7.66). Openings (doors and windows) represent on average one fourth to one third of the buildings' perimeter (Figure 7.67). Their lintels are either horizontal (supposedly, made of timber) or arched (Figure 7.68). In several cases the arches were rather squat.

Figure 7.66. Connection of transverse walls.

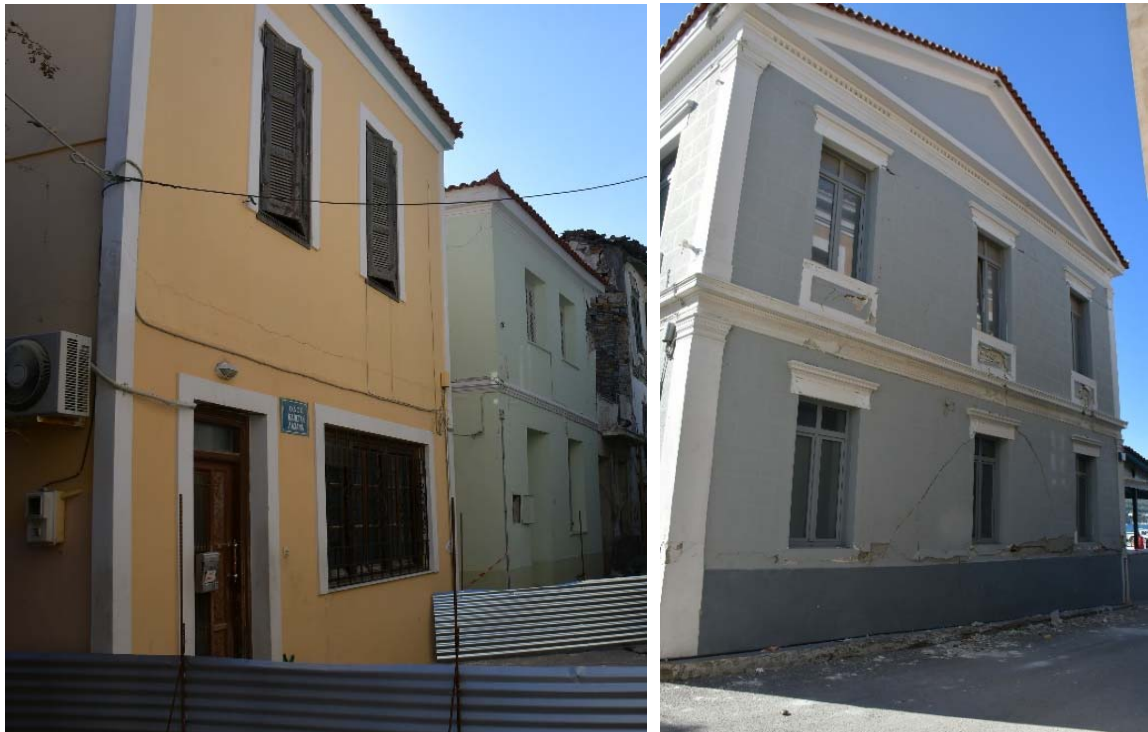
Figure 7.67. Typical dimensions of openings.

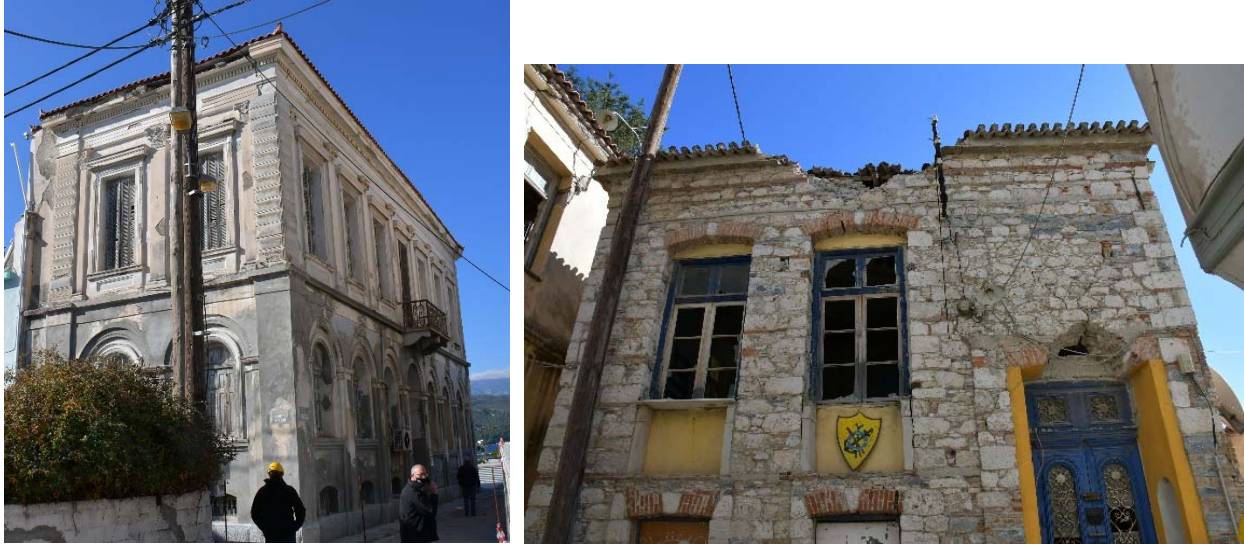
Figure 7.68. Horizontal and arched lintels. Presence of steel ties (right).

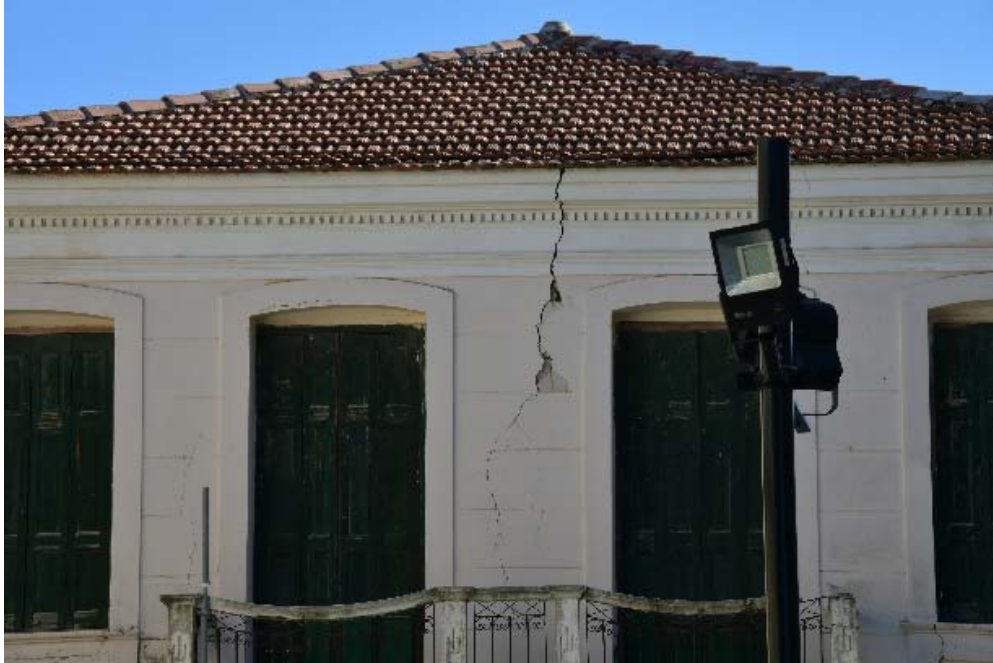
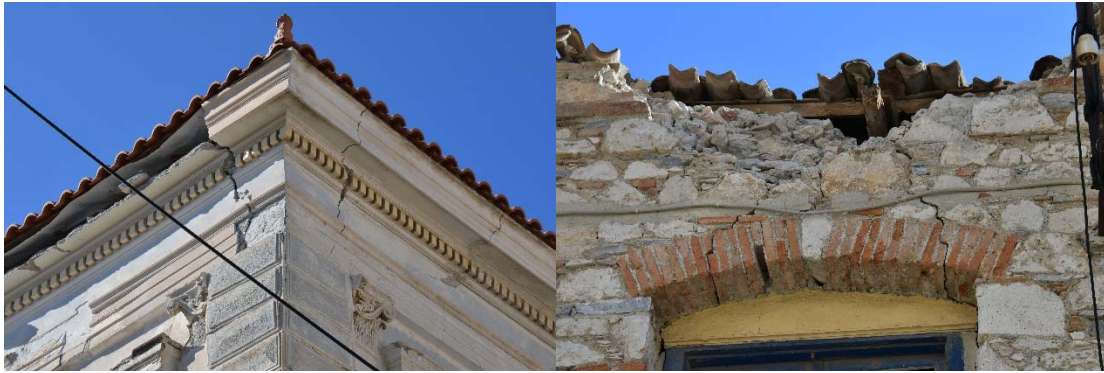
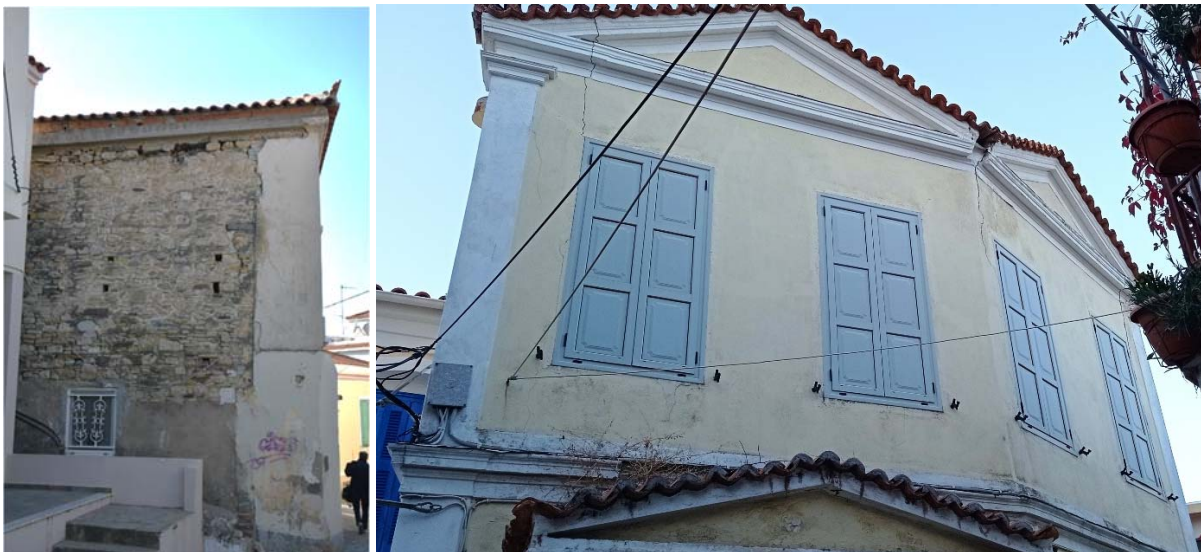
Floors are typically made of timber joists, covered with timber flooring (wooden planks), whereas roofs are made of timber trusses covered with ceramic roof tiles. Residential buildings typically suffered structural damage regardless of whether they belonged in the past to wealthy families or not. However, the extent of damage differs from building to building and from location to location. Typical diagonal or bi-diagonal cracks occurred, frequently extending to the, vulnerable in shear, lintels (Figure 7.68). The lack of stiff in-plane diaphragms at the floor and the roof level, as well as the poor quality of the, typically used, three-leaf masonry led to out-of-plane damage. The observed damage varies in extent and severity, ranging from simple cracks at mid-length of the walls and close to the corners of the building (Figure 7.69) to collapse (Figure 7.70).

Figure 7.70. Shear cracks at mid-length of the walls and corner failures.

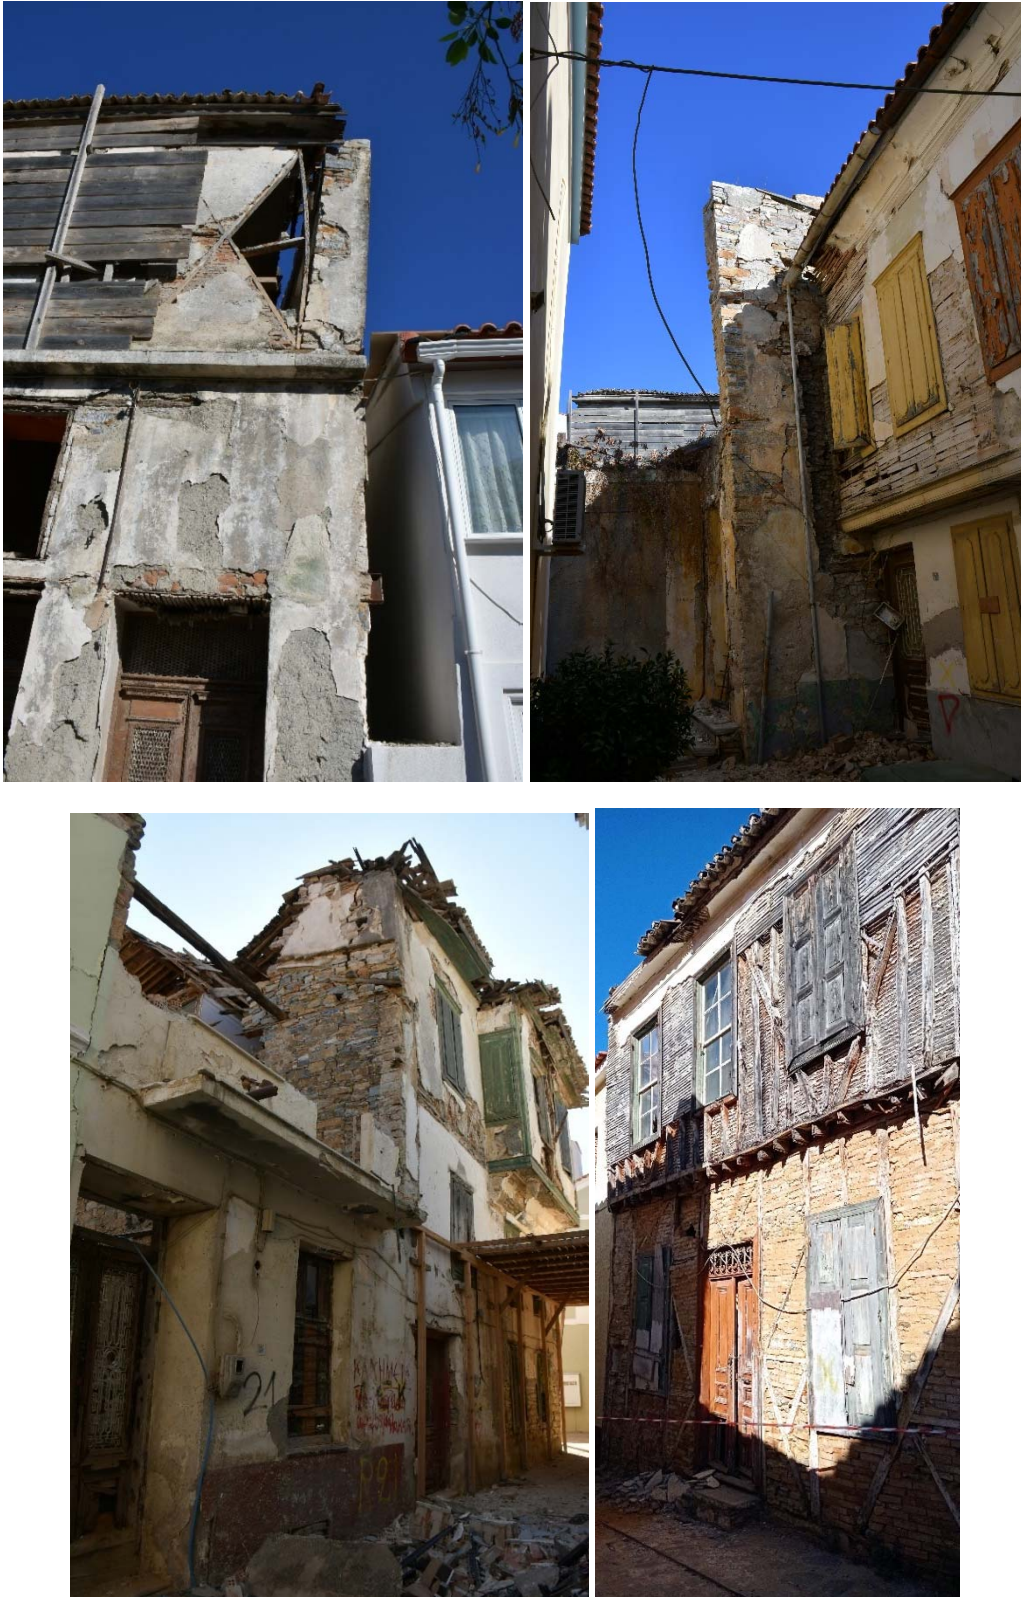
In some town neighborhoods and several villages, there are buildings of a masonry ground floor and an upper story made of timber-framed masonry or of timber walls. In those buildings, part of the upper story façade is cantilevered (Figure 7.72). Apparently, the majority of those buildings were uninhabited. They were found at an advanced decay stage and hence it is not possible to identify possibly pre-existing damage that deteriorated due to the earthquake.

Figure 7.72. Buildings in which the ground floor is made of masonry and the upper story is made either of timber-framed masonry or timber walls.

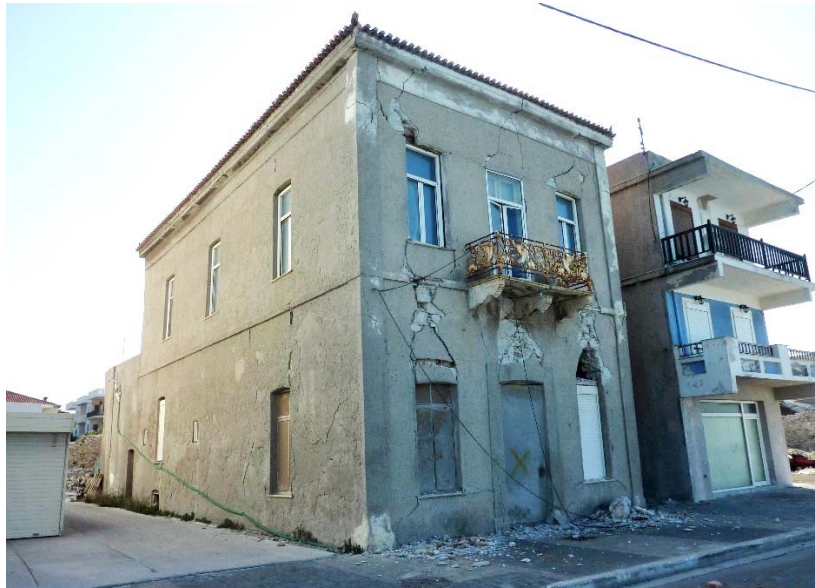
Figure 7.73. Masonry building with extensive damage adjacent to a concrete building with no damage.

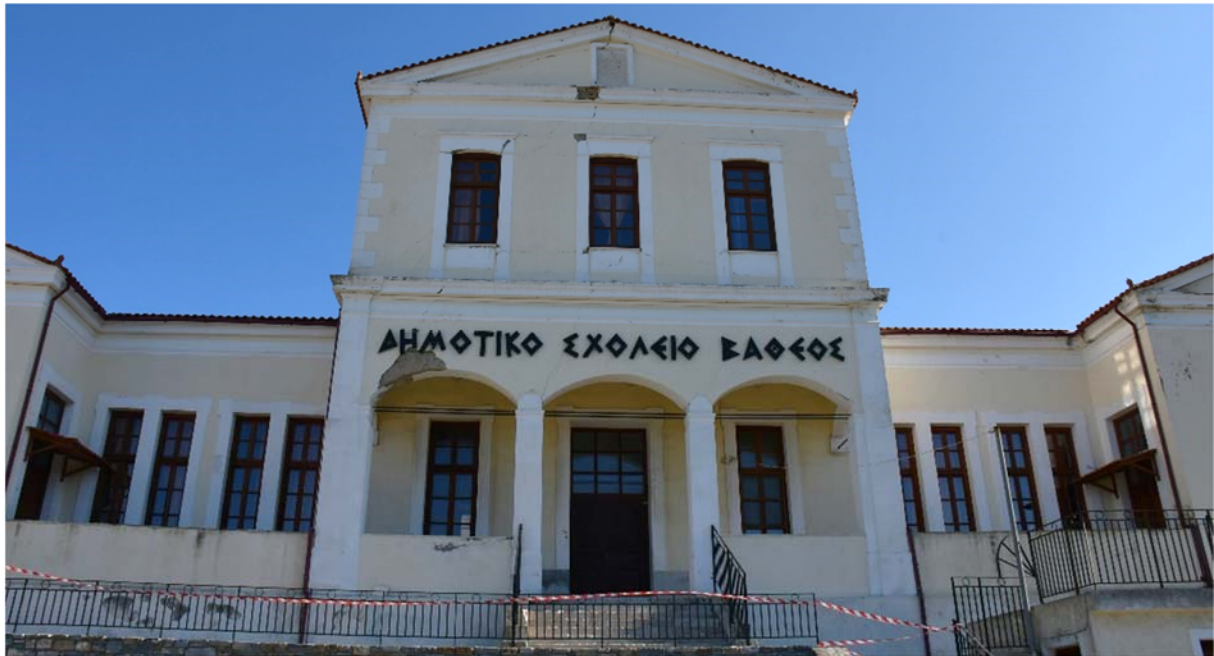
Figure 7.75. Damage to the primary school at Vathy.

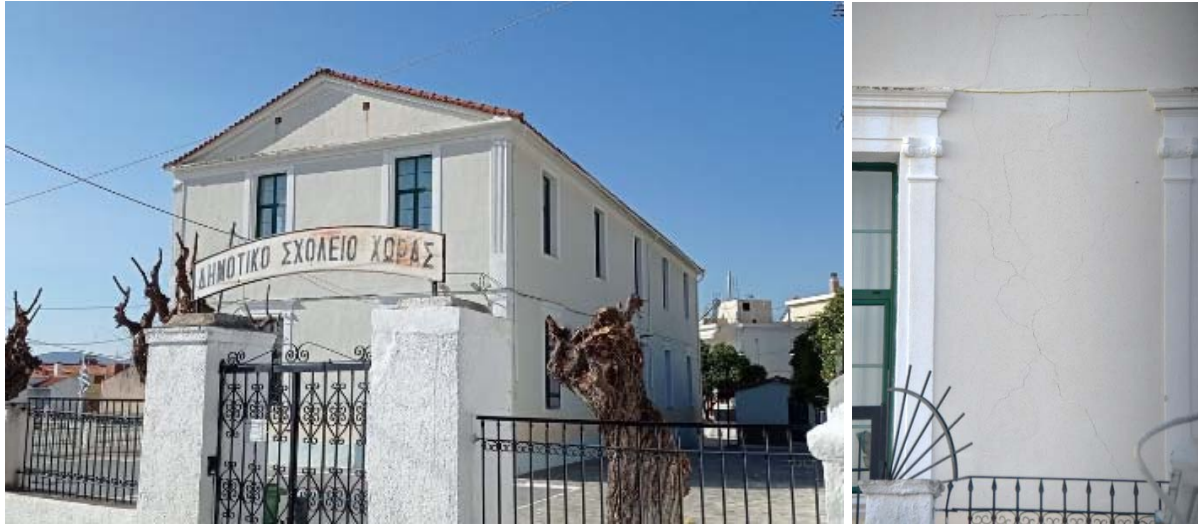
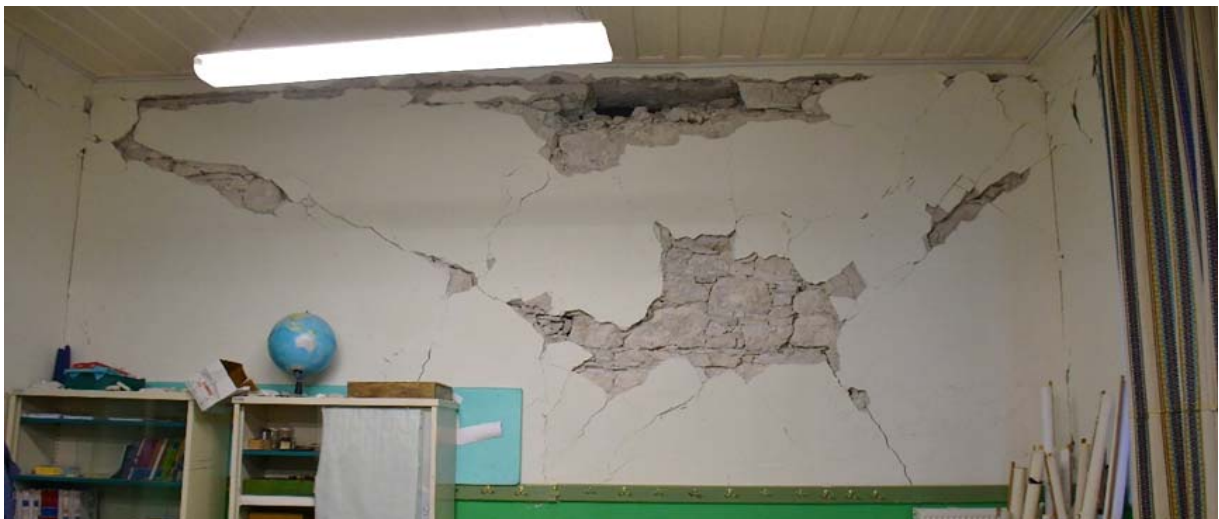
Figure 7.76. Primary school at Chora: Shear failure of masonry wall.

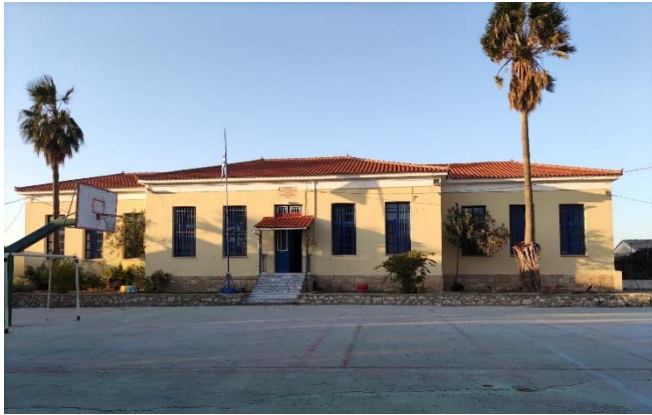
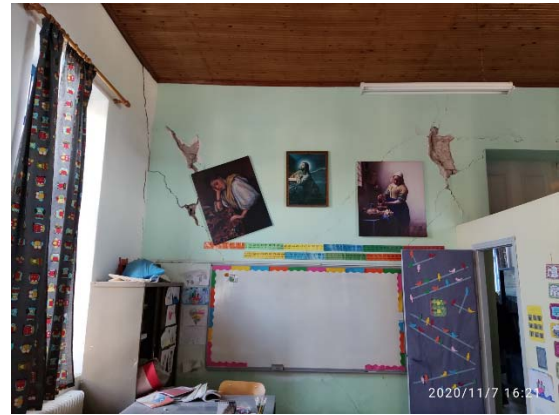
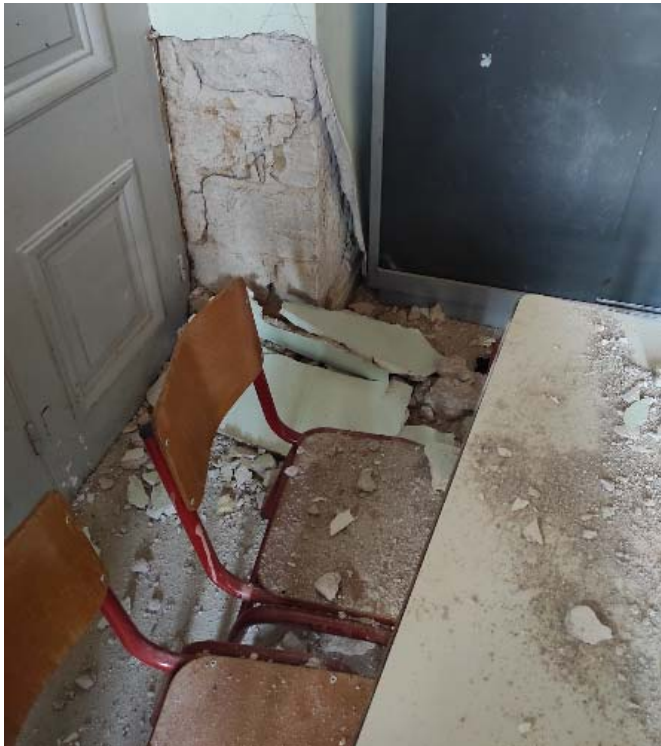
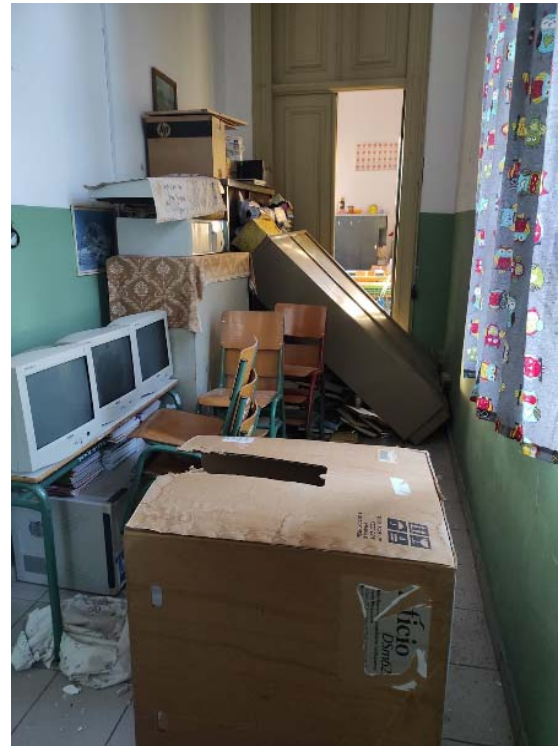
Figure 7.77. Primary school at Kontakeika: Major shear failure at the masonry walls, delamination of coating and overturning of equipment.

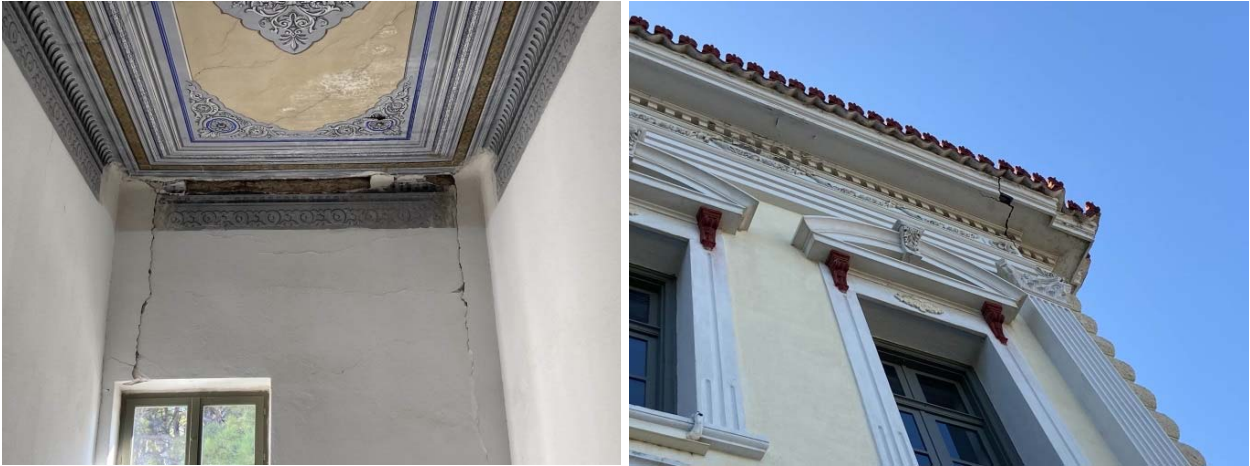
Figure 7.79. Out-of-plane masonry wall failure and corner detachment at the Lyberi building of the University of Aegean (School of Sciences).

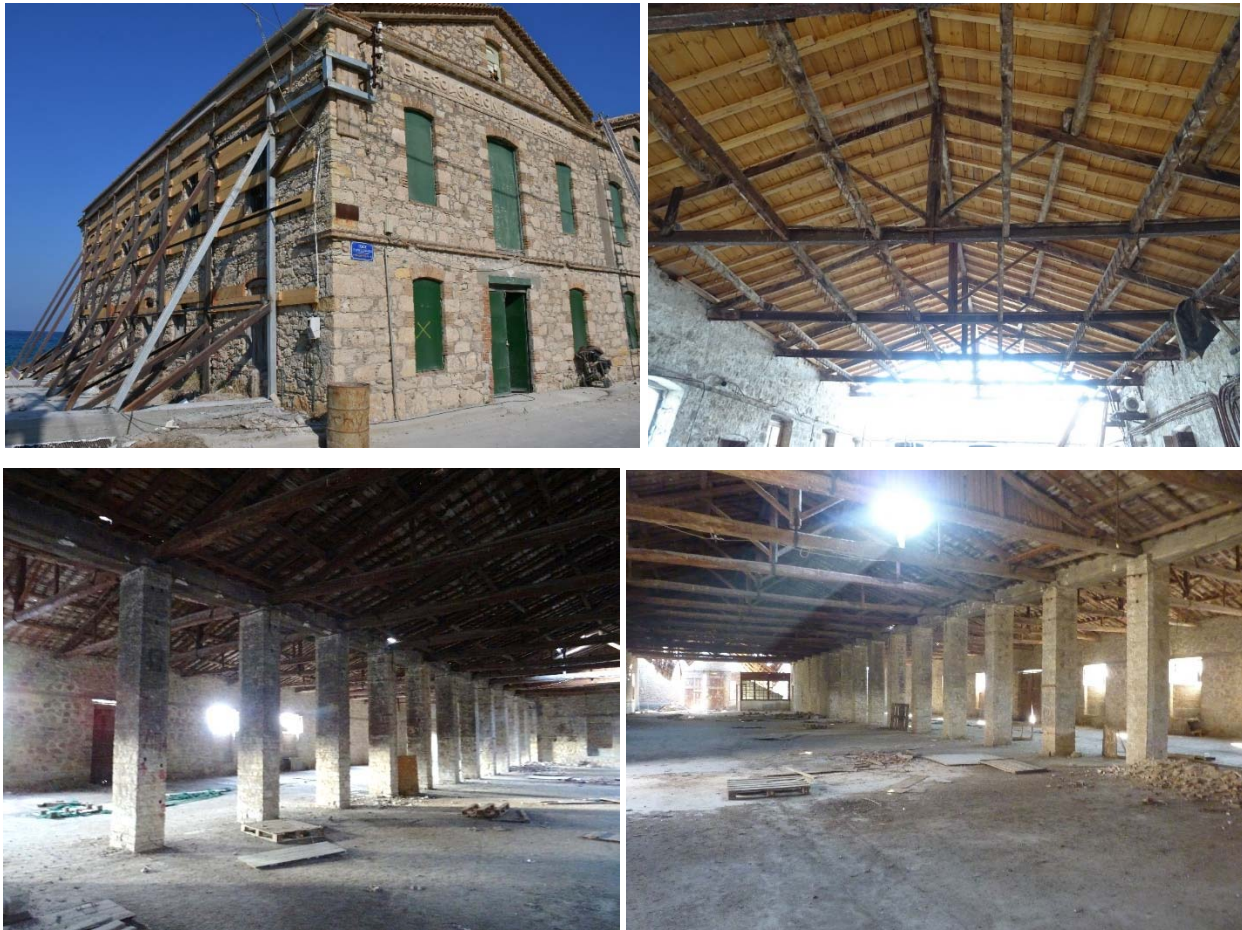
The buildings exhibited typical damage, mainly out of the plane of their long walls. For the tanneries closer to the sea, some of the damage observed could also be attributed to the lateral spreading of the soil, as further discussed in Chapter 5.

Figure 7.80. Typical tannery buildings at Karlovassi. Temporary out-of-plane support (top left).

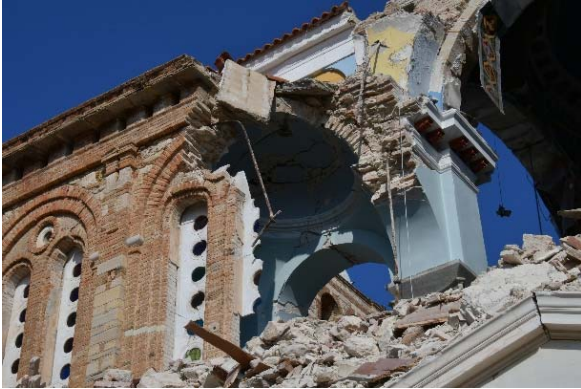
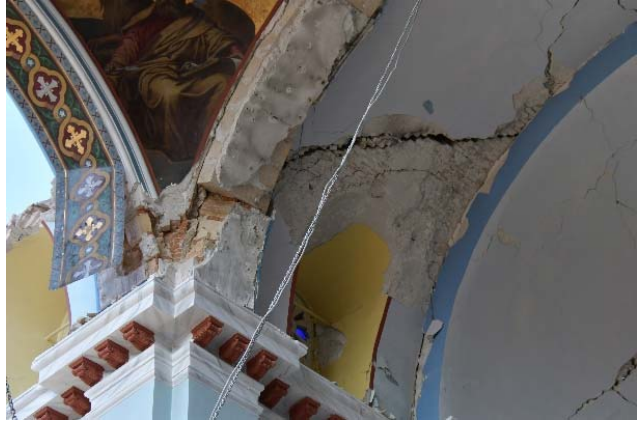
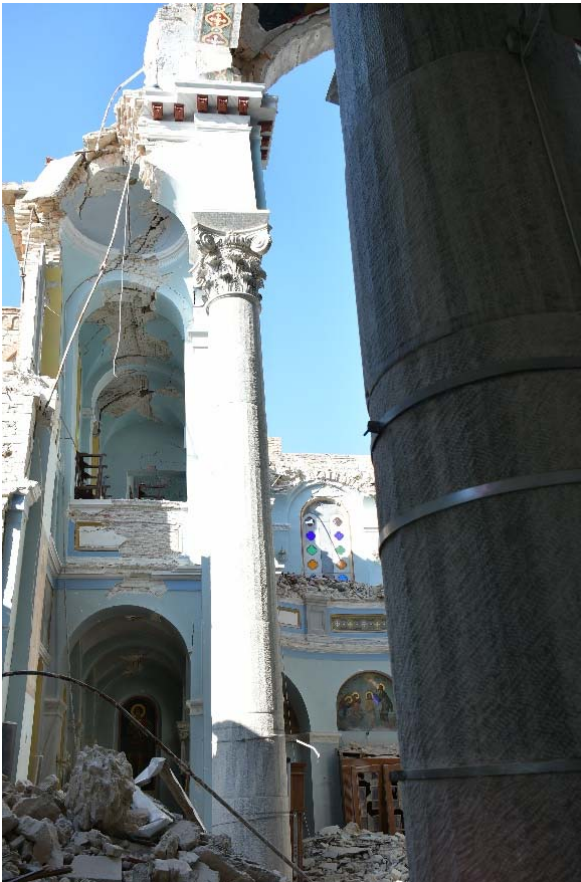
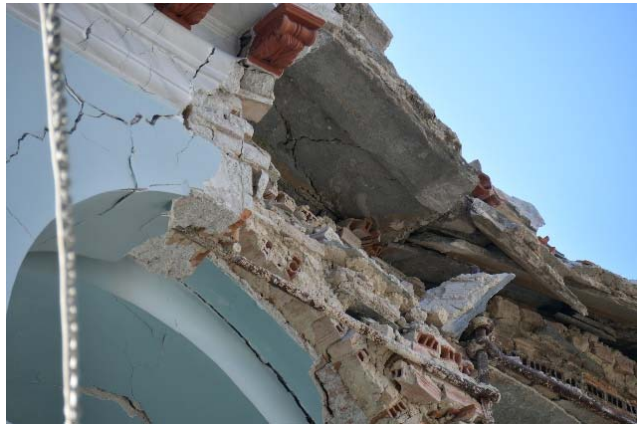
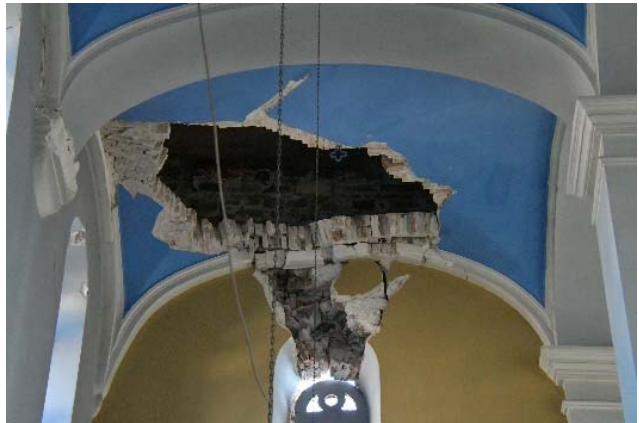
From a structural point of view, religious buildings are usually challenging structures due to their architecture and hence their dynamic response is interesting to study. Most of the churches of the island are characterized by well-constructed walls (Figure 7.82) that suffered significant, but repairable damage. On the contrary, arches and cupolas—some of which are of significant span/diameter—are rather poorly constructed and not well connected (Figure 7.83) to the body of the main structure. Thus, the well-known vulnerability of the dome-and-arches system is further accentuated by poor construction which in, several cases, led to catastrophic consequences (Figure 7.84).

Figure 7.83. Poor construction of the dome-and-arches system.

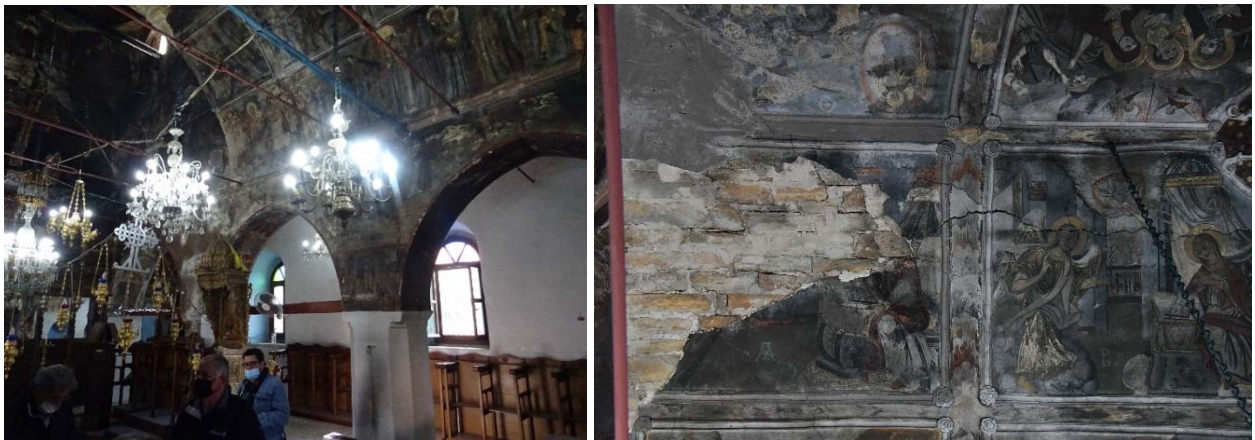
In cases where interventions were applied and the dome-and-arches system was provided with steel ties (Figure 7.85), collapse was avoided, although significant damage was not prevented. Of special interest is the seismic response of bell towers. These structures generally exhibit seismic behavior dissimilar to other masonry structures, because of their unique characteristics such as the slenderness and the shape. Damage in bell towers is shown in Figures 7.86, 7.91 and 7.92.

Figure 7.85. Steel ties were installed to alleviate the effect of the thrust of dome-and-arches roofs.

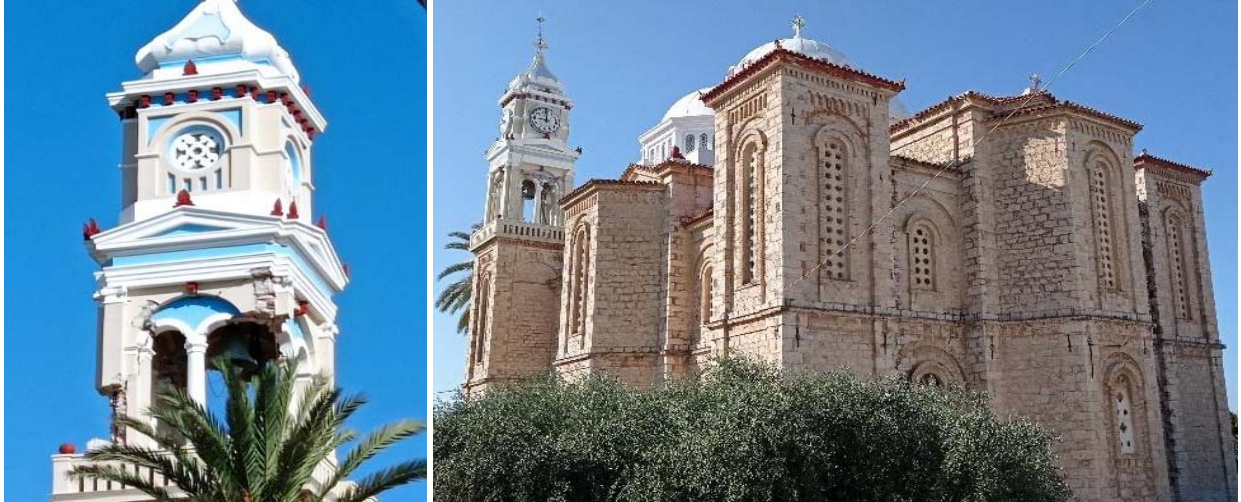
Figure 7.86. Cathedral of the Assumption of the Virgin Mary in Karlovasi. Heavy damage observed in both bell towers which were not built at the same time as the main part of the temple but were added afterwards.

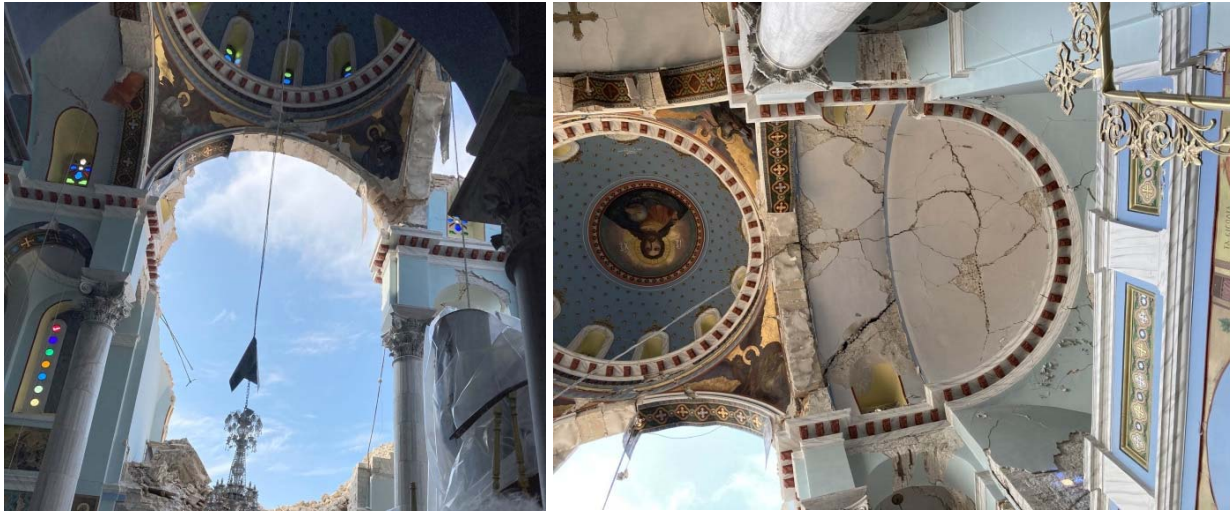
Figure 7.87. Roof failure on the west side of the Cathedral of the Assumption of Virgin Mary in Karlovasi.

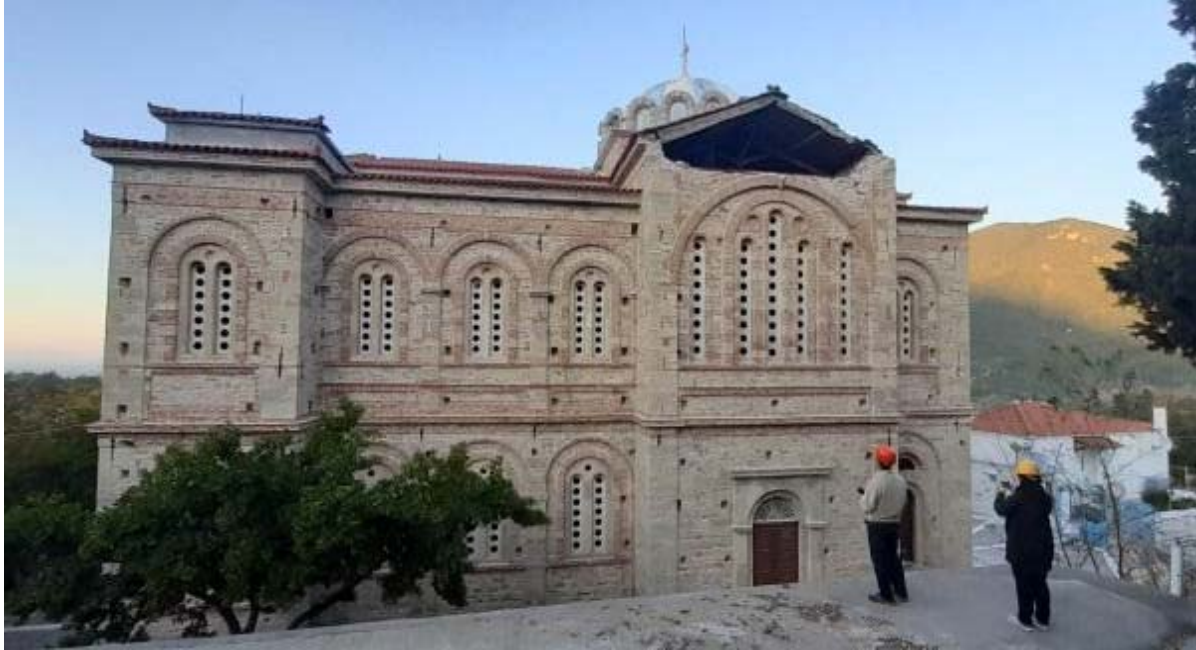
Figure 7.90. Out-of-plane failure of the gable below the roof of the Church of Genesis of Virgin Mary at Konteika, which dates back to the 19th century.

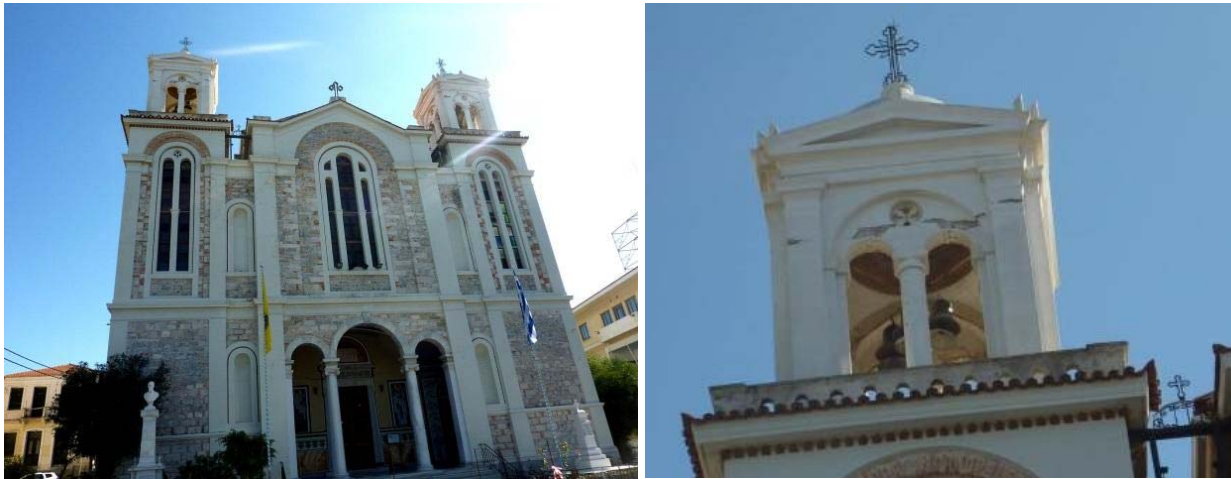
Figure 7.91. Shear failure at the bell tower of the Agios Spyridon Cathedral at Bathi.

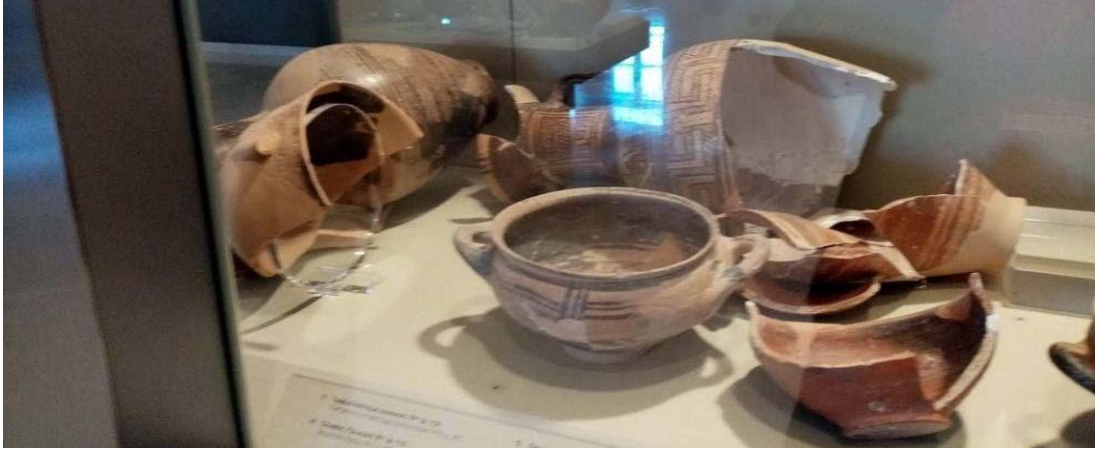
In Samos there is a large number of cultural buildings, archeological sites, monuments and museums with important exhibits. The earthquake caused failures, some of which led to irreparable damage. In the Archaeological Museum of Pythagorion city, ancient vessels suffered damage due to overturning, while in some sculptures the welds were broken (Figure 7.94). Close to Pythagorion city, segments of the perimeter walls of the Castle of Lycurgus Logothetis collapsed (Figures 7.95-7.96). Furthermore, in the same area, columns of the Early Christian Basilica of the Castle overturned as shown in Figure 7.97. On the other hand, the Castle of Lykourgos Logothetis survived the earthquake suffering no damage due to fact that it was recently seismically rehabilitated (Figure 7.98). At the Archaeological Museum of Vathy, a crack was formed at the thigh of the famous oversized marble sculpture of Kouros, which dates back to 570 BC (Figure 7.99). At the archaeological site of Heraion of Samos (dedicated to the goddess Hera during the 6th century BC) no displacement was observed in the single upright multidrum column (Figure 7.100) that survives today. However, contemporary structures that are part of the archaeological site, suffered some minor damage.

Figure 7.93. Breaking of ancient vessels in the Archaeological Museum of Pythagorion in Samos due to overturning.³
