Seismological and Engineering Effects of the M 7.0 Samos Island (Aegean Sea) Earthquake

Hellenic Association of Earthquake Engineering: Report 2020/02

Geotechnical Extreme Events Reconnaissance Association: Report GEER-069

December 31, 2020

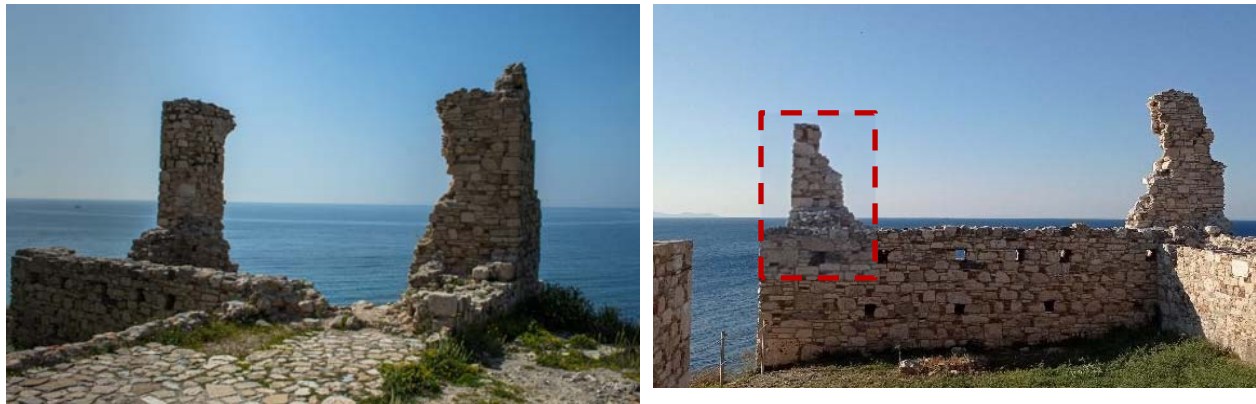
Figure 7.94. The Castle of Lykourgos Logothetis (a) before the earthquake⁴, (b) after the earthquake of the October 30th 2020, showing the partial collapse of the perimeter walls into the sea.

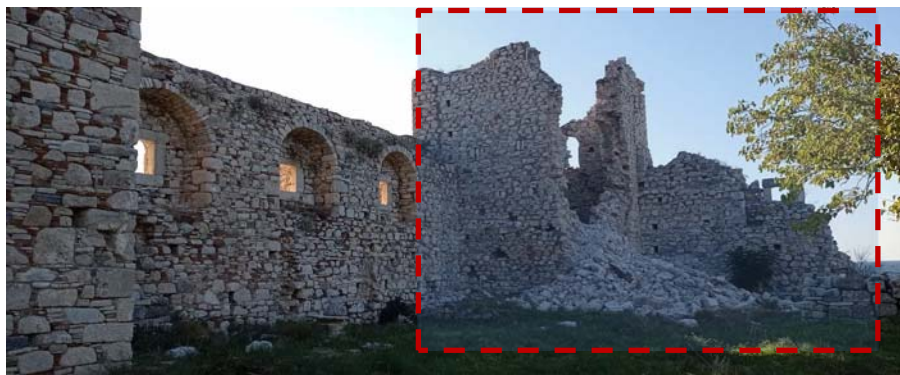
Figure 7.95. Partial collapse of the perimeter walls of the Castle of Lykourgos Logothetis.

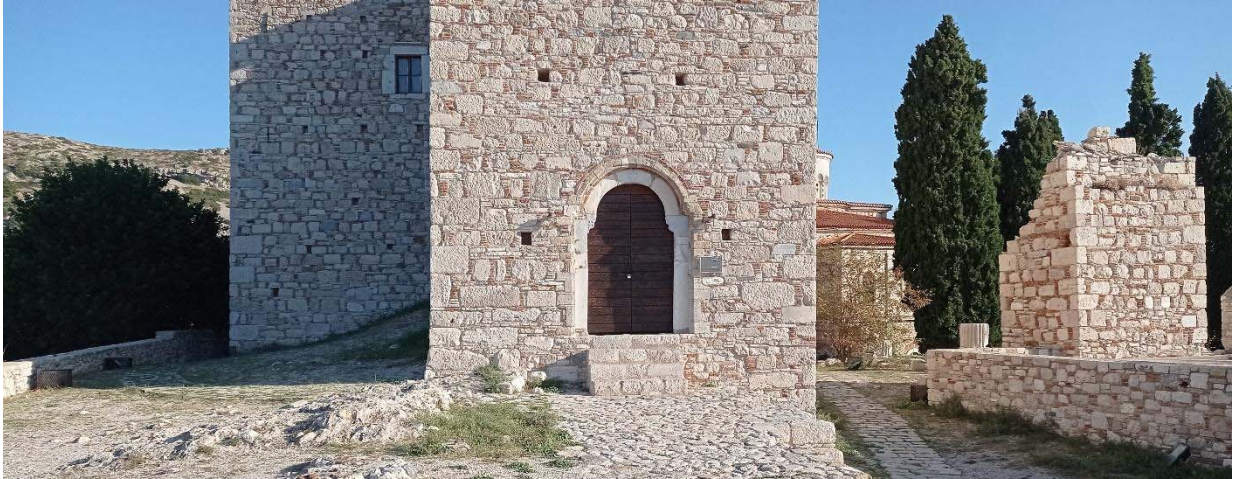
Figure 7.97. The Castle of Lykourgos Logothetis. No damage was observed; the seismic behavior of the structure was very good due to fact that it has been recently seismically rehabilitated.

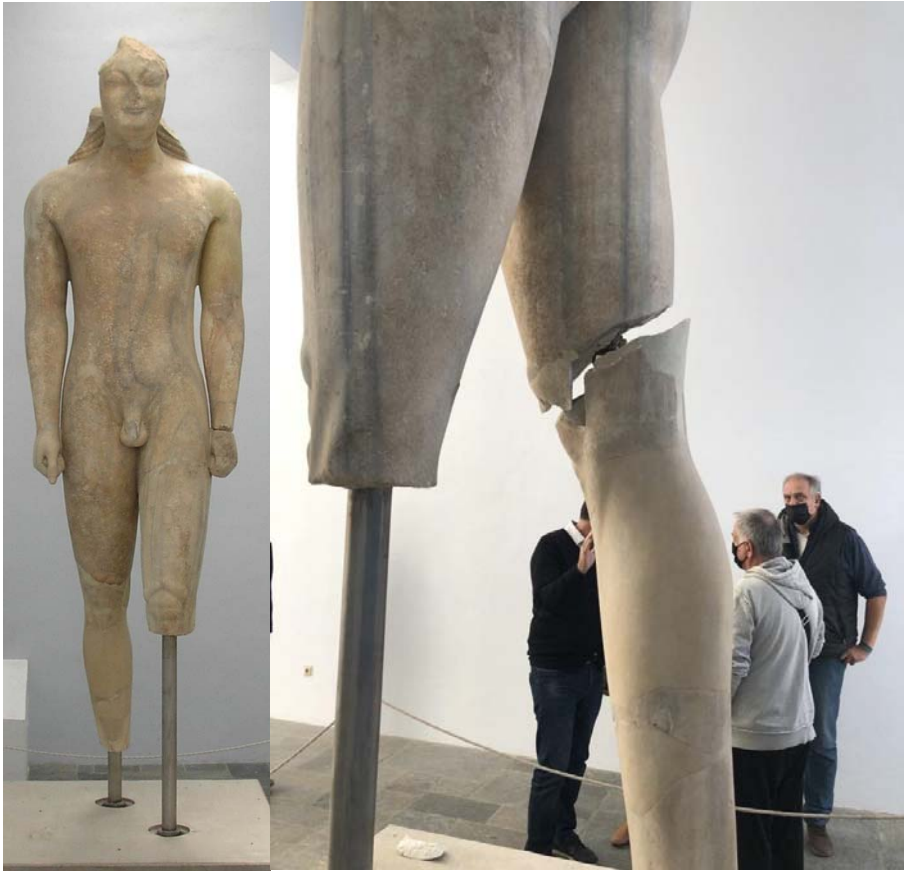
Figure 7.98. Overview of the sculpture of Kouros at the Archaeological Museum of Vathy in Samos (the largest Kouros in Greece) before the earthquake (left) and crack in the thigh of the sculpture as a result of the recent earthquake (right)⁶

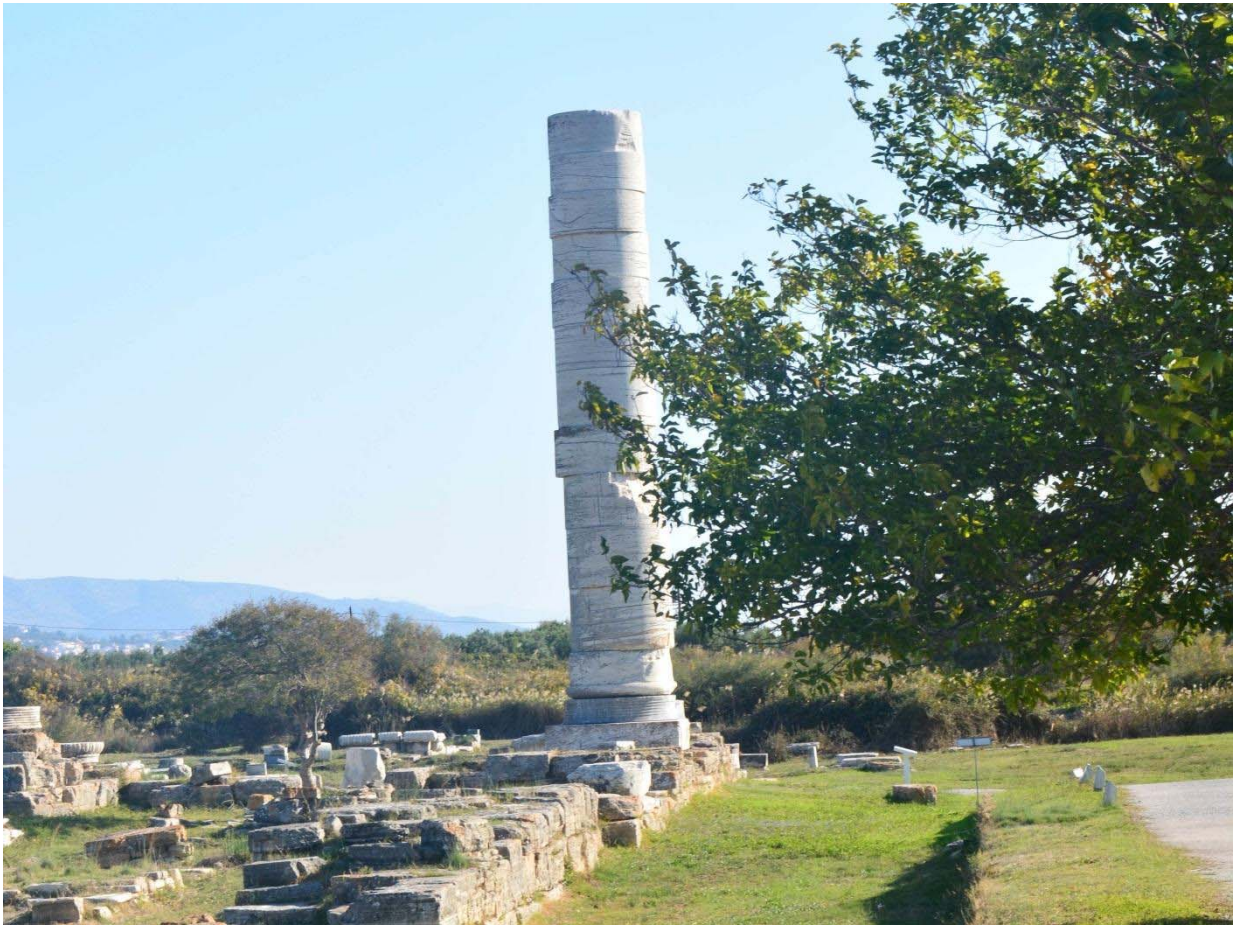
Figure 7.99. Archaeological site of Heraion of Samos. No evident displacement was observed on the single upright multidrum column (though minor displacements could be possible).

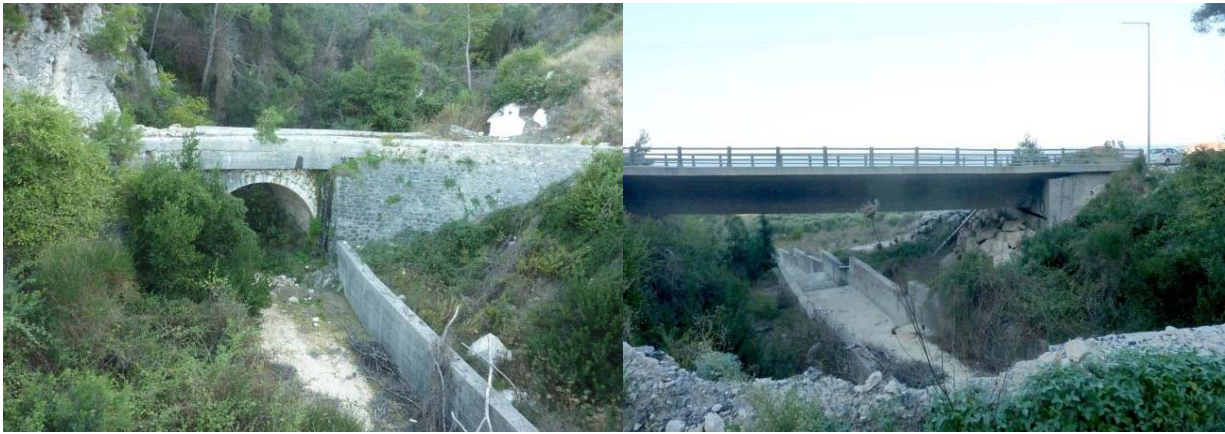
Figure 7.100. Stone and reinforced concrete bridges along the roadway network of Samos

Given the size and the topography of the island of Samos, the number of bridges is limited. No damage was observed or has been reported to any of the bridge structures.

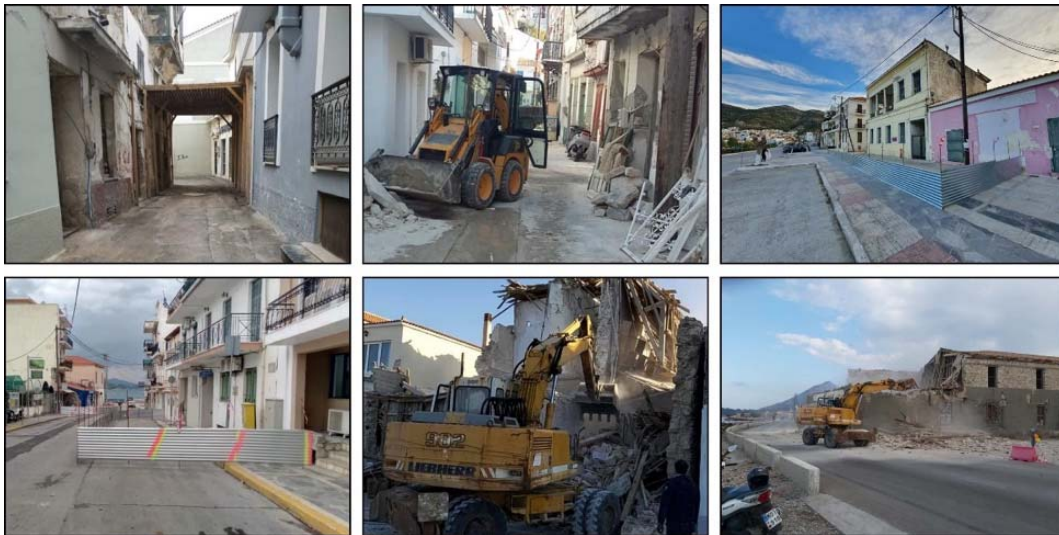
Figure 8.11. Actions for the mitigation of hazards the affected population and workers will likely encounter in the aftermath of the earthquake in Samos. Supporting of buildings, removing debris from roads and pavements, placement of markings and protective barriers to severely affected buildings in order to avoid approaching, demolition of unstable buildings dangerous for cars and passersby.

- Identification of damage induced to electricity, water supply and regional and municipal road networks by the earthquake and repair.
- Identification of hazards and placement of markings and protective barriers

- Cleaning of regional, municipal and community roads and removal of debris accumulated on the roads after landslides and rockfalls.
- Cleaning of regional, municipal and community roads and removal of debris resulting from partial and total collapse of buildings.
- Demolition of unstable and dangerous buildings after the final consent of the owners as well as abandoned buildings.

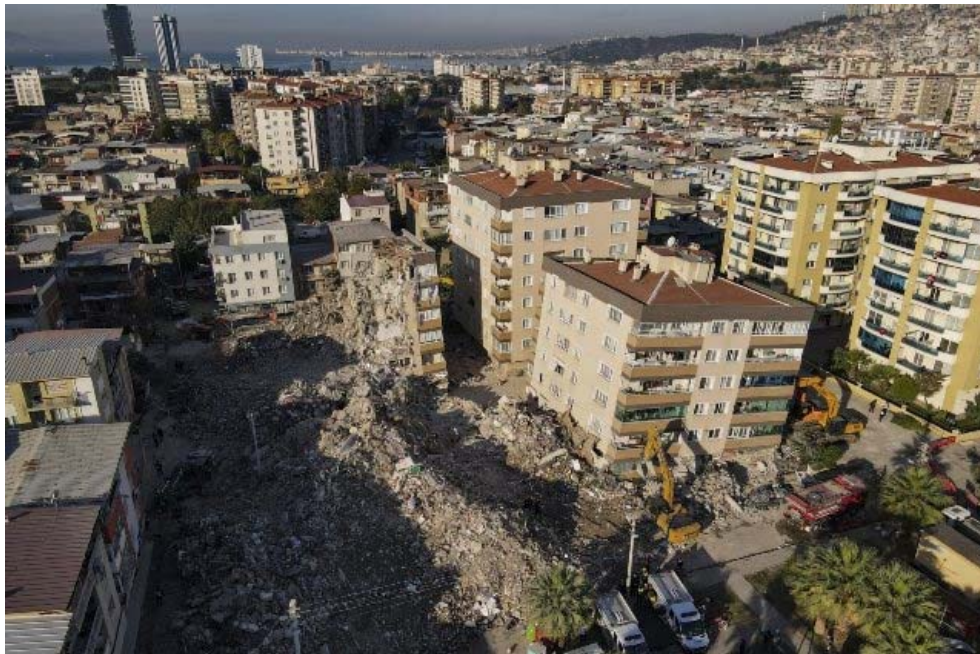
Figure 8.17. Collapsed buildings in Izmir on Friday, Oct. 30, 2020.

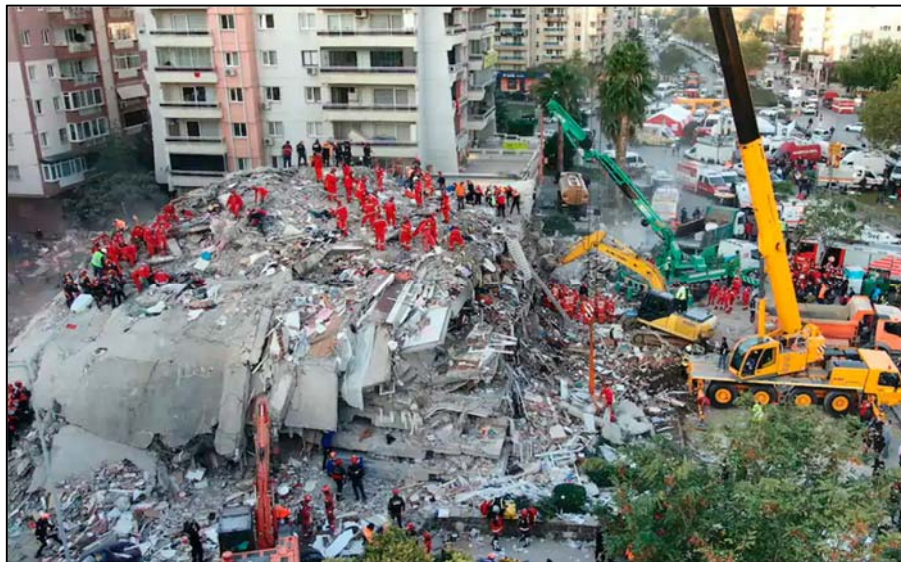
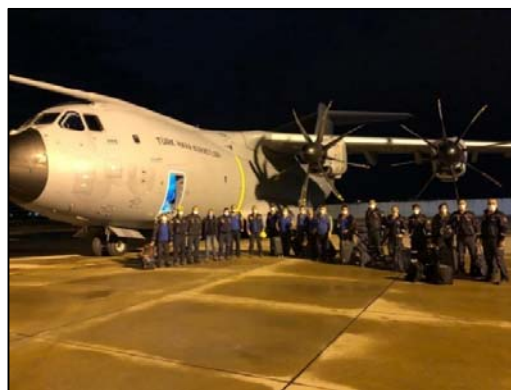
Figure 8.18. Rescue teams arriving Izmir and operating on the debris of a collapsed building

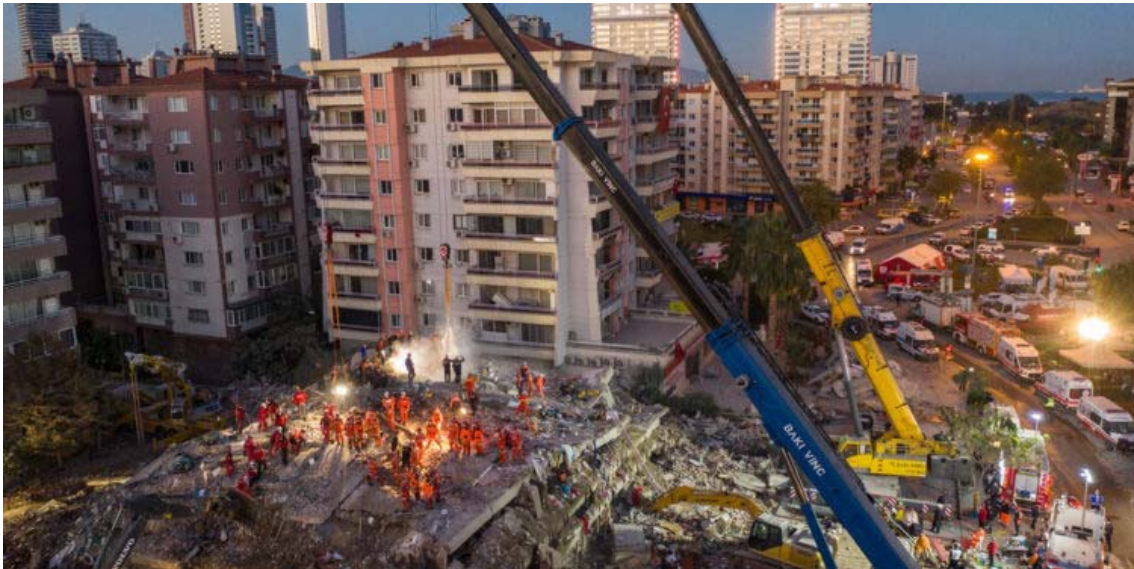
Figure 8.23. Search and rescue teams on a collapsed building
