The Corps of Engineers and ERDC Geotechnical related activities during Earthquakes

Richard S. Olsen, PhD, PE

U.S. Army Engineer Research and Development Center (ERDC)

October 7, 2004

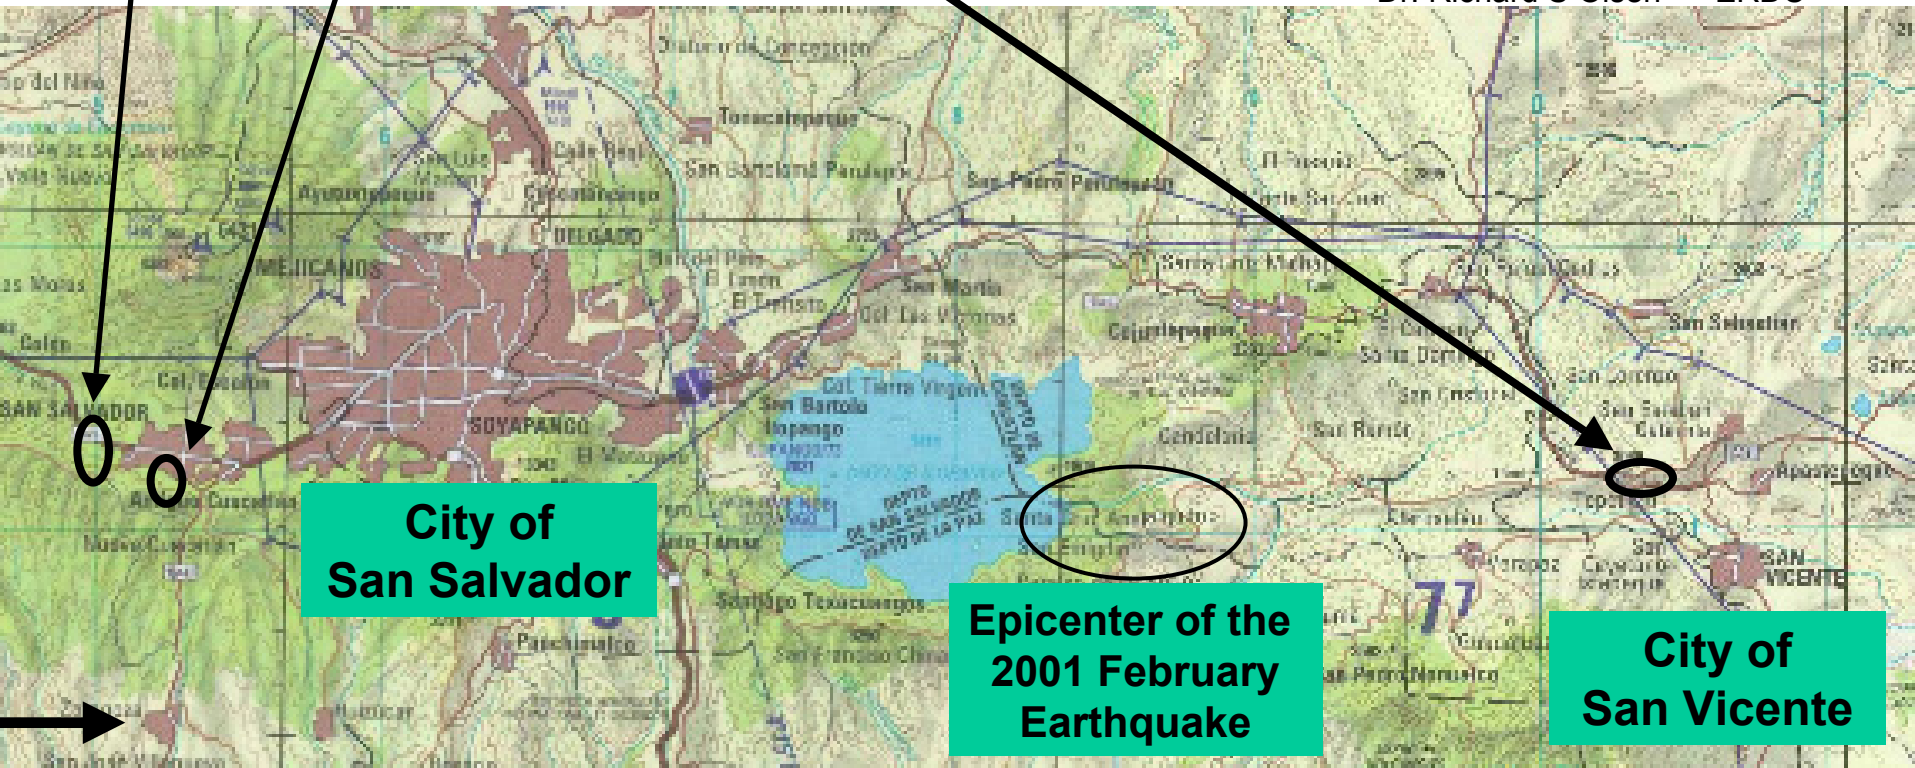
Landslide observations along the Pan American highway

Traveled at 50 mph plus – several deaths

Closed Pan American highway for a week

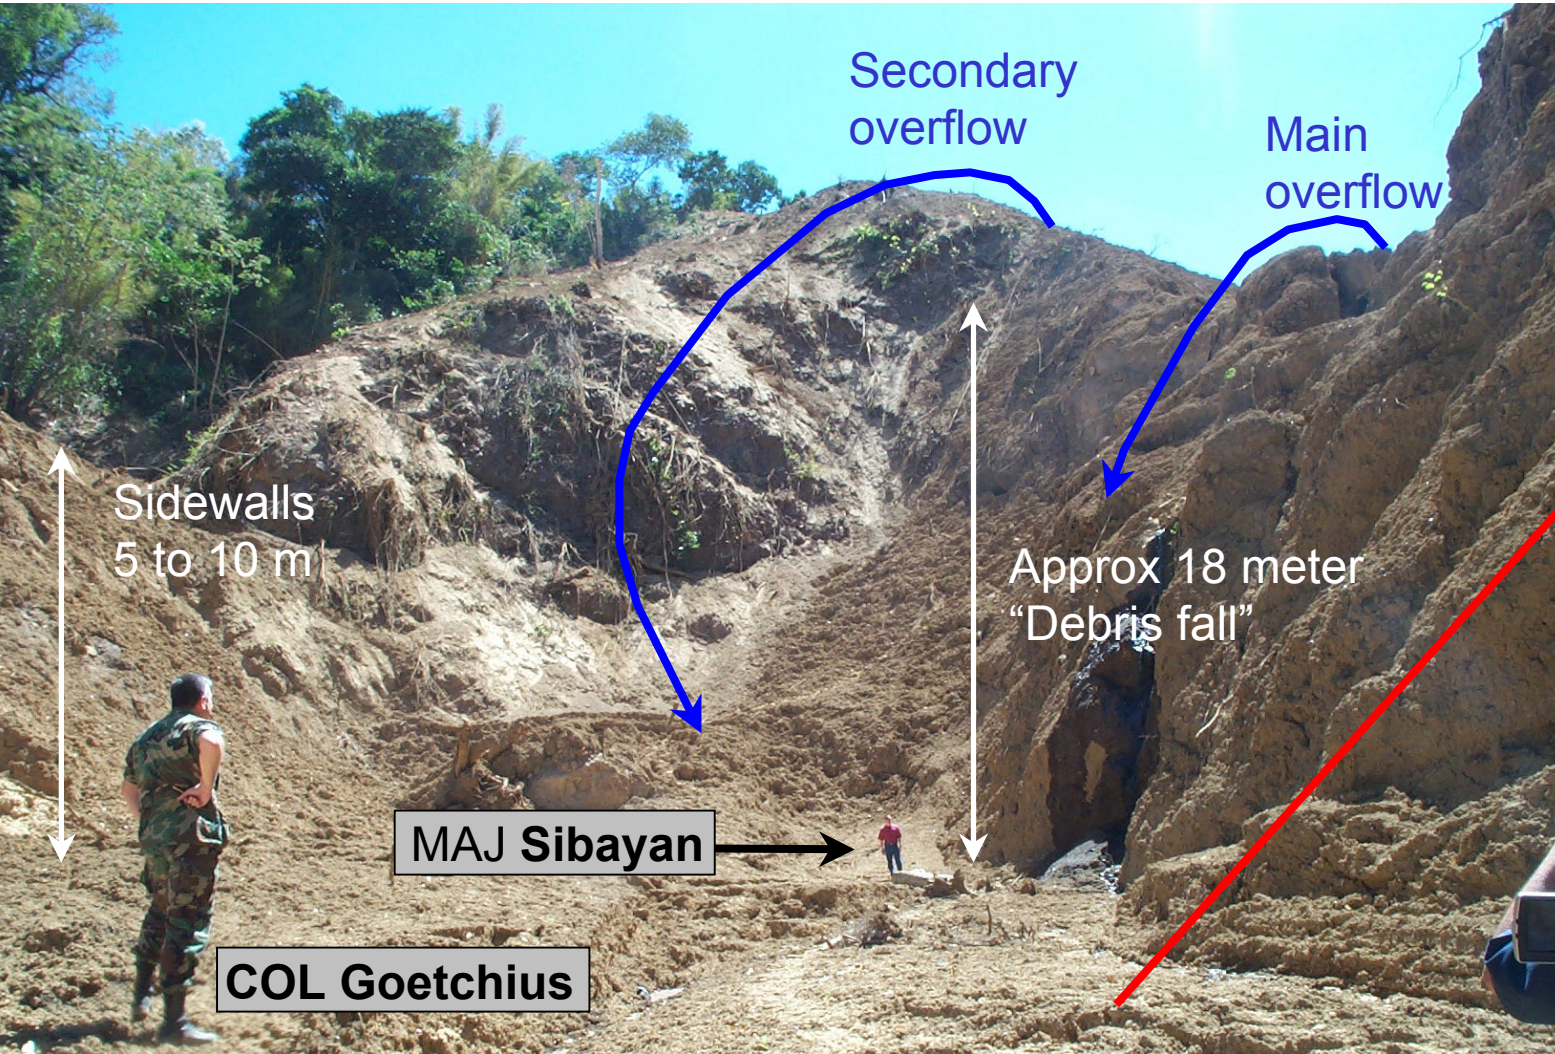
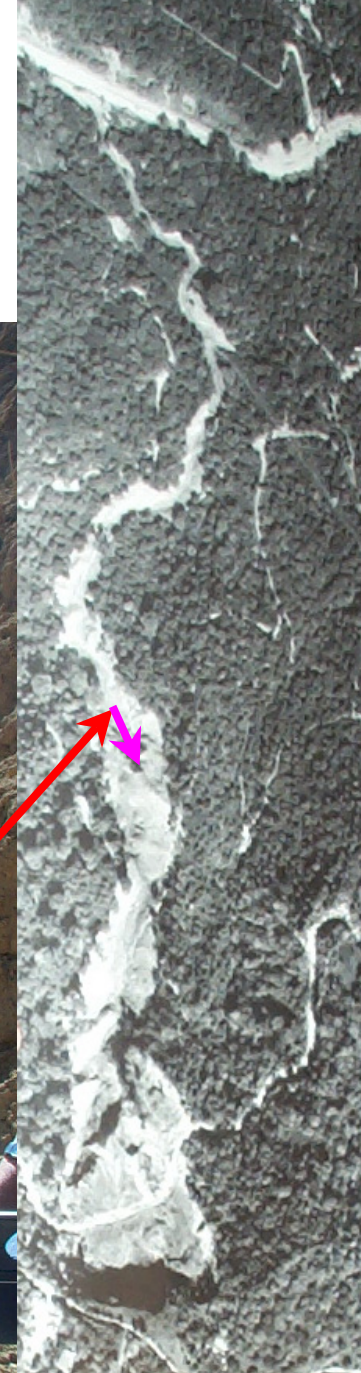
Los Chorros "Chute" Landslide

The main landslide was triggered because of a 20 year old dirt road. The initial failure jumped the road and started the debris chute slide.

The “chute” Landslide

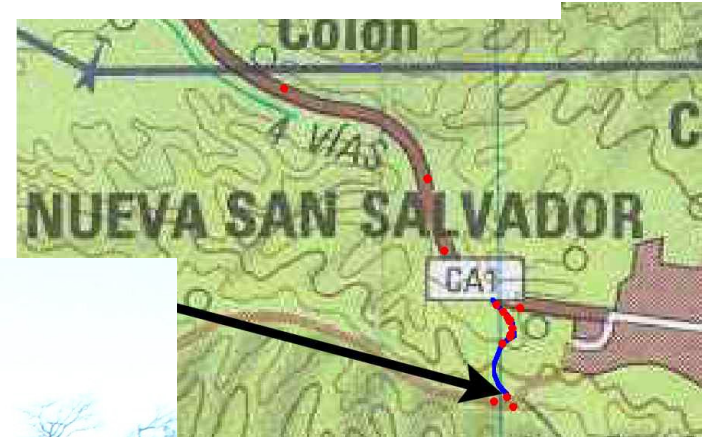
The headwall

Pre Slide shape

Road cut (40 years ago) removed the toe from the future landslide

Land developers appeared to have cut into the toe of this future landslide mass. The missing toe was the main ingredient that triggered this devastating landslide
THE TRIGGER

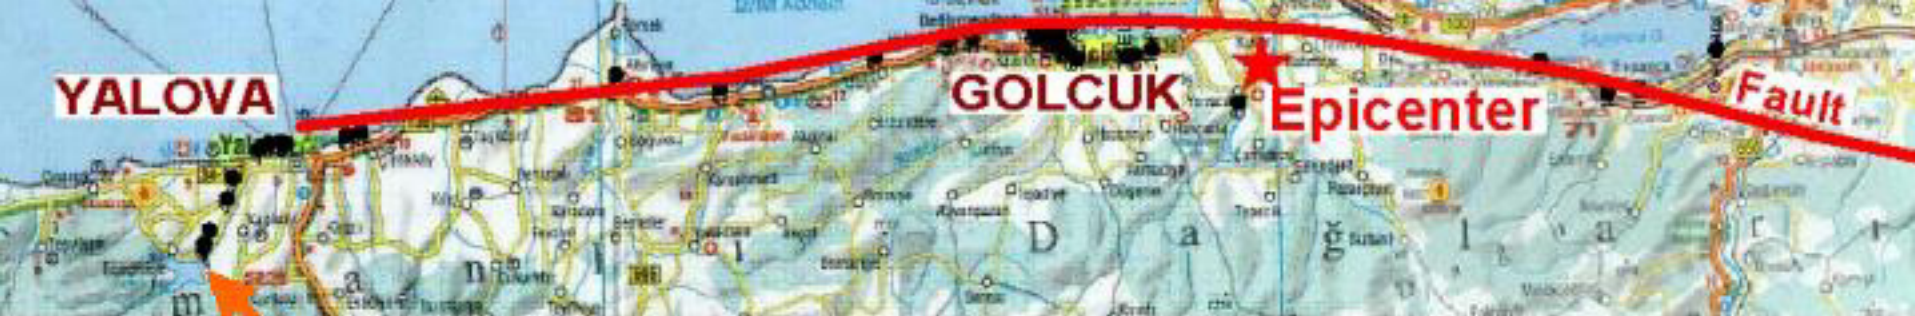
N40.598 E29.204 Near the City of Yalova, Turkey

A single 9 mm wide crack the length of the dam was observed on the upstream side of the crest gravel road. The upstream side of this crack was 2 mm lower than the downstream side.

A 7mm wide crack (and 2mm drop) over a potential 150 m slip length represents 0.005% slippage. This dam experienced minor elastic based movement to reestablish the static strength – excellent performance.

This type of crack and crack width should be expected for a magnitude 7+ earthquake event because a stiffer compacted dam is bad for many other reasons.

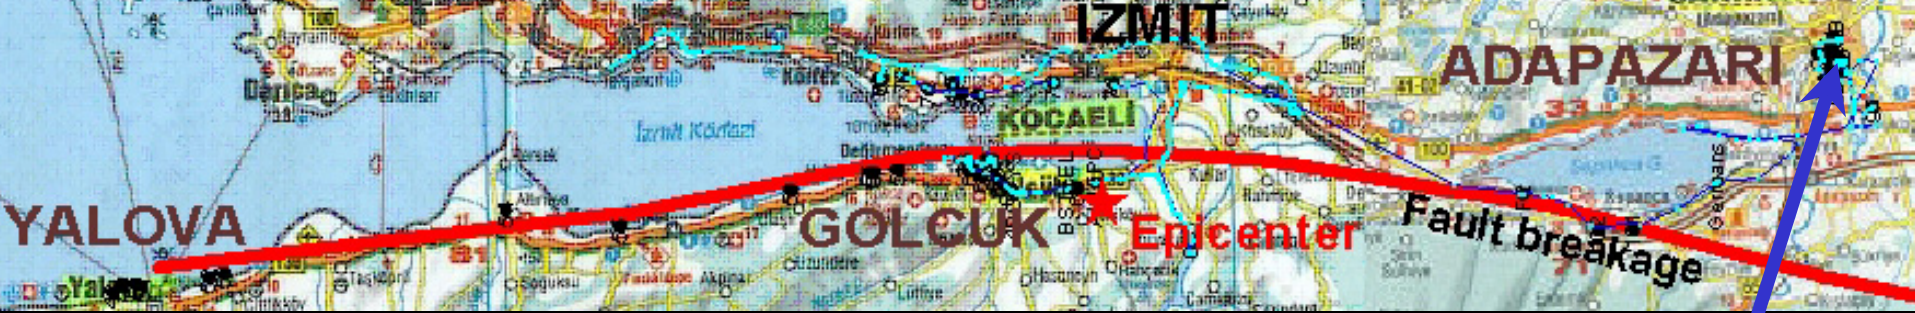
N40.775 E30.4045
City of Adapazari, Turkey

**Silt liquefaction caused bearing failure
(no liquefaction boils were observed)**

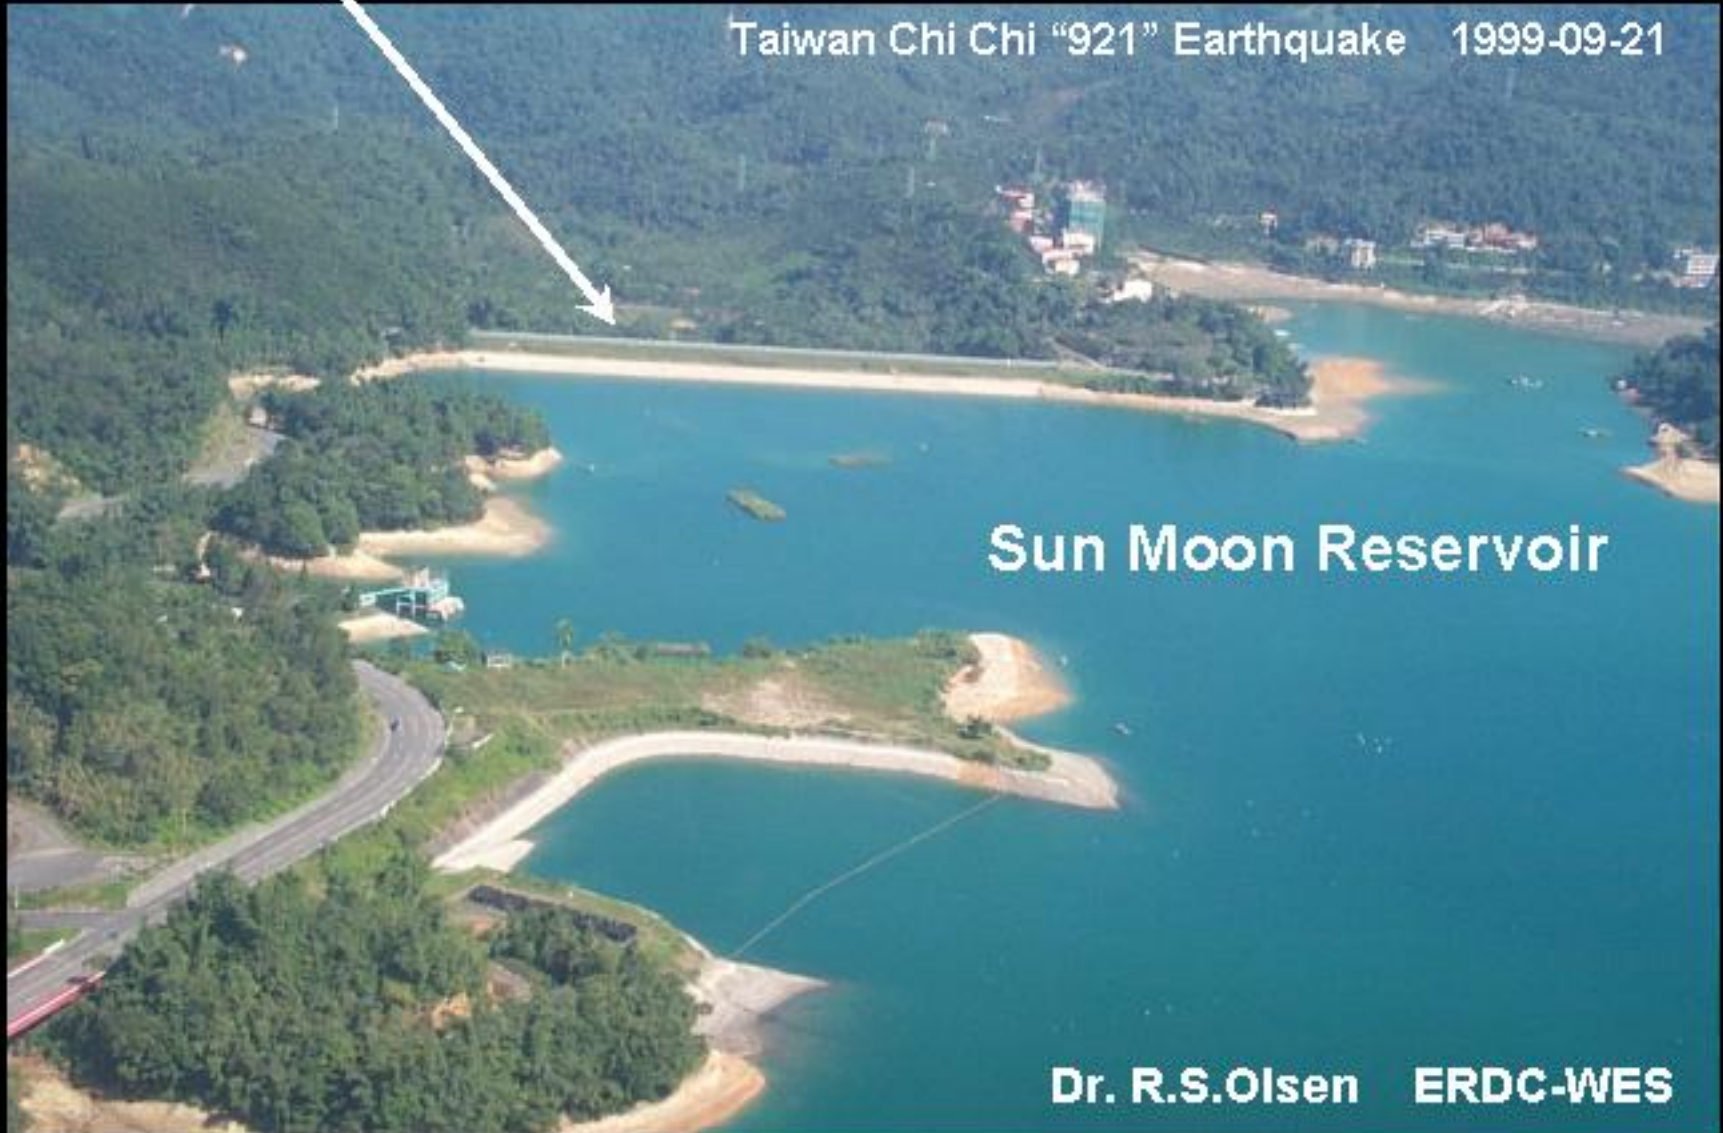
Shuishih Dam

Shuishin dam, build in 1934, experienced 30 cm of settlement within the shell during the Chi Chi earthquake. This shell settlement caused the shell to move away from the concrete cutoff wall resulting in reflection cracks, as shown.

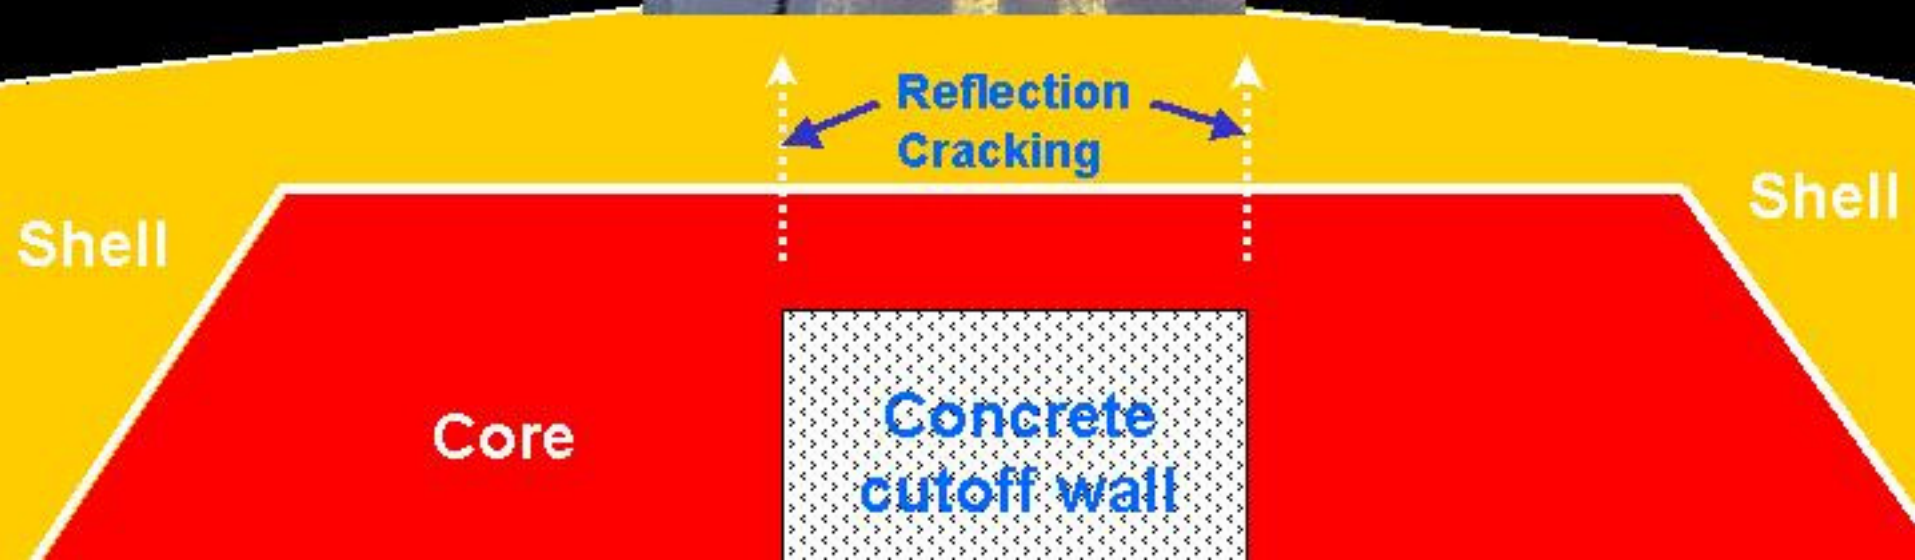
Shuishih Dam – Sun Moon Reservoir

What causes the settlement and cracks?

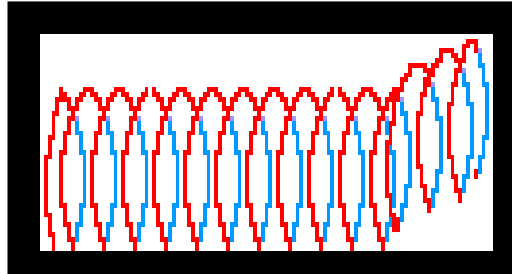
El Berrinche Landslide (during Hurricane Mitch) Tegucigalpa, Honduras

Large landslides generally move in segments with time

The El Berrinche landslide moved in segments based on interviews with people that experienced it

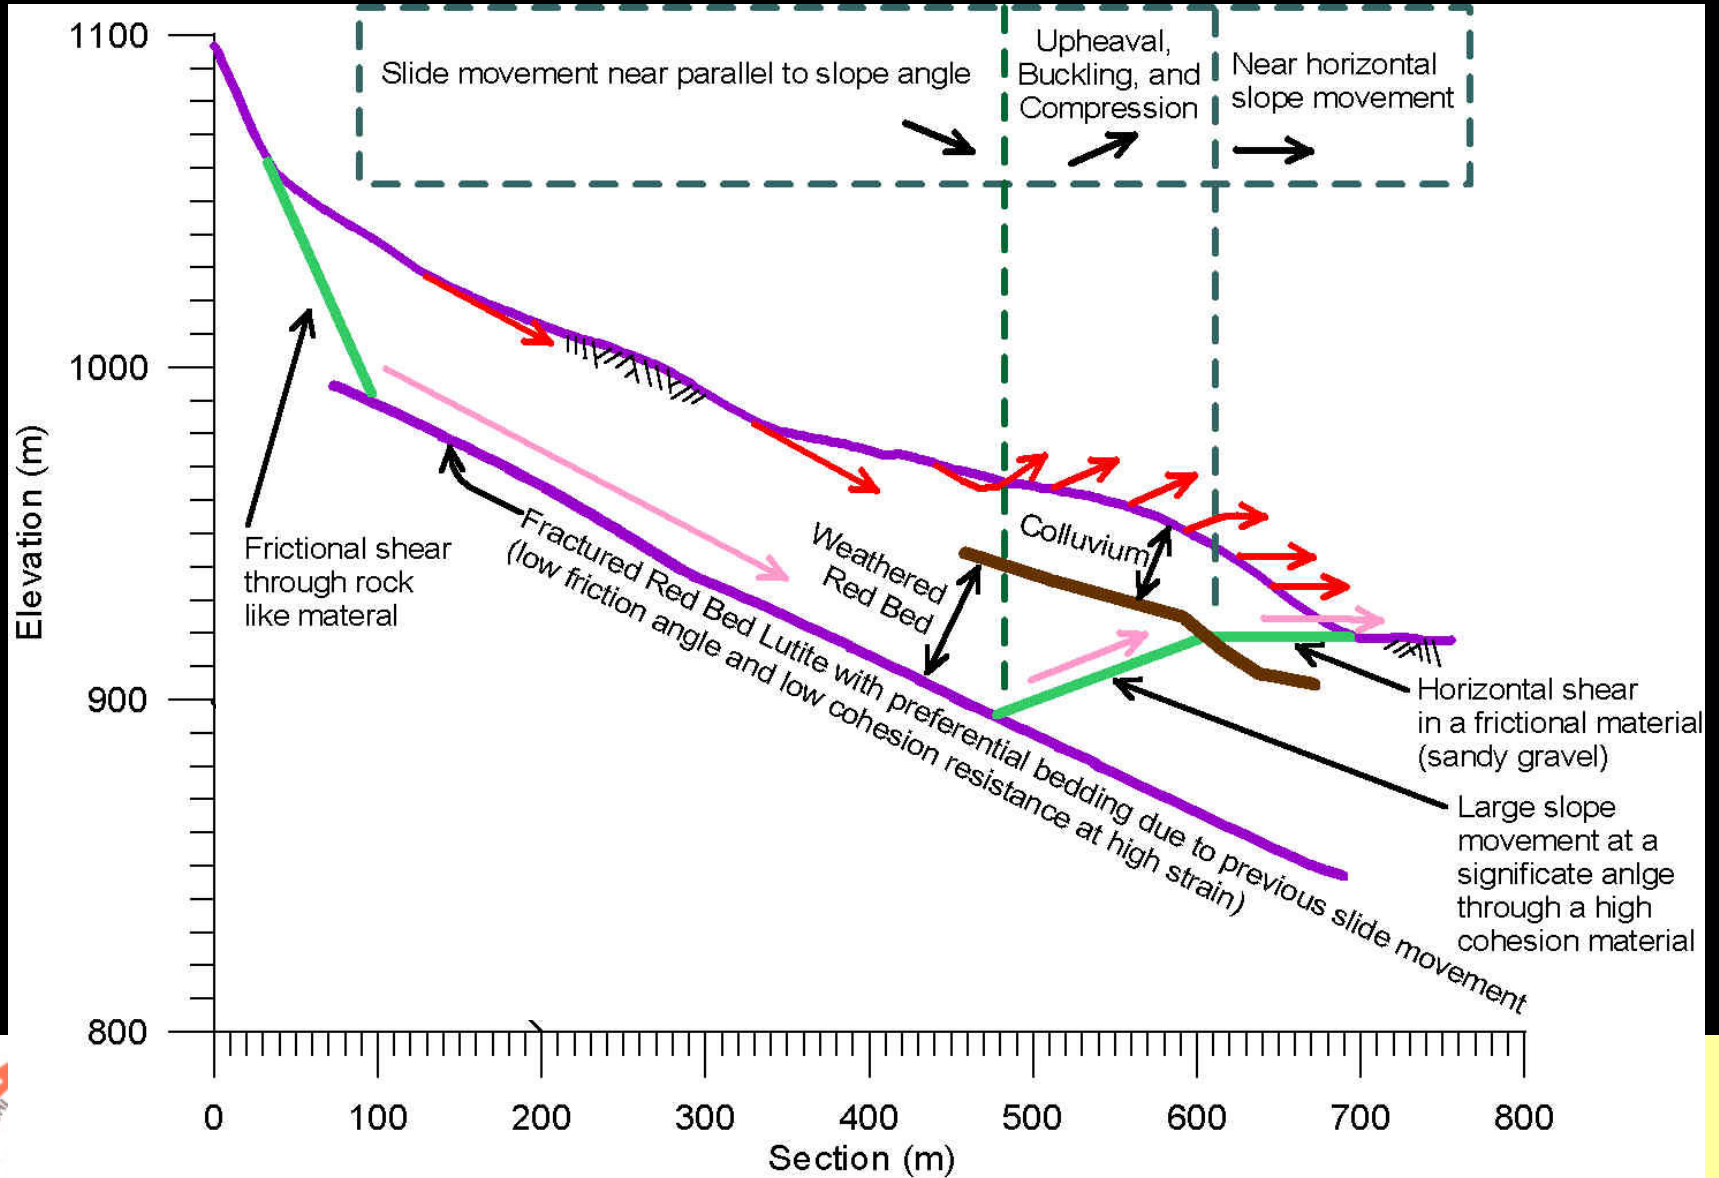
**El Berrinche
Landslide**

Mechanics of Failure of the Main Slide Block

Main slip plane

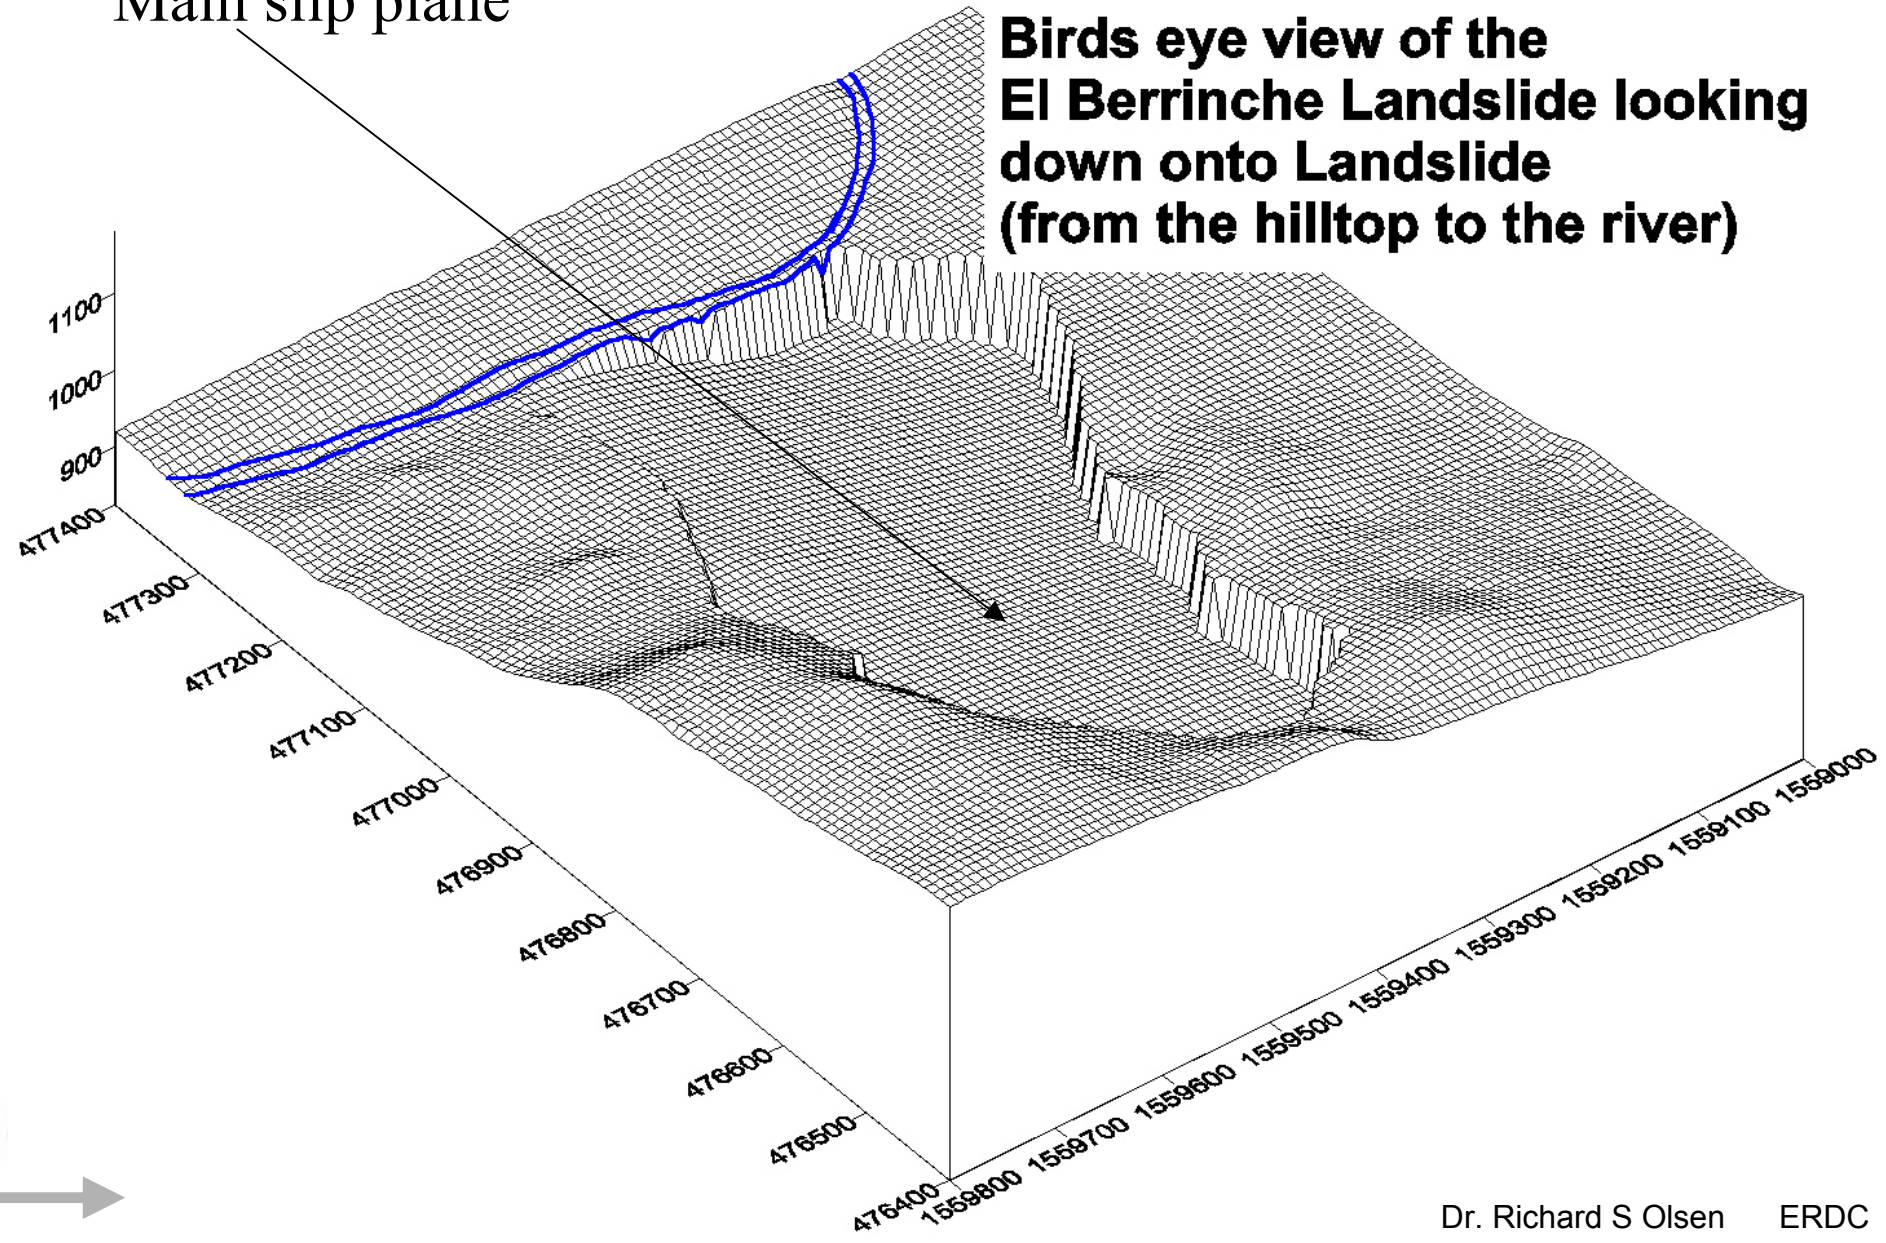
**Birds eye view of the
El Berrinche Landslide looking
down onto Landslide
(from the hilltop to the river)**

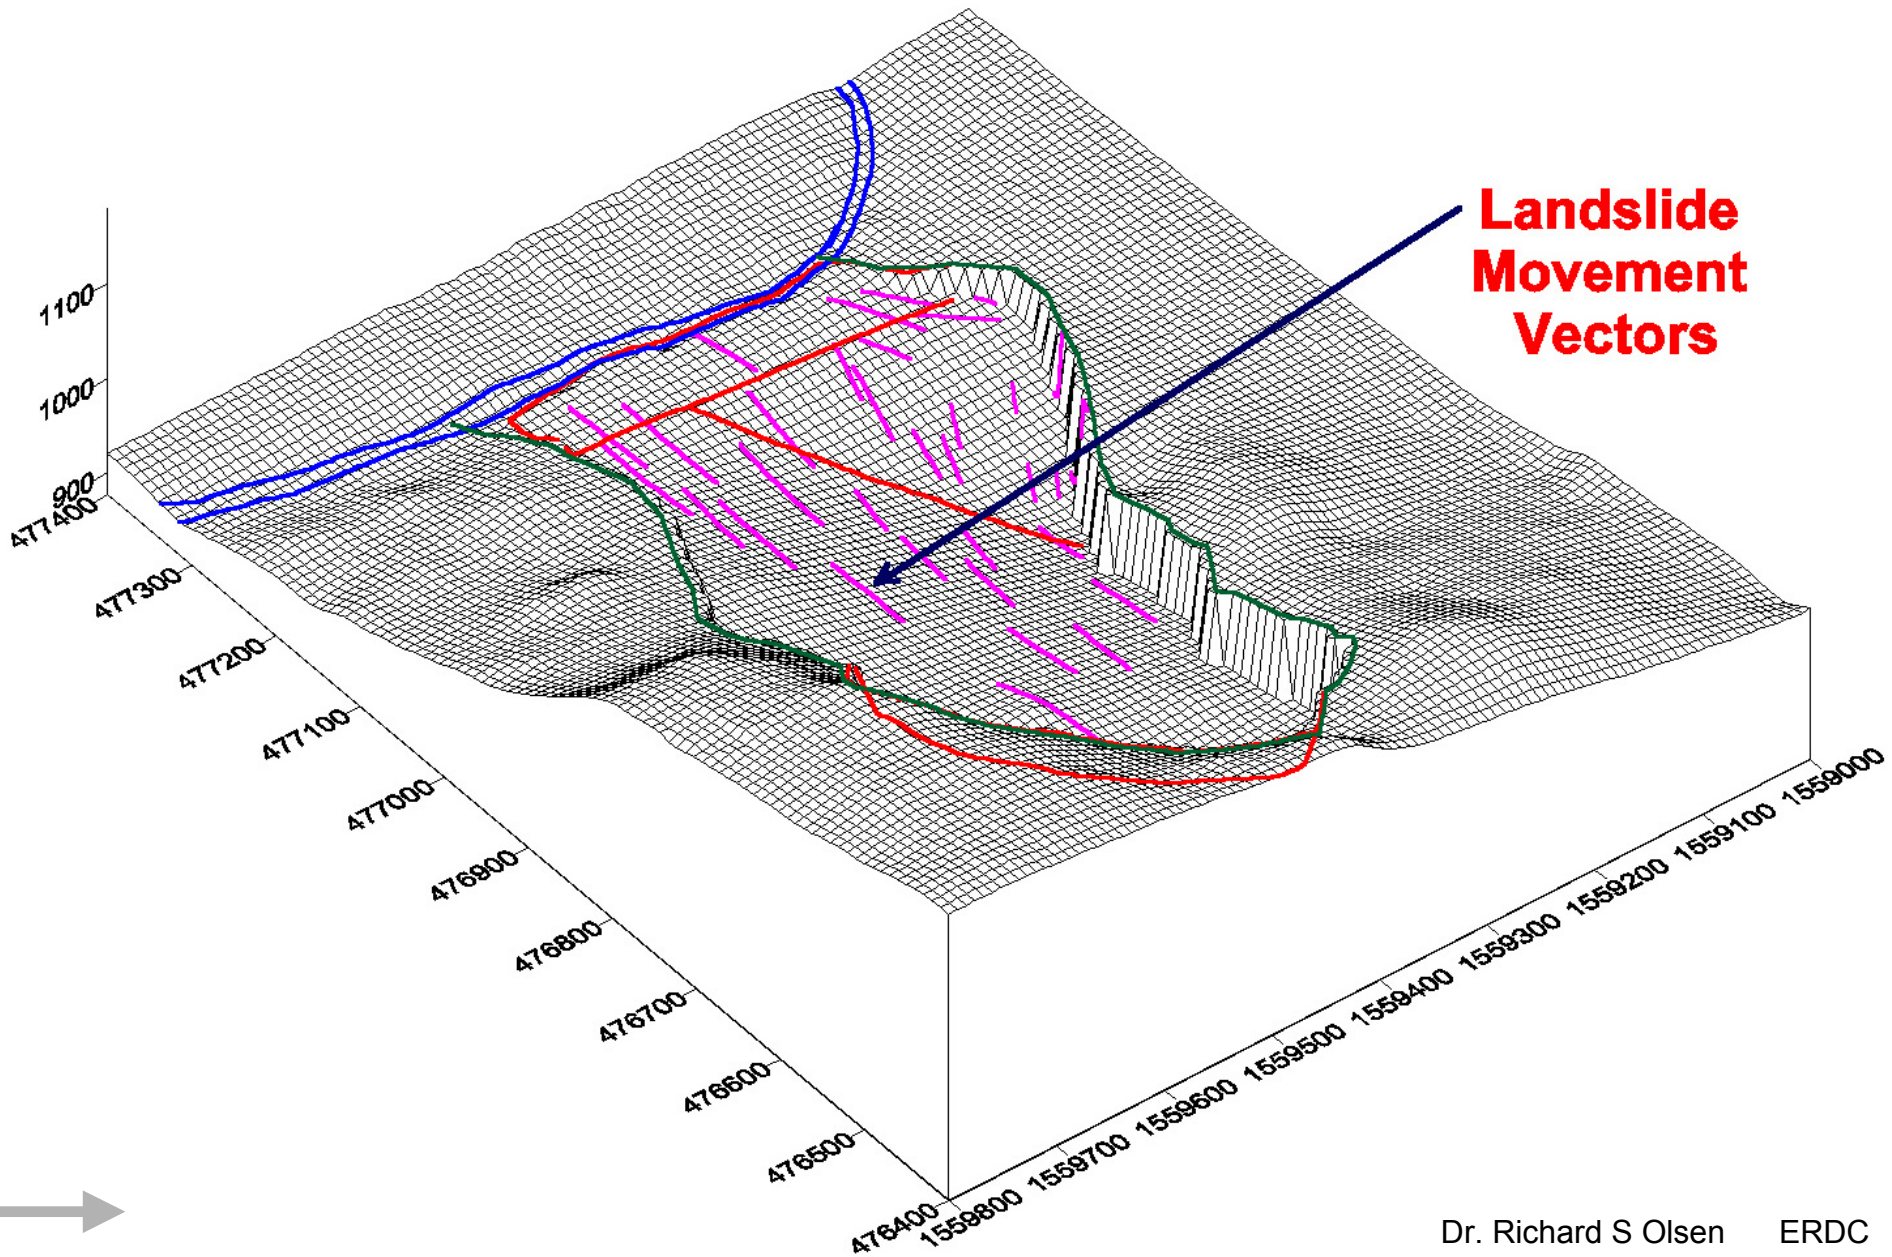
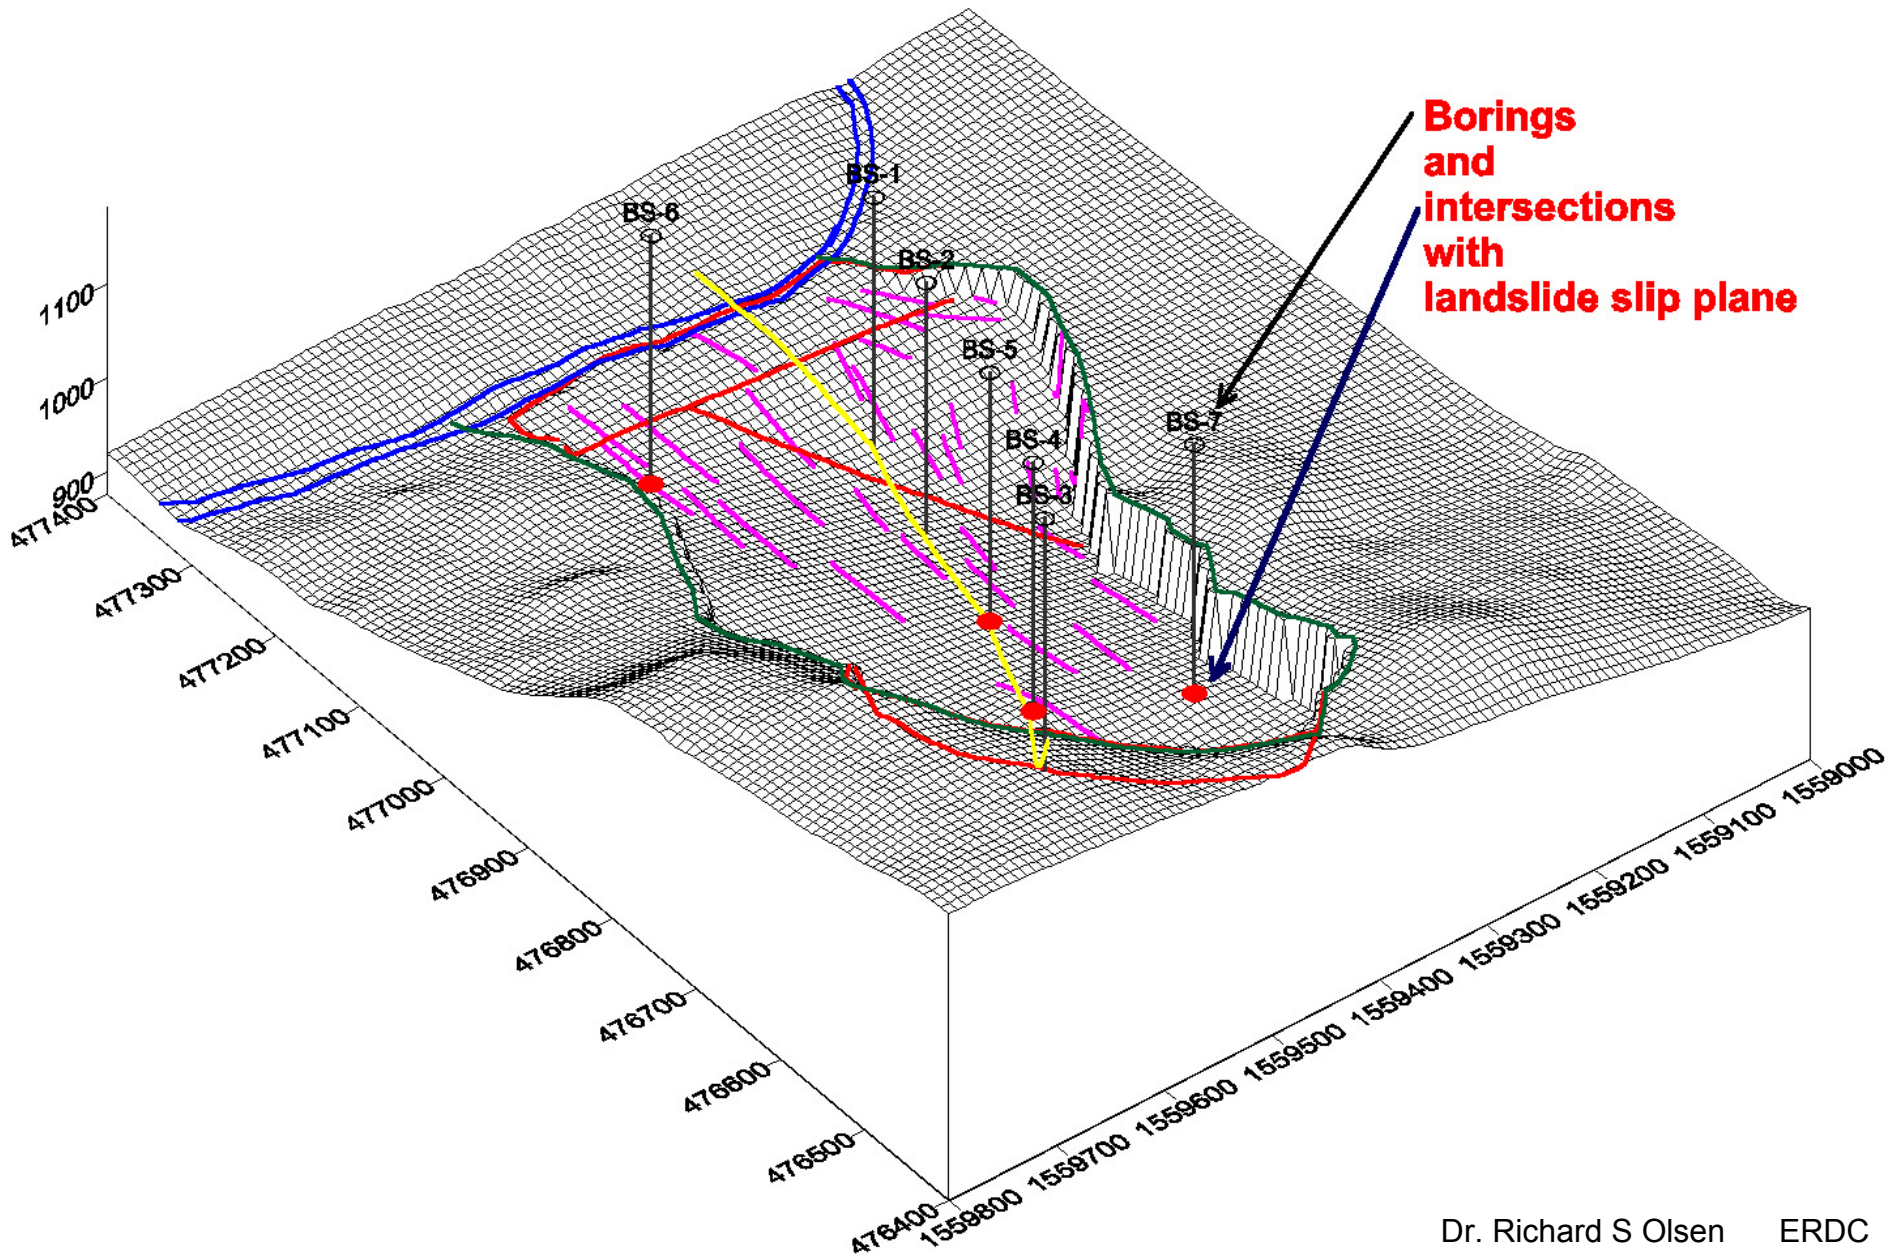
**Sliding Surface
Made up of
Several
Segments**

Landslide was trigger at the north side of the toe (toe was blown out due to high exit seepage gradient)

The two evaluated slip plane locations

Times for Maximum landslide movement

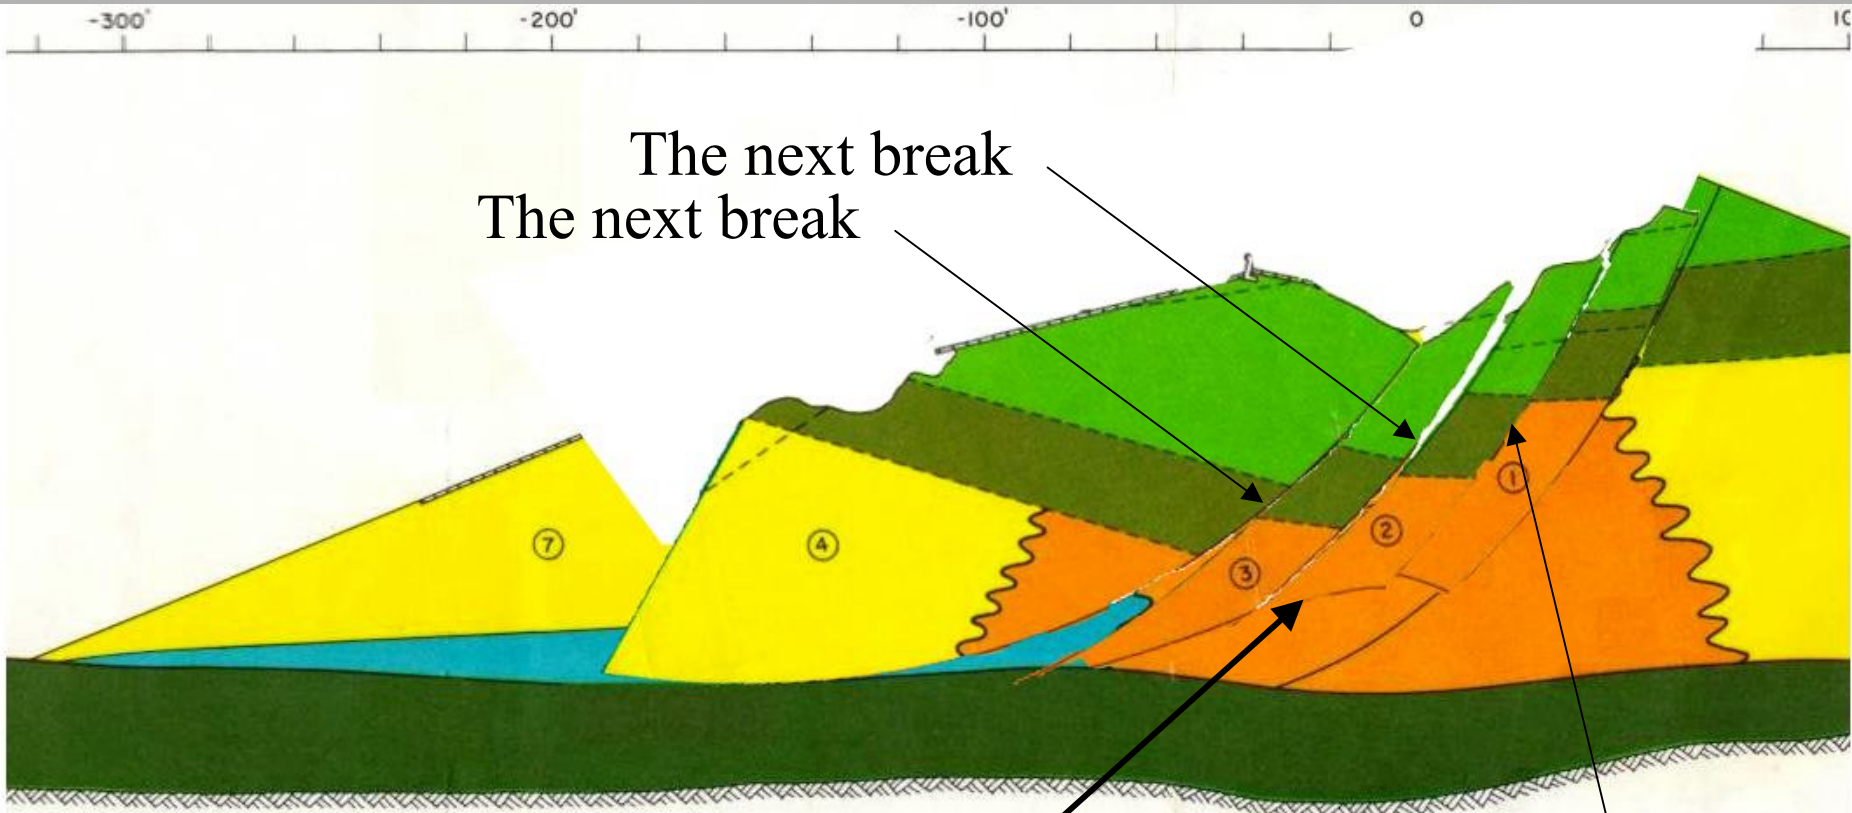
Example of a complex failure – Lower San Fernando Dam during the 1971 San Fernando Earthquake

The next break
The next break

The segment stops moving because of bearing stress and confinement on the bottom edge of each wedge

A new slip surface is then broken

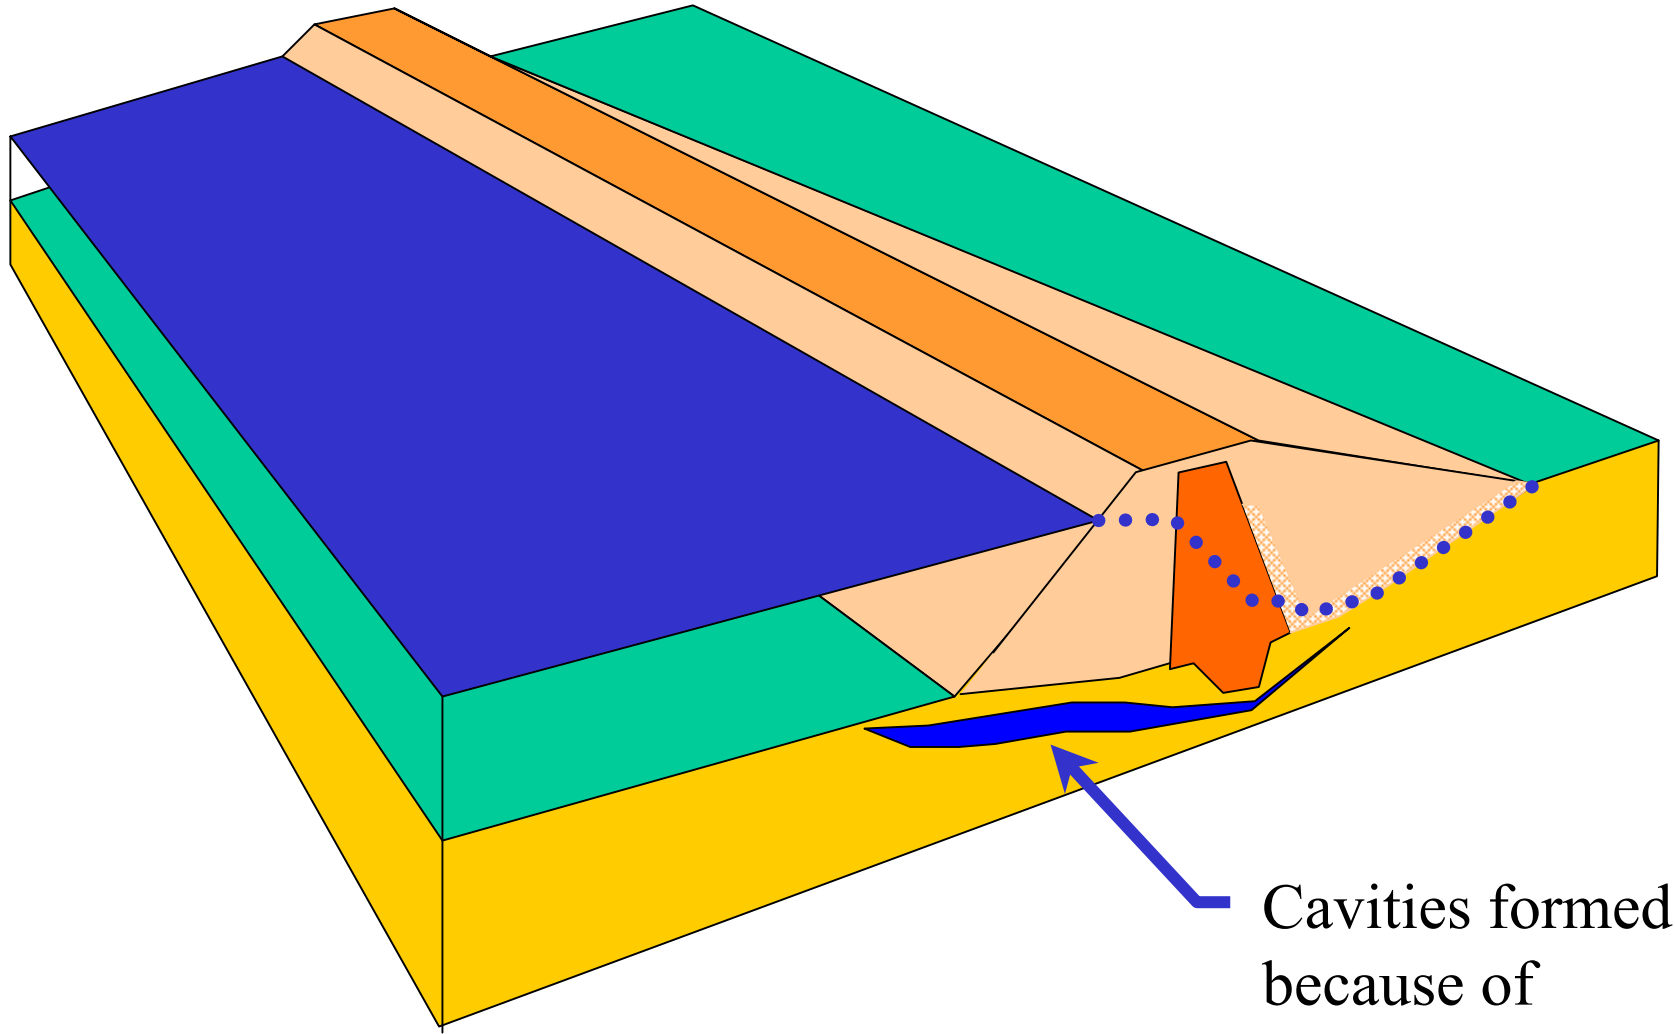
What can happen when cavities in the foundation becomes large?

Cavities formed
because of
internal erosion
