The Corps of Engineers and ERDC Geotechnical related activities during Earthquakes

Richard S. Olsen, PhD, PE

U.S. Army Engineer Research and Development Center (ERDC)

October 7, 2004

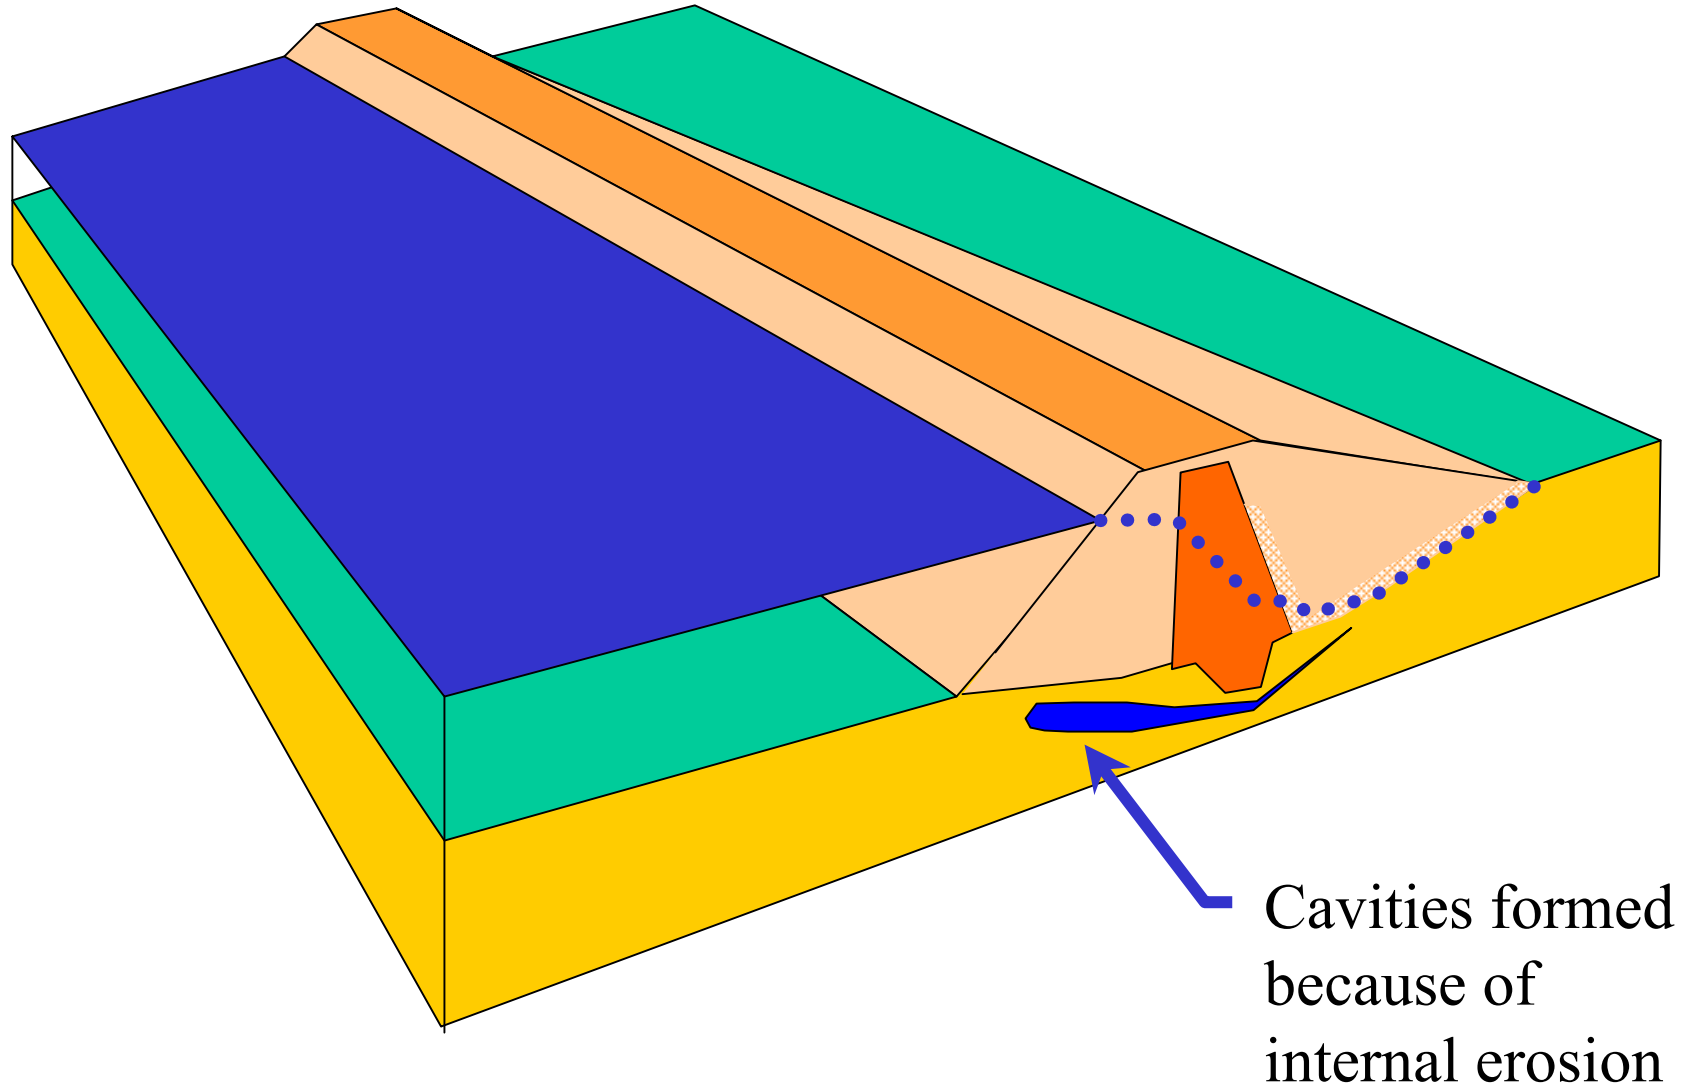
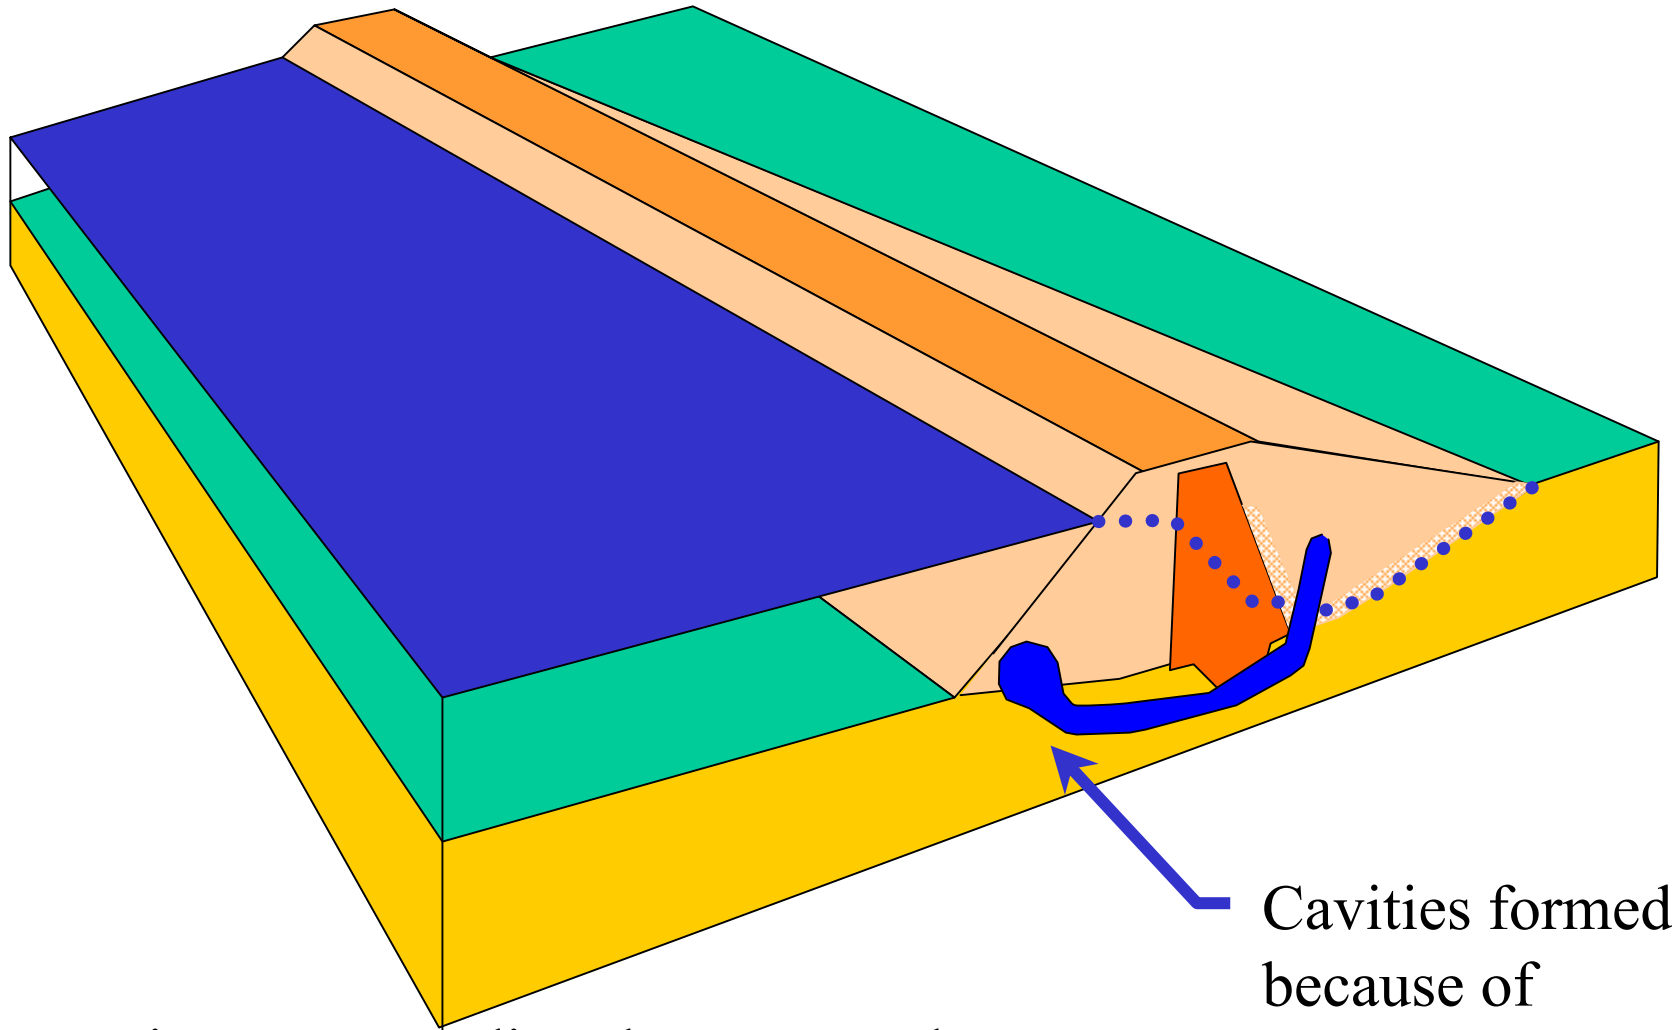
The cavity can extend to the ground surface and ultimately collapse the total dam (like Teton Dam)

The cavity can extend to the ground

Cavities formed because of internal erosion

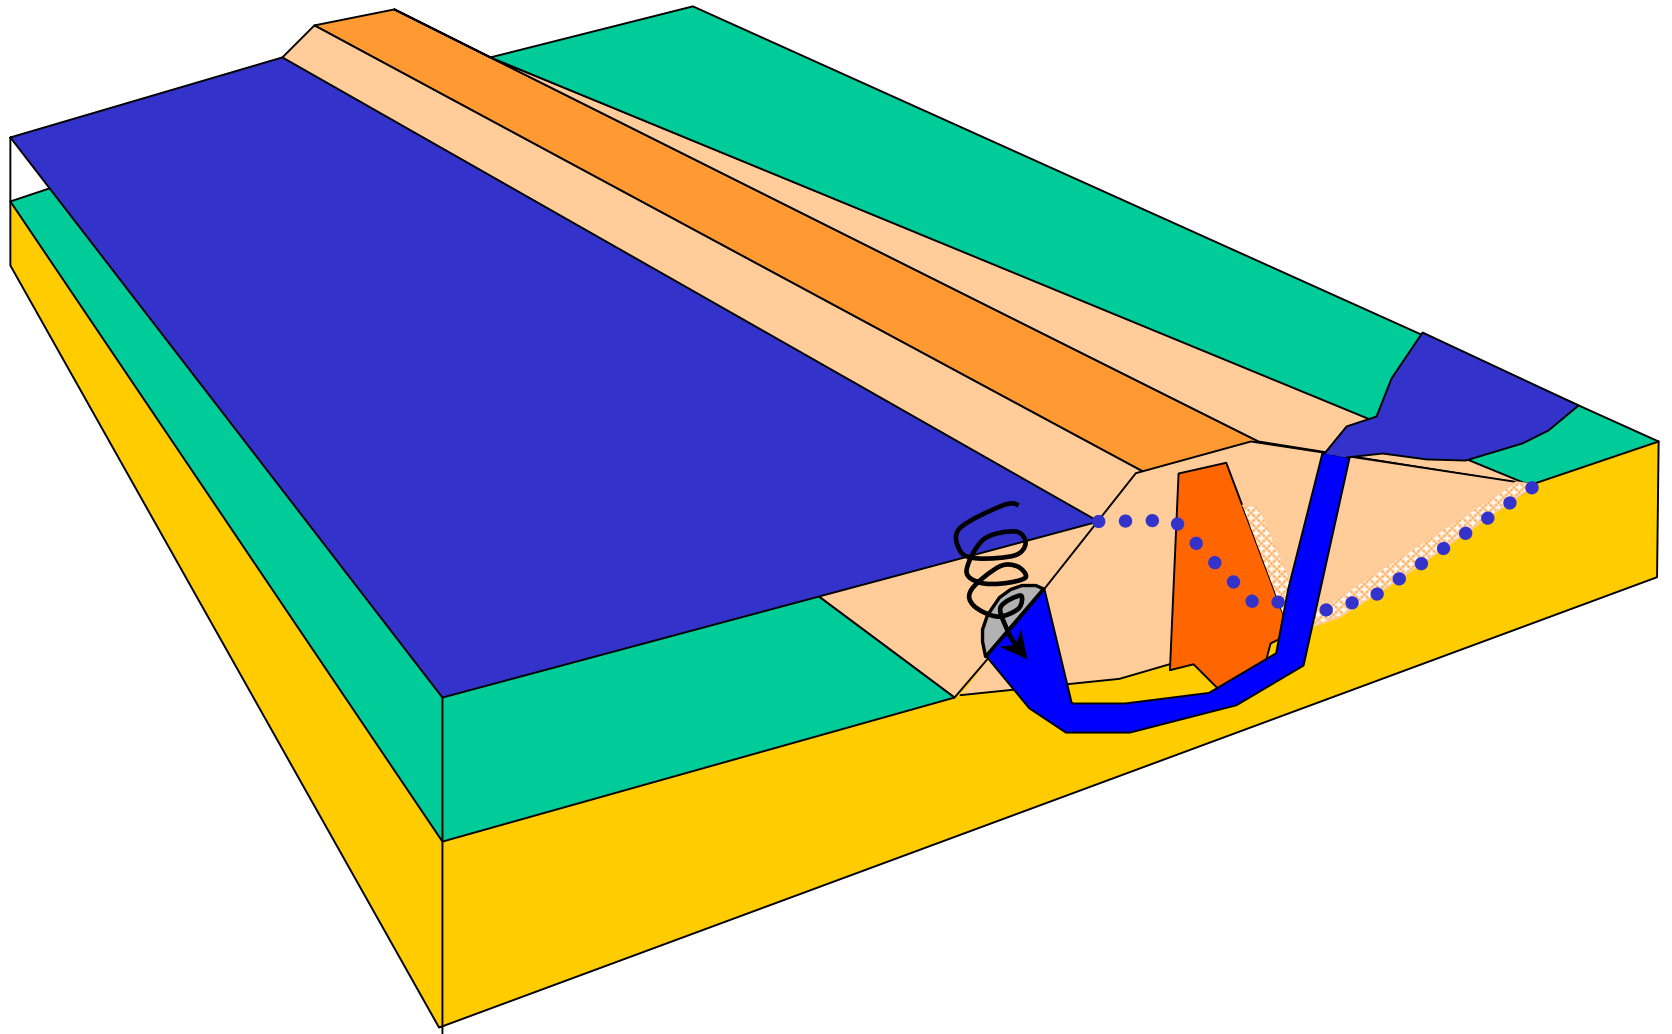
The cavity is now releasing the reservoir

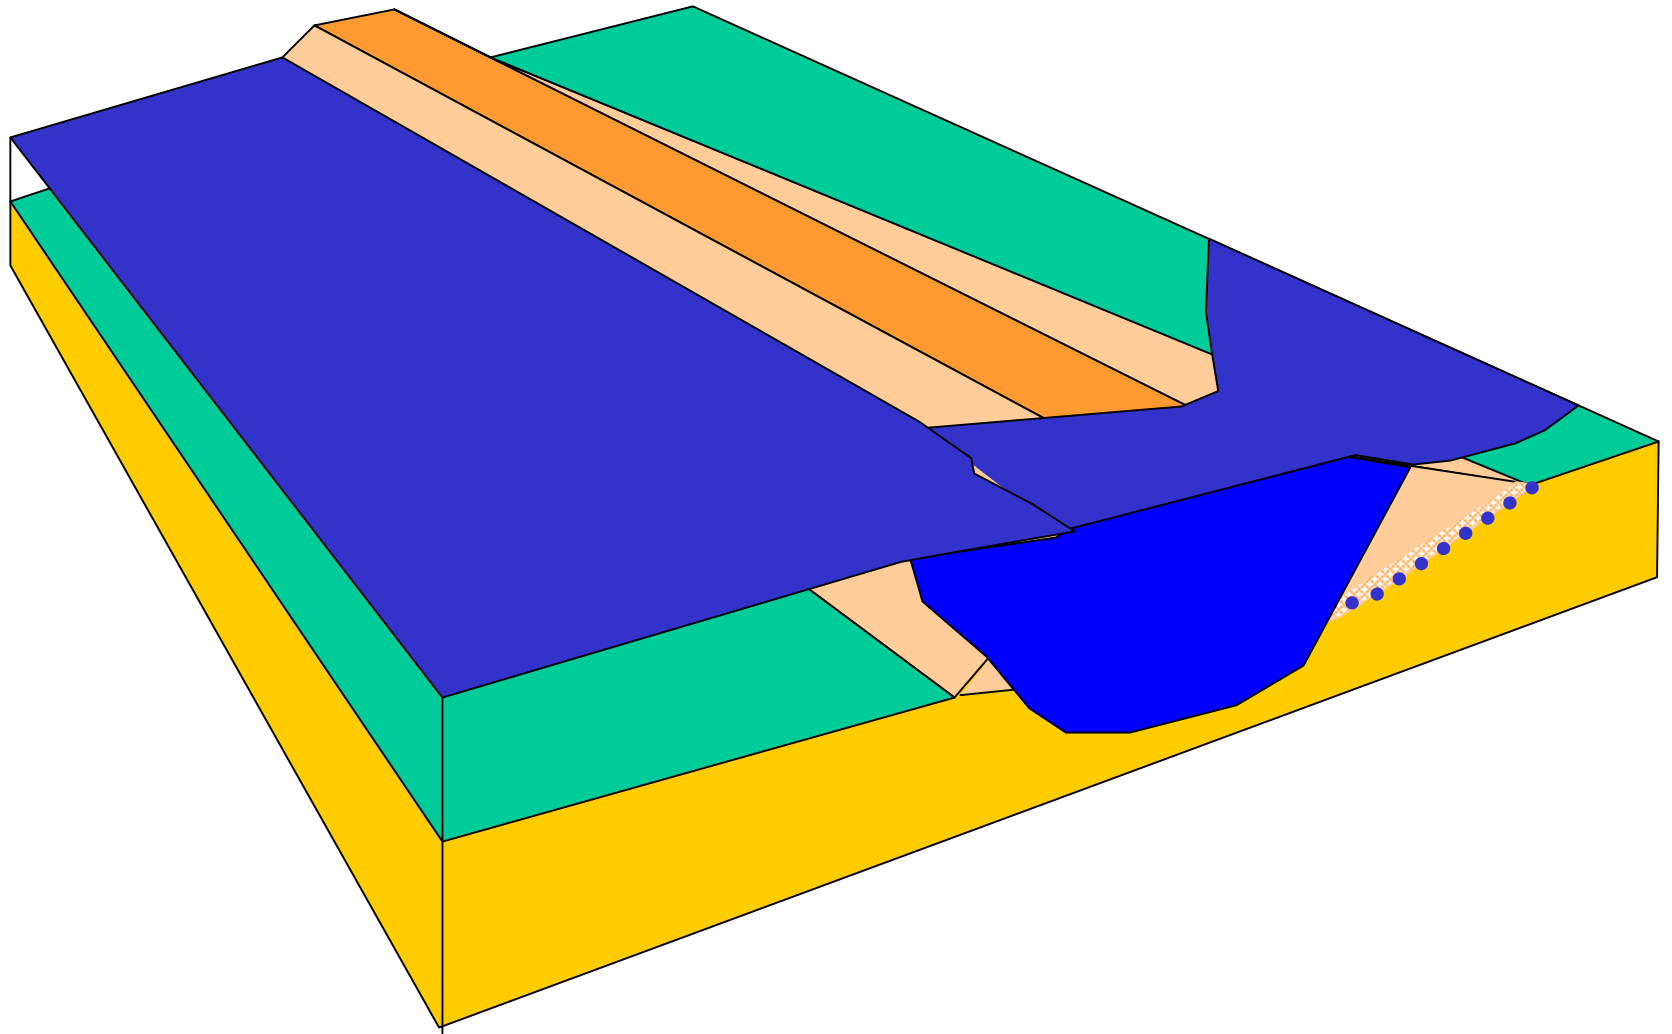
Total release of the reservoir

Alternatively the cavity can cause slope instability and total failure

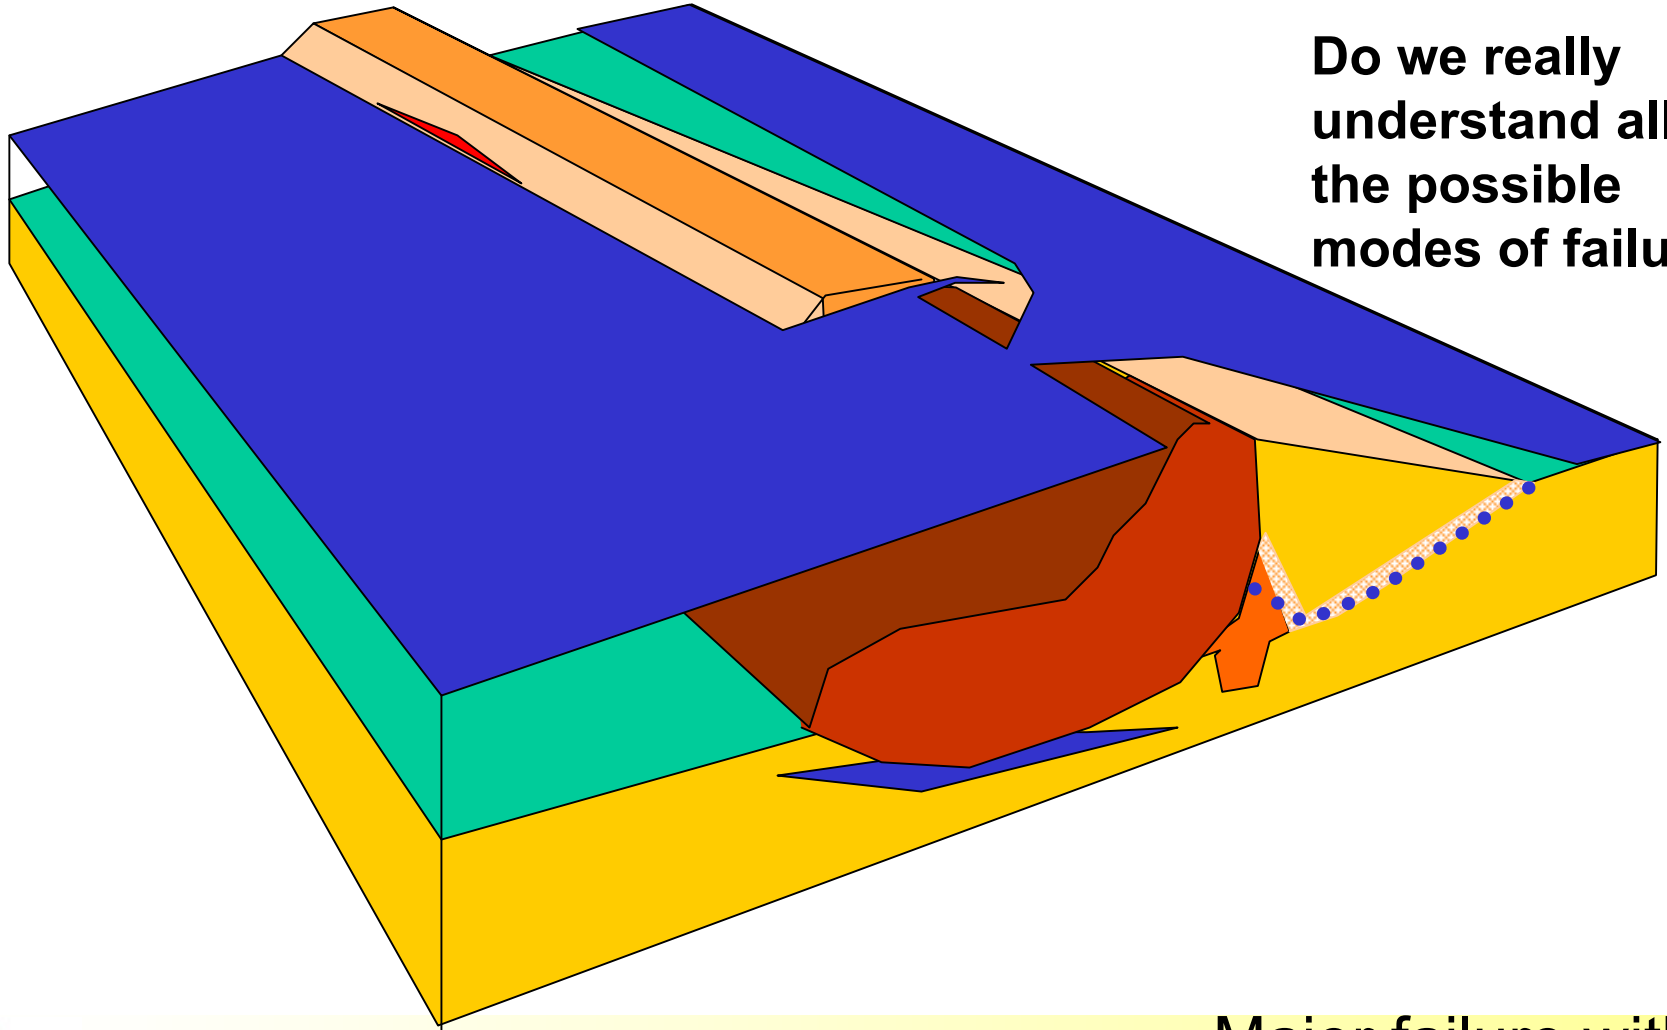
**Major failure with
water release
because of cracks**
