# GEOTECHNICAL IMPACTS OF HURRICANE MARIA IN PUERTO RICO

Event Date: September 20, 2017

**Geotechnical Extreme Events Reconnaissance**

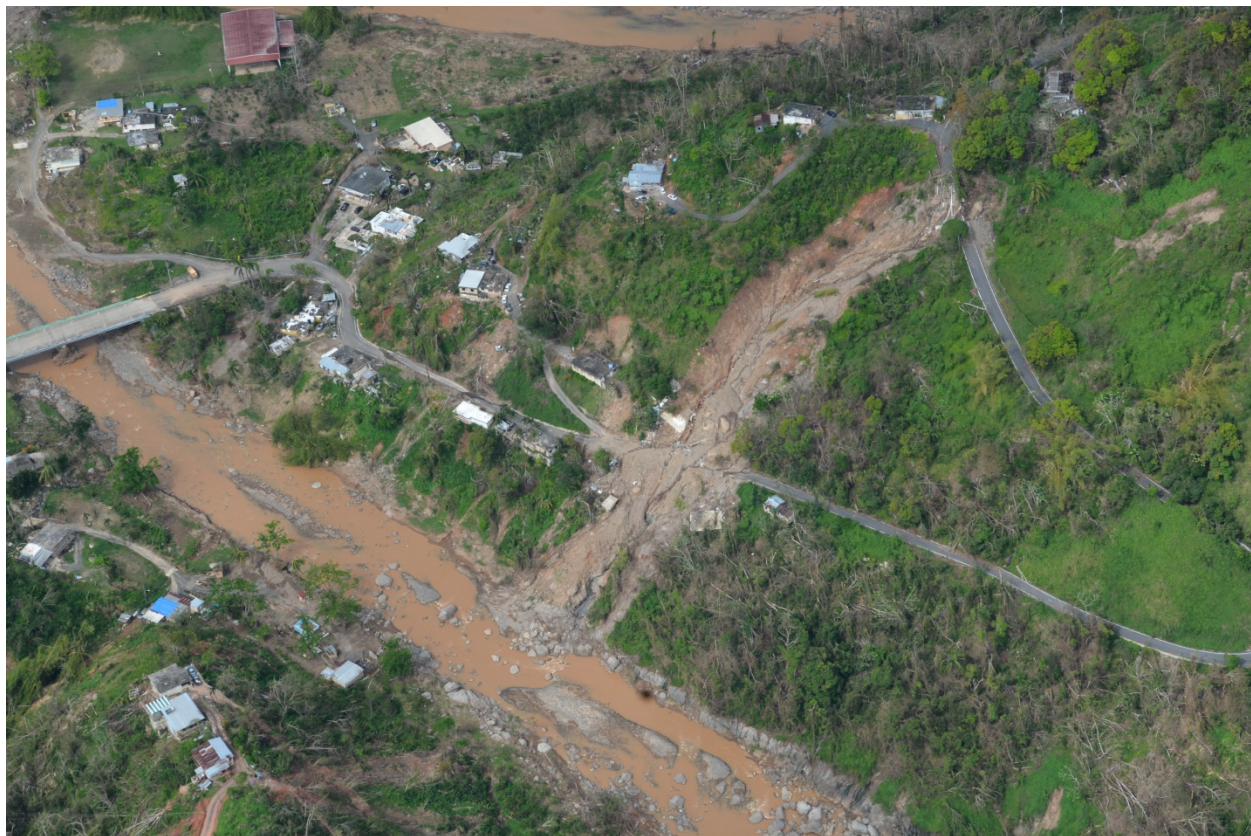
**Figure 2-10: Photo taken by the Civil Air Patrol on October 15, 2017 of the PR-4131 debris flow site (Lat: +18.247885, Lon: -66.882794).**

The failure initiated just above the highest road cut on a switchback along PR-4131 (not PR-431 as often erroneously referenced by other reports; the road was recently re-designated as PR-4131 before Hurricane Maria's landfall). The upper area is the primary area of volume loss; in fact, the lower portion of the road was not lost, only covered by debris from above. The

liberated hillslope material was delivered directly to the fluvial system below. Much of the small- to medium-sized sediment was carried downstream by the river on September 20, 2017, and in the following days; however, a toe of large boulders remained at the site. Aerial imagery of the landslide site before and after Hurricane Maria are shown on Figure 2-11.

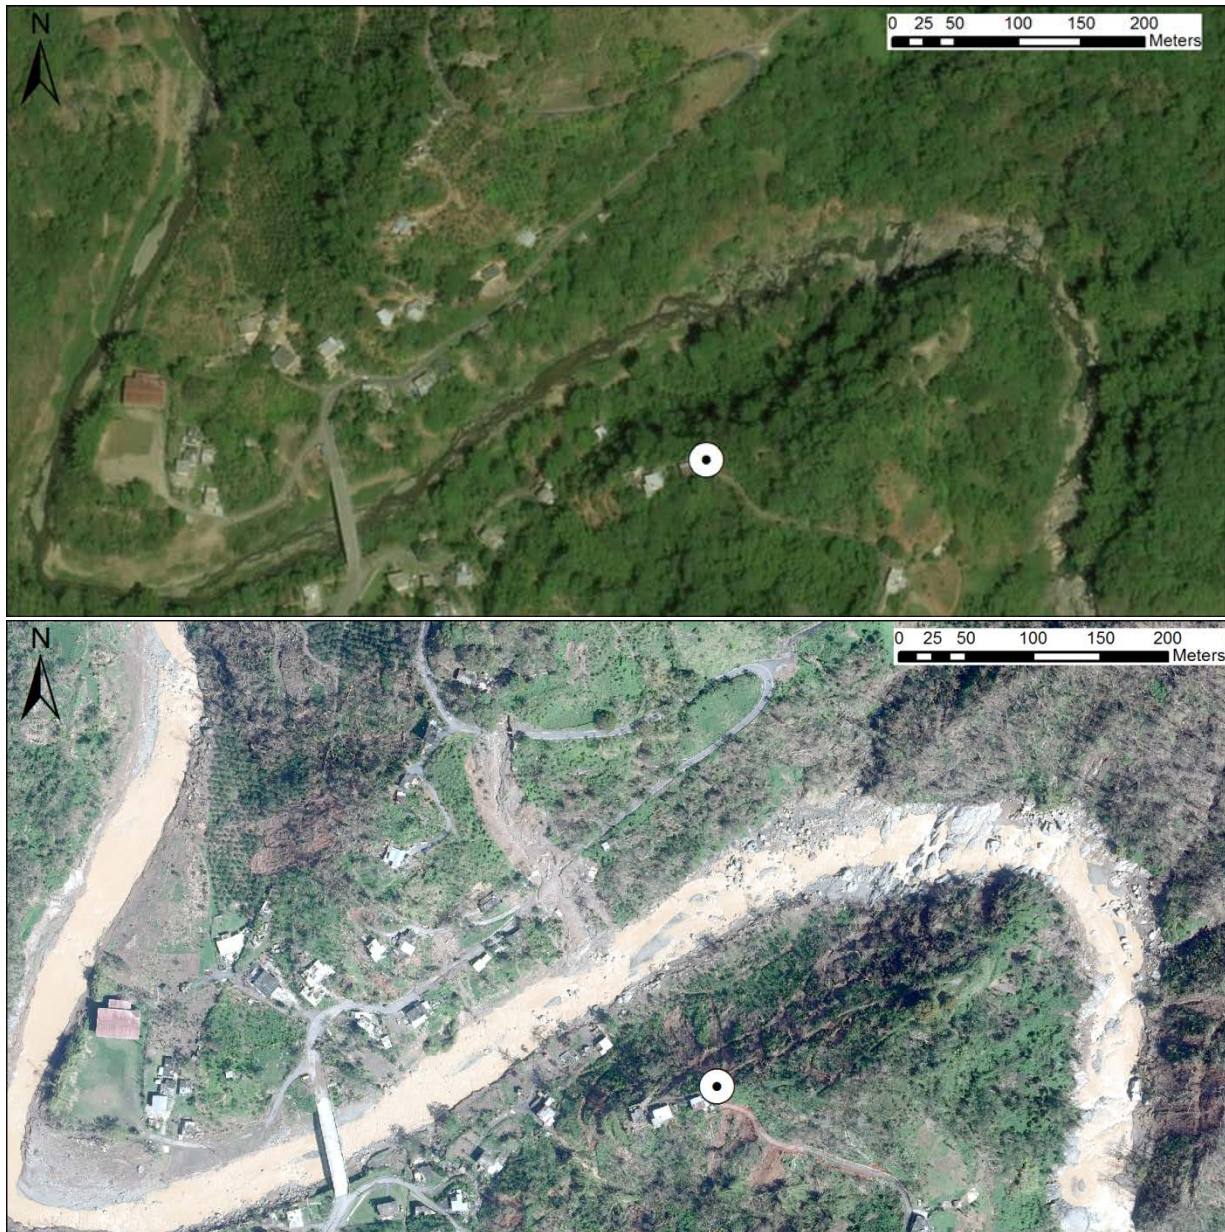
**Figure 2-11: Large debris flow site on PR-4131 in central Lares along the Rio Blanco.**

Note: Upper image from before Hurricane Maria. Lower photo captured by FEMA on October 12, 2017. The location of our January 2018 TLS scan position (Lat: +18.247885, Lon: -66.882794) is shown as a white circle with black center dot on the south bluff of the river.

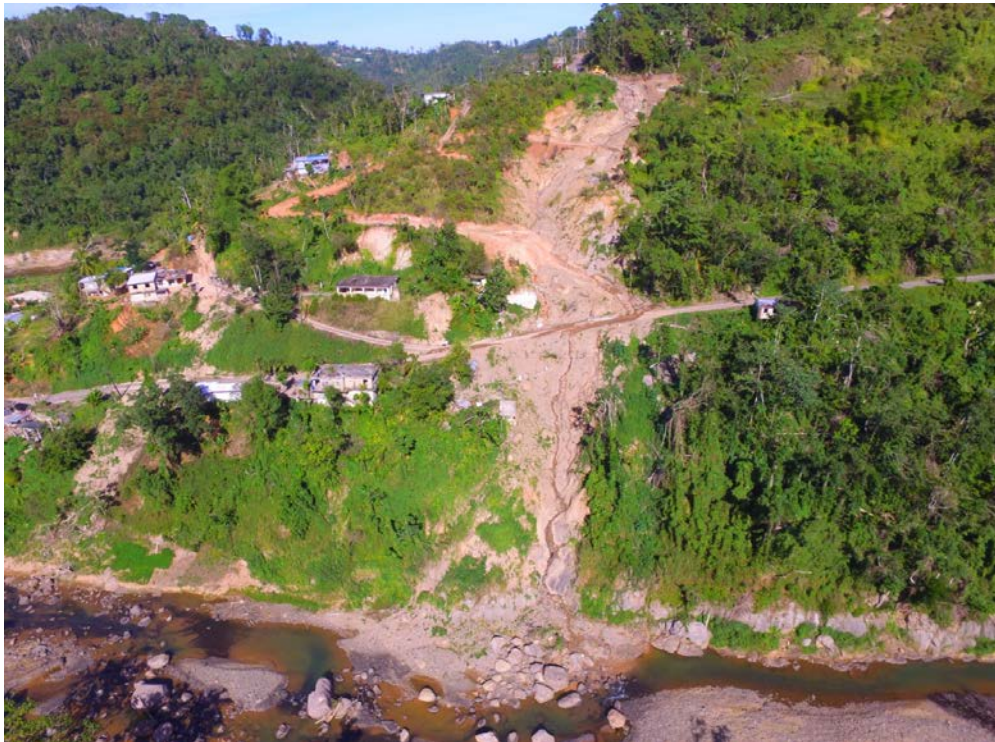
**Figure 2-12: Photo taken by GEER team in January 2018 of the PR-4131 debris flow site (Lat: +18.247885, Lon: -66.882794).**

Note: Notice a new primitive access road that has been developed by local residents with 4-wheel drive vehicles. Other detours around the site add an additional half hour to a normally 15-minute drive to essential services available in the small city of Lares. Notice the toe of the debris flow that has re-routed the flow of the Rio Blanco River.

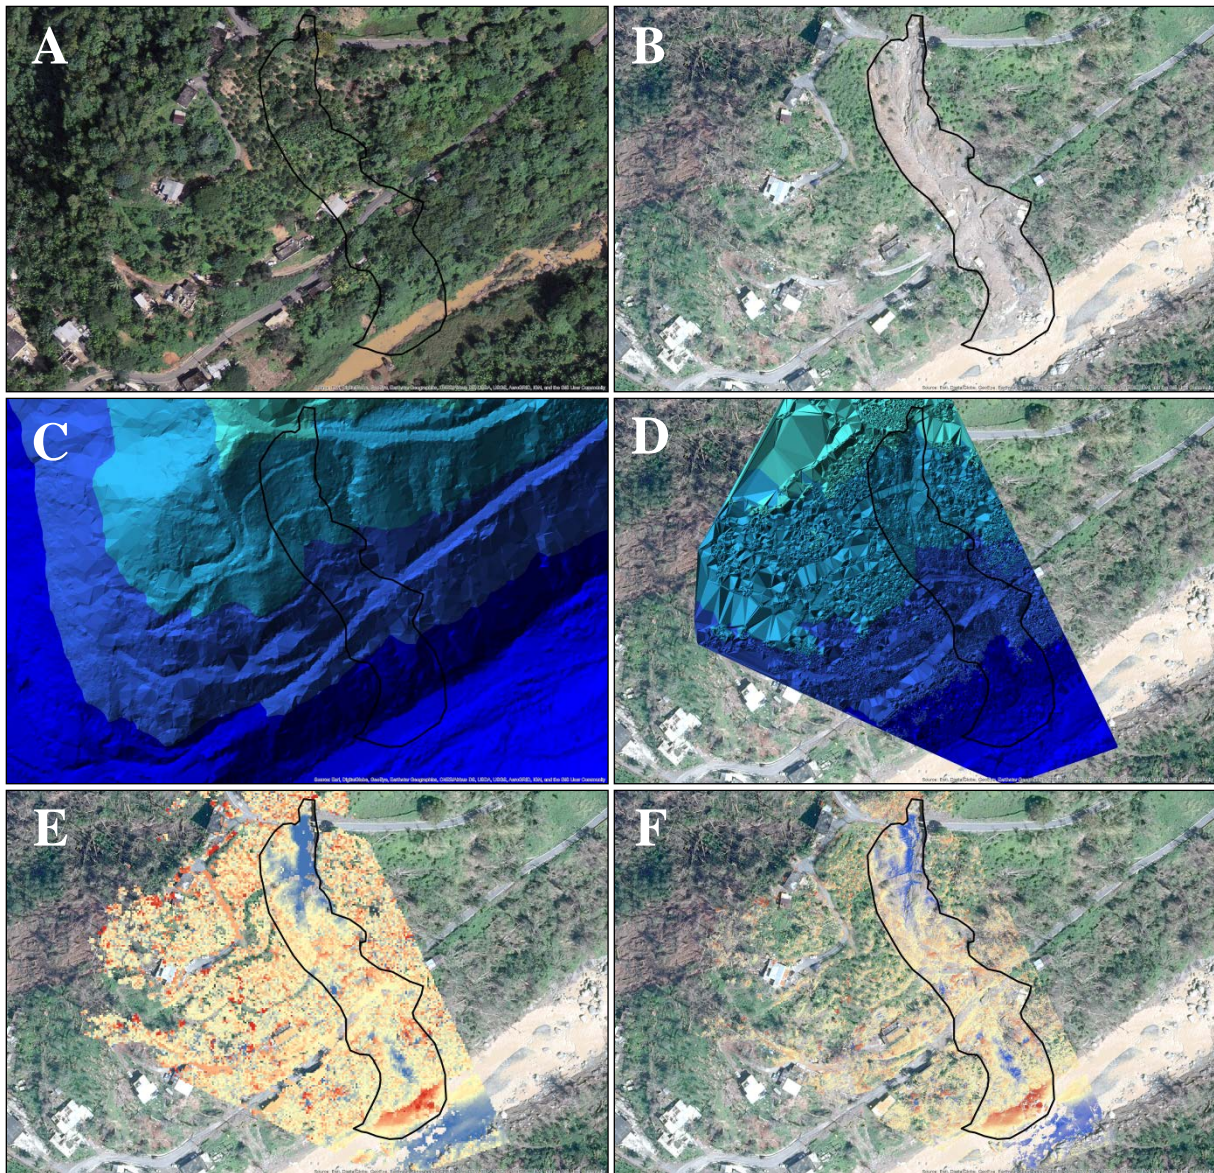
**Figure 2-14: Images from LiDAR PR-4131 debris flow site.**

**A)** PR-4131 debris flow site before Hurricane Maria. **B)** PR-4131 debris flow site on October 12, 2017. **C)** Shaded relief map of the same area created with classified ground point data from a 2016 airborne LiDAR survey. **D)** Digital surface model of the site created with data from Terrestrial LiDAR Scan survey in January 2018. Compare the footprint of the model with the position of the scanner shown in Figure 2-13. **E)** One-meter resolution change raster from 2016 to January 2018; blue areas indicate volume loss, red areas indicate volume addition, and beige areas show no major change. Point clouds were aligned using Cloud Compare software. **F)** Ten-centimeter resolution change raster for the same time span. Key features to note are the loss primarily in the head scarp, a small zone of loss in the center-west of the site that reflects a house that was destroyed by the debris flow, a scour channel in the lower center of the site, a toe area of large boulders, and a zone of loss on the southern bank of the river, likely the result of a forced shift in the river's course around the toe.

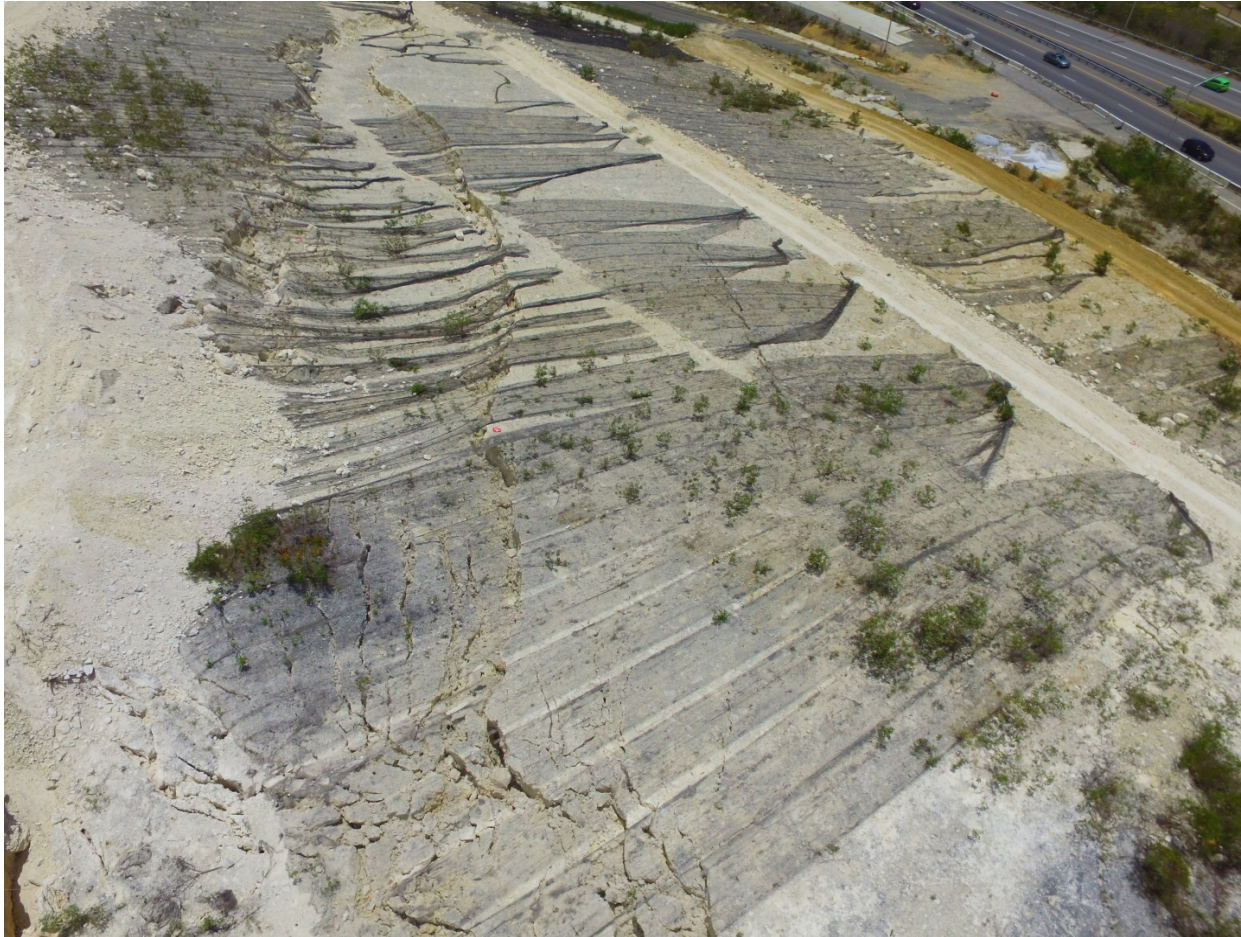
**Figure 2-15: Aerial image showing pre-Maria condition of preexisting landslide at PR-9 north of Ponce (Lat: +18.033145, Lon: -66.637579).**

To the north of the city of Ponce and along PR-9 is a large deep-seated block failure (Lat: +18.032, Lon: -66.636), that initially failed well before Hurricane Maria. This site is important because it is located in the Juana Diaz Formation, the same unit that failed during the nearby Mameyes landslide disaster of 1985. Drs. Hughes and Morales Vélez visited this site in June of 2017 (Figure 2-15).

Note: Photo taken June 2017. Shaded areas are netting features originally intended to prevent surficial erosion.

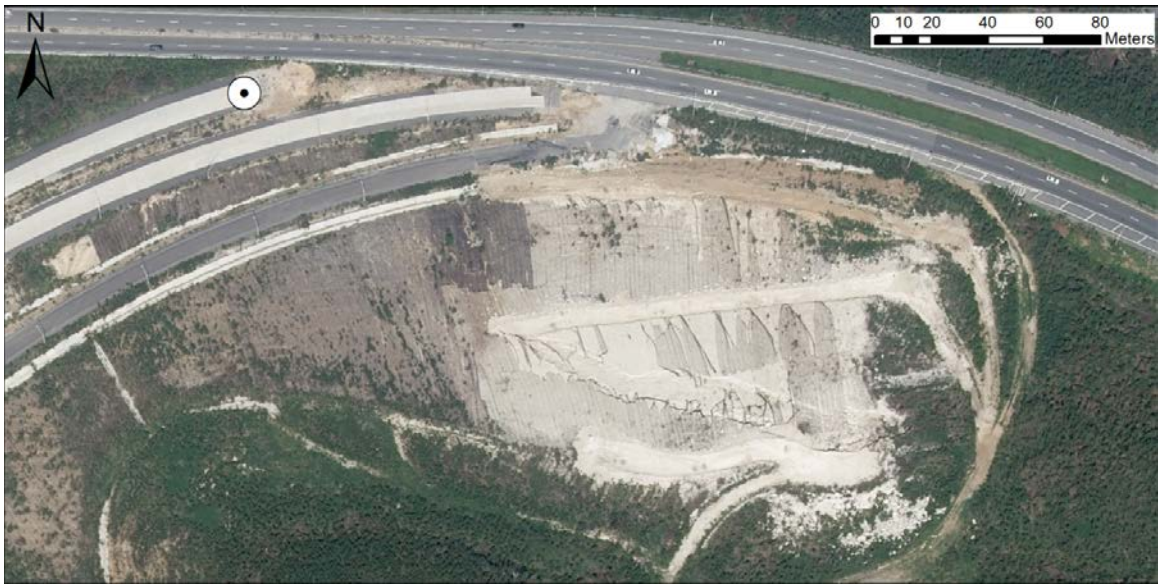
**Figure 2-16: Post-Maria condition of preexisting landslide site at PR-9 north of Ponce.**

As part of the GEER mission, this pre-existing landslide site was visited to by the GEER team on October 31, 2017. No observable changes were noticed with respect to the pre-hurricane condition in June 2017. To further confirm this, the GEER mission performed TLS and drone surveys in January 2018. These surveys were performed to generate data, which will be available for updated DEMs that can be used to confirm that no additional ground displacements have occurred at this site after Hurricane Maria. A photo from FEMA, taken in October 2017, is shown on Figure 2-16. This photo shows the location of the TLS instrument used during the January 2018 survey. The TLS instrument is shown in Figure 2-17.

Note: Position of TLS survey in January, 2018 (Lat: +18.033145, Lon: -66.637579) shown as white circle with center black dot. Shaded areas are netting features originally intended to prevent surficial erosion. FEMA photo from October 9, 2017.

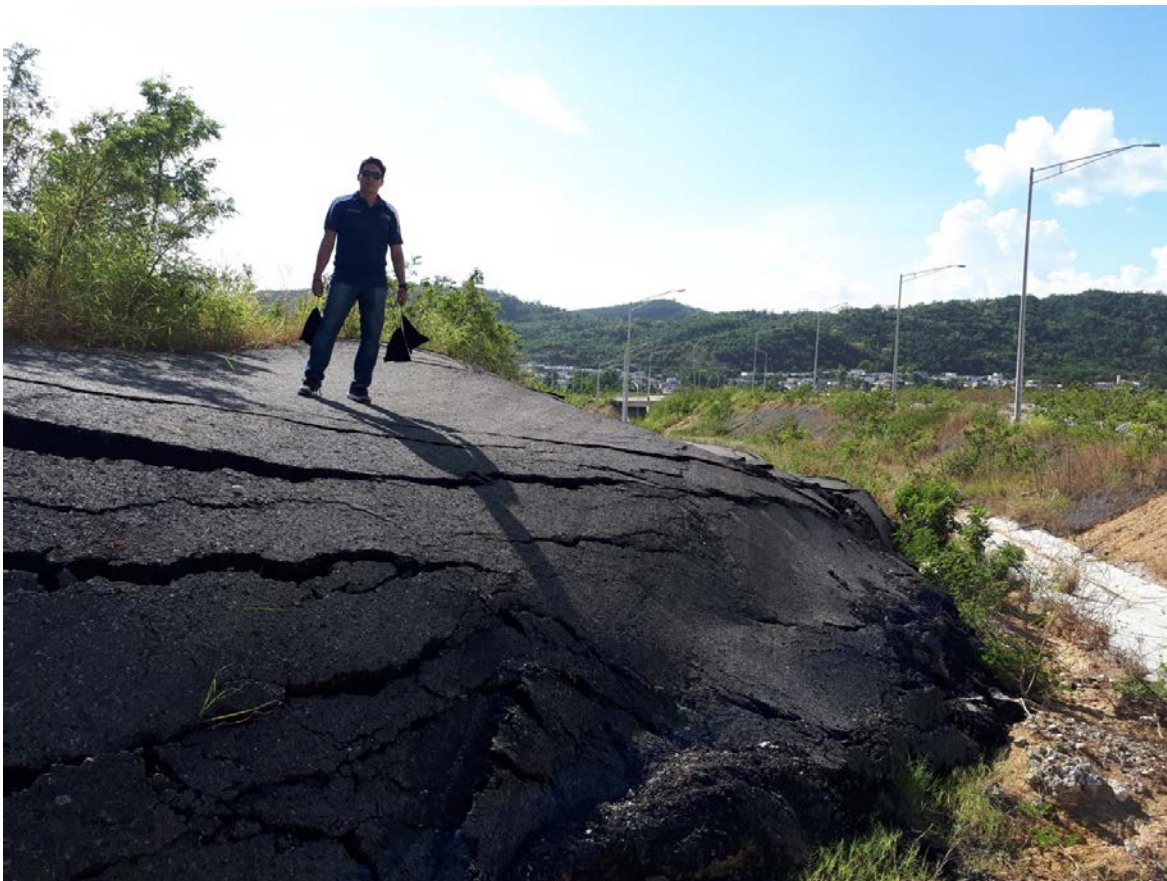
Figure 2-18: Photo of Toe of PR-9 landslide in January 2018 (Lat: +18.033145, Lon: -66.637579).

A photo of the toe of the landslide is shown in Figure 2-18. In summary, at this site field observations and measurements by the GEER team did not reveal any movement or activation of this preexisting landslide. However, surface erosion is evident, which could lead to altered geometry that could change the stability of the site.

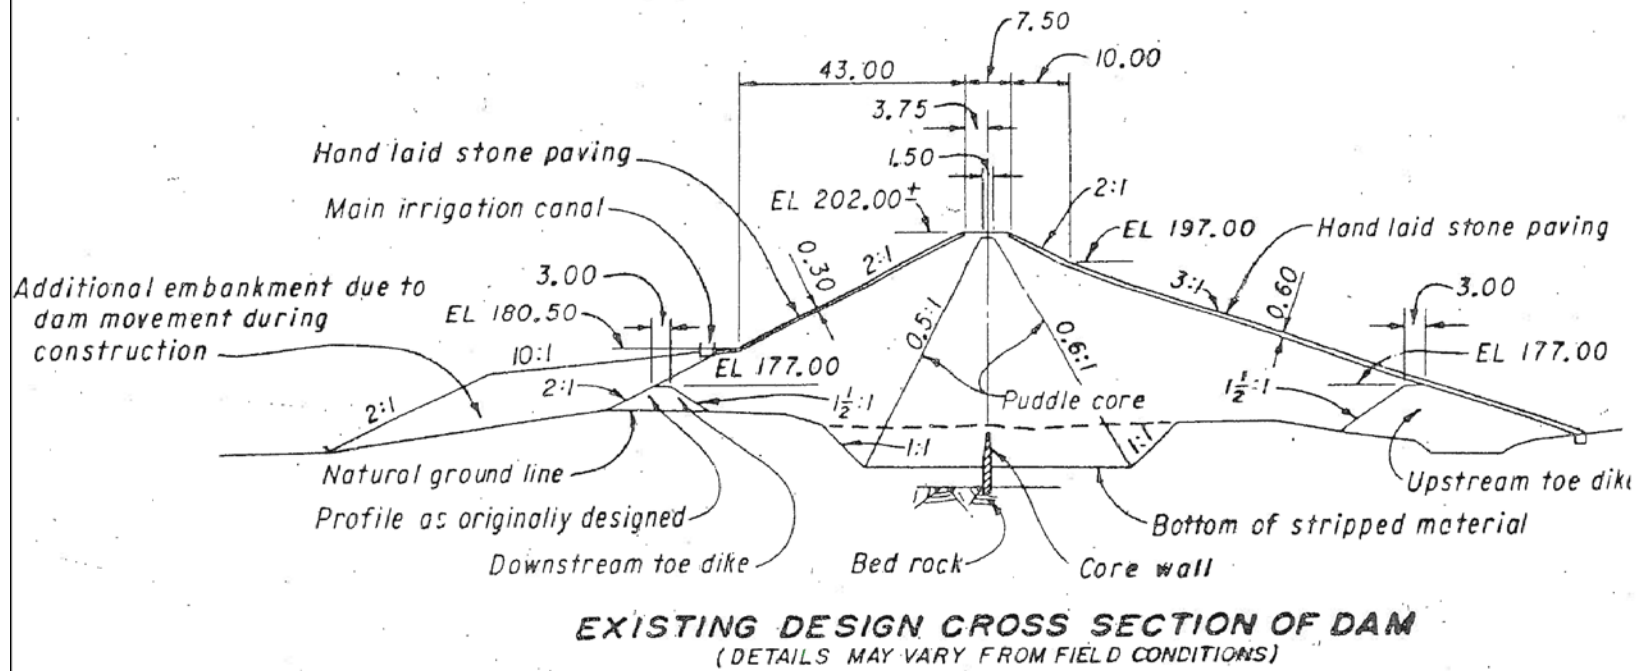
Figure 3-3: Cross-section of Guajataca Dam from the 1920's (date of drawing is unknown).

Records suggest that a large part of the dam consists of hydraulic fill, but its limits are unclear. For example, Figure 3-3 describes the center of the dam as a “puddle core”, but a June 2002 USBR report suggests that the hydraulic fill process left the coarsest fill materials near the dam faces and the finest in the core area; the same report indicates that fill placement was changed to “dry” roller compaction in 1927.

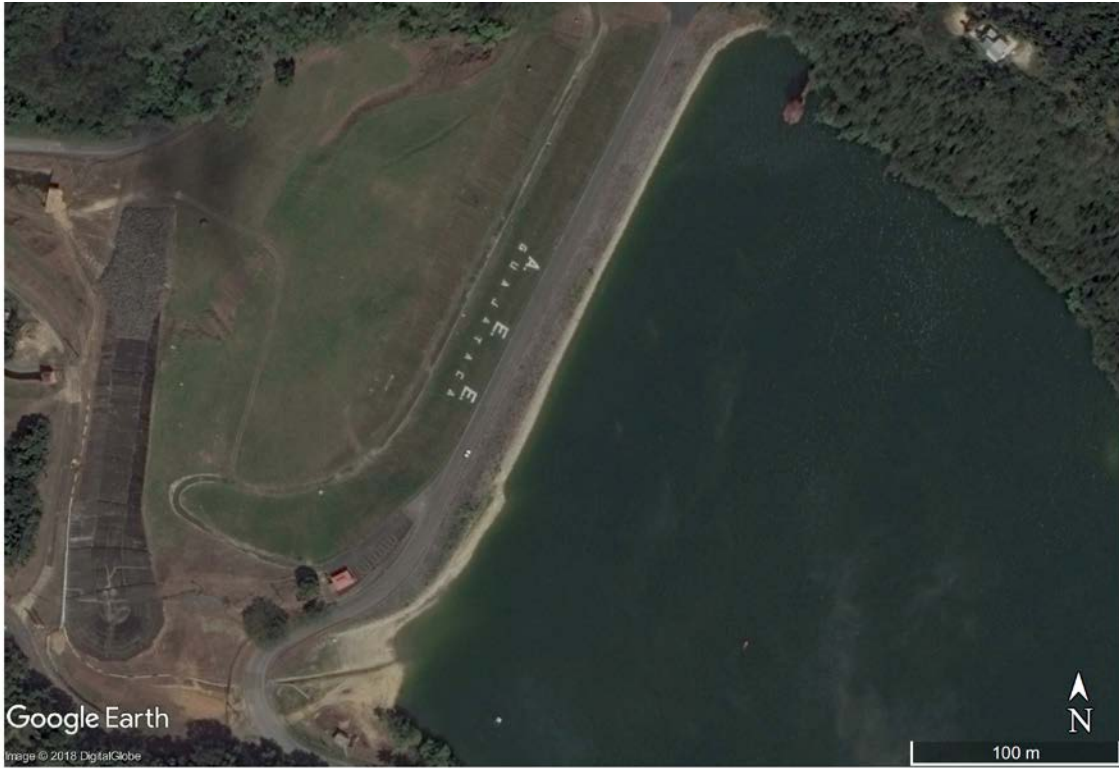
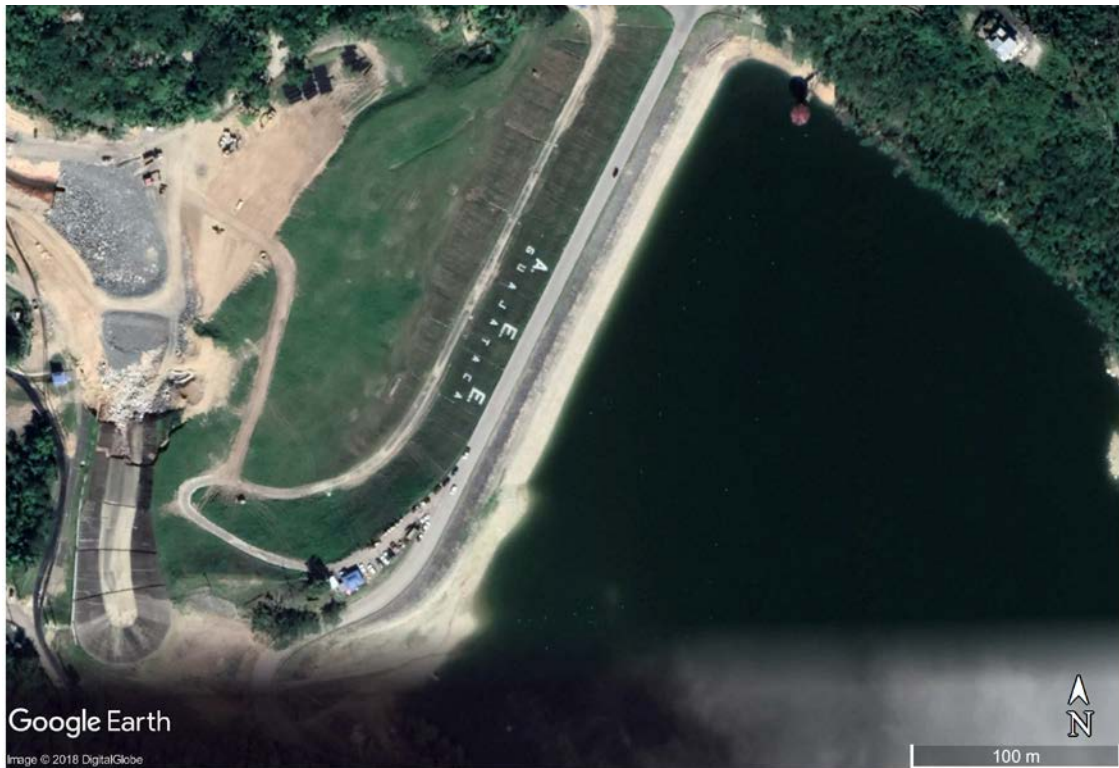
**Figure 3-8: Comparison of condition between March and November 2017.**

Aerial photographs indicate that the spillway was apparently in good condition as of March 2017 (Figure 3-8) and suffered significant damage as a result of Hurricane Maria. Figure 3-8 shows that about 100 m (300 feet) of spillway was completely destroyed (roughly 40 m of concrete and 60 m of riprap), and that an additional 25 m of concrete spillway was significantly undermined and displaced (Figure 3-13). A siphon located under the spillway (Figure 3-4, Figure 3-11, and Figure 3-12) was also destroyed. Aerial photographs taken during the aftermath of Hurricane Maria show water spilling out of the upstream side of the siphon (on the north side of the spillway), indicating that the siphon was operational during Hurricane Maria. Scour depths below the spillway could not be measured since the area had already been partly filled, but the scour was massive.

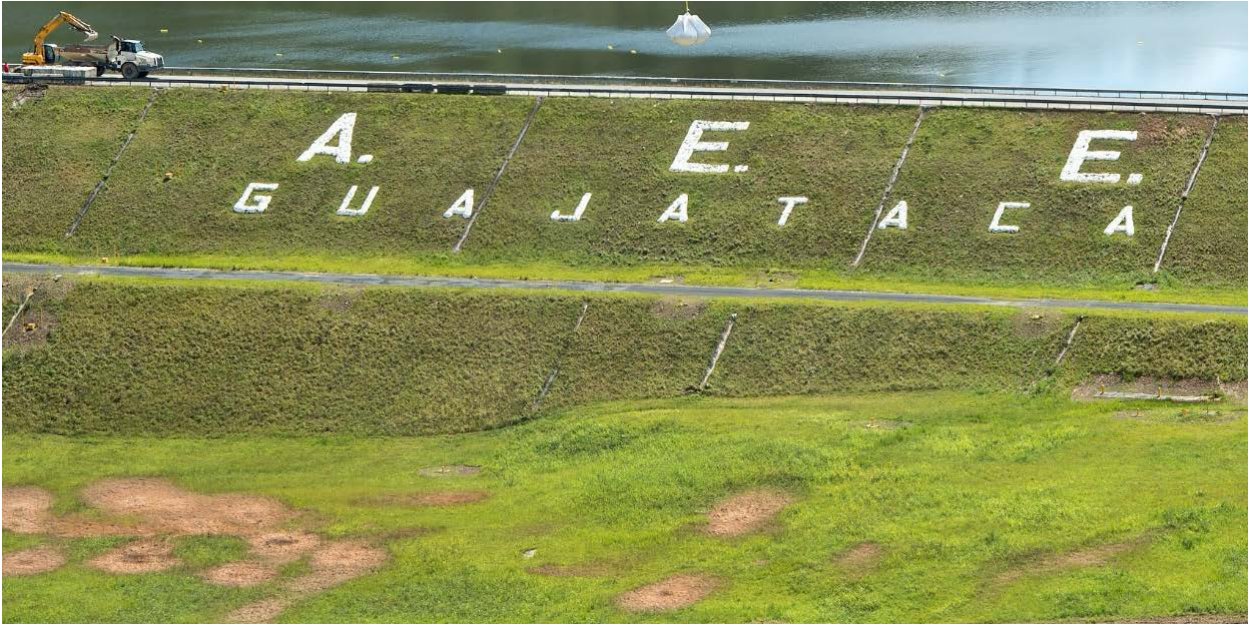
Figure 3-9: Sand boils downstream of the dam toe (photographs from the Pennsylvania National Guard).

Aerial photographs taken during emergency repairs show circular features at the surface of the fill blanket located near the toe of the dam. These features have the distinct appearance of sand boils and suggest that subsurface materials were affected by internal erosion. Although the seepage path and source of the eroded materials are unknown, underseepage should be expected since the depth of embedment of the 1920's core/cutoff wall (shown in Figure 3-3) is extremely small, and the wall may have been affected locally by historical landslide movement in a differential manner.

Note: Yellow arrows show location of sand boils downstream of the dam toe.

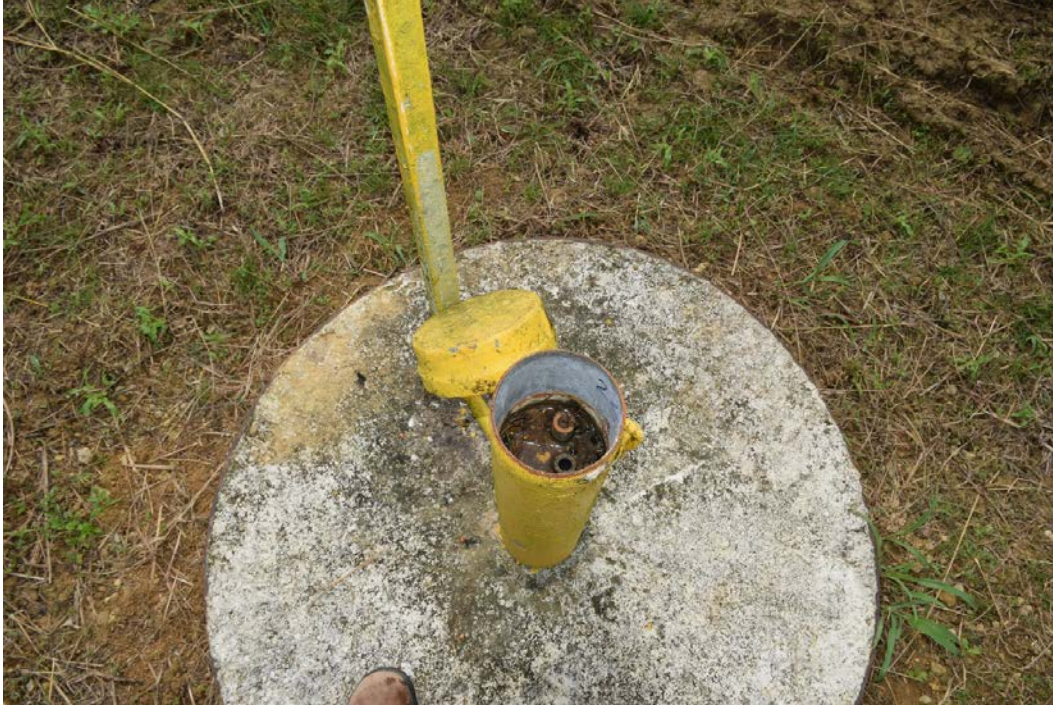
Figure 3-10: Water and debris in piezometer (Lat: +18.397658, Lon: -66.924462).

The surface of fill blanket downstream of the dam is generally level, and surface water tended to accumulate within low spots during our visit. Although the piezometers had been covered, we observed water, soil, and other debris in the casings (Figure 3-10), which would be consistent with a recent spike in groundwater pressures. Furthermore, a large void, approximately 30 centimeters in diameter and located 10 m downstream of the toe and

directly downstream of the “A” of the AEE sign on the downstream slope, was noted during the team’s visit. Note that excavations, structures, poles, and/or post were not reported or visible in aerial photographs at/near the location of the reported cavity. Hence, it is likely that the void was either created or exacerbated by underseepage resulting from the high hydraulic head caused by Hurricane Maria.

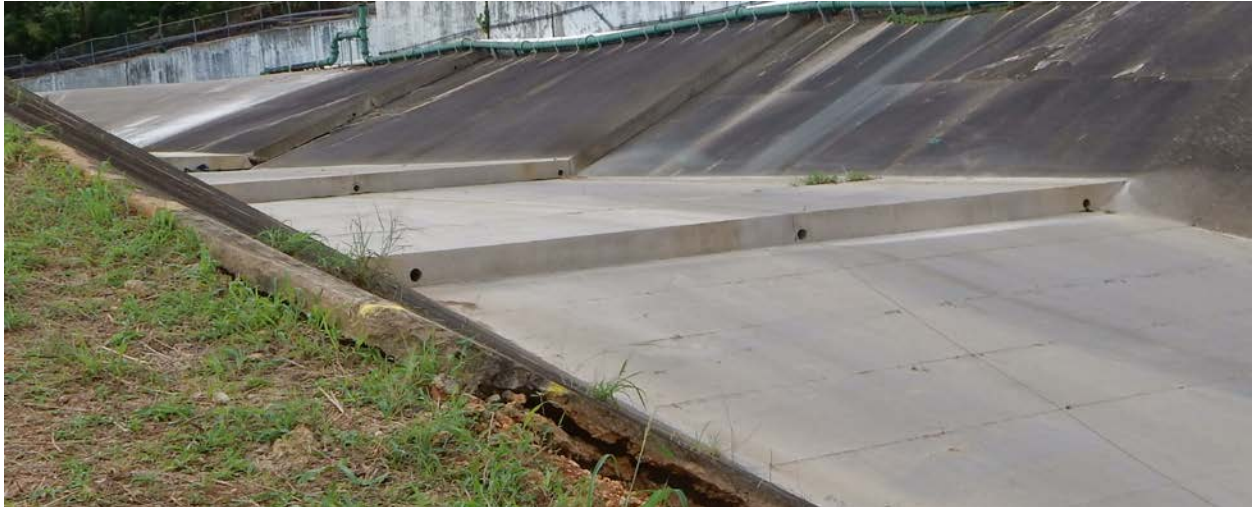
Figure 3-14: Spillway aeration pipes (Lat: +18.39684, Lon: -66.92561).

The spillway was equipped with aeration pipes to mitigate cavitation damage of the concrete (Figure 3-14). The concrete and aeration pipes were observed to be in good condition in the upper 100 m of spillway. A section of the concrete spillway about 25 m long and located at a distance of about 100 m from the top of the spillway, was observed to have moved on the order of 1.5 m in the downstream direction and was severely undermined (Figure 3-13 and Figure 3-15). The small scarp shown in Figure 3-16 is consistent with local withdrawal of lateral support resulting from nearby scouring along the alignment of the spillway. A grab soil sample collected from the exposed scarp was found to have a USCS classification of GC (See Sample F in Appendix I). We did not observe movement consistent with the reactivation of the ancient landslide; instead, our observation strongly suggested that the failure of the spillway resulted from scour starting at the base of the spillway and progressing retrogressively upwards. We did not find indications that the aeration system contributed to the damage; however, it is likely that failure of the siphon provided an influx of water that exacerbated erosion in its vicinity. The presence of landslide materials under the spillway likely increased its vulnerability to scour.

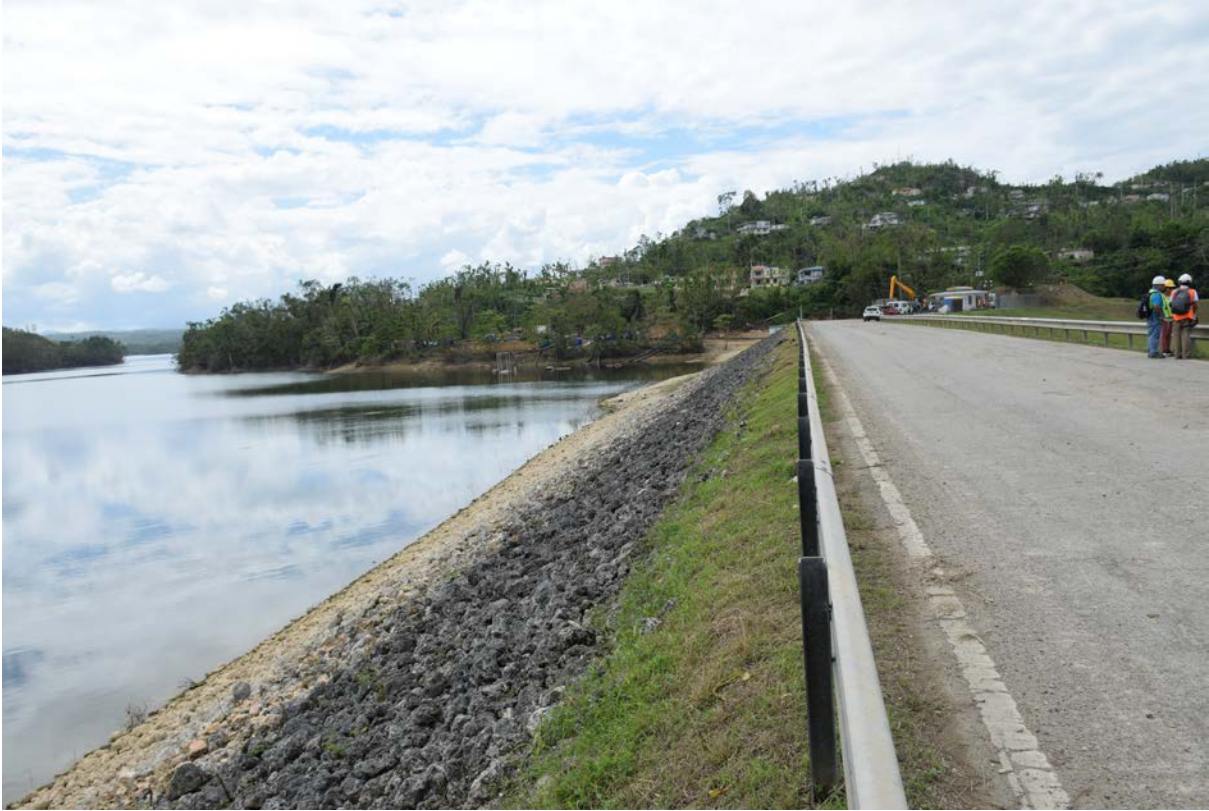
Figure 3-17: Dam crest (Lat: +18.39733, Lon: -66.92374).

During our site reconnaissance, a team of surveyors measured the alignment of the crest and reported that their measurements were roughly identical to those they had performed before Hurricane Maria. Although a crack was reported in the press (near the left abutment on the asphalt road along the crest of the dam), the team did not observe any indication of adverse movement along the crest of Guajataca Dam or along the top of the berm (Figure 3-17). Similarly, we did not observe adverse hurricane-related effects on the dam’s auxiliary hydraulic structures.

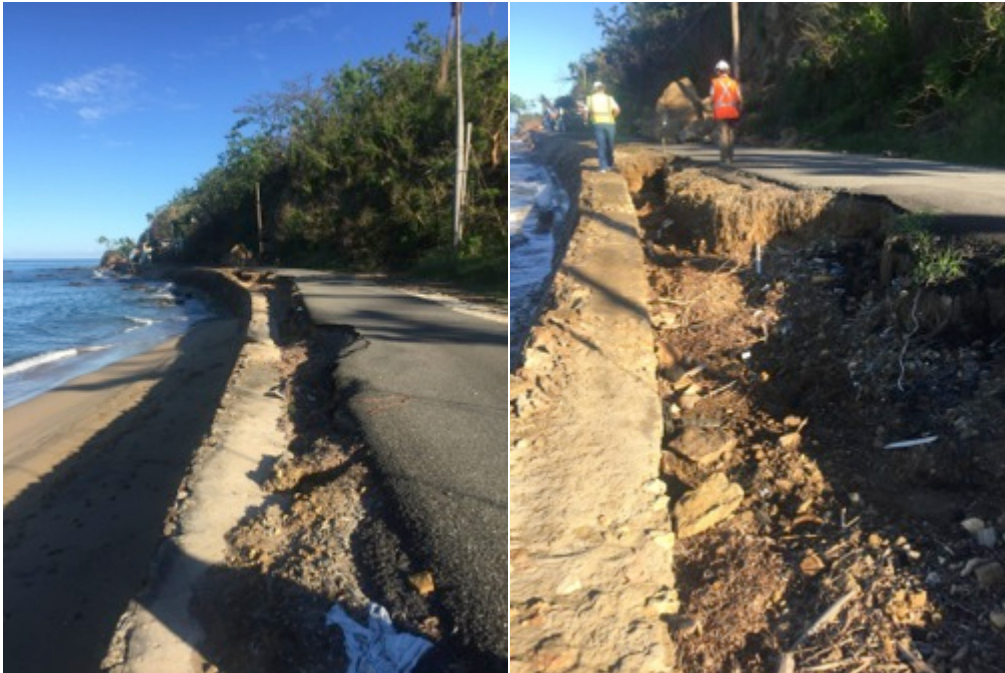
**Figure 4-6: Erosion Scar at first location of Site CE1.**

Two locations with evidence of coastal erosion associated to Hurricane Maria were found at Punta Cadena (Site CE1) in the municipality of Rincón. Site CE1 was visited by the GEER team on 11/3/17. The first location with coastal erosion of site CE1 is located at Punta Cadena in the south of Rincón near the old train tracks right-of-way. The site consists of a local one-lane asphalt pavement road supported by a seawall, which also serves as shoreline protection. An erosion scar approximately 167 feet long was observed behind the seawall (Figure 4-6). The slanted seawall, approximately 2 feet wide and 9 feet high, consists of cement/grout stabilized riprap rocks (Figure 4-7). Overall the wall had minor damage. The erosion behind the wall appeared to be caused by wave action, which also resulted in damage along the road shoulder.

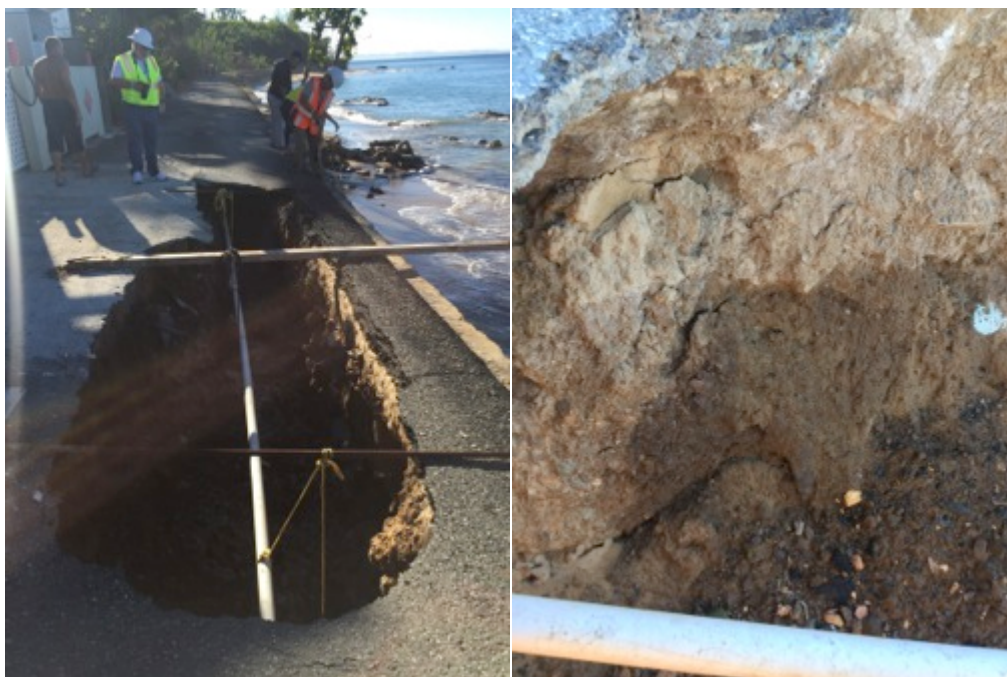
**Figure 4-8: Sinkhole and Road collapse at second location of Site CE1.**

The second location with coastal erosion, within the general site CE1, is located approximately 300 meters north of the first location. At this second location, the coastal local one-lane road had a sinkhole-type failure as shown on Figure 4-8. The sinkhole resulted in road collapse parallel to the seawall and in front of a residential house. The dimensions of the void measured at the surface were approximately 7.01 meters (23 feet) long, 1.12 meters (3.7 feet) wide, and 1.83 meters (6 feet) deep. The height of the seawall at this location is about 2.74 meters (9 feet). Evidence of seepage through the seawall was observed at bottom of the sinkhole. It is likely that the storm surge or wave action caused the embankment material to wash out and erosion undermined the road.

Left photo: Lat: +18.30246, Lon: -67.23669, 2017.11.3, 08:22 AST; Right photo: Lat: +18.30254, Lon: -67.23678, 2017.11.3, 08:19 AST. Seepage through seawall observed at the bottom of the sinkhole.

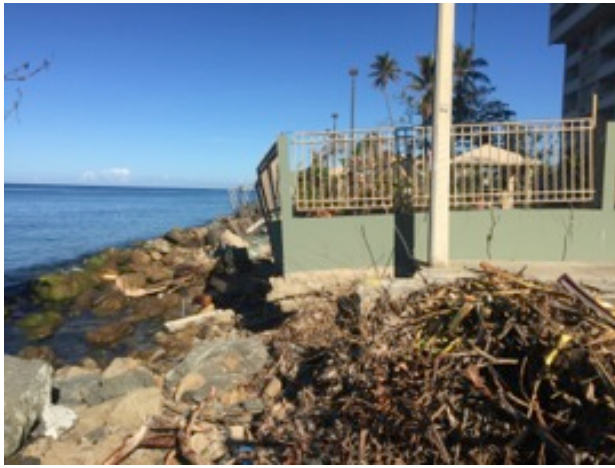
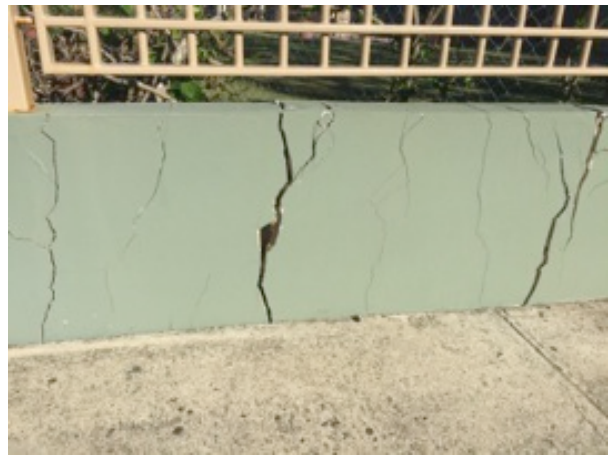
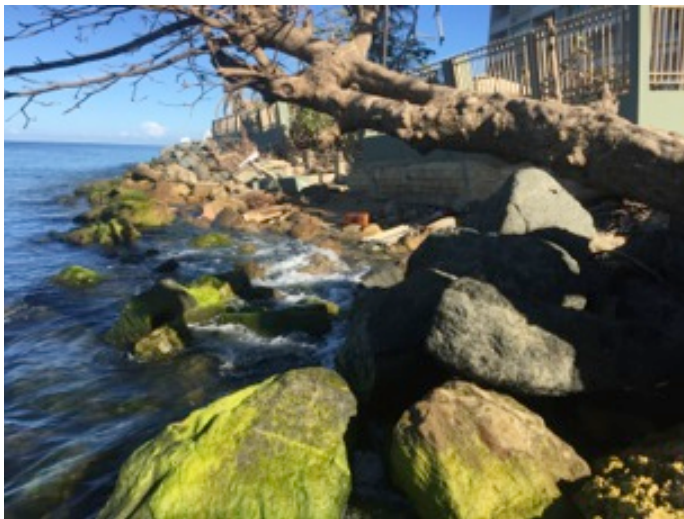
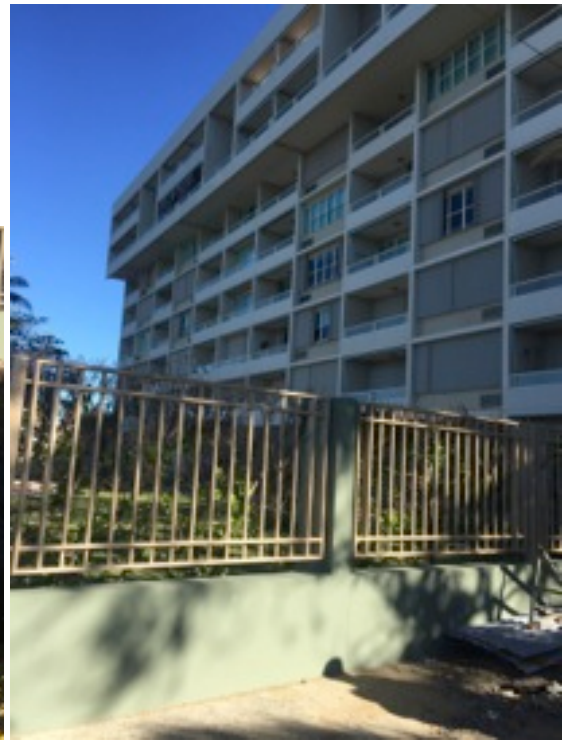
**Figure 4-10: Photos of Residential apartment complex "Pelican Reef" (Building A) at Site CE2.**

This site is located at the Córcega Beach in Rincón, and it is accessed by Calle Bastia. It consists of two buildings: one to the north and one to the south of the beach access as shown on Figure 4-9. The north building (Building A) is a residential apartment complex and the south building is a residential house. Severe damage of a perimeter wall including cracks of concrete/masonry portions and collapse of fence and gate access to the beach was observed on Building A, as presented on Figure 4-10. Based on the pre-storm aerial image, approximately 30 to 40 feet of beach was washed out during the hurricane. There was no overwash sand deposit on the shoreline at this site; therefore, the beach sand was most likely removed by the wave action to deeper depths offshore. As seen on Figure 4-11, the beach access ramp and seawall of Building B was damaged and displaced. Geotextile was left exposed near the damaged seawall. Based on visual observation, there was some minor damage to the building (e.g., broken balcony railing, damage to the walking path) but no cracks were observed on the building. Most of the damage appeared to be due to erosion on the ground surface.

Notes: Building A (Residential apartment complex "Pelican Reef"), top-left (Lat: +18.31623, Lon: -67.24442, 2017.11.3, 08:45 AST), top-right (Lat: +18.31629, Lon: -67.24444, 2017.11.3, 08:45 AST), bottom-left (Lat: +18.31625, Lon: -67.244442, 2017.11.3, 08:39 AST).

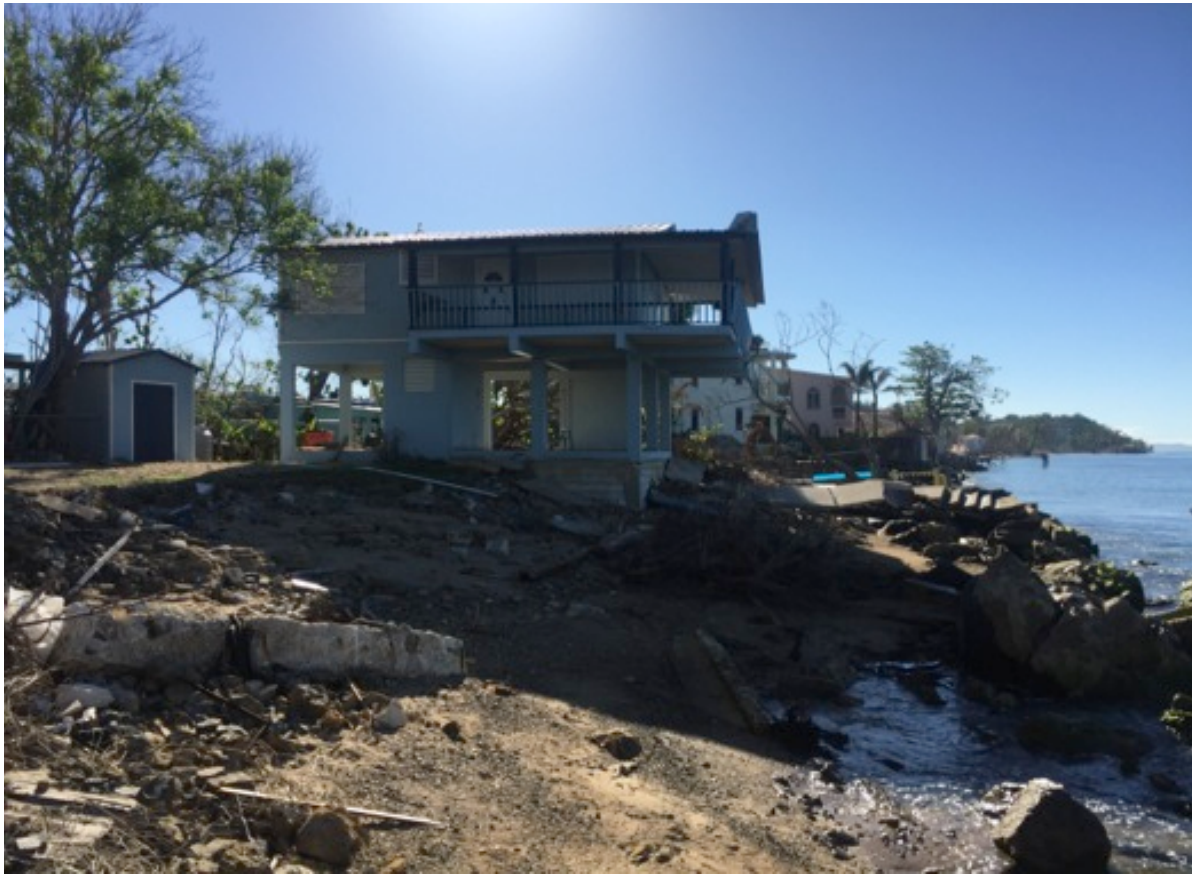
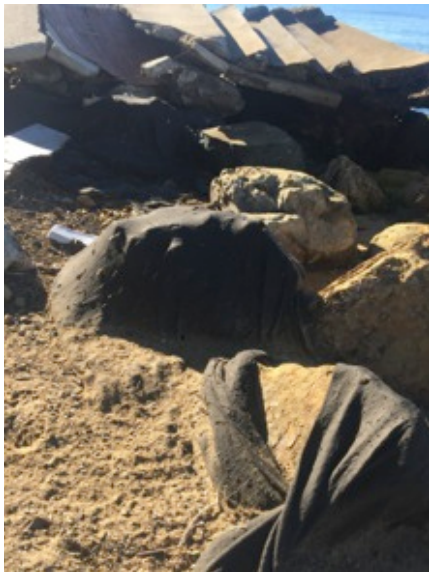
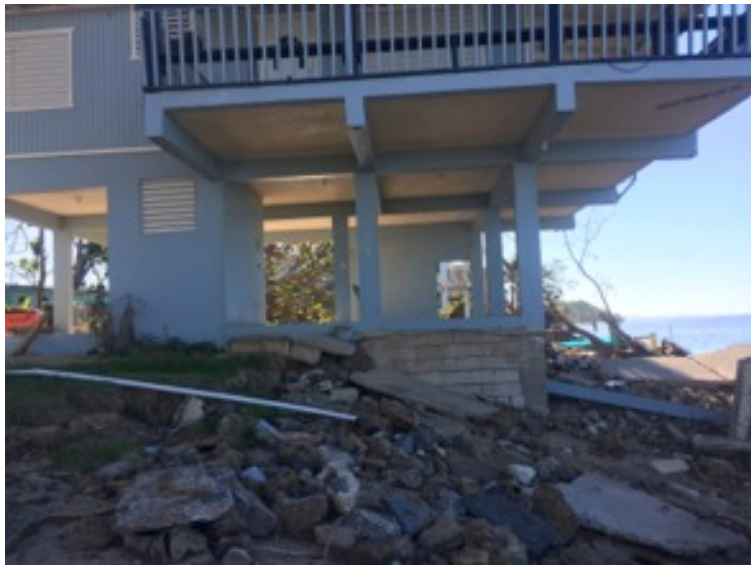
**Figure 4-11: Photos of Building B at Site CE2.**

Notes: Building B, top (Lat: +18.31620, Lon: -67.24445, 2017.11.3, 08:38 AST), bottom-left (Lat: +18.31602, Lon: -67.24432, 2017.11.3, 08:41 AST), bottom-right (Lat: +18.31614, Lon: -67.24431, 2017.11.3, 08:40 AST).
