# GEOTECHNICAL IMPACTS OF HURRICANE MARIA IN PUERTO RICO

Event Date: September 20, 2017

**Geotechnical Extreme Events Reconnaissance**

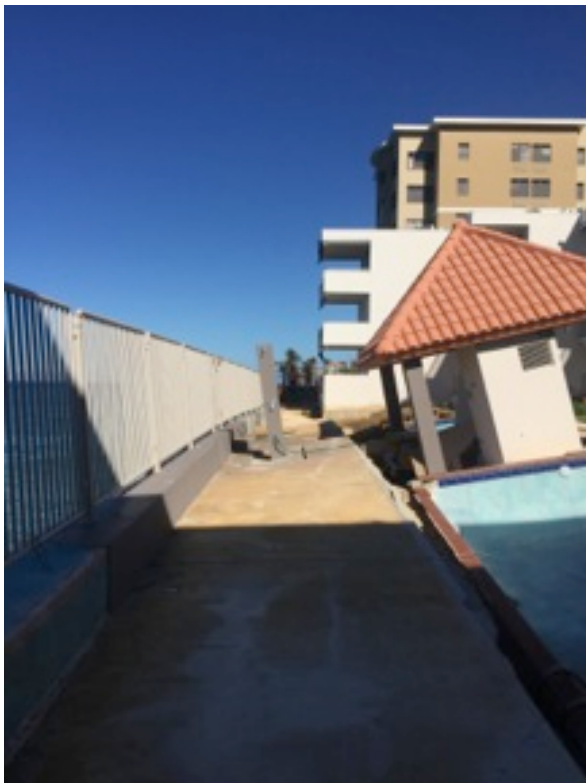
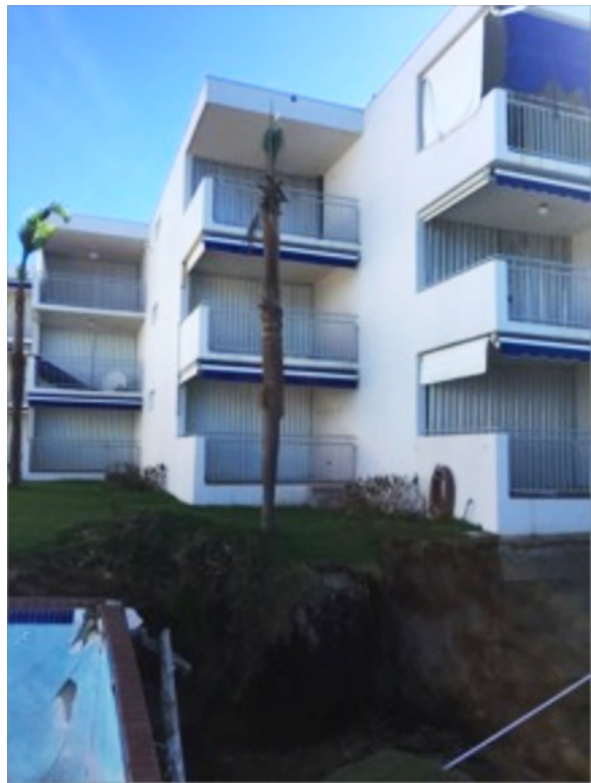
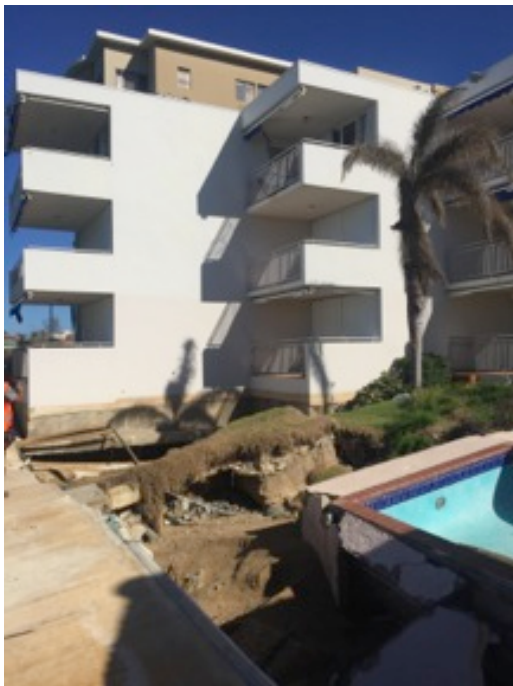
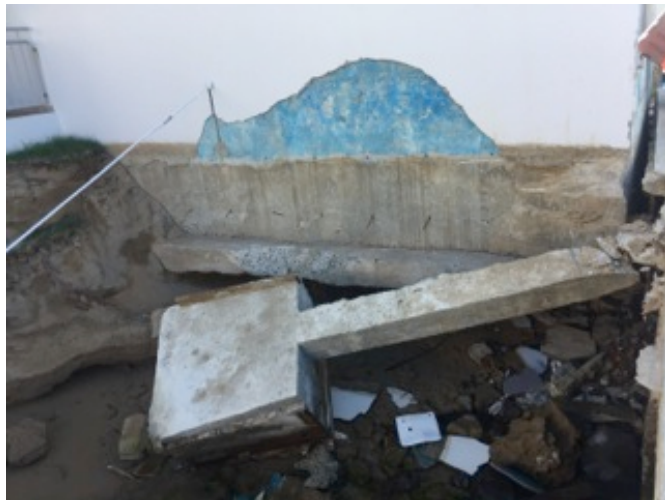
**Figure 4-15: Post-storm condition of Rincón Ocean Club I (Site CE3).**

Extensive damage of the three-story building, supported by shallow footings, of Rincón Ocean Club I, and the common areas of the terrace and swimming pool can be seen in Figure 4-14. A high volume of soil was eroded from the front of the buildings and from underneath the swimming pool. Footings and a connecting grade beams supporting the terrace were exposed and sheared off from the building foundation, as shown in Figure 4-15 (c) and Figure 4-15 (d).

Notes: (a) Damaged swimming pool, (Lat: +18.31820, Lon: -67.24583, 2017.11.3, 09:26 AST); (b) erosion in front of buildings (Lat: +18.31821, Lon: -67.24586, 2017.11.3, 09:26 AST); (c) (Lat: +18.31828, Lon: -67.24590, 2017.11.3, 09:21 AST) & (d) exposed footings (Lat: +18.31817, Lon: -67.24586, 2017.11.3, 09:32 AST).

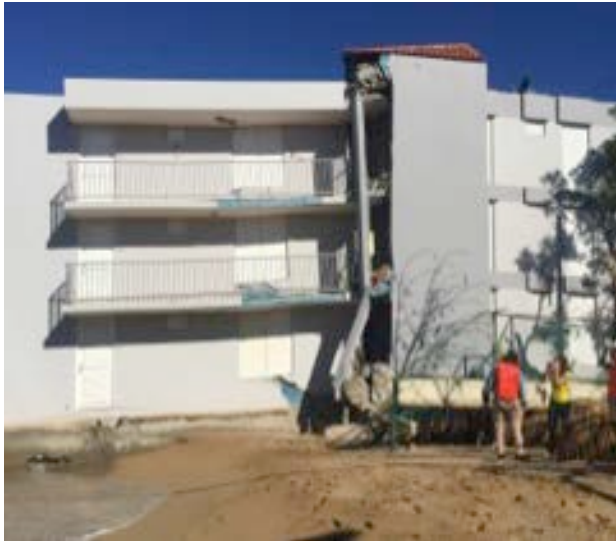
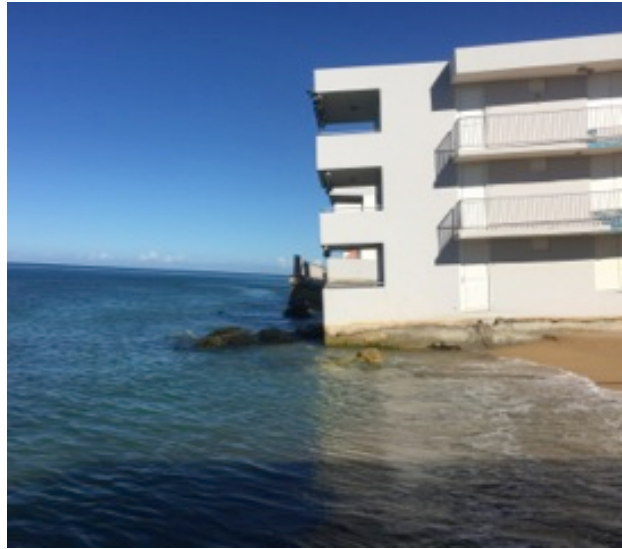
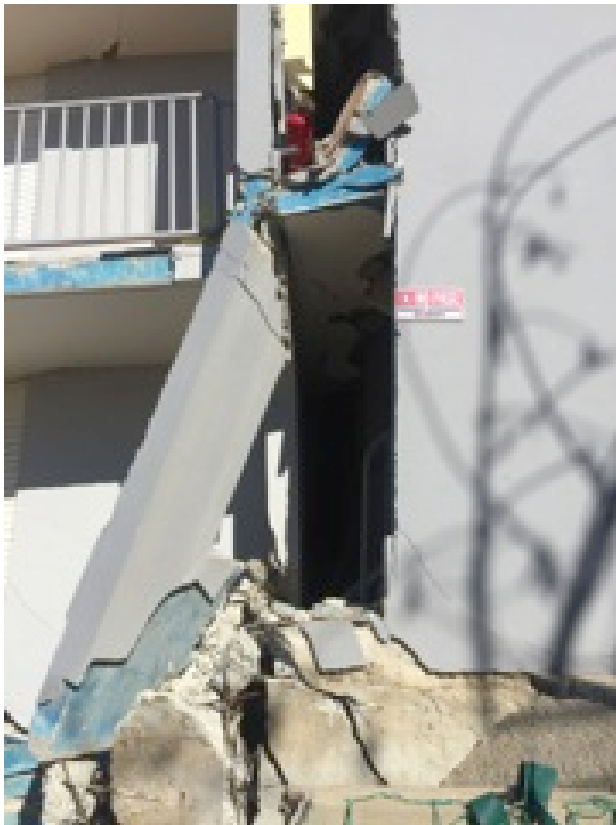
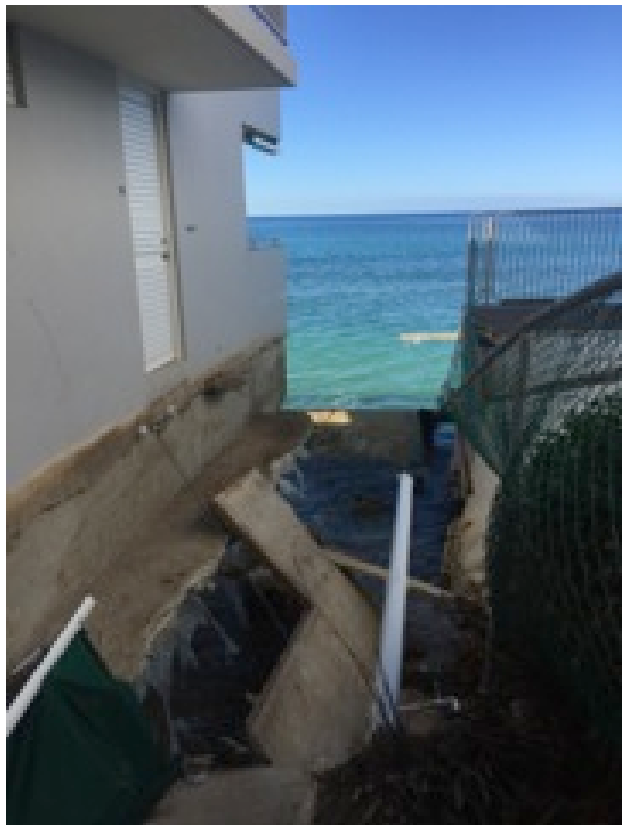
**Figure 4-16: Post-storm condition of Rincón Ocean Club II (Site CE3).**

Damage of Rincón Ocean Club II, can be seen in the different images in Figure 4-16. Washout of the beach and soil foundation materials was also observed for the Club II complex contributing to the building collapse shown in Figure 4-16 (a) and Figure 4-16 (b). The courtyard swimming pool (shown in their pre-storm condition in Figure 4-13 (c) and Figure 4-13(d) appeared to have completely collapsed and washed away, as remnant materials of these areas were not observed during the field reconnaissance of Site CE3. Damage to the reinforced concrete beams and columns were observed along the side of the building as shown in in Figure 4-16 (c) and Figure 4-16 (d).

Damage, (a), Lat: +18.31776, Lon: -67.24546, 2017.11.3, 09:04 AST, (b) Lat: +18.31769, Lon: -67.24554, 2017.11.3, 09:09 AST, (c) Lat: +18.31791, Lon: -67.24554, 2017.11.3, 09:14 AST, (d) Lat: +18.31810, Lon: -67.24571, 2017.11.3, 09:18 AST.

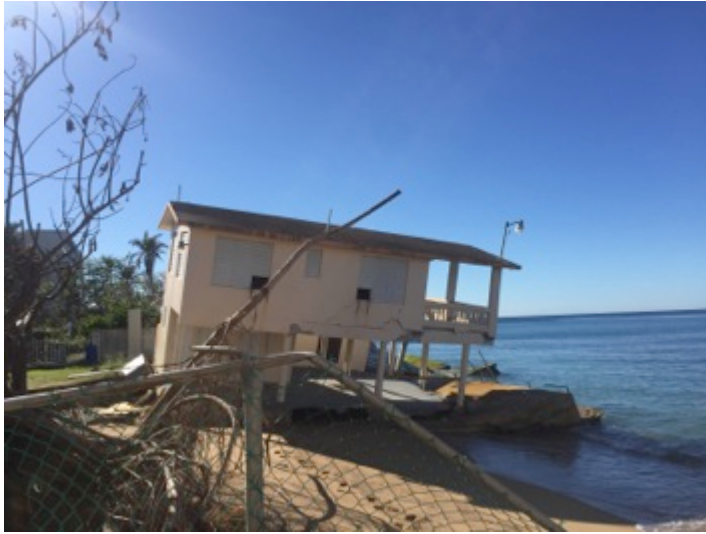
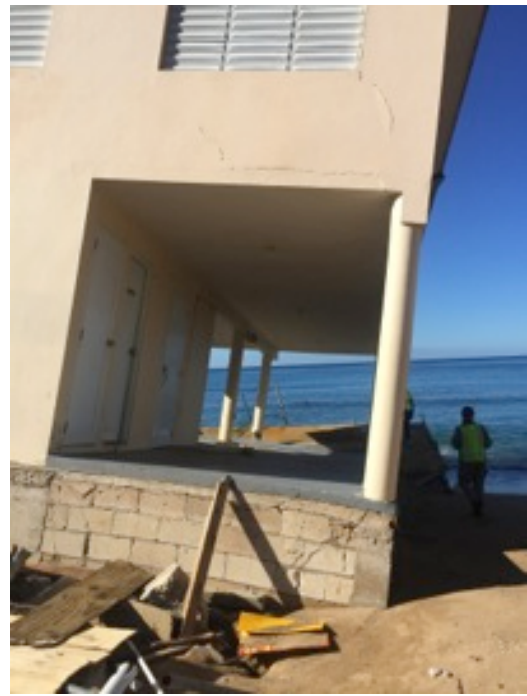
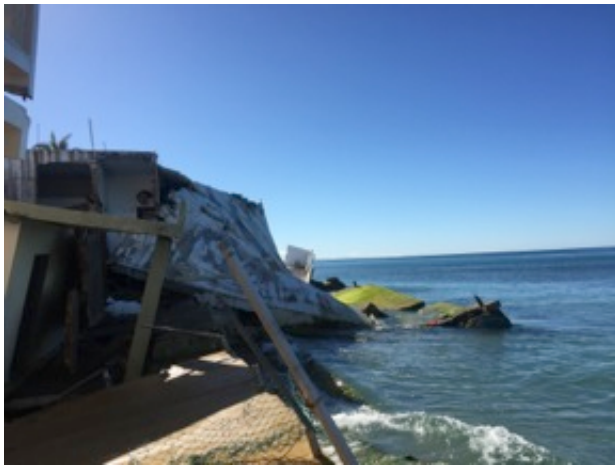
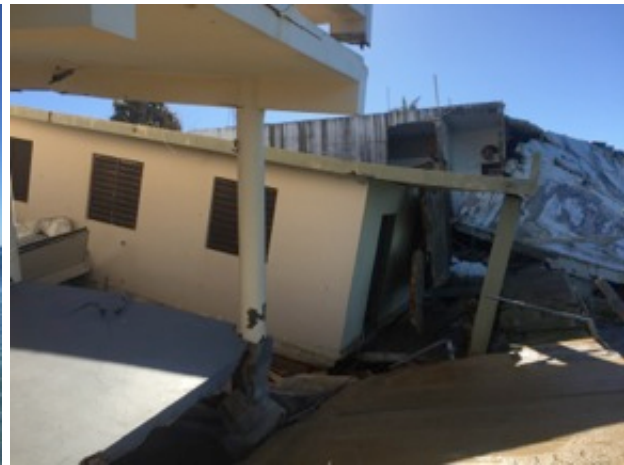
**Figure 4-17: Post-storm condition of Building A (Site CE3).**

Damage to a residential house (Building A), at the location shown in Figure 4-12, is shown in Figure 4-16. Similar to the building of Rincón Ocean Club II, Building A collapsed into the ocean and the remaining structure was severely cracked.

Notes: Photos of damage: (a) (Lat: +18.31792, Lon: -67.24552, 2017.11.3, 09:02 AST), (b) (Lat: +18.31779, Lon: -67.24540, 2017.11.3, 09:03 AST), (c) (Lat: +18.31769, Lon: -67.24549, 2017.11.3, 09:04 AST), (d) (Lat: +18.31768, Lon: -67.24549, 2017.11.3, 09:04 AST).

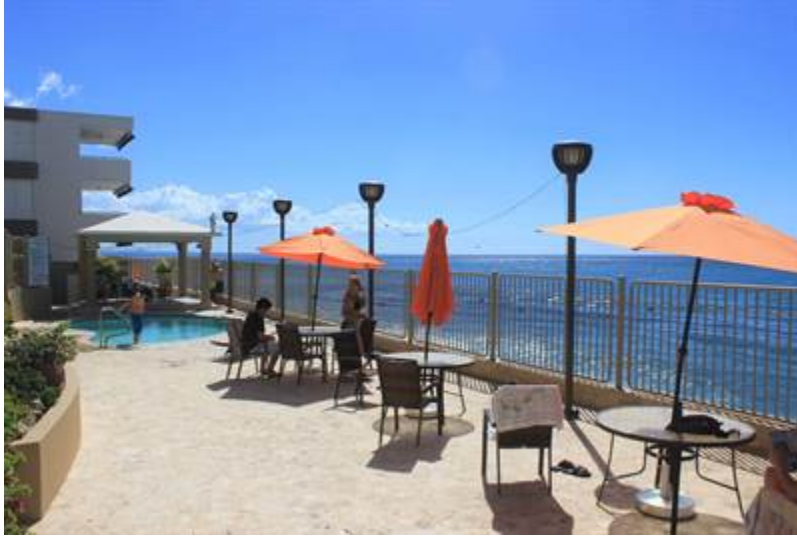
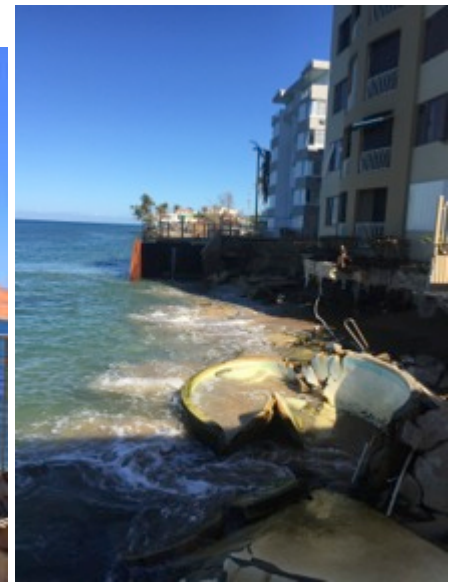
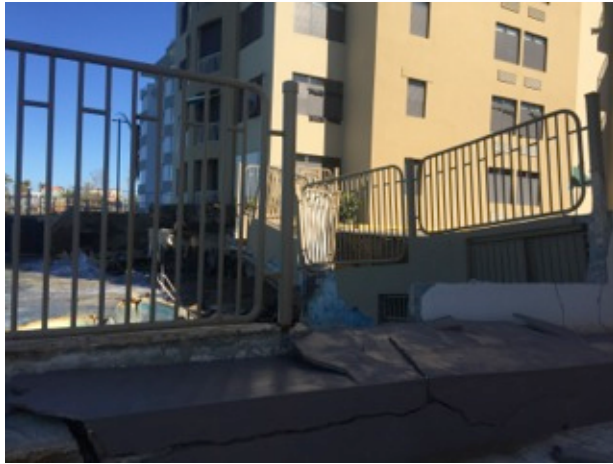
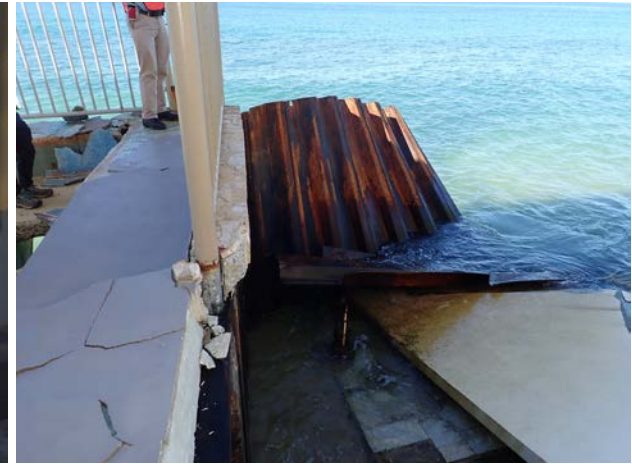
**Figure 4-18: Pre- and Post-storm damage at the Victoria Del Mar Condominium (Site CE3).**

The Victoria Del Mar Condominium, the tallest building in this area, located to the north of Rincón Ocean Club I as shown in Figure 4-15 (a), also suffered extensive damage associated to coastal erosion. The pre-storm condition of the pool and terrace area of the Victoria Del Mar Condominium is shown in Figure 4-18(a). The terrace and swimming pool area collapsed with the storm, as shown on Figure 4-18 (b) and Figure 4-18 (c).

Notes: (a) Victoria Del Mar Condominium: top: pre-failure <http://blog.realestaterinconpr.com/rentlease-dropped-on-1a-victoria-del-mar-in-victoria-del-mar-rincon/> (b) after failure (photo taken from Ocean Club I), (c) Lat: +18.31848, Lon: -67.24606, 2017.11.3, 09:25 AST (d) Lat: +18.31837, Lon: -67.24597, 2017.11.3, 09:22 AST).

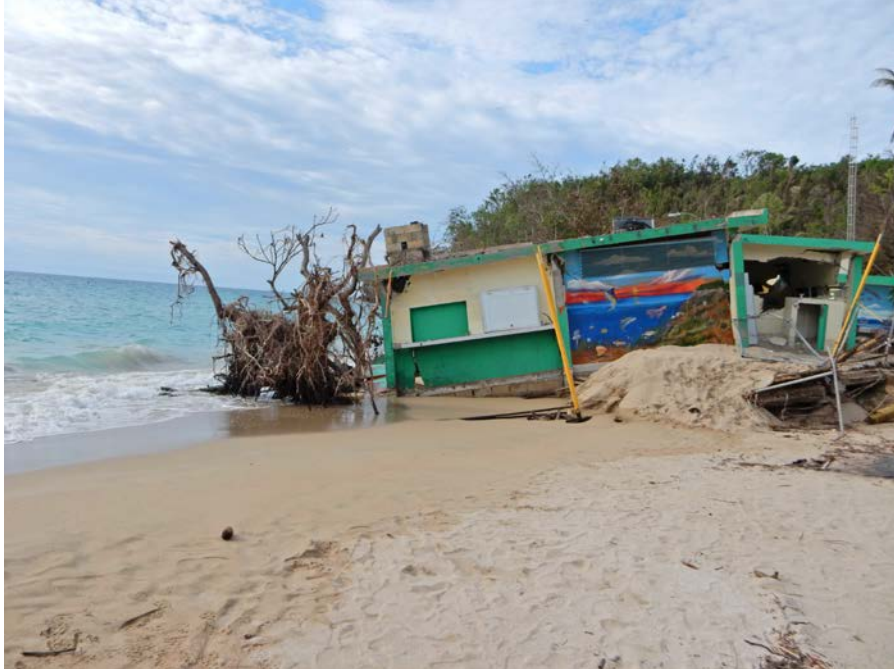
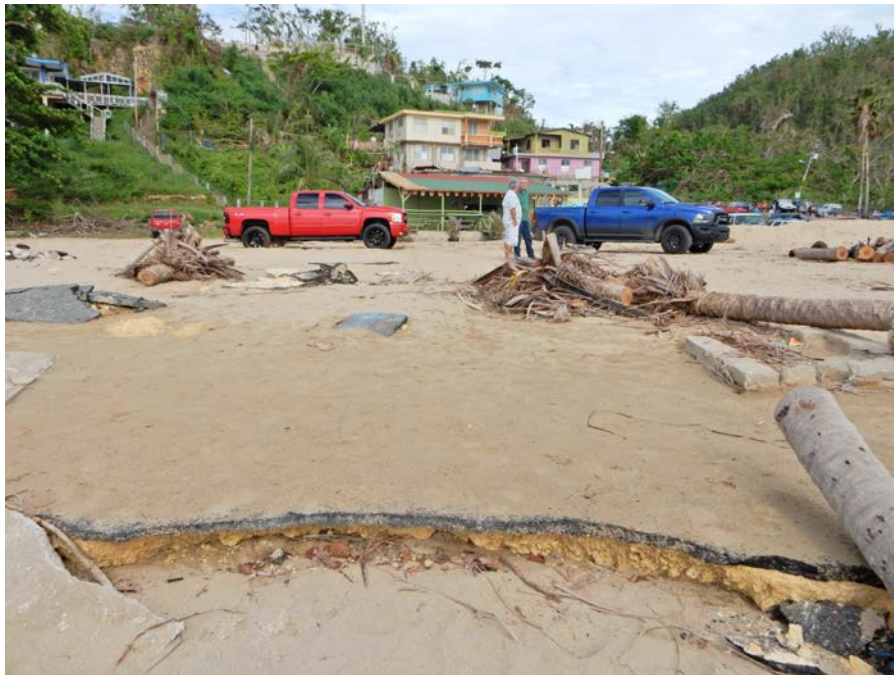
Site CE4 is located at Crash Boat Beach in Aguadilla, PR. It was visited by Drs. Silva-Tulla, Pando, and Bernal on Sunday, October 29, 2017. The top photo of Figure 4-19 illustrates the magnitude of coastal erosion at this site and scour of the foundation of the small fish store structure, where local fishermen used to sell their fish before the hurricane.

Figure 4-19: Coastal erosion at Site CE4 - Crash Boat Beach (Lat: +18.45878, Lon: -67.16413).

From the top photo of Figure 4-19, it is also possible to infer a considerable loss of sand, as shown from the elevation difference and rotation of the fish store structure. The lower photo of Figure 4.19 shows the parking area at this beach with considerable accumulation of sand.

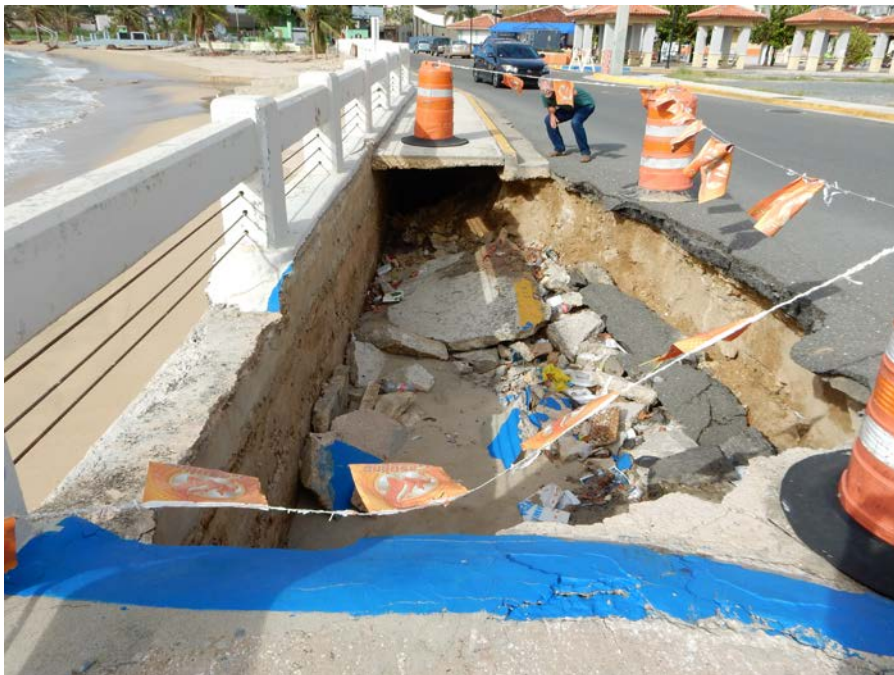
This site is located in the town center of Aguadilla along the coastal avenue that borders the west side of town. The site was visited by Drs. Silva-Tulla, Pando, and Bernal on Sunday, October 29, 2017. The photo in Figure 4-20 shows a collapse of the sidewalk. The reasons for the collapse of the sidewalk are difficult to determine. The edge of the guardrail structure shows some damage, likely related to weave action that could have overtopped and caused the sidewalk collapse. However, poor construction is also possible given the large cavity under the sidewalk still in place.

**Figure 4-20: Coastal erosion Site CE5 – Collapse of sidewalk along coastal avenue in Aguadilla Town Center (Lat: +18.43159, Lon: -67.15529).**

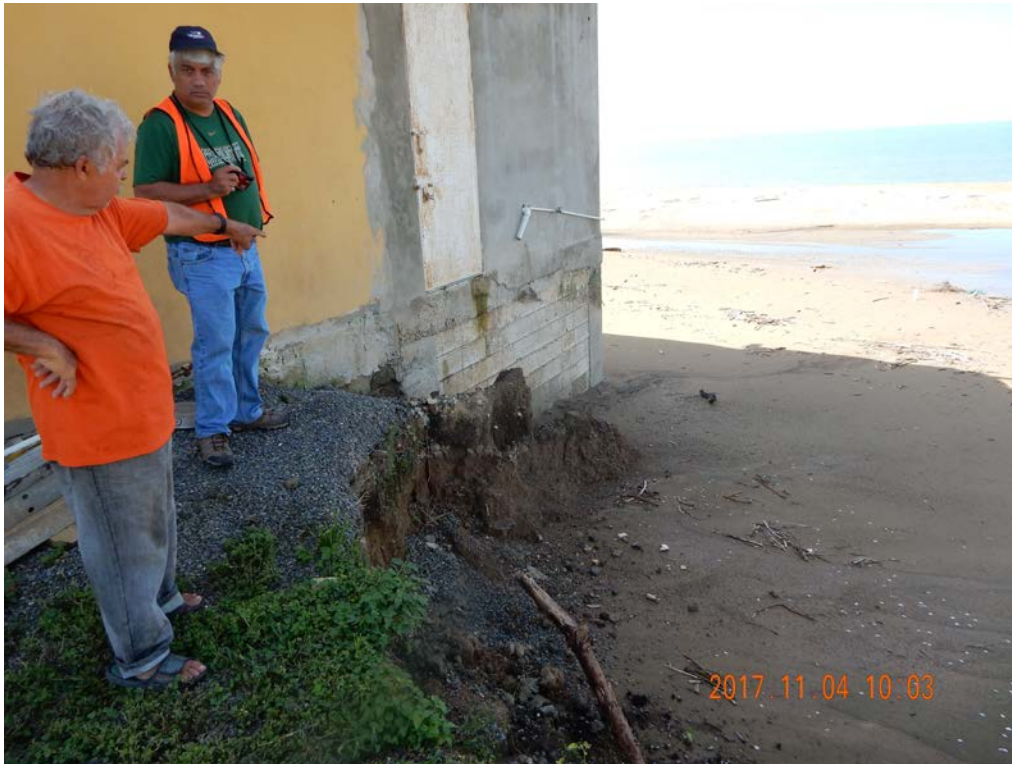
The shoreline of the beach of El Maní in Mayagüez, PR was greatly affected by Hurricane Maria due to heavy flooding and severe coastal erosion. This site was visited by GEER members Drs. Silva-Tulla, Pando, and Park on November 4, 2017. Evidence of coastal erosion can be seen on Figure 4-21 through Figure 4-25.

**Figure 4-21: Coastal erosion at Site CE6 - beachfront house at Playa El Maní, Mayagüez, PR.**

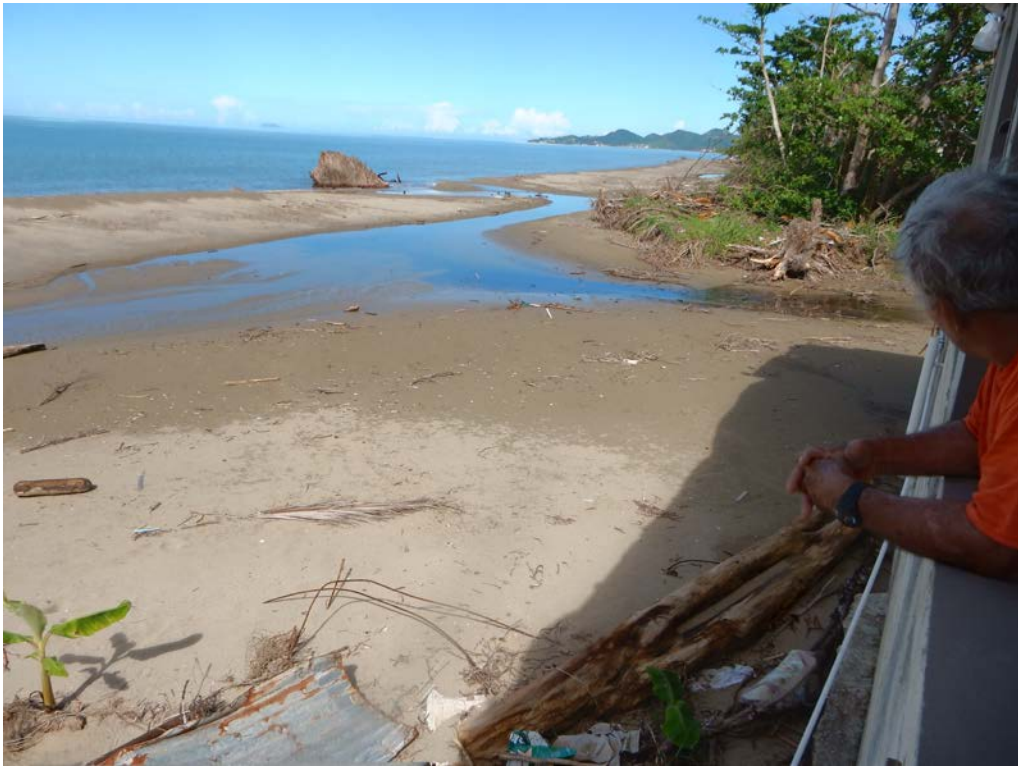
**Figure 4-22: Coastal erosion at Site CE6 - beachfront house at Playa El Maní, Mayagüez, PR.**

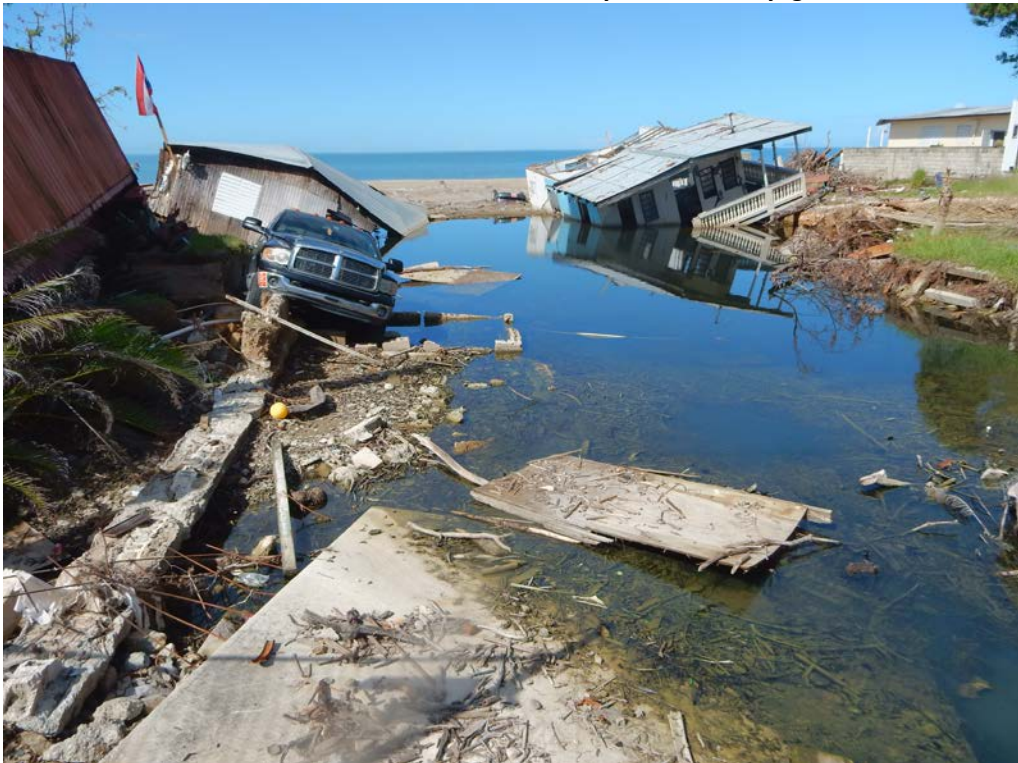
**Figure 4-23: Coastal erosion at Site CE6 - Playa El Maní, Mayagüez, PR.**

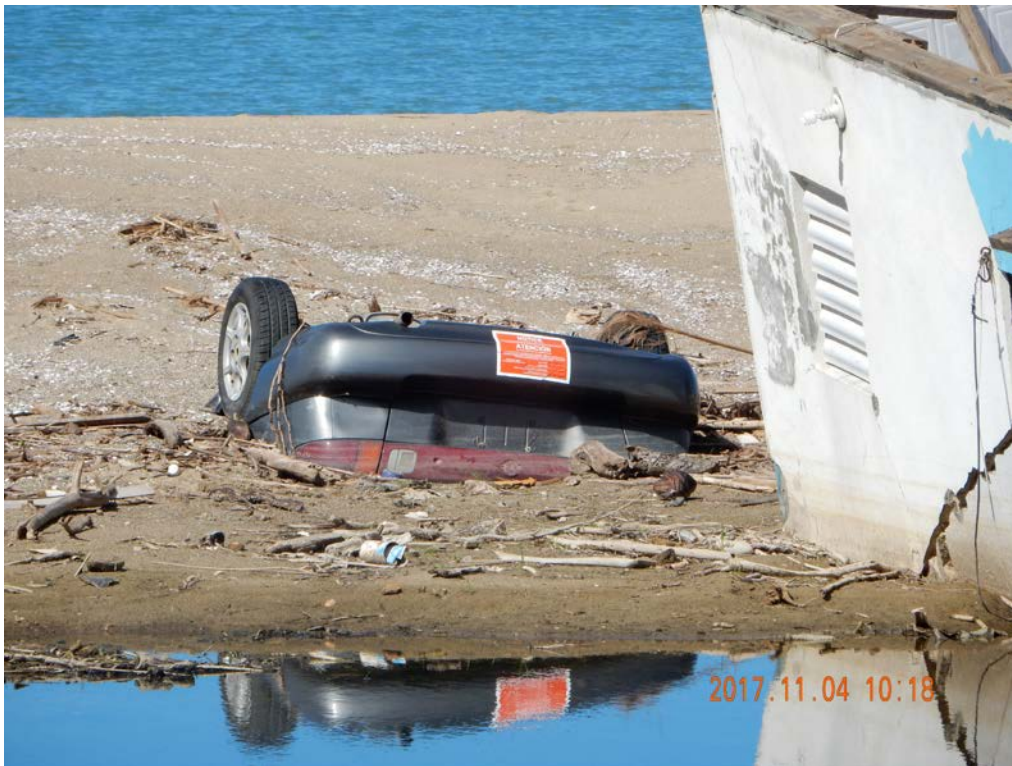
**Figure 4-24: Coastal erosion at Site CE6 - Playa El Maní, Mayagüez, PR.**

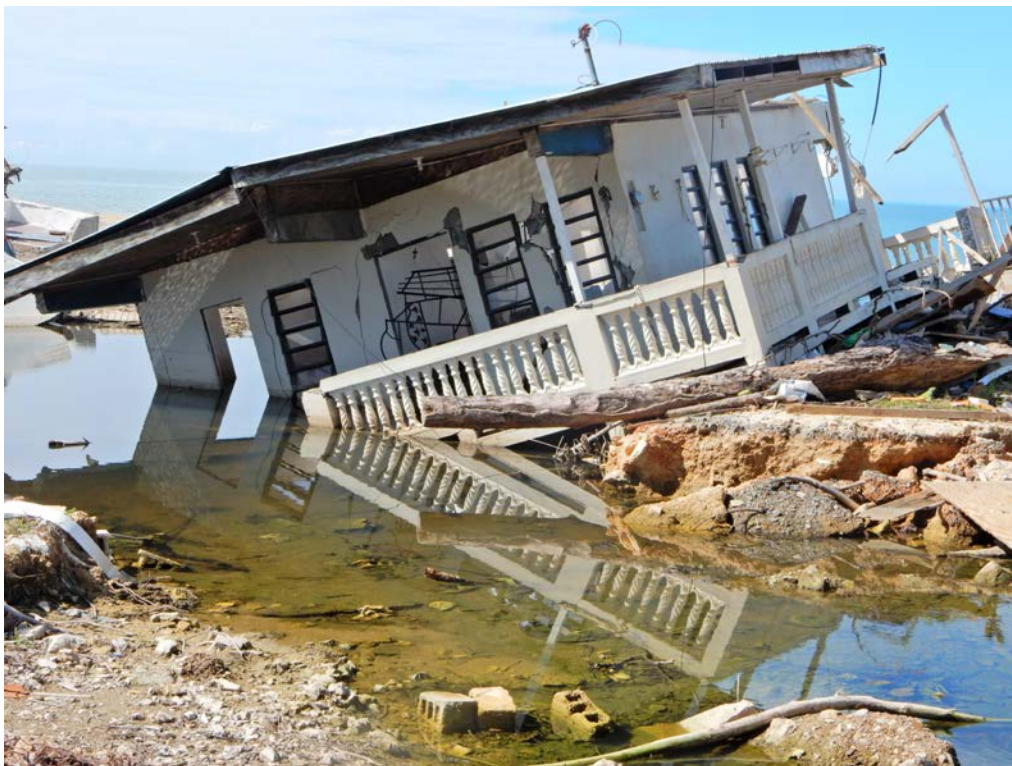
**Figure 4-25: Coastal erosion at Site CE6 - Playa El Maní, Mayagüez, PR.**

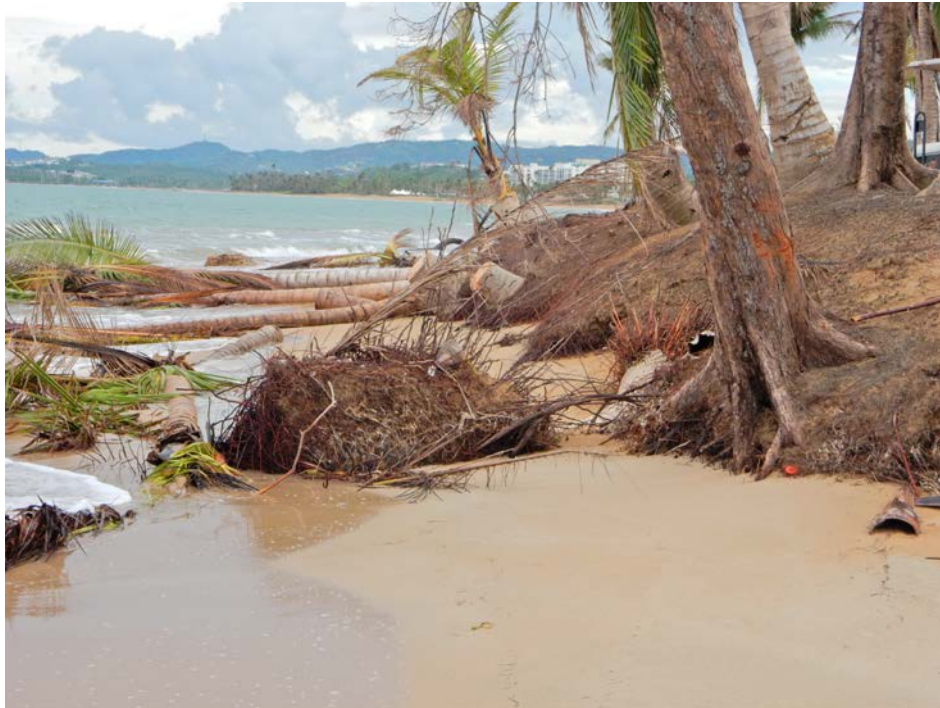
Some beach erosion was observed at Playas el Yunque in Rio Grande, PR (lat:+18.39770, lon:-65.76260). This site was visited by GEER members Drs. Silva-Tulla and Pando on October 28, 2017. Photos showing the coastal erosion can be seen on Figure 4-26 through Figure 4-29.

Figure 4-26: Coastal erosion at Site CE7 - Playas del Yunque, Rio Grande, PR (Lat: +18.39821, Lon: -65.76466).

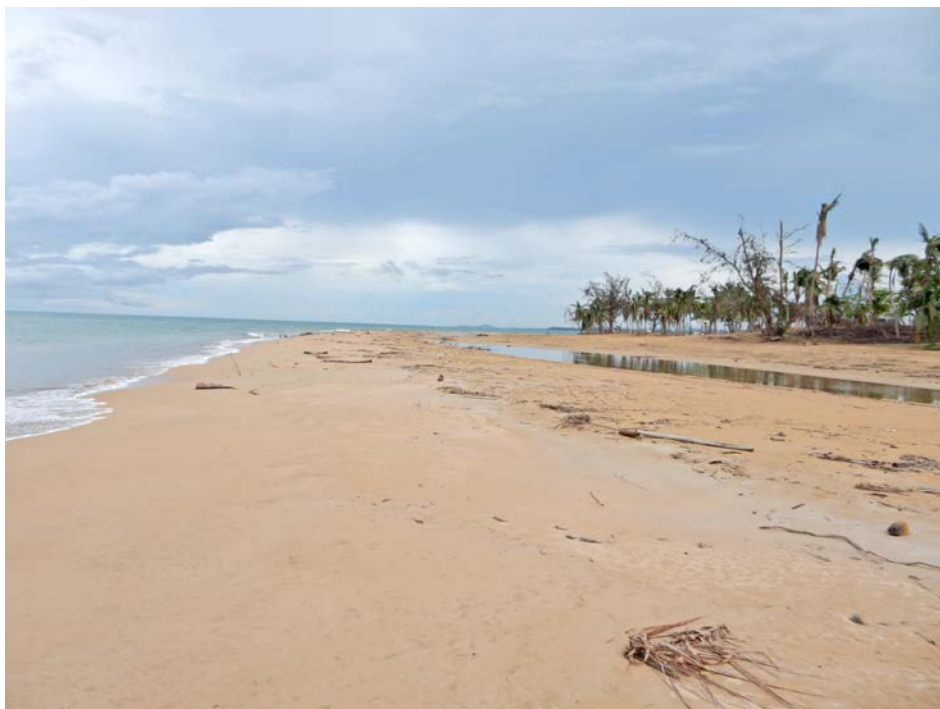
Figure 4-27: Coastal erosion site CE7: Playas del Yunque, Rio Grande, PR (Lat: +18.39823, Lon: -65.76483).

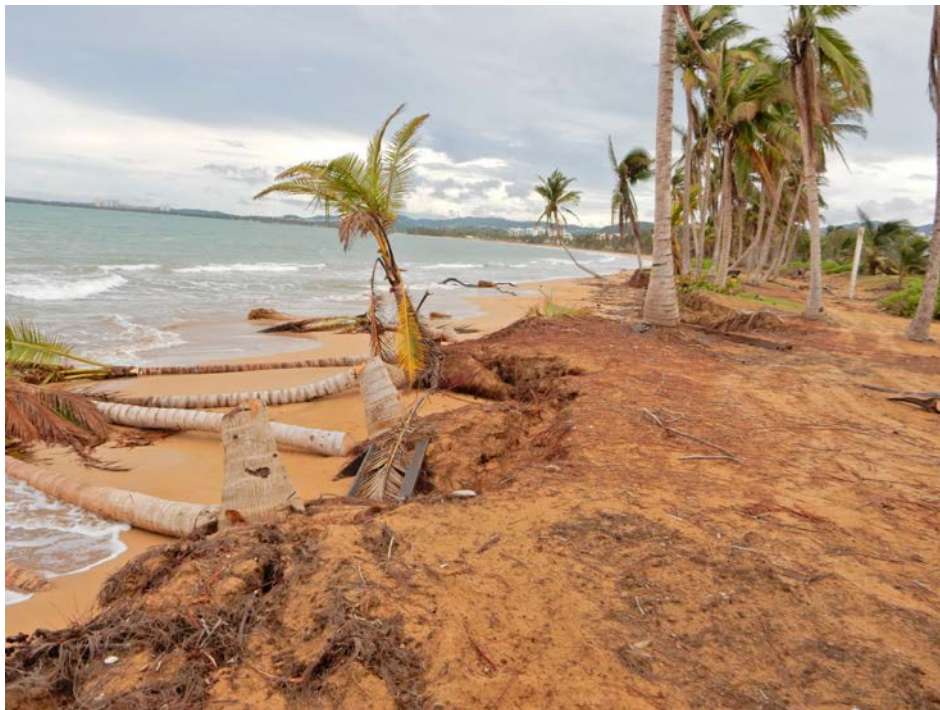
Figure 4-28: Coastal erosion site CE7: Playas del Yunque, Rio Grande, PR (Lat: +18.39754, Lon: -65.76246).

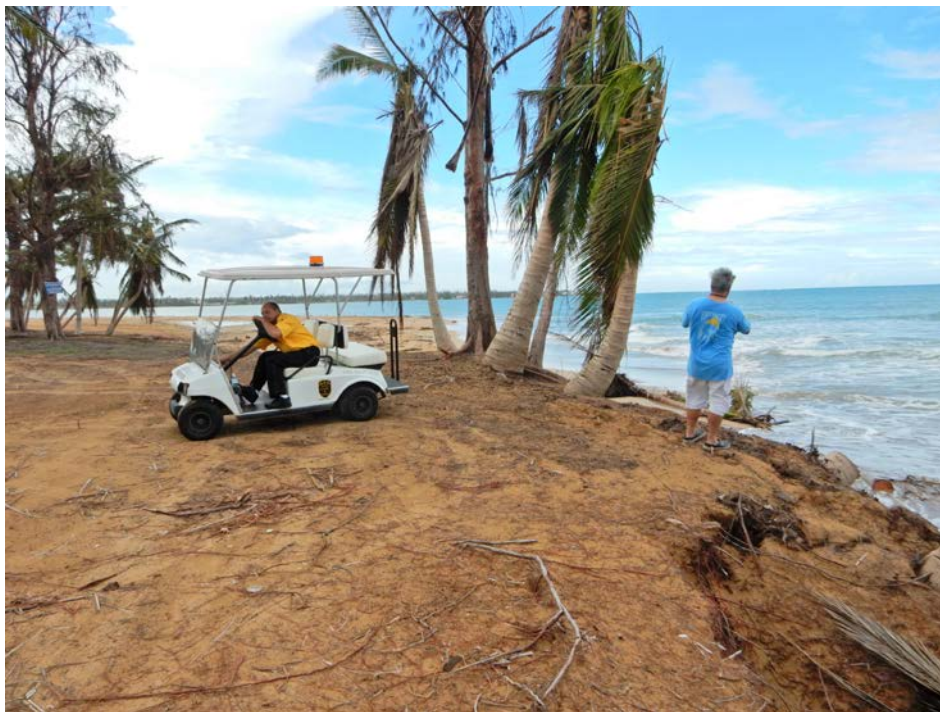
Figure 4-29: Coastal erosion site CE7: Playas del Yunque, Rio Grande, PR (Lat: +18.39754, Lon: -65.76246).

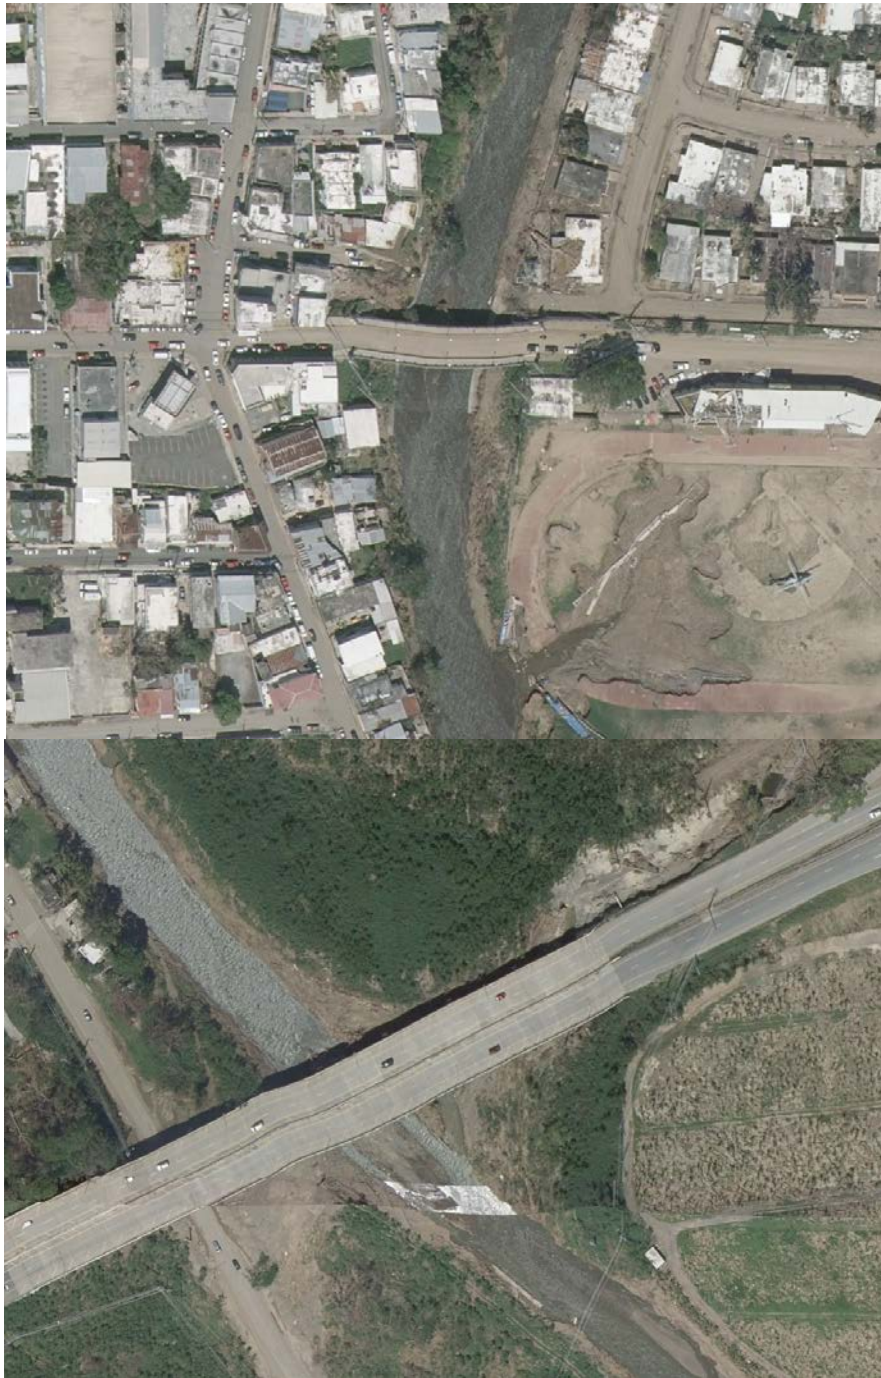
In terms of bridge damage, including partial or total failure, the GEER team visited several bridge sites where damage was related to the large hydrodynamic forces from the increased volume and flow speeds associated with Hurricane Maria. The large magnitude of these hydrodynamic forces is illustrated in Figure 5-3; this figure shows a satellite image from NOAA of the induced curvature of a bridge in Yauco.

**Figure 5-3: Images showing induced curvature on bridges near Yauco, PR, due to heavy river flows during Hurricane Maria (images from NOAA taken a few days after Maria).**

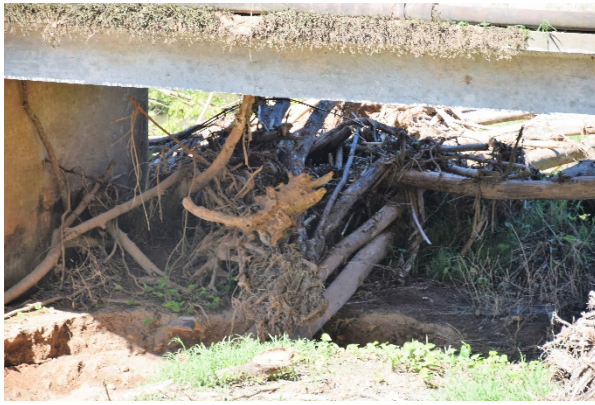
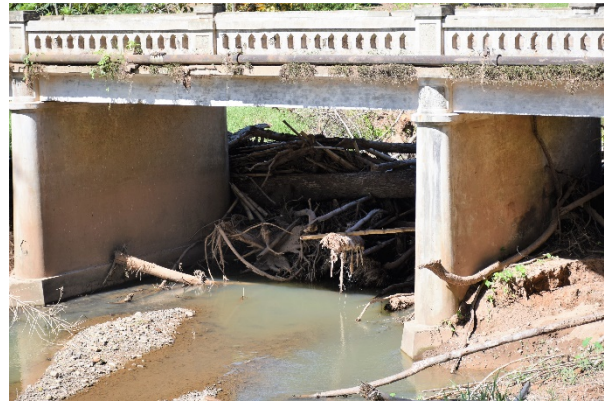
The hurricane-induced loading demand on bridges was not only related to the large hydrodynamic forces, but also related to drag and impact forces associated with large amounts of trees and debris materials transported by the rivers, as illustrated in the images shown on Figure 5-4.

**Figure 5-4: Photos showing large accumulation of debris under bridge.**

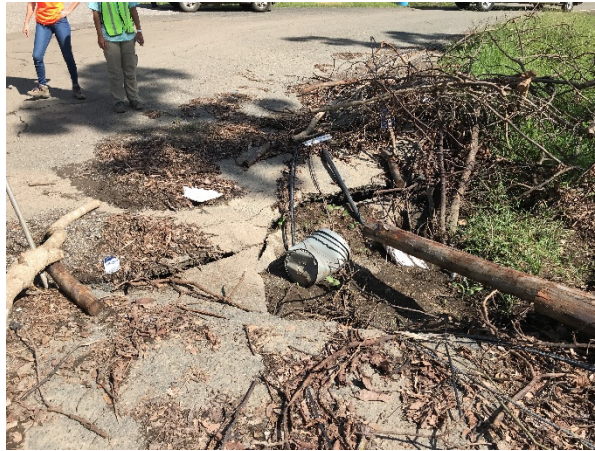
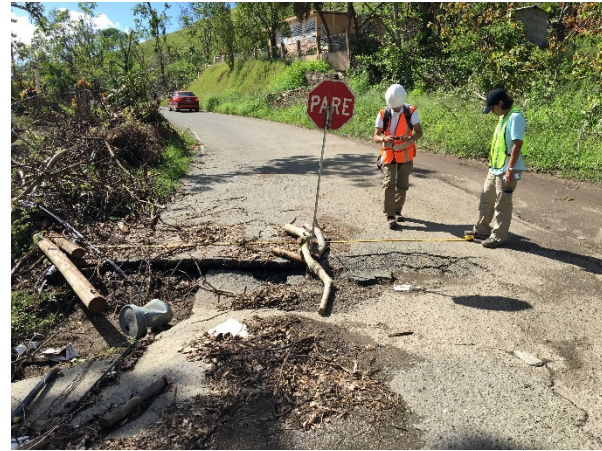
Figure 5-6(a) and Figure 5-6(b) show the subsided road surface above the culvert. Many cracks developed on the road pavement. The subsided length across the road was almost 13 feet, about half of the road width.

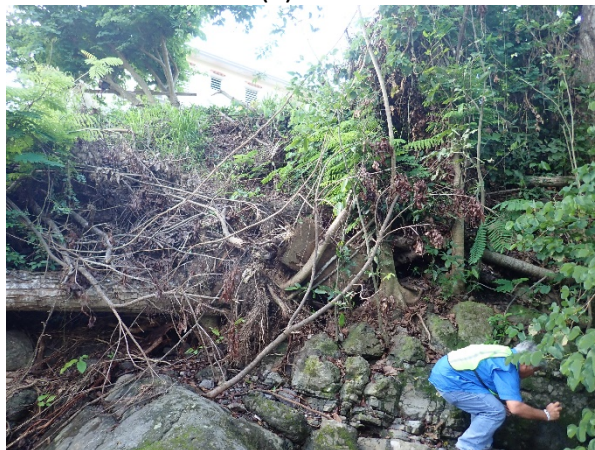
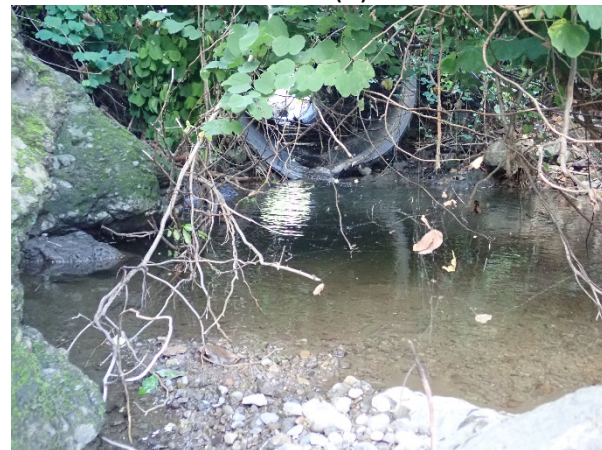
The culvert conditions were shown on Figure 5-6(c) and Figure 5-6(d). While most of the debris in the culvert was gone, many trees and other debris remained on the upstream side of culvert.

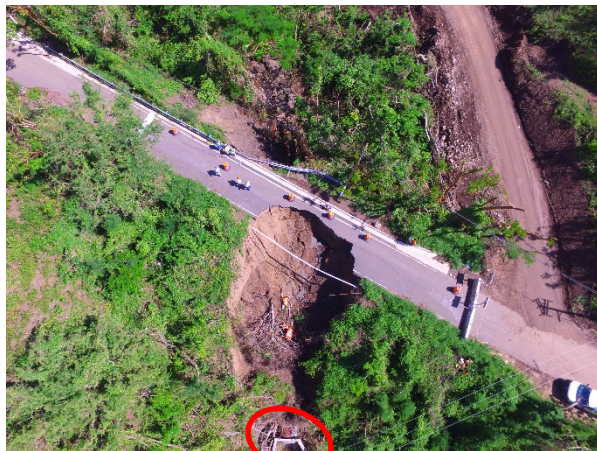
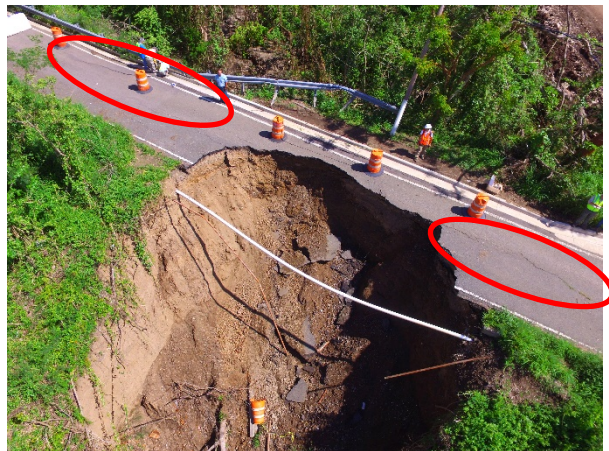
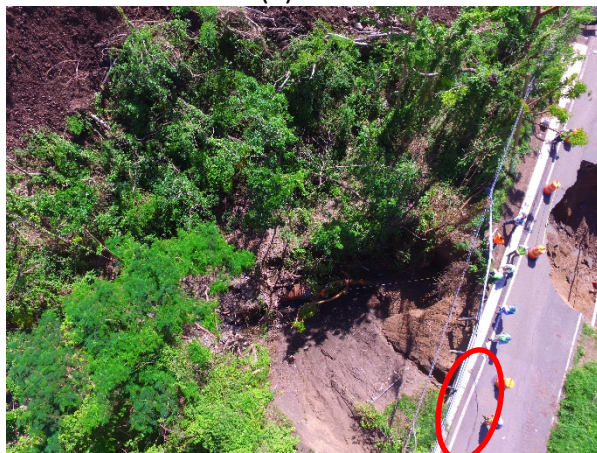
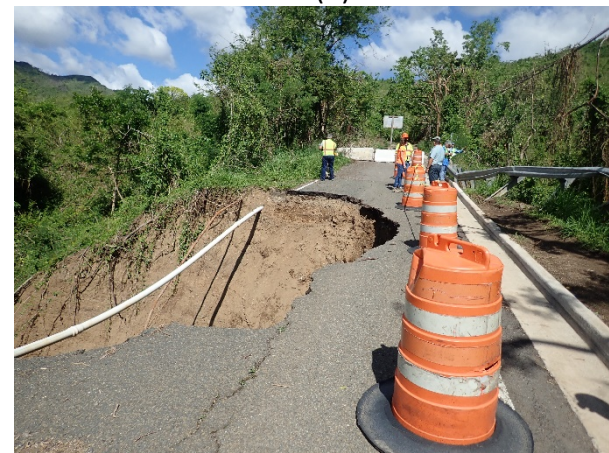
The location of this site is at Marker km 4.2 of PR-555, that is about 1.9 km East of Site 1 described above. Figure 5-7 shows the location map and a photo showing the location of the culvert and direction of water flow. This failure site involved a corrugated pipe culvert with a diameter of about five feet that crossed under the road. The red circle in the photo shown on Figure 5-8(a) marks the downstream outlet of the culvert. Photos on Figure 5-8(b) and Figure 5-8(c) show the extent of road width loss and the presence of large longitudinal cracks.

A grab soil sample collected from the exposed scarp was found to have a USCS classification of SM-SC (See Sample A in Table I-1 of Appendix I).

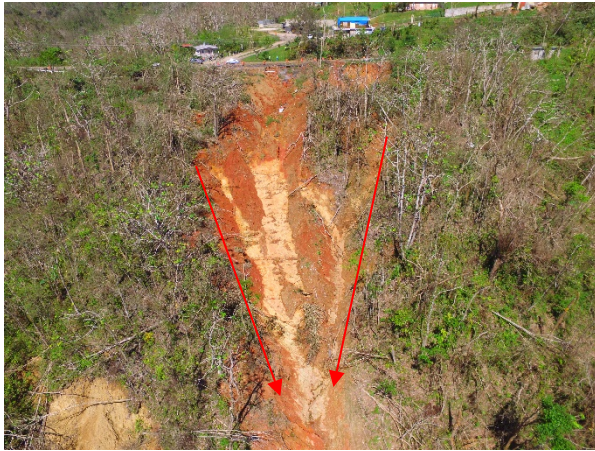
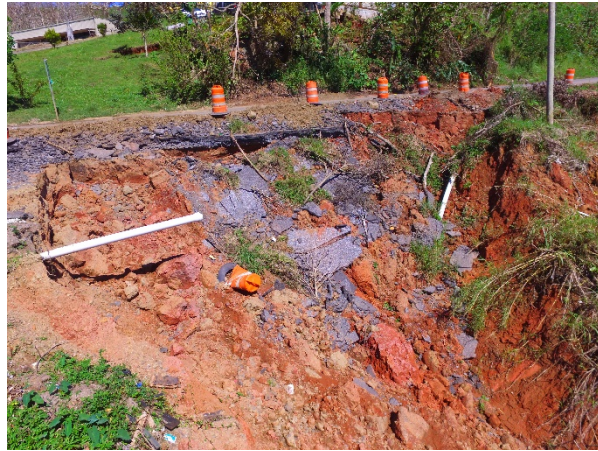
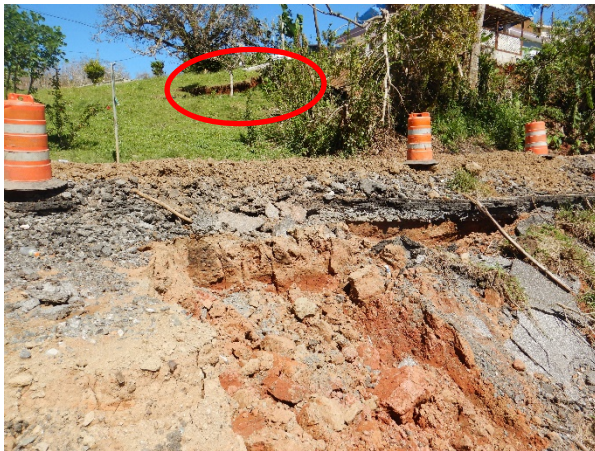
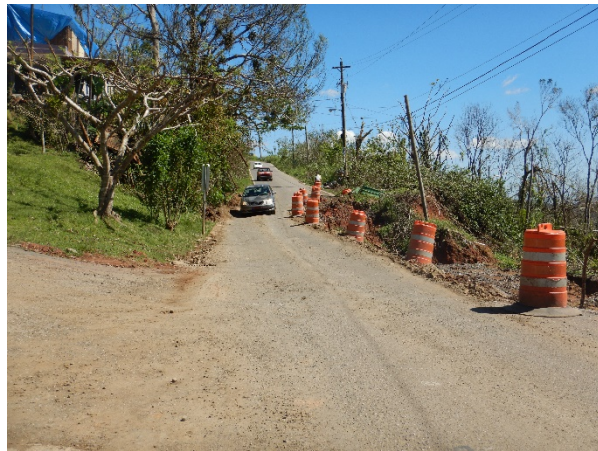
The site was visited by the GEER team on 11/1/17. The location of this road failure site is shown on Figure 5-9. At this site, the road failure was observed on the downslope side of the road, as shown on Note: Lat: +18.172445°, Lon: -66.377797°, Date: 11/01/17 12:57 EDT. Figure 5-10 via the drone photos. However, a tension cracks and a scarp were observed on the upslope side, as shown in the red circle on Figure 5-10(c). A photo showing the loss of the upper slope side of the lane is shown on Figure 5-10 (d), but it was not considered significant.

Three shear vane tests were performed by the GEER team at a location along the exposed scar near the lower right corner of photo in Figure 5-10(b). Tests involved use of a Humboldt Geovane with the small vane attachment (19 mm blade). Two of the Geovane tests were performed with the vane axis pushed vertically into the ground about 4 inches and yielded peak shear strength values of 43 and 62 kPa. Results of a Geovane tests pushed horizontally into a vertical face of the scar yielded a peak and residual shear strength of 70 and 14 kPa, respectively.

**Figure 5-10: Select photos of Road & Bridge Site 3 involving primarily road damage associated to downslope slope failure.**

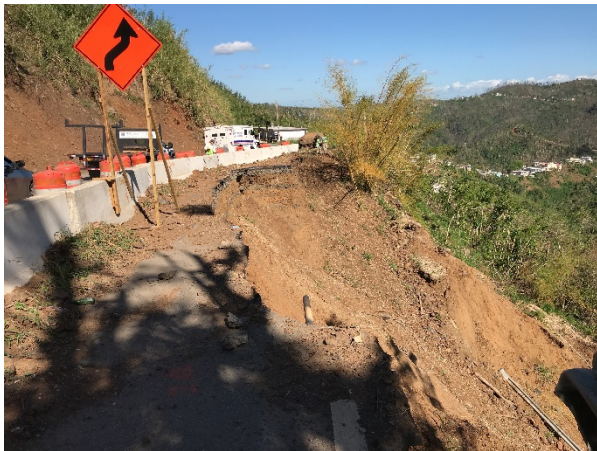
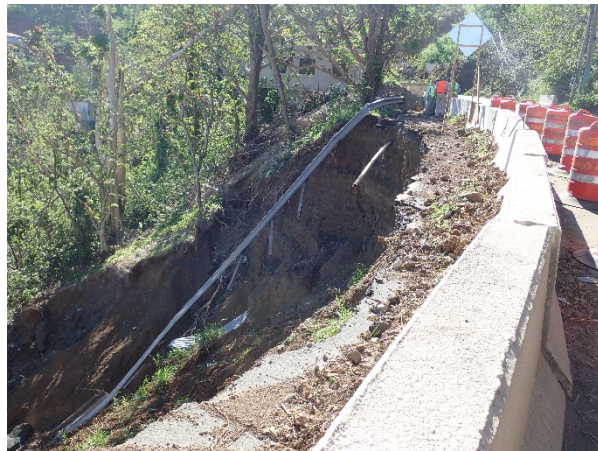
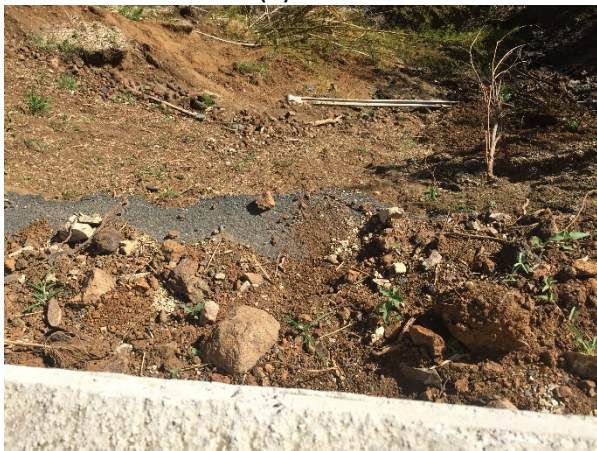
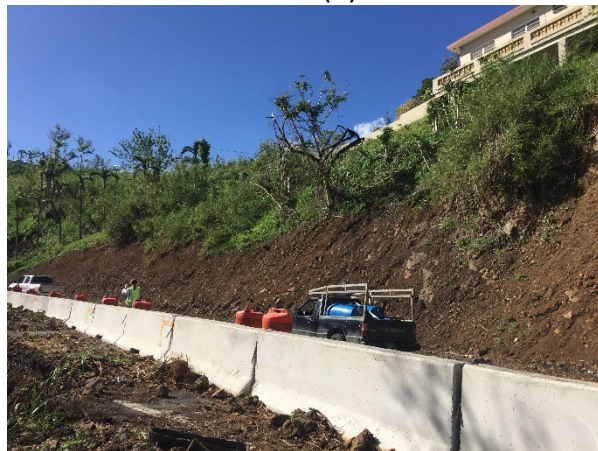
The general location of the road failure Site 4 is shown on Figure 5-11. The downslope side of this road site was lost as shown on Figure 5-12. The road lost almost a half its width. To widen the remaining access and maintain two-way traffic, the upload side was excavated.

Figure 5-12: Road & Bridge Site 4 - Road Damage by Lower Slope Failure.
