# GEOTECHNICAL IMPACTS OF HURRICANE MARIA IN PUERTO RICO

Event Date: September 20, 2017

**Geotechnical Extreme Events Reconnaissance**

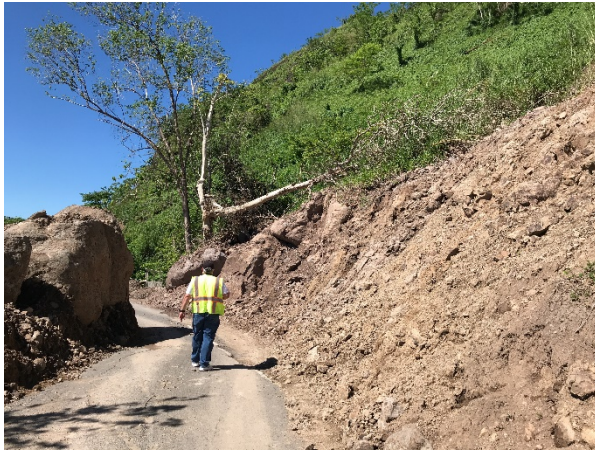
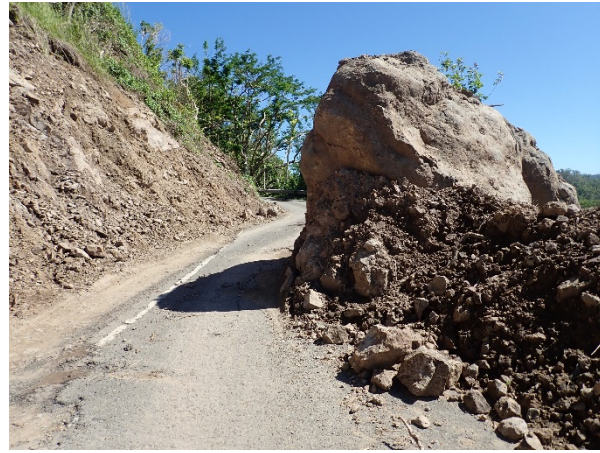
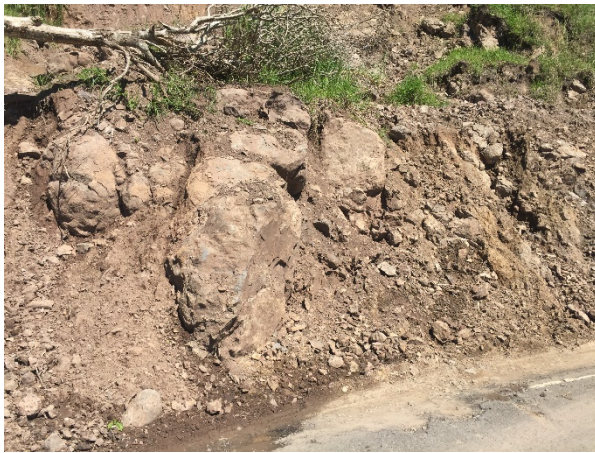
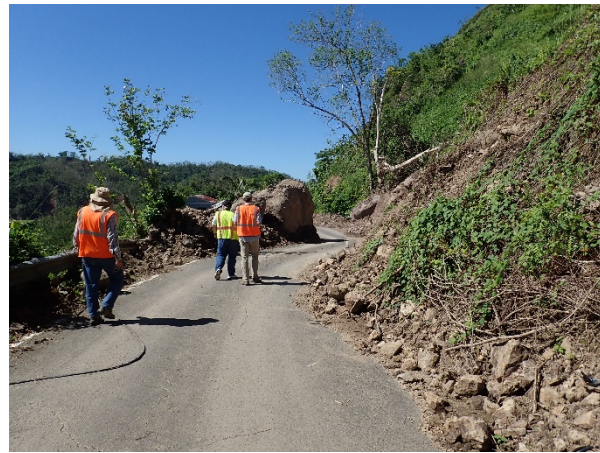
The location of Site 5 is shown on Figure 5-13. A large boulder, as well as other debris, blocked about half of the road.

**Figure 5-14: Photos of Road & Bridge Site 4 showing upslope side failure and road blockage.**

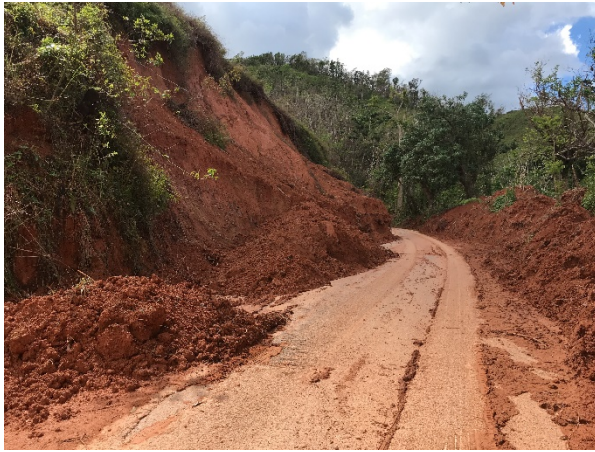
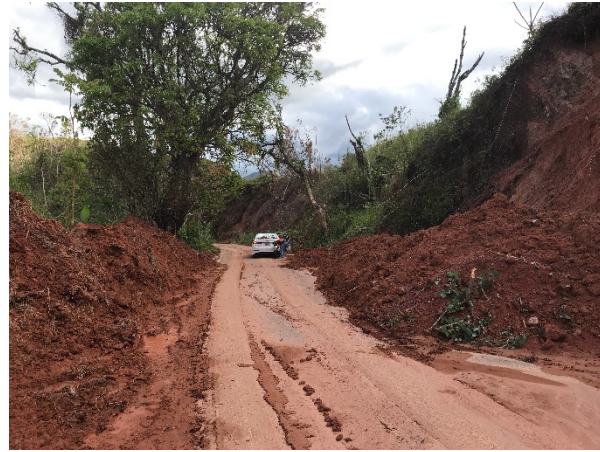
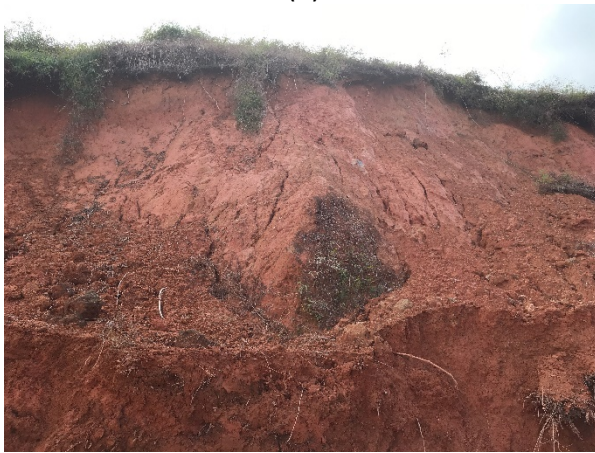
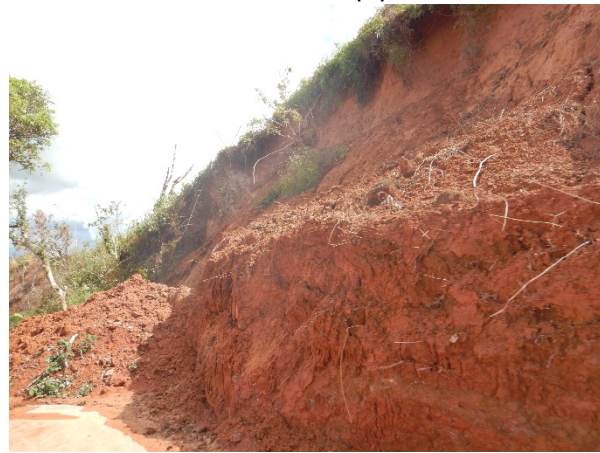
The location of the Site 6 road failure is shown on Figure 5-15. About 30 feet of the road was covered by red clay, and at the time of our visit, construction crews had opened only one lane.

**Figure 5-16: Photos of Road & Bridge Site 4 showing surficial slope failure on the upslope side of the road.**

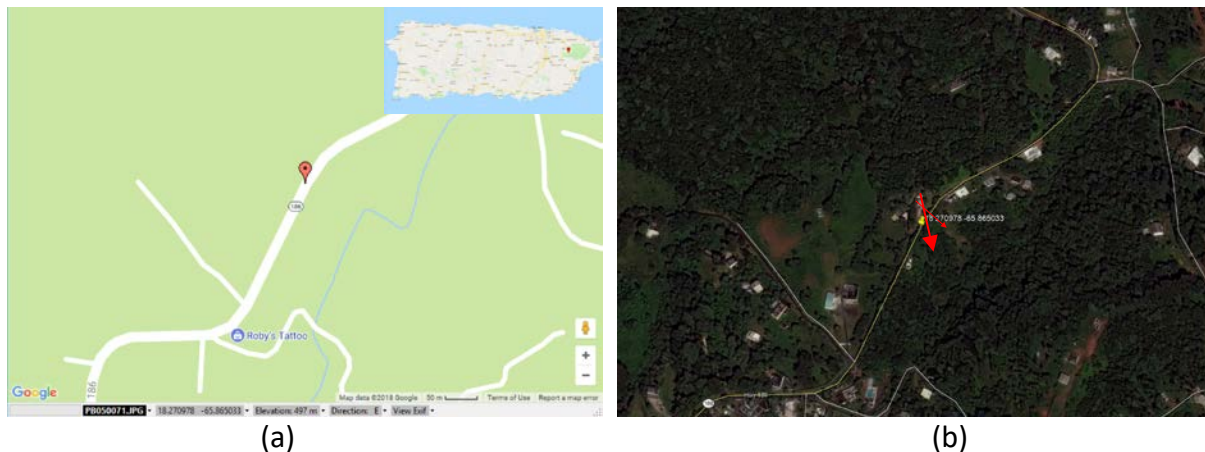
**Figure 5-17: Location of Road & Bridge Site 7.**

The location of the Road & Bridge Site 7 is shown in Figure 5-17. The site is located on the northwest side of the island along road PR-186 road near the west boundary of the El Yunque National Forest. The failure affected the full width of the PR-186 road and the entrance driveway of a residence on the west side of the road (upslope side). The arrows shown on Figure 5-17(b) point towards the slope failure direction (southeast).

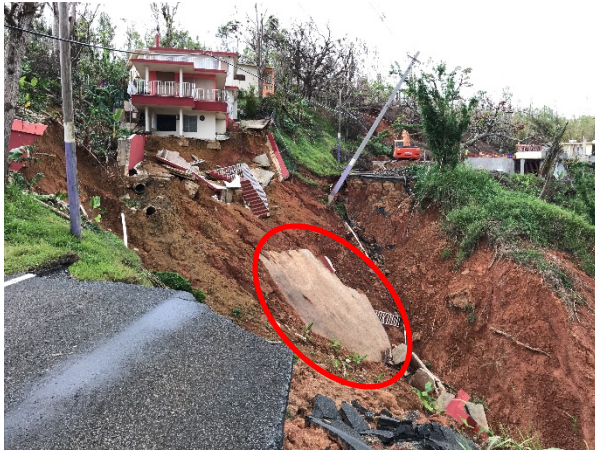
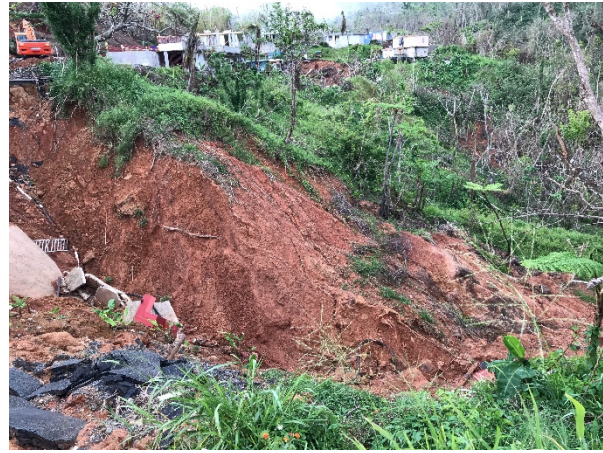
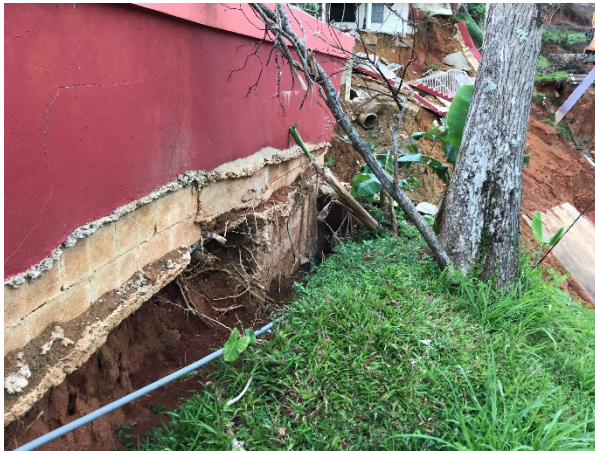
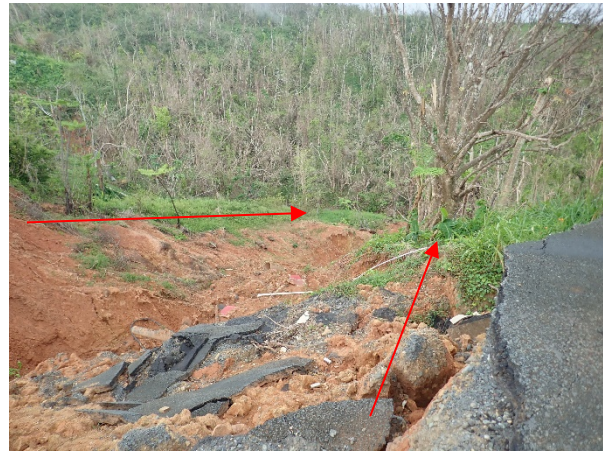
Figure 5-18: Photos of Road & Bridge Site 7 affecting PR-186.

Figure 5-18(a) shows the upper portion of the failure resulted in a complete cut-off of PR-186. This figure also shows a portion of the concrete pavement driveway of a residence to the left of the image (residence not shown). The final position of the piece of concrete driveway is shown inside the red circle. The arrow on Figure 5-18(d) points toward the slope failure direction (southeast).

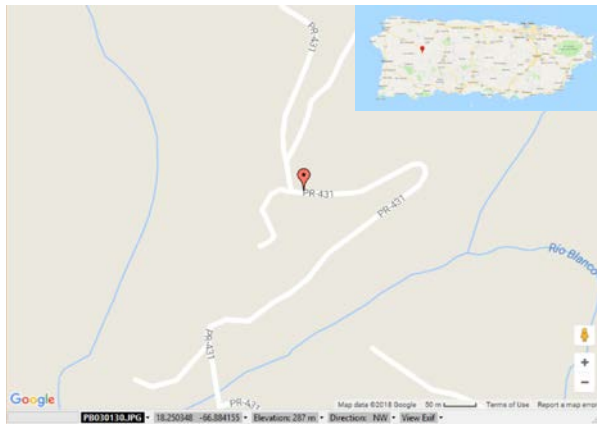
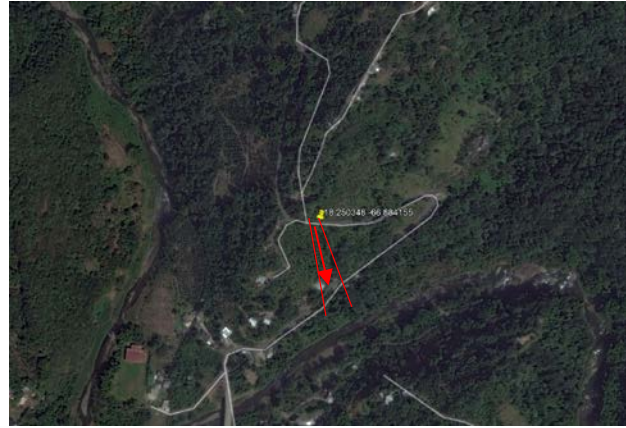
**Figure 5-19: Road & Bridge Site 8 - Complete cut-off failure along PR-431 in Lares.**

Site 8 involved a complete cut-off failure along road PR-431 in the municipality of Lares. Details of the location of this road failure site are provided in Figure 5-19. As shown in Figure 5-19(b), the failure affected two locations on parallel portions of the same windy PR-431 road. The complete cut-off occurred along the upper site, and soil and boulders from the failure debris blocked the lower site of the road.

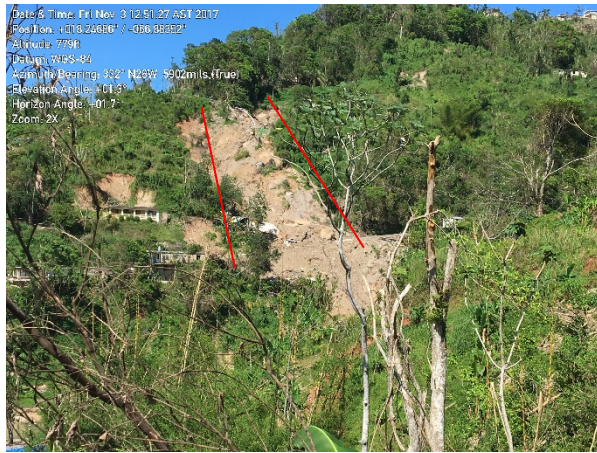
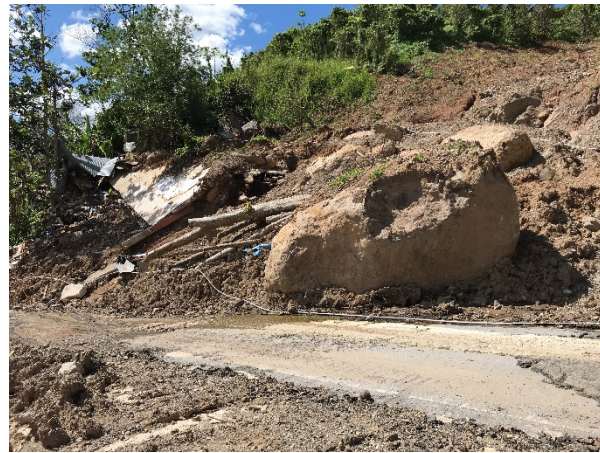
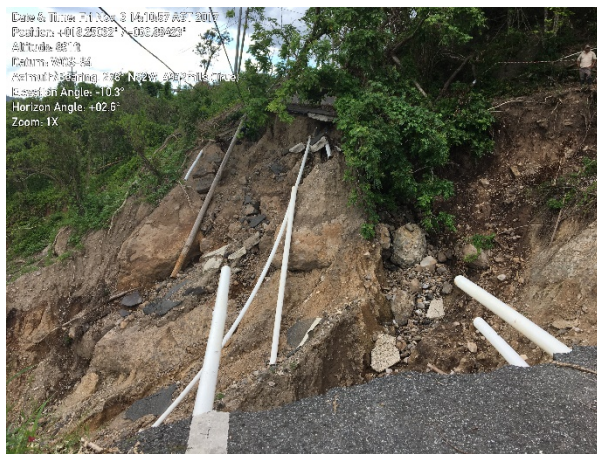
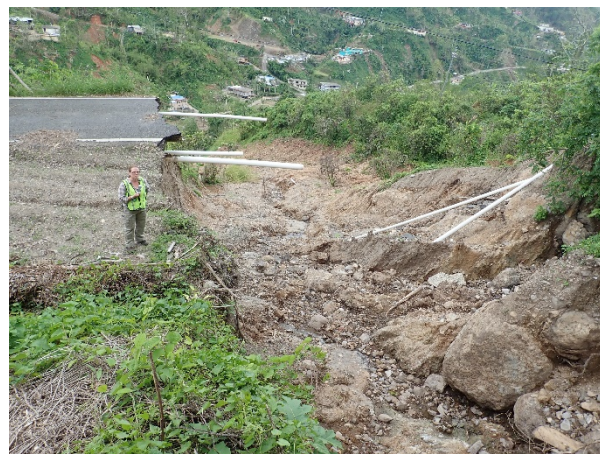
**Figure 5-20: Photos of Road & Bridge Site 8 - Road damage with complete cut-off at PR-431 in Lares.**

Figure 5-20(a) shows the whole slope failure from a photo taken from the opposite side of the mountain. Figure 5-20(b) shows the lower site of the road partially blocked by a large boulder. The upper portion of PR-431 was destroyed by the failure (see Figure 5-20(c) and Figure 5-20(d)).

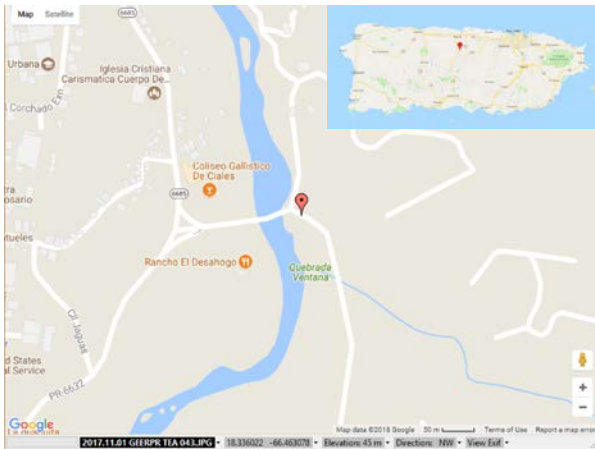
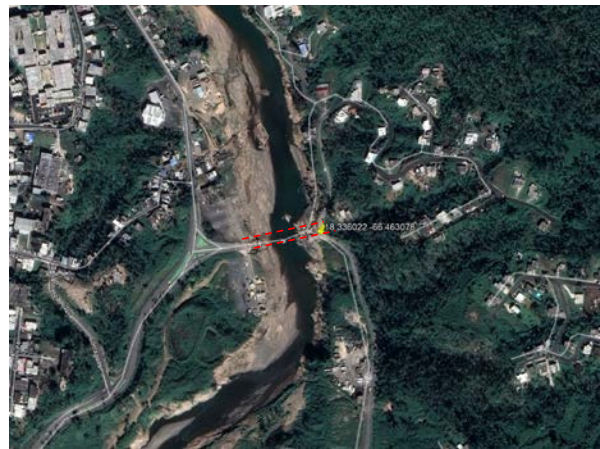
**Figure 5-21: Road & Bridge Site 9 - Washed away bridge failure in Ciales.**

Site 9 involved a bridge failure located in the eastern side of Ciales. The bridge spans over the Río Grande de Manati river and connected road PR-6632 on the west bank and PR-145 on the east side, as shown in Figure 5-21. The bridge was completely washed away, as shown in Figure 5-22. Figure 5-22(a) shows a photo of the site taken from PR-145. The red circle on Figure 5-22(b) is a photo taken looking north that shows part of the failed bridge deck resting several hundred feet downstream. Figure 5-22(c) and Figure 5-22(d) show the extent of the damage of the east bridge abutment.

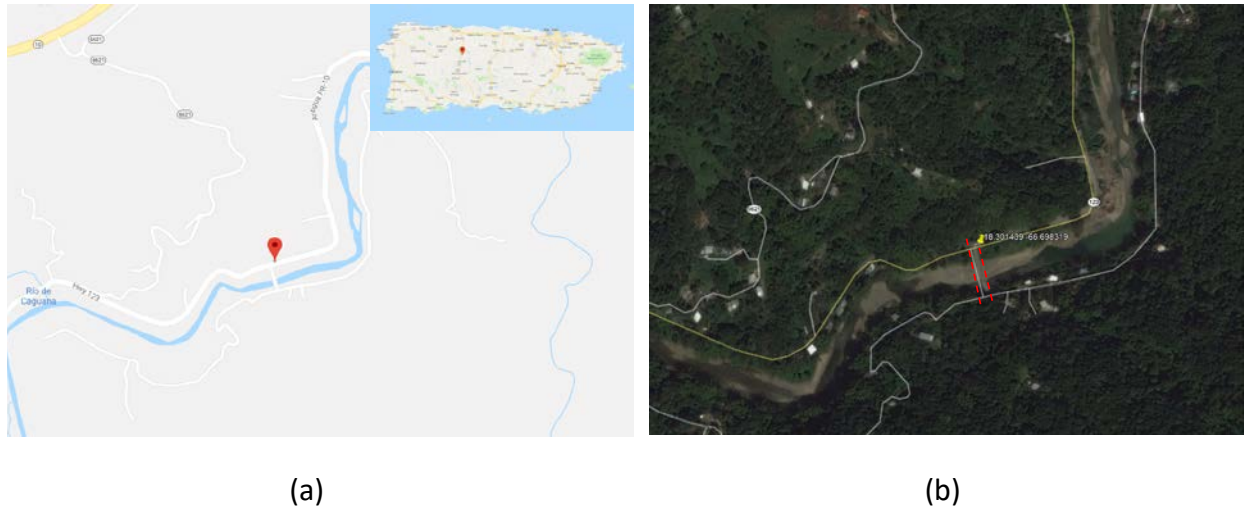
**Figure 5-23: Road & Bridge Site 10: PR-123 bridge over Río Grande de Arecibo.**

Site 10 involved the failure of the bridge along PR-123 ((also known as the old PR-10) that spans over the Río Grande de Arecibo river as shown on Figure 5-23. This bridge is located about 2.7 miles north of Utuado. The bridge of PR-123 was completely washed away as shown in Figure 5-24. The GEER team was only able to reach the west abutment of the PR-123 bridge.

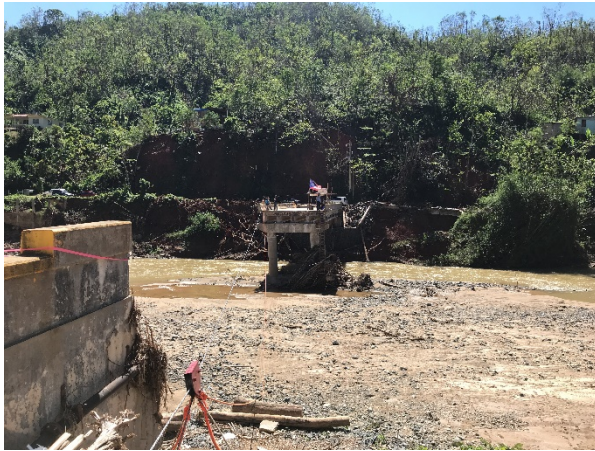
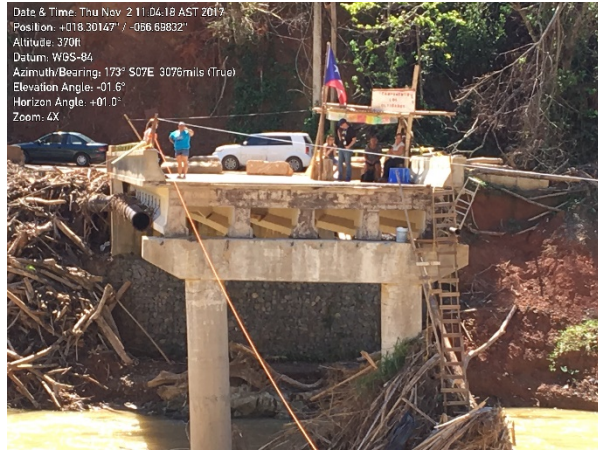
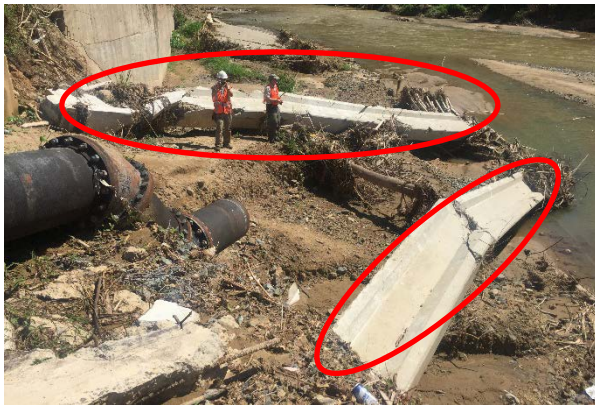
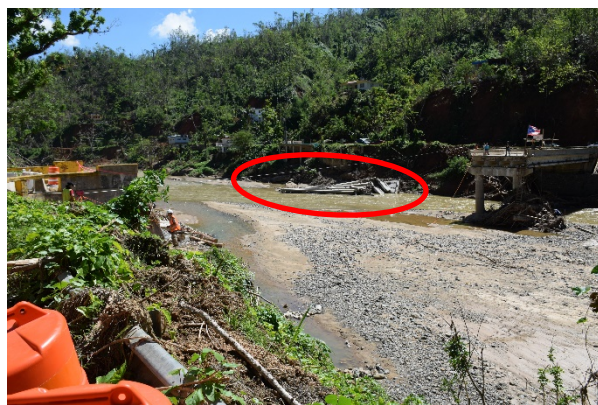
Figure 5-24: Road & Bridge Site 10 - Failure of PR 123 Bridge failure.

After hurricane Maria people living in communities on the east side of the bridge could not be reached by first responders. Videos and photos showing the ingenuity of locals that rigged a system using an old supermarket cart and zip lines to pass water and food from the west side to inaccessible communities in the east side became viral. Figure 4-24(b) shows the part of the system used to send supplies to the east side of the washed away bridge. The red circle on Figure 5-24 (c) and (d) show debris under the bridge.

Notes: Photos (a) and (b) taken from west abutment at Lat: +18.301439°, Lon: -66.698319°, Date: 11/02/17 10:58 EDT. River flows from right to left in photos (a) and (b), as shown by deposition of debris on the left side of the remaining pier. (d) shows bridge remains downstream of the east abutment.

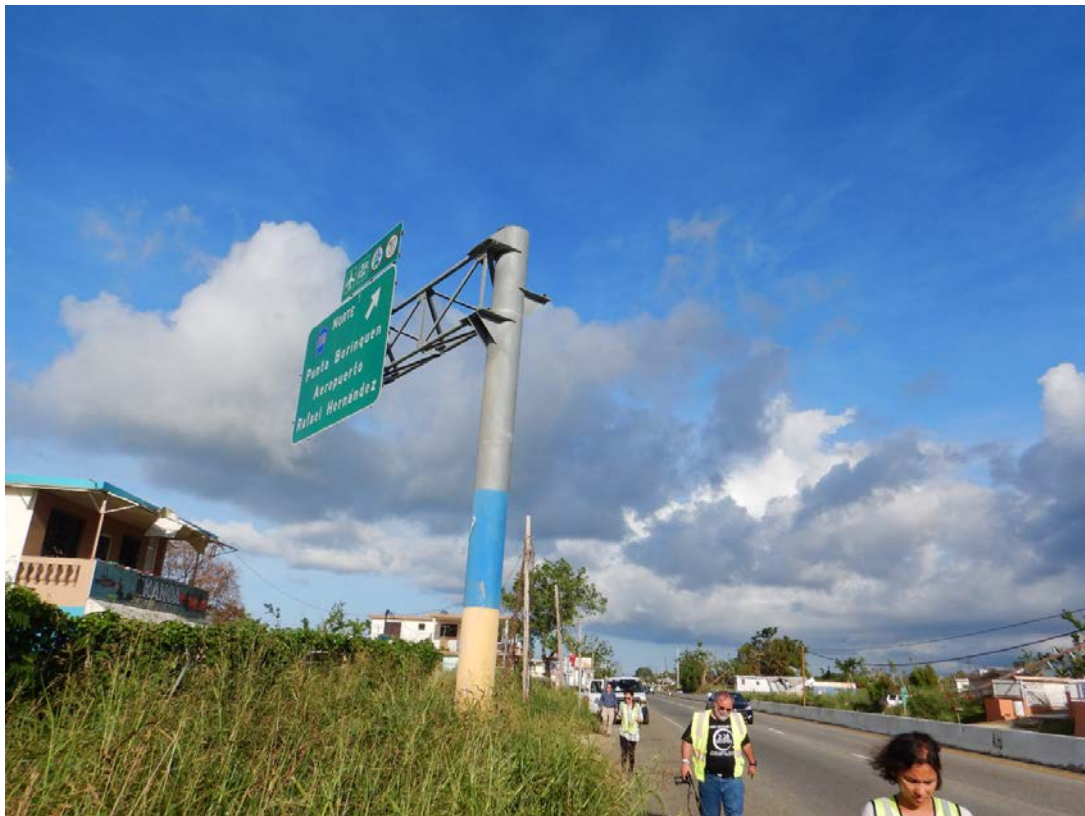
**Figure 6-2: Photo of Cantilevered sign foundation failure at Site F1.**

The first site is located along the southbound lane of Highway PR-2 in Aguadilla. The photo of the traffic sign structure is shown on Figure 6-2. The final position of the traffic signal is rotated about 100 degrees (positive using the right-hand sign convention with respect to a vertical Zenith axis) with respect to the original installation position. The diameter of the drilled shaft that supports this structure was measured to be 30 inches (0.76 m).

The high wind loading on the superstructure is complex in nature, and the resulting foundation loading involves torsion, axial and lateral loading, and bending. Furthermore, the dynamic wind load contains wide ranges of amplitude and frequency. Figure 6-2 shows some tilting of the superstructure with respect to the Zenith. The visual inspection revealed a deep gap around most of the perimeter circumference between the drilled shaft and the ground. Figure 6-3 and Figure 6-4 show photos of the top of the drilled shaft foundation where the gap formation can be observed. The gap, which likely formed due to the large bending and lateral forces transmitted to the drilled shafts, reduced the contact area between soil and foundation, and thus, the torsional resistance of the drilled shafts.

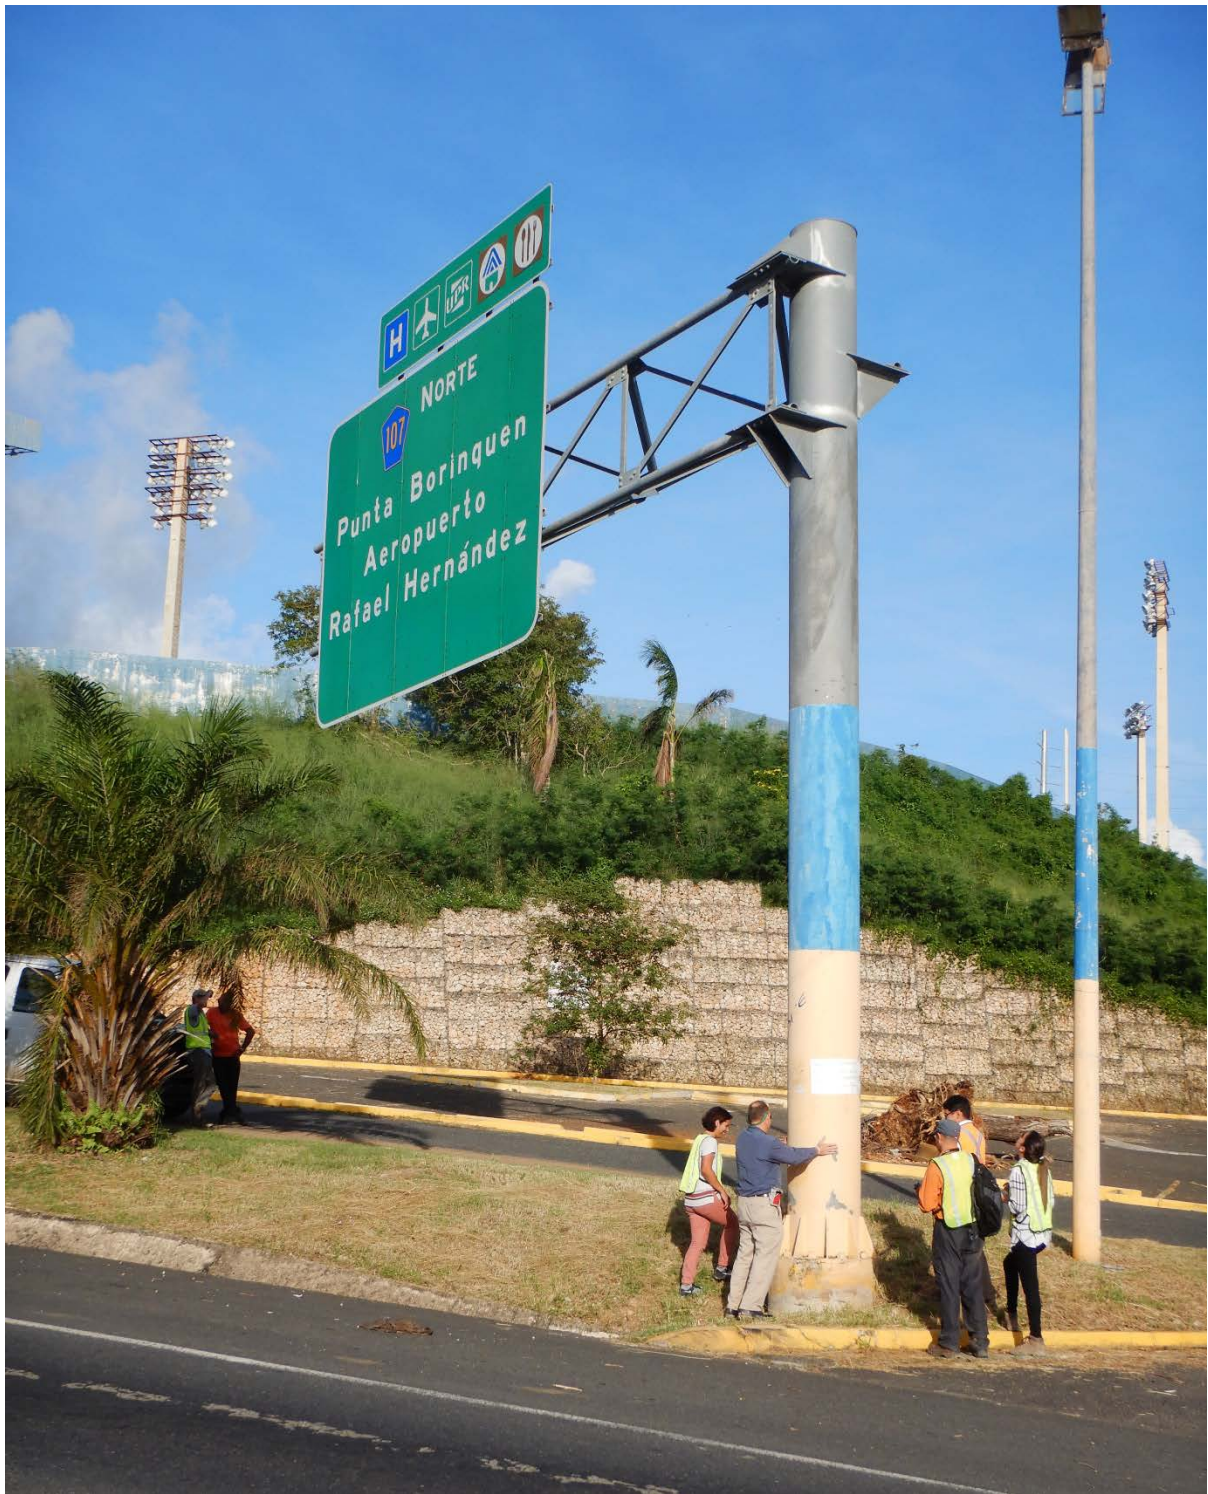
**Figure 6-5: Photo of Cantilevered sign foundation failure at Site F2.**

The second cantilevered sign site is located at the southwest corner of the Luis A. Canena Marquez Stadium in Aguadilla. The sign is located along the northbound lane of Highway PR-2. A photo of the rotated mast-arm traffic sign is shown on Figure 6-5. The diameter of the drilled shaft was approximately 30 inches (0.76 m). The field reconnaissance also revealed a near continuous gap around the circumference of the drilled shaft. In some locations, the gap was as wide as 10 inches. The observed depth of the gap was about 18 inches, as shown in Figure 6-6; however, the bottom of the gap had loose soils, which suggest that minor caving may have filled some of the gap. The superstructure also experienced some tilt as shown on Figure 6-6. The traffic sign experienced a rotation of about -100 degrees with respect to the zenith and using the right-hand rule sign convention.

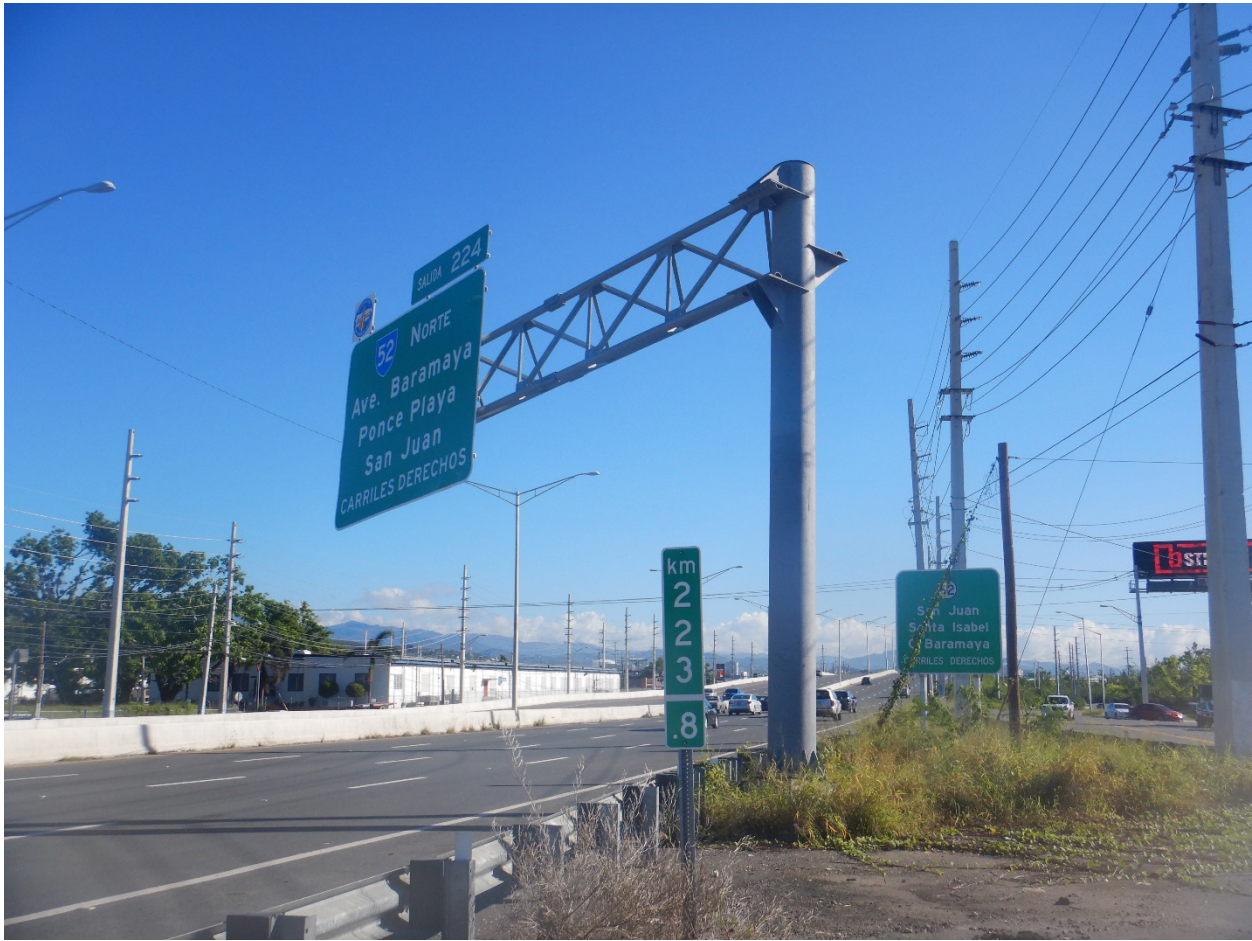
Figure 6-7: Photo of cantilevered sign foundation failure at Site F3.

The third cantilevered sign showing a rotational failure of the drilled shaft foundation is located just north of the city of Ponce along the southbound lanes of Highway PR-2. A photo of the rotated state of this structure is shown on Figure 6-7. The foundation system at this site was not confirmed, as it was only possible to see a square pedestal, as shown in Figure 6-8. The sign was severely rotated (by about 12°) and a gap between the top pedestal and the surrounding ground was observed, as shown on Figure 6-8(a) and Figure 6-8(b). Neither the depth of the pedestal, nor the presence of a drilled shaft foundation could be confirmed. Because of the severe rotation shown on Figure 6-10, a structural foundation failure could not be excluded.

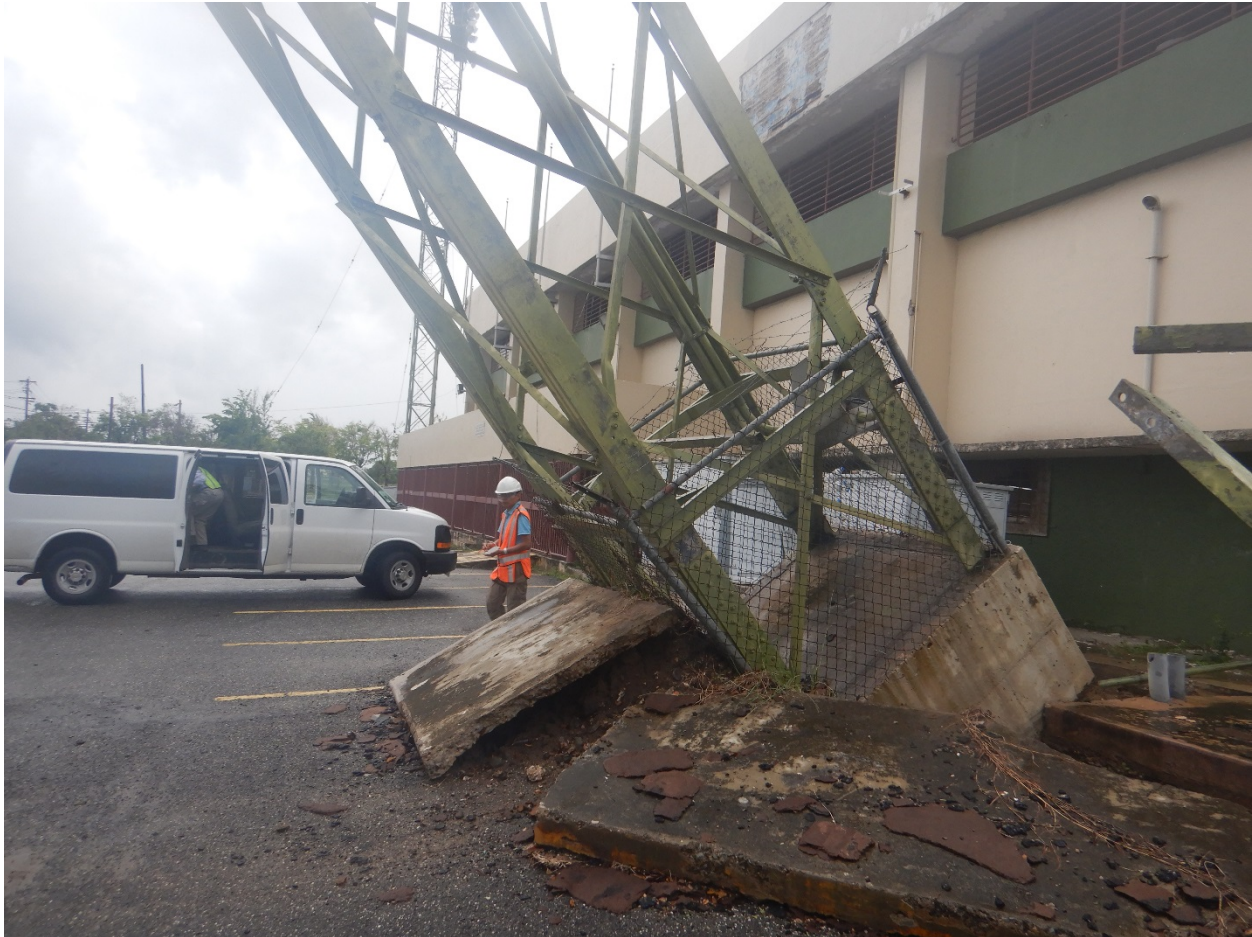
**Figure 6-10: Photo of foundation failure of illumination tower at Site F4 in Ponce.**

The fourth foundation failure (Site F4) was located at the baseball stadium, “Estadio Francisco ‘Paquito’ Montaner”, in the city of Ponce. The structure is an illumination tower with cable guys and a shallow square foundation. Bearing capacity failure was observed at this site, as shown on Figure 6-10 and Figure 6-11. The team visited the site on 10/31/17.

The light tower height above the ground is estimated to be 30 meters. It was supported by four guy wires and the foundation consisted of a 2.1 meter square concrete footing with a height of 1.25 meters. The rotation of the footing base was measured to be 40 degrees with respect to the horizontal plane. A grab sample was collected from the exposed soil under the shallow footing and consisted of a clayey sand (See Appendix I for index test results for grab sample ID E). Additional photos of this foundation failure are provided in Appendix E.

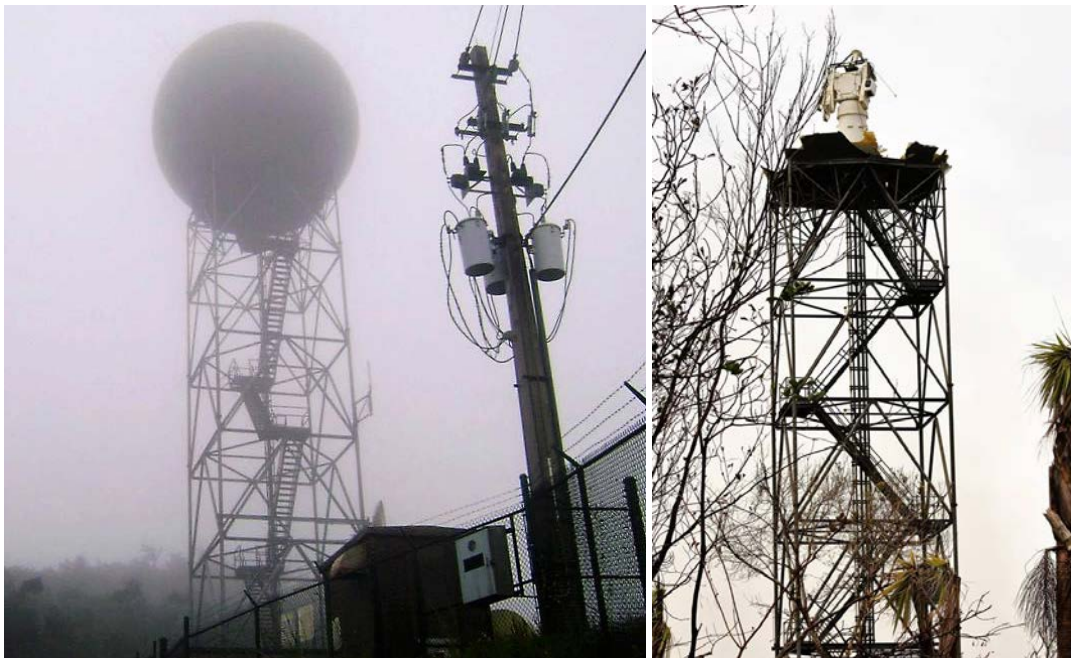
Hurricanes Irma and Maria not only impacted the performance of geotechnical facilities and components including those described in detail throughout this document, but severe wind damages were also observed through the island of PR. A team of professors from the UPRM and local meteorologist Ada Monzón visited the town of Cayey for a structural site reconnaissance on 10/27/17. During that visit, they found the NEXTRAD NOAA Doppler radar completely destroyed. As shown on Figure 7-1, the shell of the dome covering the radar was completely blown away from the tower, resulting in limited reliable weather data in PR during the passage of the storm. Ada Monzón stated that this is an unprecedented case history because the National Weather Center and other federal and local agencies were left without access to the valuable data recorded by this radar.

**Figure 7-1: Before and after pictures of the NEXTRAD NOAA Doppler radar in Cayey, PR. (photo credit: Dr. Luis Suarez) (Lat: +18.115483, Lon: -66.077978).**

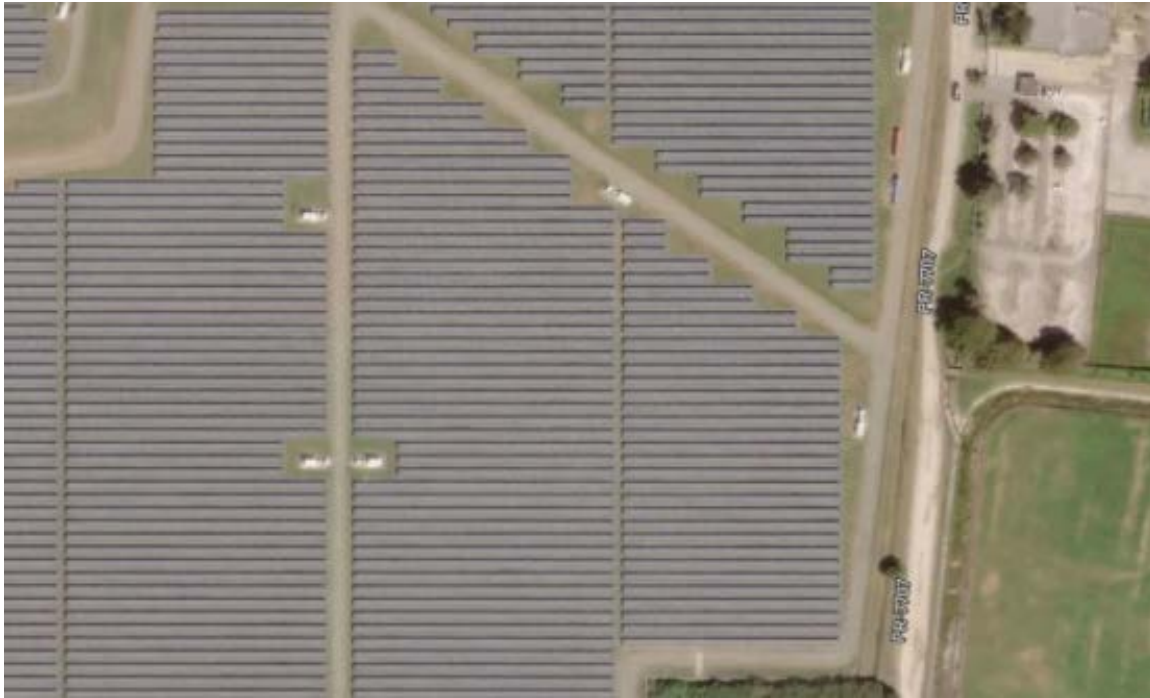
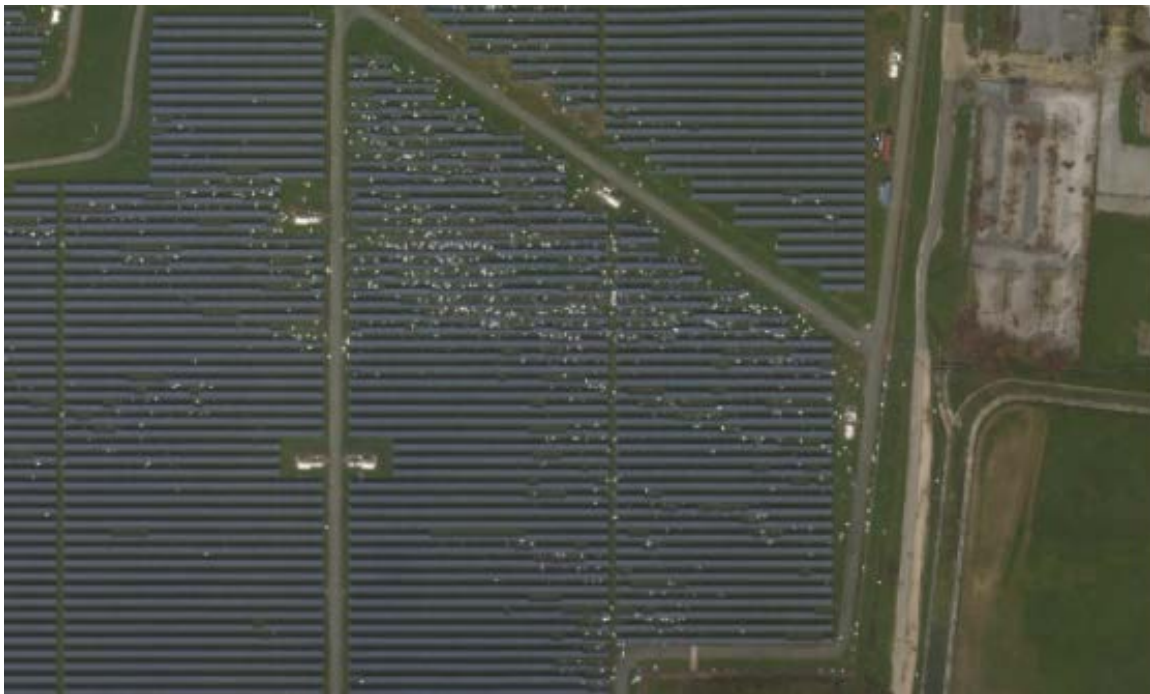
Another solar farm, which was considered the largest in the Caribbean when built in 2012, also suffered damages. This farm, Ilumina Project, is located in Guayama, PR. Pictures are shown in Figure 7-3. Also the Humacao Solar Project, LLC, a small-scale solar farm, located in Humacao, PR, was nearly completely destroyed during Hurricane Maria. This small solar farm was designed and built to provide up to 60% energy to Humacao's sewage treatment facility. Before and after pictures are shown in Figure 7-4. The TSK solar farm, located in Loiza, PR, survived the strong wind and rains of Hurricane Maria. This design by TSK was developed for harsh weather, with panels mounted on structures 2 to 4 ms above ground level capable of withstanding winds of up to 160 miles per hour (mph). Additionally, a 645-kilowatt (kW) rooftop solar panel array in the Veterans Affairs Hospital in San Juan, PR, which was installed in 2015, was fully operational after the hurricanes. NOAA estimated winds of 180 mph in this area. According to Rothschild (2017) in an article for PV Magazine, "the array was installed with a combination of ballasts and mechanical anchors. It's a pliant racking system that is polymer based, and injection molded from galls-reinforced nylon. This gives the array the ability to flex in multiple directions without breaking – the main reason it's still on the roof".

Figure 7-3: Before and after pictures of Ilumina Project Farm in Guayama, PR (Lat: +17.947233, Lon: -66.156011).

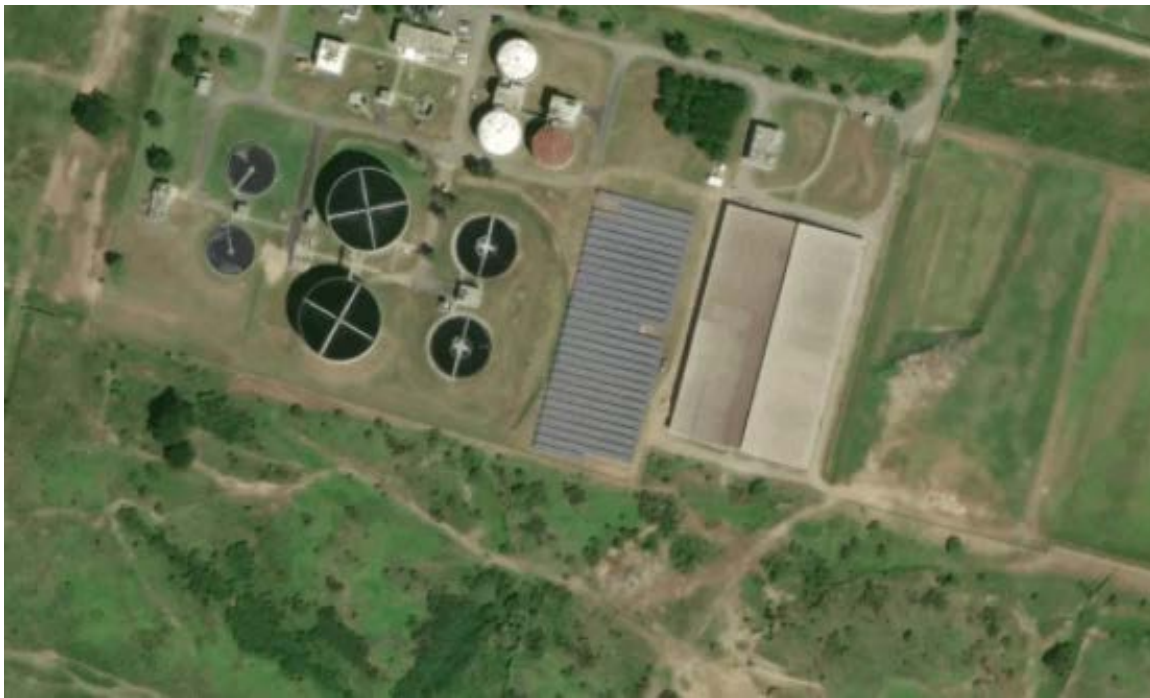
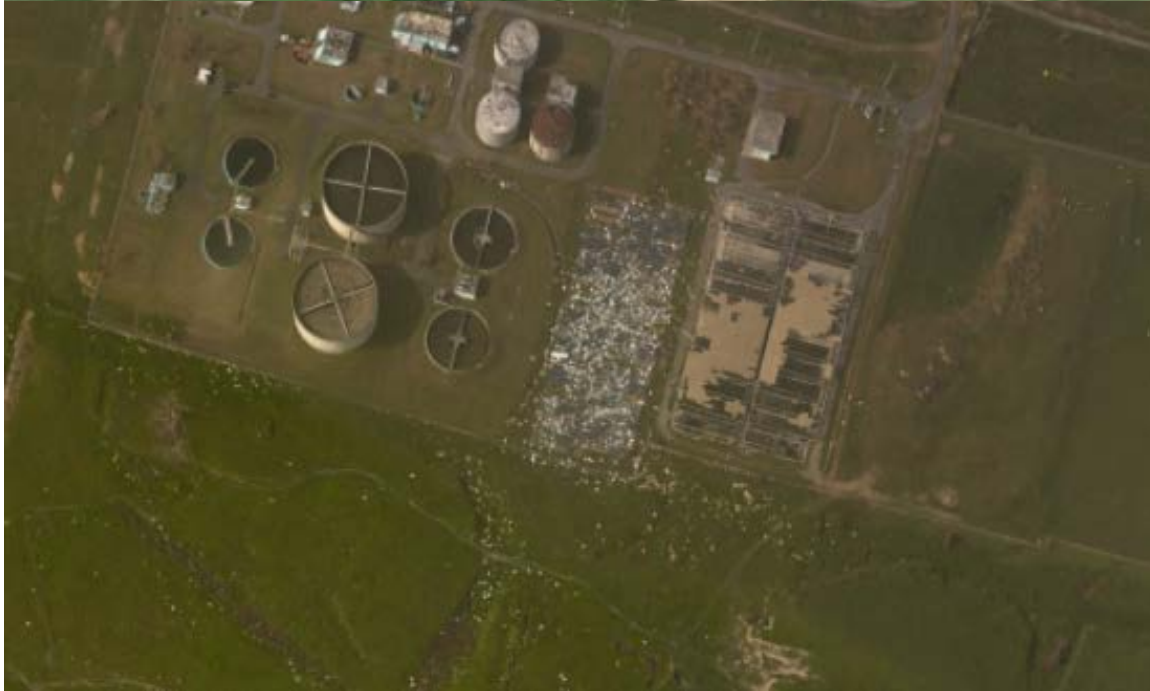
The second largest solar farm in PR, located on the east side of the island in the town of Humacao, was also almost completely destroyed by Hurricane Maria. This solar farm used to produce approximately 40% of the solar-generated electricity in PR. Significant numbers of solar panels were torn from their foundations.

Figure 7-4: Before and after pictures of the Humacao's sewage treatment facility solar farm (Lat: +18.130247, Lon: -65.789883).

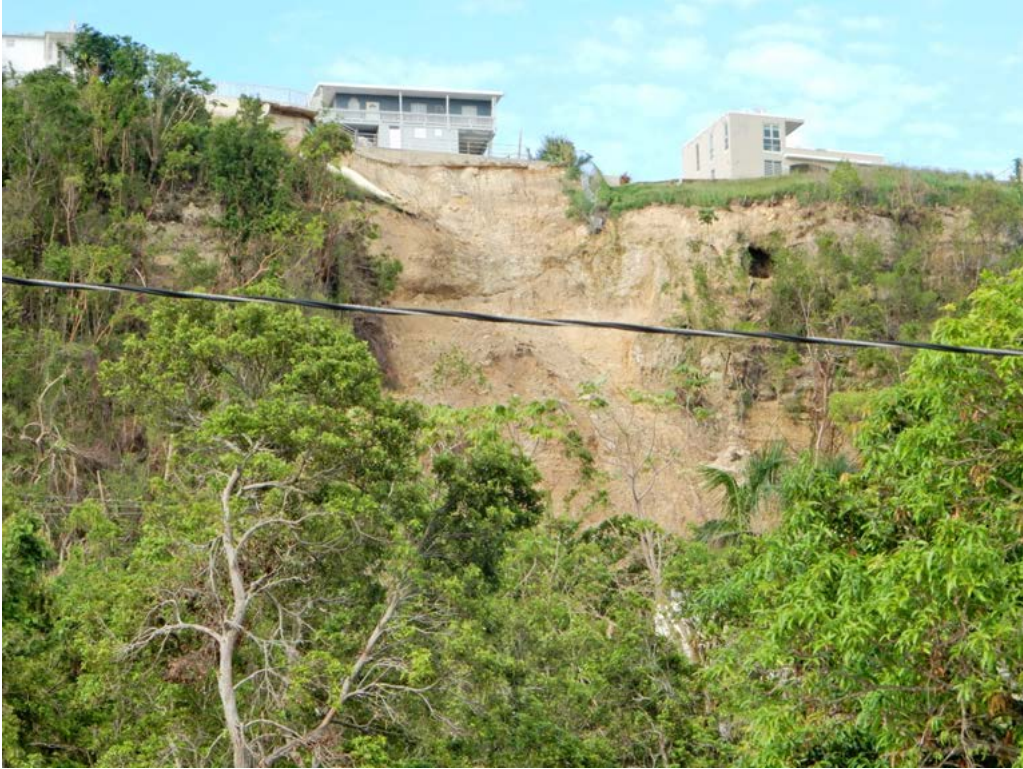
**Figure A-6: Moca, PR-110; Lat: +18.40492, Lon: -67.11142; 2017.10.29; #3287.**

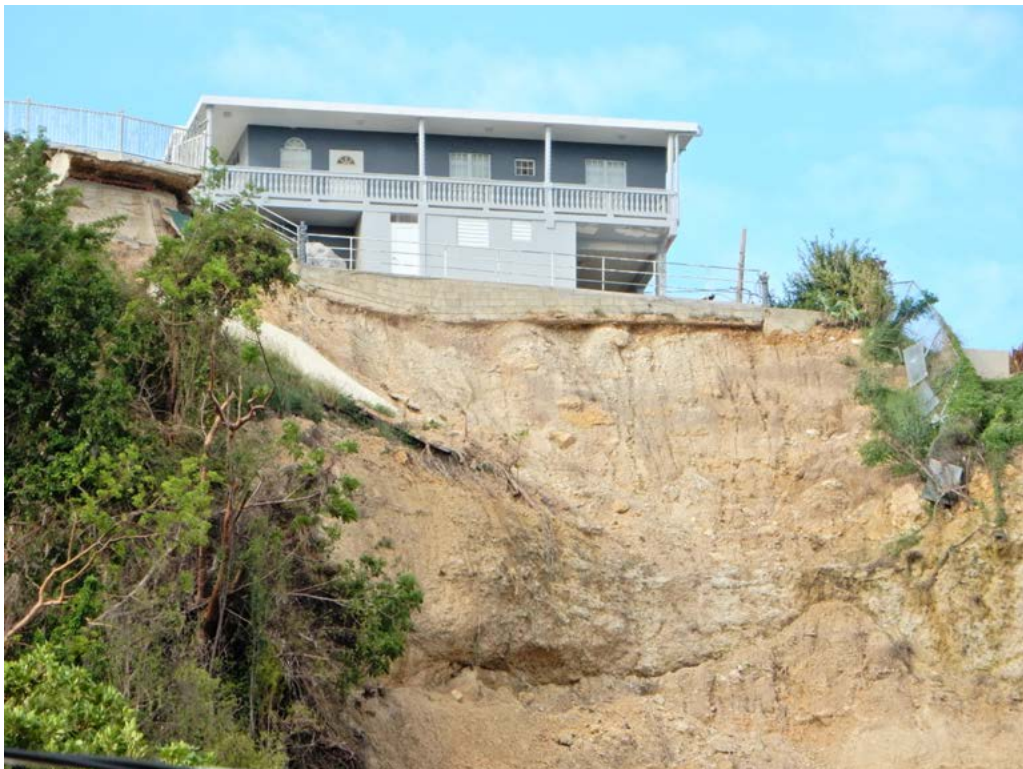
**Figure A-7: Moca, PR-110; Lat: +18.40493, Lon: -67.11146; 2017.10.29; #3289.**

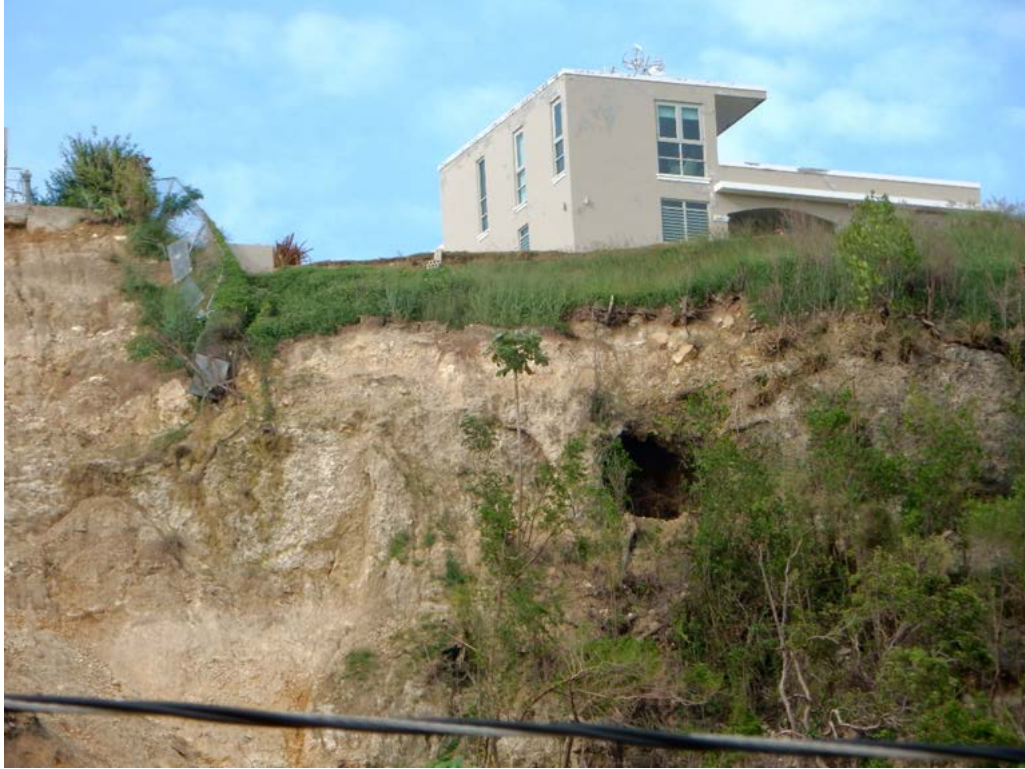
**Figure A-8: Moca, PR-110; Lat: +18.40490, Lon: -67.11138; 2017.10.29; #3292.**

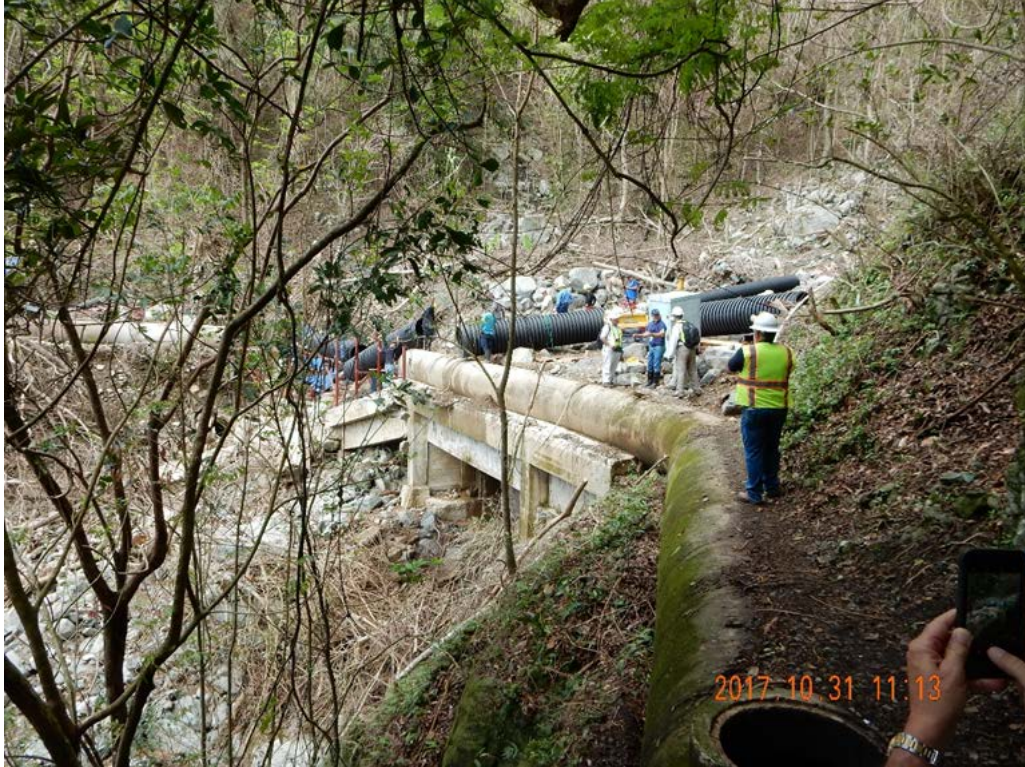
Figure A-14: Raw water line severed by debris flow, Carillo, Villalba, PR-149, Km 59.1; Lat: +18.15855, Lon: -66.49808; 2017.10.31; #3500.
