# GEOTECHNICAL IMPACTS OF HURRICANE MARIA IN PUERTO RICO

Event Date: September 20, 2017

**Geotechnical Extreme Events Reconnaissance**

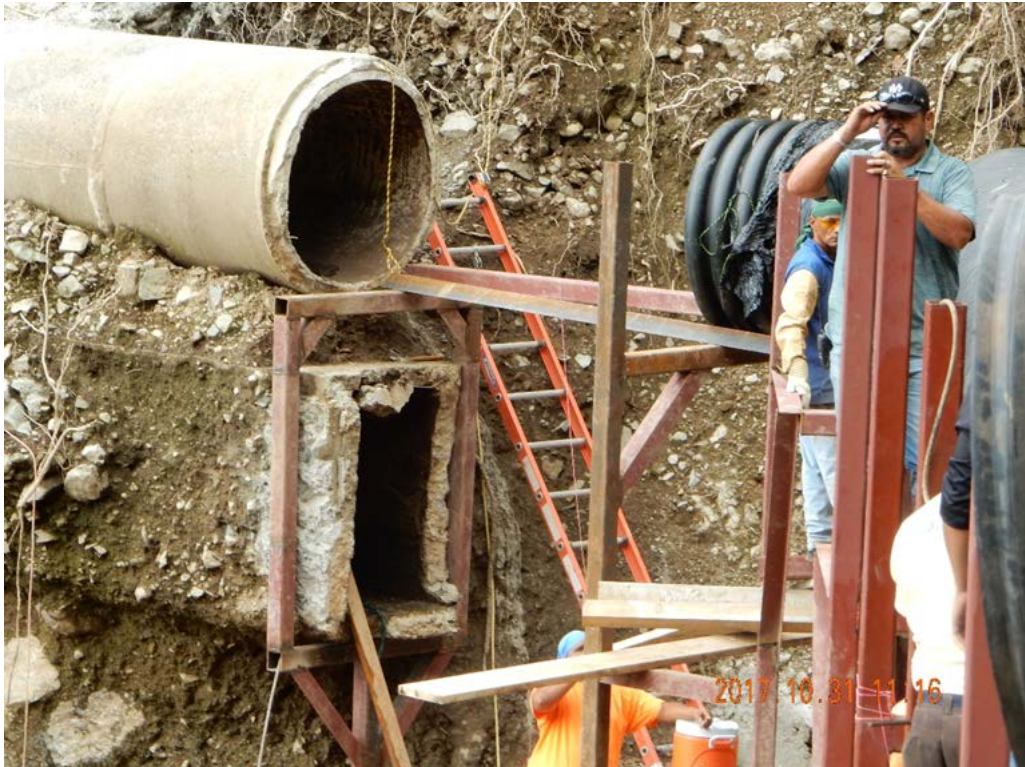
Figure A-15: Raw water lines, rectangular section about 100 years old; Lat: +18.15848, Lon: -66.49798; 2017.10.31; #3503.

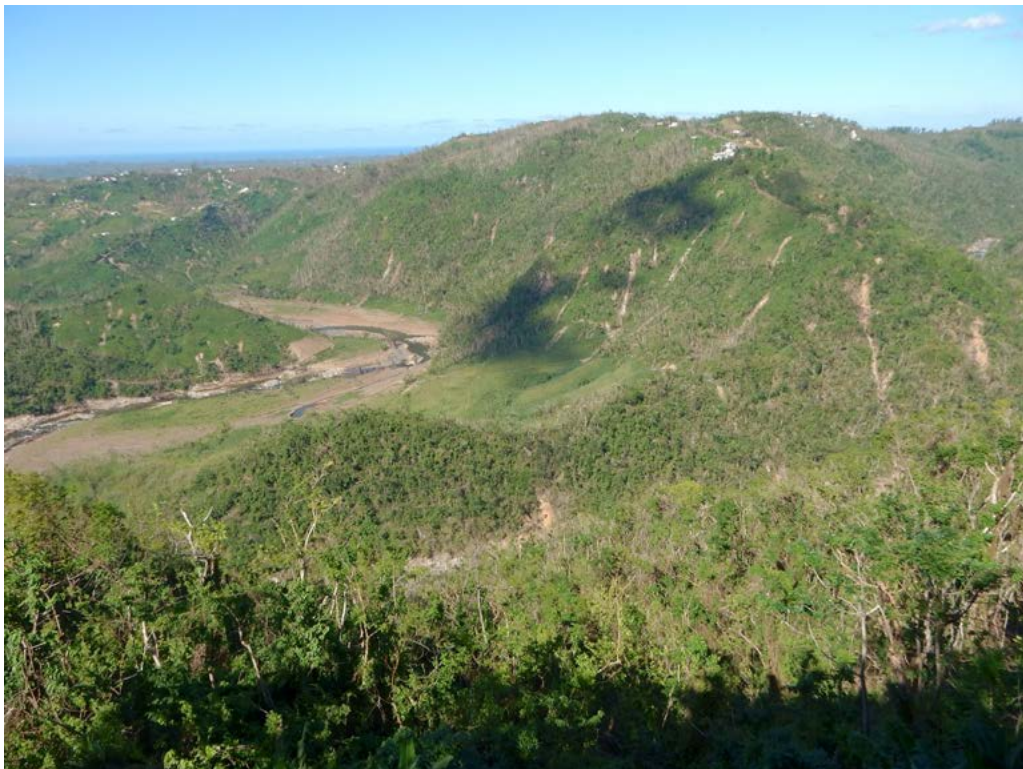
Figure A-21: Debris Flows; Lat: +18.28422, Lon: -66.40087; 2017.11.01; #3700.

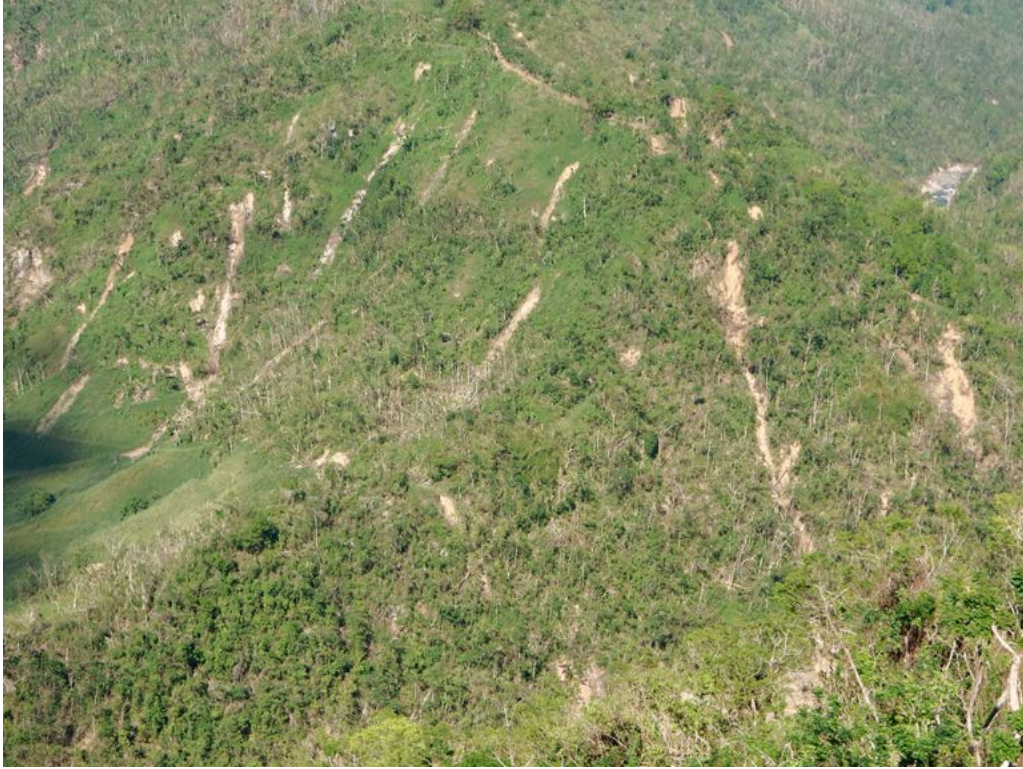
**Figure A-22: Debris Flows; Lat: +18.28414, Lon: -66.40093; 2017.11.01: #3706.**

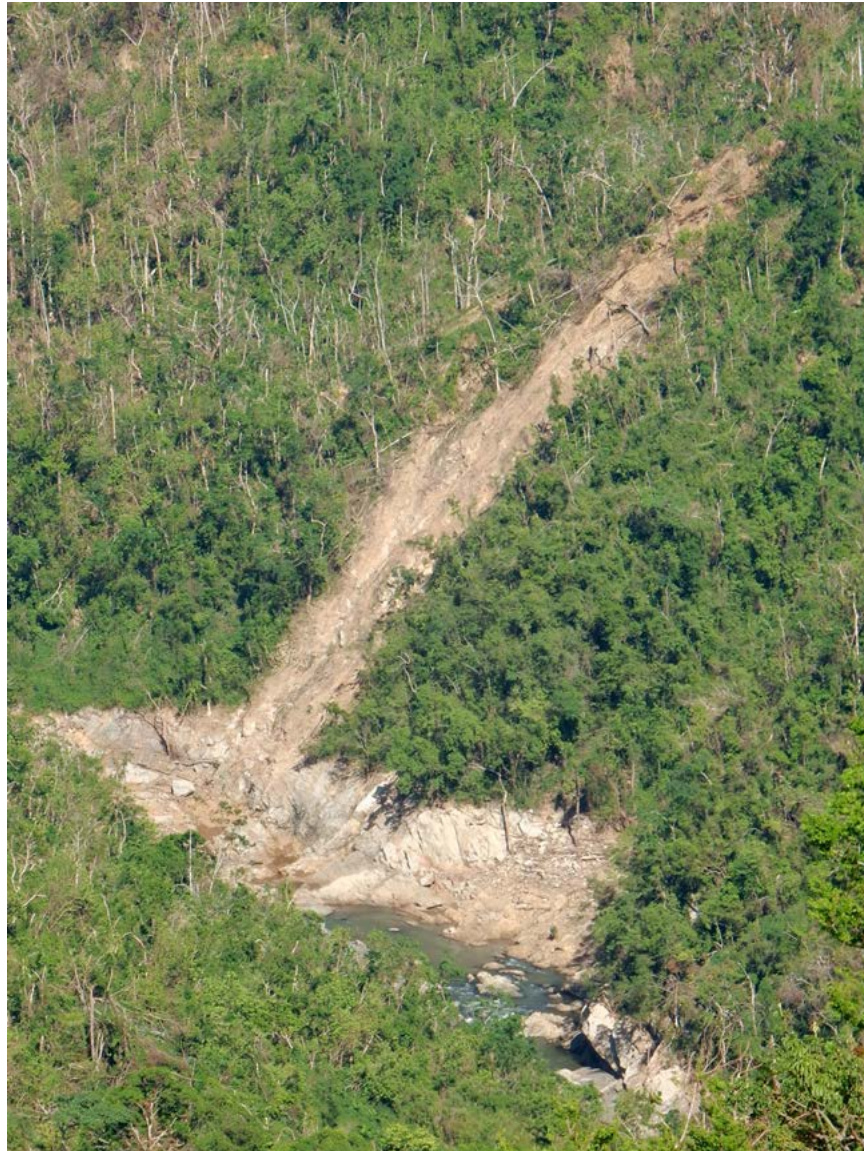
Figure A-24: Debris flow; Lat: +18.28397, Lon: -66.40132; 2017.11.01; #3710.

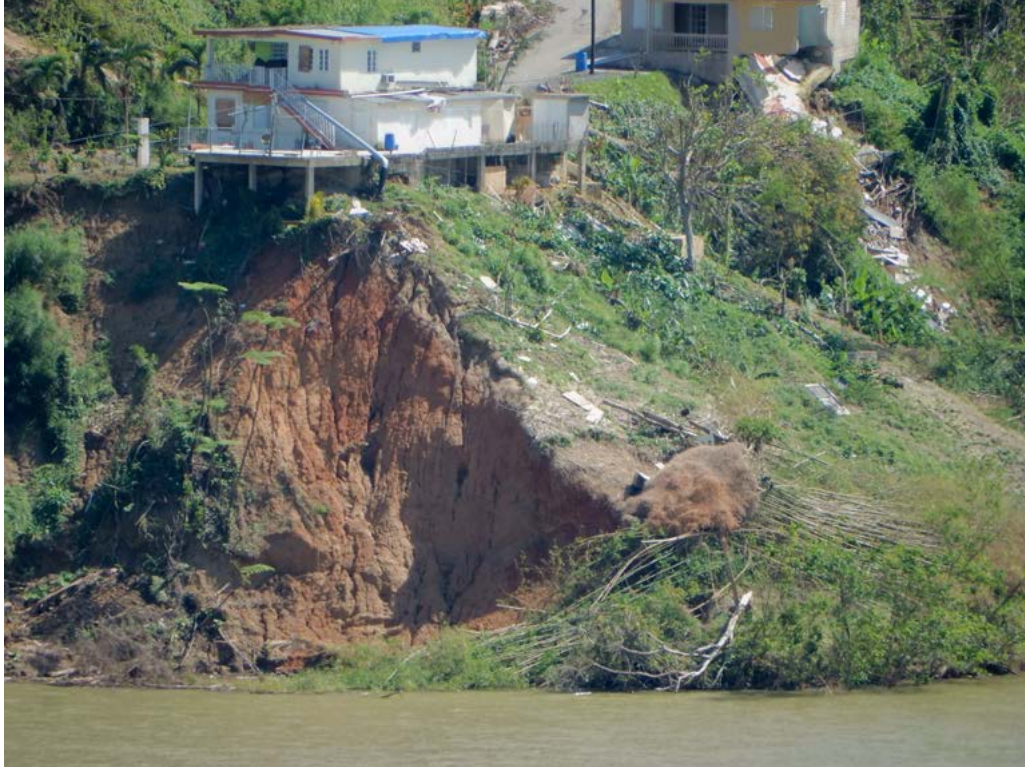
Figure A-29: Utuado, Caonillas Lake; Lat: +18.26701, Lon: -66.66009667; 2017.11.02; #3889.

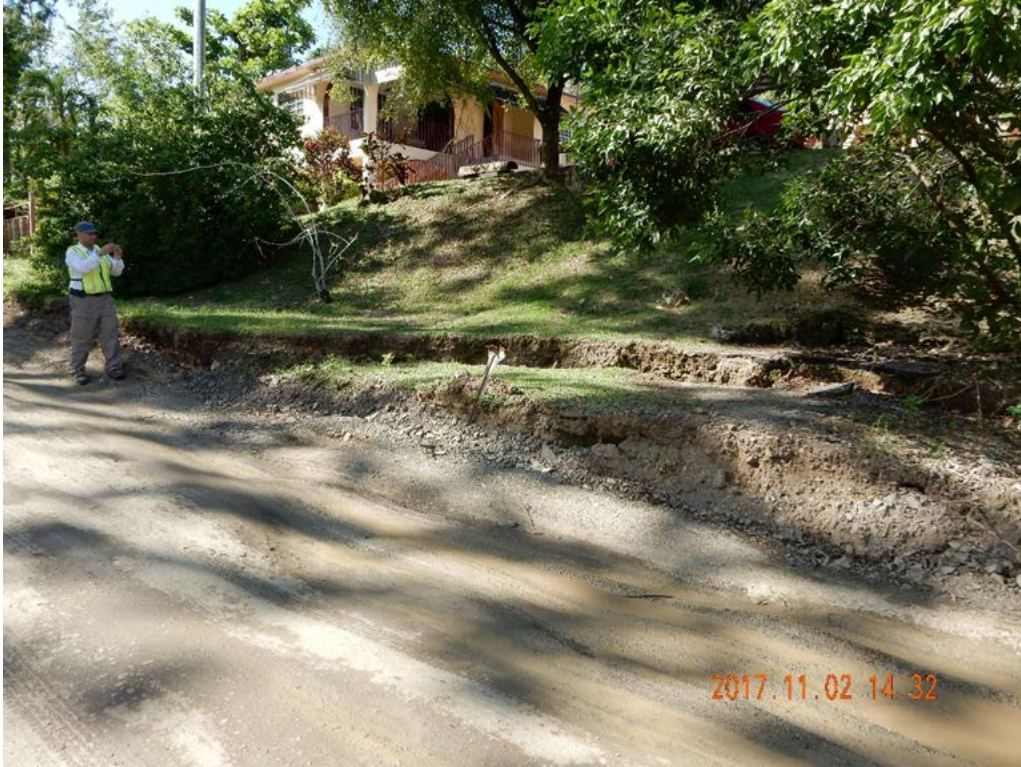
Figure A-31: Utuado, PR-146, Km 9.3, Rio Limón Slide, Head Scarp; Lat: +18.32294444, Lon: -66.599125; 2017.11.02; #3929.

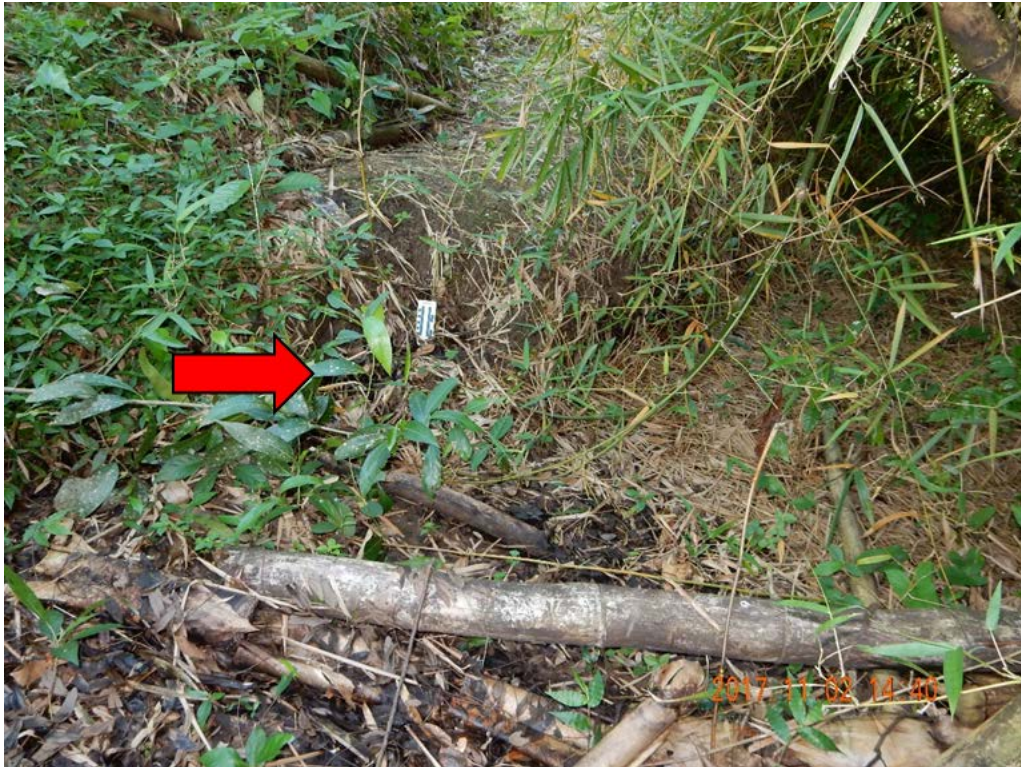
Figure A-32: Utuado, PR-146, Km 9.3, Rio Limón Slide, Toe; Lat: +18.32237833, Lon: -66.59932833; 2017.11.02; #3931.

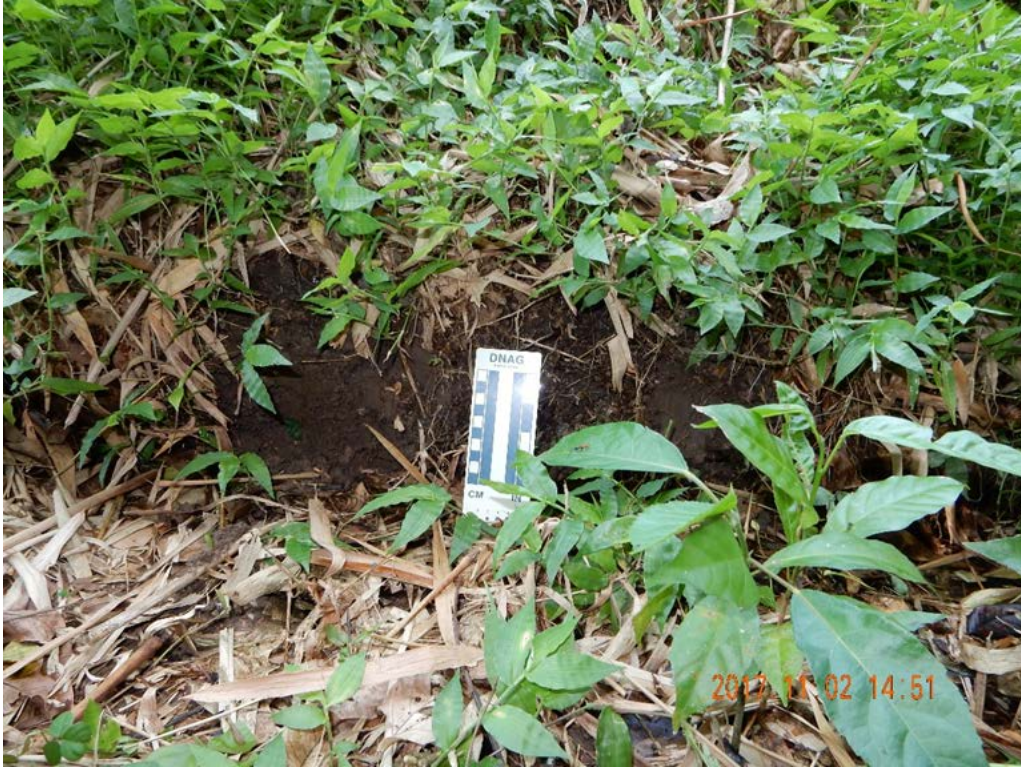
Figure A-33: Utuado, PR-146, Km 9.3, Rio Limón Slide, Toe; Lat: +18.32237833, Lon: -66.59932833; 2017.11.02; #3934.

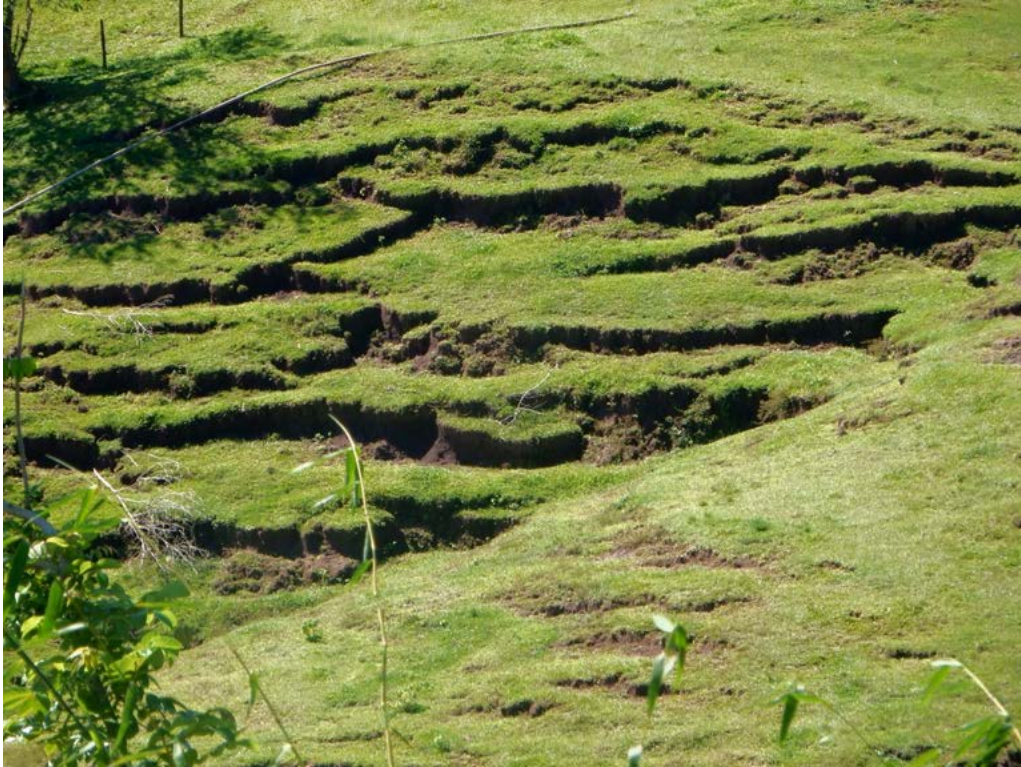
**Figure A-37: PR 424, Km 1.0; Lat: +18.291862, Lon: -67.007809; 2017.11.03; #4089. Gently sloped hillside shows evidence of sliding on three sides. According to geologist Alejandro E. Soto, it has always been that way.**

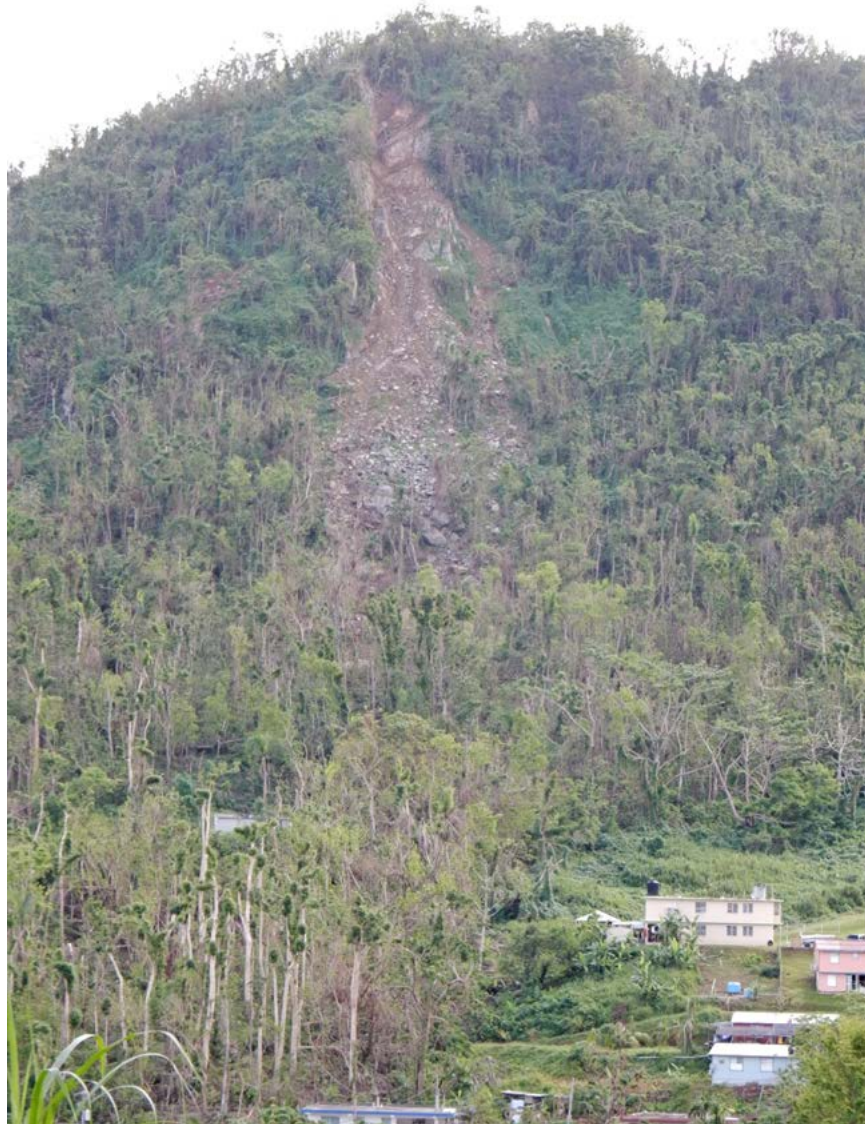
Figure A-39: Debris flow; Lat: +18.309755, Lon: - 65.89074333; 2017.11.05; #4231.

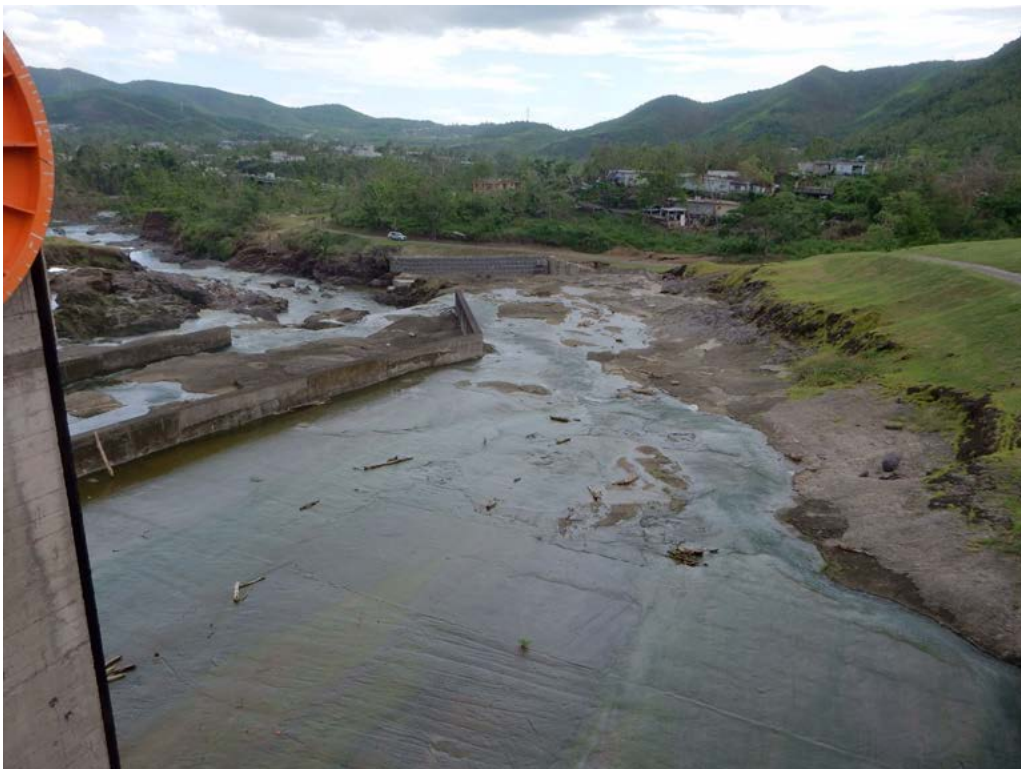
Figure B-6: Lago Guayabal Dam; Lat: +18.08733, Lon: -66.50503; 2017.10.31; #3564.

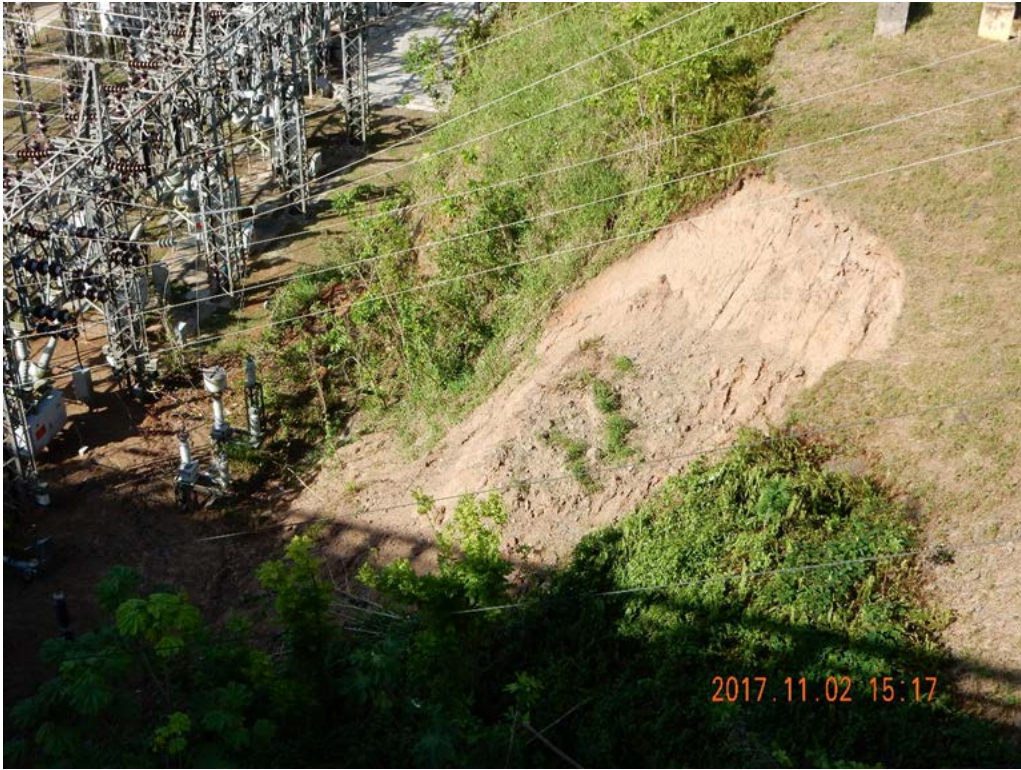
Figure B-9: Utuado, Dos Bocas Dam, Surficial slide near transformer's yard; Lat: +18.33541333, Lon: -66.66602664; 2017.11.02; #3940.

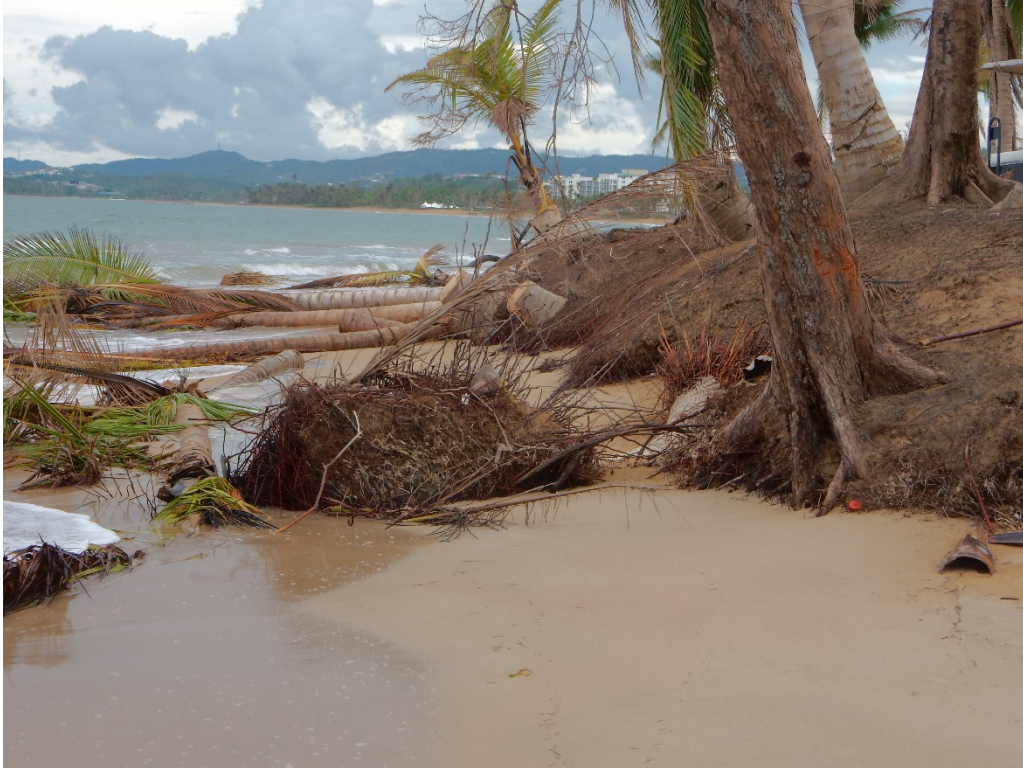
Figure C-1: Coastal Erosion, Yunque Mar, Rio Grande, PR; Lat: +18.39770, Lon: -65.76260; 2017.10.28; #3209.

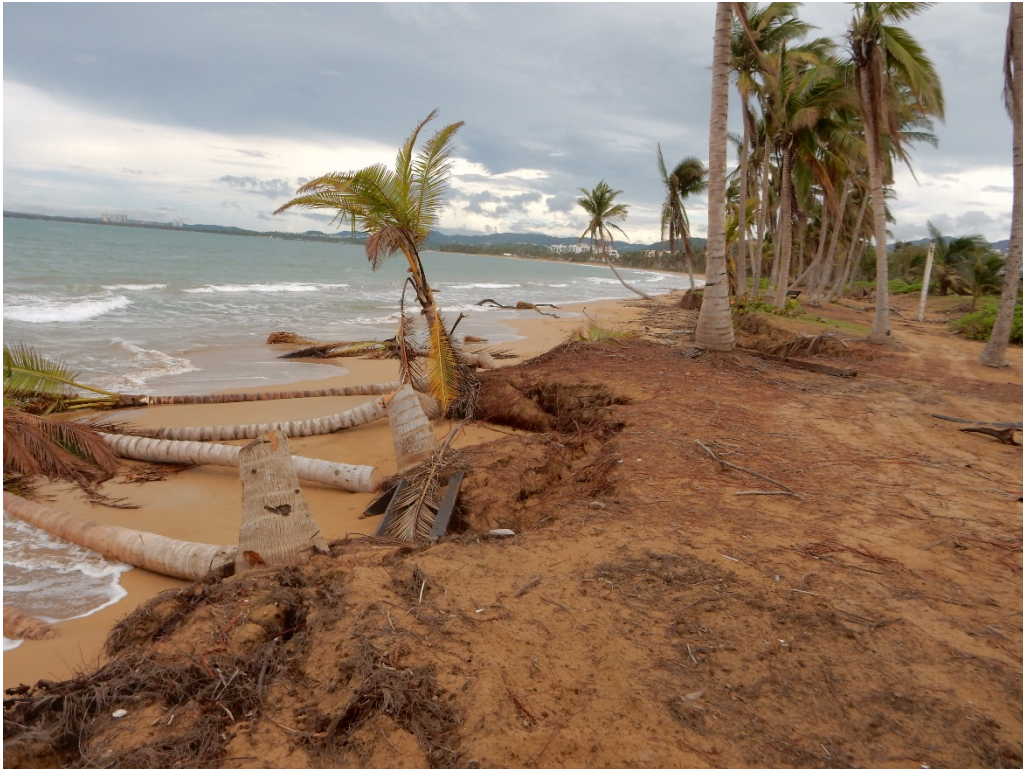
Figure C-2: Coastal Erosion, Yunque Mar, Rio Grande, PR; Lat: +18.39774, Lon: -65.76471; 2017.10.28; #3211.

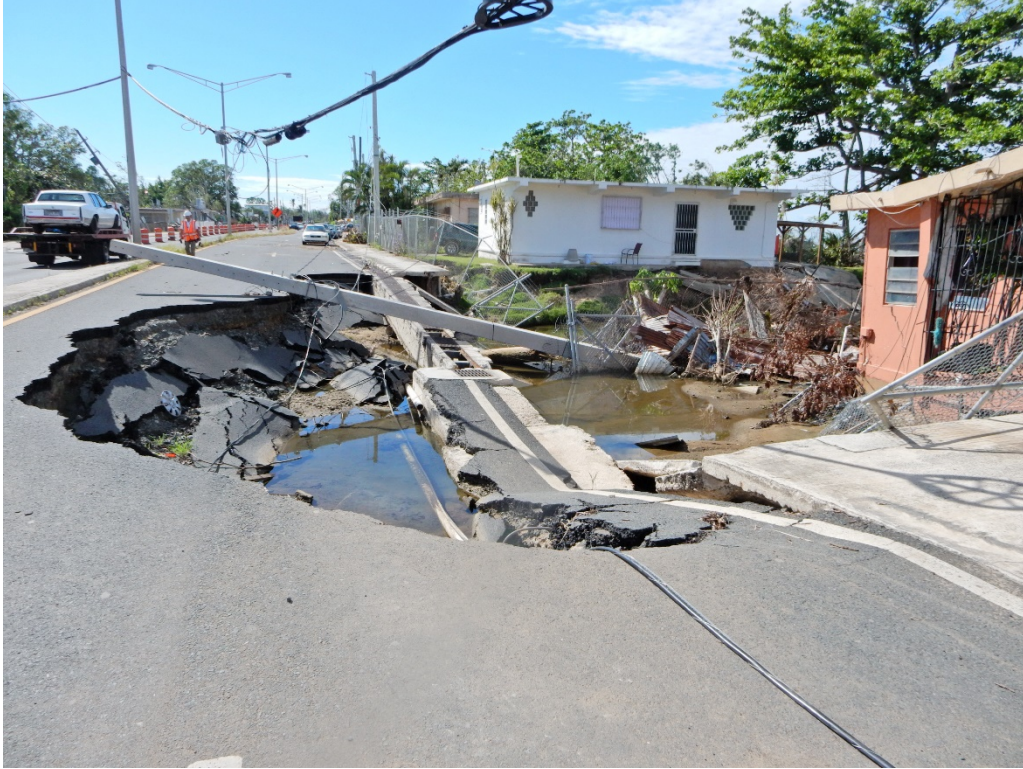
Figure C-8: Coastal erosion at El Maní, Mayagüez; Lat: +18.24457, Lon: -67.17390; 2017.11.04; #4151.

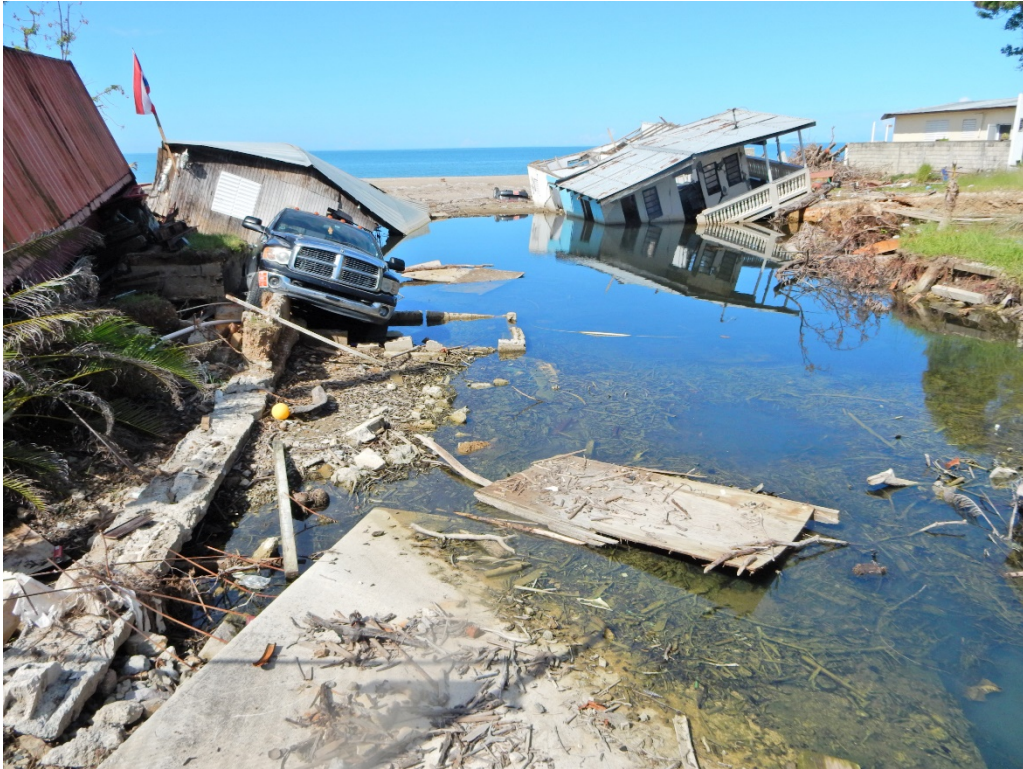
Figure C-9: Coastal erosion at El Maní, Mayagüez; Lat: +18.23323, Lon: -67.17270; 2017.11.04; #4180.

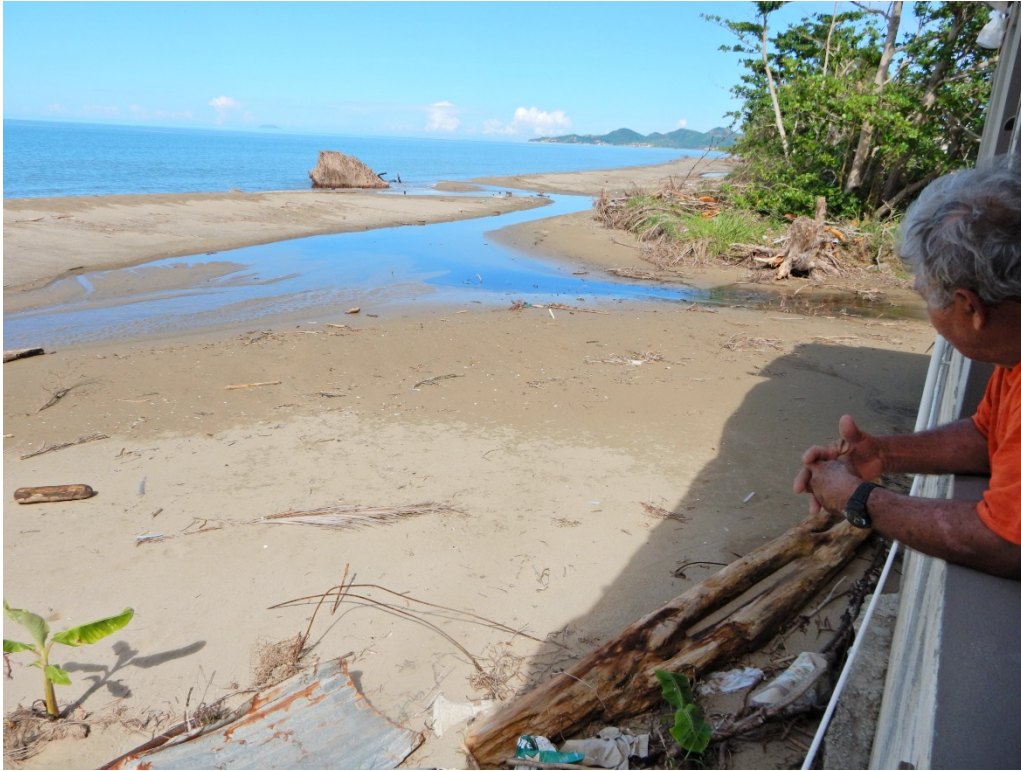
**Figure C-10: Coastal erosion at El Maní, Mayagüez; Lat: +18.24732, Lon: -67.17516; 2017.11.04; #4176. Previously grassy area after Hurricane María.**

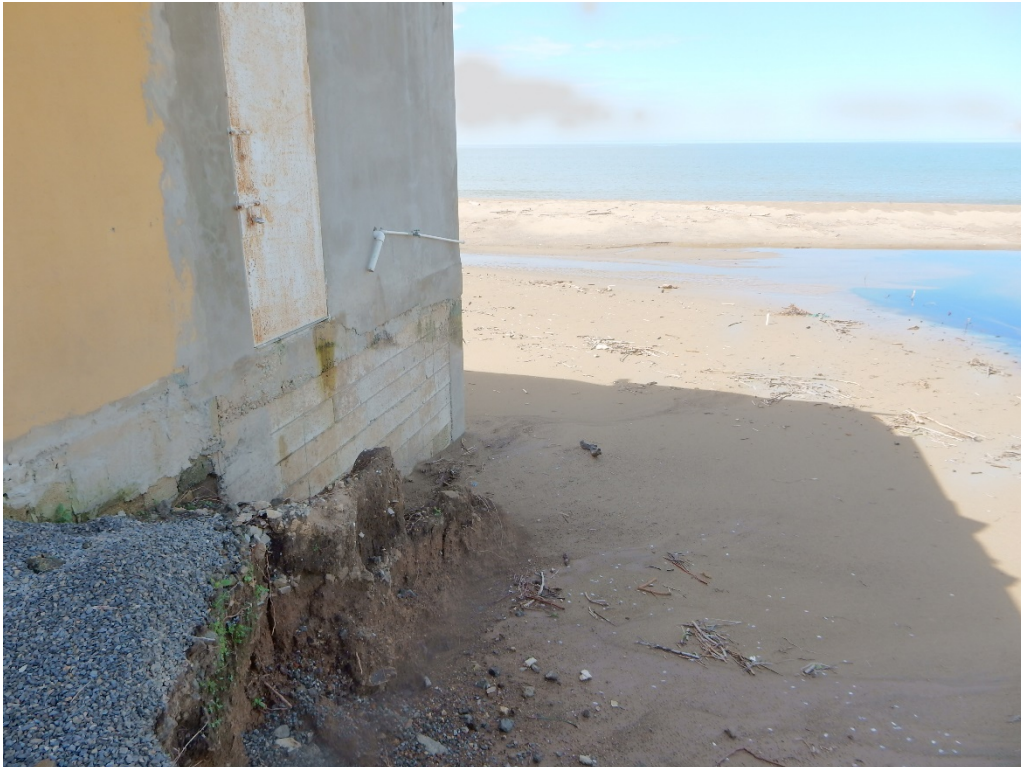
**Figure C-11: Coastal erosion at El Maní, Mayagüez; Lat: +18.24732, Lon: -67.17516; 2017.11.04; #4175.**

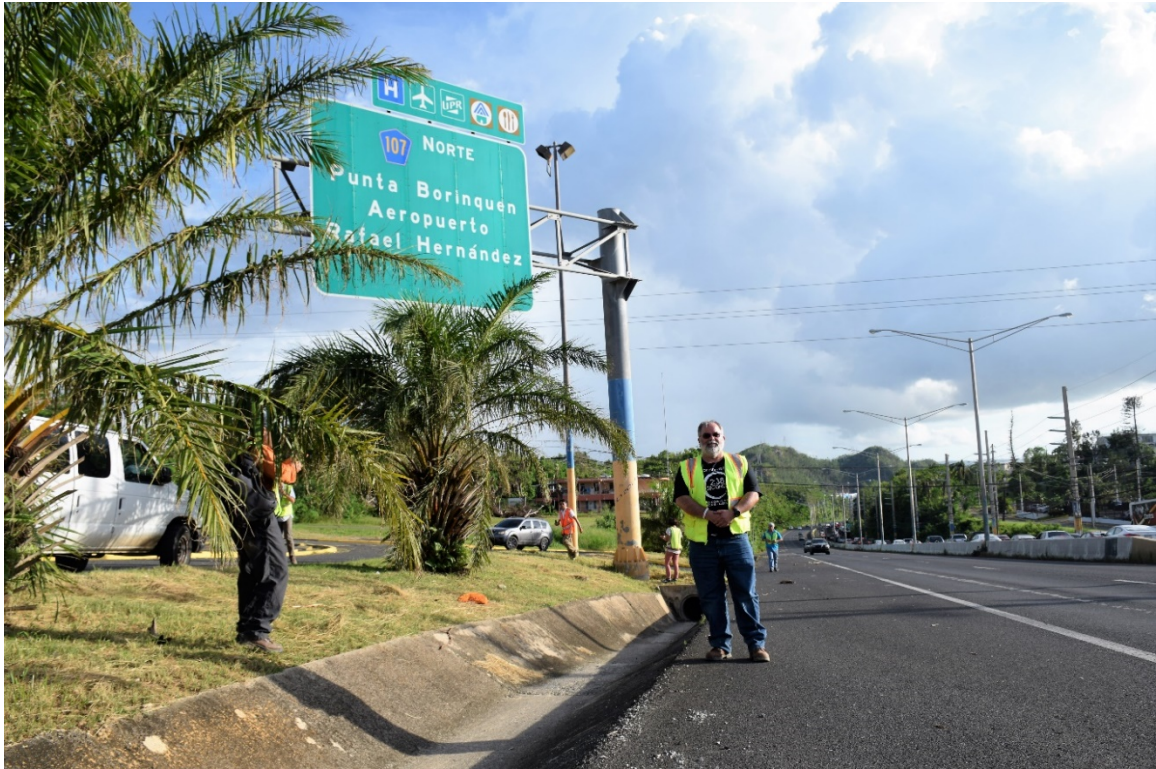
Figure E-1: Photo looking south of Site F2 (Lat: +18.43681, Lon: -67.14776; 2017.10.30).

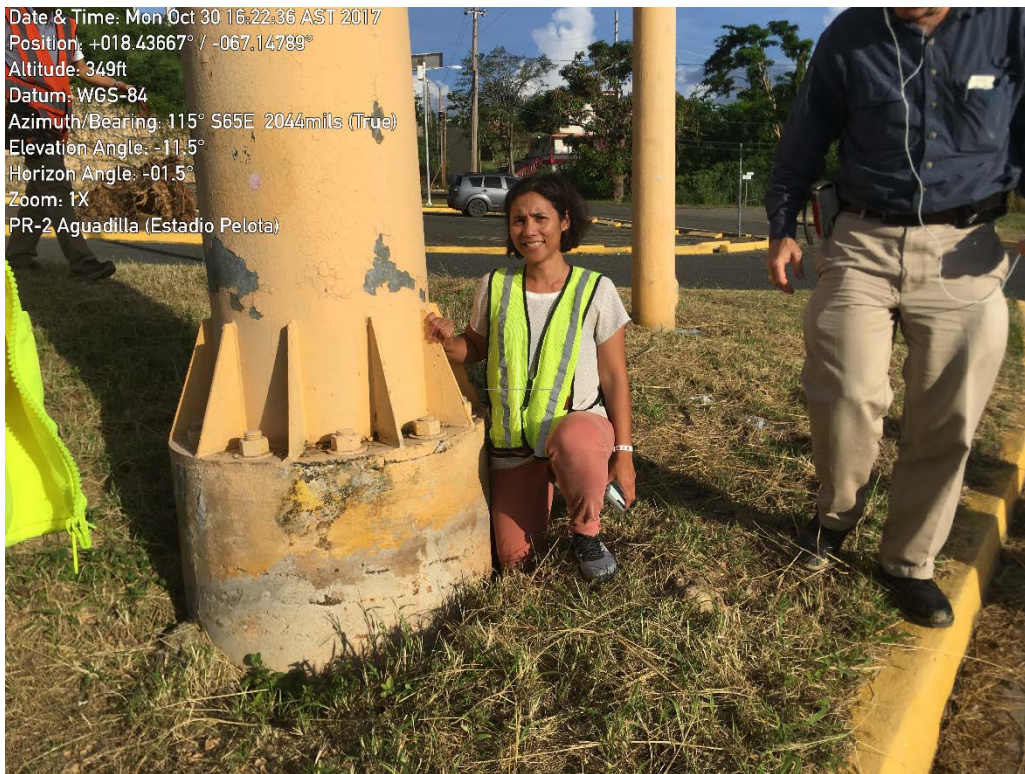
Figure E-2: Photo of drilled shaft of cantilevered traffic sign at Site F2 (Lat: +18.43681, Lon: -67.14776; 2017.10.30).

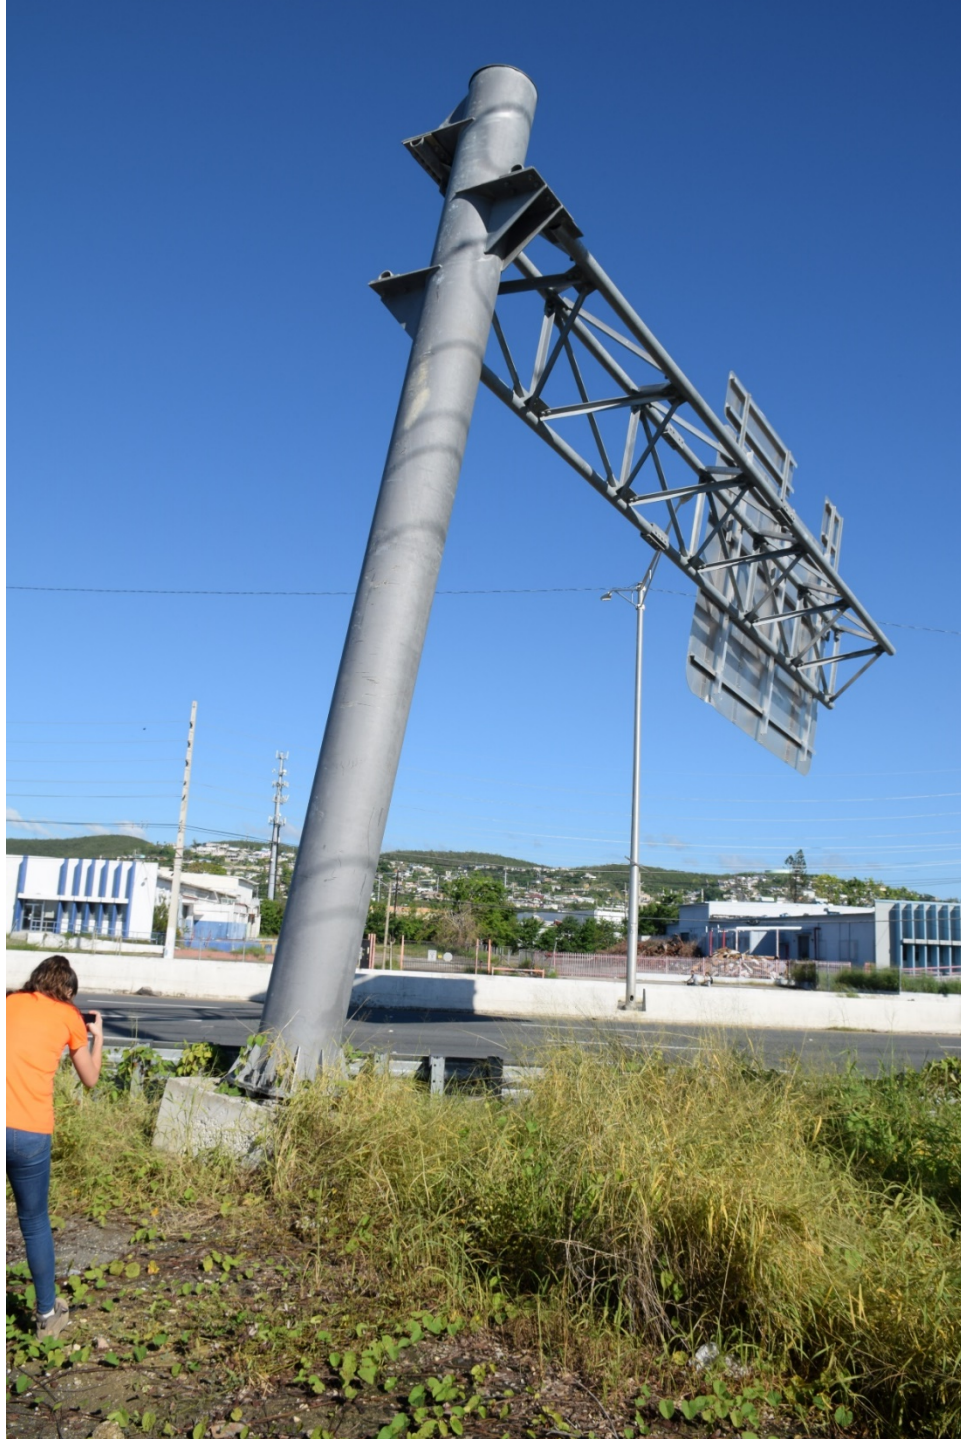
Figure E-3: Photo of cantilevered traffic sign at Site F3 (Lat: +17.987991, Lon: -66.648788; 2017.11.1).

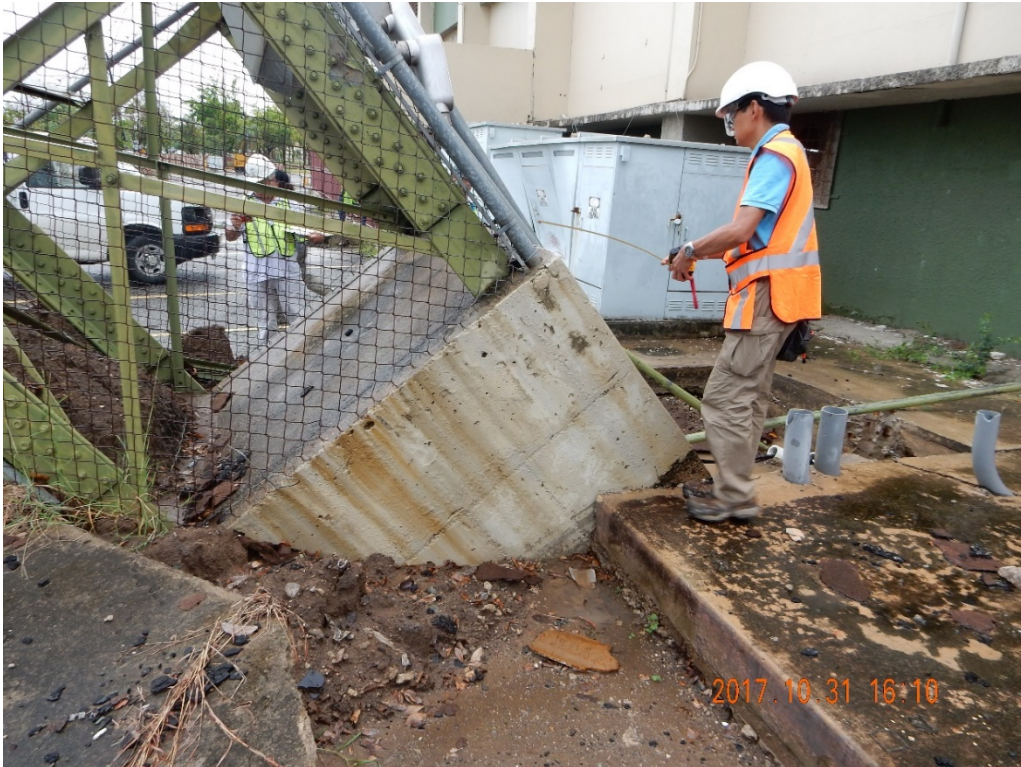
Figure E-5: Photo of illumination tower foundation pedestal at Site F4 (Lat: +18.00207, Lon: -66.63098; 2017.10.31).

A grab sample was collected 10/31/17 from the exposed foundation soil. Atterberg limits for this sample yielded a LL = 47.5%, and a PI = 29.8%. Grain size distribution tests for this sample resulted in 29.8% of gravel sizes, 20.7% of sands fraction, and 49.5% of fines. A shear vane test carried out on exposed foundation (See Figure E-6) yielded a shear strength (affected by failure mechanism) of about 54 kPa.

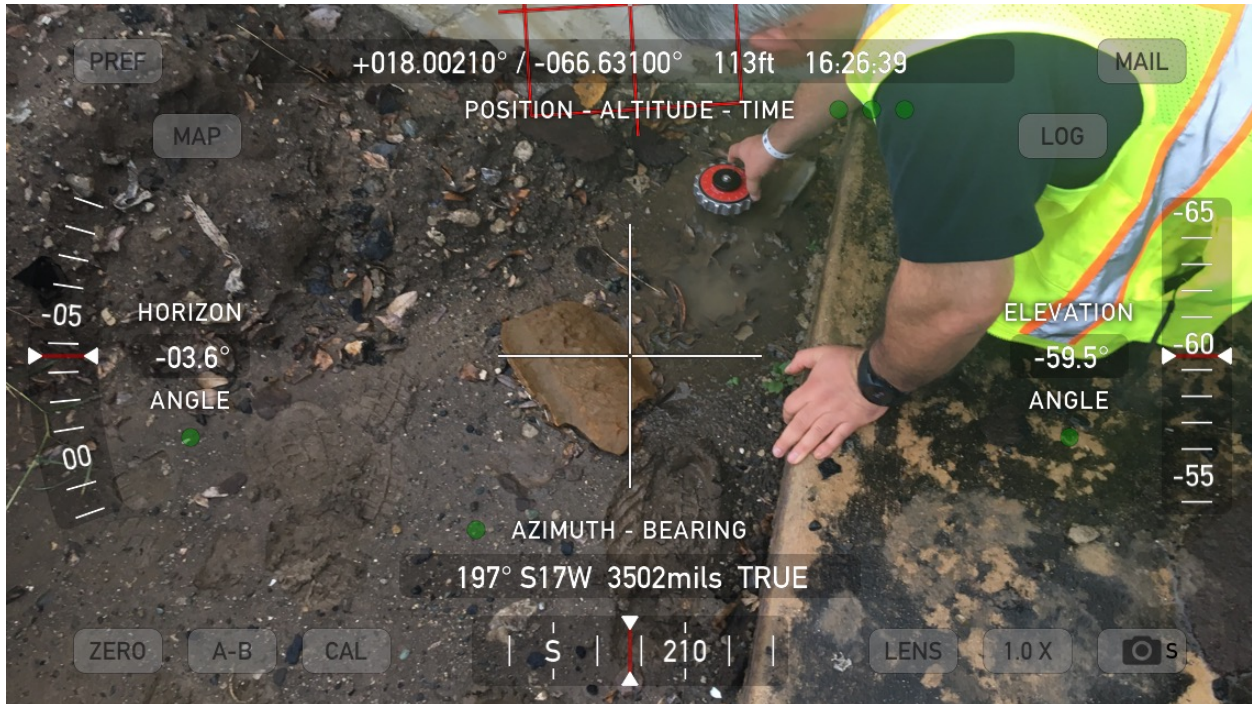
Figure E-6: Shear vane test on exposed foundation soil. Photo also shows location of grab sample (Lat: +18.00207, Lon: -66.63098; 2017.10.31).

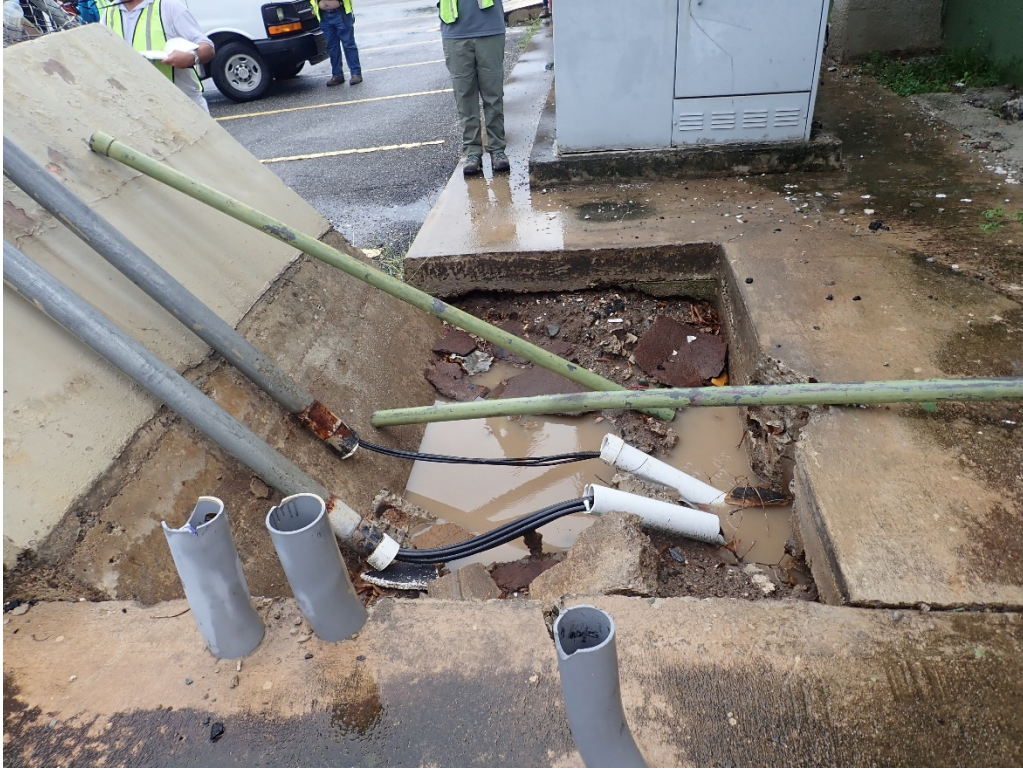
Figure E-7: Photo of the foundation spot of the tower (Lat: +18.00207, Lon: -66.63098; 2017.10.31).

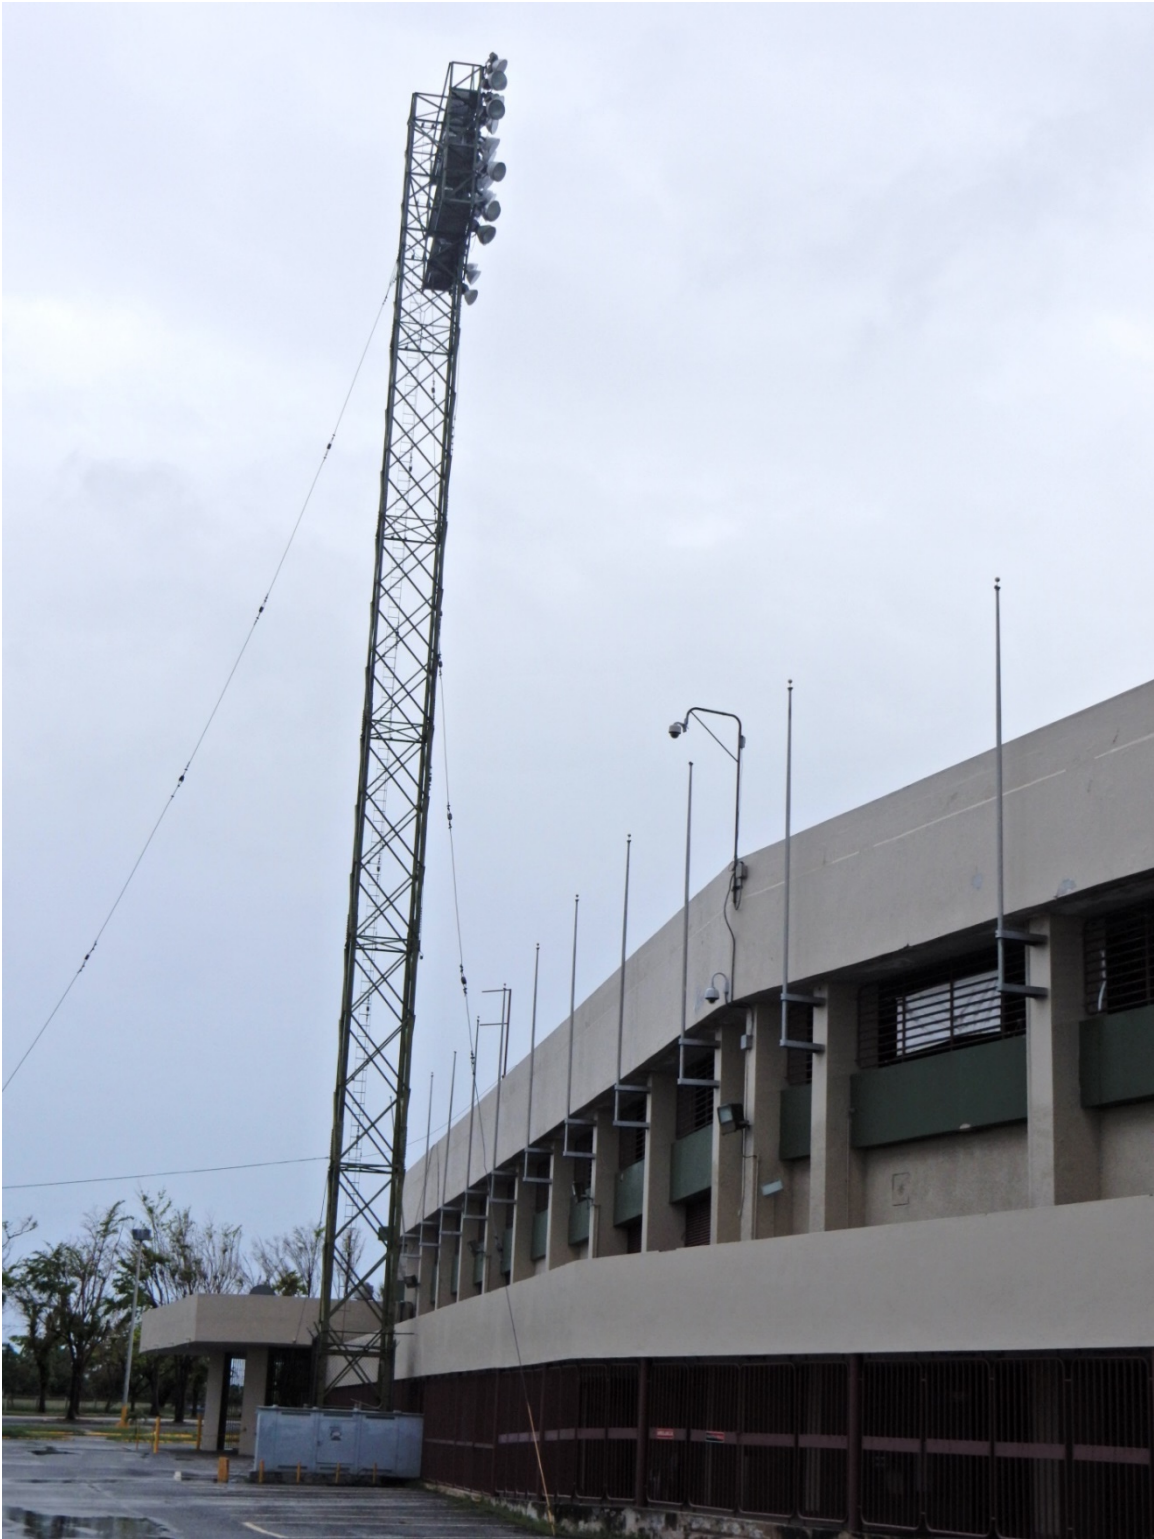
Figure E-9: Photo of adjacent illumination tower with similar height and design at the same stadium shown in Figures E-4 and 5 (Lat: +18.00207, Lon: -66.63098; 2017.10.31).
