# GEOTECHNICAL IMPACTS OF HURRICANE MARIA IN PUERTO RICO

Event Date: September 20, 2017

**Geotechnical Extreme Events Reconnaissance**

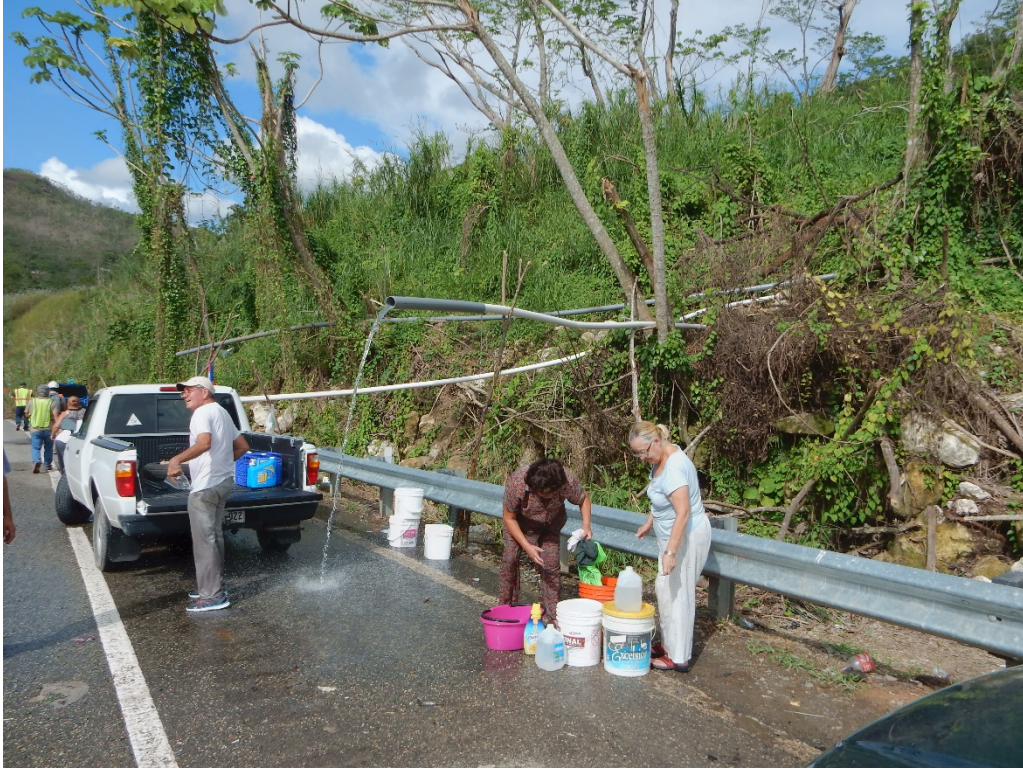
Figure F-4: Interim water supply; Lat: +18.30687, Lon: -66.71299; 2017.11.02; #3755.

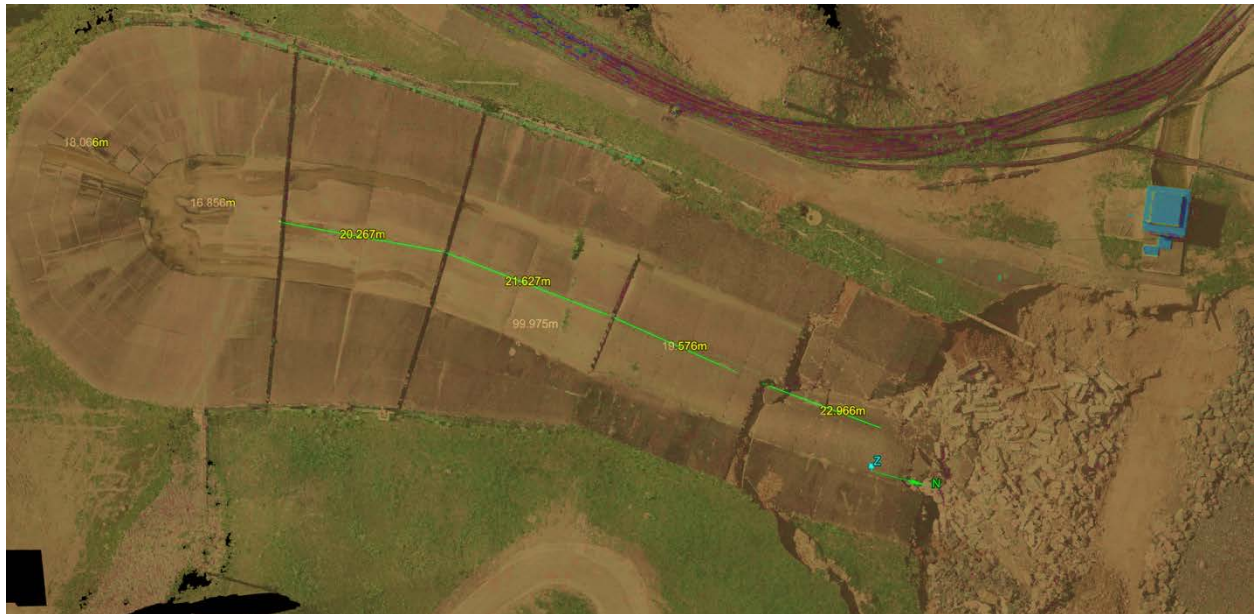
**Figure G-2: Hybrid SFM-TLS model of Guajataca spillway with length measurements of individual panel segments.**

The spillway design is segmented into 5 sections. A steeply sloped apron at head of the concrete spillway is 19 m in horizontal length with a slope of 11 degrees. The spillway transitions to flatter slopes in four segments. Segment A (the highest elevation) is 17 horizontal meters in length with a slope of 2.2 degrees. The second segment B is 19 horizontal meters in length with a slope of 3.5 degrees. The third segment C is 20 horizontal meters in length with a slope of 3.0 degrees. The failed fourth segment D was approximately 22 horizontal meters in length with a slope of 10 degrees.

Damage to the spillway occurred exclusively to section D. Discussion with engineers of the site indicate that cracks in the spillway concrete facing allowed for water to seep into the underlying soil and undermine the bottom of the spillway structure. A large cavity formed beneath the last 30 meters of the spillway. From the terrestrial laser scanning data (structure from motion data could not see into the void) The depth of the void varies and approximately 2 meters deep at the greatest depth.

Undermining of the spillway structure triggered a slide of the concrete facing. The section that slid 2.4 meters down slope (2.3 horizontal, 0.75m vertical) included the entire lower 23-meter portion of section D. On Spillway right, a small slump occurred on the north eastern side of the spillway. The concrete facing failure slid downslope and impacted into a rip rap toe at the transition zone beneath the concrete spillway.

Emergency repair and maintenance work can be seen in the hybrid model. New rip rap is being placed at the base of the damaged concrete spillway to provide a Erosion protection. Hydraulic pumps in the reservoir are diverting water past the spillway into the water canal to the west, and creek that is fed at the small concrete bridge beneath the spillway. New concrete riprap can be seen at the toe of the spillway (see from Figure G-3 to Figure G-6). Bypass flexible hydraulic pipes can be seen west of the spillway, diverting water released from the reservoir.

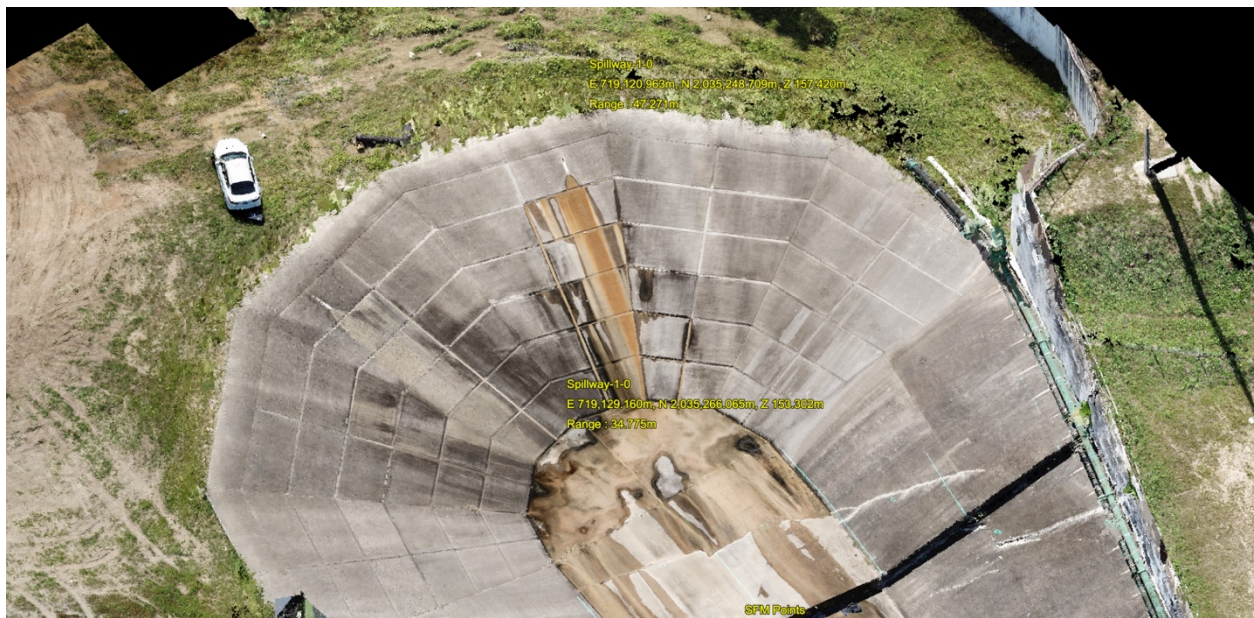
Figure G-7: Figure 7. Hybrid SFM-TLS model of the upper apron of the spillway, above section A. Reservoir waters pass over a soil bench before plunging down the apron when entering the spillway.

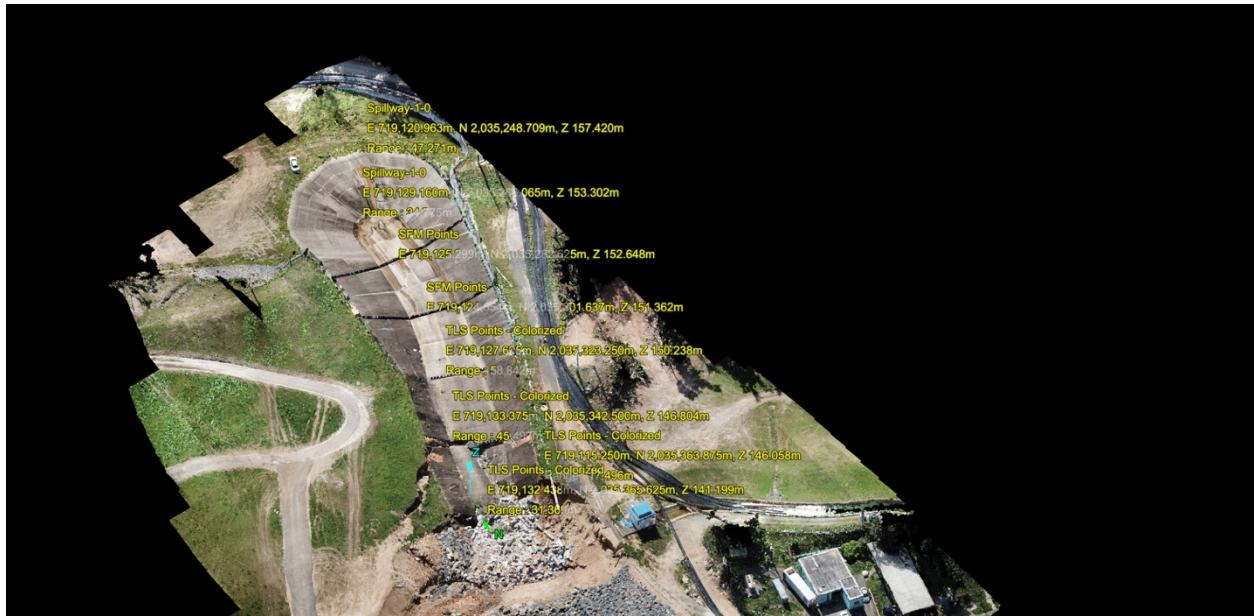
Figure G-8: Oblique hybrid SFM-TLS model of the entire concrete and riprap spillway at Guajataca dam with UTM-based coordinates used for project measurements.

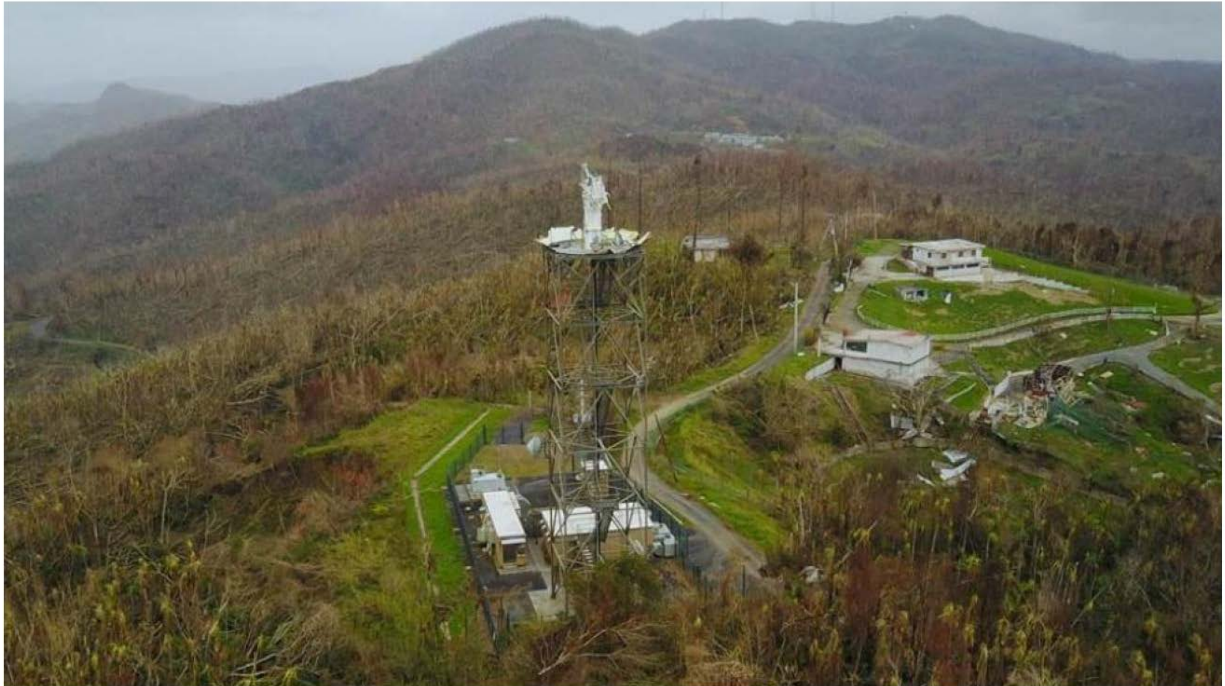
Figure 10. The remnants of the San Juan WSR-88D radar after its destruction by Hurricane Maria. Photo credit: WFO San Juan.
