GEOTECHNICAL ASPECTS OF SEPT. 5, 2012 M7.6 SAMARA, COSTA RICA EARTHQUAKE

Version 1.0

January 30, 2013

Prepared by

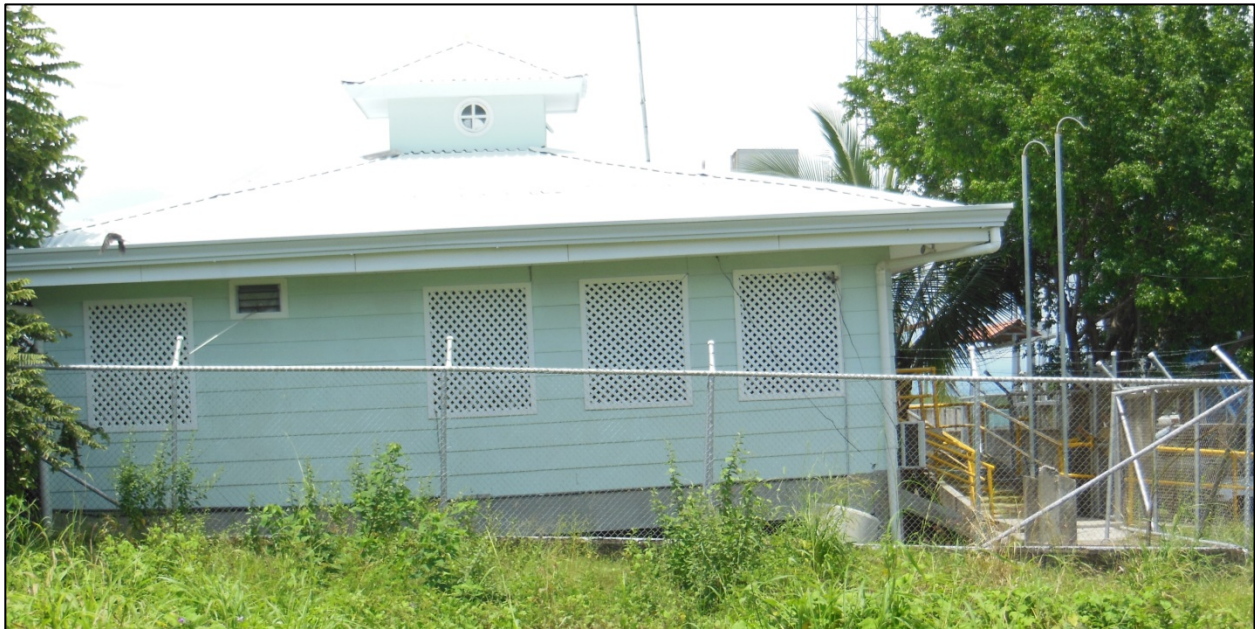
Liquefaction damage was observed at a site in Puntarenas, a relatively thin barrier peninsula within the Gulf of Nicoya. This city is one of the largest along the Pacific coast and several other port facilities are located nearby. Port services are available within this city and on the north side of the peninsula there is a small office for port security and fisheries. The Capitanía is a port of entry office in charge of security and shipments. This building is a relatively small structure built on concrete pedestals or stilts supported on shallow foundations. The structure was recently renovated (6 months previously) and a handicapped ramp was installed. The entire structure rotated as a monolith during the earthquake when the foundation soils liquefied. The foundations punched through the liquefied ground at different rates to produce the tilting and failure of some of the reinforced 12-inch square concrete stilts (see Fig. 2.4). It is estimated that the building sank about 50 to 75 cm. The building was supported on nine (9) 30cm square concrete stilts. Each column foundation had a clear crater developed around the footing. The center stilt developed a crater of about 2.6 meters wide and 0.6 m deep.

Fig. 2.4 - Capitanía Port Office in Puntarenas (9.978153° N 84.840758° W)

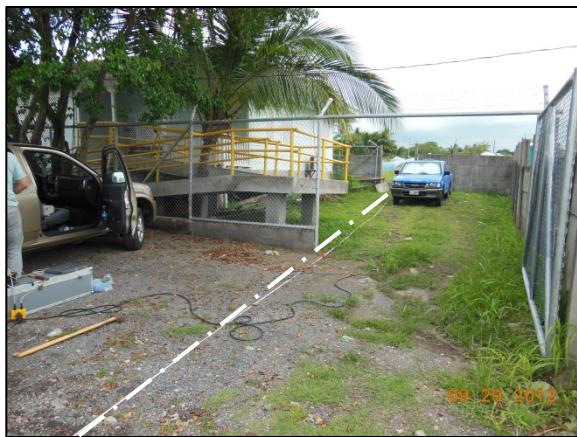
After the field reconnaissance of the property and surrounding ground an MASW geophysical survey was carried out about 20 feet away from the structure damaged due to liquefaction. Fig. 2.7 shows the location of the survey and the shear wave velocity (V_s) profile. The upper 5 meters varied between 100 and 150m/s, several cracks were also observed at the ground surface, probable indication of oscillation of fill soils on top of liquefied ground. From 5 to 15 meter depth the V_s increased linearly to 200m/s and then more firm ground reached a V_s of up to 400m/s. Clearly, the ground near the surface was quite loose and unstable with numerous surface cracks.

Location of the MASW geophysical survey on the north side of structure.

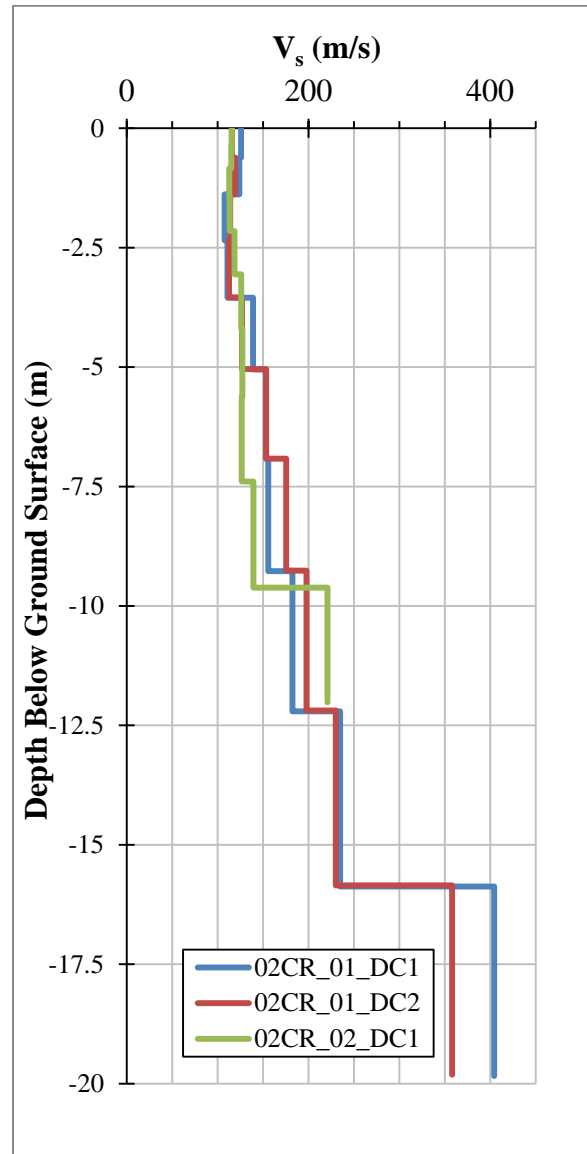
Fig. 2.7 - MASW Shear Wave Velocity (V_s) Profile near the Capitanía Office Building, which was subjected to liquefaction failure. (Lat. $9^{\circ}58'41.35''N$ / Long. $84^{\circ}50'26.73''W$)

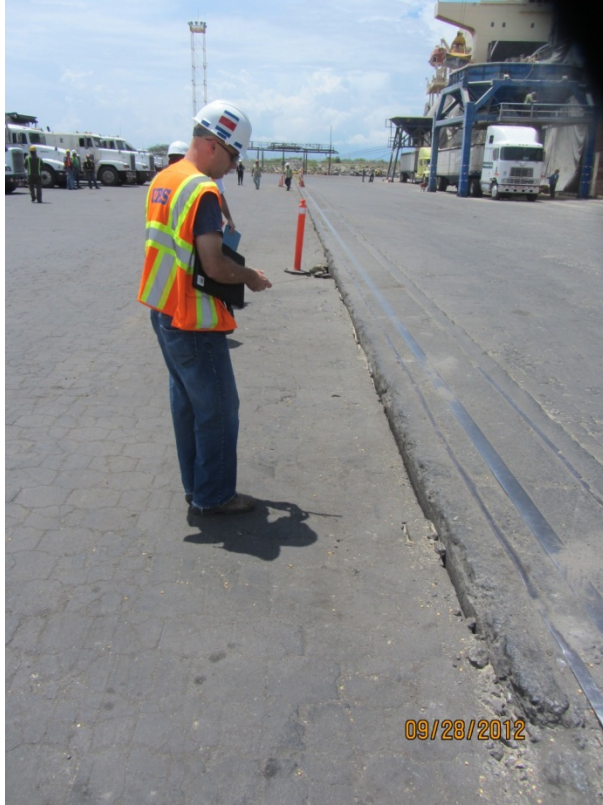
Damage to the port was relatively minor and cargo operations continued after the earthquake without significant problems. A continuous concrete beam was originally constructed parallel to the wharf to support a track mounted crane. That crane was subsequently replaced by a mobile crane unit which was under routine maintenance at the time of the quake and was therefore lightly loaded. Settlement of the surrounding soil relative to the continuous beam were generally less than 8 mm but in some local areas settlement troughs were as great as 100 mm as shown in Fig. 3.2.

Fig. 3.2 - (a) Earthquake induced settlement in local zones adjacent to the longitudinal beam running parallel to the wharf (9.91197° N 84.72112° W). (b) Settlement was approximately 100 mm (4 inches).

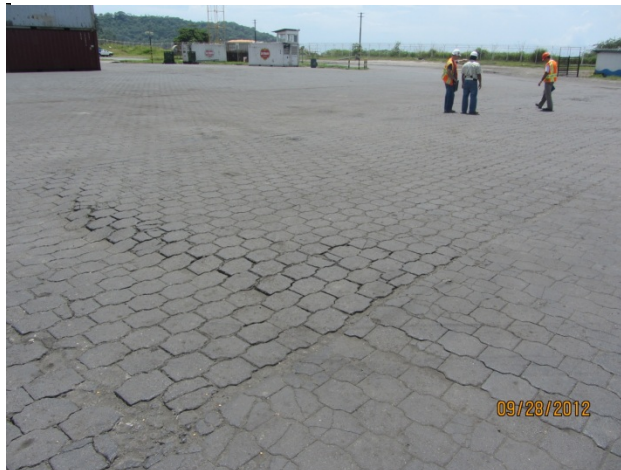
At the west and east ends of the port, rectangular zones appeared to heave upwards relative to the surrounding ground suggesting that some underground structure was made buoyant during the earthquake as shown in Fig. 3.3.

Fig. 3.3 - Apparent heave of rectangular area on the (a) west (9.91170° N 84.72194° W) and (b) east (9.91246° N 84.71811° W) ends of the port.

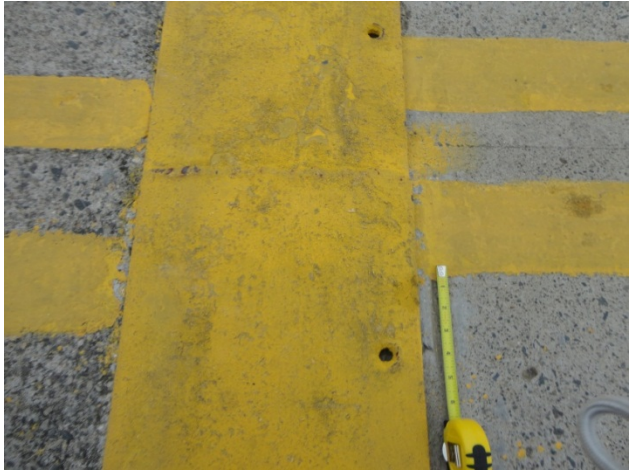
Damage to the pier was visible during our visit, but appeared to be relatively minor and primarily limited to the pile-supported section of the pier. The pier has remained operational since the earthquake, though sections of damaged railing were blocked off with orange cones for safety concerns. A lateral offset of about 76 mm (3 inches) was measured between the pile- and caisson-supported sections of the pier (Figs. 3.7 and 3.8). Damage to the 100mm-diameter steel guardrail of the pier, particularly on the west side, was visible in various locations throughout the rotated portion. Several portions of the railing were pulled apart approximately 76 mm (3 inches) as shown in Fig. 3.9, presumably due to extension on the west side of the pier. No evidence of buckling in the railing was visible on the east side of the pier. The connections between the guardrail posts and the pier were significantly damaged throughout much of the pile-supported section of the pier (Fig. 3.10). From our observations, it appeared that many of the railing posts had been previously welded, perhaps from a need to temporarily remove the railing for some type of pier maintenance. In nearly every location where damage was observed in the connection between the guardrail and the pier, damage to or failure of the weld was observed (Fig. 3.11). A utility pipe, presumably water, was observed on the west side of the deck of the pier. The pipe appeared to have sustained some cracking in a few locations along the pile-supported section of the pier (Fig. 3.12). At this point, security personnel approached the reconnaissance team requesting that no more photos be taken of the pier. However, the security personnel allowed the team to continue its investigation and to note its observations. A 38-meter portion of the pile-supported section appeared to have rotated slightly resulting in a 25 mm (1 inch) gap in the deck slab on the west side of the pier and crumbling/spalling of the deck slab on the east side of the pier due to compression and pounding. Further evidence of pounding between deck slabs was observed approximately 105 meters from the head of the pier on the pile-supported section.

Fig. 3.7 - Lateral offset between the pile- and caisson-supported sections of the pier (9.97177° N 84.83068° W).

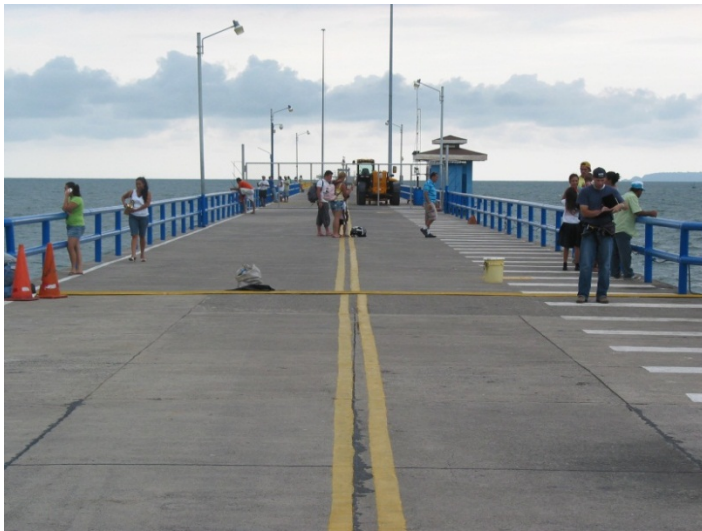
Fig. 3.8 - Lateral offset between pile- and caisson-supported sections of the pier (facing south).

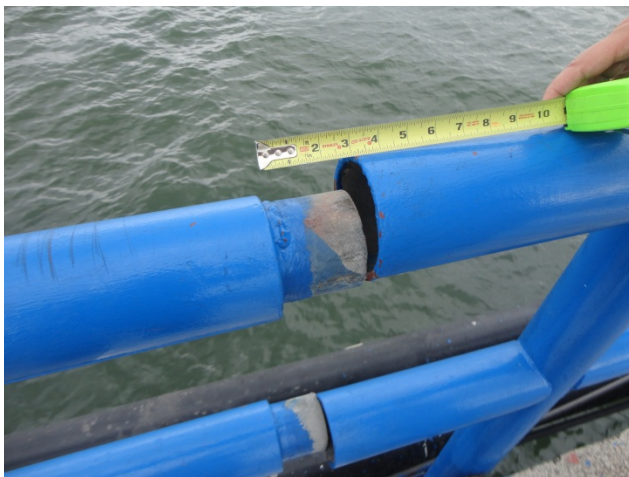
Fig. 3.9 - Sections of the steel guardrail that had pulled apart during the earthquake (9.97205° N 84.83078° W).

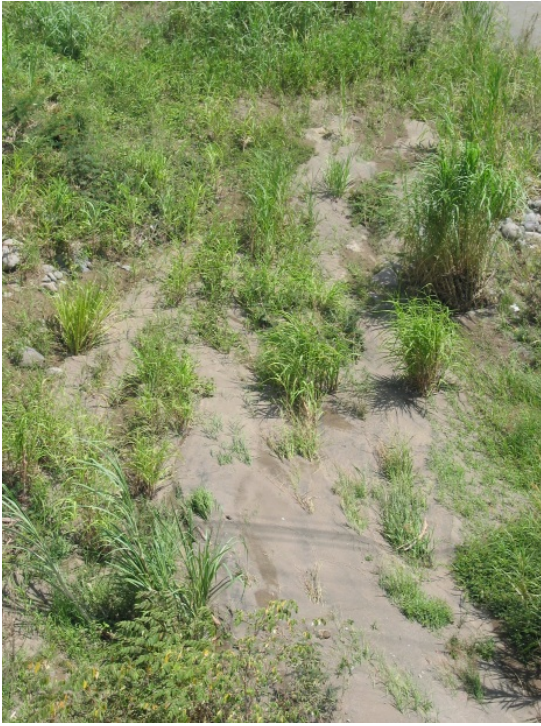
The GEER reconnaissance team identified possible evidence of liquefaction along the east bank of the river immediately south of the bridge. Remnants of what appeared to be subsided sand boil approximately 1.5 meters (5 feet) in diameter were visible, along with traces of what appeared to be residual runoff sand that had flowed towards the river Fig. 4.6 and 4.7). However, we could find no strong visible evidence that liquefaction had caused damage to the Rio Barranca Bridge.

Fig. 4.7 - Ejecta and sand runoff adjacent to the subsided sand boil (9.99676° N 84.69442° W).

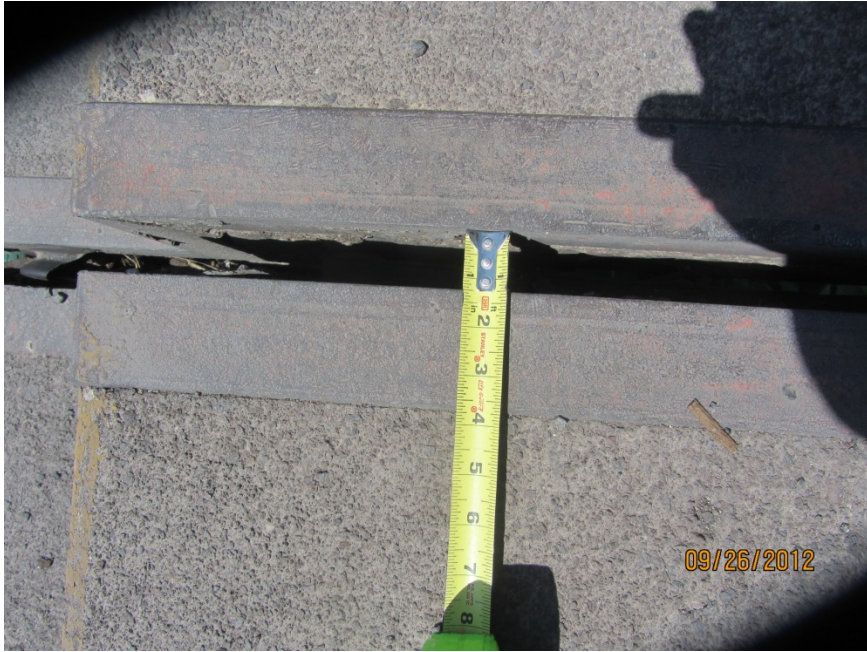
The Costa Rican Ministry of Transportation inspected the bridge just a few days after the September 5 event, and identified it as having sustained damage from the earthquake. While our reconnaissance team confirmed this report, the damage we observed appeared relatively minor. Investigation of the bridge deck at the abutments revealed an offset of 76 mm (3 inch) at the west abutment (Figs. 4.10 and 4.11) and an offset of 25 mm (1 inch) at the east abutment (Fig. 4.12). According to the Costa Rican Ministry of Transportation, the bridge deck was designed to have offsets of approximately 25-50 mm (1-2 inches) at the abutments. In addition, vertical offsets of

Fig. 4.12 - Longitudinal offset of about 25 mm (1 inch) at the east abutment (10.00231° N 84.31025° W).

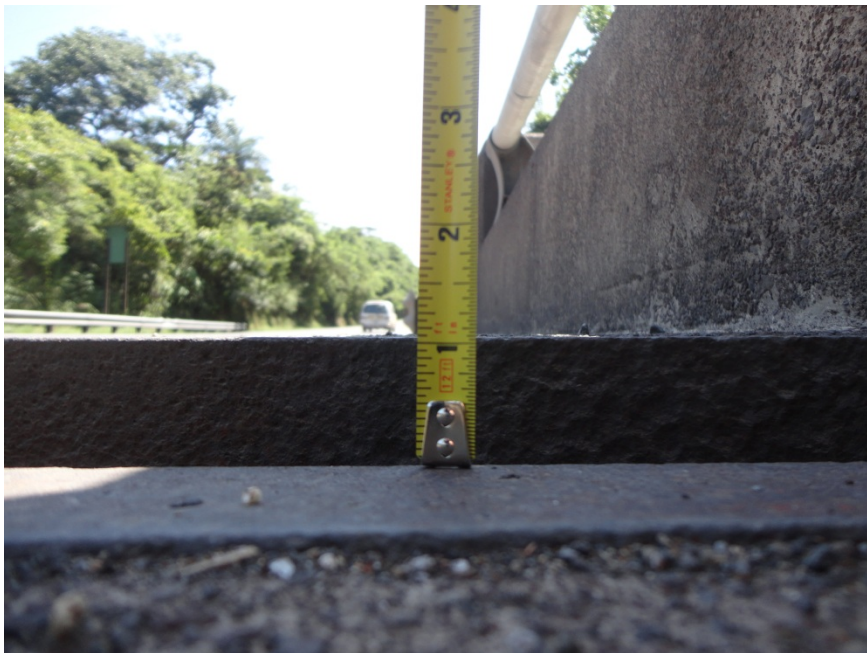
about 25 mm (1 inch) were measured at the east abutment (Fig. 4.13). These offsets suggest that the entire bridge permanently displaced about 25 mm (1 inch) to the east and settled about 25 mm (1 inch). Inspection of the guardrail near the west abutment showed damage to the concrete and exposed rebar (Fig. 4.14), possibly due to pounding between the bridge and the abutment during the earthquake.

Fig. 4.13 - Vertical offset of about 25 mm (1 inch) at the east abutment.

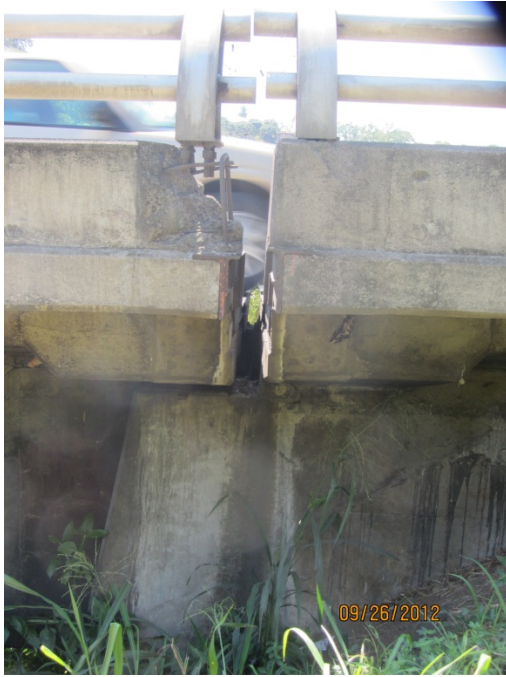
Fig. 4.14 - Possible evidence of pounding beneath the guardrail at the west abutment (10.00193° N 84.31131° W).

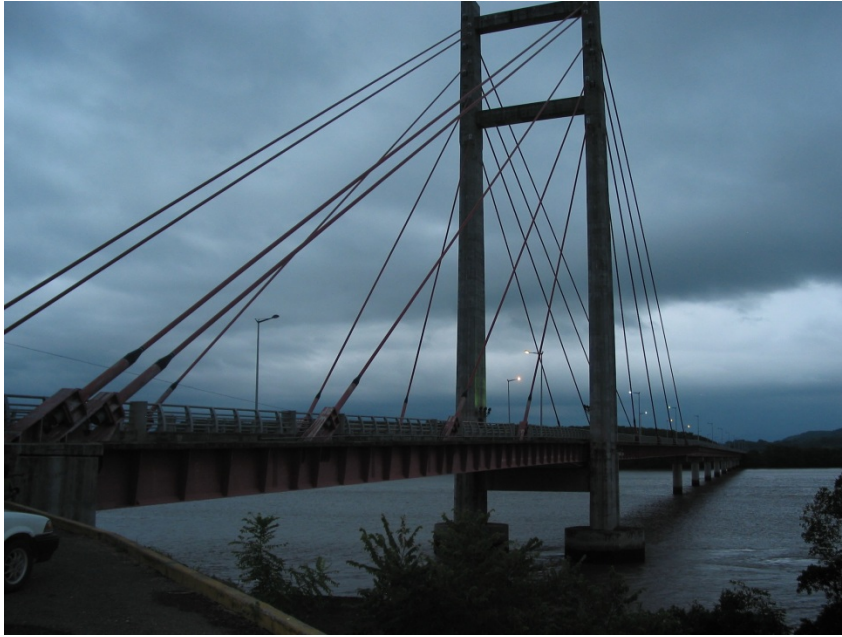
Fig. 4.16 - Photo of the bridge over the Rio Tempisque taken during our reconnaissance from near the west abutment (10.24555° N 85.24895° W).

The Costa Rican Ministry of Transportation inspected the bridge just a few days after the September 5 event, and identified it as having sustained damage from the earthquake. Reported damage was generally limited to concrete spalling at the joint between the cable-stayed bridge and the box girder bridge due to pounding (Fig. 4.17). Our investigation confirmed that spalling in the concrete had occurred at the joint between the two bridges (Fig. 4.18), resulting in the exposure of steel rebar in a few locations. We measured a gap of approximately 25 mm (1 inch) at the joint between the two bridge sections (Fig. 4.19). Investigation of the east abutment of the bridge revealed a large crack about 25 mm (1 inch) in width spanning the width of the abutment slab, as shown in Fig. 4.20. This crack appeared to have been caused by differential settlement or slope movement beneath the slab. It is unclear whether these settlements or movements occurred as a result of the September 5 earthquake or prior to it. Visual inspection of the bents from the east abutment showed no evidence of tilting or other damage. No evidence of liquefaction was observed in the vicinity of the bridge abutments.

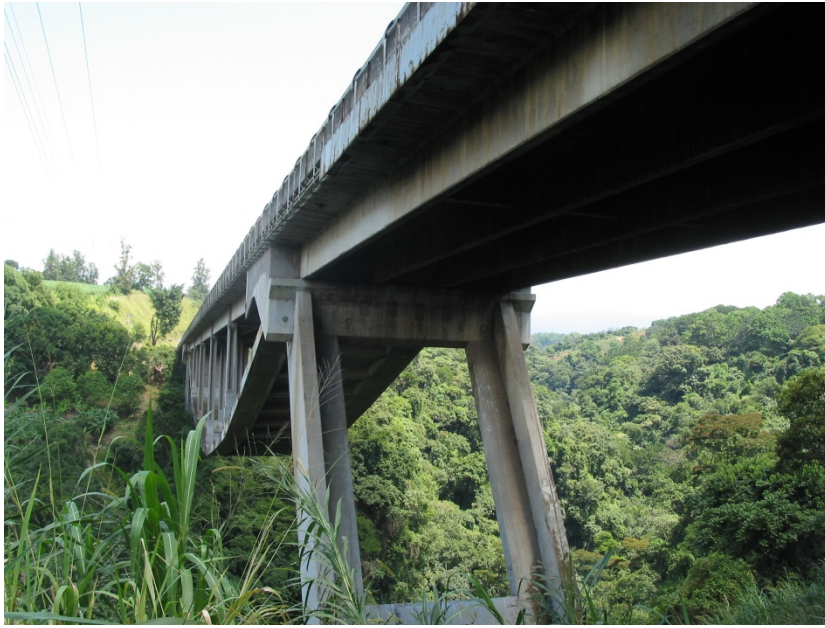
Overall the bridge performance following the Nicoya earthquake was good, with no noticeable cracking or excessive separation between bridge segments. However, the Costa Rican Ministry of Transportation inspected the bridge a few days after the earthquake and identified some potential problems owing to the offset between the bridge and the abutment. The GEER team observed that the gap between the bridge and the southeast abutment had increased by about 1.5 inches from its original position as shown in Fig. 4.25 (a) and (b). This offset had caused the metal sheathing around two of the cables to be pulled apart so that the steel wire cables were exposed to the atmosphere. Although this does not pose any immediate threat to the safety of the bridge, the potential for accelerated corrosion is significantly increased. In addition, the movement of the bridge in the northwest direction has reduced the seat length on the abutment to only about 7 inches (see Fig. 4.25(c)).

Fig. 4.22 - Pivot and inverted arch, Rafael Iglesias bridge (10.01907° N 84.35651° W).

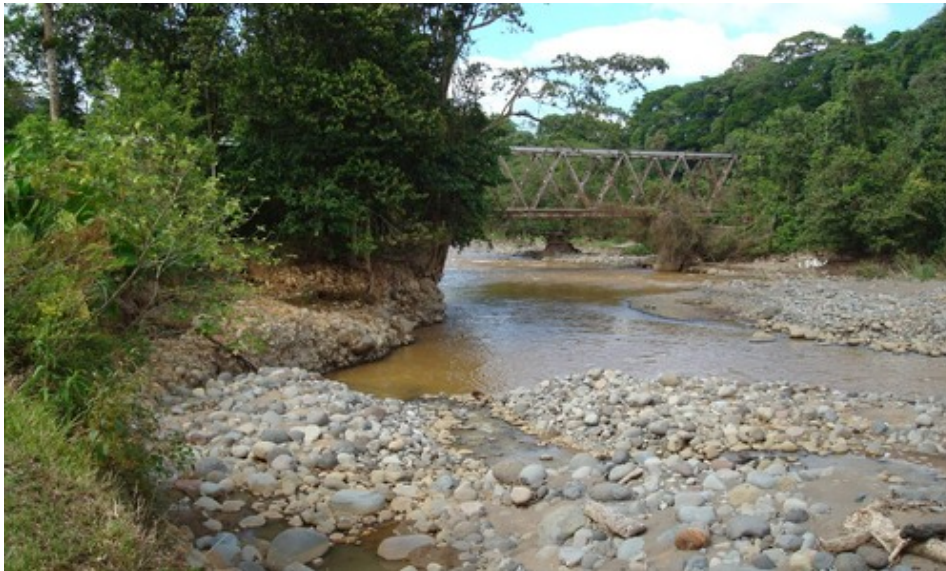
Fig. 4.27 - Bridge De Hierro Sobre El Rio Sarapiquí-La Virgen (10.38825° N 84.13859° W).

Photographs looking along the longitudinal axis of the bridge from one abutment (a) before and (b) after the earthquake are shown in Fig.4.28. The bridge appears to be a 1930s vintage bridge with built-up sections to form the truss members. The bridge had been demolished prior to the arrival of the GEER team and new pile foundations were being driven to support a replacement bridge. Given that the bridge was relatively old and the ground motions were quite low, it seems likely that the bridge failed by falling off the support on one side which led to a failure of the top truss. A similar failure occurred to a steel girder bridge at Rio Estella during the 1991 Limon Cost Rica earthquake. A newer, well constructed bridge would have survived this low acceleration level with little problem.

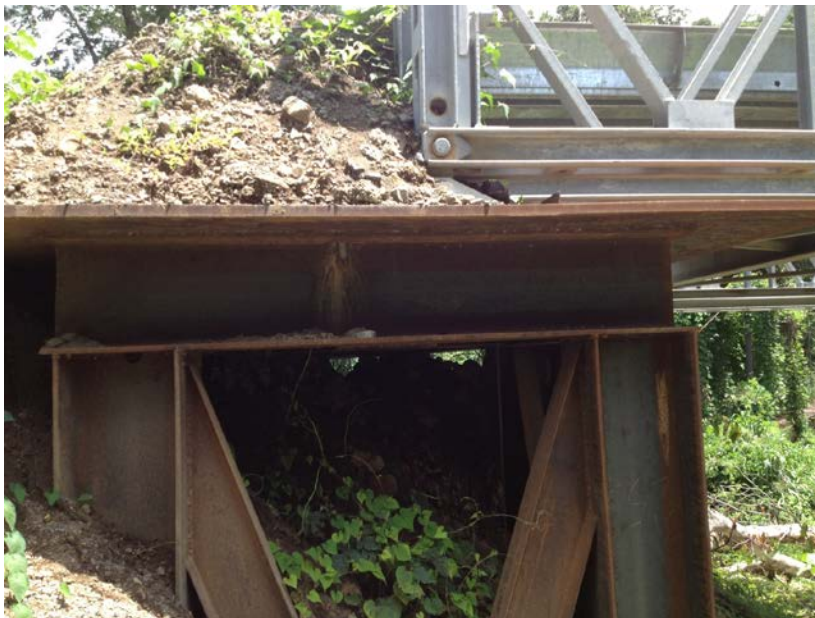
In contrast to the poor performance of the truss bridge over the Sarapiquí river, this two span bridge at Nosara (≈ 70 m length) shown in Fig. 4.29 weathered the earthquake with no apparent damage with the exception of some sloughing of the steeply inclined approach fill. The abutments and center pier, shown in Fig. 4.29, were supported by a framework consisting of eight steel H piles (HP12x63) driven 8 m into the underlying soil profile. The bridge was attached with a pin connection to a plate section which was welded atop the eight H piles as shown in Fig. 4.30. A recording station in Nosara about 2 km from the bridge recorded a peak acceleration of 1.38 g. This case history points to the fact that well-constructed bridge can perform very well despite strong ground shaking, particularly if the bridge support seats are adequate.

Fig. 4.30 Pin connection between bridge and pile supported abutment consisting of eight H piles.

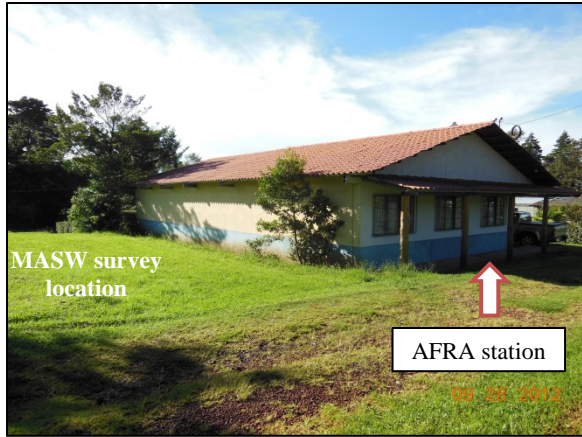
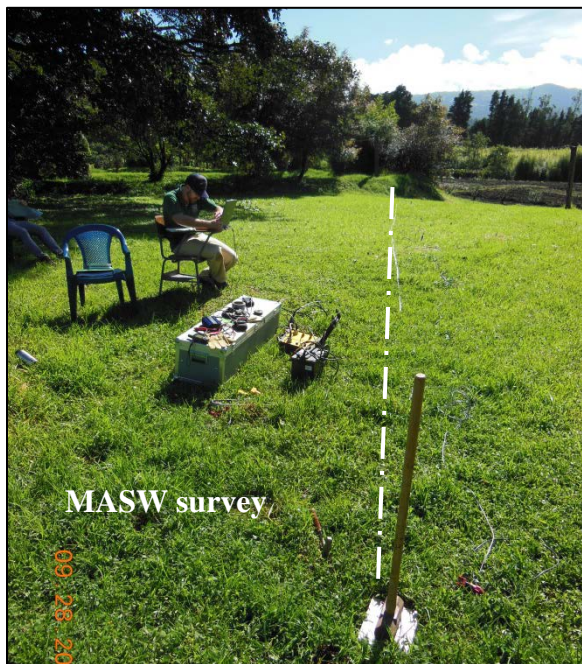
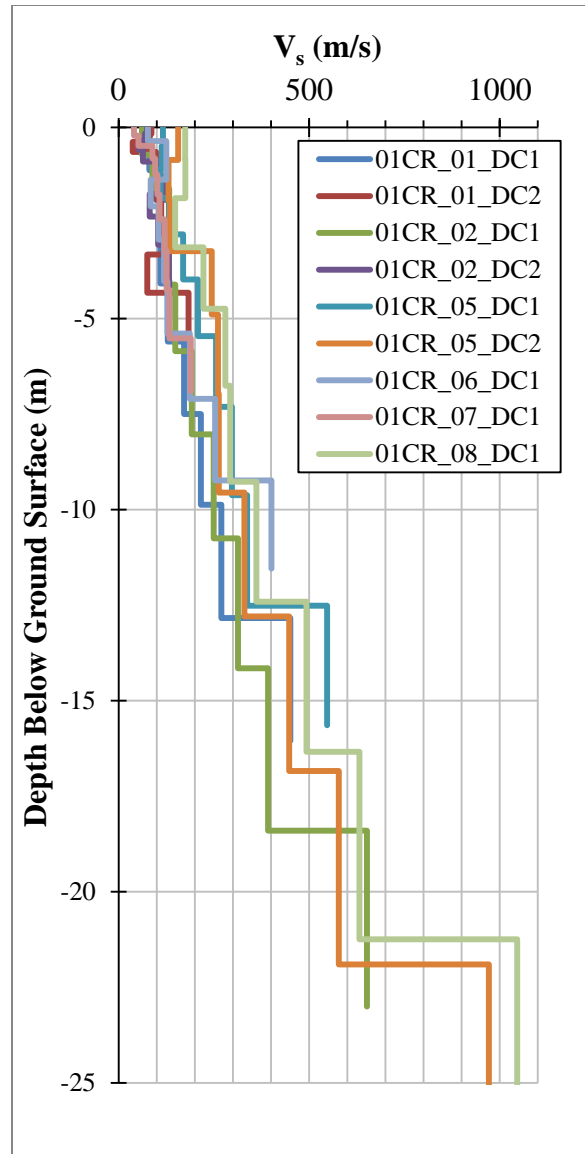
Fig. 5.1 – MASW Shear Wave Velocity (V_s) Profile near the Fraijanes Station (AFRA), which was reported to undergo amplification in volcanic soils. (10.13747° N 84.19305° W).

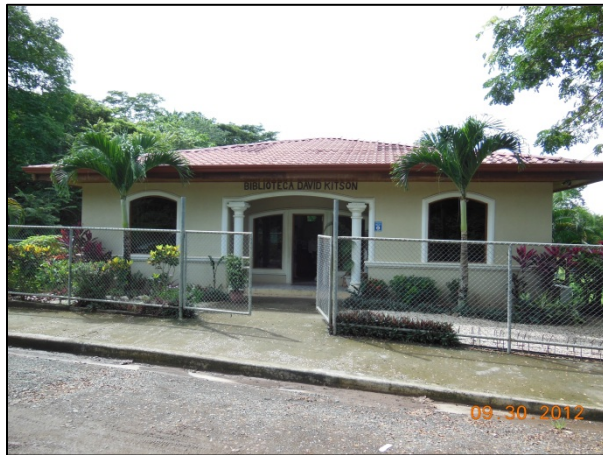
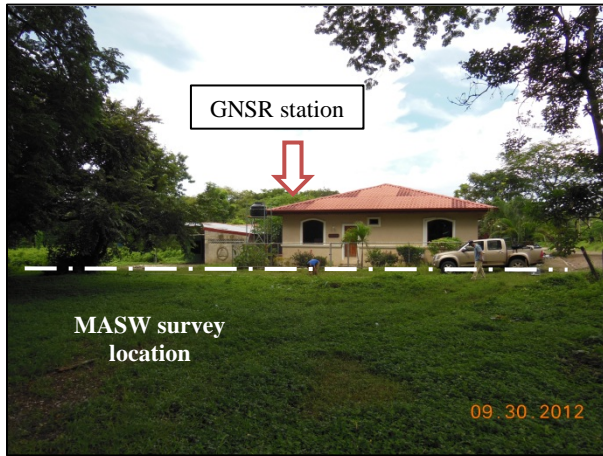
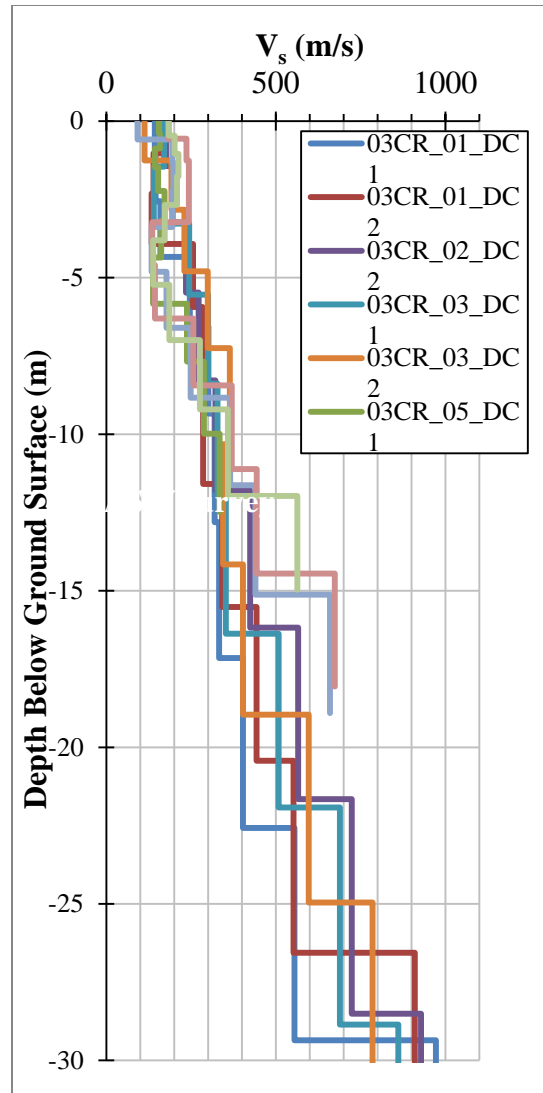
Fig. 5.3 – MASW Shear Wave Velocity (V_s) Profile in the Biblioteca David Kitson in Nosara (GNSR), reported one of the largest amplitudes in the vertical direction. (9.97902° N 85.648

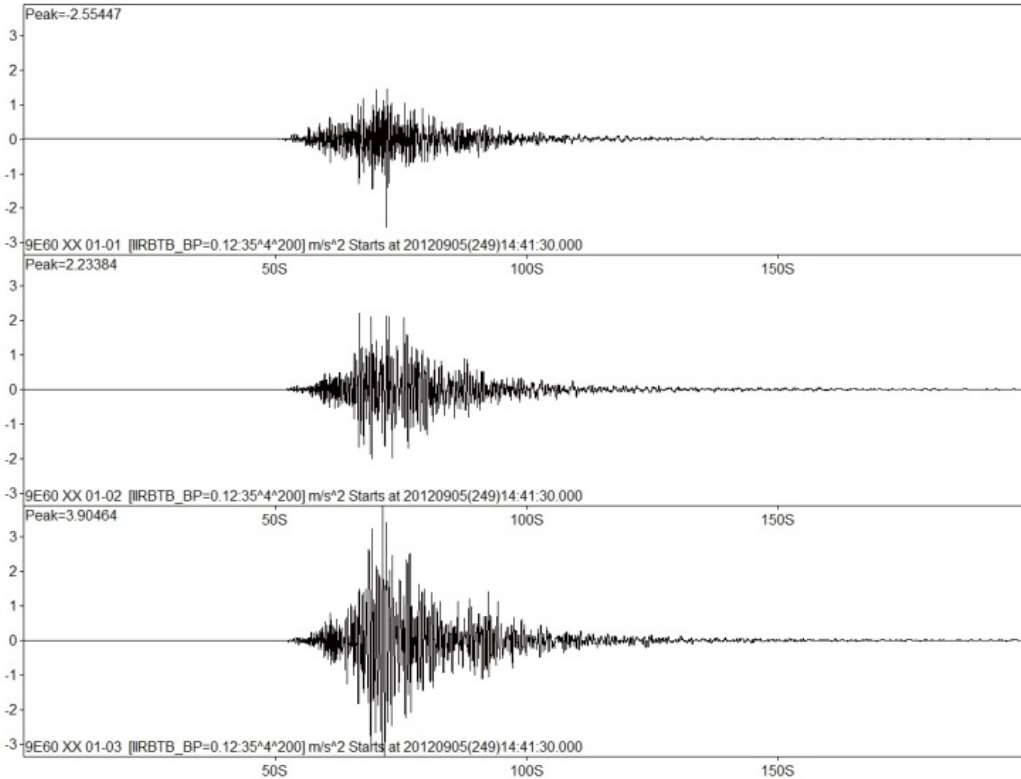
Fig. 6.3 - Acceleration time history for the three components at the crest of Sandillal Dam, September 5, 2012 main event (Vertical, Horiz-1, and Horiz-2).

The level of ground shaking at the crest (0.40g) is considered severe with the potential of generating moderate damage. Based on site visits by the ICE personnel the reported damage consists of small longitudinal cracks along the crest and a maximum settlement of about 12cm.
