# Geotechnical Reconnaissance and Engineering Effects of the December 29, 2020, M6.4 Petrinja, Croatia Earthquake, and Associated Seismic Sequence

A report to the NSF-Sponsored Geotechnical Extreme Event Reconnaissance (GEER) Association<sub>1</sub>

Report GEER-072: <https://doi.org/10.18118/G63T0S>  
August 3<sup>rd</sup>, 2021

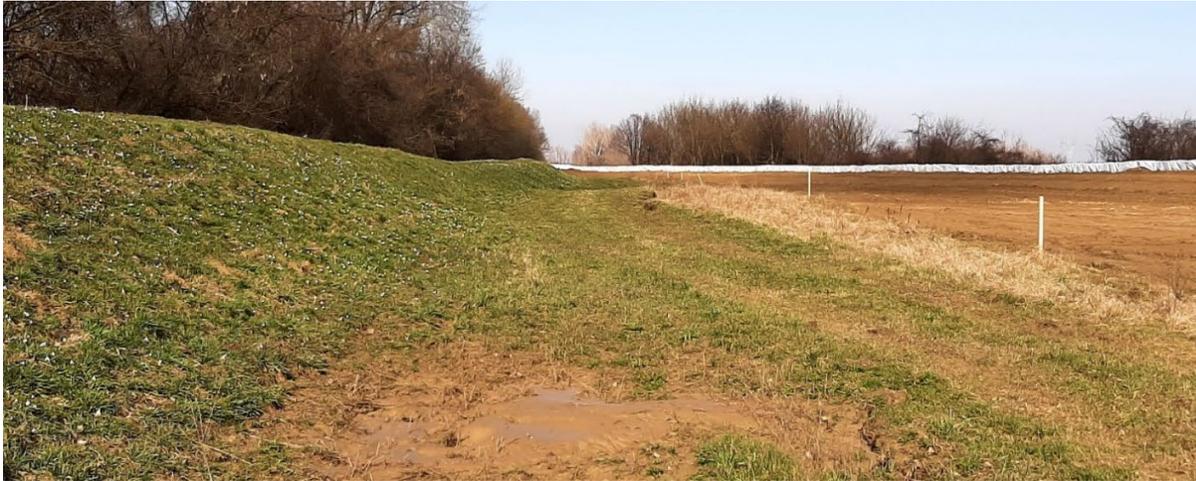
Geology of the area is presented in more details in Chapter 3. The area affected by the earthquake is the mostly flat valley of the meandering rivers Kupa and Sava with their tributaries, with mostly soft layers and a high ground water table. The underlying limestone is visible in rare locations. The levees erected to protect the cities, villages and the fields from the high waters of the Sava and Kupa rivers, were inspected by the geotechnical engineers who later joined the GEER team. Mostly built in or since the 1950s from the local clays, in several stretches, the levees got longitudinal cracks. In some cases, cracks crossed the levee crest, in some cases connection of two levees failed. Measured depth of the cracks is up to 2 m.

**Figure 1.4** Levee south from Stara Drenčina, along the Kupa river. Sand ejecta are visible in front, levee on the left, settlement of the levee in the distance, and secondary levee (white box barrier) on the right side of the photograph (45.4609N, 16.3362E).

Along the toes of the levees sandy ejecta, were often found. Croatian Waters, the institution in charge of flood protection in Croatia, immediately repaired some of the damages, and built secondary levees where necessary. Descriptions of levee damages are presented in Chapter 8. Although liquefaction was observed in the past in Croatia, the sand boiling was a surprise (**Figures 1.4-1.6**). Sand ejecta were found in a series of yards and around family houses in Petrinja, Glina, some villages and in many fields (**Figure 1.7**).

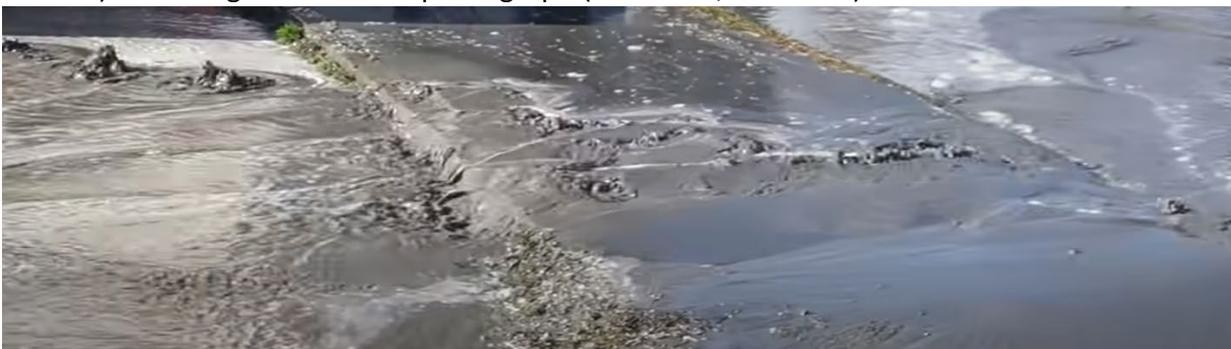
**Figure 1.5** Sand boiling observed during the main shock in Sisak – a snapshot from the video recorded by Daniel Pavlič (45.4735N, 16.3926E) at the distance of 15km from the epicenter and under the levee along the Sava river.

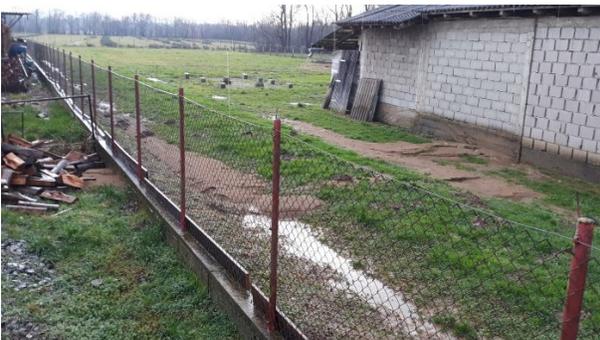
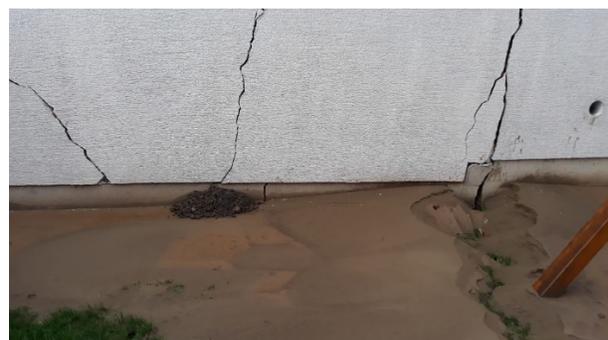
**Figure 1.6** A crack in Brest Pokupski which opened through several yards and houses, ejecting water and sandy soil in time of the main shock (**left** 45.4553N, 16.2628E; **right** 45.4539N, 16.2611E; photos by Igor Gukov).

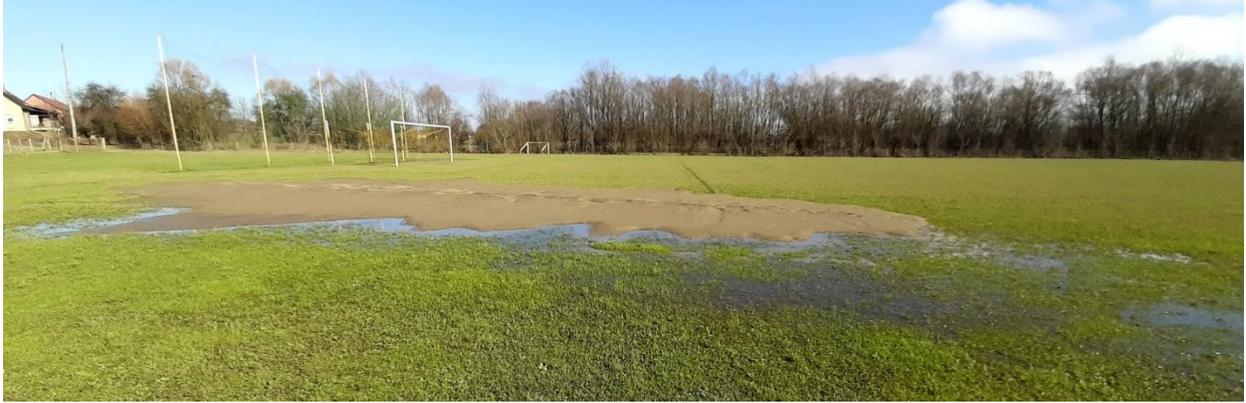
**Figure 1.7** A 15 m long crack with sand ejecta at the football playground in Letovanić (45.5057N,16.1979E).

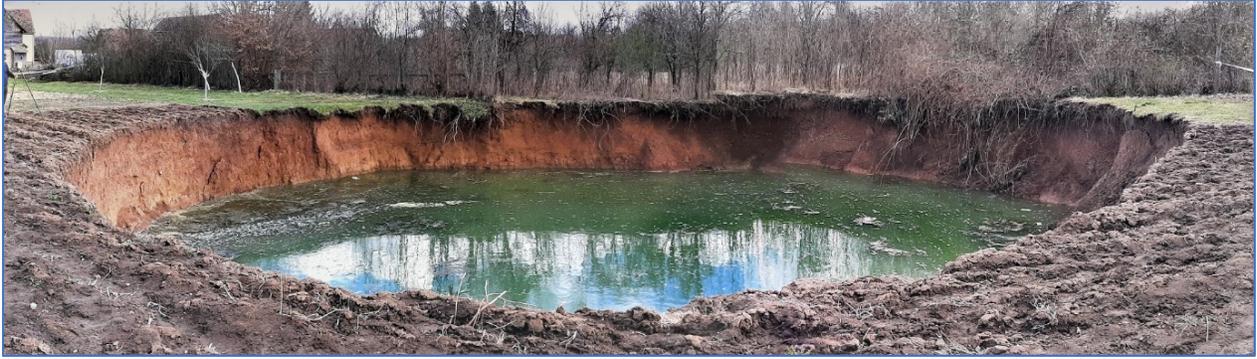
The most prominent, surprising, and relatively rare geotechnical earthquake effect includes the collapse of numerous sinkholes in the time frame of three months after the main shock. Ninety-one new sinkholes collapsed within a 4km<sup>2</sup> area surrounding Borojevići and Mečenčani villages between Petrinja and Hrvatska Kostajnica. Sinkhole diameters vary from 1 m to 25 m, with a maximum depth of 11.7 m. Cover-collapse sinkholes occurred in the past but very sparsely and were considered rare events. Residents refer to historical sinkhole events through jokes, such as saying, “I wish your field turned into a pond”. The GEER team registered 136 sinkholes, 91 which opened after the 29 December, and 45 old ones, as well as three potential sinkholes, as shown in Chapter 6, together with an overview of the geological and hydrogeological characteristics of the area, and details of the most interesting sinkholes. The geotechnical and geophysical investigations consisted of 61 nanometrics ambient noise readings, four geotechnical boreholes, two Multichannel Analysis of Surface Waves (MASW) profiles, and one compound electrical resistivity tomography (ERT) profile performed by the joint effort of the US and local GEER teams in the period between March 15 and March 26. The comprehensive database of lidar images of around 60 sinkholes is available as open-source in DesignSafe Data Depot. The most interesting sinkholes are presented in detail in Chapter 6, with the results of geotechnical and geophysical investigation. Chapter 10 describes details of the extent of complementary investigation works. **Figures 1.8 - 1.10** show some characteristic examples. Although not included as part of this GEER report, the Croatian company Terra Compacta in cooperation with the University of Zagreb, Faculty of Mining, Geology and Petroleum Engineering, performed geophysical investigations in the area, in order to find a safe location for the temporary container settlement for the villagers of Mečenčani and Borojevići, and to inspect the roads. The Croatian companies Karst and Geotehnički studio performed borings in order to inspect safety of some houses, however, still uncertainty remains.

**Figure 1.8** The largest (diameter of 26m) of the sinkholes which opened a week after the main earthquake in Mečenčani (45.2833N, 16.4259E; 26 February 2021).

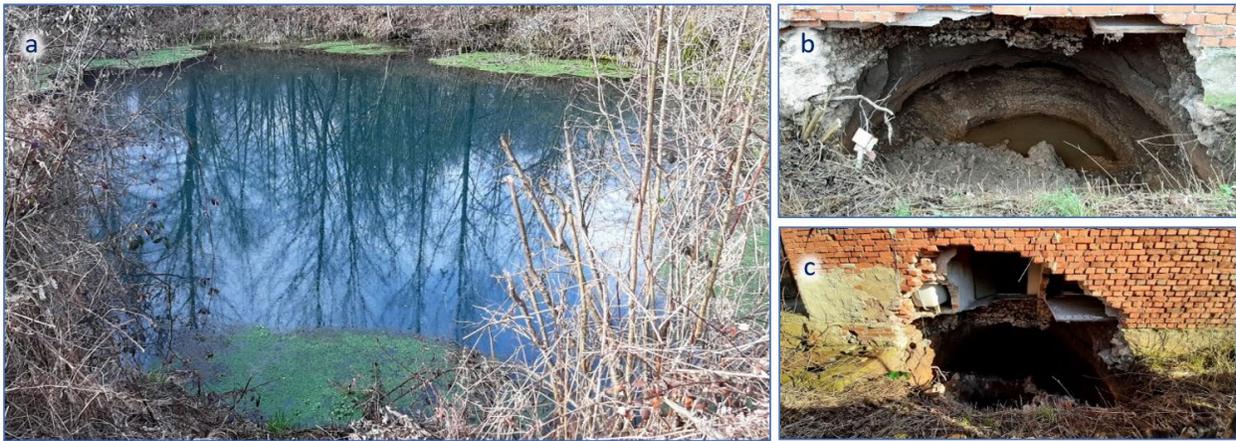
**Figure 1.9** (a) One of the previously known sinkholes with pond containing spring (45.286953N, 16.426297E). (b, c) a sinkhole which opened under an unoccupied house two days after the main earthquake (45.283, 16.4295) photographed on 4 January and 15 February 2021.

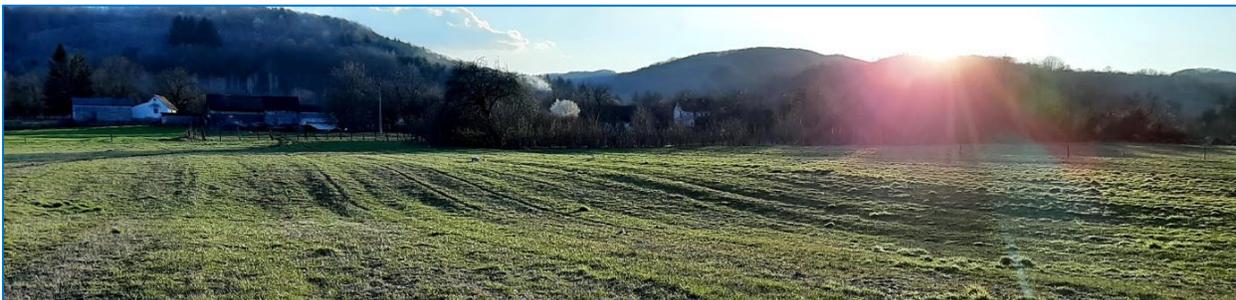
**Figure 1.10** Deformed ground surface in the previously flat field as a potential sinkhole near Borojevići (45.2963N,16.4140E) on 19 March 2021.

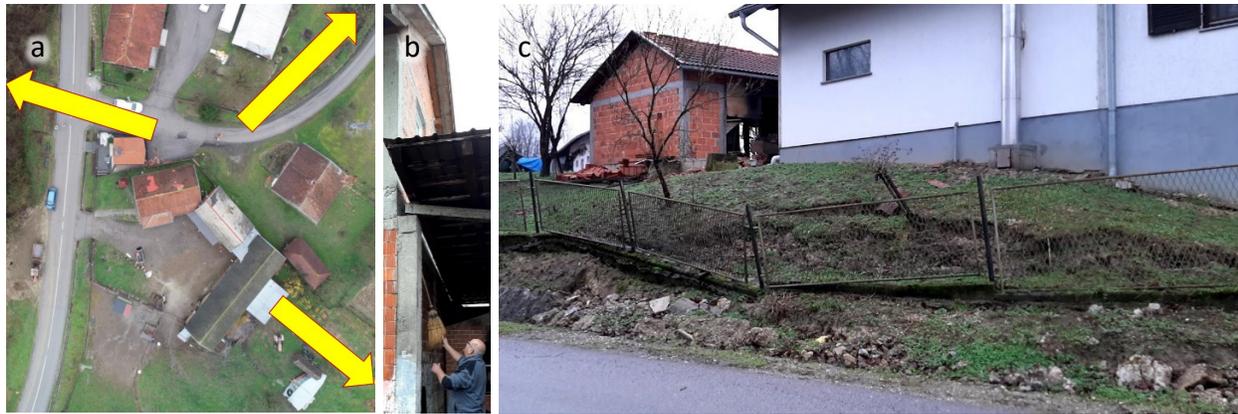
Some landslides were affected or initiated in the area. **Figure 1.11** shows sliding in Hađer, at the distance of around 8km from the epicenter. The Croatian volunteers, geotechnical engineers and geologists, detected 36 slides and 4 rockfalls Pollak et al. (2021). The data will be presented on the pages of the Croatian Geologic Survey ([www.hgi-cgs.hr](http://www.hgi-cgs.hr)).

**Figure 1.11** Sliding in Hađer on the top of a hill, (a) in three directions (45.3795N, 16.1200E; Bačić & Terzić 2021). Ground is recognized by the farmer as exceptionally soft (b) consequent gap opening (45.3793N,16.12016E). (c) An existing landslide situation worsened in the earthquake (45.3798N,16.1198E).

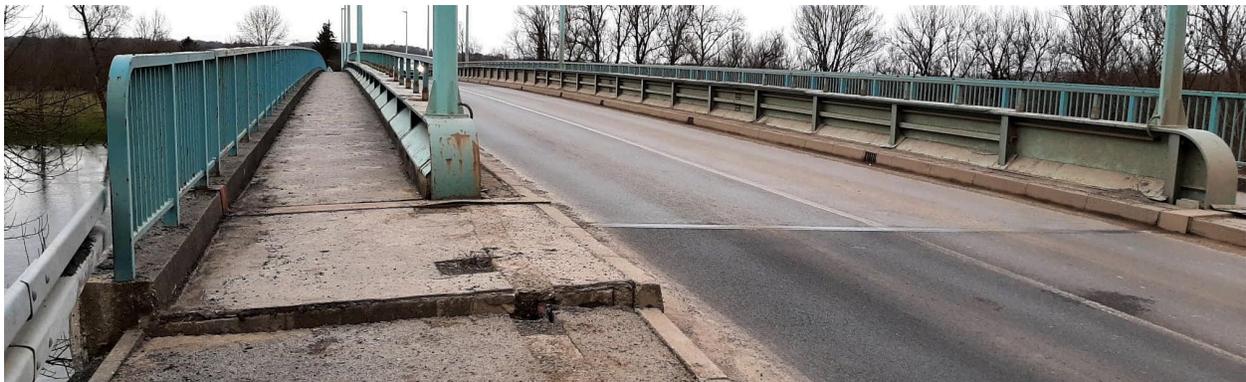
**Figure 1.12** Bridge Brest after the earthquake (45.4481N,16.2600 E).

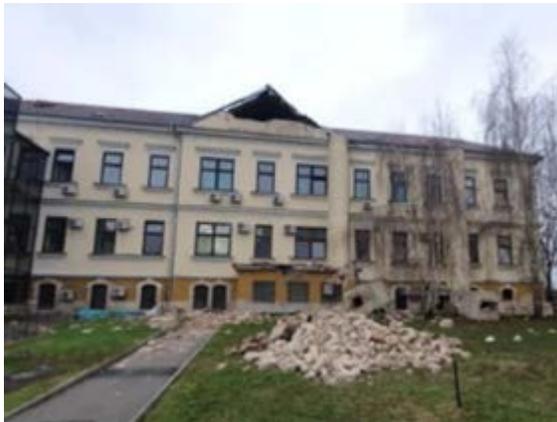
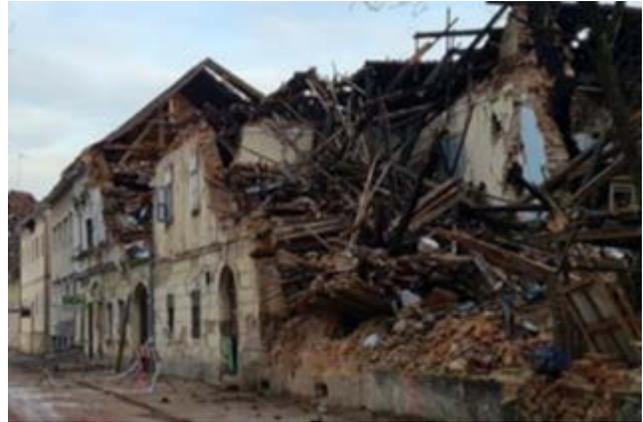
**Figure 1.13** Photos of the damaged buildings after an earthquake rocked (a) Sisak, and (b) Petrinja, Croatia (Source: Miranda et al., 2021), Coordinates of the photo (a) 45.476794, 16.368347, and (b) 45.441082, 16.277061).

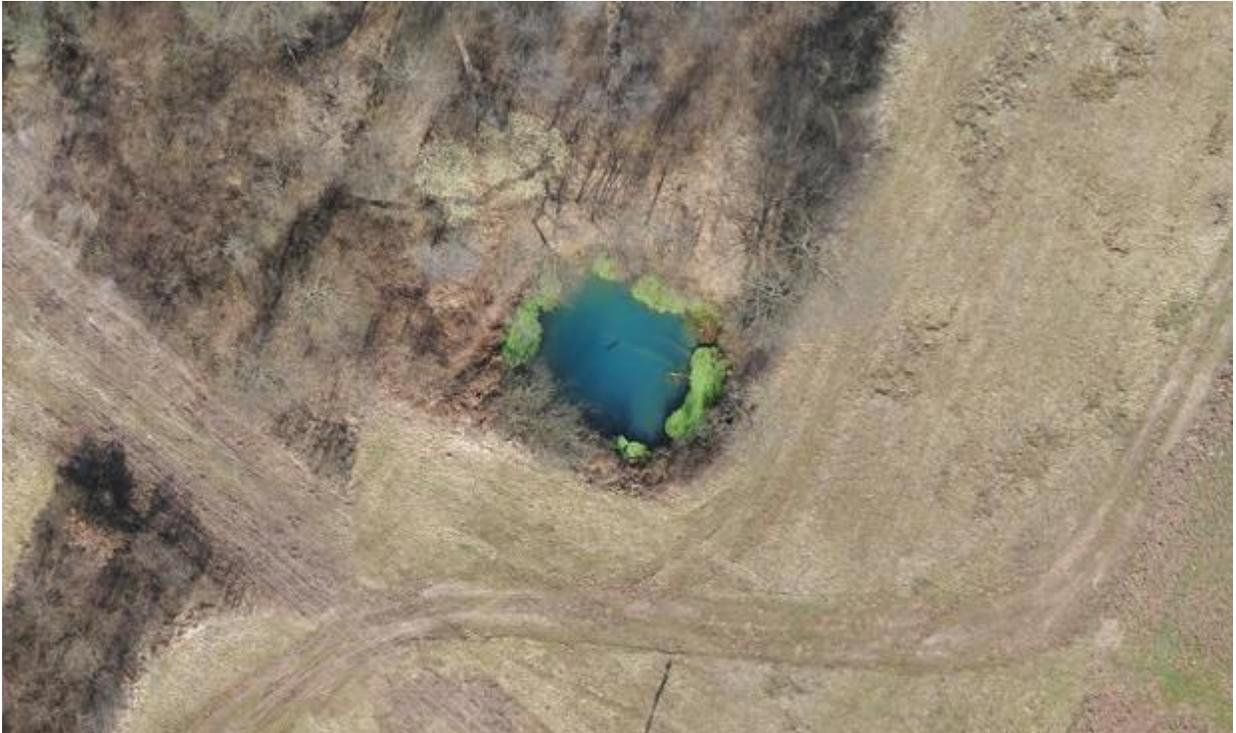
**Figure 6.4** Sinkhole S069, with the largest diameter of 16.8 m, is a fossil cover-collapse sinkhole representing a freshwater spring (45.28696N, 16.42630E).

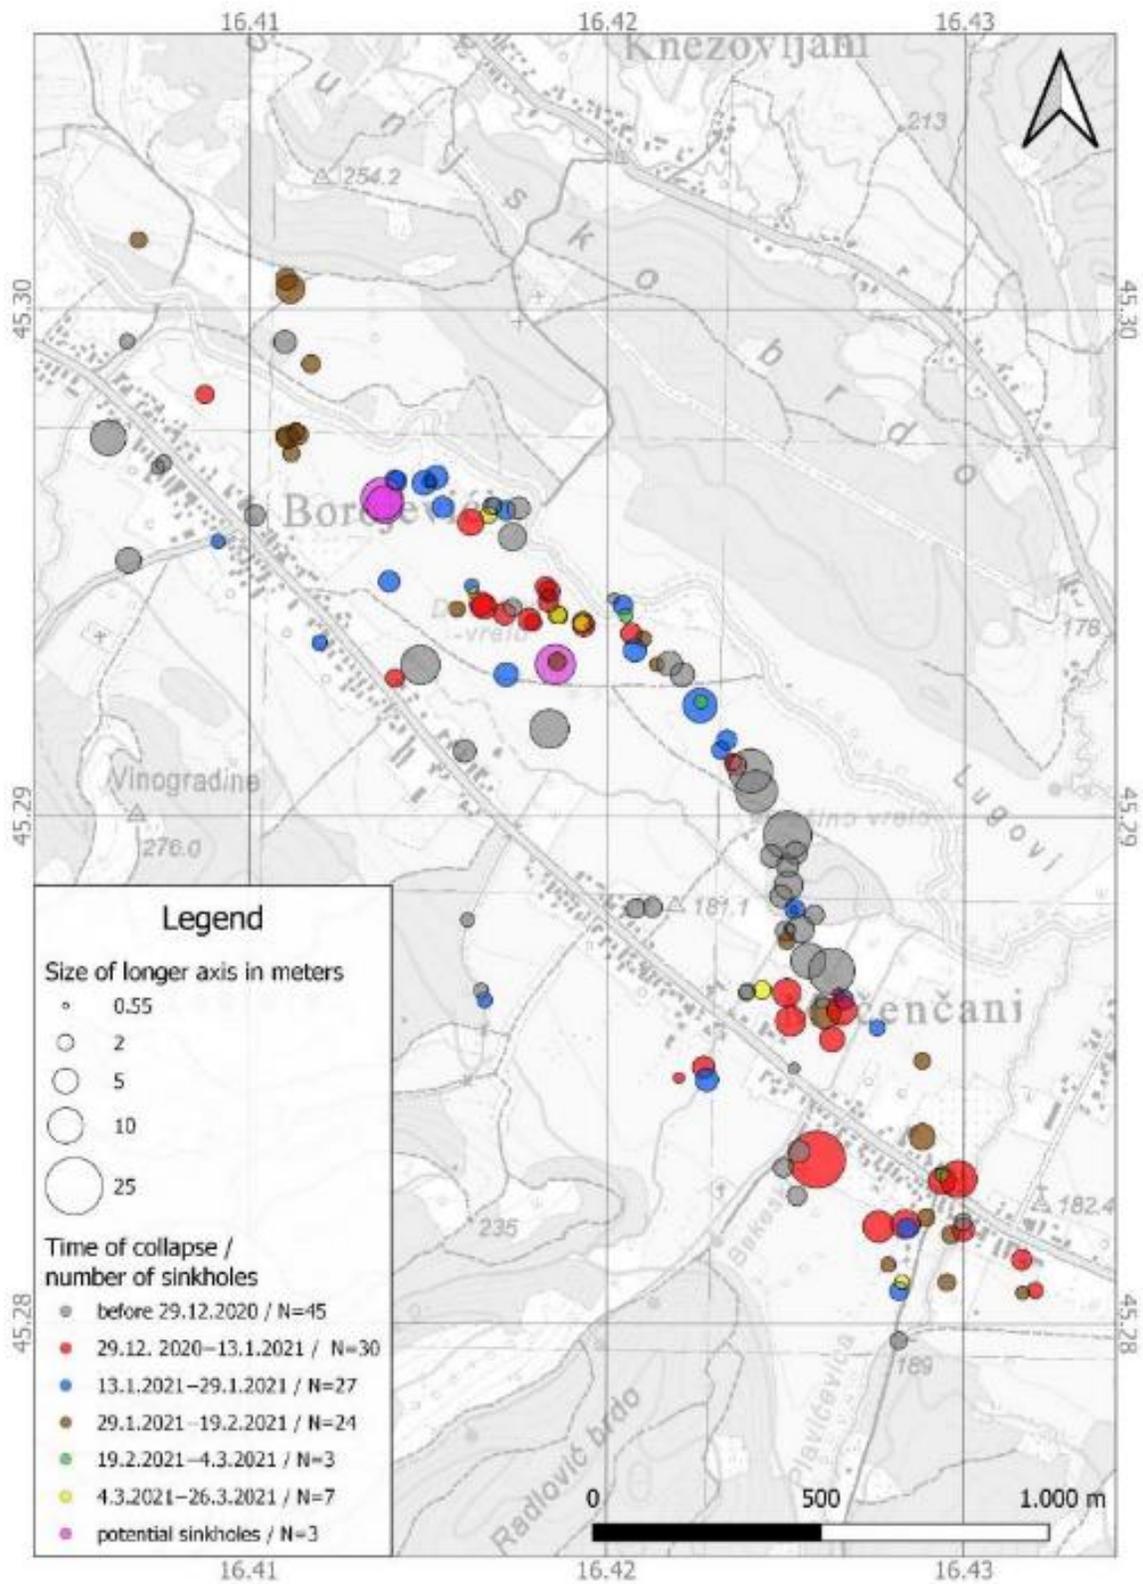
**Figure 6.5** shows spatio-temporal positions of sinkholes sorted into time windows of appearance and sizes. The GEER team could not obtain better resolution data than the time windows presented in **Figure 6.5**. Grey-colored circles represent fossil sinkholes, which are pre-existing cover-collapse sinkholes. A more significant number of fossil sinkholes characterize the area between two villages, including Pašino vrelo (vrelo meaning spring in Croatian). Pašino vrelo has been turned into a commercial well and serves as a drinking water source for Hrvatska Kostajnica. Fewer but relatively larger and deeper sinkholes and fewer of them per area collapsed in the eastern part around Mečenčani than in the north of Borojevići. The biggest sinkhole, 25x23 m in

diameter and 11.7 m deep, is in Mečenčani and the second-largest new sinkhole, 10.8x9.8 m in diameter and 3.6 m deep.

**Figure 6.5** Spatio-temporal map of sinkholes in Borojevići and Mečenčani and their longer diameter on the topographic map.

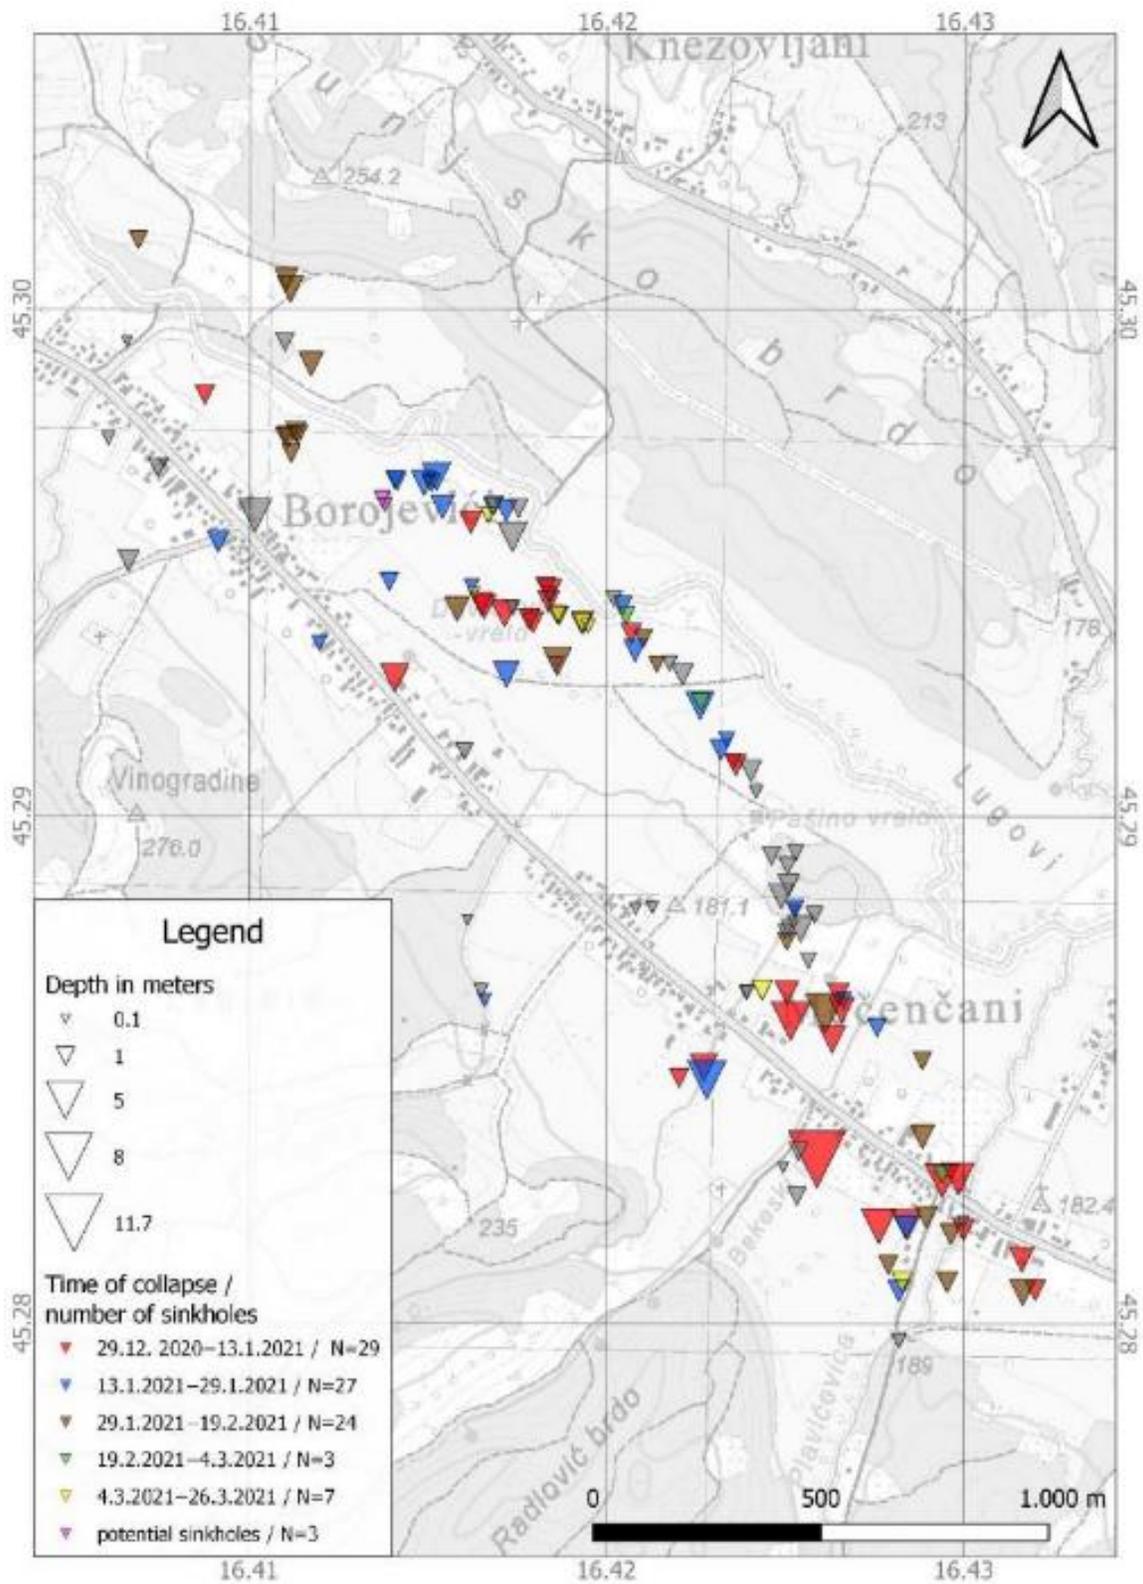
**Figure 6.6** Spatio-temporal map of sinkholes in Borojevići and Mečenčani area and their depths on the topographic map.

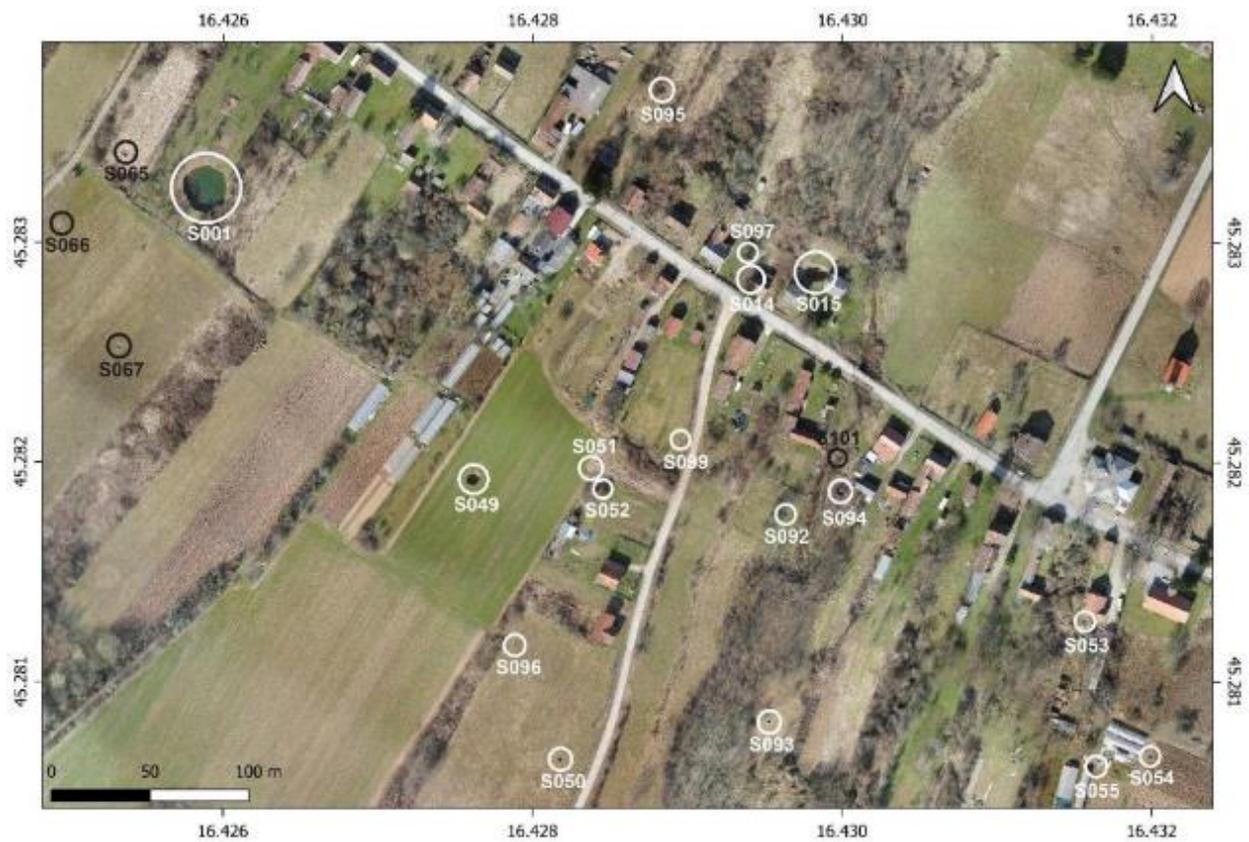
A total of 136 cover-collapse sinkholes (45 fossil and 91 newly opened), as well as three potential sinkholes were observed and documented. Lengths, widths, and depths were measured directly on-site for each sinkhole, and lidar point clouds were collected for 63 sinkholes and are curated in NHERI NSF DesignSafe Data Depot. The majority of sinkholes appeared dry during the reconnaissance, while some also had standing water. Depths of sinkholes and time of appearance are shown in **Figure 6.6**. Areal images of drone flights acquired by the Croatian Geological Survey show parts of the area in **Figures 6.7 to 6.11**. The GEER team identified the fossil in black circles and new, in white circles, cover-collapse sinkholes. The largest sinkhole is shown in **Figure 6.7** as S001, Pašino vrelo pumping station is in Figure 6.6 between S113 and S118.

**Figure 6.7** Areal image of cover-collapse sinkholes in Mečenčani village (white – new sinkholes opened after M6.4 earthquake, black – fossil sinkholes opened before the Petrinja earthquake sequence). Image by Croatian Geological Survey.

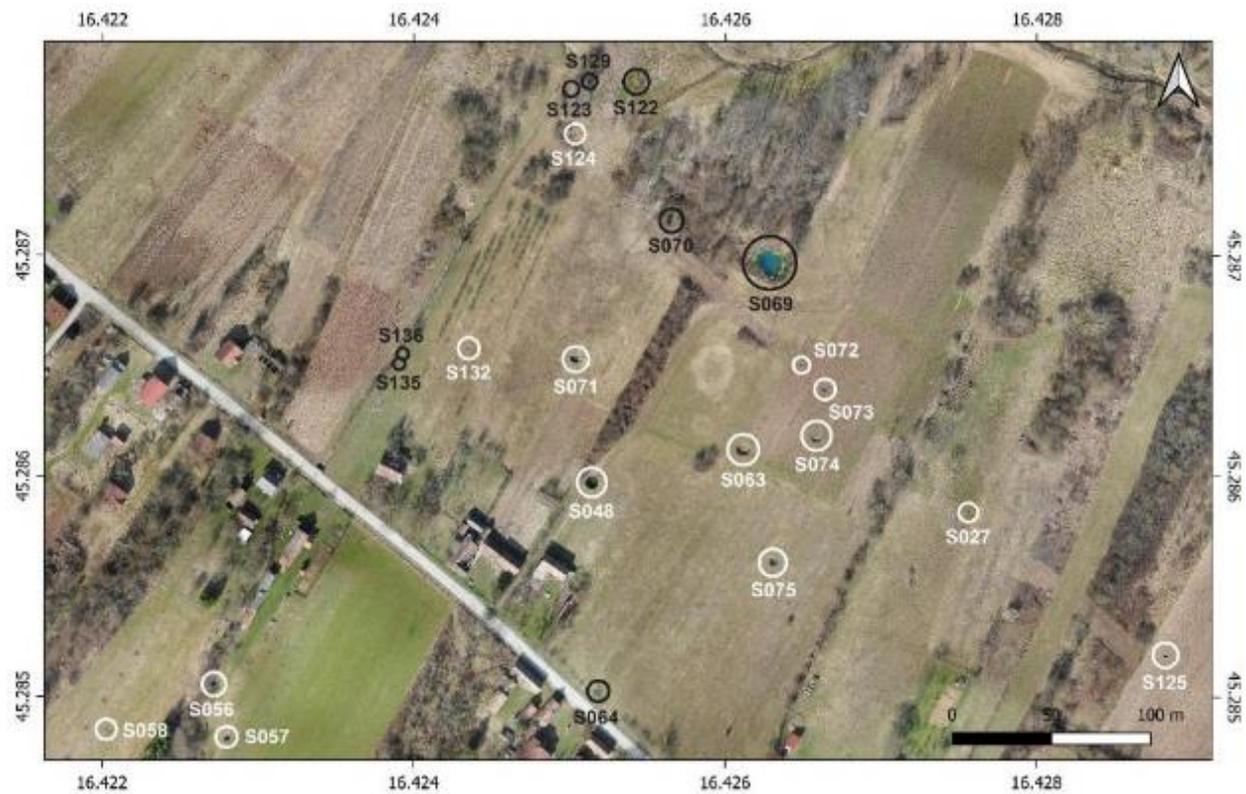
**Figure 6.8** Areal image of sinkholes north of Mečenčani village (white – new sinkholes opened after M6.4 earthquake, black – fossil sinkholes opened before the Petrinja earthquake sequence). Image by Croatian Geological Survey.

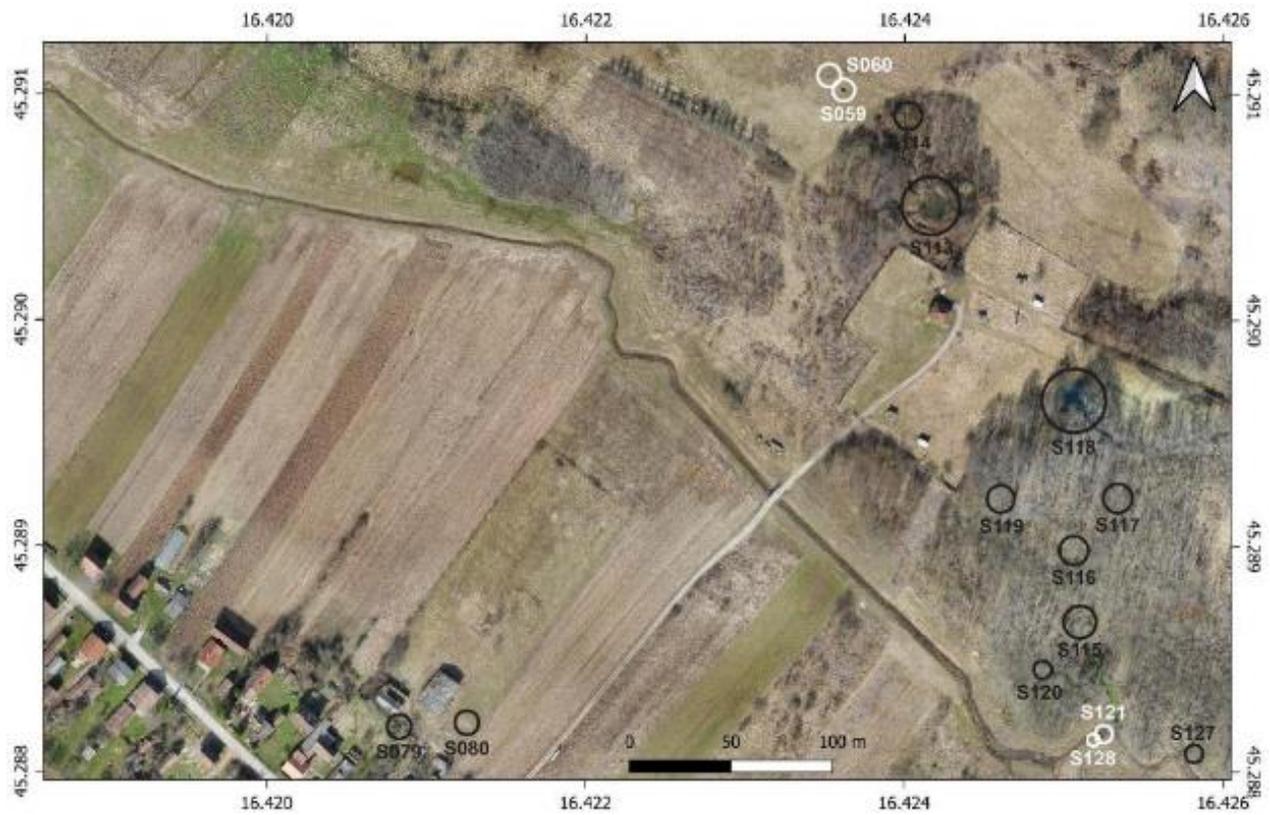
**Figure 6.9** Areal image of sinkholes between Borojevići and Mečenčani villages (white – new sinkholes opened after M6.4 earthquake, black – fossil sinkholes opened before the Petrinja earthquake sequence). Image by Croatian Geological Survey.

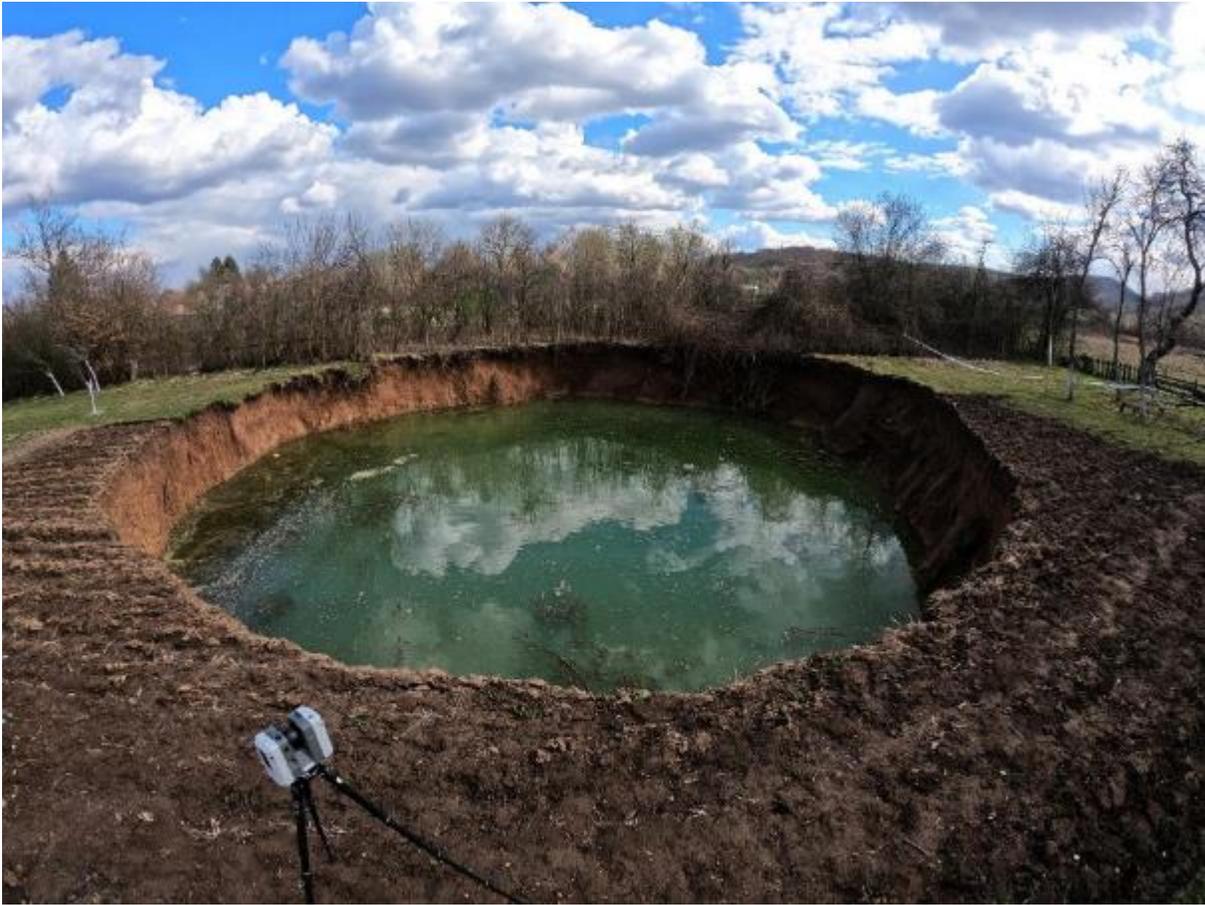
The largest sinkhole, S001 (**Figure 6.17**) collapsed in Mečenčani between the January 4, 2021 afternoon and 13:00 h of January 5, more than 30 hours before the main aftershock, which took place at 18:01 on January 6 (M 4.9). The first subtle subsidence of the area was noticed by land-owners on January 4 afternoon. Two major foreshocks on December 28 (M 5.2 and M 4.7) and the main earthquake of December 29, 2020 (M 6.4) preceded a week before the S001 collapse. The surface soil collapsed at once into S001, forming a sinkhole about 15 m in diameter, followed by minor adjustments and collapses of walls, which remained sub-vertical. **Figure 6.18** shows snapshots from the video recorded on January 6, where the walls are collapsing with an unstable, brittle clay block of approximately 2–3 m, and S001 is widening (Vidić, 2021. Available at: <https://www.youtube.com/watch?v=br-ocSaXIDgwww>).

**Figure 6.17** A giant sinkhole (S001) in the Mečenčani. The photograph was taken on March 15, 2021, during lidar imaging (45.283243N, 16.425887E).

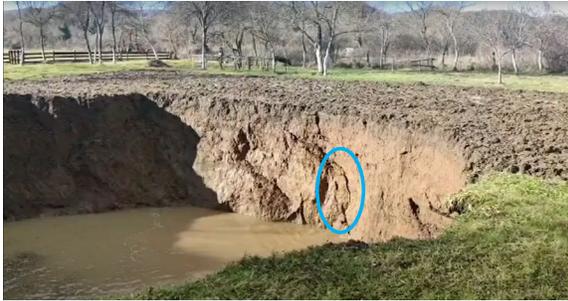
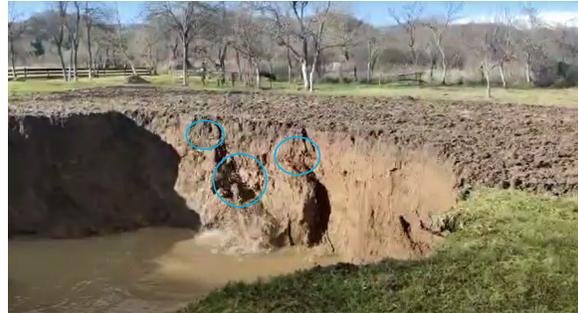
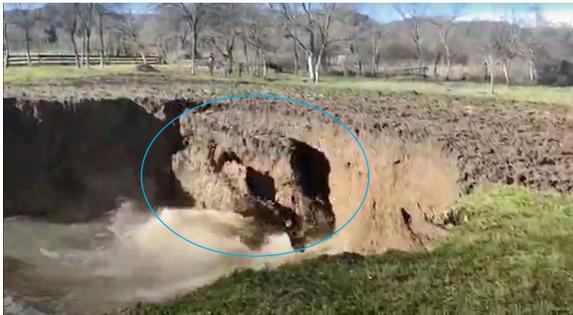
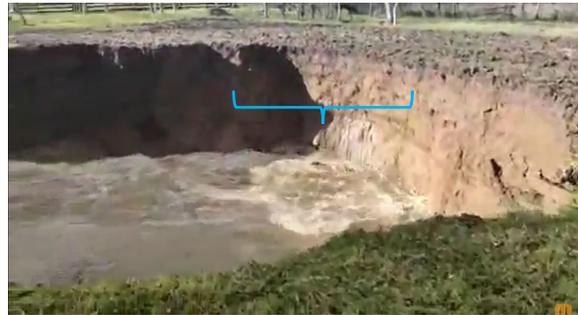
a) The collapse of the edge of a larger unstable clay block.

b) Upper portions of the block are falling.

c) Large block collapse.

d) Material sinks under the water

**Figure 6.18.** S001 brittle wall collapse sequence on January 6, 2021 (45.2833444N, 16.4259639E) (Vidić, 2021. Available atČ <https://www.youtube.com/watch?v=br-ocSaXIDgwww>).

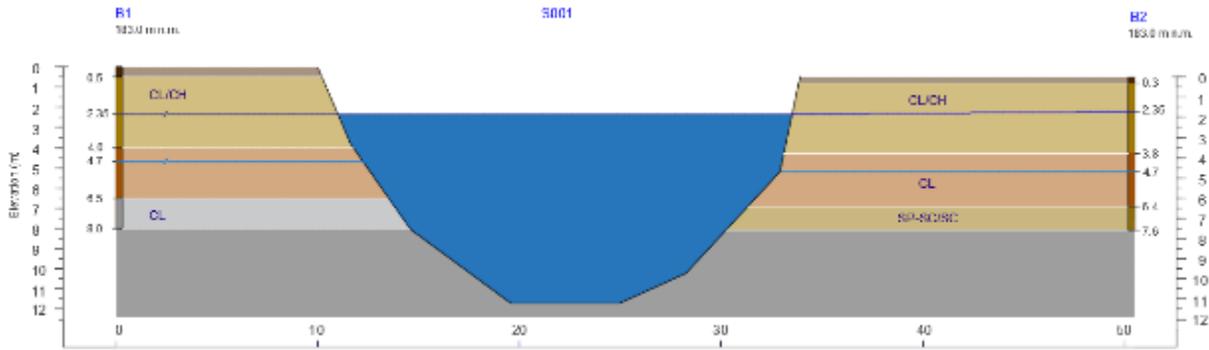
Insight into two geotechnical boreholes reveals that soil consists of 0.5 of fill, 3.5 of sandy lean, and fat clay that is firm to stiff, containing sparse traces of limestone particles up to 20 mm in diameter, with sharp edges (**Figure 6.25**). Limestone particles are distinct and white. Below is stiff to very stiff clay, interlayered by very moist clay with gravel. Boreholes were drilled without heavy machinery and stopped where the equipment could not penetrate stiffer layers at approximately 8,0 m depth. Lower layers are in B-1 gray lean marly clay, with low plasticity and high stiffness. Bedrock or cobbles appeared below 8 m, where also the Standard Penetration Test equipment bounced off without penetration.

Figure 6.25 Soil profile around S001, dimensions are given in mm (45.2833444N, 16.4259639E).

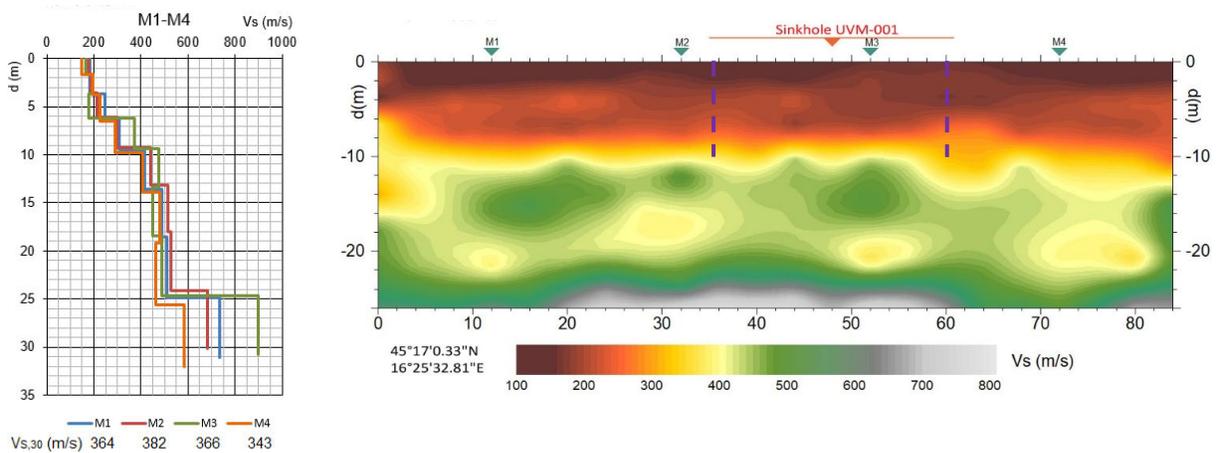
Multichannel Analysis of Surface Waves (MASW) has been performed just along the edge of S001. **Figure 6.26** shows a two-dimensional interpretation of the MASW profile near S001, where lower shear wave velocities of 180–220 m/s occur until 5–6 m depth, under which are slightly higher velocities 300–400 m/s between 6 and 10 m. Relatively uniform strata down to 25 m are shown in green and yellow colors, which has heterogeneous 400–500 m/s velocities. It can be concluded that the compact rock layer appears below 25 m, which is geologically characterized as karst. Comparing to MASW profiles, indeed, shear wave velocities increase at that depth. Detailed presentation of investigation works is in Chapter 10.

Figure 6.26 MASW profile with a sketch of S001 to the depth of 11.2 m (45.2833444N, 16.4259639E).

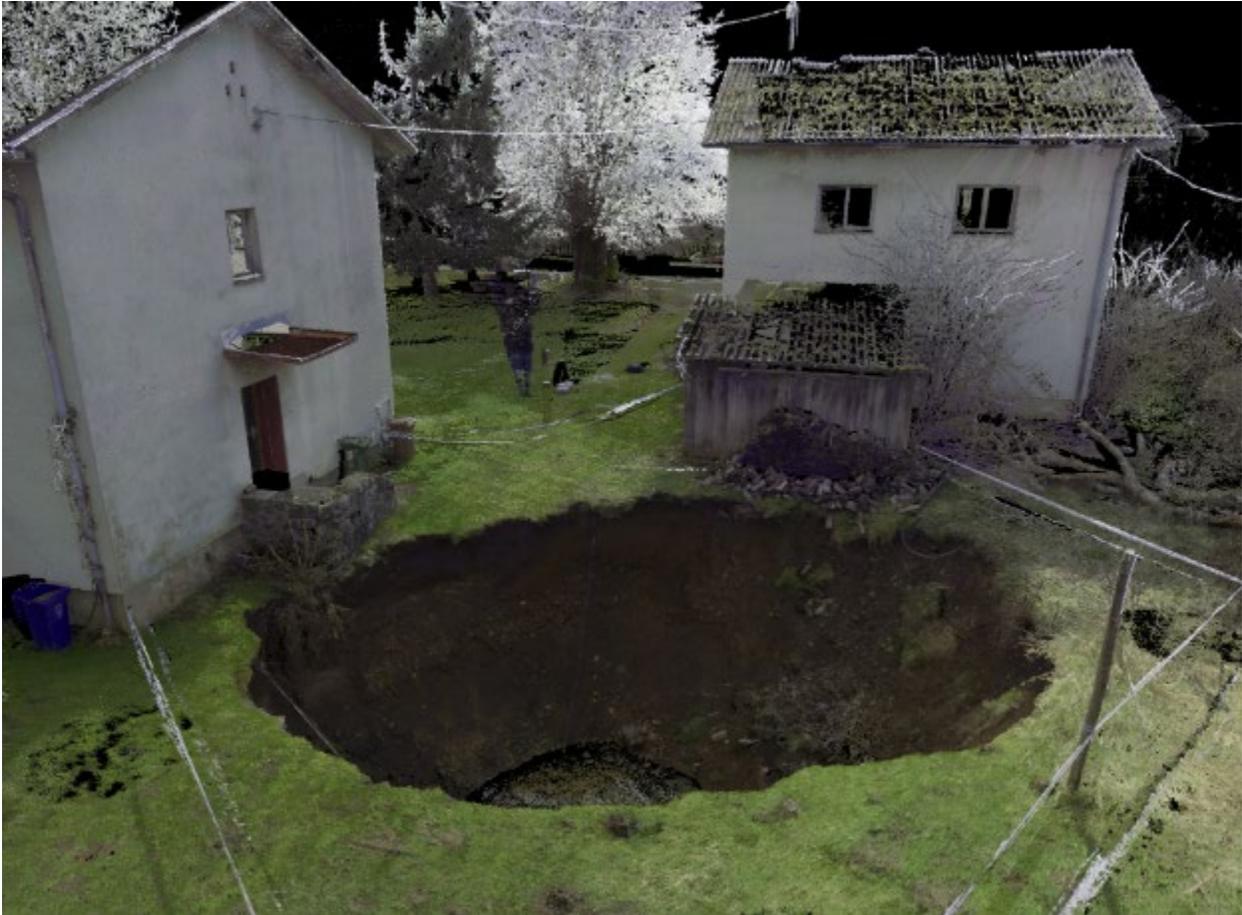
S015 collapsed on December 29, 2020, with the first subsidence noticed six hours after the main shock, followed by the opening of two cover-collapse structures (each about 1.5 m in diameter

and cca. 1 m deep) within the next three hours and further collapse and formation of united sinkhole until the morning of December 30. **Figure 6.27** shows a lidar bundle scan near a house, where **Figures 6.28** and **6.29** show measurements from point cloud data.

**Figure 6.27** The lidar scan of S015 (45.282859N, 16.429841E).

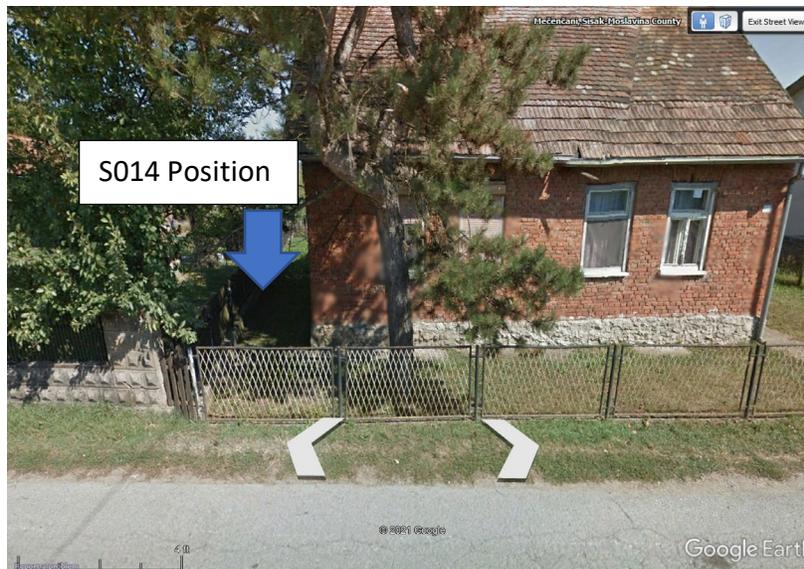
Sinkhole S014 collapsed on December 31, 2020, near a brick wall family house, as shown in **Figures 6.30** and **6.31**, and is full of water. S014 caused floor slab and house walls failure, whose materials then fell into the sinkhole.

**Figure 6.30** Street view of the house and S014 position (45.282822N, 16.429389E).

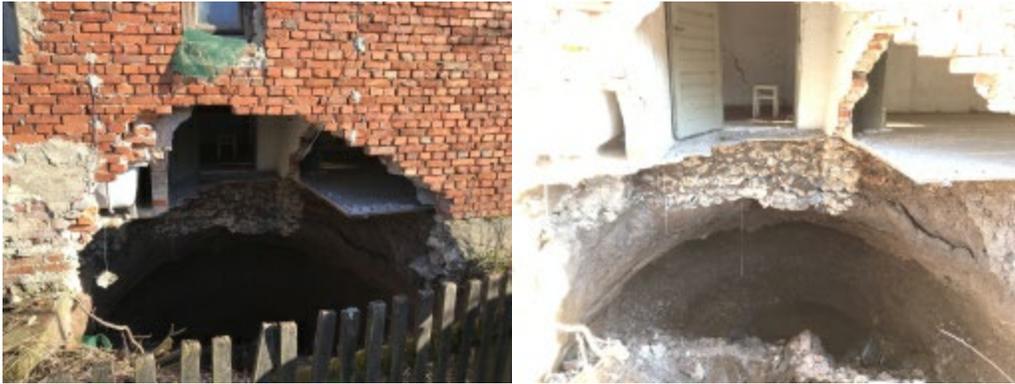
**Figure 6.31** S014 images (45.282822N, 16.429389E).

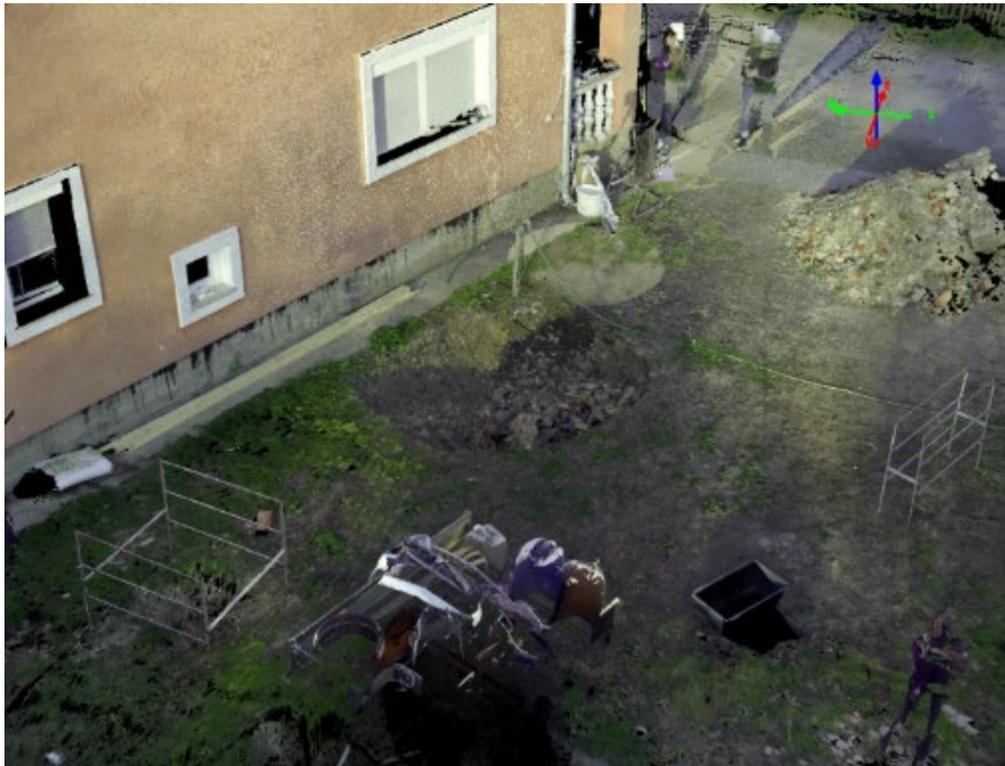
Sinkholes S053, S054, and S055 have a relatively small diameter, as shown in **Figures 6.32 to 6.38**. Three sinkholes collapsed within an agricultural family compound in Mečenčani. S053 was just next to the family house wall, as shown in **Figure 6.32**. S054 and S055 collapsed near greenhouses.

**Figure 6.32** S053 bundle image (45.281270N, 16.431618E).

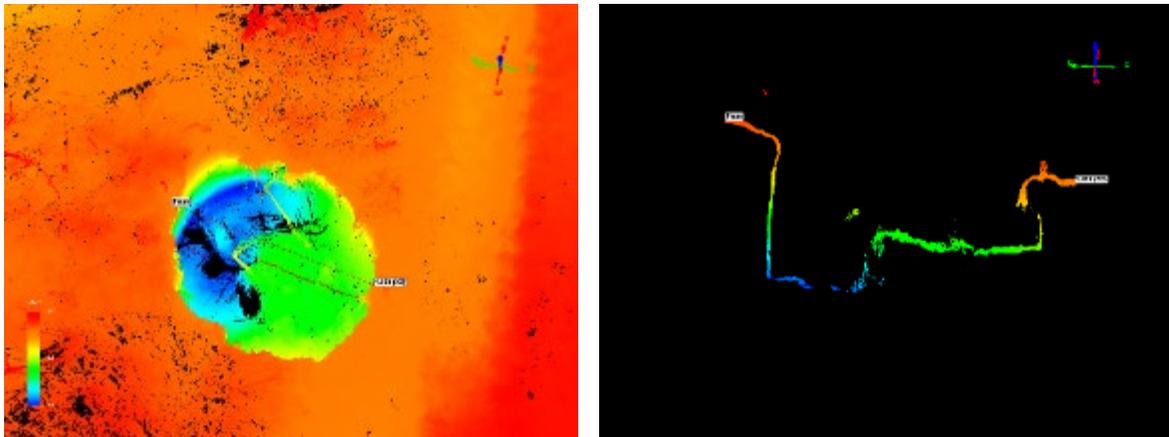
Figure 6.36 S054 plan view and cross section (45.280665N, 16.431996E).
