# Geotechnical Reconnaissance and Engineering Effects of the December 29, 2020, M6.4 Petrinja, Croatia Earthquake, and Associated Seismic Sequence

A report to the NSF-Sponsored Geotechnical Extreme Event Reconnaissance (GEER) Association<sub>1</sub>

Report GEER-072: <https://doi.org/10.18118/G63T0S>  
August 3<sup>rd</sup>, 2021

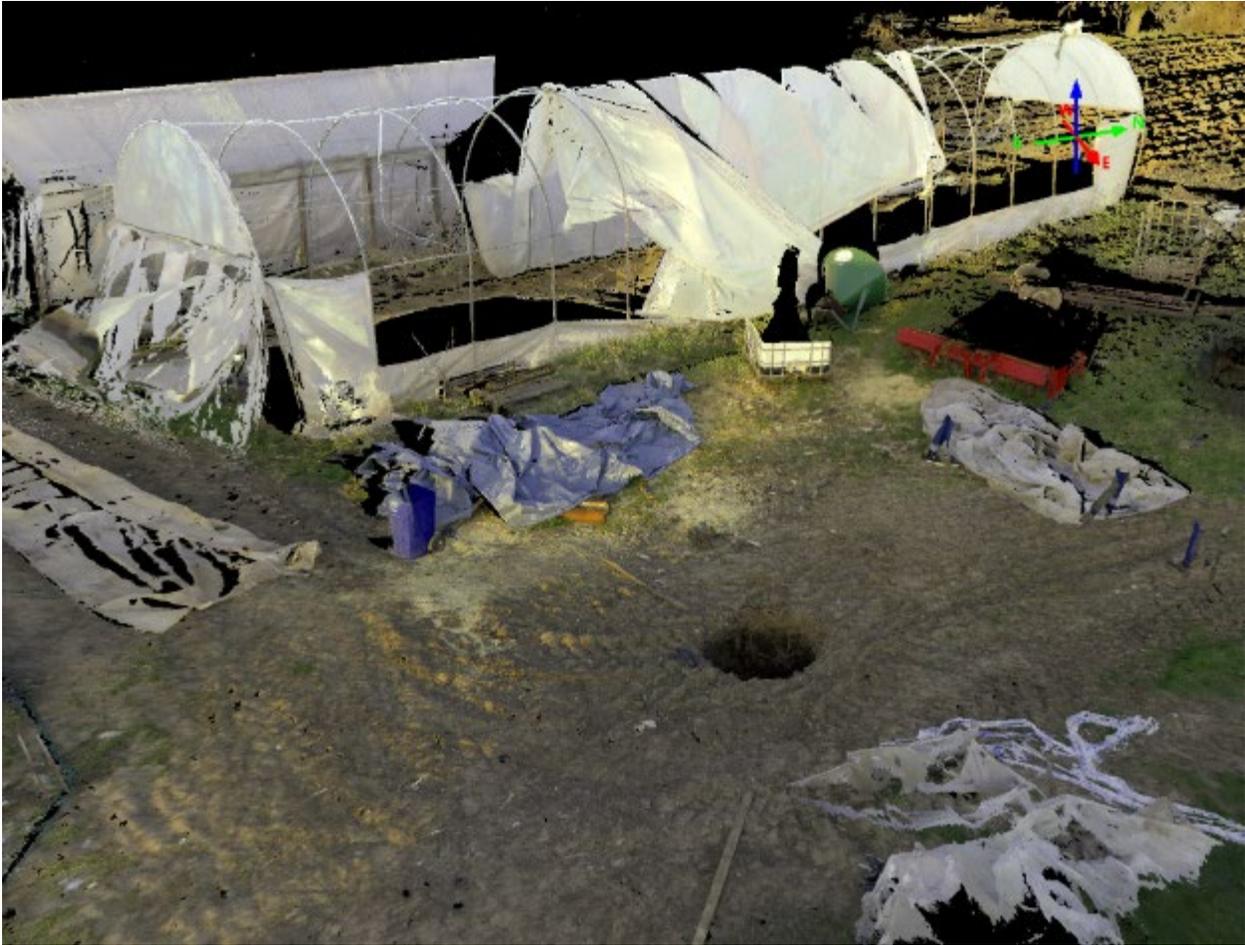
Figure 6.37 S055 lidar scan bundle view (45.280618N, 16.431644E).

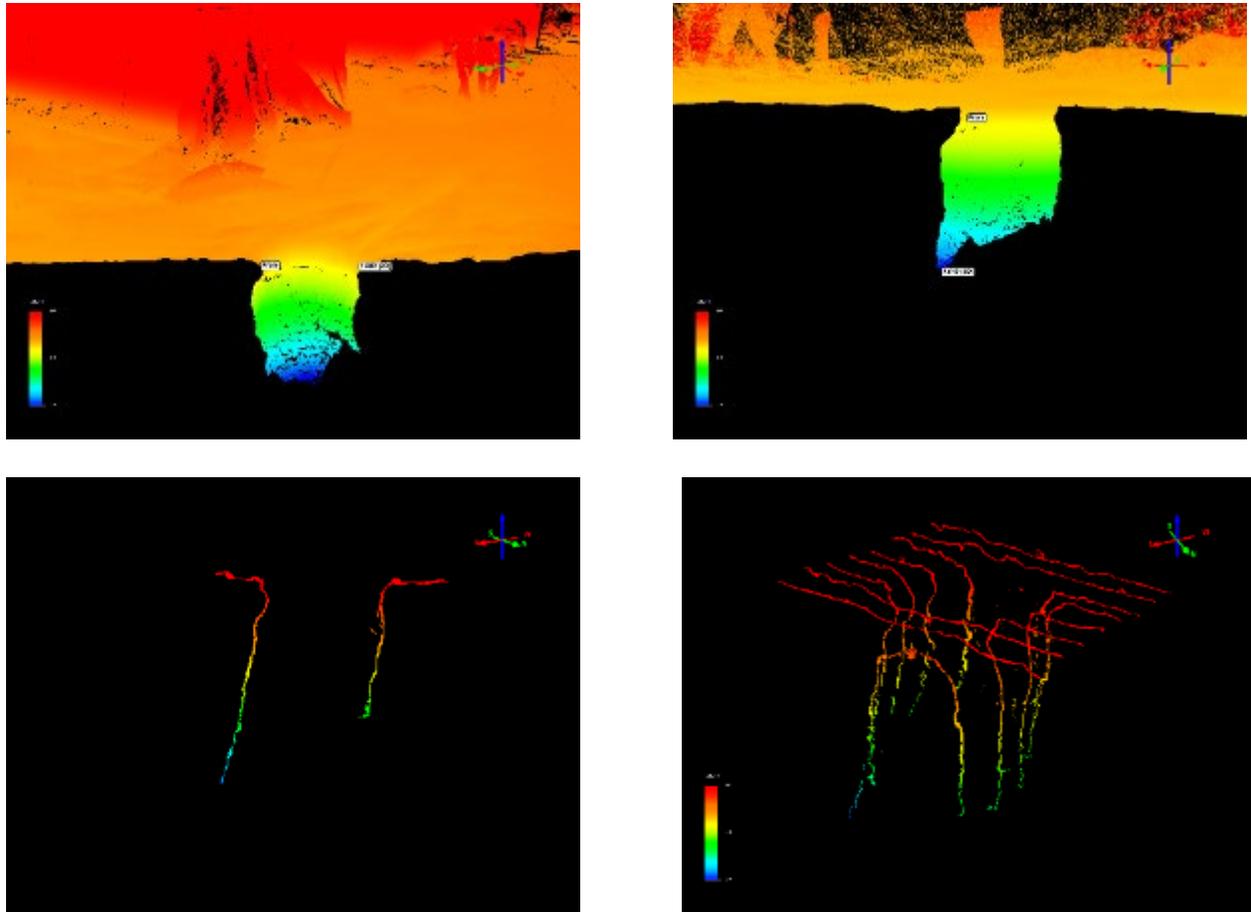
**Figure 6.38** S055 cross sections (45.280618N, 16.431644E).

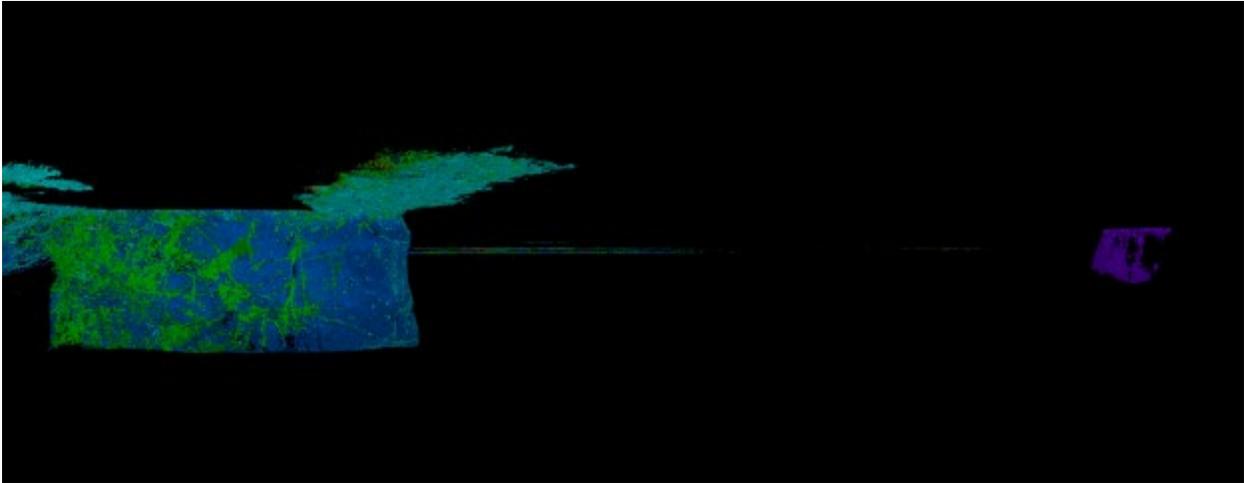
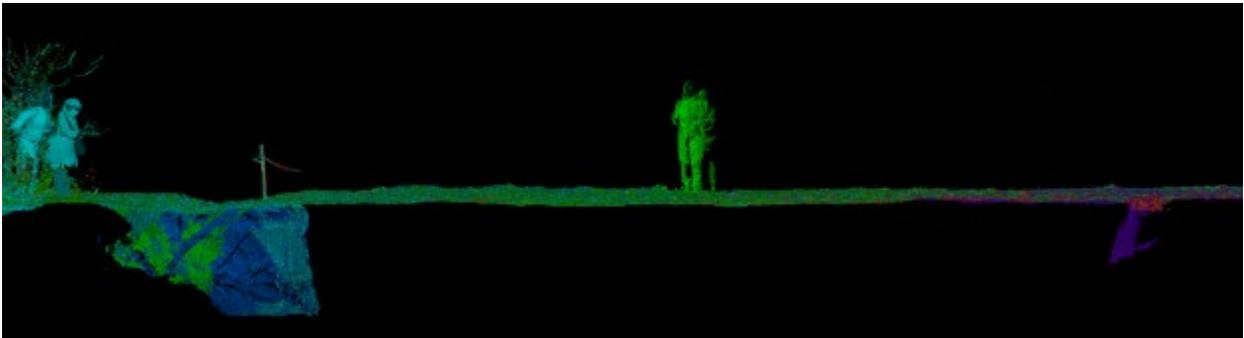
Numerous sinkholes collapsed in Borojevići, where many are near and along the Sunja river. Sinkholes in this particular area are generally shallower and have a smaller diameter. **Figures 6.39** to **6.45** show a few typical examples of lidar scans and measurements. It was possible to bundle scans of two or three sinkholes into one in several locations, which provided a good idea about the qualitative spatial variability of sinkhole characteristics. Sinkholes were either similar or very different next to each other. In some locations, new sinkholes opened near fossil sinkholes. Such variability depicts the heterogeneity and unpredictability of underlying karstic formations in these locations.

**Figure 6.39** Cross-sections of the lidar bundle with two adjacent sinkholes, S007 (45.296599N, 16.415005E) and S008 (45.296589N, 16.415085E).

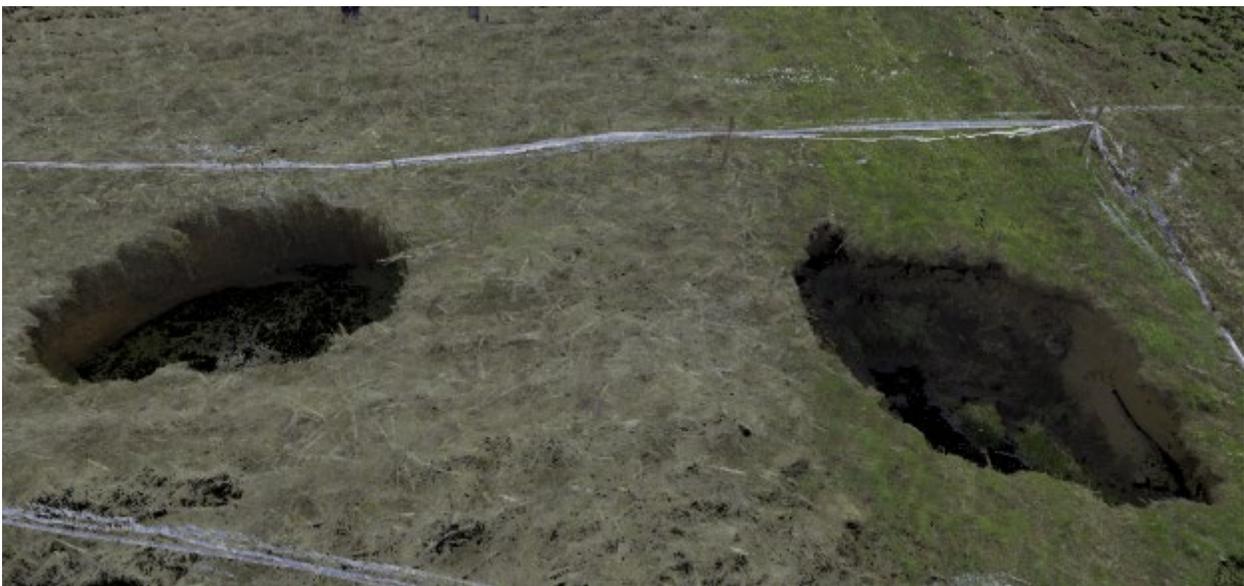
**Figure 6.40** Cross-section of the lidar bundle with two adjacent sinkholes, S023 (45.294192N, 16.416487E) and S024 (45.294139N, 16.416563E).

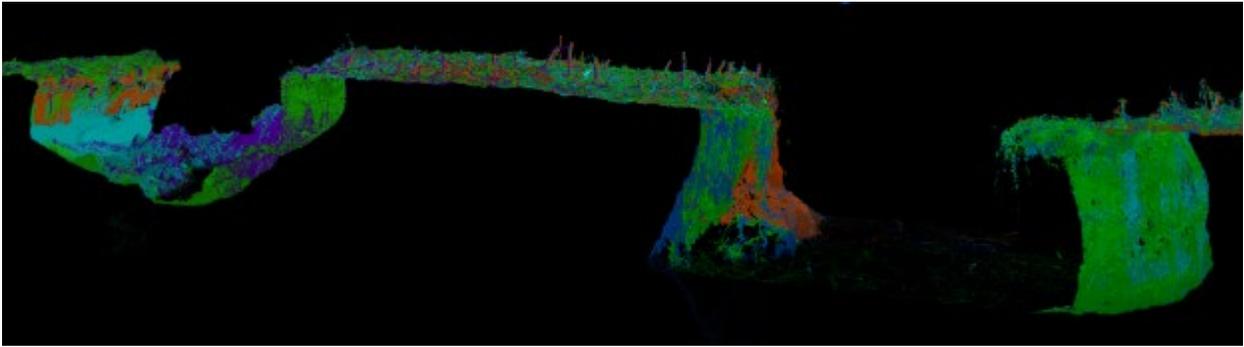
**Figure 6.41** Cross-section of the lidar bundle with two adjacent sinkholes, S023 (45.294192N, 16.416487E) and S024 (45.294139N, 16.416563E).

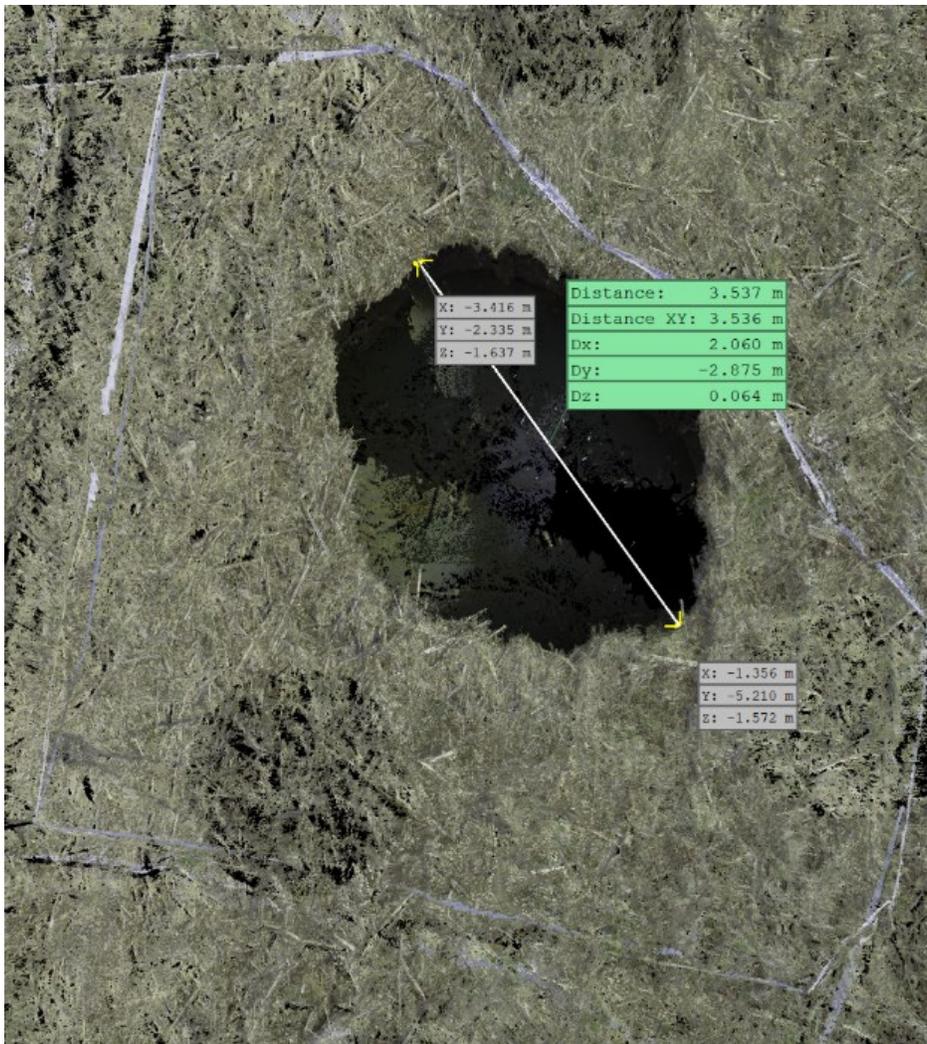
**Figure 6.42** The lidar scan of the sinkhole S025 (45.293997N, 16.417133E).

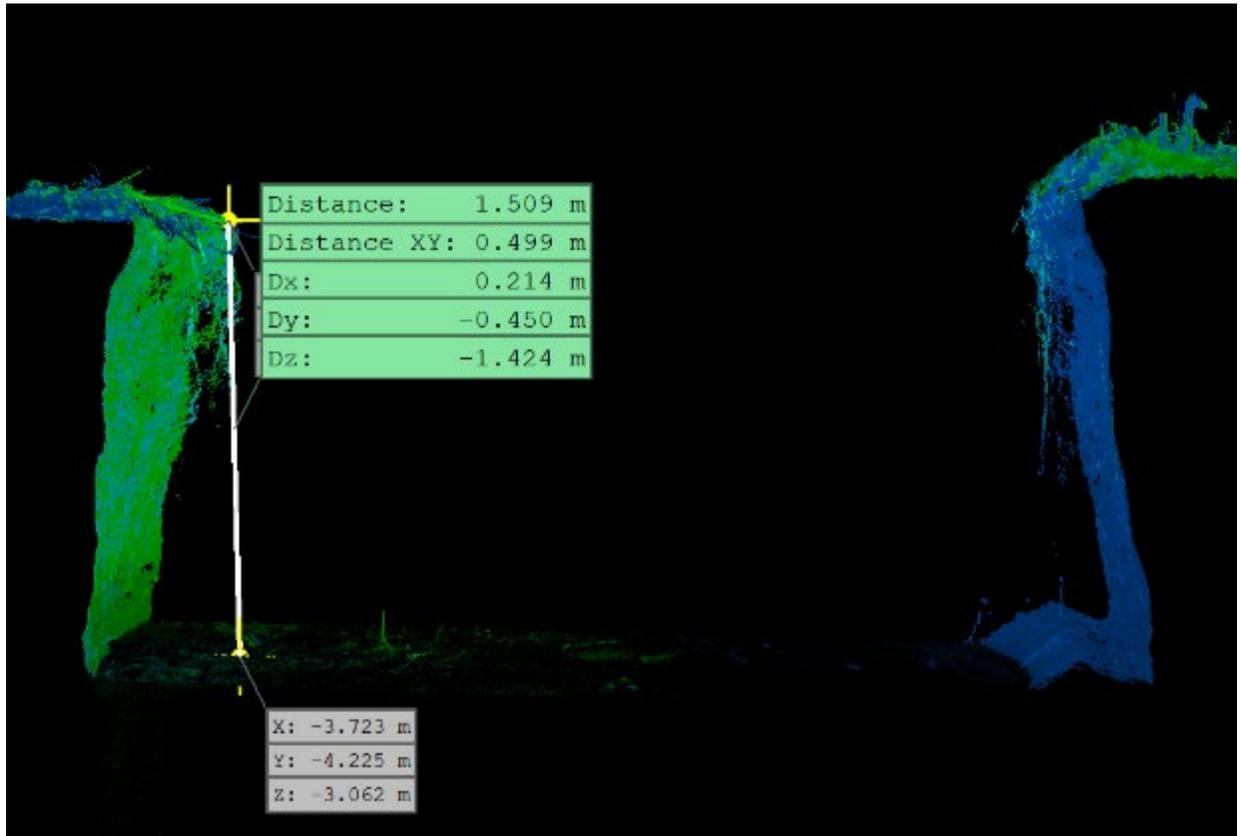
**Figure 6.43** The lidar scan with the cross-section of the sinkhole S025 (45.293997N, 16.417133E).

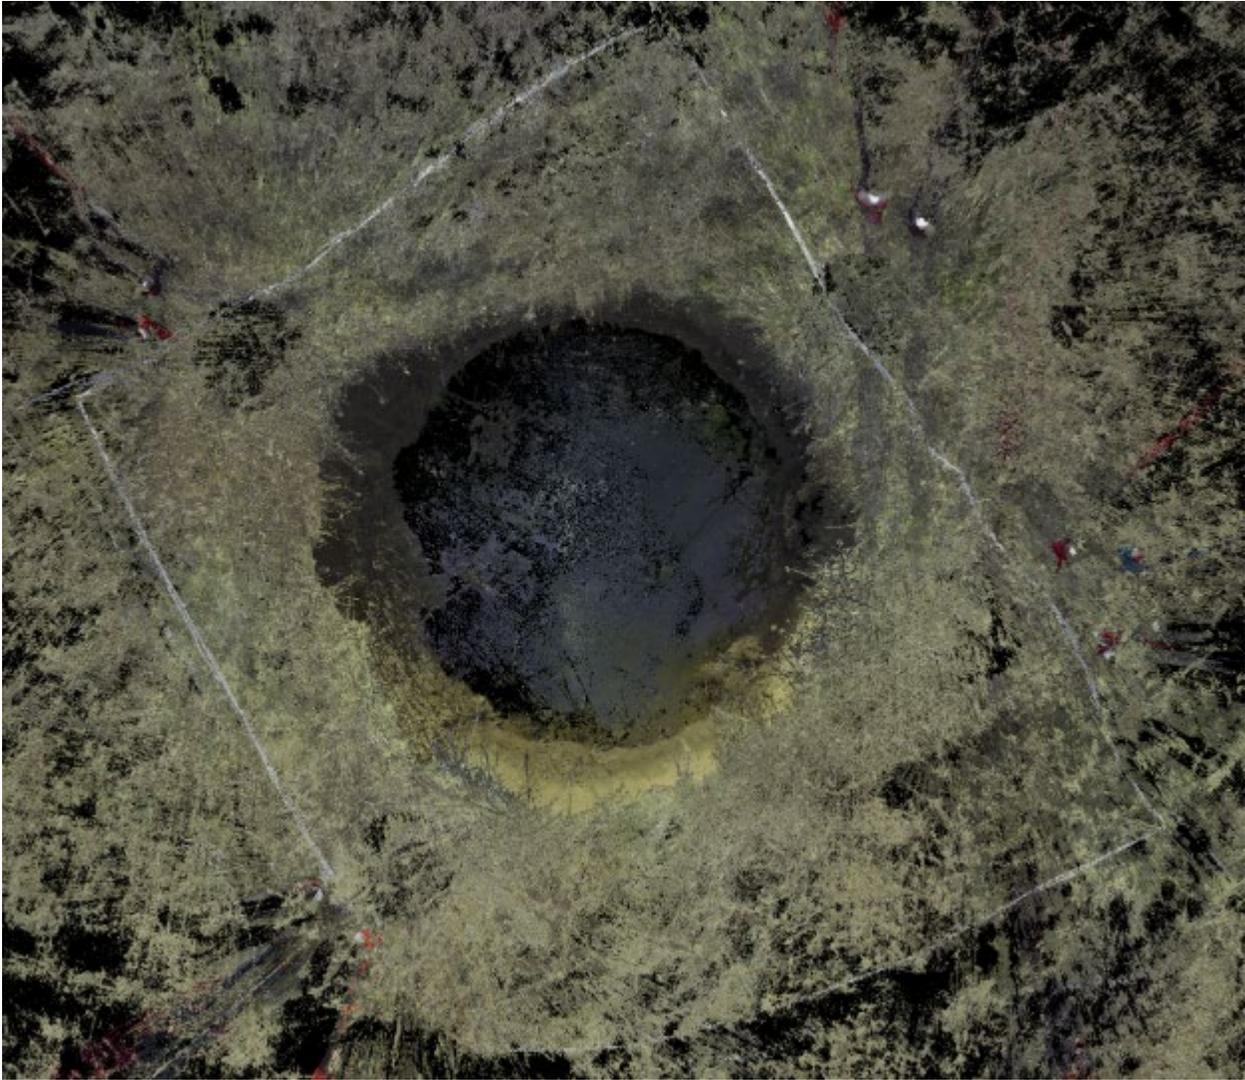
**Figure 6.44** The lidar plan view of the sinkhole S043 (45.292195N, 16.422607E).

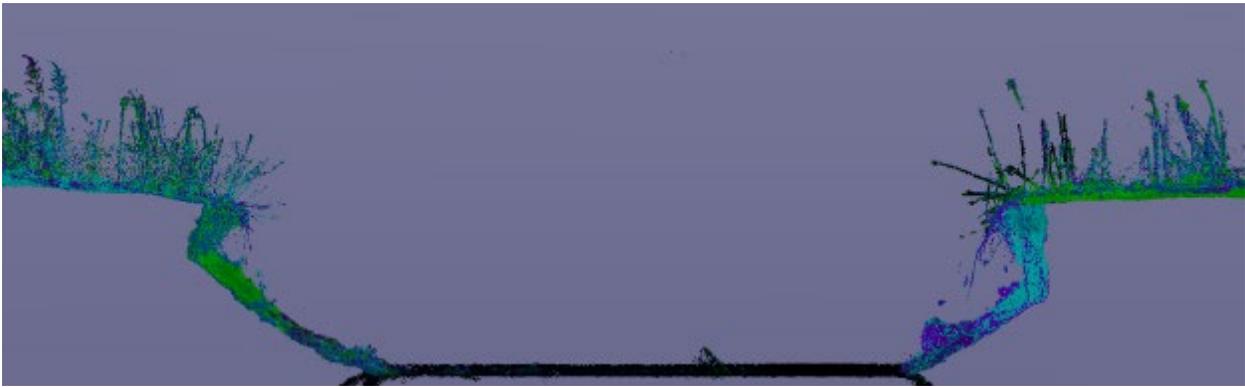
**Figure 6.45** The lidar scan with the cross-section of the sinkhole S043 (45.292195N, 16.422607E).

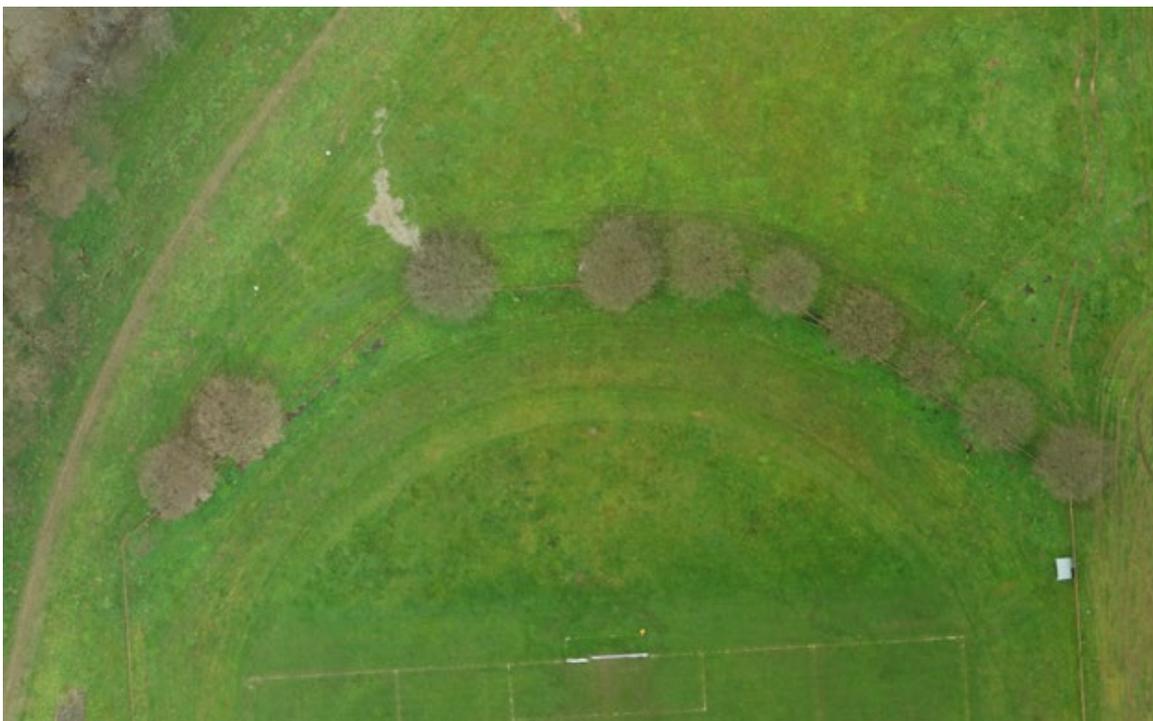
**Figure 7.10** Linear pattern of sand boils at a field north of Glina (45.343889N, 16.084722E).

One common observation in both the aerial and field images was the linear pattern of sand boils emerging from surface cracks (e.g., **Figures 7.10 - 7.13**). For the locations shown in **Figures 7.10-7.13**, no ejecta were observed without cracks. Ejecta were also commonly observed within water wells in residential areas that penetrate through the overlying non-liquefiable soil layers to the sandy liquefiable soils below. **Figure 7.14** shows a nearby water well that was partially filled with sand following the earthquake, as well as the road settlement in Drenačka Street, Petrinja, without the presence of ejecta. This non-liquefiable crust found in this region may partially explain the lack of significant damage associated with liquefaction.

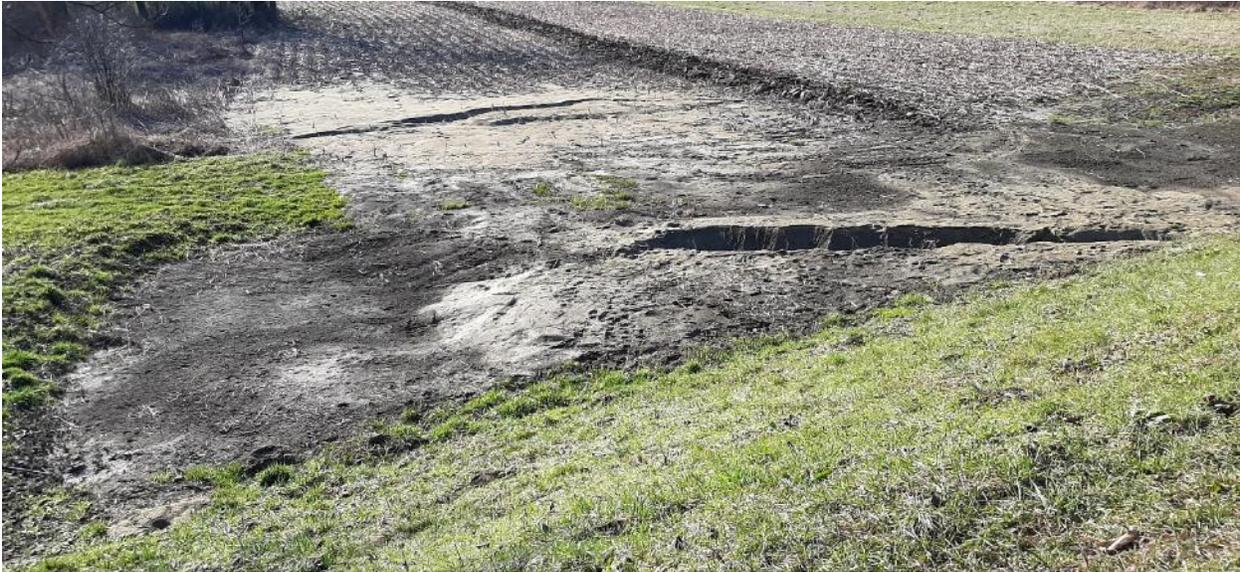
**Figure 7.11** Ejecta in an agricultural field near Hrastelnica (45.5009N, 16.4166E).

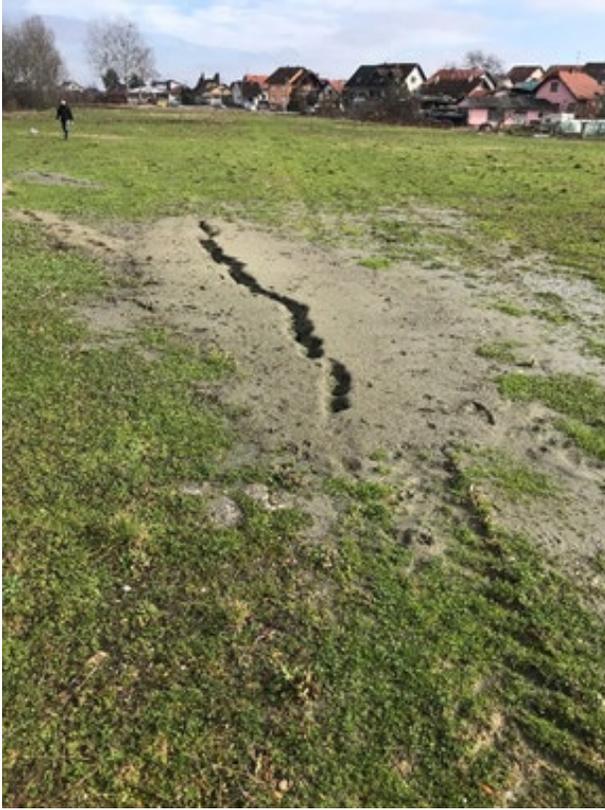
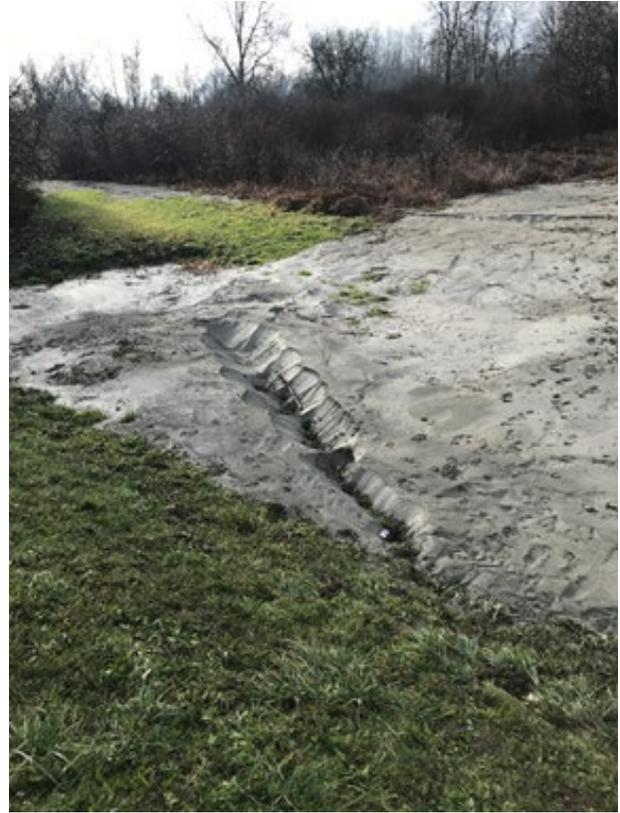
**Figure 7.13** Linear patterns of ejecta located along cracks in Petrinja (left; 45.444714N, 16.274728E) and Hrastelnica (45.500594N, 16.416287E).

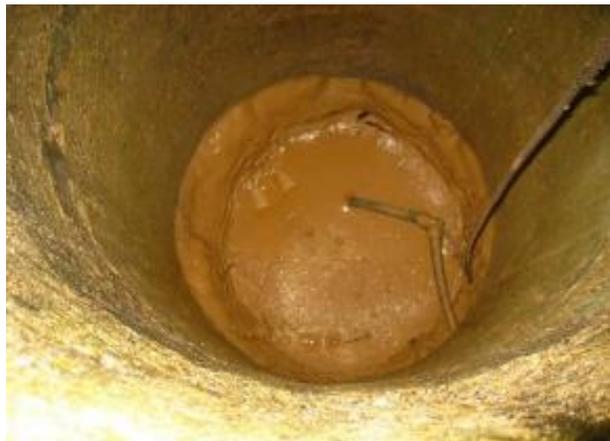
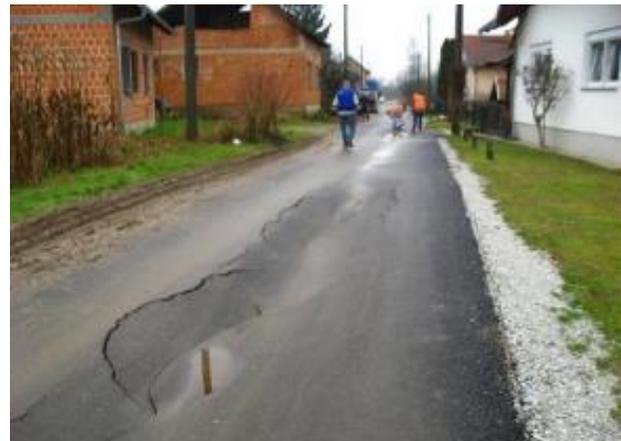
**Figure 7.14** Liquefaction under the Drenačka Street in Petrinja (45.4560936N,16.3173009E) and sand in the well nearby (45.4562236N, 16.3164433E).

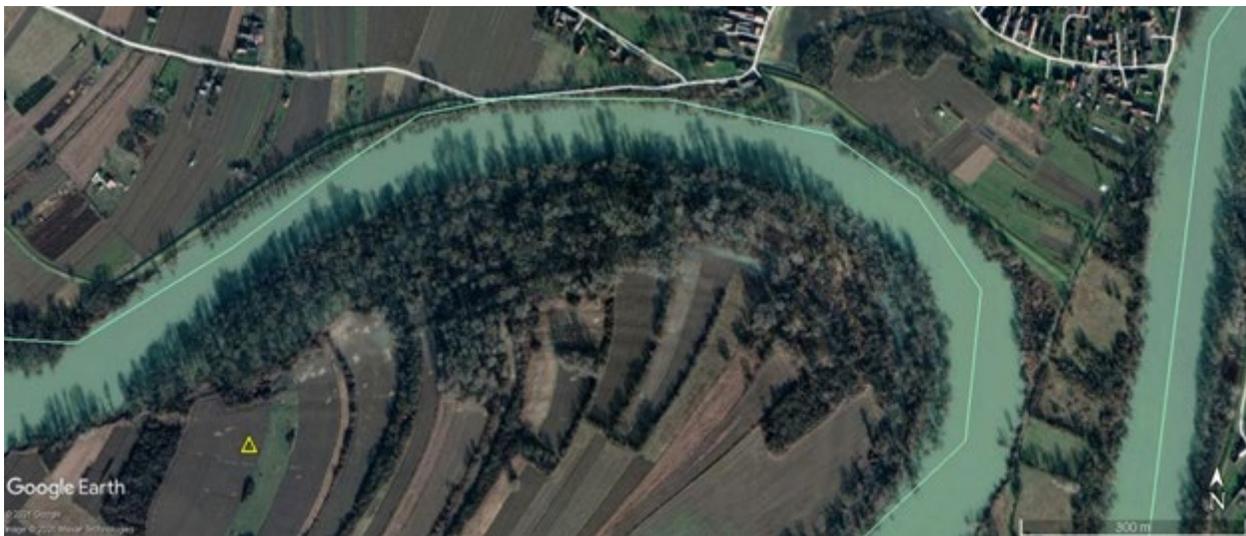
Lateral spreading is shown for two locations in Figure 7.2. Additional spreading and cracking of levees is discussed in Chapter 8. In Bok Palanječki, cracking and lateral offsets were observed on both sides of the river (**Figure 7.15**). Vertical offsets of approximately 30 cm and lateral offsets of approximately 10 cm were observed for the driveway of one of the residences in Bok Palanječki (**Figure 7.16**). Cracks were observed in the fields too, but no damage to the structures in this area was noted.

**Figure 7.15** Post-earthquake satellite imagery (01/27/2021) near Bok Palanječki (45.510N, 16.409E). The yellow triangles indicate locations where cracking was observed.

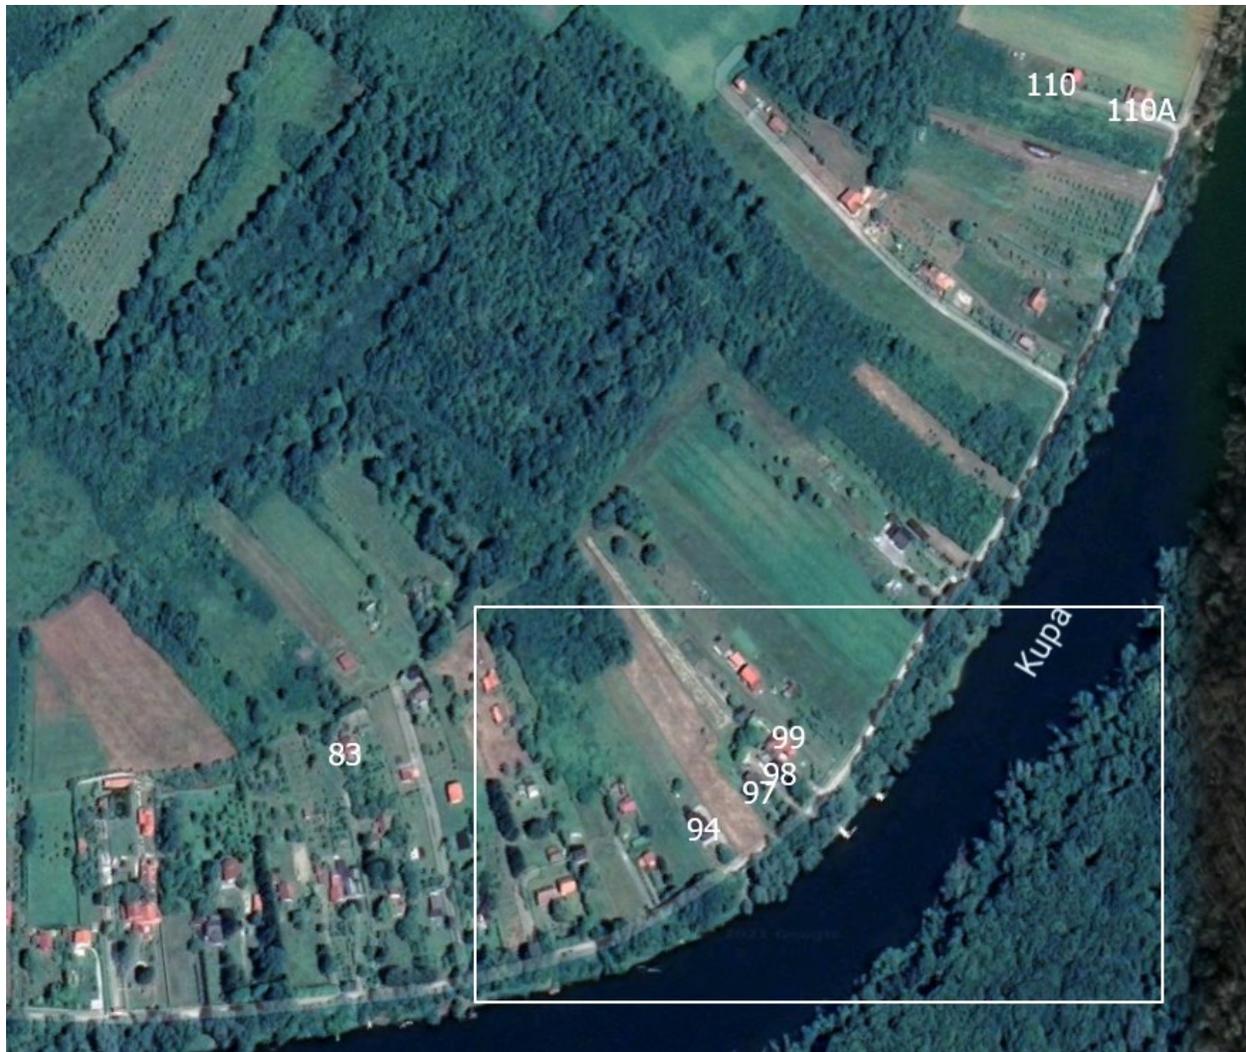
In the village of Stari Brod (approximately 10 km from the epicenter of the main shock), liquefaction and lateral spreading were identified around a series of houses along the Kupa River. The residents noticed water with sand and mud coming out from the ground around houses, in their yards, and the fields. Like other locations in the region, many water wells were filled with liquefied sand and became unusable. Liquefaction was noted at 83, 97, 98, 99, 99B, 110, and 110A Ižišće Street (Bostjančić, 2021), and their positions are shown in **Figure 7.17**.

**Figure 7.17** Location of the liquefaction ejecta by the Kupa River in the Ižišća Street in Stari Brod. (45.480N, 16.182E; [Google Maps](#)). Numbers show street numbers where liquefaction was observed. Cracks and sliding due to lateral spreading is shown in the area bordered by the white rectangle and enlarged in **Figure 7.24**.

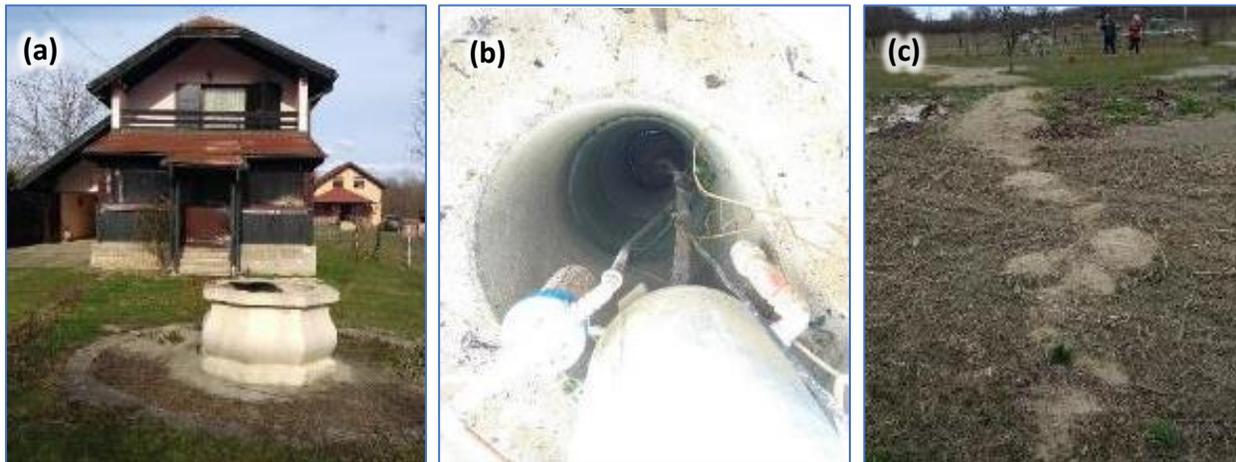
Furthermore, the neighboring 99 Ižišća Street property had the same “western” crack that now passed through the house causing severe damage and the same crack on the bank side that originated at 97 Ižišća Street. **Figure 7.20** gives a southeastern view of the house and the water

well at the property. During the earthquake, sand was ejected upward through the well and onto the surrounding ground, as visible in **Figure 7.20a**. The well remained filled with sand up to the 6-m depth below the ground surface level (**Figure 7.20b**).

**Figure 7.20** (a) The southeastern view of the house at 99 Ižišća Street (45.480248N, 16.184285E) with the water well and sand ejected through the well and onto the ground during the Mw 6.4 earthquake and (b) the water well filled with sand to a depth of 6 m below the ground surface level. (c) Sand ejecta.

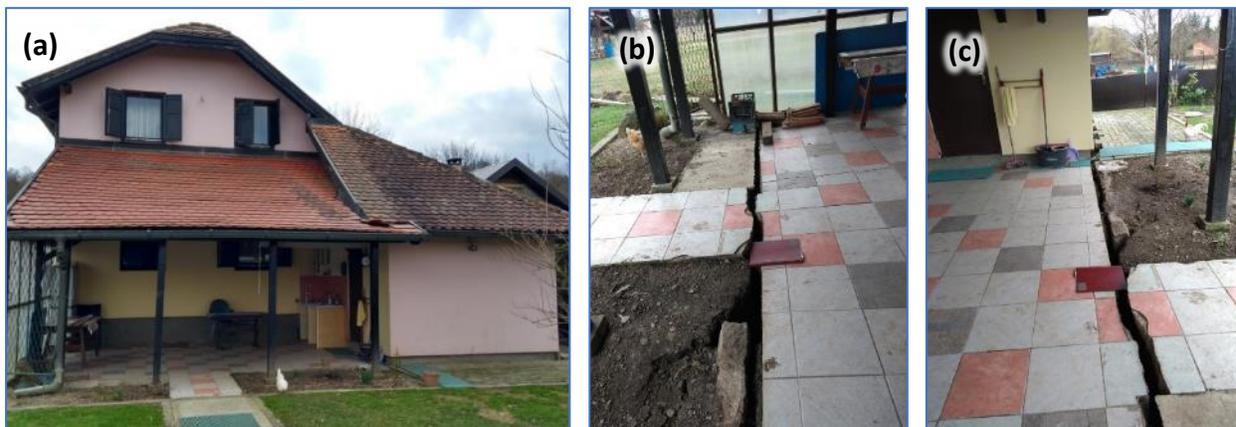
The cracks passing through the house floor at 99 Ižišća Street (**Figure 7.21** and **Figure 7.22**) were aligned with the crack in the neighboring yards at 97 and 98 Ižišće Street. Ejecta at this property were also observed, as shown in Figure 7.23. The cracks were mapped across the different homes (**Figure 7.24**) and indicated this portion of the bank was moving towards the free face of the river.

**Figure 7.21** (a) Northwestern side of the house at 99 Ižišća Street (45.480248N, 16.184285E) in Stari Brod, (b, c) the propagation of the crack through the western yards of the houses at 97 and 98 Ižišća Street marked (1) in Figure 7.23. Crack is deeper than 1m, with opening of around 10 cm and a vertical offset of 8cm.

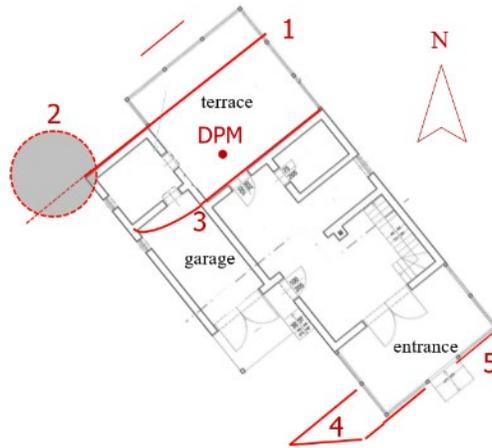
**Figure 7.23** Plan of house at 99 Ižišće Street (45.480248N, 16.184285E) in Stari Brod and cracks shown in red. Numbers indicate features of interest: (1) Crack shown in Figure 7.21; (2) Pavement deformation shown in Figure 7.22a-b; (3) Water pipe rupture caused shown in Figure 7.22c-d; (4) Cracks in the pavement as in Figure 7.22f; (5) Cracks along the south east wall, probably widening. Steps are moving away from the terrace. Red dot: DPM location.

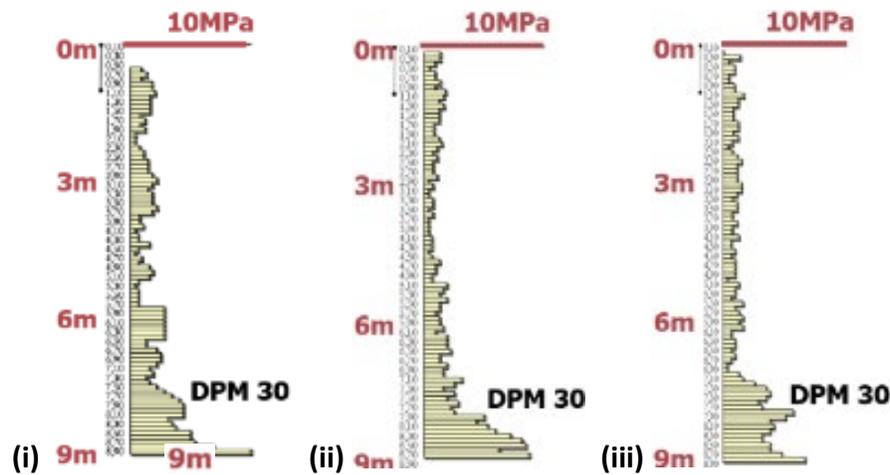
Dynamic penetrometer (DPM 30) testing was performed near the foundations of the three aforementioned houses (97, 98, and 99 Ižišća Street). The test results are shown in **Figure 7.25**. The DPM 30 uses rods with a 20-mm diameter and the crown bottom that is 35.6 mm in diameter (i.e., its cross-sectional area is 10.00 cm<sup>2</sup>). A hammer with the mass of 30.0 kg is dropped from

the height of 20 cm and the number of blows required to drive the crown 10 cm into the soil is counted. The counted values are then converted into dynamic cone resistance. The test results indicate low penetration resistance in the upper 6 meters of the soil profiles.

**Figure 7.25** The DPM 30 test results obtained at (i) 97 Ižišća St (45.480060N, 16.184103E), (ii) 98 Ižišća St (45.480158N, 16.184210E), and (iii) 99 Ižišća St (45.480229N, 16.18433E7) (Taus 2021e-g).

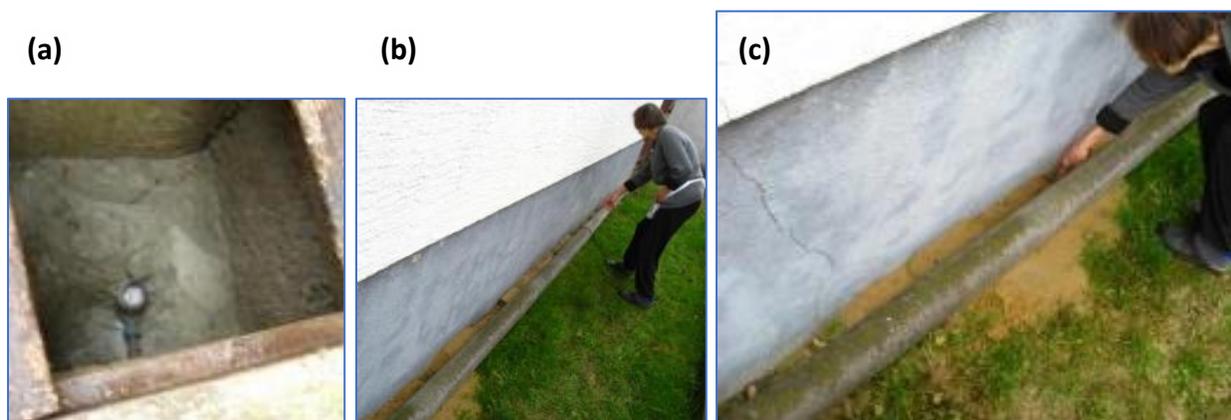
Many residential properties in Petrinja had sand ejecta in yards or around house foundations. **Figure 7.26** illustrates thin cracks above the foundation of a house in Petrinja. At the property across the street from this house, the sand ejecta were visible in the yard and along the fence foundation, and part of the yard heaved, all contributing to the formation of thin cracks in the house wall around the balcony near the single column, as shown in **Figure 7.27**.

**Figure 7.26** (a) Sediment ejecta in the water meter shaft, (b) sand ejecta by the house, and (c) cracks above the foundation near the sand ejecta pointed at by the owner in Petrinja (45.4349N, 16.2683E).

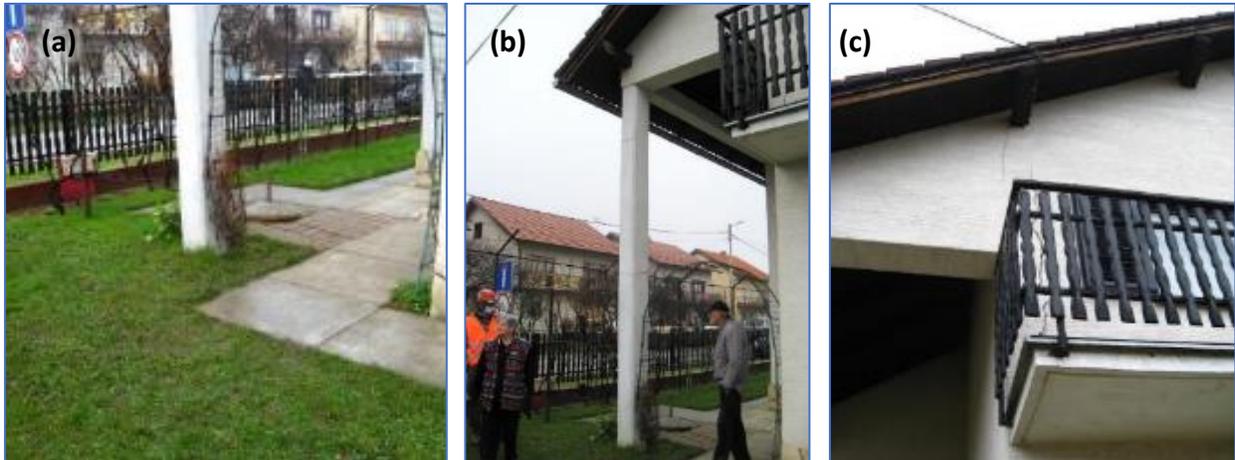
**Figure 7.27** (a, b) During the main shock, sandy soil appeared along the fence foundation and the central part of the yard heaved. (c) Several thin cracks appeared in the house wall around the column and the balcony in Petrinja (45.43515N, 16.26844E).

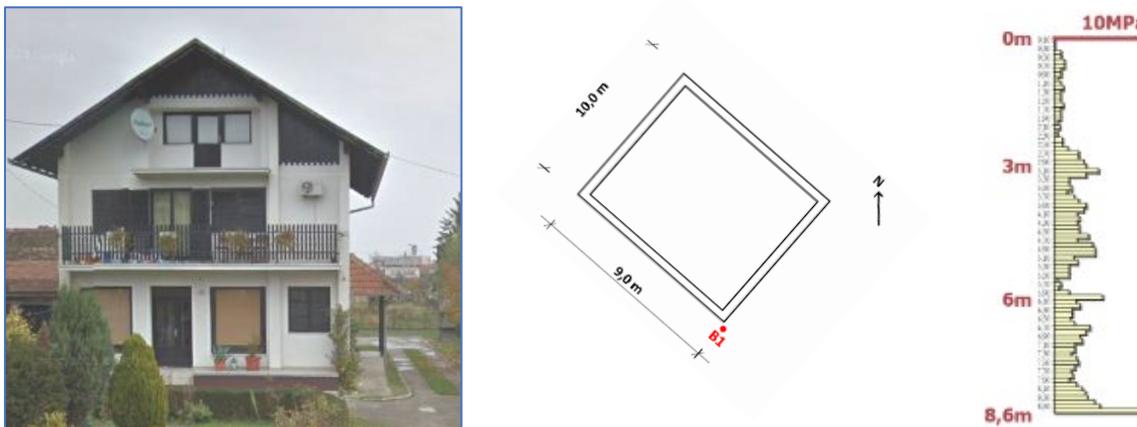
Evidence of liquefaction was found at residential properties in Milana Makanca Street in Petrinja starting from the house number 1 all the way to the house number 44, with the volume of the ejecta around each house measuring typically up to  $1.5 \text{ m}^3$  (Gulam 2021). At 11 Milana Makanca Street, liquefaction induced flooding of the property by groundwater mixed with some soil sediments, as illustrated in **Figure 7.28**. The house itself was not damaged, but it was suggested that further investigations be undertaken. In accordance with that, a dynamic penetrometer (DPM 30) test was performed at the house corner (Taus 2021a). The test results provided in **Figure 7.29** show that the soil in the upper 3 m is very loose.

**Figure 7.29** The house at 11 Milana Makanca Street in Petrinja (45.436061N, 16.262898E), test location at the southern corner of house, and DMP 30 test results (Taus 2021a).

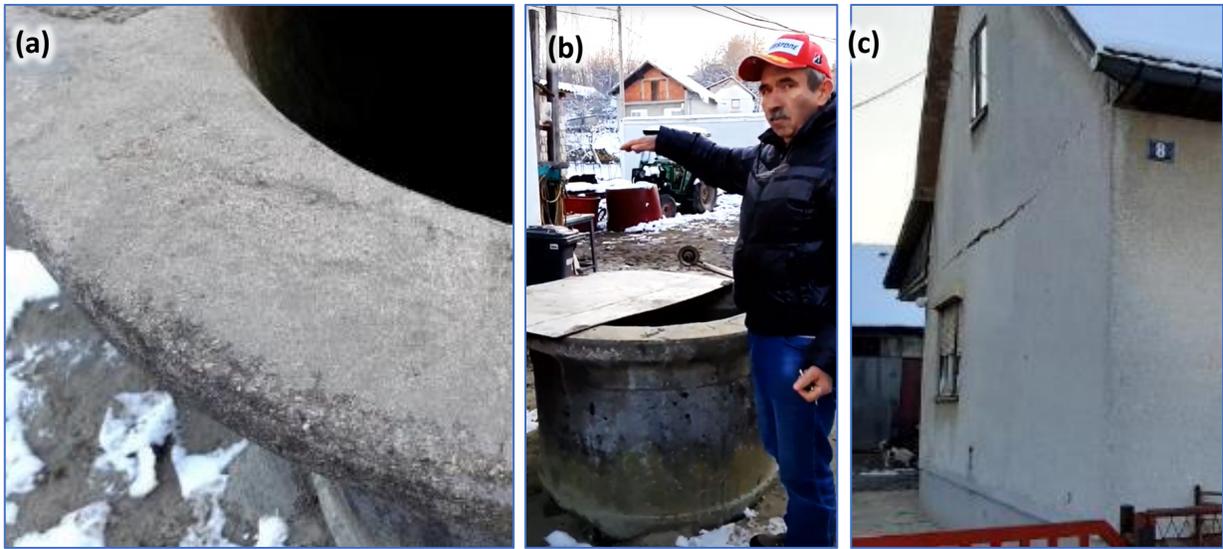
Many water wells in the area were filled with liquefied sandy soil. A well at 8 Milana Makanca Street in Petrinja was seen to eject sand some 150 cm above the ground level, as shown in **Figure 7.30**, causing cracks in the nearby house that was abandoned before the earthquake (also shown, in **Figure 7.30c**). The neighboring house at 10 Milana Makanca Street, also abandoned before the earthquake, had damage in the ceiling visible at **Figure 7.31**.

**Figure 7.30** (a) Rim of the water well at 8 Milana Makanca Street in Petrinja (45.4359N, 16.2627E) covered by the ejected sand. (b) A neighbor shows that during the earthquake sand and water were ejected upward from this well, around 150 cm above the ground level. (c) The abandoned house near the well.

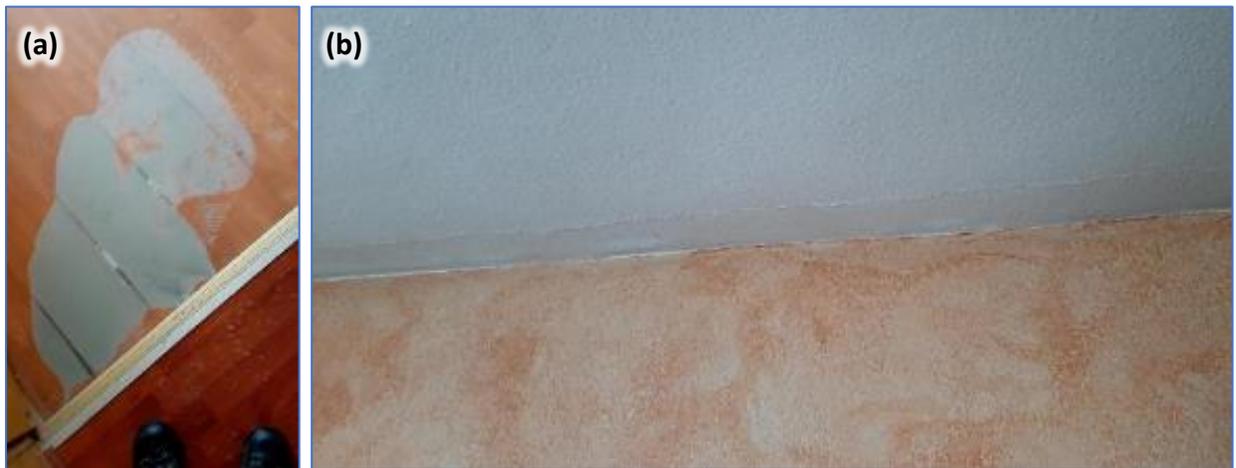
**Figure 7.31** (a) Traces of sand ejecta and (b) the crack in the ceiling inside the house at 10 Milana Makanca Street in Petrinja (45.4358N, 16.2628E).

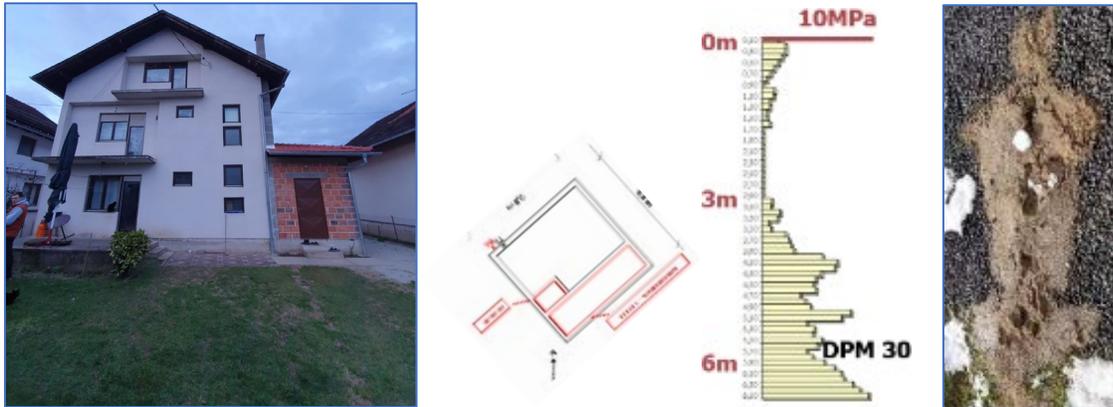
DPM 30 testing was also performed at several locations in Glina, approximately 12 km from the epicenter, to evaluate the subsurface conditions. Evidence of liquefaction was identified in the streets as well as at the properties. Liquefaction effects were especially notable in the streets along the former riverbed of the Maja River. DMP 30 testing was performed at one of these locations (20 6. kolovoza 1995. Street) with the results presented in **Figure 7.32**. The test results show that the soil in the upper 3 m of the profile (especially from the 1.5-m to 3-m depth) is extremely loose. Similar soil conditions were observed across the street (25 6. kolovoza 1995.

**Figure 7.32** The house at 20 6. kolovoza 1995. Street (45.3430N, 16.0911E), test location at the western corner, DMP 30 test results, and characteristic ejecta (Taus 2021b).

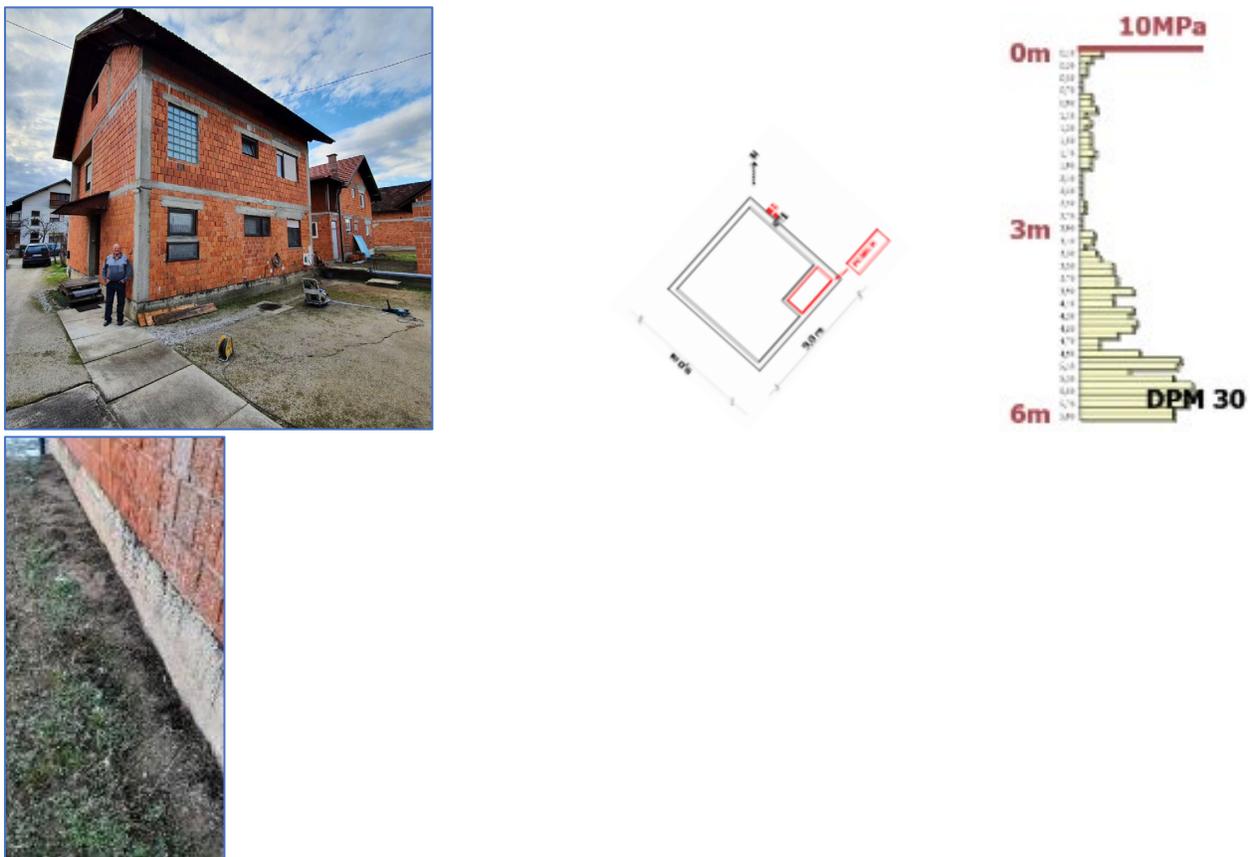
Street), as shown in **Figure 7.33**. Slightly stronger soils were found at the nearby location (35 6. kolovoza 1995. Street), as shown in **Figure 7.34**.

**Figure 7.33** The house at 25 6. kolovoza 1995. Street (45.3431N, 16.0911E), test location near the northern corner, DMP 30 test results, and characteristic ejecta (Taus 2021c).
