# Geotechnical Reconnaissance and Engineering Effects of the December 29, 2020, M6.4 Petrinja, Croatia Earthquake, and Associated Seismic Sequence

A report to the NSF-Sponsored Geotechnical Extreme Event Reconnaissance (GEER) Association<sub>1</sub>

Report GEER-072: <https://doi.org/10.18118/G63T0S>  
August 3<sup>rd</sup>, 2021

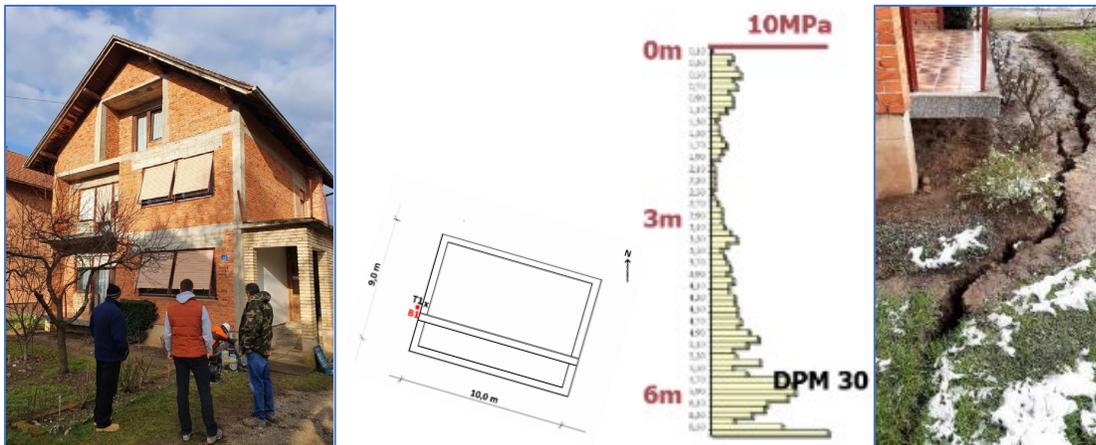
Street), as shown in **Figure 7.33**. Slightly stronger soils were found at the nearby location (35 6. kolovoza 1995. Street), as shown in **Figure 7.34**.

**Figure 7.34** The house at 35 6. kolovoza 1995. Street (45.3429N, 16.0920E), location of the testing near the eastern wall, DPM 30 test results, and characteristic crack (Taus 2021d).

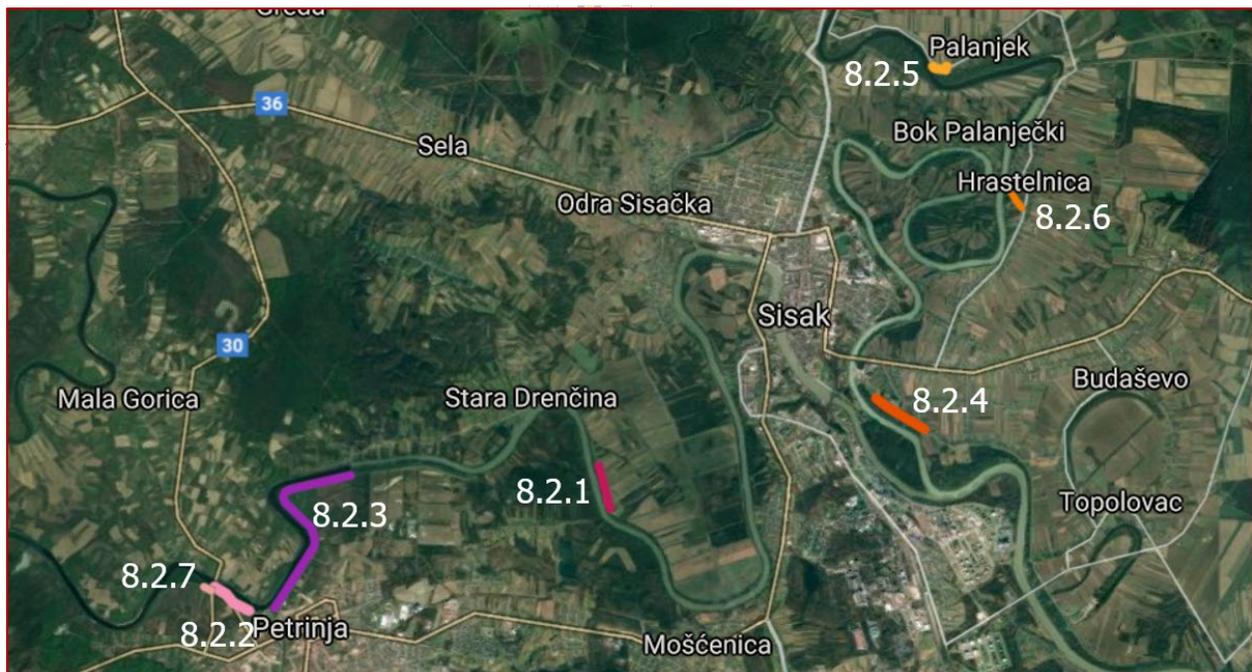
**Figure 8.3** Locations of damaged levees on the Google Map as shown by frame in Figure 8.1. Individual stretches of the levees are shown in the corresponding indicated subchapters.

On six sections (**Figure 8.3**) longitudinal cracks appeared on the levees or near them. Near a few of the cracks, sand ejecta was visible, but around most of the damaged sections, ejecta was found on the distance of several meters or more. Damage was also observed on the connection of two perpendicular levees (Palanjek) and on the connection of a levee and a canal (near bridge Brest) where cracks perpendicular to the levee were seen. Typical damage is shown by location in the following sections with some additional details on the subsurface conditions where available.

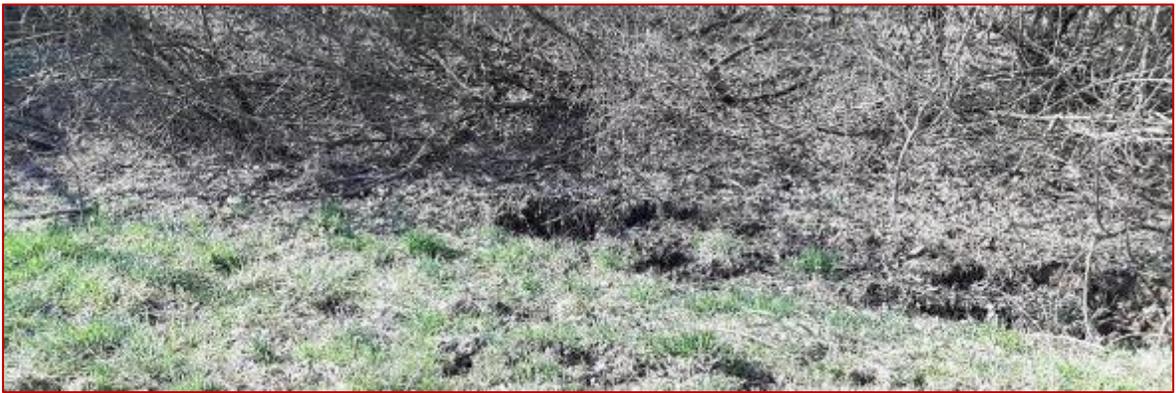
The crack which spreads across the crest and continues down the slope of the levee extending for about 30 m along both sides of the levee is shown in **Figure 8.4** and **Figure 8.5** from above, in **Figure 8.7** on the field side, and **Figure 8.8** and **Figure 8.9** on the river side. Cracks are vertical in general but irregular in shape, so a maximum depth of 2 m was measured.

**Figure 8.8** At the river side of the levee crack is 2 m deep (21.2.2021.; 45.4612192N, 16.3358308E).

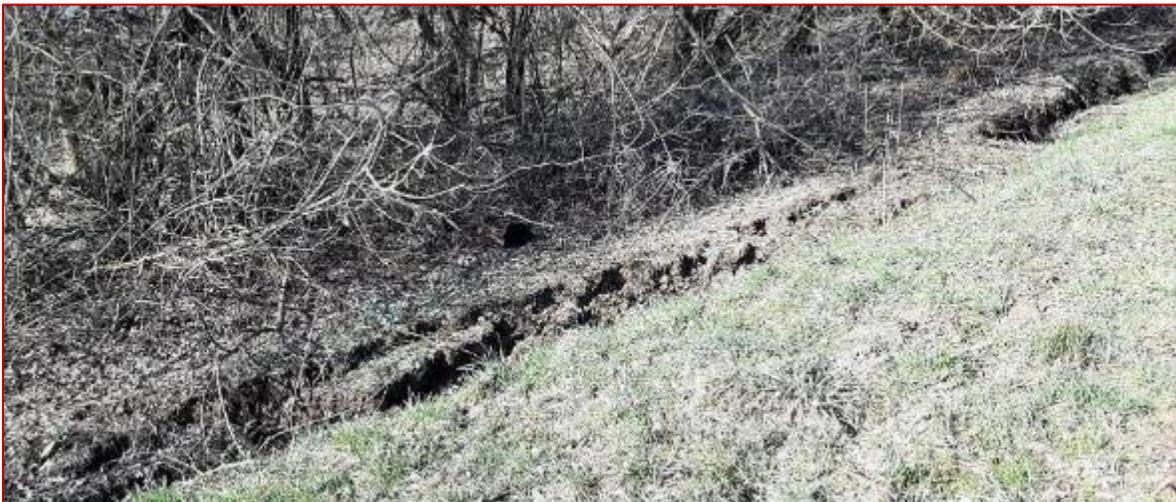
**Figure 8.9** At the river side of the levee (21.2.2021.; 45.4612015N, 16.3358606E).

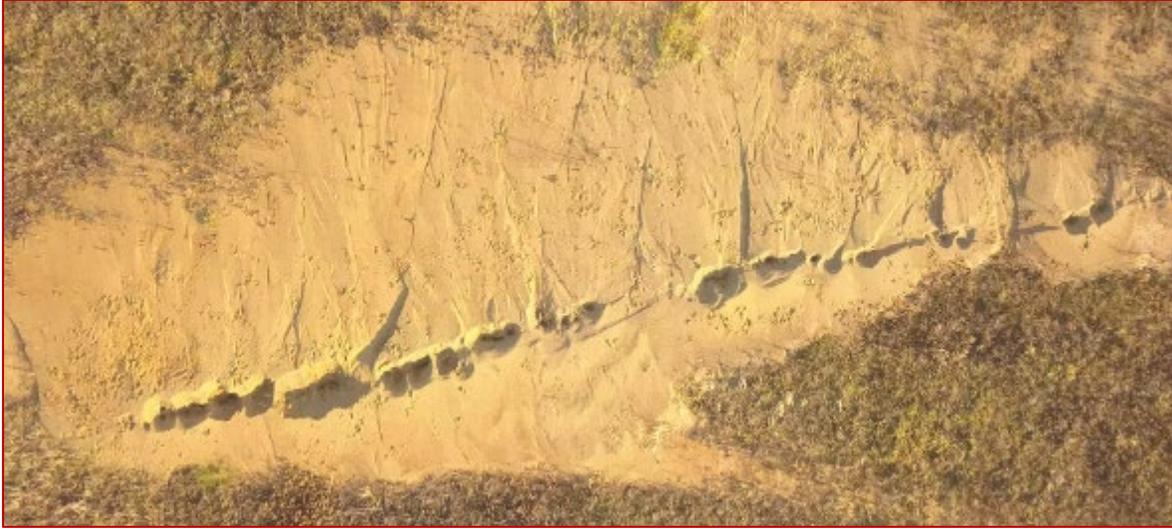
On both sides in the field irregular ejecta was found, the longest stretch being approximately 60 m long as seen in the air photo in **Figure 8.10**.

**Figure 8.10** Ejecta in the field: length approximately 60m (Photodocumentation Geokon-Zagreb d.o.o.; January 7 2021; 45.46006N, 16.33759E).

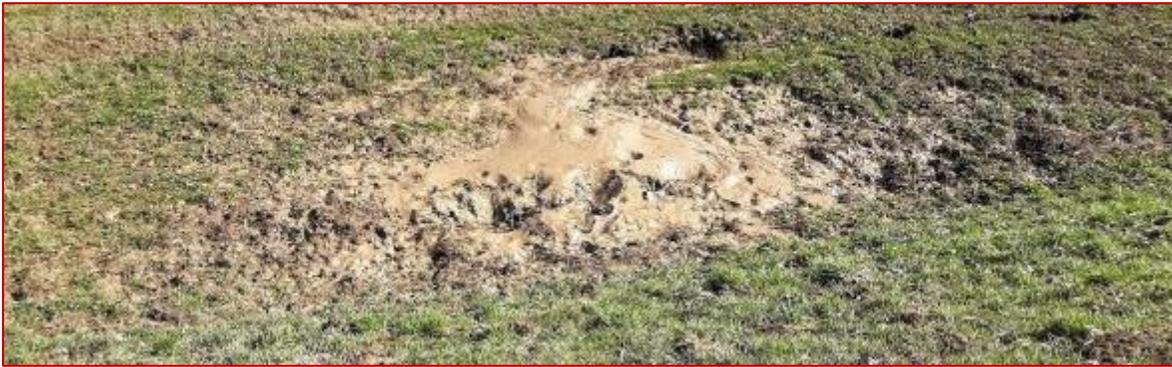
**Figure 8.11** Ejecta in the field (21.2.2021.; 45.4611943N, 16.3358866E).

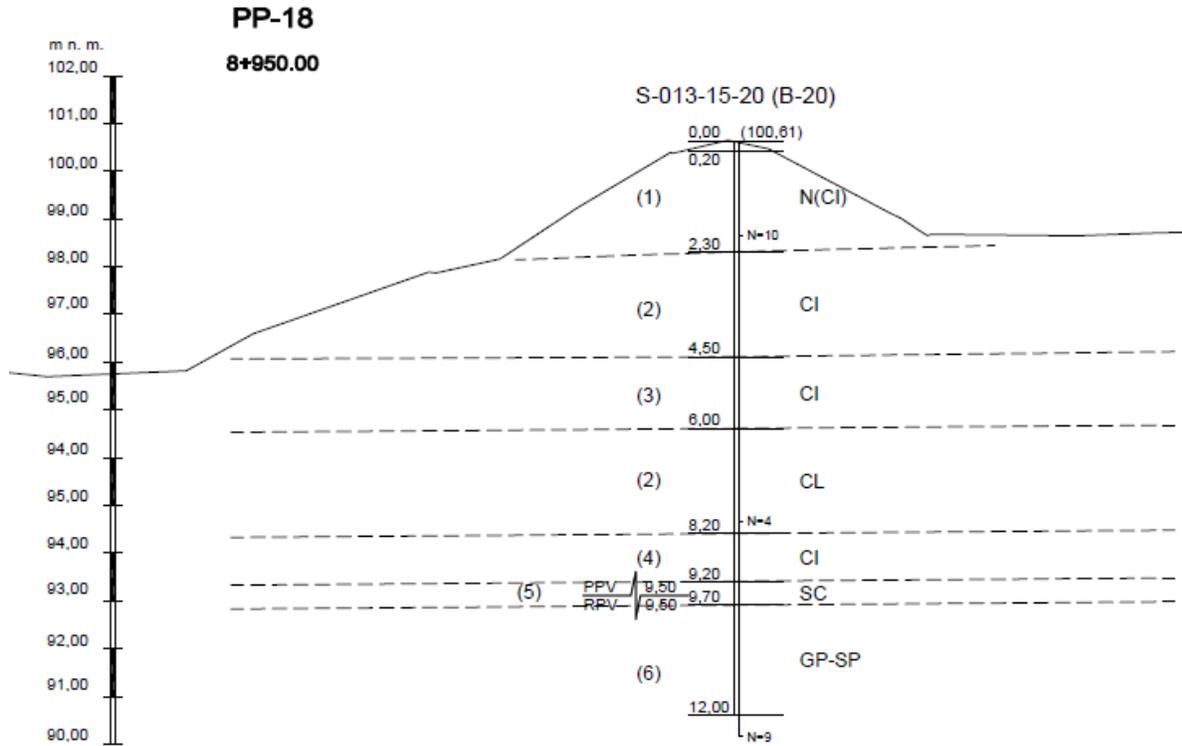
Information on the subsurface soil conditions through a borehole conducted by Geokon-Zagreb in 2015 (Geokon-Zagreb 2016) for the upgrade of the levee was available near the crack and is shown in **Figure 8.12**. The levee is underlain by 7 m of clays, which are underlain by a 0.50m clayey sand layer, and finally a mixture of poorly graded gravel and sand.

**Figure 8.12** Cross-section of the levee south from Stara Drenčina, on the left bank of the river Kupa at the position 45.46134N, 16.33583E (Geokon – Zagreb LLD 2016).

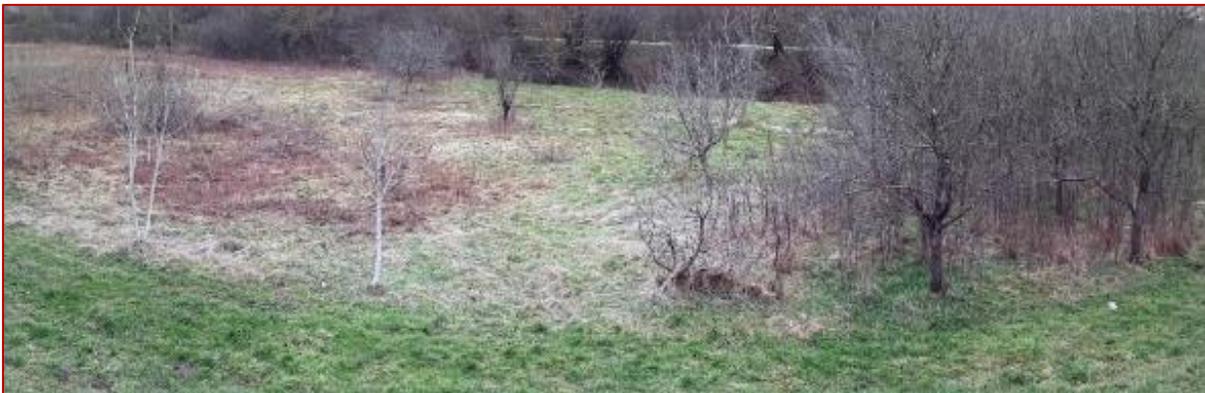
**Figure 8.14** Liquefied sand ejecta on the field side of the levee (45.4453N, 16.2649E).

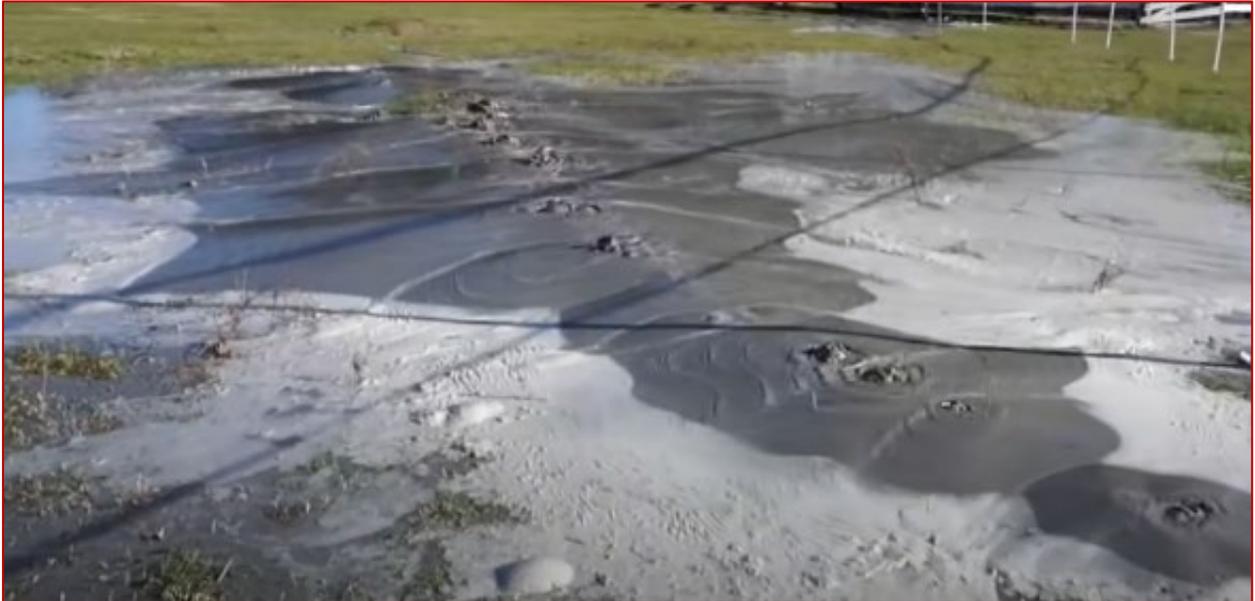
**Figure 8.20** A snapshot from the video made during the M6.4 earthquake near Galdovo levee (Udruga Kas, recorded by Daniel Pavlič (Pavlič, 2020) (45.4735, 16.3926)

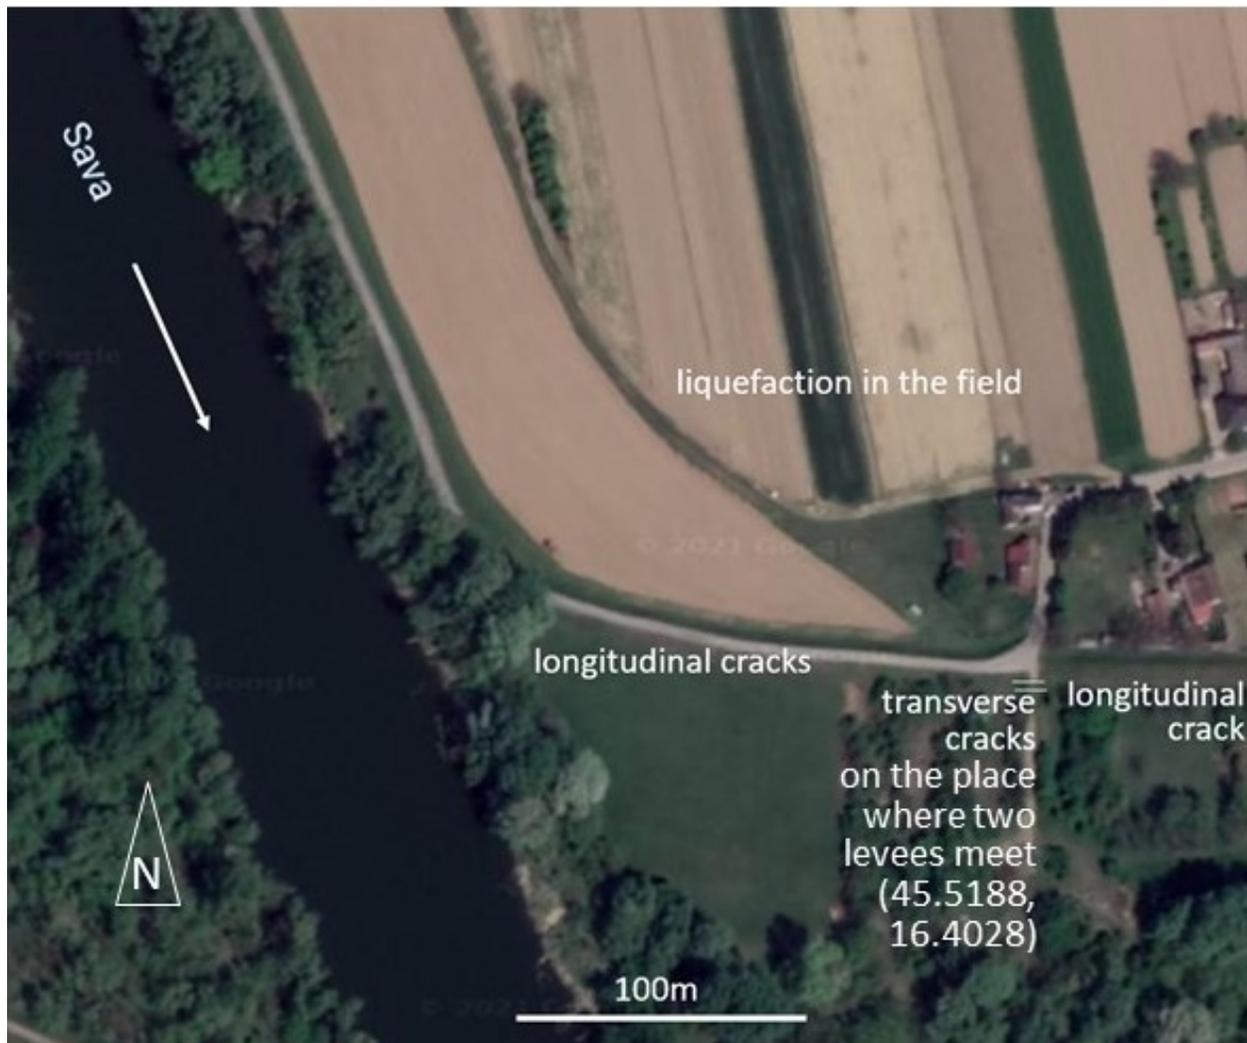
At a distance of 19.5 km from the epicenter, the levee on the left bank of the Sava river was damaged over a length of approximately 250m in the area shown in **Figure 8.23**. Transverse cracks followed by vertical displacement of about 50 cm occurred near the location where two levees meet as shown in **Figure 8.24**. Longitudinal cracks along the road and the toe are shown in **Figure 8.25**, together with some ejecta on the river side. On the field side, more sand was ejected to the surface as seen in **Figure 8.26a**. A sand layer was found at a depth of about 5m as shown in **Figure 8.26b**.

**Figure 8.23** Map of the damaged section of the levee on the left bank of the Sava river near Palanjek.

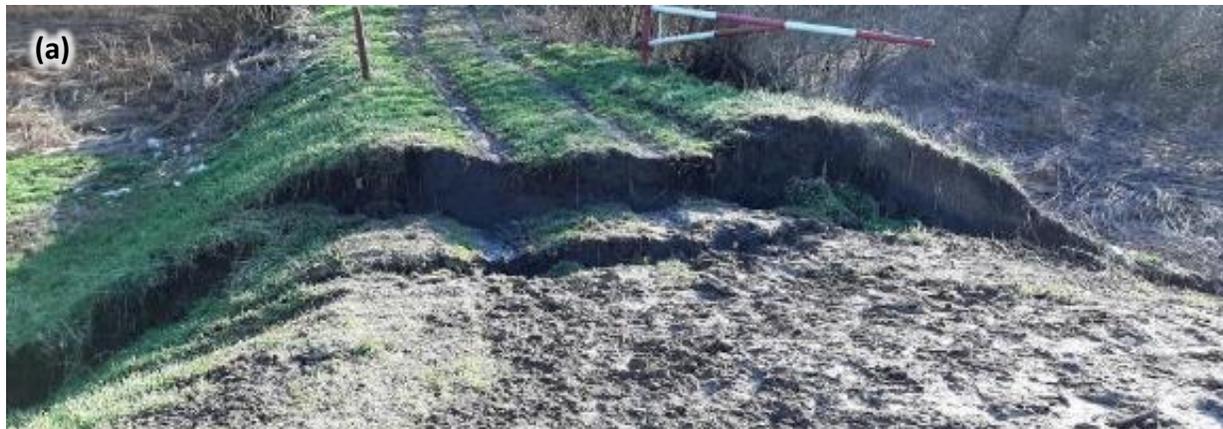
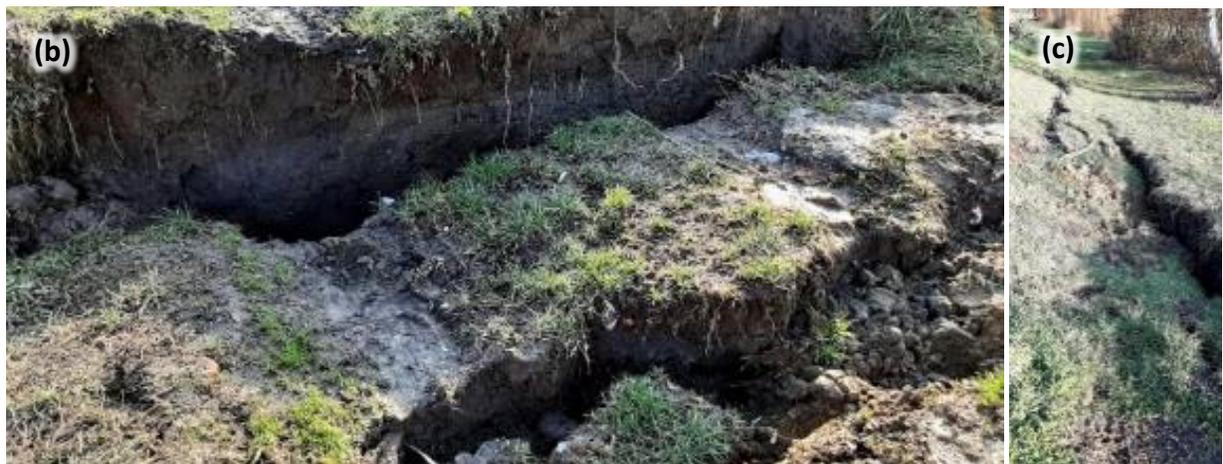
**Figure 8.24** (a,b) Transverse cracks and settlement. (45.518732N, 16.4028826E), (c) longitudinal cracks along the levee toe on the eastern side.

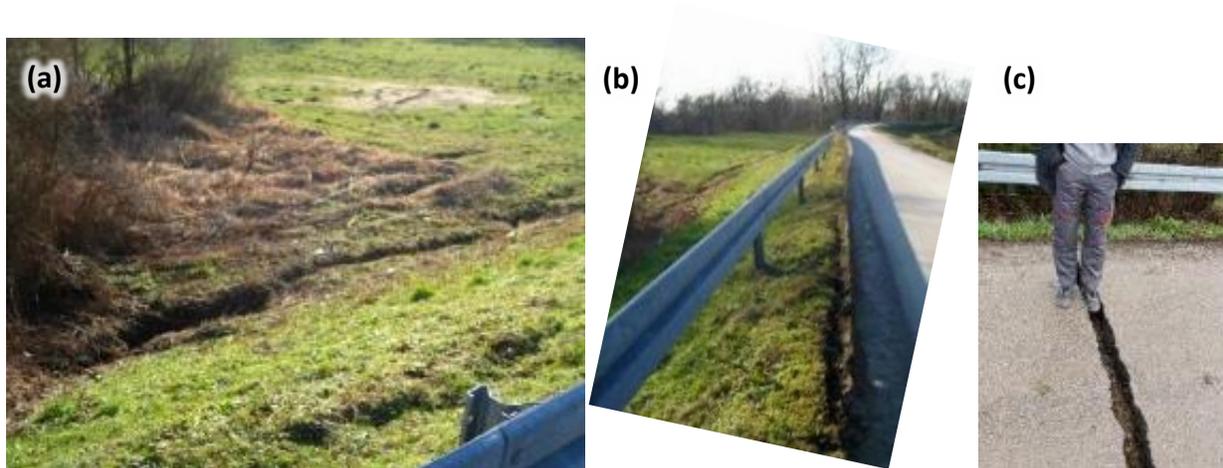
**Figure 8.25** (a) Sand ejecta in the field, longitudinal cracks along the levee along the toe and (b) along the crest and settlement. (45.51874, 16.402). (c) Transverse crack on the road on the levee crest (Photo documentation Geokon – Zagreb LLD).

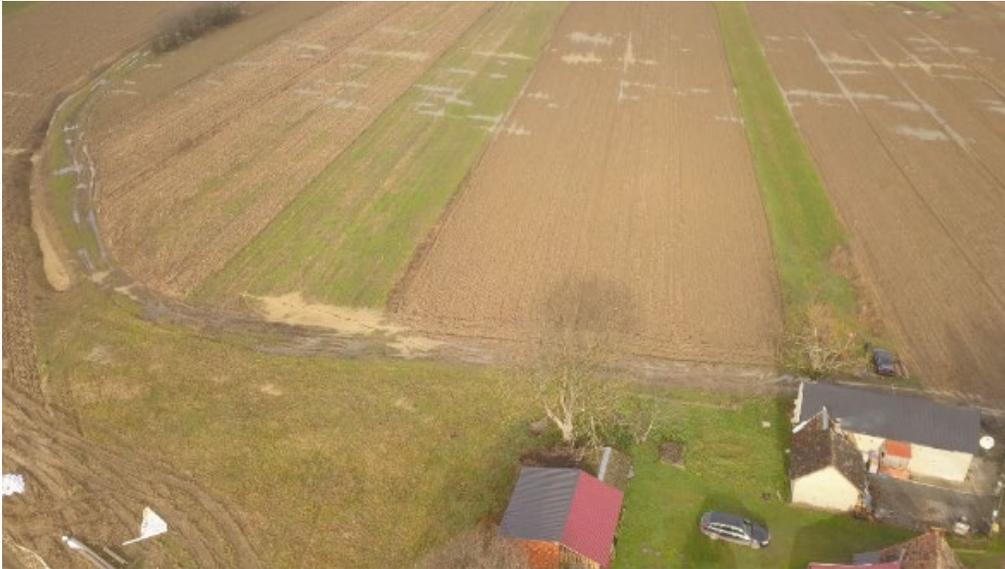
**Figure 8.26** (a) Aerial view of the liquefaction in the field near Palanjek. (45.520N, 16.402E, Photo documentation Geokon – Zagreb LLD. (b) Borehole from 2013 (Geokon-Zagreb LLD 2021) on a nearby location shows the presence of clayey sand at the depth of around 5 m below the ground surface.

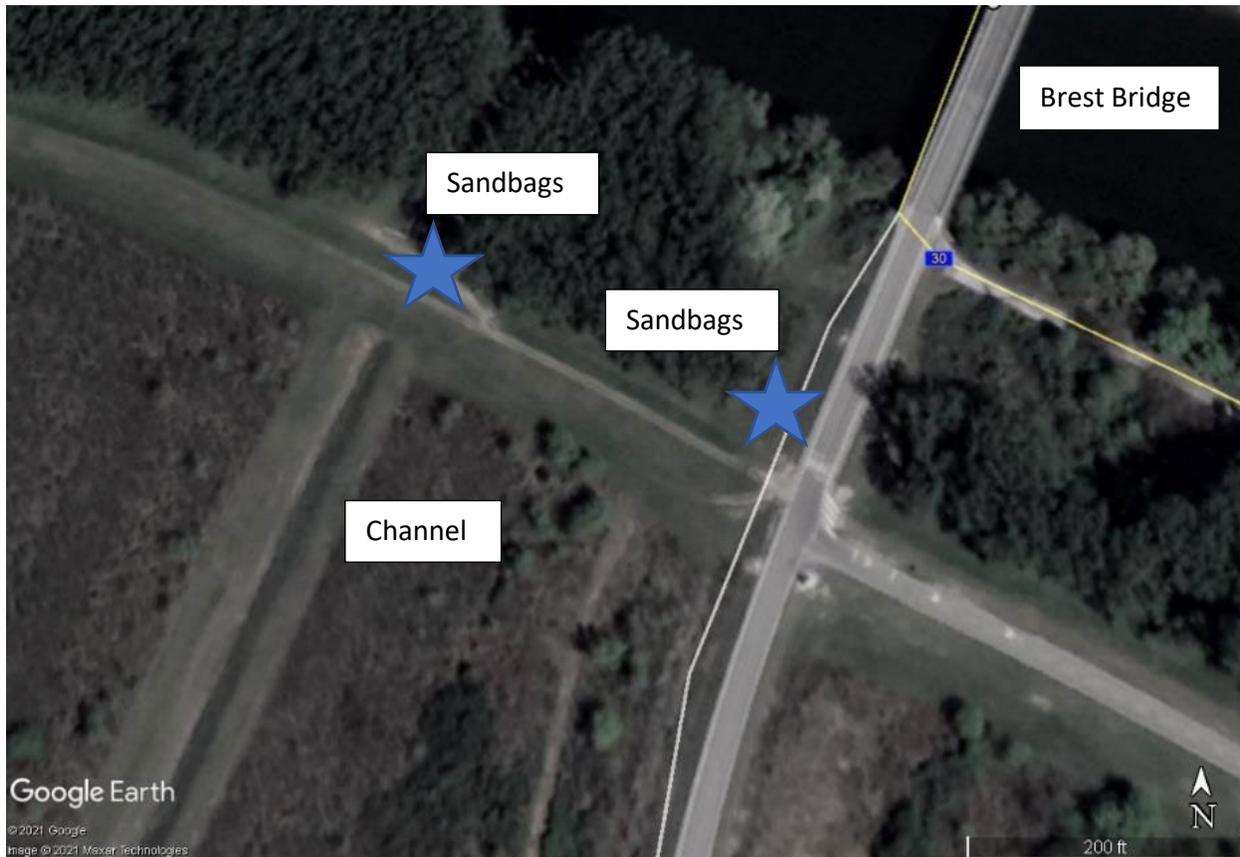
A levee south of Brest Bridge along the Kupa river was damaged in two locations. The first location is at the contact of the levee and the bridge embankment and the second is where a water channel perpendicularly crosses the levee. **Figure 8.29** shows the plan view and **Figure 8.30** damaged concrete channel under the levee and remediation works that were performed immediately after the earthquake. The images were taken on March 22<sup>nd</sup>, 2021.

**Figure 8.29** Plan view of the Brest Bridge and levee damage in Brest Pokupski, near Petrinja (45.4476N, 16.259E) (source: Ingrid Tomac)

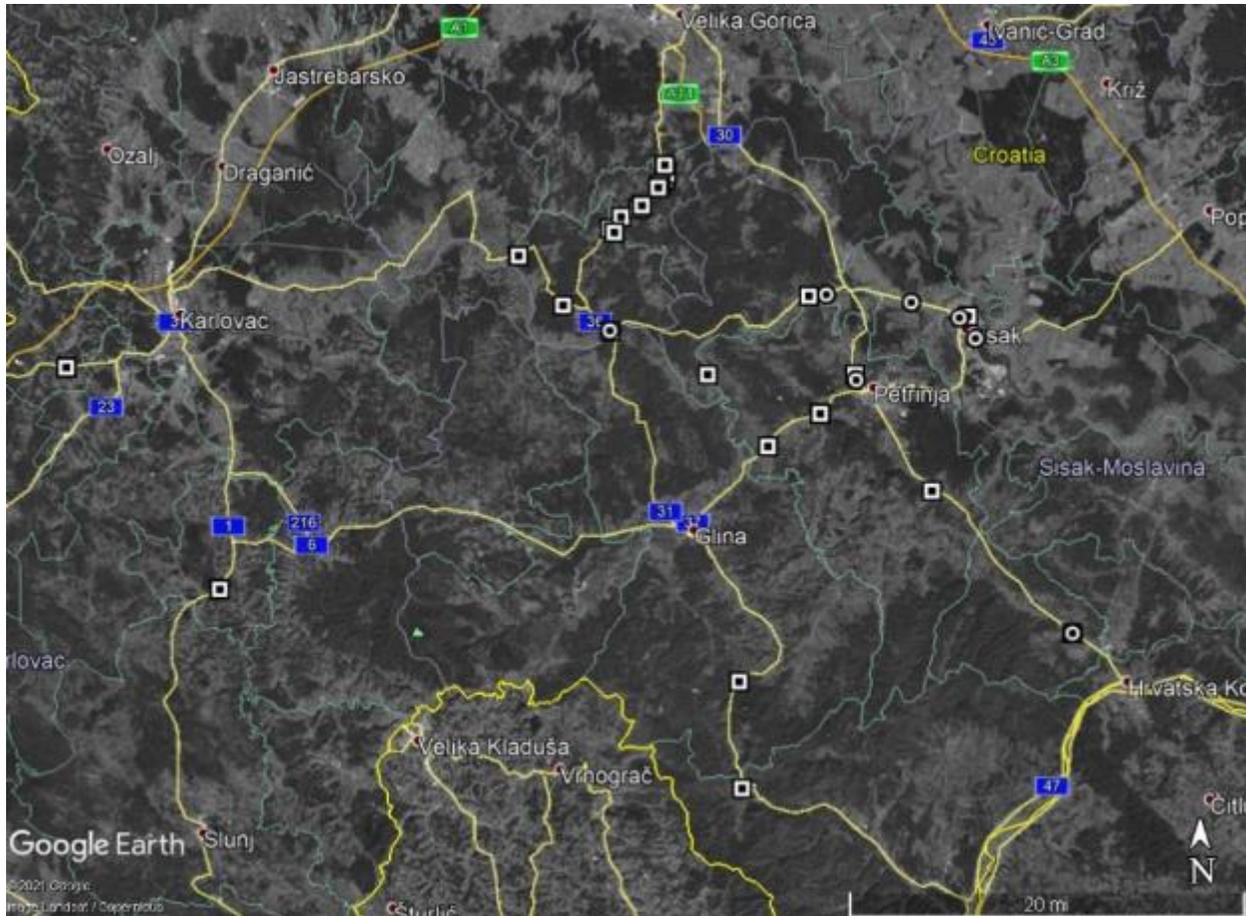
**Figure 9.2** Specific locations of road damage (squares) and damaged bridges (circle) (Justin Wong and Ingrid Tomac).

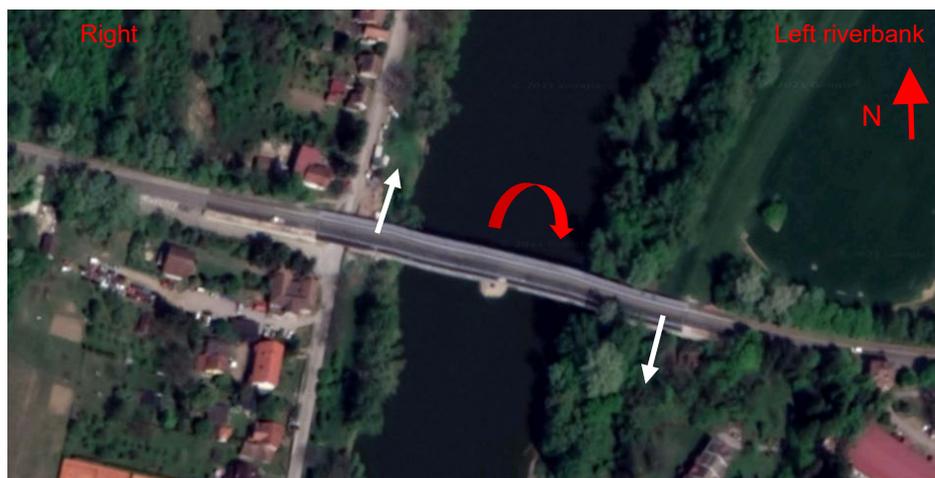
**Figure 9.5** shows an aerial image of the Galdovo Bridge. Some liquefaction evidence in the proximity of the Galdovo bridge is shown in Chapter 7. Geotechnical soil reconnaissance revealed cracks in soil around the east abutment and the adjacent column on the left riverbank, while no visible soil surface damage was observed on the right riverbank near the bridge (**Figures 9.6 and 9.7**). It should be noted that there is a shaft in the area between the east abutment and the adjacent column to which some cracks in soil seem to be directed.

**Figure 9.5** Galdovo Bridge over the river Sava (source: Google Maps).

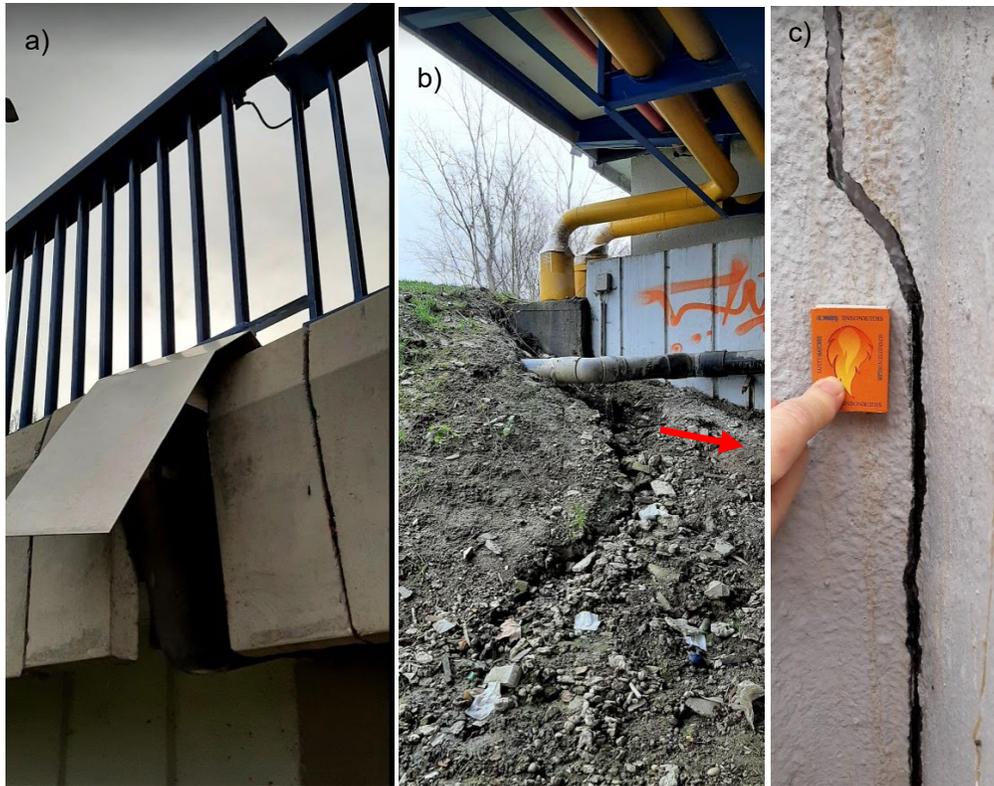
**Figure 9.6** Left Sava riverbank, east bridge abutment a) north face, upstream, b) north face, upstream and c) south face, downstream (45.4790N, 16.3854E).

- There was a longitudinal displacement during the earthquake of at least 8 cm (**Figures 9.6 – 9.10**) – evidenced by pulling out of the railing at its expansion joint, and misalignment of the bridge finger expansion joint,
- There was a failure of transversally unmovable bridge bearing on the east abutment, and permanent 15-cm transverse displacement of the bridge (**Figures 9.6 and 9.9**). The bearings on the columns also suffered damage due to the bridge rotation.

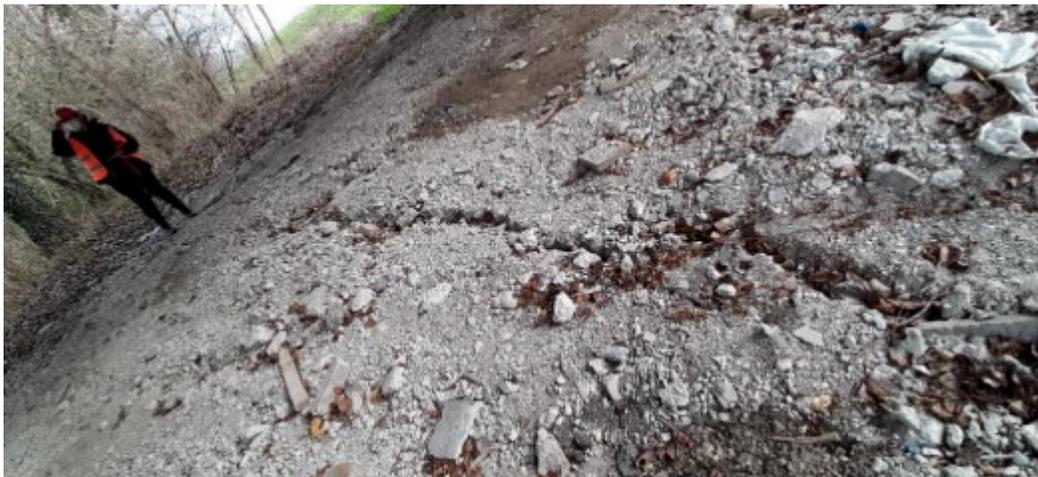
**Figure 9.7** Left bank of Sava, soil cracks between the abutment and the adjacent column (45.4790N, 16.3854E).

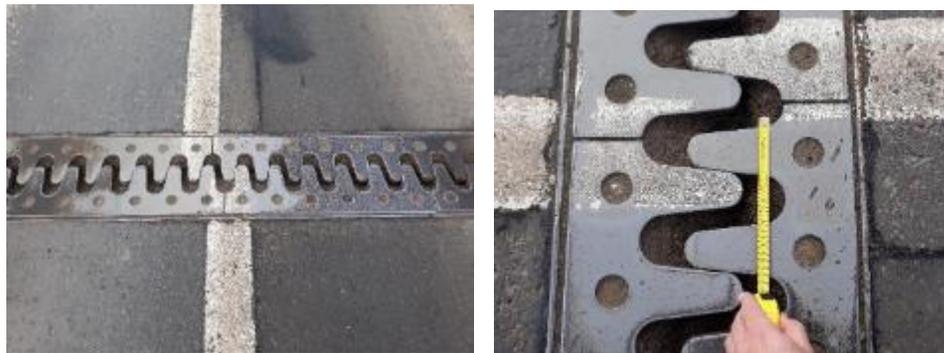
**Figure 9.8** Galdovo Bridge, displacement of the bridge expansion joint on the east abutment (45.4790N, 16.3854E).

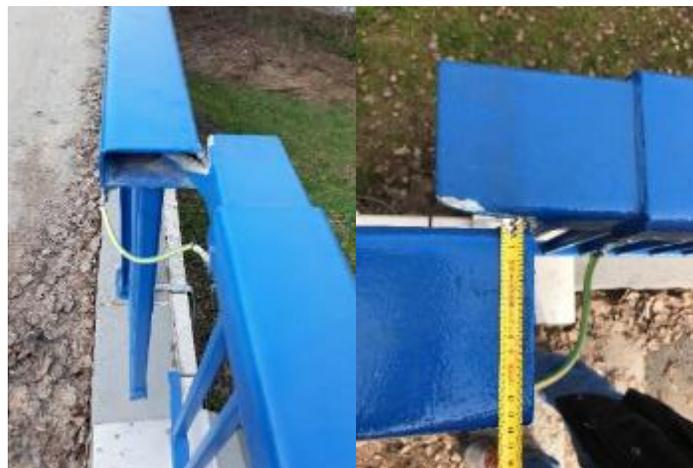
**Figure 9.9** Galdovo Bridge, 15-cm transverse displacement of the bridge railing (45.4790N, 16.3854E).

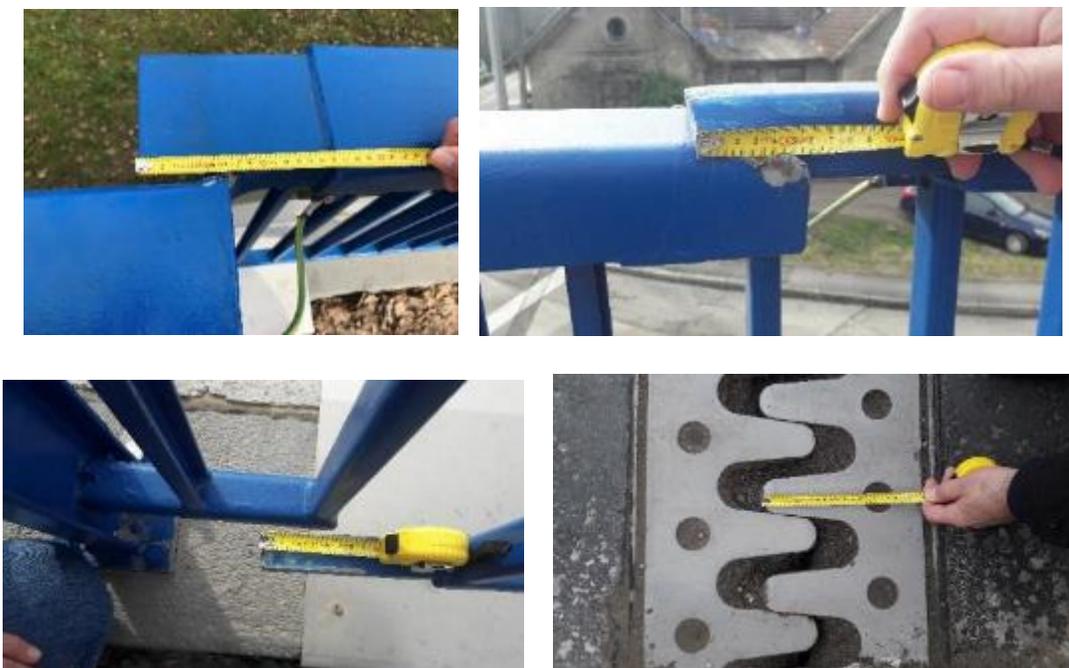
**Figure 9.10.** Galdovo Bridge, measuring longitudinal displacement on railing and expansion joint (45.4790N, 16.3854E).

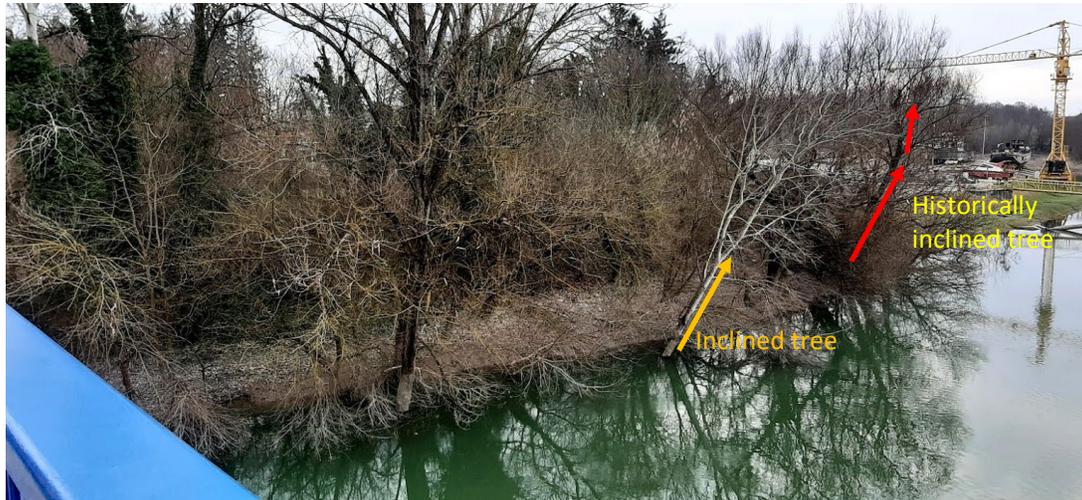
**Figure 9.12** shows inclined trees on the riverbank, which typically indicate recent in inclined trees or historical in partially inclined trees slope instability. An absence of images and information before an earthquake makes it difficult to draw any conclusions about earthquake effects.

**Figure 9.12** Inclined trees on the left bank of Sava river, the eastern side of the bridge, view towards the south (45.479N,16.385E).

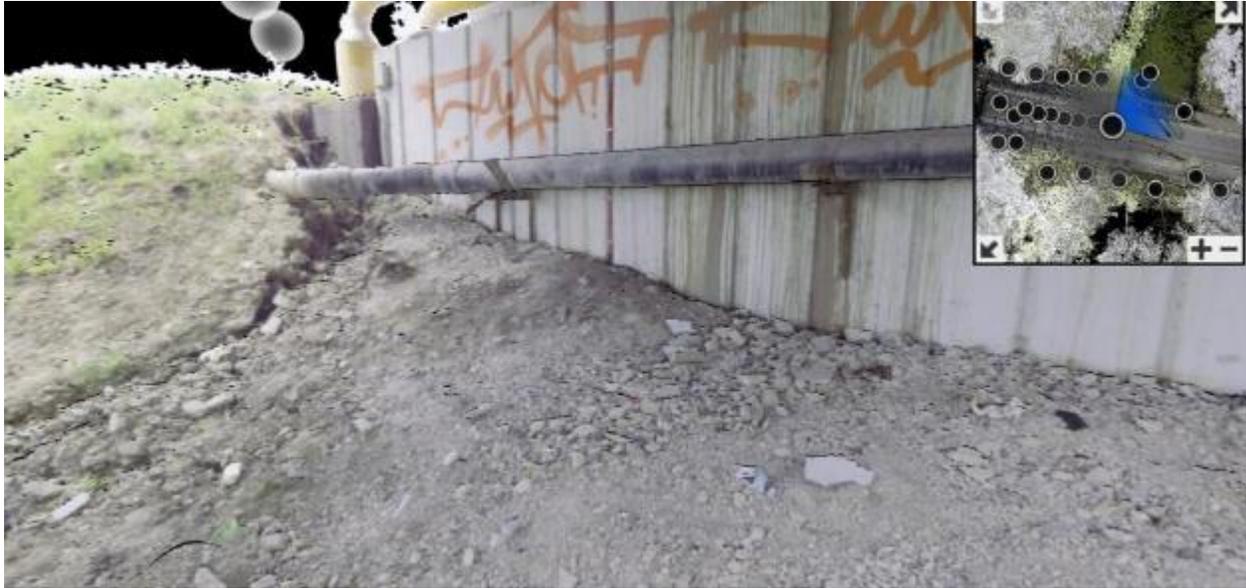
**Figure 9.14** Galdovo Bridge, Point cloud of the east abutment.

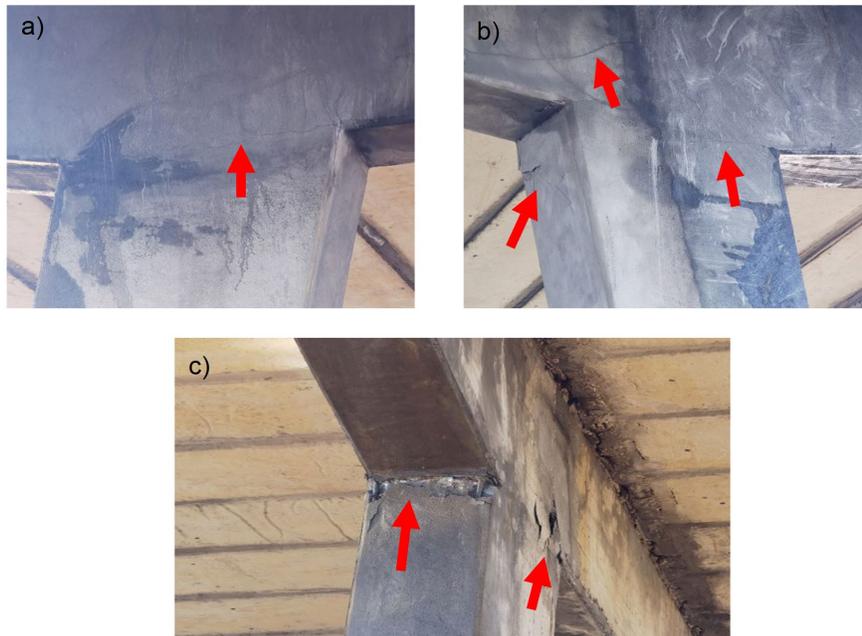
Damage was detected after the earthquake on columns S4, S7, and S20 at the column-cap beam joint. On S4 (**Figure 9.16a**), the west column has horizontal cracks on the side facing south. On S7 (**Figure 9.156b**) the east column also has horizontal cracks on the south-facing side. On S20 (**Figure 9.16c**), the east column, the eastern and southern face at the top of the column show surface cracks.

**Figure 9.16.** a) damage at S4, b) damage at S7 and c) damage at S20. (source: Earthquake Petrinja 29 12 2021 GP HC\_Road and bridge damage report", in Croatian).

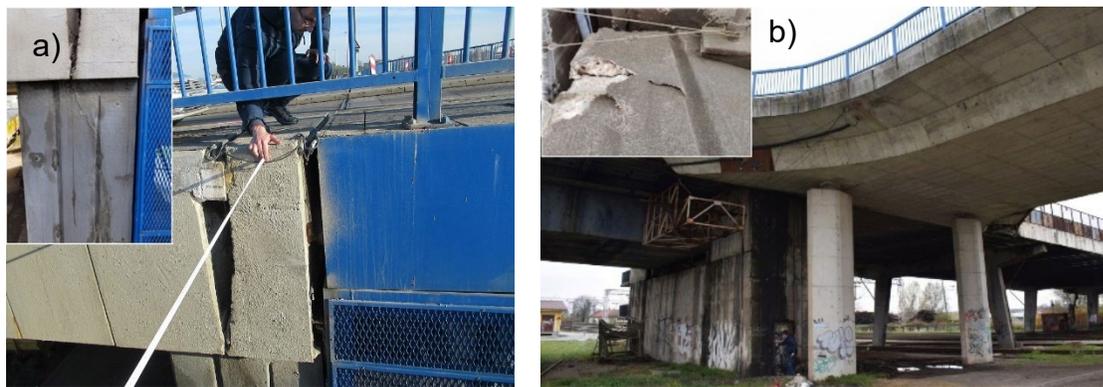
Column at S13 is the edge column under the steel span on the northern side (**Figure 9.17**). Previously existing crack was repaired with concrete anchors during the retrofit in 2019. **Figure 9.17 b**) shows the side ramp as it was before the retrofit. The ramp is a reinforced concrete viaduct supported on elastomeric bearings, that suffered a visible crack on the asphalt along with the connection to the bridge and was sideways hitting the S13 column during the earthquake and caused local column damage, which is only superficial. **Figure 9.18** shows cracks on the soil surface between S4 and S5, which are in the east-west direction, perpendicular to the bridge longitudinal axis. To summarize, the damage on the Gromovi Bridge was detected on the columns and connections between columns and the roadway slab on the northern side of the Kupa river. The damage suggests a lateral spread of the northern embankment. It is interesting to note that most of the damage occurred on the parts of the bridge with shallow foundations, while the deep-founded bridge supports were not damaged. **Figure 9.19** links an aerial image obtained after the earthquake where liquefaction was detected on a wider area of the city of Sisak, including both sides of the Gromovi Bridge. The approximate position of identified damage is also shown.

**Figure 9.17** a) reinforced pre-existing crack and dilation above on the column S13 on the northern side of the Kupa river and b) side ramp. (Source: Metal Projekt Ltd).

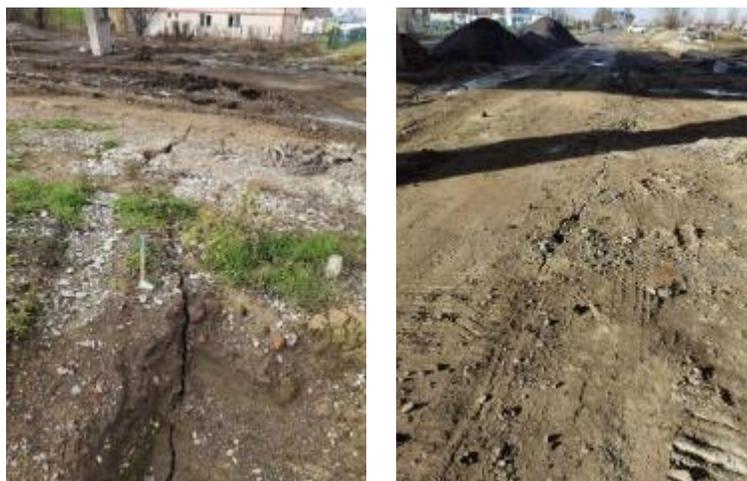
**Figure 9.18** Cracks in soil between S4 and S5 (source: Hrvatske ceste 2021).

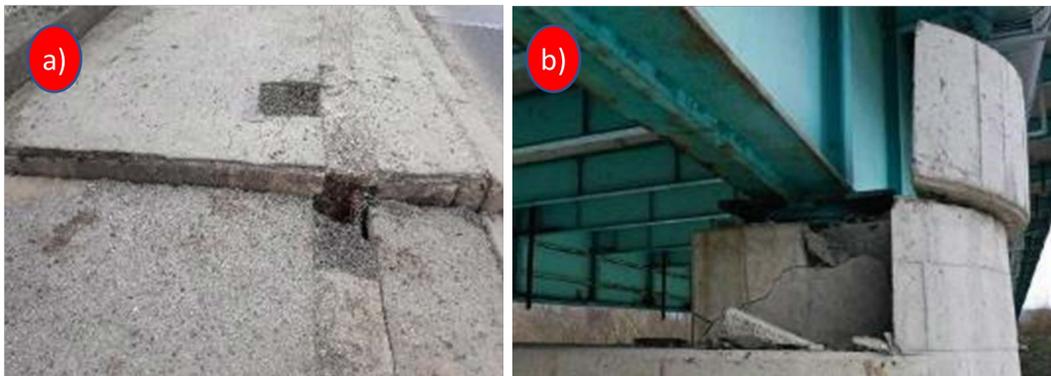
The column and abutments were constructed of cut stone filled with lean concrete and founded on 12-18 m deep caissons (Lazić, 1998). Fixed pot bearings (6000 kN) are installed on the central pier, while the pot bearings on the abutments (2000 kN) are movable in one direction (Lazić, 1998). Expansion joints KT-160 are installed at both abutments (Lazić, 1998). Damage observed includes settlement and damage to bridge embankment and asphalt layer just before the bridge, and damage to the bridge bearing and bearing pedestal on the column, as shown on **Figure 9.20**.

**Figure 9.20** Brest Bridge damage indicated in longitudinal and cross-section of the bridge (from Radić et al., 2007): a) settlement of the sidewalk before the abutment, b) damage to the bearing pedestal on the column (right).

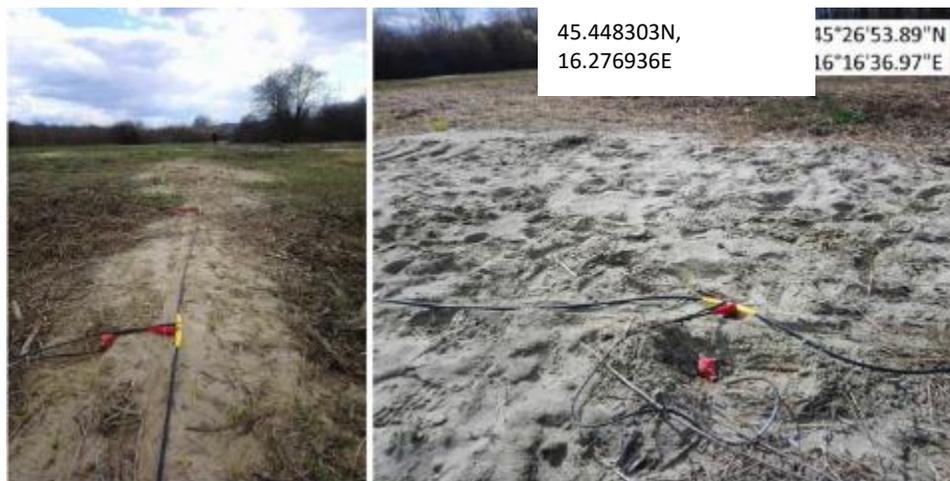
A total of four sites were selected for the survey. Two sites in the Mečenčani and Borojevići area (**Figures 10.6 to 10.8**) and two sites in Petrinja - one where clear evidence of liquefaction in form of sand boils was present (**Figure 10.9**) and a nearby site without sand boils present.

**Figure 10.9** MASW in Petrinja on a site with sand boils.

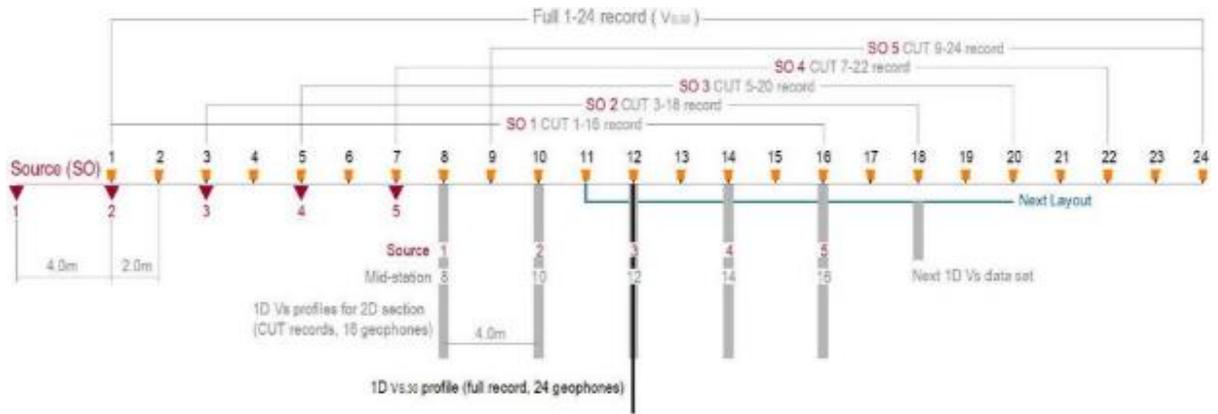
**Figure 10.10** Survey layout for 24 channel array.

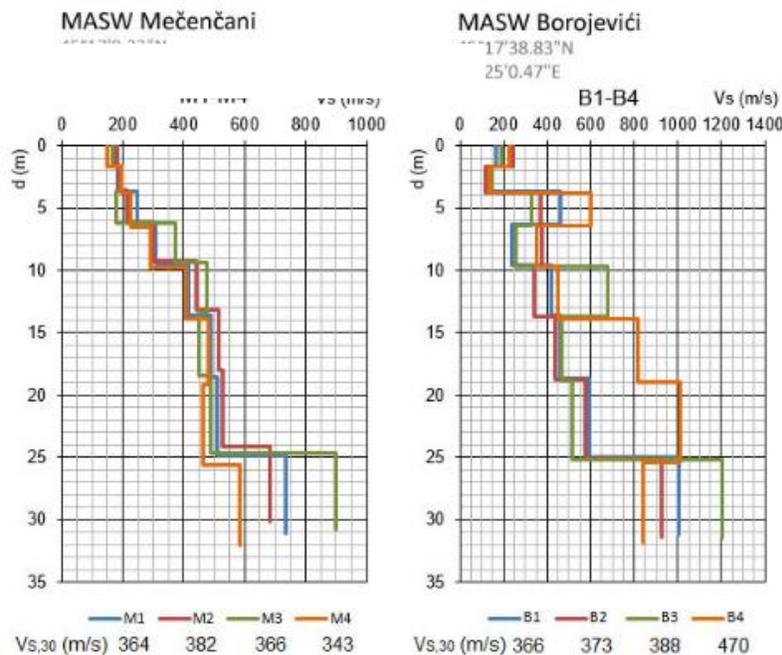
**Figure 10.11** 1D shear wave ( $V_s$ ) profiles with calculated average shear-wave velocity values of 30 m depth ( $V_{s30}$ ) in Mečenčani (45.283425N, 16.425781E) and Borojevići (45.294119N, 16.416797E).

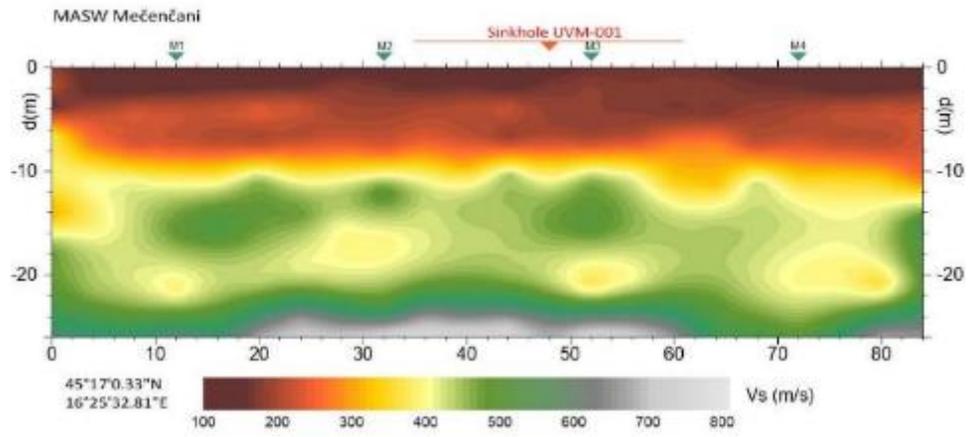
**Figure 10.12** 2D shear wave ( $V_s$ ) profile adjacent to the largest sinkhole in Mečenčani (45.283425N, 16.425781E).

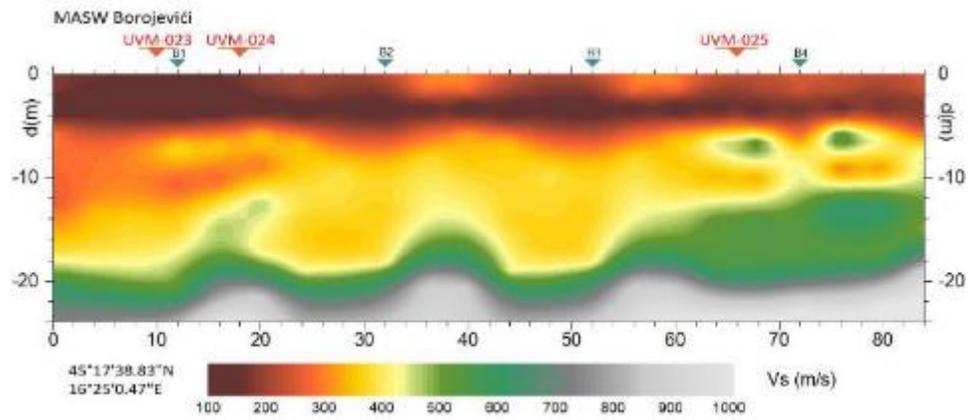
**Figure 10.13** 2D shear wave ( $V_s$ ) profile adjacent to three small sinkholes in Borojevići (45.294119N, 16.416797E).
