# Geotechnical Reconnaissance and Engineering Effects of the December 29, 2020, M6.4 Petrinja, Croatia Earthquake, and Associated Seismic Sequence

A report to the NSF-Sponsored Geotechnical Extreme Event Reconnaissance (GEER) Association<sub>1</sub>

Report GEER-072: <https://doi.org/10.18118/G63T0S>  
August 3<sup>rd</sup>, 2021

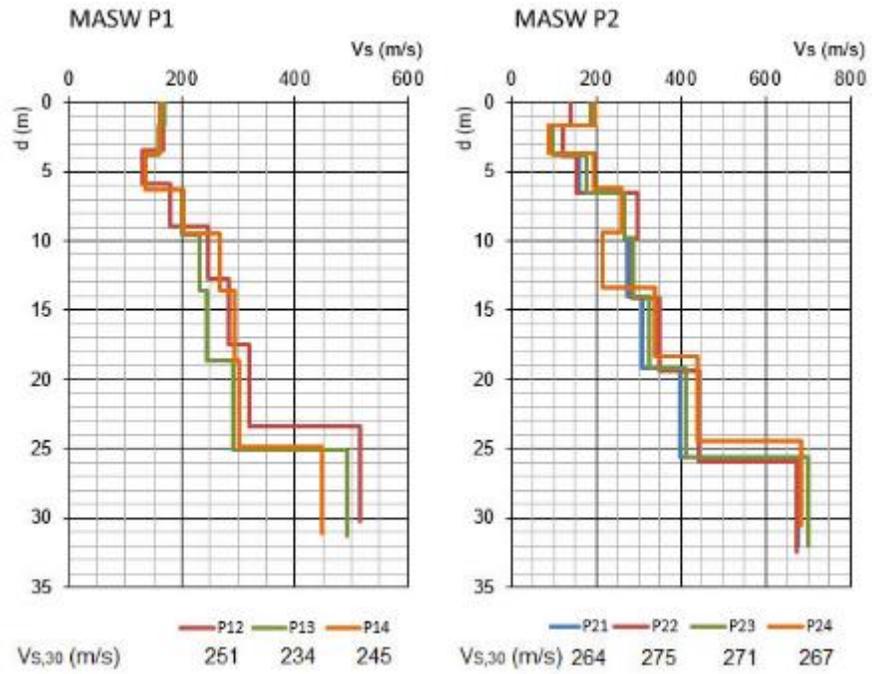
**Figure 10.14** 1D shear wave ( $V_s$ ) profiles with calculated average shear-wave velocity values of 30 m depth ( $V_{s,30}$ ) - MASW P1 and P2 in Petrinja (45.448303N, 16.276936E).

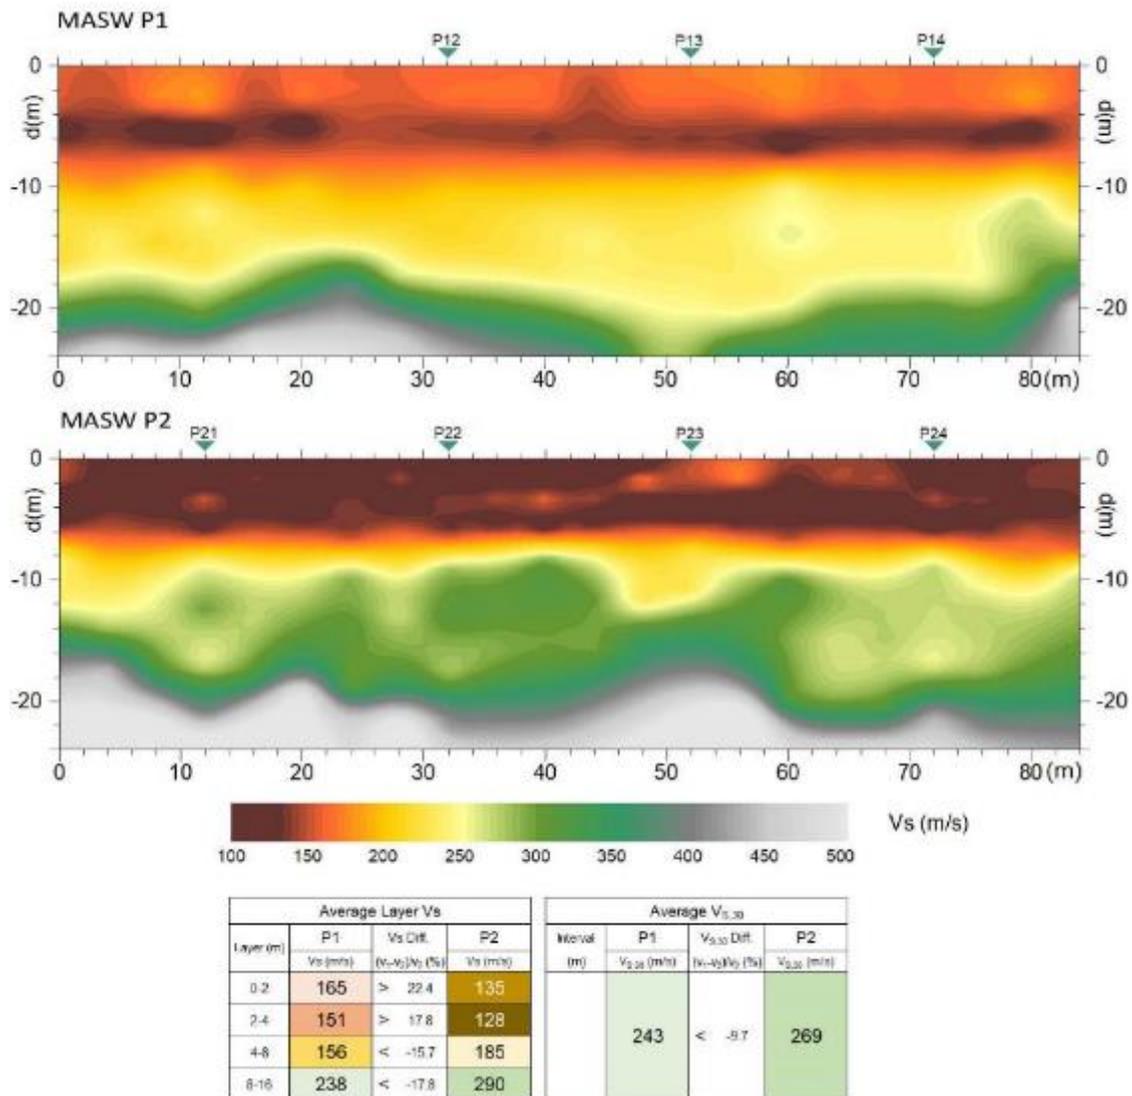
Figure 10.15 2D shear wave (Vs) profiles in Petrinja.

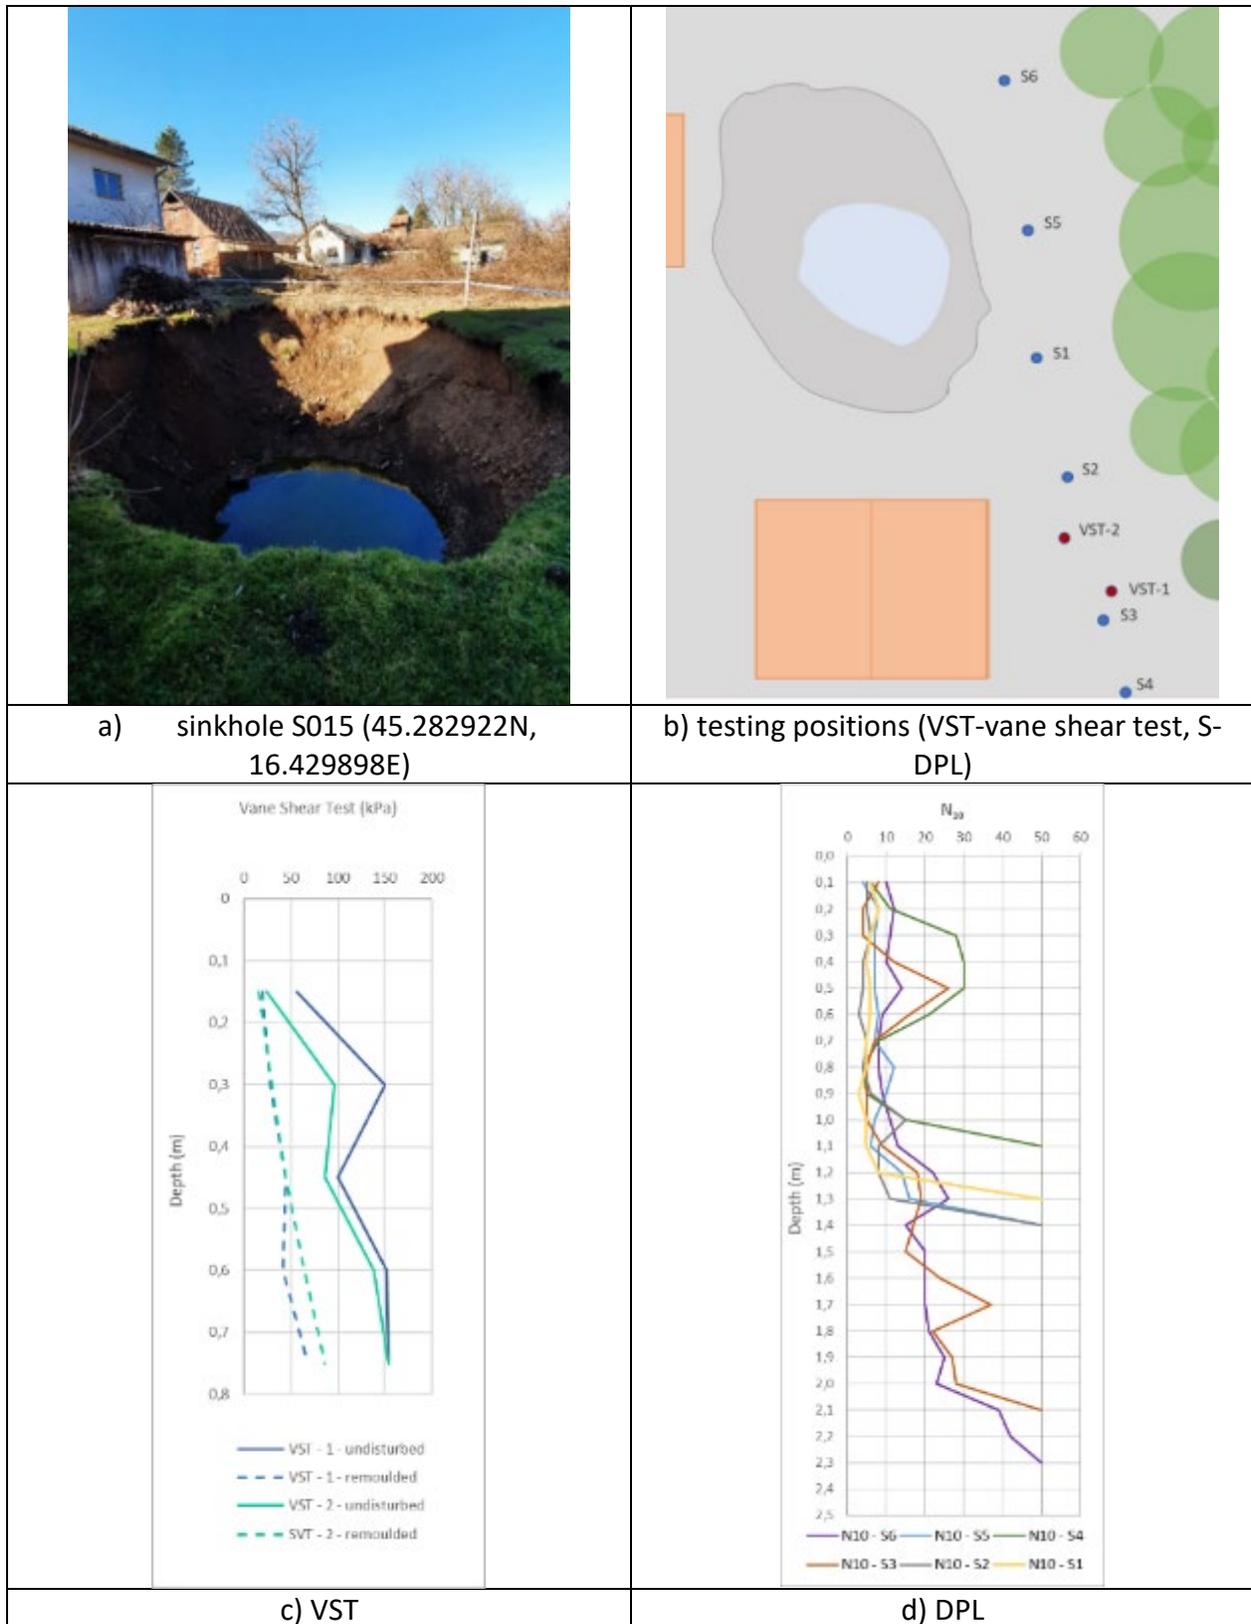
**Figure 10.17** Field work at location 1 (S015).

All the equipment was manually driven. Because of that fact together with the appearance of a shallow layer (depth of approximately 1.0 – 2.0 m) of coarse gravel with cobbles, field testing results are relevant only for a very shallow vertical profile (as shown in **Figure 10.17c** and **10.17d**). Two undisturbed samples were also taken (0.0 - 0.3 m; 0.3 - 0.6 m), preserved in the original plastic foil. Grain-size analyses and Atterberg limit test, which were performed in the Geotechnical laboratory at the Faculty of Mining, Geology and Petroleum Engineering University of Zagreb, showed that these samples belong to the group CL – sandy lean CLAY according to the ASTM classification (ASTM D 2487).

VST could be performed only to the depth of 0.75 m, showing the trend of undrained strength increase with depth, and 1.5 to 5.4 times smaller strength in remolded state comparing to the undisturbed strength. Six dynamic penetration tests were conducted at the site of the sinkhole S015. In all six probes, the test was terminated at depths of 1.1 m to 2.3 m because the probe penetrated negligible at 50 blows. The occurrence of water was observed at a depth of 1.7 m only at the DP03 probe. Based on the visible walls of the sinkhole and the number of blows per 10 cm of cone penetration,  $N_{10}$ , three units could be distinguished: a surface layer and lean clay with a low resistance to cone penetration ( $N_{10}$  3-15 blows); second unit where fine gravel is present ( $N_{10}$  15-42 blows), and bedrock or large cobbles with  $N > 50$ . When handling the probe, the friction of the metal against the gravel grains was felt in the second layer. With the appearance of coarse gravel (grains with a diameter of 20 cm were visible in the sinkhole), penetration was no longer possible. By visual inspection of the sinkhole and DPL results, up to the depth of 1-1.5 m, a yellowish-brown sandy lean clay can be seen. Below that depth, the content of coarse gravel and cobbles increases. The water level was pretty high, at the depth of approximately 2.0 m, and the soil was visible moist from the depth of 1.5 m.

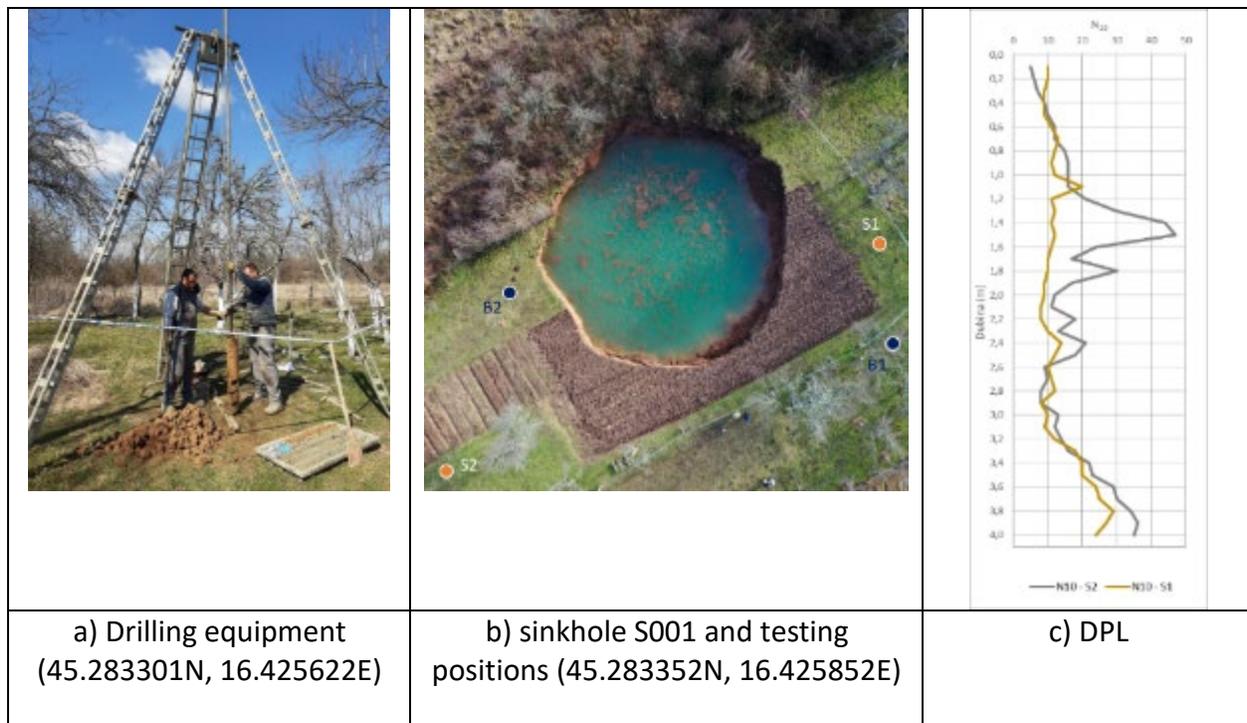
**Figure 10.18** Field work at location 2 (S001).

Two dynamic penetration tests were conducted at the site of the sinkhole S001. For both probes, the test was terminated at a depth of 4.0 m, as the declared maximum penetration depth for the equipment was reached. No occurrence of water was observed during testing. S2 probe (**Figure 10.18c**) showed small values of  $N_{10}$  to the depth of 3.2 m ( $N_{10}$  8-14 blows), only one reading showed a higher value (at 1.1 m,  $N_{10}$  was 20 blows). Below the depth of 3.3 m  $N_{10}$  was 18-29 blows. S1 probe showed significantly higher values of  $N_{10}$ . The maximum value ( $N_{10}$  47 blows) was measured at the depth of 1.5 m.

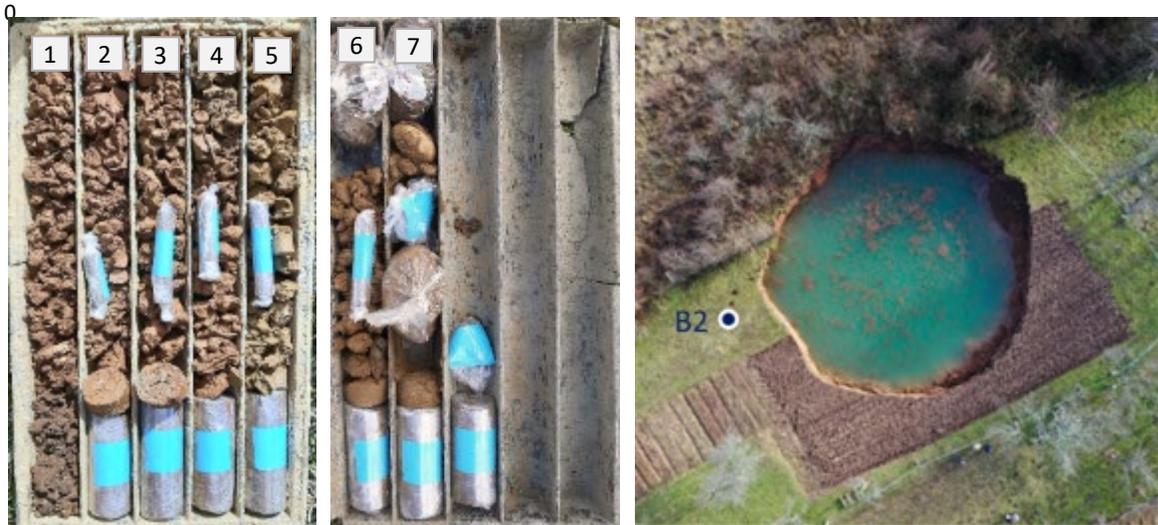
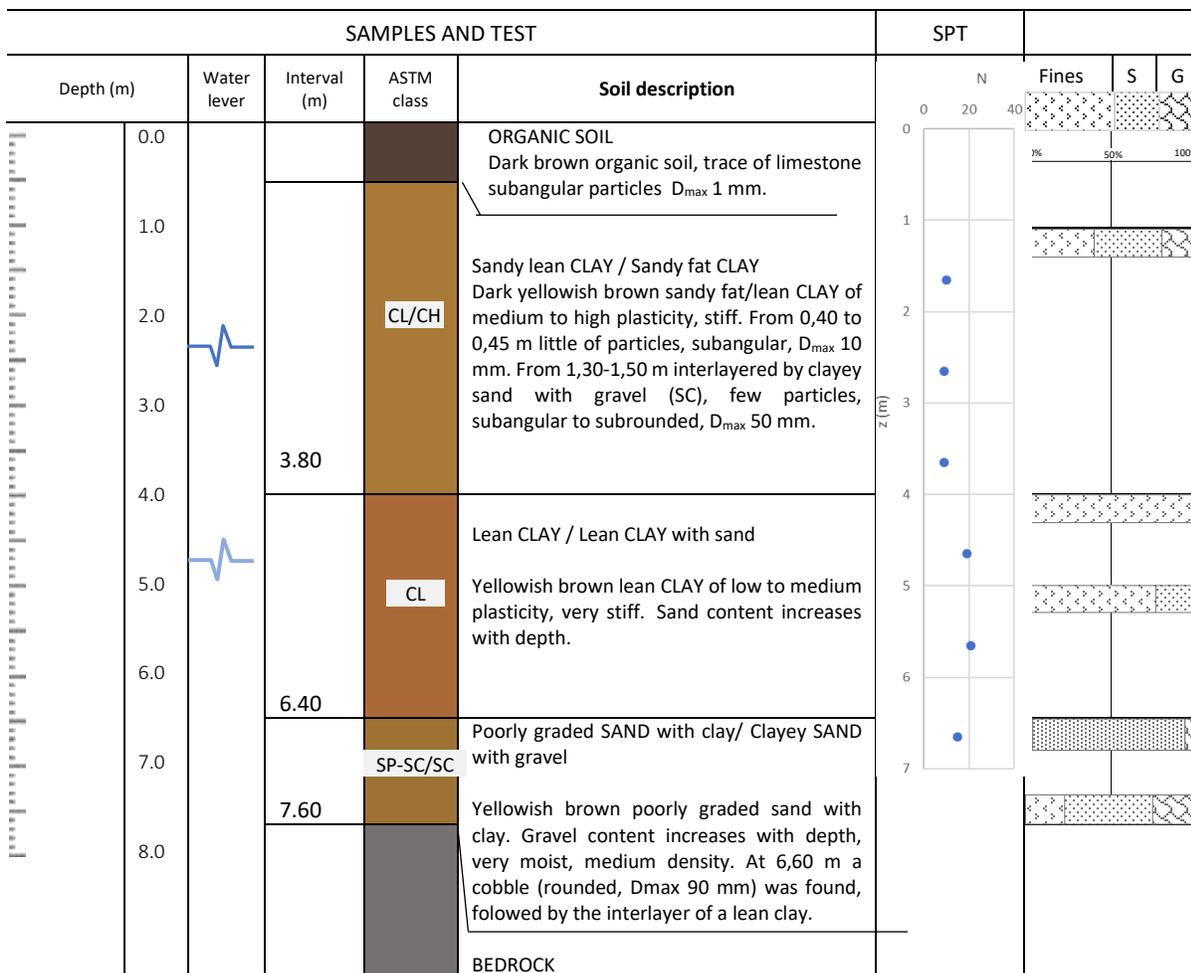
Figure 10.25: Borehole log B2

BOREHOLE LOG		B-2 Mečenčani (S001)		
Project GEER Petrinja		Date 23.03.2021.	Equipment Portable rotary power auger	Coordinates 45.283416, 16.426094

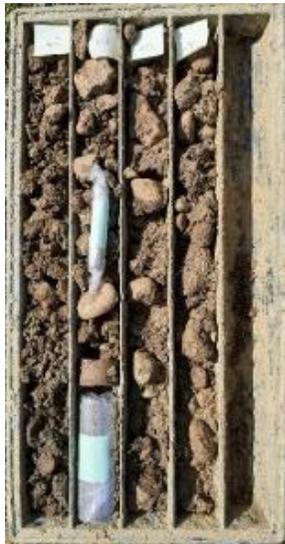
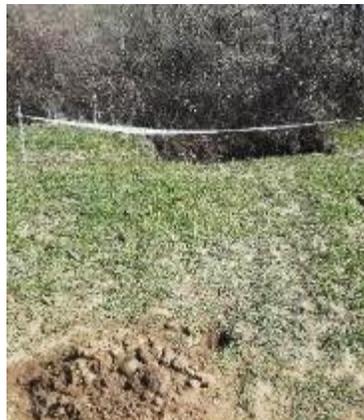
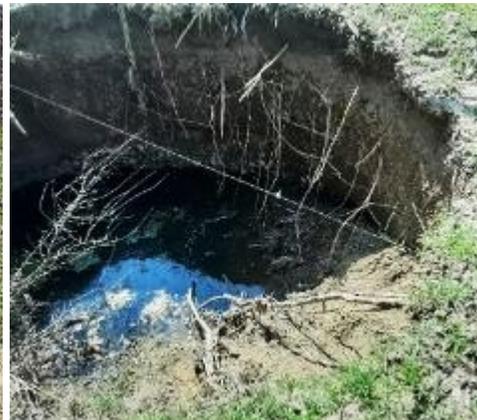
Figure 10.26: Borehole log B3

SAMPLES AND TEST					SPT	Fines S G			
Depth (m)	Water lever	Interval (m)	ASTM class	Soil description	N	Fines S G			
						0	50	100	
0.0		0.30		ORGANIC SOIL, dark brown					
				Lean CLAY					
1.0		1.40	CL	Yellowish brown lean clay of medium plasticity, stiff. Limestone concretions in traces.					
2.0				Poorly graded GRAVEL with sand					
3.0				Yellowish brown coarse to fine poorly graded gravel with sand, soft, medium density. From 3,10 m very moist.					
4.0		4.00		COBBLES ?					
5.0									
6.0		5.80		BEDROCK					
7.0

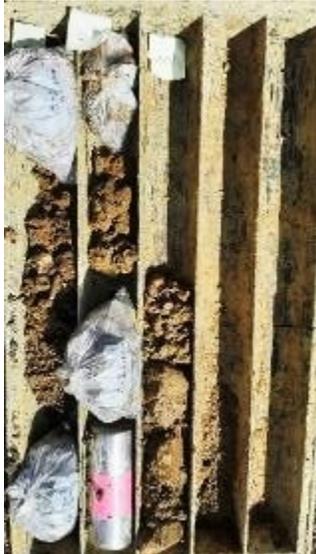
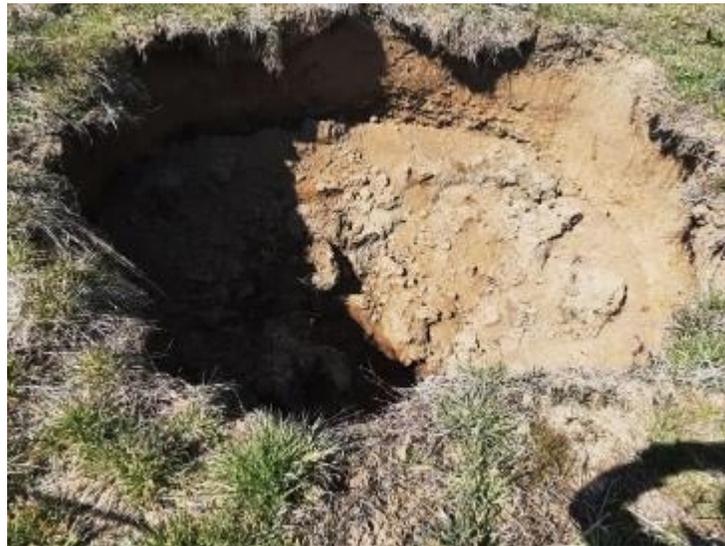
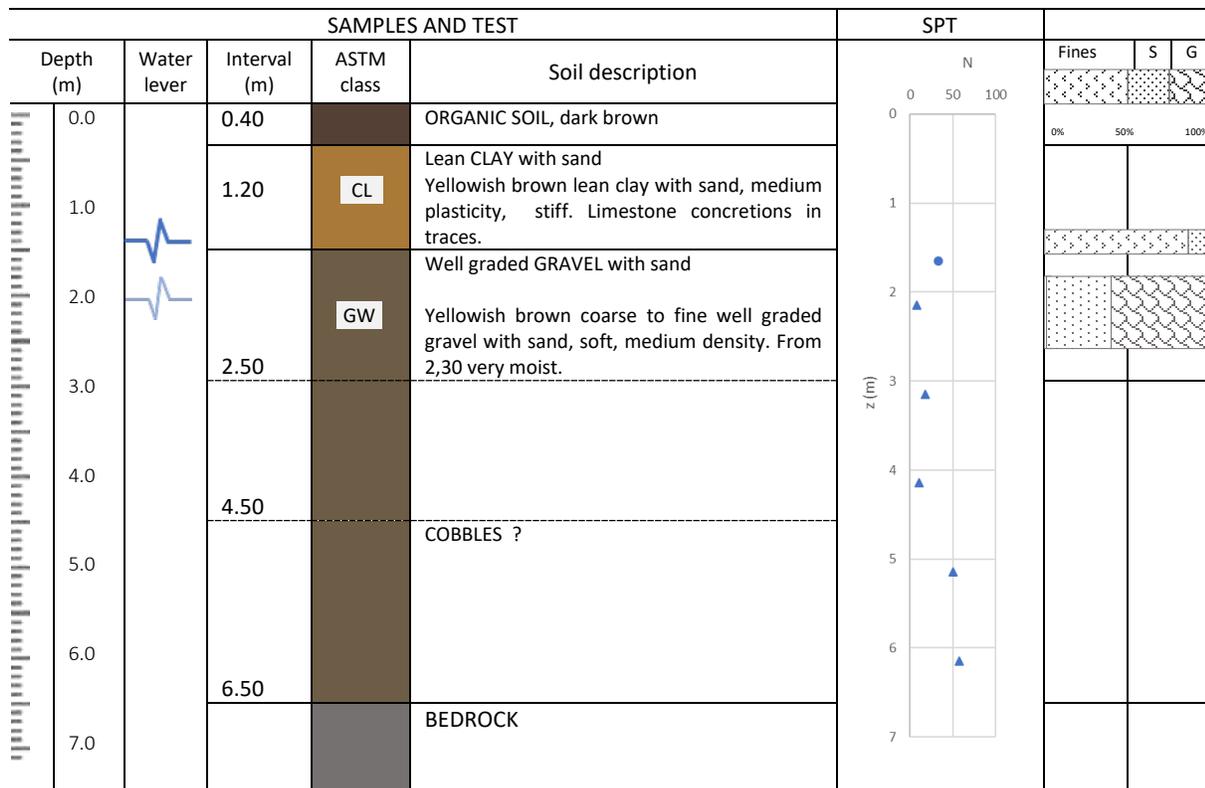
Figure 10.27: Borehole log B4

BOREHOLE LOG		B-4 Borojevići (S040)		
Project GEER Petrinja	Date 26.03.2021.	Equipment Portable rotary power auger	Coordinates 45.292921, 16.422418
