Turning Disaster into Knowledge

**GEOLOGICAL AND GEOTECHNICAL ENGINEERING
RECONNAISSANCE OF THE SEPTEMBER 19, 2022,
MICHUACAN EARTHQUAKE, MEXICO**

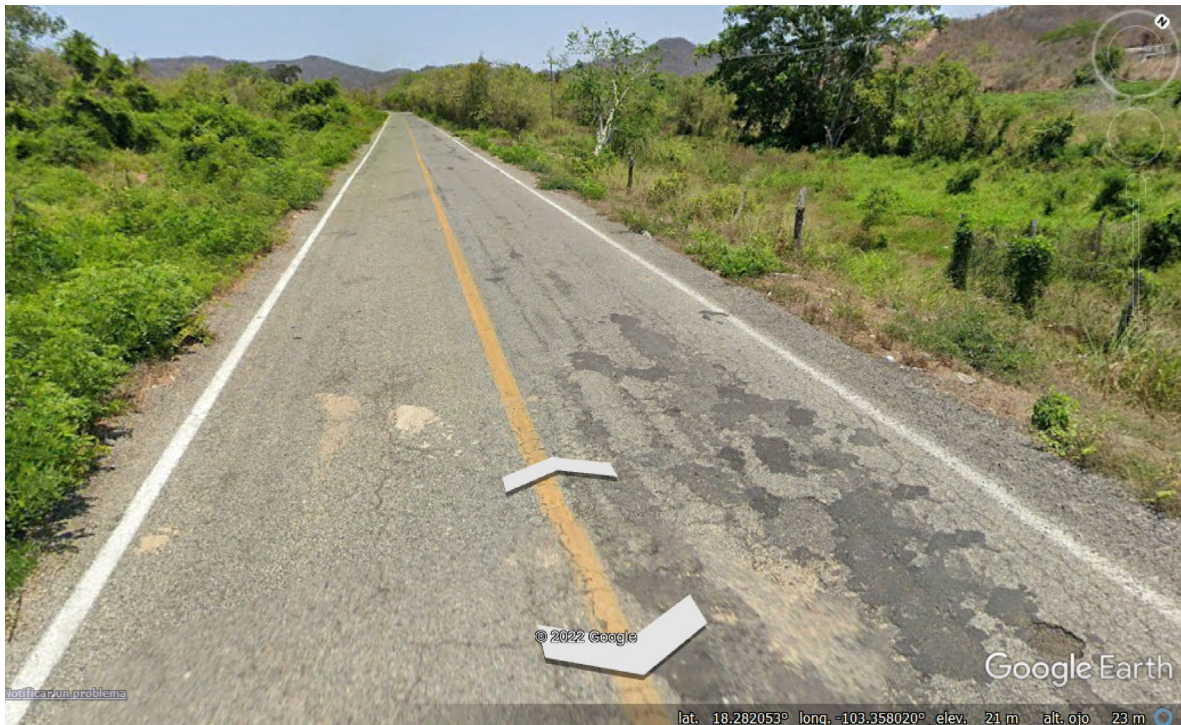
Figure 28a. Road before the earthquake, (Google Earth, image date: May 2022).
(Coordinates: 18.282195°, -103.358294°)

Minor damage in the form of cracking was noted along roads and highways within 50 km of the epicenter. Near the epicenter in Maruata, Michoacan, severe longitudinal cracking was detected on the road due to lateral movement. On average, the observed cracks were 6 m long, 38 cm wide, and 100 cm deep. Figure 28a depicts the road conditions before the earthquake; Figure 28b shows the conditions observed by the reconnaissance team.
