**THE GEOTECHNICAL ASPECTS OF THE
CENTRAL TEXAS FLOODS OF MAY 23-25, 2015**

Report of the NSF Sponsored GEER Association Team

GEER Association Report No. GEER-039

Version 1: June 12, 2015

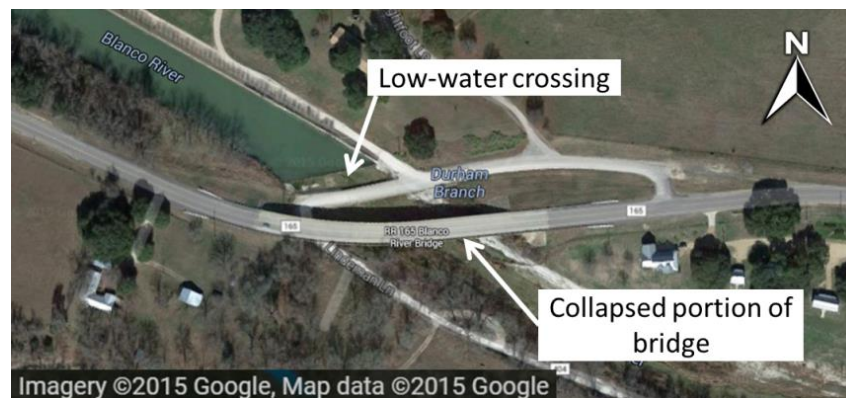
Figure 6. Layout of RM 165 Bridge (Figure courtesy of Google Maps)

The RM 165 Bridge over the Blanco River is located approximately 1.5 miles east of Blanco, TX and is approximately 25 river-miles upstream of the Fischer Store Road/CR181 Bridge (Figure 2, 30.090978°N, -98.401736°W). The bridge, built in 1994, was very heavily skewed as shown in Figure 6 and had a curve in the western portion of the bridge. The superstructure was supported by four wall piers on the eastern portion of the bridge, aligned with the channel flow direction, and one four-column bent near the west abutment. Similar to the Fischer Store Road Bridge, the lateral forces in the superstructure appeared to have been transferred to the substructure via shear pins at the exterior girder supports.

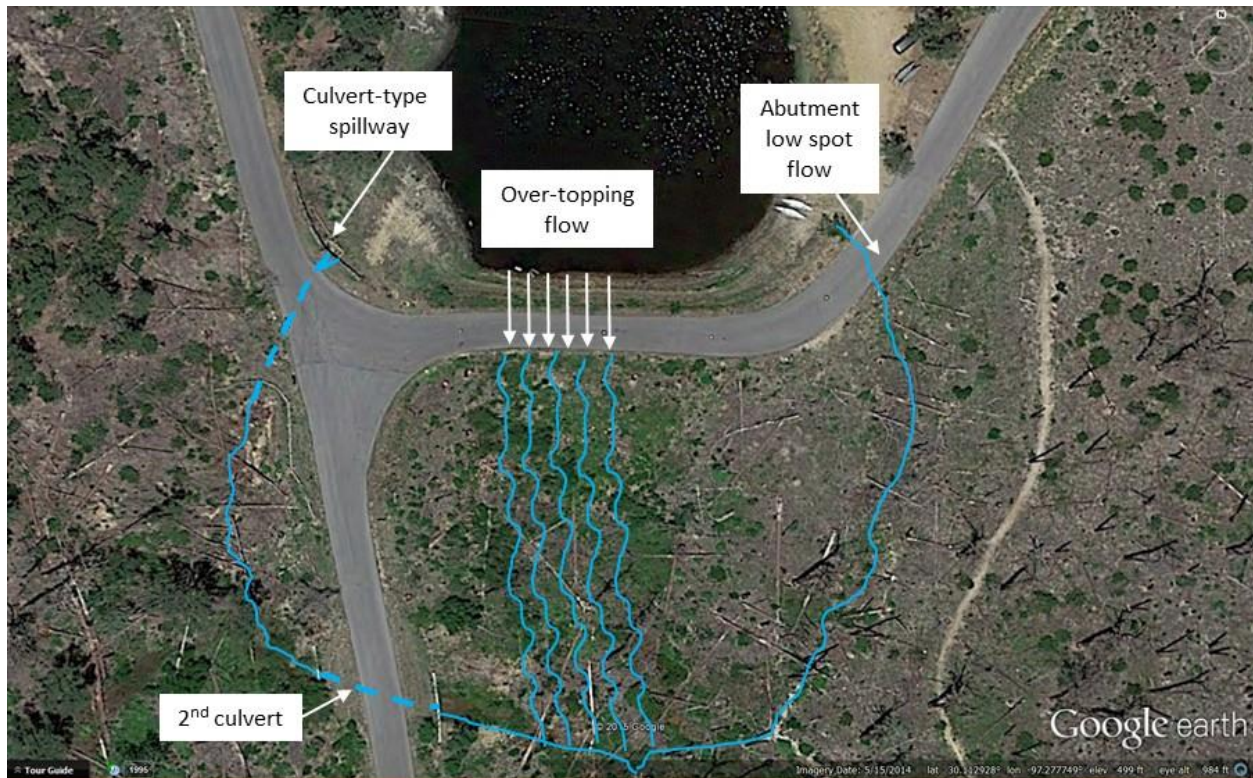
Figure 12. Schematic of the flow conditions at the time of failure
(imagery courtesy of Google Earth).

The lake was approximately 70 m wide at the dam and approximately 350 m long (Figure 11). The dam was outfitted with a small culvert-type spillway that runs approximately northeast-to-southwest underneath the existing road (Figure 12). While small, this culvert-type spillway had historically been sufficient to keep the water in the lake from over-topping the dam. Exceptions to this occurred in 1992 (TCEQ 2005) and January 2012, when water in the lake flowed over a low spot on the east abutment (Figure 12). Although not designed as a spillway, this low spot is referred to as the emergency spillway in a Dam Safety Report by TCEQ (2005). The low spot is approximately 0.64 m above the top of the culvert-type spillway and 0.29 m below the crest of the dam (the crest of the dam was inferred by connecting survey points from the remaining segments of the dam after the failure). While the flow across the low spot on the east abutment caused little-to-no erosion/damage to the dam in 2012 (personal communication, Greg Creacy, TPWD), flow through the culvert-type spillway was intense, leading to a washout of the second culvert that passes approximately west-to-east under the main approach road (Figure 12), which is well below the downstream toe of the dam.

On Monday, May 25, 2015 significant rain began in the Bastrop area at about 5 pm. Between about 5 pm and 6:30 pm, over 4 inches of rain fell in the Bastrop area as inferred from LCRA rain gauges at Lake Bastrop, 2.2 miles north of the dam (4.4 inches of rain measured), and at the Colorado River in Bastrop, 2.5 miles west of the dam (4.6 inches of rain measured). The rain gauge at Bastrop State Park only reports daily rain fall, and measured 4.83 inches on May 25. At approximately 6:30 pm a TPWD employee approached the dam. He noticed water running across the road at the location of the second culvert. He passed through this water in his pickup truck and drove to the top of the dam, where he noticed water from the lake flowing over the crest near the mid-point of the dam. At this time, he reported that a section of the asphalt approximately 5-m long by 3-m wide (approximately 15 ft by 3 ft) had been eroded from the south-side of the road that crossed the crest of the dam (personal communication, Robert Trudeau, TPWD). At this time, he left the dam to warn others of the impending failure. At approximately 6:48 pm, TPWD employee Greg Creacy approached the dam and witnessed the complete overtopping flow and failure shown in the photograph of Figure 13.
