Site Visit and Drone Based Reconnaissance Study of the Severely Affected Infrastructure by February 7th, 2021, Chamoli Rock-Ice Avalanche Disaster, Uttarakhand, India

Barrage of Tapovan Vishnugad hydroelectric project

GEER – 074
doi:10.18118/G6V95B

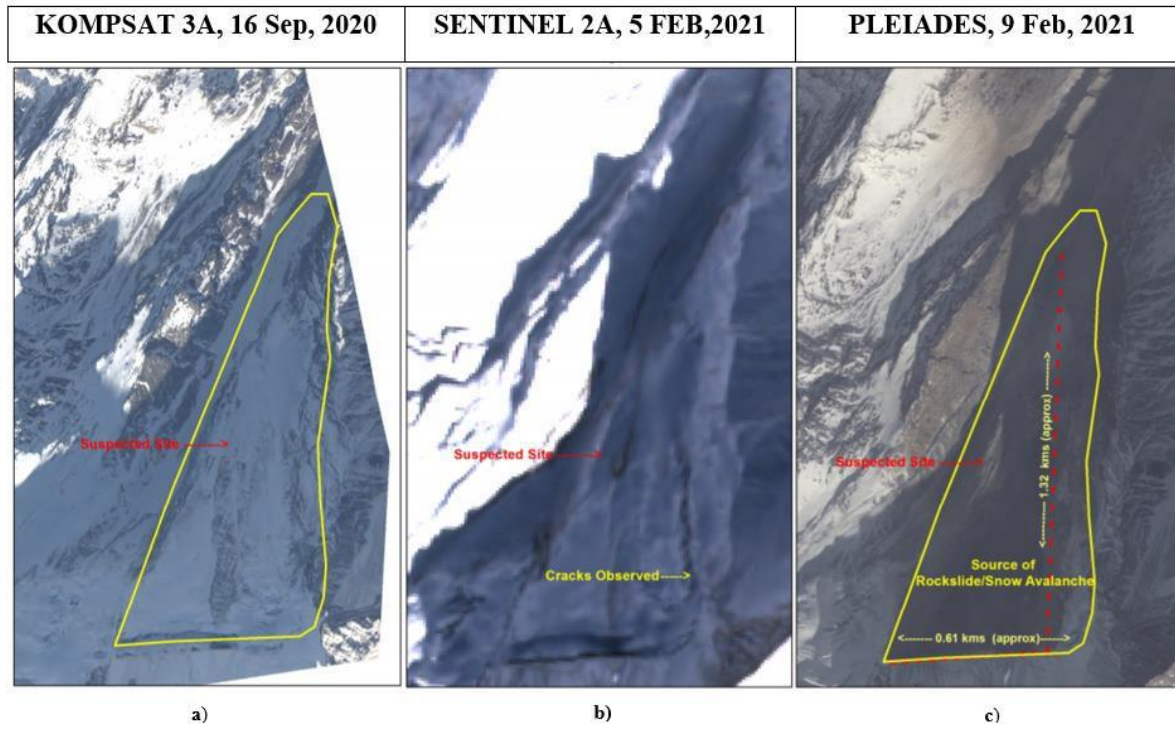
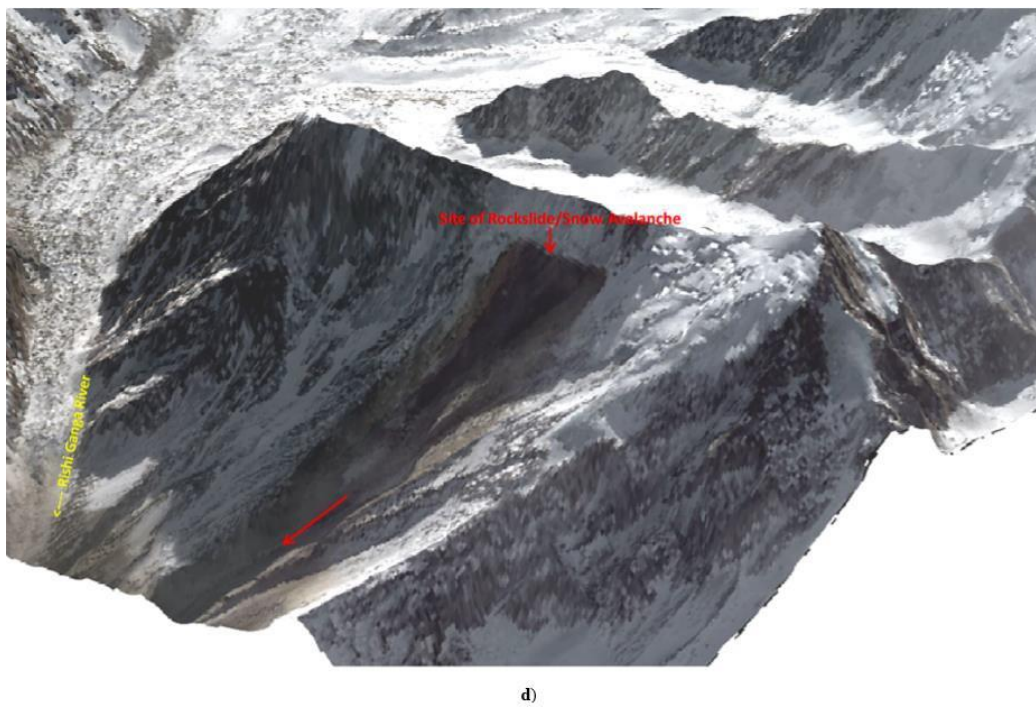
The satellite images (KOMPSAT 3A, SENTINEL 2A, and PLEIADES) that were released immediately after the event revealed that the source of the flash flood was found at Ronti Peak (Glacier Valley) at an altitude of about 5500 m Mean Sea Level (MSL). Figures 1.1a and 1.1b

present the satellite images of suspected rock-ice slide avalanche location (captured on 16th Sep 2020) and crack formation just before the event, i.e., 5th Feb 2021, respectively. The image presented in Figure 1.1(c), captured on 9th Feb 2021, clearly indicates that a massive and suspended site was dislodged, forming a vast cavity with approximate dimensions of 0.61 km wide and 1.32 km high. Figure 1.1(d) presents a 3D interpretation of the slide and its location. Figure 1.2 gives the overviews of the rock-ice avalanche travel path (bold blue line) from the event source to the point where the floodwater and debris were detained.

Figure 1.1 a) Suspected Site of Rockslide/Snow Avalanche (16 September 2020, source: KOMPSAT 3A) (b) Observed cracks (05 February 2021, source: SENTINEL 2A) (c) Crack width (source: PLEIADES) (d) 3D Rendition of the Suspected Area of Rockslide/Snow Avalanche (09-Feb2021, source: ISRO-CARTOSAT-3 satellite)

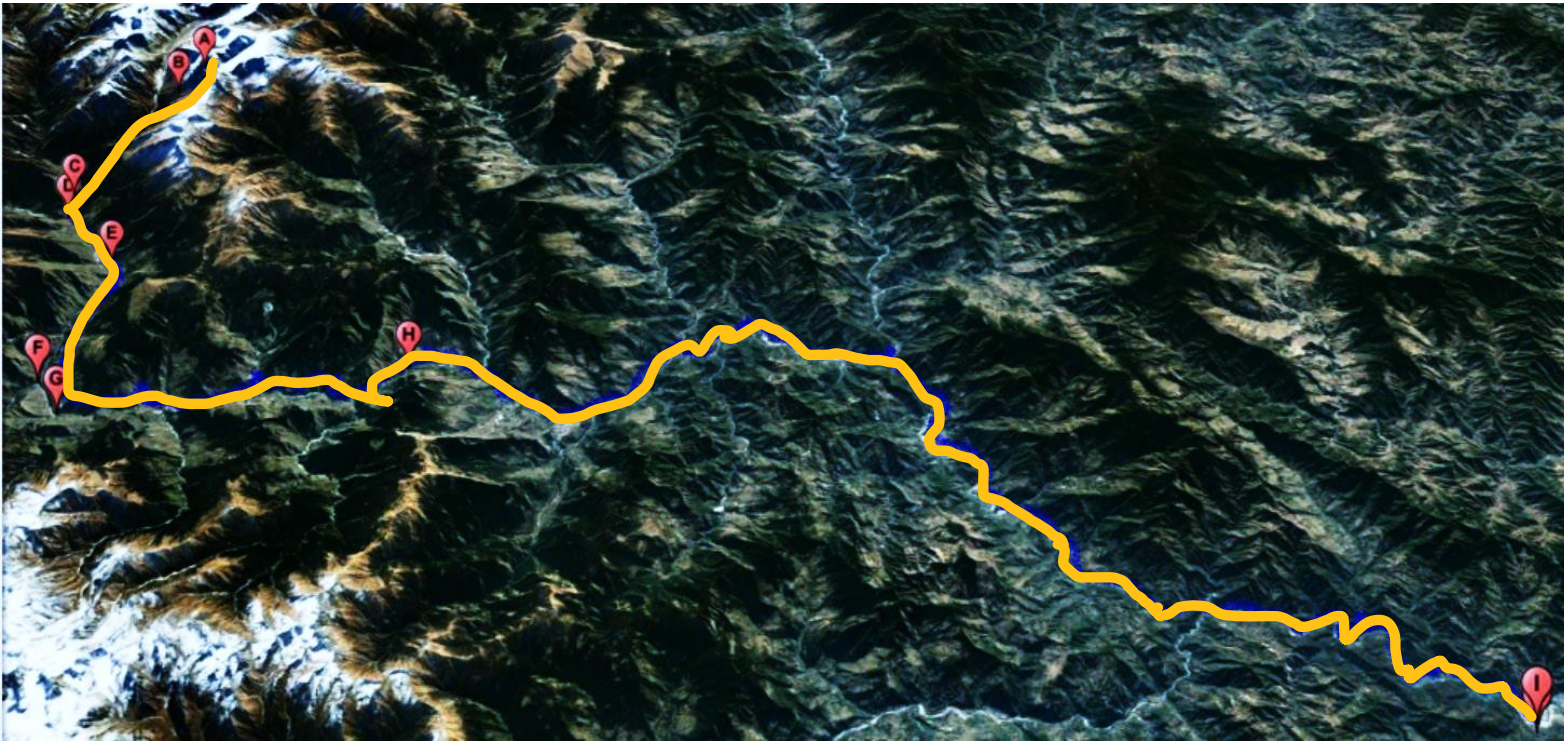
Figure 1.2 Overview of the rock-ice avalanche travel path (bold blue line) from the event source to the point where the floodwater and debris were detained.

A - Source of rock-ice avalanche (30°22'35.05"N, 79°42'59.15"E)
B - Ronti Gad (30°23'39.27"N, 79°43'18.71"E)
C - Rishiganga HEP (30°28'42.04"N, 79°41'59.65"E)
D - Confluence: Rishiganga and Dhauliganga (30°29'17.54"N, 79°41'24.47"E)
E - Tapovan HEP (30°29'32.85"N, 79°37'52.51"E)
F - Confluence: Dhauliganga and Alaknanda (30°33'44.68"N, 79°34'33.99"E)
G - Vishnuprayag HEP (30°34'1.09"N, 79°32'48.56"E)
H - Vishnuprayag Pipalkoti HEP (30°25'58.80"N, 79°25'26.40"E)
I – Srinagar Dam/ Alaknanda HEP (30°14'31.28"N, 78°49'20.41"E)

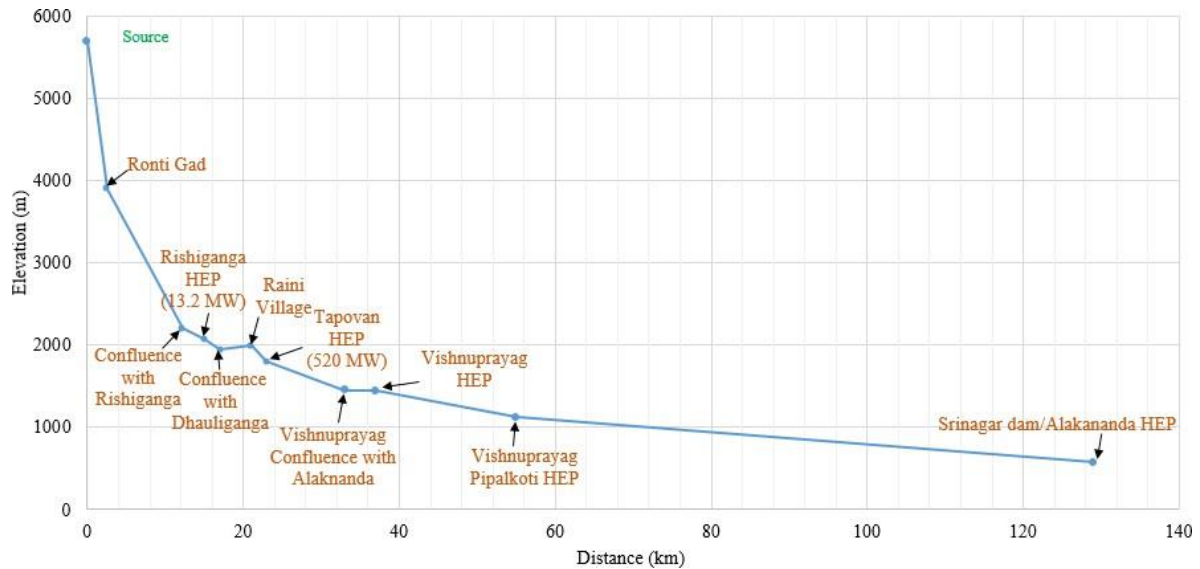
Figure 1.3 Distance and elevation difference of different affected areas from the source of rock-ice avalanche

Figure 1.3 depicts the distance and elevation difference of different hydropower projects and rivers from the source of the rock-ice avalanche. One can imagine the impact and the intensity of the damage incurred by hydroelectric projects and associated structures due to the flash flood. The first interaction of dislodged mass with the ground surface was with a small stream through which the glacier drains, i.e., Ronti Gad, at a distance of approximately 1.6 km and about an elevation of 1800 m below the source. Then it traveled along the valley of Ronti Gad and mixed with Rishiganga River, a source for the 13.2 MW Rishiganga hydroelectric project (HEP) near Raini Village at an approximate distance of 15 km with an elevation difference of 3631 m from the impact (source) site. It is the first HEP to face the brunt of the intense rock-ice avalanche. Most of its structures/components were swept away and buried. Debris from R-HEP damaged other units downstream and several megastructures, including one of the essential RCC bridges at Rishiganga

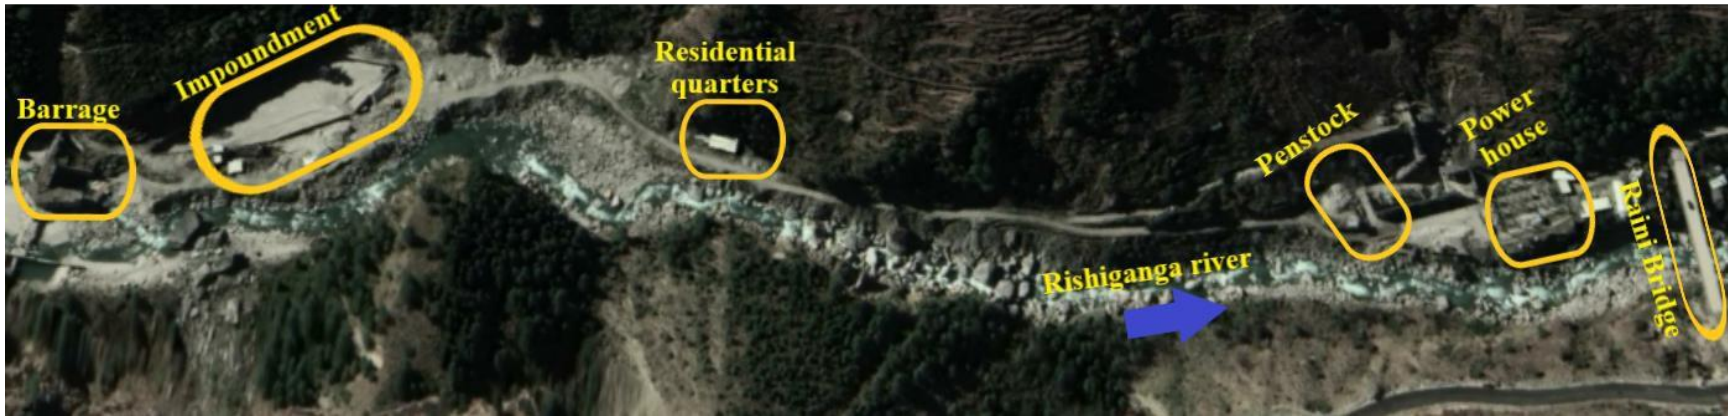
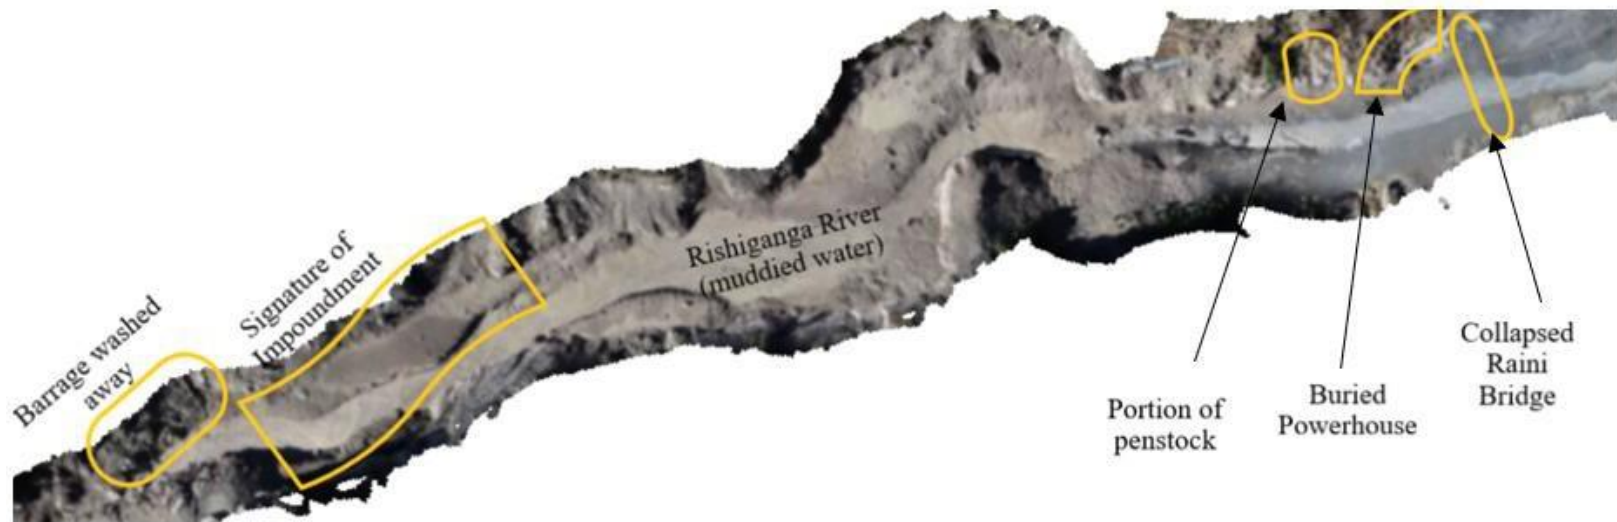
The first reconnoitered area consisted of several vital infrastructures, including a barrage, impoundment, and components of the hydropower plant, roads, and a reinforced concrete bridge, as shown in Figure 3.1a. Figure 3.1b presents the post-event orthophoto generated from the drone survey of the same area. The hydroelectric project commissioned in September 2012 was a Run-of-River (RoR) with a capacity of 13.2 MW on the Rishiganga River, expected to generate approximately 59,031 MWh (net) electricity per annum, and was completely damaged. The RCC Bridge is a crucial and necessary structure connecting the two parts of the Raini village and links 13 villages close to the border with China that got completely washed away. Along with these structures, several other associated and supporting buildings of HEP and connecting roads also suffered severe damage, as shown in Figure 3.1b, due to the flash floods. Figures 3.2-3.4 give the close-up view images of the REP and Raini bridge components collected from the locals. Figure 3.2 presents the impoundment connected to the diversion tunnel before and after filling the water. Figure 3.3 shows staff quarters, office buildings, and some utility structures of the powerplant before the event. The powerhouse, penstock, and three-story building are on the Rishiganga river left bank. Figure 3.4 presents an inside view of the power plant. These structures were destroyed and thus missing after the disaster (Figure 3.1b).

Figure 3.1 Status of Infrastructure in the Rishiganga HEP location before and after the event. The locations of the structures are marked by solid yellow line shapes a) Google Earth imagery, November 2018. b) ortho-imagery from drone survey, February 11th, 2021

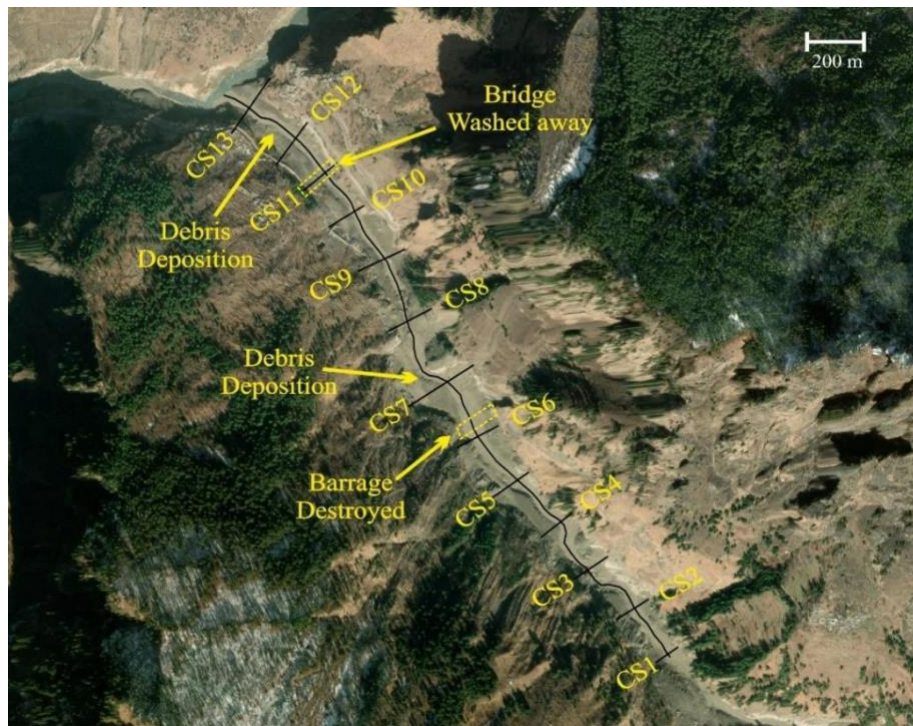
A total of 13 cross-sections at important locations were examined for pre and post-event to understand the debris flow dynamics. The selected cross-sections are abbreviated as CS# (#1 through 13), as shown in Figure 3.8. CS1 and CS13 represent cross-sections located near upstream of the barrage and the confluence of the rivers, respectively. The barrage is located around CS6, the powerhouse is between CS9 and CS11, and the bridge was at CS11. The elevation profile across cross-sections CS-1 to CS-13 are shown in Figure 3.9, and can significantly influence the flow velocity.

Figure 3.7 Proposed cross-sections along the riverbed from CS1 to CS13 from post-event orthophoto and DEM @30°29'5.11"N 79°41'40.46"E

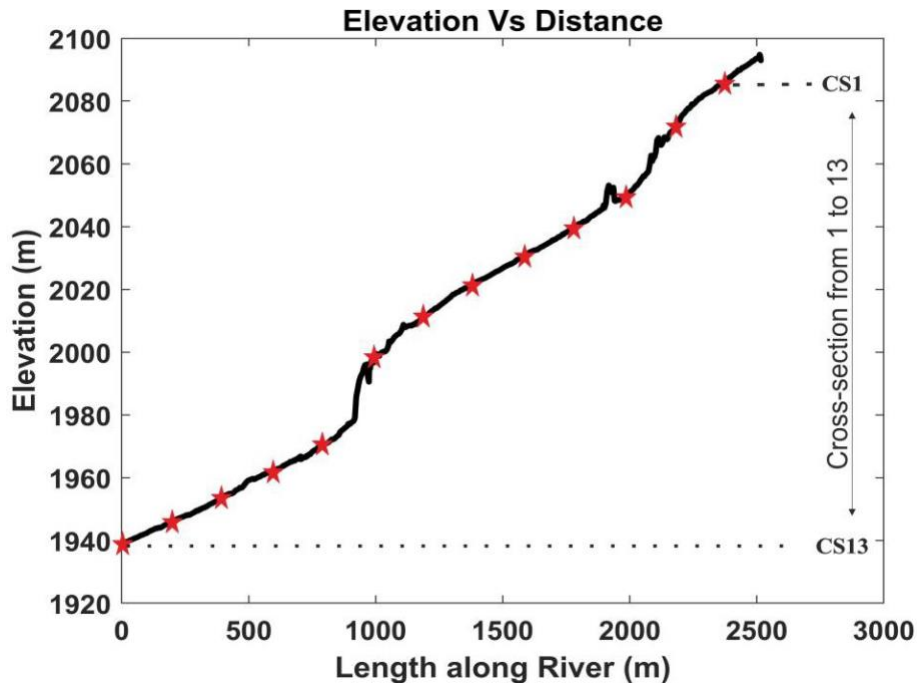
Figure 3.8 Surface elevation profile in the valley along the riverbed from CS-1 to CS-13.

Similarly, from Figure 3.9, it is evident that there is a significant change in elevations between the cross-sections from CS1 to CS13; the maximum and minimum are 2090m and 1950m, respectively. A steep decline in elevation and increase in slope is observed between CS8 and CS9. This could have increased the flow velocity, aggravated debris flow's momentum, and caused massive destruction to the nearby powerhouse and bridge. These rapid and sudden changes in cross-sections (shapes and sizes) and elevations explain the extent of damage to the structures due to increased flow velocity and energy. An analysis of the cross-section study revealed the critical flow dynamics and plausible relation to the extent of damage and debris deposition.

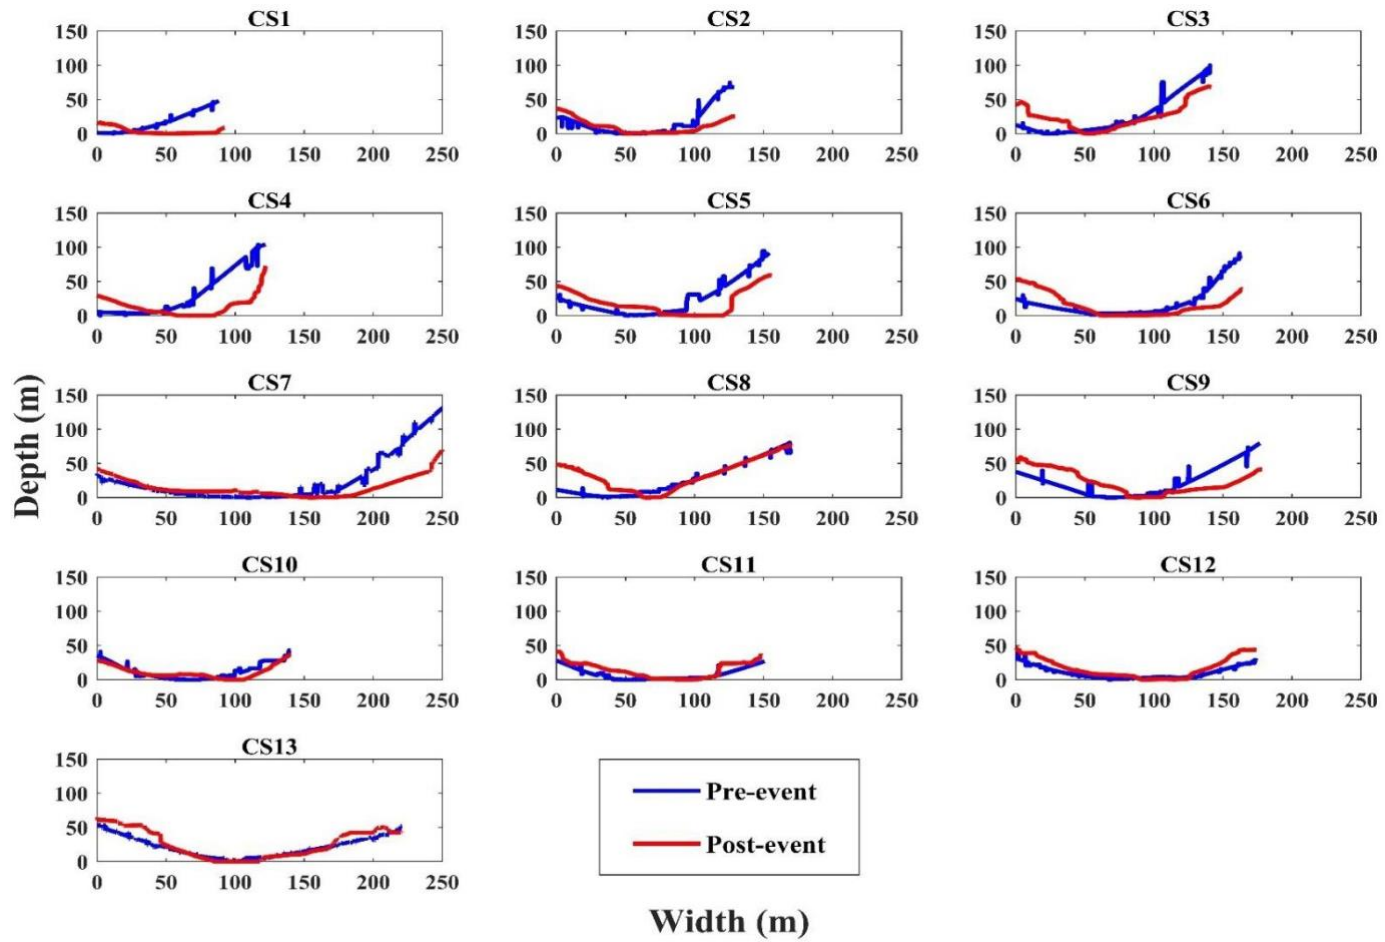
The pre-event and post-event cross-sections were obtained from their respective DEMs. Figures 3.10 and 3.11 compare the pre and post-event cross-section shapes and areas, respectively. The cross-sectional profiles were generated from DEM using the ArcGIS Spatial Analyst tool. Further these profiles were opened in MATLAB to generate the valley cross-sectional area. It can be observed that the shape and area of the post-event cross-sections are due to erosion and debris deposition in the valley. A majority of the erosion can be noticed on the right bank of the valley and deposition on the left side of the bank.

Figure 3.10 Variation of cross-sectional shape in the valley along the river from CS-1 to CS-13.

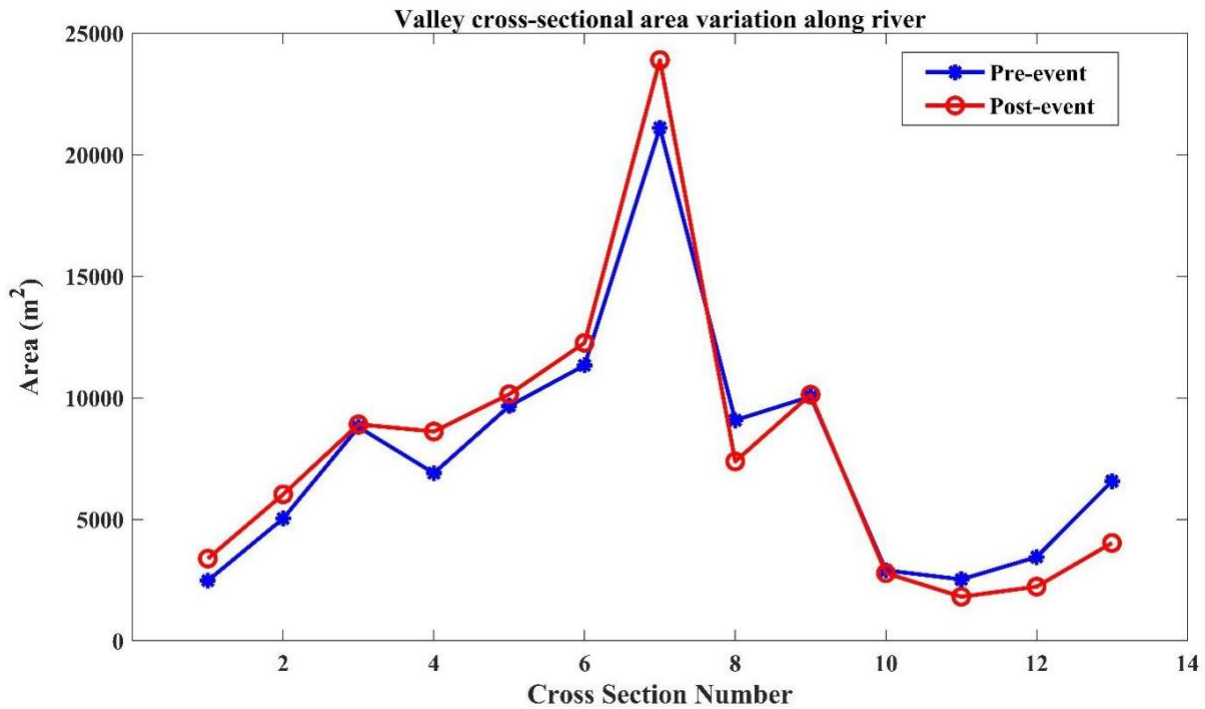
area was noticed at CS10. Again gradual increase after CS10 till CS13 can be observed.

Figure 3.11 Variation of the cross-section area in the valley along the river from CS-1 to CS-13

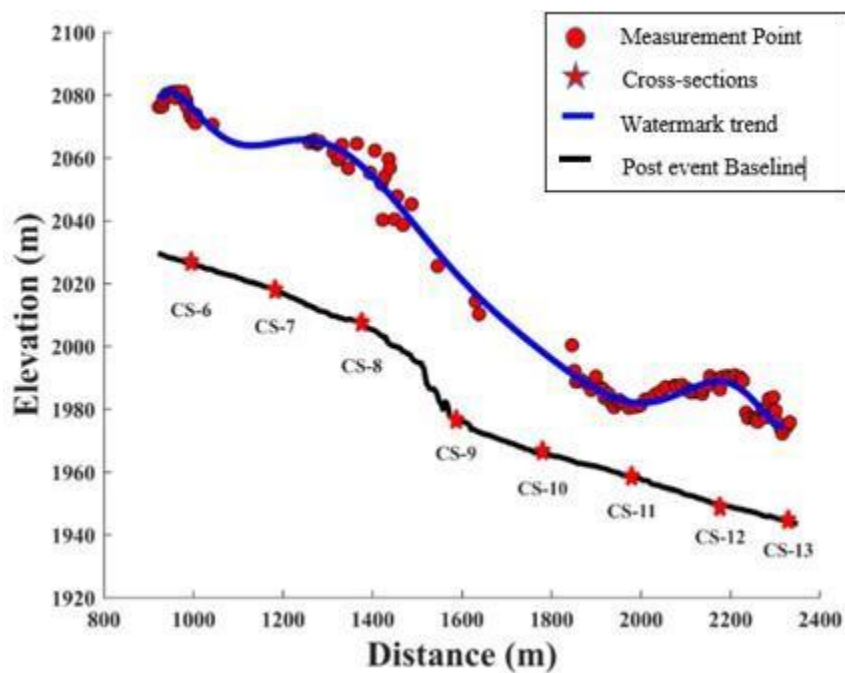
The visible watermarks left by the debris flow along the Rishiganga river were identified using DEM draped by the mosaic images. The post-event baseline is assumed at the centerline of the Rishiganga river flowing in the longitudinal direction (middle of the Rishiganga) observed on February 11th, 2021. The debris flow watermark elevations, baseline elevations, and location of cross-sections are shown in Figure 3.12. Only the debris watermarks selected in the region from CS6 through CS11 are shown, as they were distinctly visible. The maximum and minimum elevations for debris watermark and baseline at CS6 and CS11 are 2090m and 1990m and 2030 m and 1950 m, respectively. The watermark profile is decreasing with the decrease in the elevation from CS-6 to CS-13 as expected. However, sudden variations in the watermarks are noticed at different locations from CS-6 to CS-13. These variations can be attributed to their valley cross-section shape and area. At Raini bridge (CS-11), the elevation of the debris, watermark rises

despite the increase in the cross-section area of the valley. This increase may be attributed to splashing caused by the obstruction at the Raini bridge and temporary blockage of the flow at the confluence of Rishiganga and Dhauliganga (Figure 3.27). The steep decrease in the cross-sectional area after CS-7 (Figure 3.10) causes an increase in the flow velocity and the watermark trendline between CS-7 and CS-8 (Figure 3.11). Watermark decreases again after CS-12, which is due to the increase in cross-sectional area.

Figure 3.12 Variation of flood watermark along Rishiganga and Raini village

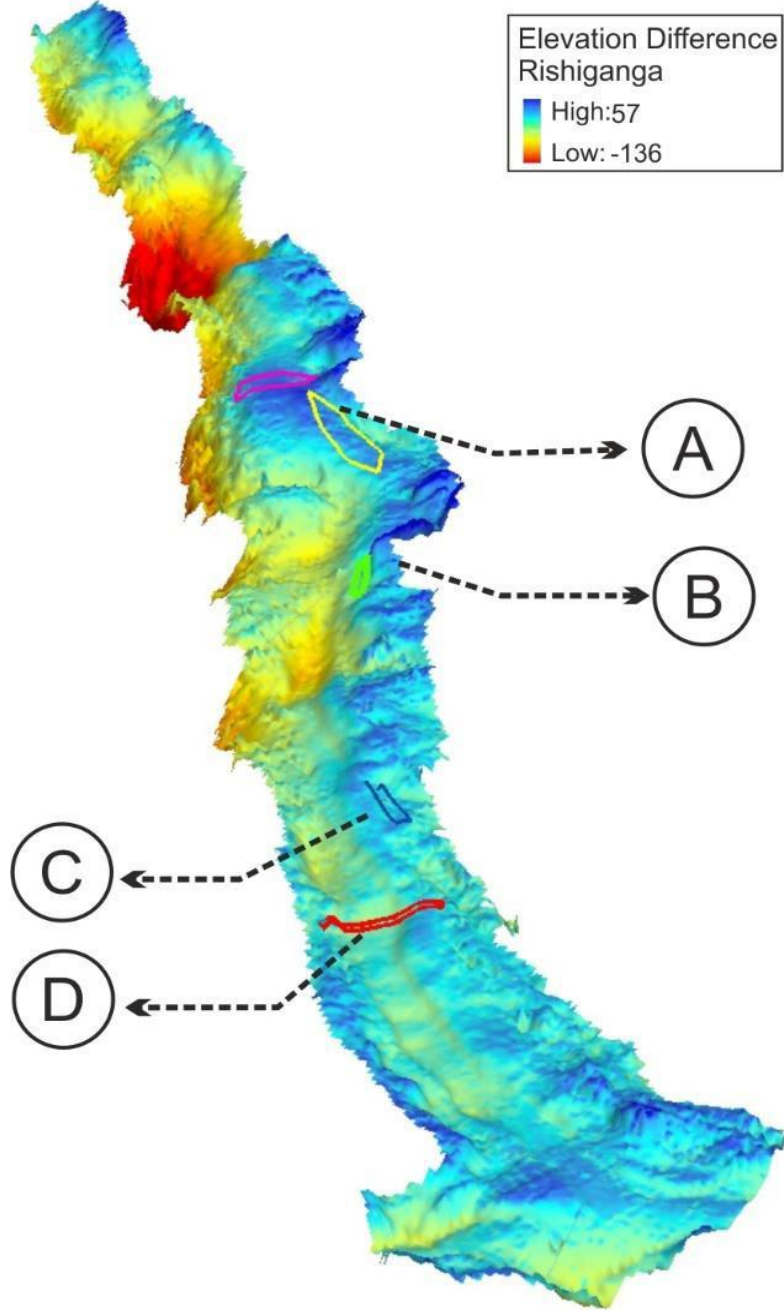
The raster image calculation of subtracting pre-event DEM (Figure 3.7a) from post-event DEM (Figure 3.7b) produced a new raster image, often addressed as DEM of Difference (DOD), as shown in Figure 3.13. The pixels of the DOD raster image include positive and negative elevation values (in meters) representing deposition and erosion, respectively. The red and blue shaded zones are used to distinguish the positive and negative elevations, as shown in Figure 3.13. It can be

observed that the majority of the right bank of the valley is in the blue shade, indicating debris deposition consistent with observations deduced from the pre and post-event cross-section analysis. It is also evident from Figure 3.13 that the infrastructure at locations A, B, and C got buried by the debris deposition, as is also evident in Figures 3.1b, 3.5, and 3.6. Significant erosion is observed at the location just above A and B, and moderate erosion along the valley center portion and left bank. The bridge location C experienced both erosion and deposition.

The shape and size of the cross-sections, and their elevations, as well as the built infrastructure, significantly influenced erosion and debris deposition patterns. For instance, a gradual increase of cross-sectional area is observed between CS-10 to CS-12, causing debris deposition in these areas. The increase in cross-sectional area from CS-6 to CS-7 is abrupt but decreases afterward. This sudden increase in the area reduces the increased flow velocity through CS-6 and deposits massive debris at CS-7 just after eradicating the barrage and side slopes of the valley.

*Figure 3.13 DEM of difference between pre-event and post-event DEM of Rishiganga
HEP@30°29'5.11"N 79°41'40.46" E*

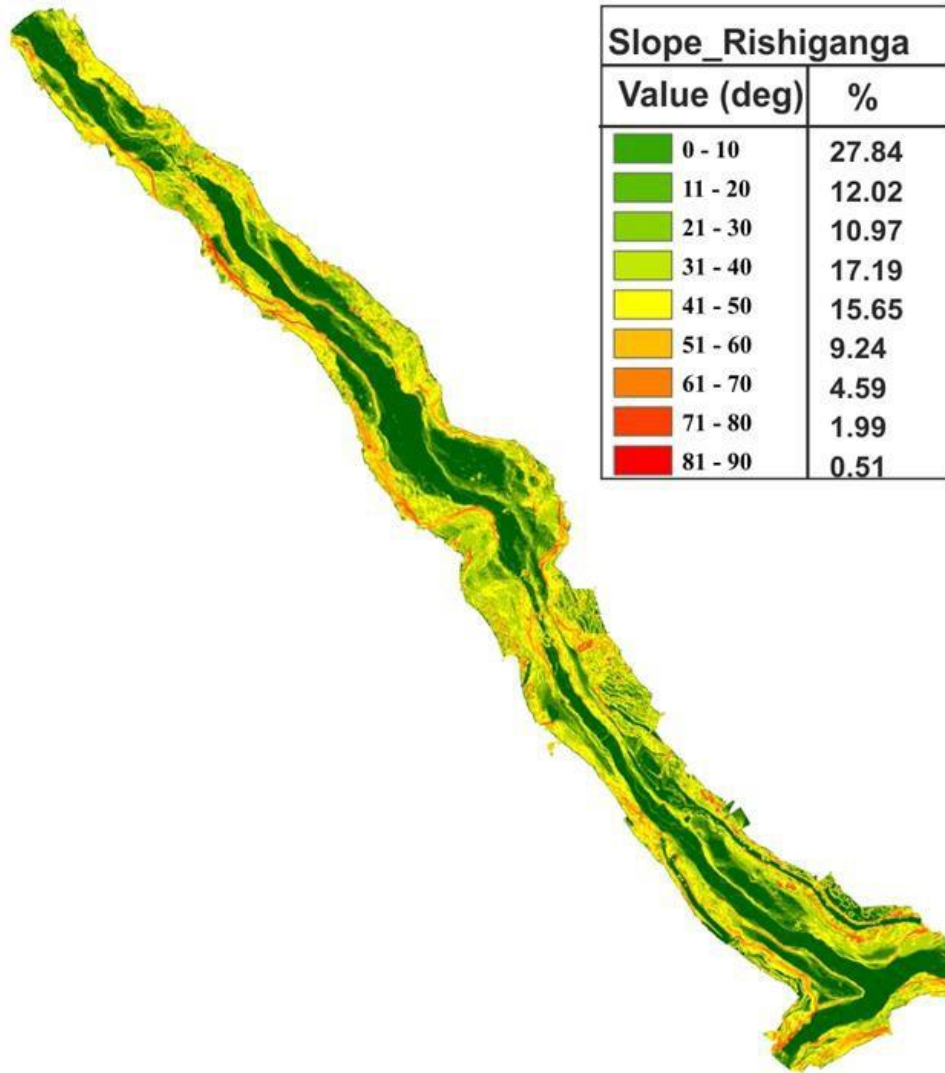
To further understand the effect of debris flow on the valley, the slope and curvatures of the valley have been examined by estimating these parameters using ArcGIS. The rate of elevation change for each digital elevation model (DEM) cell is represented by a slope. Slope values are estimated from the post-event DEM (resolution-1m) of Rishiganga using ArcGIS and categorized in nine different classes from 0 to 90 degrees (Figure 3.14). The locations “A-D” in Figure 3.12b have a slope between 0-10 degrees after the debris deposition. The analysis shows that slope values were minimal in the observed impact zone, indicating that the terrain has flattened, which may be due to the erosion and subsequent deposition of debris. The curvature values (second derivative of the surface) are calculated from the post-event DEM (resolution-1m) of Rishiganga using ArcGIS. The curvature function displays the shape or curvature of the slope, which can be concave, convex, or flat (Figure 3.15). Figure 3.16 shows more than 75% of the coverage area in blue shades that have positive curvature values indicating that the surface is upwardly convex. This might be due to the debris deposition and signifies a tendency for accelerated flow and erosion. The zone near the bank of Rishiganga shows negative curvature values indicating that the surface is upwardly concave. This might be due to the cutting and eroding of the valley due to the debris flow and now tends to decelerate flow and deposition. (Figure 3.16).

*Figure 3.14 Slope calculated from DEM (resolution-1m) of Rishiganga HEP@30°29'5.11"N
79°41'40.46"E*

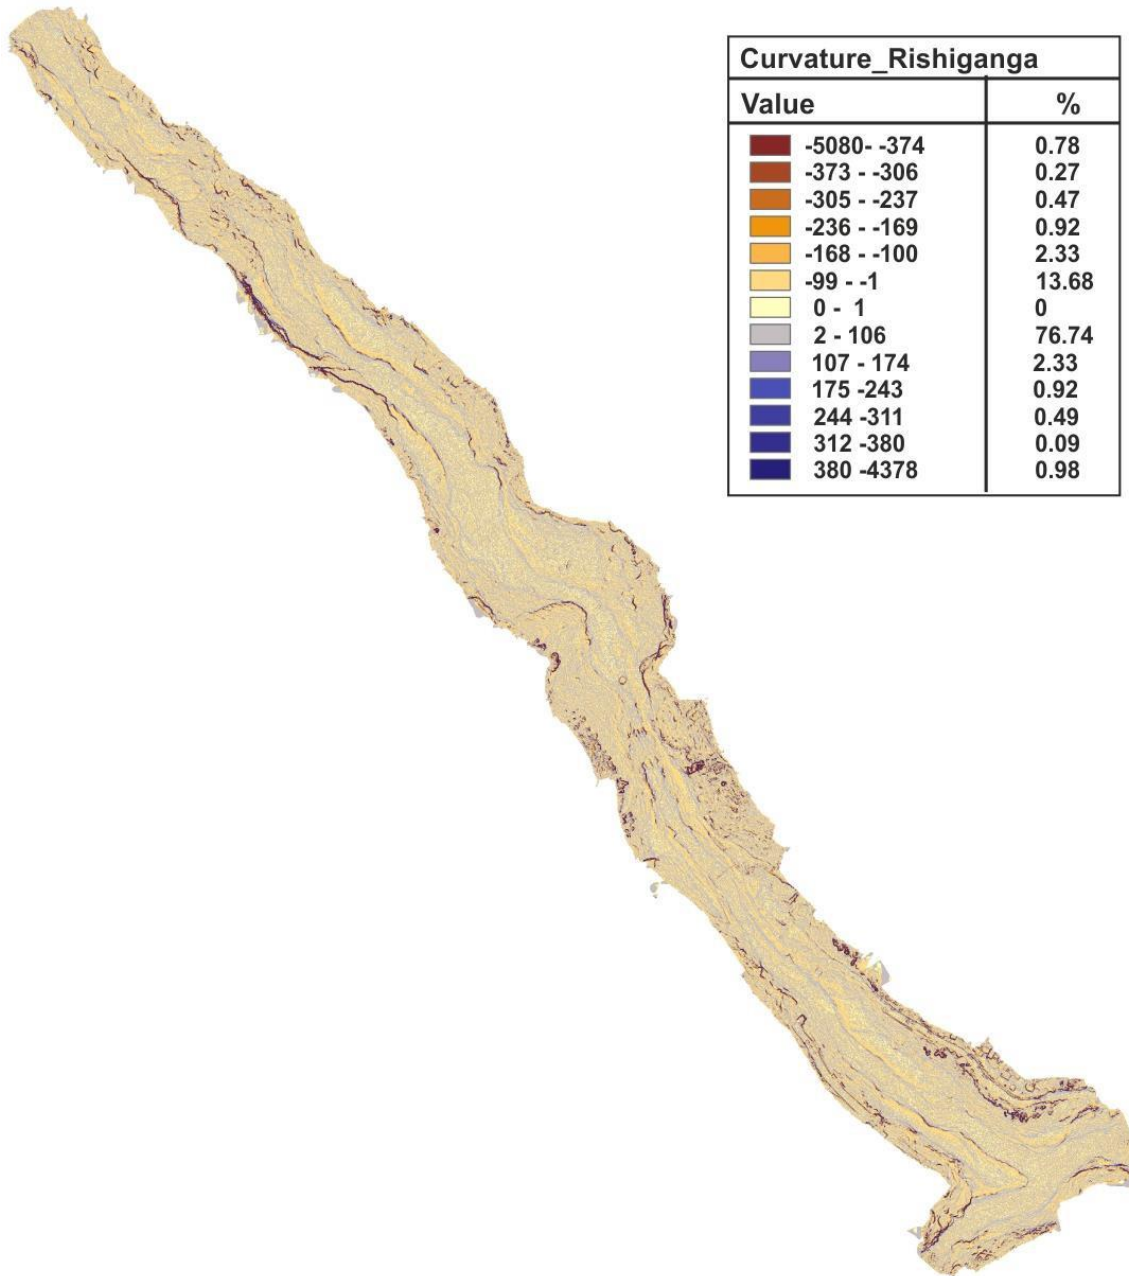
Figure 3.16 Profile curvature calculated from DEM (resolution-1m) of Rishiganga HEP

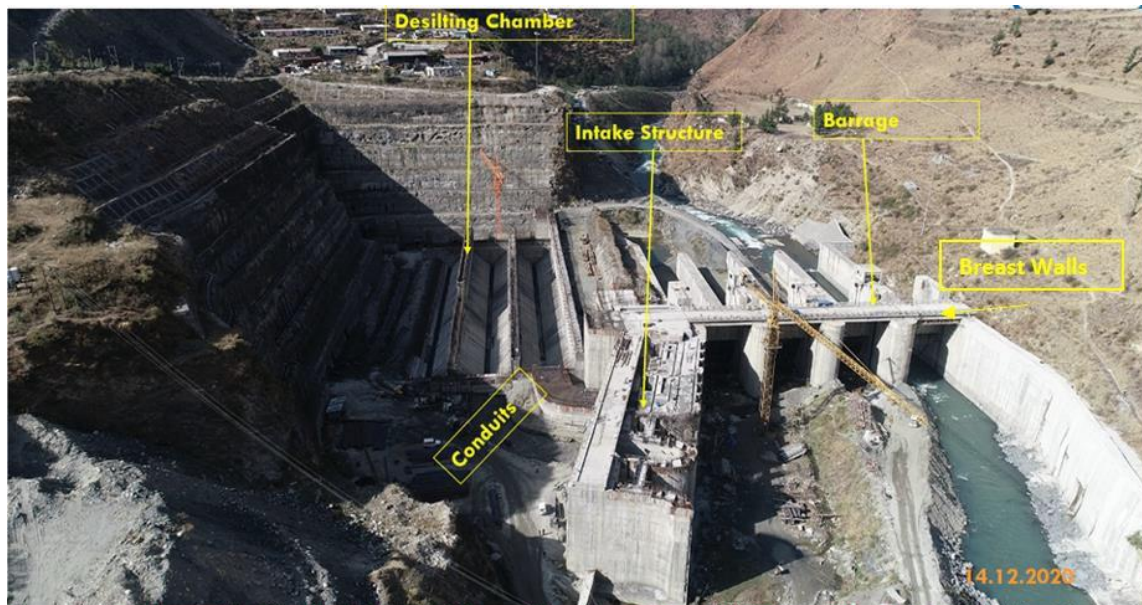
Figure 3.28 Close-up view of barrage site infrastructure (Source: NTPC Tapovan via National Institute of Disaster Management (NIDM), MHA-Webinar on Lessons from Chamoli Disaster 2021 <https://www.youtube.com/watch?v=fE6vjZE6pUg&t=1709s>) @ 30°32'7.84"N 79°31'10.71" E

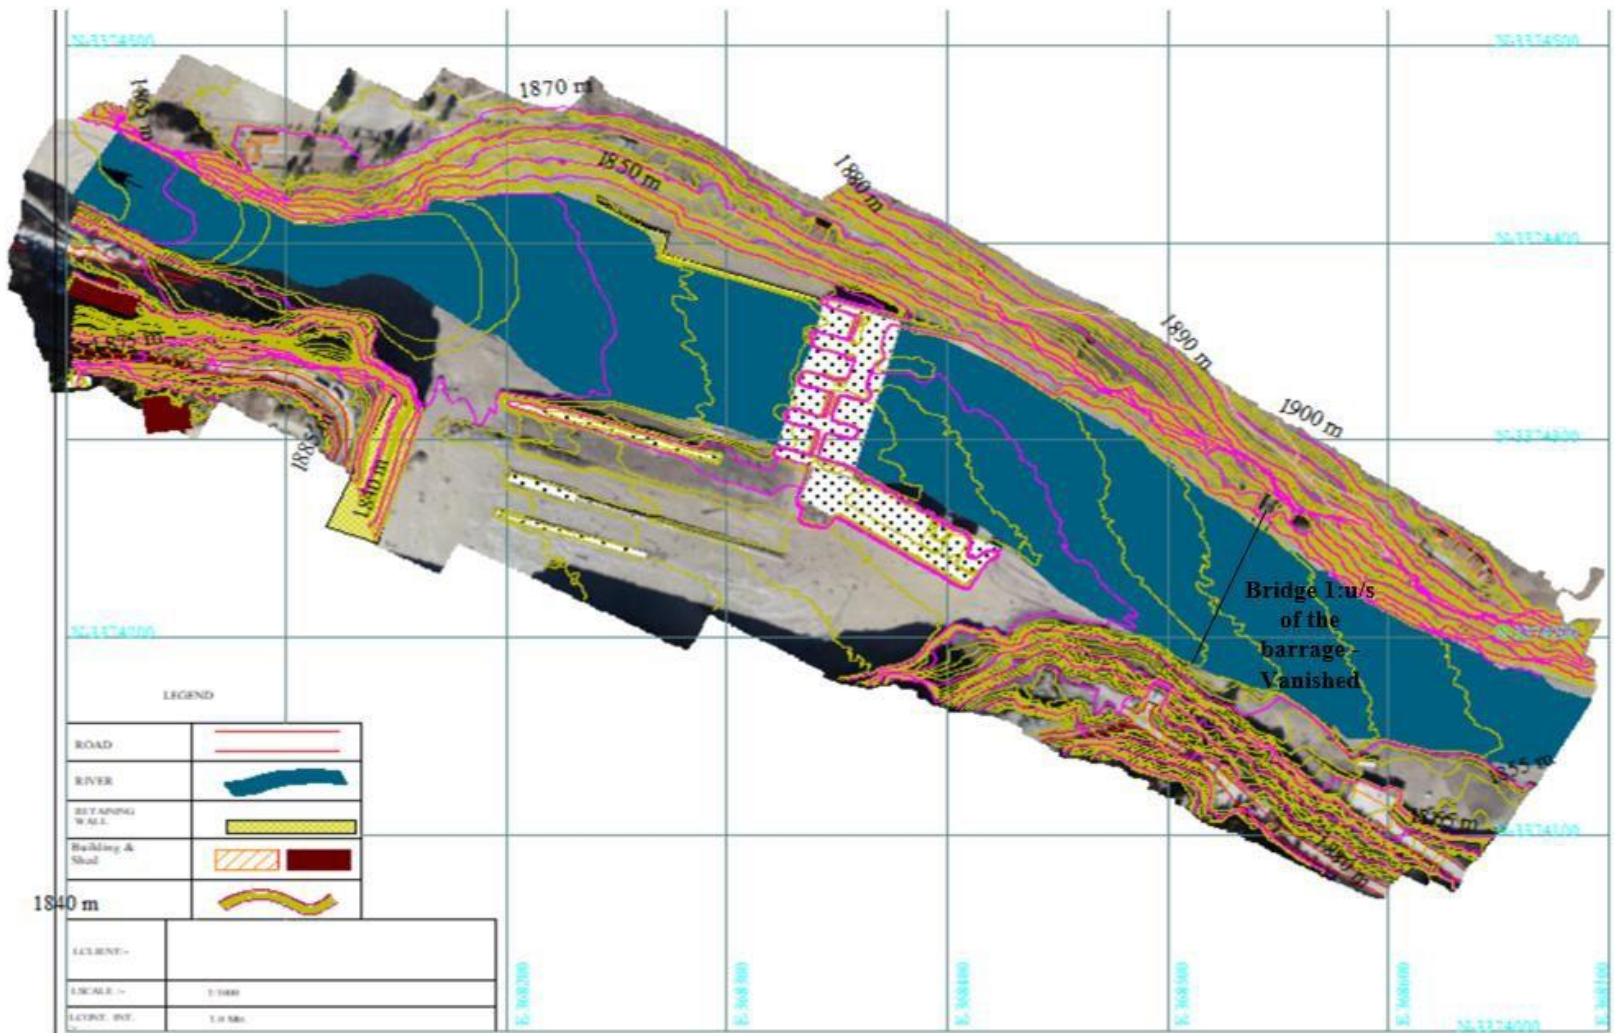
A post-event drone-based reconnaissance study similar to Rishiganga HEP was conducted at the affected TV-HEP site to visualize and document the damage caused by the flash flood. The entire data of this site captured by the drone survey was aligned by aerial triangulation. Further, the aligned data was orthorectified and geo-referenced using the GCP information obtained from EMLID RS2 DGPS equipment. Subsequently, the contour lines were generated on a scale of 1:1000. Figure 3.30 clearly shows the contour drawing draped over the orthoimage of TV-HEP. The contours, namely of pink and yellow colors, represent the major and minor contours at an interval of 5 m and 1 m, respectively. The irregular contour lines indicate the uneven surface, whereas closely spaced lines represent steep terrain. The minimum and maximum contour traced by the drone survey are 1840 m and 1905 m. Also, from the generated surface profile, the observed lowest point of the river is noted at 1851 m. The bridge-1, which was upstream of the barrage site, was estimated to be about 117.70 m in length and 7.95 m wide at a height of approximately 20 m from bedrock, and got washed away entirely, as marked by the black color line plotted in Figure 3.30 for reference.

Figure 3.30 Surface plan overlaid on orthophoto @ 30°32'7.84"N 79°31'10.71" E

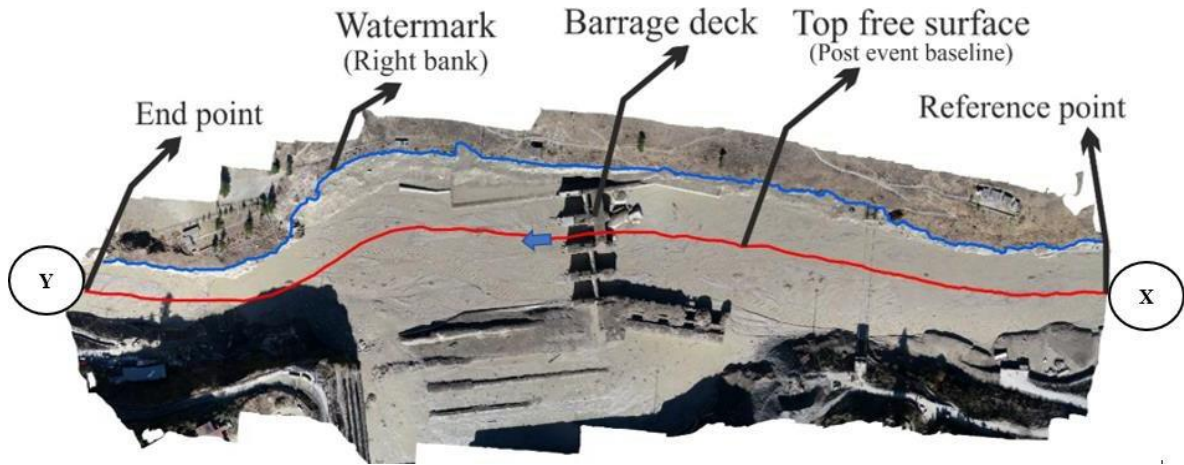
(a)

Figure 3.31a illustrates the ortho mosaic draped over the surface profile of DEM, which is used for identifying the watermarks left by the debris flow at Tapovan HEP. A reference point (X) and an endpoint (Y) were considered at the upstream and downstream line along the selected post-event baseline to obtain the variation of flood watermarks along the scanned area. The points obtained in this region are plotted against the traverse length of the flood, as shown in Figure 3.31b for further analysis. The post-event baseline is assumed at the centerline of the Rishiganga observed on February 11th, 2021. The dotted line in Figure 3.31b represents the deck level of the barrage at an elevation of about 1861m MSL, which is considered the datum point for establishing the high flood level at different elevations. The trend line (solid blue) of the data in the graph clearly shows the debris mark along the valley of the Tapovan-HEP. It's evident from the figure that the difference between the baseline and the debris mark is decreasing from the upstream and downstream reference points X and Y, respectively. However, the elevation difference increased suddenly after the X reference about 100 m (upstream) due to the narrow valley cross-section. It reached a height equal to the barrage about 1864 m MSL including bridge-I and collapsed the bridge and severely affected the barrage.

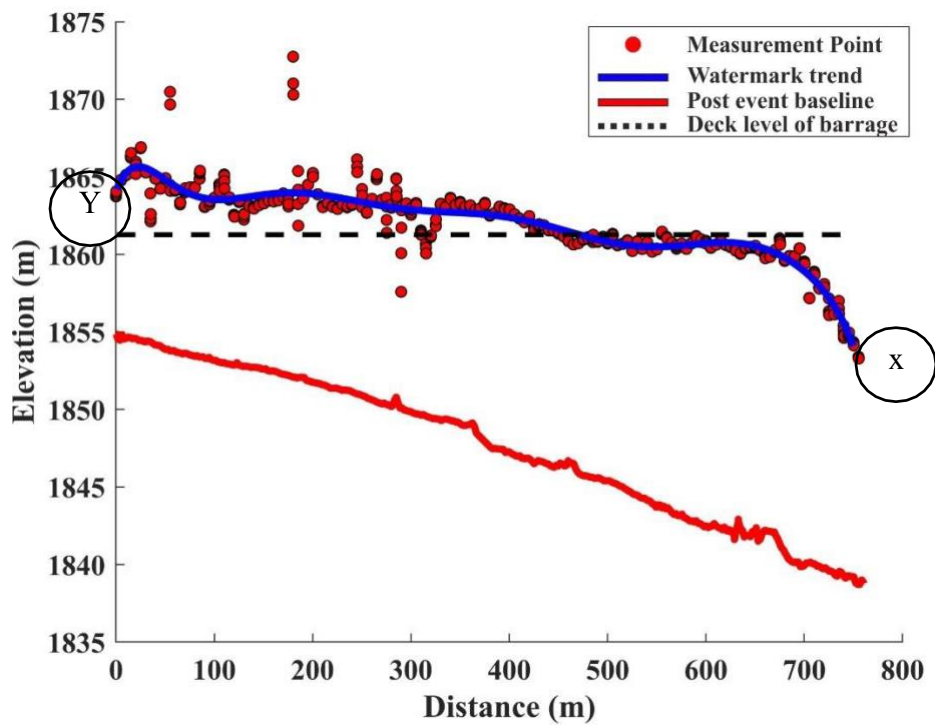
(b)

Figure 3.31 Variation of flood debris marks along the study area a) Orthorectified mosaic image b) elevation of debris marks vs. the traverse distance of flood @ $30^{\circ}32'7.84''N$ $79^{\circ}31'10.71''E$

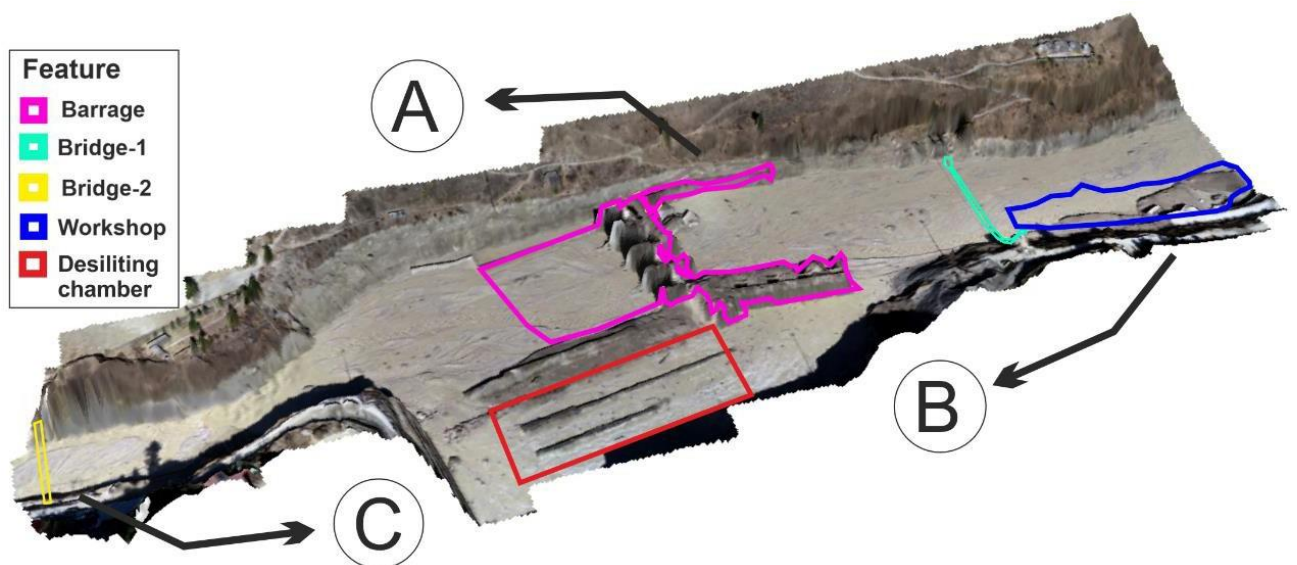
The post-event aerial view of the entire scanned area of TV- HEP in three dimensions was reconstructed using an ortho mosaic and DEM, as shown in Figure 3.32. The ortho mosaic is draped over the DEM to follow the surface profiles and provide a clear visual understanding of the post-event topography and the conditions of the prominent features at the site. In particular, the barrage, intake structure, and desilting chamber are marked as A, upstream bridge-1, the workshop area is highlighted and marked as B, and bridge-2 in the downstream is marked as C. Figure 3.33 presents the close-up 3D view of these prominent structures (A, B, and C) before and after the event, showing the extent of damage to these structures. The pre-event and post-event 3D views were obtained from the Google Earth imagery and ortho mosaic draped DEM, respectively. The finer details of each feature's damage and ground conditions are discussed with the help of high-resolution geotagged images in the subsequent sections.

Figure 3.32 3D view of Tapovan barrage site@ 30°32'7.84"N 79°31'10.71" E
