Site Visit and Drone Based Reconnaissance Study of the Severely Affected Infrastructure by February 7th, 2021, Chamoli Rock-Ice Avalanche Disaster, Uttarakhand, India

Barrage of Tapovan Vishnugad hydroelectric project

GEER – 074
doi:10.18118/G6V95B

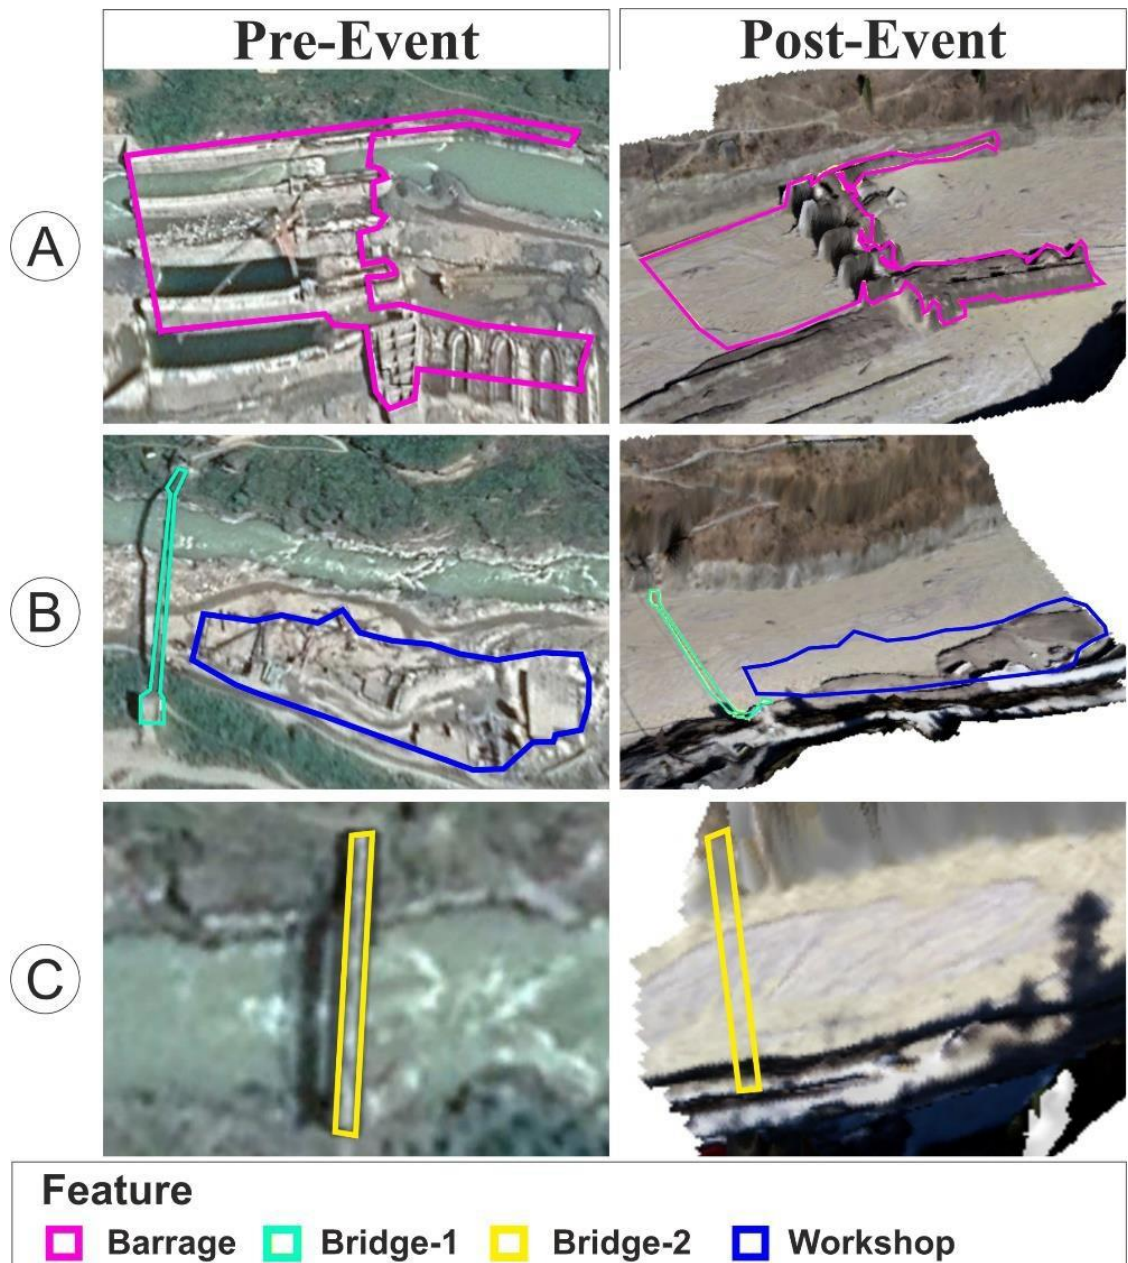
Figure 3.33 Pre-and post-disaster situation at the barrage site. @ 30°32'7.84"N 79°31'10.71" E

The piers of the barrage and intake structures suffered massive damage, and large debris deposits were observed over them. The conduits and the desilting chamber, as shown in Figure 3.28, are missing in Figure 3.34, and are probably buried by the debris deposition. Figure 3.35 shows a detailed view of the damaged intake structure with a visible layer of deposits, whereas, Figure 3.36 shows the broken and exposed steel bars at the tail of the intake structure (downstream of barrage).

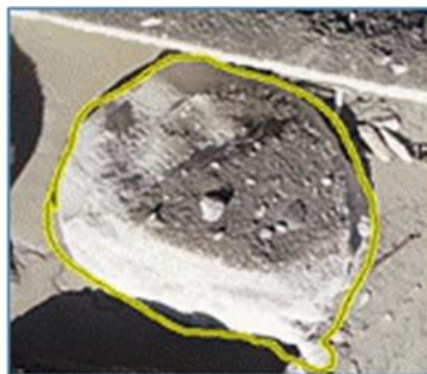
The post-event orthophoto and Global Mapper were used to estimate the dimensions of the damaged barrage, breast walls, and the boulders behind the barrage piers. The total length of the breast wall over the barrage before the event was about 83 m long, whereas post-event, about 41 m length of this breast wall had been washed away, as shown in Figure 3.38. The approximate length of the boulders came out 10.2 m and 19.6 m which is 1/8th and 1/4th of the calculated total length of the breast wall, which indicates that the flow velocity must have been sufficiently high, which led to the accumulation of huge boulders near the gates.

Figure 3.39 Close-up view of a boulder @ 30°29'35.89"N 79°37'41.67"E (Dated:11/02/2021)
