Geotechnical Reconnaissance and Engineering Effects of the December 29, 2020, M6.4 Petrinja, Croatia Earthquake, and Associated Seismic Sequence

Chapter 7: Liquefaction and Related Building Damage

7. Liquefaction and Related Building Damage

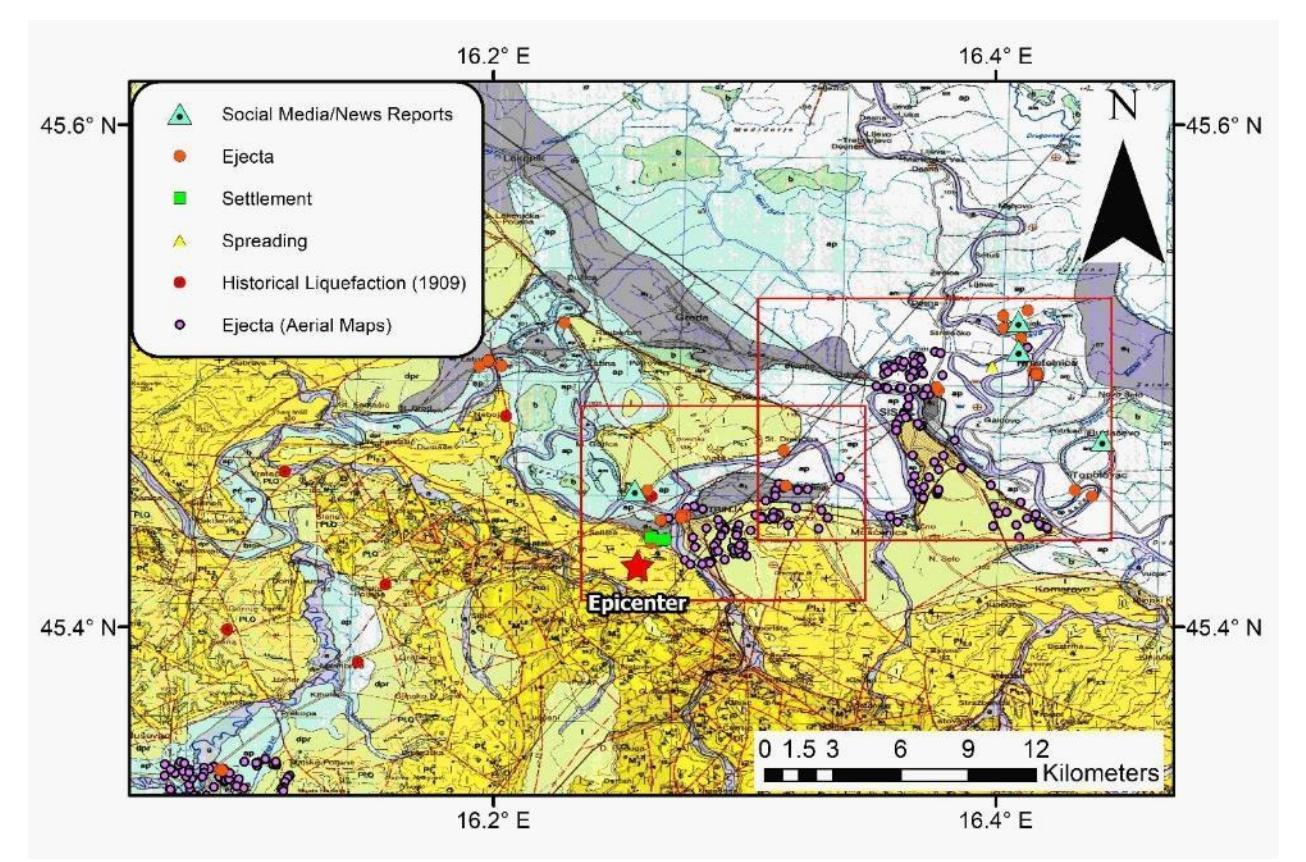
The region where liquefaction was observed is underlain by Quaternary alluvial deposits (**Figure 7.2**). The primary geologic units in the affected areas are Holocene floodplain (ap) and terrace deposits (a_1) near the active river channels along with deluvium-proluvium (dpr). Only few locations with liquefaction effects were identified in the Pleistocene and Pliocene deposits ($Pl_{2,3}$ and Pl_Q); however, all of them were located near the contact with the Holocene deposits near Glina and Petrinja. Given the scale and date of the geologic map, the locations of these contacts are approximate; hence, and it is likely that these observations occurred within the Holocene sediments.

Figure 7.2. Geologic map of the study area showing locations of liquefaction observations. The red boxes indicate the extent of the focused maps of Petrinja and Sisak. Historical observations from the 1909 earthquake were mapped based on the LIQUEFACT GIS database (Lai et al. 2018). The translated legend of the geologic map from Pikija (1987) is shown in **Figure 7.3**.

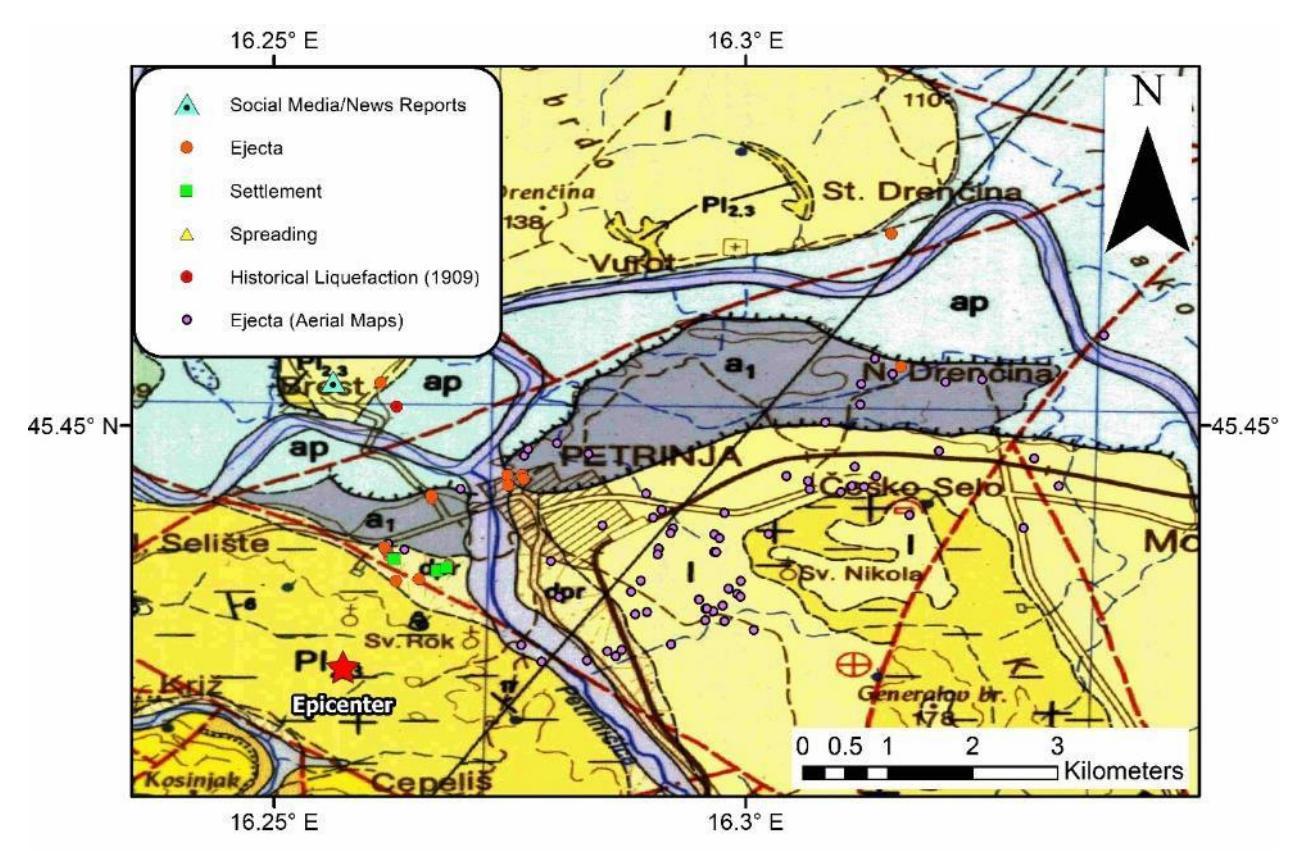
Moreover, Figure 7.4 shows the geologic units in the Petrinja region along with the liquefaction observations and historical reports of liquefaction (discussed in a subsequent section). The epicenter of the earthquake was located approximately 2 km west of Petrinja (**Figure 7.4**). Many of the locations where ejecta were observed occurred along with the contact between the terrace sediments (a₁) and the flood sediments (ap) or within the area mapped as diluvium-proluvium (dpr).

Figure 7.4. Geologic map of the Petrinja region showing locations of liquefaction observations. A single observation from the 1909 earthquake was in this region (Lai et al. 2018). The translated legend of the geologic map from Pikija (1987) is shown in **Figure 7.3**.

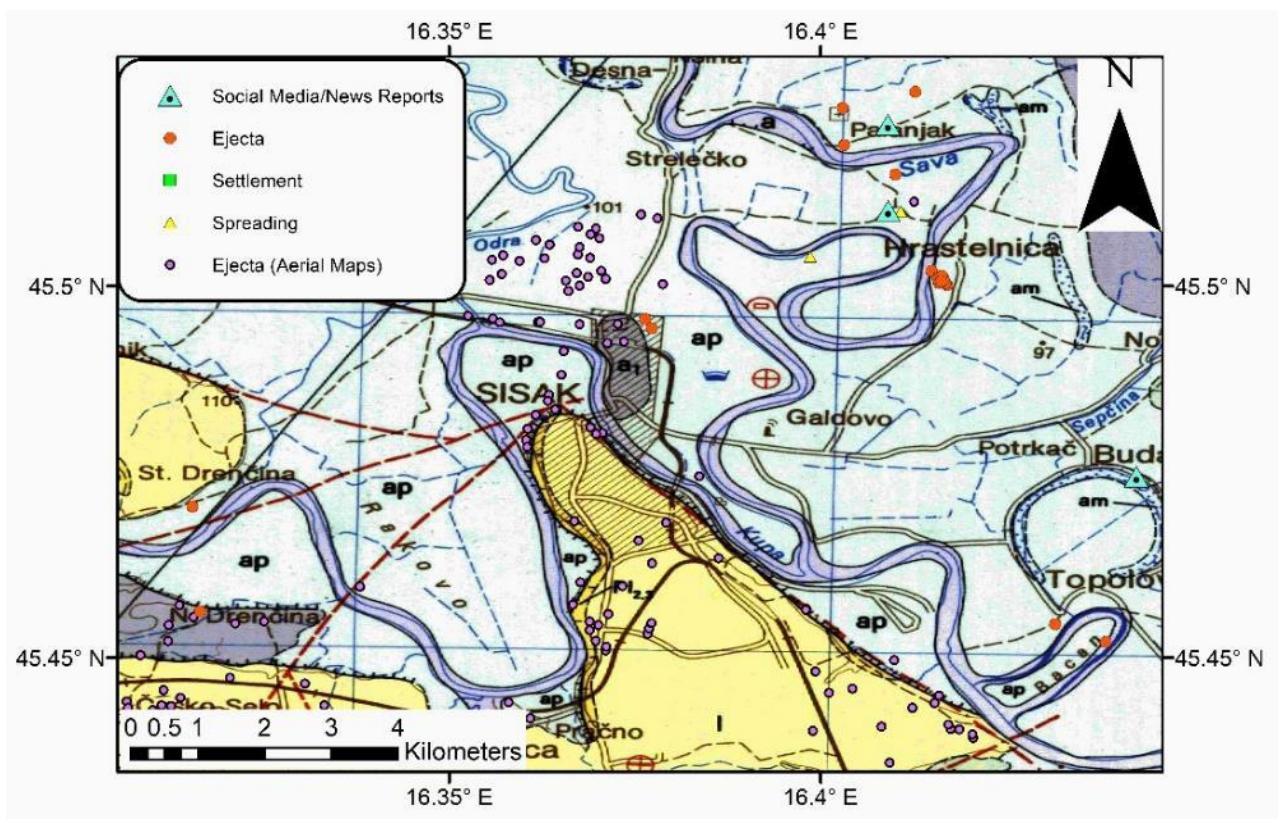
Finally, **Figure 7.5** shows the geologic units in the Sisak region along with the liquefaction observations and historical reports of liquefaction (discussed in subsequent sections). All of the locations where ejecta were observed occurred within the flood sediments (ap). All of the observations were relatively close to the active river channels.

Figure 7.5. Geologic map of the Sisak region showing locations of liquefaction observations. No observations from the 1909 earthquake were mapped in this region. The translated legend of the geologic map from Pikija (1987) is shown in **Figure 7.3**.

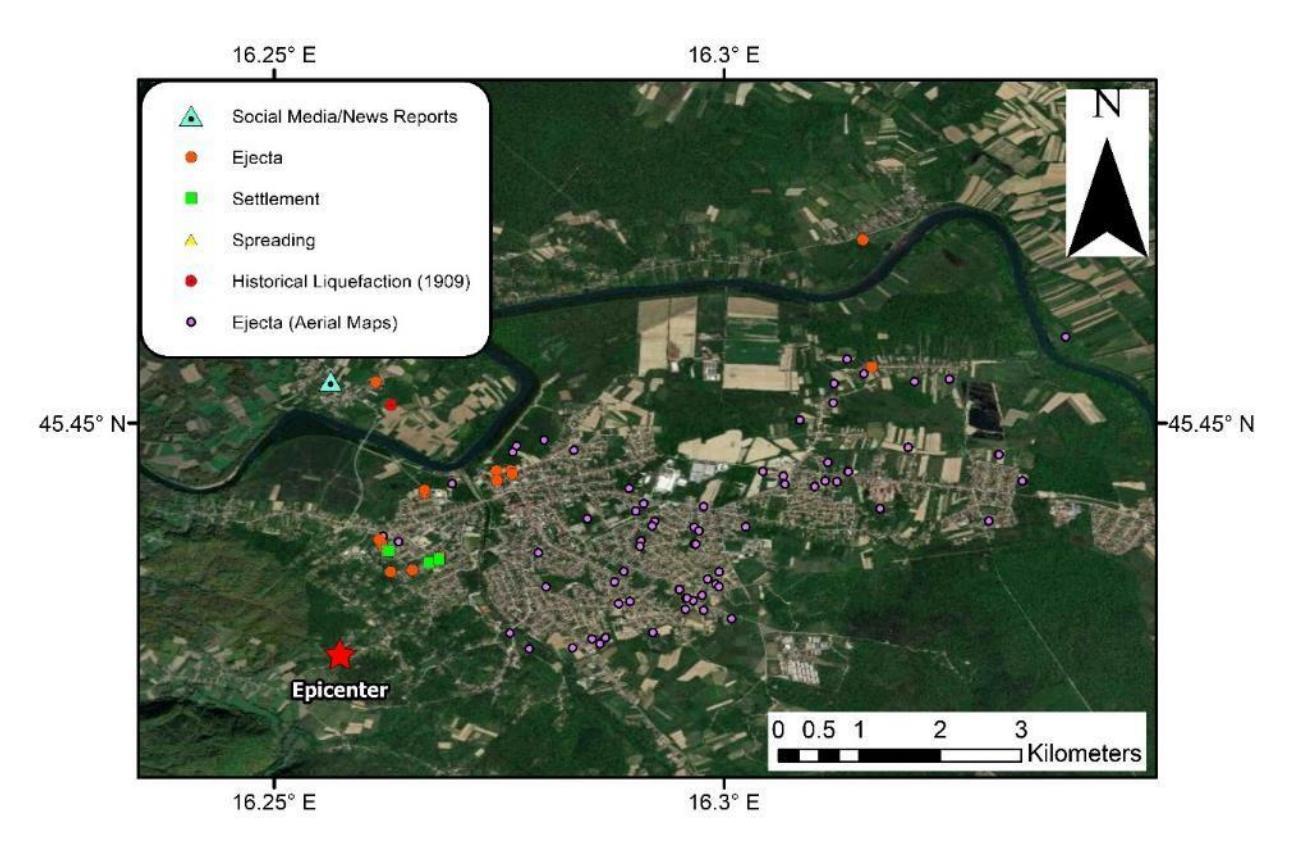
Figure 7.7 Satellite map of the Petrinja region showing locations of liquefaction observations.

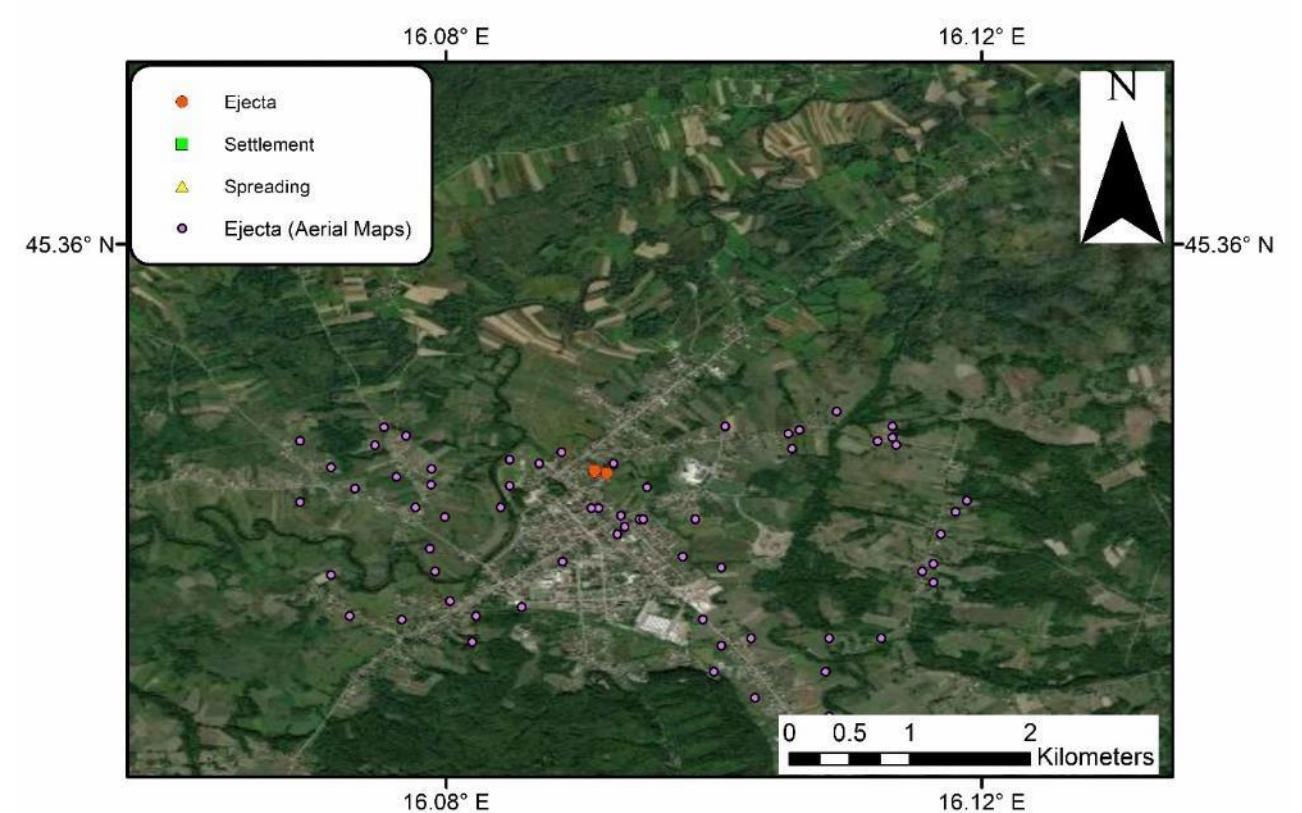
Figure 7.9 Satellite map of the Glina region showing locations of liquefaction observations mapped from aerial imagery and by the field team.

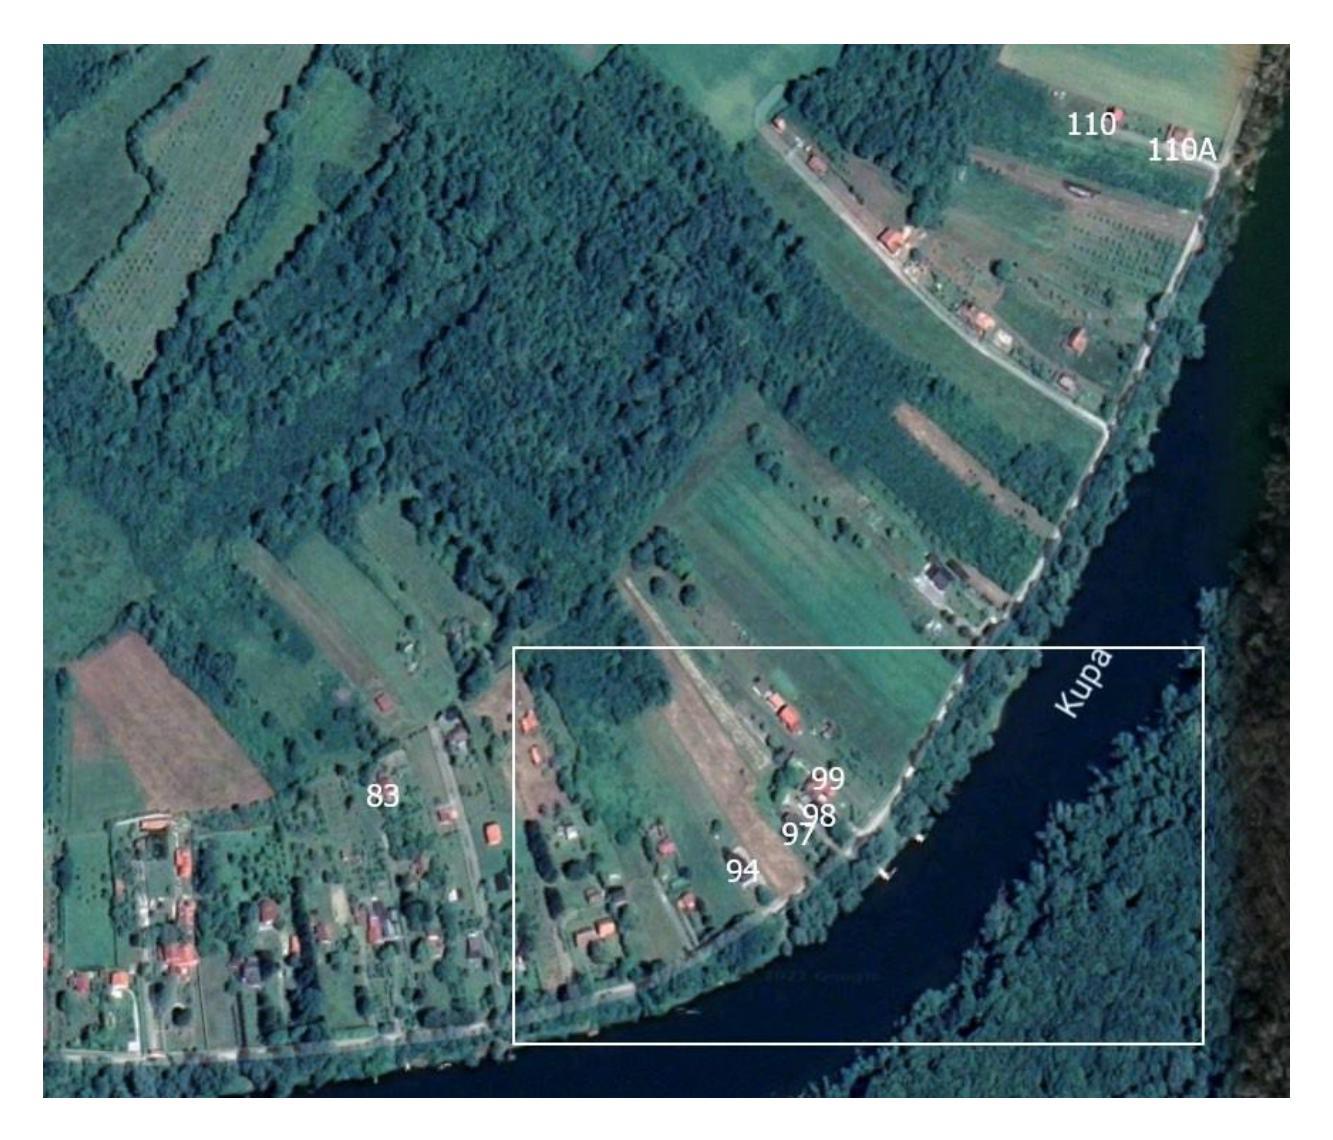
In the village of Stari Brod (approximately 10 km from the epicenter of the main shock), liquefaction and lateral spreading were identified around a series of houses along the Kupa River. The residents noticed water with sand and mud coming out from the ground around houses, in their yards, and the fields. Like other locations in the region, many water wells were filled with liquefied sand and became unusable. Liquefaction was noted at 83, 97, 98, 99, 99B, 110, and 110A lžišće Street (Bostjančić, 2021), and their positions are shown in **Figure 7.17**.

Figure 7.17 Location of the liquefaction ejecta by the Kupa River in the lžišća Street in Stari Brod. (45.480N, 16.182E; Google Maps). Numbers show street numbers where liquefaction was observed. Cracks and sliding due to lateral spreading is shown in the area bordered by the white rectangle and enlarged in **Figure 7.24**.
