Geotechnical Reconnaissance and Engineering Effects of the December 29, 2020, M6.4 Petrinja, Croatia Earthquake, and Associated Seismic Sequence

Chapter 9: Infrastructure Damage

Authors: Jelena Bleiziffer, Igor Gukov, Ingrid Tomac, Sonja Zlatović, Petar Krešimir Žderić, Zvonimir Vlahović

9. Infrastructure Damage

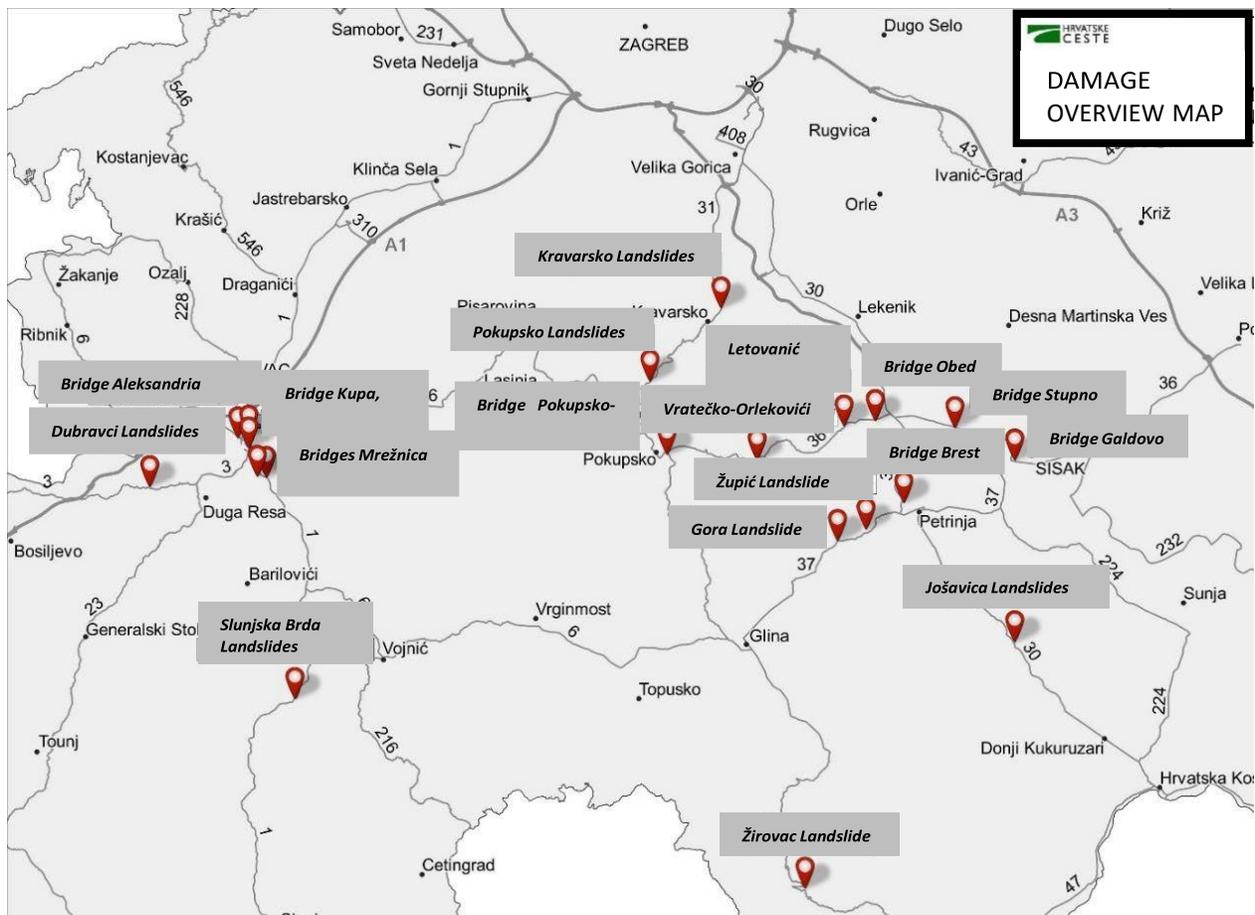
Figure 9.1 A comprehensive infrastructure damage overview map in Sisak-Moslavina, Zagreb, and Karlovac Counties (source: Hrvatske Ceste - Croatian Roads).

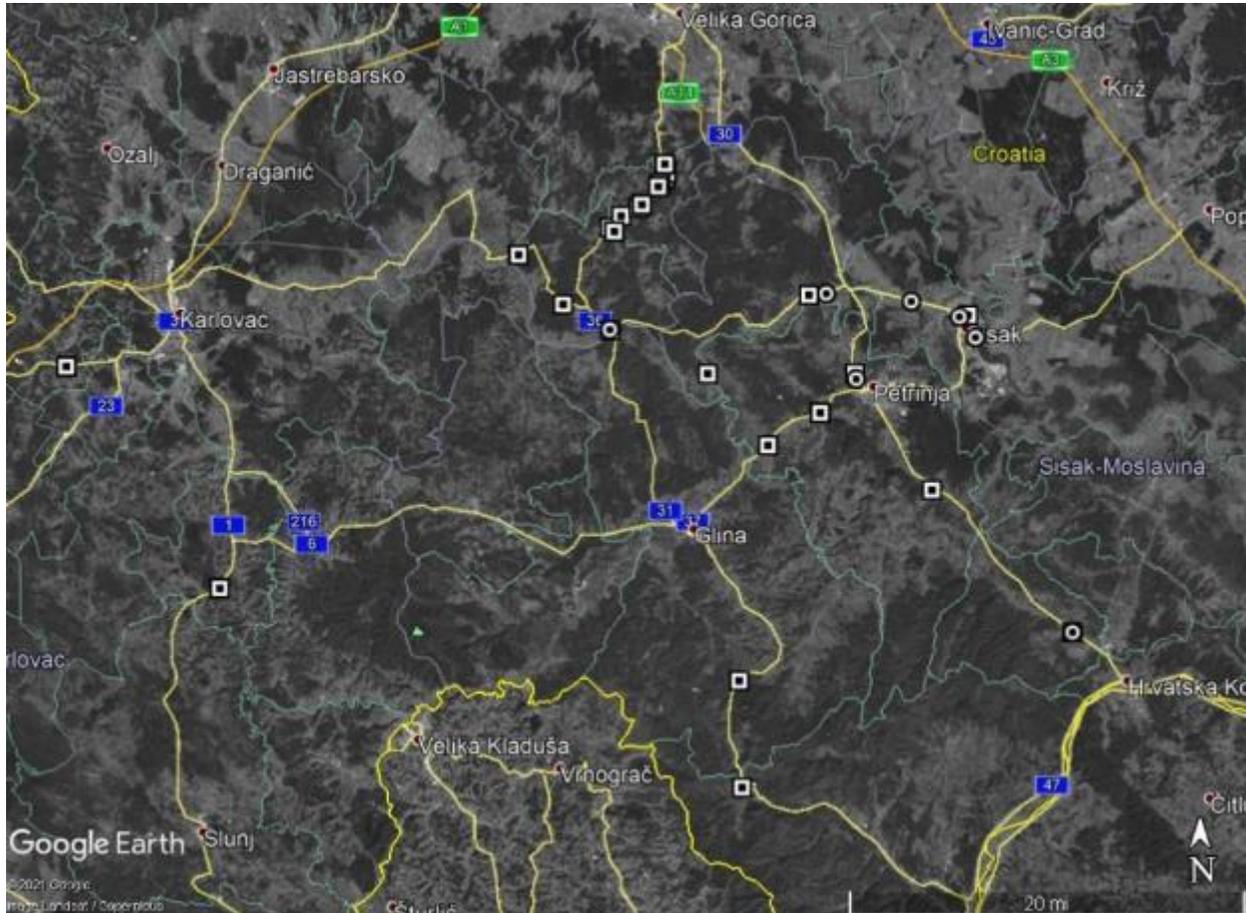
Figure 9.2 Specific locations of road damage (squares) and damaged bridges (circle) (Justin Wong and Ingrid Tomac).

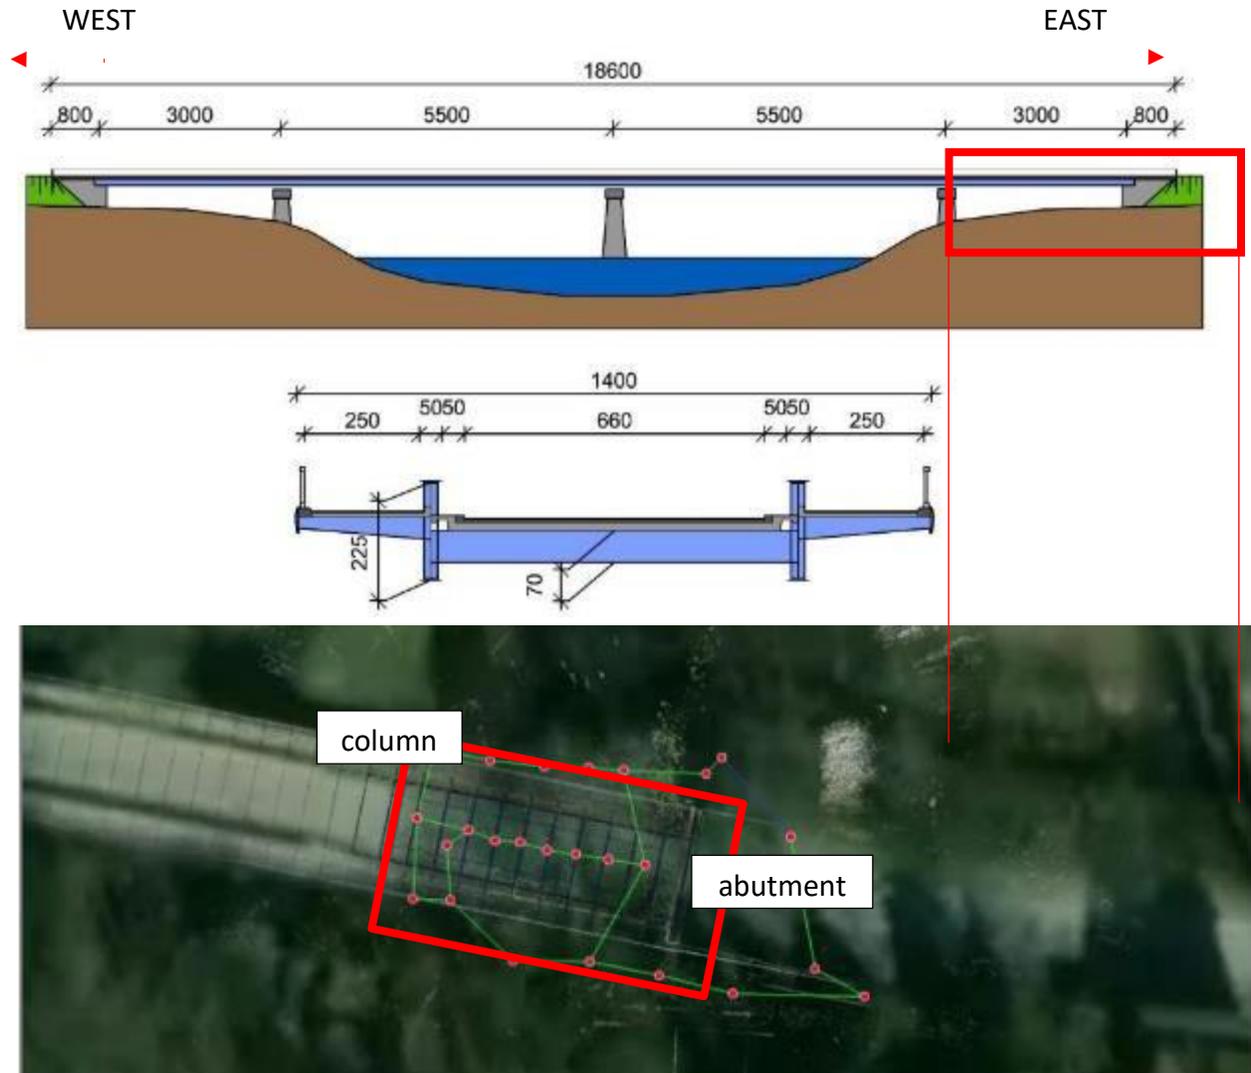
As a part of the reconnaissance effort, a Lidar scan of what was identified as the bridge span with the most obvious damage was carried out on March 27, 2021, i.e., the bridge span between the east abutment and the adjacent column. 25 setups (**Figure 9.13**) were linked with 28 links in a bundle with a bundle error of 5 mm (NHERI RAPID Facility, 2021). The point cloud data obtained has not yet been fully analyzed, but it might provide further data. An example of the point cloud obtained is shown in **Figure 9.14**.

Figure 9.13 Galdovo Bridge, Lidar setups (location indicated on longitudinal bridge section obtained from Radić, Žderić & Puž, 2007).

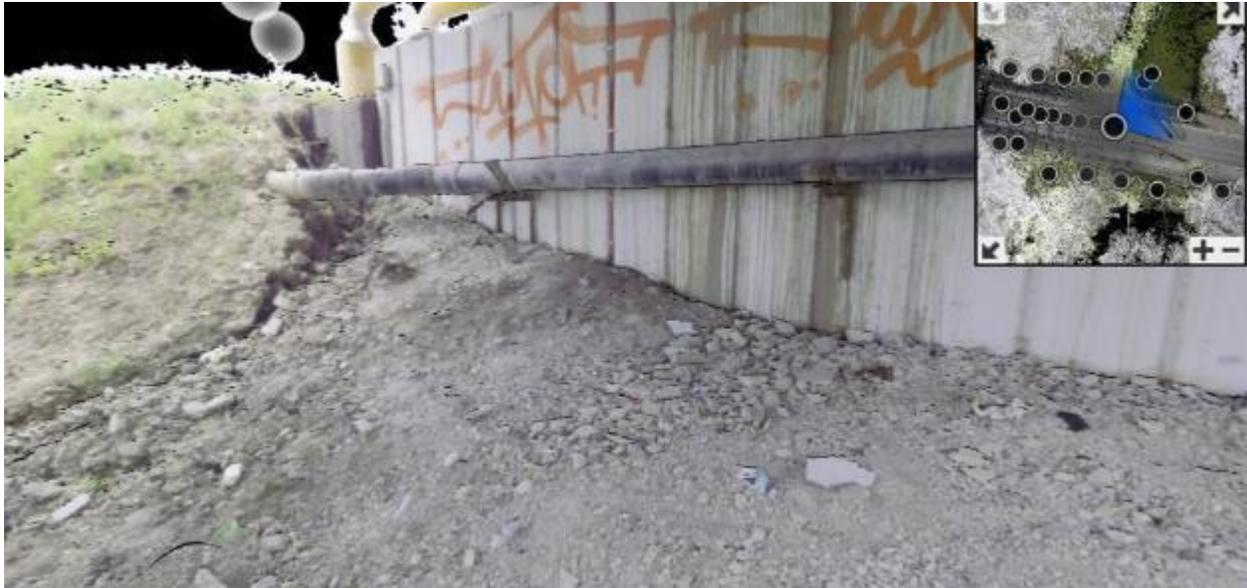
Figure 9.14 Galdovo Bridge, Point cloud of the east abutment.

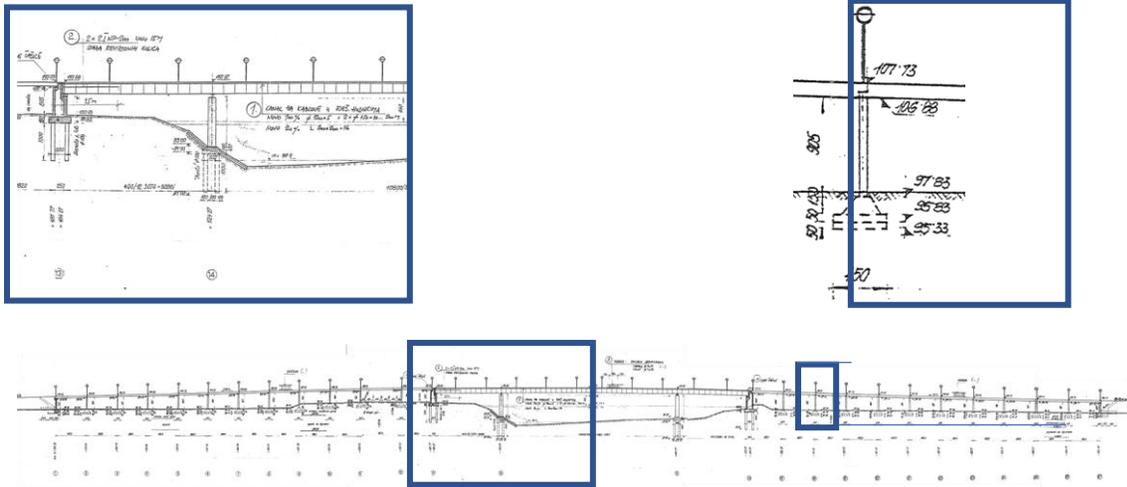
The original blueprint of the Gromovi Bridge dates from 1971, as shown in **Figure 9.15**. Gromovi Bridge is in Sisak and crosses river Kupa, with an axis oriented north-south. The bridge consists of a central 3-span structure, and approach viaducts at both sides. Bridge superstructures – in steel for the central portion of the bridge, and prestressed concrete for the approach viaducts, are supported by a series of 2-column piers consisting of 2 inclined columns and a cap beam with cantilevers on top. The piers of the approach viaducts are founded on shallow concrete spread footings, 4.5 x 4.5 m, 1.0 m deep embedded 2.5 m under the soil surface. Retrofit in 2019 focused on the steel structure of pedestrian passageways, the central bridge end columns, which provide a transition from concrete to steel superstructure and vice versa, and bearings on positions S13 and S16. The column S13 top portion, which had a crack, was strengthened with concrete anchors. Columns of the central steel bridge are founded on 100 cm in diameter reinforced concrete circular piles 10 m deep. There are 12 piles under each column. **Figure 9.15** shows the original bridge with the original foundation types.

Figure 9.15 An original blueprint of Gromovi Bridge from 1970 (ŽPB, 2002).

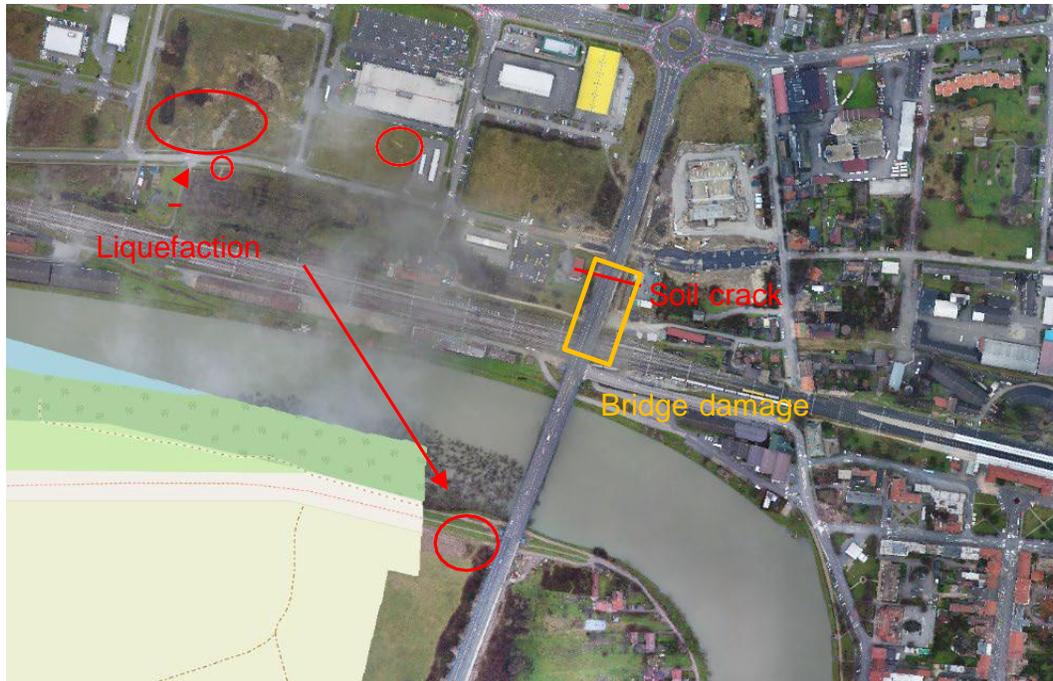
Figure 9.19 Aerial view of the area with “Most Gromova” bridge after the earthquake.
