Geotechnical Reconnaissance and Engineering Effects of the December 29, 2020, M6.4 Petrinja, Croatia Earthquake, and Associated Seismic Sequence

Chapter 6: Cover-Collapse Sinkholes

Authors: Ingrid Tomac, Igor Vlahović, Jelena Parlov, Bojan Matoš, Darko Matešić, Ivan Kosović, Ivica Pavičić, Tihomir Frangen, Josip Terzić, Davor Pavelić, Nguyen Pham

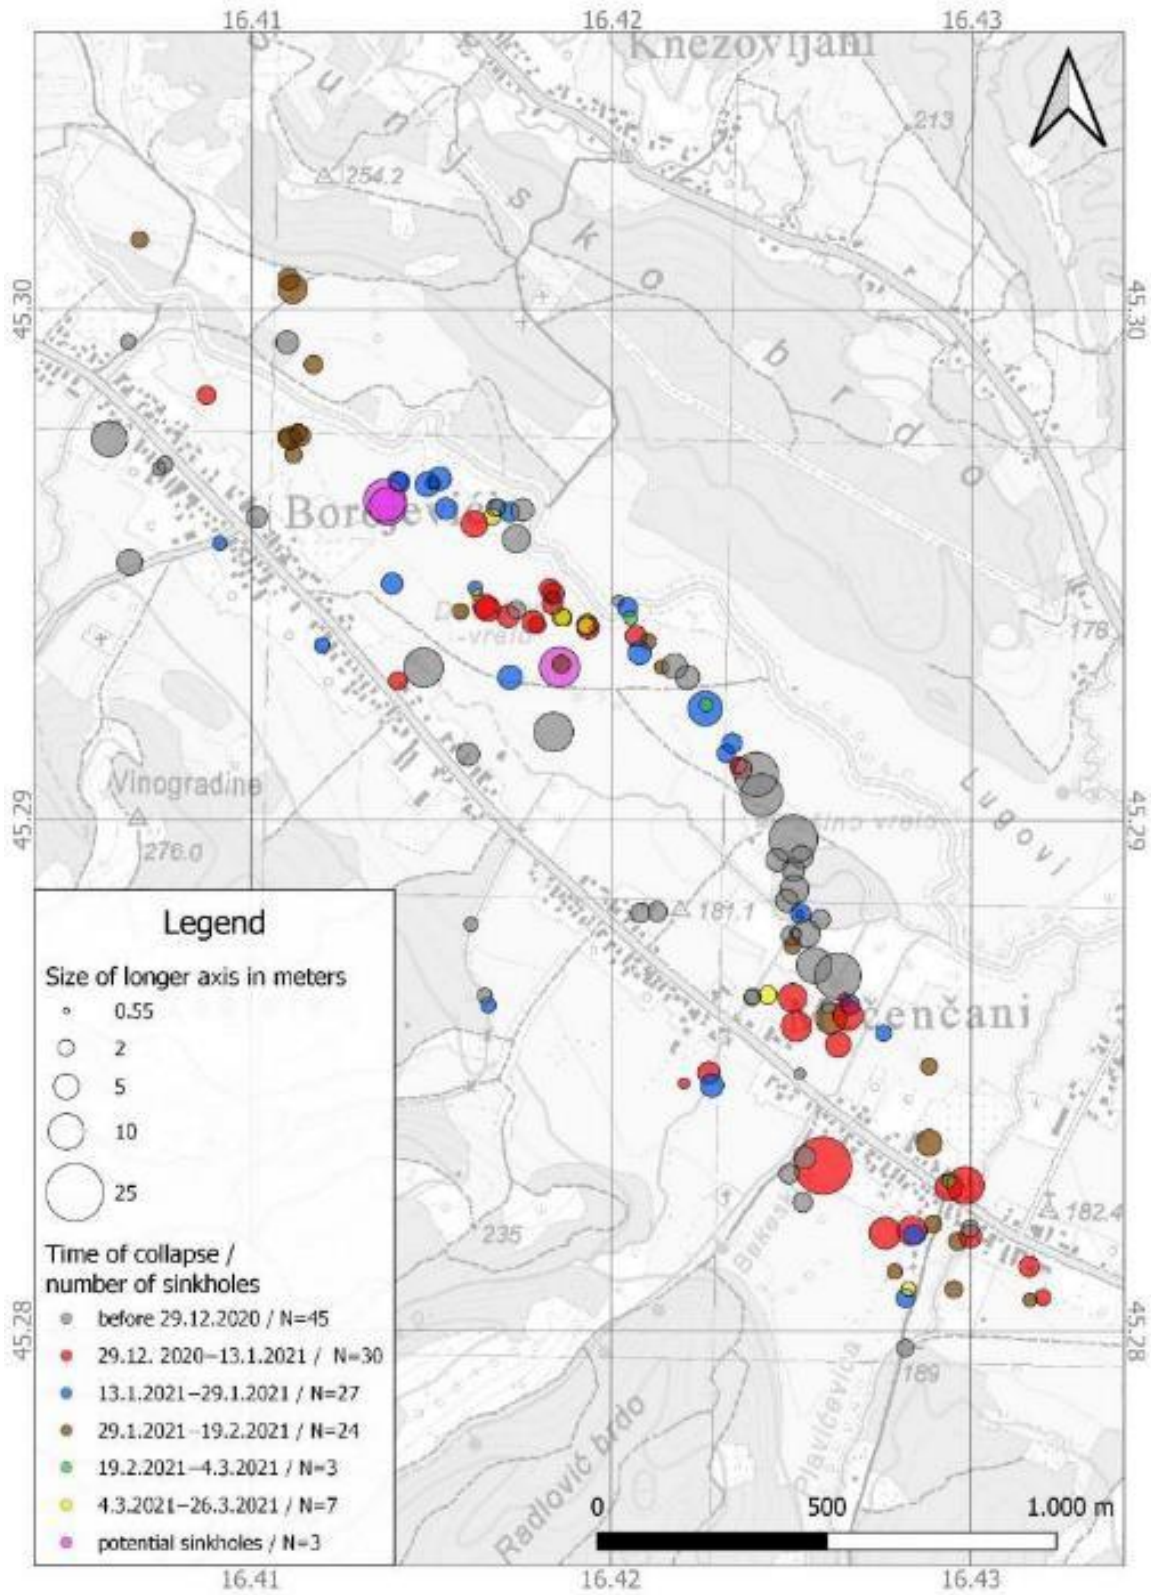
Figure 6.5 shows spatio-temporal positions of sinkholes sorted into time windows of appearance and sizes. The GEER team could not obtain better resolution data than the time windows presented in **Figure 6.5**. Grey-colored circles represent fossil sinkholes, which are pre-existing cover-collapse sinkholes. A more significant number of fossil sinkholes characterize the area between two villages, including Pašino vrelo (vrelo meaning spring in Croatian). Pašino vrelo has been turned into a commercial well and serves as a drinking water source for Hrvatska Kostajnica. Fewer but relatively larger and deeper sinkholes and fewer of them per area collapsed in the eastern part around Mečenčani than in the north of Borojevići. The biggest sinkhole, 25x23 m in

diameter and 11.7 m deep, is in Mečenčani and the second-largest new sinkhole, 10.8x9.8 m in diameter and 3.6 m deep.

Figure 6.5 Spatio-temporal map of sinkholes in Borojevići and Mečenčani and their longer diameter on the topographic map.

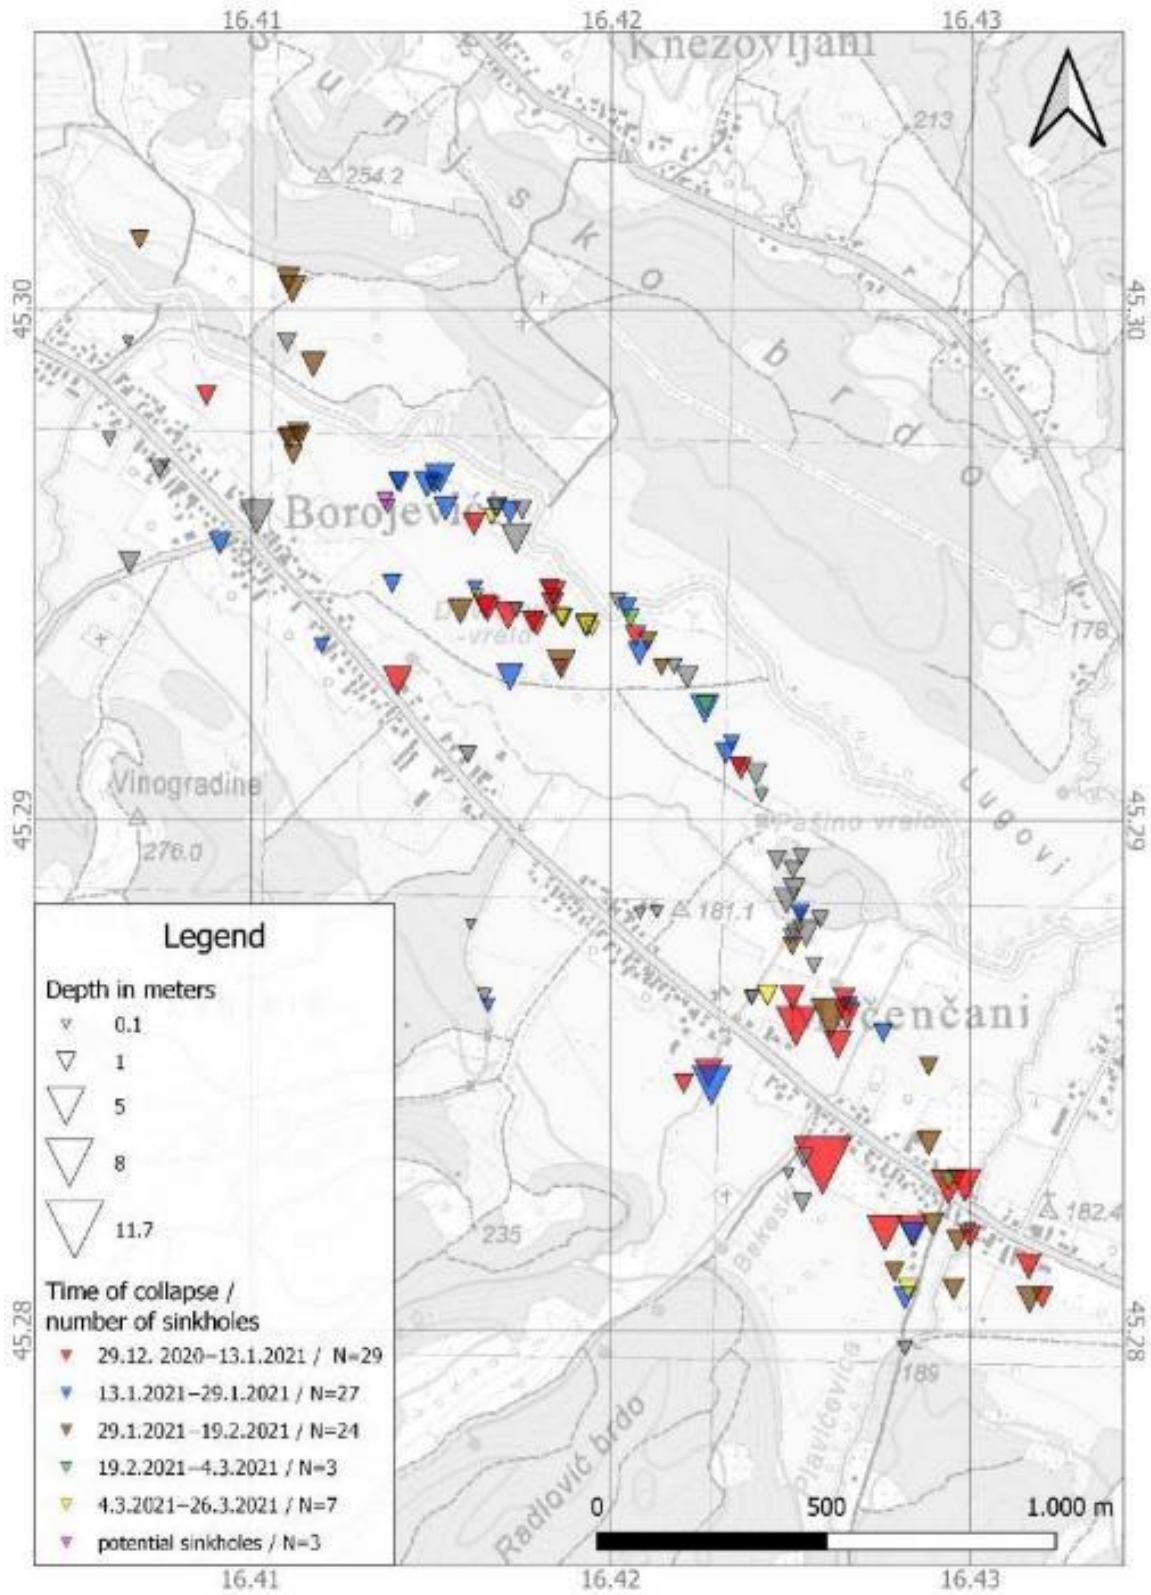
Figure 6.6 Spatio-temporal map of sinkholes in Borojevići and Mečenčani area and their depths on the topographic map.

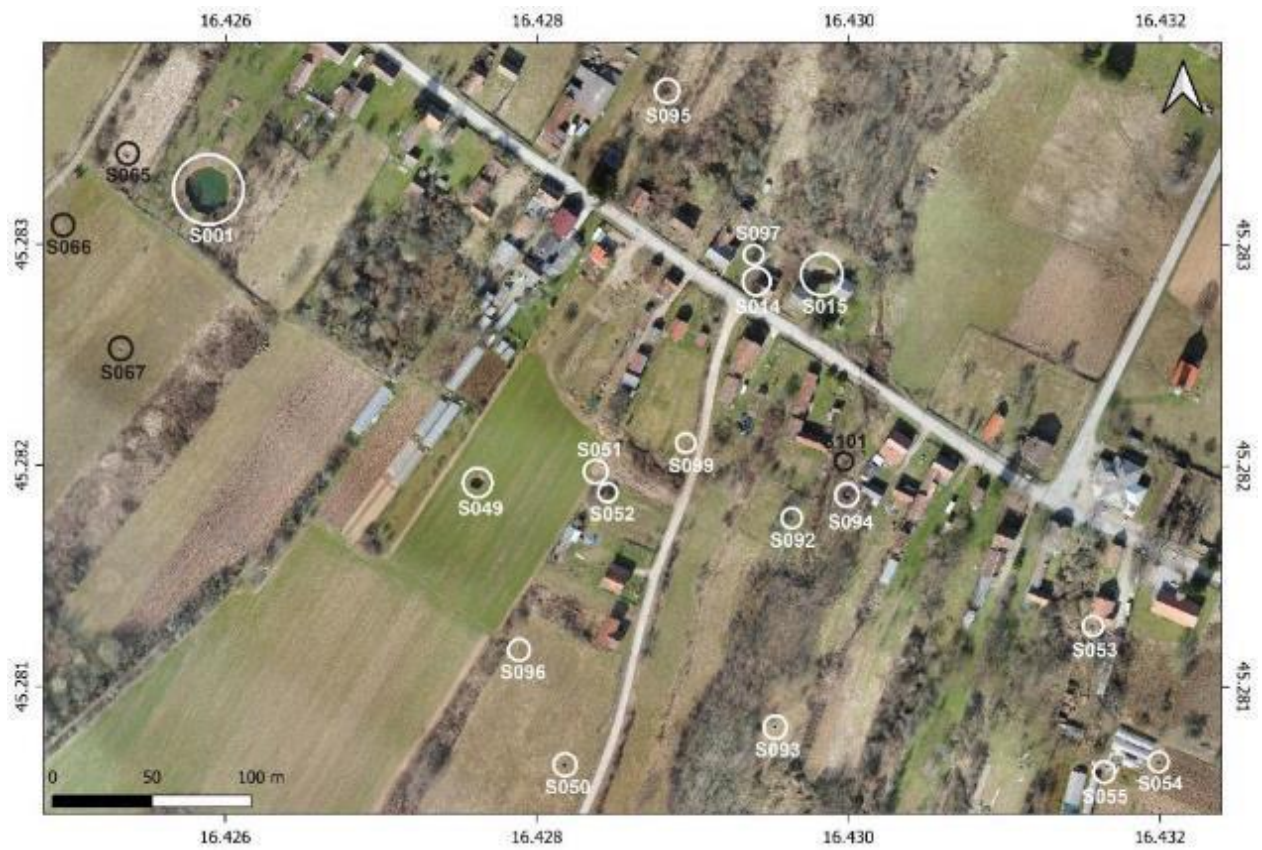
Figure 6.7 Areal image of cover-collapse sinkholes in Mečenčani village (white – new sinkholes opened after M6.4 earthquake, black – fossil sinkholes opened before the Petrinja earthquake sequence). Image by Croatian Geological Survey.

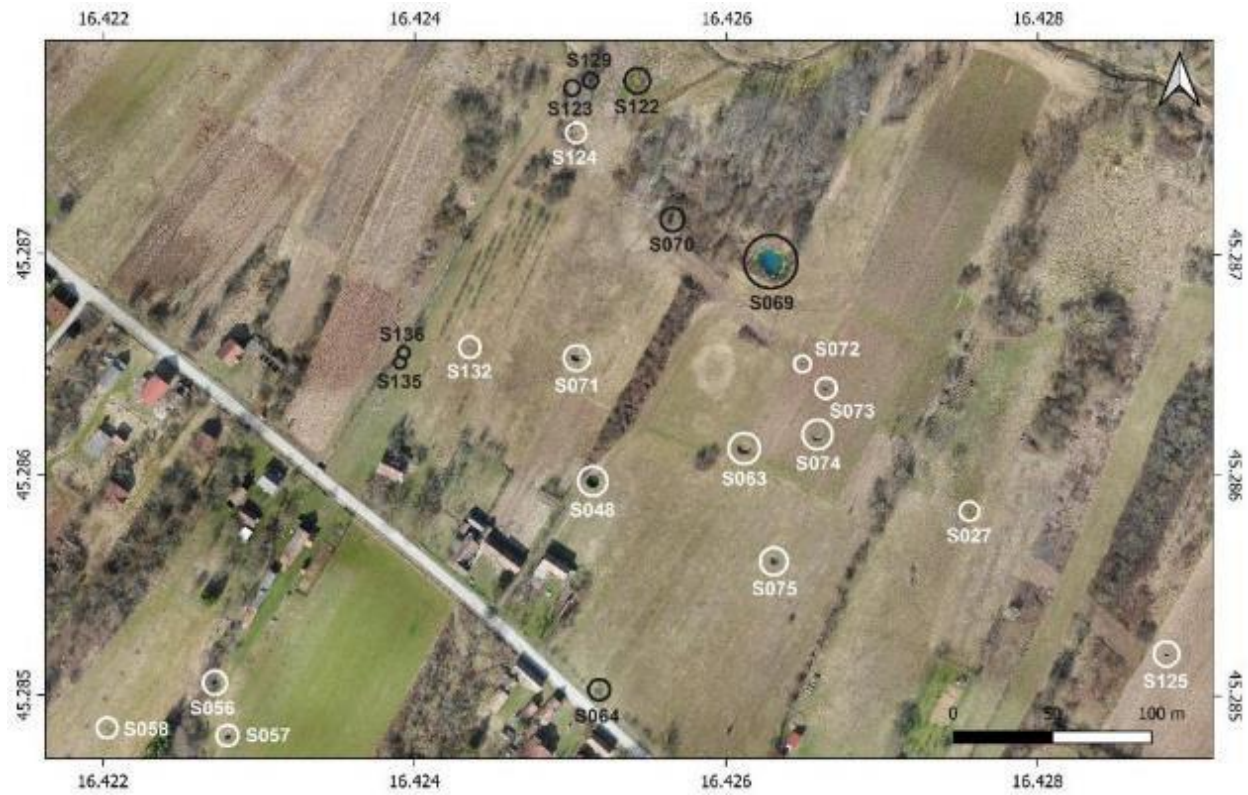
Figure 6.8 Areal image of sinkholes north of Mečenčani village (white – new sinkholes opened after M6.4 earthquake, black – fossil sinkholes opened before the Petrinja earthquake sequence). Image by Croatian Geological Survey.

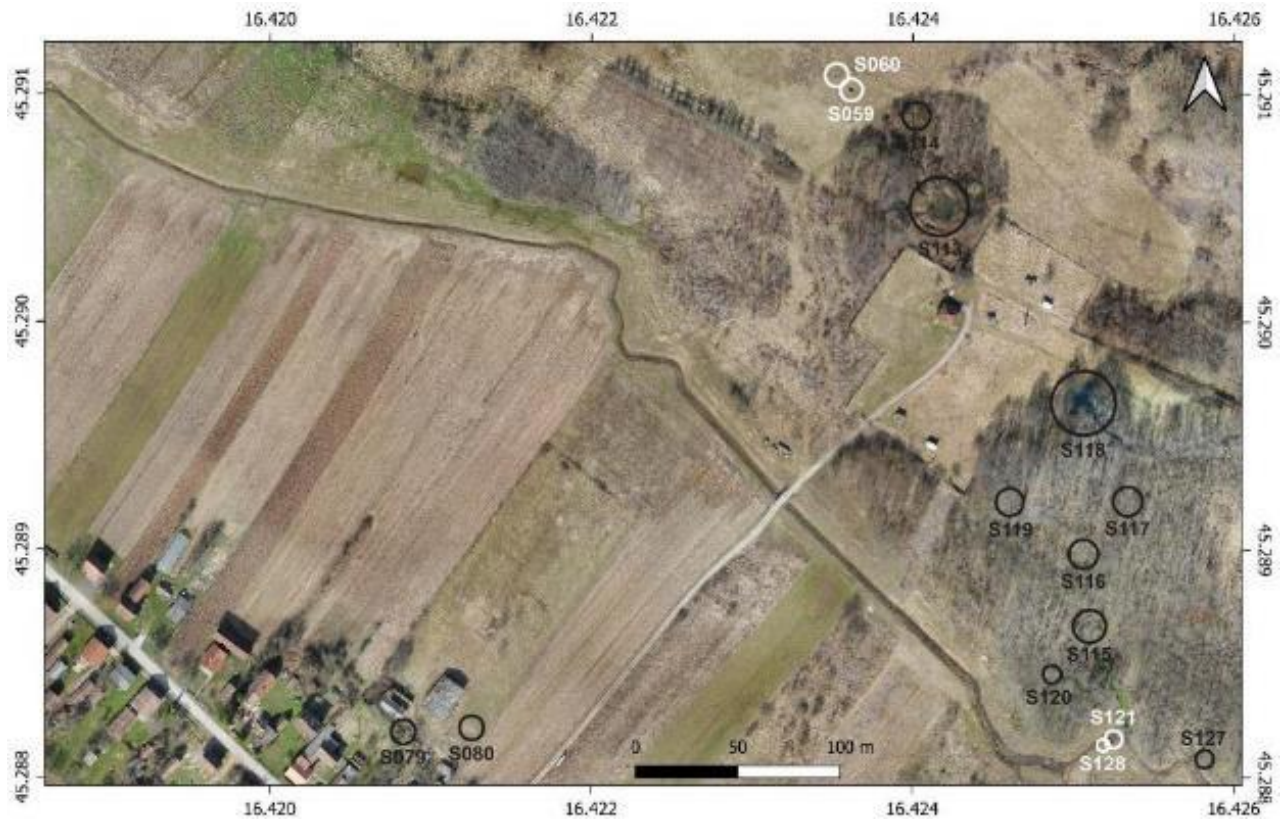
Figure 6.9 Areal image of sinkholes between Borojevići and Mečenčani villages (white – new sinkholes opened after M6.4 earthquake, black – fossil sinkholes opened before the Petrinja earthquake sequence). Image by Croatian Geological Survey.

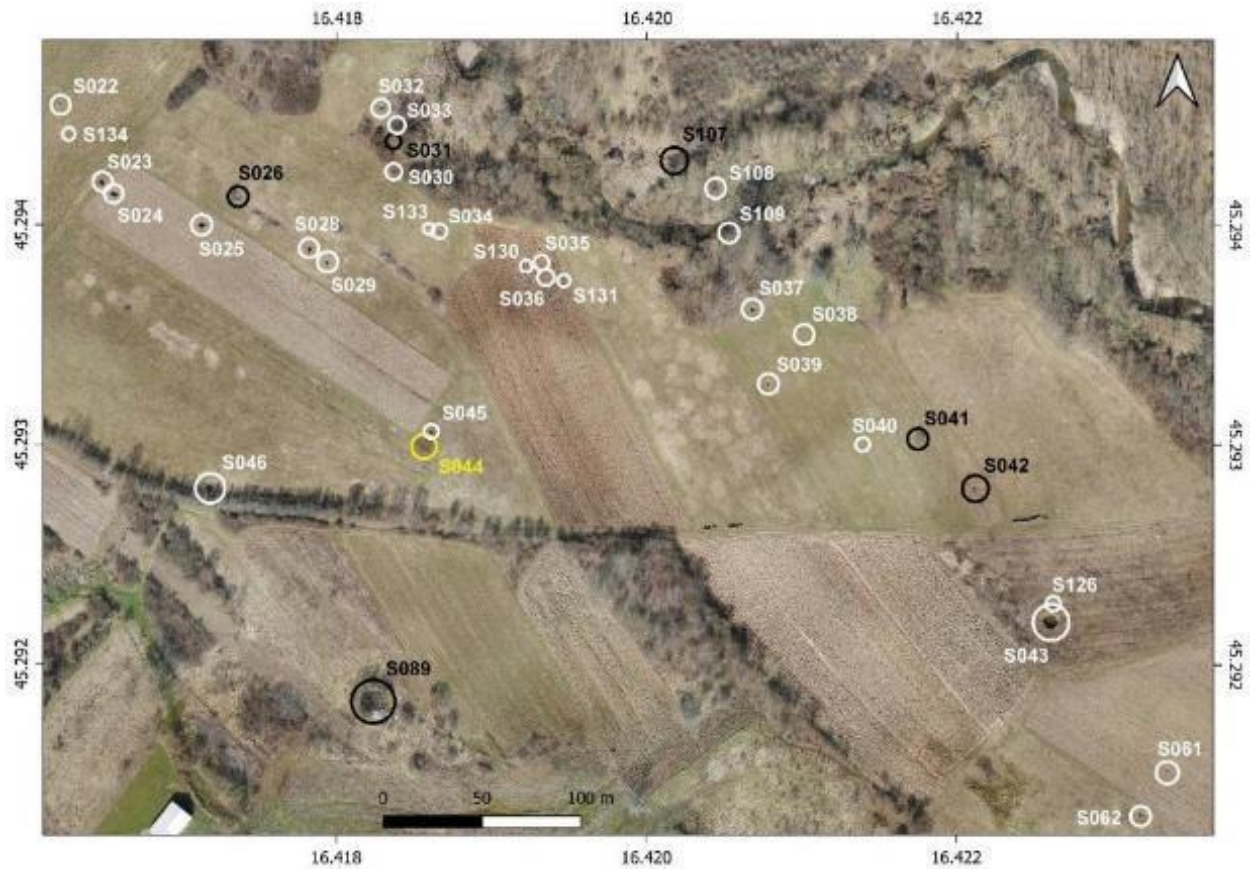
Figure 6.10 Areal image of sinkholes north of Borojevići village (white – new sinkholes opened after M6.4 earthquake, black – fossil sinkholes opened before the Petrinja earthquake sequence, yellow – potential locations of new cover-collapse sinkholes). Image by Croatian Geological Survey.

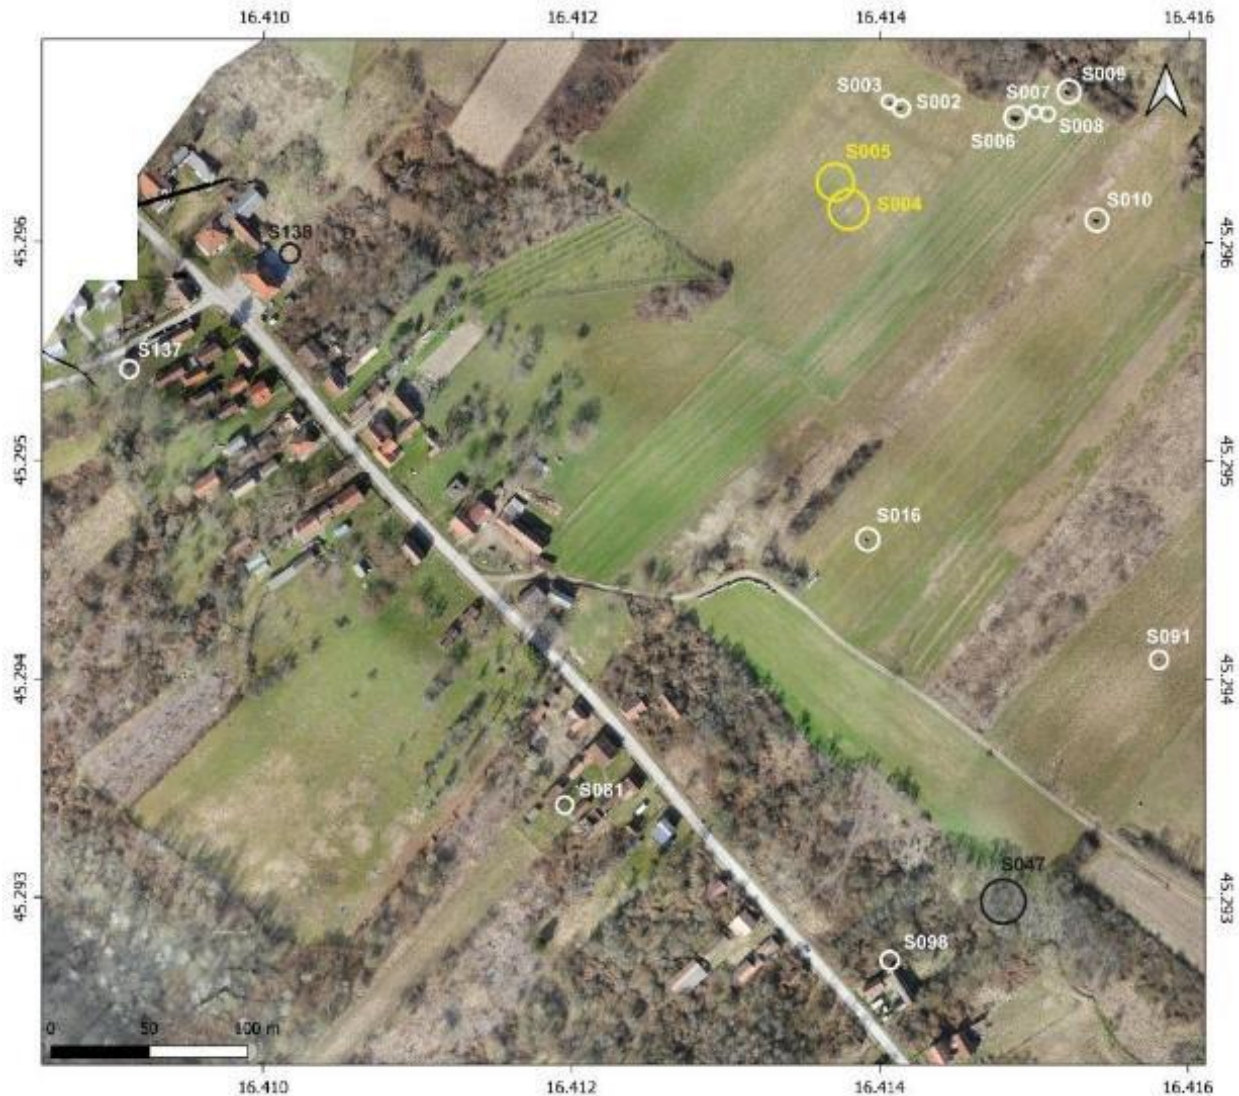
Figure 6.11 Areal image of sinkholes north of Borojevići village (white – new sinkholes opened after M6.4 earthquake, black – fossil sinkholes opened before the Petrinja earthquake sequence, yellow – potential locations of new cover-collapse sinkholes). Image by Croatian Geological Survey.

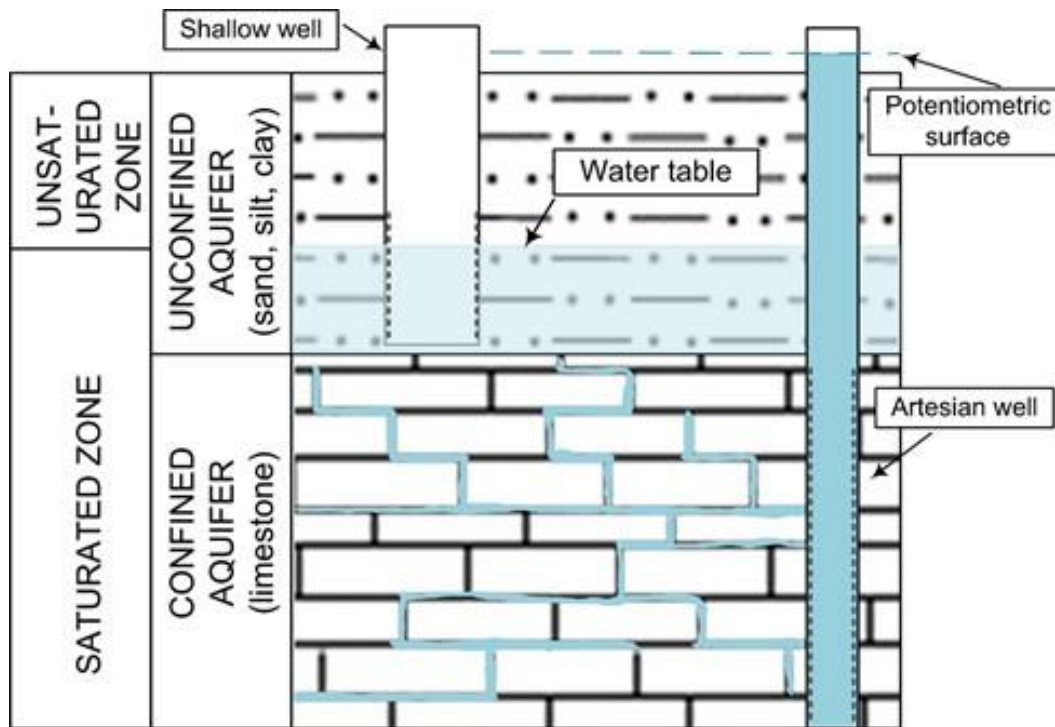
These two aquifers are hydraulically connected, and pressure changes in one aquifer cause changes in hydraulic conditions in the other. They form a single aquifer system (**Figure 6.13**). The recharge of the karst aquifer is almost exclusively done through precipitation falling on the nearby hills where the Badenian Lithothamnium limestones and calcarenites crop out. Discharge of the karst aquifer takes place in the spring of Pašino vrelo. Next to the spring couple of deep wells were made, from which water is pumped for the public water supply. The spring of Pašino vrelo is a fossil cover-collapse sinkhole, which at its bottom has a direct connection with the karstified carbonate aquifer. Close to the Pašino vrelo spring, several other springs with a similar origin also play the role of discharge points.

The earthquake of December 29, 2020, occurred during a period of high waters. The water level in the alluvial aquifer was very close to the surface, and in the karst aquifer, artesian conditions prevailed. The piezometric level was about ten centimeters above the surface (**Table 6.1**).

Figure 6.13 A conceptual model of hydrological condition in aquifer system during the earthquake (Mečenčani, Croatia).

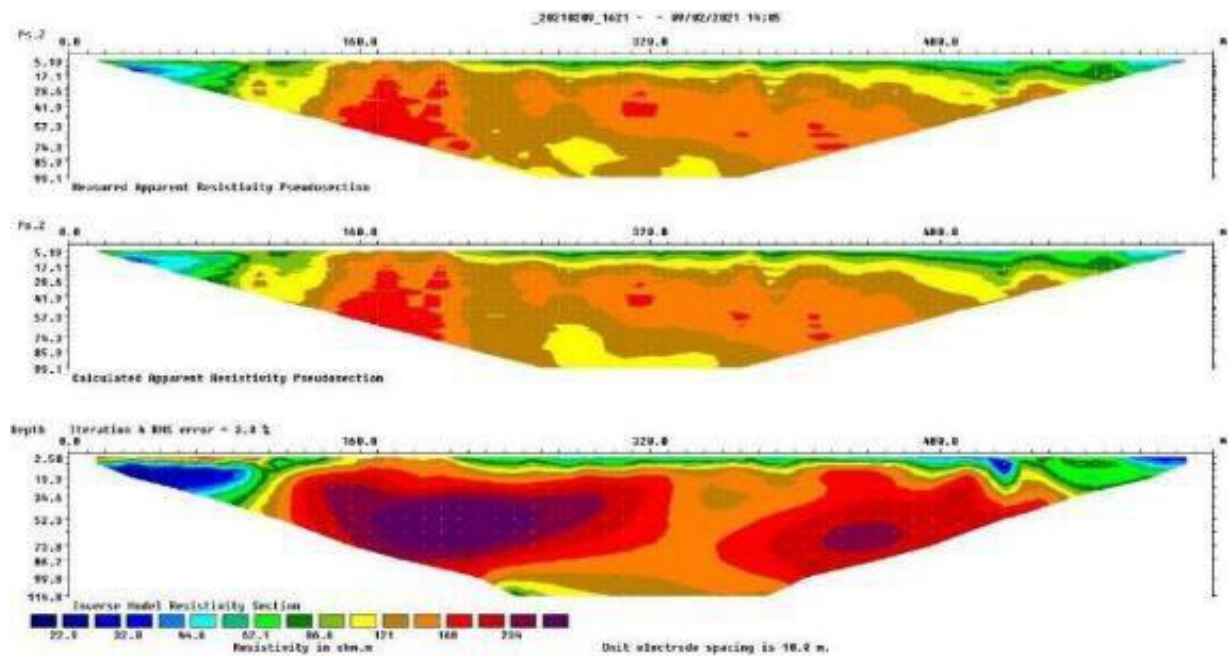
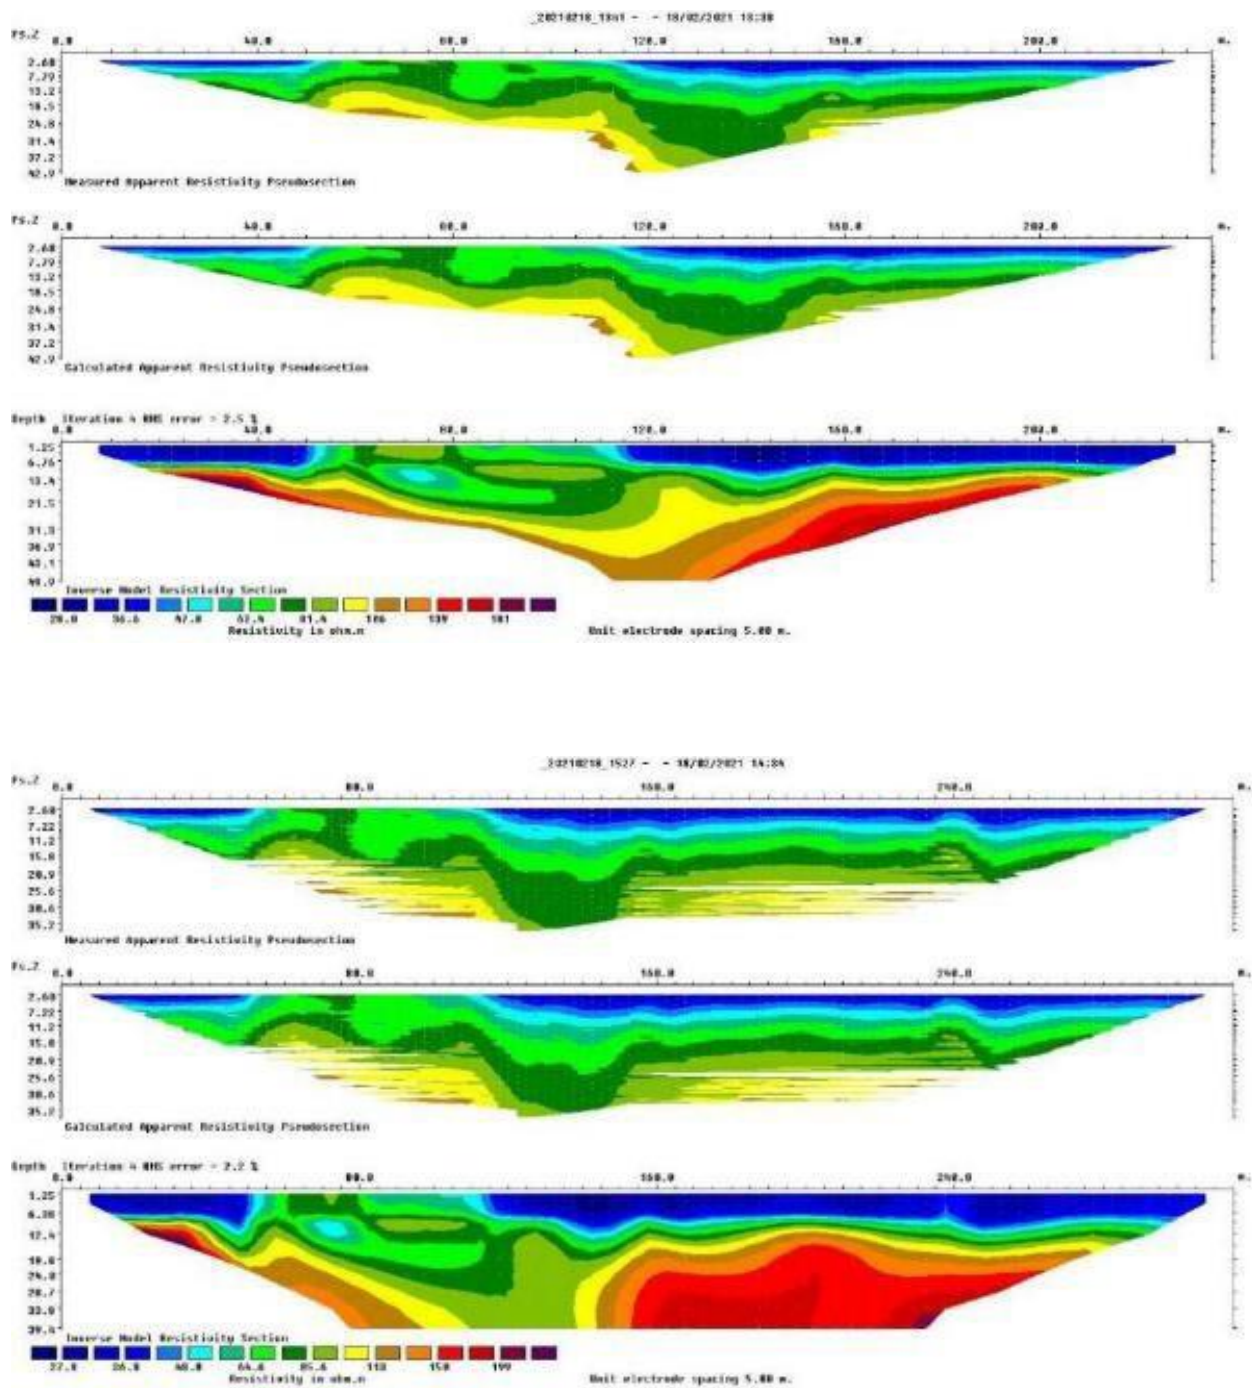
Three electrical resistivity tomography (ERT) profiles were recorded by GEER team members from the Croatian Geological Survey (**Figures 6.14 and 6.15**). The POLARES 2.0 system with Wenner–Schlumberger array recorded all profiles, while interpretation and 2D visualization utilized Res2Dinvx64 software. ERT-1 profile was oriented 43–223°, 630 m long with 10 m distance between electrodes, and crosses perpendicularly from the Sunja river through the area between Mečenčani and Borojevići towards the hill at SW. The electrical resistivity profile detected a couple of predominately fossil sinkholes. To obtain a better resolution, two additional profiles with the same orientation, ERT-2 and ERT-3, were recorded with a distance of 5 m between the electrodes and lengths of 235 and 315 m.

Figure 6.15 Electrical resistivity tomography (ERT) profiles recorded in the area between Mečenčani and Borojevići (left side of profiles NE, right side SW). For the position of profiles, see Figure 11.

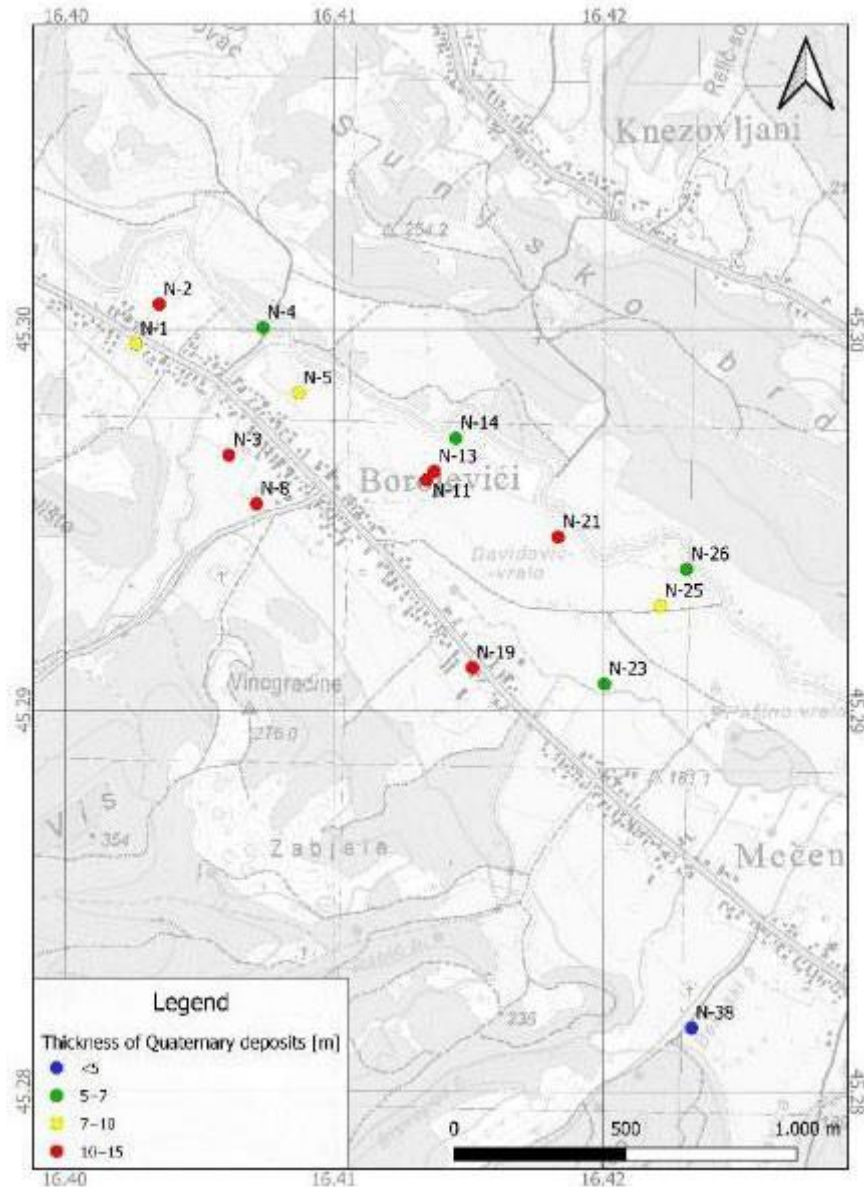
An HVSR analysis is shown in **Figure 6.16** that sorts approximate depths of karstic bedrock with colors. Although the research performed at this stage is a unique process described in Chapter 10, it should be noted that the fundamental resonant frequency f_0 determination was challenging

for some positions. Therefore, the analysis accuracy may be low. However, a few reliable results yielded representative data of the cover layer's relatively low thicknesses, which we detected for positions in proximity and along the Sunja river. We detected karst at deeper levels in the area between Mečenčani and Borojevići, and thicker cover in these locations could explain the absence of new sinkholes. Geotechnical boreholes near Sunja river were performed until shallow depths because the manual drilling equipment had difficulties penetrating through the alluvial deposits of clayey gravel with up to 15 cm grain sizes. The actual depth of the karst was not detected, unlike the B-1 in Borojevići, where the karst depth correlates with the N-1 nanometric result.

Figure 6.16 Estimated karst depths from HVSR measurement and analysis on a topographic map.

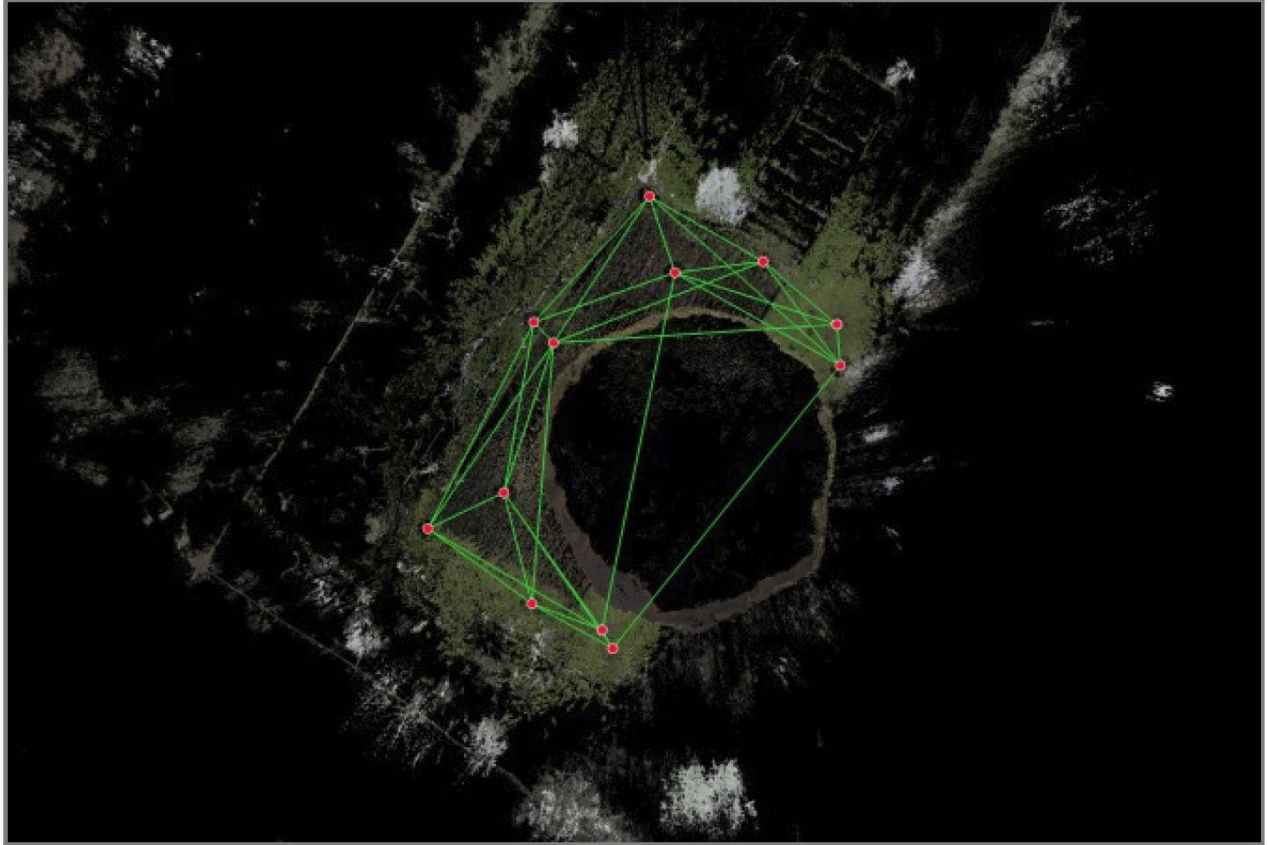
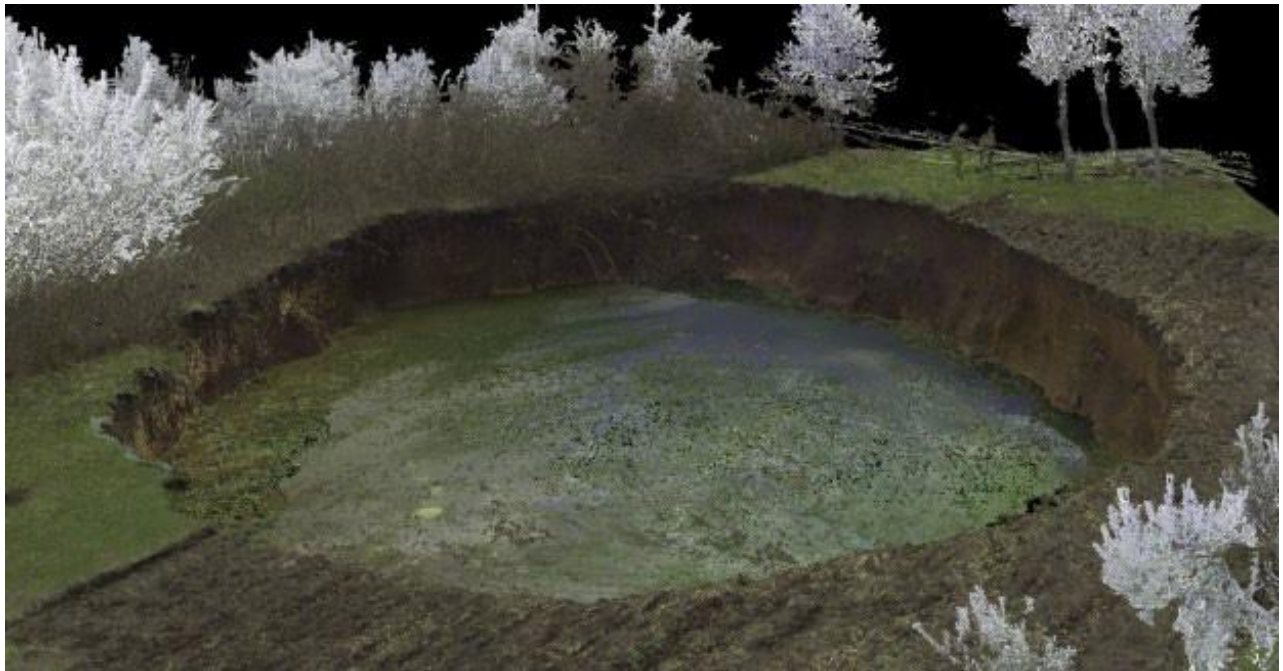
S001 is characterized by vertical walls in brown clay, with sparse 30–60 cm thick lenses of round grain gravel. **Figure 6.20** shows a photograph taken by the lidar imaging positions and a sample scan. The bundle links 13 setups with 35 links with the bundled error 8 mm. **Figure 6.21** shows the top view where the longest axis diameter is about 24.55 m, and the largest diameter at the bottom of the scan is 21.865 m (**Figure 6.22**). The water depth is 2.507 m from the upper edge of the sinkhole, as shown in **Figure 6.23**. **Figure 6.24** shows an example of sinkhole volume calculation from terrestrial lidar point cloud data. However, due to the relatively high water level, the GEER team could not obtain information about the sinkhole contours under the water.

Figure 6.20 Lidar bundle with 13 setups and 35 links around S001 (45.2833444N, 16.4259639E).

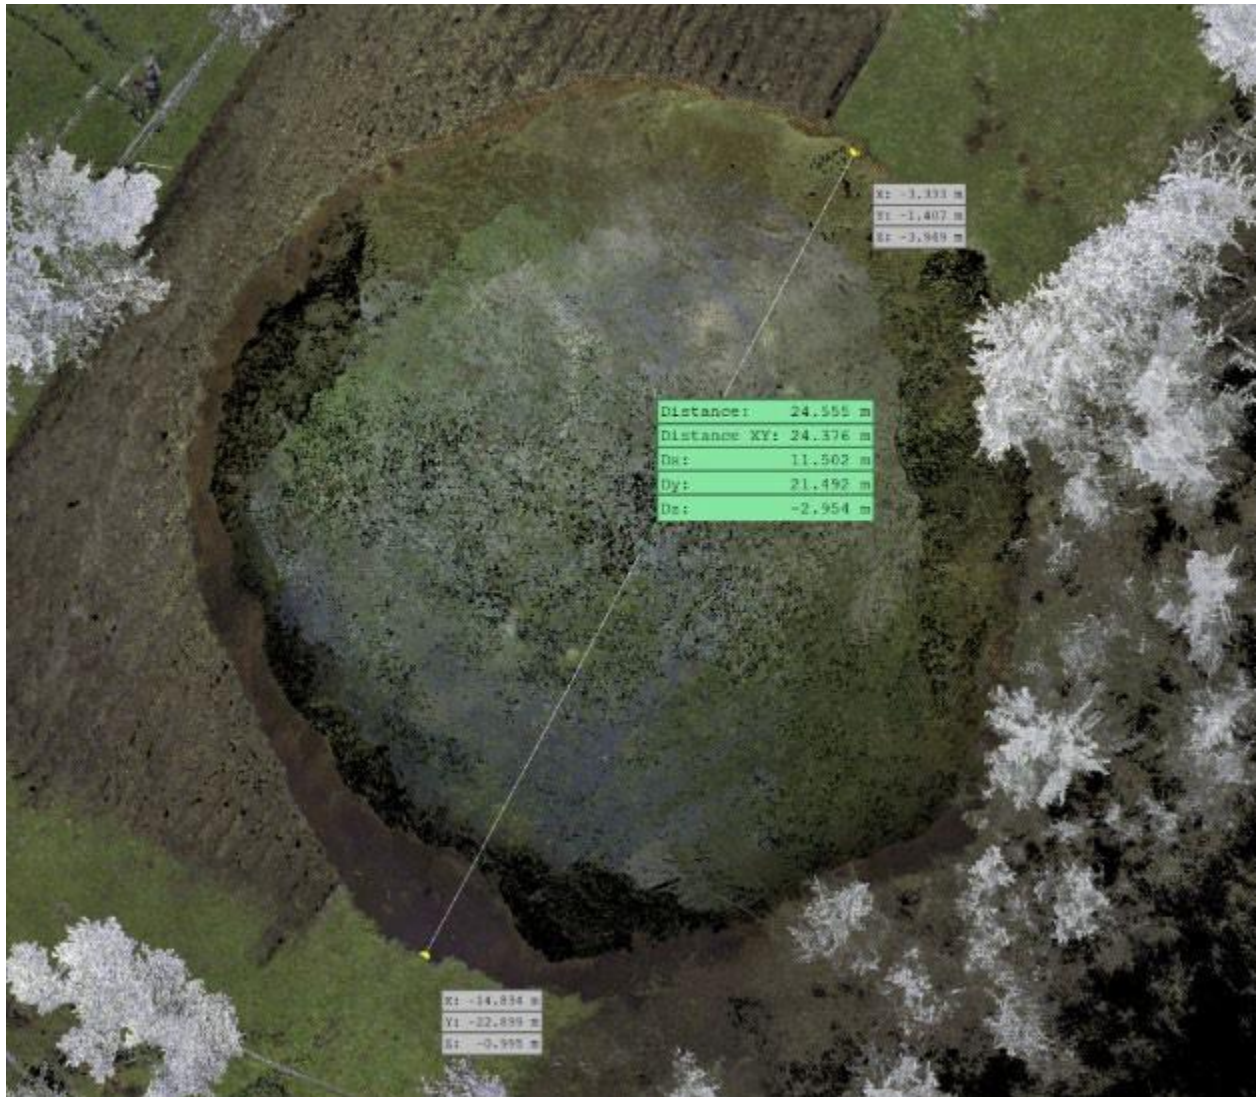
Figure 6.21 Top view diameter of S001 from lidar scan (45.2833444N, 16.4259639E).

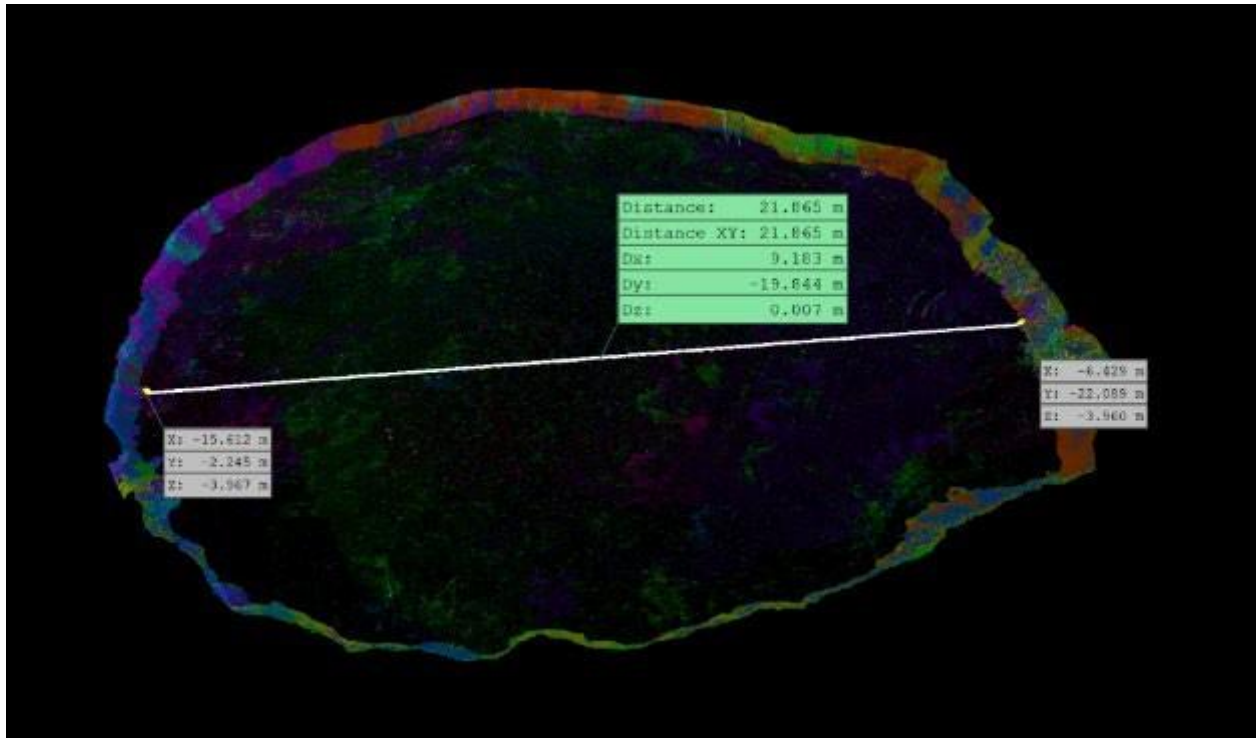
Figure 6.22 Diameter at the lidar scan on the bottom level of S001 (45.2833444N, 16.4259639E).

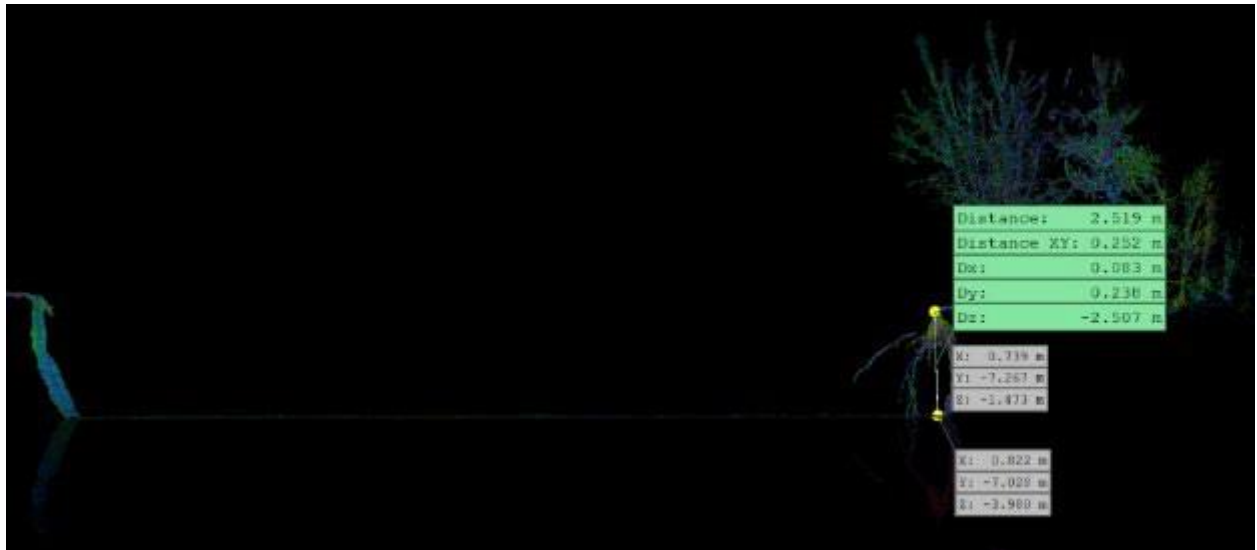
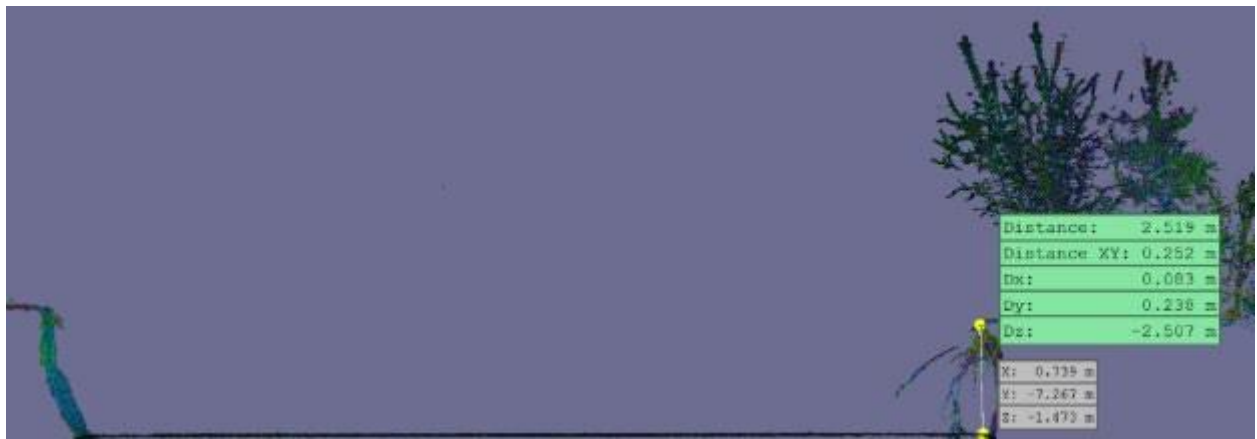
Figure 6.23 Y-axis cross-section scans with dimensions of S001 (45.2833444N, 16.4259639E).

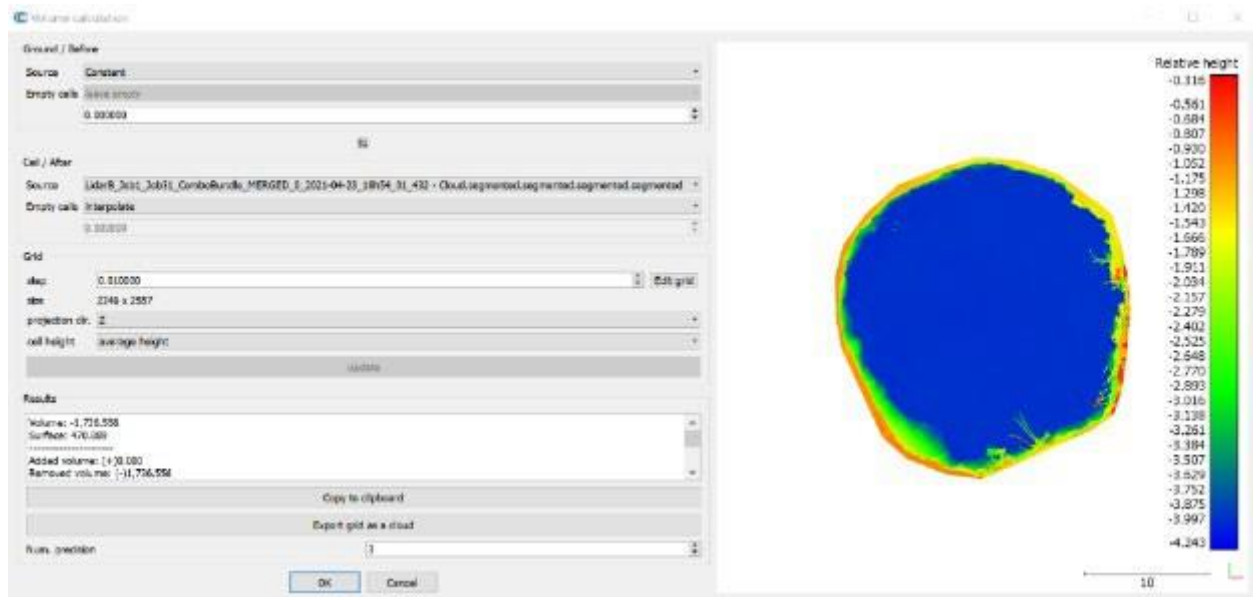
Figure 6.24 Volume calculations of S001 (45.2833444N, 16.4259639E).
