Geotechnical Reconnaissance and Engineering Effects of the December 29, 2020, M6.4 Petrinja, Croatia Earthquake, and Associated Seismic Sequence

Chapter 6: Cover-Collapse Sinkholes

Authors: Ingrid Tomac, Igor Vlahović, Jelena Parlov, Bojan Matoš, Darko Matešić, Ivan Kosović, Ivica Pavičić, Tihomir Frangen, Josip Terzić, Davor Pavelić, Nguyen Pham

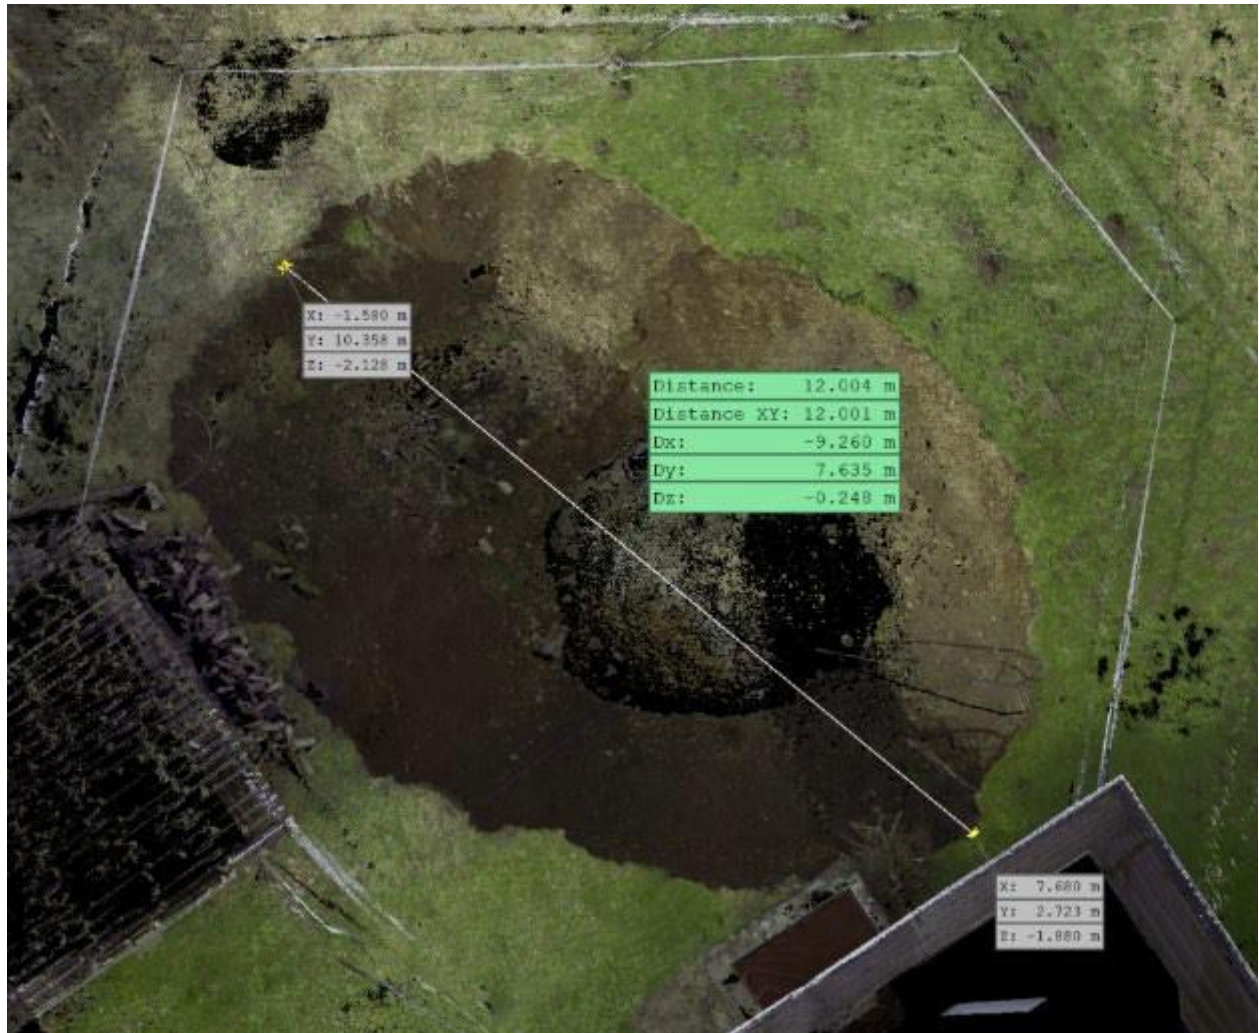
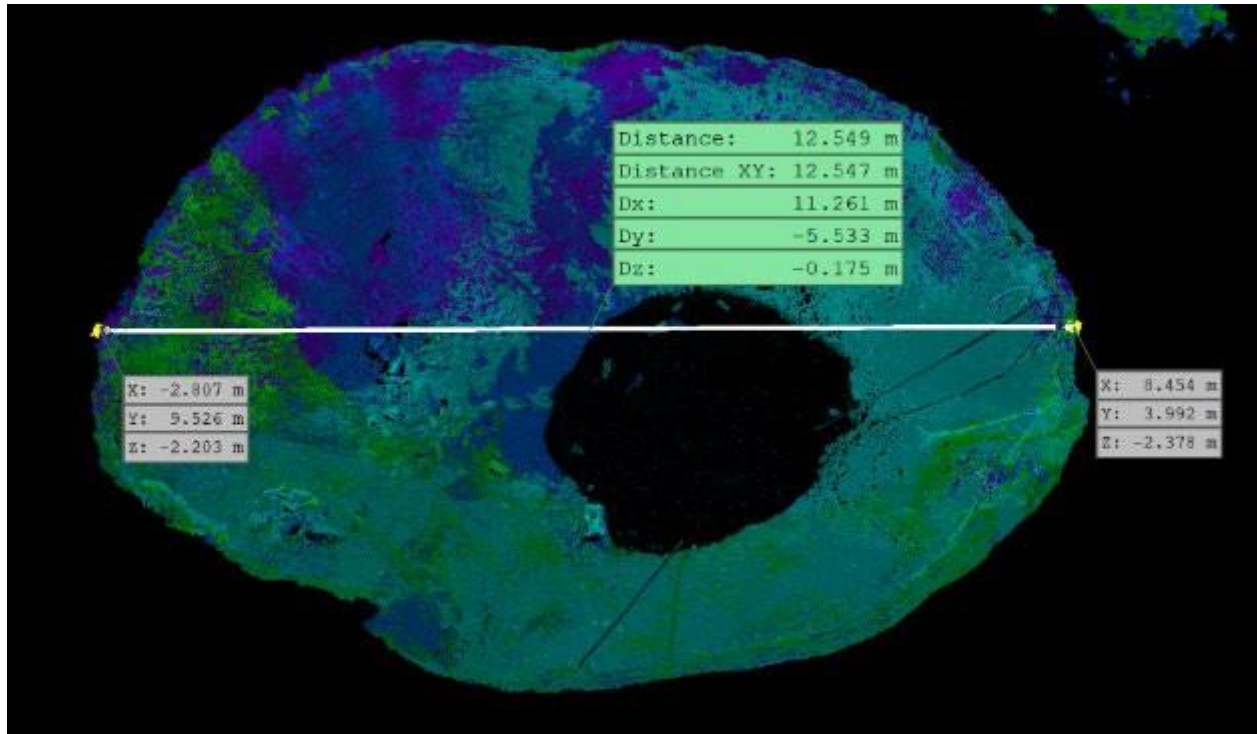
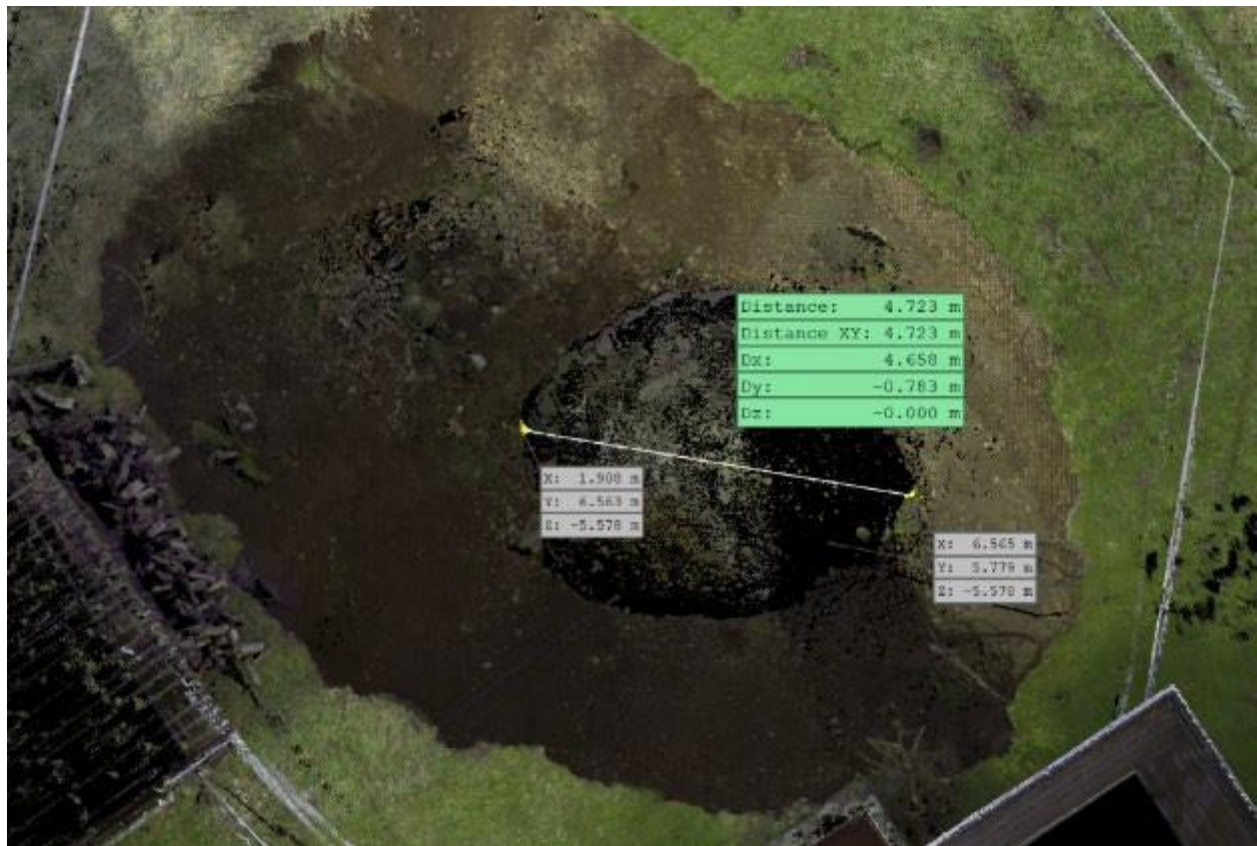
S015 collapsed on December 29, 2020, with the first subsidence noticed six hours after the main shock, followed by the opening of two cover-collapse structures (each about 1.5 m in diameter

and cca. 1 m deep) within the next three hours and further collapse and formation of united sinkhole until the morning of December 30. **Figure 6.27** shows a lidar bundle scan near a house, where **Figures 6.28** and **6.29** show measurements from point cloud data.

Figure 6.28 Top and bottom diameters from the lidar scan of S015 (45.282859N, 16.429841E).

Figure 6.28 (cont.) Top and bottom diameters from the lidar scan of S015 (45.282859N, 16.429841E).

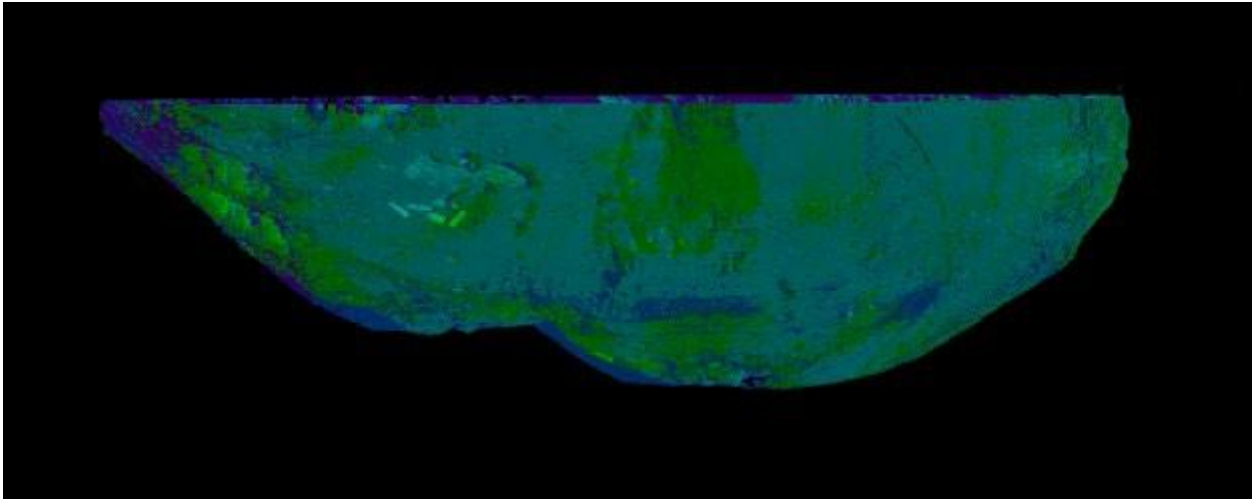
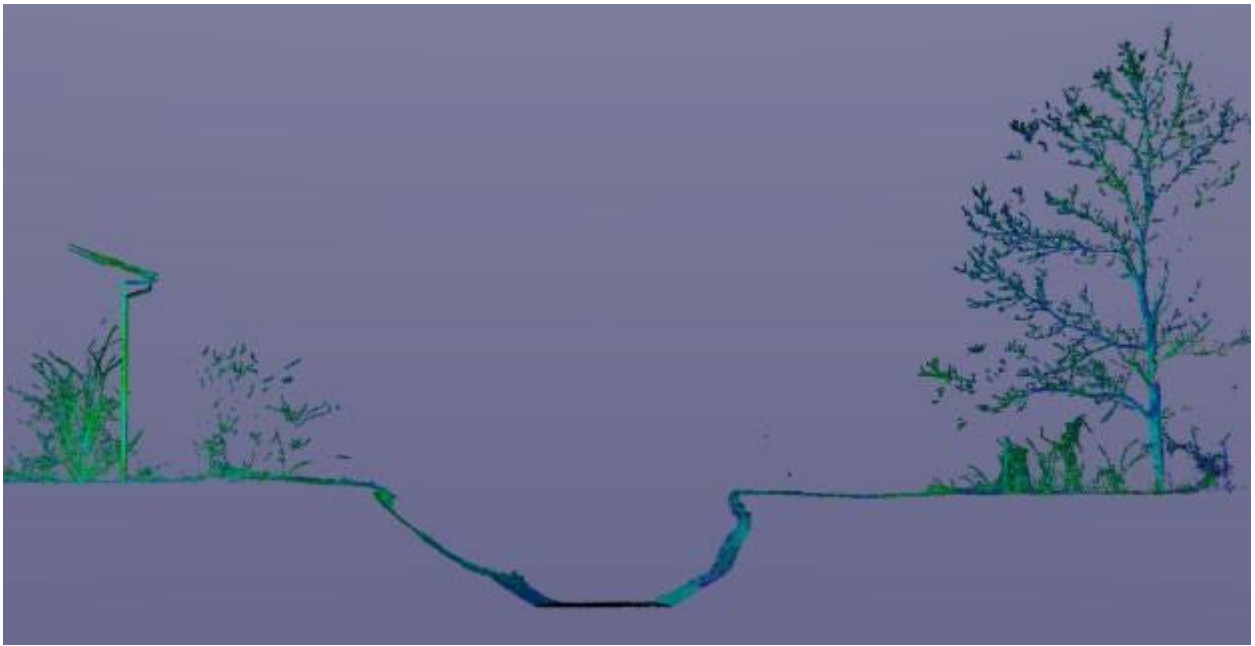
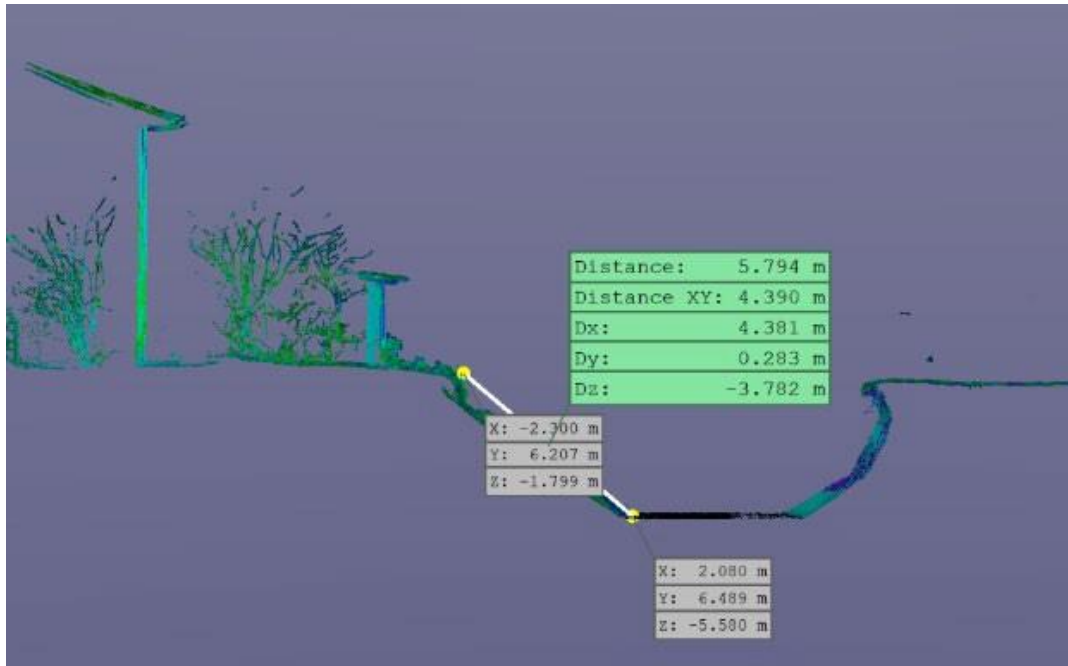
Figure 6.29 Below surface cross-sections from the lidar scan of S015 (45.282859N, 16.429841E).

Figure 6.29 (cont.) Below surface cross-sections from the lidar scan of S015 (45.282859N, 16.429841E).

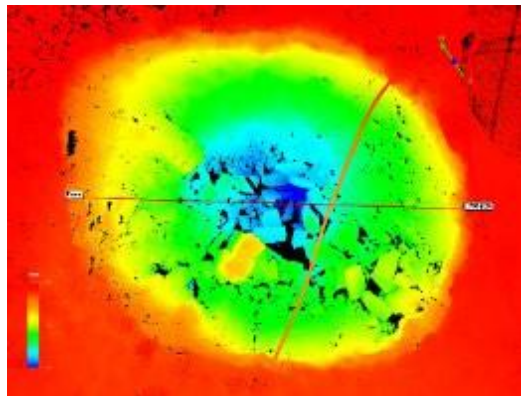
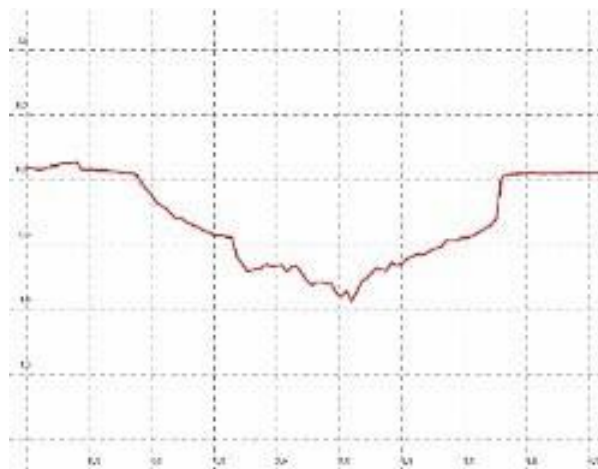
Figure 6.33 S053 Surface level measurement and cross-sectional profile (45.281270N, 16.431618E).

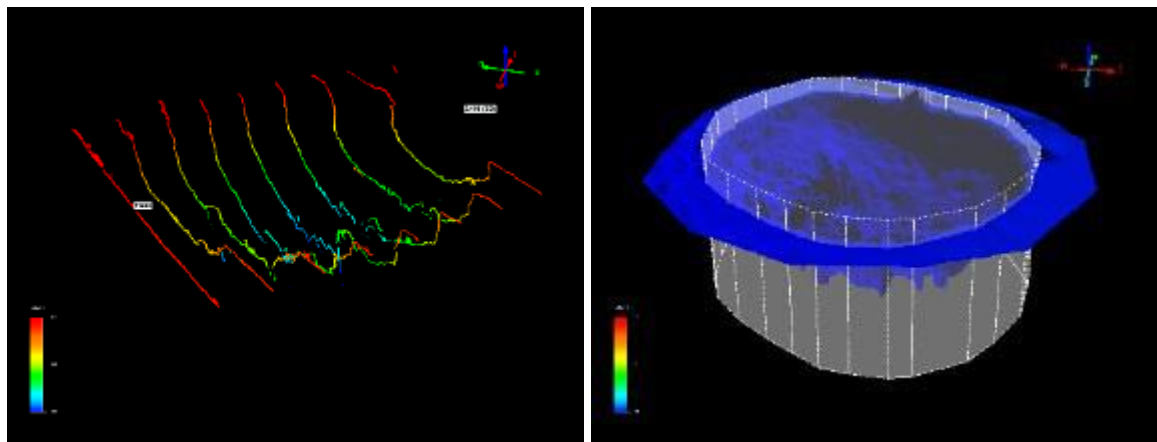
Figure 6.34 S053 Cross sections and volume estimate $V=2.98 \text{ m}^3$ (45.281270N, 16.431618E).

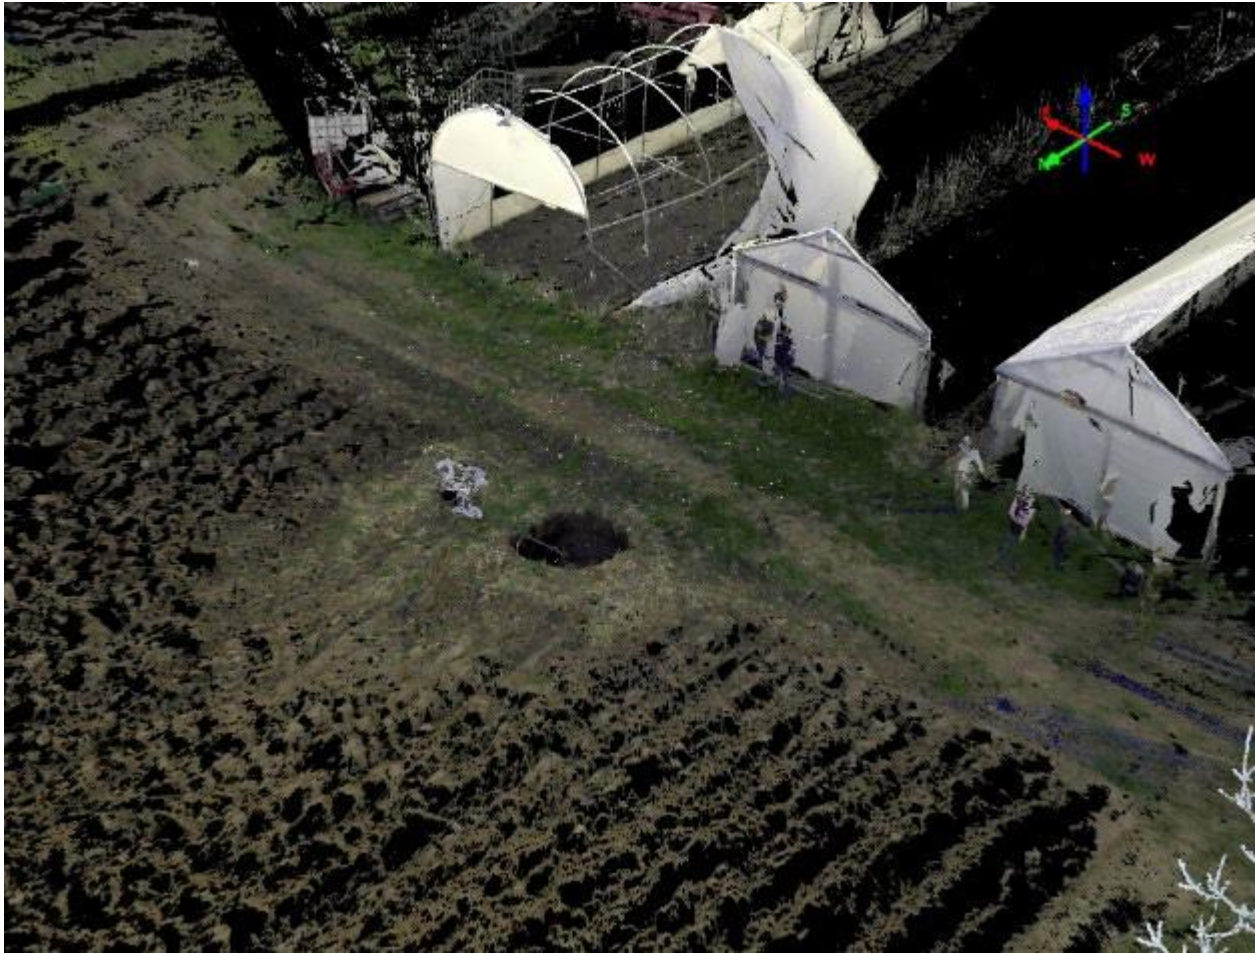
Figure 6.35 S054 lidar scan bundle view (45.280665N, 16.431996E).

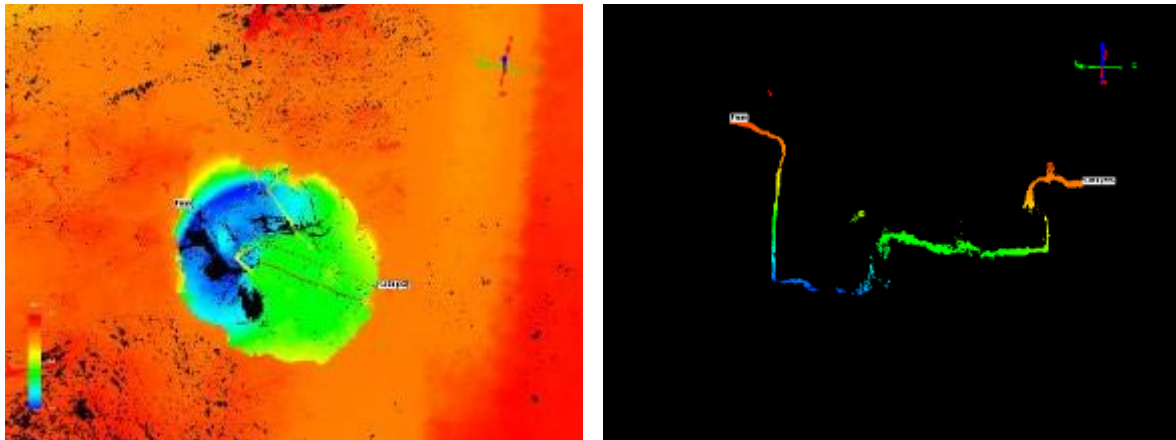
Figure 6.36 S054 plan view and cross section (45.280665N, 16.431996E).

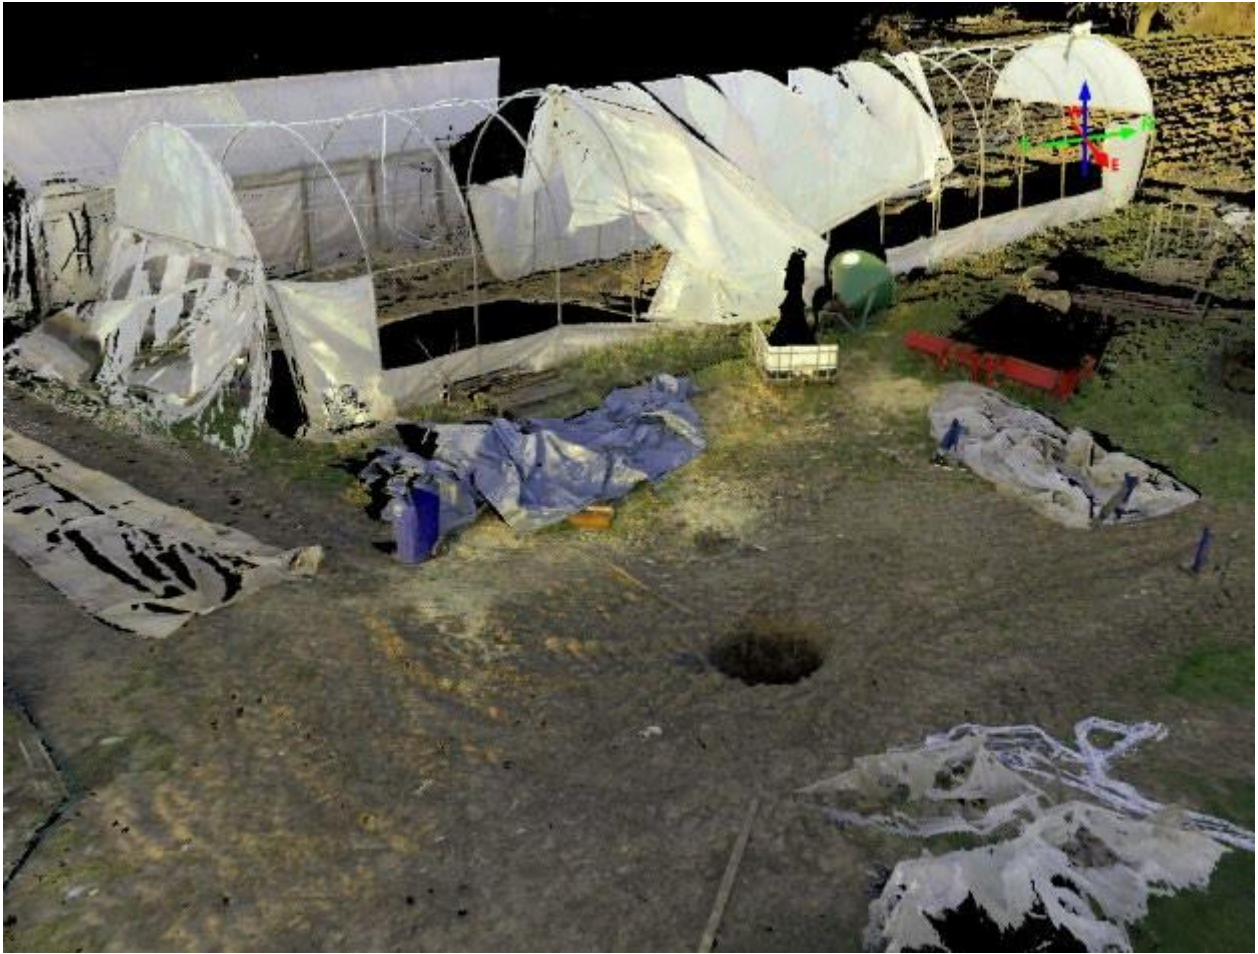
Figure 6.37 S055 lidar scan bundle view (45.280618N, 16.431644E).

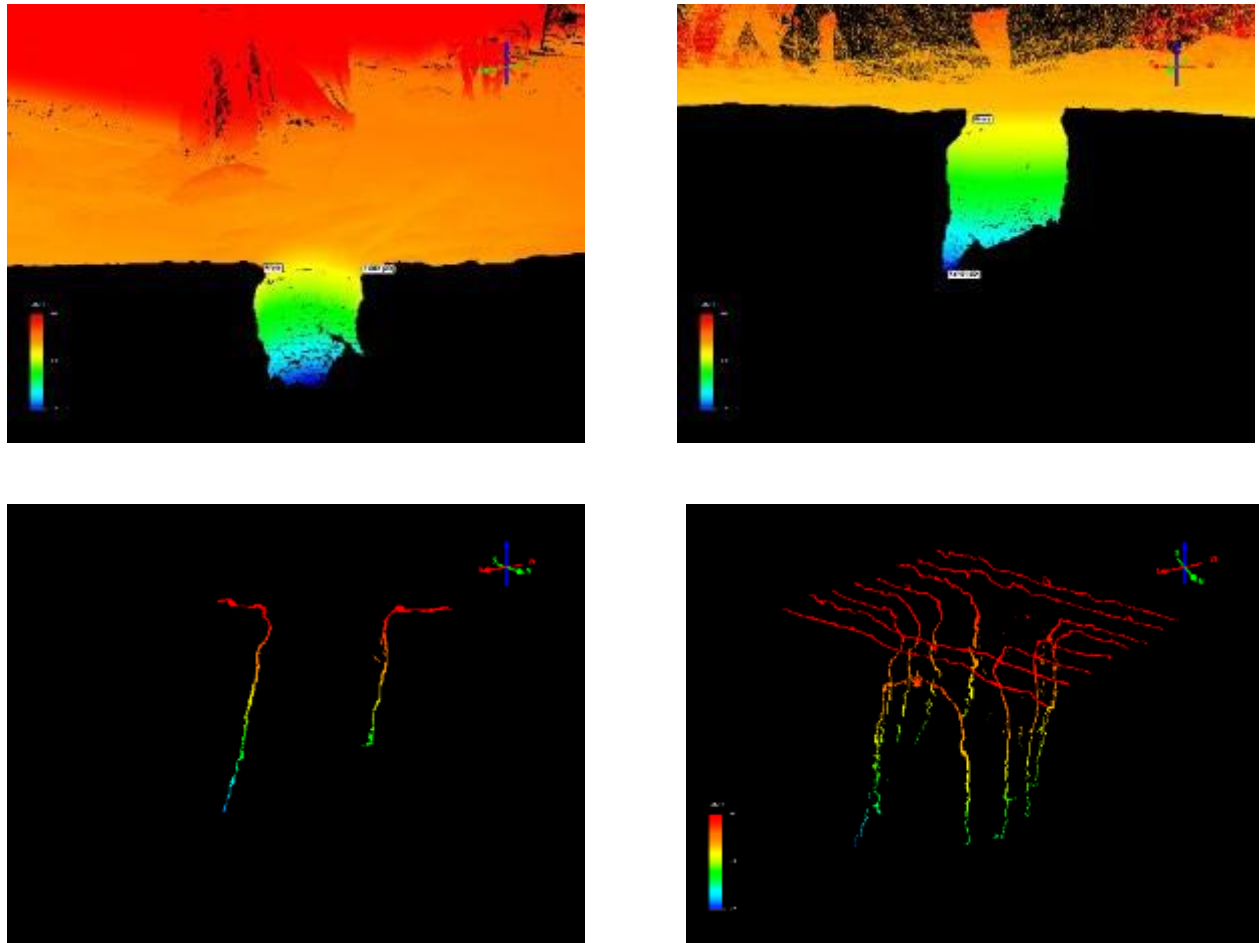
Figure 6.38 S055 cross sections (45.280618N, 16.431644E).

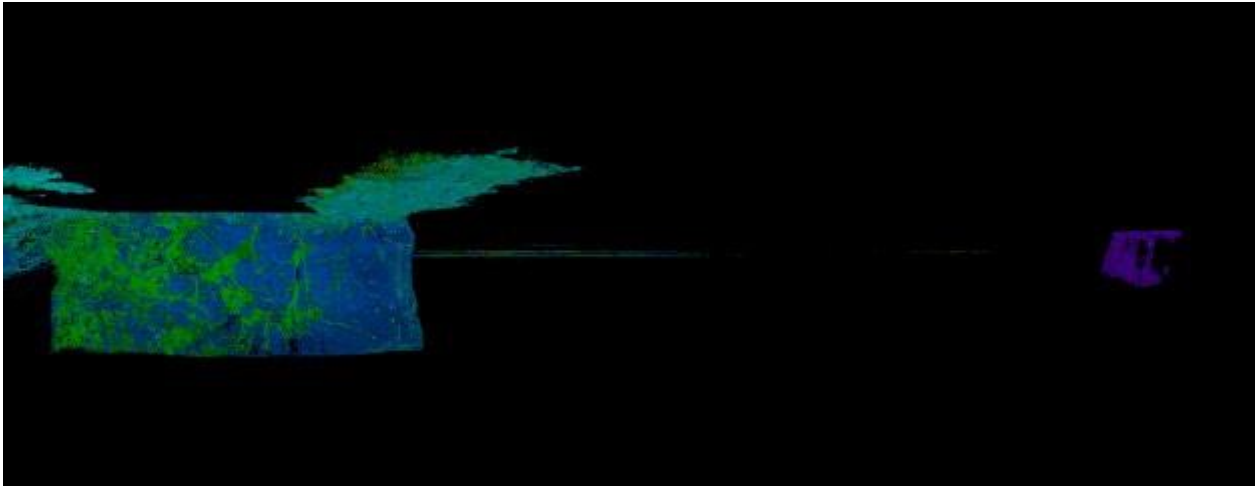
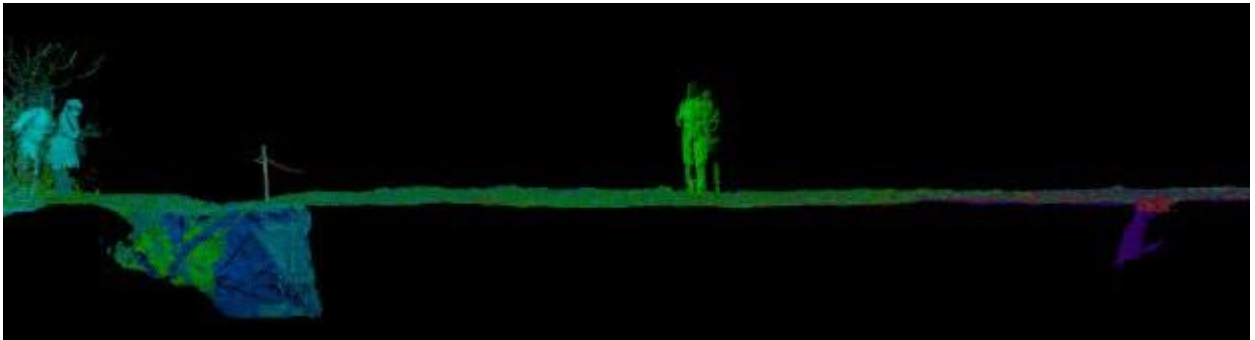
Numerous sinkholes collapsed in Borojevići, where many are near and along the Sunja river. Sinkholes in this particular area are generally shallower and have a smaller diameter. **Figures 6.39** to **6.45** show a few typical examples of lidar scans and measurements. It was possible to bundle scans of two or three sinkholes into one in several locations, which provided a good idea about the qualitative spatial variability of sinkhole characteristics. Sinkholes were either similar or very different next to each other. In some locations, new sinkholes opened near fossil sinkholes. Such variability depicts the heterogeneity and unpredictability of underlying karstic formations in these locations.

Figure 6.39 Cross-sections of the lidar bundle with two adjacent sinkholes, S007 (45.296599N, 16.415005E) and S008 (45.296589N, 16.415085E).

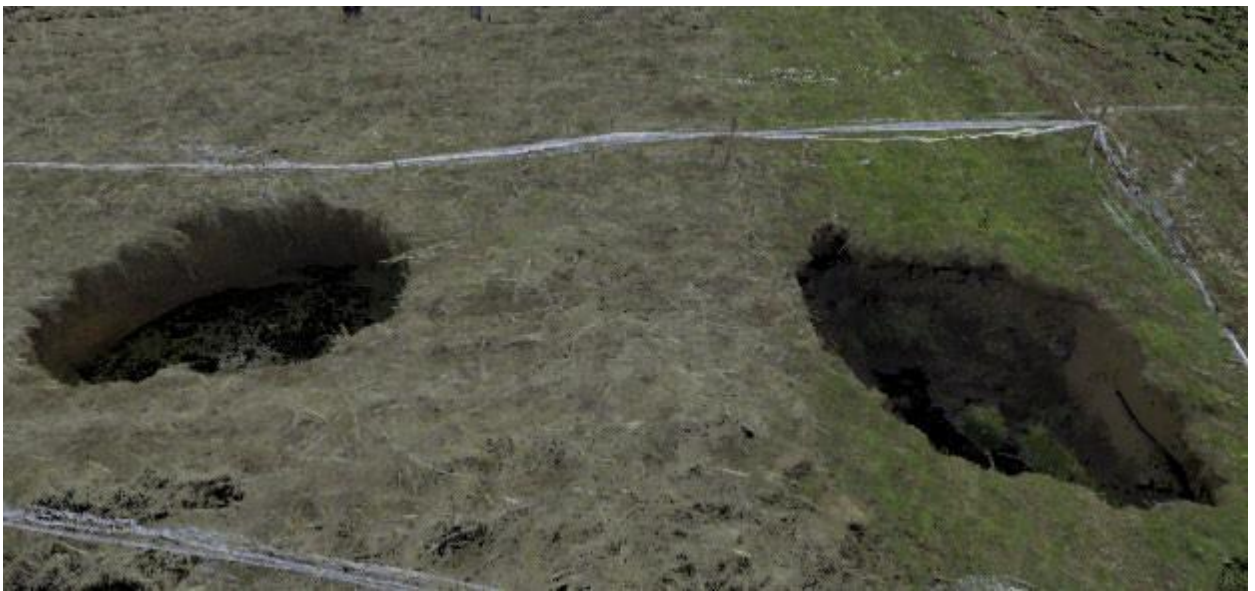
Figure 6.40 Cross-section of the lidar bundle with two adjacent sinkholes, S023 (45.294192N, 16.416487E) and S024 (45.294139N, 16.416563E).

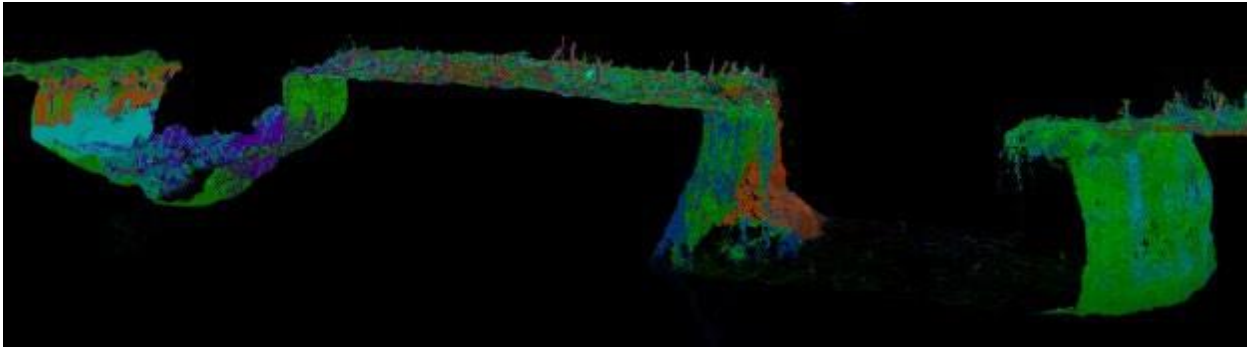
Figure 6.41 Cross-section of the lidar bundle with two adjacent sinkholes, S023 (45.294192N, 16.416487E) and S024 (45.294139N, 16.416563E).

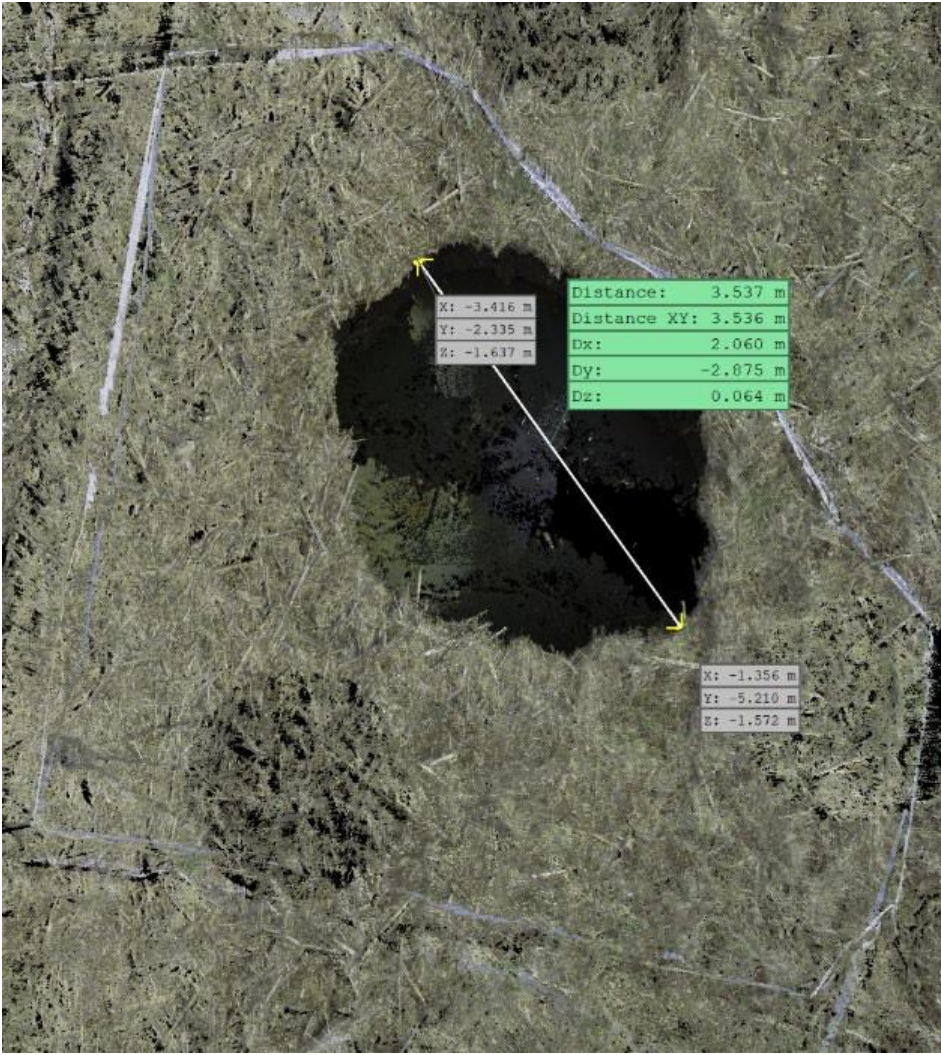
Figure 6.42 The lidar scan of the sinkhole S025 (45.293997N, 16.417133E).

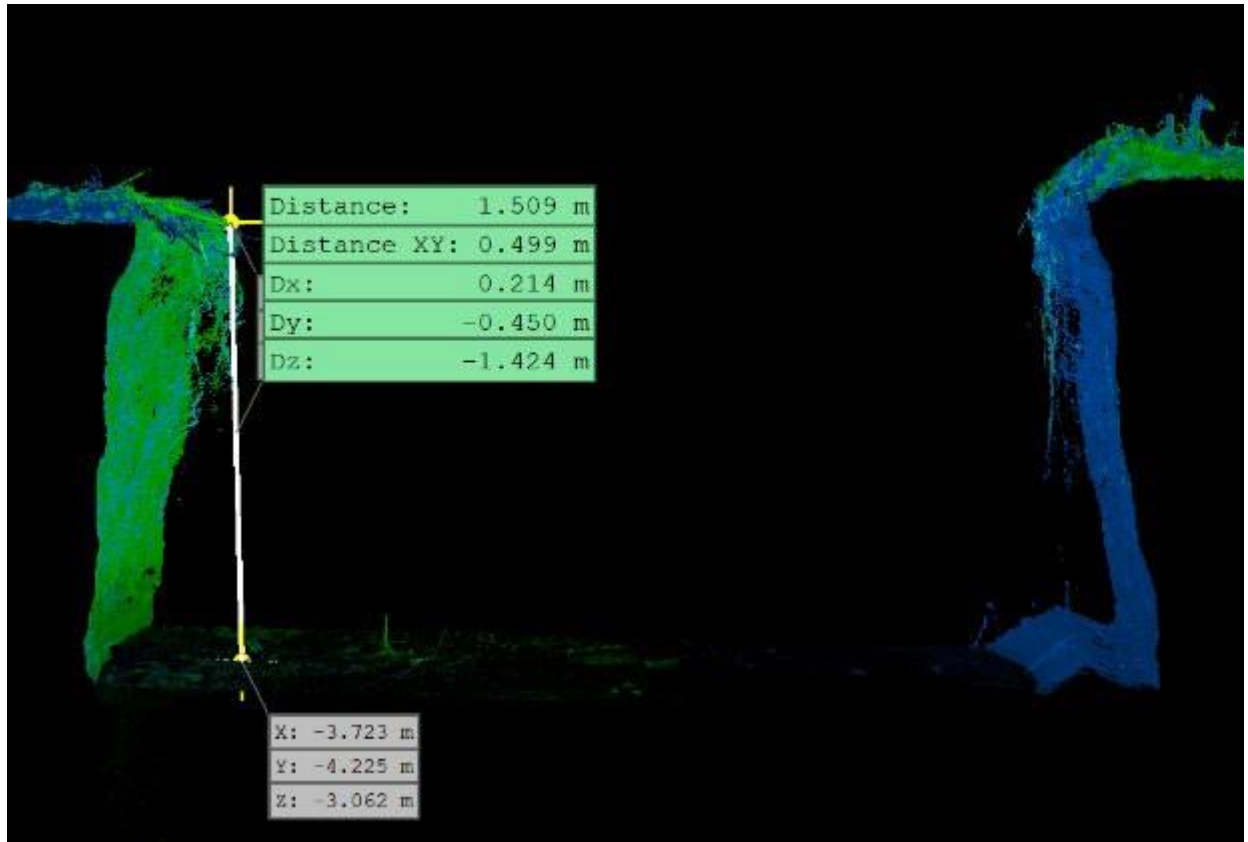
Figure 6.43 The lidar scan with the cross-section of the sinkhole S025 (45.293997N, 16.417133E).

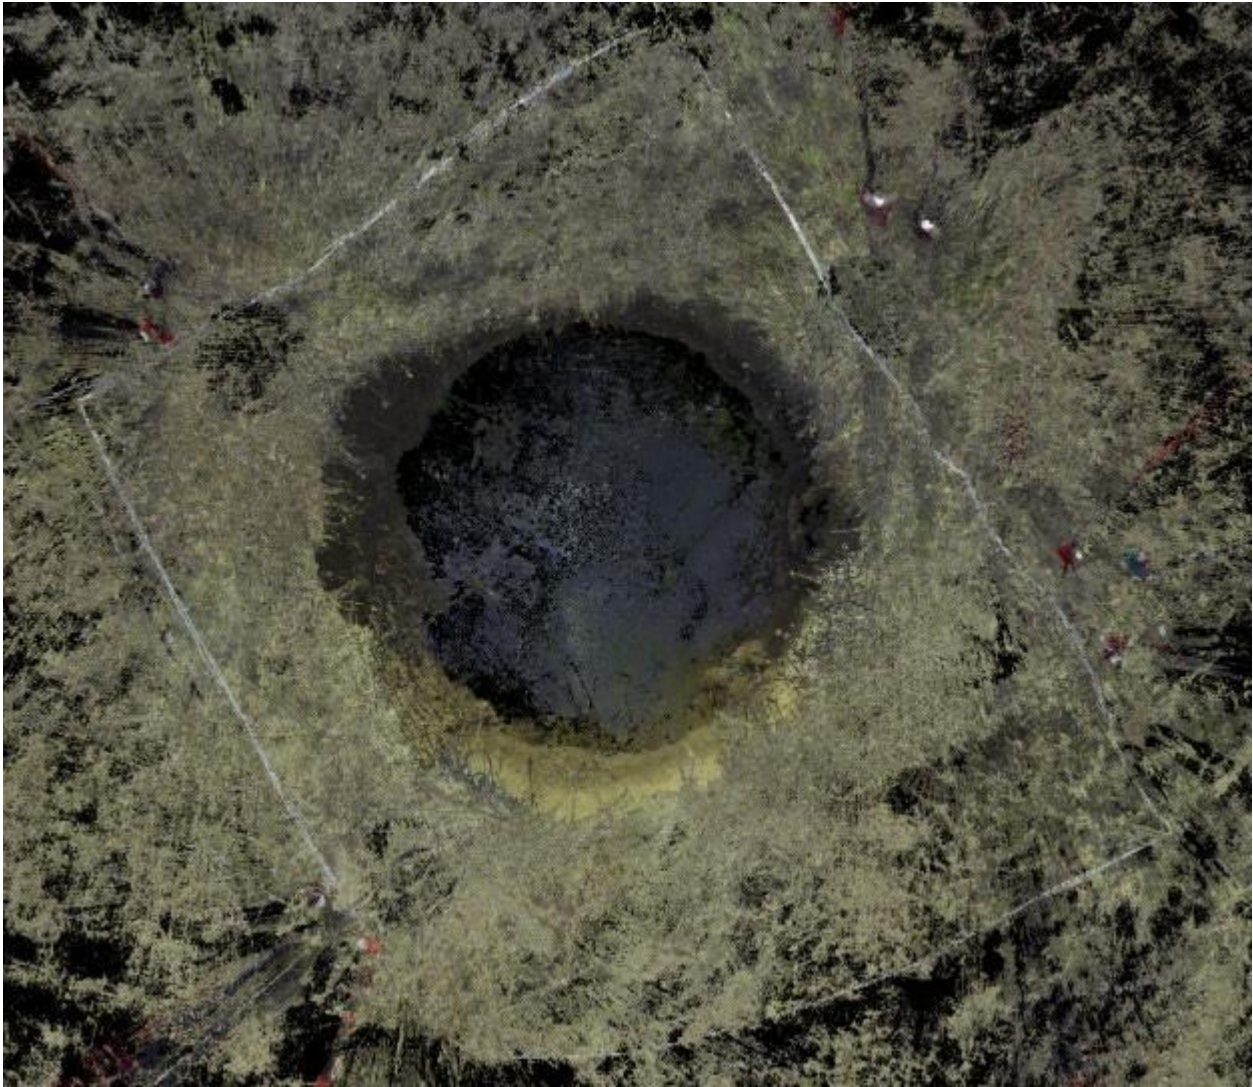
Figure 6.44 The lidar plan view of the sinkhole S043 (45.292195N, 16.422607E).

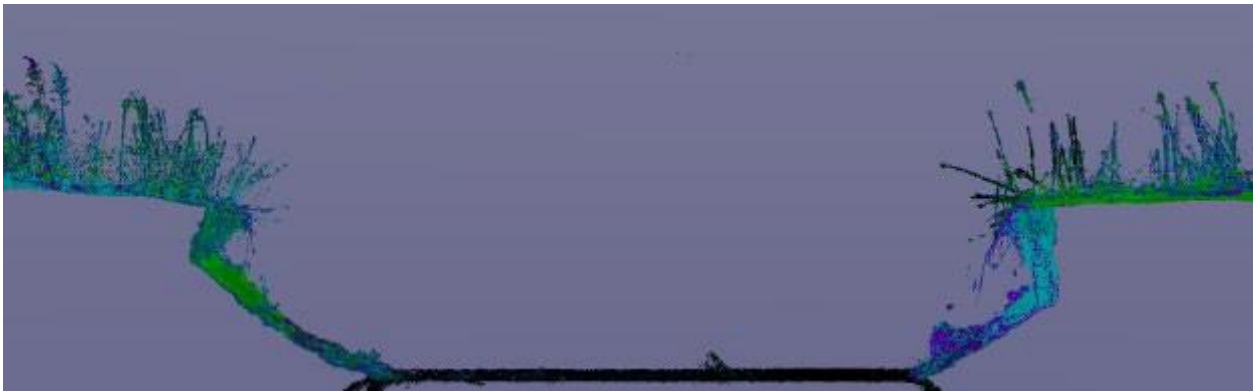
Figure 6.45 The lidar scan with the cross-section of the sinkhole S043 (45.292195N, 16.422607E).
