Geotechnical Reconnaissance and Engineering Effects of the December 29, 2020, M6.4 Petrinja, Croatia Earthquake, and Associated Seismic Sequence

Chapter 8: Earthen Levee Systems

8. Earthen Levee Systems

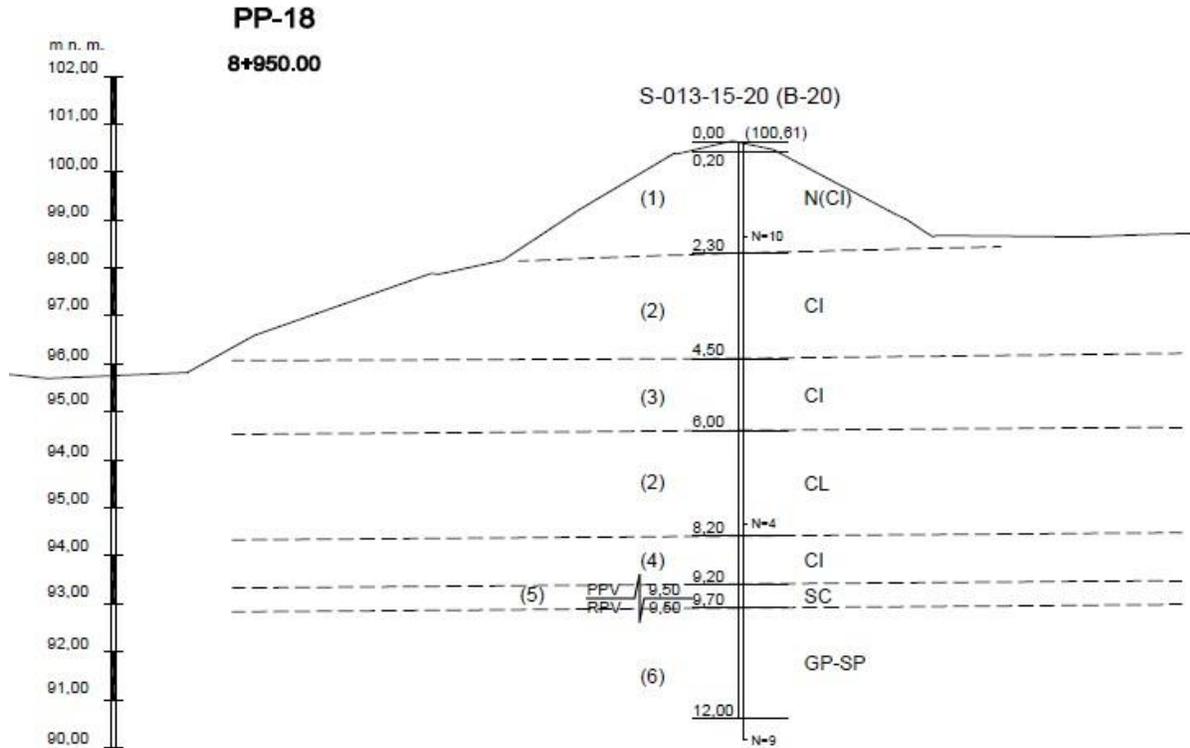
Information on the subsurface soil conditions through a borehole conducted by Geokon-Zagreb in 2015 (Geokon-Zagreb 2016) for the upgrade of the levee was available near the crack and is shown in **Figure 8.12**. The levee is underlain by 7 m of clays, which are underlain by a 0.50m clayey sand layer, and finally a mixture of poorly graded gravel and sand.

Figure 8.12 Cross-section of the levee south from Stara Drenčina, on the left bank of the river Kupa at the position 45.46134N, 16.33583E (Geokon – Zagreb LLD 2016).

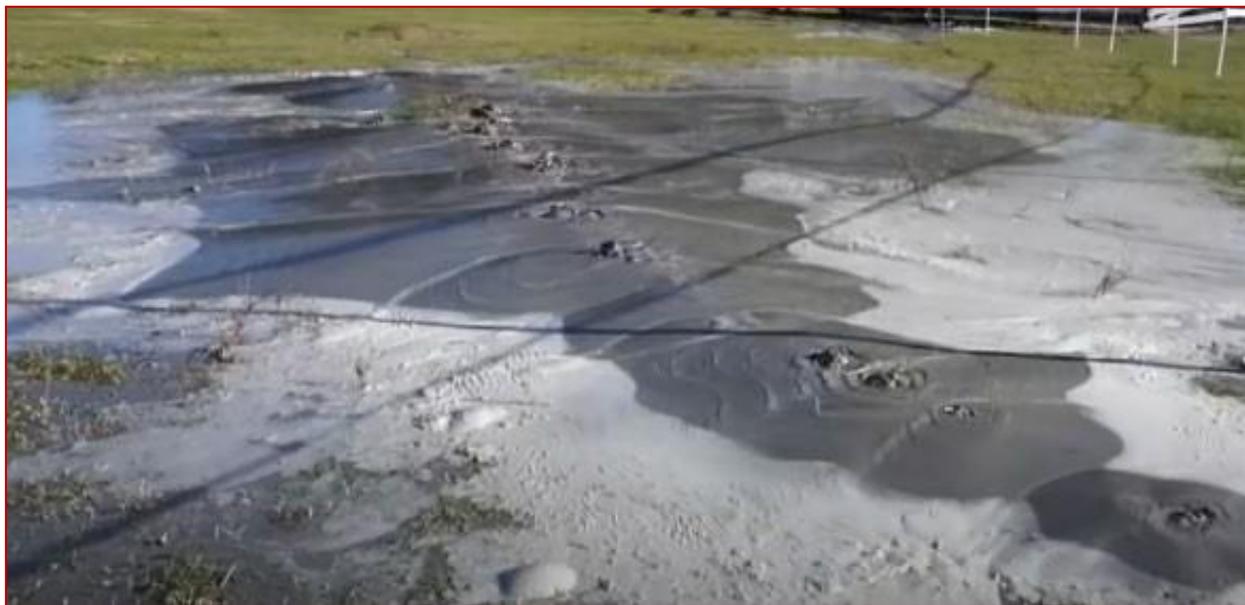
Figure 8.20 A snapshot from the video made during the M6.4 earthquake near Galdovo levee (Udruga Kas, recorded by Daniel Pavlić (Pavlić, 2020) (45.4735, 16.3926)

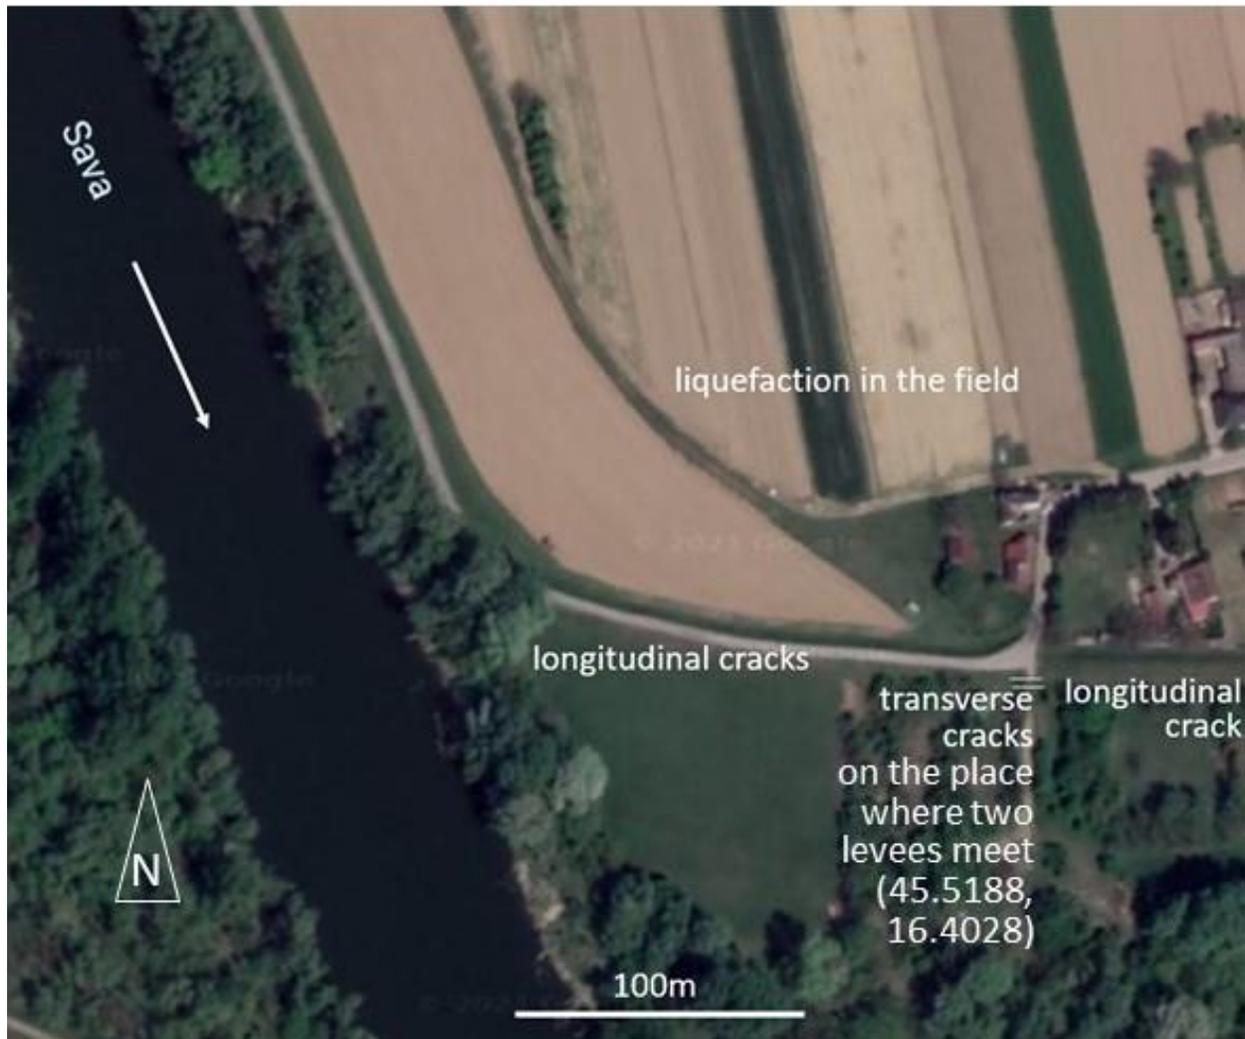
At a distance of 19.5 km from the epicenter, the levee on the left bank of the Sava river was damaged over a length of approximately 250m in the area shown in **Figure 8.23**. Transverse cracks followed by vertical displacement of about 50 cm occurred near the location where two levees meet as shown in **Figure 8.24**. Longitudinal cracks along the road and the toe are shown in **Figure 8.25**, together with some ejecta on the river side. On the field side, more sand was ejected to the surface as seen in **Figure 8.26a**. A sand layer was found at a depth of about 5m as shown in **Figure 8.26b**.

Figure 8.23 Map of the damaged section of the levee on the left bank of the Sava river near Palanjek.

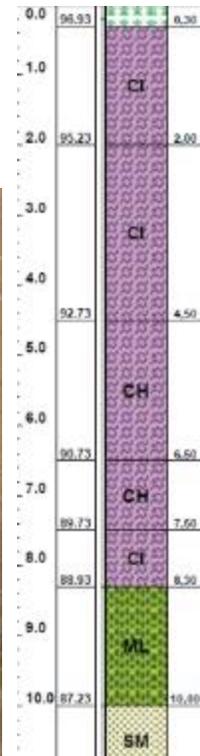
Figure 8.26 (a) Aerial view of the liquefaction in the field near Palanjek. (45.520N, 16.402E, Photo documentation Geokon – Zagreb LLD. (b) Borehole from 2013 (Geokon-Zagreb LLD 2021) on a nearby location shows the presence of clayey sand at the depth of around 5 m below the ground surface.
