# **Damage due to Liquefaction and Associated Lateral Flow during the 2024 Noto Peninsula Earthquake, Japan**

A report prepared by Kyushu University, Kawasaki Geological Engineering Co., Ltd, Tokyo City University, National Research Institute for Earth Science and Disaster Resilience, Shimizu Corporation, Geo Disaster Prevention Institute, Yoshimitsugumi Inc., Kyushu University, Toyama Prefectural University, Kanazawa University, Chuo University in cooperation with Geotechnical Extreme Event Reconnaissance Association

GEER Association Report 084

February 24, 2025

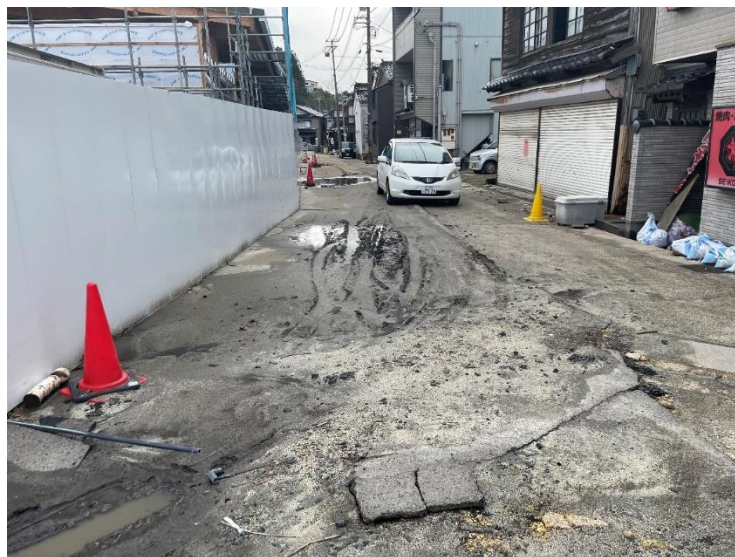
**Figure 5.7.** Liquefaction around private houses near Uitsu Port(Noto Town, Ishikawa Prefecture). Lat: 37.30706°, Lon: 137.15016°

In Noto Town, where the earthquake intensity was comparable to Suzu City, uneven subsidence and lateral flow due to liquefaction were observed at Uizu Port, as shown in Figure 5.6. Additionally, Figure 5.7 shows that roads surrounding private homes near Uizu Port were covered with sand from sand eruptions caused by liquefaction. While several houses collapsed,

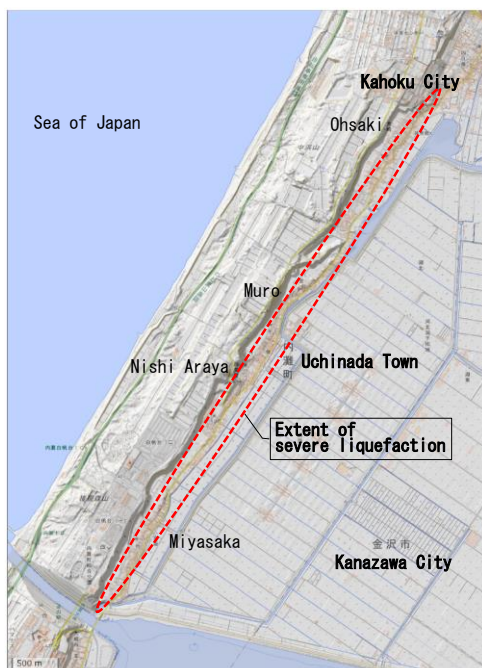
**Figure 5.16.** Area affected by severe soil liquefaction

In the area extending from Ōhsaki in Kahoku City to Miyasaka in Uchinada Town (Figure 5.16), significant ground deformation has been observed, particularly along the base of the sand dune slopes near Prefectural Road 8, where it occurs in a continuous, belt-like pattern. Soil liquefaction has led to the formation of sand boils, resulting in uneven settlement and ground uplift, which has caused numerous buildings to tilt or sink. In addition, retaining walls have collapsed or shifted, road pavements have been damaged and raised, and utility poles have

Our investigation revealed a pattern of ground subsidence and uplift occurring simultaneously, characterized by multiple parallel subsidence lines, interpreted as tension cracks. Uplift has occurred on the lower side of these subsidence lines (on the reclaimed land side), forming along the compression axis in the same direction as the slope of the ground. Above the subsidence lines (on the sand dunes side), ground deformation is minimal. Notably, between the subsidence and uplift zones, there are prominent features such as sand boils, ground settlement, and tilting of structures. The compression axis of the tension cracks and uplift aligns in a northeast-southwest direction along the dune ridge. Based on these observations, it can be concluded that the subsidence and uplift resulted from ground failure induced by lateral movement due to liquefaction.

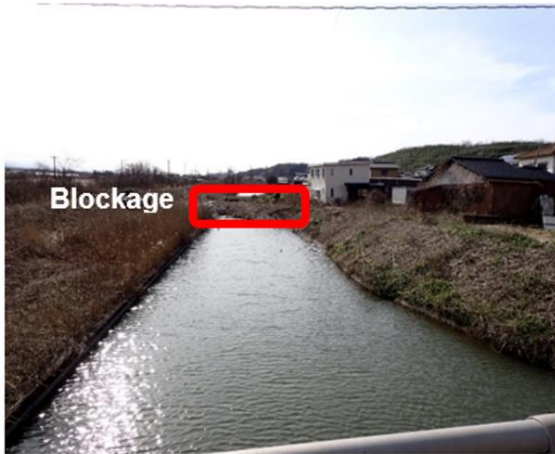
**Figure 5.18.** (a) Blockage of water channel due to liquefaction-induced lateral spreading. Lat:  $36^{\circ}41'30.8''$ , Lon:  $136^{\circ}40'51.4''$  (b) 12 m lateral displacement experienced by a residential building owing to lateral spread. Lat:  $36^{\circ}41'32.43''$ , Lon:  $136^{\circ}40'49.62''$

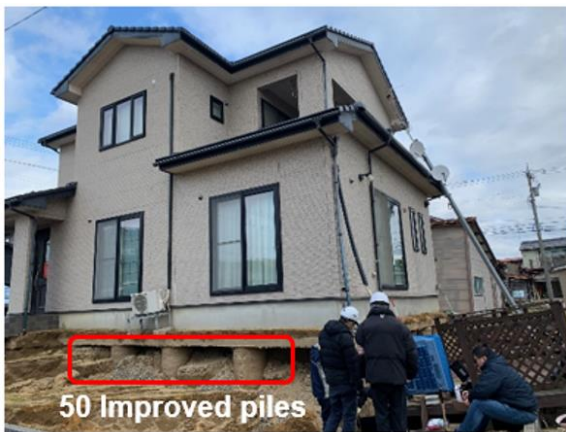
**Figure 5.19.** (a) Pile supported undamaged house in Muro. Lat:  $36^{\circ}41'31.58''$ , Lon:  $136^{\circ}40'50.06''$  (b) Differential settlement for a building with shallow foundation in Miyasaka. Lat:  $36.67329^{\circ}$ , Lon:  $136.66323^{\circ}$

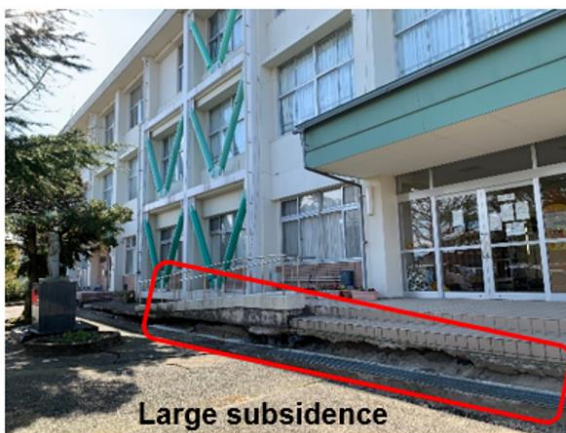
**Figure 5.20.** (a) Subsidence of the Nishi Araya school building. Lat:  $36^{\circ}40'42.25''$ , Lon:  $136^{\circ}40'3.53''$  (b) Uplifting of the road. Lat:  $36^{\circ}40'37.89''$ , Lon:  $136^{\circ}40'2.71''$

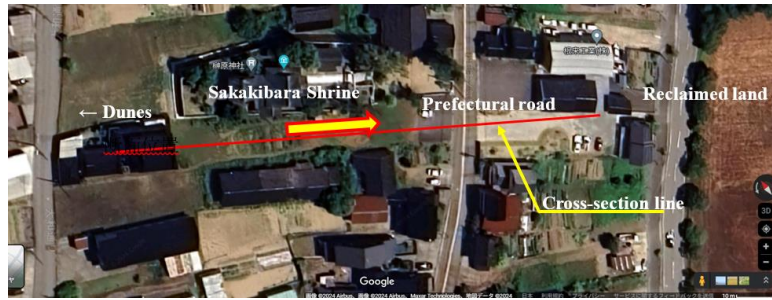
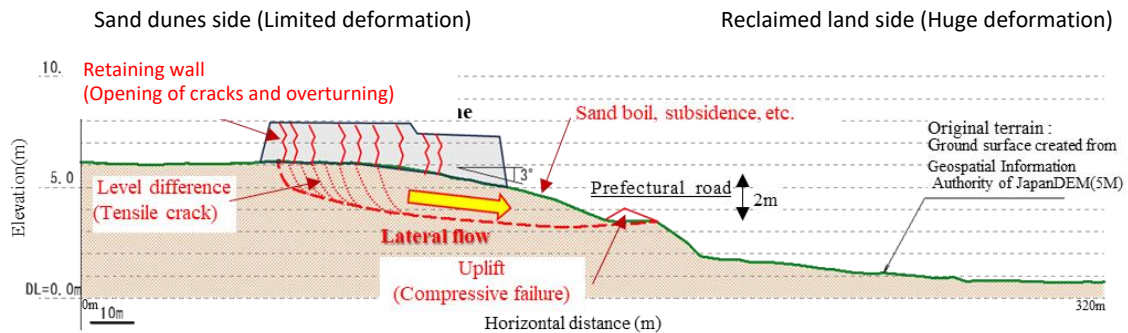
**Figure 5.21.** Liquefaction-induced lateral spreading along the Sakakibara shrine located in Ohsaki area (Kahoku City)

An example of ground deformation caused by lateral movement at Sakakibara Shrine in Ōhsaki, Kahoku City, is shown in Figure 5.21, along with a schematic cross-section. This deformation appears to have been caused by a slope failure resulting from lateral flow on a gently sloping area with a gradient of approximately 3 degrees and a height difference of around 2 meters. Interestingly, Prefectural Road 8, located at the base of the slope, did not collapse due to the lateral flow induced by liquefaction. Instead, the road effectively prevented the flow from the west side and was uplifted due to compression, experiencing horizontal bending in several locations.

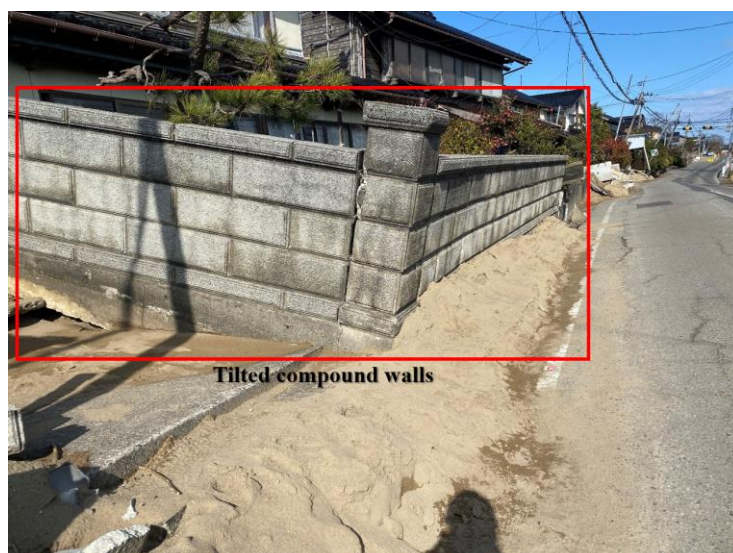
**Figure 5.24.** Close-up view of the building's compound wall tilted towards Prefectural Road 8. Lat: 36°40'42.03", Lon: 136°40'5.18"

The uplift of the road pavement due to liquefaction-induced lateral spreading is clearly visible. The lateral spreading occurred in the direction of the reclaimed land, exerting a substantial lateral thrust on the utility poles, buildings, and other infrastructure in the vicinity, causing them to tilt significantly toward the reclaimed land. Figures 5.24 and 5.25 provide close-up views of two buildings that sustained severe damage, with the compound walls and staircases tilted toward Prefectural Road 8 as a result of the considerable lateral thrust applied. Figure 5.26 illustrates the collapse of a parking shed caused by lateral spreading, accompanied by notable sand ejecta.

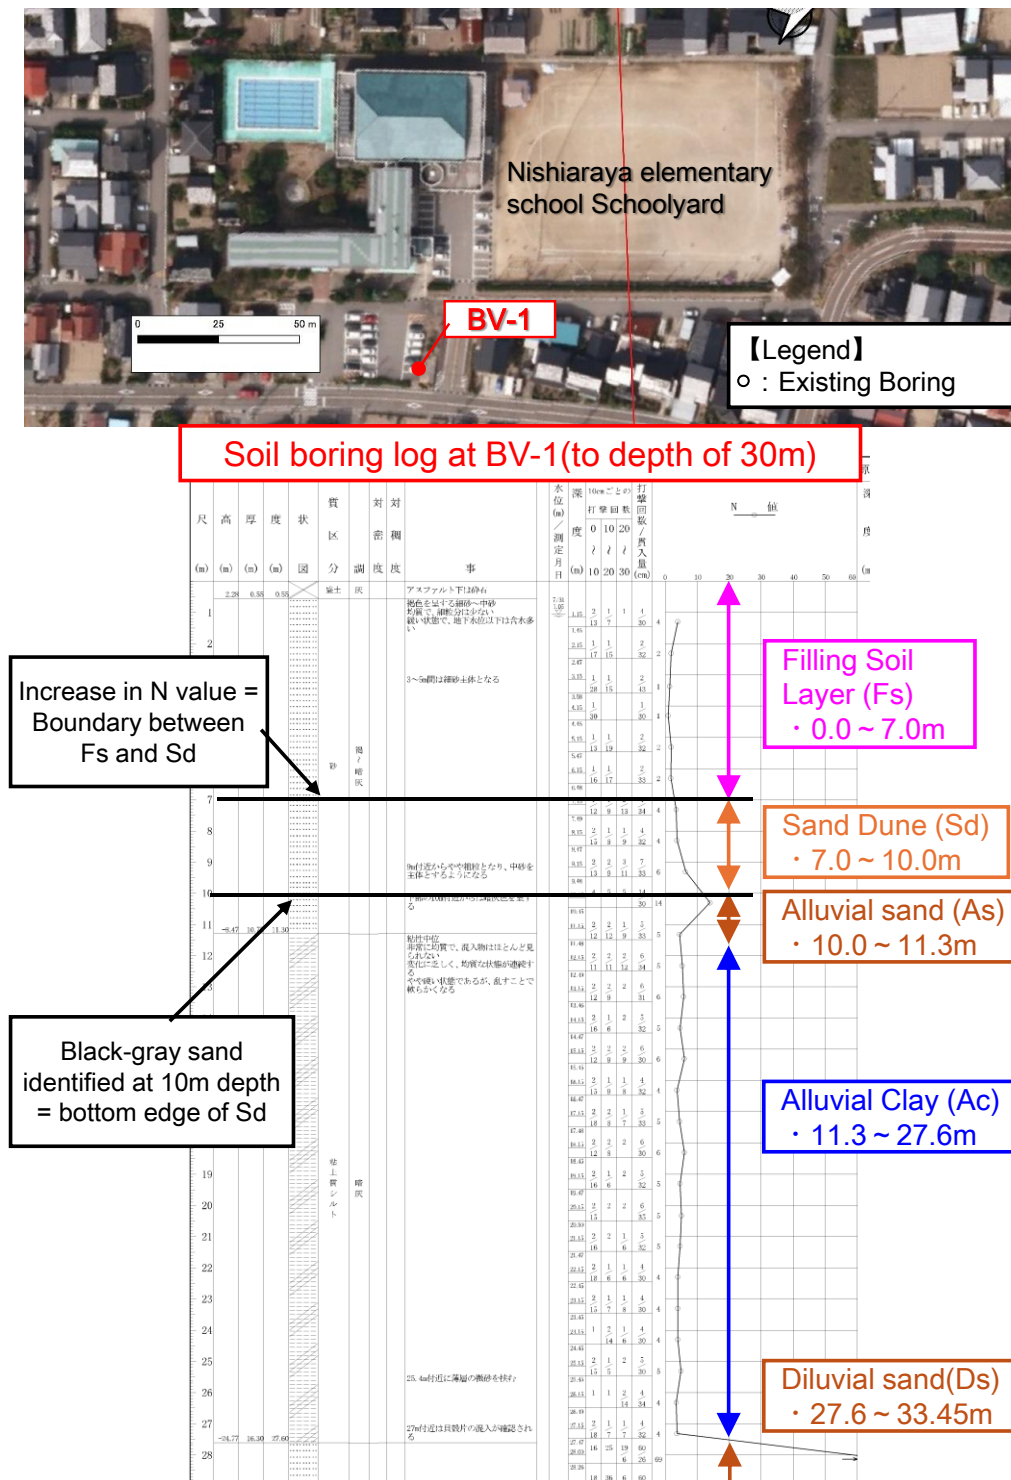
**Figure 7.3.** Borehole investigation result near the Nishi Araya elementary school

Additionally, a borehole investigation conducted in August 2023, prior to the disaster, revealed that the reclaimed layer (Fs) extends from the surface to a depth of approximately 7.0 meters (Figure 7.3). Beneath this layer, a dune layer (Sd) was identified from 7.0 to 10.0 meters,

followed by an alluvial sand layer (As) from 10.0 to 11.3 meters, an alluvial clay layer (Ac) from 11.3 to 27.6 meters, and a diluvial sand layer (Ds) from 27.6 to 33.45 meters.

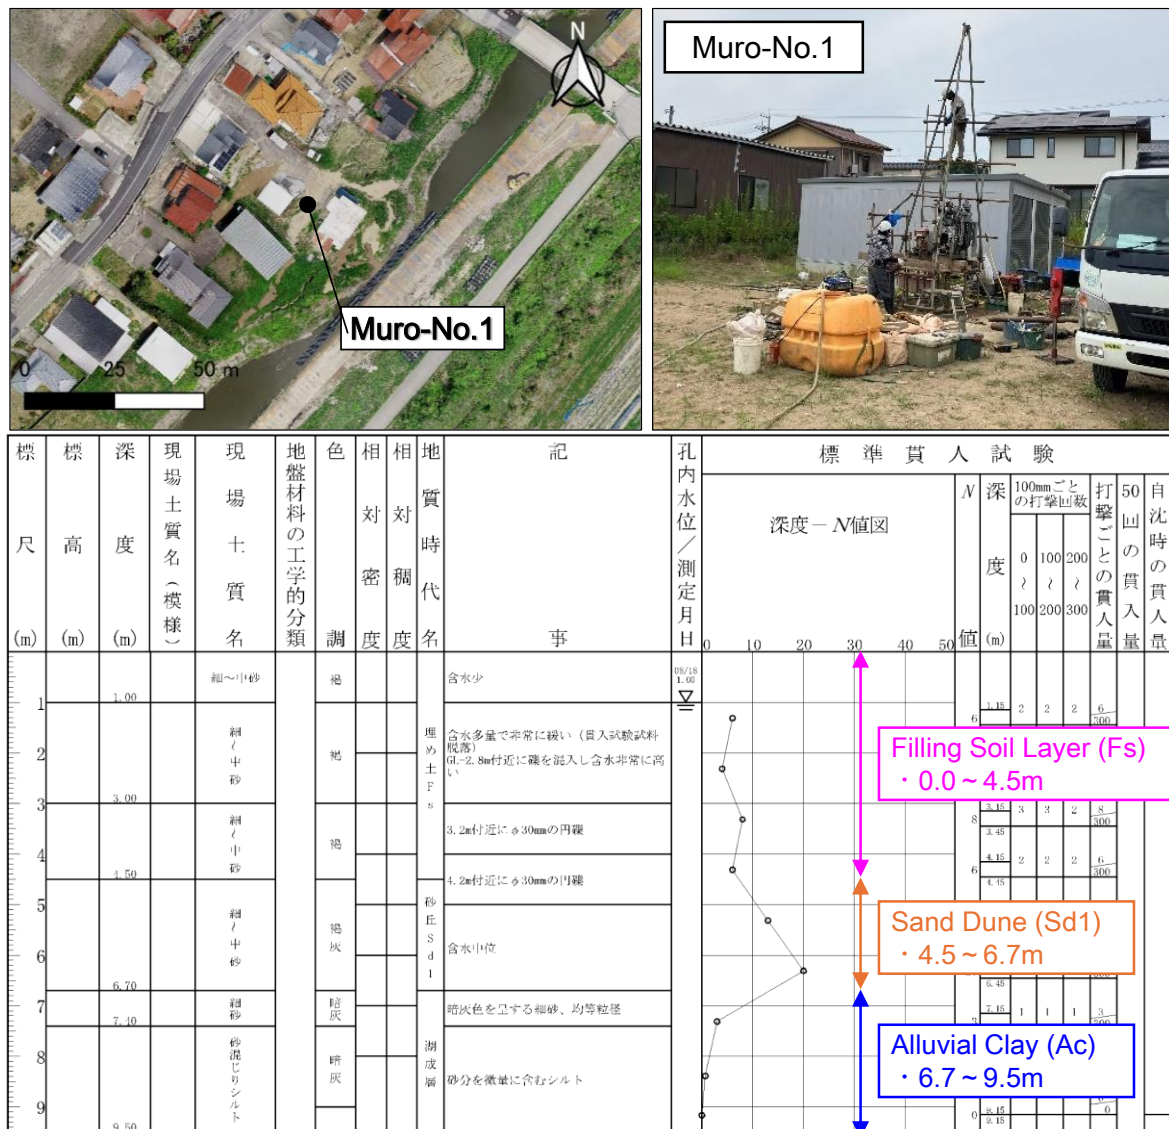
**Figure 7.5.** Geological survey in Muro district

The Muro area is situated at the edge of the Uchinada sand dunes and is believed to have been reclaimed following the installation of waterways during the reclamation of the former Kahoku Lagoon (Figure 7.4). Analysis of historical aerial photographs, land records, and geological survey results revealed the presence of a reclaimed layer extending from 1.5 to 4.5 meters in

depth within this region (Figure 7.5). Significant liquefaction and lateral flow-induced damage were observed in the area to the east of Prefectural Road 8. A borehole investigation conducted by the authors after the disaster (Figure 7.5) confirmed the presence of a reclaimed layer (Fs) extending from the surface to a depth of 4.5 meters, a dune layer (Sd1) from 4.5 to 6.7 meters, and an alluvial clay layer (Ac) from 6.7 to 9.5 meters.

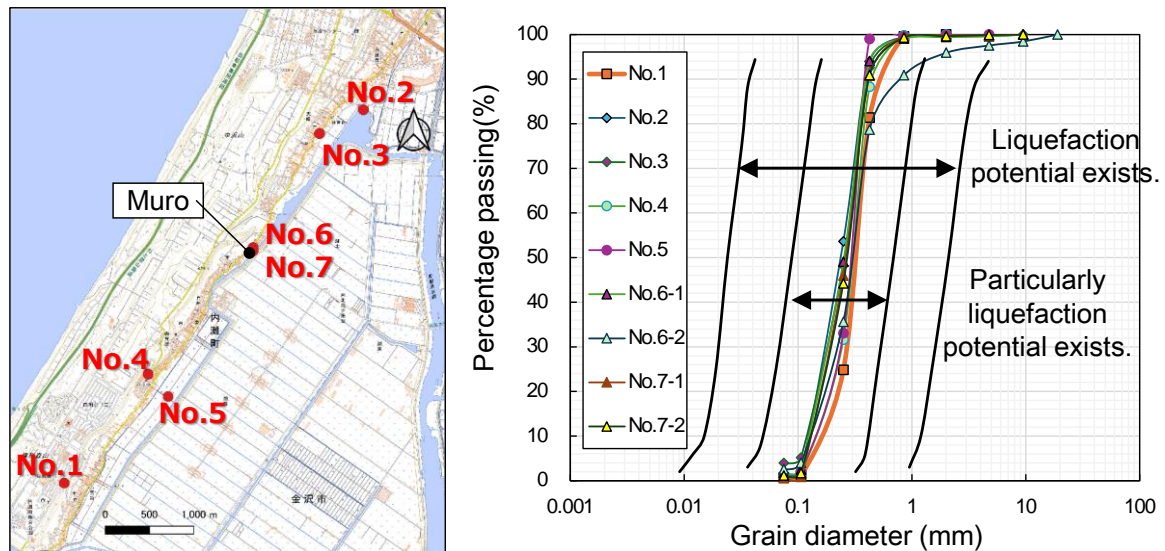
**Figure 7.6.** Results of grain size analysis for samples collected in Uchinada Town

Figure 7.6 presents the results of the grain size analysis for samples collected from the top of a dune (Sample No. 1) and from sand boiling sites (Samples No. 2 to No. 7).

Table 7.1 summarizes the typical geotechnical features observed at each sampling location post-disaster. The grain size distributions of the samples from both the dune and the sand boiling sites are generally similar, with both locations classified as sands exhibiting characteristics that suggest a high potential for liquefaction.

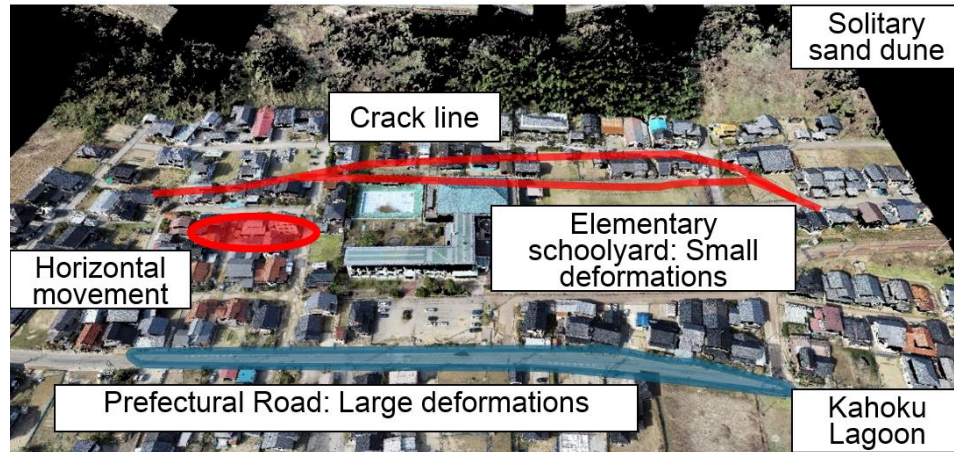
**Figure 8.2.** Deformation pattern observed in Nishi Araya area following the UAV surveying

Figure 8.2 presents the 3D point cloud data derived from UAV photogrammetry along with the field survey results from the Nishi Araya area. The UAV photogrammetry identified several key features, including crack patterns on the playground of Nishi Araya Elementary School (denoted by red lines), lateral displacement of houses (indicated by red ellipses), and deformation along Prefectural Road 8 (highlighted by a blue ellipse), all of which were also observed during the field survey. Furthermore, the crack line was found to coincide with the location of the excavation site, which was later filled during the reclamation process, as shown in Figure 8.2.

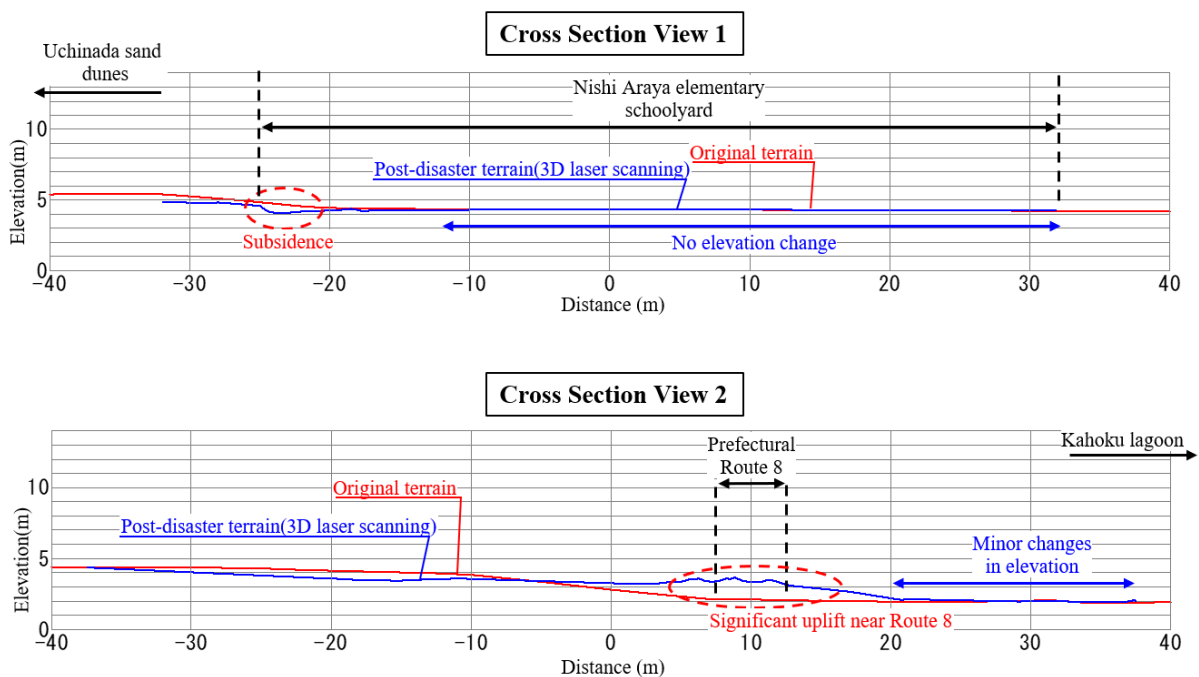
**Figure 8.3.** Comparison between the pre-disaster and post-disaster terrain (3D laser scanning)

Figure 8.3 presents a comparison between the pre-disaster topography (5m mesh DEM data from October 5, 2016, obtained from GSI, Japan) and the post-disaster topography (remote

sensing data from February 4, 2024) collected through our 3D laser scanner survey, for the two cross-sections (1 and 2) near Nishi Araya Elementary School, as shown in Figure 8.1. In cross-section 1, subsidence is evident at the playground of Nishi Araya Elementary School (on the Uchinada sand dunes side), where cracks had formed. However, no change in elevation was observed from the center of the playground to the side of Prefectural Road 8. In contrast, cross-section 2 shows significant uplift near Prefectural Road 8, with no major topographical changes detected in the paddy field area toward Kahoku Lagoon.

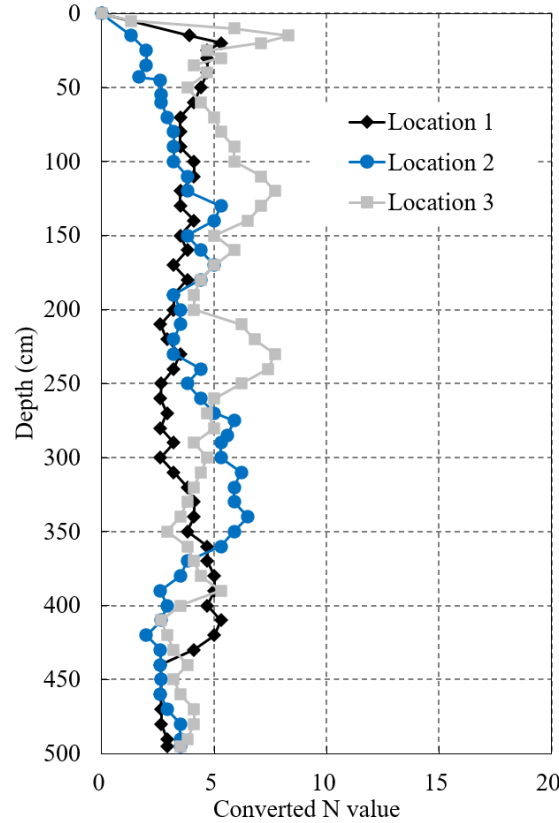
**Figure 8.5.** Converted N value along the depth

Figure 8.5 presents the converted SPT N-value profiles along the penetration depth for the three locations. It is evident that the soil is extremely soft, with estimated SPT N-values consistently below 10 throughout the 5-meter penetration depth. Notably, there is a decrease in the SPT N-value as the penetration depth approaches 5 meters at all three locations, indicating that the soil becomes relatively looser under increased confining stress. This suggests that, under cyclic loading, the loose bottom layer is highly susceptible to liquefaction.

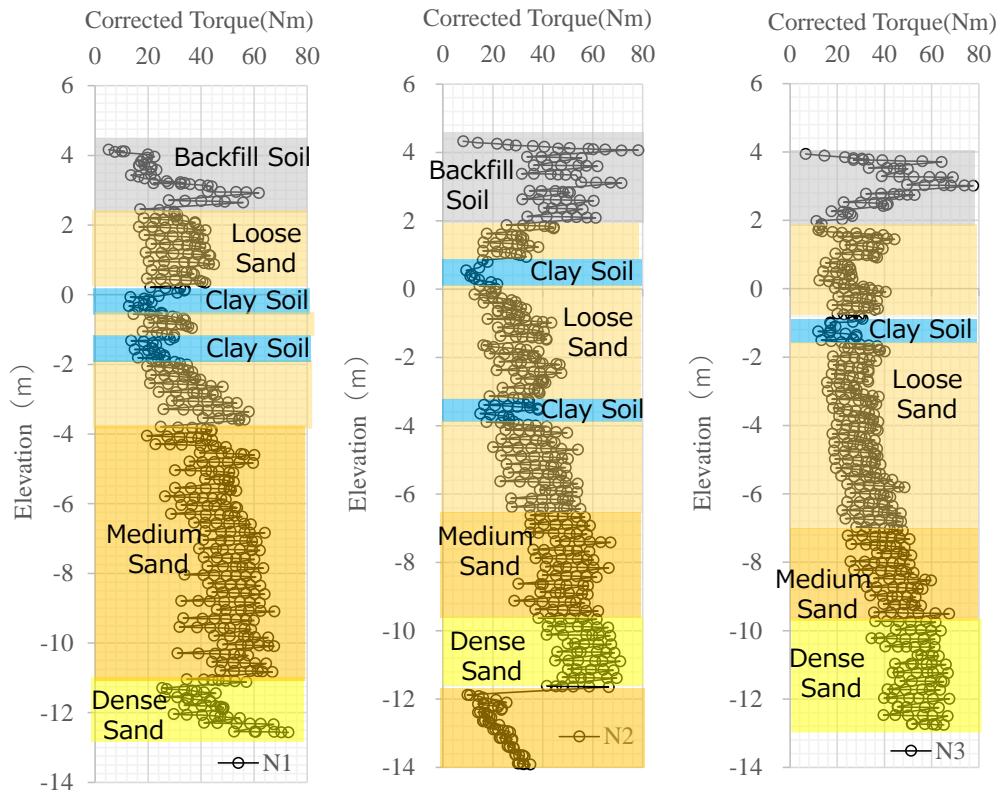
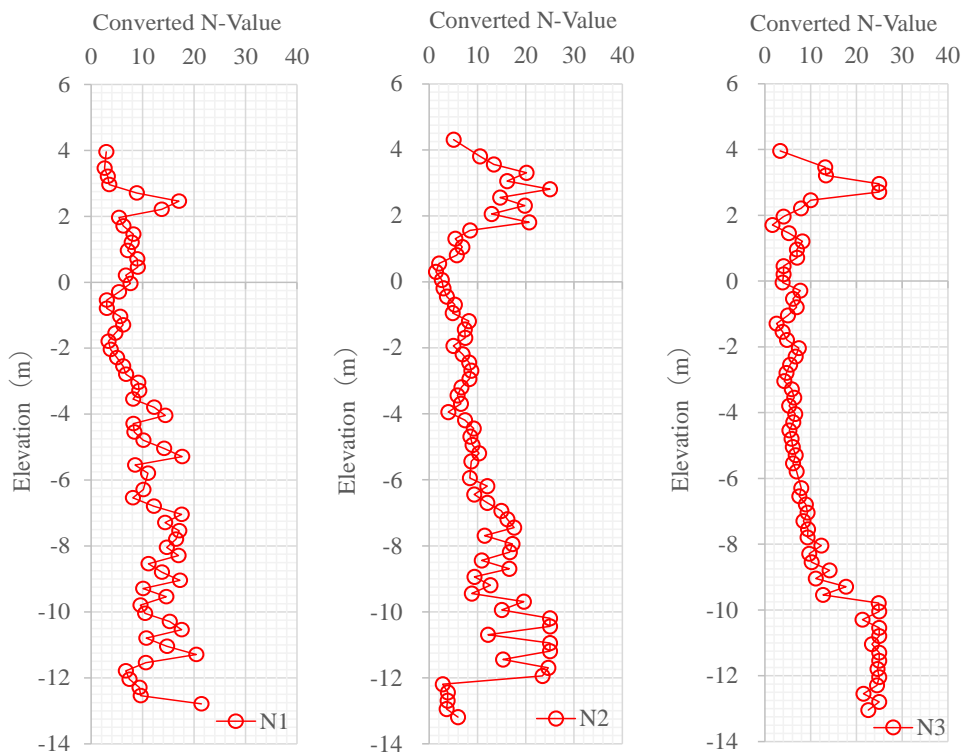
Figures 8.6 and 8.7 present the relationship between corrected torque and elevation, and the correlation between the converted N-value and elevation at each survey site, respectively. At the N1 site, the corrected torque values near the surface are smaller than those observed at other survey sites. From the SDS test results, it was determined that the soil at N1 is clayey at elevations of 0 m and 1 m. At the N2 site, a clay layer was identified at an elevation of -3 m, while at N3, the clay layer is present at -1 m. The smaller increase in corrected torque near the surface (i.e., above -1.5 m) suggests that the soil is sandy with a high fine-grained content. The estimated N-value at -11 m is less than 10, while at -14 m it exceeds 20, indicating that the depth range between -11 m and -14 m consists of dense sand, although slight differences exist among the N1, N2, and N3 sites.

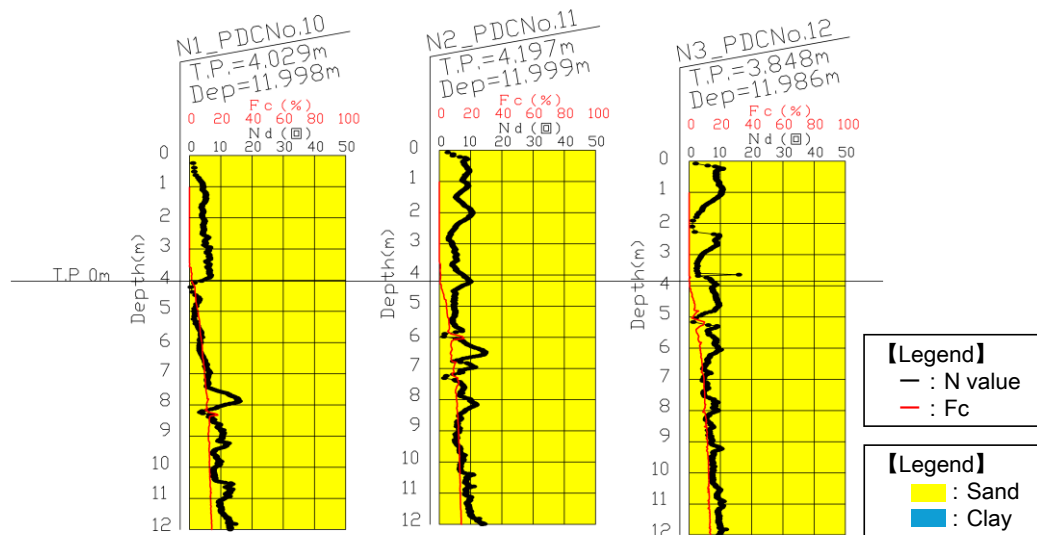
**Figure 8.8.** Depth profiles of fine grain content  $F_c$  based on PDC test (Nishi Araya area)

Soil classification using the PDC test indicated the presence of a loose sandy layer with a fine-grained content ( $F_c$ ) of less than 10% and an  $N_d$  value of less than 10, extending to a depth of 12 meters, as shown in Figure 8.8.

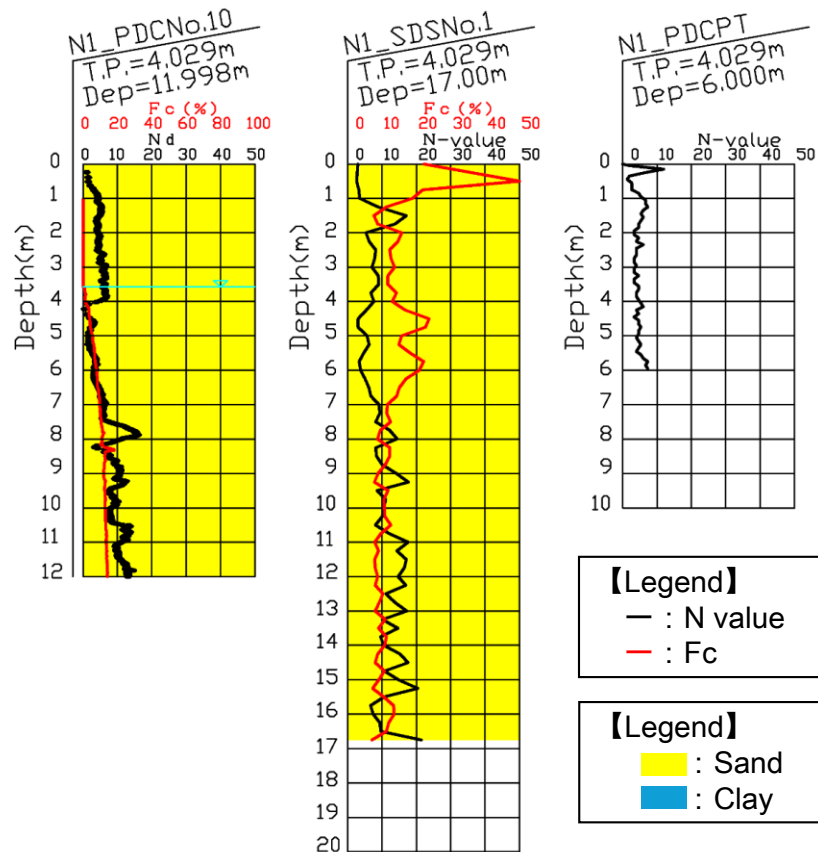
**Figure 8.9.** Comparison among the SDS test, PDC test, and PDCPT results at location N1 in the elementary school's playground

Figure 8.9 presents the depth profiles of the equivalent N-values and fine content ( $F_c$ ) at location N1 (refer to Figure 8.1), which is situated at the crack site on the playground of Nishi

As observed from Fig. 8.9, for all tests, N-values remain below 10 up to a depth of 6 to 7 meters, indicating that the soil remains in a loose state following the earthquake. A gradual

increase in N-values with depth is observed beyond this point, as indicated by the PDC and SDS test results. It should be noted that PDCPT tests were conducted only to depths of 5 to 7 meters, depending on the specific location. Additionally, based on the fine content (Fc) estimates from the PDC and SDS tests, it is inferred that sandy soil with  $F_c < 50\%$  extends to a depth of approximately 17 meters below the surface. The discrepancy in the estimated fine content (Fc) between the PDC and SDS tests is attributed to the differing methodologies: the PDC test estimates fine content based solely on pore water pressure, whereas the SDS test uses two parameters—torque and applied load. As a result, when torque values show little variation, the estimated Fc is likely to be more influenced by the applied load.

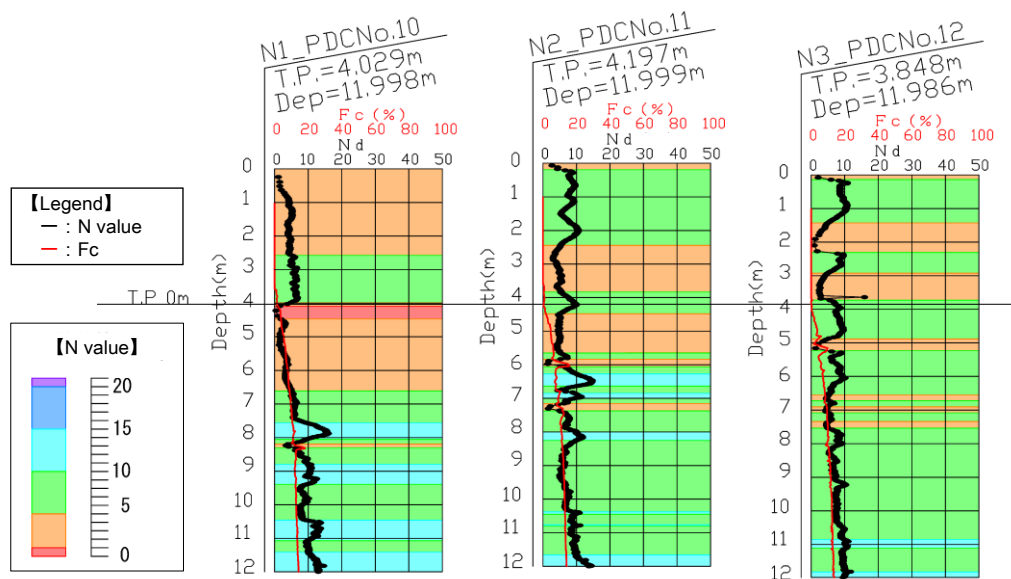
**Figure 8.10.** PDC results at locations N1, N2 and N3 in the elementary school's playground

Figure 8.10 presents the profiles of N-values and fine content with depth from the PDC tests conducted at locations N1, N2, and N3. The results reveal a loose soil zone with N-values below 5 extending to a depth of approximately 6 meters. Notably, a very loose soil layer, characterized by N-values ranging from 0 to 1, is localized around 4 meters in depth at location N1, situated toward the Uchinada sand dunes, as indicated by the penetration data.

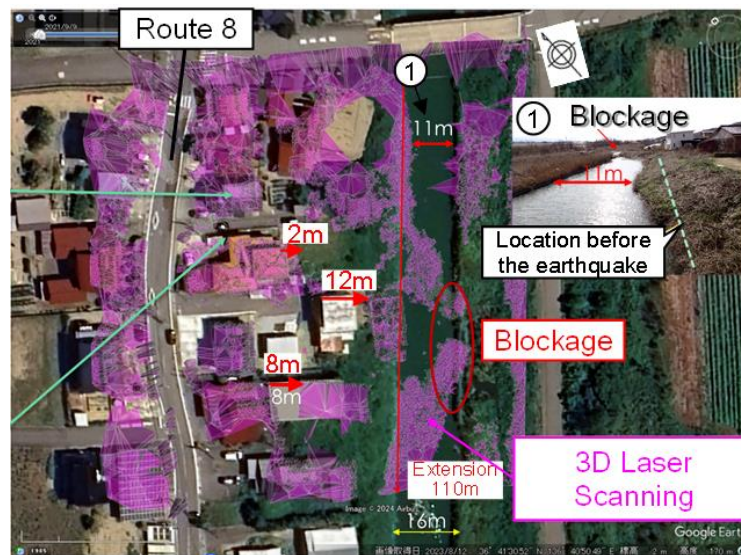
**Figure 8.12.** Comparison of 3D laser scanner survey results (after the disaster) and aerial photographs (before the disaster) in the Muro area

The figure clearly shows that houses on the eastern side of Prefectural Road No. 8, facing the waterway, had shifted by approximately 2 to 12 meters toward the waterway. Furthermore, the surrounding ground of these houses also displaced toward the waterway, causing a shift in the waterway itself over a distance of about 11 meters, with some areas nearly obstructing the majority of the waterway. In contrast, no significant movement was observed in the houses situated on the mountainside (Uchinada sand dunes side), including those along Prefectural Road No. 8.

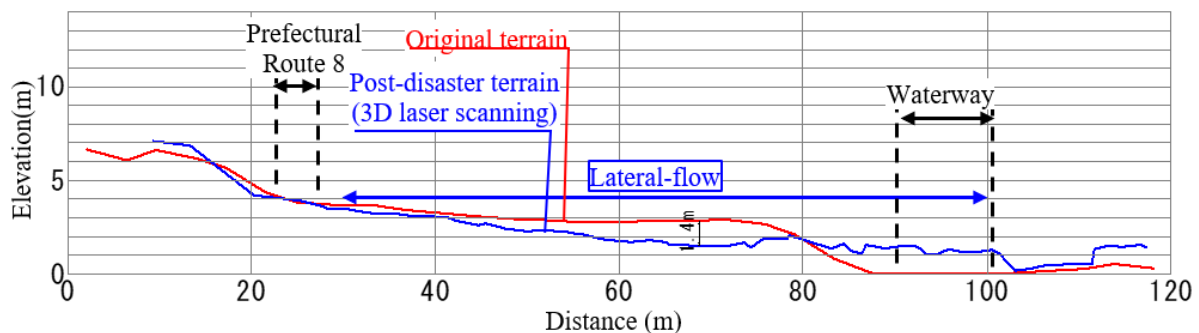
**Figure 8.13.** Comparison between existing topographic data (GSI) and 3D laser scanner survey results

At the location exhibiting the greatest lateral displacement, a comparison was made between the pre-disaster topography (represented by the red line, based on 5m mesh DEM data from October 5, 2016) and the post-disaster topography (represented by the blue line, based on remote sensing data from February 4, 2024), as shown in Figure 8.13. The comparison revealed that the maximum lateral displacement of the ground caused by liquefaction-induced lateral spreading was approximately 20 meters, which resulted in the blockage of most of the waterway. Furthermore, the ground surface experienced a maximum settlement of about 1.4 meters. In contrast, minimal to no changes in ground elevation were observed on the western side of Prefectural Road 8.

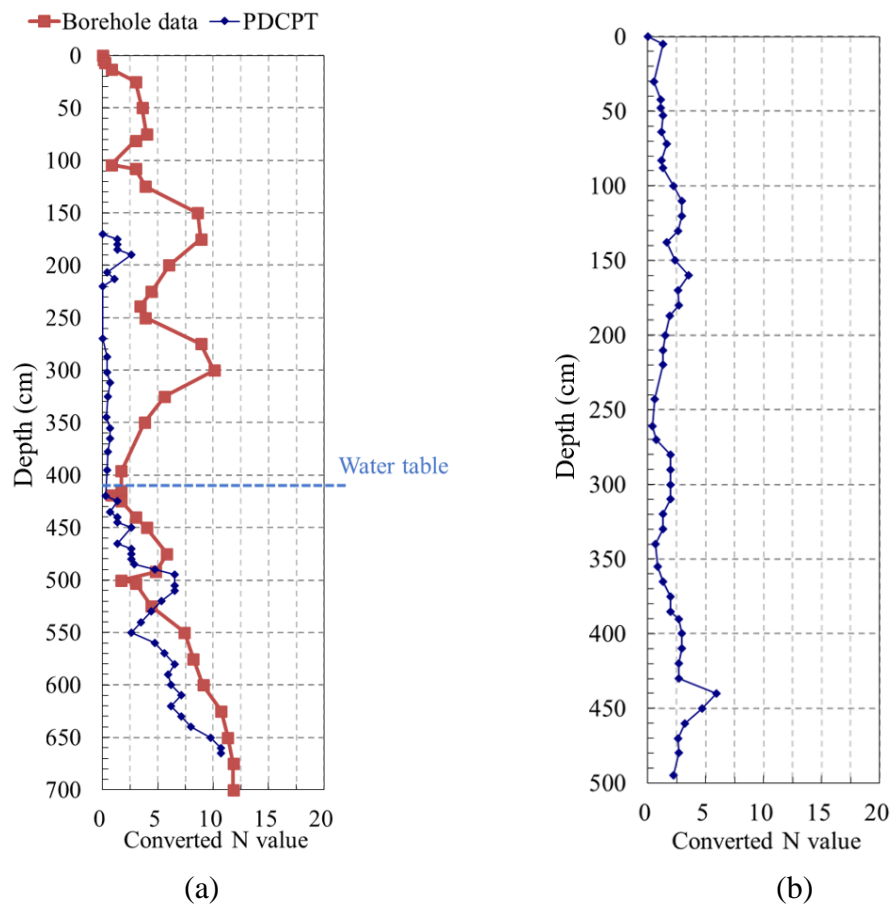
**Figure 8.15.** Converted N-values along the penetration depth at locations (a) and (b)

Figure 8.15 reveals that, prior to the foundation installation, the N-values at depths of approximately 1.5 m and 3 m were around 10, indicating adequate bearing capacity. However, post-earthquake N-value data show that, between depths of 2.2 m and 4.2 m, the N-values were consistently below 2, suggesting very soft soil within this section. Below 4.2 m, two N-value readings are relatively similar. A comparison with data from the same location (Fig. 8.15a) indicates that the 2.5-meter depth range, from 1.7 m to 4.2 m, was significantly impacted by the earthquake. The water table was observed at 4.1 m below the foundation. Additionally, the N-values in Figure 8.15(b) suggest that the soil remained highly susceptible to liquefaction following the earthquake. Figure 8.16 illustrates the locations of the PDCPT tests conducted across the Muro area, while Figure 8.17 presents the converted N-values along the depth at various locations.

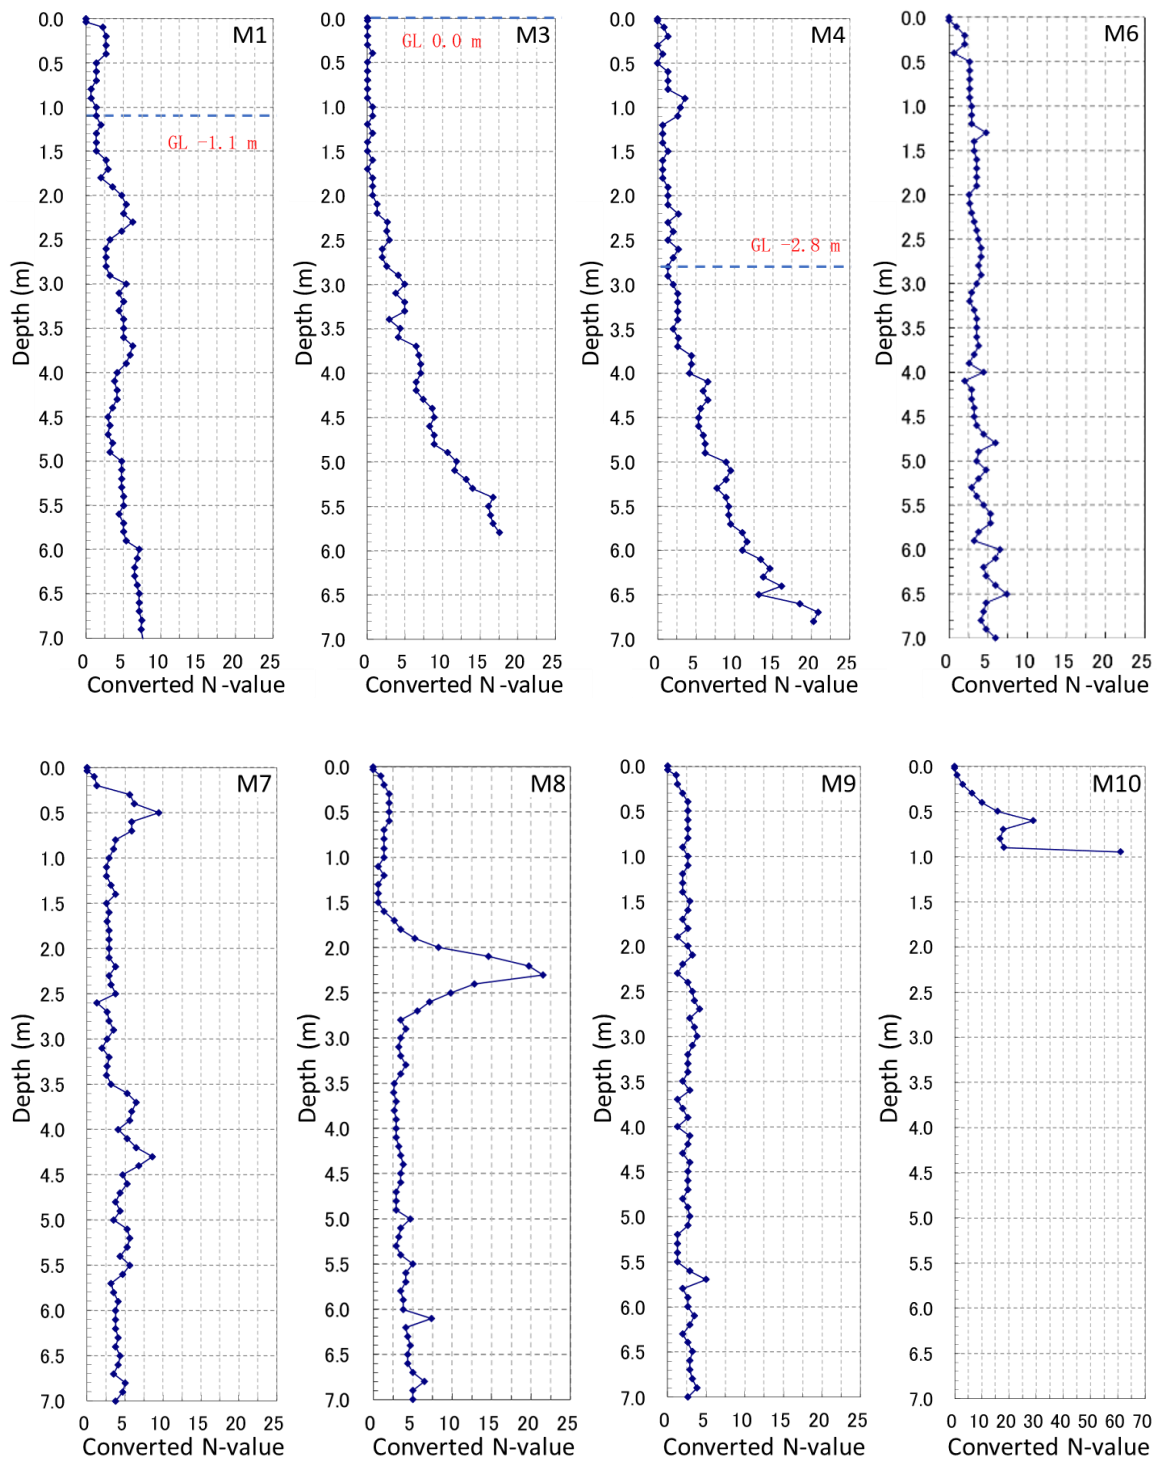
**Figure 8.17.** Converted N-value along the penetration depth

M1, M3, and M4: These locations show varying groundwater levels (GL-1.1 m, GL-0 m, and GL-2.8 m, respectively), which directly impact the soil's vulnerability to liquefaction. The lower N-values and fluctuating profiles at M1 and M3 suggest that these sites may have experienced notable softening and density reduction due to the earthquake. M3, with groundwater at the surface, likely saw extensive liquefaction, contributing to its decreased resistance and heightened susceptibility to lateral spreading. The post-liquefaction N-values at

M4, showing a denser layer at GL-2.8 m, may indicate partial resilience or recovery of this layer, while the looser upper layers remain vulnerable.

M6, M7, M8, and M9: These locations, without observed groundwater levels, show moderate to uniform N-values, indicating that while they may have been affected by seismic shaking, they did not experience the same level of liquefaction as fully saturated sites. M8's denser layer at shallow depth may suggest partial resilience to the liquefaction process, while M6, M7, and M9 show relatively consistent profiles, which could indicate a more stable response to the earthquake-induced liquefaction.

The PDCPT results indicate that sites with shallow or surface-level groundwater (e.g., M3) experienced severe liquefaction and subsequent loss of resistance, leading to significant ground deformation and lateral movement. In contrast, sites with dense underlying layers (such as M10) demonstrated resilience to liquefaction, suggesting that pre-existing density and stratification play a critical role in post-earthquake stability. This understanding can inform future ground improvement efforts, targeting loose or fully saturated zones and incorporating strategies to strengthen or densify susceptible layers to mitigate liquefaction risk in similar seismic environments.

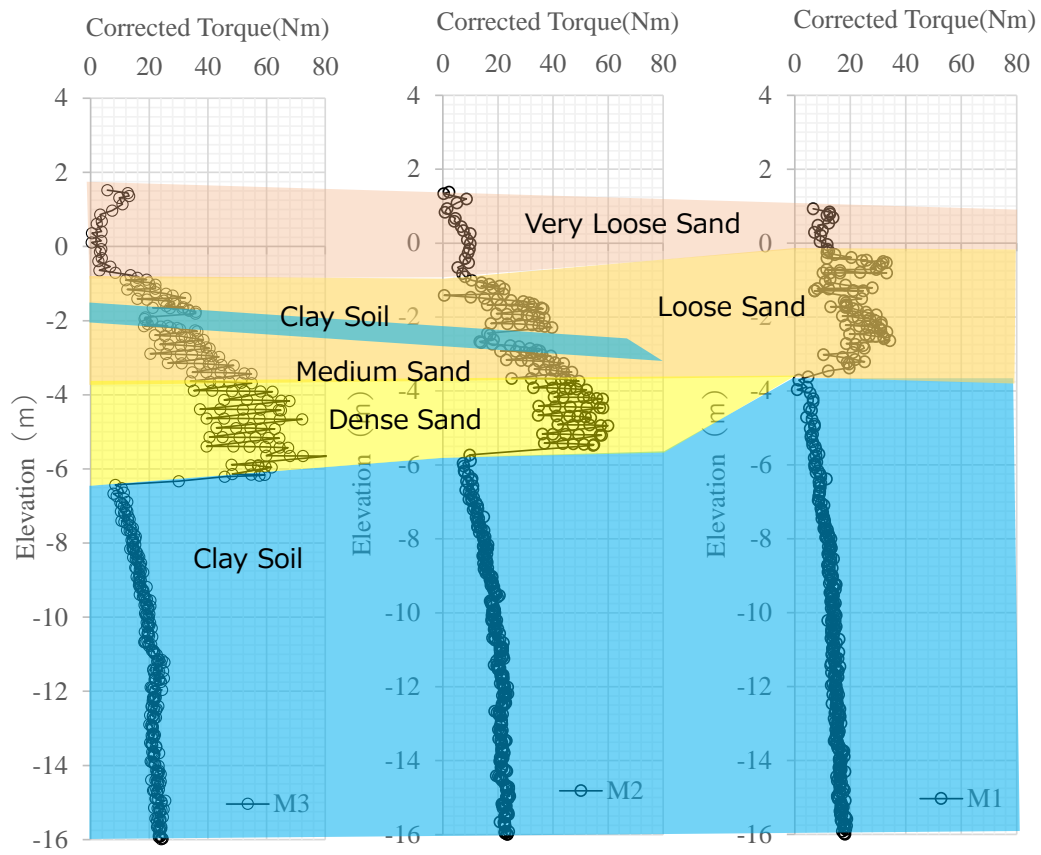
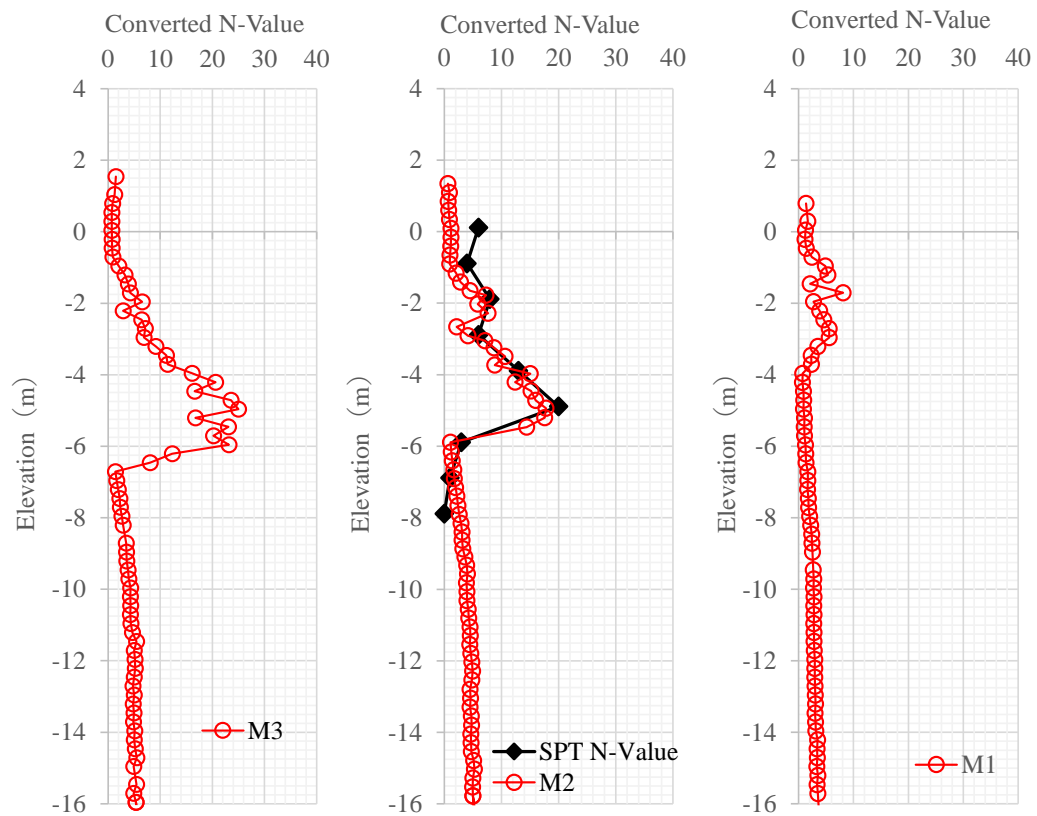
Figure 8.18 illustrates the relationship between the corrected torque and elevation, while Figure 8.19 depicts the relationship between the converted N-value and depth at survey points M1 through M3. The results from the SDS test indicate that the corrected torque values within the 2-4 m depth range were quite low, with a response similar to that of cohesive soils. However, it is likely that liquefaction of the underlying sandy soil led to a significant reduction in the stiffness of the overlying cohesive soil layer. A thin clay layer was observed at an elevation of -2 m at survey points M1 and M2. Relatively higher N-values were recorded at the -5 m elevation at M2 and M3, and soil below -4 m was identified as clayey based on the test results. The estimated N-value from the SDS testing was lower than that obtained via the SPT at an elevation of +3 m at M2; however, a good agreement was observed under higher confining stress. Based on the test data, it can be concluded that liquefaction likely occurred in the shallow depth range between 2 m and 4 m, as both the corrected torque and converted N-values were notably low in this zone.

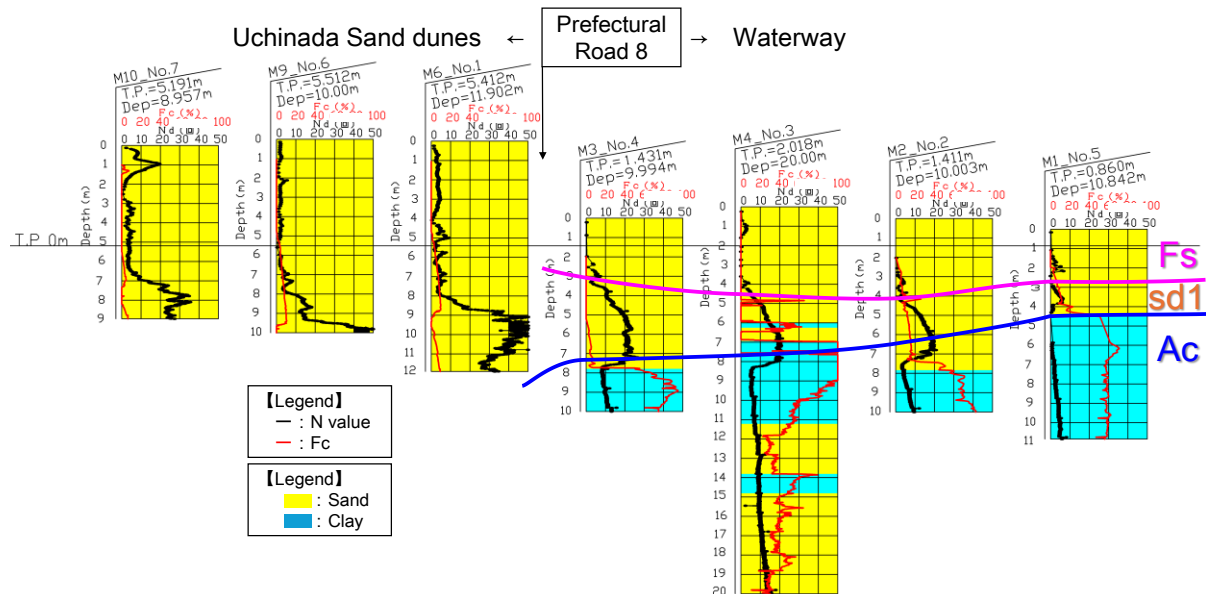
**Figure 8.20.** Depth profiles of fine grain content Fc based on PDC test (Muro area).

Similar to the Nishi Araya area, the PDC test was used to classify the soil types in this area. The results indicated that both the buried soil layer (Fs) and the dune layer (Sd1) on the reclaimed land side were predominantly sandy layers with negligible fine-grain content, as illustrated in Figure 8.20.
