# **Damage due to Liquefaction and Associated Lateral Flow during the 2024 Noto Peninsula Earthquake, Japan**

A report prepared by Kyushu University, Kawasaki Geological Engineering Co., Ltd, Tokyo City University, National Research Institute for Earth Science and Disaster Resilience, Shimizu Corporation, Geo Disaster Prevention Institute, Yoshimitsugumi Inc., Kyushu University, Toyama Prefectural University, Kanazawa University, Chuo University in cooperation with Geotechnical Extreme Event Reconnaissance Association

GEER Association Report 084

February 24, 2025

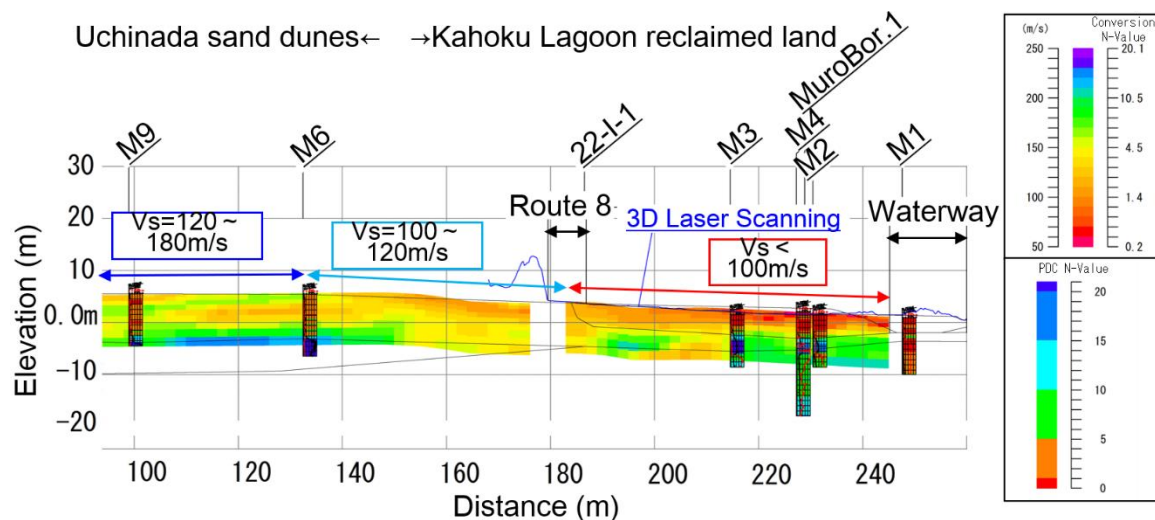
**Figure 8.21.** Result of surface wave exploration survey in the Muro area

The distribution of S-wave velocities reveals that the region on the mountainside (sand dunes side) of Prefectural Road 8 exhibits S-wave velocities ranging from 100 to 180 m/s, while the area on the waterway side of the road shows a significant reduction, with S-wave velocities of

less than 100 m/s. This lower velocity zone roughly corresponds to the fill layer (Fs) and the very loose area (with N-values between 0 and 1) identified in the PDC test. The relatively low S-wave velocity within the fill layer, composed primarily of dune sand, is attributed to the land reclamation efforts conducted in the 1930s, suggesting that the fill was not adequately compacted.

Focusing on variations within the fill layer, it is noteworthy that localized zones with particularly low S-wave velocities are present near the waterway. These areas are associated with liquefaction-induced sand boils and lateral flow, which caused blockages in the waterway. It is likely that lateral flow due to liquefaction has contributed to soil looseness and a reduction in shear stiffness in this region. The boundary between the fill layer and the natural sand dune layer (Fs) is assumed to be located near Prefectural Road 8. However, the S-wave velocity distribution indicates an additional zone with S-wave velocities ranging from 100 to 120 m/s, extending approximately 40 meters from the edge of the fill layer. This area displays features such as tensile cracks and step-like terrain, which are indicative of flow slides. These characteristics suggest that secondary slope movements may have occurred due to lateral flow within the fill layer.

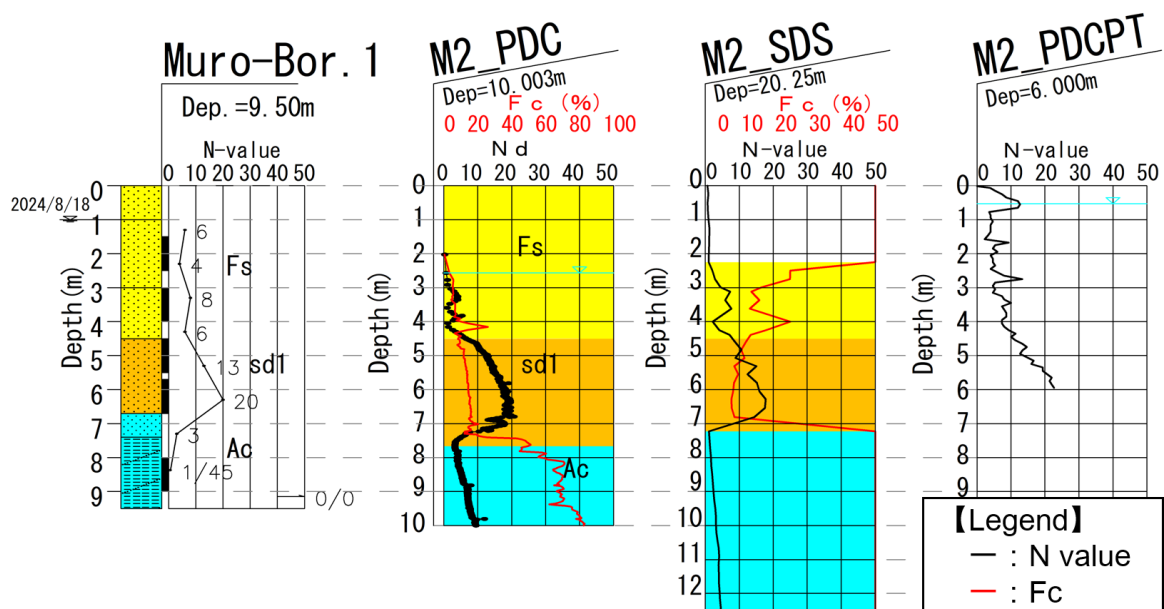
**Figure 8.22.** Comparison of N value and fine content, Fc at a representative location (M2)

Figure 8.22 illustrates the depth profiles of equivalent N-values and fine content (Fc) at location M2, where sand boils were observed, representing the test results from the SDS test, PDC test, and PDCPT. All tests indicate equivalent N-values between 0 and 1 at a depth of approximately 2 meters, signifying an extremely loose soil condition. The higher N-values obtained from the SPT at around 2 meters, compared to the equivalent N-values from the SDS and PDC tests, are likely due to the SPT being conducted four months after the other tests, suggesting that the ground stiffness may have recovered during that period. Below 2 meters, the equivalent N-values gradually increase to approximately 20 by 6 meters, after which a decrease in equivalent N-values and an increase in fine content (Fc) are observed around 8 meters.

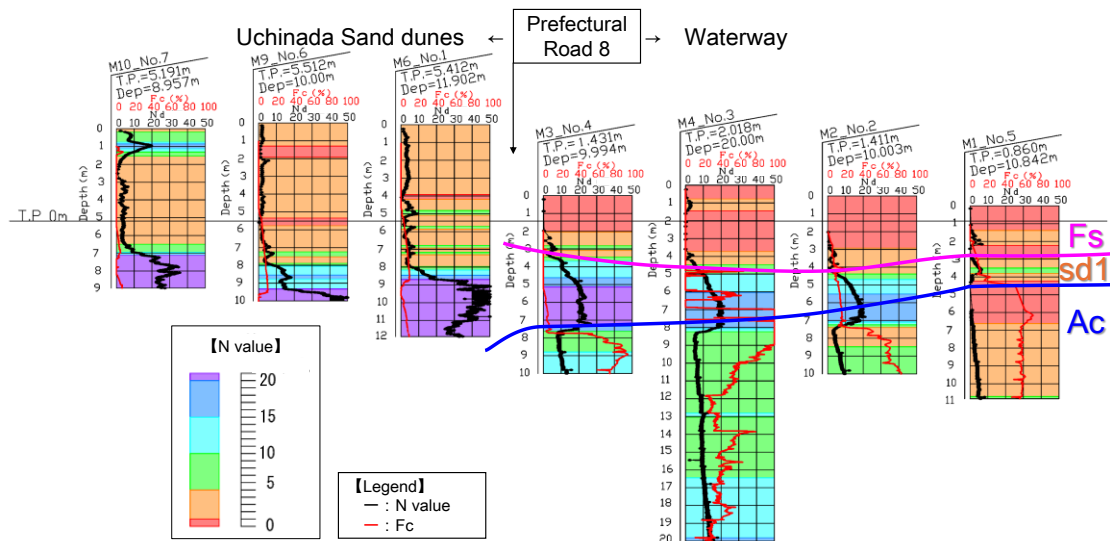
**Figure 8.23.** PDC test results in the cross section

Based on the comparison outlined above, the N-values were zoned using the depth profiles of N-values and fine content (Fc) obtained from the PDC test along the cross-section, as shown in Figure 8.23. For soil classification, areas with low N-values and fine content (Fc) exceeding 50% were categorized as clayey soil. The results of this classification are presented in the geological cross-section in Figure 8.24.

As previously mentioned, the Muro area is reclaimed land, created by filling the edge of the sand dunes facing Kahoku Lagoon with sandy soil. Very loose zones, with N-values ranging from 0 to 1, are observed continuously at depths of approximately 2 to 4 meters on the waterway side (east side) of Prefectural Road 8, where the fill layer is present. In contrast, on the mountainside (west side) of the road, where the sand dunes are located, although localized areas with N-values of 0 to 1 are present, this trend is not observed to be continuous.

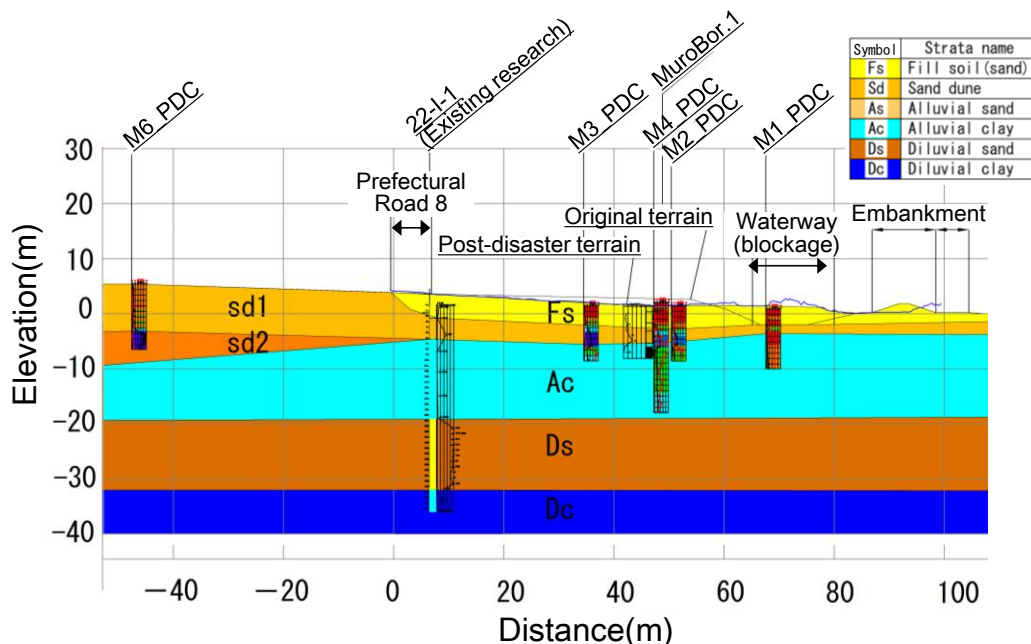
**Figure 8.24.** Estimated geologic cross section obtained from PDC test

- 3) **Very Loose Zones in Muro:** In the Muro area, a continuous zone of very loose soil with N-values between 0 and 1 was identified on the waterway side of Prefectural Road No. 8, extending to depths of approximately 2 to 4 meters. In contrast, on the mountainside of the road, while localized zones with N-values of 0 to 1 were present, no significant continuity was observed.

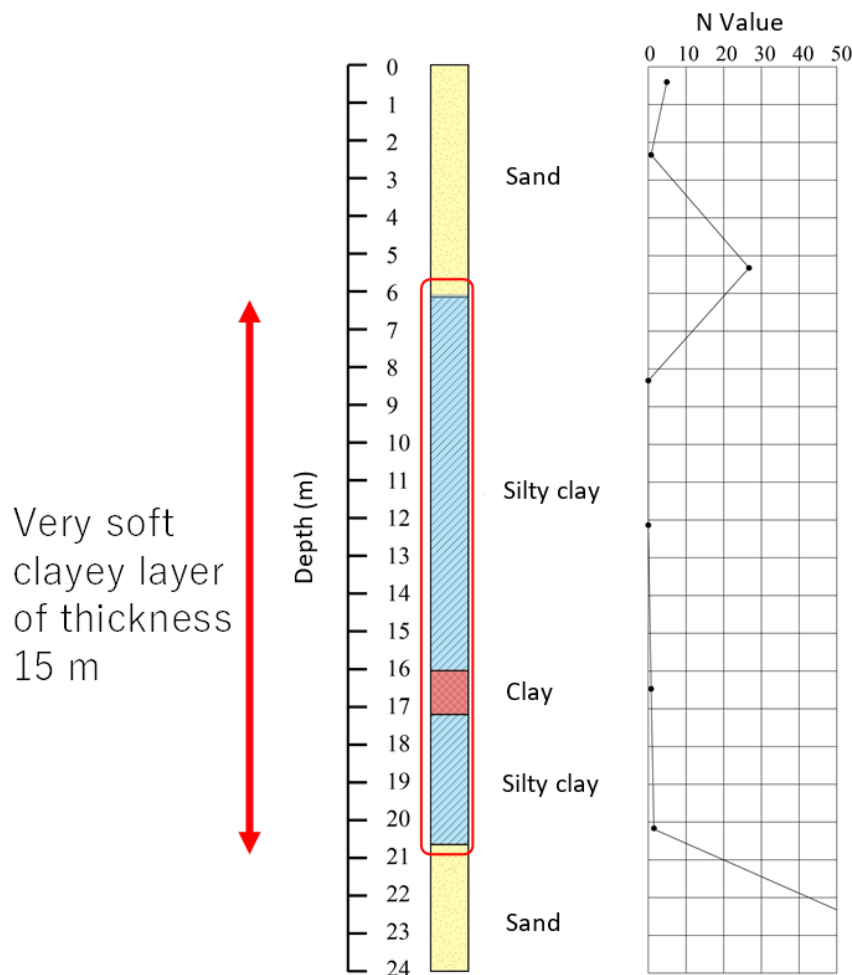
**Figure 10.1.** Existing boring survey data

- a. Amplification of motion: Figure 10.1 presents the existing boring survey data from the Muro area. The data reveal the presence of a 15-meter-thick layer of very soft clay, which may have amplified seismic motion, thereby contributing to the extensive and localized liquefaction observed across the area.

- 5) Amplification Through Alluvial Clay: Both the existing boring data and the geological cross-section from PDC testing identified a 15-meter-thick alluvial clay layer located approximately 6 meters below the surface. Amplification of seismic waves through this clay layer is believed to have been a significant factor contributing to the widespread liquefaction observed.

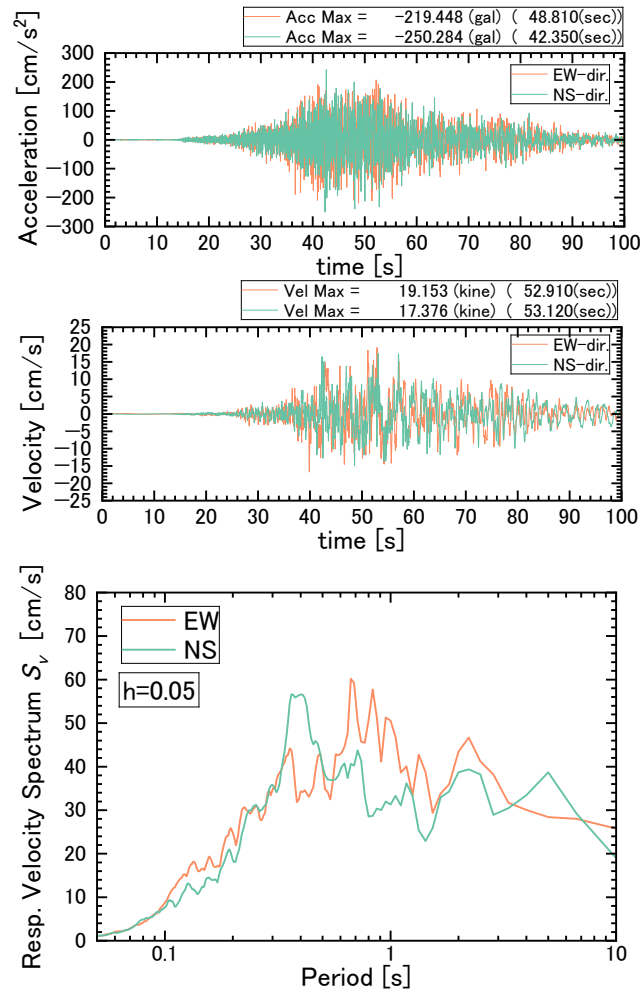
**Figure 10.2.** Acceleration record and response spectra

- b. Short predominant period with high velocity: Figure 10.2 illustrates the acceleration record from the station nearest to Uchinada Town, along with the corresponding response velocity spectra. The velocity spectrum exhibits a pronounced dominance of short periods, with a notably high response velocity of 60 cm/s. This indicates that the substantial seismic energy generated during the event may have been another contributing factor to the widespread and localized liquefaction observed in the area.

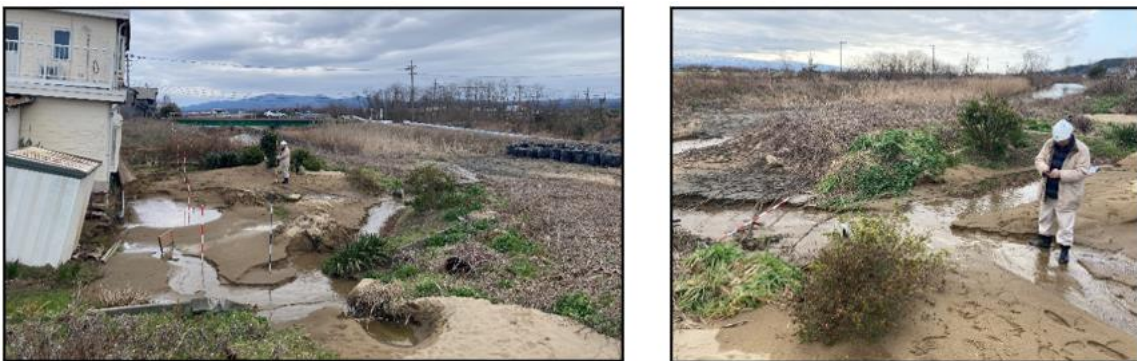
- c. Landfilling and high-water table: Both the Nishi Araya and Muro areas of Uchinada Town are reclaimed land with a high-water table. During the post-disaster survey, significant water accumulation was observed along the periphery of the reclaimed land in the Muro area (Fig. 10.3). Additionally, a contour map generated using pre-disaster elevation data (Fig. 10.4) revealed that the areas affected by lateral movement displayed concave terrain typical of a drainage basin, indicating a high groundwater level.

**Figure 10.3.** Waters seen during the post disaster survey

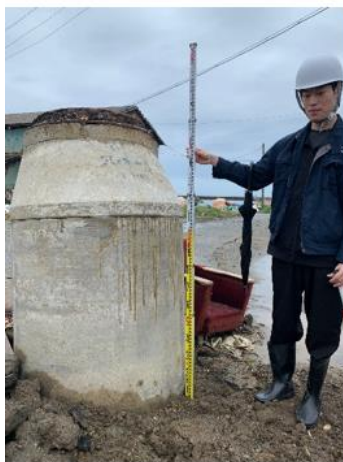
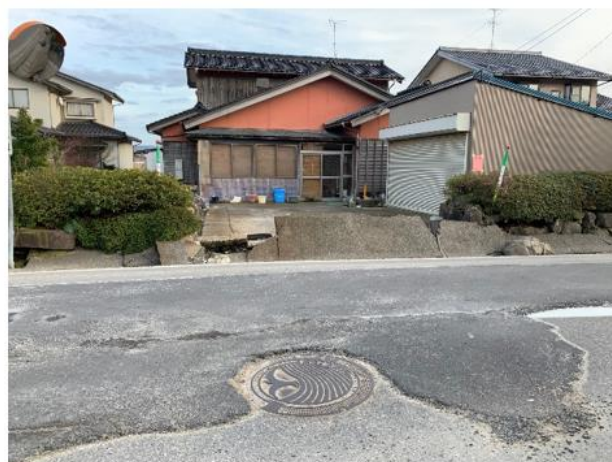
**Figure 10.5.** Manhole upliftment

- d. Liquefaction at shallow depth: Our post-disaster boring investigation revealed that the water table in the Muro area was located within 1.0 meter of the ground surface. The upper 4.5 meters of the soil consisted of fill material with N-values less than 5, underlain by an original sand dune layer approximately 2.2 meters thick, with N-values ranging from 15 to 20. Based on this data, it can be inferred that liquefaction likely occurred at a relatively shallow depth, between 1.5 and 2.0 meters below the ground surface. This inference is further supported by observations of manhole behavior in Uchinada Town. Figure 10.5 illustrates the post-disaster condition of manholes in Uchinada Town and Suzu City. While no manhole uplift was observed in Uchinada Town, significant uplift exceeding 1.6 meters was recorded in Suzu City.
