2023 Turkey Earthquake Virtual Report on Geotechnical Impacts

Report Date: 2/09/2023

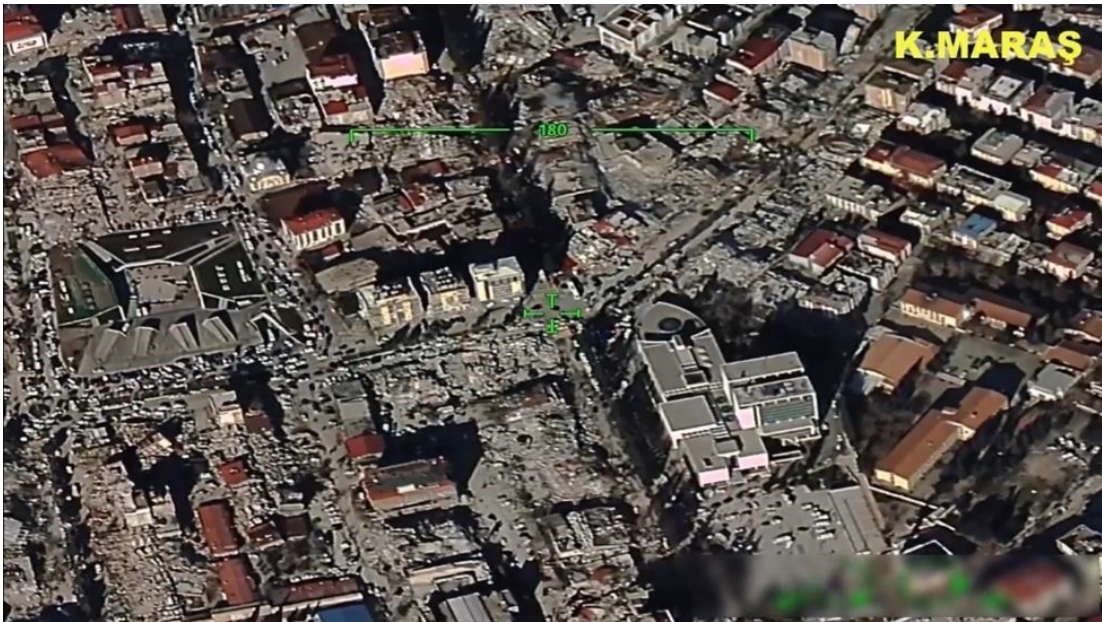
Figure 4: An image taken by UAV from Kahramanmaras
(<https://www.milliyet.com.tr/galeri/buyuk-afette-ucuncu-gun-deprem-bolgesinde-zamana-karsi-yaris-6900343/1>)

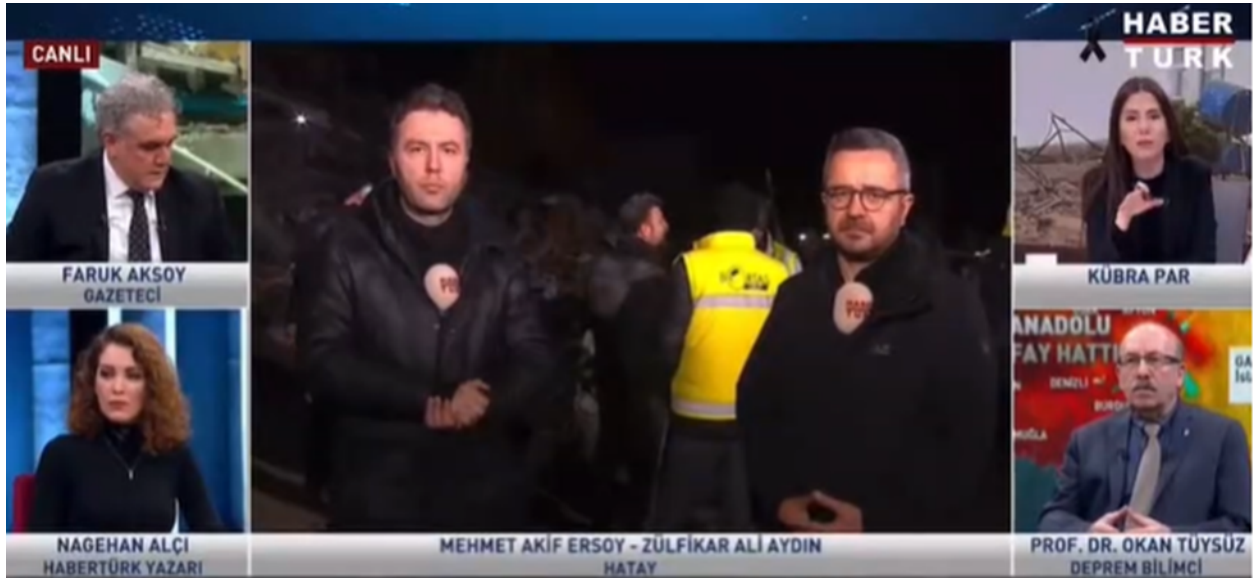
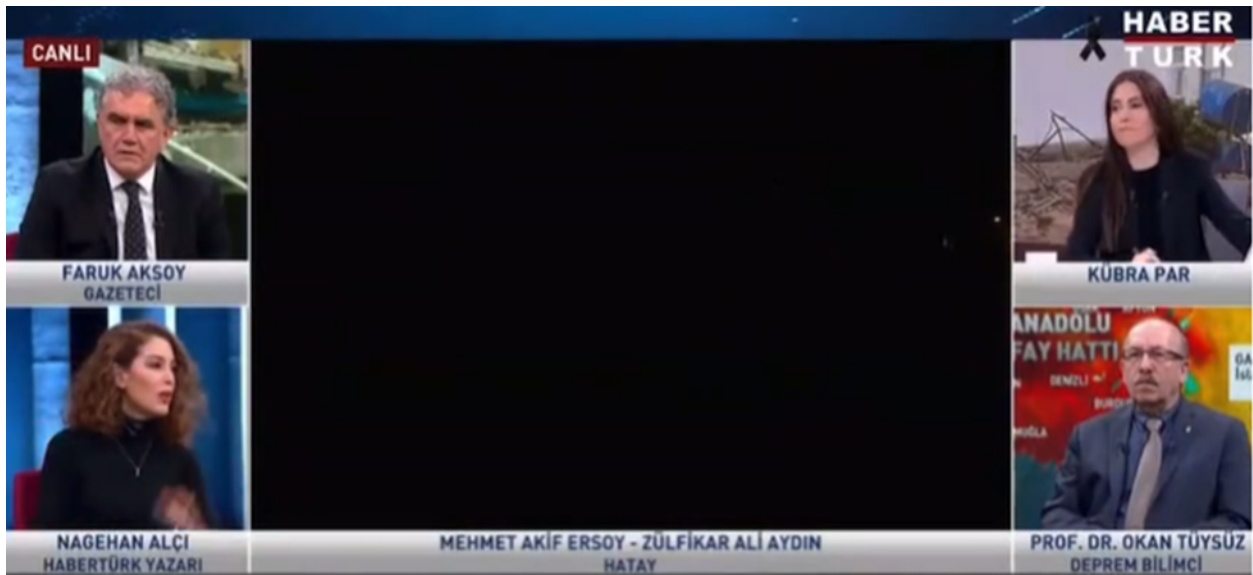
One reporter showed the lack of lighting during the search and rescue on the second day of the earthquake in Hatay. The only lighting rescuers had in the field was the lighting of the camera crew.

Figure 5: A live Turkish news broadcast showing no lighting in the field (February 7)

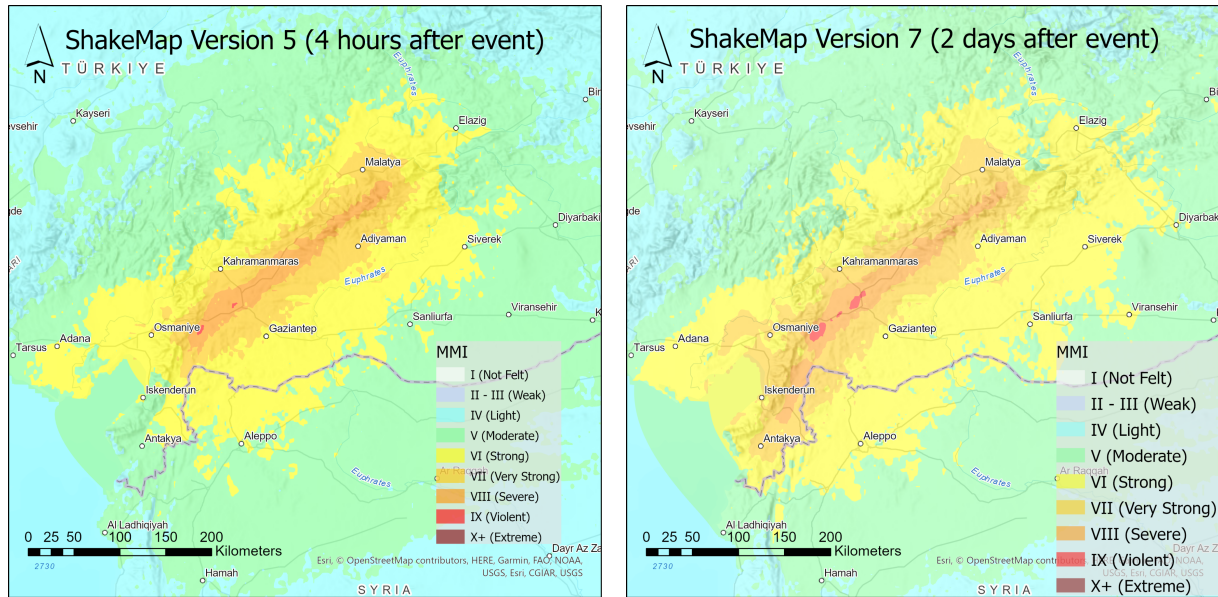
Figure 8: Earthquake intensity for two ShakeMap versions (Source: USGS)

Version 5 was the one used by most news reports because it was not updated during the first day of the event. This is why most information from February 6th references this data. Then, two days after, the finite rupture model was modified to account for the rupture of the southern border between Turkey and Syria (See ShakeMap version 7). Note that the earthquake intensity increases for the city of Antakya (located to the East of Aleppo) from V (Moderate) to VII (very strong).

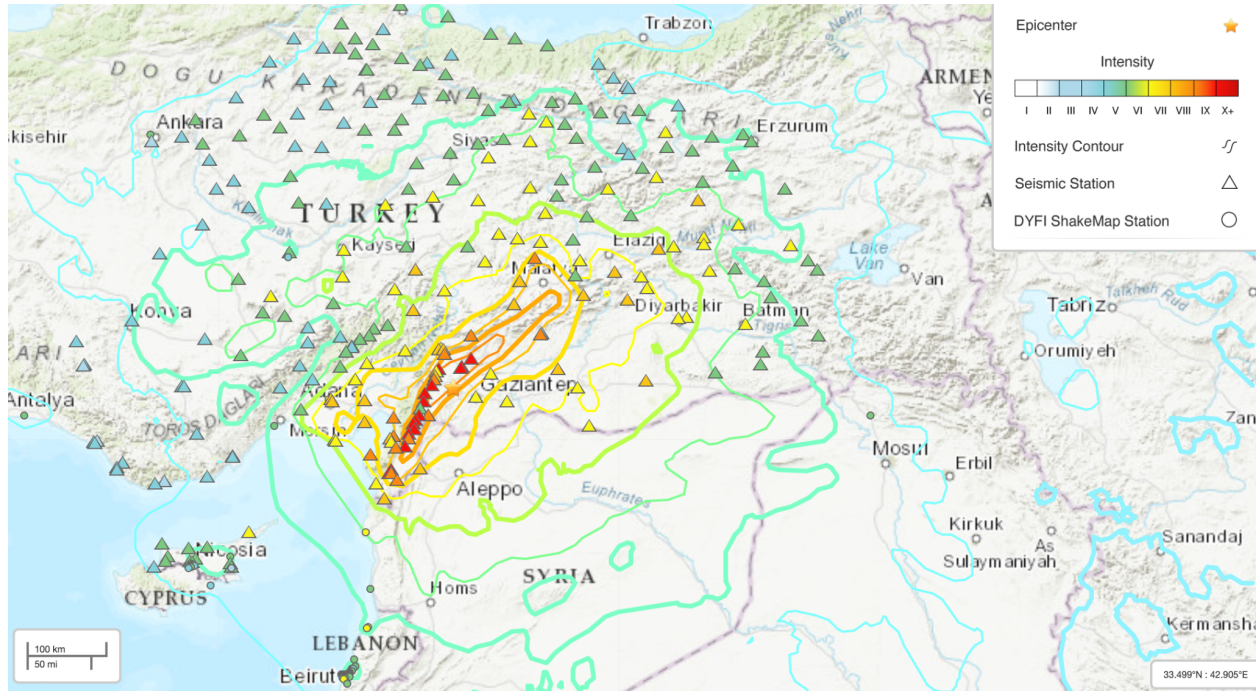
Figure 9: Earthquake intensities at seismometer locations of the ShakeMap (Source: USGS)

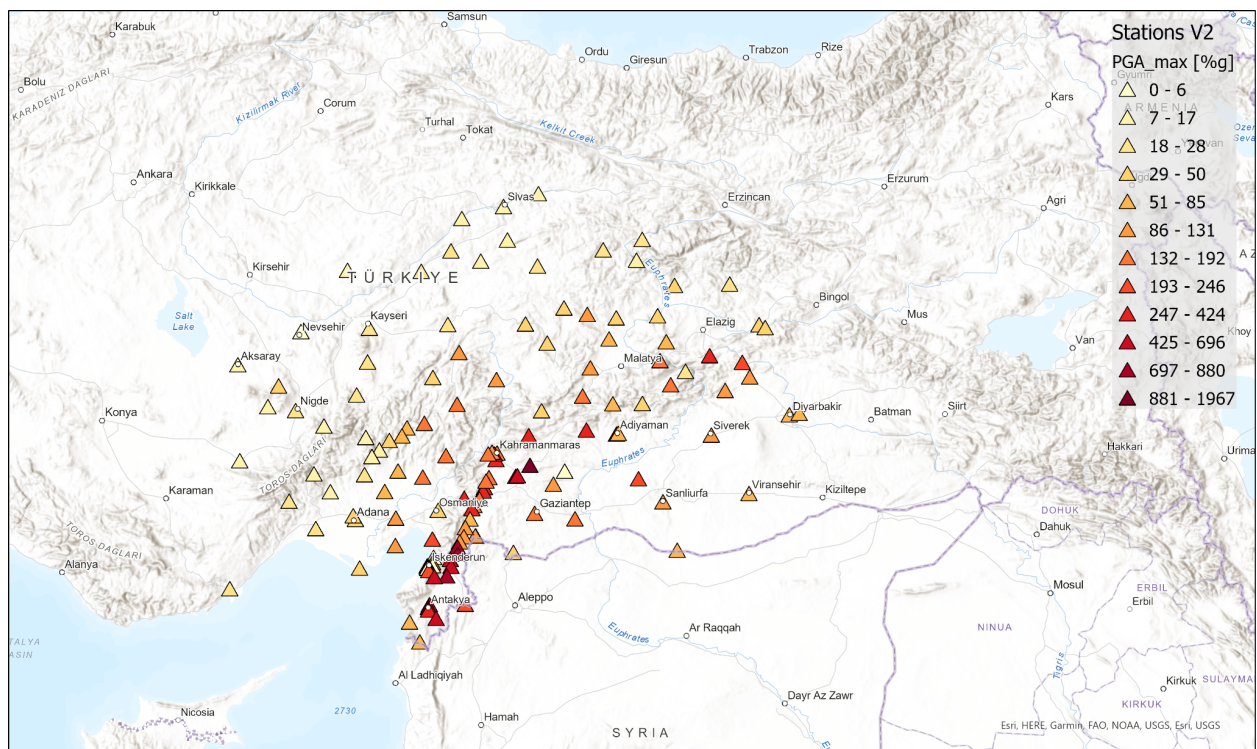
Figure 10: Peak Ground Acceleration recorded by seismometers near the fault rupture (Source: Cetin, 2023).

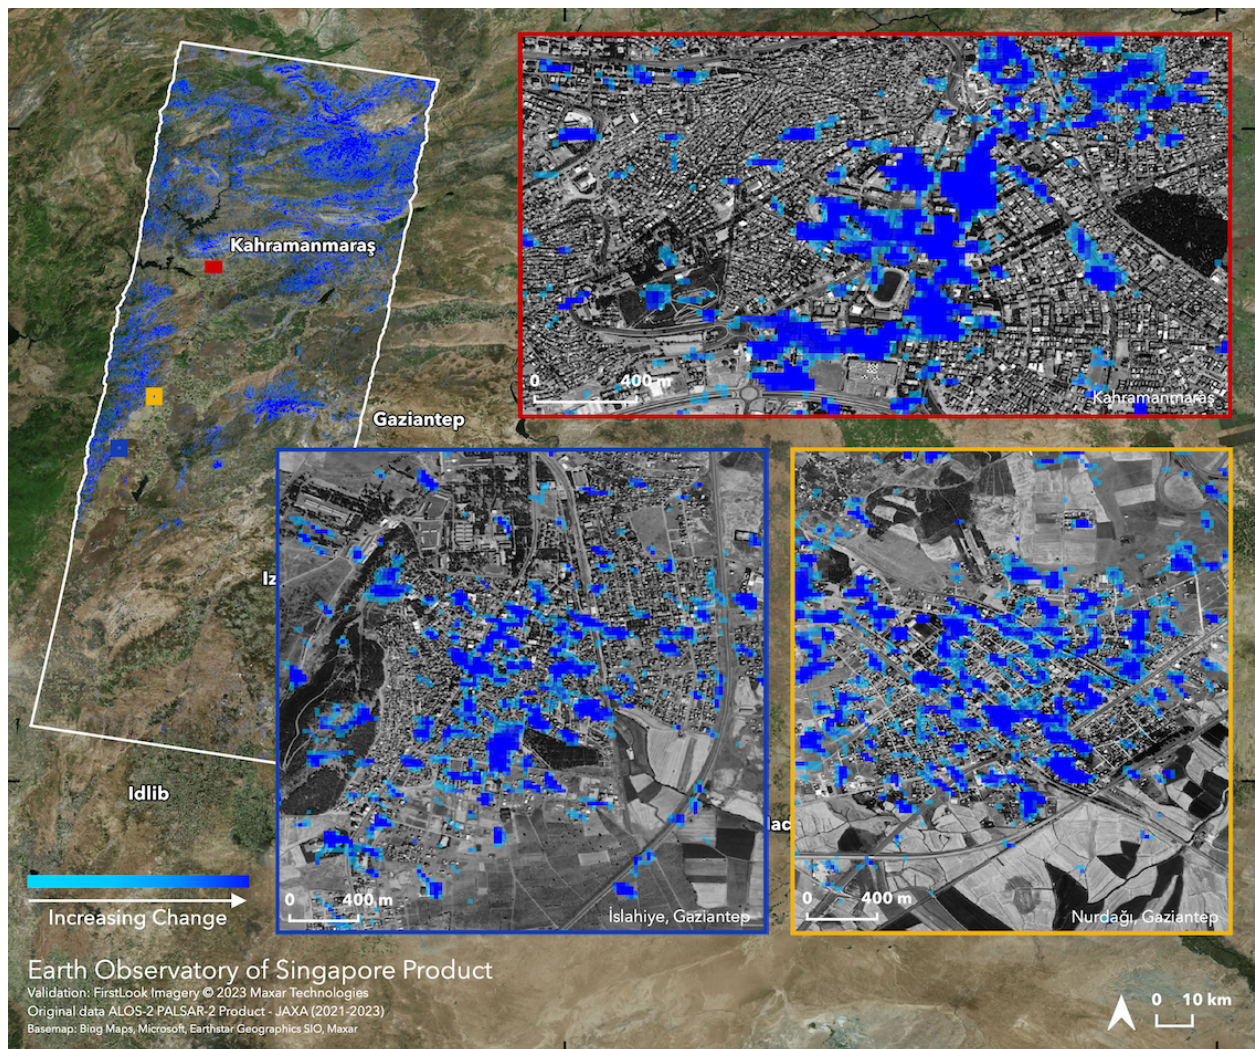
One of these products is the Damage Proxy Map (DPM), which highlights the areas that likely suffered damage after the earthquake. This dataset was computed using synthetic aperture radar (SAR) images captured by the ALOS-2 satellite before the event (from April 2021 to April 2022), and after the event (February 8 2023).

Figure 11: Damage Proxy Map (Source: Earth observatory of Singapore)

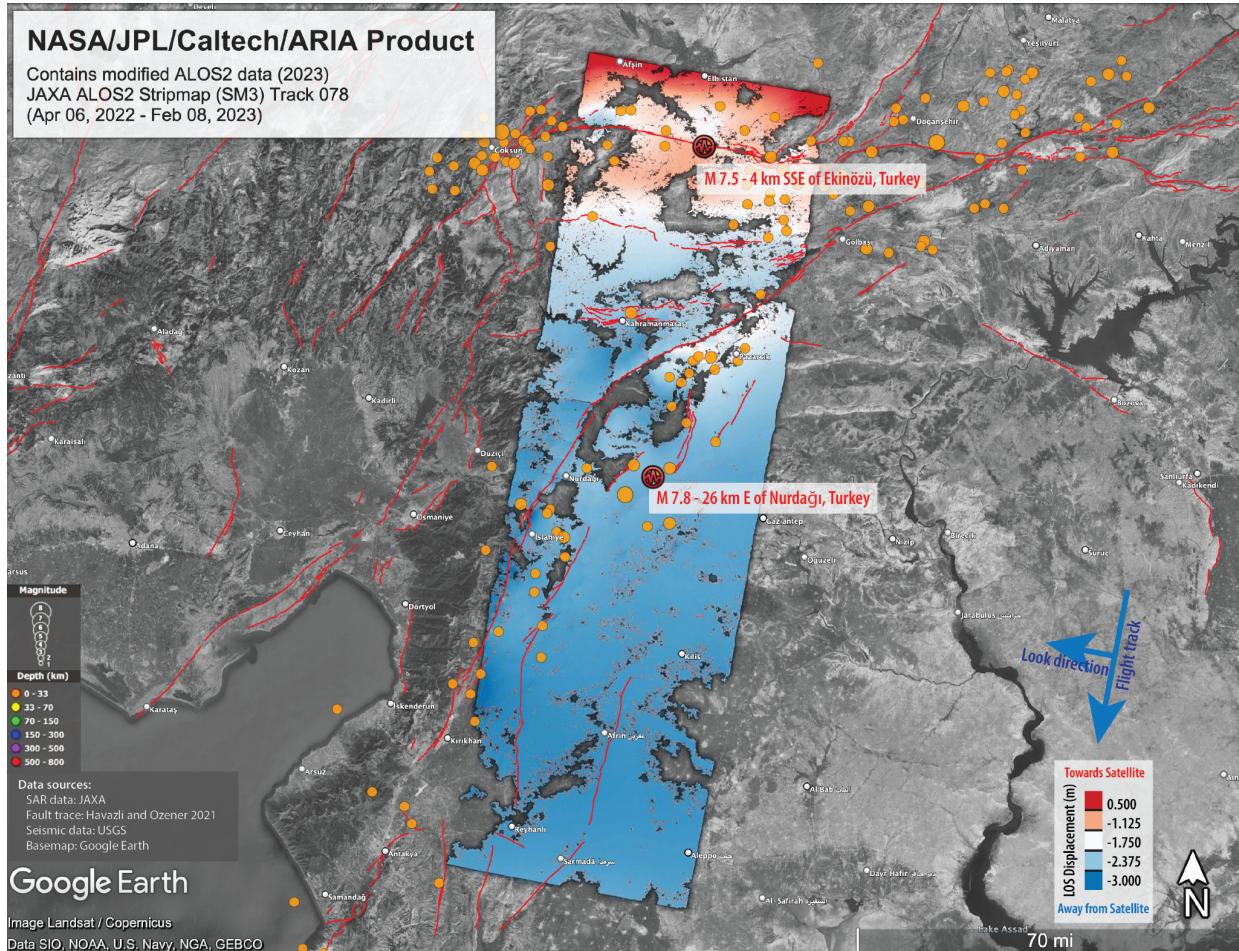
NASA JPL Laboratory has generated Stripmap displacement maps by computing the interferometric difference (interferogram or interferometric SAR) and pixel offset tracking between the post-event image acquired on February 8, 2023 with a pre-event image acquired on April 6, 2022, on the ALOS-2 descending (satellite moving south) track 78.

Figure 12: Preliminary dataset on surface displacement (Source: NASA JPL)

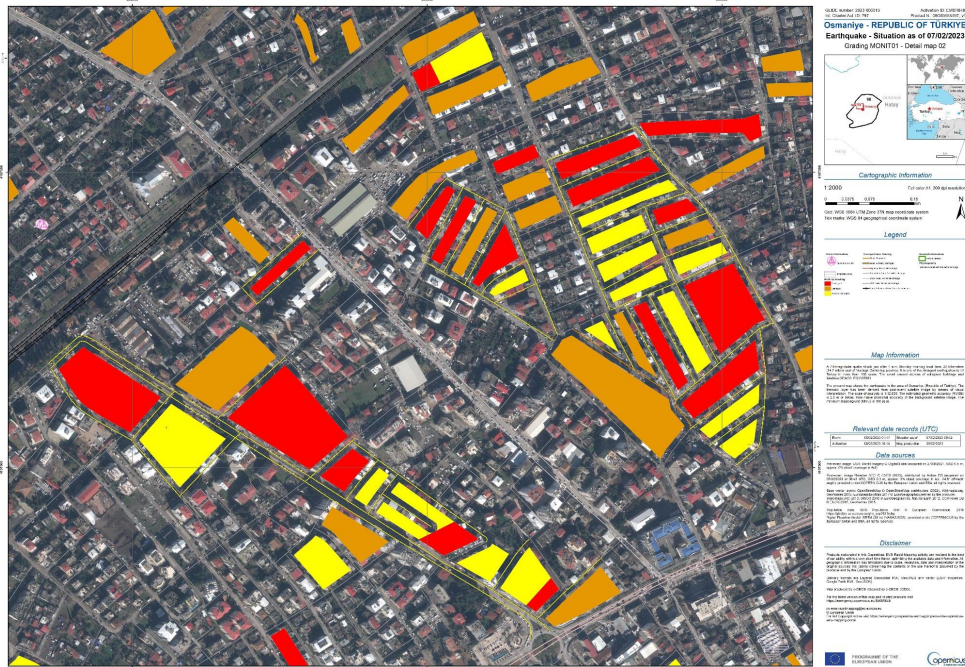
For each of these areas, satellite imagery is used to manually identify damage to infrastructure. The next figure shows the damage grading product for Osmaniye (Turkey) where red areas represent Destroyed, orange Damaged, and yellow Possibly Damaged. A larger grading product was released for the city of Kahramanmaraş.

Figure 14: Damage grading in Osmaniye (Source: Copernicus EMS)

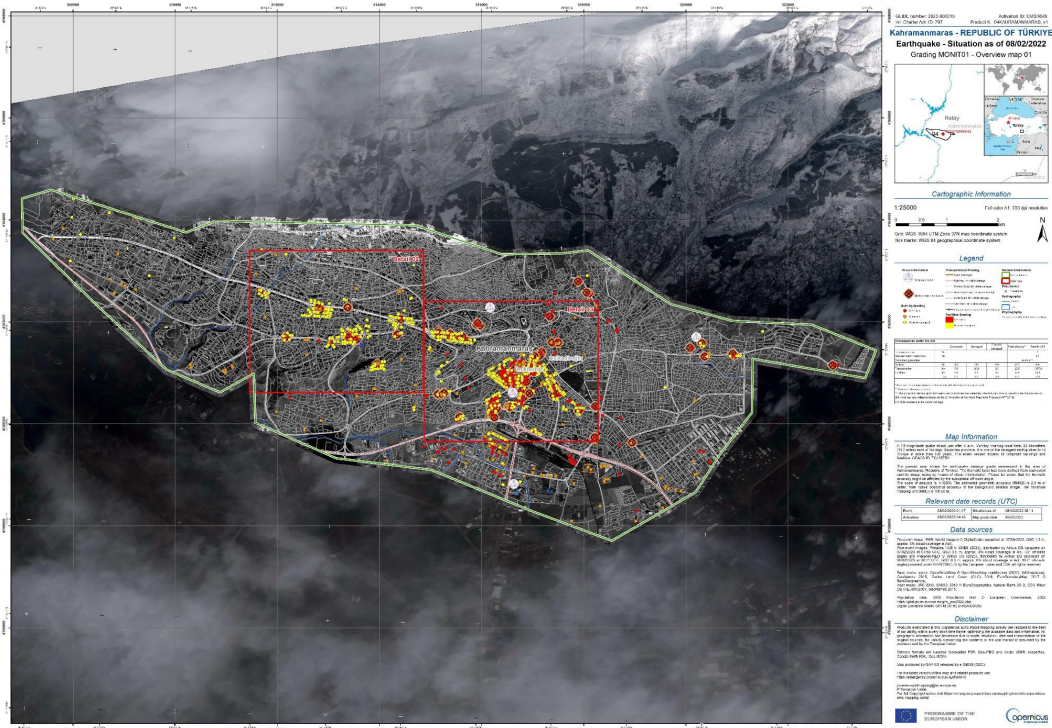
Figure 15: Damage grading in Kahramanmaraş (Source: Copernicus EMS)

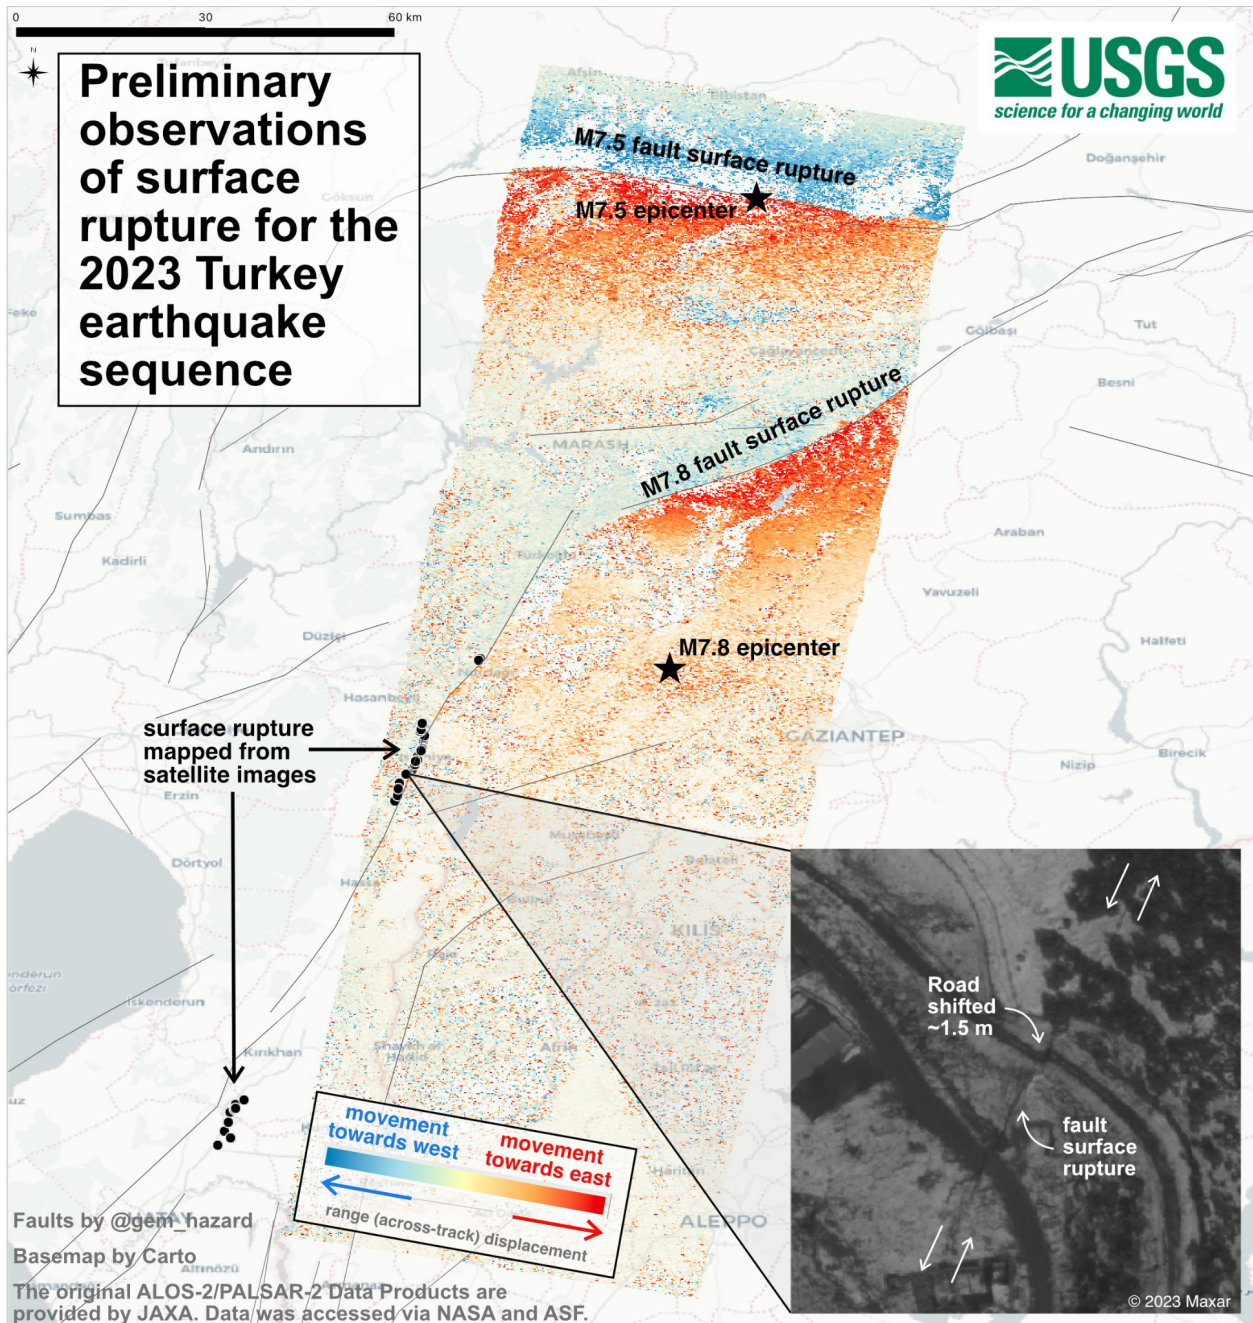
Figure 16: Surface Rupture estimation from satellite imagery (Source: @USGS_Quakes on Twitter)

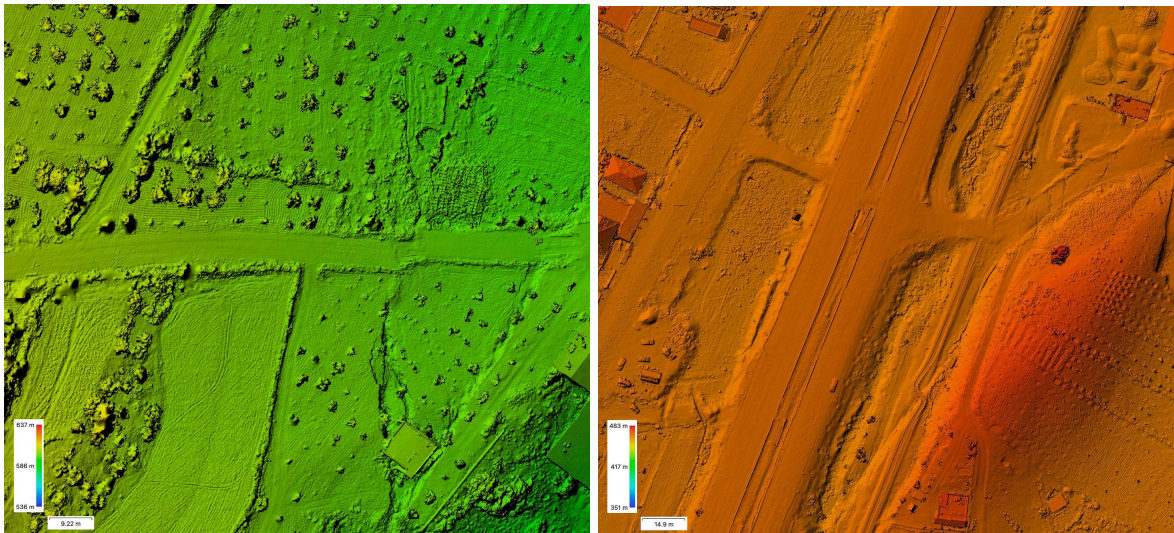
Figure 18: UAV-based Digital Surface Model in Şekeroba, Turkey (Source: Twitter Cengiz Zabcı <https://twitter.com/CengizZabci/status/1623569420554493953>)
