#### **Geotechnical Effects of Hurricane Florence**

Geotechnical Extreme Events Reconnaissance (GEER) Association.

GEER Association Report No. GEER-063

April 2019 Revision 1 - June 2019

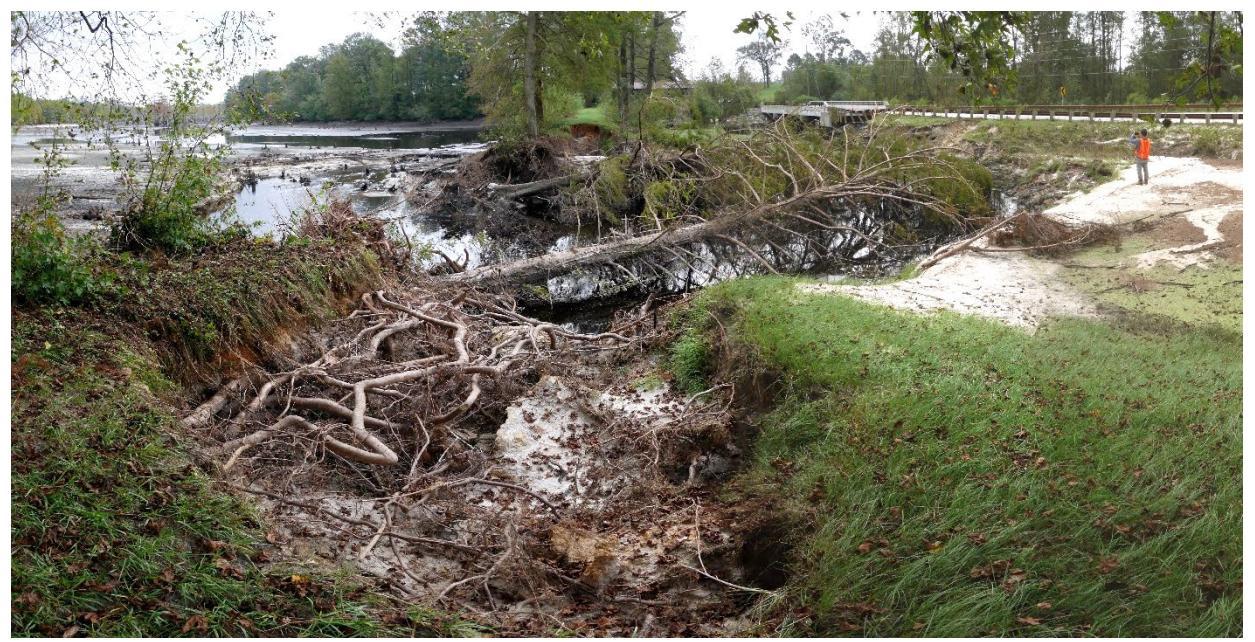
Of the 23 dams that we visited, flood flows overtopped 17 structures, 14 of which were breached by the overtopping. Fortunately, most of these dams were low or significant hazard such as Maxwell Mill Pond Dam (Fig. 1.3-2). However, one dam, Boiling Spring Lake Dam, south of Wilmington, NC, was classified as high hazard and was the largest overtopped dam (30-ft-high, 1584-ft-long) that we observed (Fig. 1.3-3). Four other smaller dams abutting Boiling Spring Lake area also failed (see cluster on Fig. 1.2-1). The one levee-protected area that we visited, in Lumberton, NC, flooded due to the inadequate closure of a rail and road underpass through the I-95 embankment that formed the northwestern flood barrier for the city.

Fig. 1.3-2 – Maxwell Mill Pond Dam breach, Duplin County, NC (September 25, 2018, 35.0706 N, 77.7880 W)

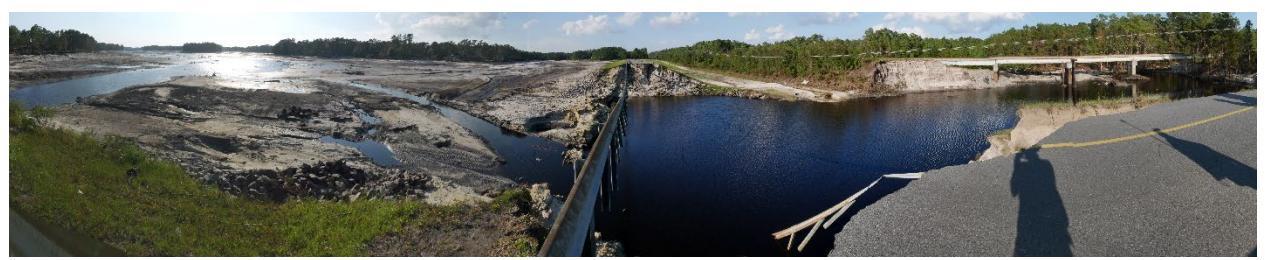
Fig. 1.3-3 – Boiling Springs Dam breach, Brunswick County, NC (September 26, 2018, 34.0465 N, 78.0373 W)

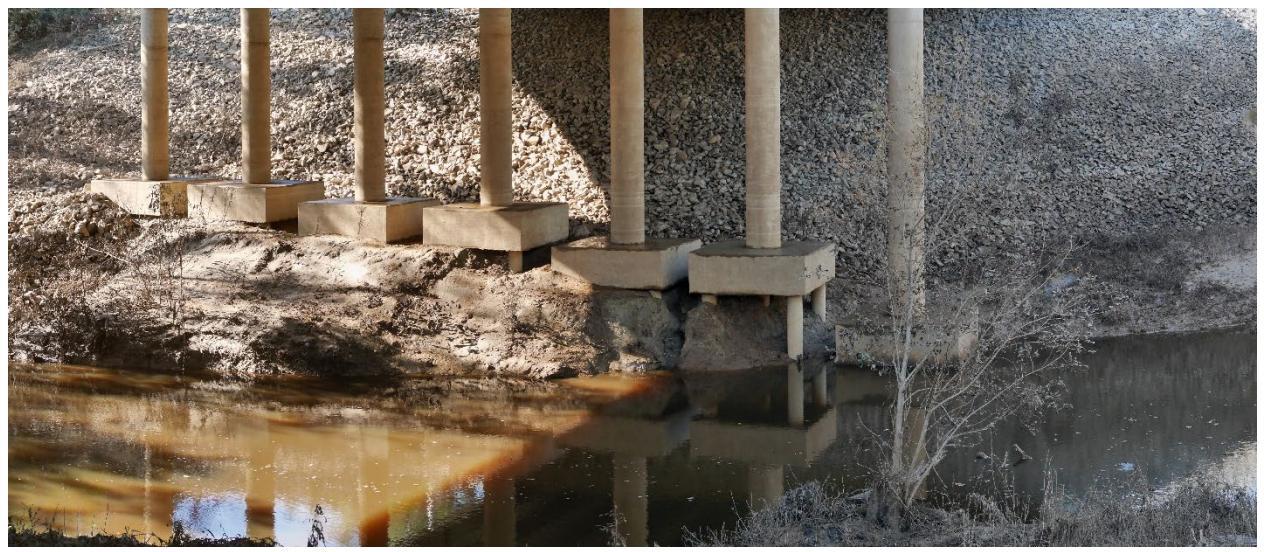
Fig. 1.3-4 – Bridge pier scour, Business 95 Bridge, Cross Creek, Fayetteville, NC (September 26, 2018, 35.05507° N, 78.86251° W)

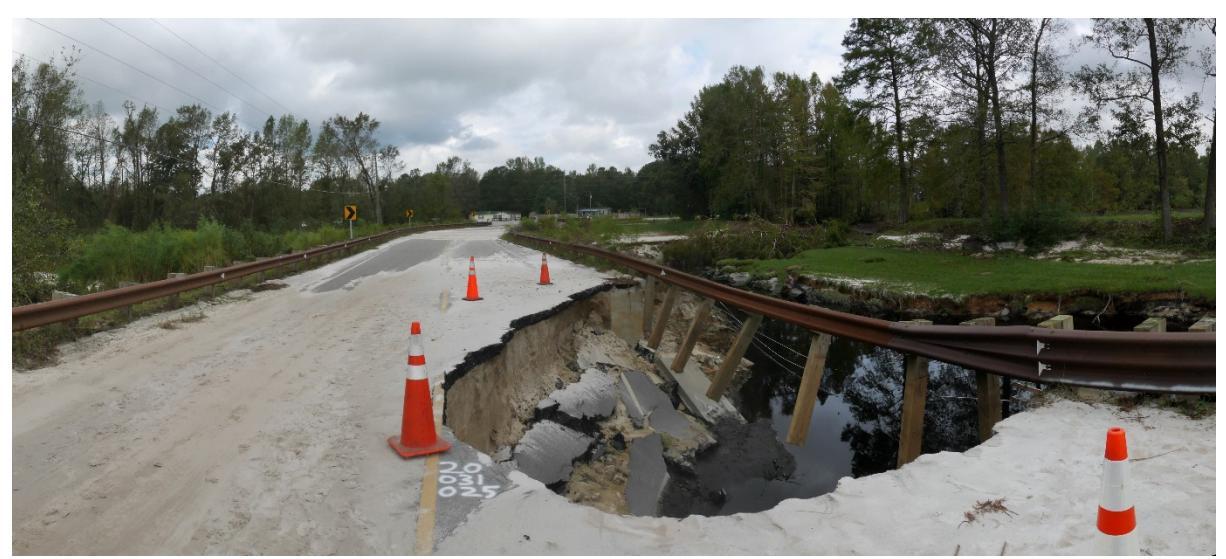
Fig. 1.3-5 – Road embankment washout downstream of Maxwell Mill Pond Dam, Duplin County, NC (September 25, 2018, 35.0701 N, 77.7876 W)

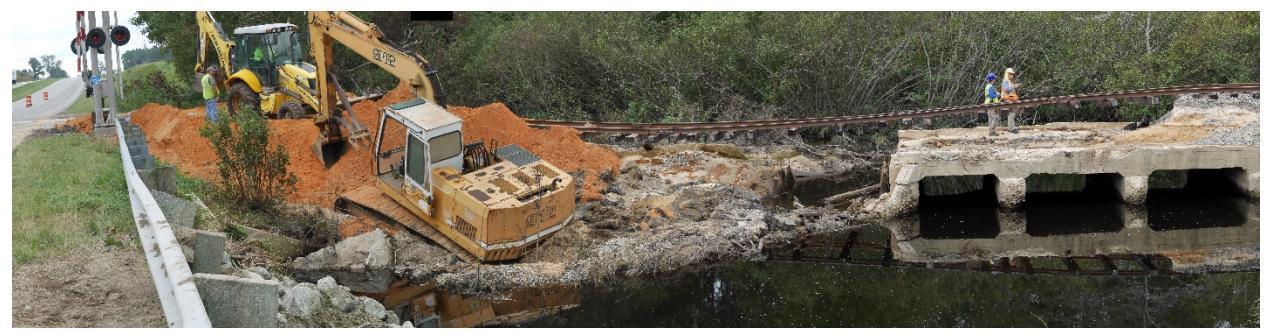
Fig. 1.3-6 – Rail line embankment washout and repair, Laurinburg, NC (September 27, 2018, 34.7936 N, 79.4619 W)

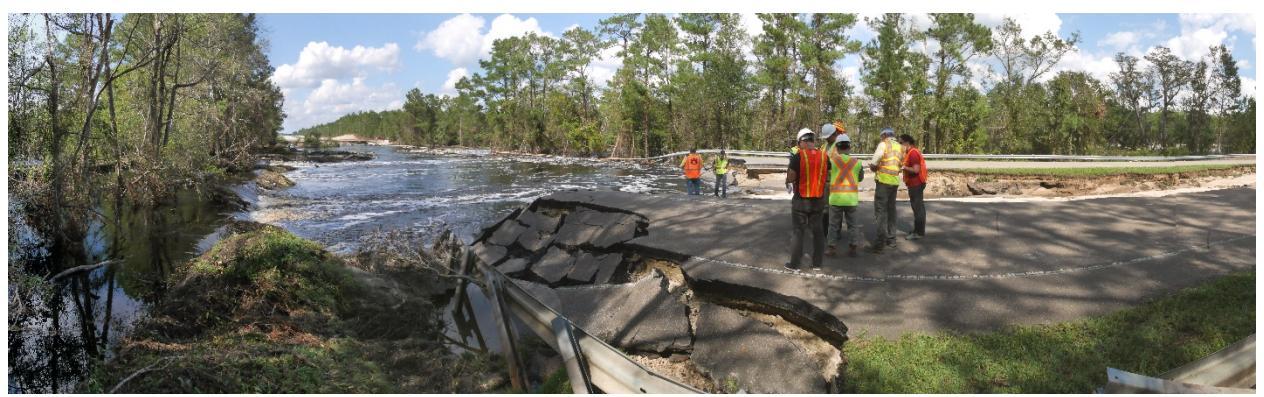
Fig. 1.3-7 – US 421 highway washout between the Cape Fear River from west (left) to the Northeast Cape Fear River on the east (right), looking northwest across washout (September 26, 2018, 34.3307° N, 77.9997° W)

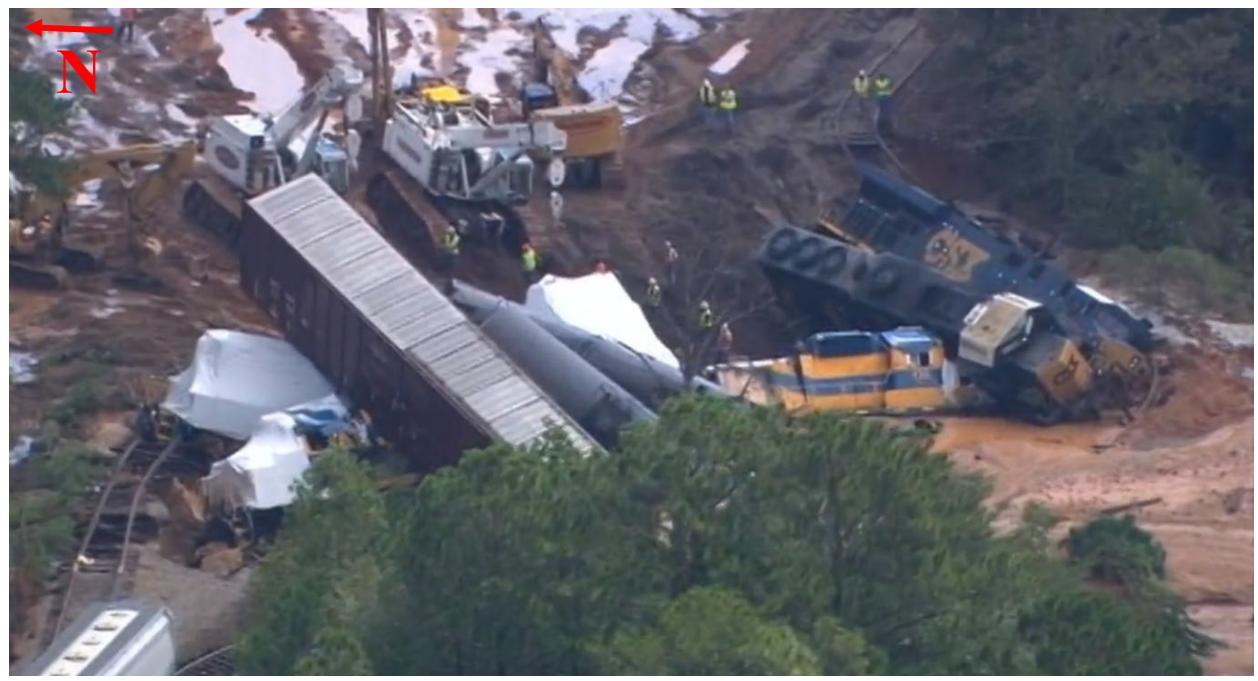
Fig. 1.3-8 – CSX Train Derailment aftermath, Anson County, NC (WSOC-TV, September 17, 2018, 34.9513 N, 79.9446 W)

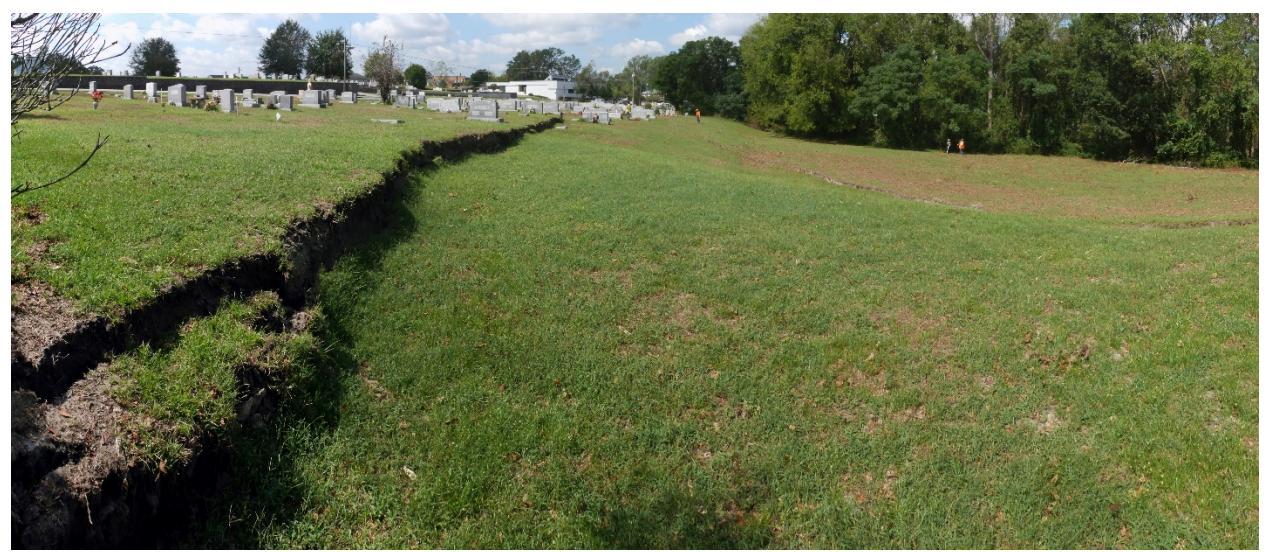
One site of geotechnical interest that did not fit into our categories was the Cape Fear river bank in Elizabethtown. We observed several scarps, which were long ( $\sim$ 500 ft) with short heights ( $\sim$ 2 ft) in the area around a cemetery at this location indicating movement of a large part of the river bank (Fig. 1.3-9). We did not have enough information to assign a likely cause, but investigators could consider elevated seepage pressures and rapid-drawdown-induced shear stresses.

Fig 1.3-9 – Slope movement, Elizabethtown, NC (September 26, 2018, 34.6297 N, 78.60211 W)

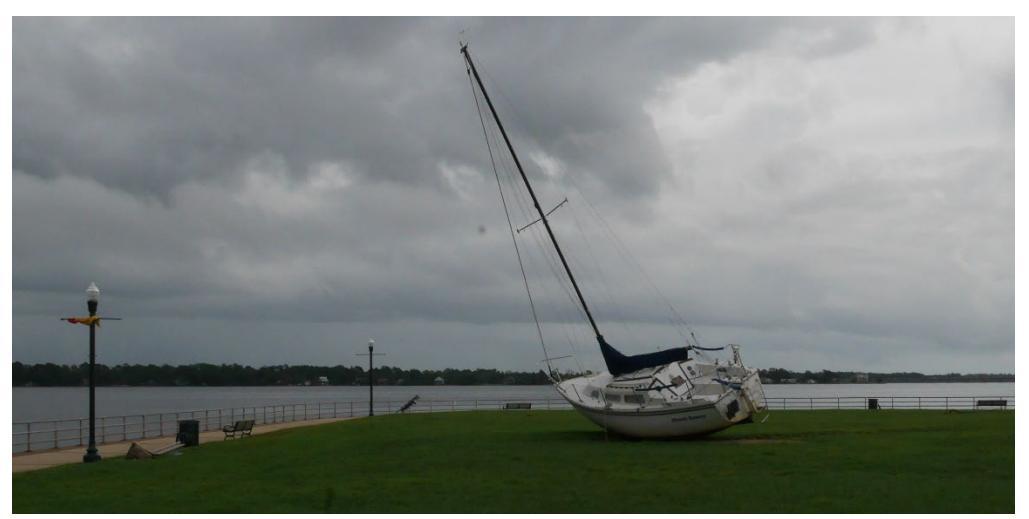
We also made visits to the hard-hit coastal communities of New Bern, Surf City, Emerald Isle, and Wilmington. The storm surge affected all of these areas and caused severe damage to homes and businesses in those communities. The storm surge in New Bern was notably high at slightly more than 10 ft (Fig. 1.3-10) and was probably amplified by the converging mouth of the Neuse River.

Fig. 1.3-10 – Evidence of storm surge, New Bern, NC (September 25, 2018, 35.1082 N, 77.0353 W)

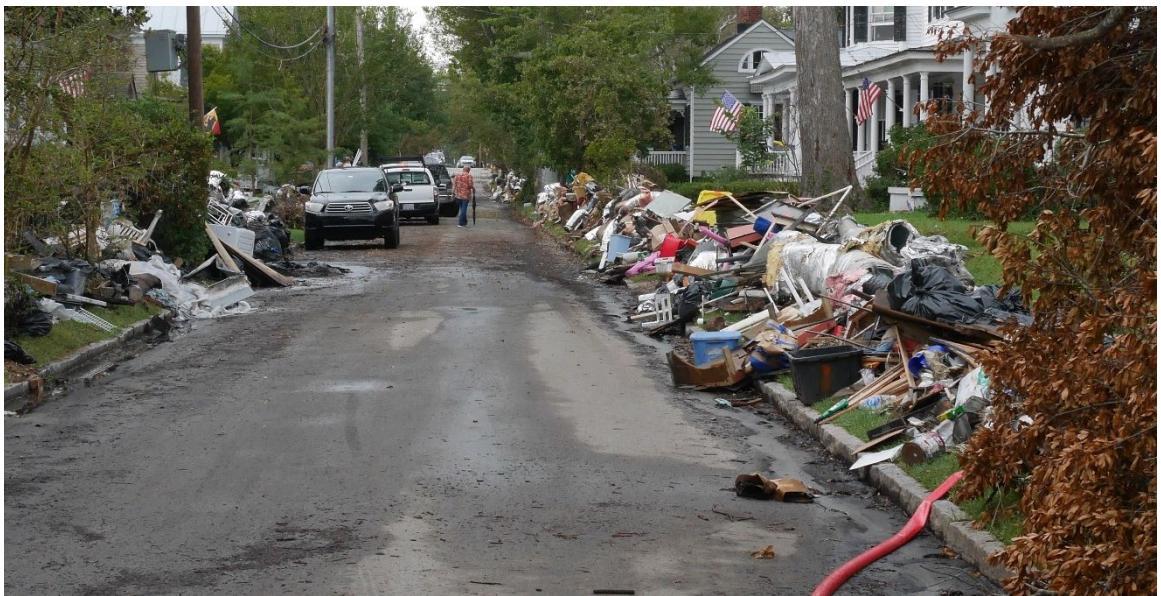
Overall, the infrastructure damage from hurricane Florence was significant and, while widespread, was clustered near waterways. As we have seen at other disaster sites, residents and businesses in areas of river flooding and storm surges suffered dramatic property losses (Fig. 1.3-11), especially in low-lying areas of Lumberton, New Bern, and Kinston. However, we hope and

Fig. 1.3-11 – Debris from residential clean-up, New Bern, NC (35.1091 N, 77.0355 W)

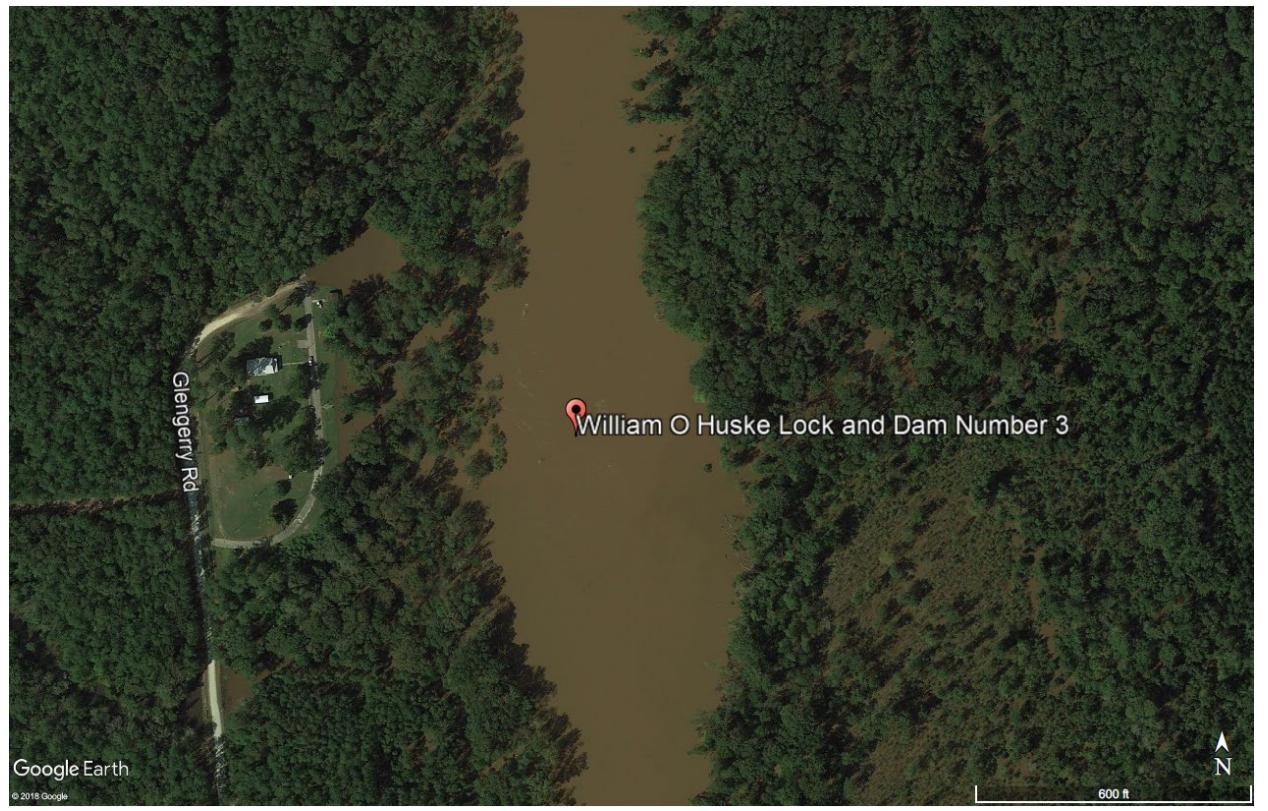
intakes for cities and industries along the river by backing up the water. Lock and Dam 1 was originally constructed in 1915 and modified in 1934 to increase the lift by 3 ft to a total of 11 ft. The lock is 40 ft by 200 ft. William O. Huske lock and dam was constructed in 1935. The lock chamber is 40 ft by 300 ft with a total lift of 9 ft. The lower pool is at elevation +23 ft and the upper pool is maintained at elevation +32 ft. Aerial photographs of the lock and dam before (Fig. 3.4-3) and during the flooding on September 18, 2018 (Fig. 3.4-4), show that the river totally covered the structure.

Fig. 3.4-4 – Aerial photograph of the William O'Huske Lock and Dam Number 3 during Hurricane Florence flooding (Google Earth, September 18, 2018, 34.835 N, 78.823 W)

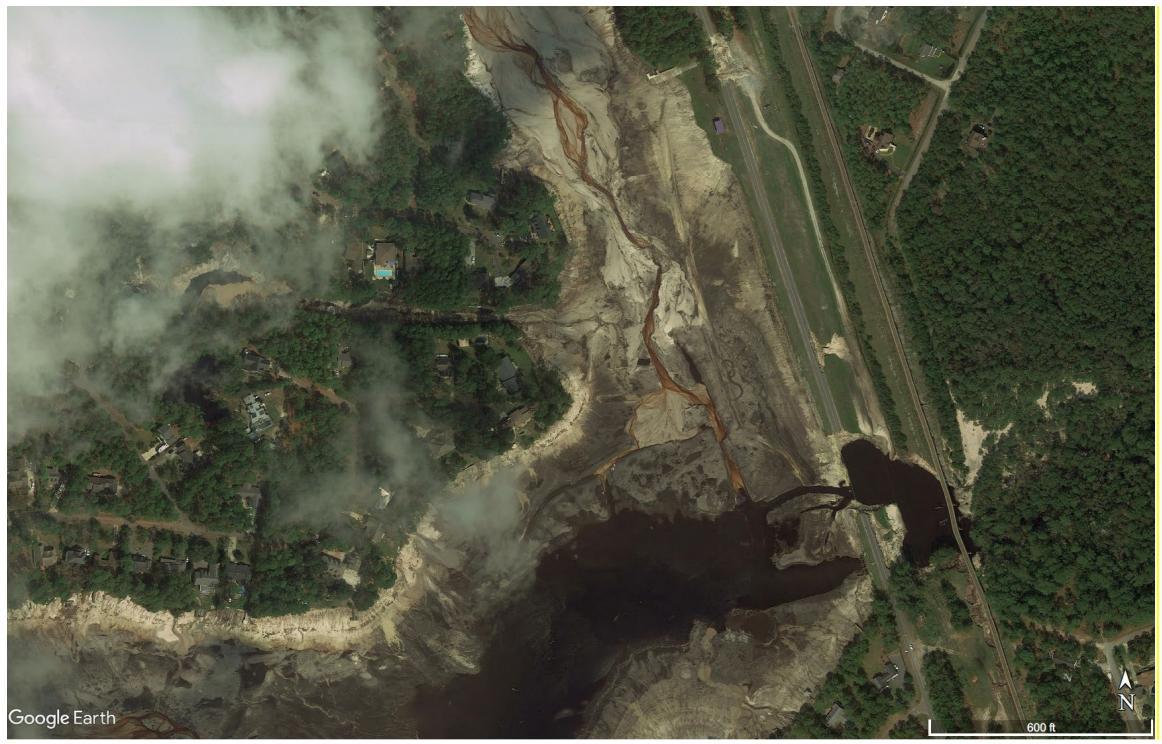
The breach of the dam occurred near the mid-length point of the dam and was about 200 ft wide (Fig. 4.2.1-3). We saw evidence of overtopping in the form of erosion along downstream face at multiple locations. We also observed sand deposits on the downstream slope and toe. Because there were no indications of piping on the upstream face, and no sinkholes, voids or settlements, we expect that the sand was breach erosion material left by backwater flows. We were told by a resident that on Saturday, September 15, 2018, around 11:15 p.m., the dam started to overtop and that it failed around 11:30 p.m.

Fig. 4.2.1-3 – Post-failure aerial photograph (Google Earth September 19, 2018, 34.046 N, 78.037 W)

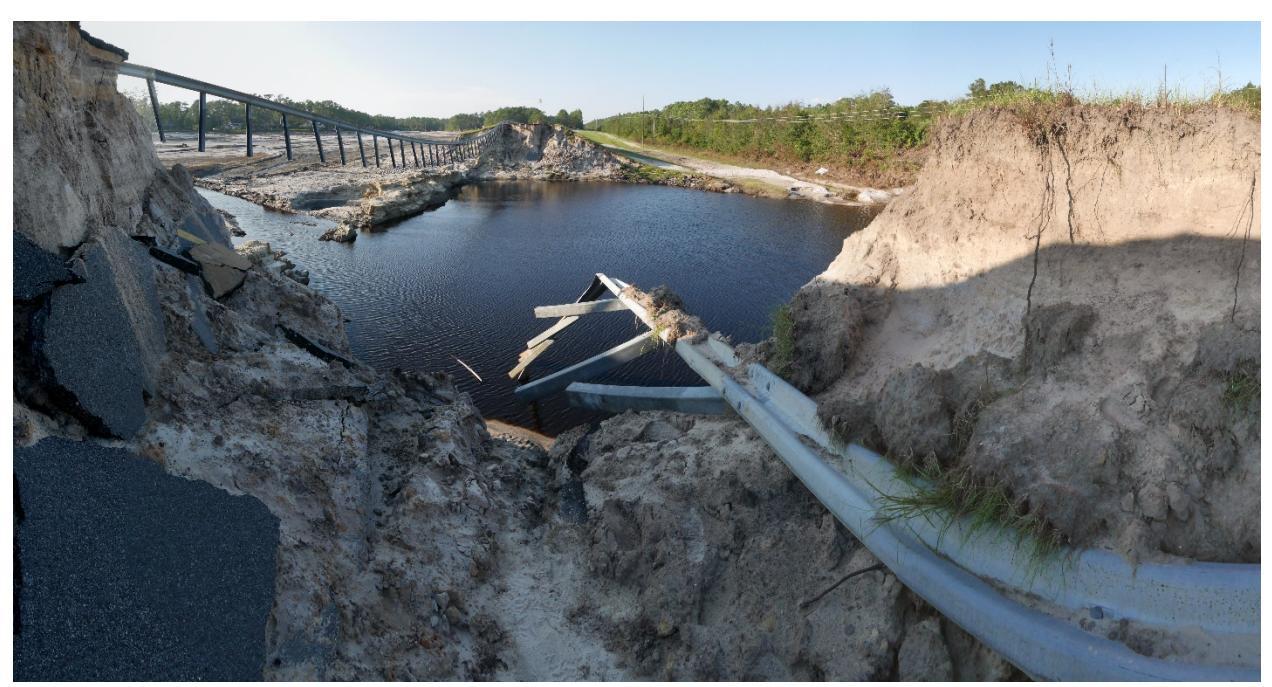
Fig. 4.2.1-5 – Breach from right side (September 26, 2018, 34.0465 N, 78.0373 W)

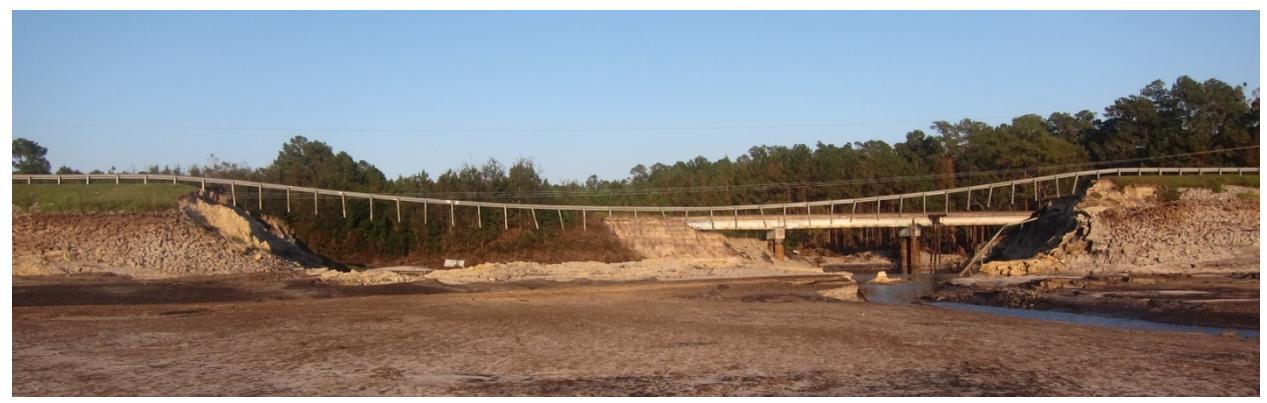
Fig. 4.2.1-6 – Looking to breach from empty reservoir (September 26, 2018, 34.0469 N, 78.0395 W)

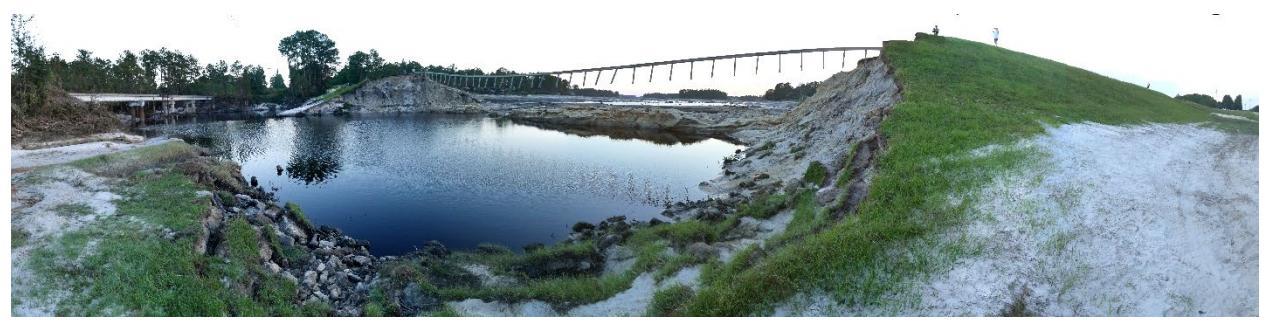
Fig. 4.2.1-7 – Looking to breach from downstream (September 26, 2018, 34.0473 N, 78.0373 W)

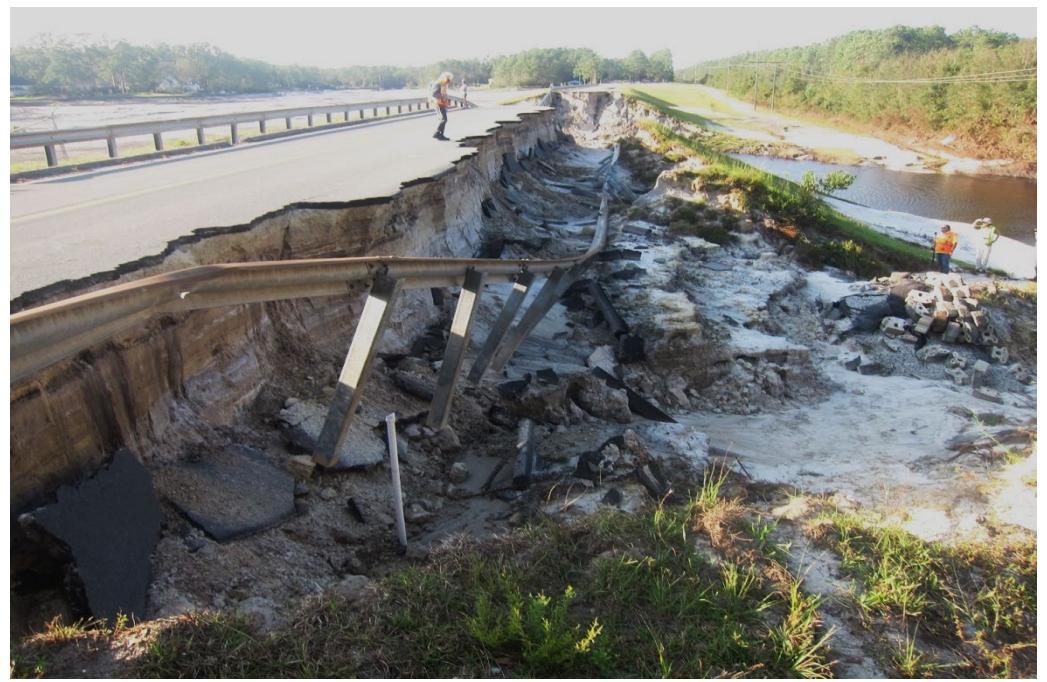
Fig. 4.2.1-8 – Downstream right slope erosion, looking across to left abutment (September 26, 2018, 34.0462 N, 78.0371 W)

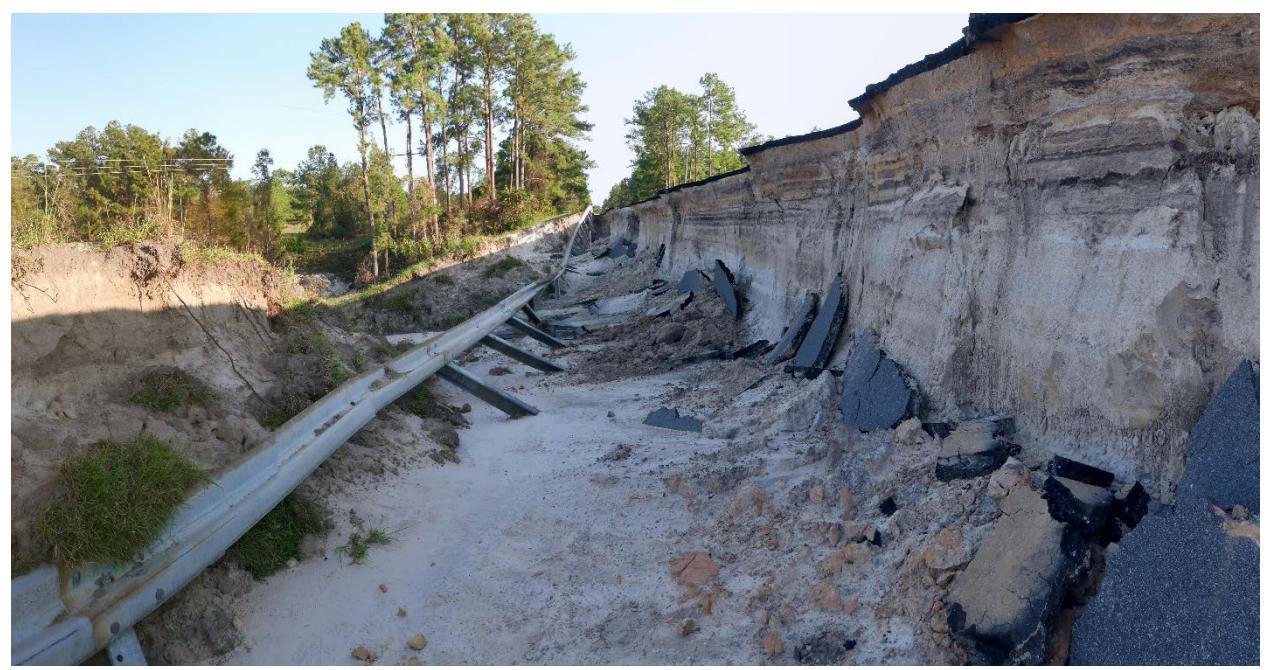
Fig. 4.2.1-9 – Downstream right slope erosion, facing right abutment (September 26, 2018, 34.0466 N, 78.0373 W)

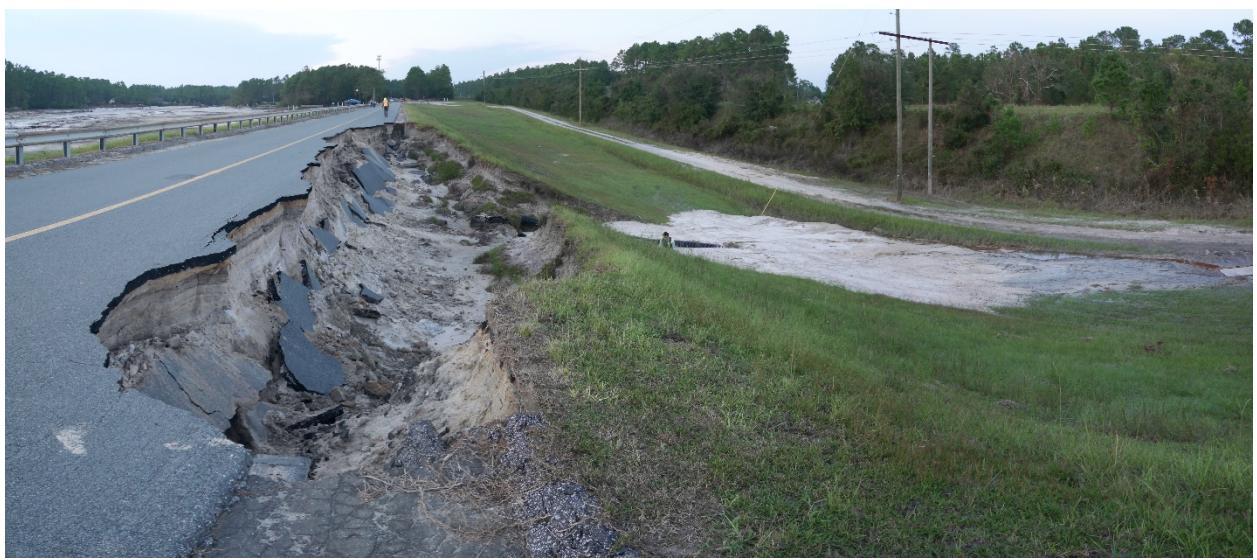
Fig. 4.2.1-10 – Downstream left slope erosion, facing left abutment (September 26, 2018, 34.0476 N, 78.0378 W)

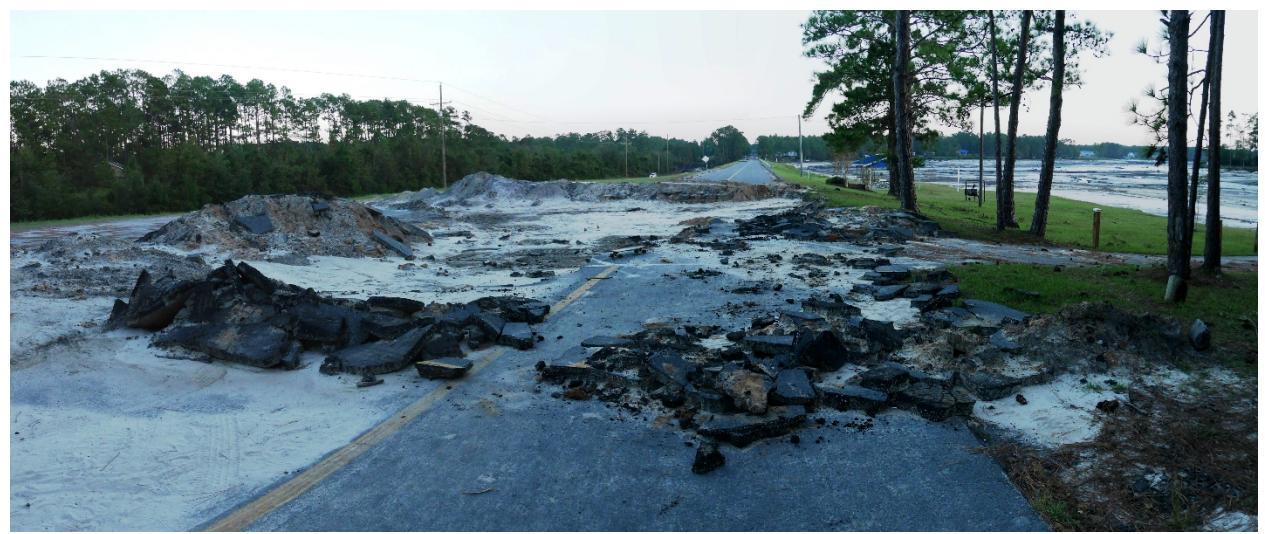
At the left abutment, we observed that the crest road had been excavated and that small berms had been constructed on either side of the excavated road in a failed attempt by municipal workers to save the dam by constructing an emergency spillway that would divert the overtopping flows (Fig. 4.2.1-11).

Fig. 4.2.1-11 – Attempted emergency spillway construction, left abutment (September 26, 2018, 34.0500 N, 78.0388 W)

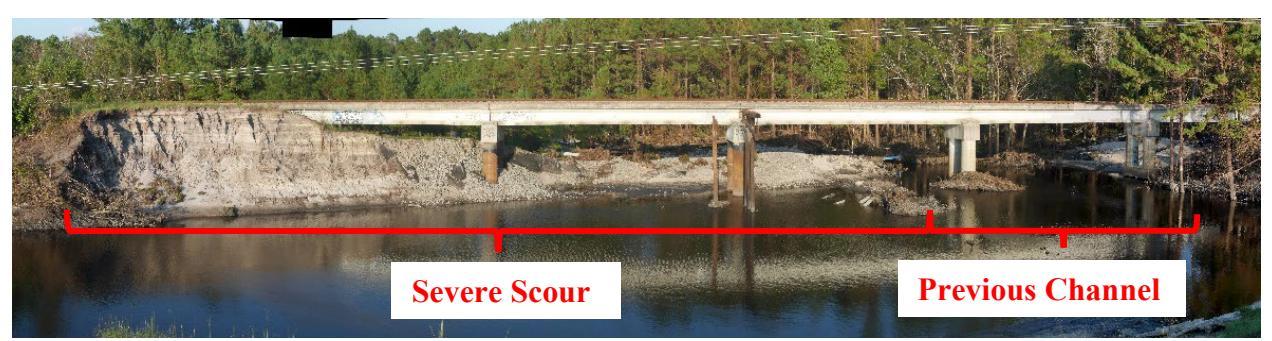
Fig. 4.2.1-12 – Rail line to Military Ocean Terminal Sunny Point showing scour due to breach flows (September 26, 2018, 34.0465 N, 78.0374 W)

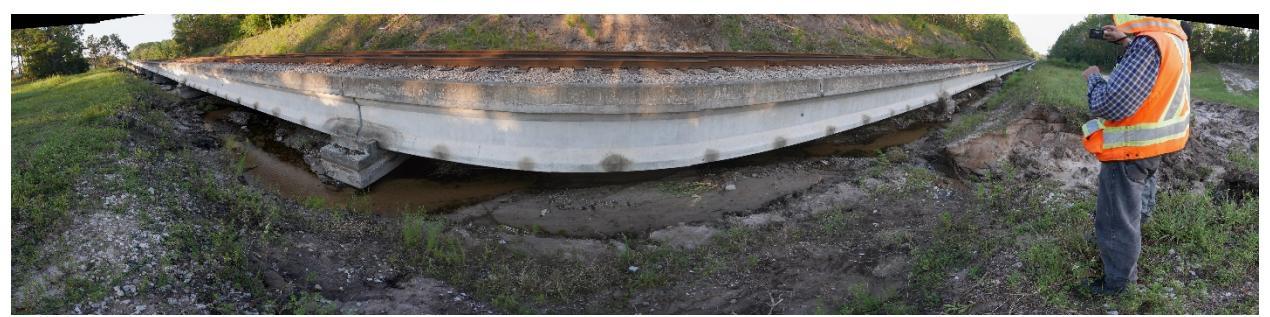
Fig. 4.2.1-13 – Scour along rail line to Military Ocean Terminal Sunny Point about 250 ft from channel on right abutment, likely due to abutment overtopping (September 26, 2018, 34.0457 N, 78.0363 W)

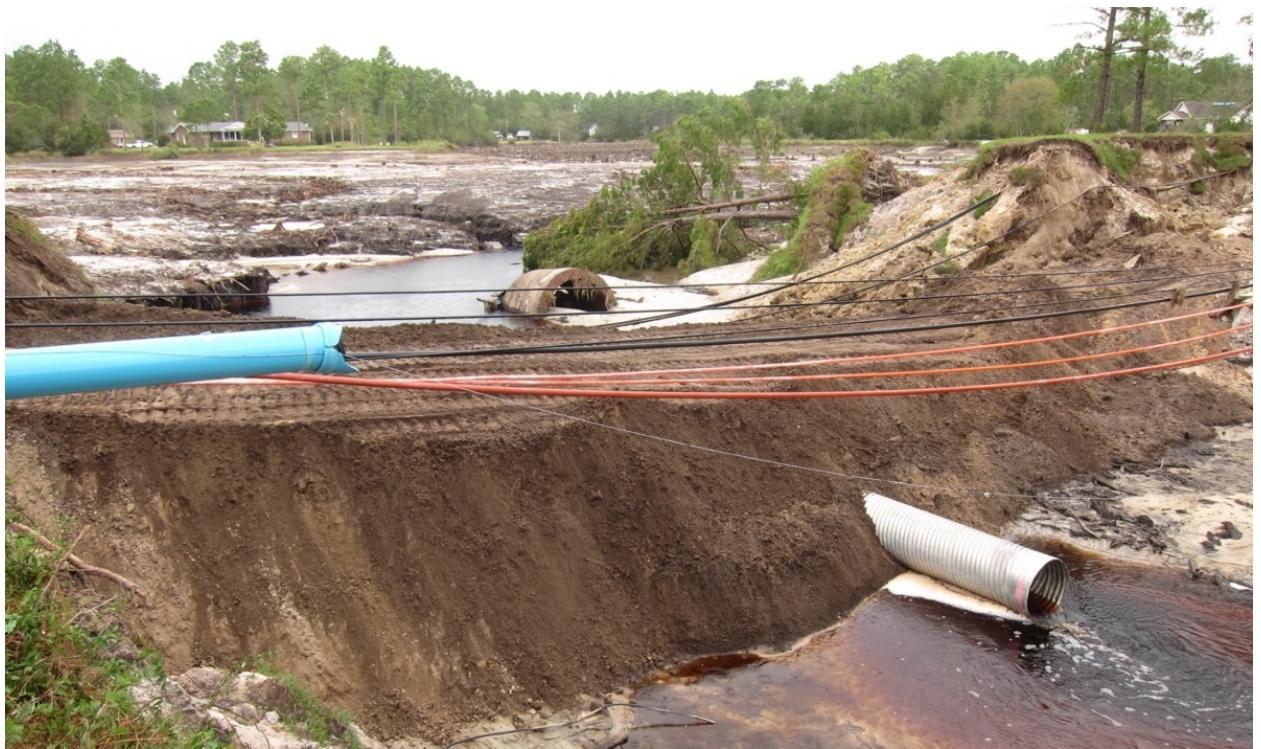
The breach occurred at the location of the low-level pipe (Figs. 4.2.2-1, -2, -3). We observed indications of overtopping and toe cutting downstream of dam at multiple locations. NC DEQ informed us that the dam failed after the failure of downstream Boiling Springs Dam. The sudden drawdown of Boiling Springs Lake and the added exposure of the downstream slope to overtopping erosion without the cover of the downstream lake may have contributed to the dam failure.

Fig. 4.2.2-3 – Looking from downstream right abutment to partially filled breach and empty reservoir (September 28, 2018, 34.0334 N, 78.0635 W)

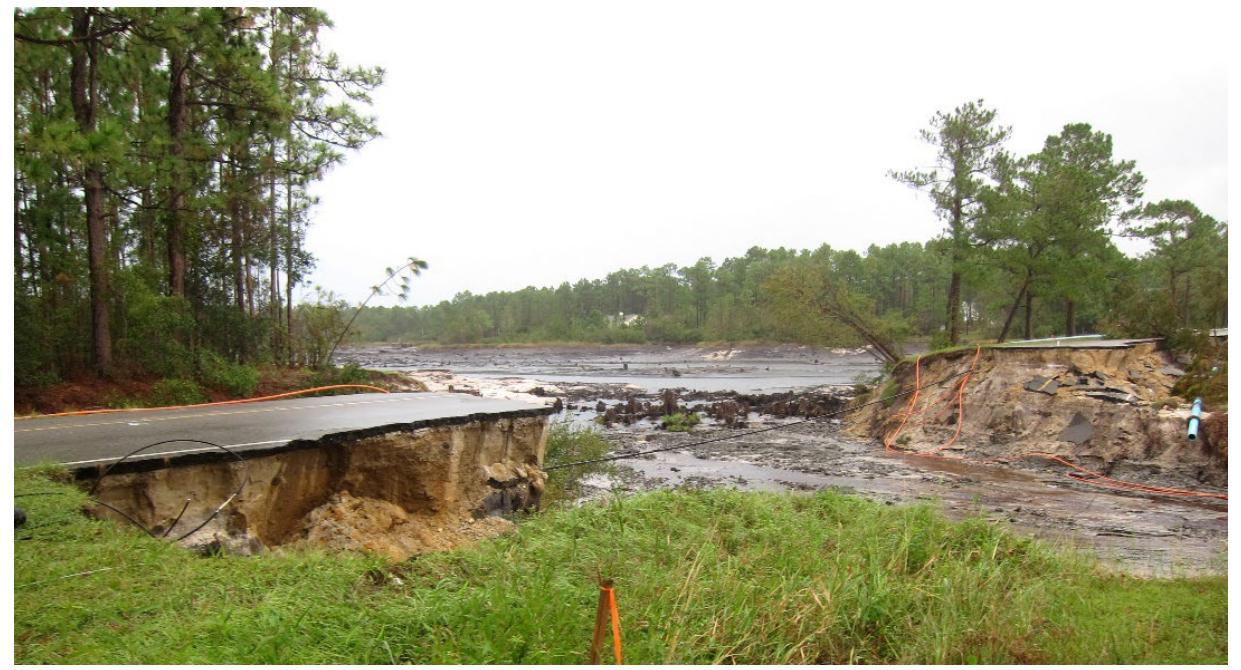
In addition to the breach near the right abutment (Figs. 4.2.3-1, -2), we observed indications of severe overtopping erosion and toe cutting near the left abutment (Figs. 4.2.3-3, 4). We also noted the possibility that part of dam toe may have eroded due to drainage pipe discharge.

Fig. 4.2.3-1 – Looking from upstream right abutment to overtopping erosion and empty North Lake reservoir (September 28, 2018, 34.0412 N, 78.0528 W)

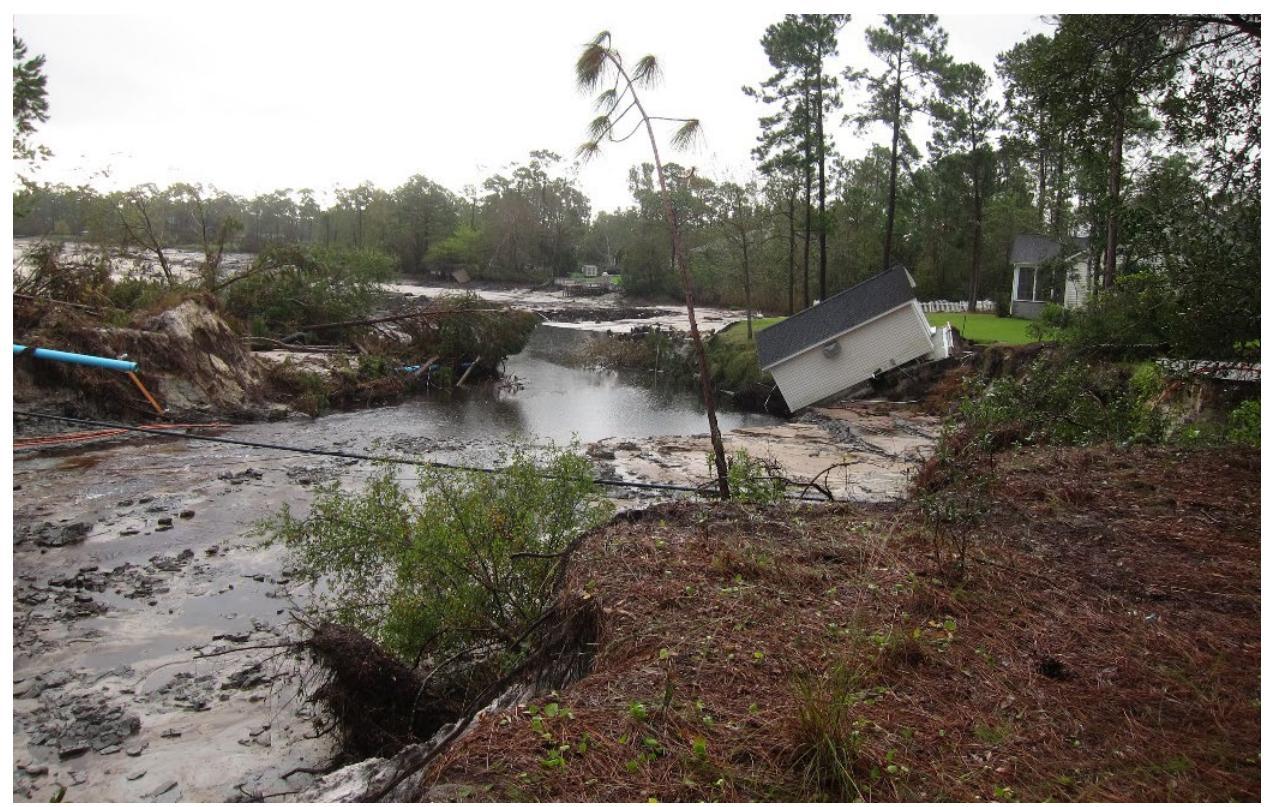
Fig. 4.2.3-2 – Looking downstream from right abutment to breach and erosion downstream (September 28, 2018, 34.0421 N, 78.0530 W)

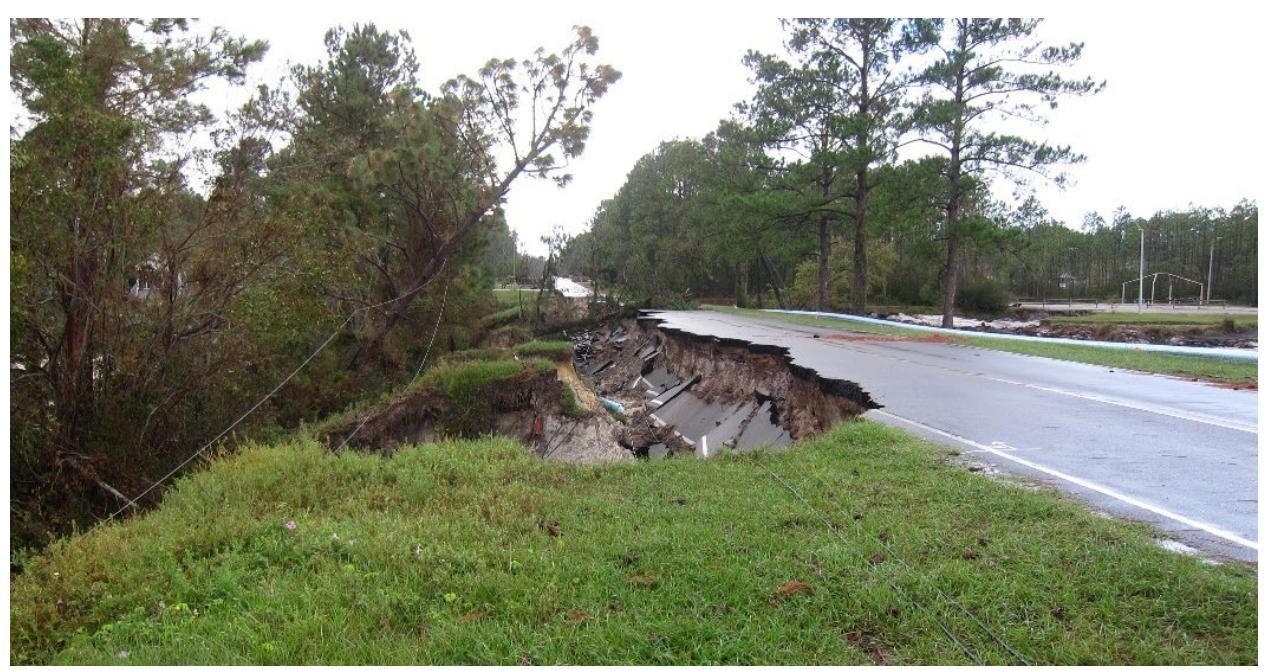
Fig. 4.2.3-3 – Looking from downstream left abutment to overtopping erosion and empty reservoir (September 28, 2018, 34.0430 N, 78.0517 W)

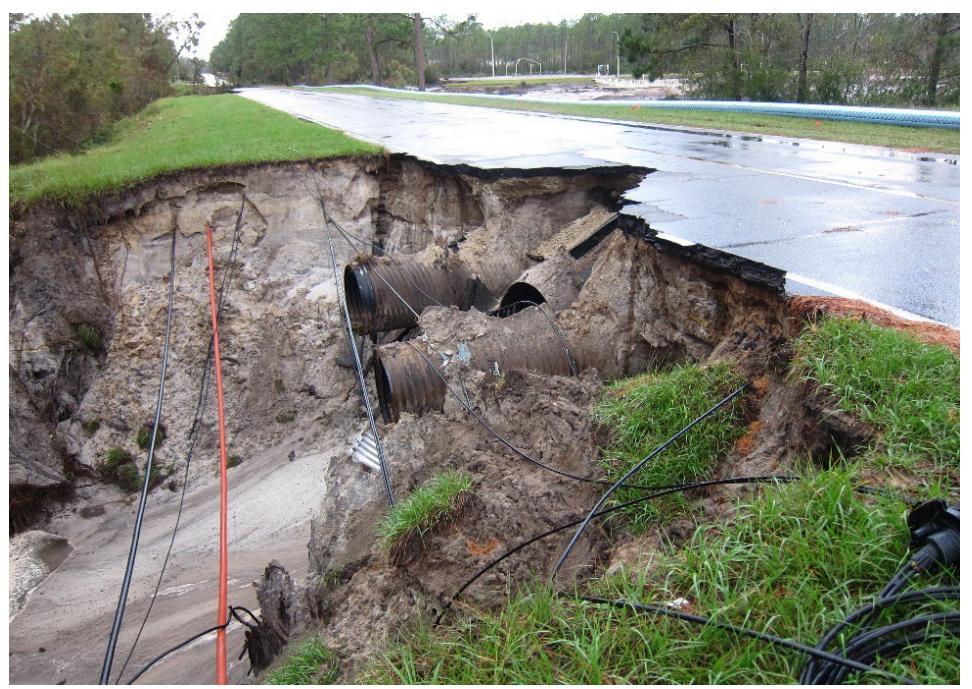
Fig. 4.2.3-4 – Looking from left abutment to overtopping erosion and possible culvert discharge erosion (September 28, 2018, 34.0430 N, 78.0517 W)

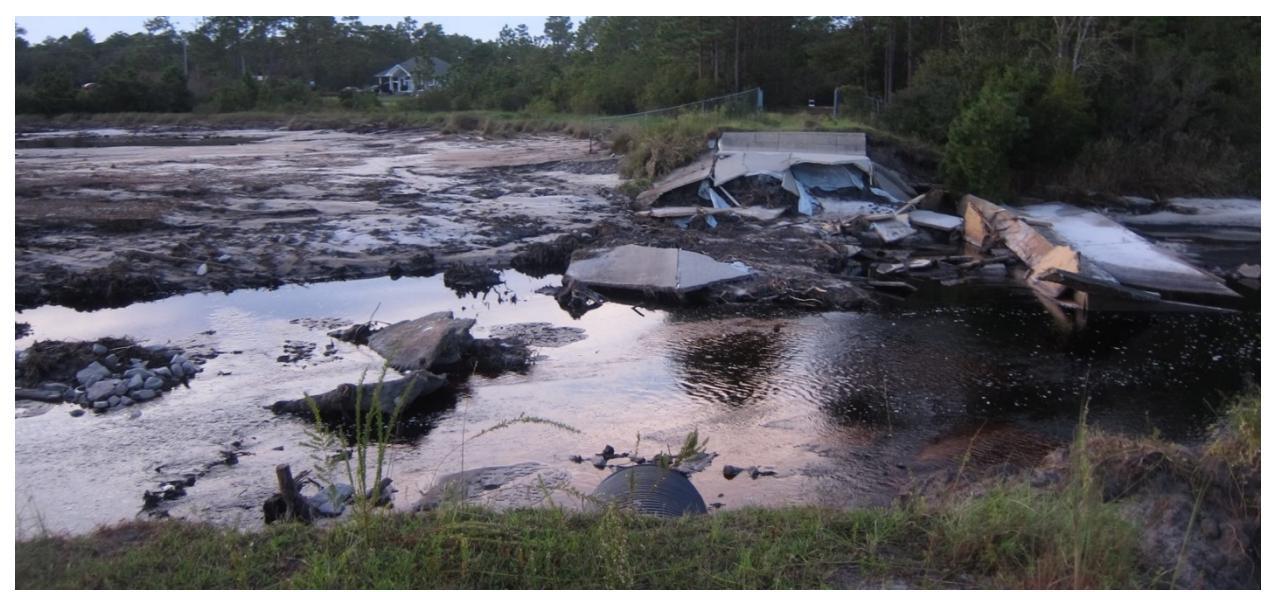
Fig. 4.2.4-1 shows the Google Earth aerial photograph of the dam breach taken on September 19, 2018. Fig. 4.2.4-2 shows the breach from ground level at the time of our visit. Figs 4.2.4-3 and - 4 show evidence that the dam was overtopped, which, in possible combination with the rapid drawdown of Boiling Spring Lake downstream and lack of backwater to mitigate erosion, was a likely cause of the breach.

Fig. 4.2.4-2 – Middle Dam breached embankment close to northwest abutment and the concrete culvert structure, looking at left abutment (September 26, 2018, 43.024 N, 78.066 W)

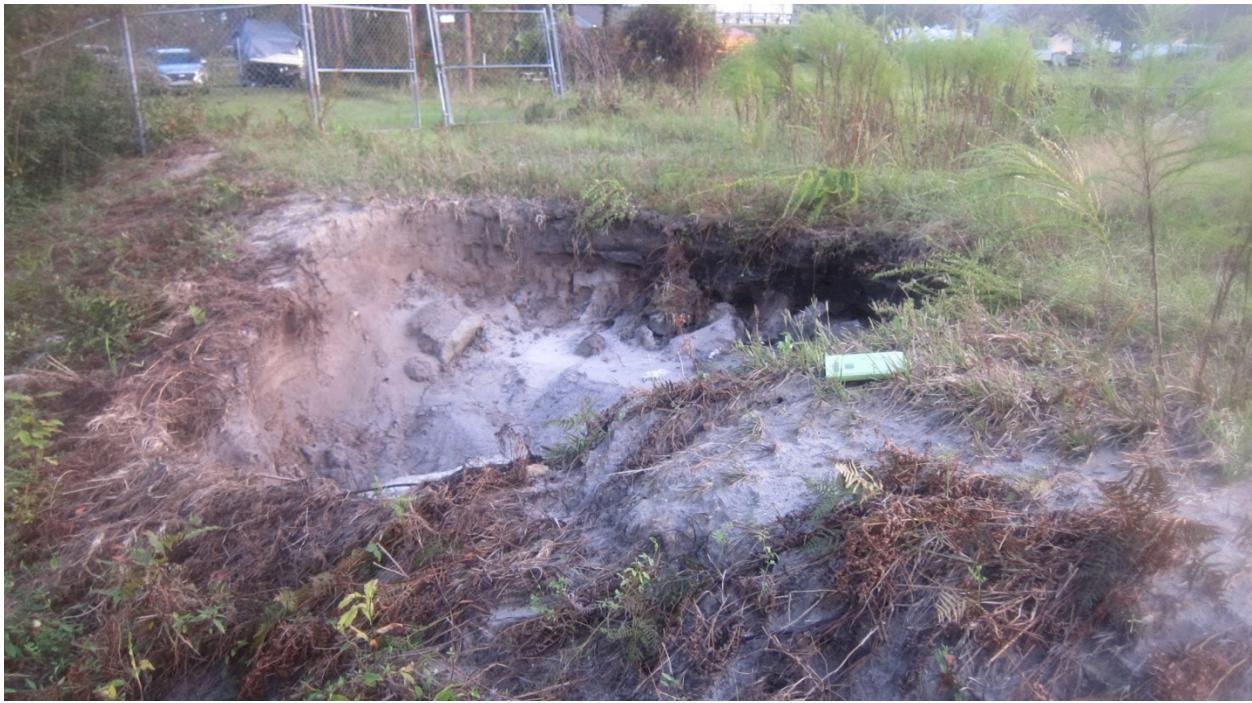
Fig. 4.2.4-3 – Middle Dam overtopping downstream slope erosion close to right abutment, looking at right abutment (September 26, 2018, 43.024 N, 78.066 W)

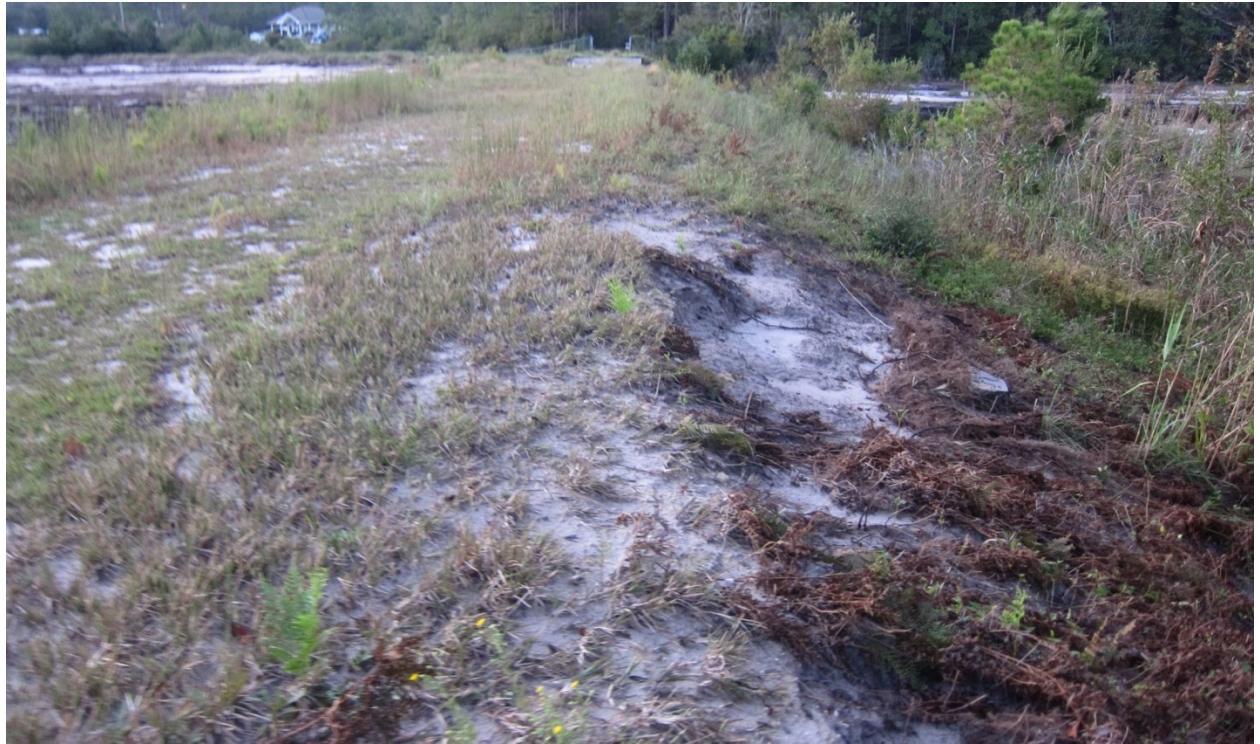
Fig. 4.2.4-4 – Middle Dam overtopping downstream slope erosion of embankment, looking at northwest abutment (September 26, 2018, 43.024 N, 78.066 W)
