#### **Geotechnical Effects of Hurricane Florence**

Geotechnical Extreme Events Reconnaissance (GEER) Association.

GEER Association Report No. GEER-063

April 2019 Revision 1 - June 2019

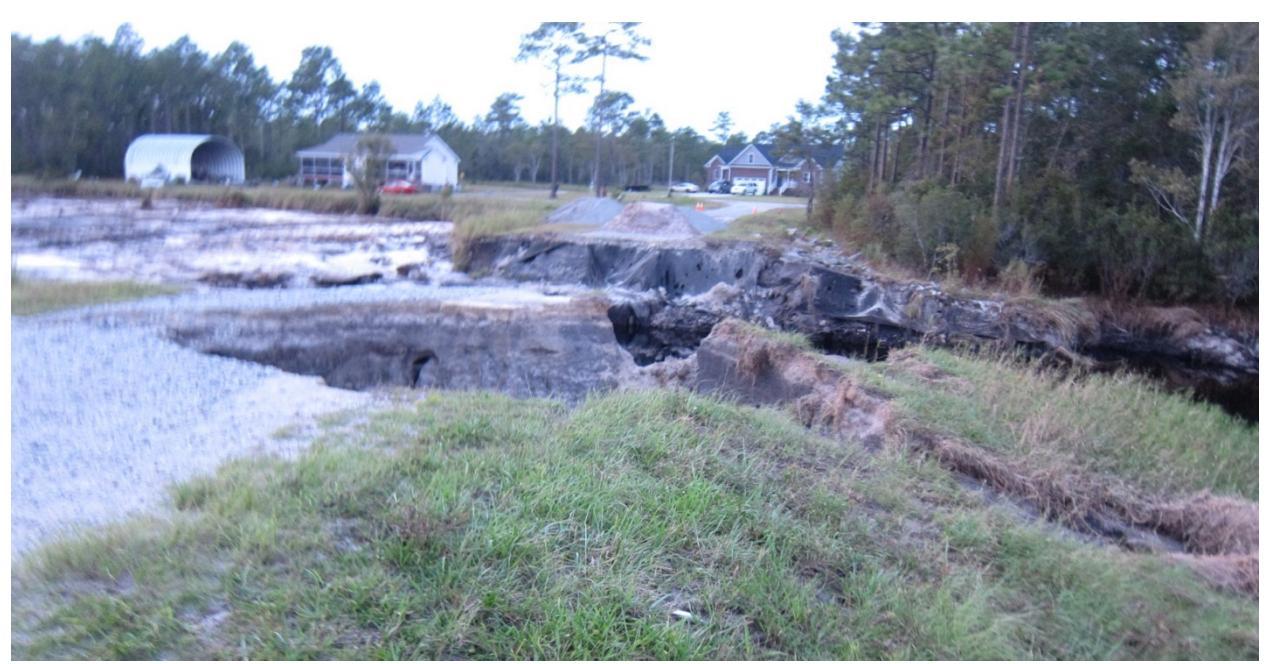
Fig. 4.2.5-1 shows the Google Earth aerial photograph of the dam breach taken on September 19, 2018. Fig. 4.2.5-2 shows the breach from ground level at the time of our visit. Fig 4.2.4-3 shows evidence that the dam was overtopped, which, in possible combination with the rapid drawdown of the Middle Dam impoundment downstream and lack of backwater to mitigate erosion, was a likely cause of the breach.

Fig. 4.2.5-2 – Upper Dam breached embankment looking at northwest abutment (September 26, 2018, 43.022 N, 78.069 W)

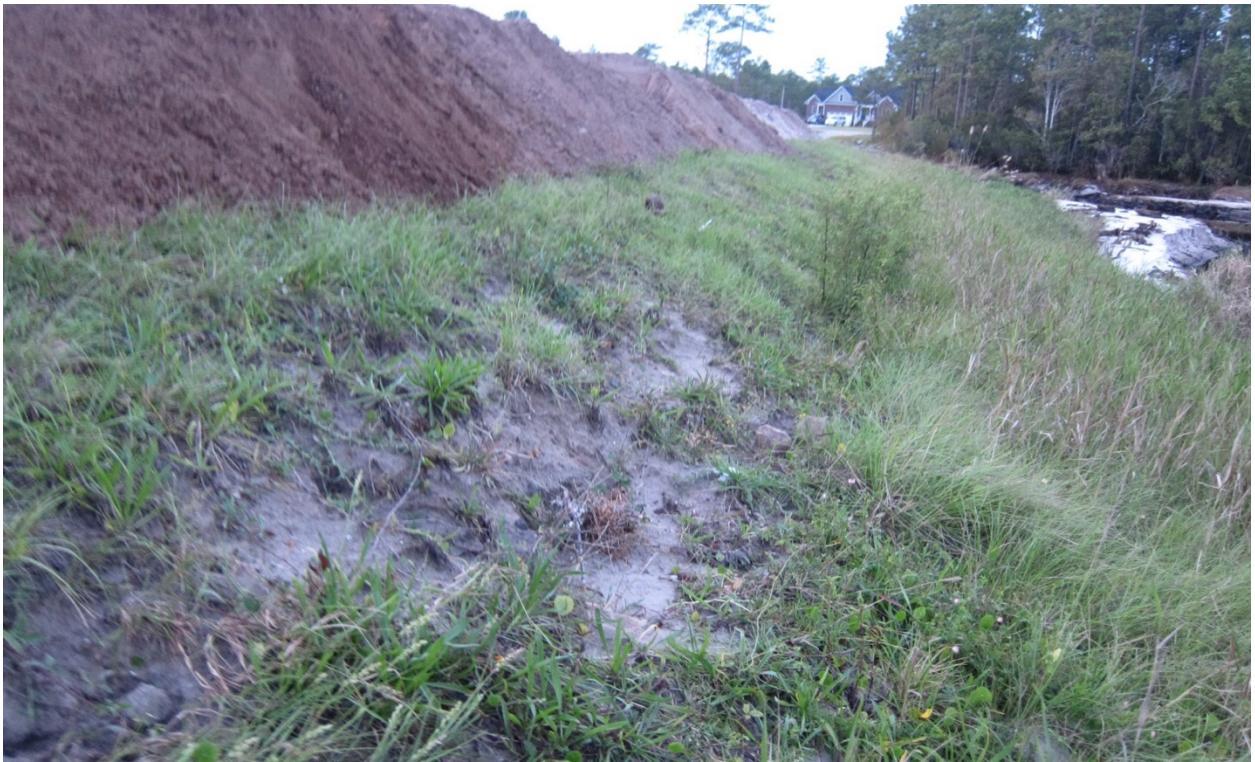
Fig. 4.2.5-3 – Upper Dam overtopping downstream slope erosion and new fill, looking toward northwest abutment (September 26, 2018, 43.022 N, 78.069 W)

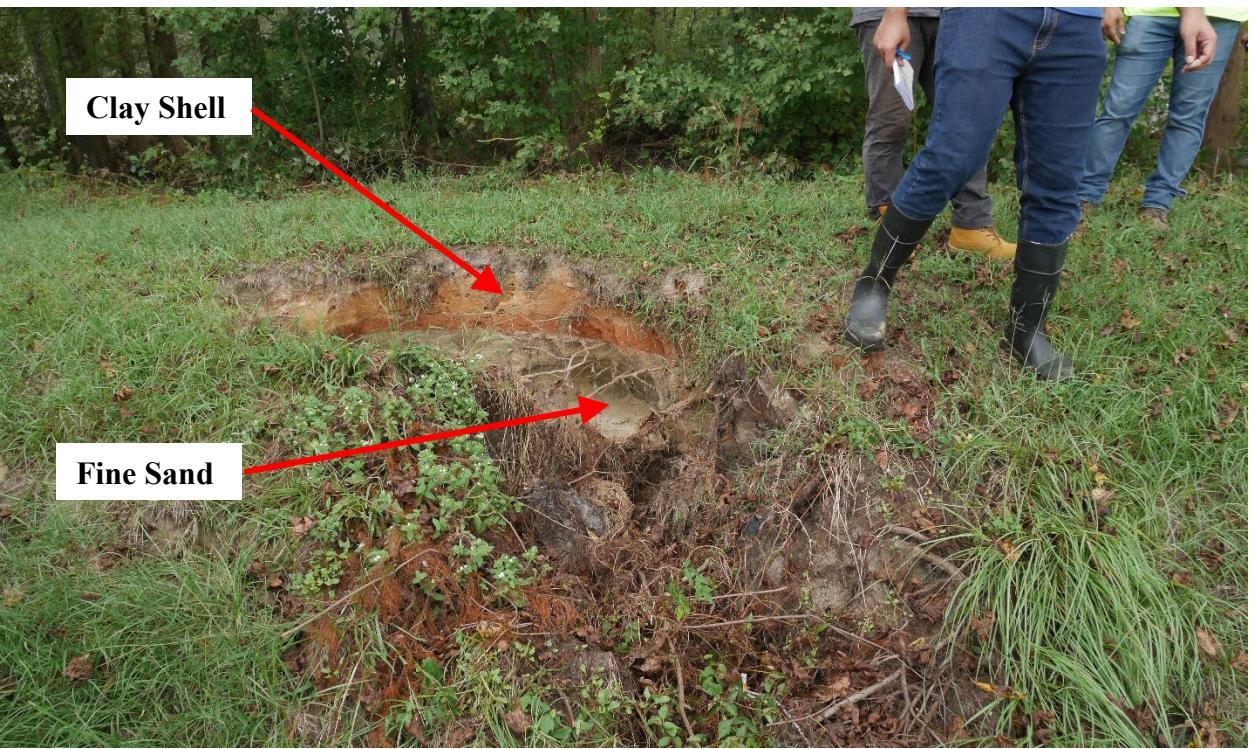
Fig. 4.2.6-3 – Scour near breach at Maxwell Mill Pond Dam showing embankment materials (September 25, 2018, 35.0706 N, 77.7879 W)

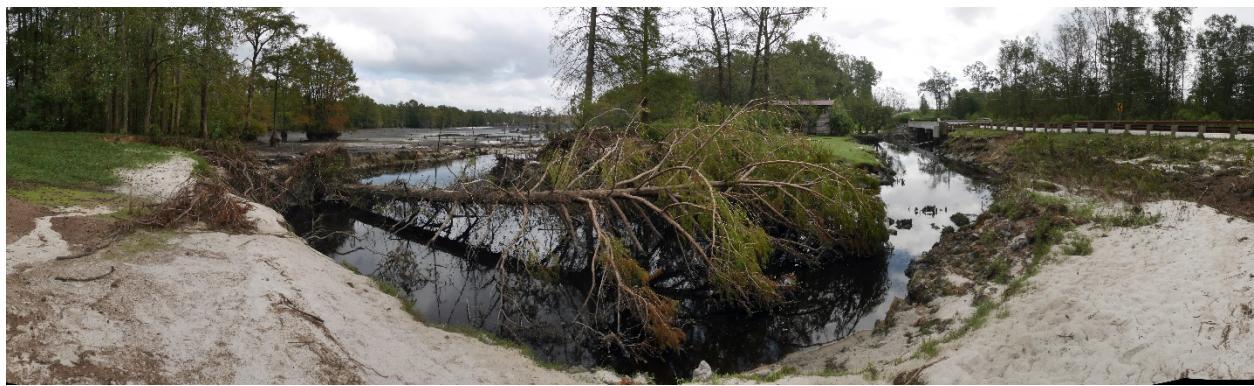
The dam failed during Florence, creating an embankment breach about 100 ft to the left of the spillway (Figs. 4.2.6-4, -5). We observed evidence of overtopping, the most likely cause of the failure. The breach and overtopping flows severely scoured the upstream side of Maxwell Mill Road along the right abutment of the mill outlet bridge (Figs. 4.2.6-6). Spillway and overtopping flows also overwhelmed the spillway outlet and channel and severely scoured along both sides of the outlet structure (Figs. 4.2.6-7, -8).

Fig. 4.2.6-4 – Maxwell Mill Pond Dam breach from downstream (September 25, 2018, 35.0706 N, 77.7880 W)

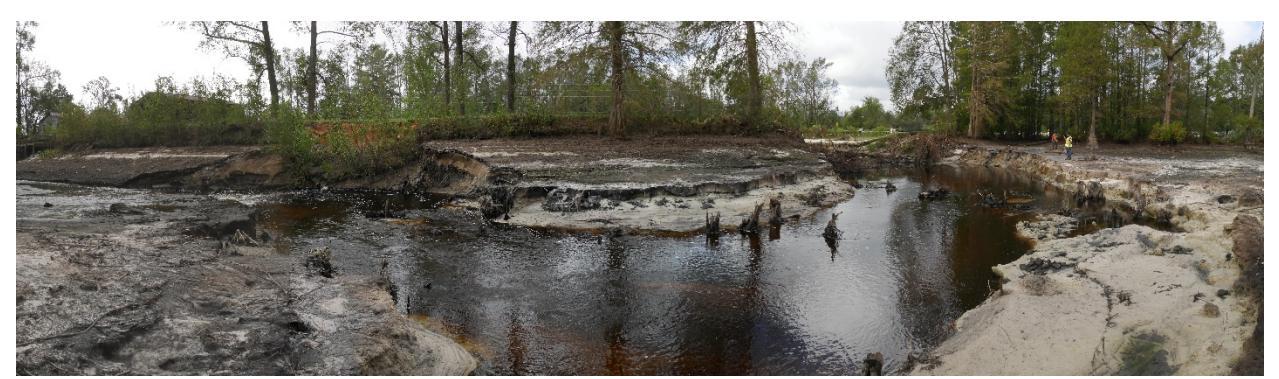
Fig. 4.2.6-5 – Maxwell Mill Pond Dam breach from upstream (September 25, 2018, 35.0706 N, 77.7875 W)

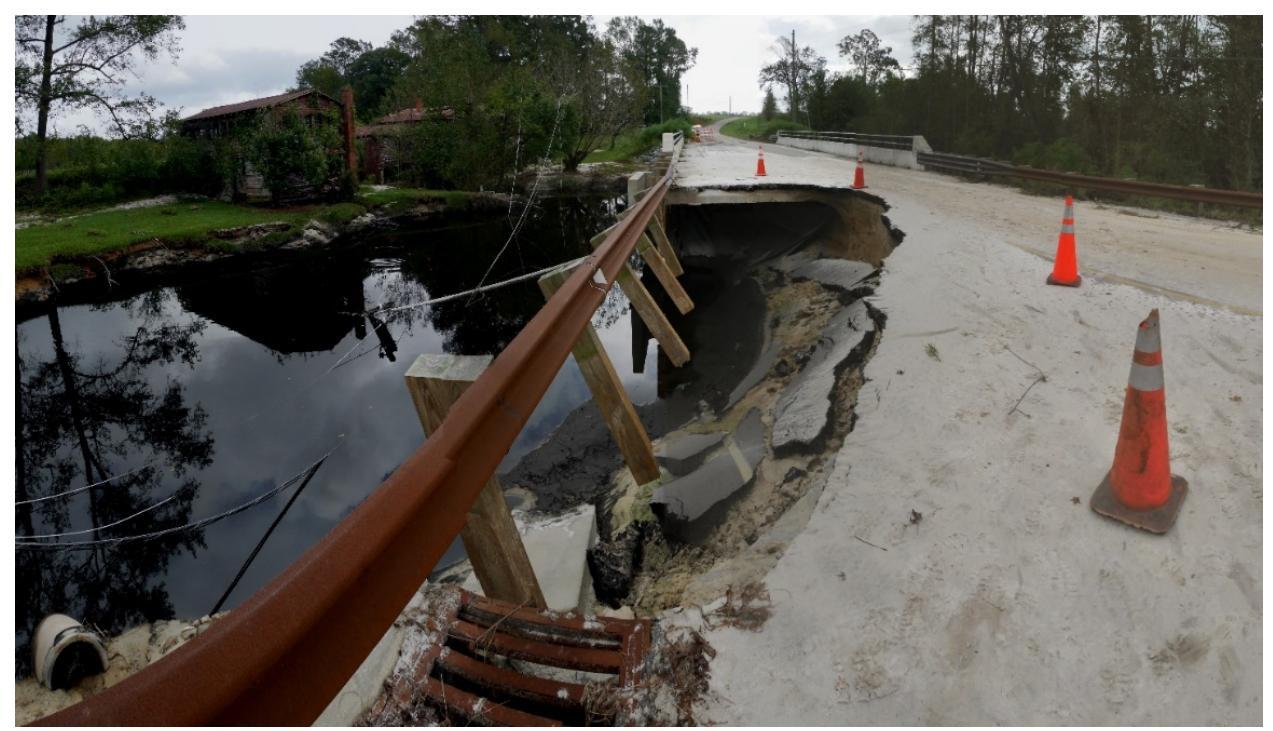
Fig. 4.2.6-6 – Maxwell Mill Road scour at outlet channel bridge abutment (September 25, 2018, 35.0701 N, 77.7876 W)

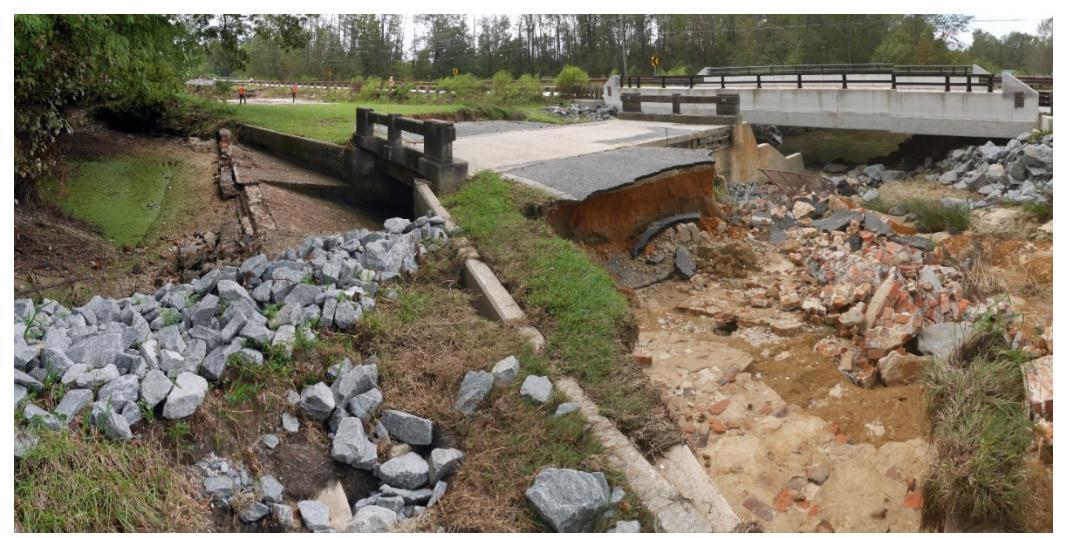
Fig. 4.2.6-7 – Maxwell Mill Pond Dam spillway from upstream (September 25, 2018, 35.0708 N, 77.7882 W)

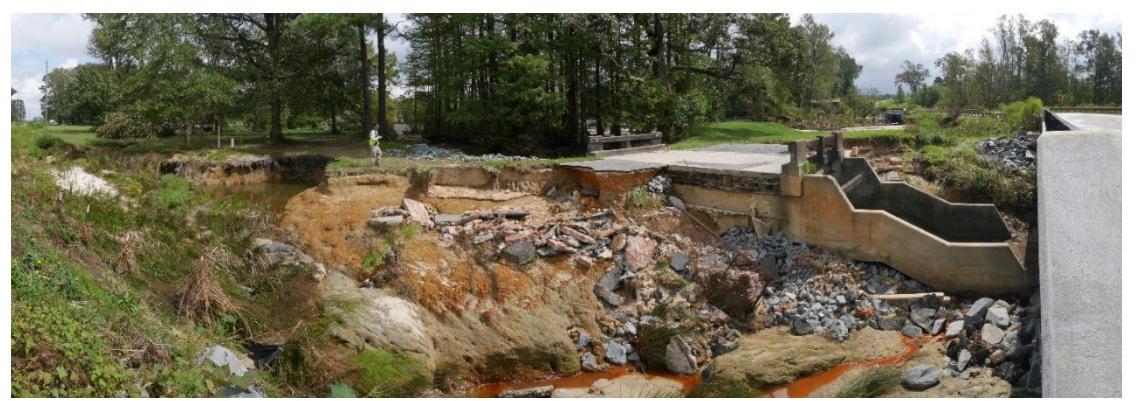
Fig. 4.2.6-8 – Maxwell Mill Pond Dam spillway from downstream (September 25, 2018, 35.0708 N, 77.7883 W)

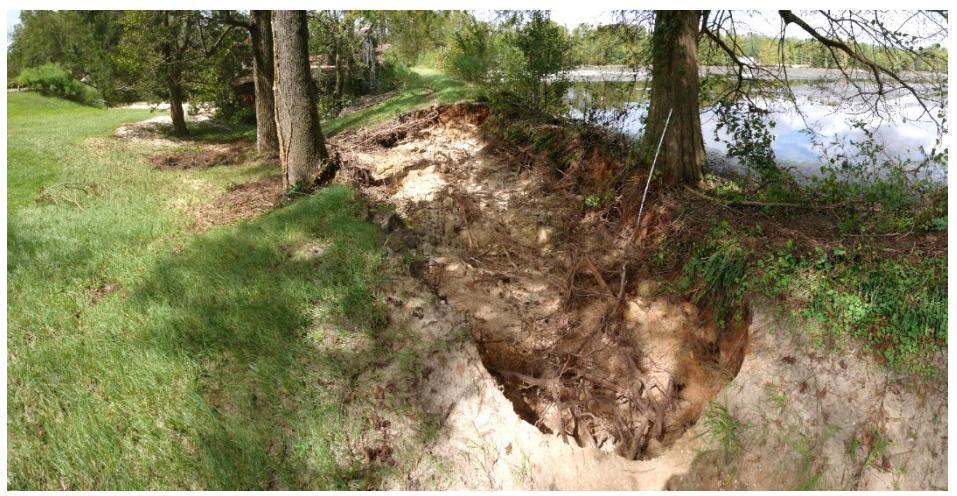
Overtopping flows eroded the embankment at numerous other locations. We observed a pattern of scour on the downstream side of the trees on the embankment, presumably due to the turbulence induced below the trees (Figs. 4.2.6-9). Felled trees were also noted in the dam breach. While tree roots were present in all scoured areas and may have provided some hinderance to erosion, in general, it appears that the mature tree growth on the dam was most likely a contributing or accelerating factor to the breach.

Fig. 4.2.6-9 – Maxwell Mill Pond Dam embankment scour near left abutment (September 25, 2018, 35.0700 N, 77.7868 W)

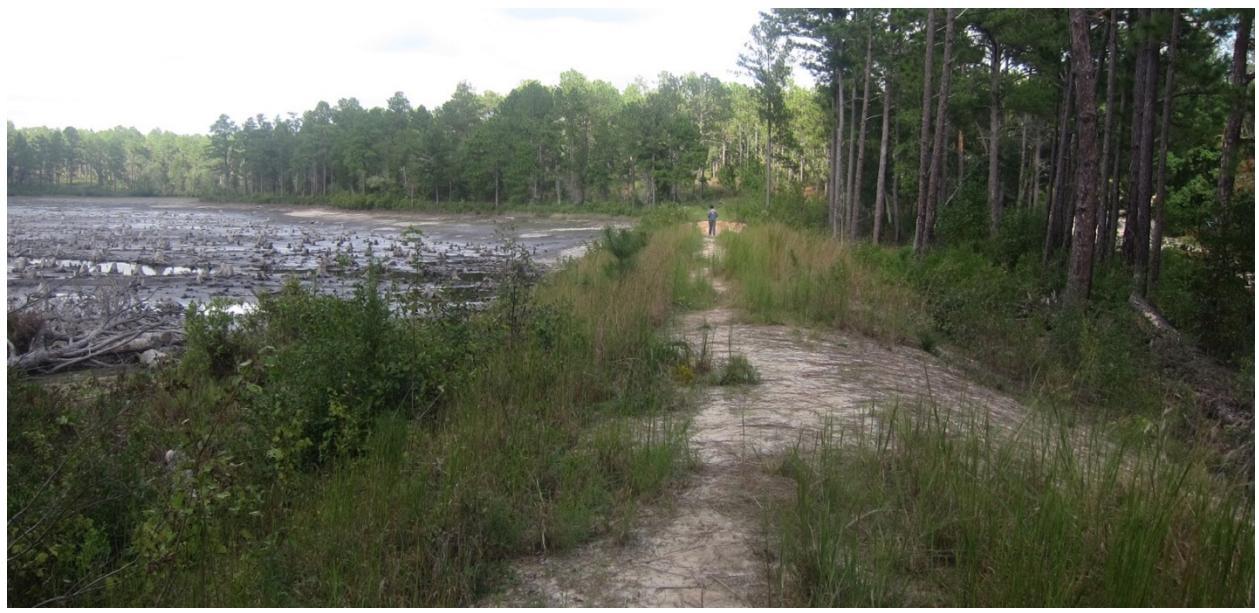
The dam appeared to have been overtopped at multiple locations, and the breach occurred over and on both sides of the outlet structure (Fig. 4.2.7-4, -5, -6, -7). The flood flow also breached the downstream road, resulting in a displaced automobile (Fig. 4.2.7-8).

Fig. 4.2.7-4 – Dam crest, looking toward breach from right abutment with multiple overtopping areas (September 24, 2018, 34.9103 N, 79.5624 W)

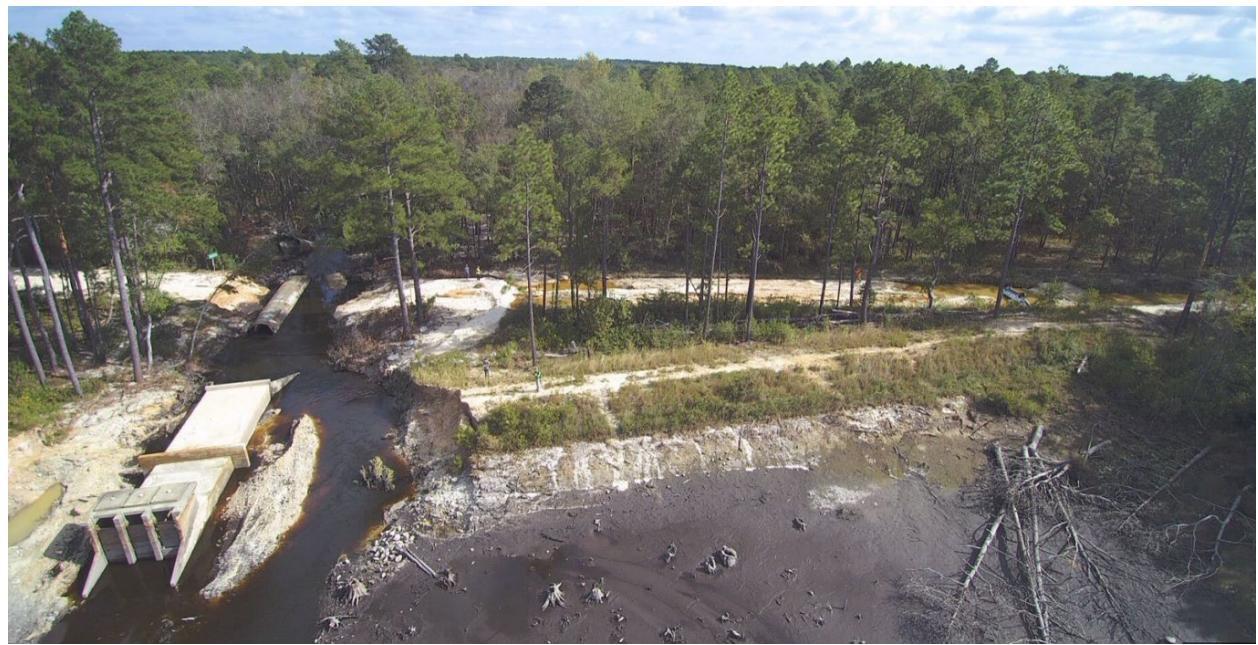
Fig. 4.2.7-5 – Upstream view of dam and breach (September 24, 2018, 34.9106 N, 79.5621 W)

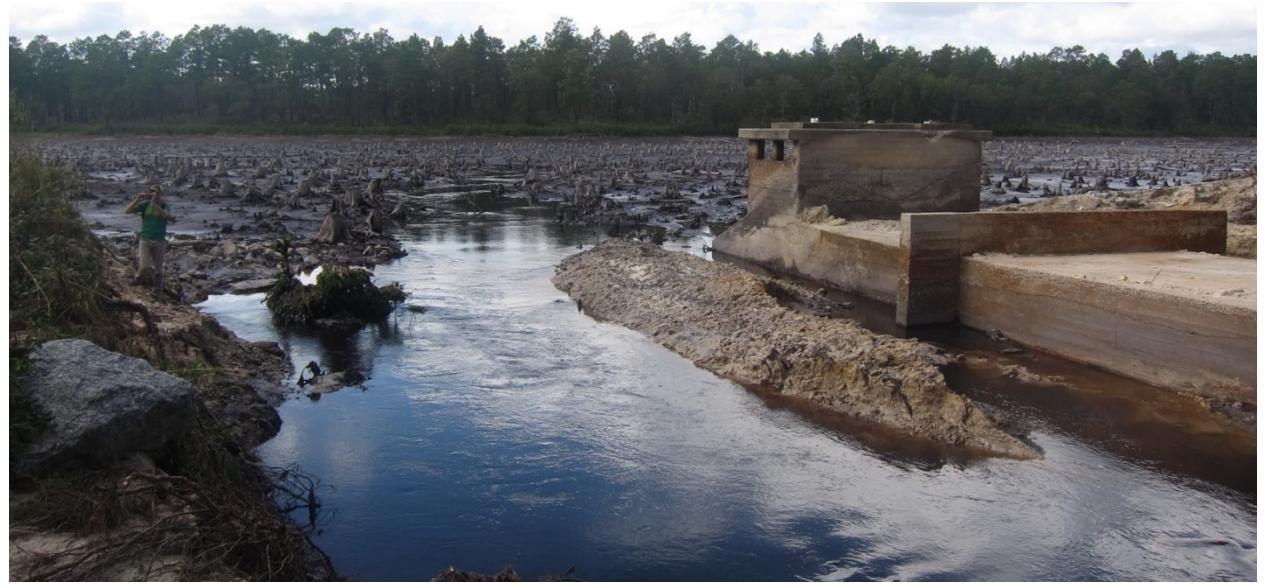
Fig. 4.2.7-6 – Empty reservoir, outlet structure and breach from downstream (September 24, 2018, 34.9106 N, 79.5621 W)

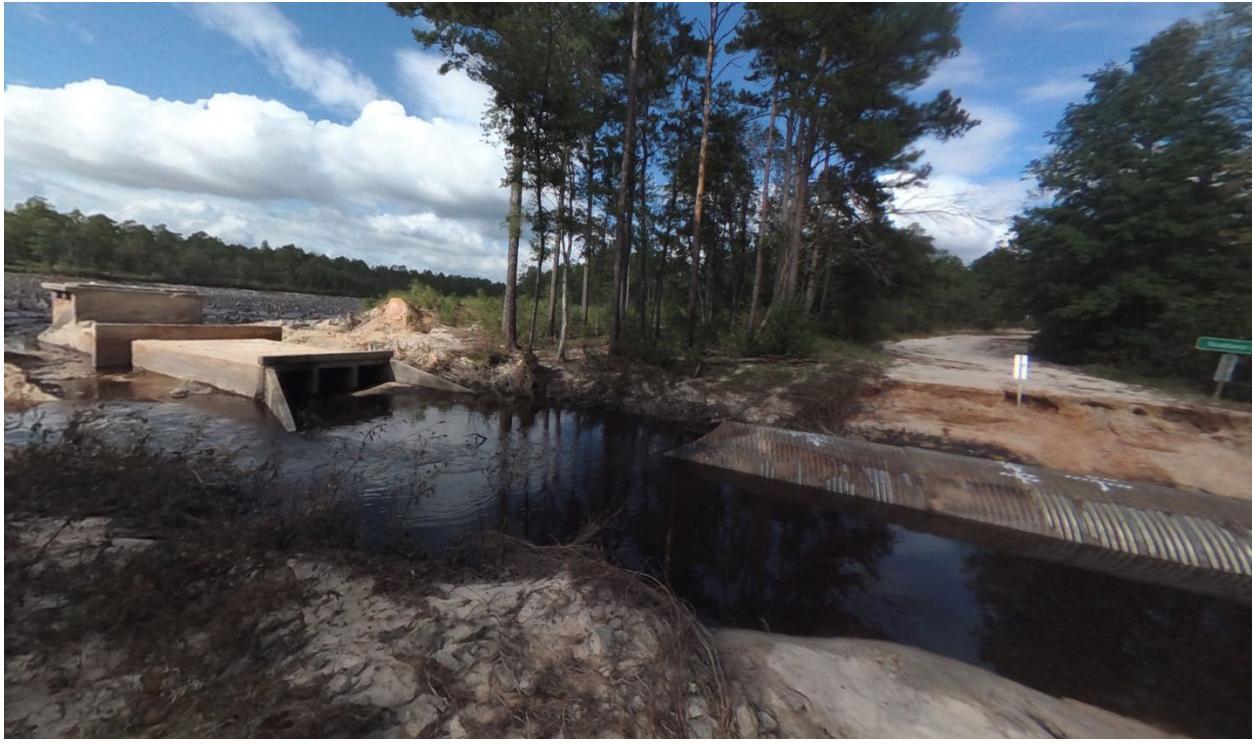
Fig. 4.2.7-7 – Dam breached and destroyed at Gum Swamp Lake (September 24, 2018, 34.9106 N, 79.5621 W)

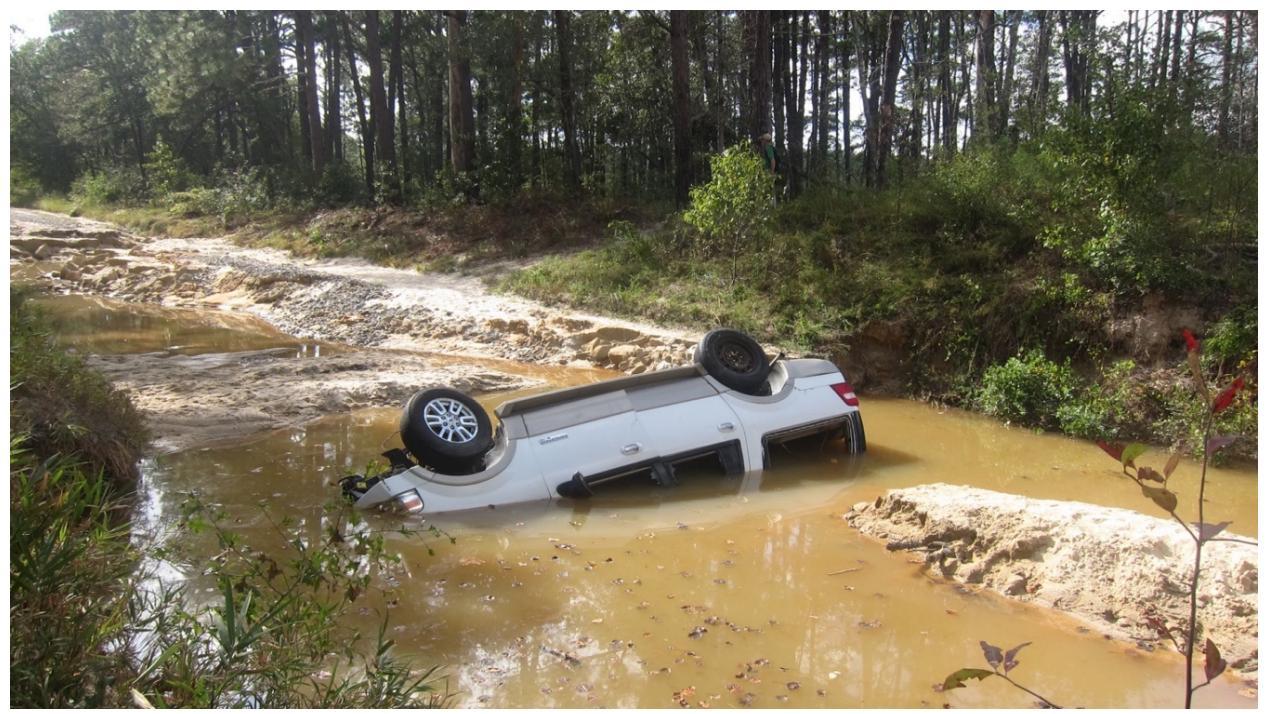
Fig. 4.2.7-8 – Downstream eroded dirt road and flooded / displaced vehicle (September 24, 2018, 34.9104 N, 79.5619 W)

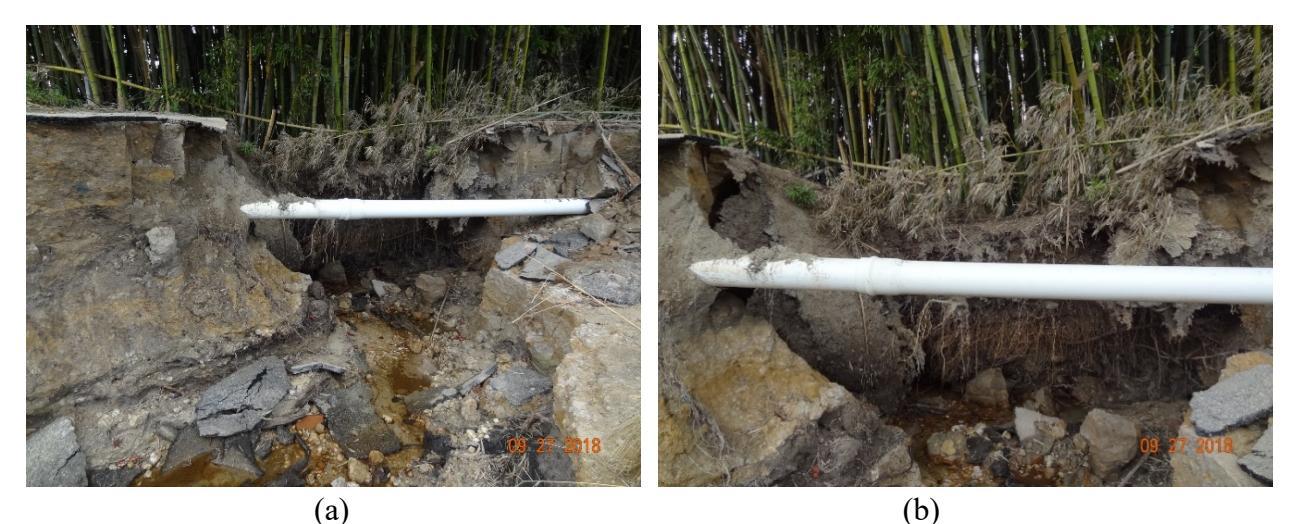
Fig. 4.2.8-7(a) - Water flowing through the breach area and (b) - Close-up of significant settlement of the crest where the dam was breached (September 27, 2018, 34.7509 N, 79.4150 W).

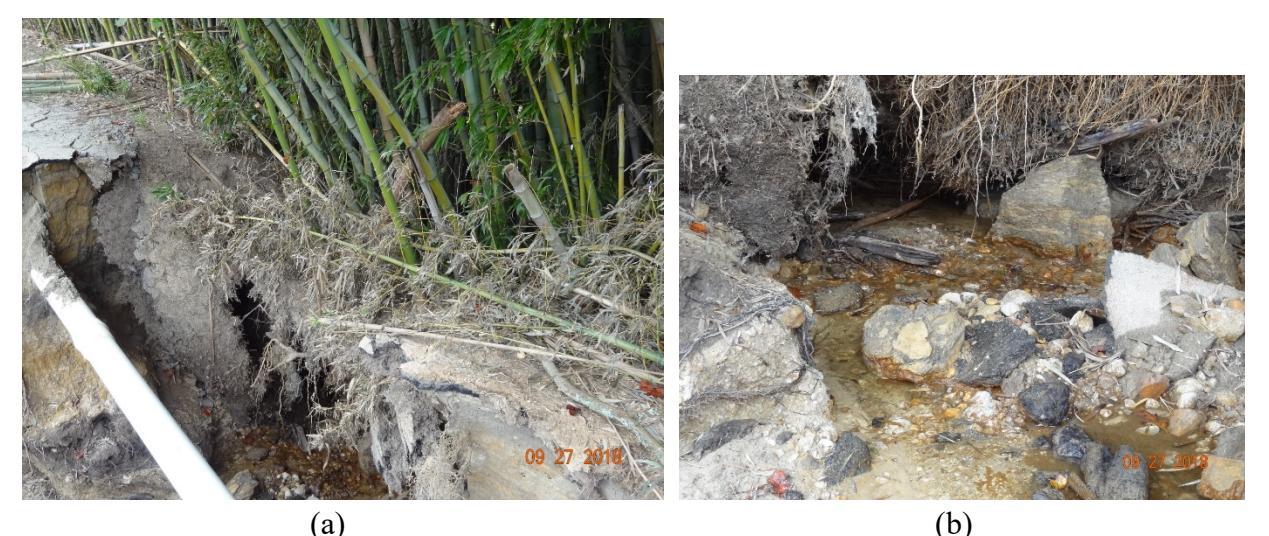
Fig. 4.2.8-8(a) is a closeup of the thick and strong bamboo root mat that supported the remaining portion of the downstream slope. Fig. 4.2.8-8(b) is a closeup of the seepage occurring under the remaining portion of the downstream slope. There was a clear breach from upstream to downstream near the center of this photograph where the water flowed under the root mat. This seepage was observed exiting the downstream slope on the other side of the dam.

Fig. 4.2.8-8(a) - Close-up of significant vegetation and settlement of the downstream slope due to underlying seepage and erosion and (b) - Water flowing through the breach area and under the downstream slope at the base of the dam (September 27, 2018, 34.7509 N, 79.4150 W).

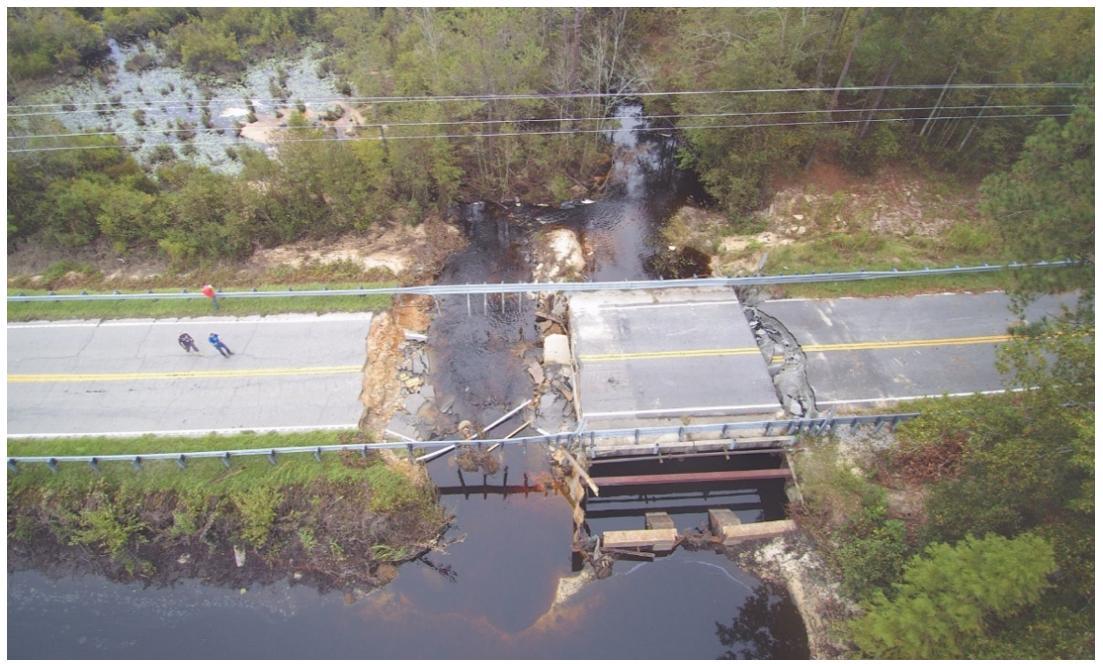
The dam appeared to have overtopped at multiple locations and failed along the side of the box culvert (Figs. 4.2.9-3, -4, -5). A complete breach to the base of the dam was eroded on the left

side of the culvert, and a shallower channel was eroded on the right side of the box culvert. In addition, the overtopping flows eroded the downstream embankment in one location about halfway across the crest road (Figs. 4.2.9-6, -7).

Fig. 4.2.9-3 – Looking from upstream to overtopping erosion and breach next to concrete outlet structure (September 25, 2018, 34.7375 N, 79.7997 W)

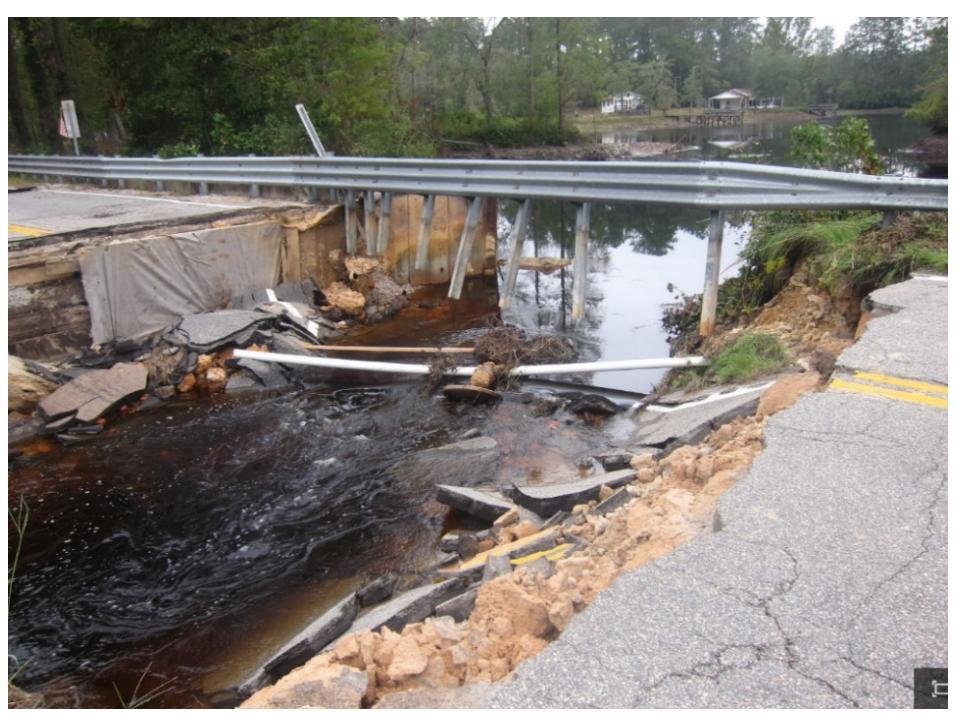
Fig. 4.2.9-4 – Looking from downstream corner of the breach to concrete outlet structure, left abutment (September 25, 2018, 34.7375 N, 79.7997 W)

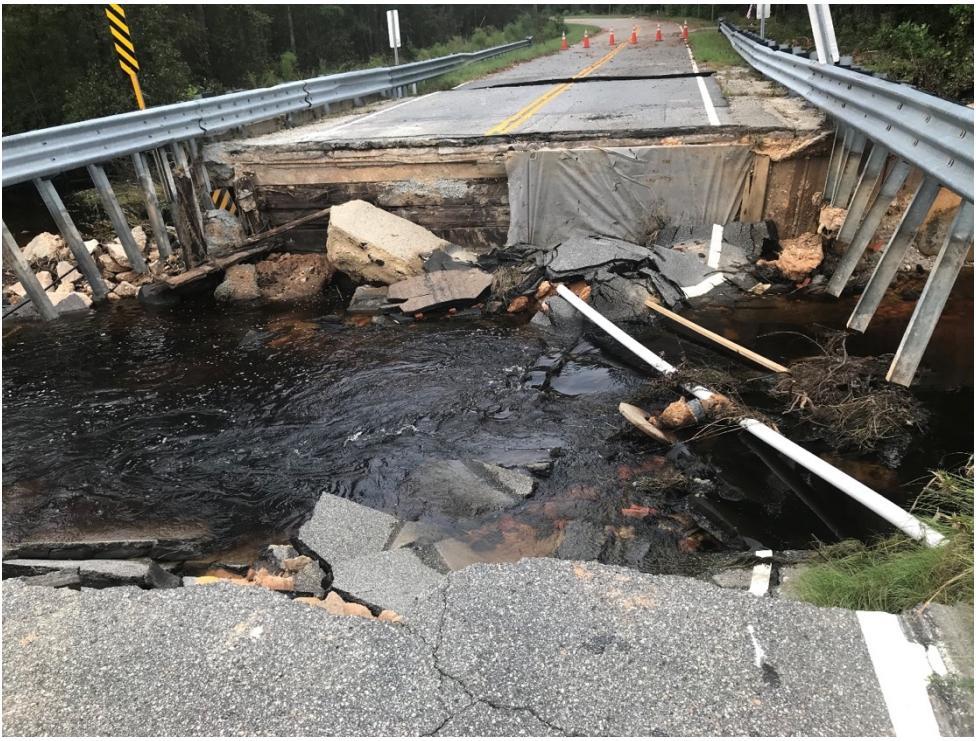
Fig. 4.2.9-5 – Scour of bridge abutment and breach of McMeekin's Pond Dam (September 25, 2018, 34.7375 N, 79.7997 W)

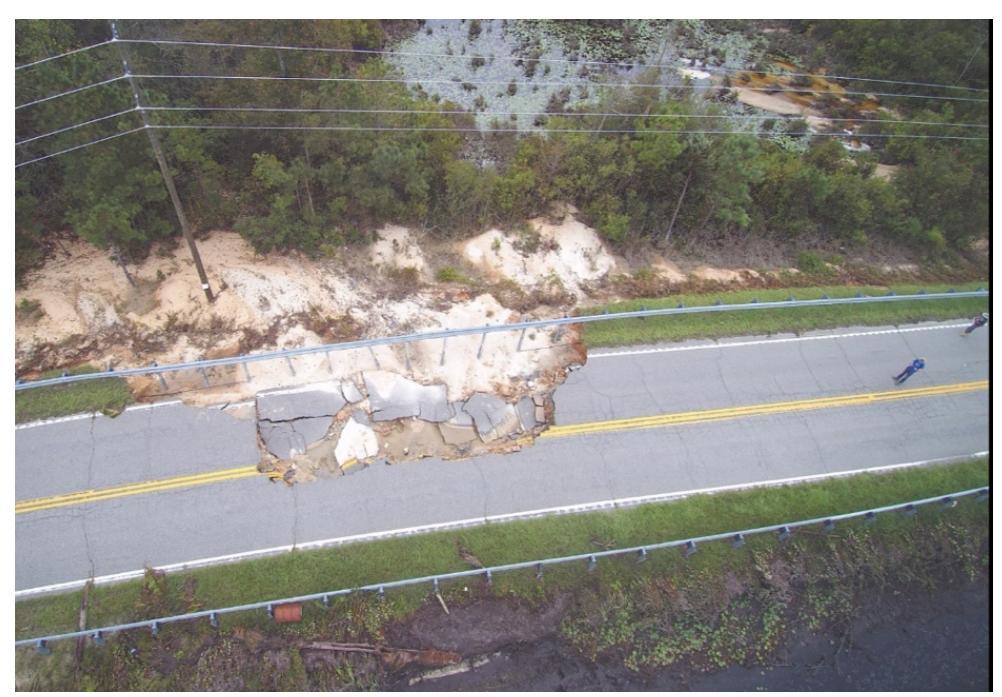
Fig. 4.2.9-6 – Looking from upstream to overtopping erosion, left abutment (September 25, 2018, 34.7376 N, 79.7991 W)

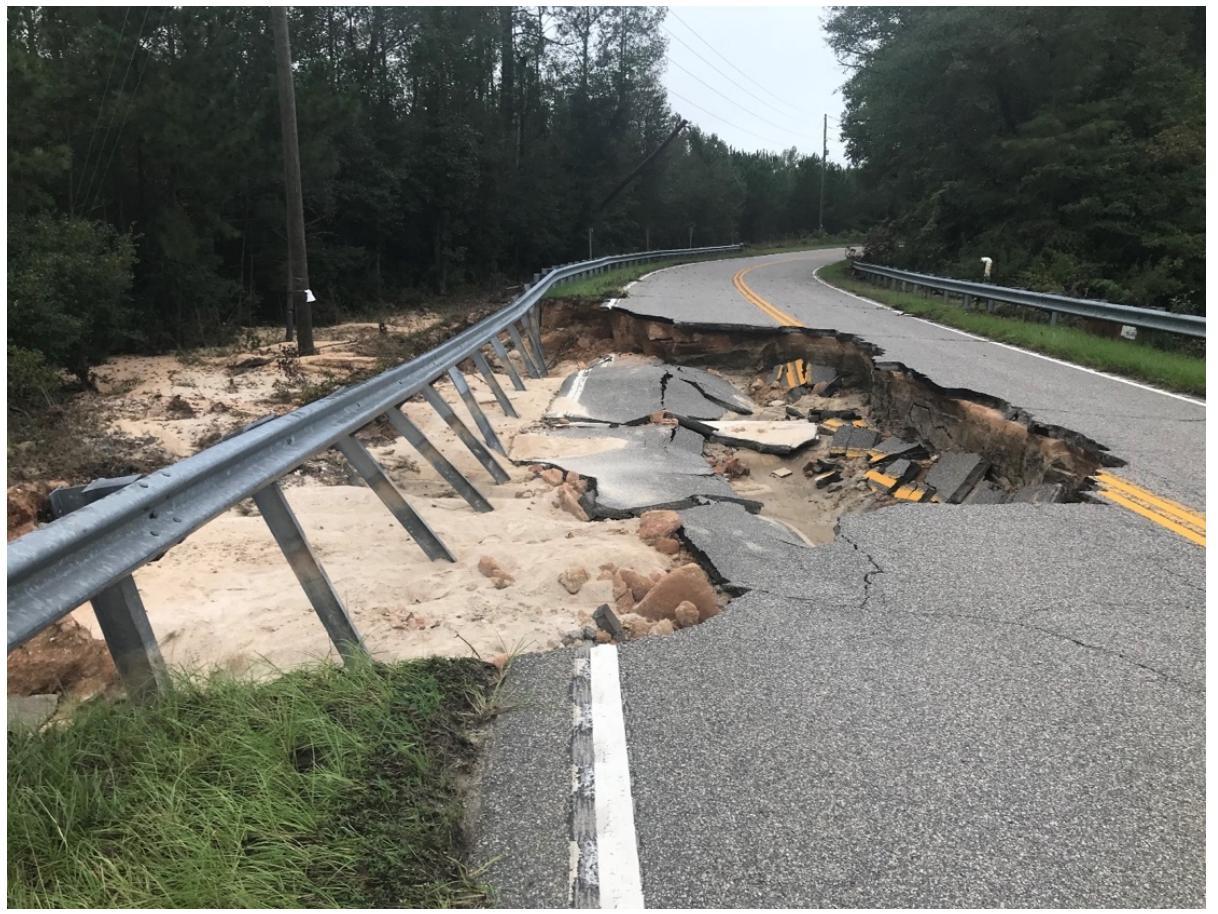
Fig. 4.2.9-7 – Erosion due to overtopping at McMeekin's Pond Dam (September 25, 2018, 34.7376 N, 79.7991 W)

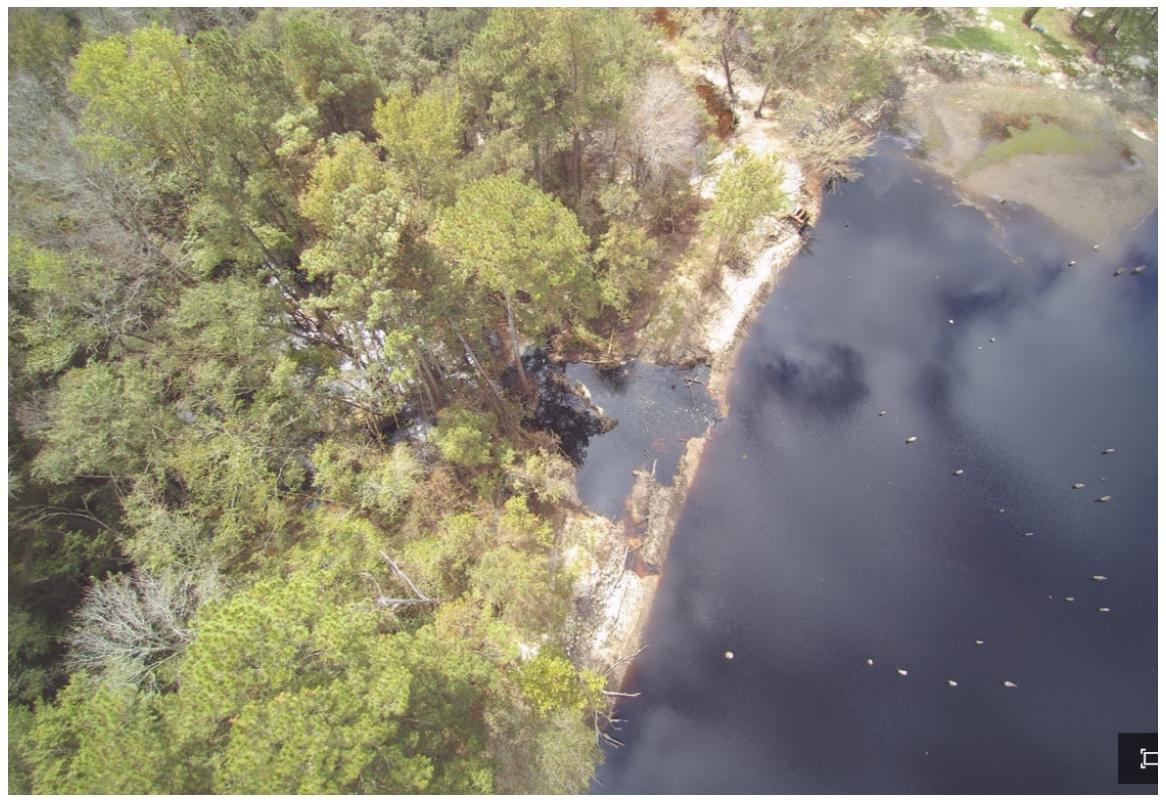
Fig. 4.2.10-2 – Aerial photograph of left abutment, spillway structure and breach (September 25, 2018, 34.675 N, 79.759 W)

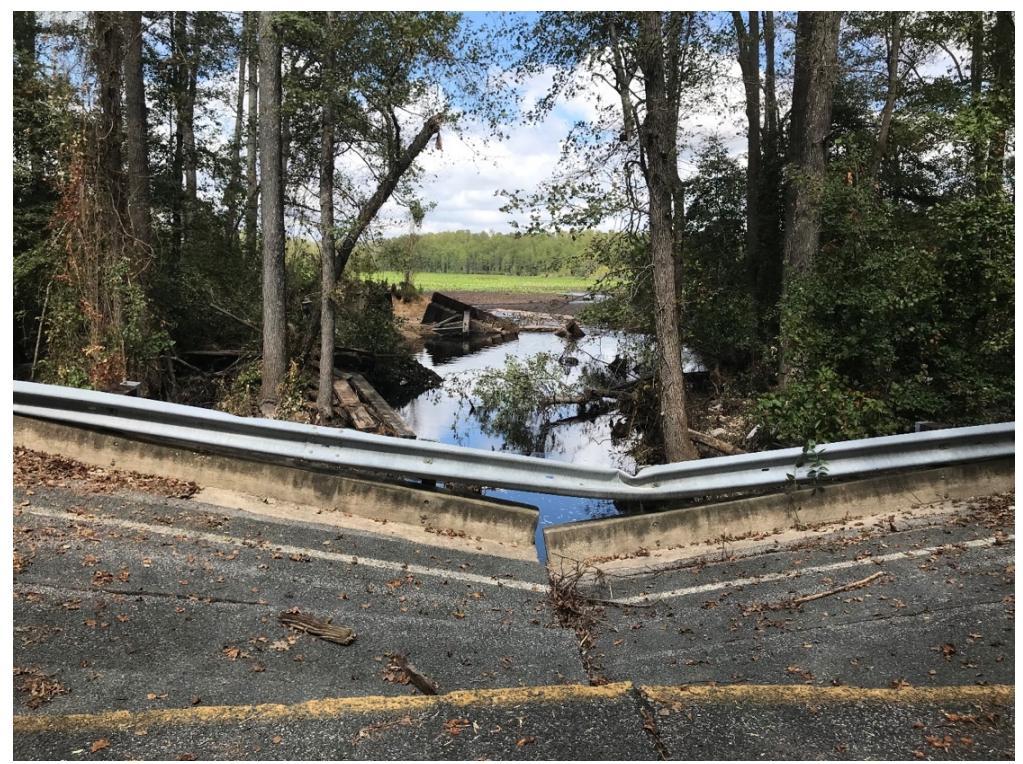
Flood flows destroyed the spillway (Fig. 4.2.11-2) and scoured the piles for the bridge immediately downstream of the spillway such that it was failing. At the time of our visit the pond was largely drawn down by the breach but still draining. We also observed that Davids Mill Pond Road was breached at a location 0.5 mile east of the dam (Figs. 4.2.11-3 and -4).

Fig. 4.2.11-2 – View of destroyed spillway at Davids Mill Pond (September 25, 2018, 34.6440 N, 79.7482 W)

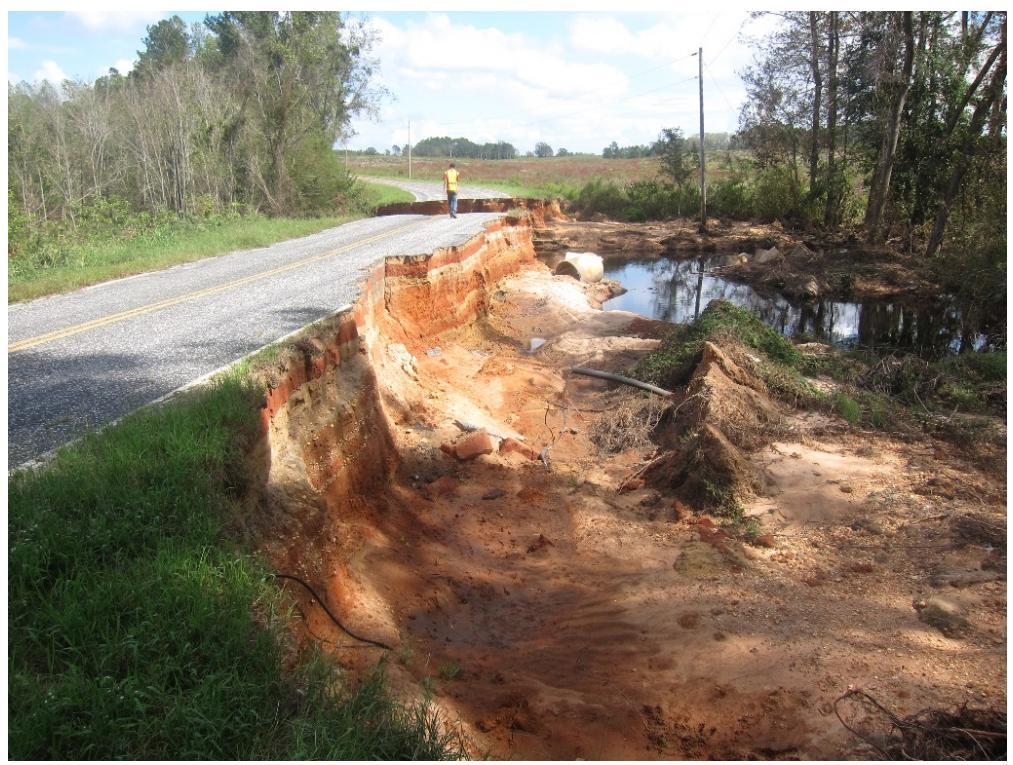
Fig. 4.2.11-3 - Scour and breach of Davids Millpond Road 0.5 mile east of the dam ((September 25, 2018, 34.6432 N, 79.7356 W)

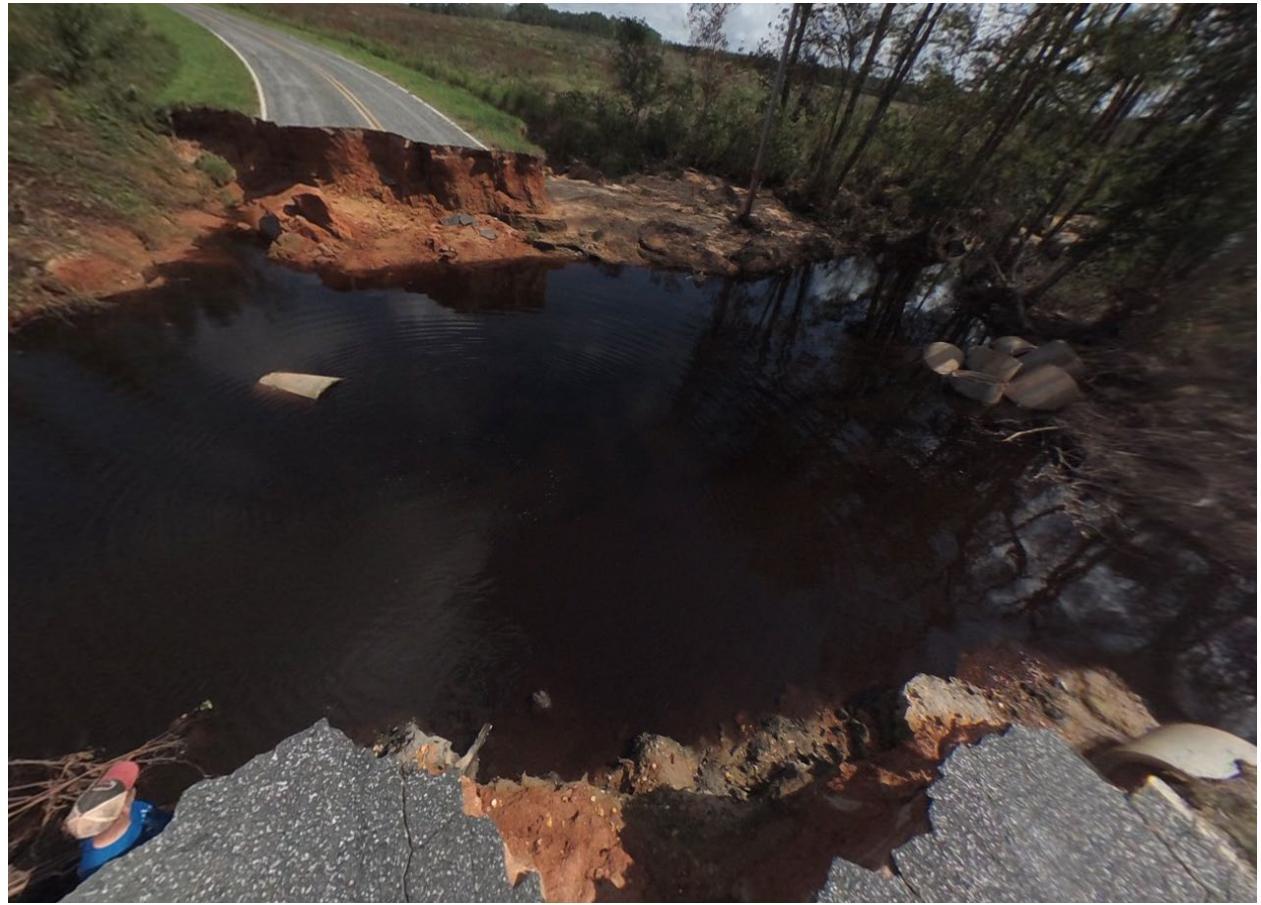
Fig. 4.2.11-4 – David's Mill Pond Road culvert washout from above (September 25, 2018, 34.6432 N, 79.7356 W)

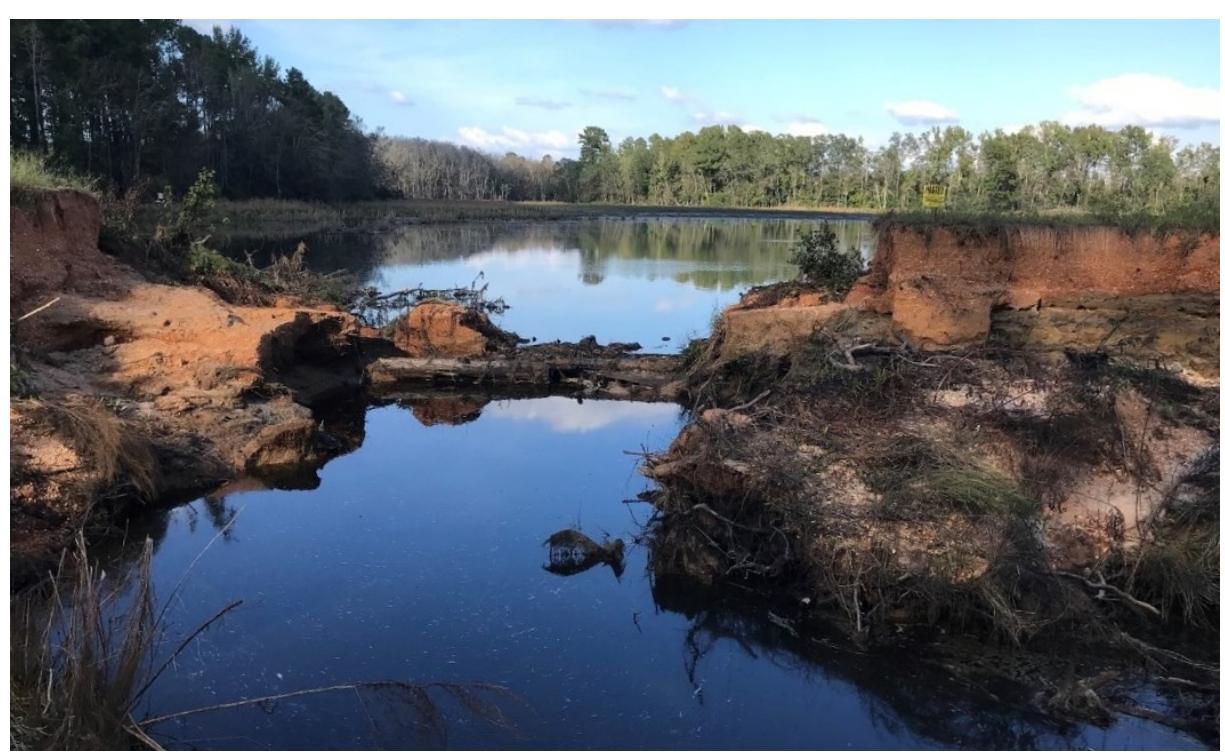
We observed a breach of the dam about 200 feet to the west of the intakes. Figs. 4.2.12-2 and -3 show the breach from the vantage point of the downstream road. In addition to the breach, other areas of the crest were eroded, indicating that the dam was overtopped.

Fig. 4.2.12-2 - Covington Millpond Dam breach looking northeast (September 25, 2018, 34.6079 N, 79.6317 W)
