#### **Geotechnical Effects of Hurricane Florence**

Geotechnical Extreme Events Reconnaissance (GEER) Association.

GEER Association Report No. GEER-063

April 2019 Revision 1 - June 2019

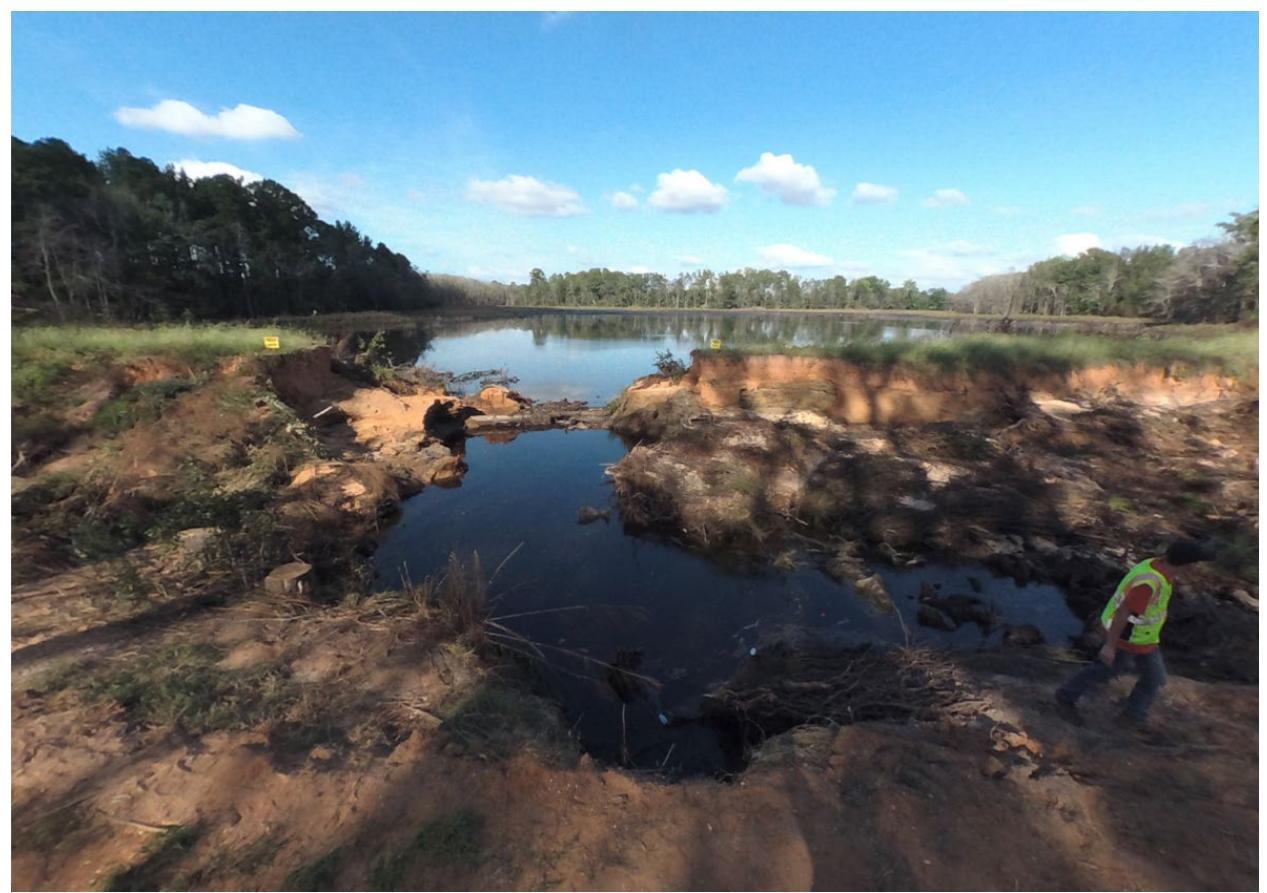
We observed a breach of the dam about 200 feet to the west of the intakes. Figs. 4.2.12-2 and -3 show the breach from the vantage point of the downstream road. In addition to the breach, other areas of the crest were eroded, indicating that the dam was overtopped.

Fig. 4.2.12-3 – Covington Millpond Dam breach looking east (September 25, 2018, 34.6079 N, 79.6317 W)

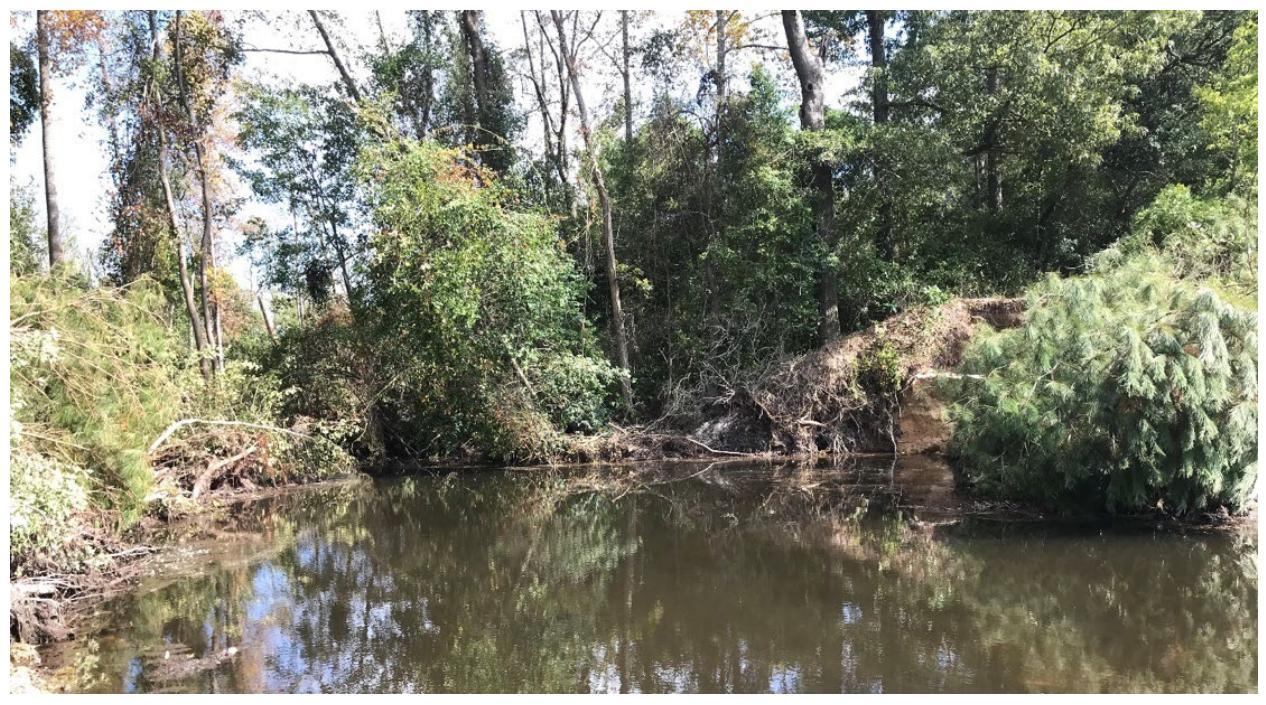
Lake Darpo Dam is located about 4 miles south of Society Hill, SC in Darlington County, along Bucholtz Creek, which feeds into the Great Pee Dee River from the south (Fig. 4.2.13-1). Based on Google Earth aerial imagery (Fig. 4.2.13-2), the earth embankment dam appears to be about 700 ft long. We observed the breach of the dam (Fig. 4.2.13-3) and the drained lake (Fig. 4.2.13-4). We understand from SC Department of Health and Environmental Control (DHEC) records that the dam breached at a 36-inch corrugated metal pipe outlet that served as the auxiliary spillway.

Fig. 4.2.13-3 - Lake Darpo Dam breach (September 25, 2015, 34.4578 N, 79.8805 W)

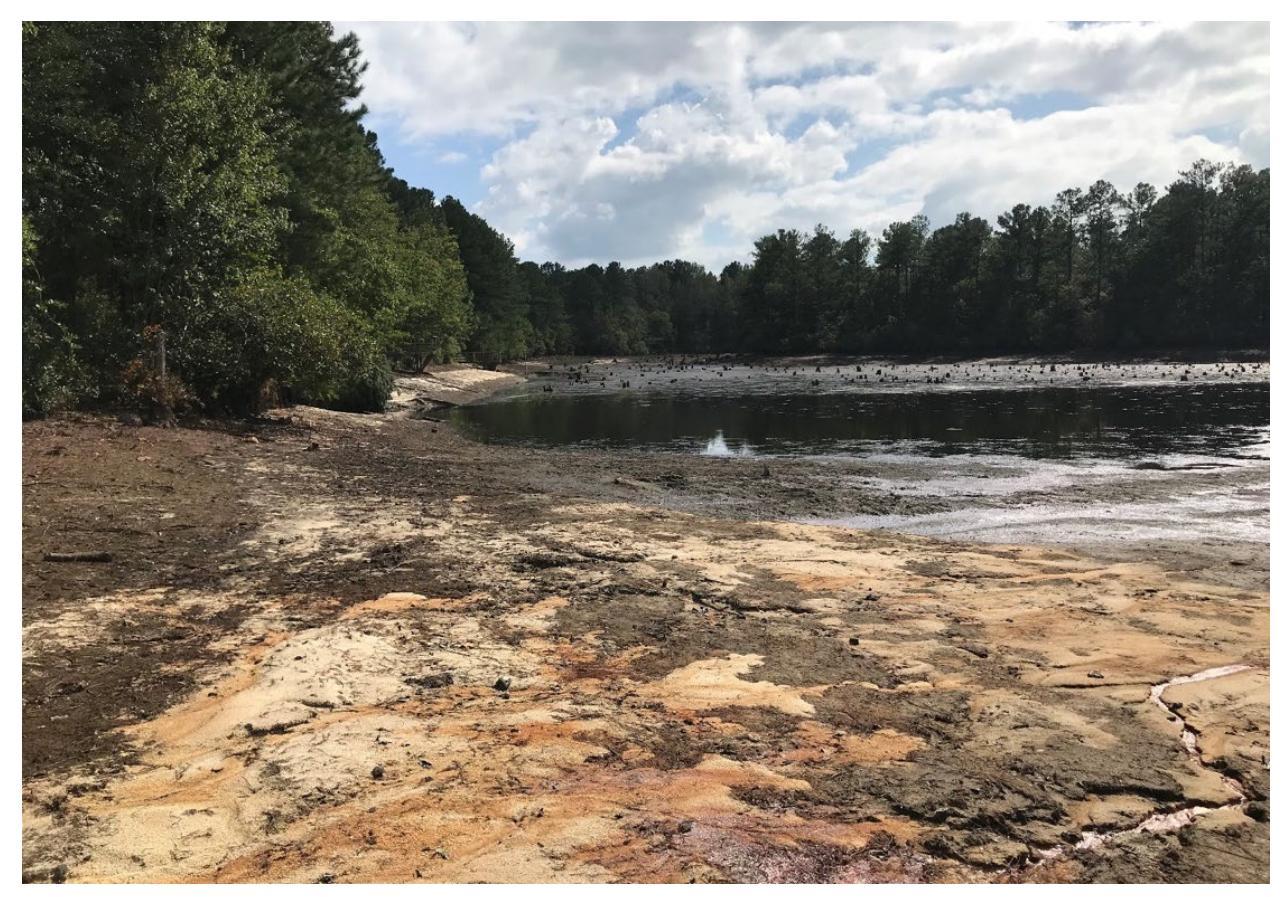
Fig. 4.2.13-4 - Lake Darpo remnants (September 25, 2015, 34.4583 N, 79.8806 W)

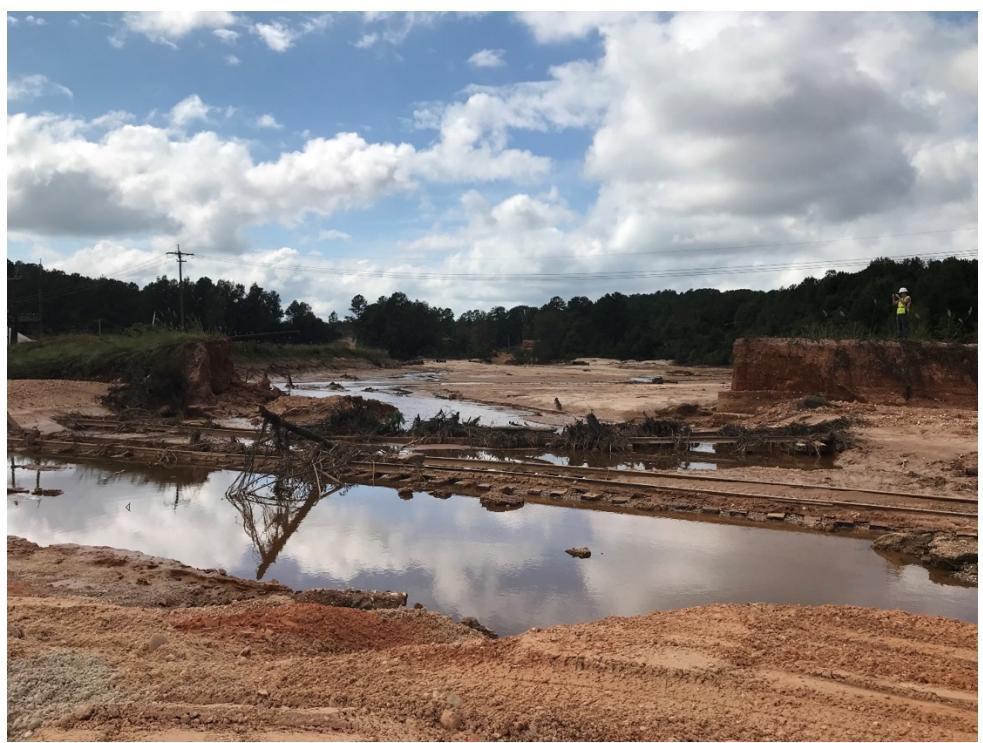
The Florence flooding breached the main haul road and a haul road embankment and caused a train derailment (Fig. 4.2.14-2). We discuss observations of the breach of the main haul road and the train derailment in Chapter 6. The breach of the haul road appears to have released flooding that breached Hedrick Tailing's Dike #1, which was completely destroyed (Fig. 4.2.14-3), and flooded out the downstream mining operation, submerging the office facility to near the roofline (Fig. 4.2.14-4).

Fig. 4.2.14-3 – View of breached dike at the Hedrick Tailing's Dike #1 (September 24, 2018, 34.9498 N, 79.9316 W)

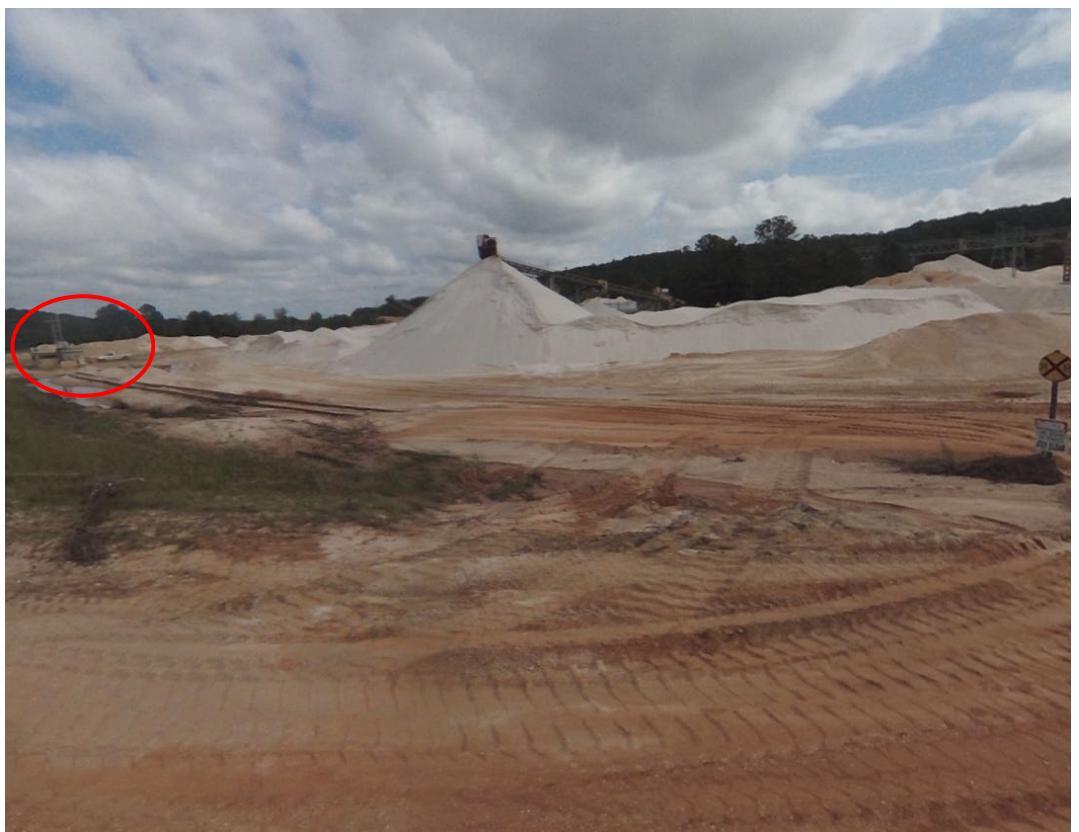
Fig. 4.2.13-4 – View downstream of breach – note office structure on left, circled (September 24, 2018, 34.9498 N, 79.9316 W)

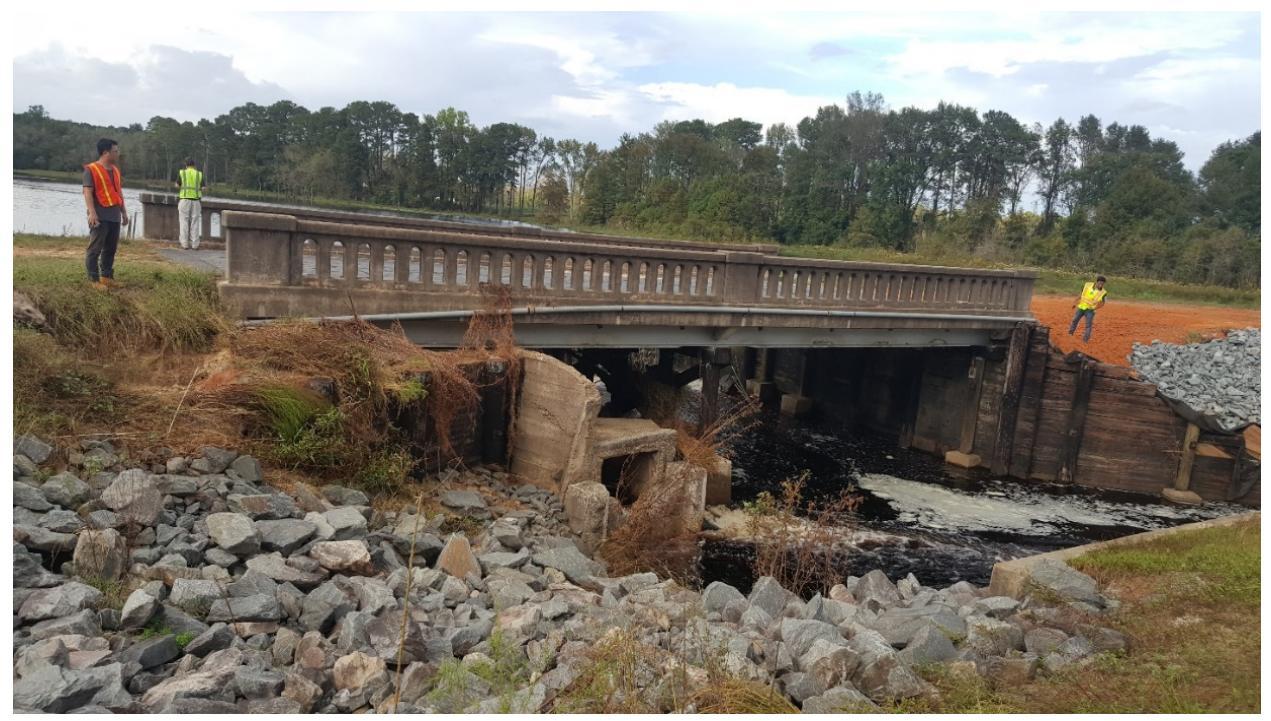
On September 25, 2018, we observed evidence of the overtopping due to the Hurricane Florence. Although the dam did not breach, erosion occurred adjacent to both ends of the spillway bridge.

The dam appeared structurally sound and functional at the time of our visit. Compared to the prehurricane condition (Fig. 4.3.1-3), the soil at downstream slope and part of the crest adjacent to the east end of the bridge appeared to have eroded by several feet (Fig. 4.3.1-5). The broken laggings on the wooden soldier post retaining wall might have had a role in dam erosion during the hurricane (Fig. 4.3.1-6), and as a result, the integrity of the wall could be a source of potential future issues. The upstream slopes at each end of the bridge also experienced some erosion (Fig. 4.3.1-7, -8). Flood flows overtopping the adjacent downstream Highway 55 East appeared to have caused no observed effects on the highway upstream slope (Fig. 4.3.1-9) but eroded part of the downstream lane, which had been repaired at the time of our visit. (Fig. 4.3.1-10).

Fig. 4.3.1-4 - Williams Millpond dam after hurricane Florence (September 25, 2018, 35.1867 N, 77.9844 W)

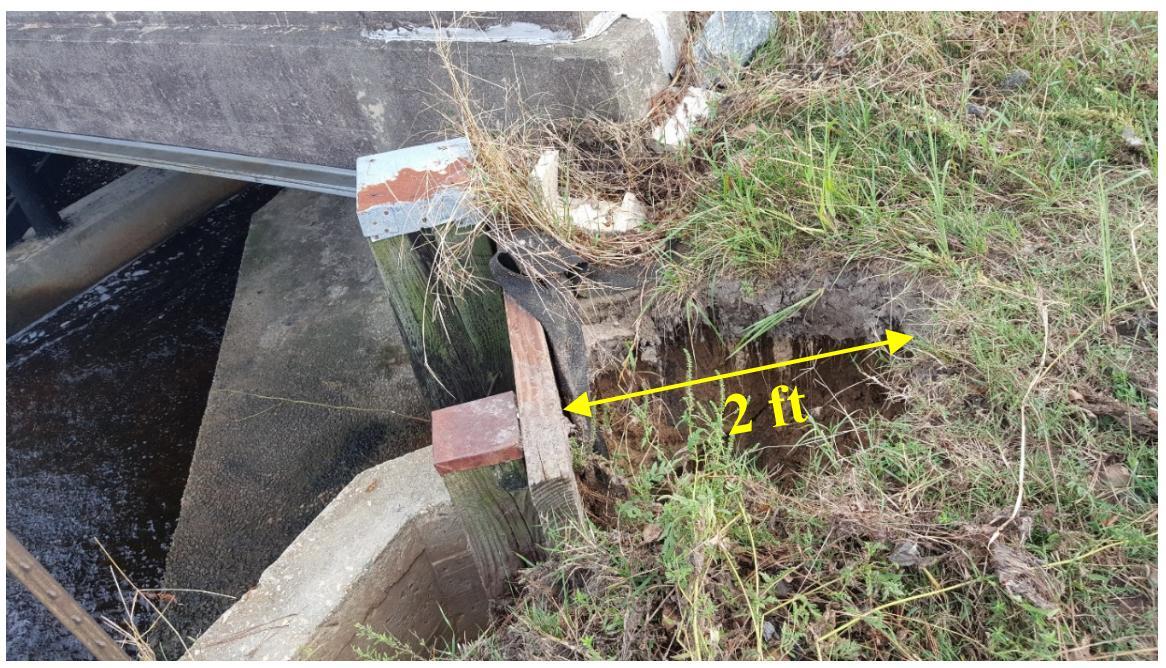
Fig. 4.3.1-8 - Upstream slope erosion (adjacent to the west end of the bridge) (September 25, 2018, 35.1868 N, 77.9843 W).

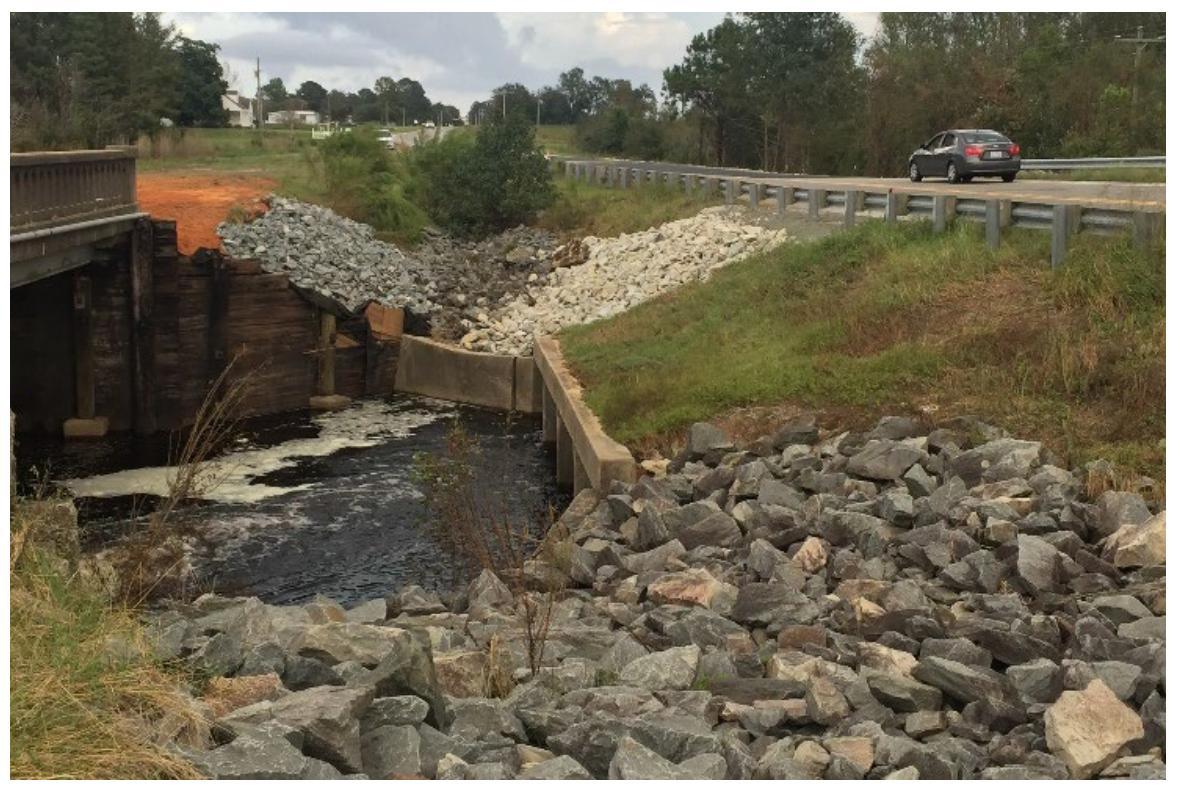
Fig. 4.3.1-9 - The upstream slope of the NC Highway 55 East was covered with grass and did not experience erosion. The riprap shows three different colors (September 25, 2018, 35.1867 N, 77.9844 W)

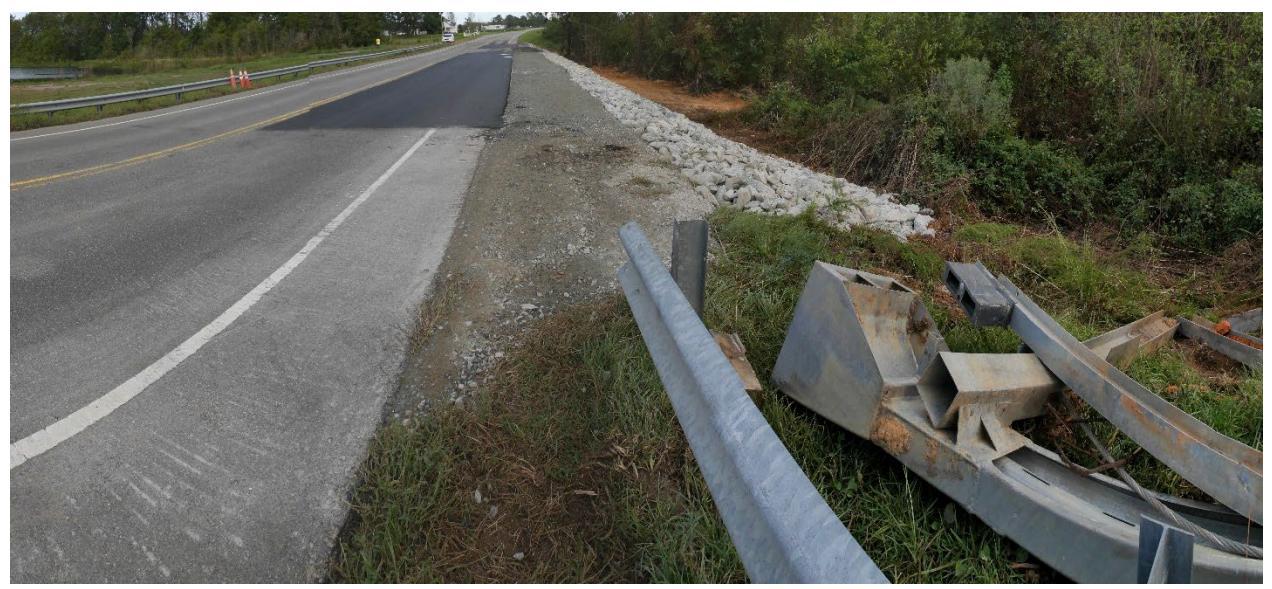
Fig. 4.3.1-10 – Repair of downstream slope of the NC Highway 55 East (September 25, 2018, 35.1865 N, 77.9839 W)

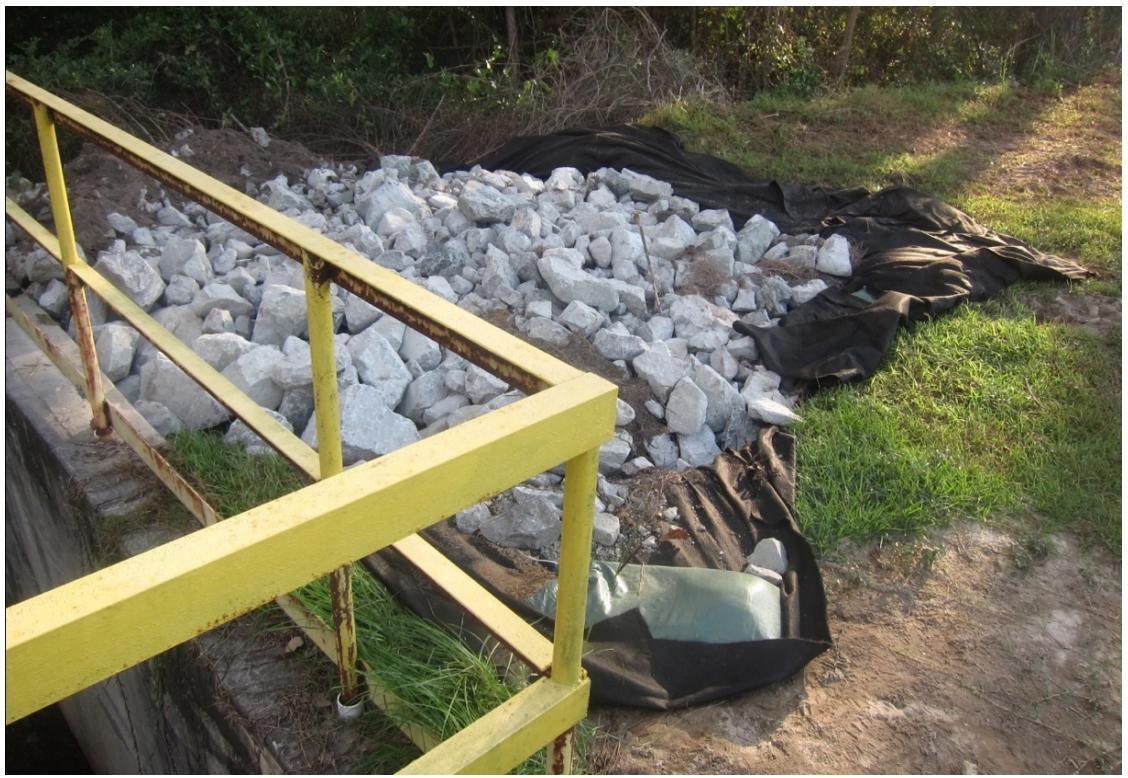
During the hurricane, the impoundment overtopped at multiple locations and eroded the embankment at two locations. Flood flows also scoured around the spillway structure. The National Guard patched the erosion during the storm. There may have been some internal erosion parallel to the concrete structure. The dam was saved from breaching by combined efforts of the dam owner, emergency managers, state dam safety, and the National Guard. Figs. 4.3.2-3 through 4.3.2-6 show evidence of the overtopping and emergency repairs that were visible when we visited the dam.

Fig. 4.3.2-3 – Temporary fix at the right side of spillway (September 24, 2018, 34.7418 N, 79.5167 W)

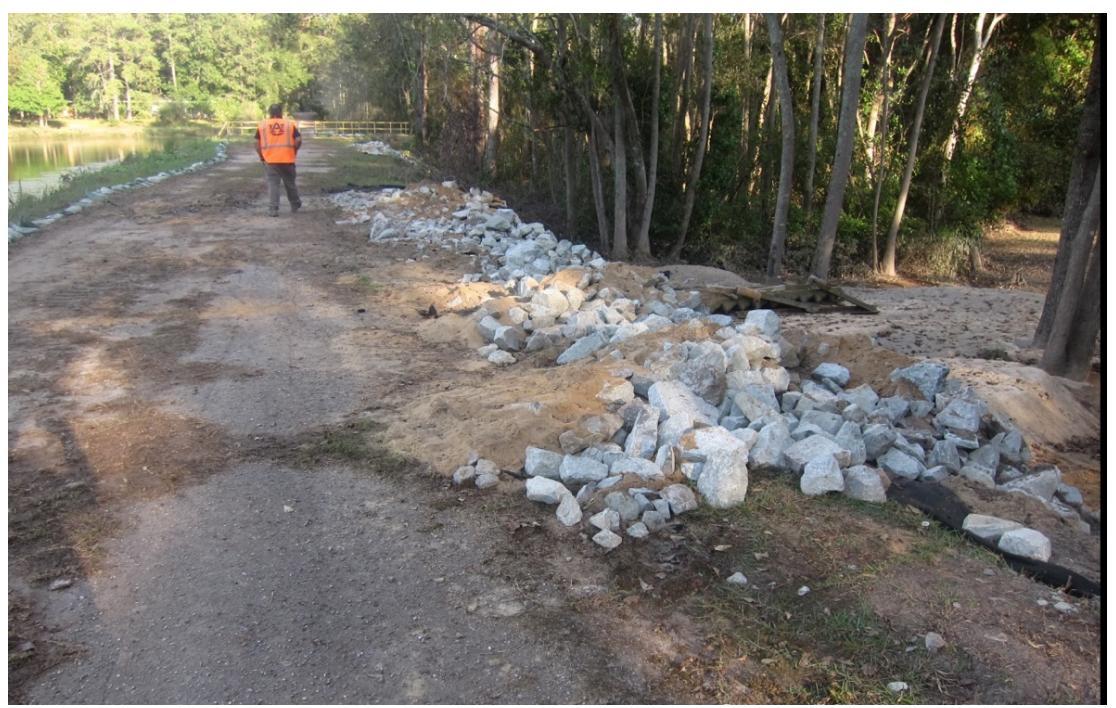
Fig. 4.3.2-4 – Looking to dam and spillway from the right abutment temporary fix at the toe of the right abutment (September 24, 2018, 34.7419 N, 79.5178 W)

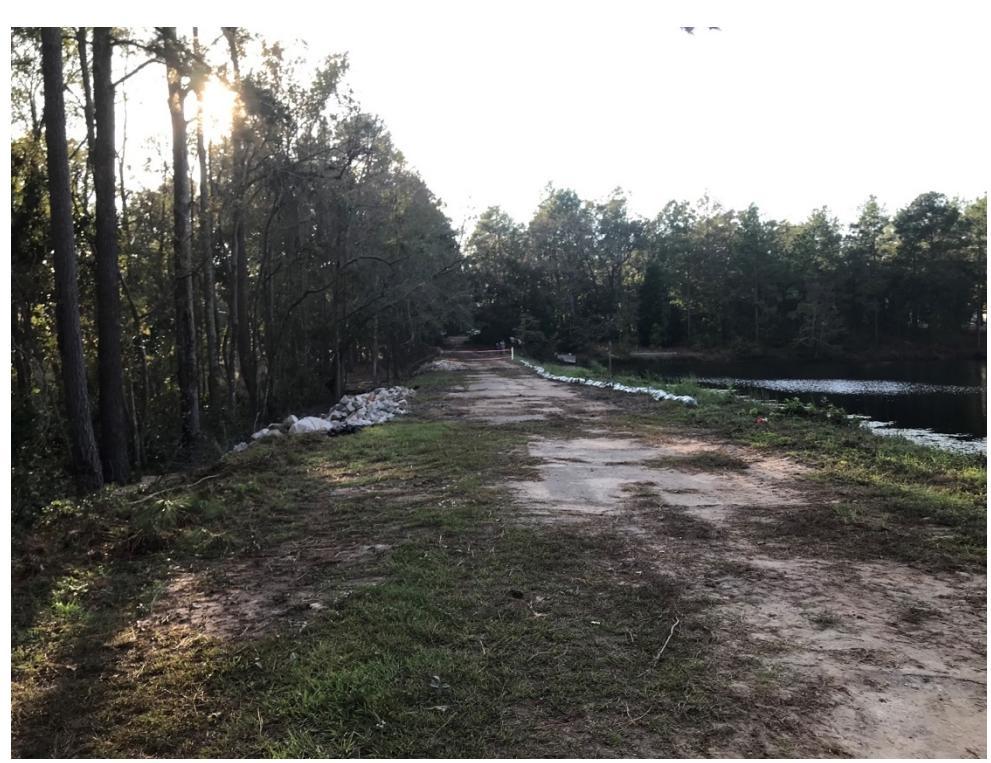
Fig. 4.3.2-6 – Overtopping erosion failures where riprap is visible at Fairs Lake (September 24, 2018, 34.7418 N, 79.5168 W)

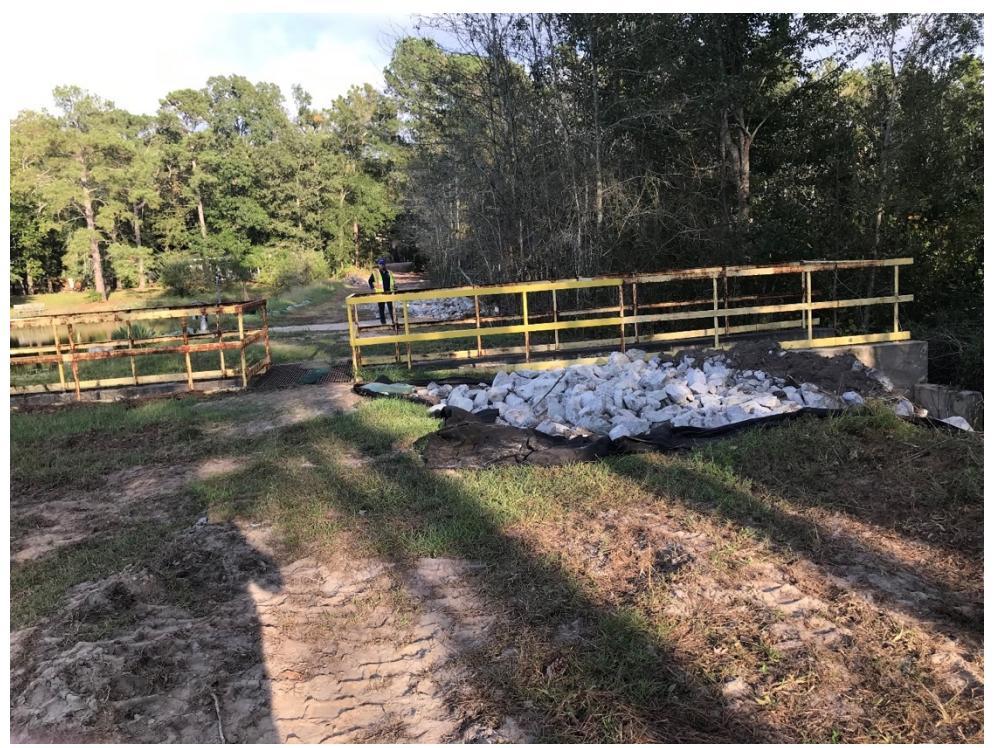
Fig. 4.3.2-6 – Erosion repairs around spillway structure at Fairs Lake (September 24, 2018, 34.7418 N, 79.5168 W)

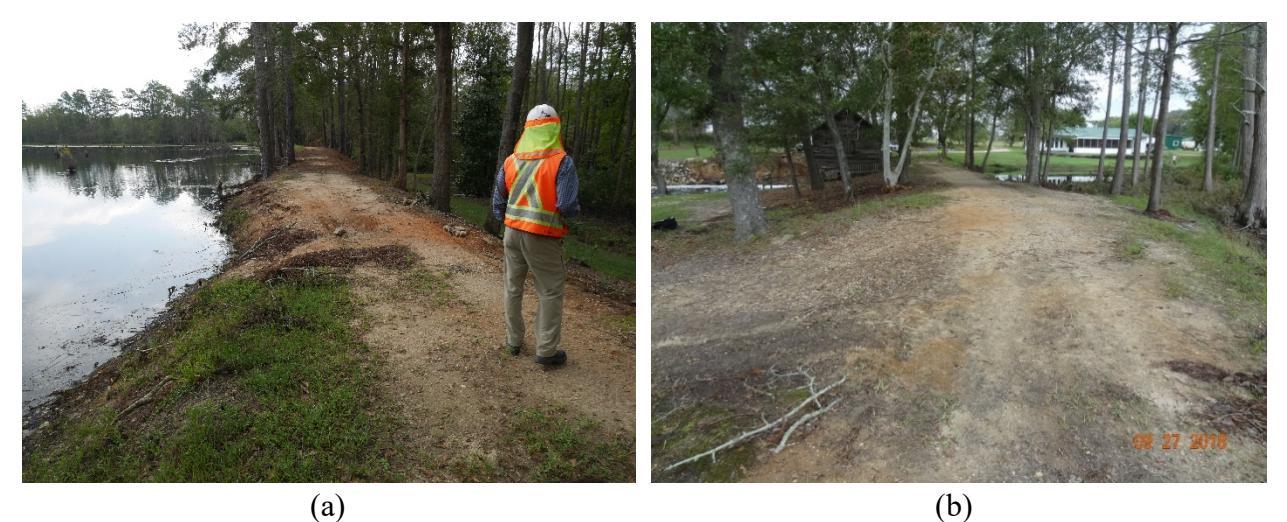
During Florence, the dam was overtopped at multiple locations along the length of the embankment. Fig. 4.3.3-4(a) shows the dam from the right abutment and surrounding forest. Near the left abutment area, discussed below, the height of the dam is about 4 ft high. Fig. 4.3.3-4(a) also shows trees, which could be found along most of the dam. Erosion was observed around a few, but not most tree roots. Fig. 4.3.3-4(b) shows the dam from the left abutment looking back towards the clubhouse and parking area.

Fig. 4.3.3-4(a) - Dam crest from right abutment and surrounding forest and (b) Dam crest looking toward right abutment showing clubhouse and parking area (September 27, 2018, 34.7041 N, 79.7312 W)

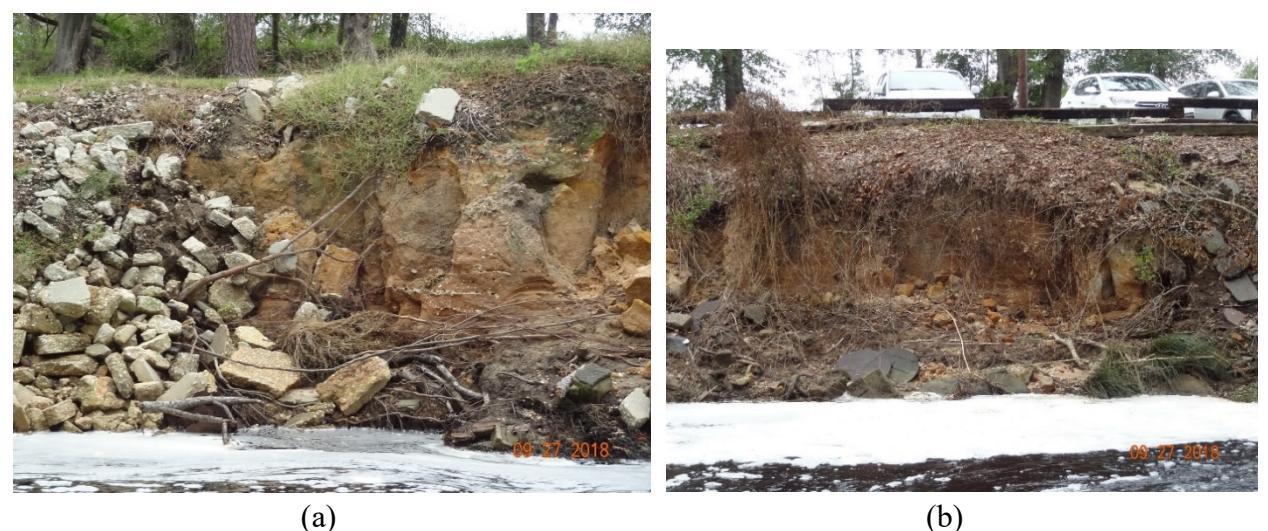
Fig. 4.3.3-6(a) and (b) show the stream bank downstream of the outlet structure. In the left portion of Fig. 4.3.3-6(a), the stream bank has been protected with previously placed rock riprap. Fig. 4.3.6(b) shows recently eroded fine-grained stream bank material and slope failure slide debris in the stream channel.

Fig. 4.3.6(a) - Stream bank erosion transition from prior stream bank erosion (see previously placed rock rip-rap) and more recent erosion and (b) - Recently eroded finegrained stream bank material, accompanying slope failures, and resulting slide debris in stream channel (September 27, 2018, 34.7042 N, 79.7315 W)

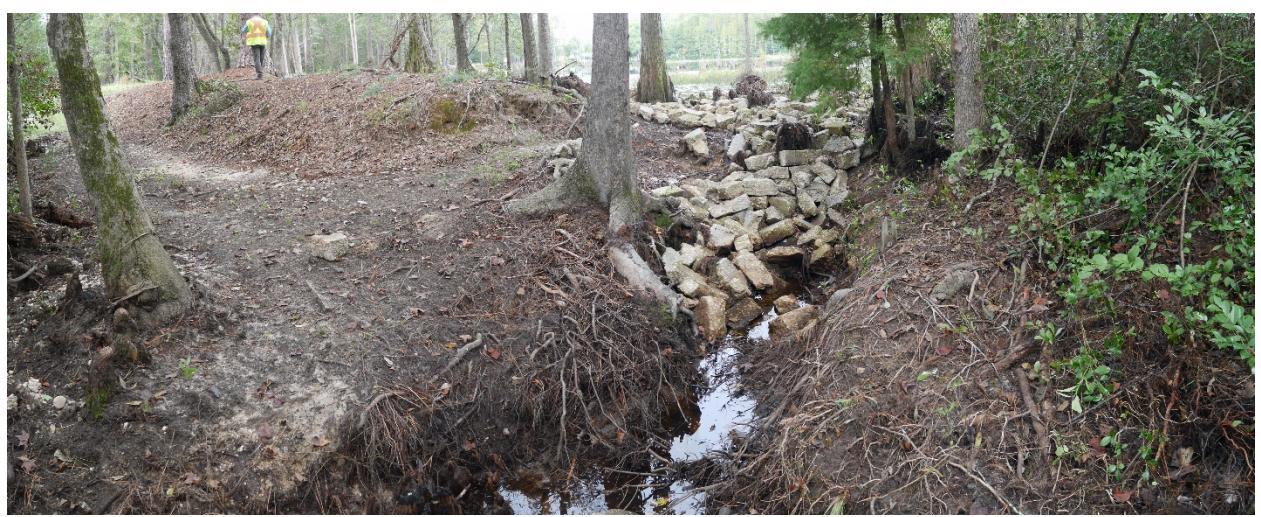
Fig. 4.3.3-7 shows a make-shift emergency spillway and downstream channel at the left abutment, about one-quarter of a mile from the outlet structure. The emergency spillway appeared to be an earth channel slightly lower than the dam crest that was covered with concrete rubble riprap. Fig. 4.3.3-7 also shows more of the extensive tree growth on the dam.

Fig. 4.3.3-7 - Emergency spillway, downstream channel and left end of embankment (September 27, 2018, 34.7030 N, 79.7295 W)

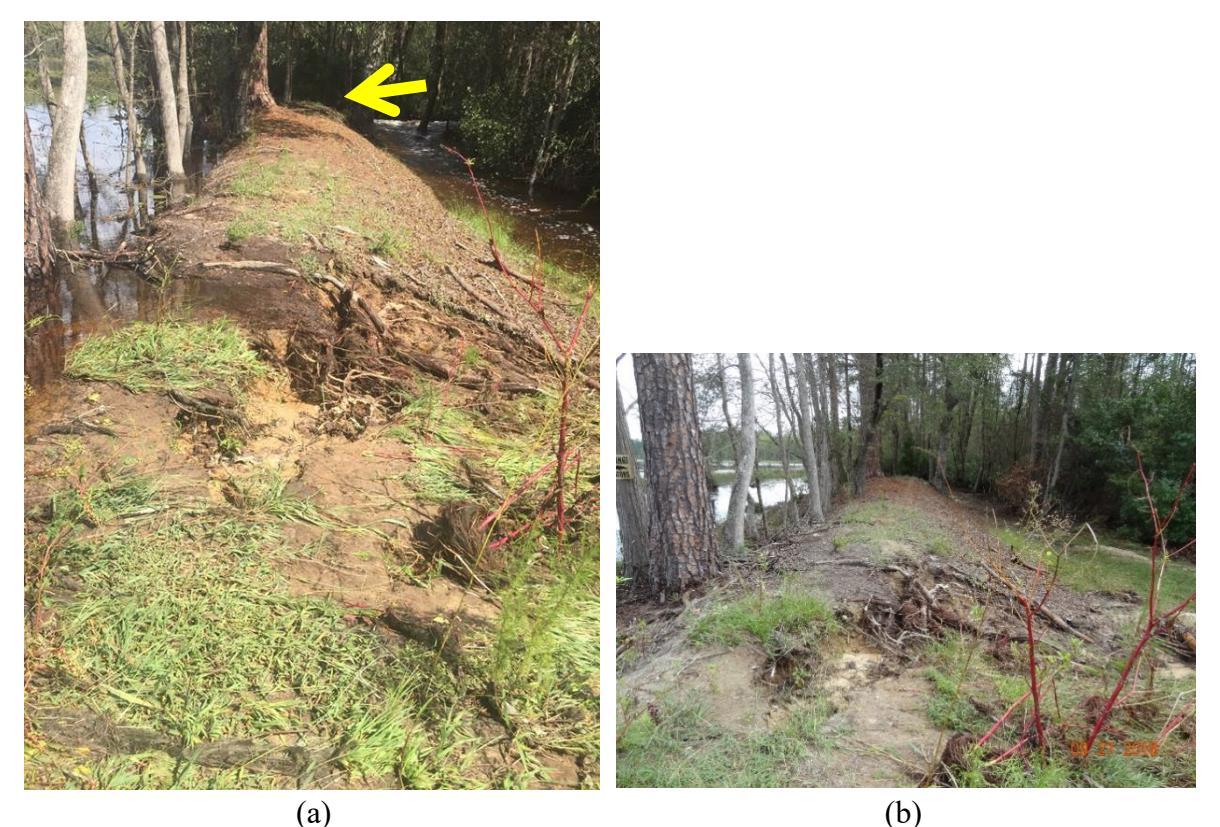
Fig. 4.3.3-8(a) shows overtopping about 100 ft from the emergency spillway with the spillway channel flow on the right side of the photo on September 17, 2018. Fig. 4.3.3-10(b) shows the resulting erosion at the same location.

Fig. 4.3.3-8(a) - Overtopping on September 17, 2018 and (b) - Erosion on September 27, 2018 at the same location about 100 ft from the emergency spillway (see yellow arrow) (September 17 & 27, 2018, (a) courtesy of SCDHEC, 34.7029 N, 79.7297 W)

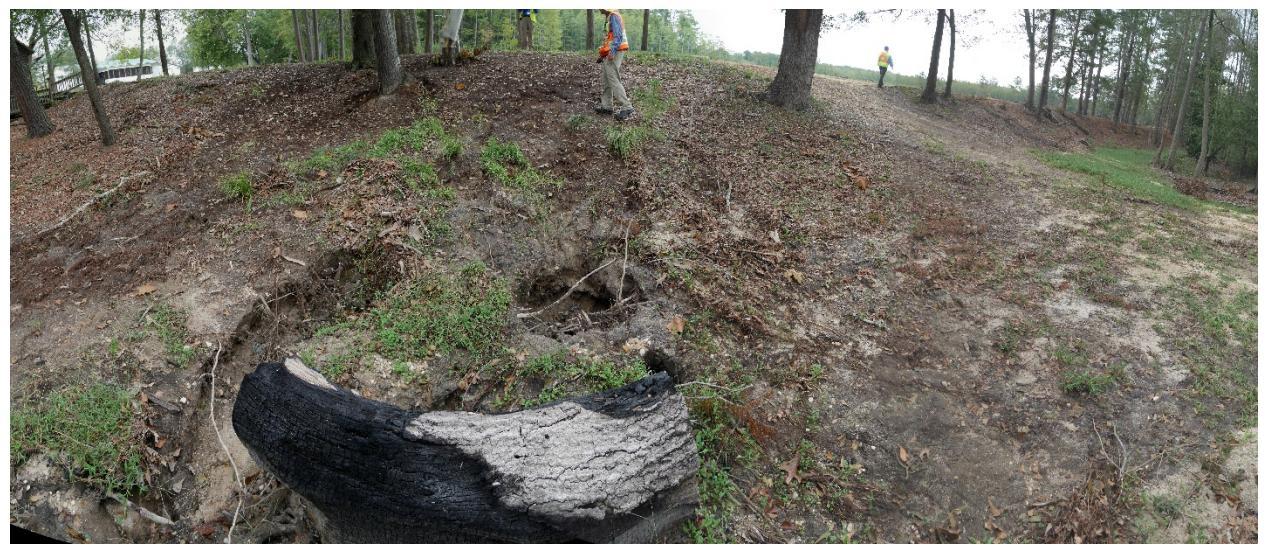
Fig. 4.3.3-9 shows another area of obvious overtopping erosion on the downstream side of the embankment about 200 ft from the outlet works. Overtopping flows at this location eroded around trees on the embankment and created scour holes at the toe of the embankment.

Fig. 4.3.3-9 - Overtopping erosion about 200 ft from the outlet works (September 27, 2018, 34.7042 N, 79.7314 W)

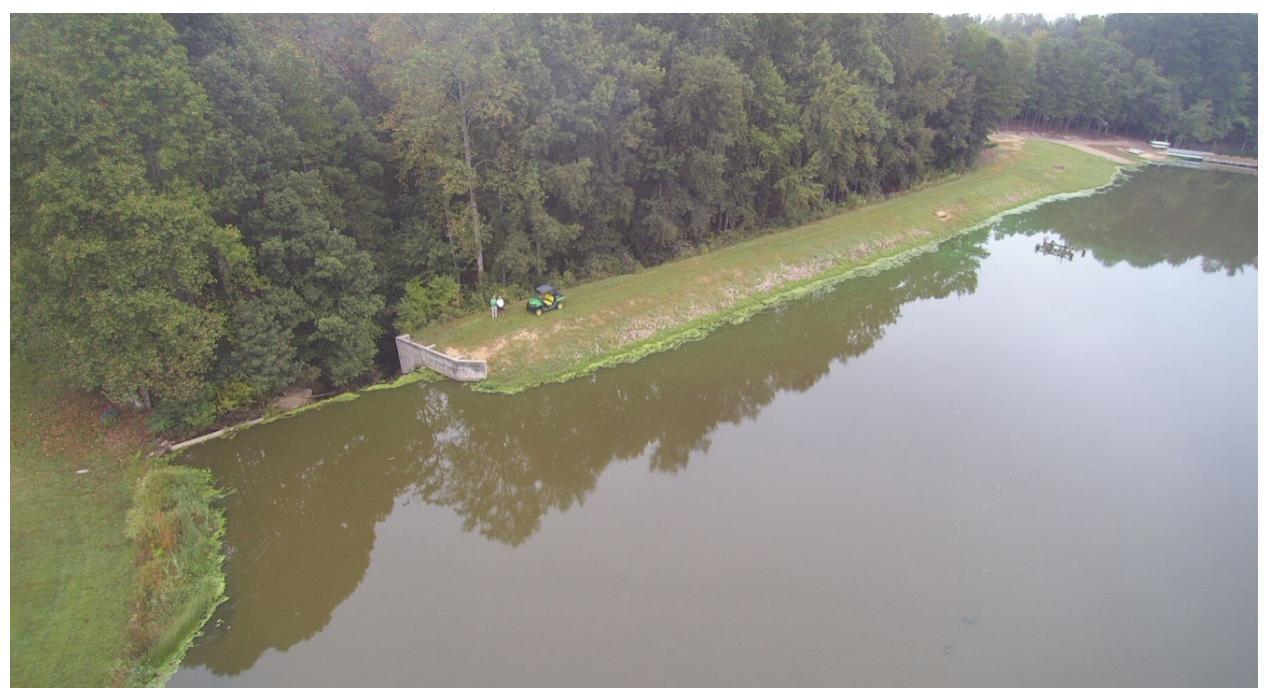
Fig. 4.4.1-4 – Lake Corriher Spillway on left Abutment (September 24, 2018, 35.566 N, 80.608 W)

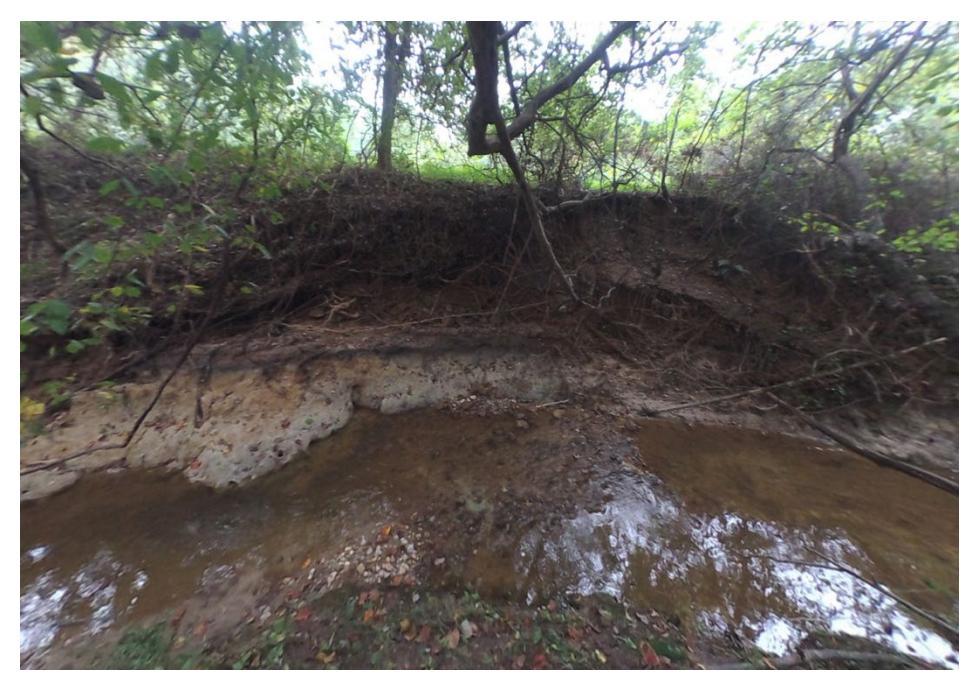
Neither dam failed. According to dam caretaker, Lake Corriher Dam had regular spillway operation during the event and had no issues. However, the Lake Corriher Dam spillway outflow appeared to have caused erosion along the Landis Lake levee (see Fig. 4.4.1-5 and -6). According to dam caretaker, the Landis Lake level was reduced before the event with a syphon. The operators of Landis Lake continued to drain the pool level after the event to allow the erosion to be inspected.

Fig. 4.4.1-6 – Erosion observed on Landis Lake levee (September 24, 2018, 35.5649 N, 80.6068 W)

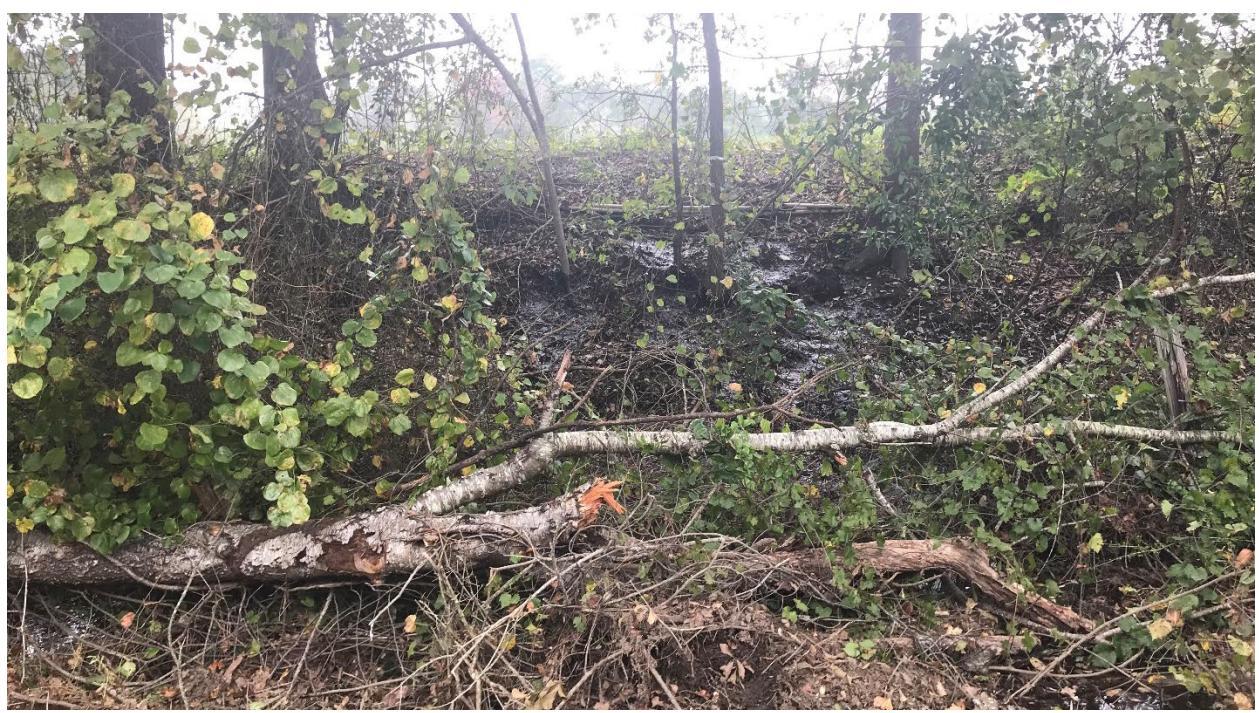
We observed a small, unregulated dam along Zoar Road in Anson, NC. The dam was located about 700 ft north of the NC/SC border, immediately north of Zoar Road (Figs. 4.4.3-1, -2). The dam is about 500 ft long and appeared to be about 5 to 7 ft high (Fig. 4.4.3-3). The most notable observations at the dam was the active seepage on the downstream slope (Fig. 4.4.3-4).

Fig. 4.4.3-4 – Seepage at unnamed dam off Zoar Rd in Anson, NC (September 25, 2018, 34.810 N, 79.987 W)

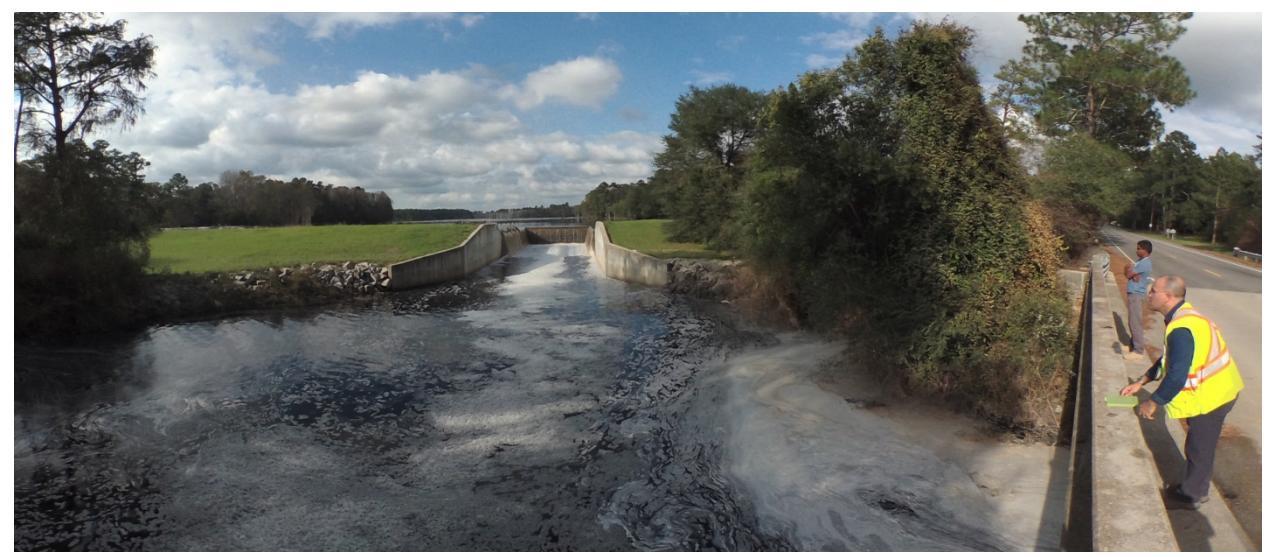
Fig. 4.4.4-3 – Richmond Millpond Dam spillway (September 24, 2018, 34.8203 N, 79.5303 W)

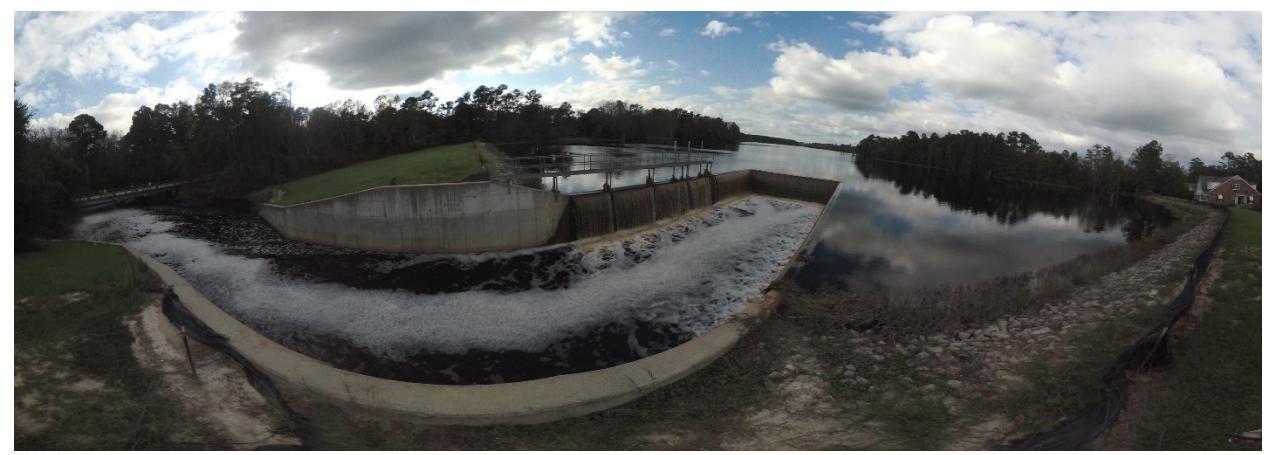
The team visited this dam based on a report of overtopping. At the time of our visit, the spillway was active and performing as designed. The operator was onsite and described recent remediation measures implemented based on flooding during a previous hurricane. The most significant remedial measure was the installation of a 70-ft-deep sheet-pile cutoff wall. It did not appear that the dam was overtopped.

Fig. 4.4.4–4 – Richmond Millpond Dam spillway and dam (September 24, 2018, 34.8207 N, 79.5302 W)

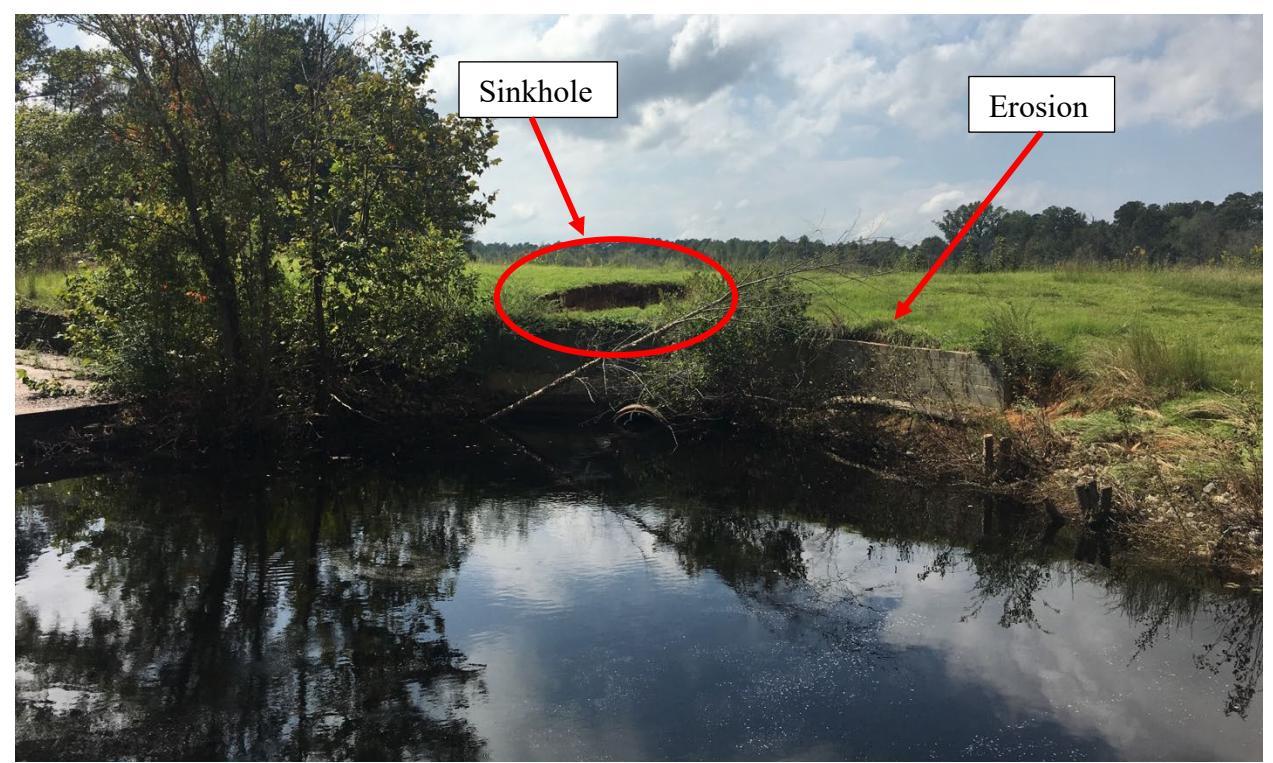
We visited the dam because of an incident report. A sinkhole developed above the reinforced concrete pipe (RCP) barrel behind the headwall (Fig. 4.4.5-4). Additional signs of erosion were observed behind the block headwall; voids were observed behind the outlet headwall (Fig. 4.4.5-4). No signs of overtopping were observed, the spillway was intact (Fig. 4.4.5-5), and the dam appeared to be stable. There were signs of road damage due to spillway channel flows on Holly Grove Road, along with fresh straw on the shoulder of the roadway (Fig. 4.4.5-6). An 8-ft by 6-ft cutout with recently placed gravel on the road (Fig. 4.4.5-6) appeared to be a temporary repair of the damage. New riprap over woven geotextile had also been placed along the roadway embankment.

Fig. 4.4.5-4 – Sinkhole developed above reinforced concrete pipe in earthen dam, and signs of erosion behind the block outlet headwall (September 27, 2018, 35.2909 N, 78.4765 W)
