#### **Geotechnical Effects of Hurricane Florence**

Geotechnical Extreme Events Reconnaissance (GEER) Association.

GEER Association Report No. GEER-063

April 2019 Revision 1 - June 2019

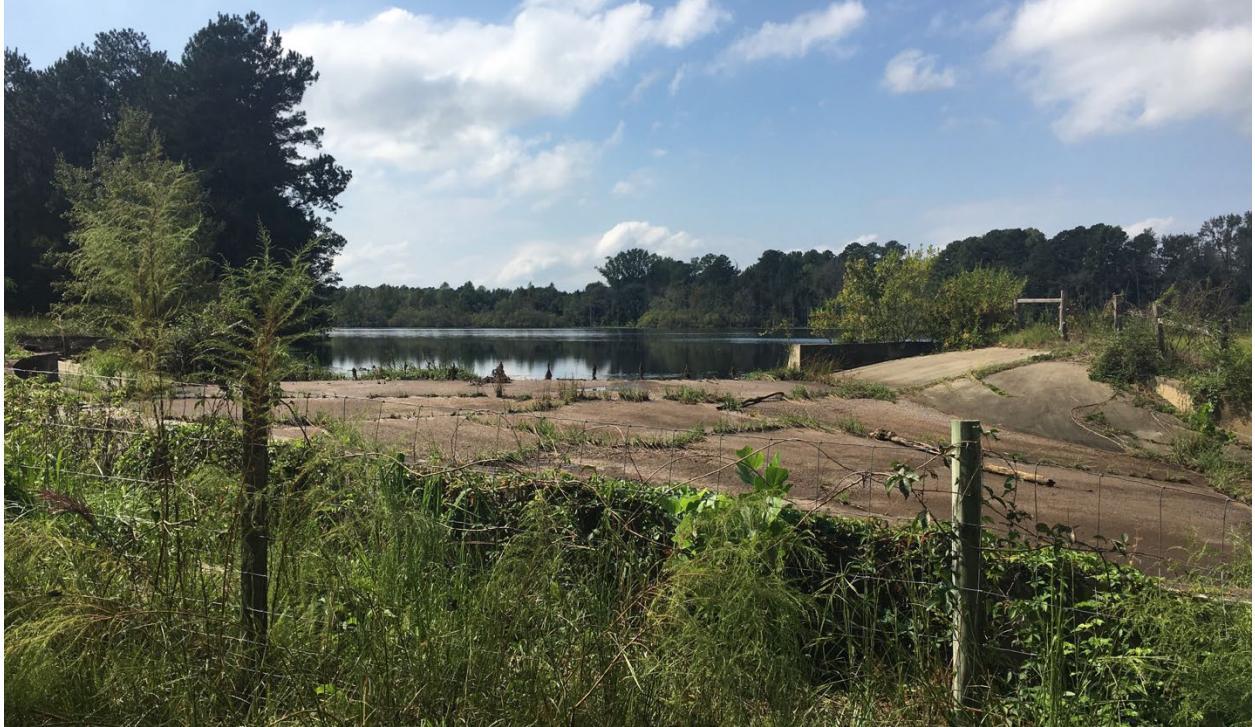
Fig. 4.4.5-5 – Spillway of dam (September 27, 2018, 35.2905 N, 78.4769 W)

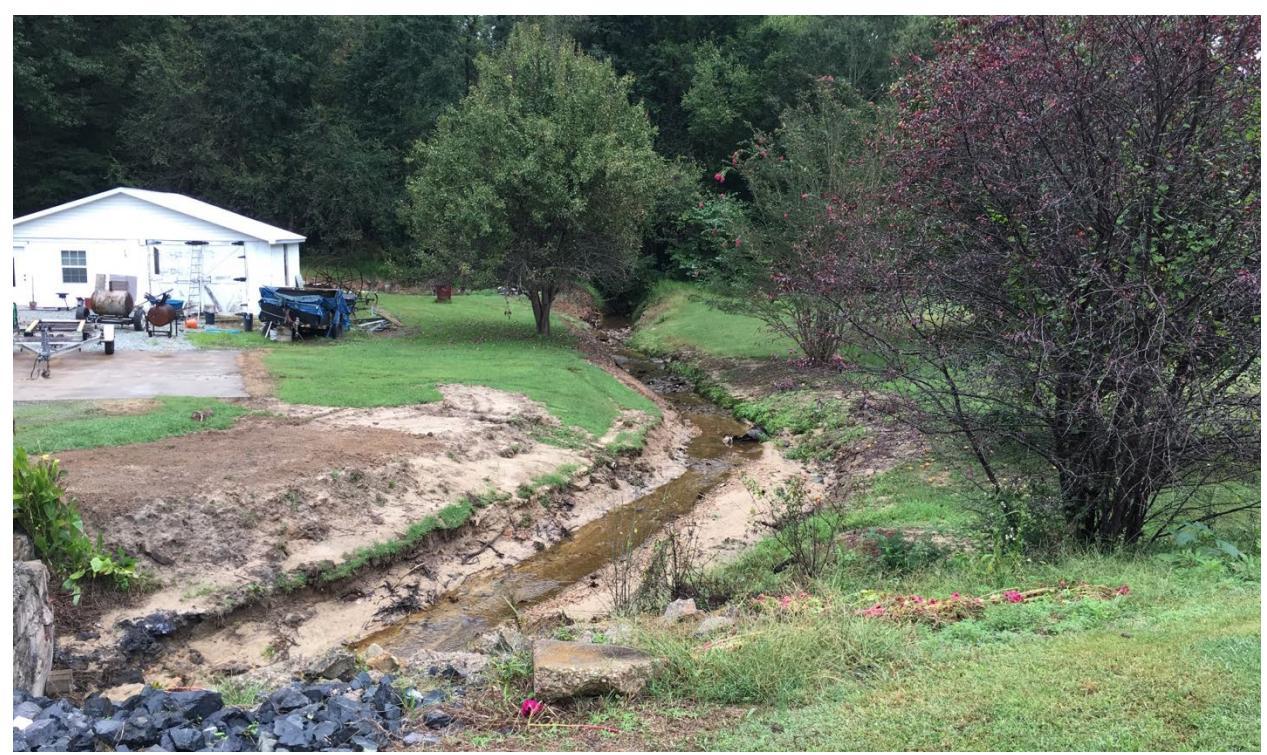
When the spillway was activated, the downstream drainage ditch through a private residence overtopped and water backed up along Clay Thomas Road. The drainage ditch flooded the grass areas shown in Figs. 4.4.6-3 and -4. The interviewed residents advised us that no flooding was experienced by the structures adjacent to the drainage ditch.

Fig. 4.4.6-3 – Private residence along Clay Thomas Road downstream of dam spillway (September 27, 2018, 36.4406 N, 78.9458 W)

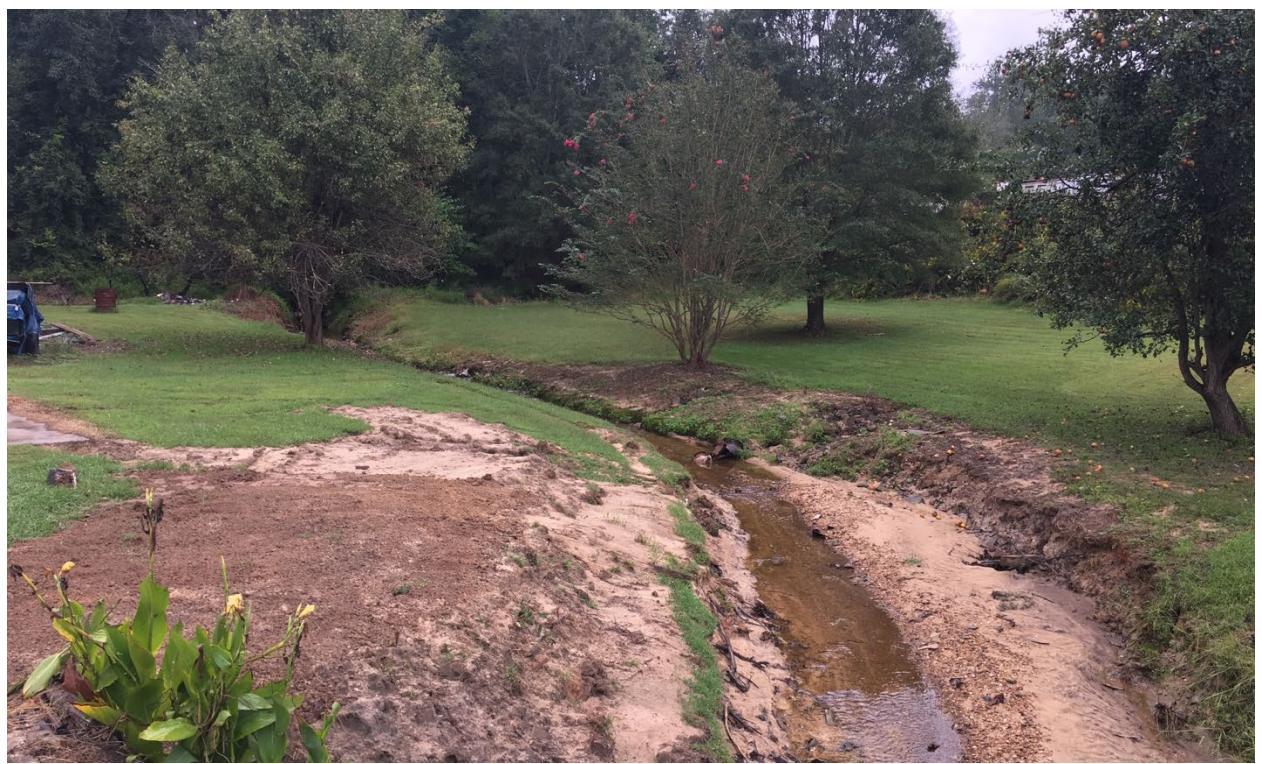
Fig. 4.4.6-4 – Private residence along Clay Thomas Road downstream of dam spillway (September 27, 2018, 36.4407 N, 78.9456 W)

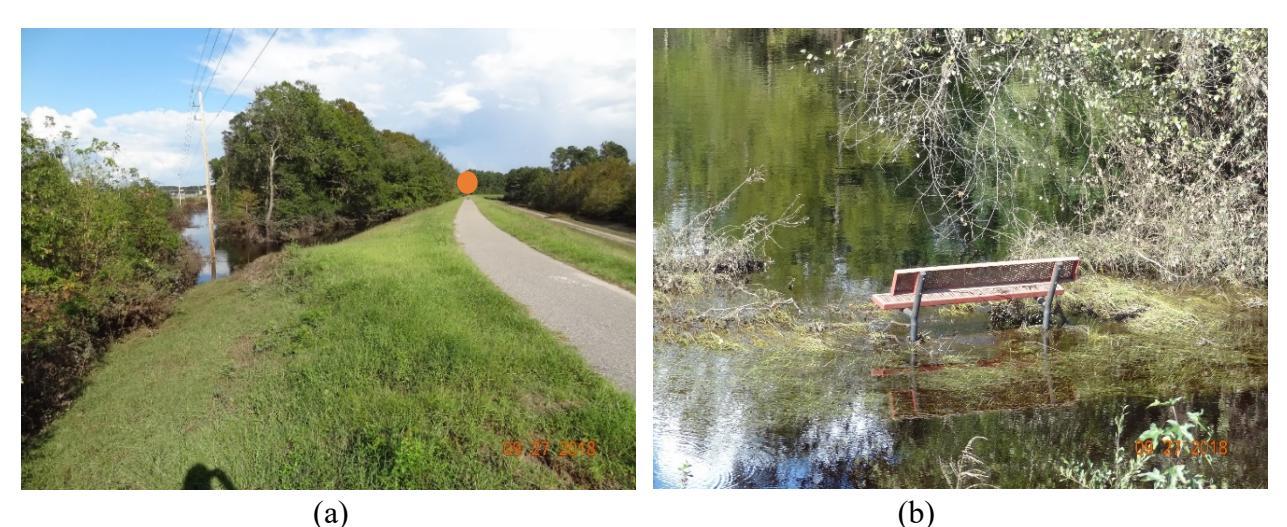
At the time of our visit, the levee was in excellent condition and appeared to range in height from a few ft to about 25 ft (estimated). We noted high water marks on the levee about 4 to 5 ft below the crest. Fig. 5.1-3(a) shows the Lumberton Levee at the western end of the Riverwalk with the river still at flood stage but receded from its maximum height. Fig. 5.1-3(b) shows a park bench near the bend in the levee in the background of Fig. 5.1-3(a) (orange dot) to give an indication of the level of flooding still present during the reconnaissance. Fig. 5.1-4 shows some residual flood water or possible underseepage on the protected side in Luther Brit Park. There was no visible seepage occurring at the time of the reconnaissance. The location of this wet area is given by the red dot in Fig. 5.1-1. We noted that several trees along this levee had fallen and pulled down telecommunication and/or power lines (Figs. 5.1.5(a) and (b)).

Fig. 5.1-3(a) - Lumber River Levee at the end of Crystal Street and (b) - Park bench still flooded near the orange dot in (a) in the Riverwalk Area (September 27, 2018, (a) 34.6312 N, 79.0309 W, (b) 34.6311 N, 79.0271 W)

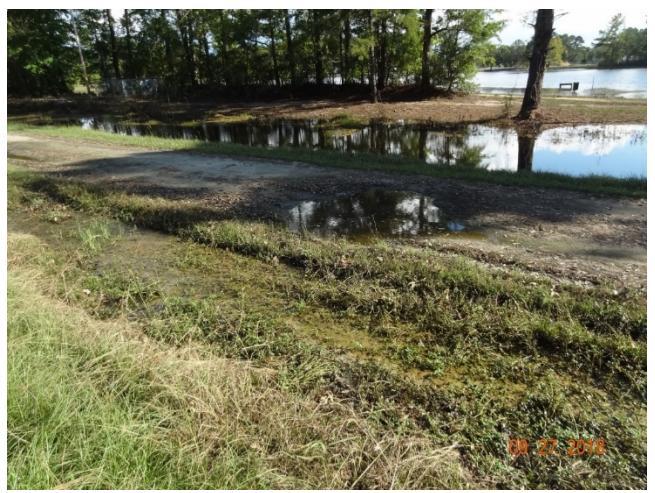
Fig. 5.1-4 – Protected side ponding along Lumber River Levee in Luther Britt Park (September 27, 2018, 34.6309 N, 79.0284 W)

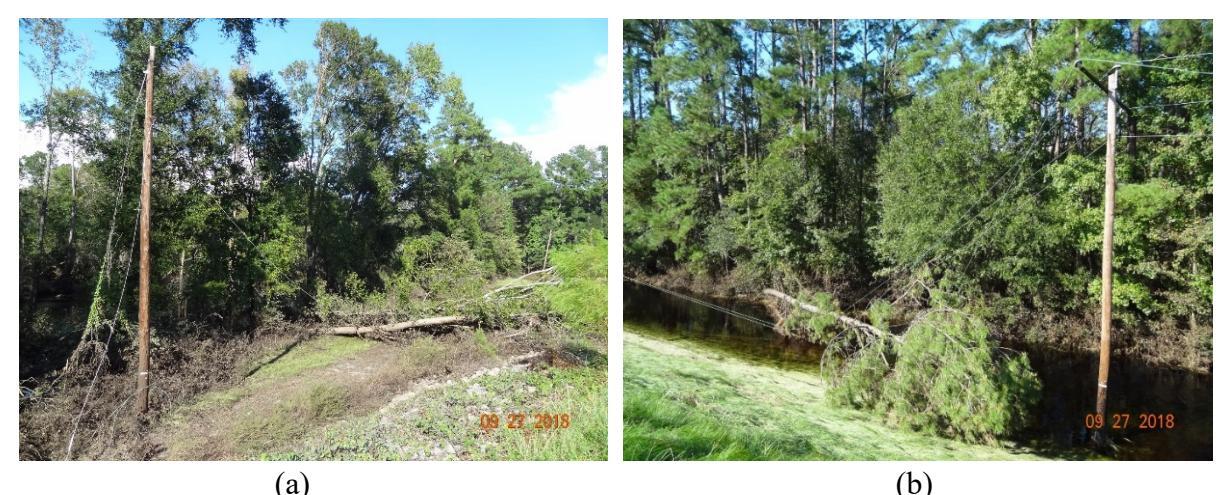
Fig. 5.1-5 - Photographs of fallen trees damaging telecommunications and/or power lines along Lumber River Levee (September 27, 2018, (a) 34.6311 N, 79.0271 W, (b) 34.6308 N, 79.0259 W)

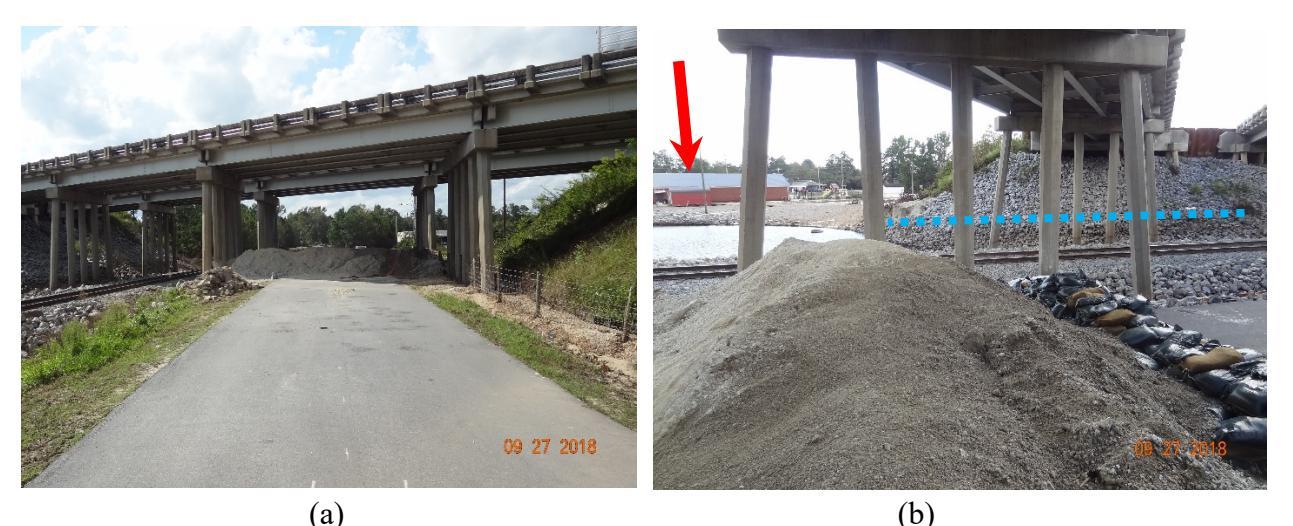
Fig. 5.1-9(a) - Temporary levee at VFW Road/ CSX Railway underpass of northbound I-95 and (b) - View from on top of temporary levee on VFW Road, uncovered CSX railway, flood level on bridge embankment (blue dashed line), and West Lumberton Baptist Church (red arrow) (September 27, 2018, (a) 34.6273 N, 79.0390 W, (b) 34.6276 N, 79.0396 W)

The full layout and configuration of the temporary levee was not in place or completely apparent at the time of our visit. The levee elements under I-95 that we saw were only across the VFW Road and not on the CSX rail line, most likely because the rail line had been cleared for traffic. Additional temporary levee elements appeared to have been placed along and across VFW Road and the CSX line forming a U-shape in plan that extended about 250 ft inboard / east of I-95. The inboard temporary levee may have been a second line of defense or a second attempt to contain or direct flood flows. The temporary levee(s) did allow residents some additional time to protect their property and move some items and property to higher ground, but significant property damage still occurred to houses, churches, vehicles (see Fig. 5.1.10), and businesses.

The flooding through the underpass confirms the importance of surveying a levee protection system and identifying and sealing all possible openings before a major storm arrives. Possible failure mechanisms for the temporary levee(s) include overtopping and underseepage erosion. The riprap in the underpass drainage channels and the coarse gravel ballast of the rail line would have provided little impedance to underseepage at the temporary levee. Construction of a permanent floodgate with appropriate seepage cutoffs certainly makes sense as a way to prevent repeats of the 2016 and 2018 flooding.

The City of Lumberton has secured a \$1.25 million FEMA grant to build a permanent floodgate under the I-95 underpass, and construction is slated to begin in 2019. Lumberton and CSX are cooperating to implement a permanent solution to this opening in the levee protection system.

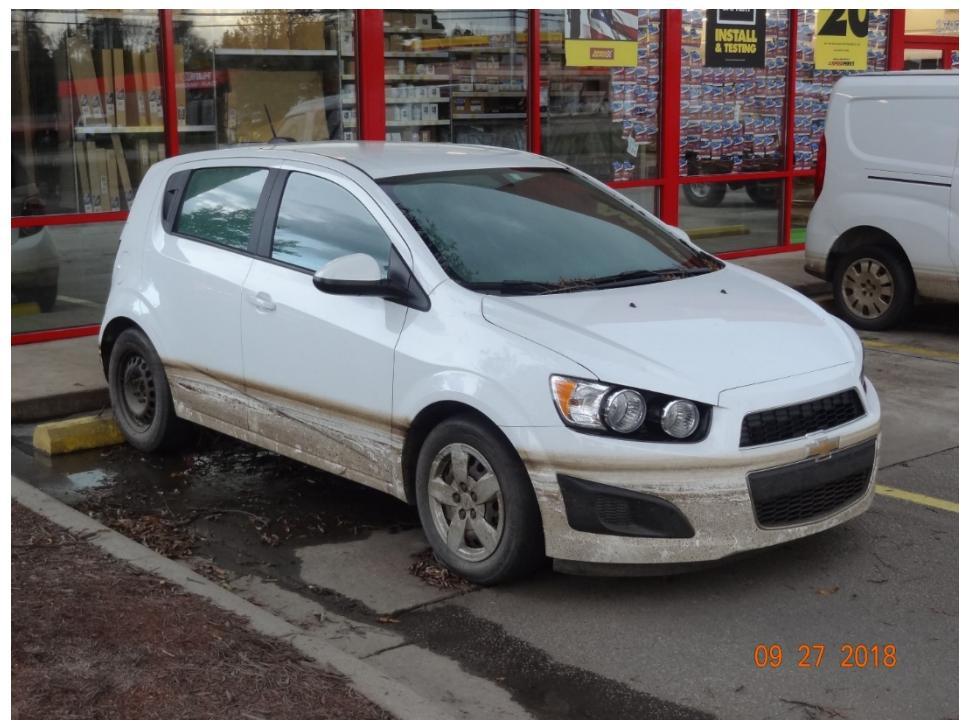
Fig. 5.1-10 – Vehicle with flood level marks in front of an auto parts store about 0.4 mile west of the I-95 underpass (September 27, 2018, 34.6236 N, 79.0452 W)

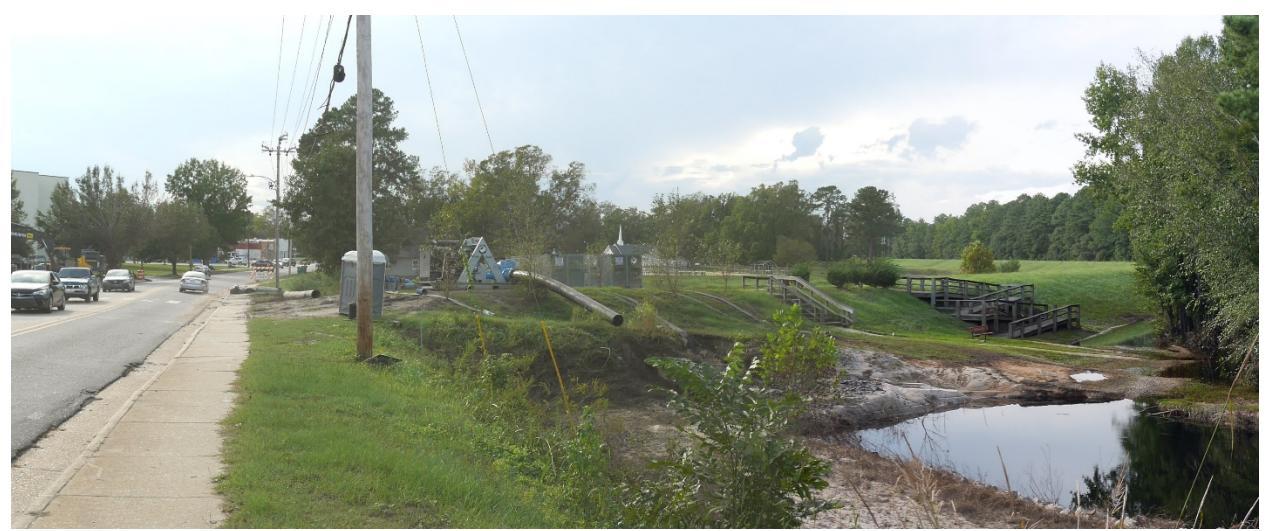
Fig. 5.1-13 shows the numerous temporary pumps that the city set up adjacent to the 5<sup>th</sup> Street levee crossing during the flooding. At the time of our visit, some of the pumps were still set up (Fig. 5.1-14). The high flows and velocities from some of the pumps resulted in erosion on the riverside of the levee (Fig. 5.1-15(a)). We also noted that the street level at the 5<sup>th</sup> Street crossing was lower than the rest of the levee by about 2 ft (Figs. 5.1-14 and Fig. 5.1-15(b)), but flood levels did not reach this street elevation.

Fig. 5.1-14 – 5<sup>th</sup> Street levee crossing of levee (September 27, 2018, 34.6202 N, 79.0113 W)

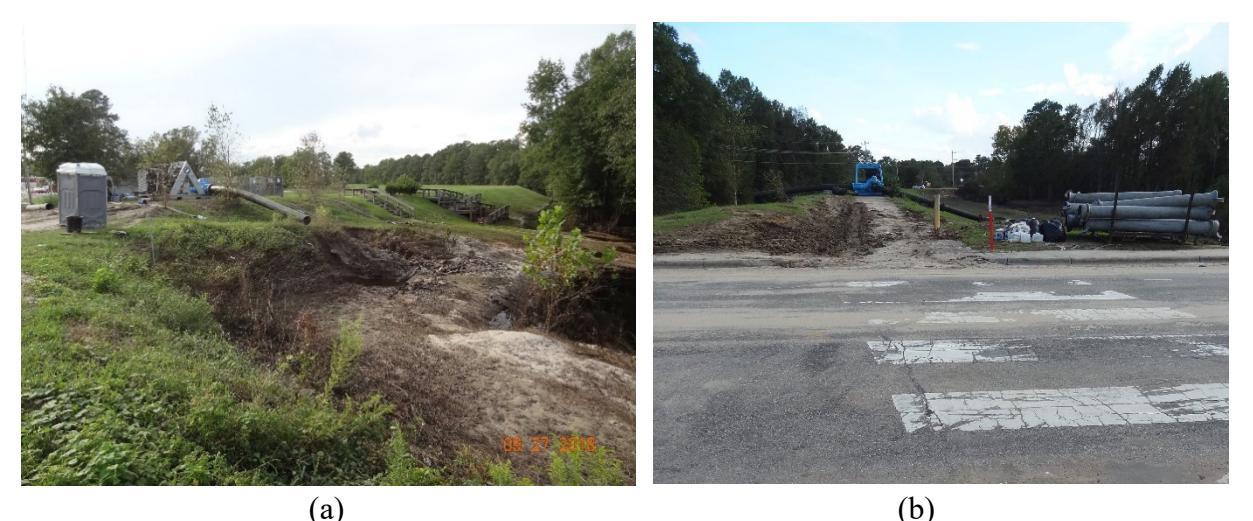
Fig. 5.1-15(a) - Erosion on river side of levee due to pumping at the 5<sup>th</sup> Street levee crossing, (b) - View across 5<sup>th</sup> Street levee crossing showing higher levee level (September 27, 2018, (a) 34.6202 N, 79.0113 W, (b) 34.62.02 N, 79.0118 W)

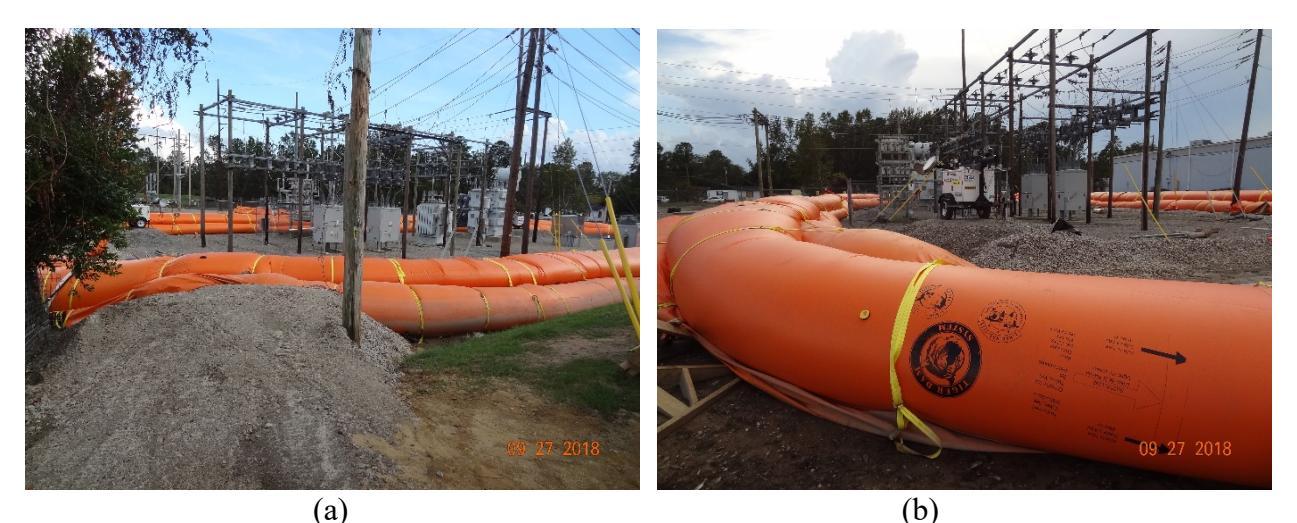
The Tiger Dam<sup>™</sup> System used at the substation is a portable system consisting of tubes that can be shipped uninflated and then filled with water to form a temporary flood barrier. Standard tubes are 100 ft long and between 3 ft and 12 ft high. The Tiger Dam<sup>™</sup> at the Lumberton

substation appeared to use the 3-ft-high tubes, stacked in some locations, with adjacent gravel berms for stability (Figs. 5.18(a) & (b)). The system was used around two of the substation transformer groups, presumably with interior pumping to remove underseepage.

Fig. 5.1-18(a) & (b) - Tiger Dam temporary flood barrier a substation near 2<sup>nd</sup> Street levee crossing (September 27, 2018, (a) 34.6179 N, 79.0136 W, (b) 34.6177 N, 79.0133 W)

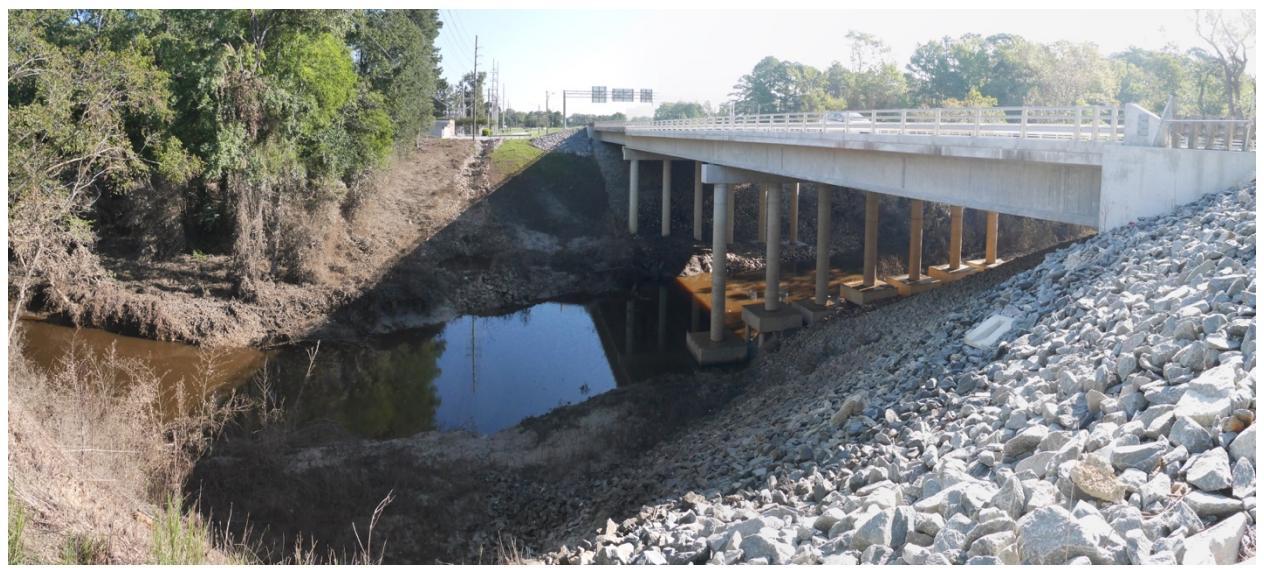
In Fayetteville, NC, we observed significant scour at the bridge foundations of Business 95 across Creek (location and aerial - Fig. 6.2.1-1 and 6.2.1-2). The bridge is about four years old, and the riprap along the slopes and settling pond were installed at that time. The foundation system of the bridge consists of four steel pipe piles in each pile cap embedded in stiff clay (Fig. 6.2.1-3). The original grade of the soil at the base of the creek was approximately 18 inches above the pile caps. After Hurricane Matthew in 2016, the initial pile cap and about 12 inches of the piles were exposed. Approximately 24 to 36 additional inches of scour was observed after Hurricane Florence and scour extended across the majority of the pile caps along the southern bank of the creek (Fig. 6.2.1-4). Insignificant scour around the foundations was observed along the northern bank of the creek.

Fig. 6.2.1-3 – Business 95 Bridge at Cross Creek, looking north across Cross Creek at the high-water elevation (shown by muddied vegetation) and bridge foundation (September 26, 2018, 35.05453 N, 78.86315 W)

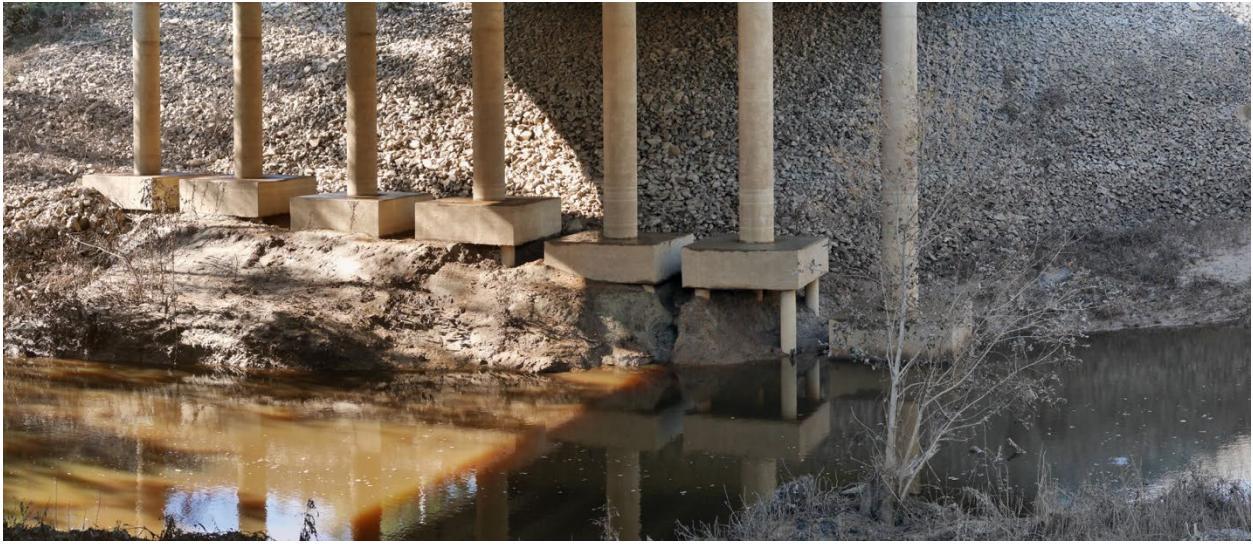
Fig. 6.2.1-4 – Business 95 Bridge at Cross Creek, looking south across Cross Creek at the exposed pile caps and pile foundations (September 26, 2018, 35.05507 N, 78.86251 W)

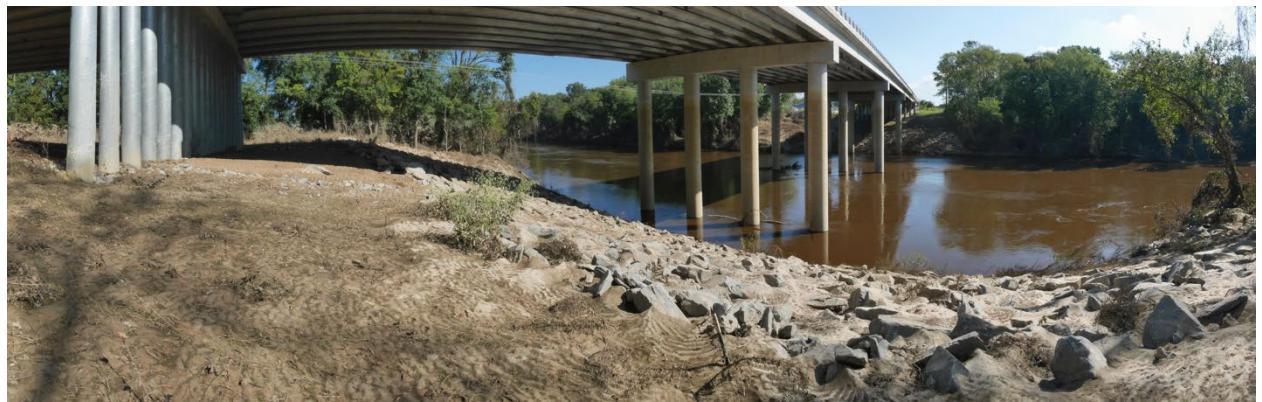
The Business 95 Bridge over the Cape Fear River in Fayetteville, NC, is about a half mile away from the Business 95 Bridge over Cross Creek (Fig. 6.2.1-1). The Business 95 Bridge over the Cape Fear River, as seen in Fig. 6.2.2-1, was exposed to significant high water, as indicated by the muddied water mark on the bridge columns (Fig. 6.2.2-2). The bridge foundations over the water consist of drilled shafts, approximately 6 ft in diameter. Hollow pipe piles supported the bridge of the southern river bank (Fig. 6.2.2-3). The shallow sloping ground beneath the bridge

Fig. 6.2.2-2 – Business 95 Bridge at Cape Fear River, looking northeast across Neuse River (September 26, 2018, 35.0582 N, 78.8557 W)

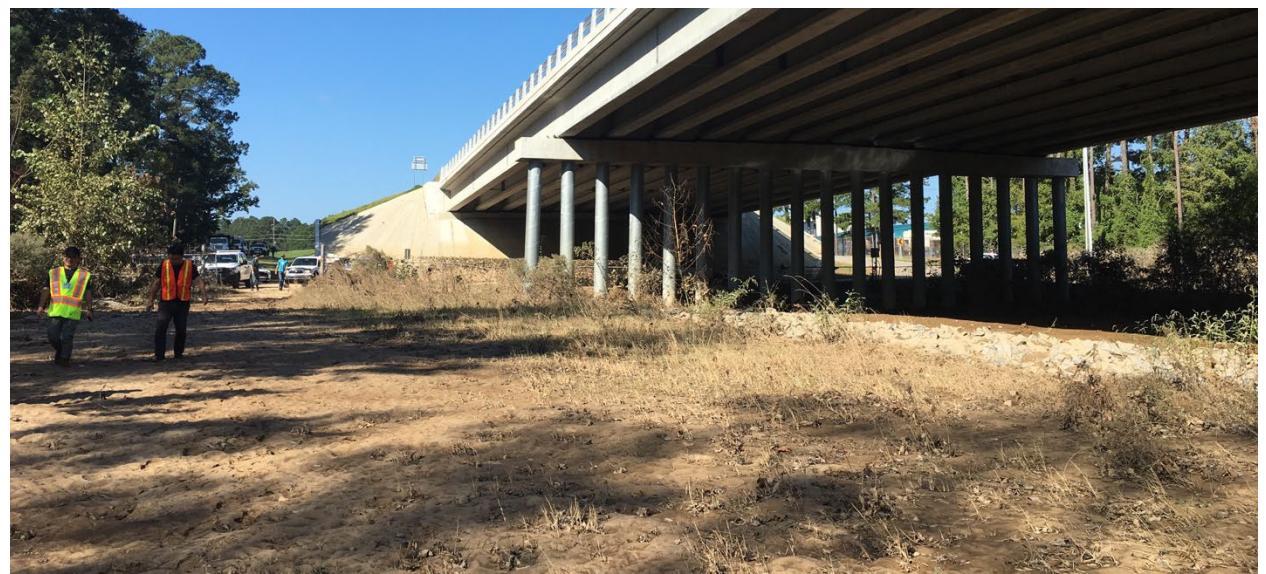
Fig. 6.2.2-3 – Business 95 Bridge at Cape Fear River, looking southwest at southern bridge abutment (September 26, 2018, 35.0582 N, 78.8559 W)

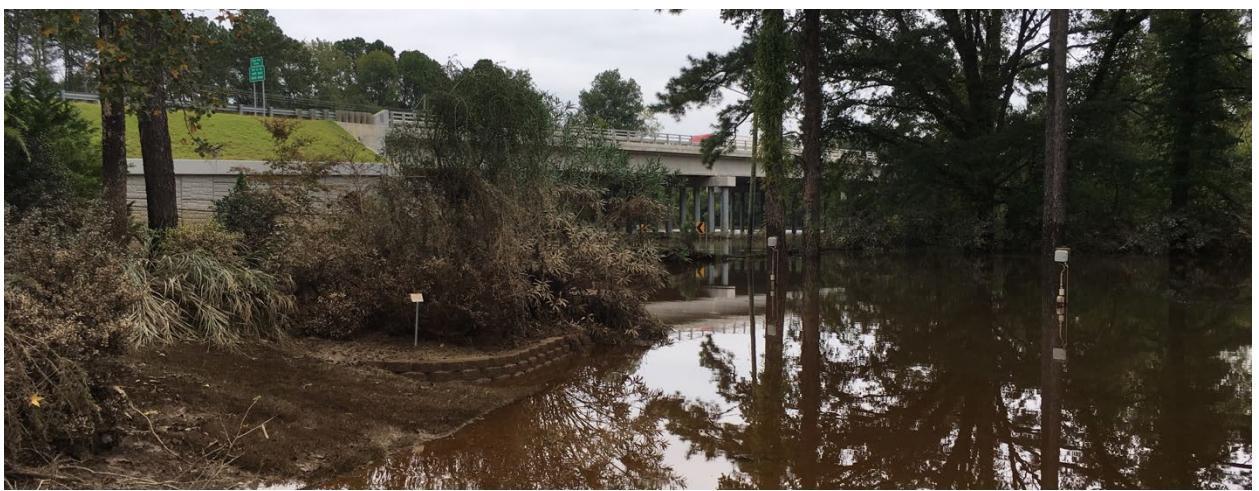
on the southern bank was under water for at least a week (Fig. 6.2.2-4) due to the prolonged flooding of the Cape Fear River. The river bank beneath the bridge was reinforced with riprap after Hurricane Matthew in 2016 (Figs. 6.2-1 - 6.2-4). The armoring of the river bank resulted in no additional erosion observed after Hurricane Florence.

Fig. 6.2.2-4 – Business 95 Bridge at Cape Fear River, looking north at southern bridge abutment; view from Fayetteville Technical Community College Horticulture Educational Center (September 21, 2018, 35.0575 N, 78.8571 W)

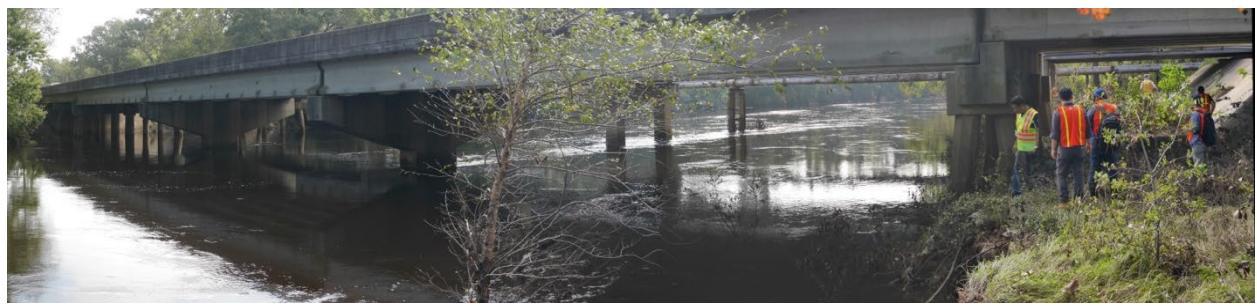
The East Team visited the I-795 Bridge at the Neuse River in Goldsboro, NC (location and aerial - Fig. 6.2.3-1 and Fig. 6.2.3-2). We observed evidence of flood levels up to the bridge deck (Fig. 6.2.3-3) and erosion of the river bank upriver of the bridge in several locations (Fig. 6.2.3-4), with erosion scarps several yards in length. The flood stranded large catfish along the western riverbank (Fig. 6.2.3-5).

Fig. 6.2.3-3 – I-795 Bridge at Neuse River, looking down river (September 25, 2018, 35.3443 N, 78.0277 W)

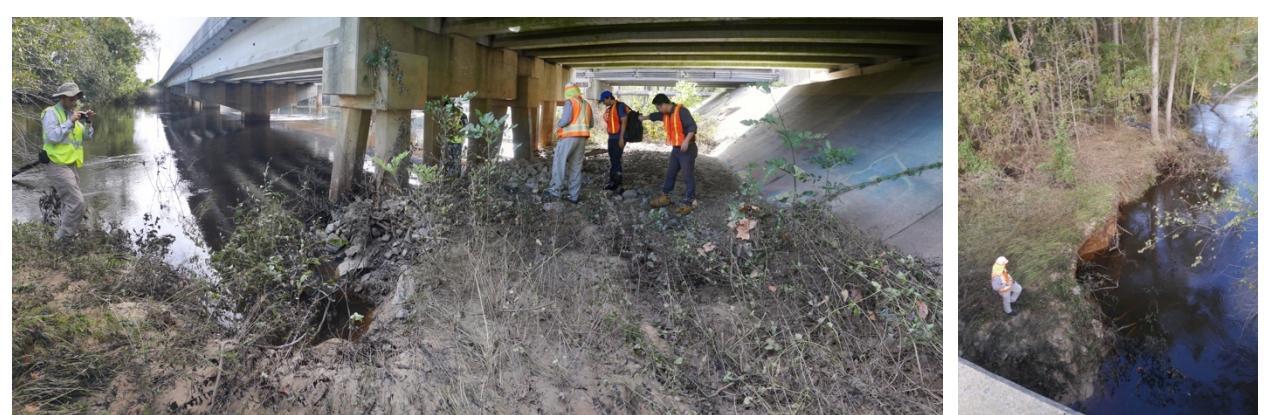
Fig. 6.2.3-4 – I-795 Bridge at Neuse River (right image) looking downriver with bank scour ahead of bridge pilings, and (left image) view of upstream bank scour from bridge elevation (September 25, 2018, 35.3442 N, 78.0277 W)

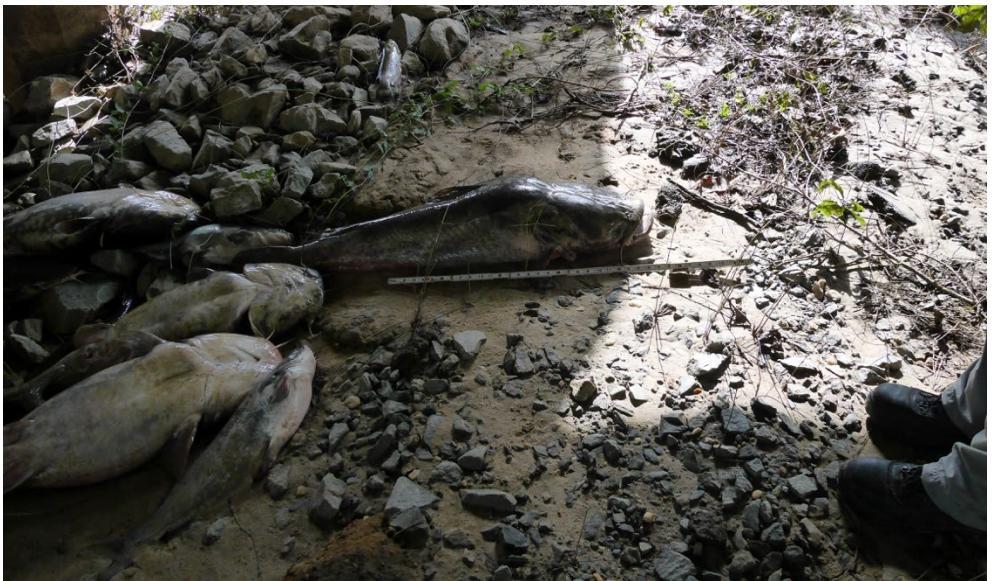
Fig. 6.2.3-5 – I-795 Bridge at Neuse River, beneath western bridge approach, evidence of high water with stranded multiple large catfish (September 25, 2018, 35.3441 N, 78.0276 W)

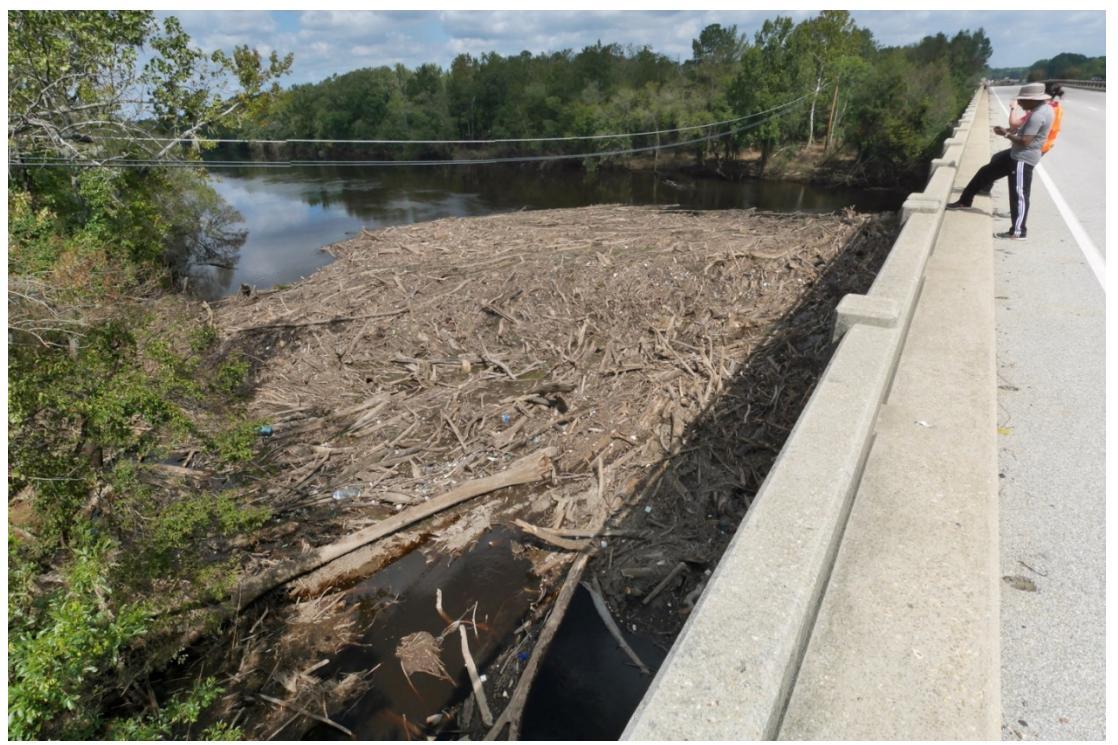
The notable observation about the bridge was the large debris pile, which had collected against the bridge supports of the southbound lane of US 701. The debris pile could be seen in the September 18, 2018 aerial photograph (Fig. 6.2.4-3) and on September 26, 2018 when we visited (Fig. 6.2.4-4). The bridge supporting the southbound lane (upstream side) of US 701 was still closed on September 26.

Fig. 6.2.4-4 – US 701 Bridge at Cape Fear in Elizabethtown, NC, looking north at the debris pile (September 26, 2018, 34.6321° N, 78.6036° W)

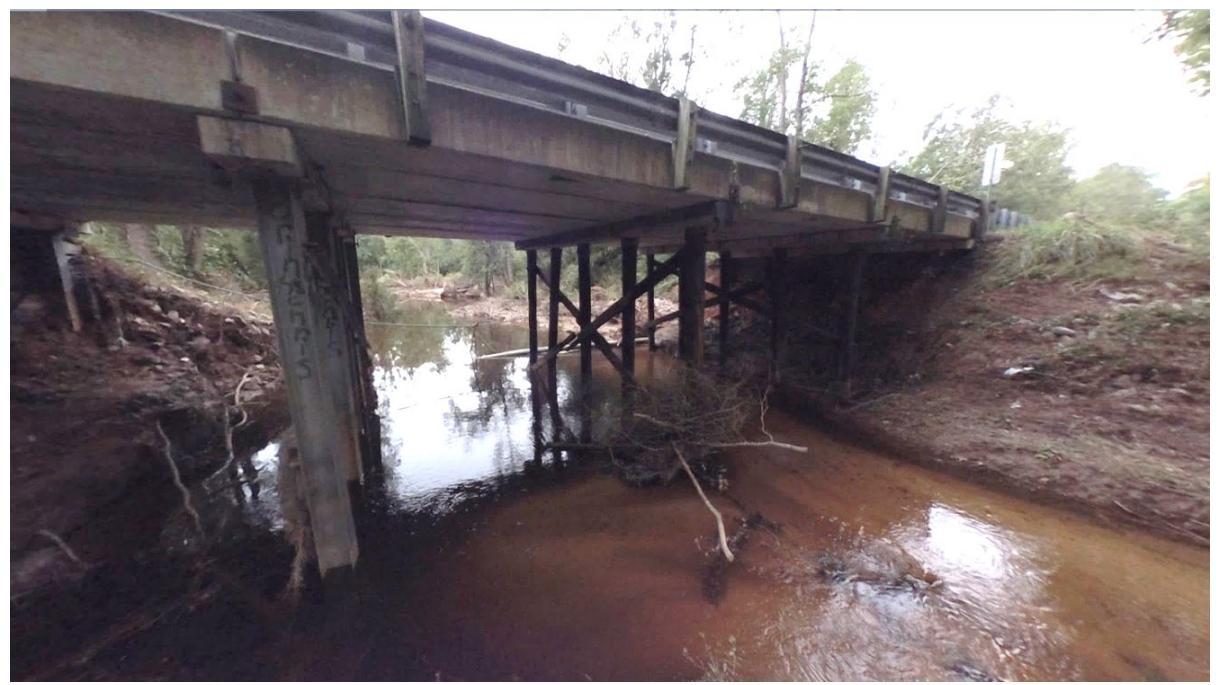
The West Team visited the Davis River Bridge in Chesterfield County, SC (Fig. 6.2.5-1) on September 25, 2018. The bridge carries Davies River Road over Jimmies Creek in the Pee Dee River Basin. The bridge was closed due to scour observed around the eastern bent (Fig. 6.2.5-2 and 6.2.5-3).

Fig. 6.2.5-2 – Davis Road Bridge looking south (September 25, 2018, 34.7883 N, 80.0802 W)

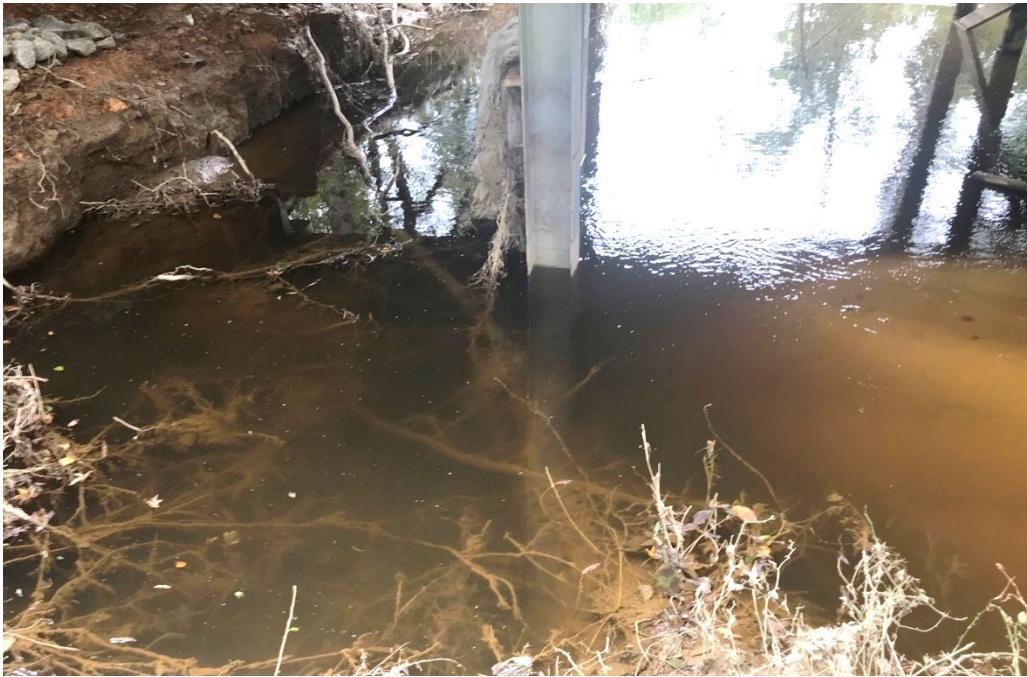
Fig. 6.2.5-3 – Davis Road Bridge scour hole (September 25, 2018, 34.7883 N, 80.0802 W)

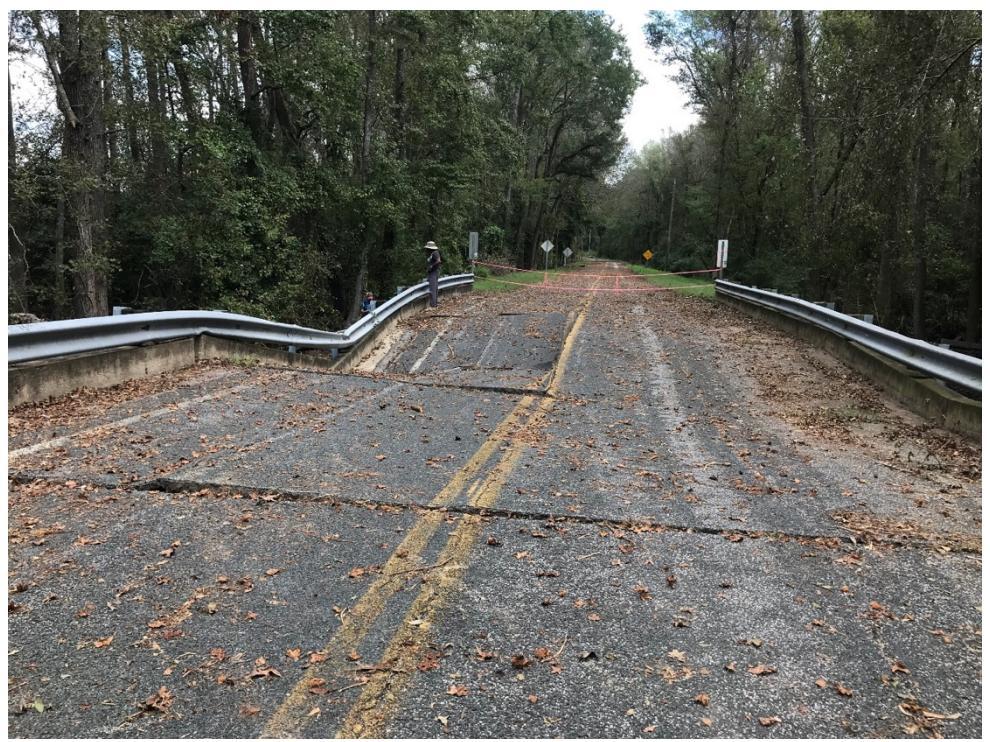
The breach of David's Millpond Dam near Bennettsville, SC (see Section 4.2.11) caused significant scour of the bridge piles just downstream of the dam (Fig. 6.2.7-1 - location and Fig. 6.2.7-2 - aerial). The bridge deck settled on the order of 2 to 3 ft (Fig. 6.2.7-3). The depth of scour was approximately 11 ft and likely completely undermined the piles (Fig. 6.2.7-4). The bridge carried David's Millpond Road / State Road S-35-33 across Naked Creek.

Fig. 6.2.7-3 – David's Mill Pond Bridge deck subsidence (September 25, 2018, 34.6443 N, 79.7482 W)

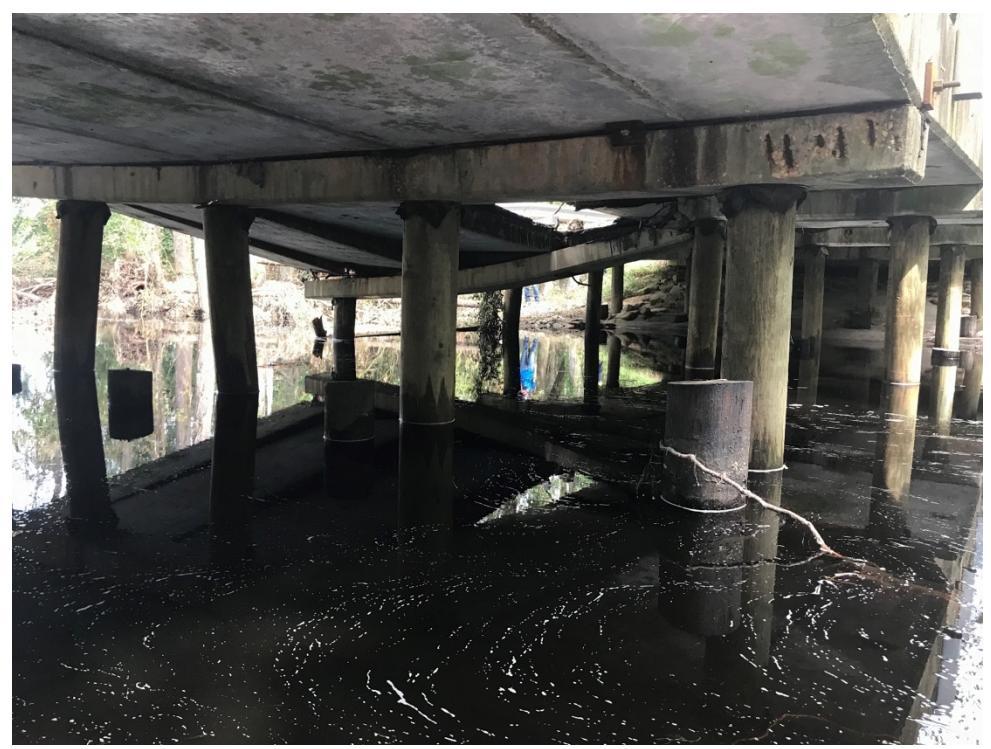
Fig. 6.2.7-4 – David's Mill Pond Bridge pile settlement (September 25, 2018, 34.6443° N, 79.7482° W)

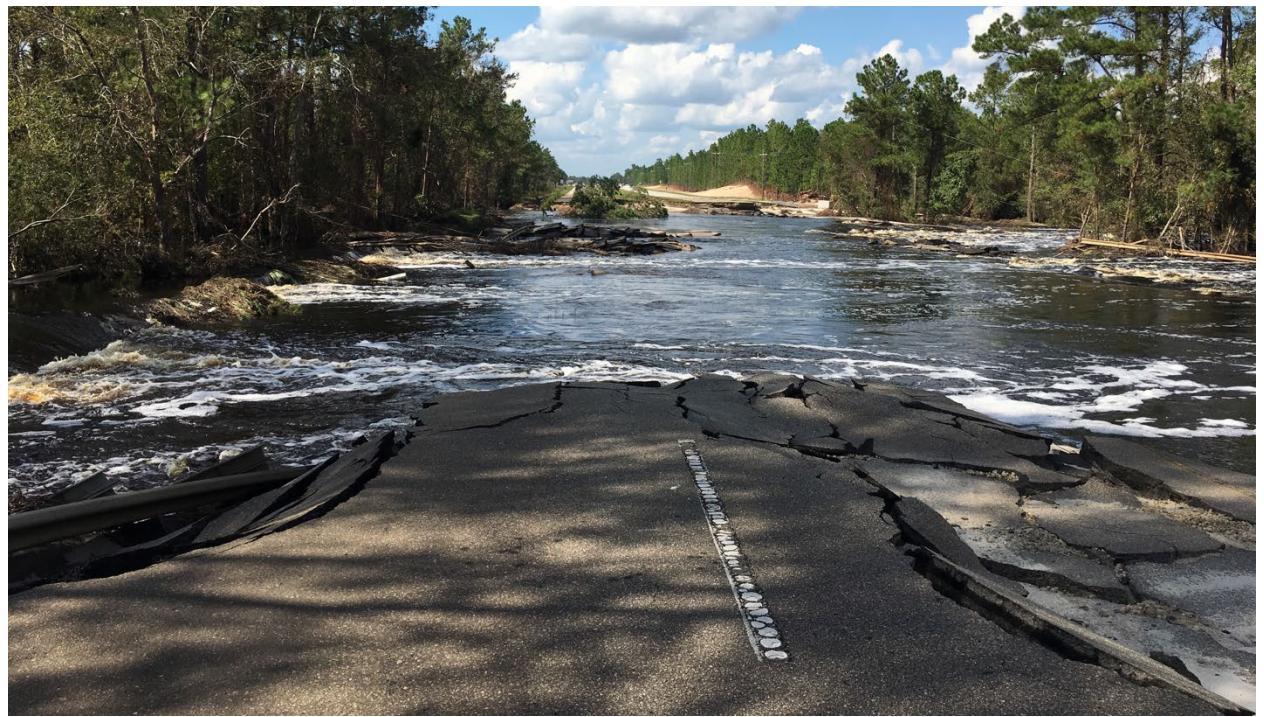
A section of US 421 north of Wilmington, in New Hanover County, NC (location - Fig. 6.3.1-1) was washed out by flow between two branches of the Cape Fear River. High water levels on the main branch of Cape Fear River on the southwest side of the highway overtopped the highway and created a breach or washout to the Northeast Cape Fear River on the northeast side of the highway (Figs. 6.3.1-2, -3). The foundation soil was significantly undermined and a large section of the roadway, estimated to be about 500 ft in length, was washed away (Fig. 6.3.1-4). Water was still flowing eastward across the site, and, based on highwater marks on the pavement, the peak flood water level reached a level about 6 ft higher than the observed water elevation at the time of our visit.

Fig. 6.3.1-4 – US 421 washout by Cape Fear River, looking northwest across washout (September 26, 2018, 34.3308 N, 77.9996 W)

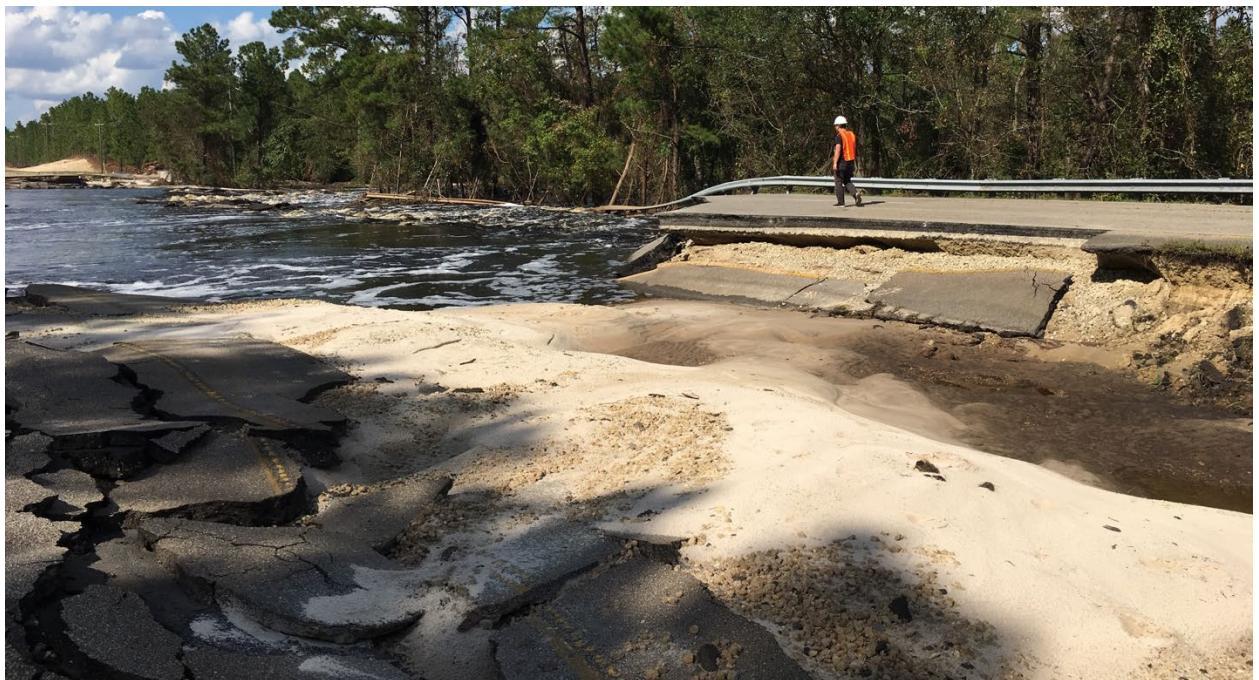
The sandy soil beneath the pavement eroded about 4.5 ft below the pavement elevation at the southern bank of the washout (Figs. 6.3.1-5 - 6.3.1-7). Additional erosion was observed further south of the washout on the northbound side of the road where the shoulder of the roadway was undermined as the flood water connected to an existing slough (Fig. 6.3.1-8).

Fig. 6.3.1-6 – US 421 washout by Cape Fear River, looking northwest across washout, undermined roadway and foundation soil in foreground (September 26, 2018, 34.3306 N, 77.9995 W)

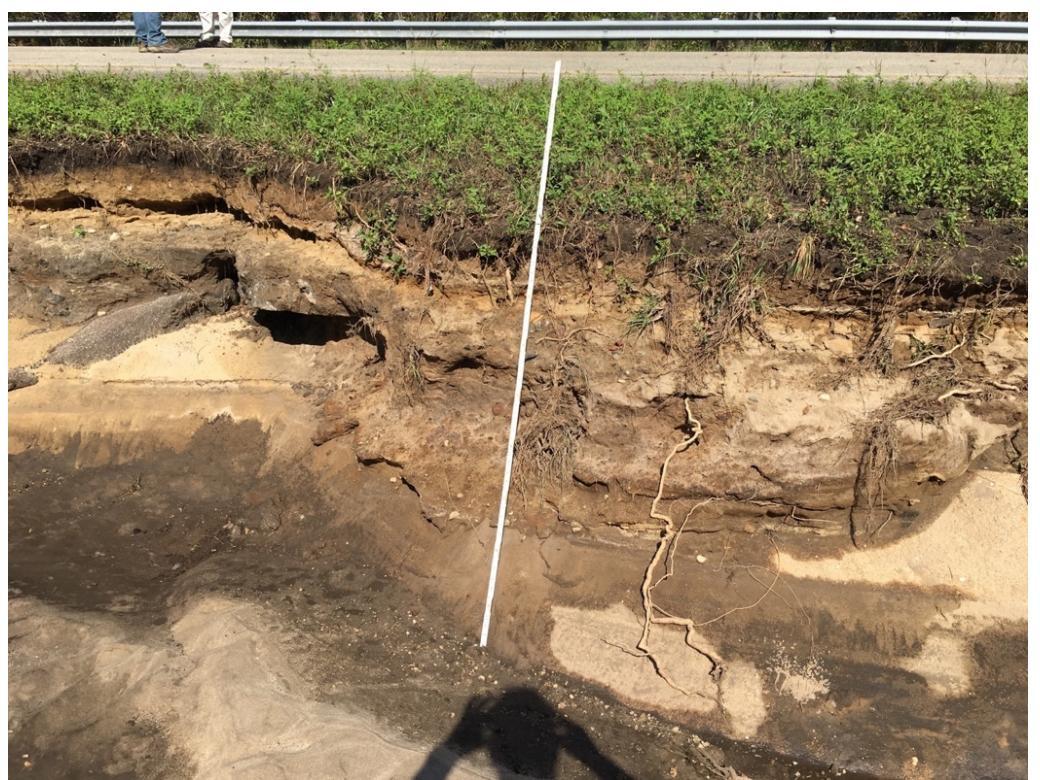
Fig. 6.3.1-7 – US 421 washout by Cape Fear River, about 4.5 ft of soil eroded, measured between the northbound and southbound lanes (September 26, 2018, 34.3306 N, 77.9995 W)
