#### **Geotechnical Effects of Hurricane Florence**

Geotechnical Extreme Events Reconnaissance (GEER) Association.

GEER Association Report No. GEER-063

April 2019 Revision 1 - June 2019

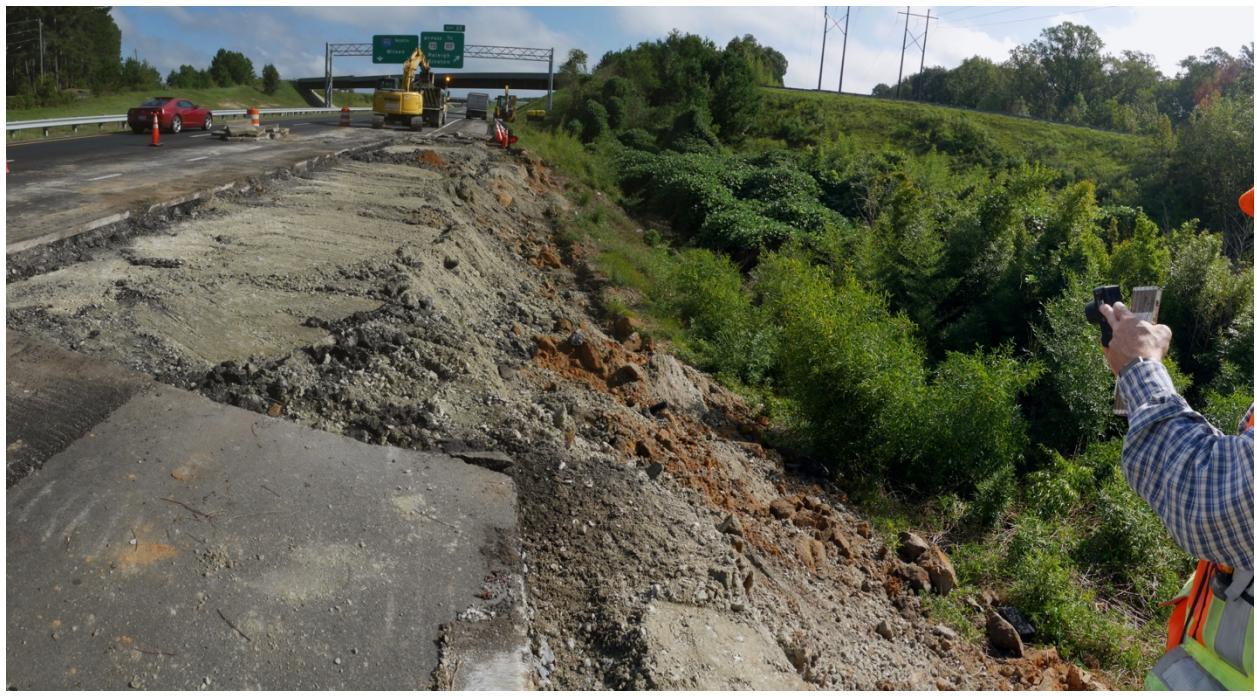
The East Team visited a section of I-795 US 421 north of Goldsboro, NC (Figs. 6.3.2-1) that was damaged due to an embankment slope failure (Figs. 6.3.2-2 through 6.3.2-4). The roadway embankment, estimated to be more than 20 ft high, was built across the flood plain of the Smith Mill Run stream, which is located at the toe of the slope and drains into the Little River and eventually into the Neuse River about 6 stream-flow miles / 3.3 straight-line miles south of the slope failure.

The slope failure appeared to have extended across the breakdown lane into the right lane of the highway a distance of about 15 ft from the top of slope. The slope failure had been repaired at the time of our visit and the highway restoration was underway. Road runoff had eroded a significant gully just south of the slope failure (Fig. 6.3.2-5), which was indicative of the rainfall intensity in the area. Contributing factors to the failure could have included saturated soil conditions, varying or perched pore pressures in the embankment soils, which include a range of silty and clayey sands, foundation soil conditions, or effects from the rise and drawdown of the adjacent stream.

Fig. 6.3.2-3 – I-795 slope failure at northbound lane (September 25, 2018, 35.4201 N, 77.9976 W)

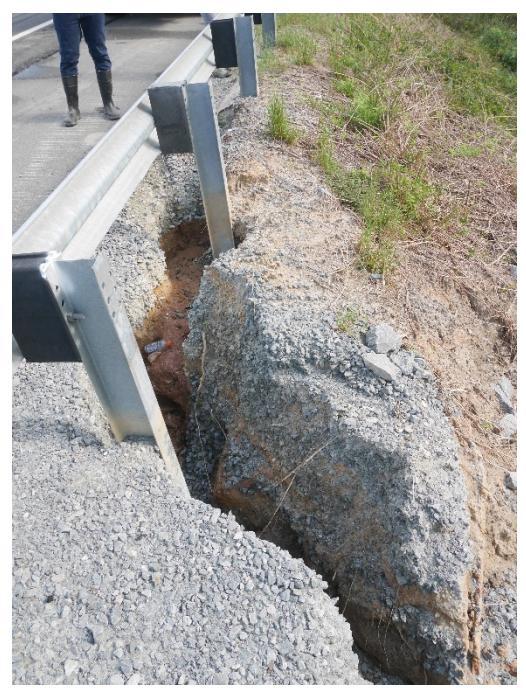
Fig. 6.3.2-5 – Erosion gully immediately south of slope failure (September 25, 2018, 35.4199 N, 77.9980 W)

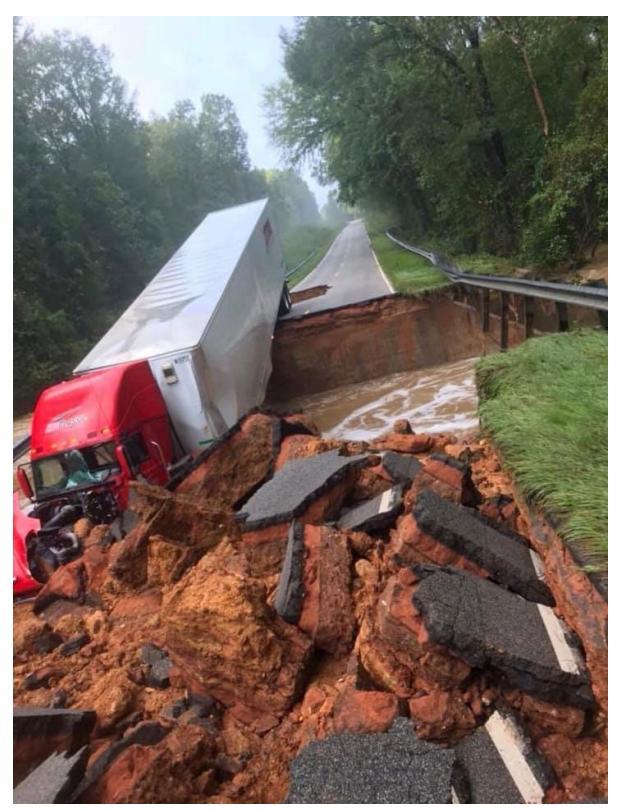
The West Team also visited a second site along Highway 145 in Chesterfield County, SC (Fig. 6.3.3-1) about 3 miles south of the previous site (Section 6.3.3). At this site, scour around a culvert at Jimmies Creek created a severe washout of the roadway. The Figure 6.3.4-1 image became viral after a social media post from the truck driver's wife. The site was under construction when the GEER Florence team visited on September 25, 2018 (Fig. 6.3.4-2).

Fig. 6.3.4-1 – Failed culvert off SC 145 Location 2 West (source WSOC TV)

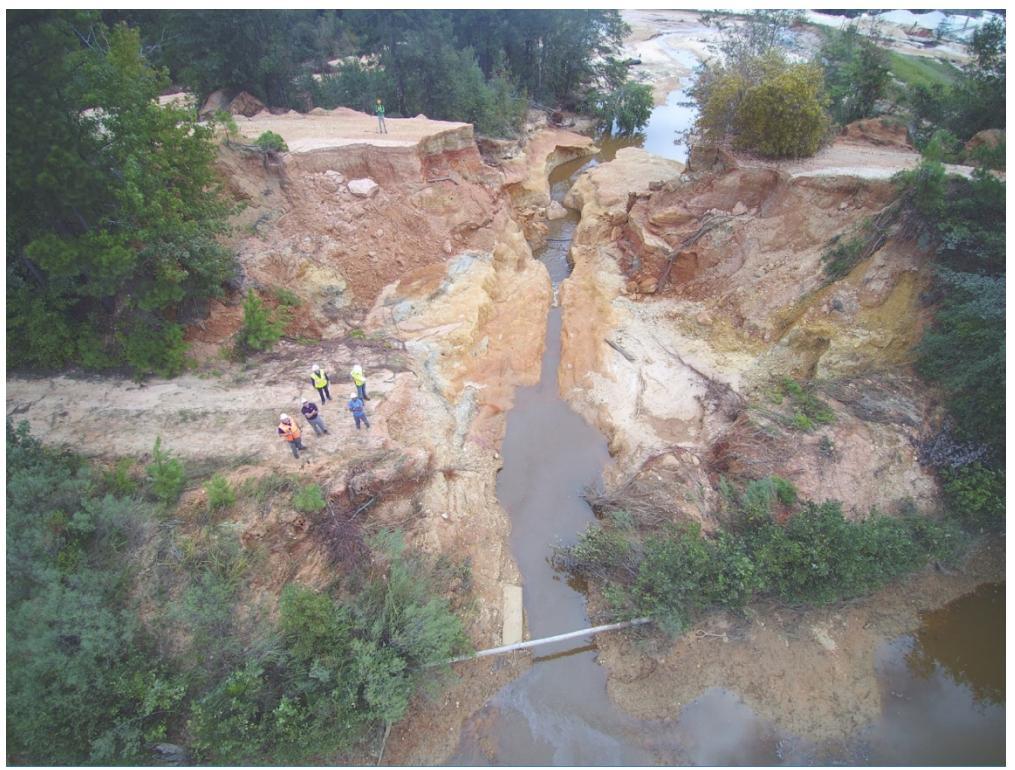
B.V. Hedrick haul road was an elevated embankment that crossed the Hedrick Tailings Pond #1 / Recirculating Pond along the Island Creek floodway and may have been created by the mining operations. The haul road was not intended to be a water retaining structure and had 48-inch and 36-inch culverts to allow flow through the embankment. During the storm the 48-inch culvert became plugged, and 36-inch culvert did not have sufficient capacity to discharge flood flows., We understand that flood water overtopped and breached the road embankment around 4:30 PM on September 17, 2018 (Figs. 6.3.5-3, -4, -5), causing the Tailings Pond #1 to overtop and breach. Upstream releases or breaches from holding ponds may have contributed to the flood flows.

Fig. 6.3.5-3 – B.V. Hedrick Haul Road breach looking downstream towards the Tailings Pond # 1 / Recirculating Pond (September 24, 2018, 34.950 N, 79.935 W)

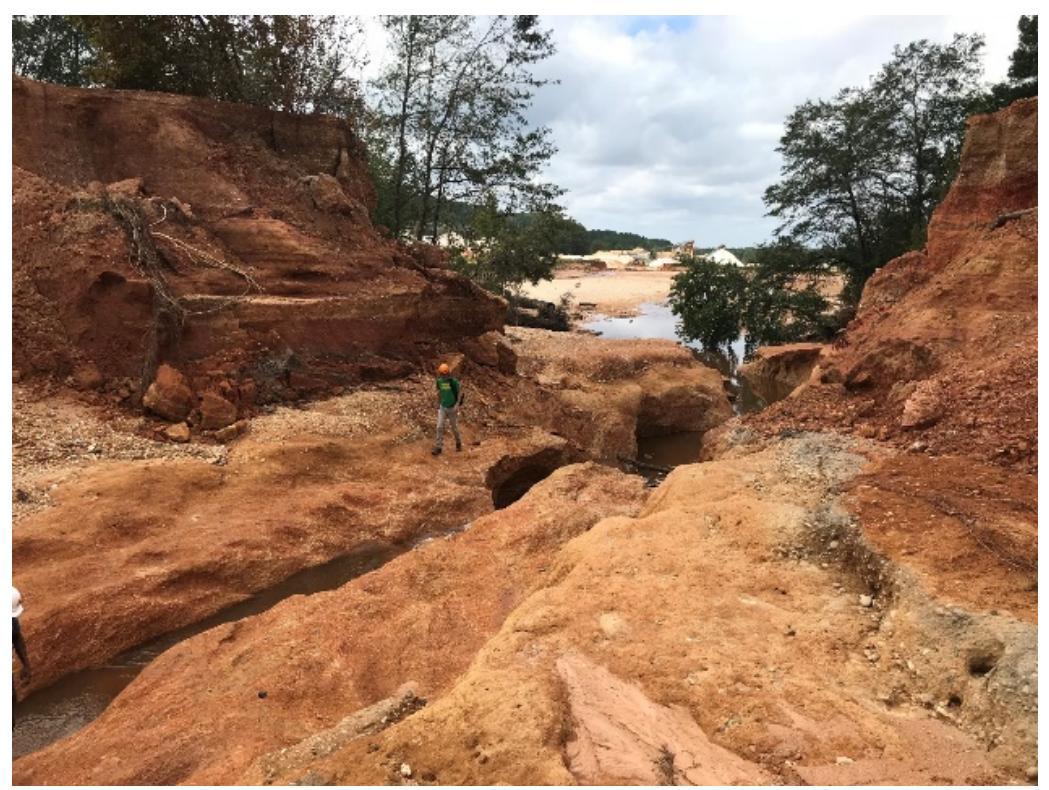
Fig. 6.3.5-4 – Hedrick Haul Road breach (September 24, 2018, 34.950 N, 79.935 W)

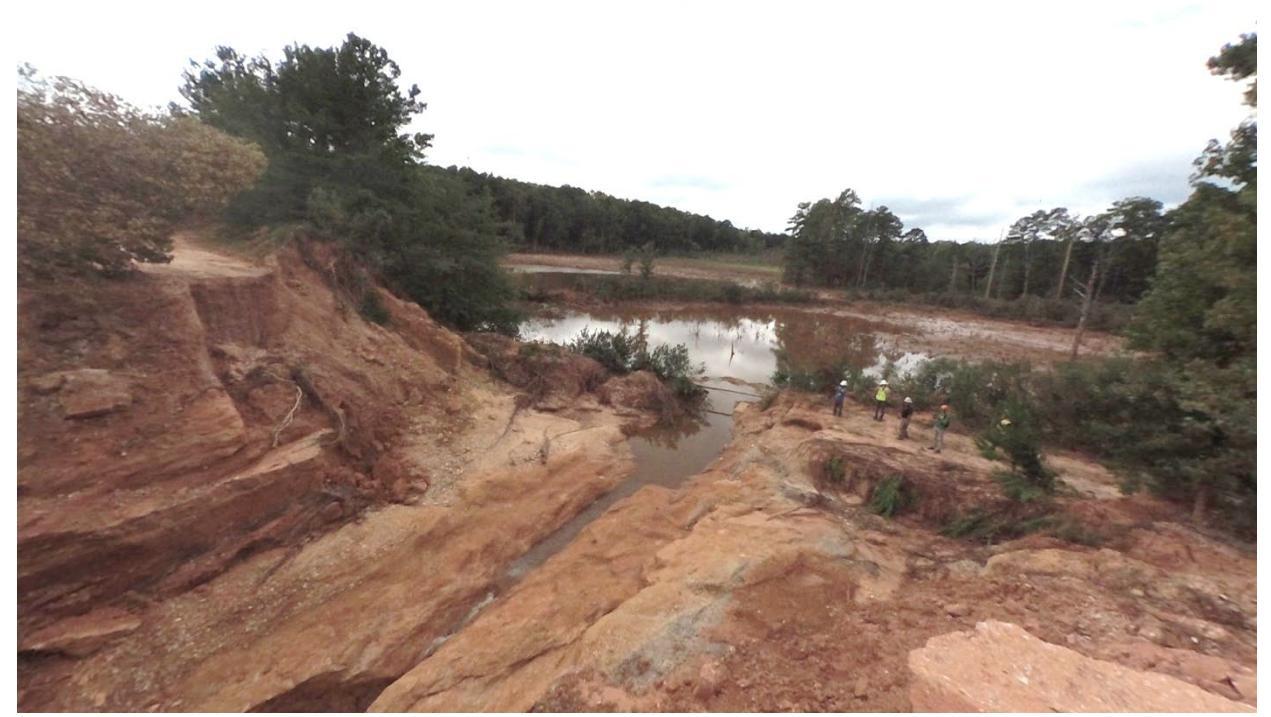
Fig. 6.3.5-5 – Hedrick Haul Road (September 24, 2018, 34.950 N, 79.935 W)

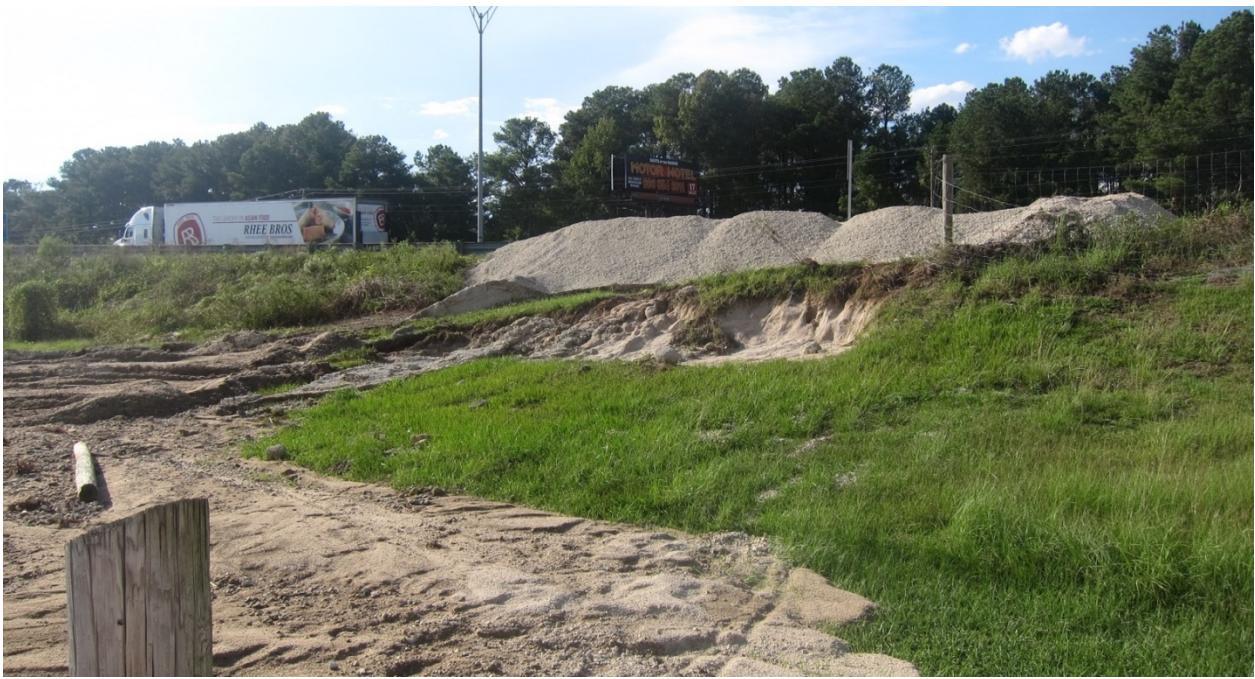
GEER Florence team visited Lumberton, NC on September 27, 2018. While driving on Crystal Road along the southeast side of I-95 (Figure 6.3.8-1), we observed a repair (Fig. 6.3.8-2) of the I-95 embankment southeast slope. At the time the team was traveling between a temporary closure levee constructed under the I-95 overpass bridge and the permanent levee to the east. The road damage was at the 18-mile marker along the south side of the I-95 embankment near a roadside drainage gutter and catch basin (Fig. 6.3.8-3). We expect that the highway catch basin did not have the sufficient capacity for stormwater flow running down the highway, which slopes down to the east from the overpass bridge, and that storm water on the road poured over and eroded the embankment slope. Gravel was placed in the area as a temporary protection and repair. The embankment damage did not appear to extend to the roadway.

Fig. 6.3.8-2 – Damaged slope and dumped gravel for repair, (September 27, 2018, 34.6289 N, 79.0361 W)

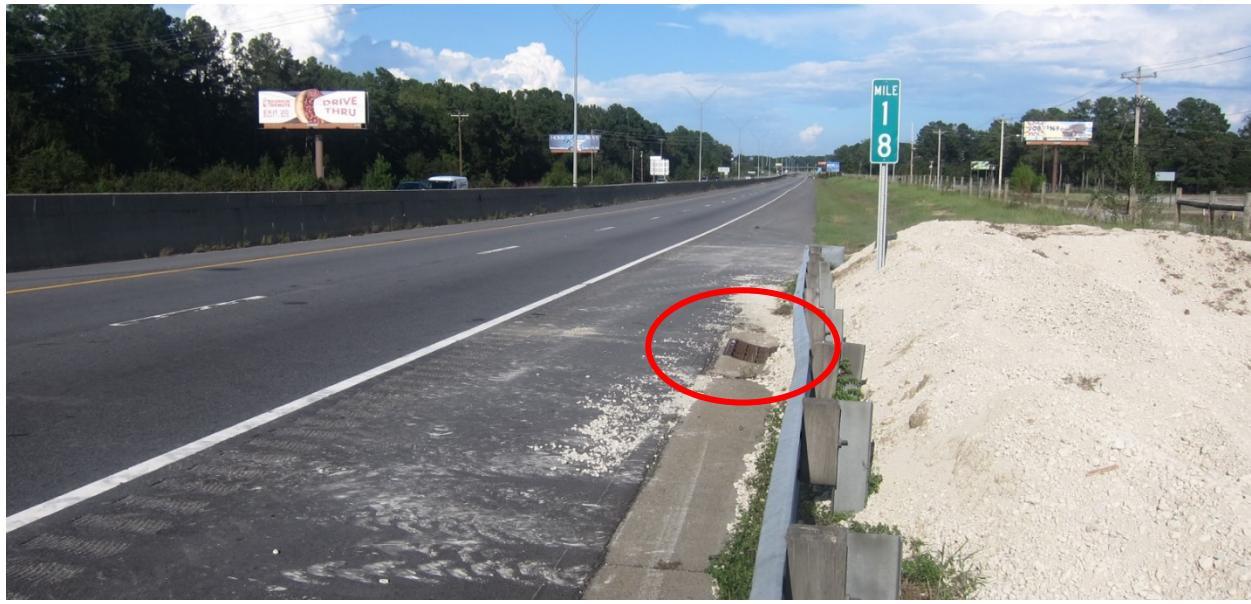
Fig. 6.3.8-3 – US-95 looking Northeast, marker 18 and catch basin, (September 27, 2018, 34.6289 N, 79.0361 W)

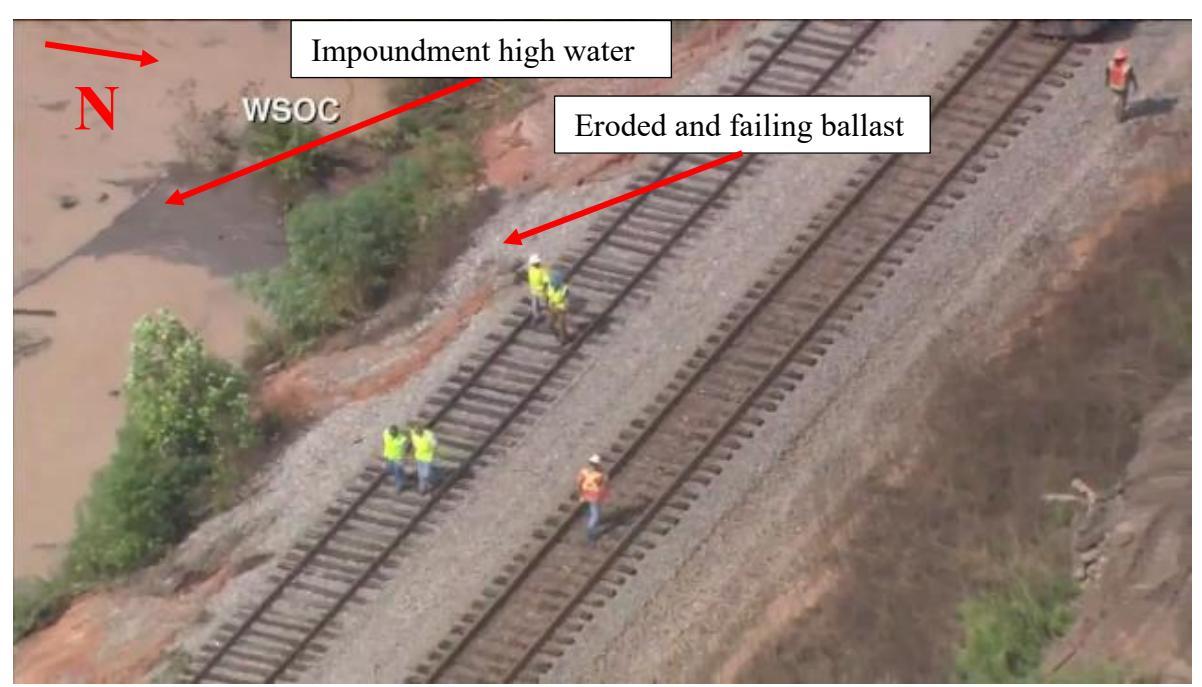
The team was unable to access the site, but the derailment was well documented by WSOC from Charlotte, NC. The GEER team walked the railroad just to the east of the Old Castle/Bonsal property. The derailment site tracks were located on the north side of a pond impounded by the Bonsal Tailings Dam along Island Creek. It appears from the April 20, 2018 Google imagery that there had been a significant ballast repair immediately east of the derailment site (Fig. 6.4.1-3). Aerial photographs (Figs. 6.4.1-4, 6.4.1-5) after the storm show significant erosion of the ballast in that section.

Fig. 6.4.1-4 – CSX Train Derailment (WSOC-TV, September 17, 2018, 34.9511 N, 79.9443 W)

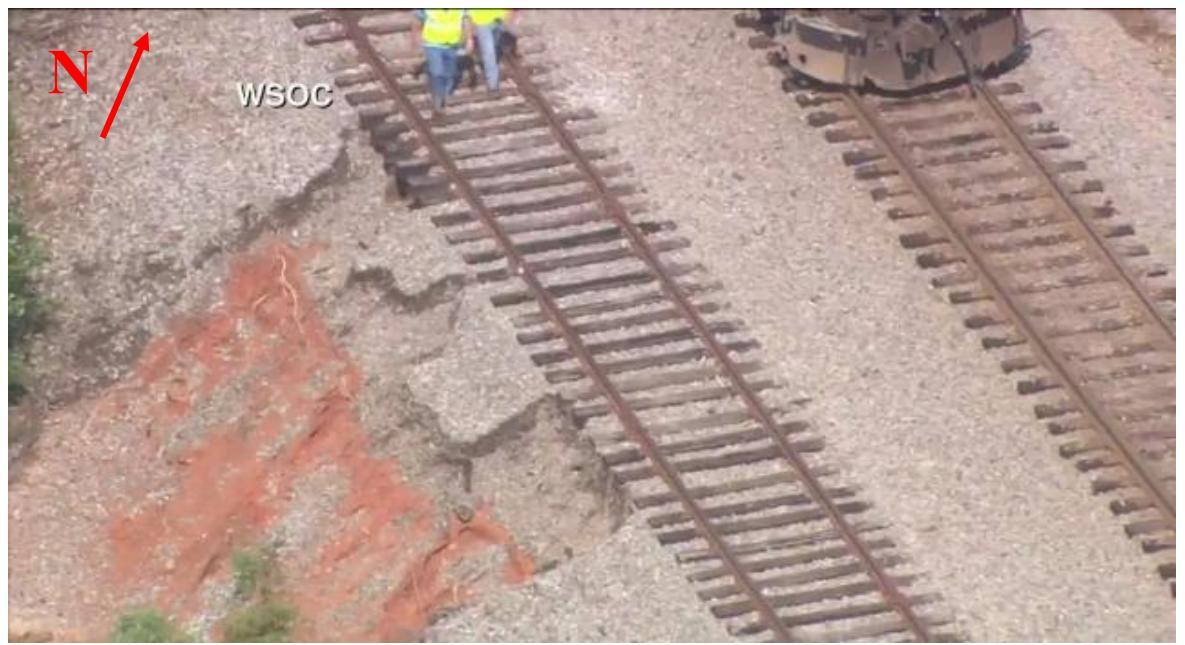
Fig. 6.4.1-5 – CSX Train Derailment (WSOC-TV, September 17, 201834.9511 N, 79.9443 W)

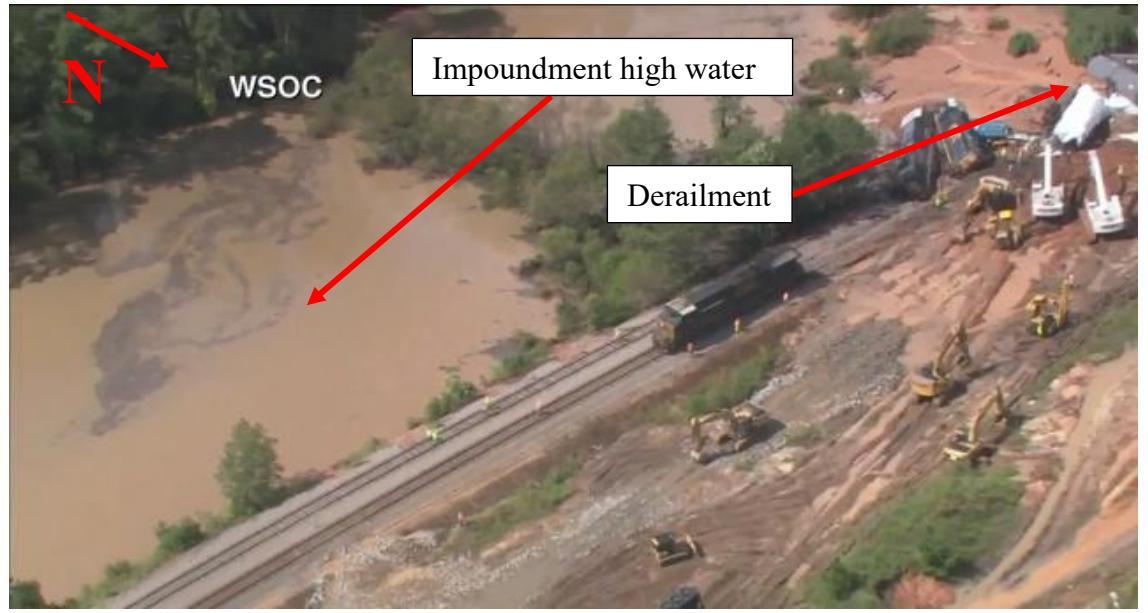
The pool of the Bonsal Tailings Dam impoundment just south of the railroad was elevated after the storm and continued to drain for several days. The water released by the dam was the event that triggered failure of the Hedrick Haul Road and the Hedrick Tailings Dike. Figures 6.4.1-6 through 6.4.1-8 show the impoundment, dam, and drainage in relation to the derailment.

Fig. 6.4.1-6 – CSX Train Derailment (WSOC-TV, September 17, 2018, 34.9511 N, 79.9443 W)

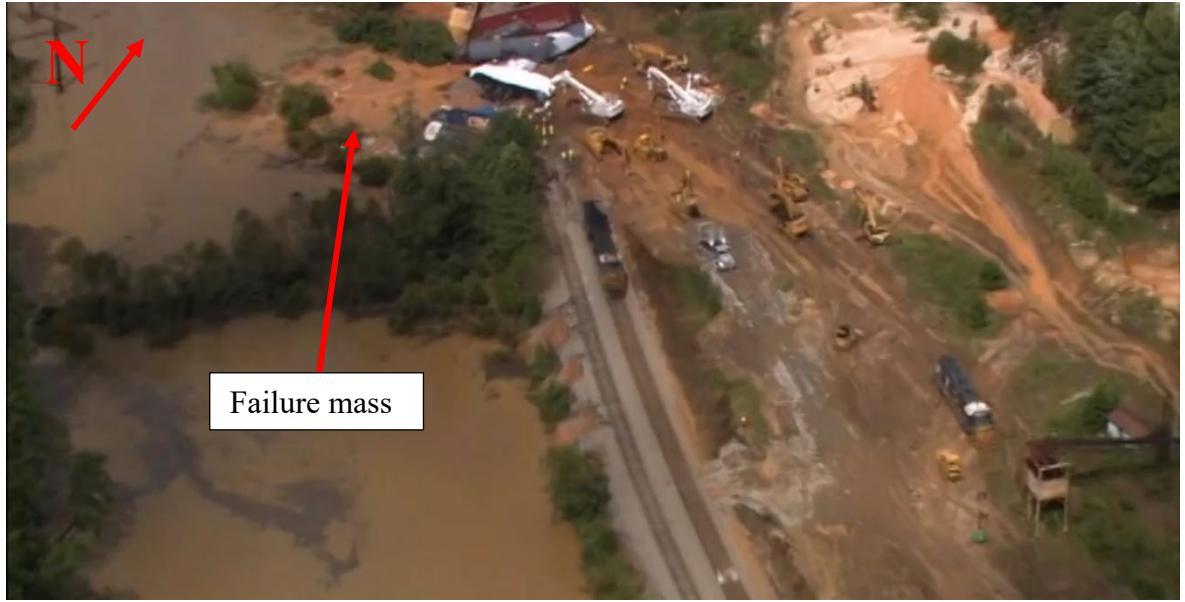
Fig. 6.4.1-7 – CSX Train Derailment (WSOC-TV, September 17, 2018, 34.9511 N, 79.9443 W)

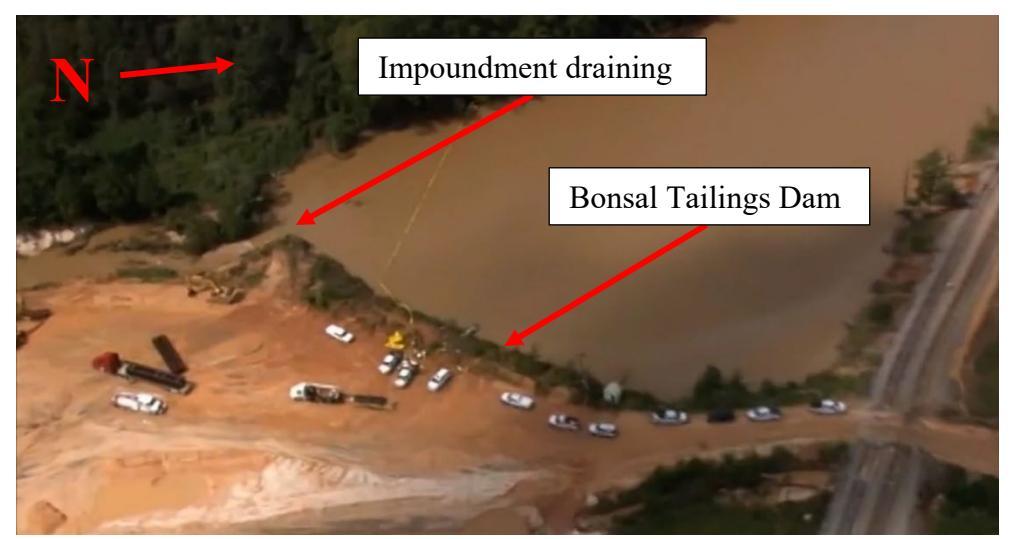
Fig. 6.4.1-8 – Bonsal Tailings Dam draining (WSOC-TV, September 17, 2018, 34.9494 N, 79.9418 W)

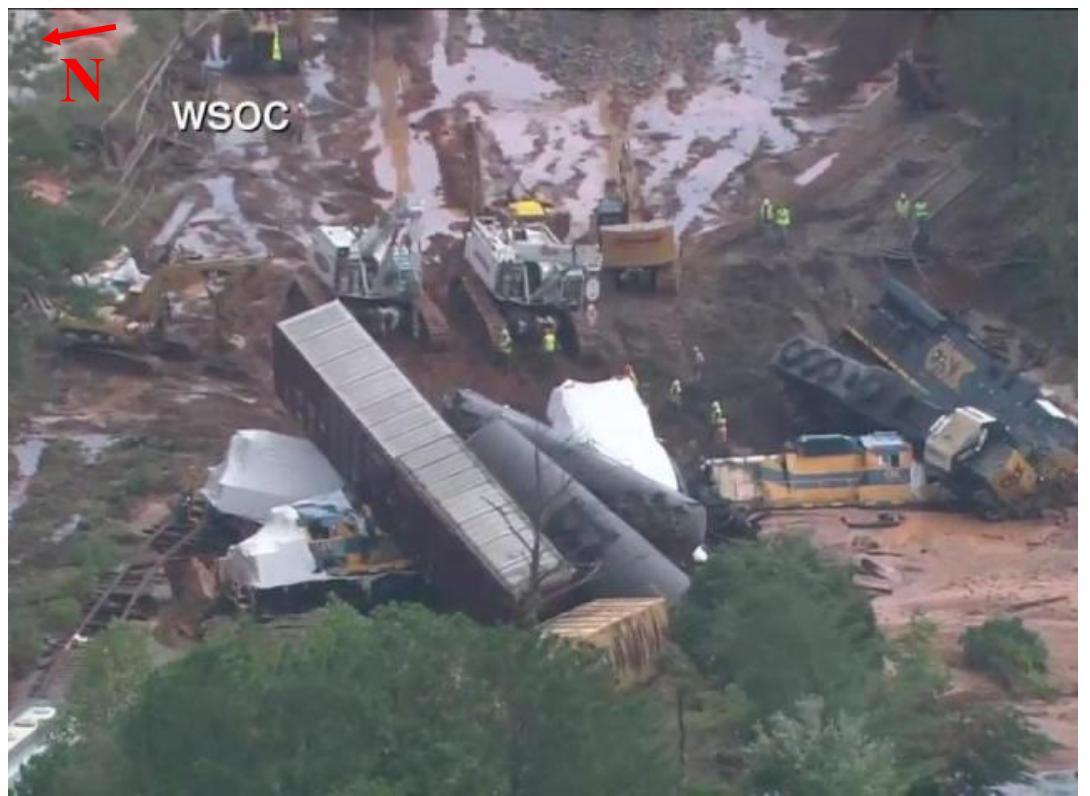
In total, nine locomotives and five rail cars derailed in the incident. By the time the GEER team visited the site on Monday, September 25, CSX had established a mobile command center and was working to clear the rolling stock and repair the main line. Rail traffic was diverted to a side track. Fig. 6.4.1-9 shows the impact of the derailment on the train and the recovery effort.

Fig. 6.4.1-9 – CSX Train Derailment aftermath (WSOC-TV, September 17, 2018, 34.9513 N, 79.9446 W)

Possible causes for the derailment include reduced bearing capacity or embankment stability due to the high water, groundwater flow and associated internal erosion, embankment scour, and overtopping erosion. The embankment appeared to fail to the south side abutting the west end of the impoundment based on the soil fan or failure mass on that side of the tracks.

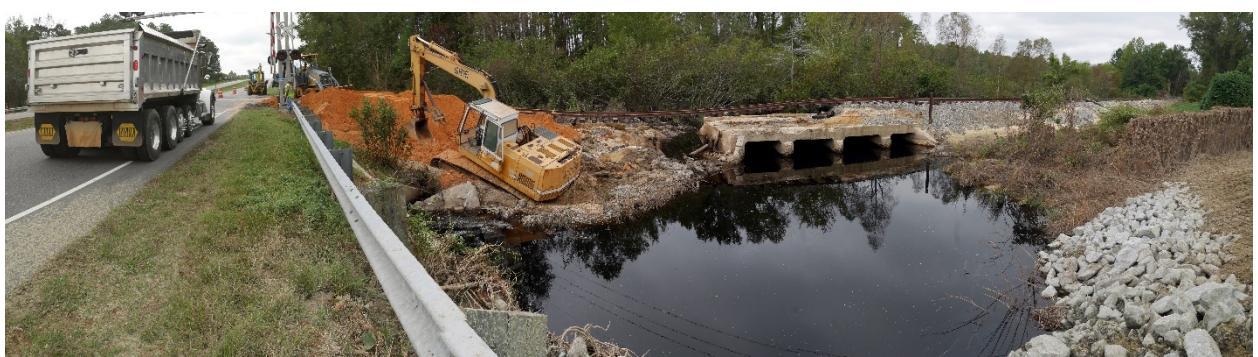
<u>US 15-501 Site Washout</u> - The washout at US 15-501 was the location of two Leith Creek culverts, one beneath the highway and one below the CSX rail line. The embankment on both sides of the rail line culvert on the west side of US15-501 was washed away (Figs. 6.4.2-3 and - 4). There was also significant damage to the ballast on the east side of US 15-501 and, based on the pavement repairs, damage to the highway (Fig. 6.4.2-5).

Fig. 6.4.2-3 – Rail line washout and repair at US 15-501 (September 27, 2018, 34.7936 N, 79.4619 W)

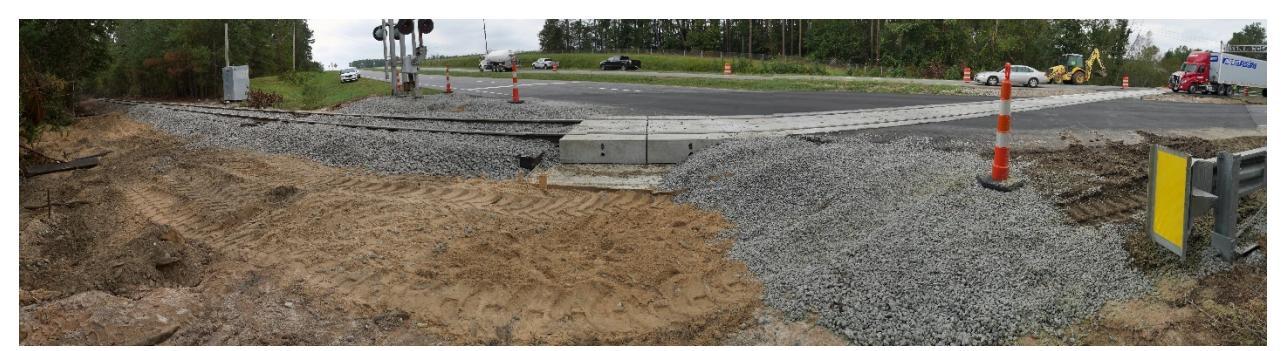
Fig. 6.4.2-5 – Washout and partial repairs northbound of US 15-501 looking south (September 25, 2018, 34.7930 N, 79.4621 W)

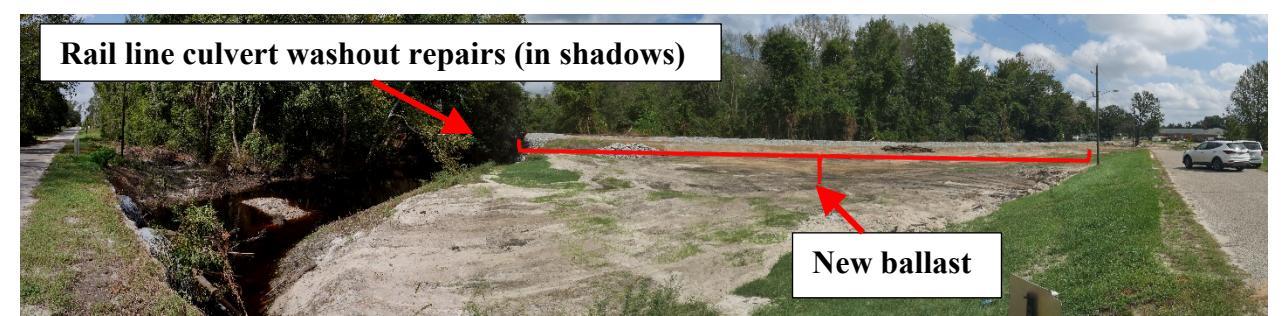
<u>McKay Street Site Washout</u> – The rail line crosses Leith Creek again just north and upstream of McKay Street. Leith Creek in this area forms the boundary between Laurinburg and East Laurinburg. The washout at this location was at a culvert crossing and, based on the new ballast to the east, washed out the embankment over a length of about 400 ft, most likely due to overtopping (Figs. 6.4.2-6, -7). The downstream culvert road crossing at McKay Street did not wash out, possibly because the rail line culvert prevented significant debris from reaching the McKay Street culverts (Fig. 6.4.2-8).

Fig. 6.4.2-6 – Looking upstream from McKay Street toward rail line (September 27, 2018, 34.7713 N, 79.4495 W)

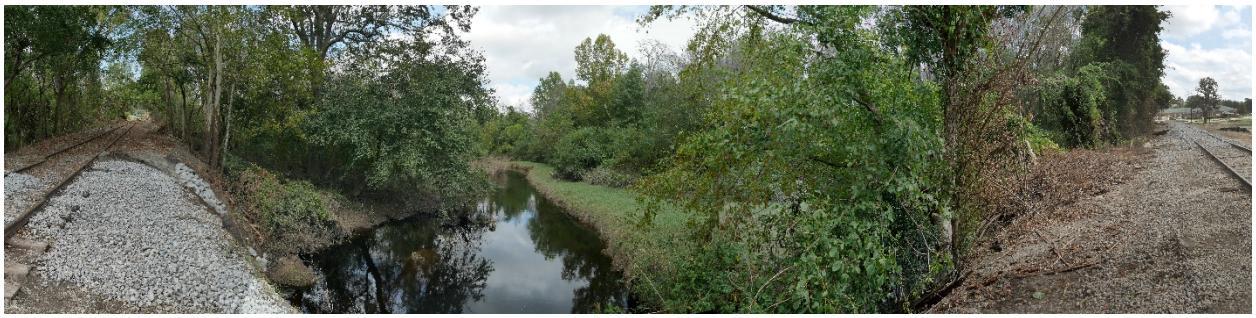
Fig. 6.4.2-7 – Looking upstream from the rail line culvert crossing (September 27, 2018, 34.7717 N, 79.4495 W)

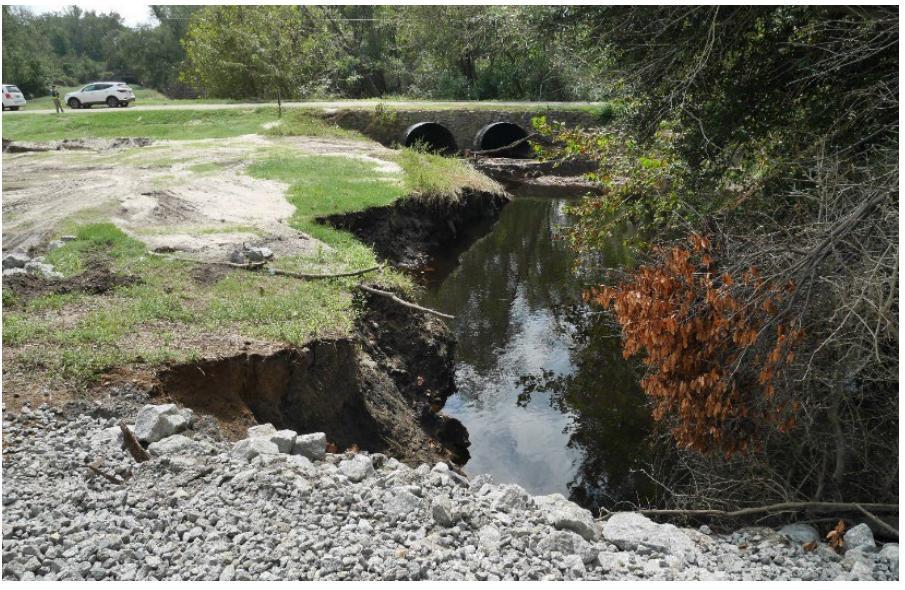
Fig. 6.4.2-8 – Looking downstream across rebuilt rail line embankment toward the McKay Street culvert crossing (September 27, 2018, 34.7717 N, 79.4495 W)

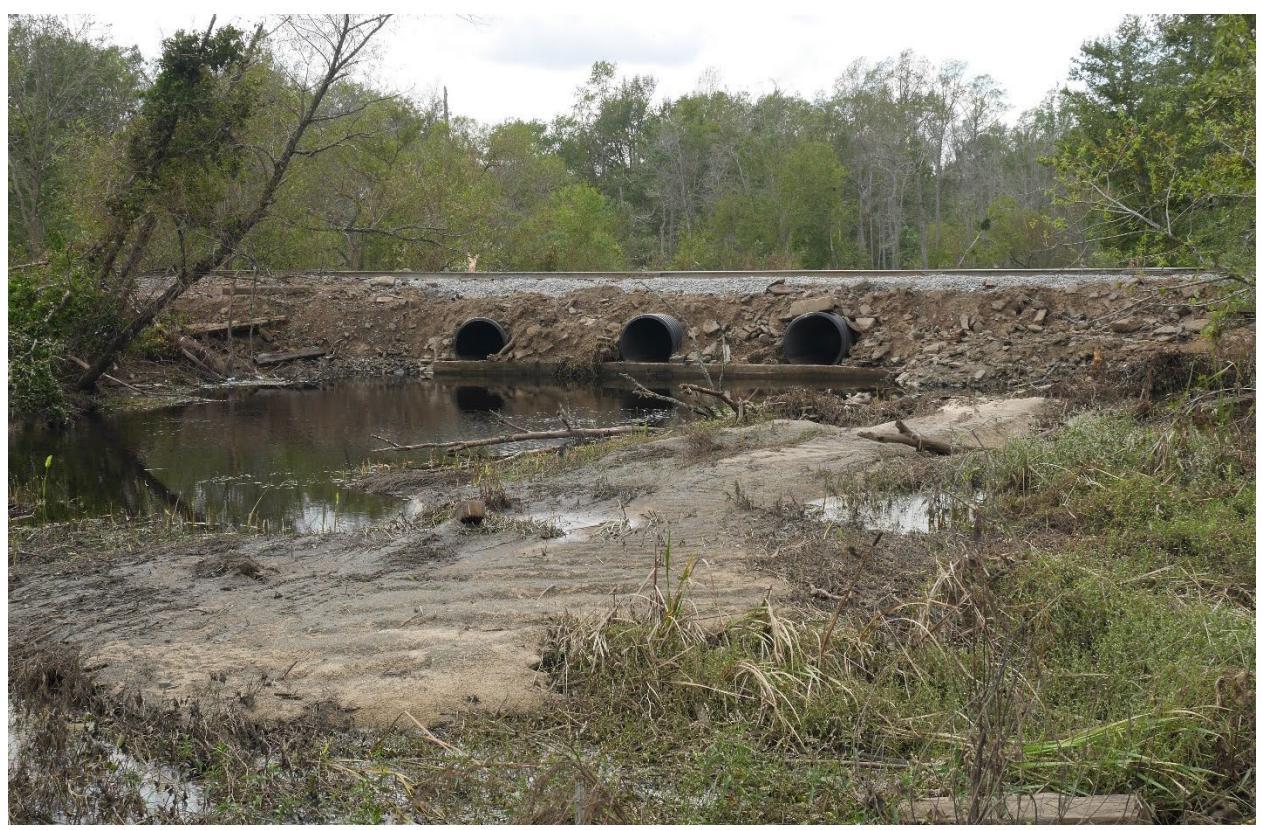
<u>Dixie Guano Road Site Washout</u> – Leith Creek also washed out the rail line stream crossing just to the east of Dixie Guano Road in East Laurinburg (Fig. 6.4.2-9). Flood flows downstream (west) also eroded ballast and the side of the road next to the rail line crossing of Dixie Guano Road (Fig. 6.4.3-10).

Fig. 6.4.2-9 – Rebuilt rail line crossing of Leith Creek east of Dixie Guano Road (September 27, 2018, 34.7665 N, 79.4391 W)

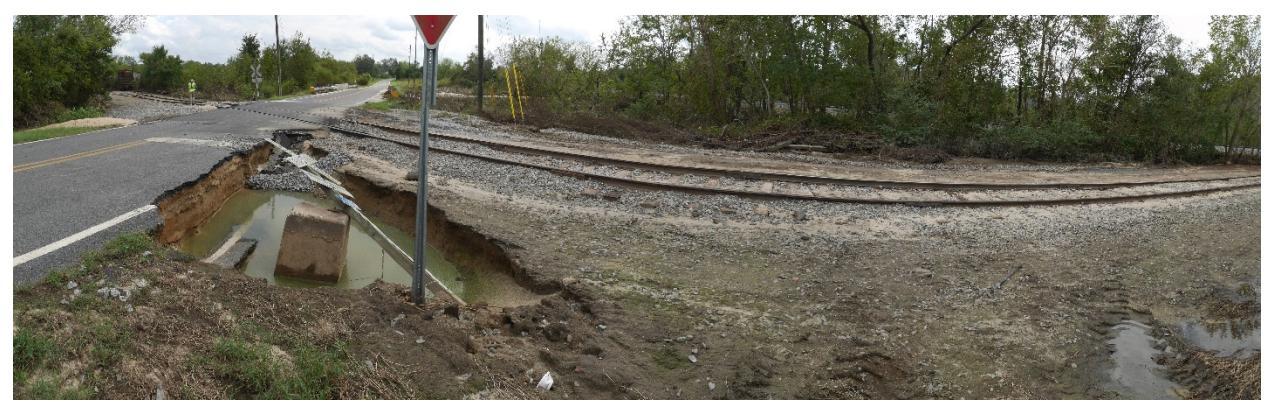
Fig. 6.4.2-10 – Erosion on upstream side of Dixie Guano Road looking south on north side of Leith Creek (September 27, 2018, 34.7671 N, 79.4389 W)

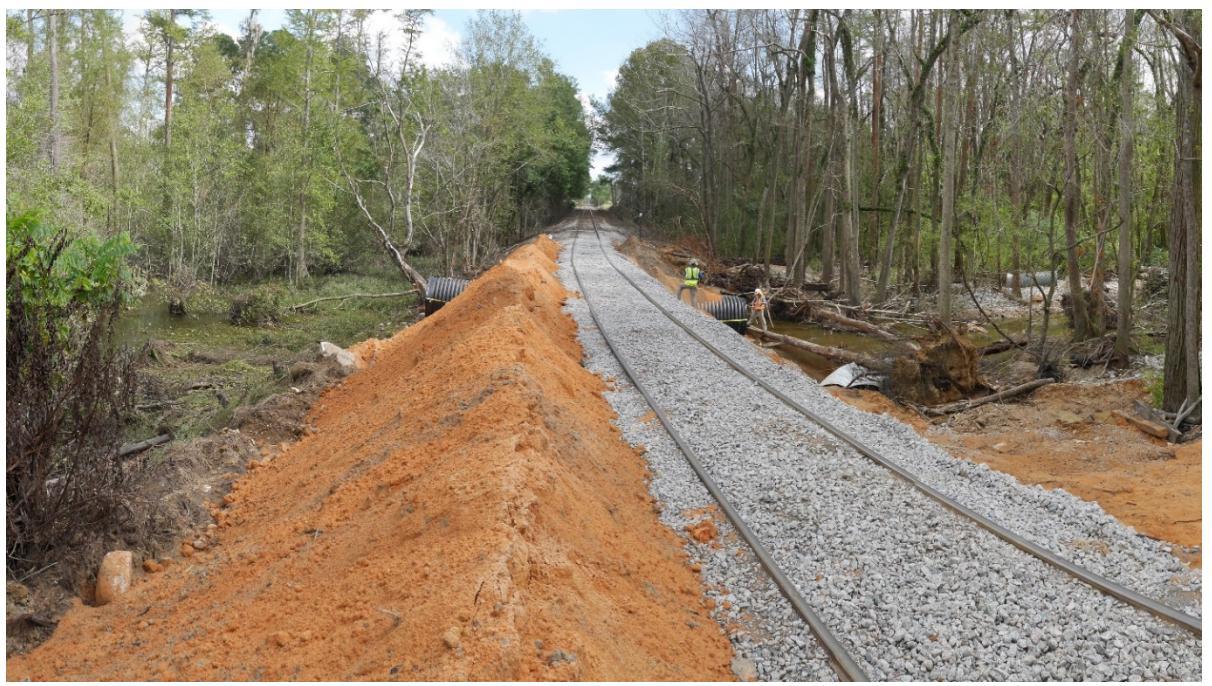
<u>Cypress Springs Links Wetland Site Washout</u> – The most downstream rail line washout that we visited was west of the Cypress Springs Links in a wetlands area east of Laurinburg (Figs. 6.4.2-11 and -12). Like two of the other rail line crossings, repairs had been performed prior to our visit.

Fig. 6.4.2-11 – Looking east across the Leith Creek crossing repair in the Cypress Springs Links wetland (September 27, 2018, 34.7665 N, 79.4188 W)

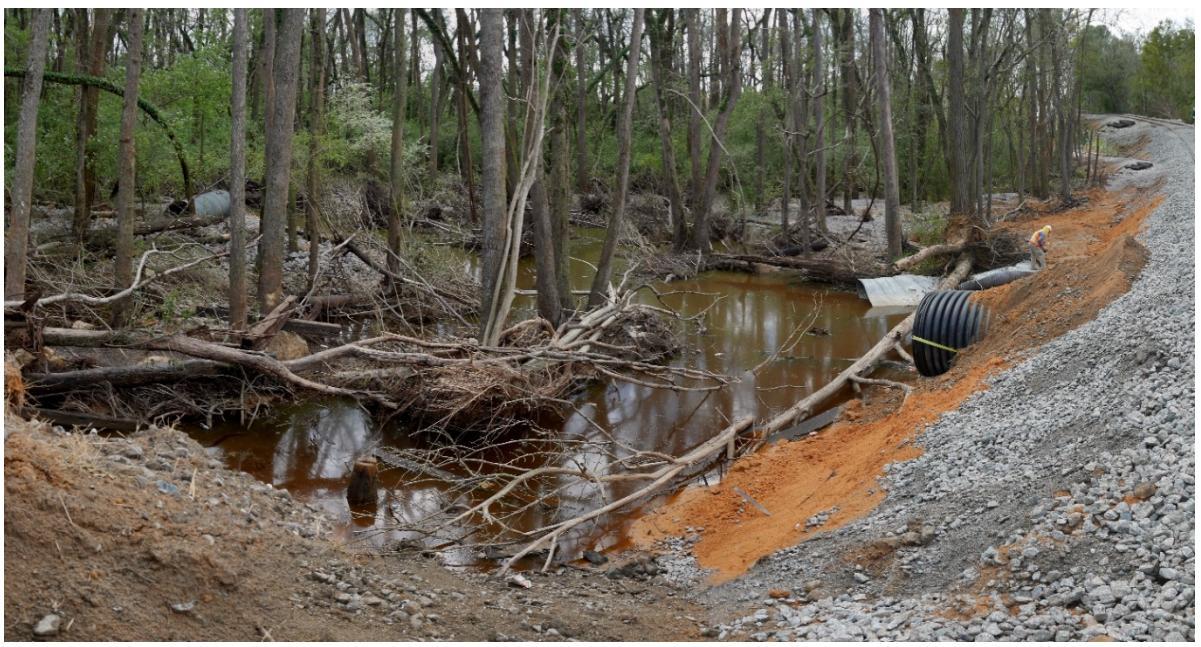
Fig. 6.4.2-12 – Looking west across downstream side of Leith Creek crossing in the Cypress Springs Links wetland (September 27, 2018, 34.7564 N, 79.4135 W)

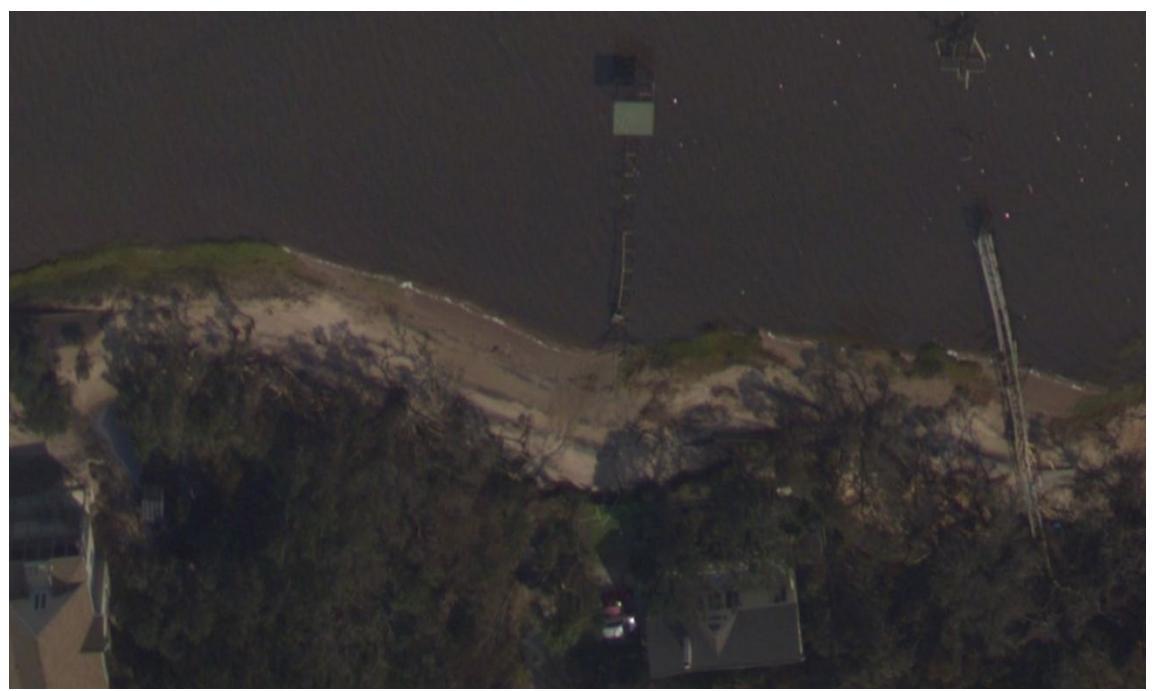
The Washington Street residence that we visited was located on the sound side of the barrier island. Many sound side homeowners constructed seawalls to increase their shoreline acreage (Fig.7.2.1-1). The retaining structure at the Washington Street residence was 80% destroyed (Fig.7.2.1-2 and Fig.7.2.1-3). The failure mode appeared to be erosion from overtopping. The wall failed into the sound due to the combination of hydrostatic pressure and wave action.

Fig. 7.2.1-2 – Emerald Isle Washington Street residence after Florence (NOAA, September 17, 2018, 34.6822 N, 76.9280 W)

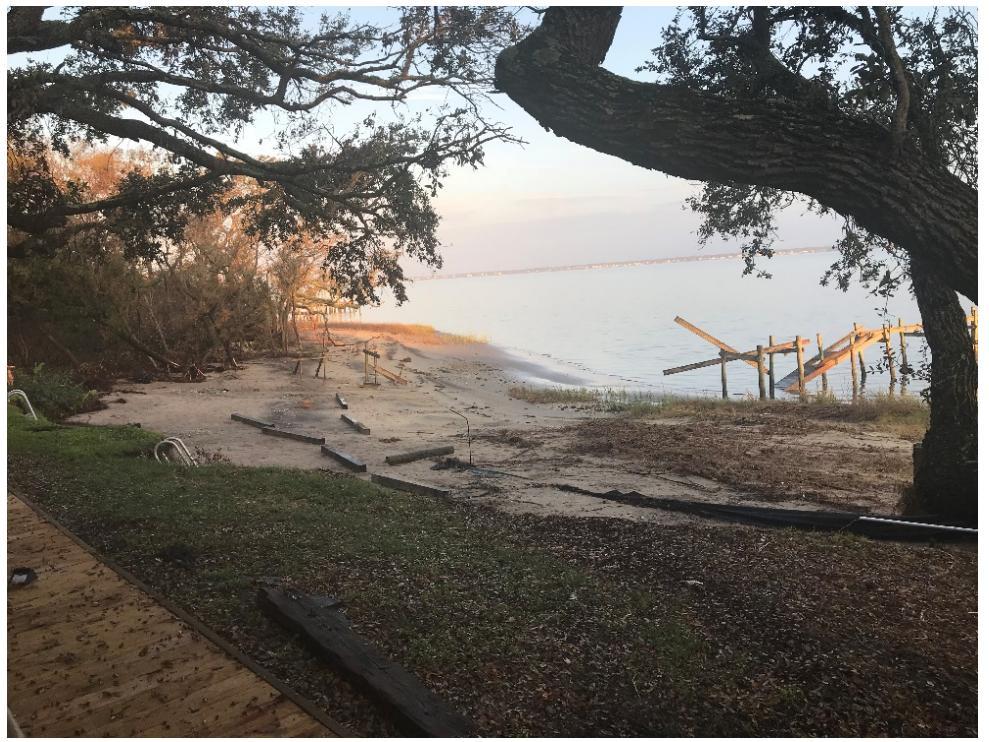
Fig. 7.2.1-3 – Emerald Isle Washington Street residence failure looking west (September 27, 2018, 34.6822 N, 76.9280 W)

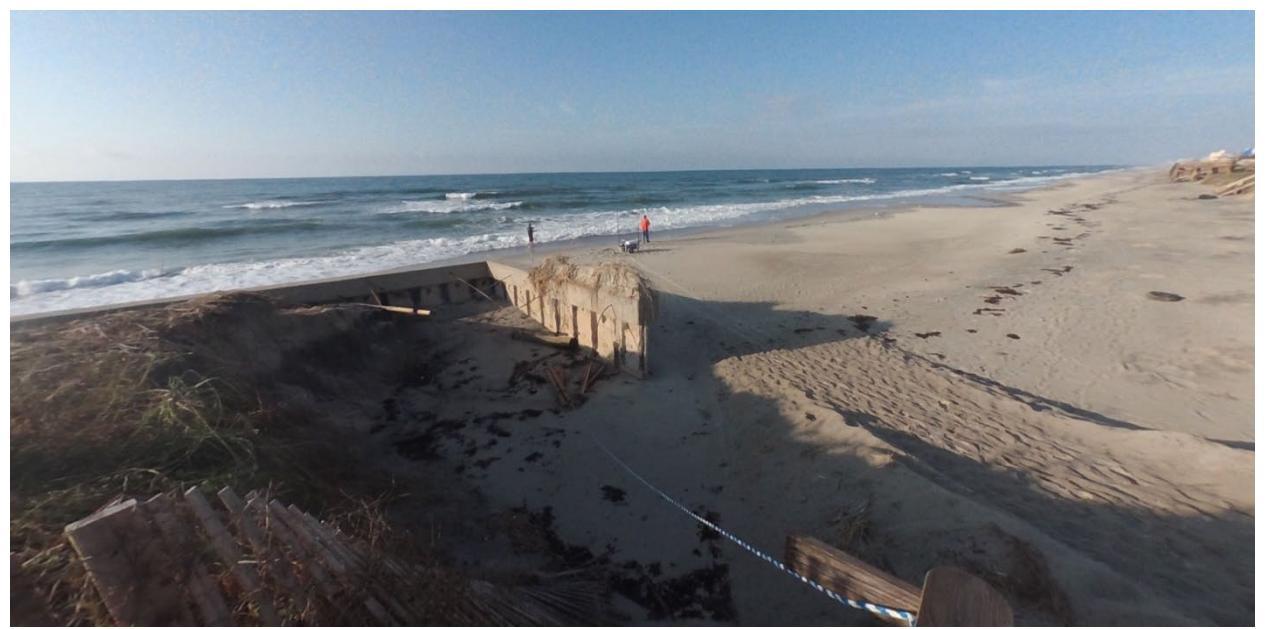
The Iron Steamer Pier was formerly located on the ocean side of the barrier island at the site of the wreck of the Civil War blockade runner SS Pevensey in Pine Knoll Shores, NC (Fig. 7.2.2-1-). An anchored concrete-panel seawall at the site failed due to overtopping and erosion of the wall backfill (Fig. 7.2.2-2). We saw no other damage around that structure save for beach erosion. The wall may be salvageable.

Fig. 7.2.2-2 – Washed out seawall with anchors visible (September 27, 2018, N34.6930 N, 76.8289 W)

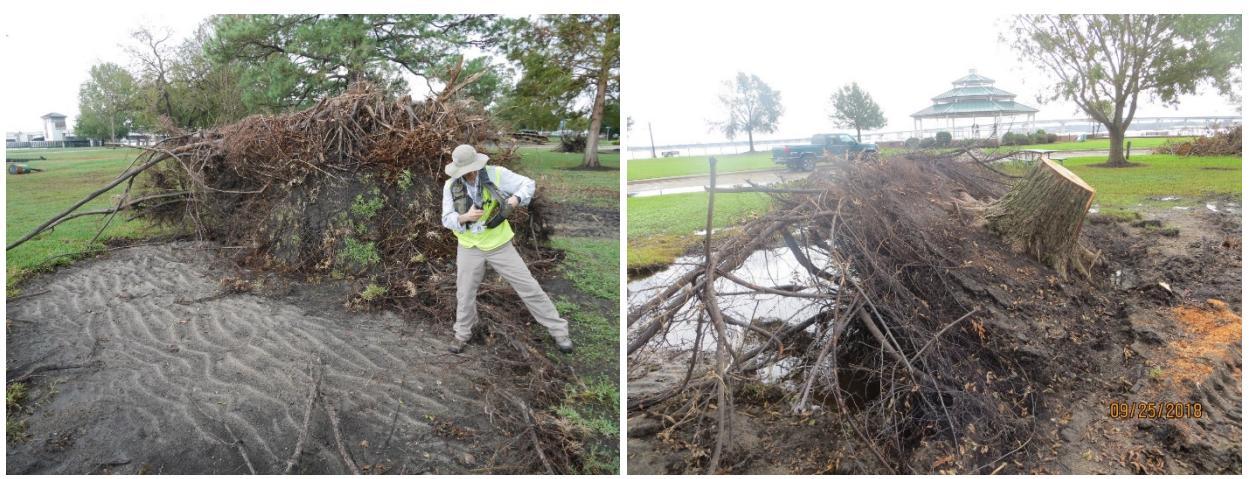
The GEER team arrived at New Bern on the afternoon of September 25, 2018. The team walked the downtown area and drove around the city documenting the effects of urban flooding. Fig. 7.3-5 shows the entrance to a locally owned business, where the depth of flooding was  $\sim$ 3.5 ft. Near the coast at the Union Point Park, the damage caused by high winds was evident from uprooted trees (Fig. 7.3-6) and downed a light pole (Fig. 7.3-7). Uprooted trees in the waterfront park resulted from a combination of factors – the force of the winds and waves and

the shallow root system, possibly the result of brackish groundwater at the river's edge. Uprooted trees are typically important factors in disasters because they down power lines, hinder emergency responses by blocking roads, damage buildings and cars, and potentially injure or kill people. The understanding of tree uprooting will require better data collection, which will have value for predicting structure and infrastructure damage. Integrating structural (wind) and geotechnical teams with landscape architects could enhance that data collection and understanding.

Fig. 7.3-6 - Evidence of tree uprooting near the shore (September 25, 2018, left: 35.10419 N, 77.03544 W, right:35.10371 N, 77.03546 W)

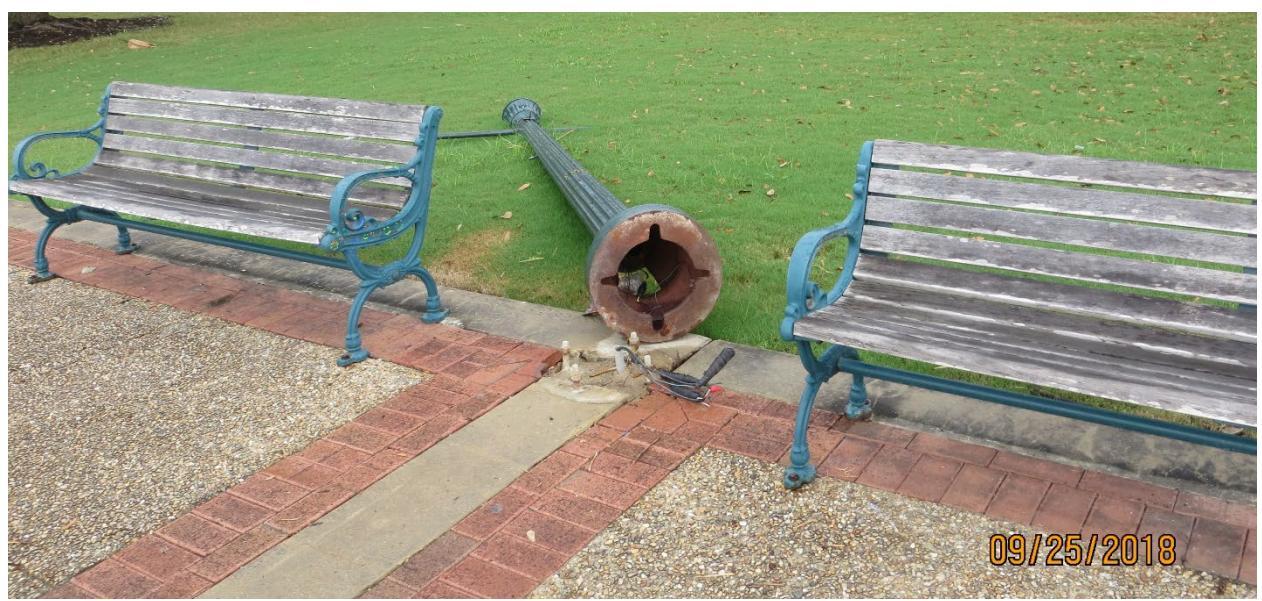
Fig. 7.3-7 - Downed light pole at Union Point Park (September 25, 2018, 35.1033 N, 77.0354 W).
