#### **Geotechnical Effects of Hurricane Florence**

Geotechnical Extreme Events Reconnaissance (GEER) Association.

GEER Association Report No. GEER-063

April 2019 Revision 1 - June 2019

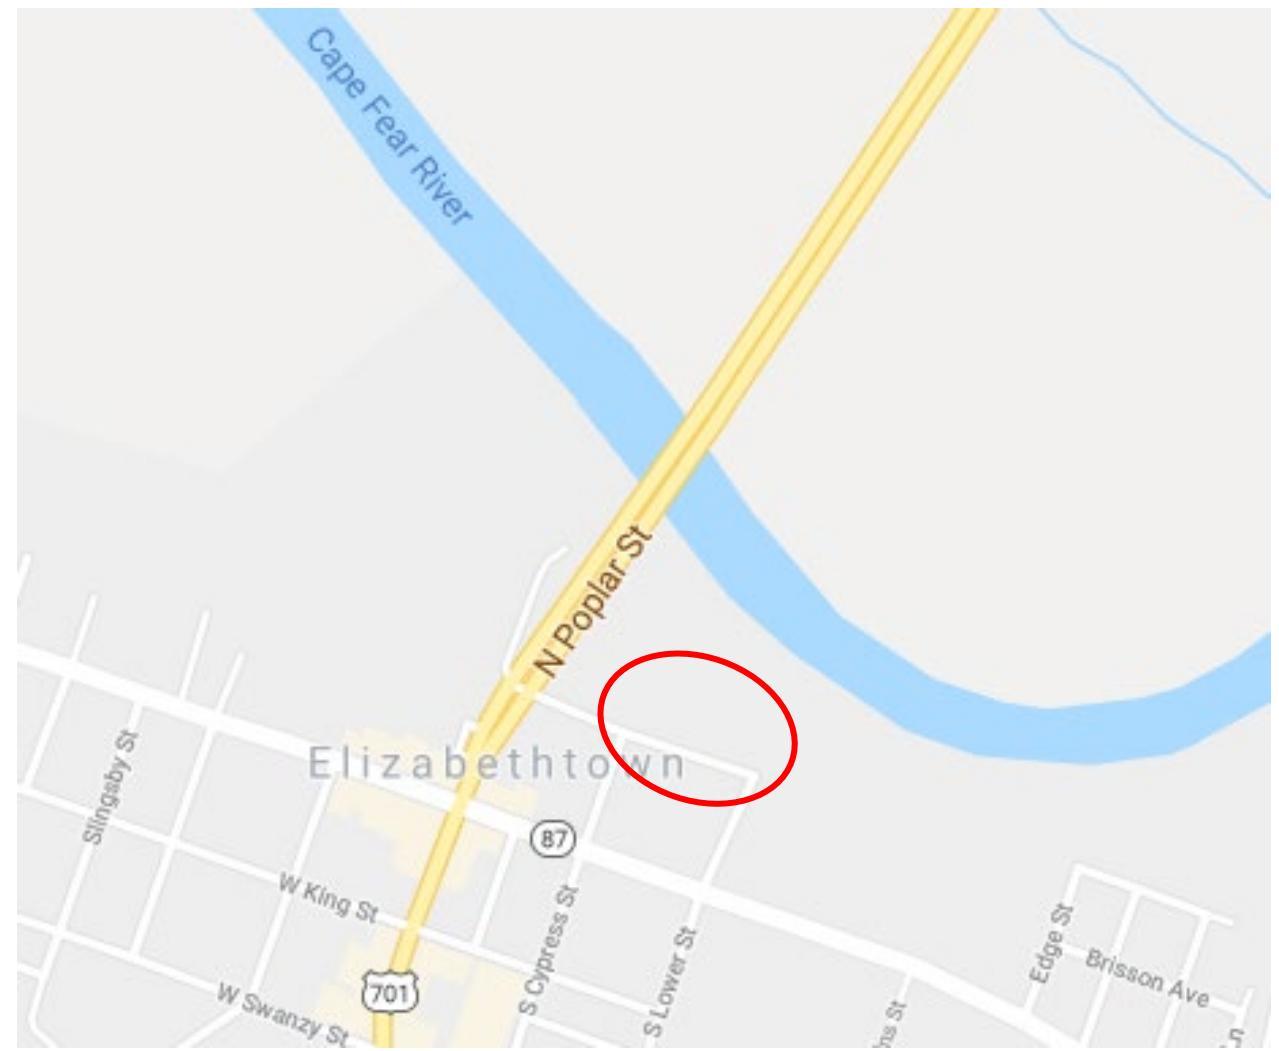
Fig. 8.1-1 shows the location of a slope failure / movement that the team observed in Elizabethtown, North Carolina. The slide mass is located near the intersection of West Broad Street and Highway 701 (see section 6.2.4 for observations of the adjacent US 701 bridge). The Cape Fear River borders the site, forming a tight concave bend. Historical imagery from Google Earth suggests that the first aerial to show indications of a slide was taken on October 2016 because of a scarp forming through the cemetery and cracks penetrating through the pavement. The subsequent aerial images show that the cracked road was repaved (Fig. 8.1-3(a) March 2018) and that the new cracks and scarps were apparent at the time of the flooding (Fig. 8.1-3(b) September 2018).

Figure 8.1-1 - Site location, Elizabethtown, NC (Google Maps, 34.6297 N, 78.6027 W)

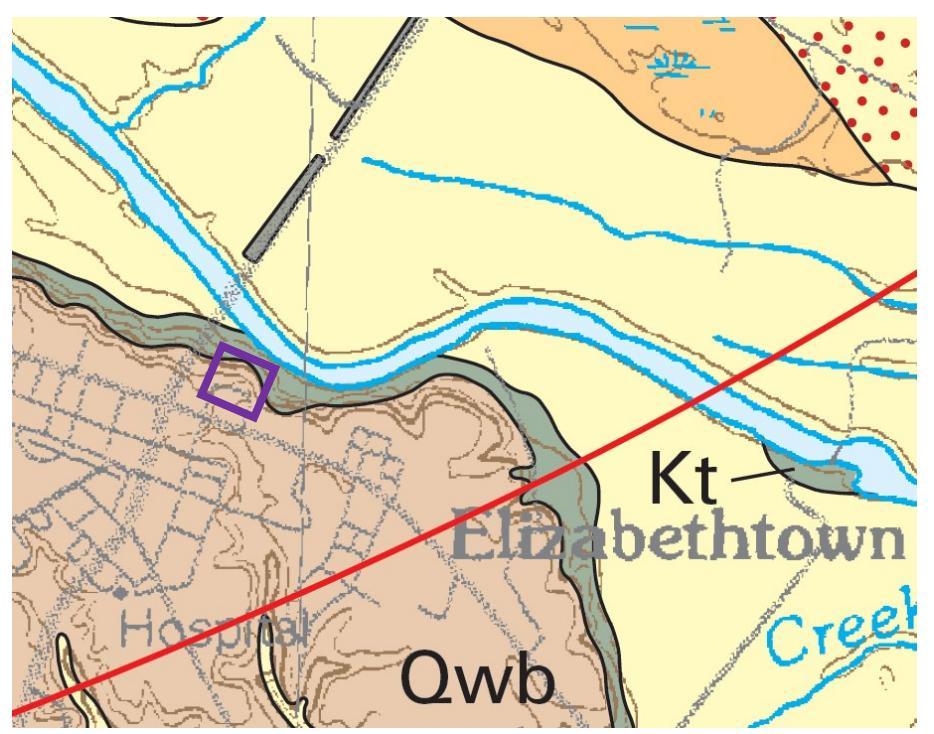
Fig. 8.1-4 shows the general surface geology at the site, which is characterized by Kt and Qwb deposits. The Kt symbol indicates the Tarheel Formation and consists of very fine to coarsegrained sand that has some silt and clay. It is also interbedded with silt, clayey pyritic soils. The soil is typically olive gray with deposits up to 265 ft thick. The Qwb symbol indicates the Bahramsville unit and consists of very fine to fine-grained sand with silt and clayey soils. Around Elizabethtown, this unit typically includes up to 22 ft of very shelly basal sand in paleochannels. The deposit color is typically reddish brown with deposits are up to 62 ft thick. In other words, the soil near the Cape Fear River is likely coarse-grained sands with silt and clay fines.

Figure 8.1-4 - Surficial geologic map of Elizabethtown with purple box representing the cemetery and slide location (obtained from Weems et al. 2011 at <u>https://pubs.usgs.gov/of/2011/1121/ElizabethtownNCGeologicMap.pdf</u>)
