Geotechnical Damage in Central and Northeastern Florida from Hurricane Irma

GEER Association Report No. GEER-056b

October 2017

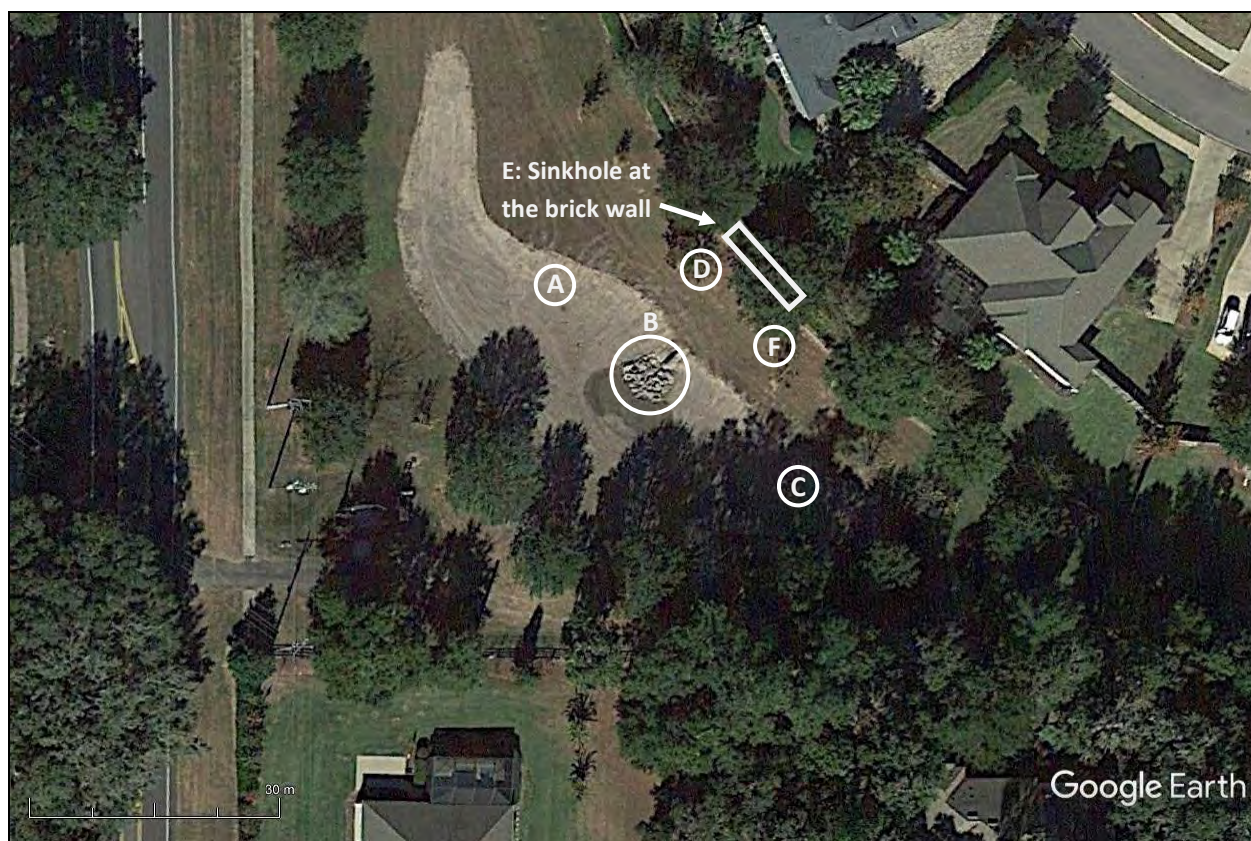
Figure 9 indicates that the location of sinkhole "B" is where a concrete drainage pipe exists to drain water from the Turnberry Lake community into the retention pond. The outfall location was previously reinforced with broken concrete, where water would run over the concrete instead onto the soil of the retention pond. During the site visit, the foreman of a work crew responsible for fencing in the location for safety that day indicated that at least one sinkhole had previously formed at the location where the reinforcing concrete was piled at the outfall.

Figure 9: Approximate locations of five sinkholes (A-E) and a depression (F) within and nearby a retention pond near 2800 NW 143 Street, Gainesville, FL (Latitude: 29°40'34.84"N / Longitude: 82°29'43.31"W) (from Google Earth, 2016).

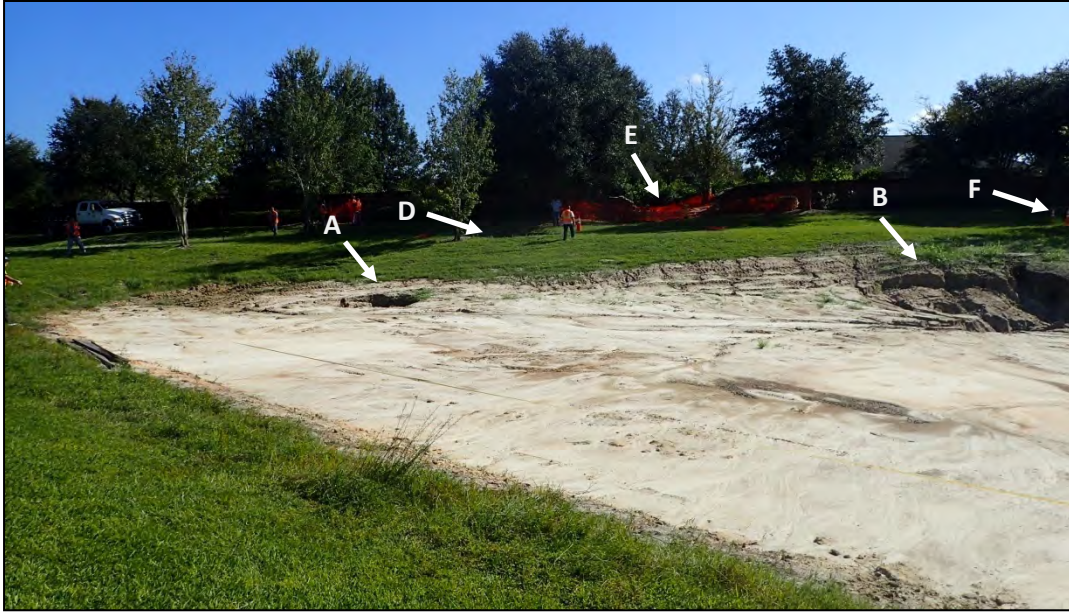
Figure 10: Image of the retention pond showing the locations of wetted clay (left), sinkhole "A", sinkhole "B" with the drainage outfall, sinkhole "D", and sinkhole "E" under the brick wall of the community, and depression "F" (Latitude: 29°40'48.05"N / Longitude: 82°29'43.61"W).

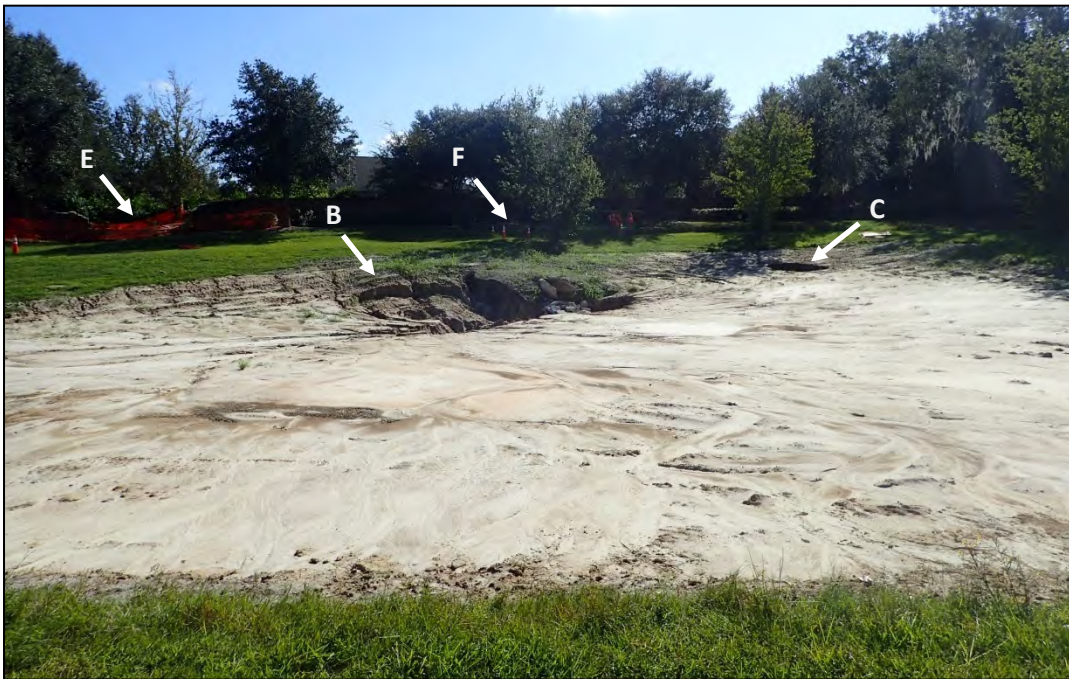
Figure 11: Image of the retention pond showing the locations of sinkhole "B" with the drainage outfall, sinkhole "C", sinkhole "E" under the brick wall of the community, depression "F", and evidence of the of water flow into sinkhole "B" in the retention pond foreground from the storm event (Latitude: 29°40'48.05"N / Longitude: 82°29'43.61"W).

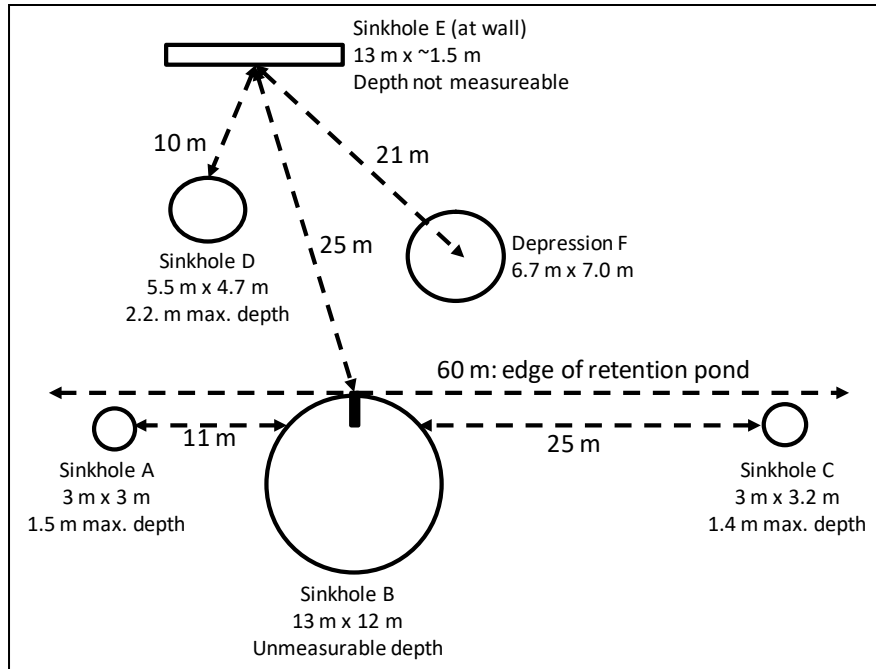
Figure 12: Approximate geometry of the five sinkholes (A-E) and depression (F) at the retention pond near 2800 NW 143 Street, Gainesville, FL (Latitude 29°40'34.84"N / Longitude 82°29'43.31"W).

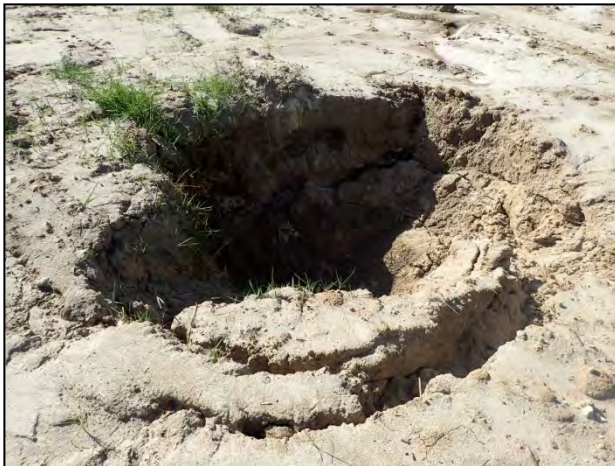
Figure 13: Image of sinkhole "A" that is 3 m in diameter with a maximum depth of 1.5 m (Latitude 29°40'47.99"N / Longitude: 82°29'42.99"W).

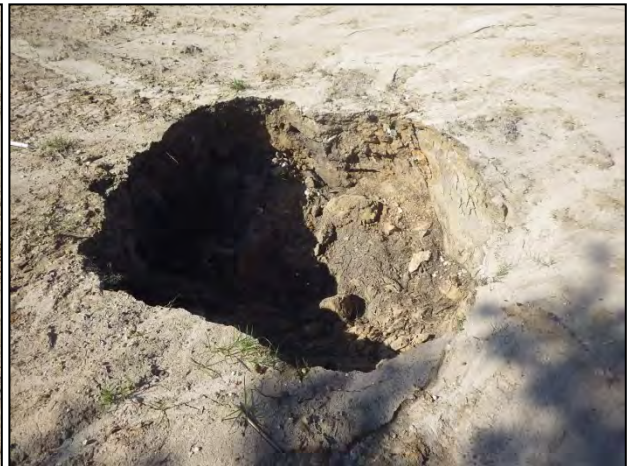
Figure 14: Image of sinkhole "C" that has 3.2 and 3.0 m diameters and a maximum depth of 1.4 m (Latitude 29°40'47.69"N / Longitude 82°29'43.25"W).

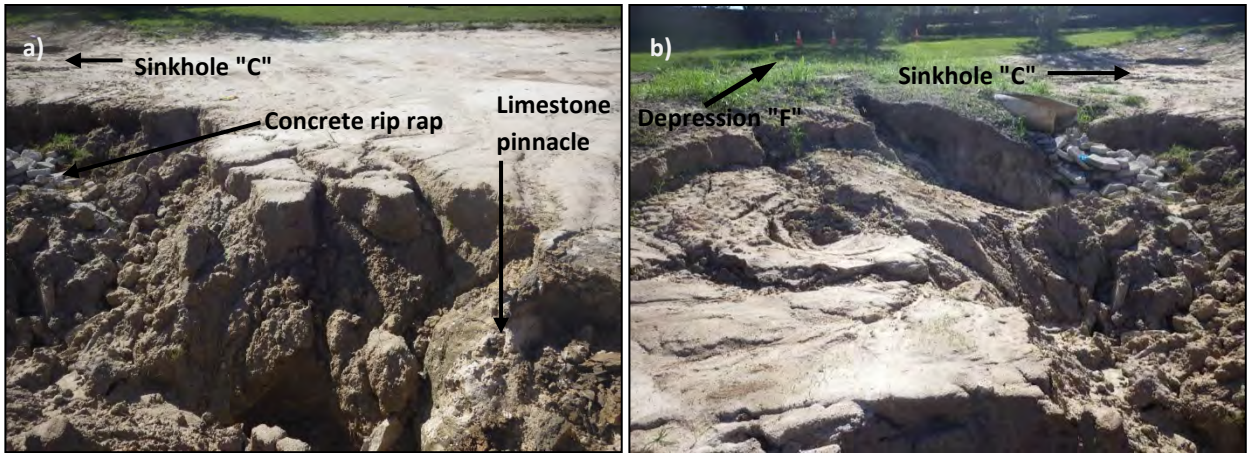
Figure 15: Sinkhole "B" showing a) limestone pinnacle (right), concrete rip rap (left), and location of sinkhole "C" (Latitude 29°40'47.57"N / Longitude: 82°29'43.37"W) and b) showing the extent of the newly developed depression behind the outfall pipe, the location of sinkhole "C", and the location of depression "F" (Latitude 29°40'47.57"N / Longitude: 82°29'43.37"W).

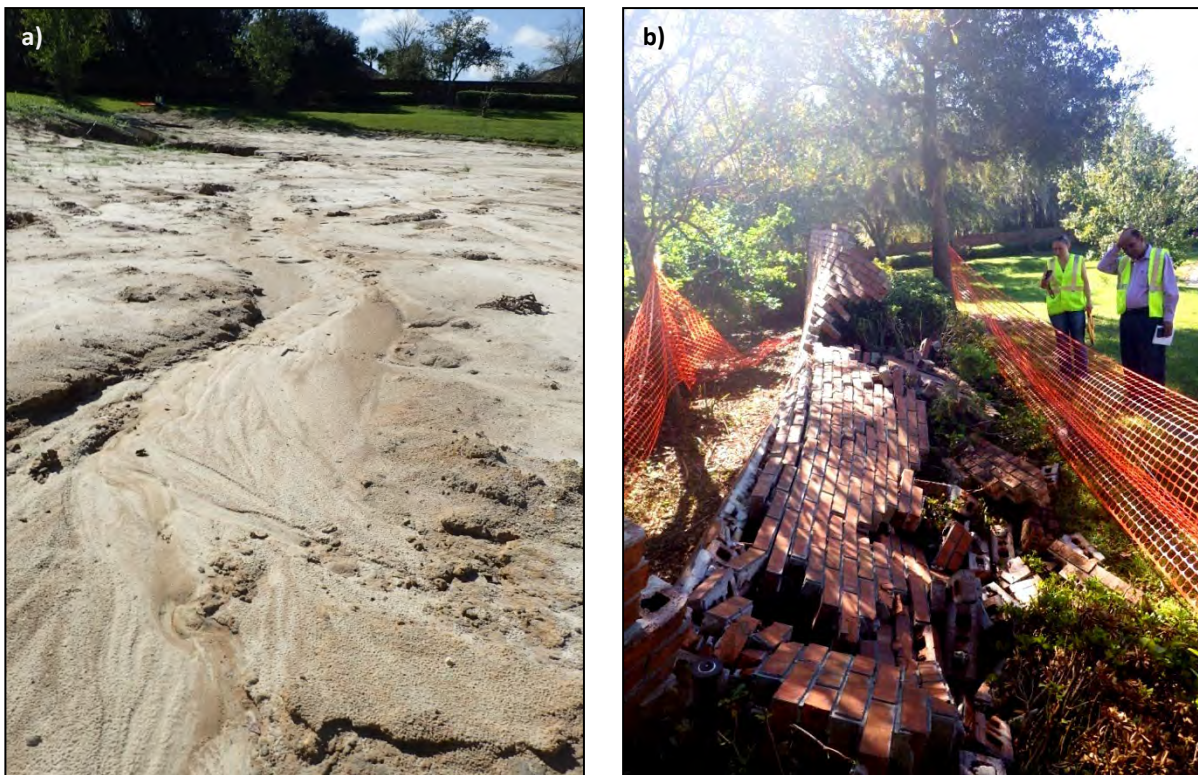
Figure 16: a) Erosion from overland flow within the retention area, where the direction of water flow was from sinkhole "A" toward sinkhole "B" (Latitude 29°40'48.47"N / Longitude 82°29'43.94"W), and b) toppled brick wall over a 12.5 m length at sinkhole "E" (Latitude 29°40'25.12"N / Longitude 82°29'48.35"W).

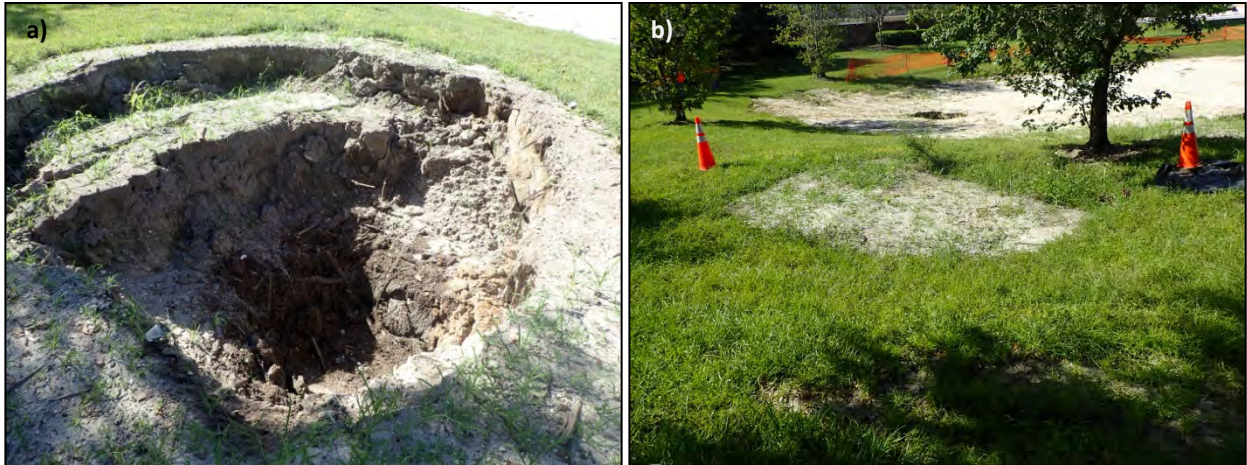
Figure 17: a) Sinkhole "D" (Latitude 29°40'48.85"N / Longitude: 82°29'43.13"W and b) newly developed depression "F" (Latitude 29°40'47.99"N / Longitude 82°29'41.99"W).

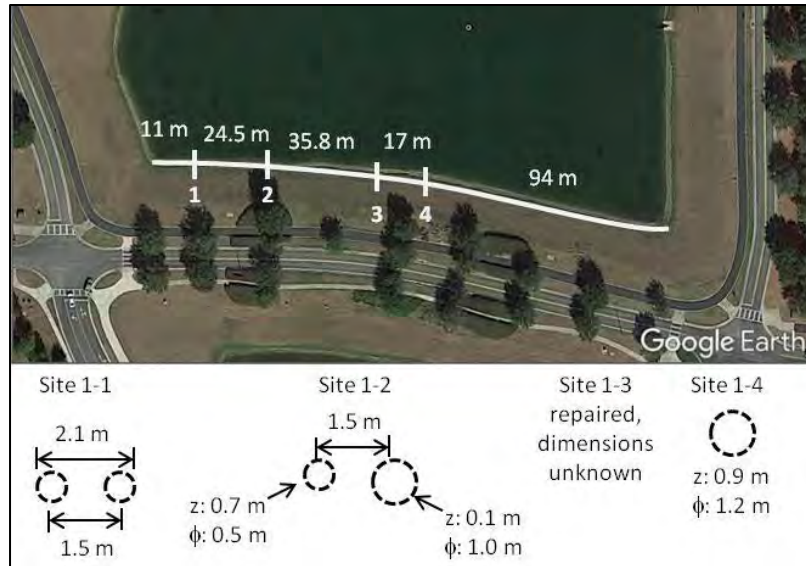
- Two small sinkholes were present at Site 1-1. They were approximately 1.5 m on center. The sinkhole throats were small in diameter, and depths could not be measured effectively.
- Two small sinkholes were at Site 1-2. They were approximately 2.5 m on center and had diameters of 0.7 m and 1.0 m and depths of 0.5 m and 0.1 m.
- One or more sinkholes of unknown geometry were identified at Site 1-3. When the GEER Team visited the site, the sinkhole(s) had been filled in.
- One sinkhole was present at Site 1-4. It was 1.2 m in diameter and had a depth of 0.9 m.

Figure 23. Schematic locations and dimensions of the sinkholes on the bank of the retention pond (from Google Earth 2017).

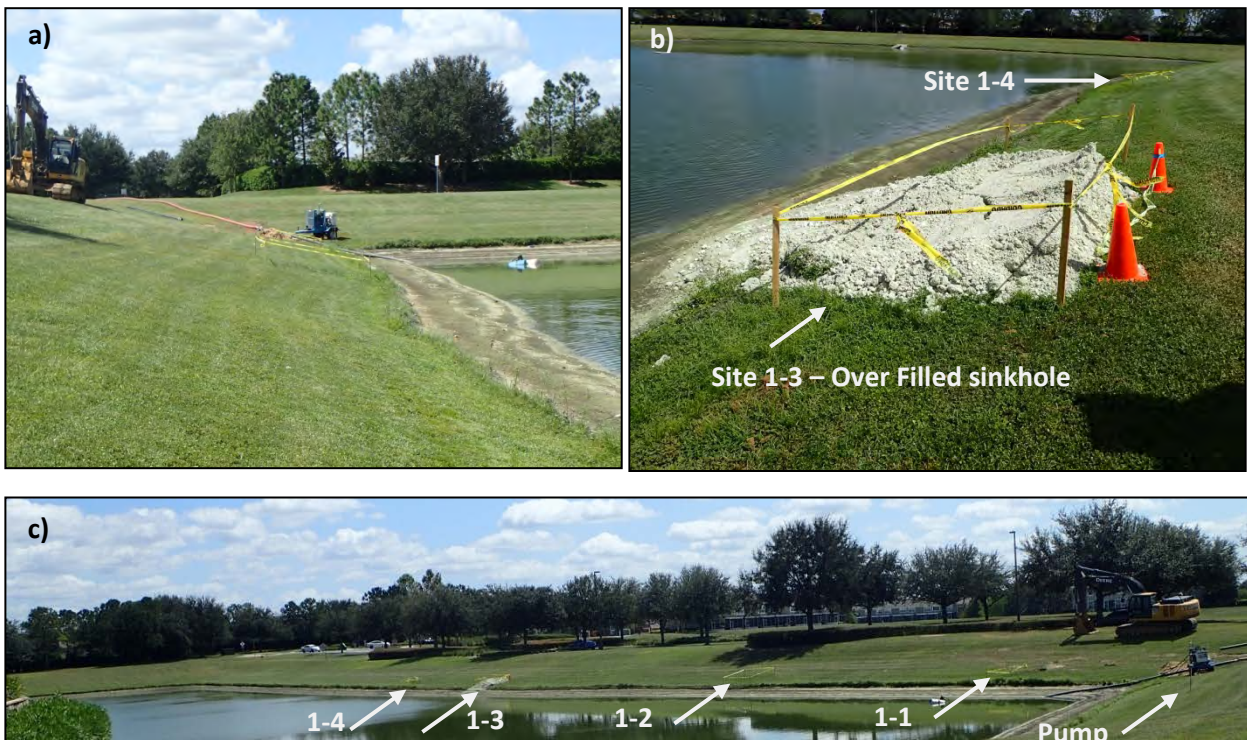
Figure 24. Images illustrating locations of the sinkholes on the bank of the retention pond (Latitude 29°8'50.99"N / Longitude 82°12'35.99"W).

The sinkholes identified at this site were relatively small and did not pose a danger to vehicles or pedestrians unless they were on the bank of the retention pond. The sinkholes, because of their small size, were most likely discovered by lawncare crews working in the community. Sinkhole 1-3 was most

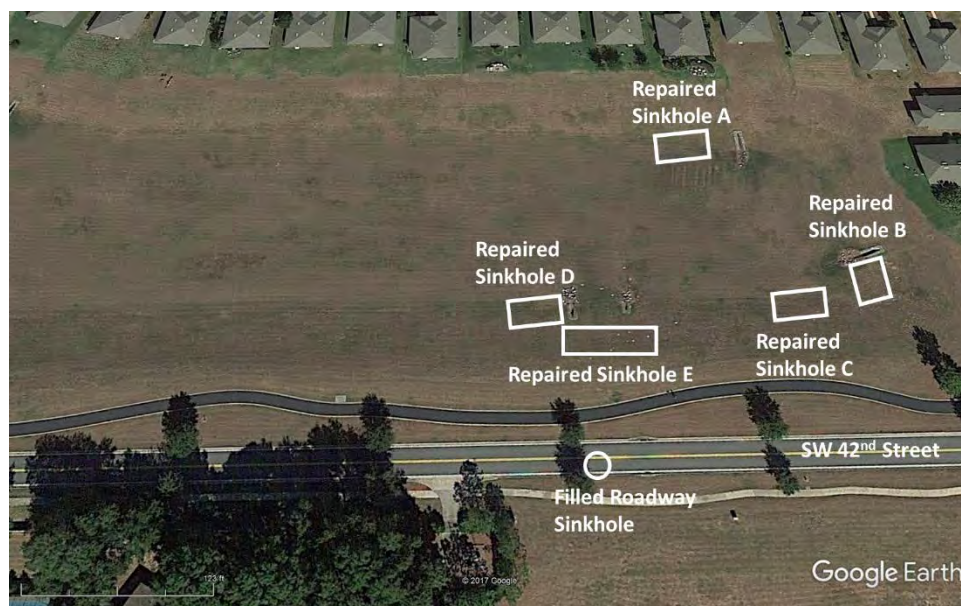
Site 2 was located at a retention pond along SW 42nd Street in the Fore Ranch community. Figure 26 is an aerial view from Google Earth showing the locations of the repaired and partially repaired sinkholes near the retention pond. A resident who lives on the north end of the retention pond verified that the sinkholes occurred during the hurricane.

Figure 26. Fore Ranch Community Site 2 repaired and filled sinkholes (from Google Earth, 2017).

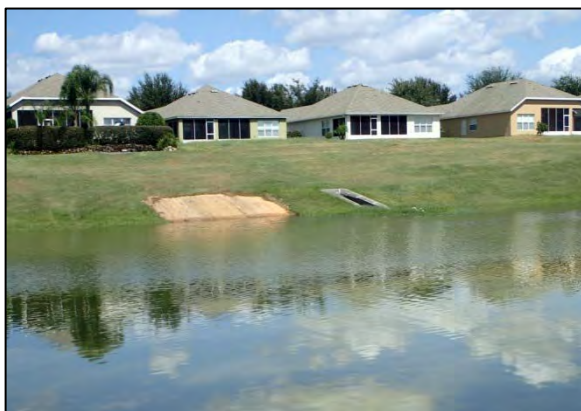
Five repaired sinkholes were present on the banks of the retention pond. The sizes of the repaired areas were not measured because they do not provide an accurate assessment of either the sinkhole size or depth. Sinkhole A was on the bank of the retention pond. Sinkhole B was on the east bank of the retention pond. Sinkholes C and D were on the south bank of the retention pond. Sinkhole E, the largest of the repaired sinkholes, was at the top of the bank of the retention pond. It is interesting to note that all of the sinkholes except sinkhole C formed near outlet structures. Figure 29 contains photographs of the repaired sinkholes. The sinkholes were repaired by filling with granular soil and compacting with equipment used to place the granular soil. The track marks on the repaired sinkholes indicate they were only recently repaired.

Repaired sinkhole A

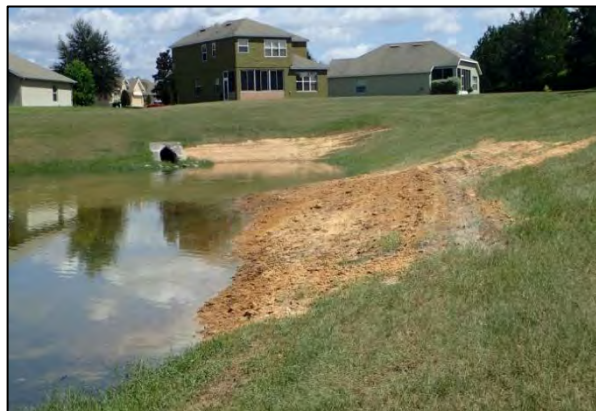
Repaired sinkhole B (back) and C (front)

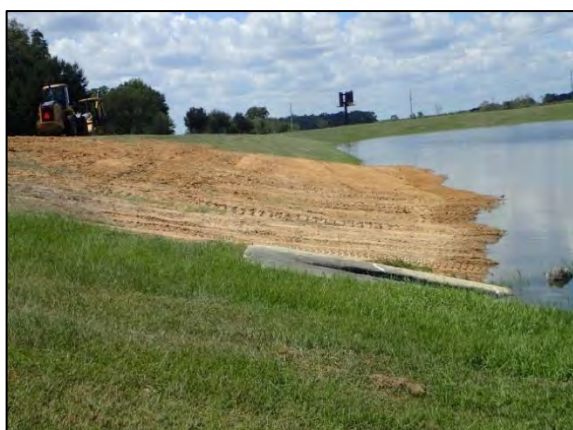
Repaired sinkhole D

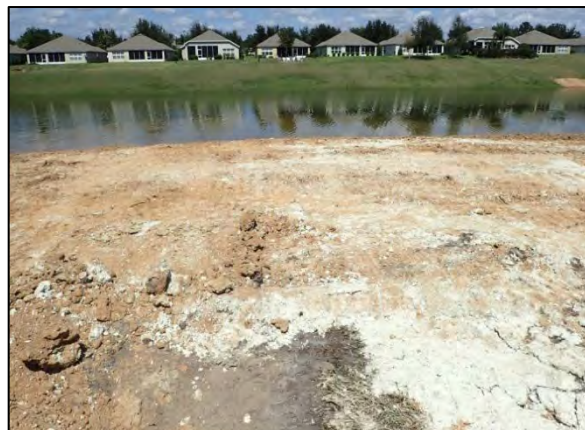
Repaired sinkhole E

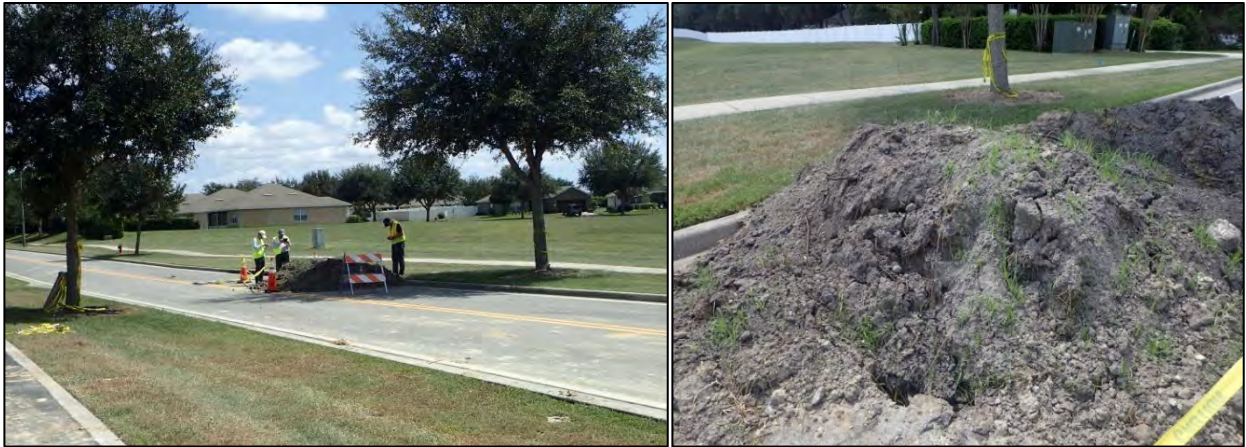
Figure 28. Sinkhole in road (Latitude 29° 8'47.52"N / Longitude: 82°12'51.36"W).

This site also had a sinkhole which had formed in the east bound lane of SW 42nd Street. This sinkhole had not been repaired but was overfilled with granular soil. Because of the sinkhole the street was closed to traffic. Figure 28 shows the overfilled sinkhole. Since the sinkhole is in the roadway, the repairs will need to be more sophisticated than simple fill and compaction with large equipment.

Sinkhole in road.

Road sinkhole overfilled with granular soil.

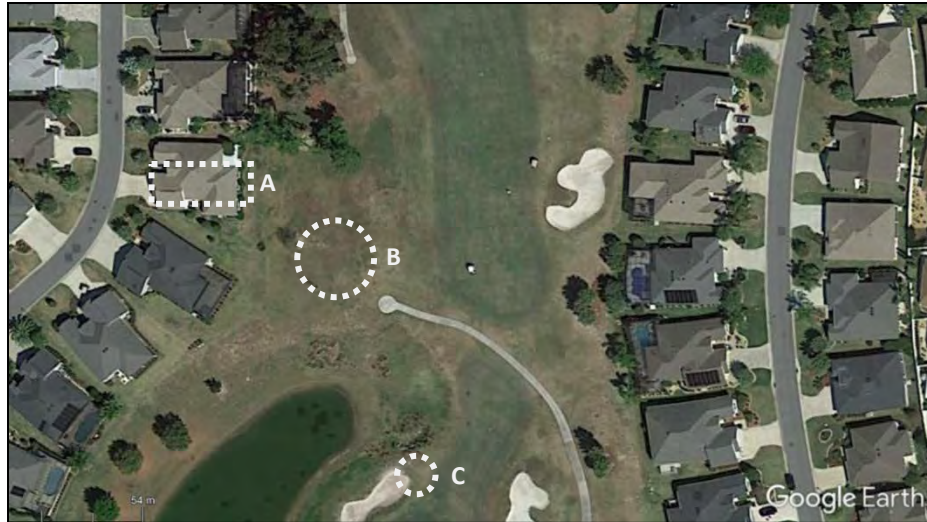
Figure 30a shows the sinkhole as formed between 2005 and 2011 Markridge Loop. The sinkhole formed in the early morning of September 12, 2017 and resulted in the evacuation of the two homes which were both subsequently condemned and residents prohibited from entering the homes. The sinkhole that developed extended under the slab foundation a distance of approximately 3 m laterally of 2005 Markridge Loop (pers. comm. Doug Wernicke) and into the shared yard between the two homes. Figure 30b illustrates the damage to the home at 2005 Markridge Loop, that included damage to wall-mounted utilities and cracks to the stucco block wall (assumed by the crack geometry). This prompted installation of crack gages to monitor continued deformation following stabilization of the slab and surrounding ground by backfilling (Figure 30c). The location included underground electric and water utilities that needed to be stabilized during the backfilling of the sinkhole (pers. comm. Doug Wernicke). Figure 30d additionally illustrates that ground subsidence resulting from the sinkhole extended to 2011 Markridge Loop, where a gap between the soil and slab foundation was identified.

Figure 29: Location of three sinkholes: Markridge Loop and Dove Hollow Run, The Villages, FL (from Google Earth, 2017).

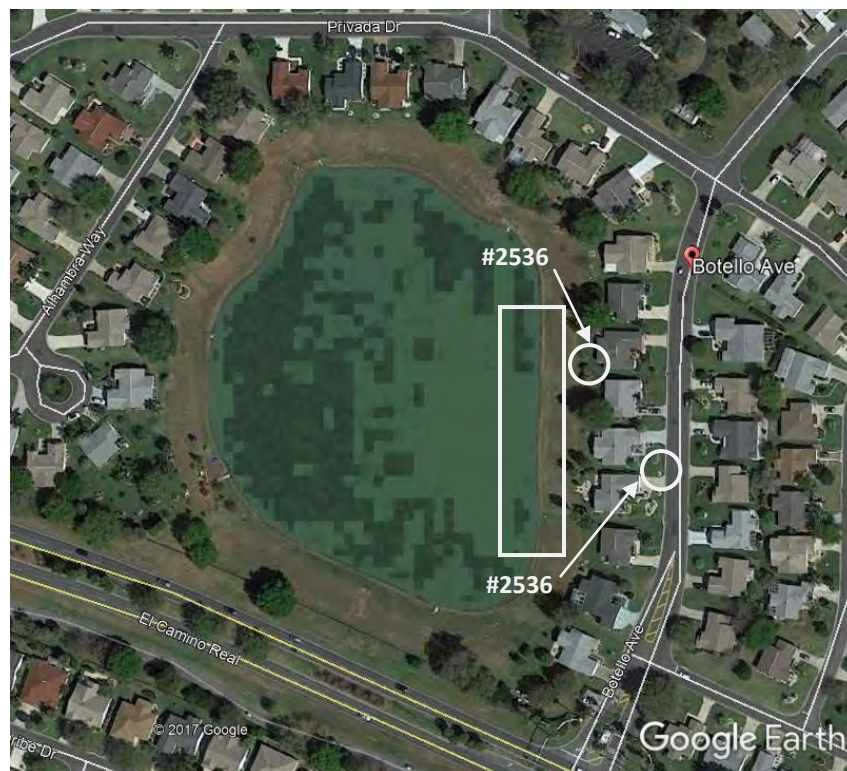
Figure 33 shows the location of the retention pond between Alhambra Way and Botello Ave. in The Villages Alhambra, FL where sinkholes were created on the bank, and within the basin, or the retention pond as a result of Hurricane Irma (rectangle). Figure 33 additionally shows the locations of two sinkholes that formed around houses nearby the retention pond location (circles).

Figure 33: The location of the Alhambra Retention Pond where sinkholes formed, The Villages, FL (from Google Earth, 2017).

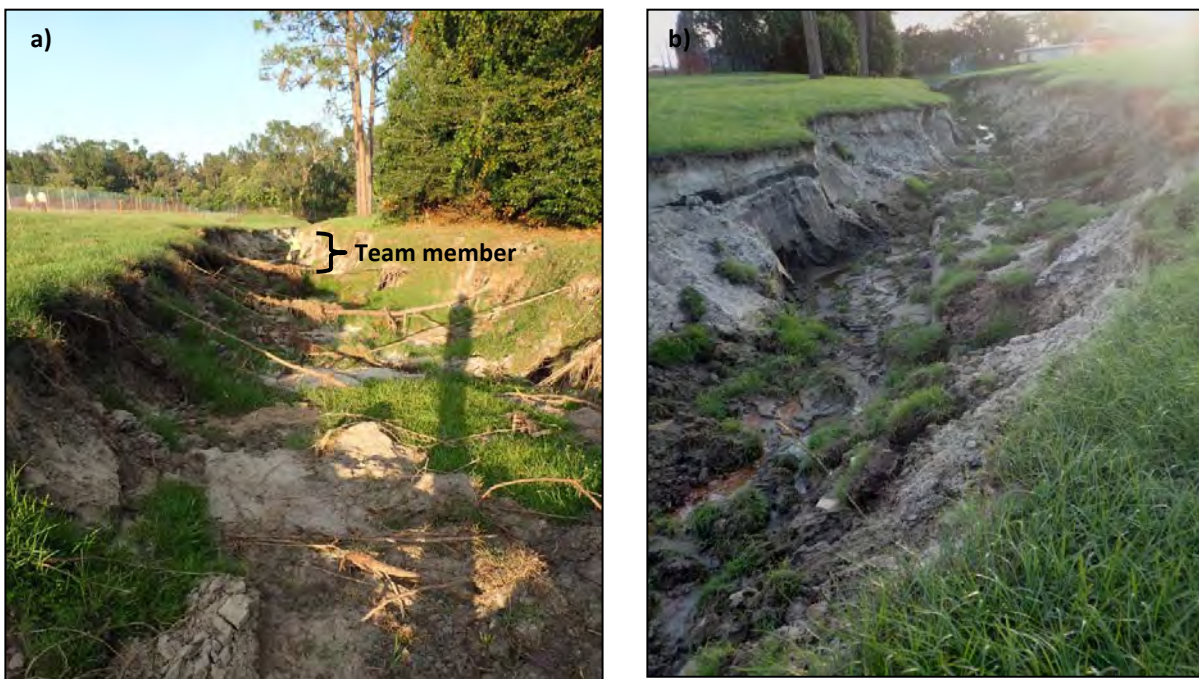
The GEER Team investigated the washout from the head of the erosion from the western extent to the West Orange Trail by walking the banks and erosion channel. Figure 42a shows the shallow erosion channel with a west to east view from near the school near the extent of where fill had brought in to raise the elevation of the grade at the school. The washout gully increased in both width and depth from the west towards drainage structure 3. The channel is about 1 m deep and 6 m across at this location. Figure 42b shows the drainage channel with an east to west view, looking back toward the school building (not shown). At this location the channel is approximately 3 m deep and 10 m across at the original ground surface. The washout gully increased in both width and depth from the west towards drainage structure 3. Figure 43 and Figure 44 illustrate the steep banks of the erosion channel. The soil in this area was fine sand deposits, which was a likely reason so much erosion occurred.

Figure 42: Images of the channel where the view is a) toward the east from the western portion of the channel (Latitude 28°41'7.87"N / Longitude 81°30'24.97"W), and b) toward the west from the channel (Latitude 28°41'8.70"N / Longitude 81°30'22.33"W).

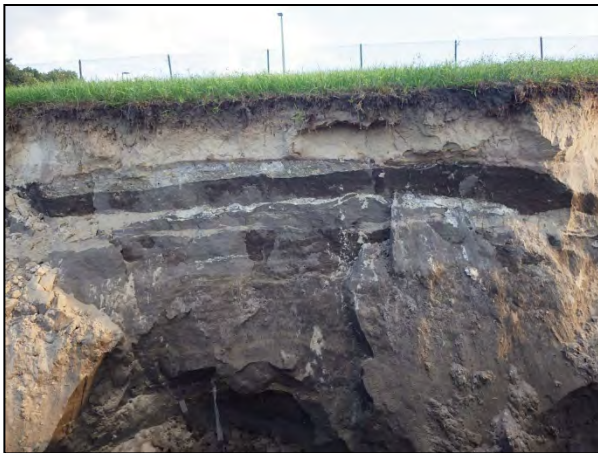
Figure 43. Interesting dark layered sand feature within washout stratigraphy (Latitude 28°41'8.54"N / Longitude 81°30'22.74"W).

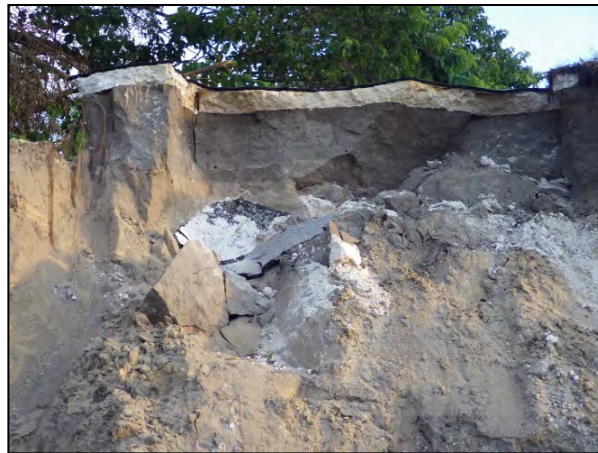
Figure 44. Washout at the West Orange Trail Surface (Latitude 28°41'8.70"N / Longitude 81°30'20.79"W).

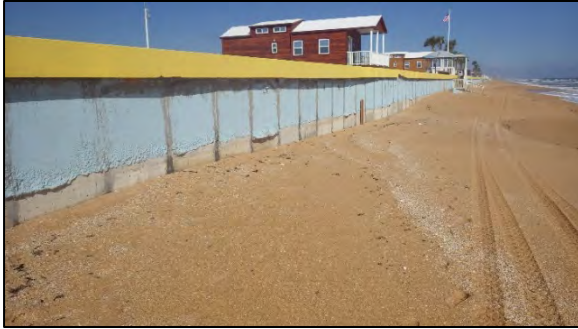
The documented damage at this reconnaissance site consisted of erosion along the sea wall and localized scour at timber staircases which provide access from the Resort, which is located on top of the seawall, to the beach.

a) Erosion across the face of the wall indicated by the exposed concrete (Latitude 29°31'15.29"N / Longitude 81°8'48.06"W).

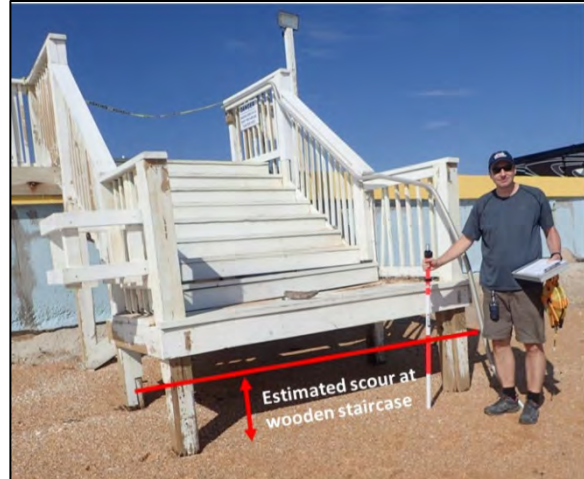
b) Scour at base of timber staircase (Latitude 29°31'14.96"N / Longitude W 81°8'48.07").

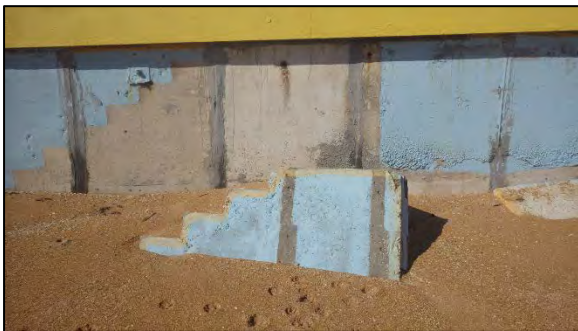
c) Damage to concrete stair structure (Latitude 29°31'16.64"N / Longitude 81°8'48.78"W).

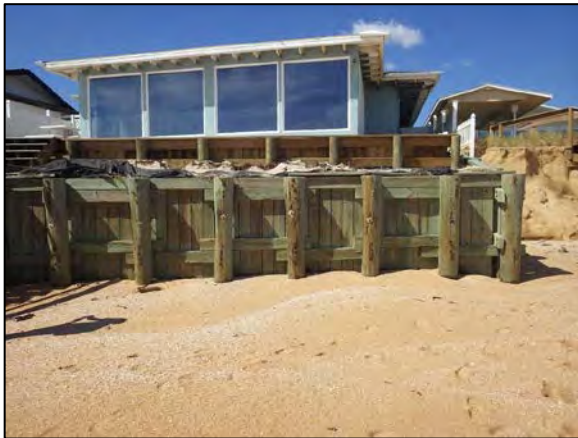
Site B is located at coordinates N 29° 32' 32.36" and W 81° 9' 28.0". The effectiveness of a dune protection system which was constructed next to an eroded dune is clearly demonstrated. The dune protection system, a two-tiered timber sheet pile structure, is shown in Figure 59a. One of the reconnaissance team members visited this site in 2016 after Hurricane Matthew. He stated the lower tier of the timber sheet pile structure was added after hurricane Mathew in 2016. The timber sheet pile structure has successfully protected the dune structure and shoreline. However some damage was noted on the north wing wall of the structure, as shown in Figure 59b. The timber sheet pile wall was not embedded far enough into the existing dune and the erosion has exposed the end of the wall, which is covered with a black tarp.

a) Two-tiered timber sheet pile structure (Latitude 29°32'28.35"N / Longitude 81°9'27.15"W).

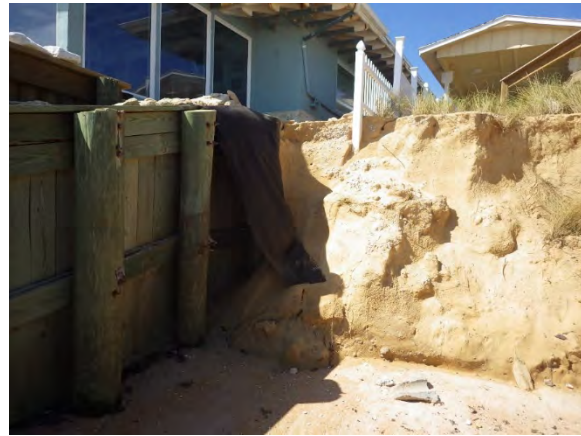
b) North wing wall scour of the timber sheet pile wall (Latitude 29°32'28.35"N / Longitude 81°9'27.15"W).

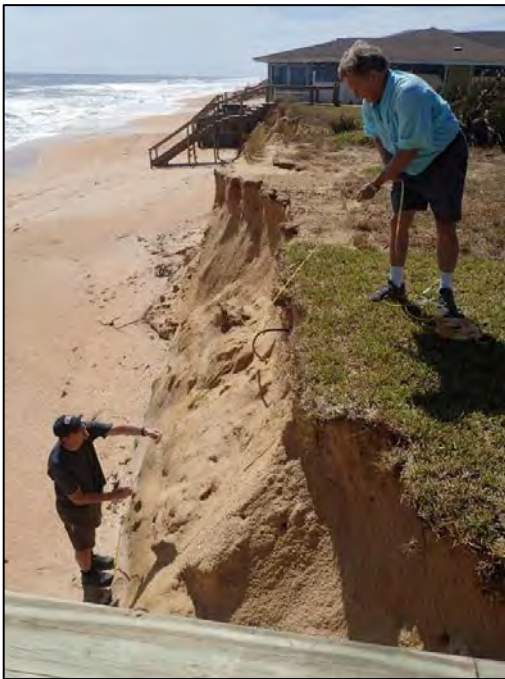
c) Measuring the almost vertical face of the eroded dune (Latitude 29°32'31.64"N / Longitude 81°9'27.27"W).

To the north of the timber sheet pile wall the dune was severely eroded. The erosion produced an unstable almost vertical face which measured approximately 3 meters in height. In some locations, the crest of the eroded face was undercut making the top of the dune unstable (Figure 59c). The erosion of the dune system in this vicinity resulted in a number of beach timber staircases to be undercut and collapse. One such example is shown in Figure 59d.

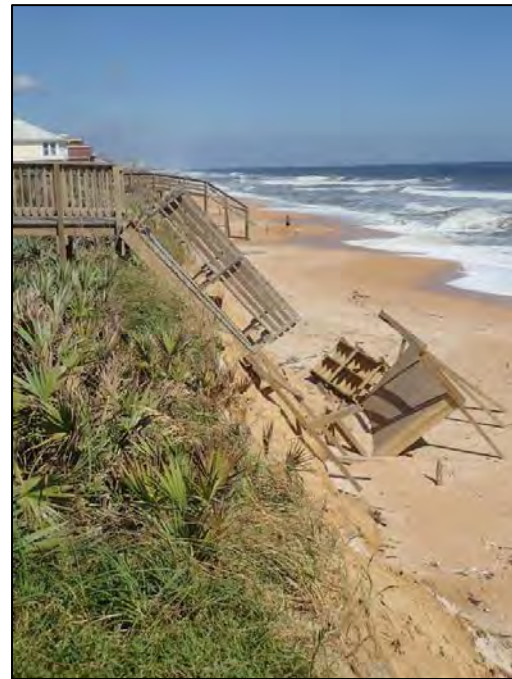
d) Example of collapsed timber staircase (Latitude 29°32'31.64"N / Longitude 81°9'27.27"W).

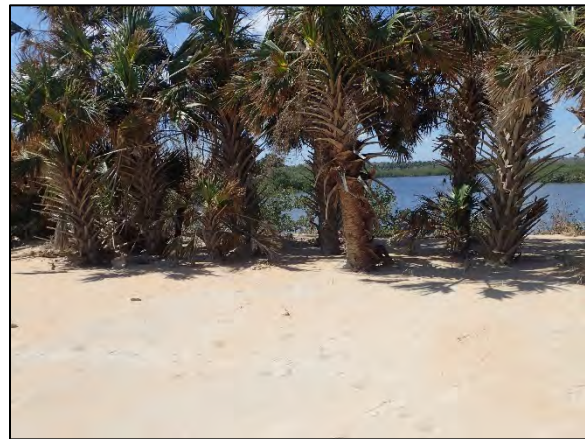
Photographs from the west side of Highway A1A are shown in Figure 63b and Figure 63c. Figure 63b is a photograph looking north along Highway A1A. The figure shows a windrow of washover deposits that were removed from Highway A1A. Figure 63c shows the extent of the overwash deposits. These sediments were eroded/scoured from the dunes and deposited on the each bank of the Matanzas River. The sediments were transported distances of up to approximately 105 m.

c). Washover deposits on the east bank of the Matanzas River (Latitude 29°40'17.59"N / Longitude 81°12'51.66"W).

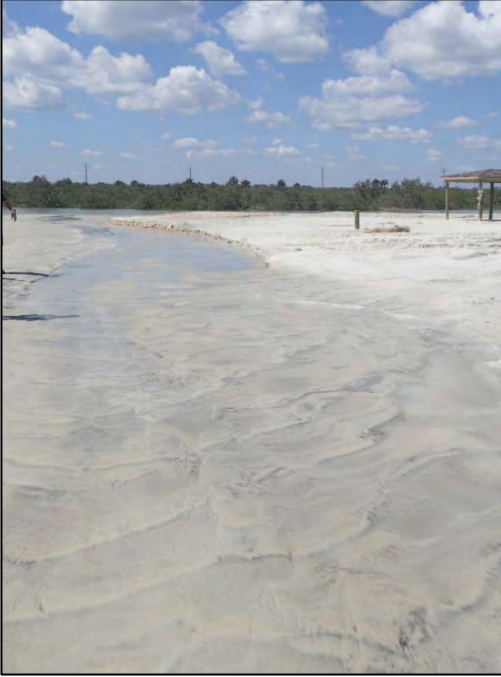
Figure 64 shows two views of the breach. Within the breach the water flows westward from the Atlantic Ocean to the Matanzas River. The depth of the breach is between approximately 0.3 m and 0.6 m. The deeper section of the breach is towards the western end. Figure 64a shows ripple marks at the eastern portion of the breach indicating sediment movement. Figure 64b shows the steep face of the edges of the

a) Photograph looking west along the breach (Latitude 29°40'59.64"N / Longitude 81°13'6.20" W).

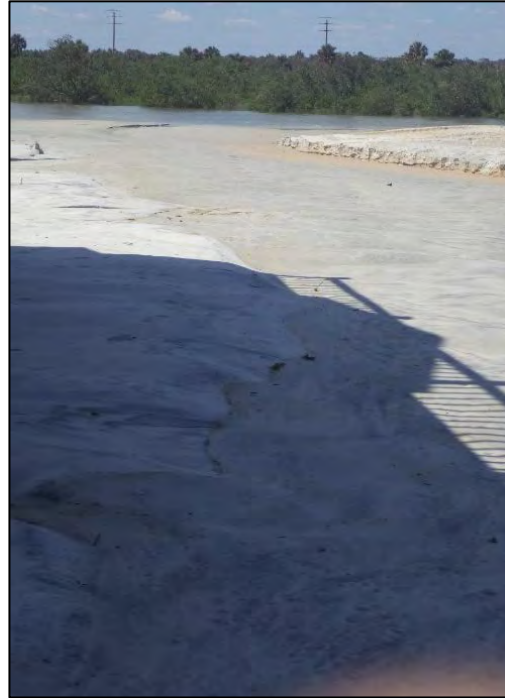
breach. Figure 64C shows water moving westward from the Atlantic Ocean to the Matanzas River. The width of the breach was approximately 6 m.

b) Photograph looking northwest along the breach (Latitude 29°40'59.38"N / Longitude 81°13'6.26" W).

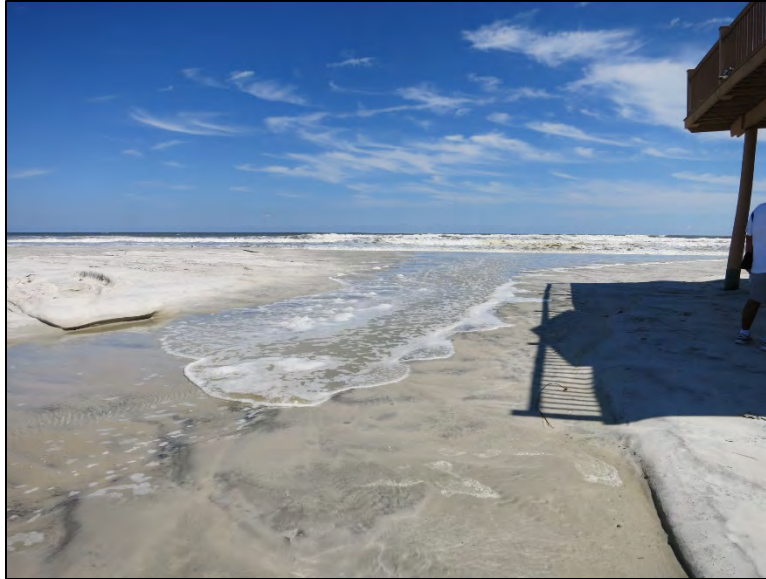
c) Ocean water flowing west into Matanzas River (approx. location Latitude $29^{\circ}40'59.64''\text{N}$ / Longitude $81^{\circ}13'6.20''\text{W}$).

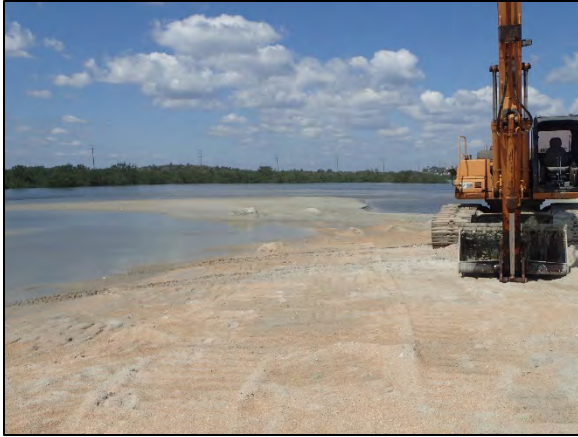
Although the breach was the emphasis at the site, there was notable structural damage and minor geotechnical damage noted along the walk from Marineland to the breach site and north of the breach site. Figure 65a is a photograph take north of the breach site. Heavy equipment was being used to remove overwash sediment deposits from the Matanzas River. The overwash sediments are clearly seen in the left hand side of the photograph. Figure 65b shows localized scour at a timber pile. The scour depth was minimal on the order of 10 centimeters and was not a contributor to structural damage. A concrete driveway was undercut by scour as shown in Figure 65c. The damage from the scour caused portions of the concrete driveway to be washed away. Figure 65d shows damage to a patio deck. The deck was constructed of brick pavers which were placed on a thin layer of cemented soil. Scour damaged a large portion of the deck.

a) Removal of overwash deposits from the Matanzas River (Latitude 29°41'6.19"N / Longitude 81°13'10.60"W).

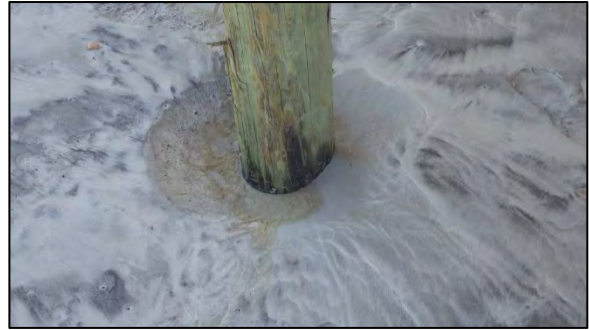
b) Localized scour along pile foundation (Latitude 29°40'57.91"N / Longitude 81°13'5.51"W).

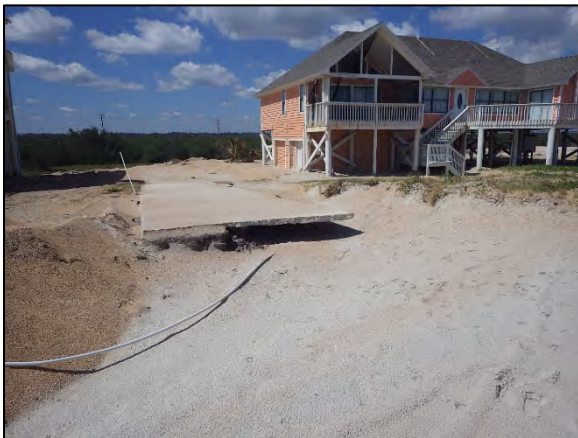
c) Scour at driveway (Latitude 29°40'20.18"N / Longitude 81°12'51.82"W).

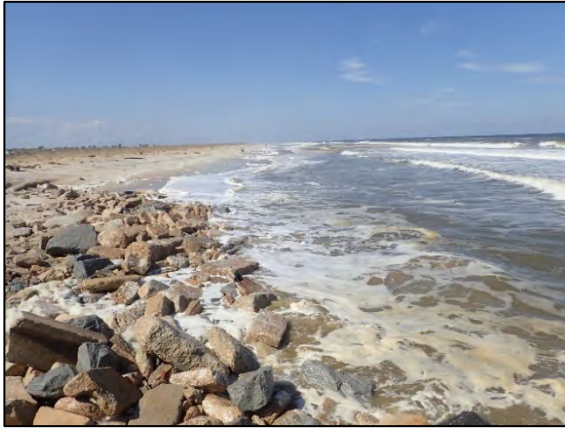
Photographs in Figure 68 were taken north of the pier near the new construction indicated in Figure 67c. Figure 68a shows the new hotel under construction in the background. Figure 68b was taken looking south towards the pier, and Figure 68c was taken looking towards the north showing the condition of the beach. Figure 68d shows evidence of overwash and unraveling of the poorly constructed revetment at the north end of the property.

c) Beach conditions (Latitude 29°51'33.61"N / Longitude 81°15'56.29"W).

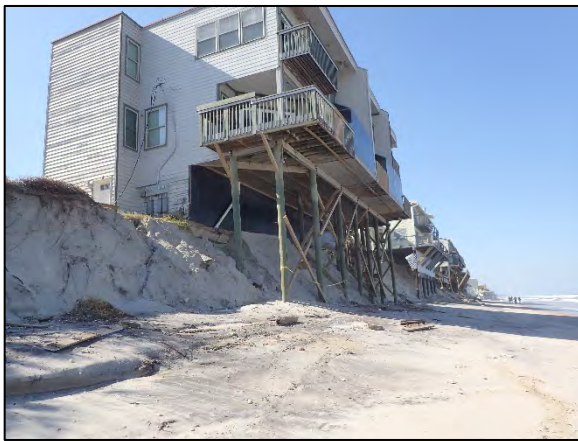
Progressing in a northeasterly direction along the beach, the coastal bluffs were not protected by seawalls. Properties located between 3930 Coastal Highway to 4010 Coastal Highway had severe bluff erosion. The erosion caused severe undermining of foundations. The undermining did not undercut the timber pile foundations but in several instances shallow foundations supporting decks were completely undercut. Figure 71a shows severe erosion exposing timber pile foundations at 3930 Coastal Highway. Note the cross bracing that has been added to provide lateral support for the exposed piles. Figure 71b also shows severe erosion exposing timber pile foundations and undercut shallow foundations supported by micropiles which support a deck. The location of this damage is 3940 Coastal Highway. The person shown in the photograph is 1.93 meters tall. Figure 71c shows the severe erosion at 3978 Coastal Highway. Once again timber piles are exposed. Note the wooden piers supporting the deck are free hanging with no support.

a) Beach house at 3930 Coastal Highway (Latitude 29°56'46.05"N / Longitude 81°18'7.46"W).

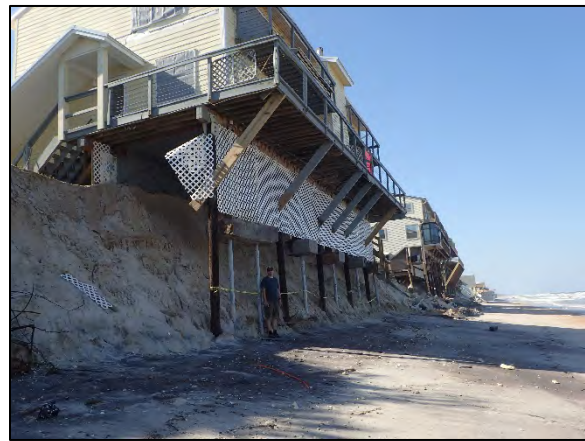
b) Beach house at 3940 Coastal Highway (Latitude 29°56'47.00"N / Longitude 81°18'8.10"W).

Figure 71. Examples of erosion exposing timber pile foundations at Vilano Beach.

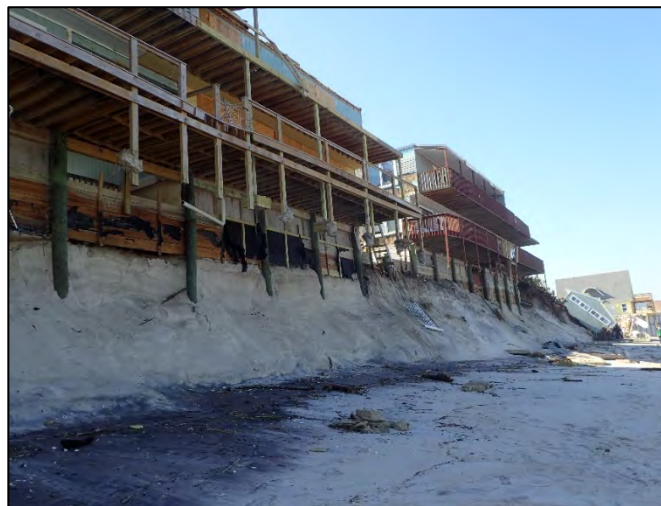
c) Beach house at 3978 Coastal Highway (Latitude 29°56'50.66"N / Longitude 81°18'10.74"W).

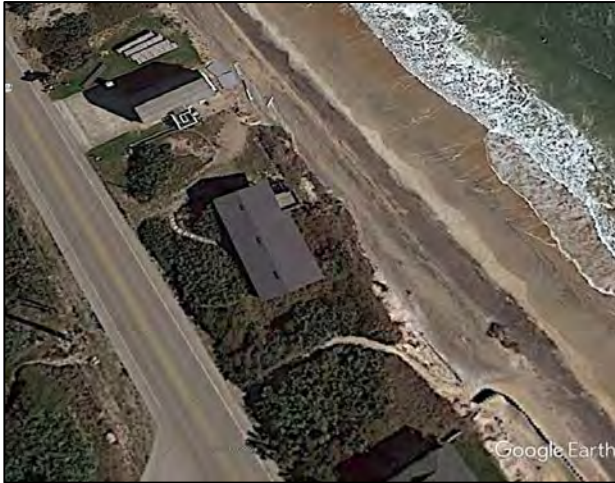
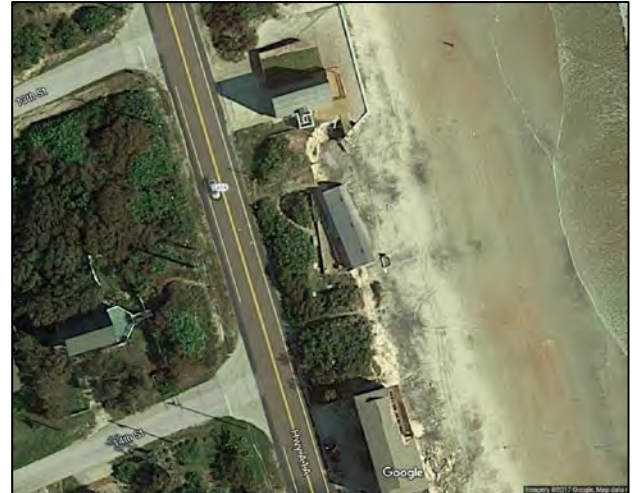
Figure 72. Aerial image of 4010 Coastal Highway in Vilano Beach (Latitude 29°56'54.04"N / Longitude 81°18'11.00"W).

A beach house located at 4010 Coastal Highway, St. Augustine FL was not supported by pile foundations. Wave action associated with Hurricane Irma caused the bluff to be cut back from the ocean approximately 15 meters towards Coastal Highway (Highway A1A). Figure 72 shows aerial images of 4010 Coastal Highway. Figure 72a shows the location of the house and dune system prior to Hurricane Irma. Figure 72b is a recent image showing the severe erosion of the dune system. Note the position of the house has shifted.

a) Prior to Hurricane Irma.

b) Post Hurricane Irma.

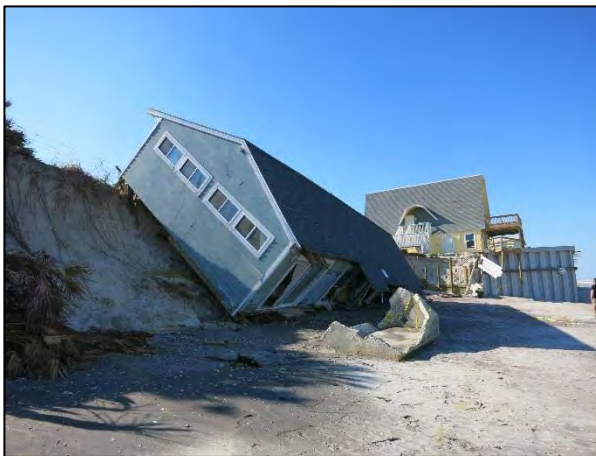
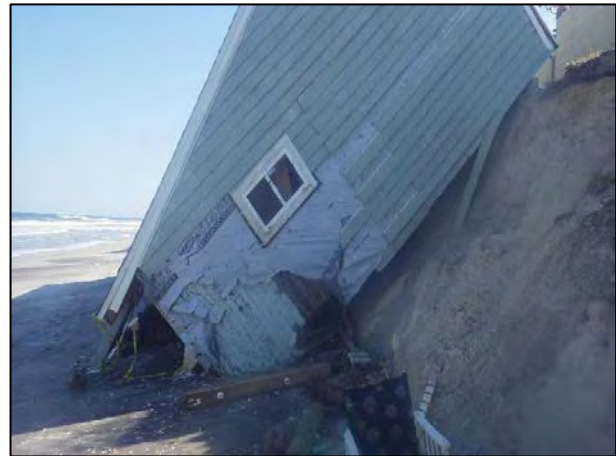
Figure 73. Collapsed house at 4010 Coastal Highway, Vilano Beach (Latitude 29°56'54.62"N / Longitude 81°18'11.03"W).

a) Picture taken facing north.

b). Picture taken facing south.

The significant erosion at the property at 4010 Coastal Highway is much more dramatic from the beach. Figure 73 shows the collapsed house at 4010 Coastal Highway. Figure 73a shows the house in a picture

taken looking north. Figure 73b shows the house in a picture looking south. Both figures clearly show the significant erosion which cause the collapse of the house.
