Geotechnical Damage in Central and Northeastern Florida from Hurricane Irma

GEER Association Report No. GEER-056b

October 2017

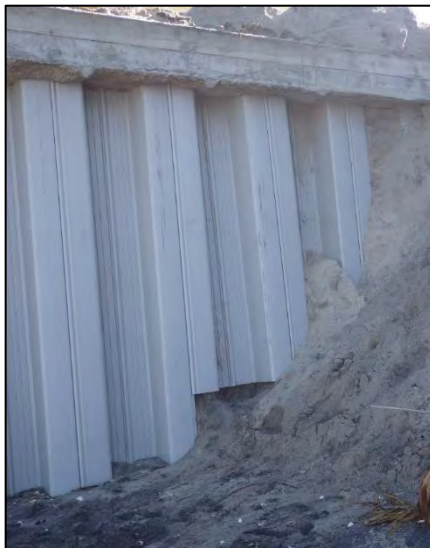
At the northern end of the seawall, there was also damage to the wing wall. However at this location (4040 Coastal Highway) the wing wall was not destroyed. However significant erosion coupled with insufficient driving depth caused the bottom of the sheet pile to be exposed, as shown in Figure 76a. Figure 76b is a close-up photograph of the exposed bottom. The close up photographs shows evidence of soil movement. The exposed bottom of the sheet pile acted as a conduit for the retained soil to escape causing significant ground loss behind the seawall. Figure 76c shows the cavity formed from escaping soil.

a) Exposed bottom of sheet pile wall (Latitude 29°56'58.35"N / Longitude 81°18'12.10"W).

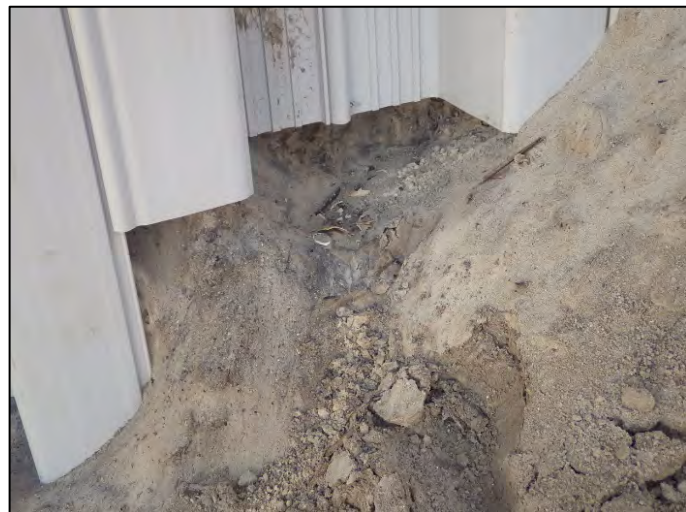
b) Close up of exposed bottom of sheet pile (Latitude 29°56'58.35"N / Longitude 81°18'12.10"W).

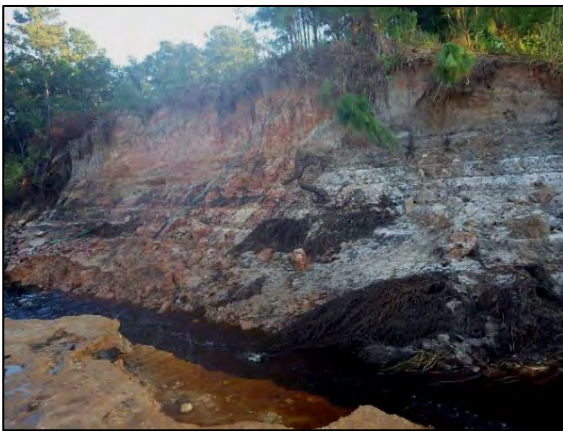
Figure 87 shows the variety of geotechnical damage associated with the dam failure. Figure 87a shows the completely failed dam with the concrete weir structure still intact. Figure 87b shows the scour on the north shoulder of the Lake Hampton Road. During the event the water overflowed the spillway area and overflowed Lake Hampton Road. Figure 87c shows the embankment erosion on the east side of the former dam. Figure 87d shows the lowered water levels in the reservoir.

c) Scour of the east embankment of the dam
(Latitude 30°46'33.89"N / Longitude
81°58'15.47"W).

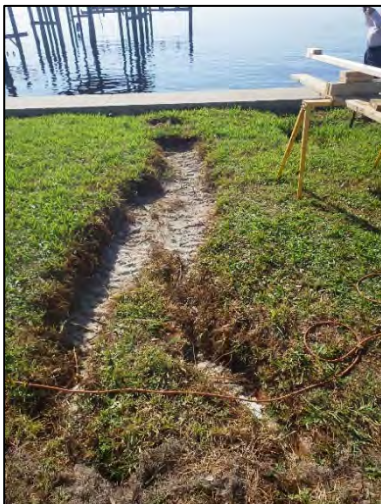
a) Localized scour behind the river bulkhead.

Localized scour from overtopping the bulkhead was noted at the Donald Street pocket park. These holes in the ground need careful repair as some of these might be extending underground up to river boundary wall. There was also considerable damage to private boat docks. Photographs of these damages are shown in Figure 89. Although the localized scour damage may not be considered significant, this type of damage occurred at a number of the pocket parks along the St. Johns River in the historic district of Jacksonville.

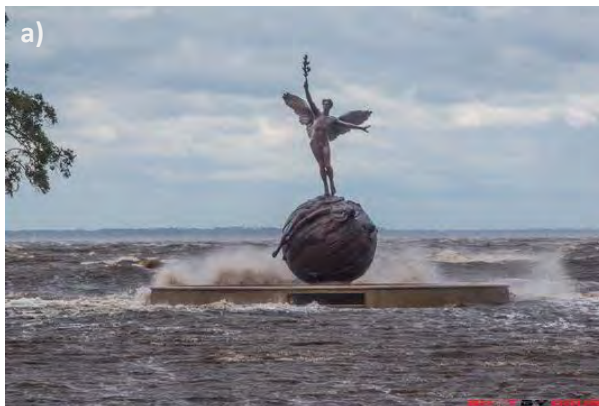
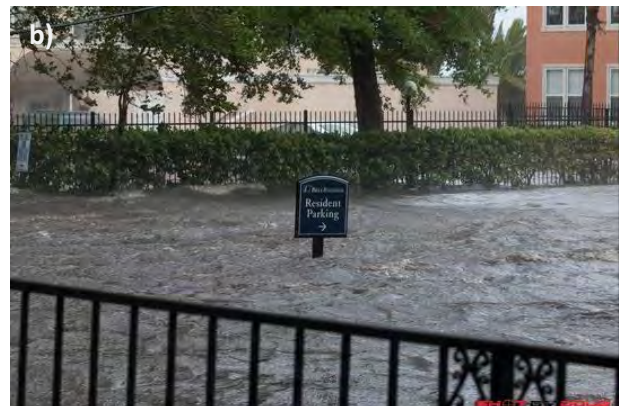
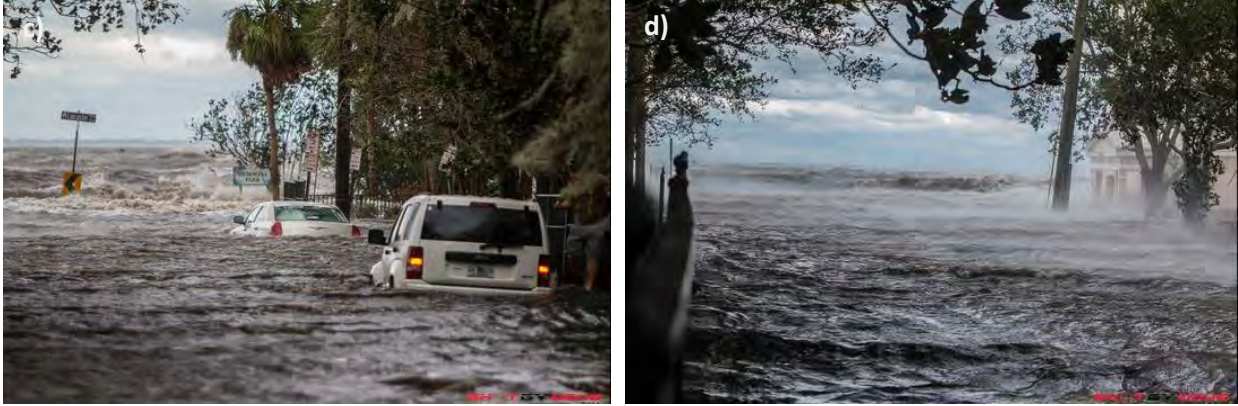
Figure 90 Images from Hurricane Irma flooding at Memorial Park³⁹ (Latitude 30°18'38.44"N / Longitude 81°40'46.16" W).

During Hurricane Irma, water of St Johns River rose about 0.75 m above the ground surface due to storm surge and rainfall. From media reports and information obtained from public, it was clear that the park and the adjacent streets along the river flooded during the hurricane. This flooding is shown in Figure 90. Following the hurricane and after flood waters receded, the railing along the riverfront was damaged and in some places was washed away by the water (Figure 91). This created a safety hazard for the people and pets using riverfront and needs to be repaired as a priority.

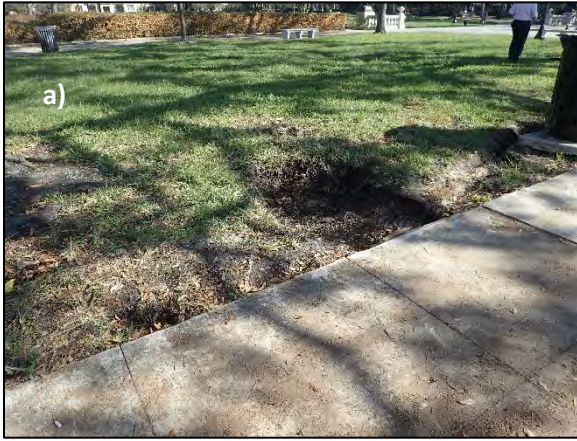
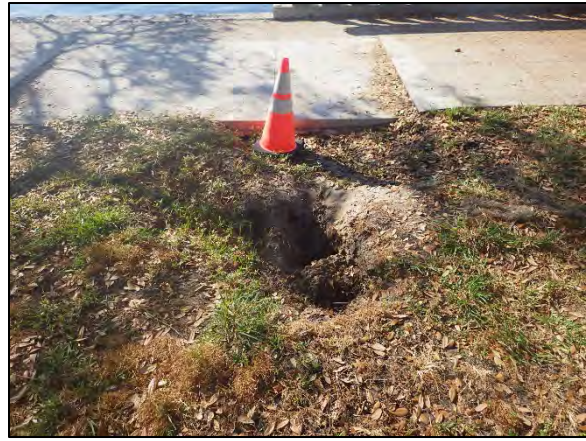
Figure 92. Example of scour holes at Memorial Park (Latitude 30°18'38.44"N / Longitude 81°40'46.16"W).

Localized deep scour holes were observed at a number of locations on the west or park side of the concrete walkway. Many of these holes appear to extend under the concrete walkway and towards the river. If left unattended these holes may cause localized failures of the walkway. Two examples of scour holes are shown in Figure 92.
