Geotechnical Extreme Events Reconnaissance

Geotechnical Damage in Central and Northeastern Florida from Hurricane Irma

GEER Association Report No. GEER-056b

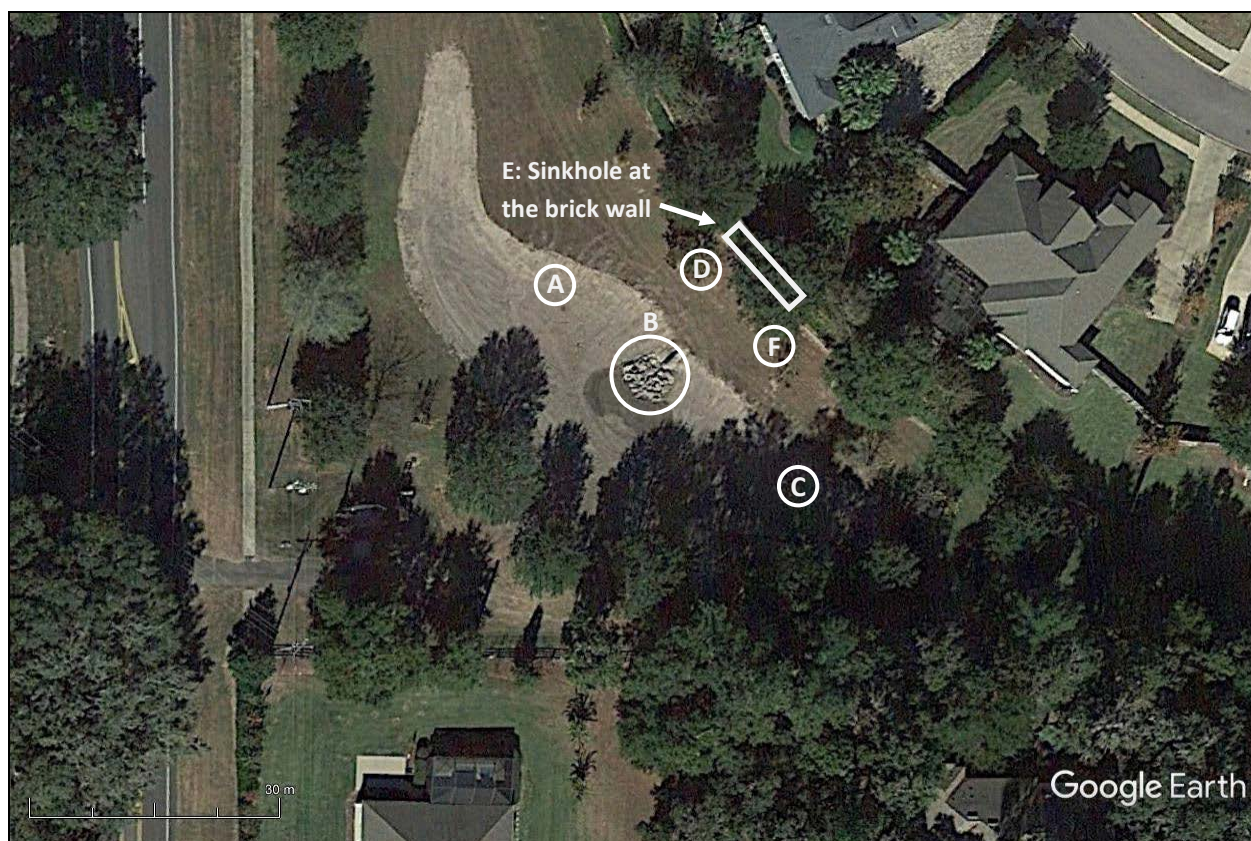
Figure 9 indicates that the location of sinkhole "B" is where a concrete drainage pipe exists to drain water from the Turnberry Lake community into the retention pond. The outfall location was previously reinforced with broken concrete, where water would run over the concrete instead onto the soil of the retention pond. During the site visit, the foreman of a work crew responsible for fencing in the location for safety that day indicated that at least one sinkhole had previously formed at the location where the reinforcing concrete was piled at the outfall.

Figure 9: Approximate locations of five sinkholes (A-E) and a depression (F) within and nearby a retention pond near 2800 NW 143 Street, Gainesville, FL (Latitude: 29°40'34.84"N / Longitude: 82°29'43.31"W) (from Google Earth, 2016).

The additional four sinkholes (A, C, D, E) and depression (F) were assumed to have occurred as a result of Hurricane Irma, however it is uncertain if any had opened prior to the Hurricane (e.g., the sinkhole "E" at the brick wall). Figure 13 through Figure 17 document in image form the sinkholes, depression, and overland flow within the retention pond from location "A" to "B" that were cataloged by the GEER team.

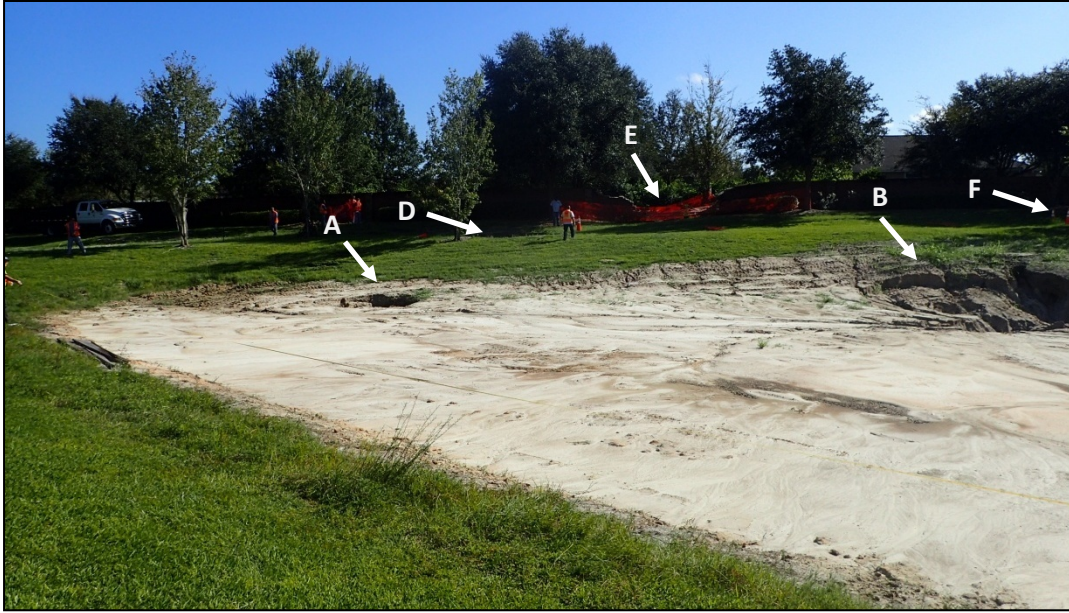
Figure 10: Image of the retention pond showing the locations of wetted clay (left), sinkhole "A", sinkhole "B" with the drainage outfall, sinkhole "D", and sinkhole "E" under the brick wall of the community, and depression "F" (Latitude: 29°40'48.05"N / Longitude: 82°29'43.61"W).

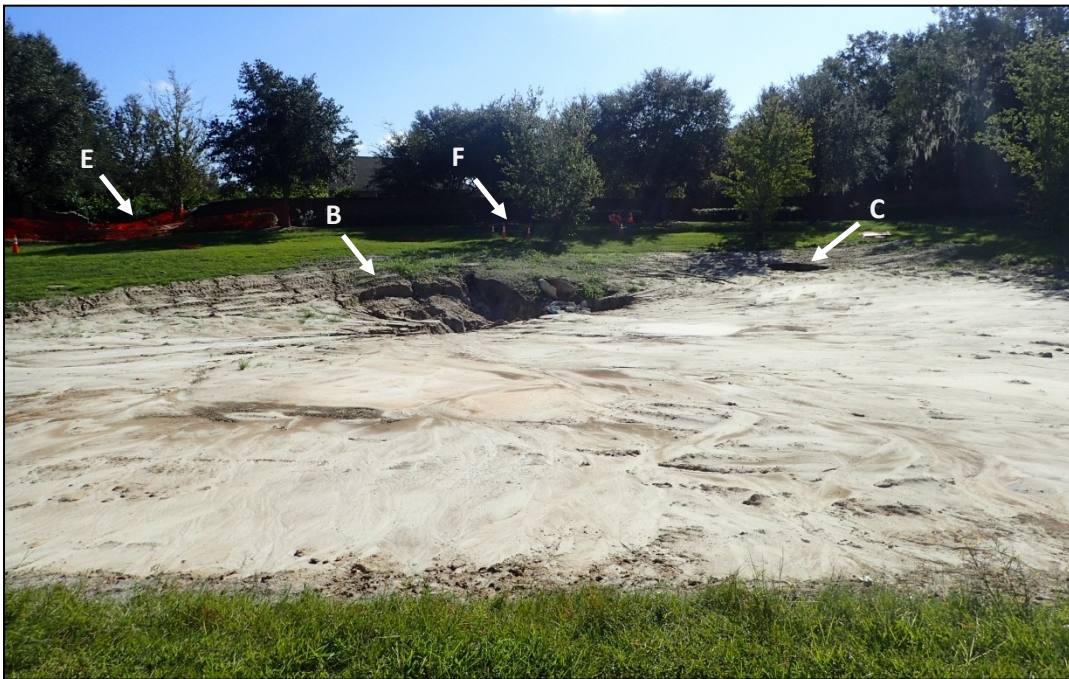
Figure 11: Image of the retention pond showing the locations of sinkhole "B" with the drainage outfall, sinkhole "C", sinkhole "E" under the brick wall of the community, depression "F", and evidence of the of water flow into sinkhole "B" in the retention pond foreground from the storm event (Latitude: 29°40'48.05"N / Longitude: 82°29'43.61"W).

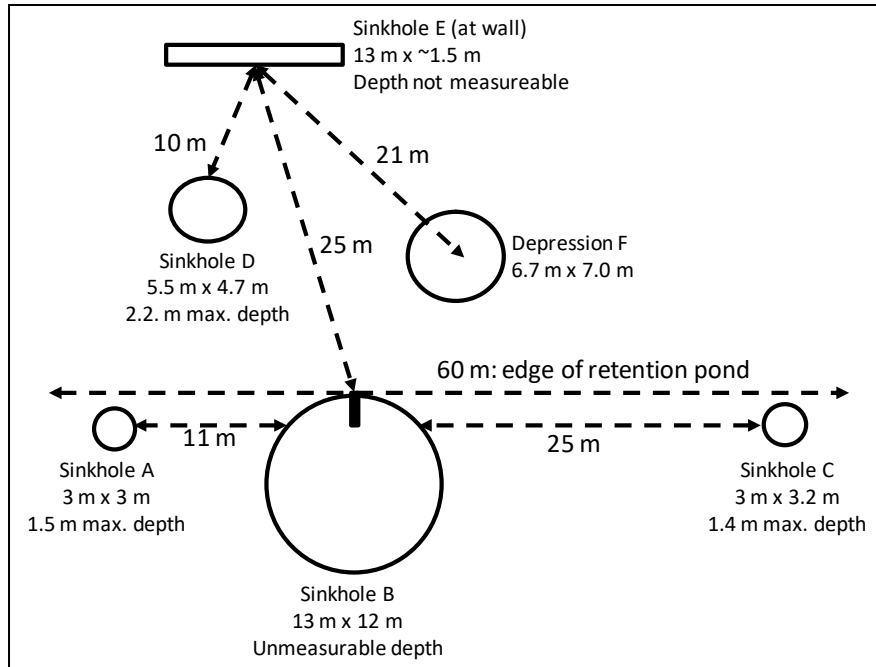
Figure 12: Approximate geometry of the five sinkholes (A-E) and depression (F) at the retention pond near 2800 NW 143 Street, Gainesville, FL (Latitude 29°40'34.84"N / Longitude 82°29'43.31"W).

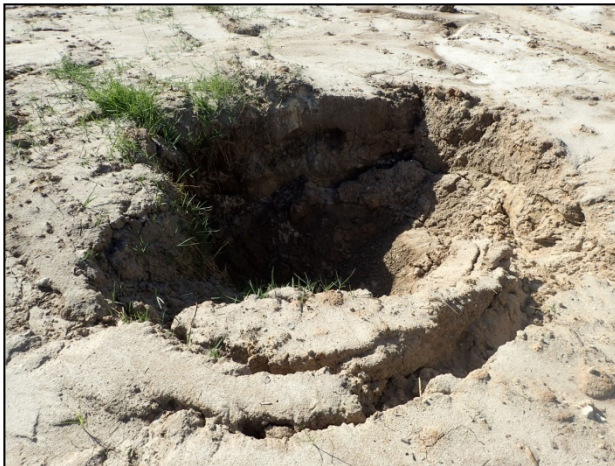
Figure 13: Image of sinkhole "A" that is 3 m in diameter with a maximum depth of 1.5 m (Latitude 29°40'47.99"N / Longitude: 82°29'42.99"W).

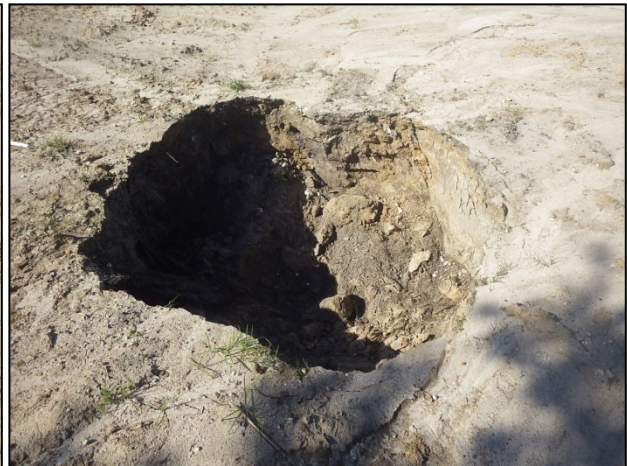
Figure 14: Image of sinkhole "C" that has 3.2 and 3.0 m diameters and a maximum depth of 1.4 m (Latitude 29°40'47.69"N / Longitude 82°29'43.25"W).

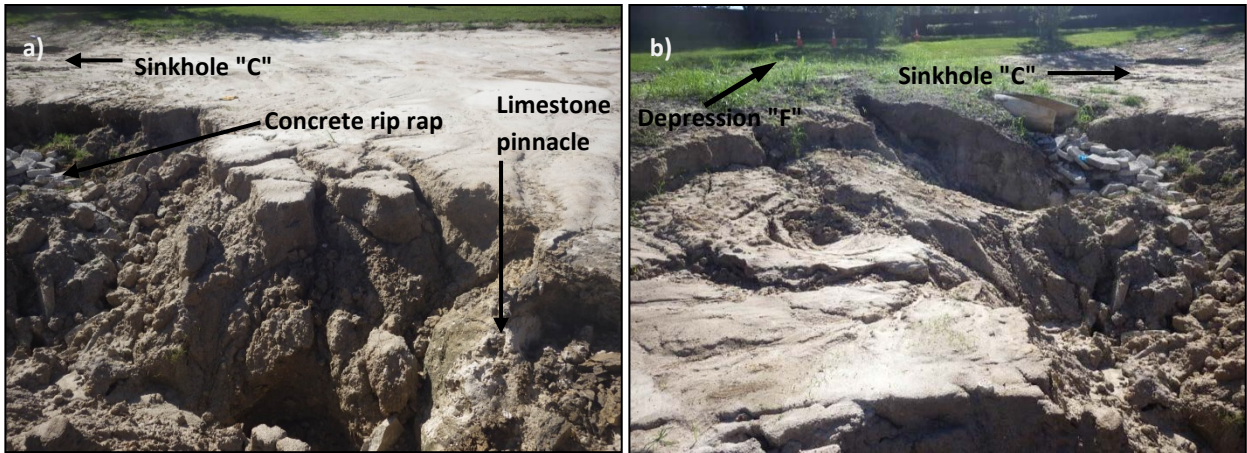
Figure 15: Sinkhole "B" showing a) limestone pinnacle (right), concrete rip rap (left), and location of sinkhole "C" (Latitude 29°40'47.57"N / Longitude: 82°29'43.37"W) and b) showing the extent of the newly developed depression behind the outfall pipe, the location of sinkhole "C", and the location of depression "F" (Latitude 29°40'47.57"N / Longitude: 82°29'43.37"W).

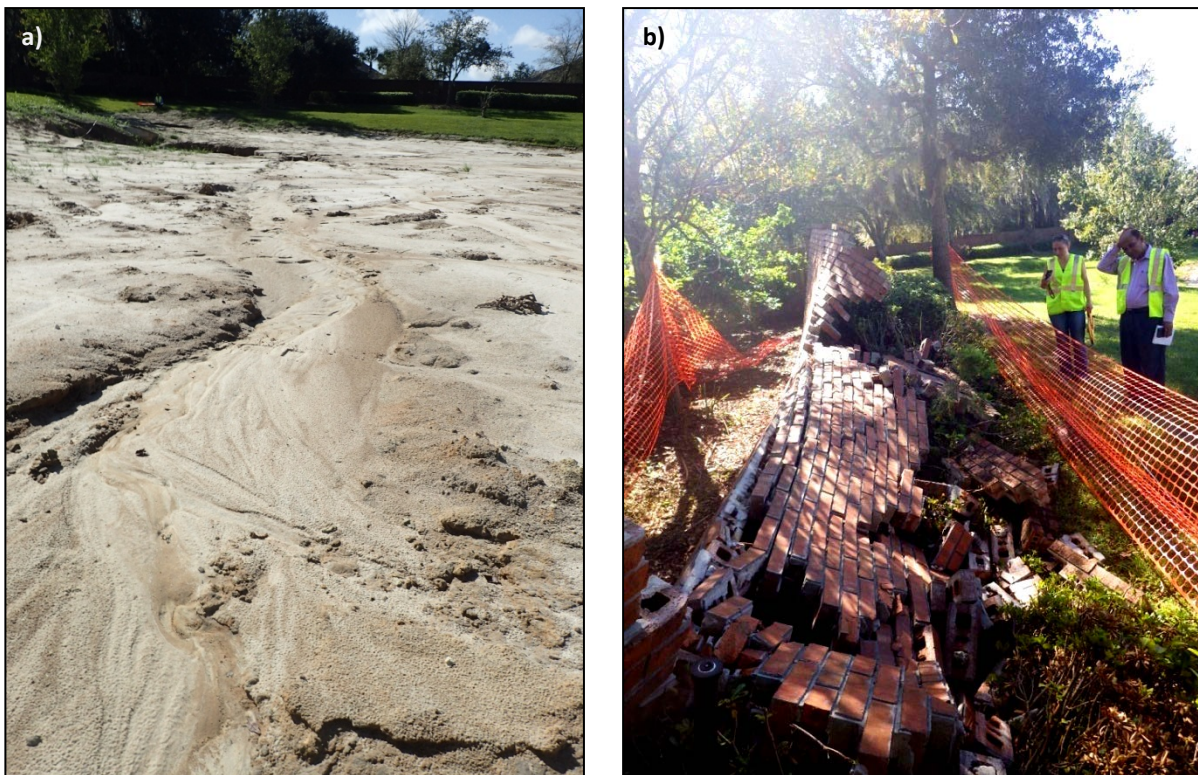
Figure 16: a) Erosion from overland flow within the retention area, where the direction of water flow was from sinkhole "A" toward sinkhole "B" (Latitude 29°40'48.47"N / Longitude 82°29'43.94"W), and b) toppled brick wall over a 12.5 m length at sinkhole "E" (Latitude 29°40'25.12"N / Longitude 82°29'48.35"W).

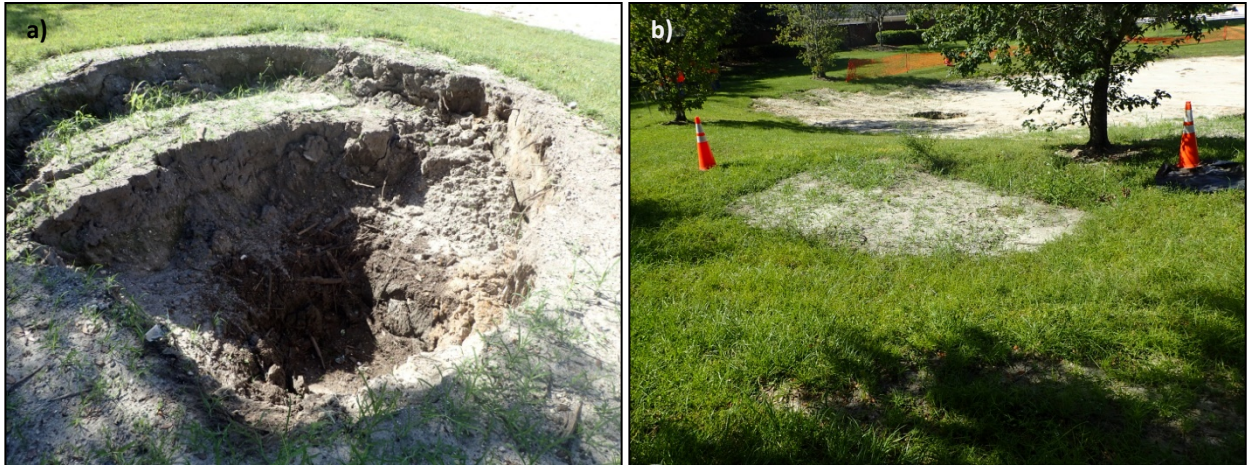
Figure 17: a) Sinkhole "D" (Latitude 29°40'48.85"N / Longitude: 82°29'43.13"W and b) newly developed depression "F" (Latitude 29°40'47.99"N / Longitude 82°29'41.99"W).

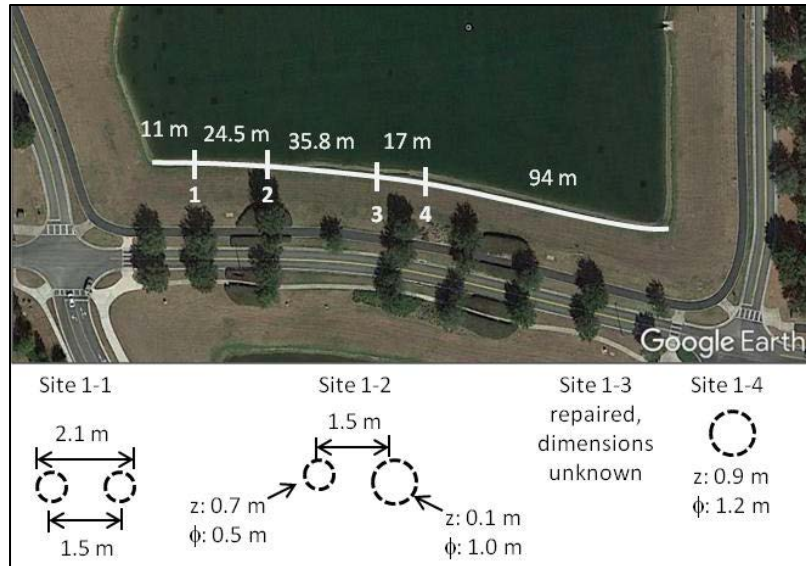
- Two small sinkholes were present at Site 1-1. They were approximately 1.5 m on center. The sinkhole throats were small in diameter, and depths could not be measured effectively.
- Two small sinkholes were at Site 1-2. They were approximately 2.5 m on center and had diameters of 0.7 m and 1.0 m and depths of 0.5 m and 0.1 m.
- One or more sinkholes of unknown geometry were identified at Site 1-3. When the GEER Team visited the site, the sinkhole(s) had been filled in.
- One sinkhole was present at Site 1-4. It was 1.2 m in diameter and had a depth of 0.9 m.

Figure 23. Schematic locations and dimensions of the sinkholes on the bank of the retention pond (from Google Earth 2017).

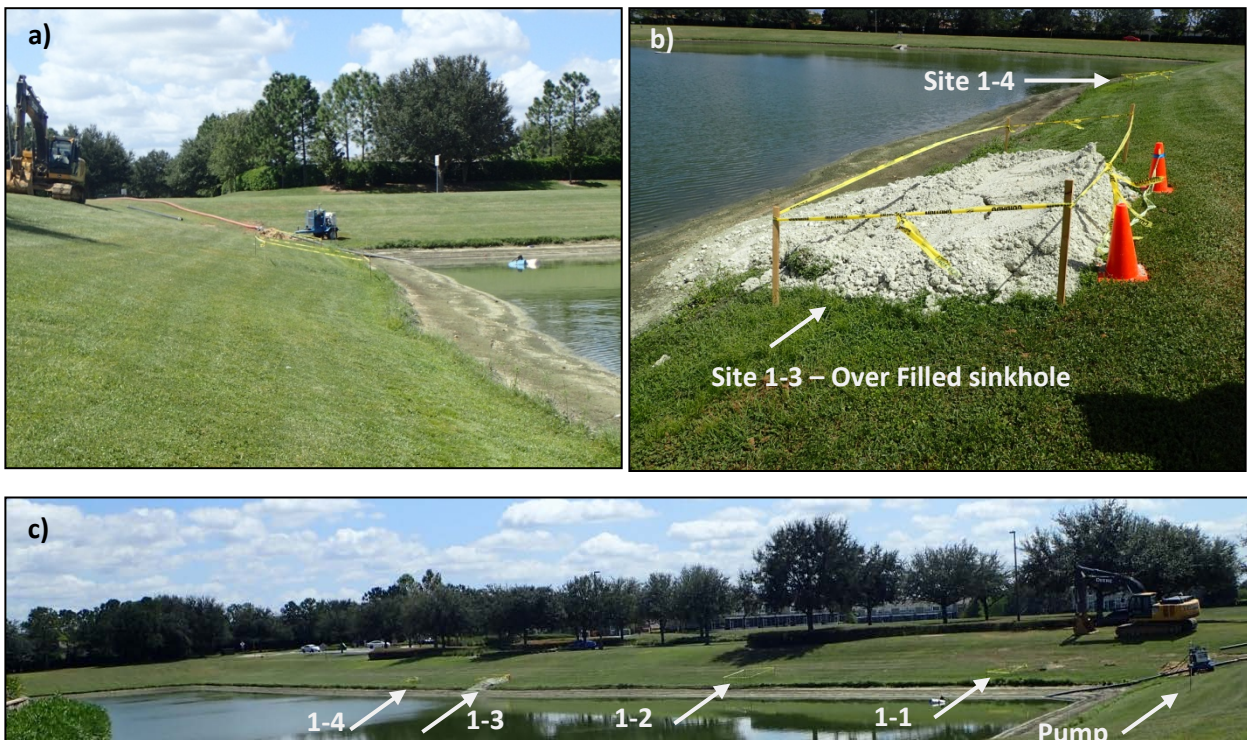
Figure 24. Images illustrating locations of the sinkholes on the bank of the retention pond (Latitude 29°8'50.99"N / Longitude 82°12'35.99"W).

The sinkholes identified at this site were relatively small and did not pose a danger to vehicles or pedestrians unless they were on the bank of the retention pond. The sinkholes, because of their small size, were most likely discovered by lawncare crews working in the community. Sinkhole 1-3 was most

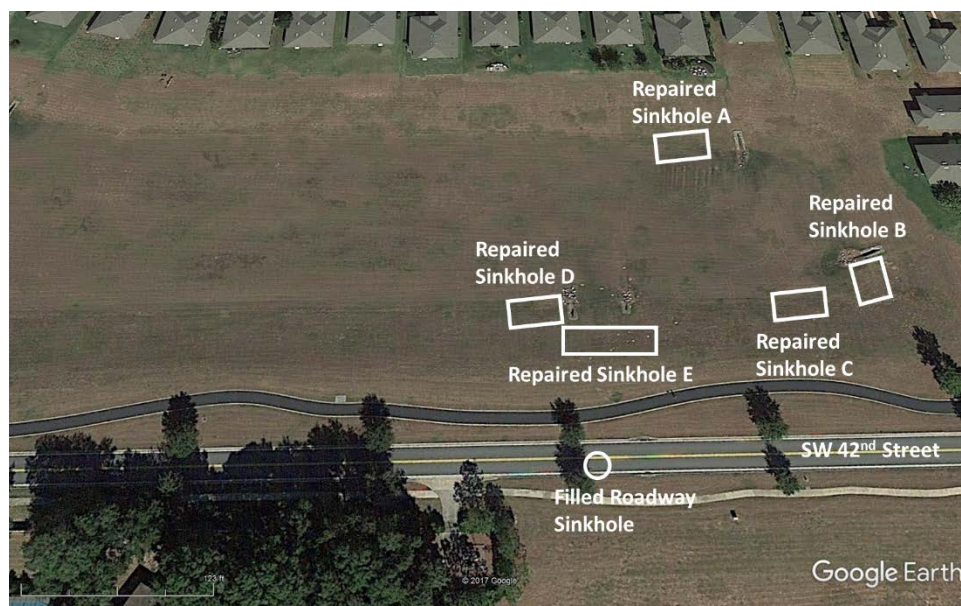
Site 2 was located at a retention pond along SW 42nd Street in the Fore Ranch community. Figure 26 is an aerial view from Google Earth showing the locations of the repaired and partially repaired sinkholes near the retention pond. A resident who lives on the north end of the retention pond verified that the sinkholes occurred during the hurricane.

Figure 26. Fore Ranch Community Site 2 repaired and filled sinkholes (from Google Earth, 2017).

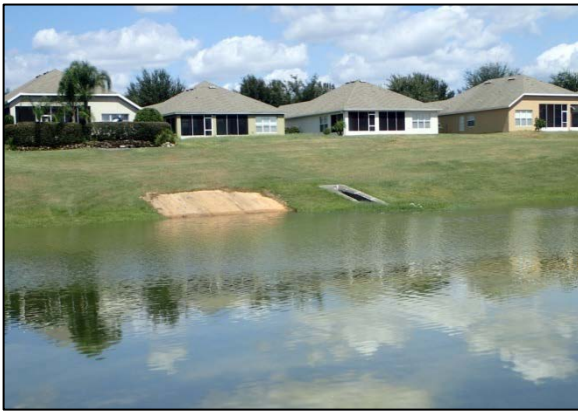
Five repaired sinkholes were present on the banks of the retention pond. The sizes of the repaired areas were not measured because they do not provide an accurate assessment of either the sinkhole size or depth. Sinkhole A was on the bank of the retention pond. Sinkhole B was on the east bank of the retention pond. Sinkholes C and D were on the south bank of the retention pond. Sinkhole E, the largest of the repaired sinkholes, was at the top of the bank of the retention pond. It is interesting to note that all of the sinkholes except sinkhole C formed near outlet structures. Figure 29 contains photographs of the repaired sinkholes. The sinkholes were repaired by filling with granular soil and compacting with equipment used to place the granular soil. The track marks on the repaired sinkholes indicate they were only recently repaired.

Repaired sinkhole A

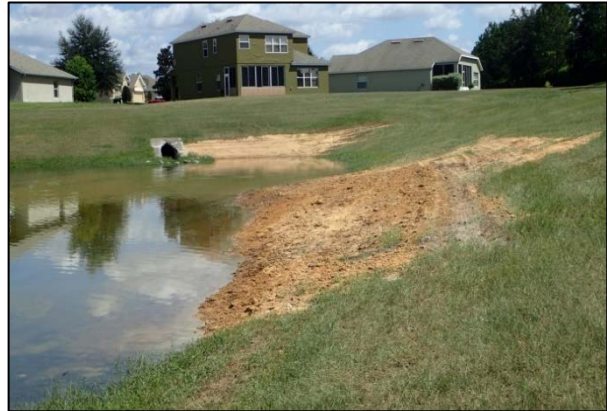
Repaired sinkhole B (back) and C (front)

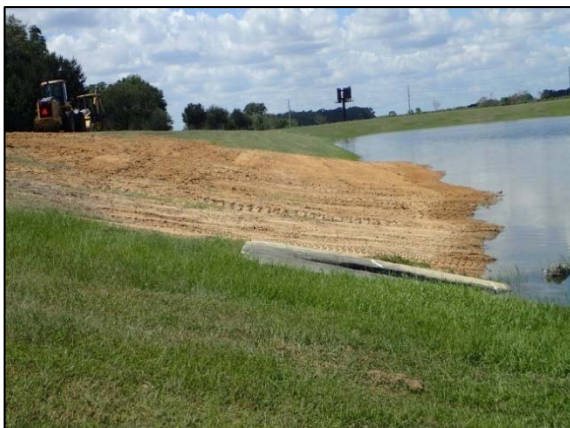
Repaired sinkhole D

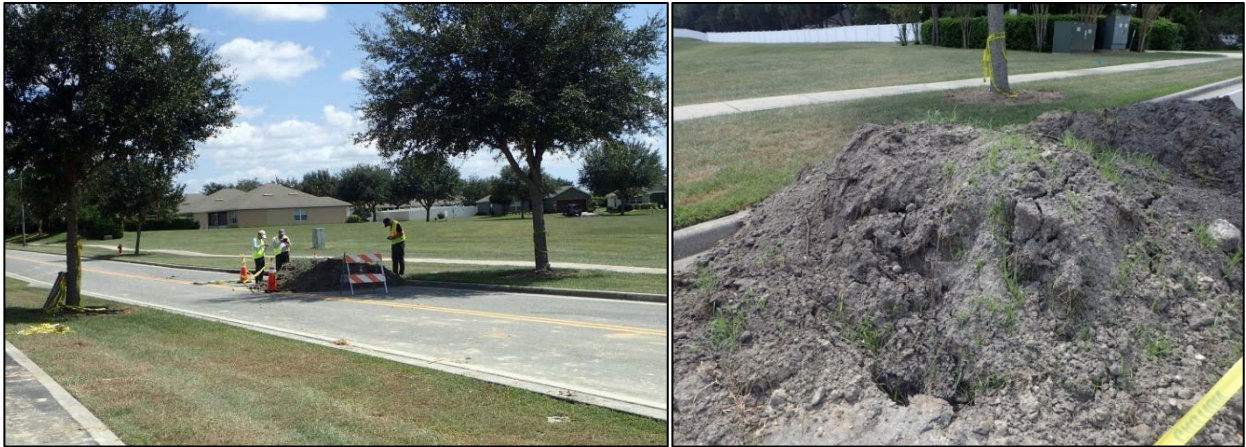
Figure 28. Sinkhole in road (Latitude 29° 8'47.52"N / Longitude: 82°12'51.36"W).

This site also had a sinkhole which had formed in the east bound lane of SW 42nd Street. This sinkhole had not been repaired but was overfilled with granular soil. Because of the sinkhole the street was closed to traffic. Figure 28 shows the overfilled sinkhole. Since the sinkhole is in the roadway, the repairs will need to be more sophisticated than simple fill and compaction with large equipment.

Sinkhole in road.

Road sinkhole overfilled with granular soil.

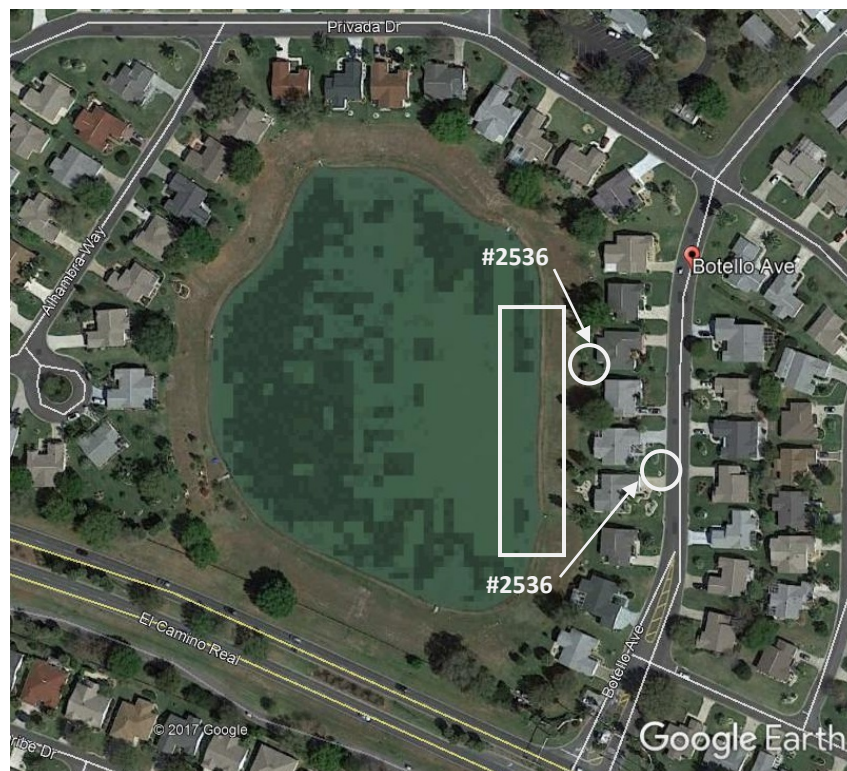
Figure 33 shows the location of the retention pond between Alhambra Way and Botello Ave. in The Villages Alhambra, FL where sinkholes were created on the bank, and within the basin, or the retention pond as a result of Hurricane Irma (rectangle). Figure 33 additionally shows the locations of two sinkholes that formed around houses nearby the retention pond location (circles).

Figure 33: The location of the Alhambra Retention Pond where sinkholes formed, The Villages, FL (from Google Earth, 2017).

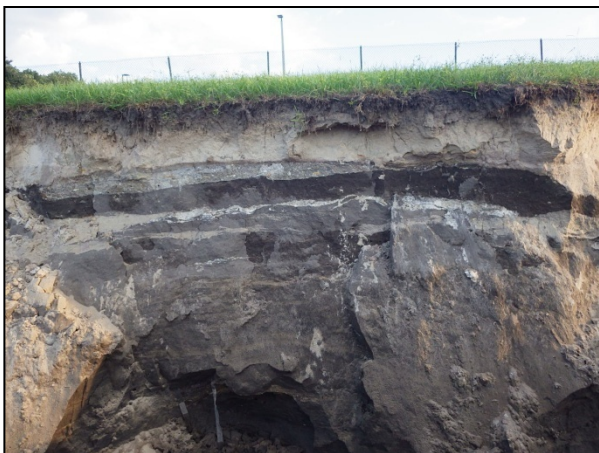
The GEER Team investigated the washout from the head of the erosion from the western extent to the West Orange Trail by walking the banks and erosion channel. Figure 42a shows the shallow erosion channel with a west to east view from near the school near the extent of where fill had brought in to raise the elevation of the grade at the school. The washout gully increased in both width and depth from the west towards drainage structure 3. The channel is about 1 m deep and 6 m across at this location. Figure 42b shows the drainage channel with an east to west view, looking back toward the school building (not shown). At this location the channel is approximately 3 m deep and 10 m across at the original ground surface. The washout gully increased in both width and depth from the west towards drainage structure 3. Figure 43 and Figure 44 illustrate the steep banks of the erosion channel. The soil in this area was fine sand deposits, which was a likely reason so much erosion occurred.

Figure 43. Interesting dark layered sand feature within washout stratigraphy (Latitude 28°41'8.54"N / Longitude 81°30'22.74"W).

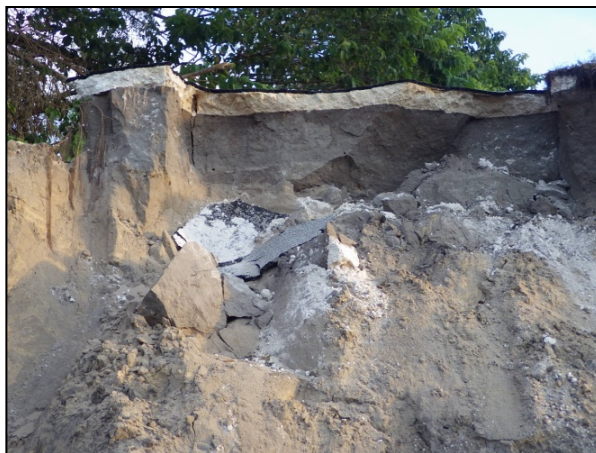
Figure 44. Washout at the West Orange Trail Surface (Latitude 28°41'8.70"N / Longitude 81°30'20.79"W).

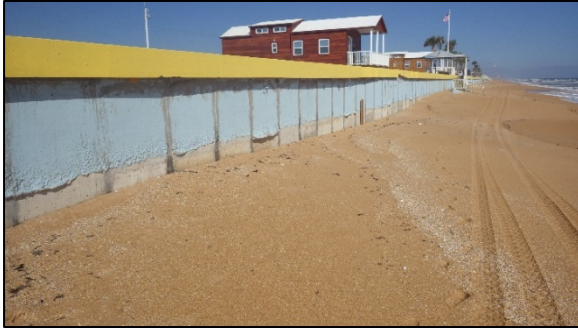
The documented damage at this reconnaissance site consisted of erosion along the sea wall and localized scour at timber staircases which provide access from the Resort, which is located on top of the seawall, to the beach.

a) Erosion across the face of the wall indicated by the exposed concrete (Latitude 29°31'15.29"N / Longitude 81°8'48.06"W).

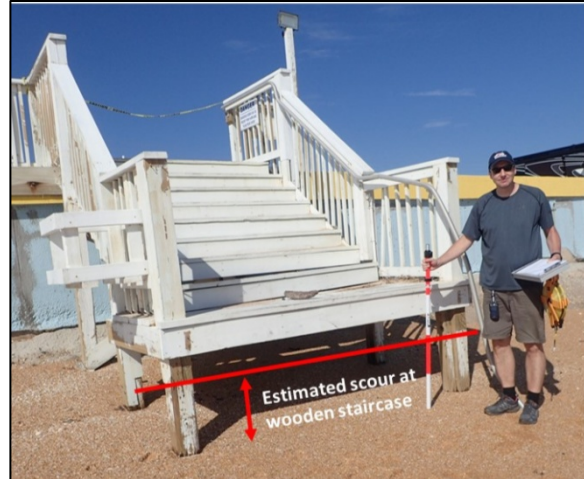
b) Scour at base of timber staircase (Latitude 29°31'14.96"N / Longitude W 81°8'48.07").

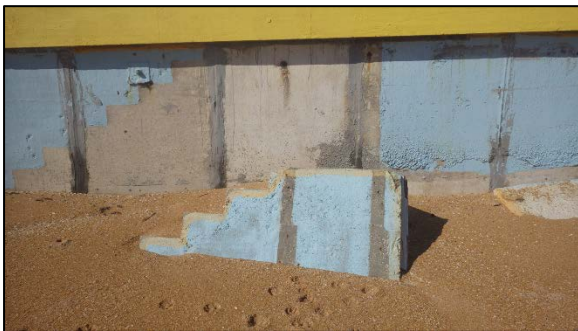
c) Damage to concrete stair structure (Latitude 29°31'16.64"N / Longitude 81°8'48.78"W).

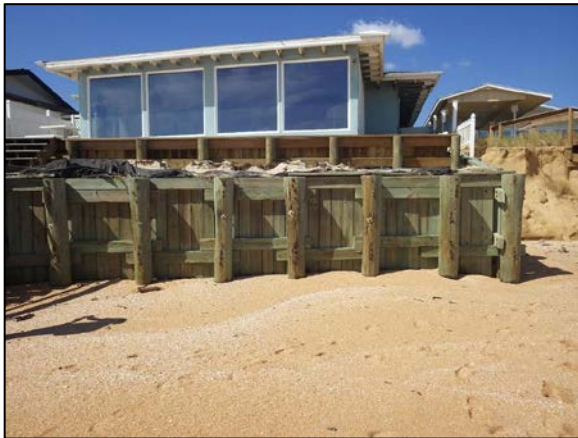
Site B is located at coordinates N 29° 32' 32.36" and W 81° 9' 28.0". The effectiveness of a dune protection system which was constructed next to an eroded dune is clearly demonstrated. The dune protection system, a two-tiered timber sheet pile structure, is shown in Figure 59a. One of the reconnaissance team members visited this site in 2016 after Hurricane Matthew. He stated the lower tier of the timber sheet pile structure was added after hurricane Mathew in 2016. The timber sheet pile structure has successfully protected the dune structure and shoreline. However some damage was noted on the north wing wall of the structure, as shown in Figure 59b. The timber sheet pile wall was not embedded far enough into the existing dune and the erosion has exposed the end of the wall, which is covered with a black tarp.

a) Two-tiered timber sheet pile structure (Latitude 29°32'28.35"N / Longitude 81°9'27.15"W).

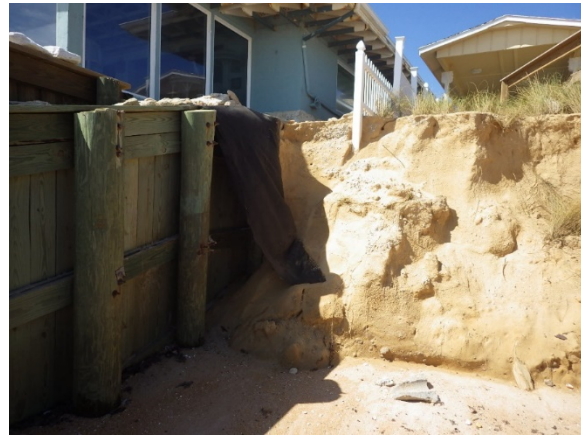
b) North wing wall scour of the timber sheet pile wall (Latitude 29°32'28.35"N / Longitude 81°9'27.15"W).

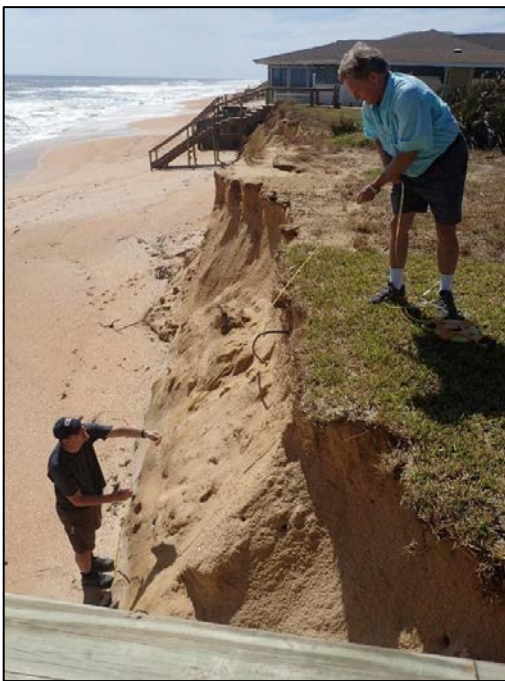
c) Measuring the almost vertical face of the eroded dune (Latitude 29°32'31.64"N / Longitude 81°9'27.27"W).

To the north of the timber sheet pile wall the dune was severely eroded. The erosion produced an unstable almost vertical face which measured approximately 3 meters in height. In some locations, the crest of the eroded face was undercut making the top of the dune unstable (Figure 59c). The erosion of the dune system in this vicinity resulted in a number of beach timber staircases to be undercut and collapse. One such example is shown in Figure 59d.

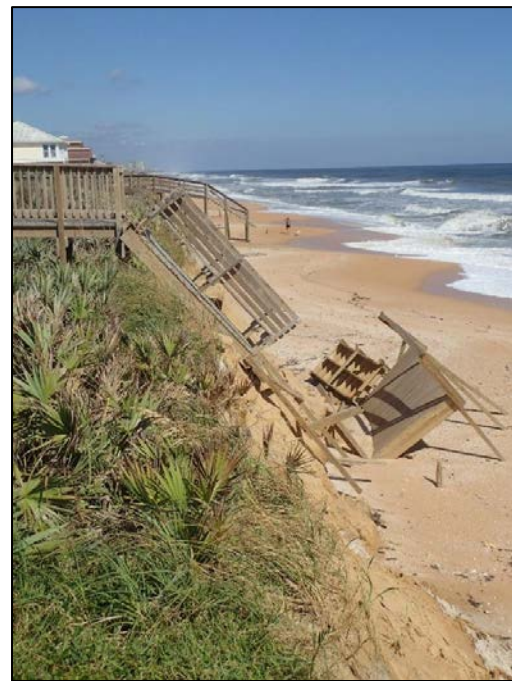
d) Example of collapsed timber staircase (Latitude 29°32'31.64"N / Longitude 81°9'27.27"W).

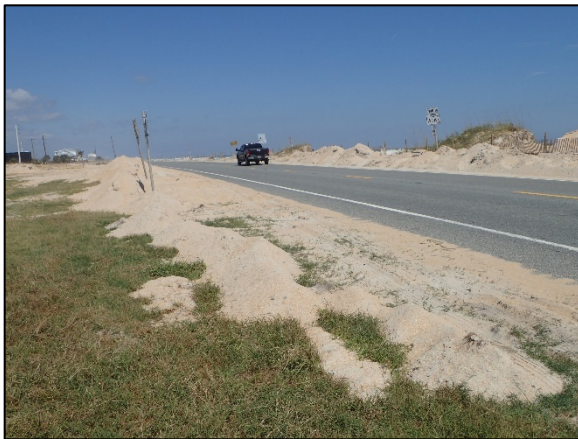
Photographs from the west side of Highway A1A are shown in Figure 63b and Figure 63c. Figure 63b is a photograph looking north along Highway A1A. The figure shows a windrow of washover deposits that were removed from Highway A1A. Figure 63c shows the extent of the overwash deposits. These sediments were eroded/scoured from the dunes and deposited on the each bank of the Matanzas River. The sediments were transported distances of up to approximately 105 m.

b) Windrows of washover deposits on west side of Highway A1A (Latitude 29°32'29.00"N / Longitude 81°9'25.0"W).

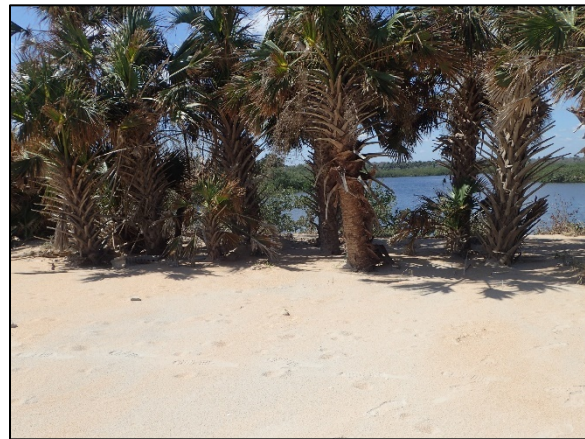
c). Washover deposits on the east bank of the Matanzas River (Latitude 29°40'17.59"N / Longitude 81°12'51.66"W).

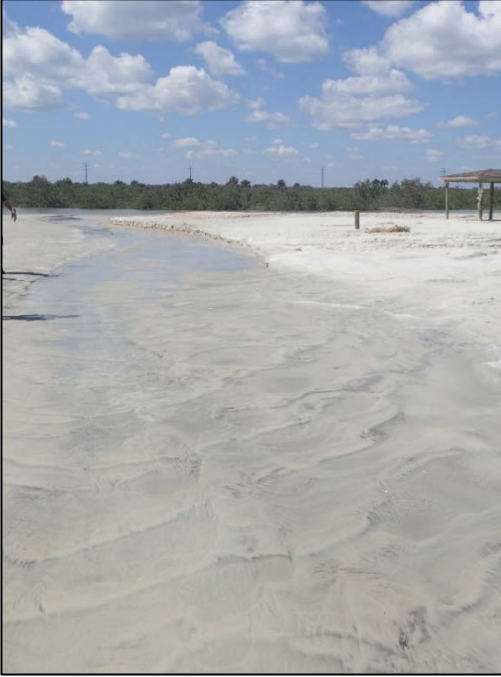
Figure 64 shows two views of the breach. Within the breach the water flows westward from the Atlantic Ocean to the Matanzas River. The depth of the breach is between approximately 0.3 m and 0.6 m. The deeper section of the breach is towards the western end. Figure 64a shows ripple marks at the eastern portion of the breach indicating sediment movement. Figure 64b shows the steep face of the edges of the

a) Photograph looking west along the breach (Latitude 29°40'59.64"N / Longitude 81°13'6.20" W).

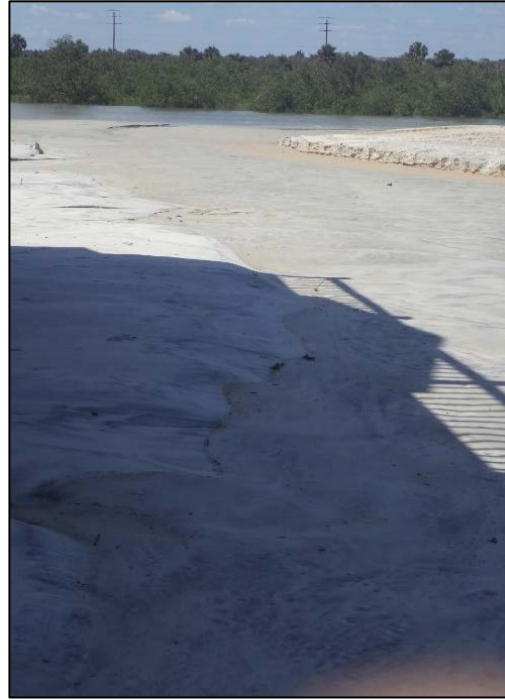
b) Photograph looking northwest along the breach (Latitude 29°40'59.38"N / Longitude 81°13'6.26" W).

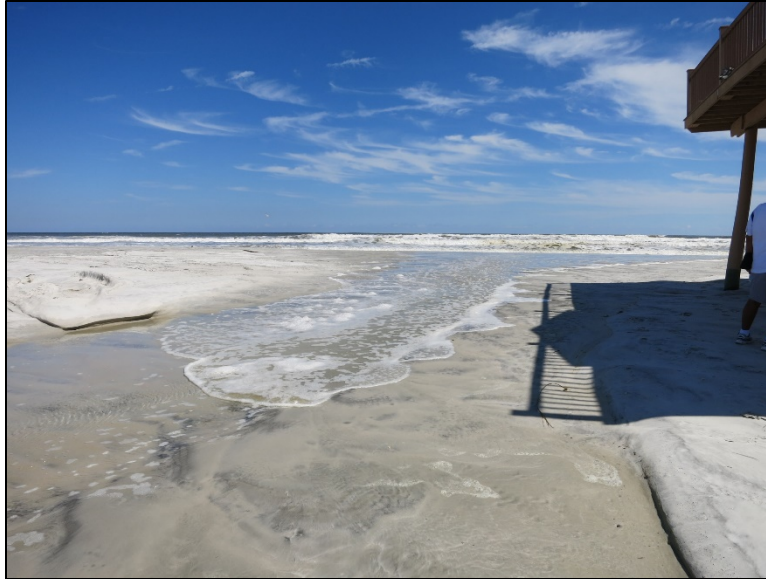
breach. Figure 64C shows water moving westward from the Atlantic Ocean to the Matanzas River. The width of the breach was approximately 6 m.

c) Ocean water flowing west into Matanzas River (approx. location Latitude $29^{\circ}40'59.64''\text{N}$ / Longitude $81^{\circ}13'6.20''\text{W}$).

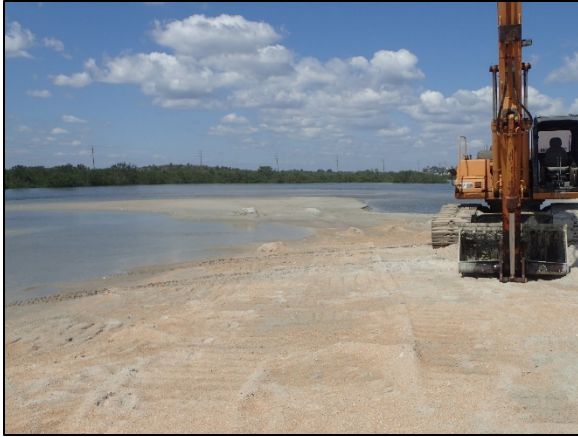
Although the breach was the emphasis at the site, there was notable structural damage and minor geotechnical damage noted along the walk from Marineland to the breach site and north of the breach site. Figure 65a is a photograph take north of the breach site. Heavy equipment was being used to remove overwash sediment deposits from the Matanzas River. The overwash sediments are clearly seen in the left hand side of the photograph. Figure 65b shows localized scour at a timber pile. The scour depth was minimal on the order of 10 centimeters and was not a contributor to structural damage. A concrete driveway was undercut by scour as shown in Figure 65c. The damage from the scour caused portions of the concrete driveway to be washed away. Figure 65d shows damage to a patio deck. The deck was constructed of brick pavers which were placed on a thin layer of cemented soil. Scour damaged a large portion of the deck.

a) Removal of overwash deposits from the Matanzas River (Latitude 29°41'6.19"N / Longitude 81°13'10.60"W).

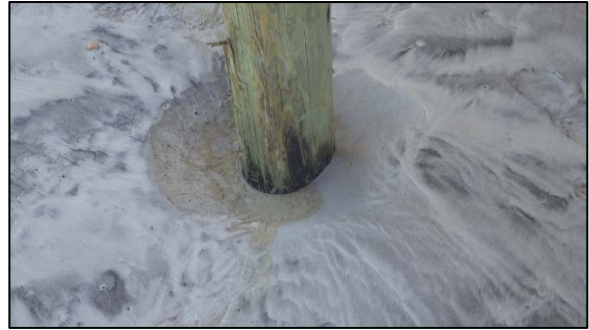
b) Localized scour along pile foundation (Latitude 29°40'57.91"N / Longitude 81°13'5.51"W).

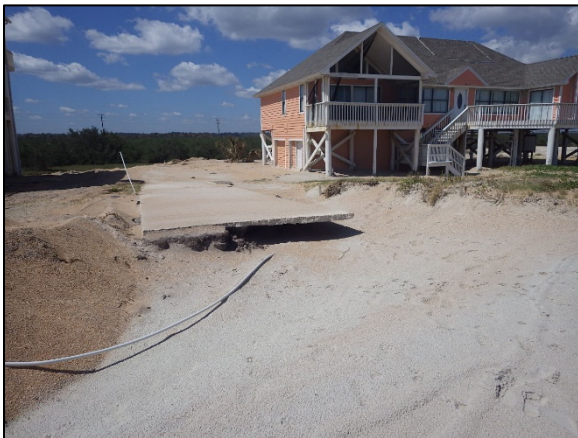
c) Scour at driveway (Latitude 29°40'20.18"N / Longitude 81°12'51.82"W).

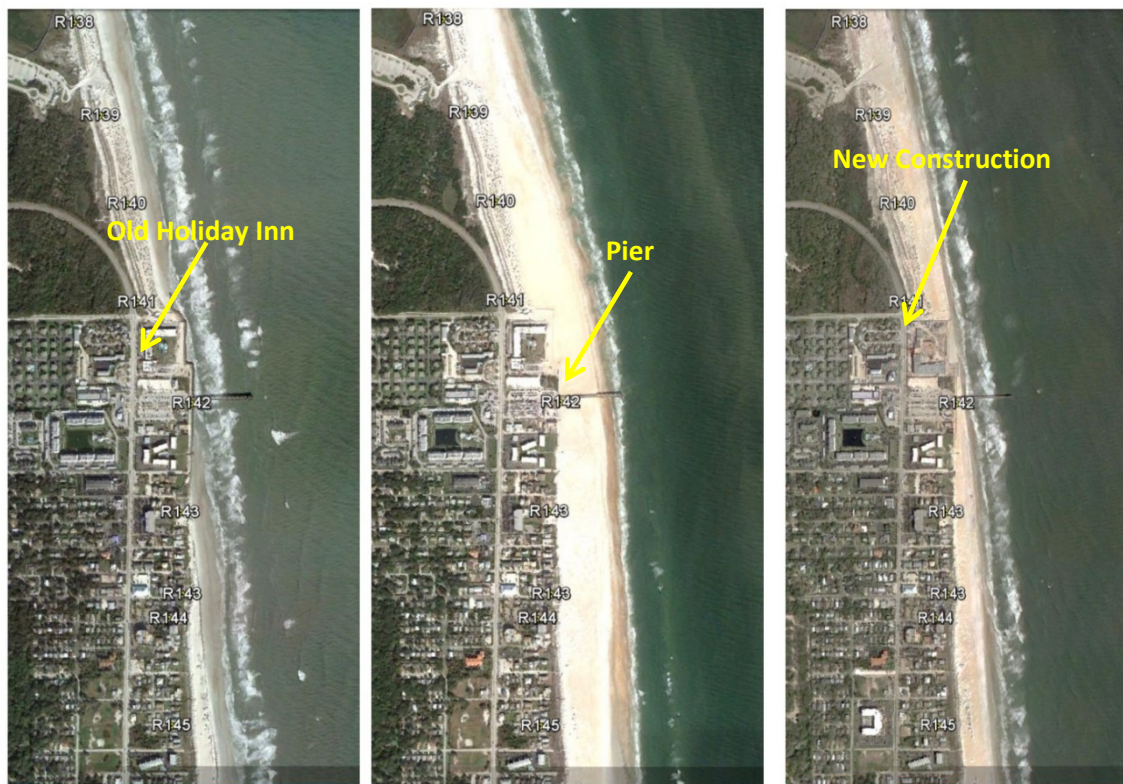
This stretch of shoreline extending roughly 2 km to the north of the St. Johns County Municipal Pier (St. Augustine Pier) and 2 km to the south is a classic example of encroachment of development into the littoral zone as a cause of beach erosion, as shown in Figure 67. Figure 67a portrays the typical condition of the shore in this location, with exposed seawall and revetment armoring. In 2003, the State of Florida teamed with the United States Army Corps of Engineers (USACE) to place approximately 4.5 mcy of sand

on St. Augustine beaches. The USACE placed a further 2.8 mcy in 2005 as renourishment in response to severe erosion from the 2004 hurricane season. Consideration was given to a section of the project domain that historically experienced extraordinary erosion rates. The resulting nourishment design template applied additional sand at this erosional hotspot – and resulted in a protruding “elbow” in the planform design²⁷. Figure 67b shows the beach after another nourishment was constructed in 2012 (note that the pier is almost landlocked by the fill). The Holiday Inn indicated in the right-hand panel was demolished in 2016, and the construction of a new hotel permitted on this protruding site. Figure 67c shows the amount of erosion that has occurred since 2012.

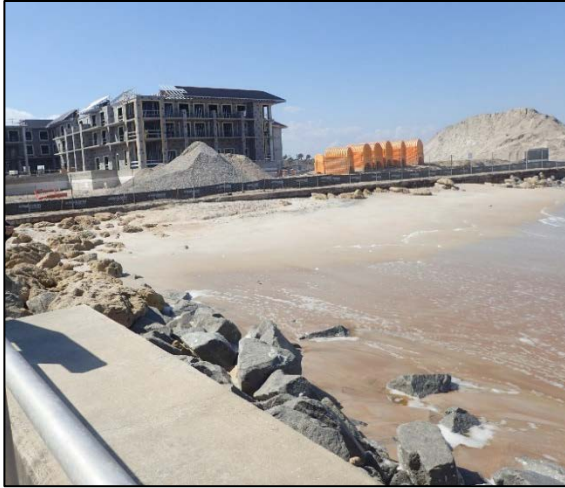
Photographs in Figure 68 were taken north of the pier near the new construction indicated in Figure 67c. Figure 68a shows the new hotel under construction in the background. Figure 68b was taken looking south towards the pier, and Figure 68c was taken looking towards the north showing the condition of the beach. Figure 68d shows evidence of overwash and unraveling of the poorly constructed revetment at the north end of the property.

a) New construction (Latitude 29°51'29.30"N / Longitude 81°15'55.49"W).

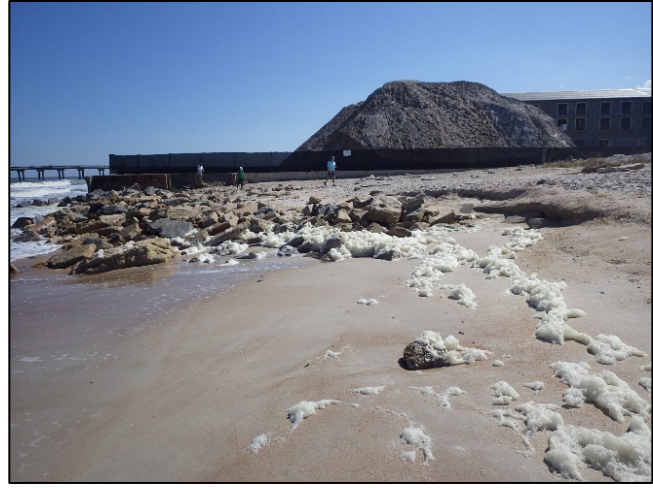
b). Seawall and pier (Latitude 29°51'34.61"N / Longitude 81°15'57.22"W).

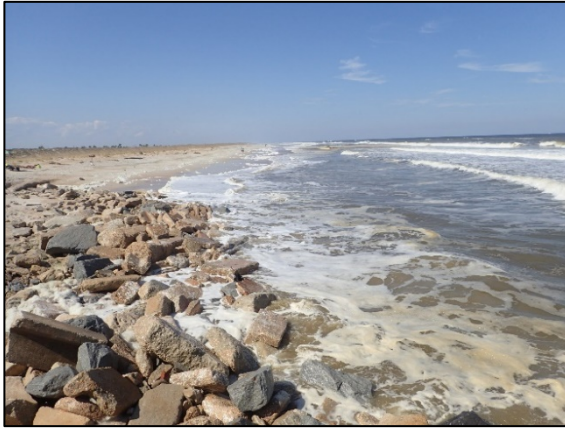
c) Beach conditions (Latitude 29°51'33.61"N / Longitude 81°15'56.29"W).

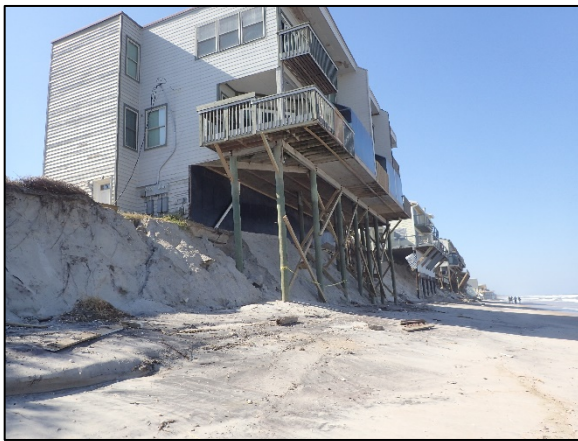
Progressing in a northeasterly direction along the beach, the coastal bluffs were not protected by seawalls. Properties located between 3930 Coastal Highway to 4010 Coastal Highway had severe bluff erosion. The erosion caused severe undermining of foundations. The undermining did not undercut the timber pile foundations but in several instances shallow foundations supporting decks were completely undercut. Figure 71a shows severe erosion exposing timber pile foundations at 3930 Coastal Highway. Note the cross bracing that has been added to provide lateral support for the exposed piles. Figure 71b also shows severe erosion exposing timber pile foundations and undercut shallow foundations supported by micropiles which support a deck. The location of this damage is 3940 Coastal Highway. The person shown in the photograph is 1.93 meters tall. Figure 71c shows the severe erosion at 3978 Coastal Highway. Once again timber piles are exposed. Note the wooden piers supporting the deck are free hanging with no support.

a) Beach house at 3930 Coastal Highway (Latitude 29°56'46.05"N / Longitude 81°18'7.46"W).

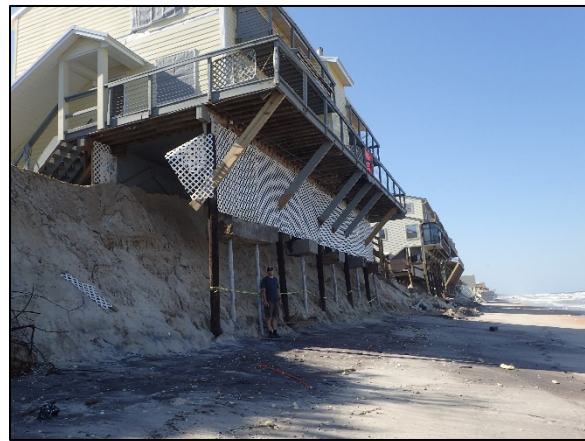
b) Beach house at 3940 Coastal Highway (Latitude 29°56'47.00"N / Longitude 81°18'8.10"W).

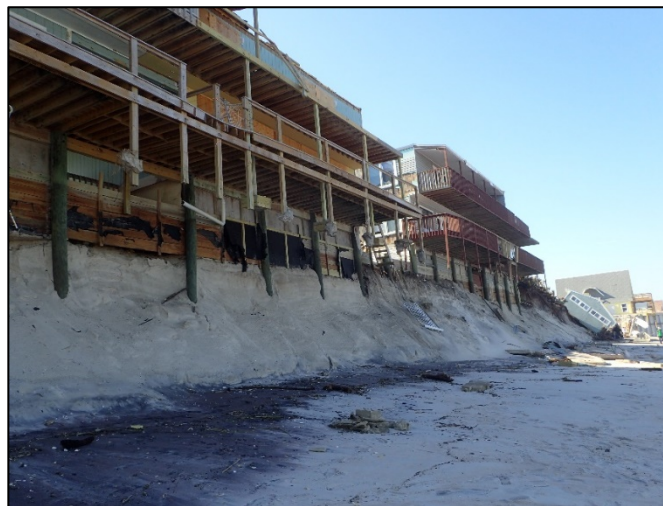
c) Beach house at 3978 Coastal Highway (Latitude 29°56'50.66"N / Longitude 81°18'10.74"W).

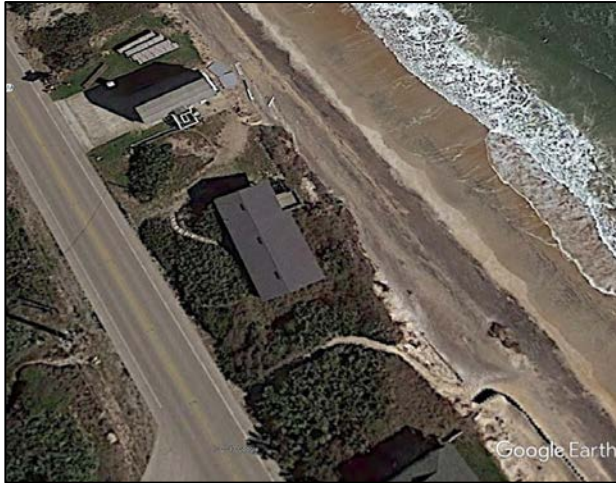
A beach house located at 4010 Coastal Highway, St. Augustine FL was not supported by pile foundations. Wave action associated with Hurricane Irma caused the bluff to be cut back from the ocean approximately 15 meters towards Coastal Highway (Highway A1A). Figure 72 shows aerial images of 4010 Coastal Highway. Figure 72a shows the location of the house and dune system prior to Hurricane Irma. Figure 72b is a recent image showing the severe erosion of the dune system. Note the position of the house has shifted.

a) Prior to Hurricane Irma.

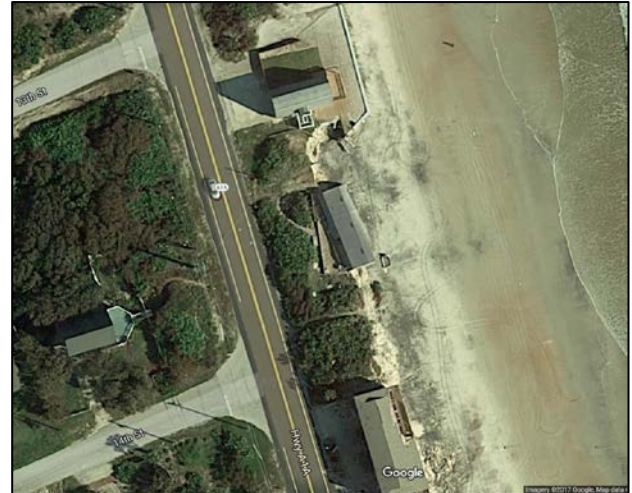
b) Post Hurricane Irma.

Figure 72. Aerial image of 4010 Coastal Highway in Vilano Beach (Latitude 29°56'54.04"N / Longitude 81°18'11.00"W).

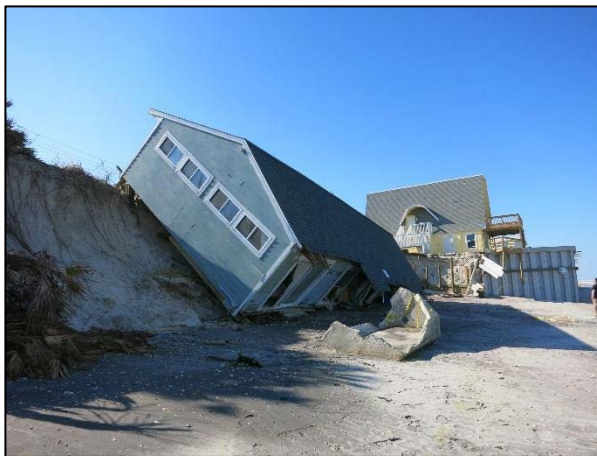
a) Picture taken facing north.

Figure 73. Collapsed house at 4010 Coastal Highway, Vilano Beach (Latitude 29°56'54.62"N / Longitude 81°18'11.03"W).

The significant erosion at the property at 4010 Coastal Highway is much more dramatic from the beach. Figure 73 shows the collapsed house at 4010 Coastal Highway. Figure 73a shows the house in a picture
