Geotechnical Extreme Events Reconnaissance

Geotechnical Damage in Central and Northeastern Florida from Hurricane Irma

GEER Association Report No. GEER-056b

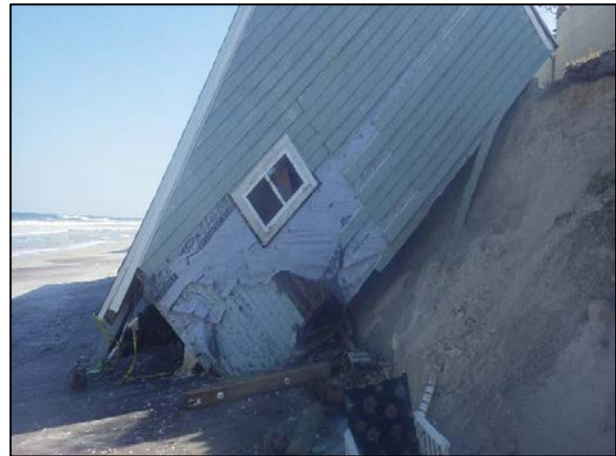
b). Picture taken facing south.

Figure 73. Collapsed house at 4010 Coastal Highway, Vilano Beach (Latitude 29°56'54.62"N / Longitude 81°18'11.03"W).

taken looking north. Figure 73b shows the house in a picture looking south. Both figures clearly show the significant erosion which cause the collapse of the house.

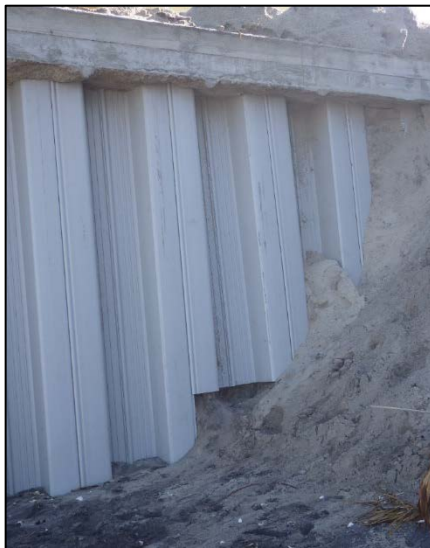
At the northern end of the seawall, there was also damage to the wing wall. However at this location (4040 Coastal Highway) the wing wall was not destroyed. However significant erosion coupled with insufficient driving depth caused the bottom of the sheet pile to be exposed, as shown in Figure 76a. Figure 76b is a close-up photograph of the exposed bottom. The close up photographs shows evidence of soil movement. The exposed bottom of the sheet pile acted as a conduit for the retained soil to escape causing significant ground loss behind the seawall. Figure 76c shows the cavity formed from escaping soil.

a) Exposed bottom of sheet pile wall (Latitude 29°56'58.35"N / Longitude 81°18'12.10"W).

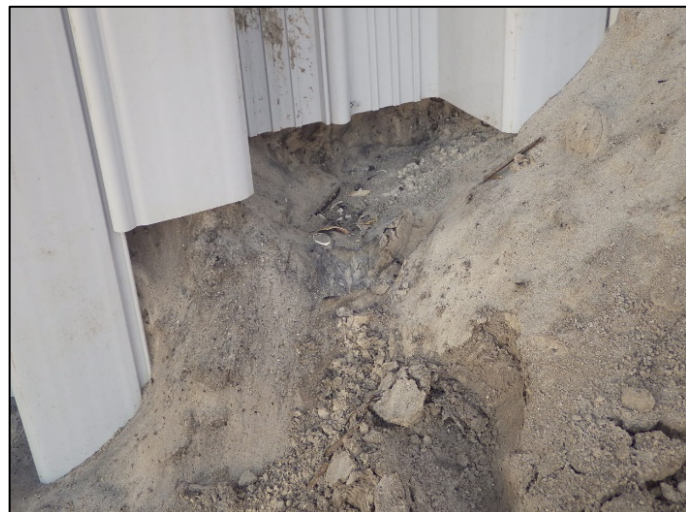
b) Close up of exposed bottom of sheet pile (Latitude 29°56'58.35"N / Longitude 81°18'12.10"W).

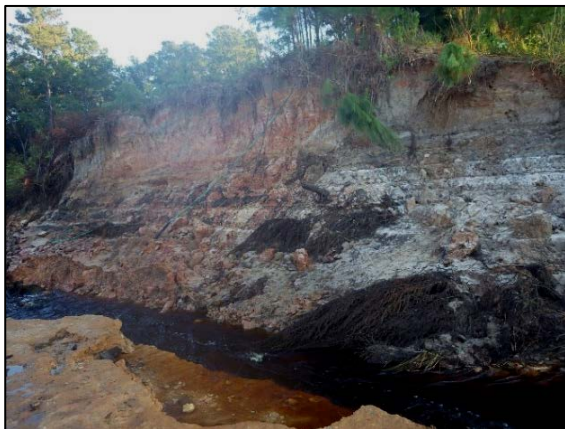
Figure 87 shows the variety of geotechnical damage associated with the dam failure. Figure 87a shows the completely failed dam with the concrete weir structure still intact. Figure 87b shows the scour on the north shoulder of the Lake Hampton Road. During the event the water overflowed the spillway area and overflowed Lake Hampton Road. Figure 87c shows the embankment erosion on the east side of the former dam. Figure 87d shows the lowered water levels in the reservoir.

c) Scour of the east embankment of the dam
(Latitude 30°46'33.89"N / Longitude
81°58'15.47"W).

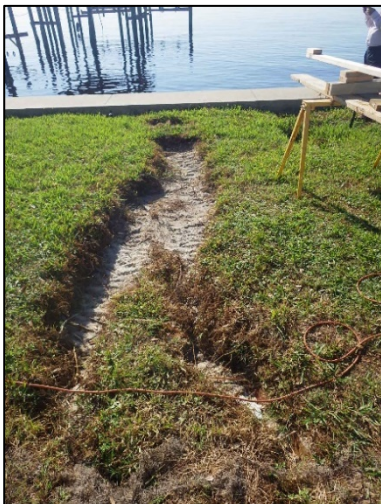
a) Localized scour behind the river bulkhead.

Localized scour from overtopping the bulkhead was noted at the Donald Street pocket park. These holes in the ground need careful repair as some of these might be extending underground up to river boundary wall. There was also considerable damage to private boat docks. Photographs of these damages are shown in Figure 89. Although the localized scour damage may not be considered significant, this type of damage occurred at a number of the pocket parks along the St. Johns River in the historic district of Jacksonville.

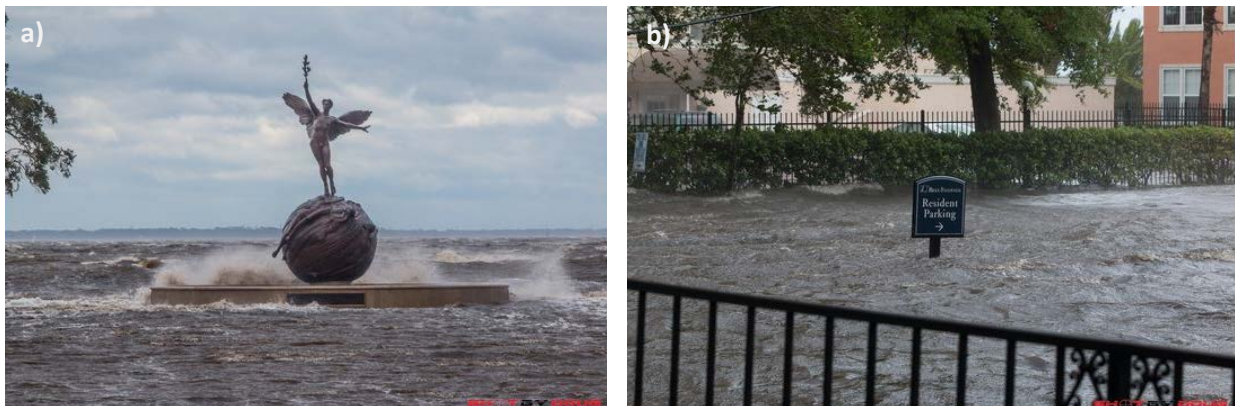
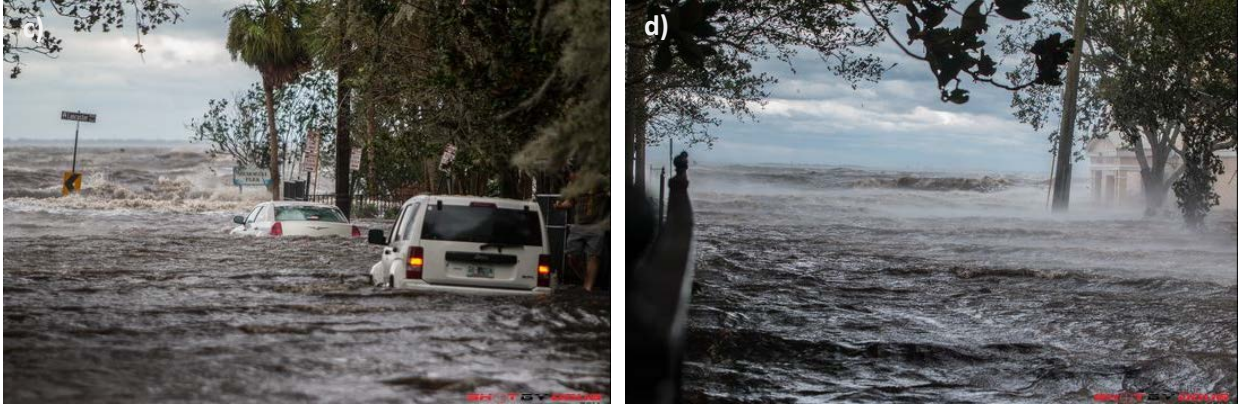
During Hurricane Irma, water of St Johns River rose about 0.75 m above the ground surface due to storm surge and rainfall. From media reports and information obtained from public, it was clear that the park and the adjacent streets along the river flooded during the hurricane. This flooding is shown in Figure 90. Following the hurricane and after flood waters receded, the railing along the riverfront was damaged and in some places was washed away by the water (Figure 91). This created a safety hazard for the people and pets using riverfront and needs to be repaired as a priority.

Figure 90 Images from Hurricane Irma flooding at Memorial Park³⁹ (Latitude 30°18'38.44"N / Longitude 81°40'46.16" W).

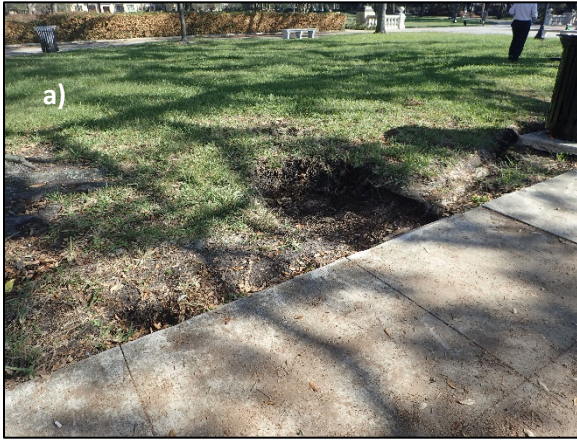
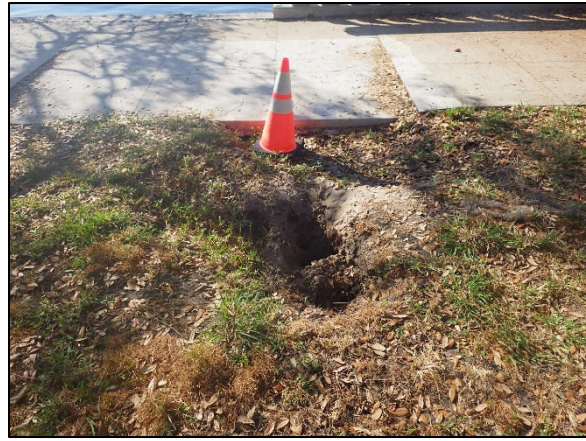
Localized deep scour holes were observed at a number of locations on the west or park side of the concrete walkway. Many of these holes appear to extend under the concrete walkway and towards the river. If left unattended these holes may cause localized failures of the walkway. Two examples of scour holes are shown in Figure 92.

Figure 92. Example of scour holes at Memorial Park (Latitude 30°18'38.44"N / Longitude 81°40'46.16"W).
