# The 2021 Marshall Fire, Boulder County, Colorado

## Geotechnical Extreme Events Reconnaissance Association

Version 1.0  
May, 2022

GEER—075

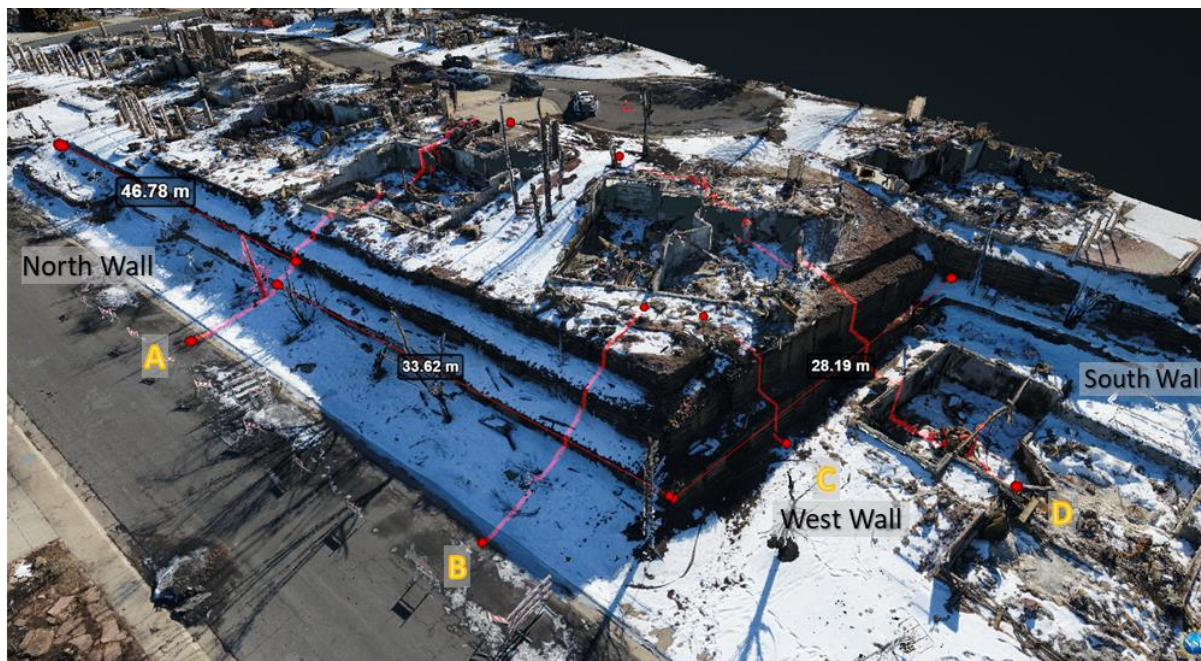
The retaining structure in the Coal Creek Ranch South (St. Andrews Ln.) neighborhood (RS1) consisted of three walls, identified as North, West and South (Figure 6-2). The location was ground surveyed, imaged via UCAV (Figure 6-3), and scanned by multiple LiDAR setups. UCAV images were used to develop a Structure from Motion (SfM) model, from which measurements were taken using DesignSAFE's HazMapper online software; data accessibility described in greater detail in Appendix A and publicly available at the following link: <https://hazmapper.tacc.utexas.edu/hazmapper/project-public/473bc0e5-0da4-492c-afe1-0b0d99d463b3>

The North Wall, along St. Andrews Ln. consisted of three tiers, each ranging from 3 – 7 ft in height, with an approximately 4 – 5.5 ft horizontal offset between the tiers. The length of each of the timber tiers is 203, 264, and 202 ft, (61.9, 80.5, and 61.6m) for the bottom, middle, and top tiers, respectively. The east end of the bottom tier was extended by a concrete block wall an additional 61 ft (18.6m) as the height of retained soil decreased.

Figure 6-2. SfM model of Coal Creek Ranch South, RS1, showing three walls and four profile cross-sections (39°57'17.0" N, 105°09'0.30" W)

Profile A provides an example cross-section of the North Wall extending from the surface of St. Andrews Ln. up the wall, through the foundation of the destroyed home and to the concrete driveway. A total vertical change from start to end of profile is nearly 24 ft (7.25m) over a distance of 100 ft (30m). Locally, a vertical change of 13 ft (4m) is accommodated over a 22 ft (6.7m) horizontal distance.

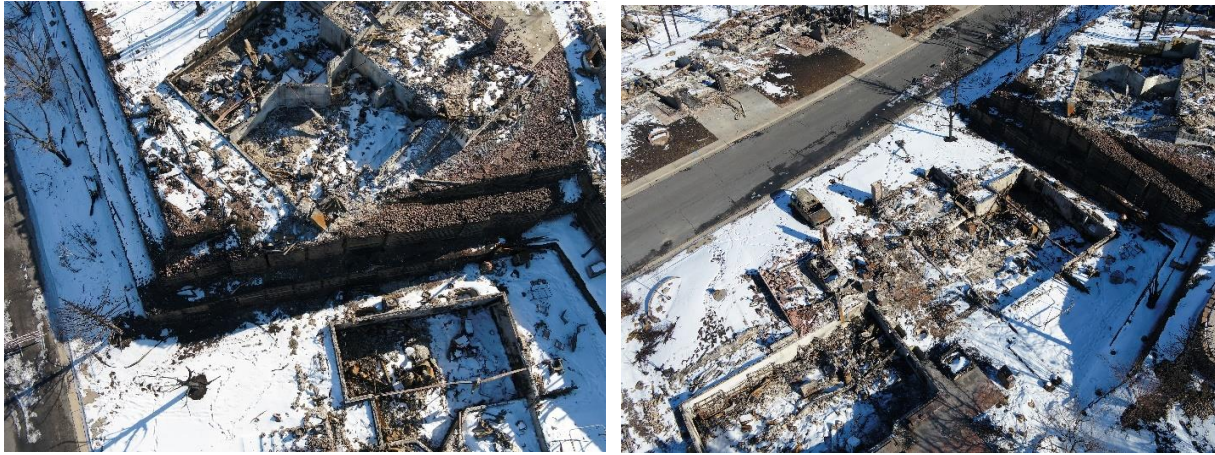
As shown in Figure 6-4 (Profile C), soil previously retained by timber components is free-standing nearly vertical and some localized vertical/horizontal displacements, or sloughing, are visible. Most of the face of the retaining structures was charred due to the fire. Timber tie backs had char depths that ranged from 6 – 35 in.

Figure 6-3. UCAV image of RS1 (39°57'17.0" N, 105°09'0.30" W)

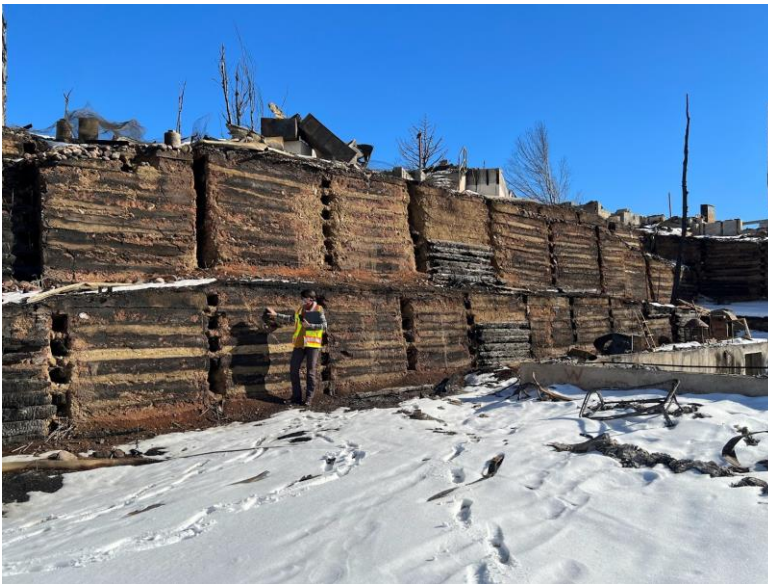
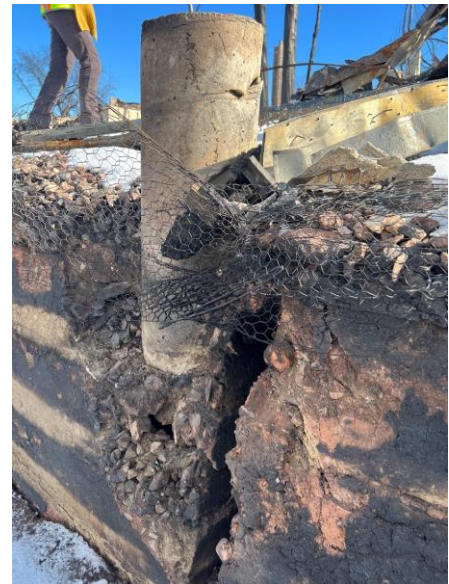
(a) West Wall

(b) Deck pier at top of Profile B

Figure 6-4. Photos of RS1 in Coal Creek Ranch South (39°57'17.0" N, 105°09'0.30" W)

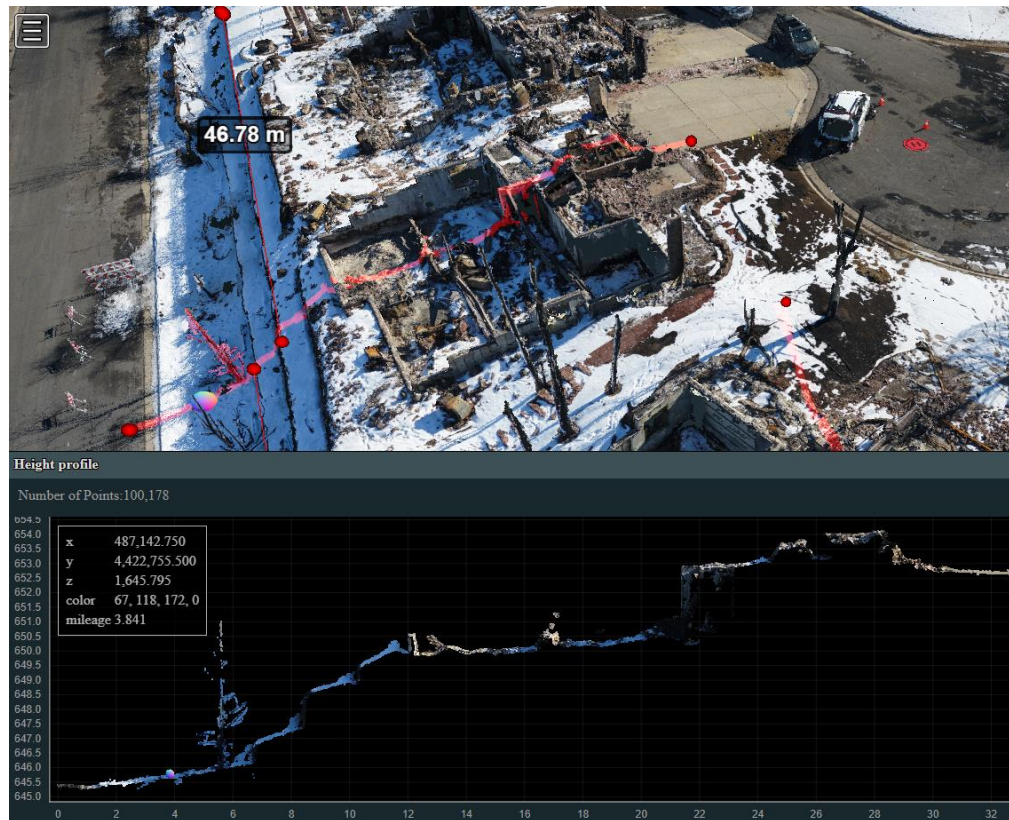
Figure 6-5. RS1 Profile A, section of North Wall extending from St. Andrews Lane to the RAPID mobile equipment vehicle on Troon Ct. (39°57'16.4" N, 105°09'01.4" W)

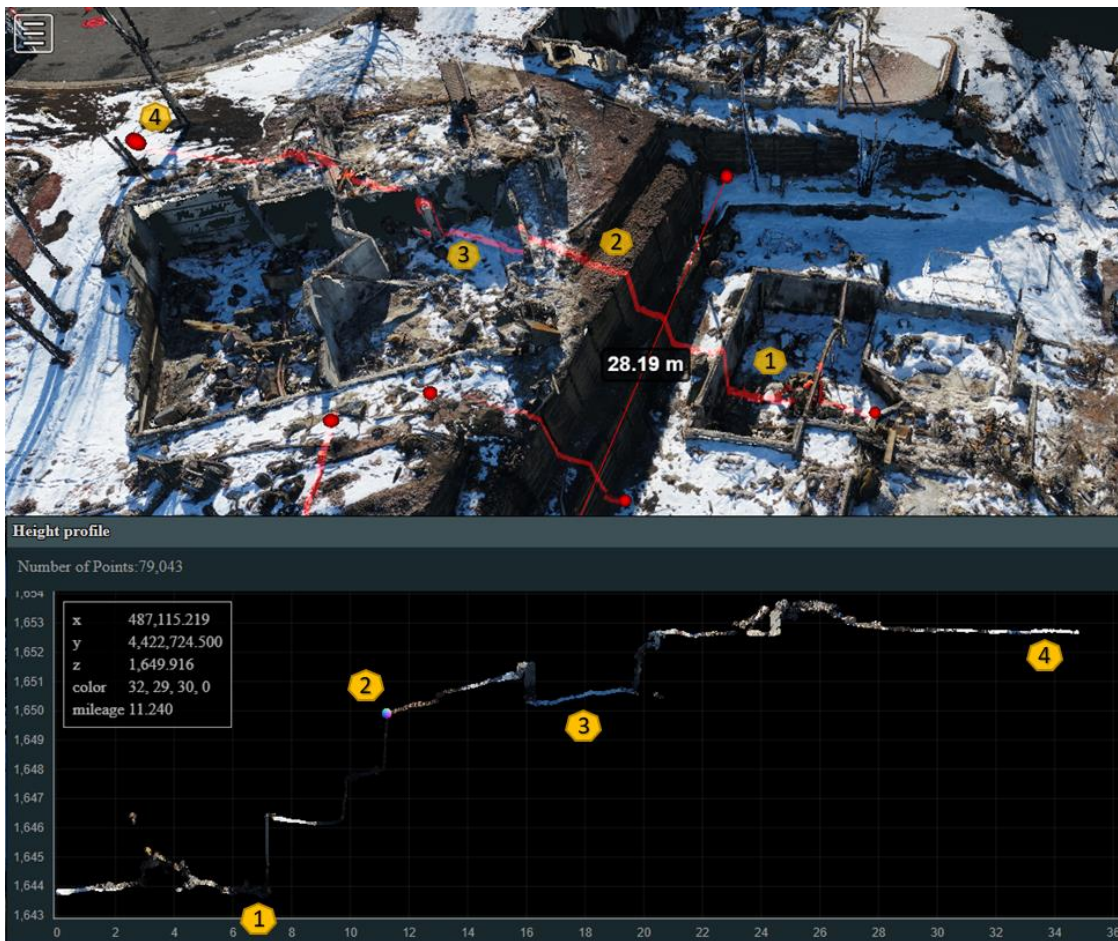
The maximum extents of Profile D (Figure 6-7) extend from the bottom of the basement at the low house (1) up to ground level beyond the elevated house (4). From the figure, the gross elevation change is measured to be 32 ft (9.8m) over a horizontal distance of 57 ft (17.5m). The local vertical offset of the wall, from point (1) to point (2) is 20 ft (6.1m) over an offset of 13.8 ft (4.2m).

Figure 6-7. RS1 Profiles D (39°57'16.3" N, 105°09'02.2" W) showing (1) basement elevation, (2) top of retaining wall, (3) upper house basement level, and (4) upper ground level

Given the absence of structural support members and loss of tieback support, local or global movement of these walls is possible, particularly with repeated moisture from snow and rain. Recognizing the potential safety concern, the town of Louisville put up traffic barriers to keep cars and pedestrians away from the north wall, along St. Andrews Ln. Stability will also need to be addressed to all three walls before reconstruction of lots at the top and bottom of the slopes.

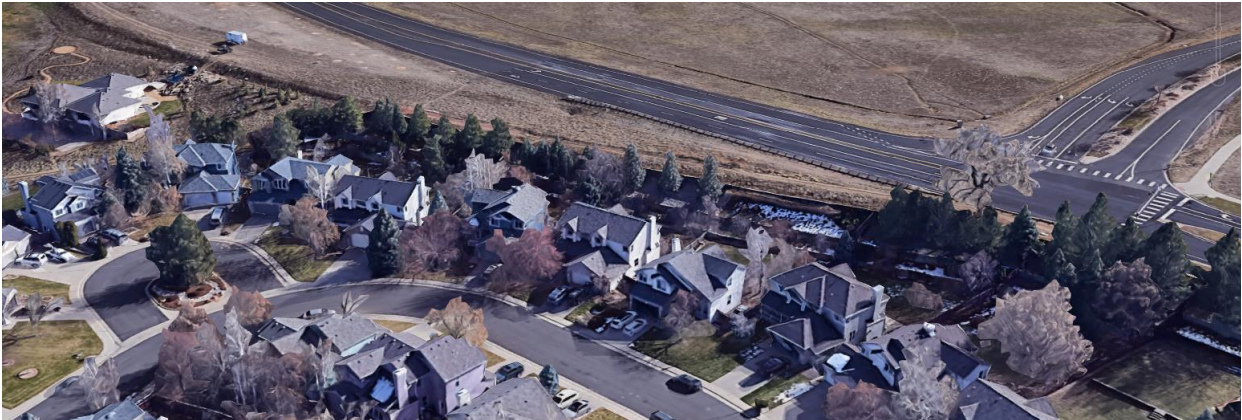
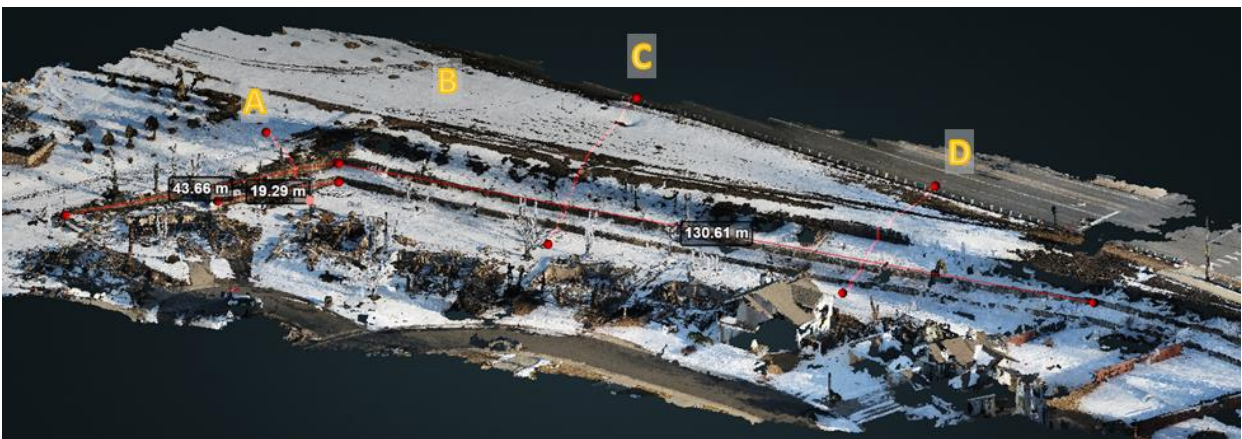
The retaining structure in the Coal Creek Ranch North neighborhood (located between Spyglass Circle and Dillion Rd) consisted of two primary wall sections (Wall A and Wall B-D), each with two tiers, shown before (google earth) and after (SfM model) the fire in Figure 6-8. Each tier was 4 – 5 ft in height with a ~5 ft horizontal offset between the tiers. The length of the bottom tier, consumed by fire, was 143 and 254 ft for Wall A and B-D, respectively. Most of the face of the bottom tier of the retaining structure was charred due to the fire. Similar to RS1, the wall was constructed of 8 x 8 in. square timbers, staked in an alternating pattern of face and tieback (embedded in soil mass) members, secured by iron nails (Figure 6-9a). Behind the horizontal face members was a thick (3/4 in.) wood sheathing, so limit soil erosion through structural components.

Figure 6-8. Coal Creek Ranch (Spyglass Cir.) Retaining Structure (a) Google earth before fire and (b) SfM model with cross-sections identified (39°57'24.4" N, 105°08'51.0" W)

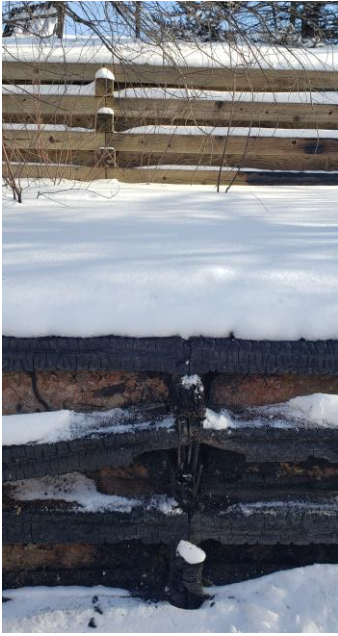
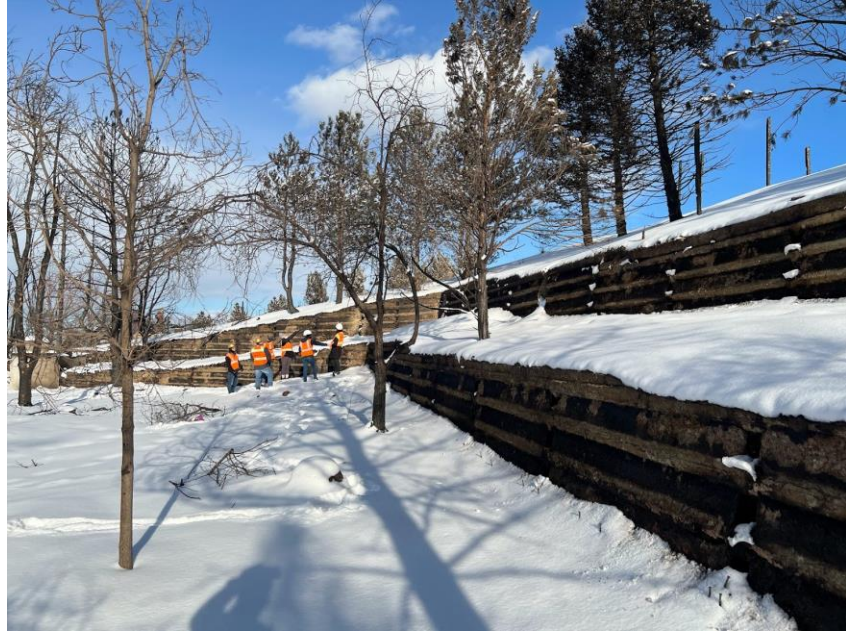
The tie backs had char depths that ranged from 4 – 36 inches. According to US codes and standards, timber chars at a constant rate of nominally 1.5 inch/hour, regardless of the species (AWC 2018). In highly turbulent environments, this char rate could be upwards of 2.6 inch/hour (Schmid et al. 2020). Because of the presence of high winds throughout the fire, areas impacted by the Marshall Fire can be considered highly turbulent. These char rates indicate that the retaining structure could have been burning for 2.7 – 24 hours with a char rate of 1.5 inch/hour and 1.5 – 13.8 hours with a char rate of 2.6 inch/hour. This burning does not have to correspond to visual combustion, rather could include smoldering behavior of the timber retaining walls; however, demonstrates the severity and length of burning that can be expected in communities impacted by a wildfire.

(a) Near Profile D

(b) Near Profile B

Figure 6-9. RS2 (a) comparison of damaged (lower) and undamaged (upper) wall ( $39^{\circ}57'23.5''$  N,  $105^{\circ}08'52.7''$  W) and (b) consumed section of RS2 wall near Profile B ( $39^{\circ}57'25.7''$  N,  $105^{\circ}08'49.5''$  W)

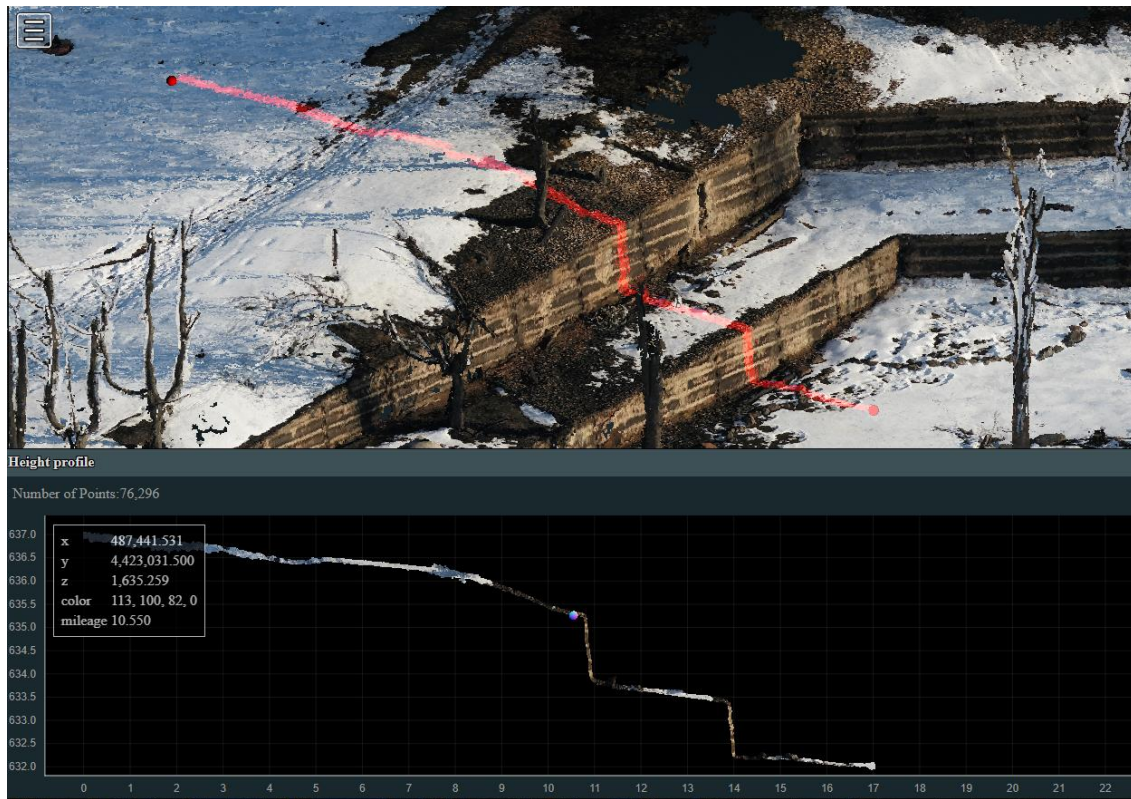
Figure 6-10. Coal Creek Ranch North, Spyglass Ln. (RS2): cross-section A (39°57'27.5" N, 105°08'49.3" W)

Figure 6-10 shows Profile A shows an elevation view of the retaining wall along Wall A while Figure 6-11 shows profiles along Wall B-D. Of particular note is a the storm sewer along the top tier of Wall B-D, a manhole of which is show at a purple indicator in Figure 6-11c, which is located approximately 30 ft from the top of the wall. This buried infrastructure could be damaged if the slope were to become unstable. Wall stability is aided at this presents of trees, and their roots, positioned along the top of the wall (Figure 6-9b). While some trees were lost due to burn damage, survival of the remaining trees may impact wall stability over time.

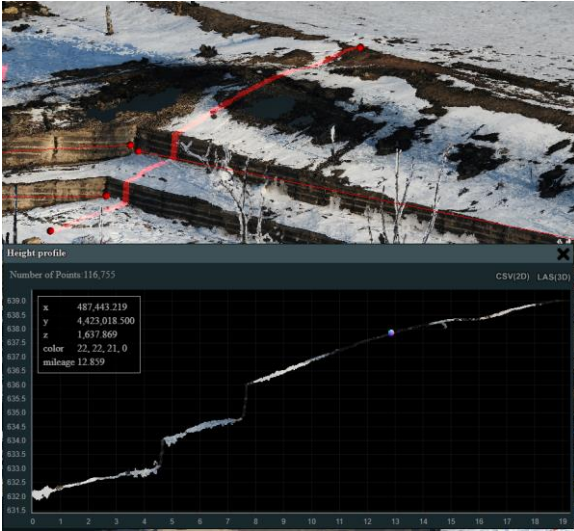
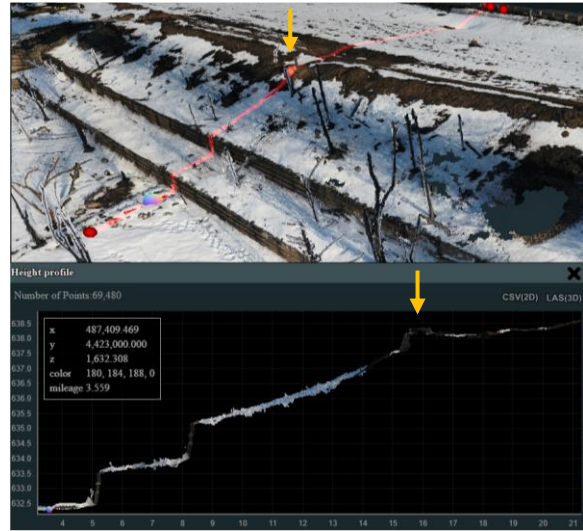
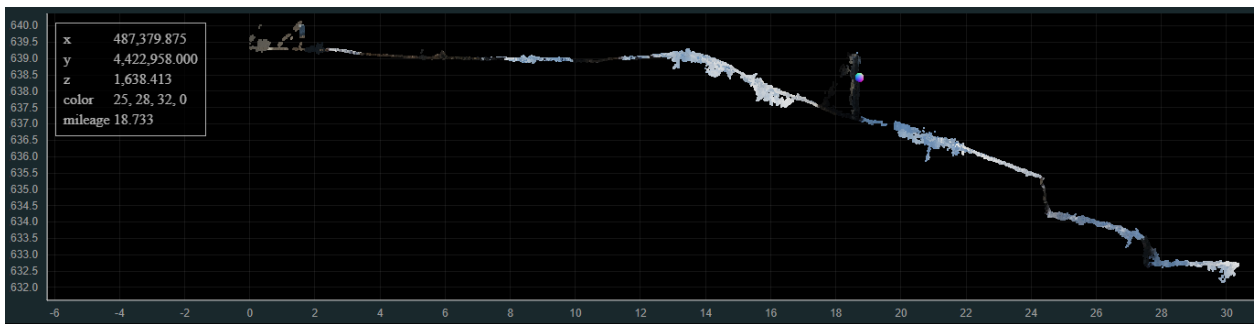
(a) Section B (39°57'25.7" N, 105°08'49.5" W)

(b) Section C (arrow indicated Storm and Drainageway Manhole) (39°57'25.5" N, 105°08'52.3" W)

(c) cross-section D (39°57'23.5" N, 105°08'52.7" W)

Figure 6-11. Coal Creek Ranch (Spyglass) retaining all sections (meters)

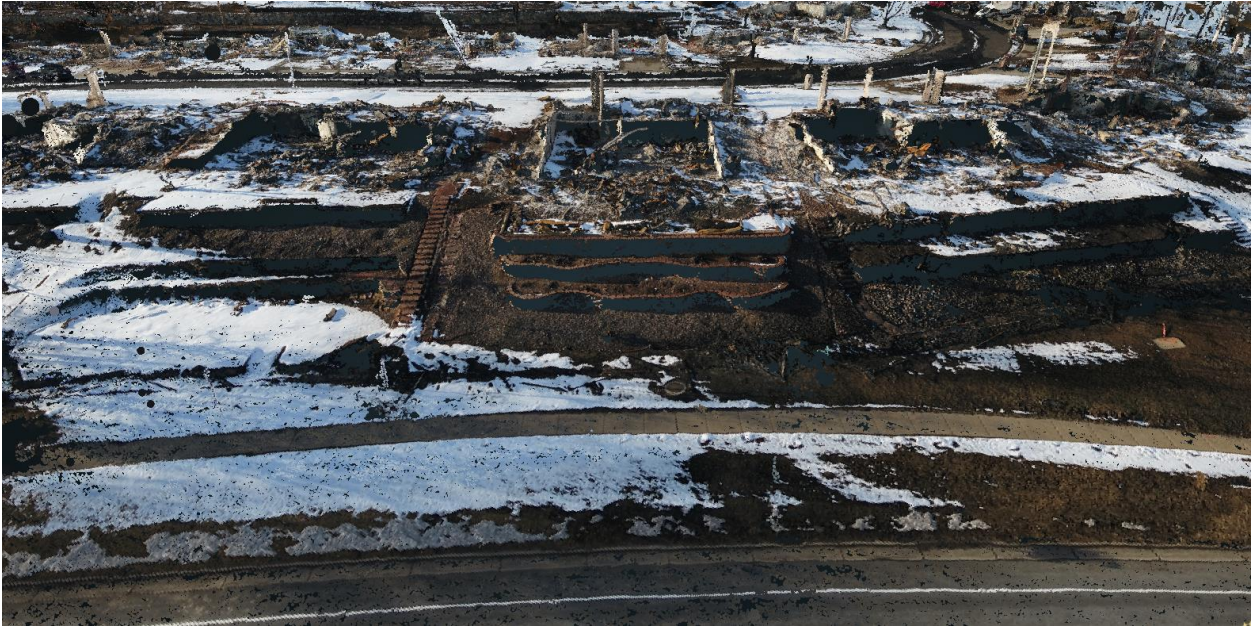
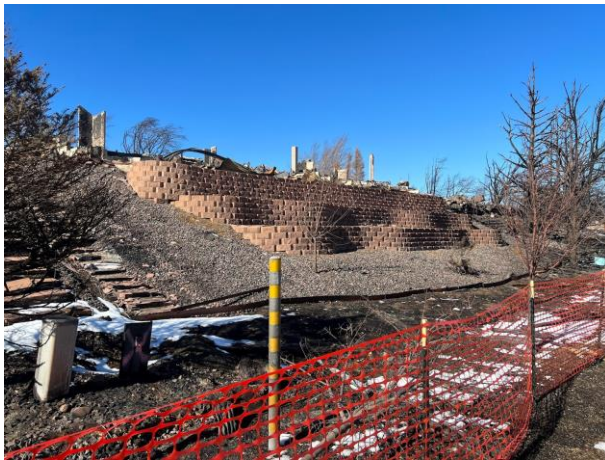
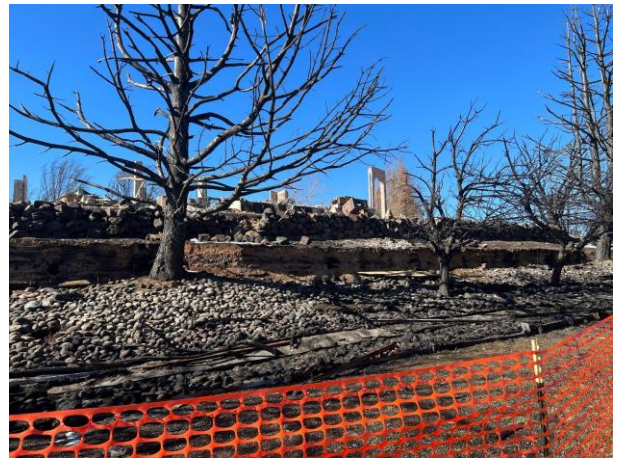
Several additional retaining structures were surveyed during reconnaissance. Figure 6-12 shows a series of backyard walls along S. Centennial Pkwy. As this location, a mixture of concrete block, stone, and timber walls performed to various levels. The cementitious walls remained relatively undamaged while the timber walls were completely lost. Another example is provided in Figure 6-13 where masonry block walls were mostly undamaged adjacent to fully compromised timber walls.

(a) SfM overview

(b) Block wall

(c) Timber wall

Figure 6-12. Backyard retaining structures in the Hillside neighborhood, along S. Centennial Pkwy (39°58'20.4" N, 105°09'54.4" W)

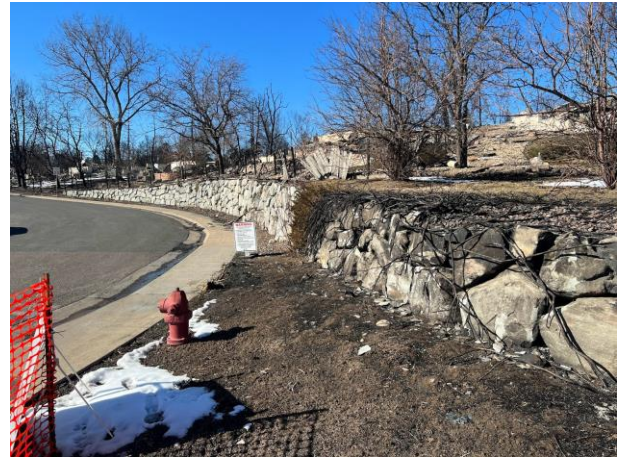
Two block retaining walls located along Via Appia Way shown in Figure 6-14. While fire damage was not noted beyond cosmetic damage (Figure 6-14b), excess water from firefighting efforts did dislodge blocks or otherwise displace wall sections, which may have long-term impacts on wall stability.

(b) Displaced blocks at Via Appia and  
Eldorado Ln (39°58'27.8" N, 105°09'41.9" W)

Figure 6-14. Stone retaining structures in Louisville, along Via Appia Way

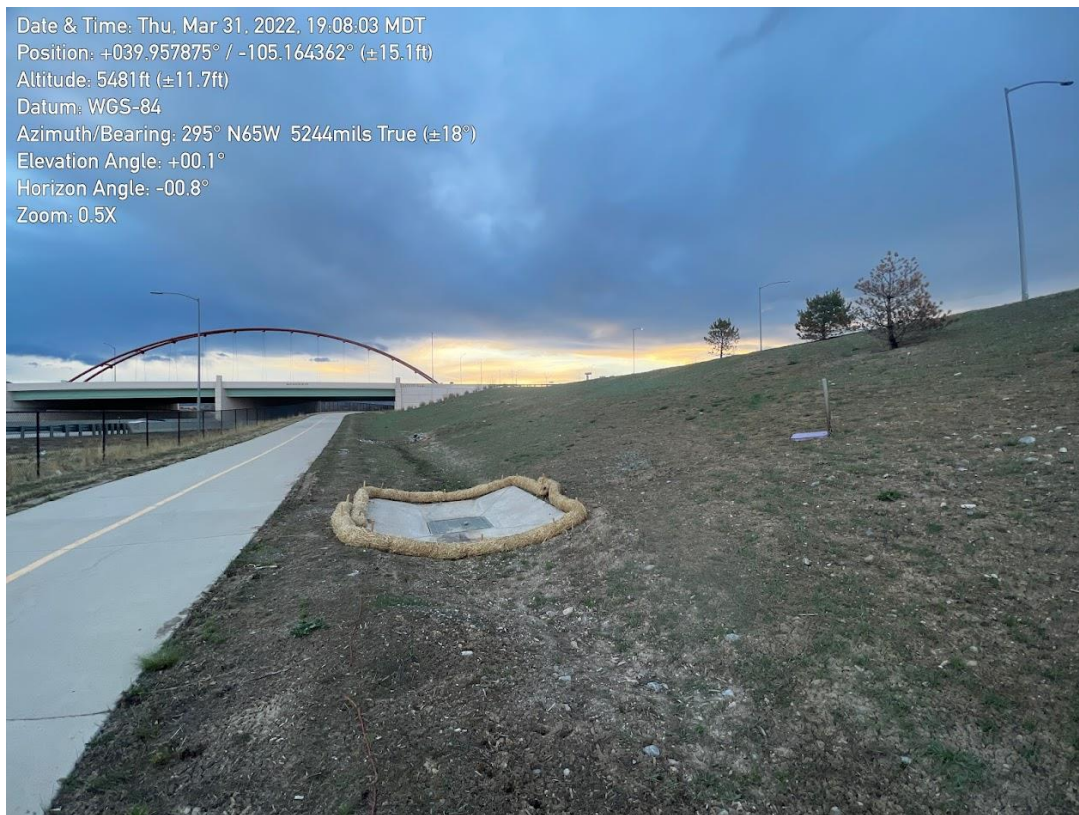
Figure 6-16. Example of stormwater erosion protection (39°57'28.4" N, 105°09'51.7" W)

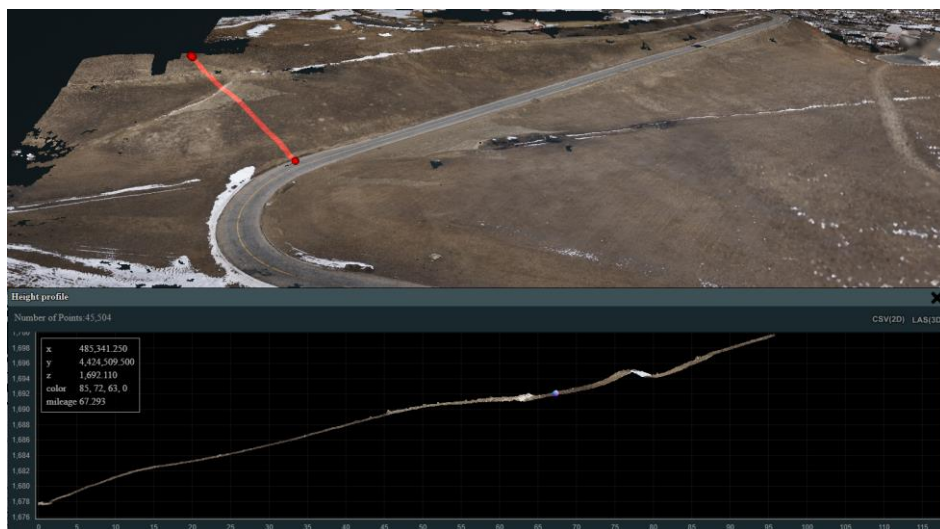
One slope of interest is located to the northwest of W. Century Blvd. Figure 6-18 shows an overview of the area, which is a commercial property that is impacting public infrastructure. Loss of vegetation and deposits of ash contributed to soil erosion at the toe of the slope, shown in Figure 6-17. The figure also shows deposits made by a street sweeping truck working around the clock to remove eroded soil from the road surface. Measurement of the profile shown in Figure 6-18 indicate slopes of 21 deg at the toe (1-13m), 13 deg along the long constant region (13 to 50m), and 22 deg at the steeper section at the top of the profile.

Figure 6-18. Slope along Century Blvd. in Louisville, CO (39°58'12.4" N, 105°10'16.1" W)

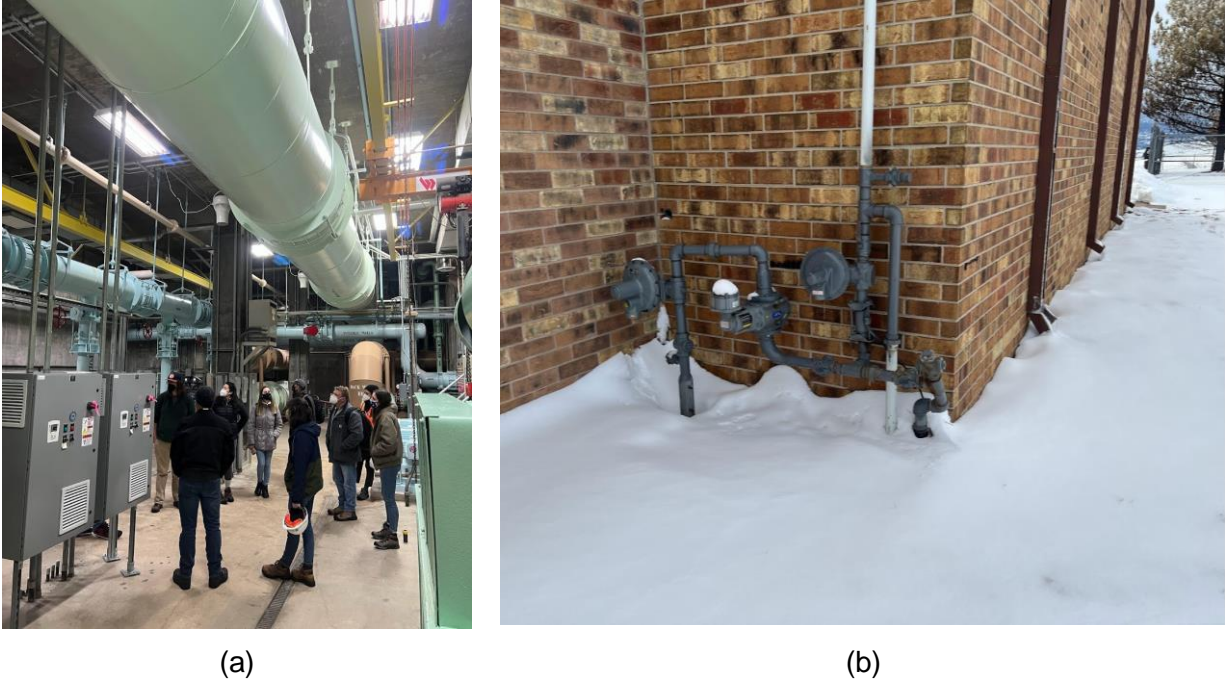
Between 9 – 10 pm Xcel Energy drives natural gas tanker trucks through the burn area to the Louisville SWTP to provide temporary power to the treatment plant to restart the plant and begin getting potable water production back on-line (the plant had been offline for winter). The location of the temporary hook-up is shown in Figure 7–2(b). After power is restored, both plants begin running at full capacity (13 MGD or 9,000 GPM). Power was restored via the temporary natural gas splice to the SWTP emergency backup generator at 10:50 PM after an approximately 11 hour outage. Utility power was restored on January 2<sup>nd</sup> at approximately 6 PM.

Figure 7-2. Louisville South WTP (a) Tour of lower-level infrastructure and (b) location of temporary natural gas hookup (39°57'45.3" N, 105°11'17.0" W)

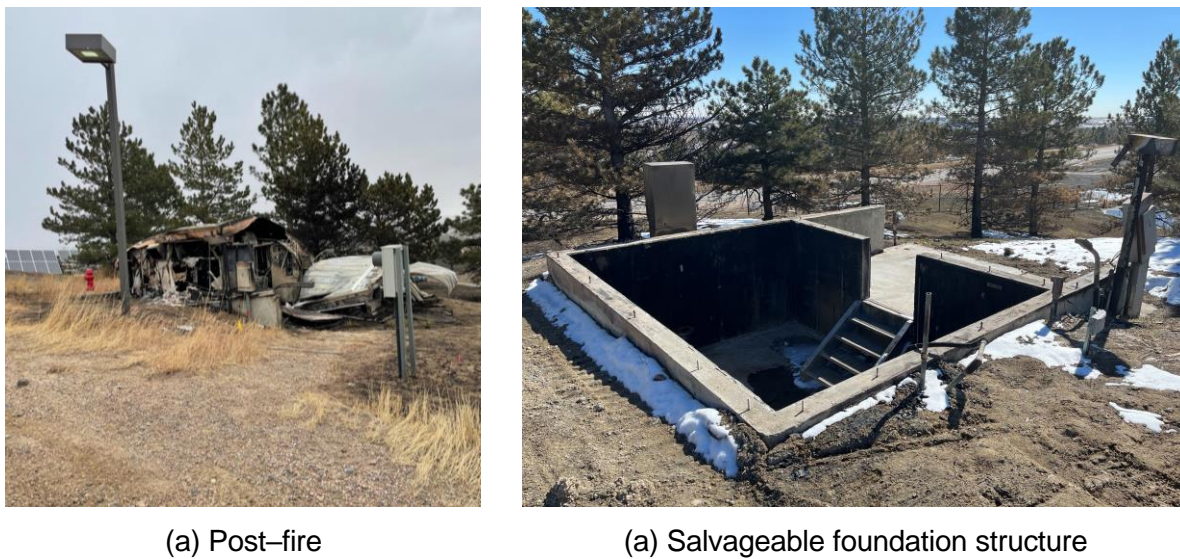
Figure 7-5. Destroyed backup generator at Superior Water Treatment Plant (39°56'33.8" N, 105°09'50.2" W)

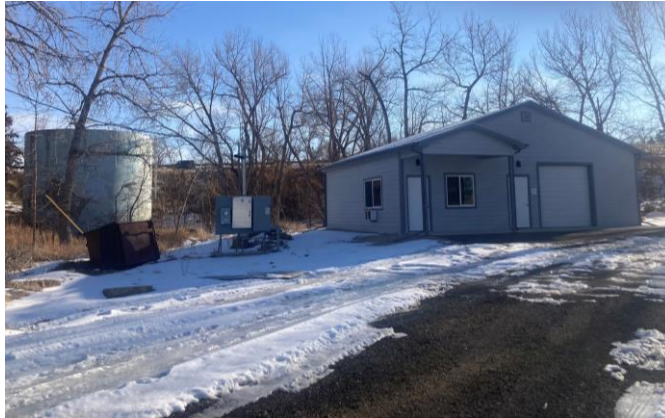
SSMHP services 150 people through one on-site well. Figure 7–7 shows an image of their well house and out-of-service storage tank. While this neighborhood was located just west of the fire perimeter (Figure 7–1) high winds caused damage to many of the homes and impacted the water supply system. A boil water notice was issued to this community by CDPHE.

Figure 7–7. Sans Souci Mobile home park water station (39°57'24.8" N, 105°13'56.3" W)

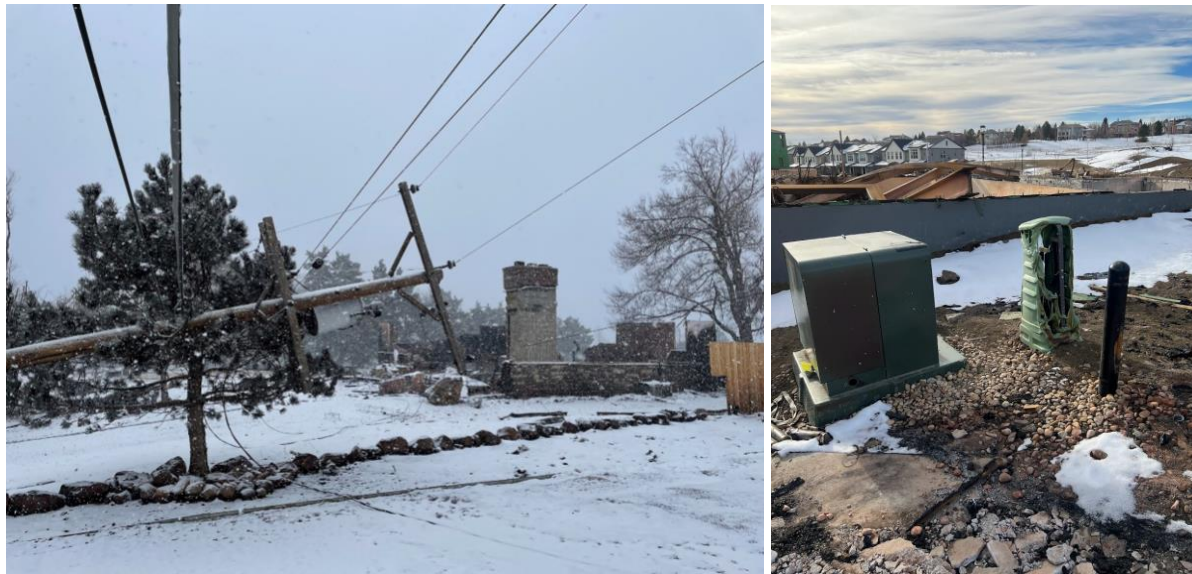
(a) (39.97543, -105.1786)

Gridmetrics™ provides real time power outage data using a Power Event Notification System (PENS). Data was logged and mapped in a 1 km by 1 km grid of the Boulder area from 6 a.m. to 6 p.m. on December 30<sup>th</sup>, 2021 (Figure 7-11). Images from the (PENS) illustrate the outages experienced in Boulder due to high winds before the Marshall Fire caused any outages (Figure 7-11a), outages increasing in the Superior and Louisville areas as the fire grew (Figure 7-11b,c), and the system losing access to the data as the fire continued to grow throughout the day (Figure 7-11d). An example of wind/fire damage to power infrastructure is provided in Figure 7-12, where a downed power pole is shown within the fire perimeter during the snowstorm that followed the fire.

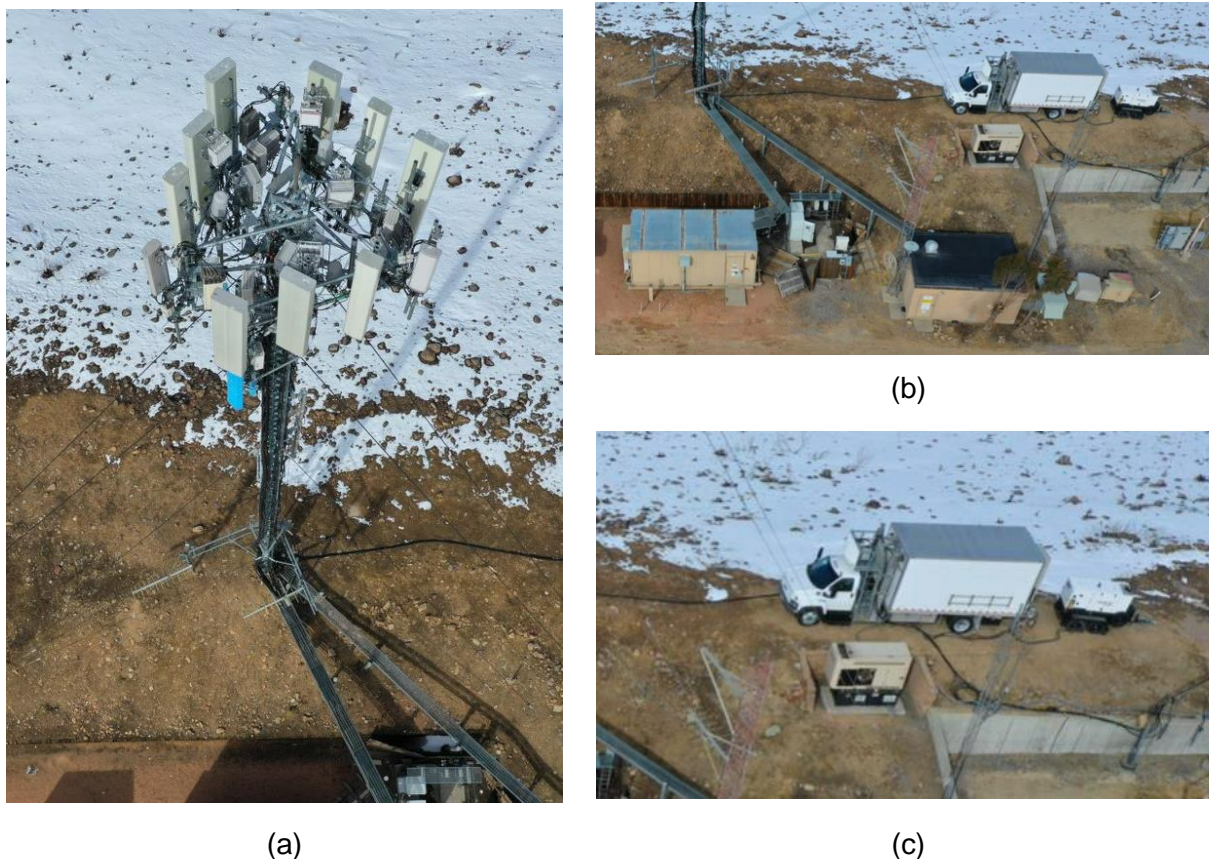
Approximate cell tower locations within the impacted area were obtained through antennasearch.com. As shown in Figure 7-13, a total of 5 cell towers were impacted by the Marshall Fire. Figure 7-14 shows a typical cell tower facility within the burn area. Preliminary inspections and reports suggest minimal damage to cell provider utilities. However, cell service and cell tower facilities were impacted during the fire by commercial power failures and damaged fiber optic cables (City of Louisville, 2022). While no significant loss of communication was reported during or after the fire, it is important to understand how damaged lifeline systems can impact one another during a disaster event such as the Marshall Fire.

Figure 7-14. UCAV images of cell tower (ID:22264) in burn area (39°57'36.3" N, 105°12'48.4" W)

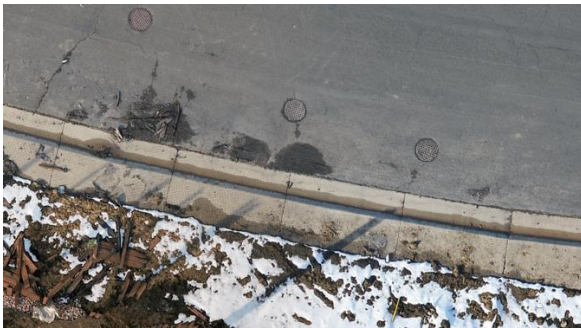
(a) ASD

A roadway and pavement investigation for neighbors heavily impacted by the fire was conducted by RockSol Consulting Group, Inc. at the request of Louisville Public Works Department (Nettleton, 2022). The report relied on visual condition assessments and core samples of effected areas throughout the City of Louisville. Visual assessments were done in destroyed neighborhoods, characterized by destroyed structures, melted cars, and burned trash bins. 10 sample cores were bored from one neighborhood, with a sample core diameter of 4 in. and depths of cores ranging from 6 – 12 in. A general outline of the various types of damage and their properties is provided in Table 7-7 below, and pictures corresponding to the types of damage is show in Figure 7-18.

Name	Location & Burned Area	Characteristics	Typical Damage Size
Asphalt Shallow Damage: ASD	Relatively further distances from localized major heat sources	Streak-like marks on pavement. Sometime downwind from burned structures	Long length of road, less than 0.5 in. deep
Asphalt Deep Damage: ADD	Close to major heat sources	Asphalt binder burning and surface cracking	12x40 ft rectangular area of road around burned vehicles, no more than 2.5 in. deep
Monolithic Sidewalk and Gutter Damage: MSGD	Very close to major heat sources on sidewalk and gutters	Sidewalk spalling, cracking and smoke stains, sampling showed no signs of deep damage	Sidewalk panels about 10 ft long, relatively shallow damage
Manholes and Valve Boxes:	Manhole and valve box covers	Valve box seal damage and concrete spalling	Immediately around openings

Figure 7-18. Examples of Roadway Damage, images from UCAV assembled orthomosaics along Arapahoe Cir. in Louisville, CO (39°58'37.452" N, 105°9'48.744" W)

RockSol provides a few rehabilitation recommendations for the various types of roadway damage observed. All burned asphalt area should be milled to their relative depth of damage (micro-milling for ASD areas, about 0.5 in. deep and ADD areas milled to 2.5 in. deep). The shallower areas should be overlaid with a new wearing surface and sealed over the entire roadway, both length and widths for best/most consistent results. The ADD areas should be overlaid with HMA consisting of SX(75)(PG64-28) material, per RockSol Consulting recommendations. Curb panel replacement is advised for MSGD areas, and surface cleaning for smoke stains if deemed necessary.

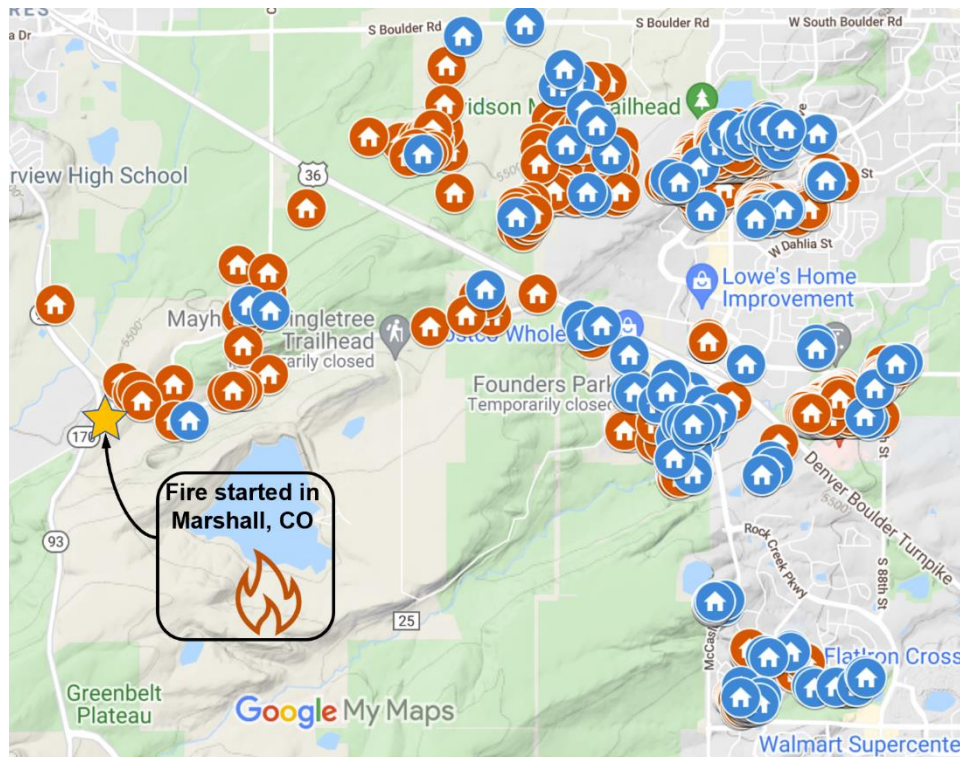
A total of 1,084 houses were destroyed and 149 houses were damaged across Louisville, Superior, and Unincorporated Boulder County. A summary of housing damage per area is shown in Table 8-1 (Boulder County, 2022(b)). The distribution of damage across the affected region is shown in Figure 8-1.

Figure 8-1. Map of damaged and destroyed homes due to the Marshall Fire. Red icons are destroyed homes and blue icons are damaged homes

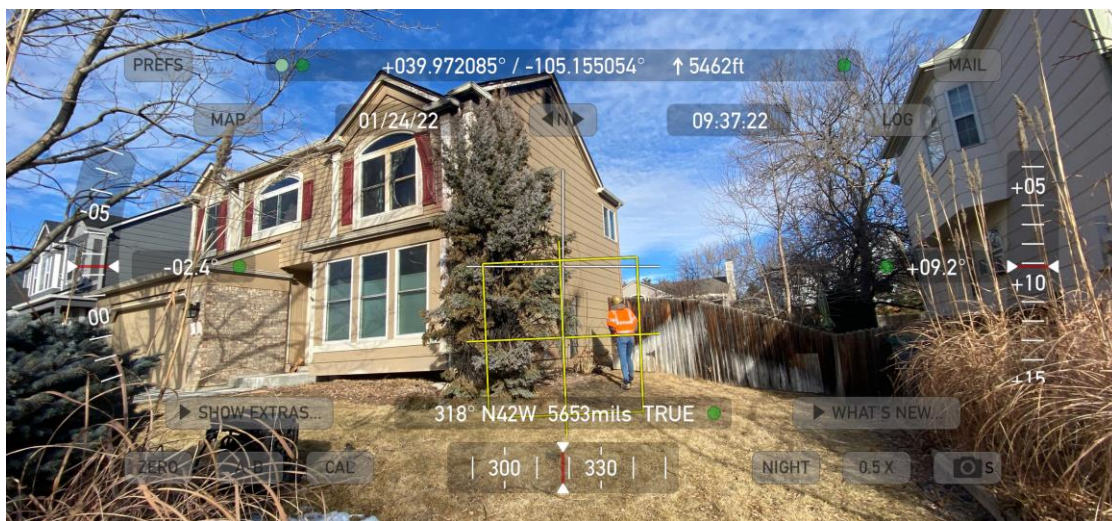
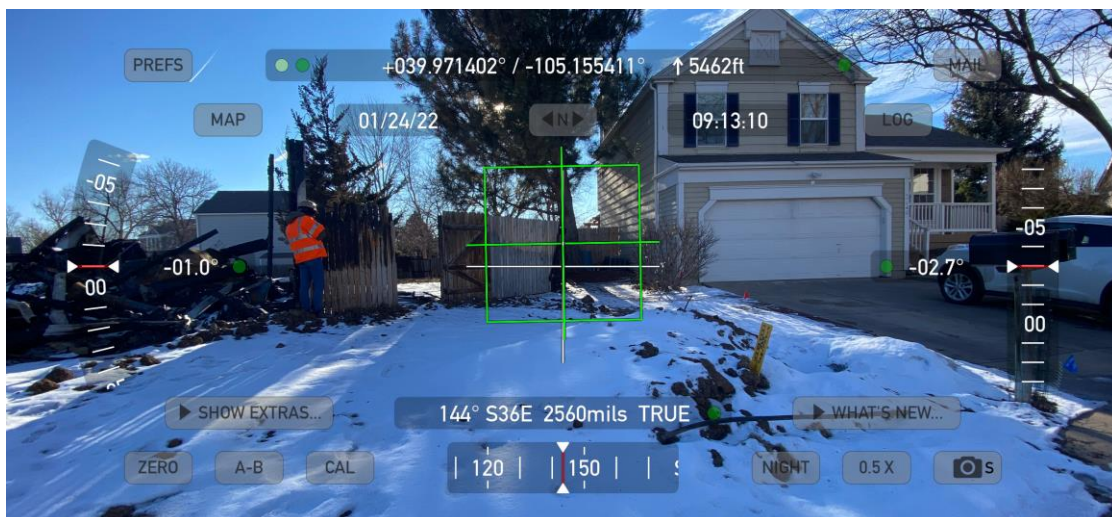
Of the 17 homes surveyed on Cherrywood Lane, 12% of the homes had 11-15 ft spacing and only 6% of the homes had a spacing greater than 30 ft. The distribution of housing spacing for each of the neighborhoods surveyed in Louisville is shown in Figure 8-6. Of the 17 homes on Cherrywood Lane that were evaluated, 94% (16 homes) of the homes had wooden fences and of the homes that had wooden fences, 100% of them had the fence touching the home itself (Figure 8-4). All of the homes had large trees either directly in front of the house or directly behind the house. Lastly, about 52% (9 homes) of the homes had decks attached to the home that were constructed out of wood (Figure 8-5). All of these housing characteristics can increase the ignitability of the home and decrease home survivability.

Figure 8-4. Example of burnt fence touching an undamaged home (a) on Tanager Ct. and (b) on Cherrywood Lane. GPS coordinates provided on the figure.

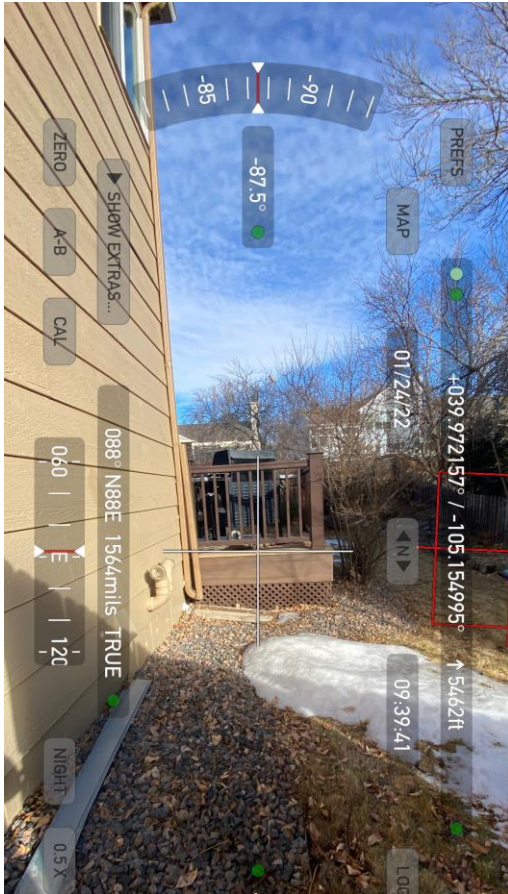
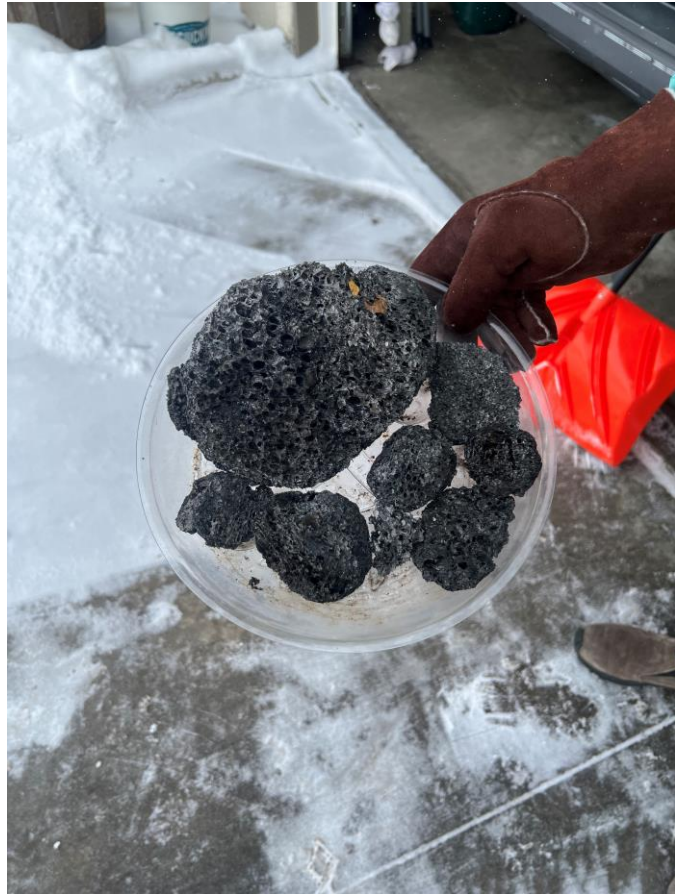
Figure 8-5. (a) Wood porch attached to home on Cherrywood Lane (GPS coordinates shown) and (b) examples of embers from an unburned neighborhood (Townhomes at Coal Creek)

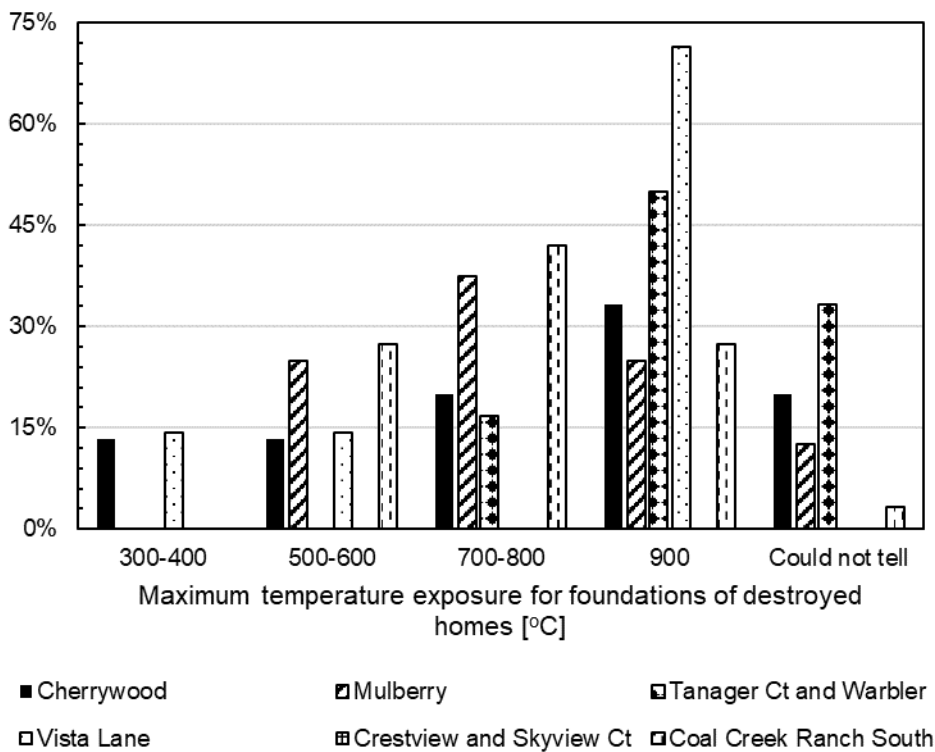
Figure 8-9. Distribution of temperature exposures to foundations of destroyed homes in neighborhoods in Louisville

On the Cherrywood Lane cul-de-sac, 88% (15 homes) were destroyed and 22% (2 homes) were standing with minimal damage. For the destroyed homes, the temperature they were exposed to was evaluated by examining the concrete foundations (Figure 8-6). From this the team determined

that the homes burned at temperatures ranging from 300°C to 900°C. The homes nearest to standing homes with minimal damage were exposed to temperatures at the lower end of the spectrum. Elevated temperatures throughout S. Tanager, S. Warbler Ct., and on Vista Lane was evident by the presence of spalling of the concrete walkways, as shown in Figure 8-10.

Along W. Mulberry Street, Vista Lane, Crestview Court, and Skyview Court, the foundation temperatures of the destroyed homes were recorded. For these homes, the temperatures they were exposed to varied between 300 and 900°C. No homes on Crestview or Skyview Court were destroyed. Figure 8-9 shows the breakdown of foundation temperatures. The breakdown of destroyed, damaged, and standing homes that were surveyed in each neighborhood is shown in Figure 8-11.

For these two streets, the temperatures the homes were exposed to were assessed by checking the foundations of the destroyed homes. The temperatures observed ranged between 700 and 900°C for the seven destroyed structures; however, for three of the homes, the temperatures were unable to be determined due to the presence of debris and snow (Figure 8-9).
