# The 2021 Marshall Fire, Boulder County, Colorado

## Geotechnical Extreme Events Reconnaissance Association

Version 1.0  
May, 2022

GEER—075

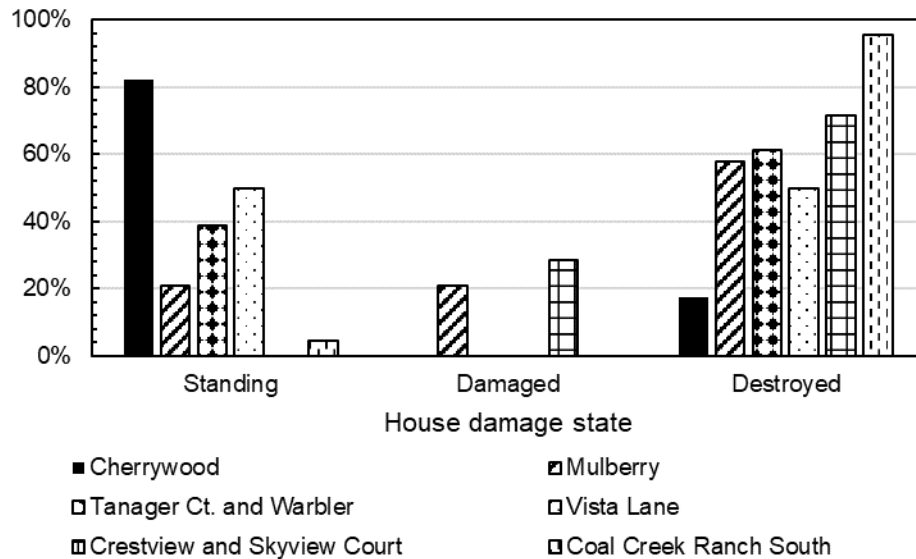
Along W. Mulberry Street, Vista Lane, Crestview Court, and Skyview Court, the foundation temperatures of the destroyed homes were recorded. For these homes, the temperatures they were exposed to varied between 300 and 900°C. No homes on Crestview or Skyview Court were destroyed. Figure 8-9 shows the breakdown of foundation temperatures. The breakdown of destroyed, damaged, and standing homes that were surveyed in each neighborhood is shown in Figure 8-11.

Figure 8-11. Breakdown of damaged, destroyed, and standing homes surveyed in each Louisville neighborhood

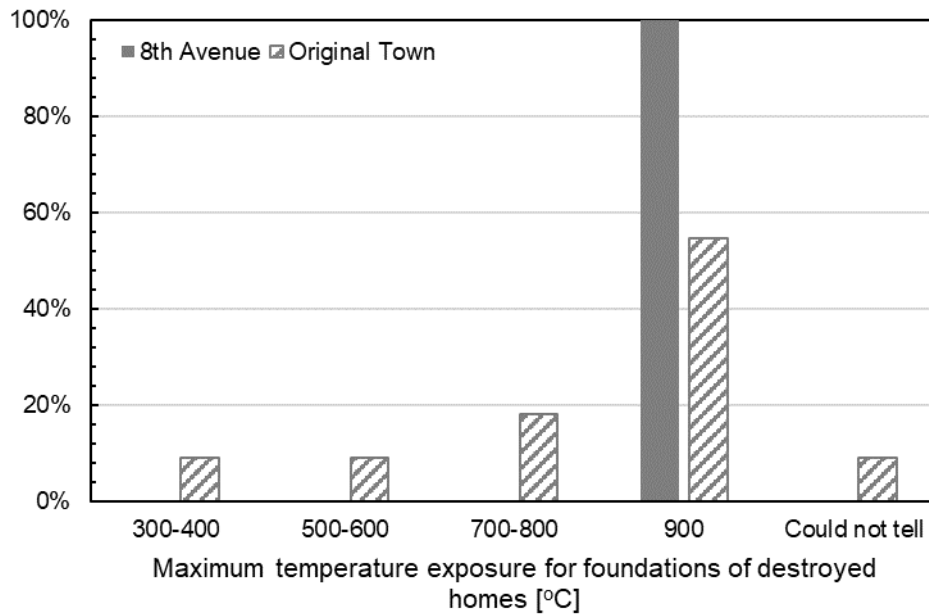
Figure 8-17. Distribution of temperature exposures to foundations of destroyed homes in neighborhoods in Superior

Due to the age range of the homes in this neighborhood, there was a diverse type of foundations present, some of which include rubble, CMU block, brick, shotcrete, and reinforced concrete. Of the destroyed homes with reinforced concrete foundation, the team determined that the homes reached temperature between 300-900°C (Figure 8-17 and Figure 8-21).

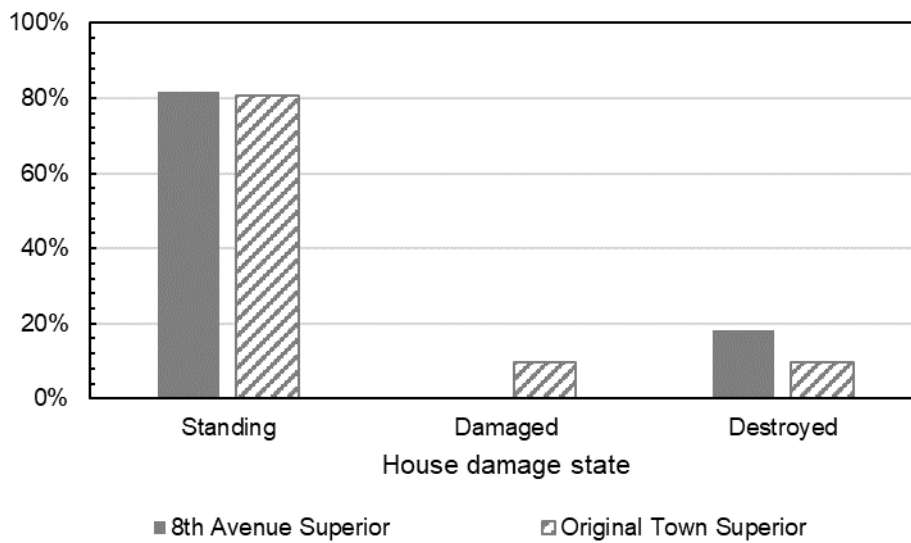
Figure 8-19. Distribution of standing, damaged, and destroyed homes surveyed in Superior

Looking at the foundations of the destroyed homes, the team was able to evaluate the temperatures at which the homes burned. The distribution of standing, damaged and destroyed homes that the team surveyed in Superior are shown in Figure 8-19. For 8<sup>th</sup> Avenue, all destroyed homes burned at a temperature of >900°C (Figure 8-17 and Figure 8-18). The presence of elevated temperatures is further demonstrated by the presence of spalling of the concrete driveways of the homes that were destroyed on 8<sup>th</sup> Avenue.

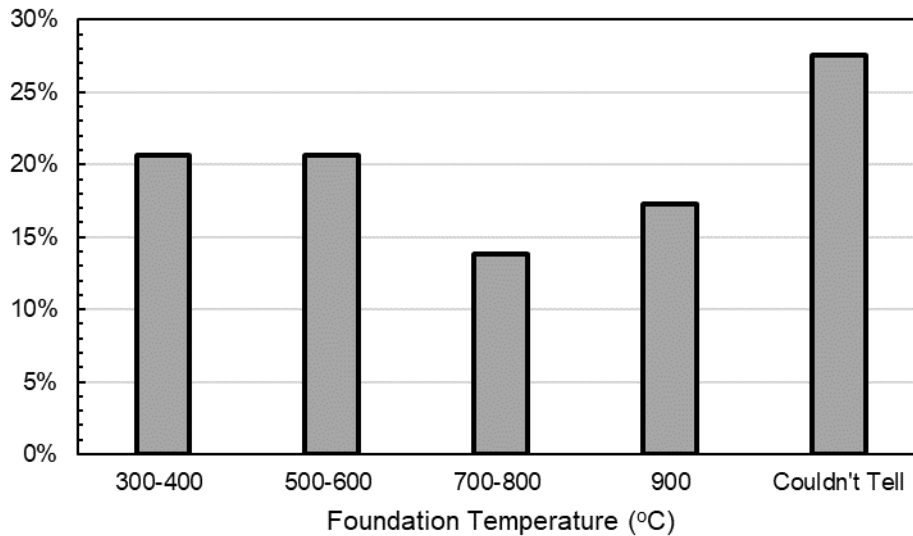
Due to snow cover on the day of the in-field surveys, foundation temperatures at 28% of the homes surveyed could not be concluded. The remainder of the homes had foundation temperatures that could be determined from the color of the concrete. These are summarized in Figure 8-23.

Figure 8-23. Distribution of foundation temperatures for homes surveyed in Unincorporated Boulder County

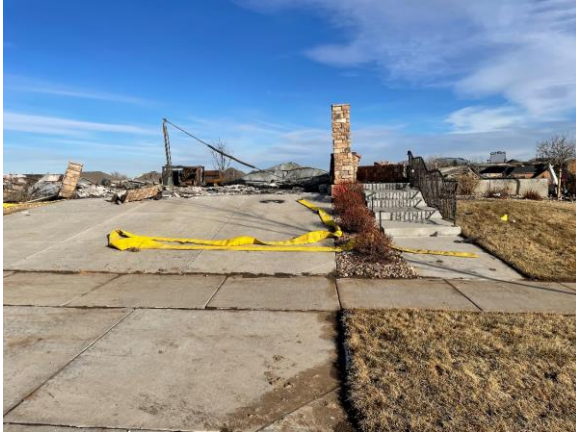
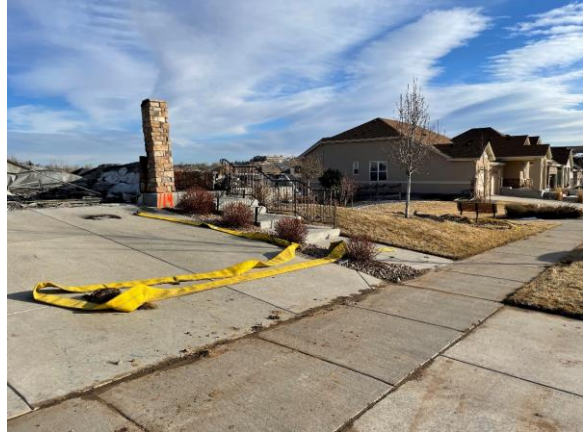
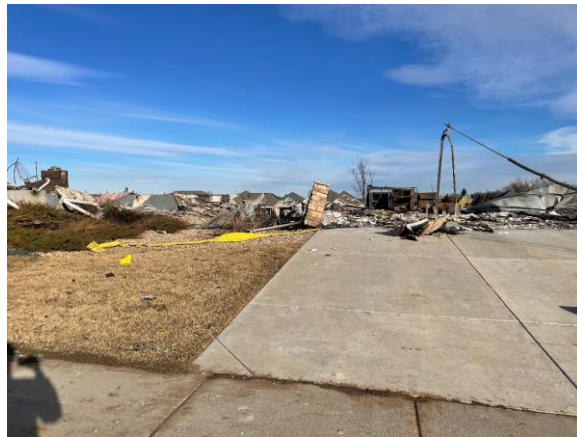
If fires in a community are too intense and life safety is at risk, firefighters will leave the community quickly. However, these are extreme circumstances and it is not preferable for firefighters to leave equipment behind. In some instances, throughout the GEER team's work, we saw locations where fire hoses were left behind at houses (see Figure 8-24). This behavior indicates the fire was uncontrollable and it was no longer safe for firefighters to be present as they would have been trapped in the community. Figure 8-24 is 8<sup>th</sup> Avenue in Superior and shows a fire hose left in a driveway and burned through by the fire.

Figure 8-24. Photos of firefighting hose left behind at a house on 8<sup>th</sup> Avenue in Superior (39°57'11.8" N, 105°10'28.9" W)

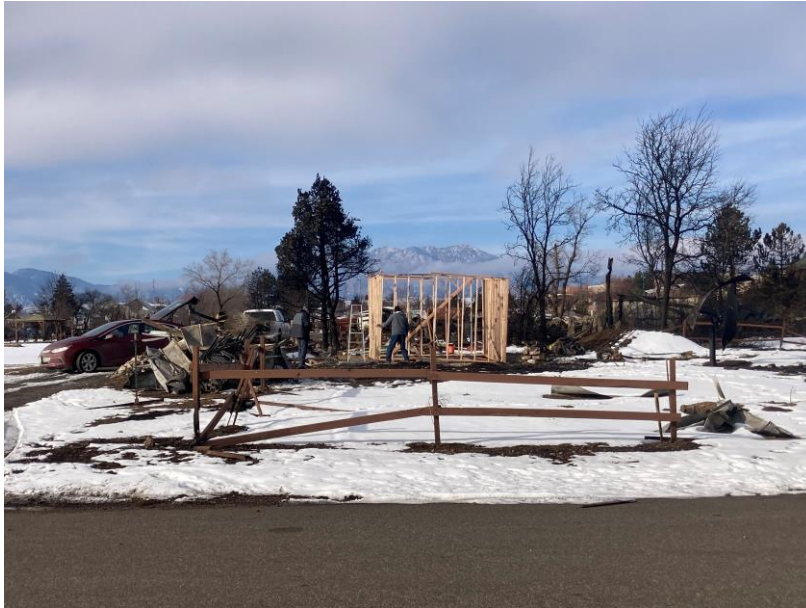
Figure 8-25. Initial signs of rebuilding, Original Town Superior, 9 January 2022 (39.95383, -105.16684)

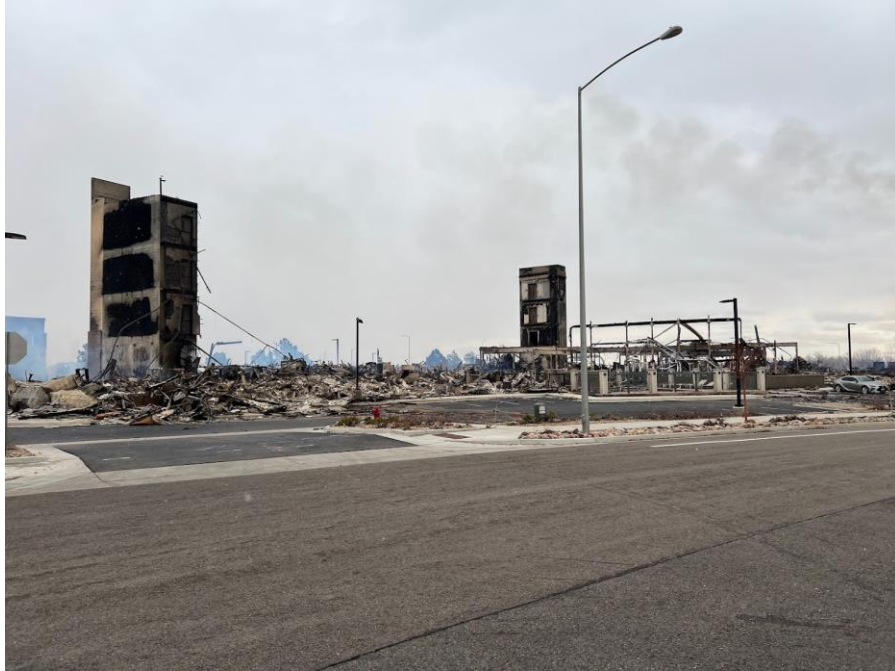
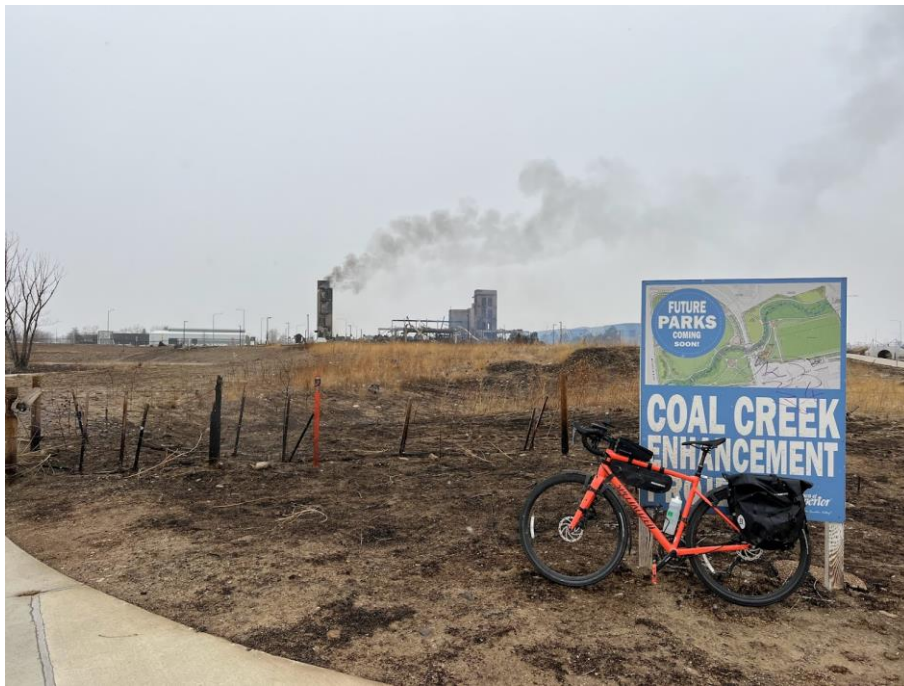
The Element Hotel, operated by Marriott and Superior's first hotel, is an example of a destroyed structure (Figure 8-26). Completed around 2019, the four-story, LEED certified building was a component of Superior's community building project and new downtown facilities, including parks and business under the program "Coal Creek Enhancement". The gravity framing used hybrid construction. The first and second stories were steel-framed construction with infill beams made of LVLs. This allowed for transferring loads from the stories above to create an open lobby space. The upper floors of the building were constructed of timber with LVL beams and columns. The lateral force resisting system consisted of two concrete core wall clusters which housed the utility and elevators for the building.

The L-shaped geometry and orientation relative to the prevailing winds may have impacted its susceptibility, as several nearby buildings did not experience significant damage. The team identified this as an important structure for future evaluation and conducted detailed LiDAR scans of the property after safety fencing has been assembled and before significant debris removal occurred (Figure 8-27).

Figure 8-26. Element Hotel, 31 December 2021 (39°57'19.1" N, 105°09'48.7" W)

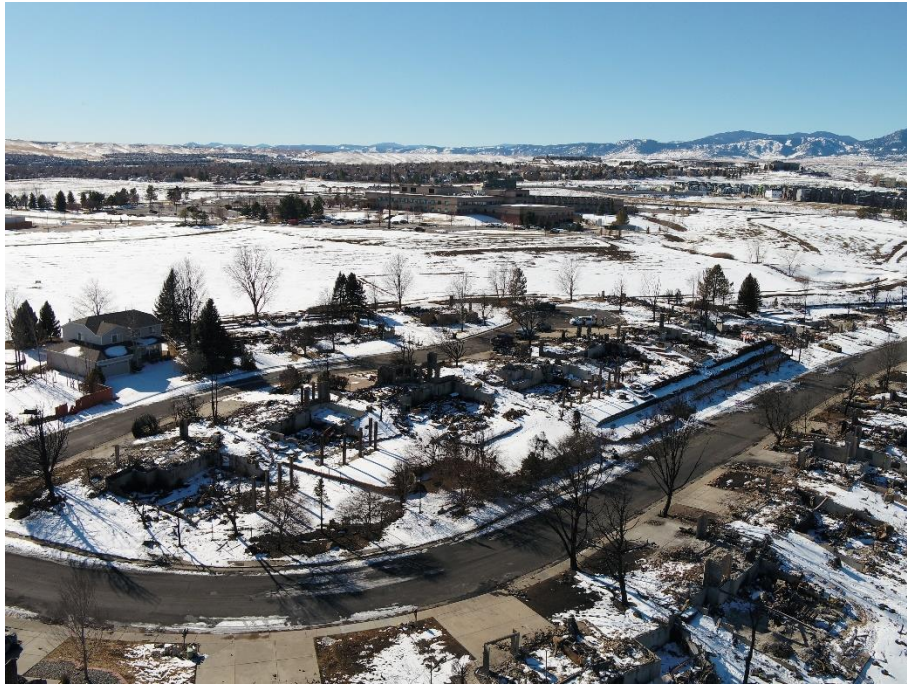
Also in Louisville is the primary hospital that was within the burn area. Located at the southwest corner of Louisville, Centura-Avista Adventist Hospital was evacuated during the fire by 5 PM (Table 4-2). As shown in Figure 8-29, the hospital is positioned adjacent to Coal Creek Ranch South Neighborhood, which lost the majority of homes. There are reports of hospital staff that fended off approaching fires with garden hoses, to keep the fire from impacting the building or the high-pressure nitrogen tanks located just outside. With the help of firefighter efforts, this structure as saved from direct fire damage. Following significant efforts to clean the interior of the building of smoke damage, the hospital reopened less than 3 weeks after the fire.

Figure 8-29. Coal Creek Ranch South neighborhood with RS1 to the right and Centura-Avista Hospital in the distance (39°57'17.1" N, 105°09'01.6" W)
