Reconnaissance of the Geotechnical and Infrastructure Impacts of Los Angeles Area Wildfires and Subsequent Storms

A report of the NSF-Sponsored Geotechnical Extreme Event Reconnaissance Association

Report GEER-085: <https://doi.org/10.18118/G6X37N>

June 13, 2025

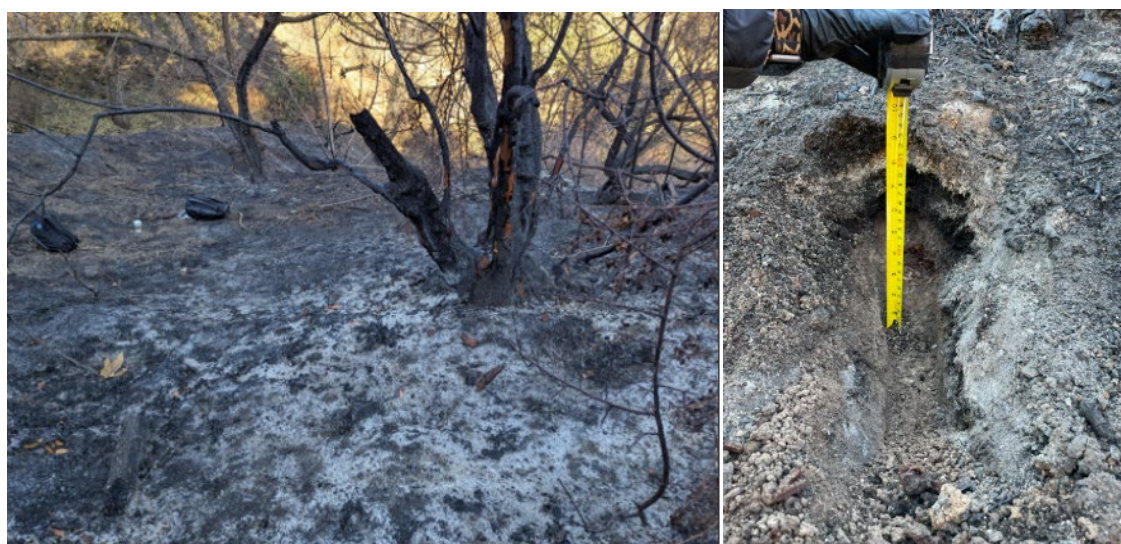
An ash layer was present at all the sites with varying thickness and continuity. On the February 4th visit in Mandeville Canyon, a thin (1 to 3 cm) layer of gray-white, black, and occasionally orange ash was covering the soil surface in the majority of the site (Fig. 2.10a). On the north-facing slopes of the Los Leones Canyon, the ash layer was less than 2 cm thick and discontinuous, whereas the thickness of the ash layer reached up to 10 cm on the south facing slopes (Fig. 2.10b). The ash layer was less widespread in subsequent field visits in February, March, and April but patches of ash were still present.

Fig. 2.10. Ash cover on February 4, 2025 in (a) Mandeville Canyon and (b) south-facing slopes of Los Leones Canyon (coordinates: 34.120333°, -118.506318°; 34.046944°, -118.559219°)

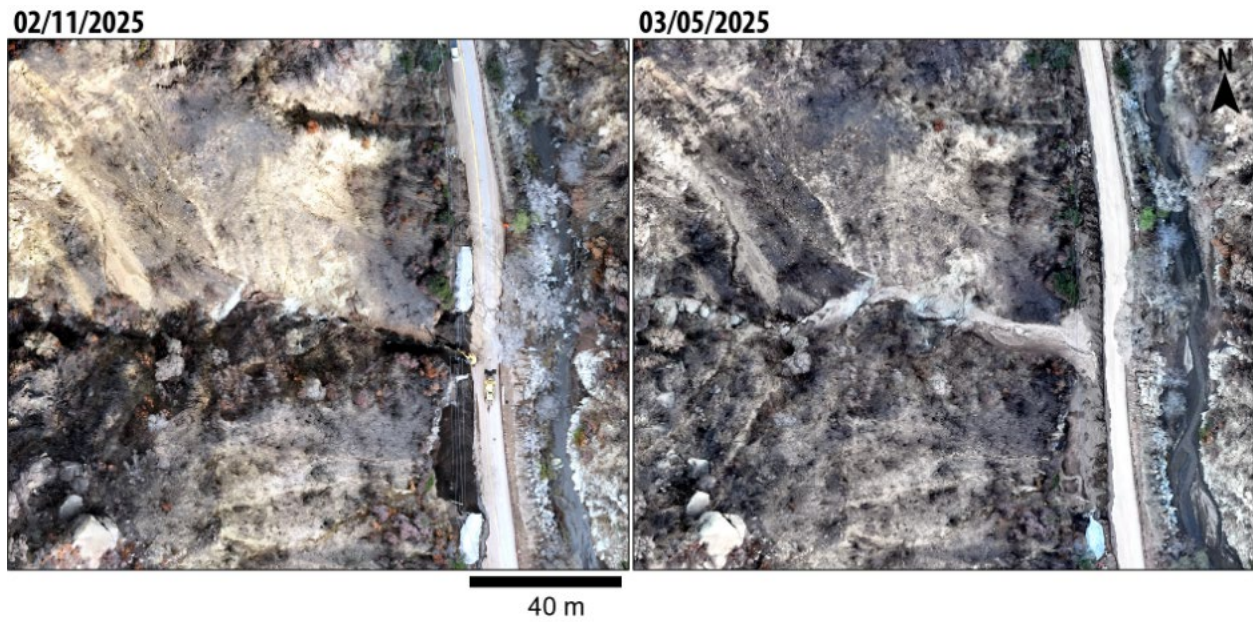
Evidence of debris floods and flows was observed near Topanga Canyon Road. A site visit immediately following the February 13th storm revealed significant sediment deposition and road blockages along State Route 27. Debris flood deposits from a small, steep tributary to the east were observed. These deposits consisted primarily of woody debris, boulders (ranging from ~0.1 m to > 0.5 m), cobbles, and fine-grained sediments (Fig. 2.17). Several sections of the road were covered by floodwaters, mudflows, debris, and sediment transported from tributaries and adjacent hillslopes (Fig. 2.18). Increased sediment accumulation was also observed within the channel of Topanga Creek (Fig. 2.19). A postfire debris flow that was triggered during the January 26, 2025 storm event was documented by Caltrans (Fig. 2.20). The extent of debris floods and flows following the January 25-26 and February 13 storms was significantly greater than under pre-fire conditions (personal communication, Caltrans).

Fig. 2.19. Drone optical image comparison before and after the Feb 13 storm. The debris flood/flow deposits near the State Route 27 road are shown in Figure 2.17.

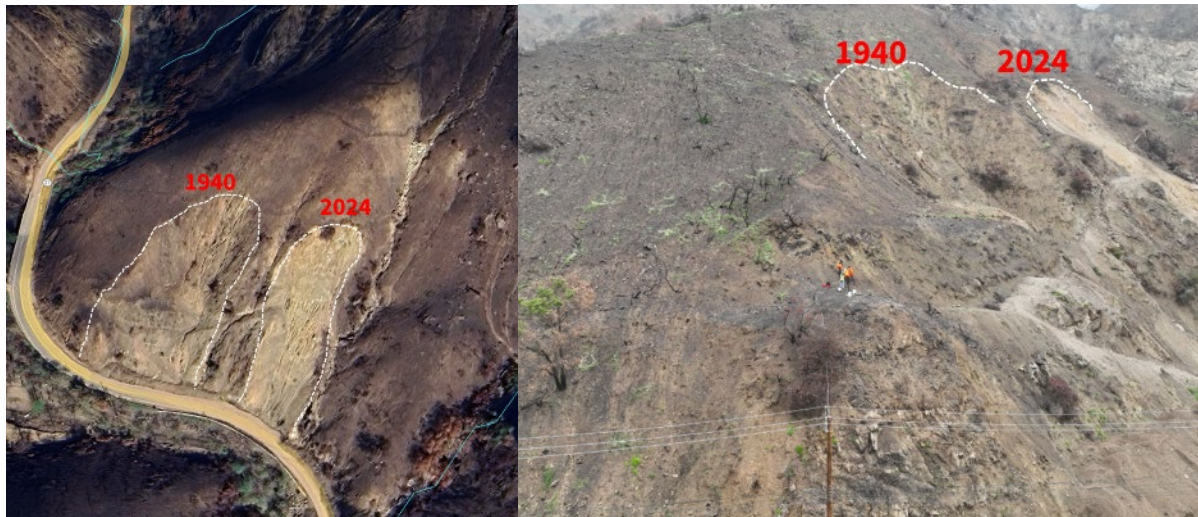
At postmile 1.8 along State Route 27 (Topanga Canyon Boulevard), a north-south roadway through Topanga Canyon, a hillside near an S-curve has experienced several episodes of major landslides (Figure 2.30). The first occurred in 1940 and is located on the northwest side of the hillside. The second and most recent event, on March 9, 2024 (Caltrans 2024), is located on the southeast side of the slope. Both landslides exhibit distinguishable scarps and planar failure surfaces, suggesting translational slides affecting hillside debris associated with colluvial deposits overlying sandstones and conglomerates of the Tuna Canyon Formation.

Fig. 2.30. Topanga Canyon landslides. (a) Google Earth image of the S-curve on State Route 27; (b) Drone photo of the area taken on 3/24/25, courtesy of Syrusa Engineering (coordinates: 34.063365°, -118.586363°).

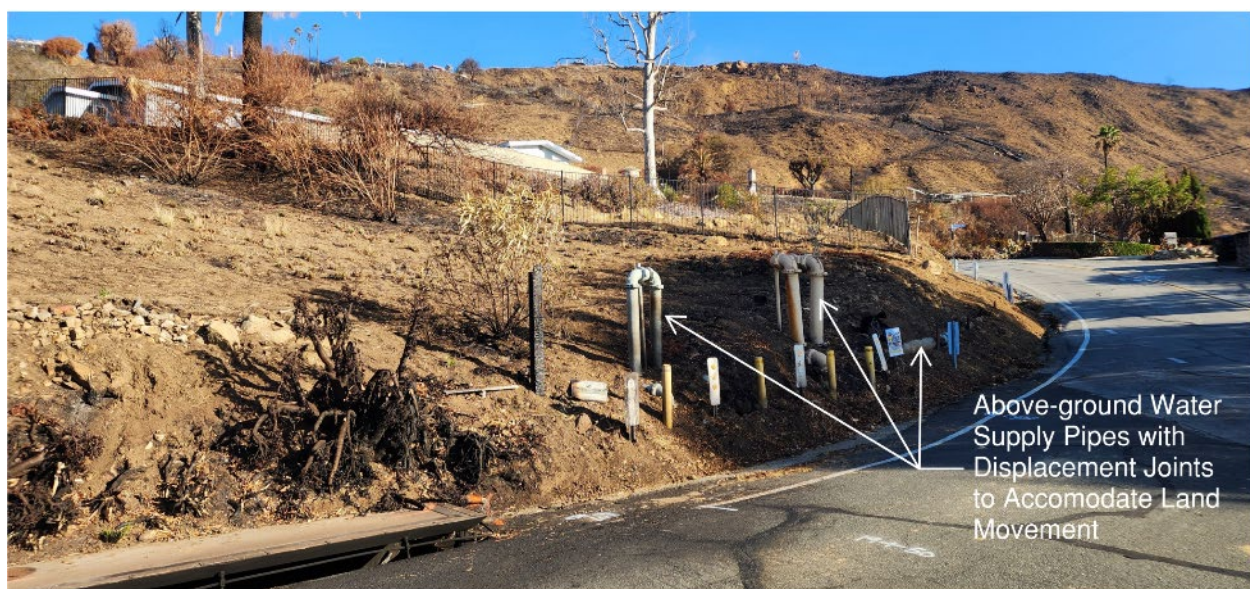
Water pipelines made of iron and mechanical joints were constructed at grade in the Big Rock Mesa region operated by LA County, likely because the area is prone to slope movement. The above-ground pipelines did not appear to have been damaged severely by the fire. An example is shown in Figure 2.35. Other pipelines in the area were clearly in operation on February 4, 2025 when observed.

Fig. 2.35. Photograph of above-ground water supply pipeline with slope-movement mitigation expansion joints (34.0412773°, -118.6194627°) in Big Rock Mesa area.

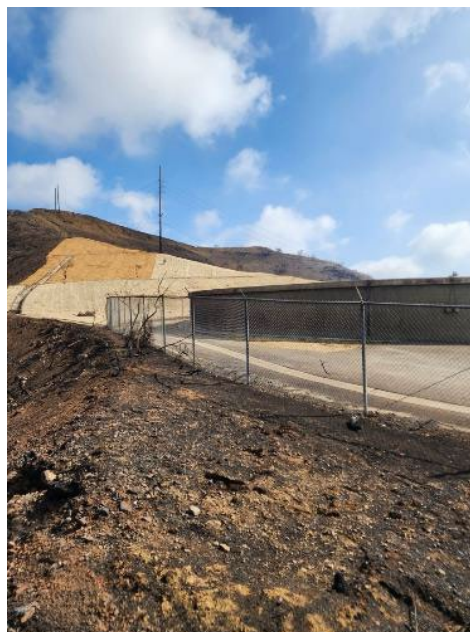
The Temescal Tank is owned and operated by the LADWP and located at the highest elevation over the Palisades Highlands area and within the burn zone. The partially buried concrete tank is shown in Fig. 2.36. Visually, signs of large-scale damage to the tank were not observed, but from the appearance of partially scorched and some new ancillary equipment and recent grading/erosion control work using jute mesh at the circular tank, it appeared some fire damage may have occurred to some of the equipment associated with the water tank. The new equipment had apparently been repaired prior to our visit.

Fig. 2.36. Photographs of the Temescal Tank circular water supply tank in Palisades Highland. Recent slope erosion mitigation (with jute mesh) had been performed behind the tank (likely post-fire), and some of the ancillary equipment attached to the tank may have been recently repaired based on observations, some equipment was scorched by the fire. (34.0777306°, -118.546853°).

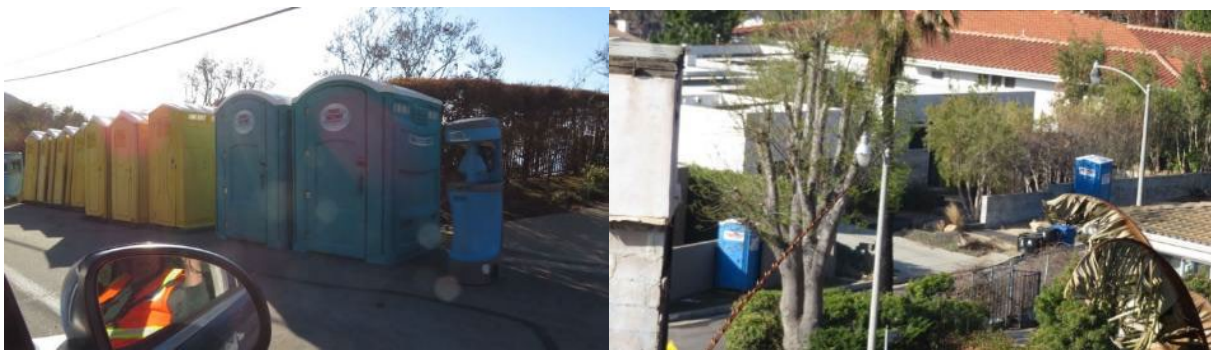
The field reconnaissance team sought specific locations of sanitary sewer wastewater infrastructure performance within the Palisades region. There were no findings of impacts to the wastewater system at the time of this report. However, as shown in Fig. 2.39 there were many observations of portable toilets at residential and commercial buildings in the Palisades area that were located for purposes other than for construction and repair crews (i.e., in driveways and side yards of homes and businesses). Since the wastewater system is on hillsides, it is expected to be a full gravity flow system and therefore the need for portable toilets is curious and implies some level of impact to the wastewater system from the fire. Future reporting will attempt to include potential impacts to wastewater.

Fig. 2.39. Portable toilets in the Palisades residential neighborhood. Many homes and businesses that survived the fire were observed to be using portable toilets on 2/4/25.

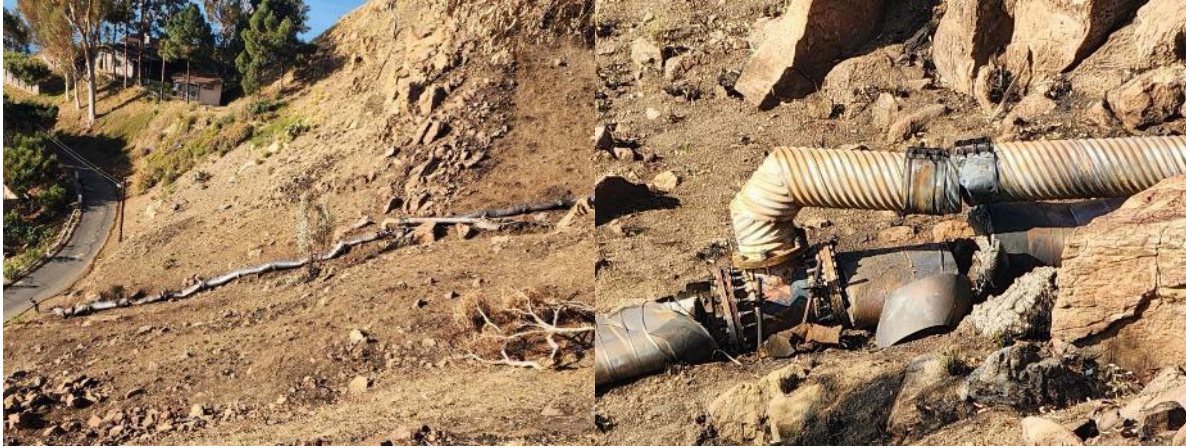
Storm drain pipes were exposed at the ground surface at a number of locations we observed, as they had been placed in areas of prior landsliding and had been constructed (temporarily) in a manner that could be maintained after future landslide movements. An example is shown in Fig. 2.40. These surface-exposed storm drain pipes had significant damage, at joints (as shown in Fig. 2.40), or had completely burned away/melted. The storm drain shown in Fig. 2.40 collects surface water flowing from above canyons at a large catch basin located on the streets above. The pipeline normally routes the runoff water around the homes located below (i.e., to the left of photos in Fig. 2.40); in the absence of the drainage pipe the neighborhood is exposed to threat of flood.

Fig. 2.40. Storm drain pipe damaged by Palisades Fire. Between Big Rock Dr. and Seaboard Rd, Big Rock Mesa, Malibu, CA (2/4/25).

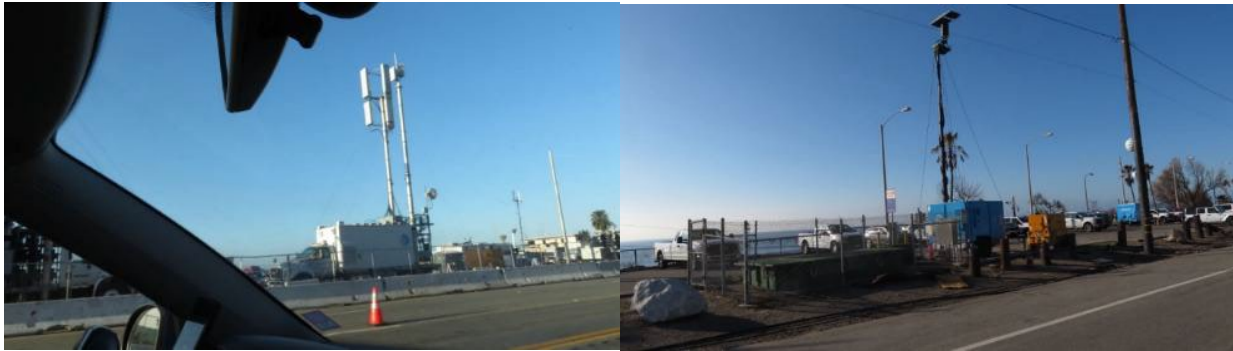
The field reconnaissance team sought specific locations of telecommunications infrastructure performance within the Palisades region. There were no findings of impacts to larger components at the time of this report, however, there are known telecommunications facilities along the ridges of the mountains in the area that are highly susceptible to impacts from the fire. Future reporting will attempt to include potential impacts to telecommunications facilities. Fig. 2.47 shows mobile cell units located along the Pacific Coast Highway. It is unknown if these were to replace damaged cell sites or for specific emergency communication purposes.

Fig. 2.47. Mobile cellular communications units placed along Pacific Coast Highway (2/4/25).

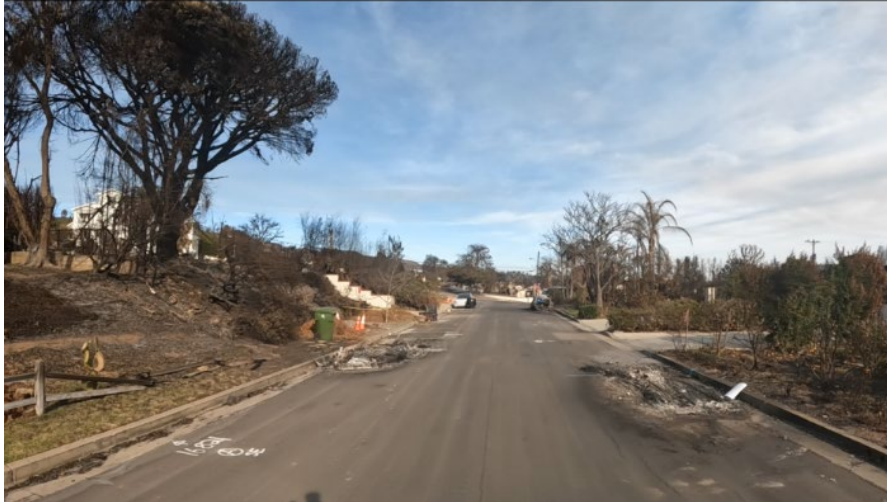
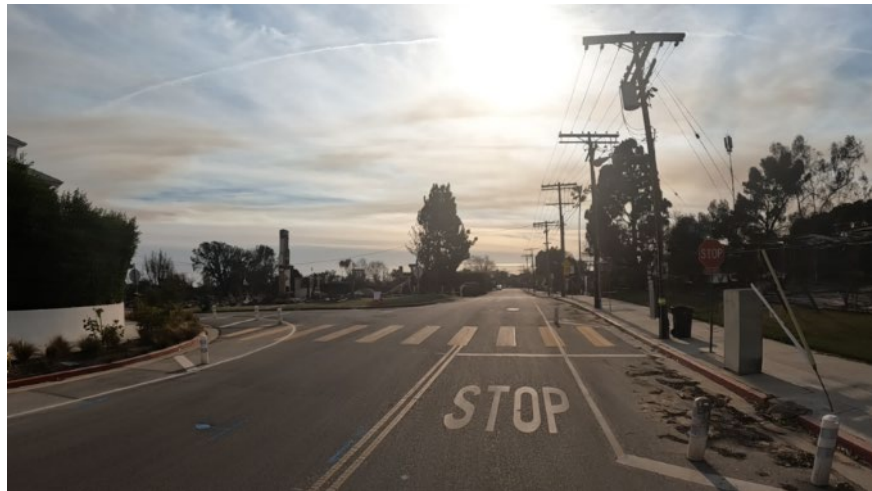
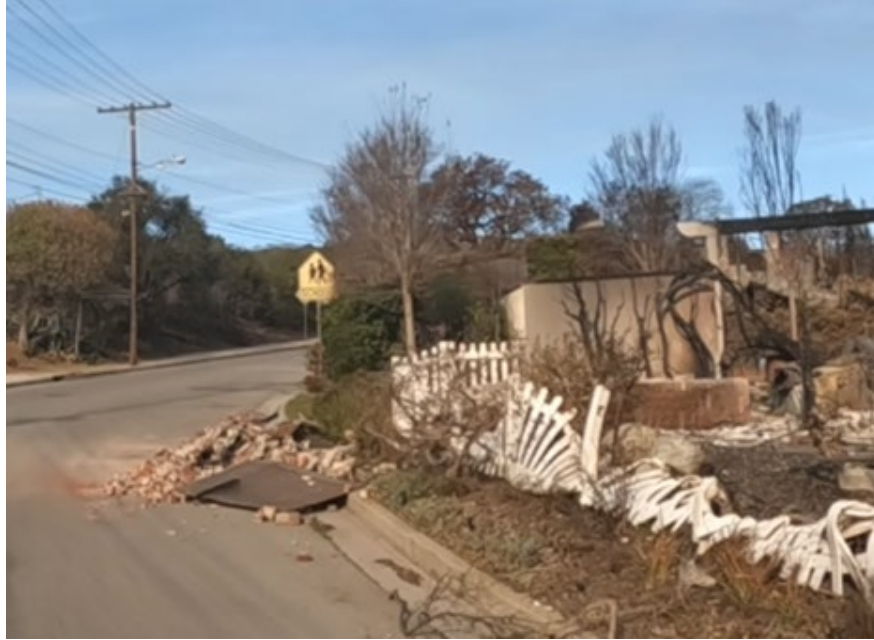
Roadways showed multiple signs of heat-related damage and obstruction due to fire debris. In Fig. 2.48a, burned vegetation lines both sides of the street, with ash and charred remnants accumulating along the curbs and gutters. Portions of the asphalt appear darkened or surface-seared, and debris from burned structures—such as melted plastic, cables, and fencing—has encroached onto the roadway. In Fig. 2.48b, the intersection area shows scorched curbs and bollards, and soil displacement near roadside signage and utility poles. The crosswalk area appears intact, but surrounding infrastructure is visibly affected by heat and soot deposits. In Fig. 2.48c, collapsed brick walls and melted fencing materials have fallen into the driving lane. The asphalt adjacent to these debris piles shows visual signs of charring and fine particulate accumulation. Overhead utility lines and poles remain upright, but the sidewalk and shoulder areas are extensively burned.

Fig. 2.48. Damage to pavements and roadside infrastructure in Pacific Palisades. (a) Vegetation and structural debris burned along the road edge, with heat-induced discoloration and material accumulation on the asphalt. (b) Scorched bollards, sidewalk curbs, and fire-related surface disruption near pedestrian and traffic signage infrastructure. (c) Collapsed brick fencing and warped plastic materials spilling onto the pavement, with surrounding areas of the road and sidewalk visibly charred.

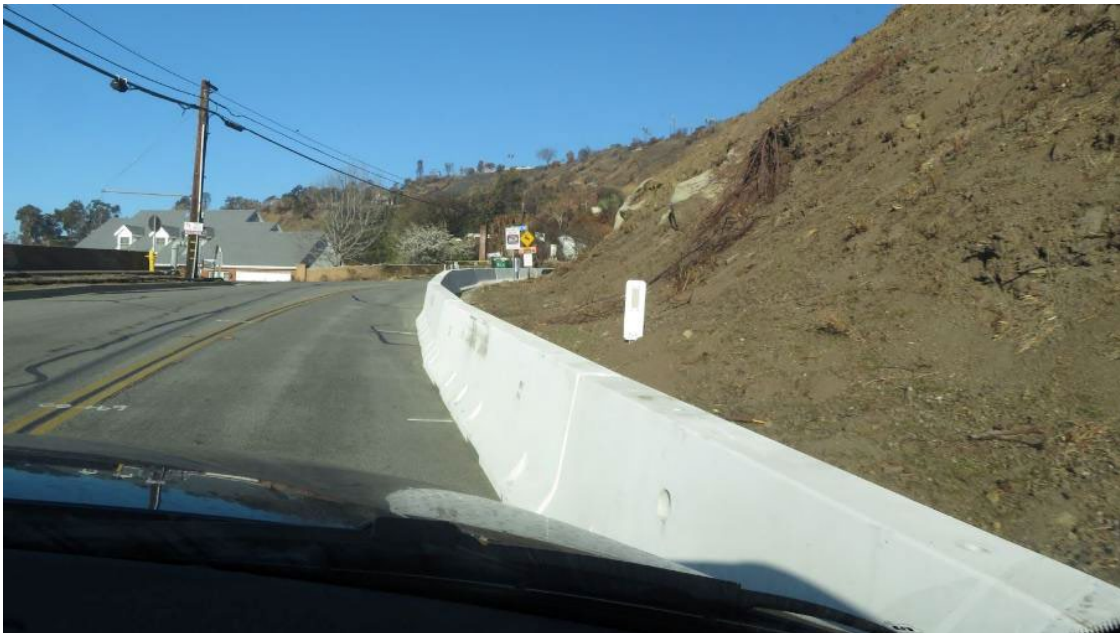
After the fire, several roadways were protected against erosion and debris running onto the drive surface by using k-rails as shown in Fig. 2.49.

Fig. 2.49. K-rail installed along roadways in the Palisades and Malibu areas soon after the fire to protect the drive surface from debris, erosion, and runoff.

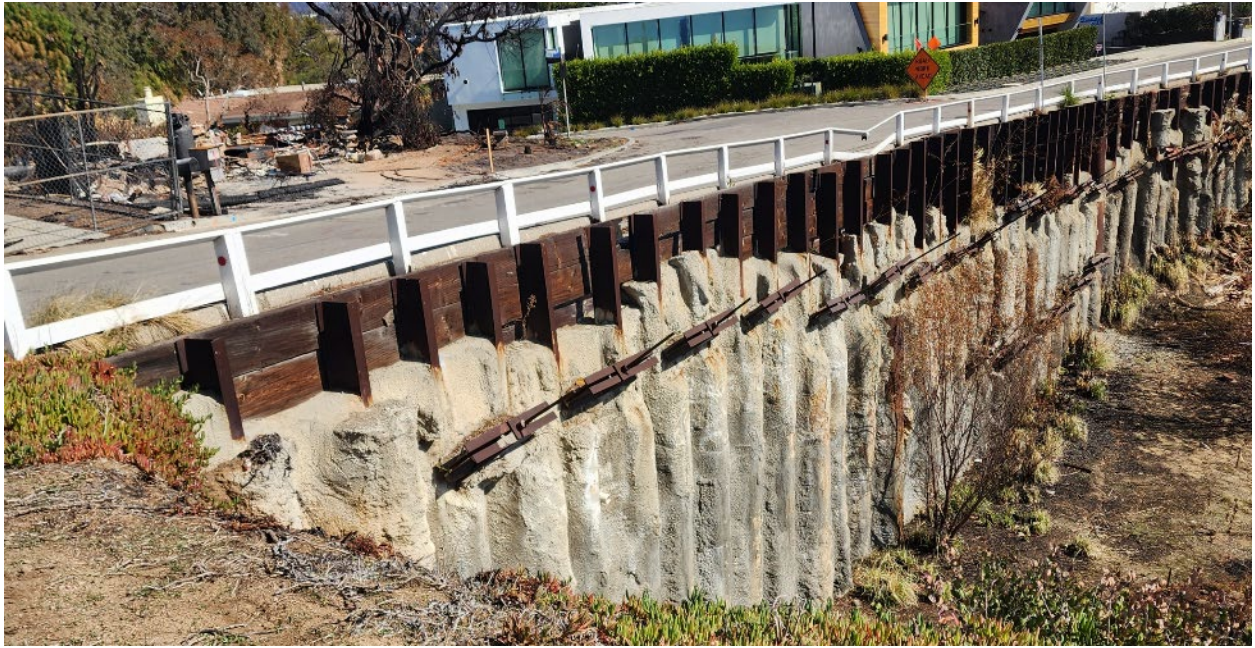
Soldier beam and tie-back anchor retaining walls have been installed in the last 50+ years in Pacific Palisades to assist in stabilization of roadways, where landslides have caused significant road damage/movement. These retaining walls, although permanent, often used treated timber lagging between soldier piles. An example of a tied-back soldier pile wall at the Tramanto Landslide that has partial shotcrete lagging and partial timber lagging is shown in Fig. 2.51. At this location, although the fires passed through this area (most of the houses on both sides of the street at this location burned down), the timber lagging was largely intact (but the degree of damage to the strength of the lagging or exposed steel soldier piles is not known). Fig. 2.52 shows one of several soldier beam with timber lagging tie-back walls along the Pacific Coast Highway. In some cases the timber lagging was burned as shown in Fig. 2.52 to 2.55. The integrity of the walls and tie-backs seem to remain intact.

Fig. 2.51. Soldier beam and tie-back anchor retaining structure with combination of timber and shotcrete lagging. Upper edge of Tramanto Dr. Landslide, Tramanto Dr., Castellammare, Pacific Palisades (2/4/25).

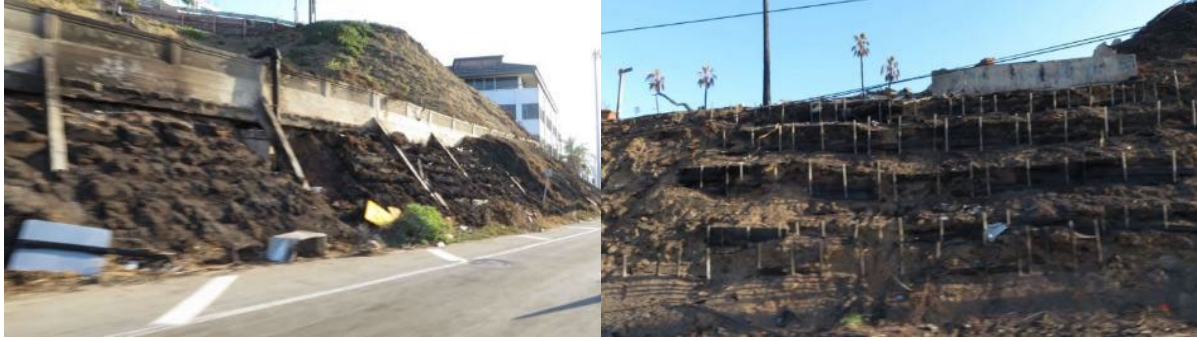
Fig. 2.55. Images of wood lagging completely burned out. The wood lagging supported slopes at several locations along the Pacific Coast Highway prior to the fire (2/4/25).

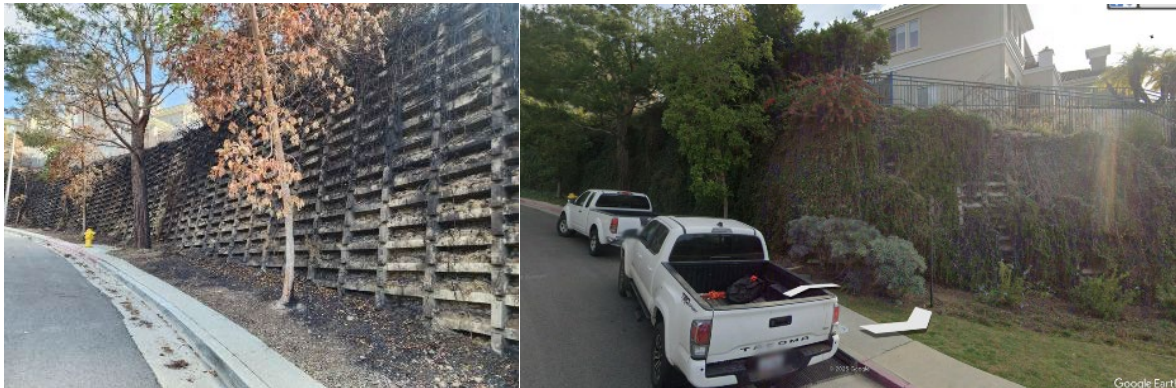
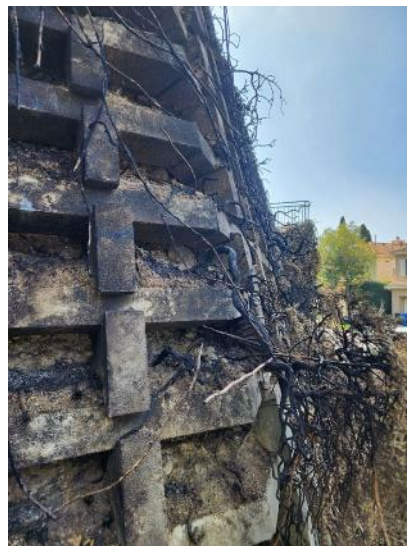
Crib wall retaining structures with fire damage were observed (Fig. 56). The wall face showed burn marks, and the pre-fire vegetation growing out of the wall face was combusted, but otherwise no evidence of wall damage or instability was observed.

Fig. 2.56. Crib Wall with Burned Surficial Vegetation and Fire Exposure in Palisades Fire. (a) Post-Fire, (b) Pre-Fire Google Street View Image, (c) Close-Up of Burned Surface. Calle Patricia at Calle Jermaine, Palisades Highlands, Pacific Palisades (a and c taken 2/4/25).

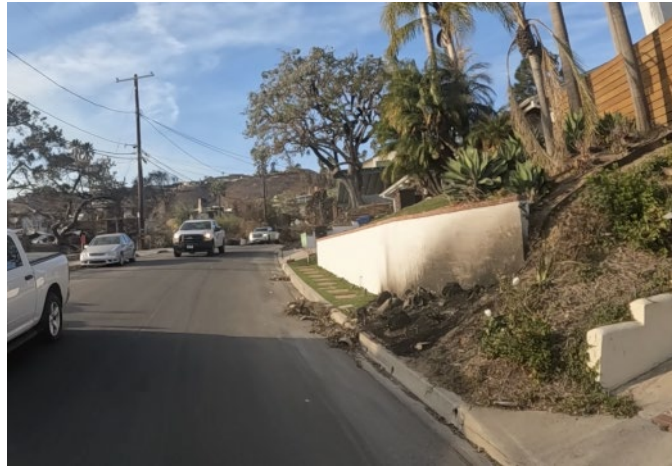
-118.53877° 34.0520076° 3117100 LAS PULGAS RD

Fire damage was also observed in stucco-faced short masonry retaining walls (Fig. 2.57), which remained intact.

Fig. 2.57. Stucco-faced short retaining wall remains intact, with debris accumulation above the slope.

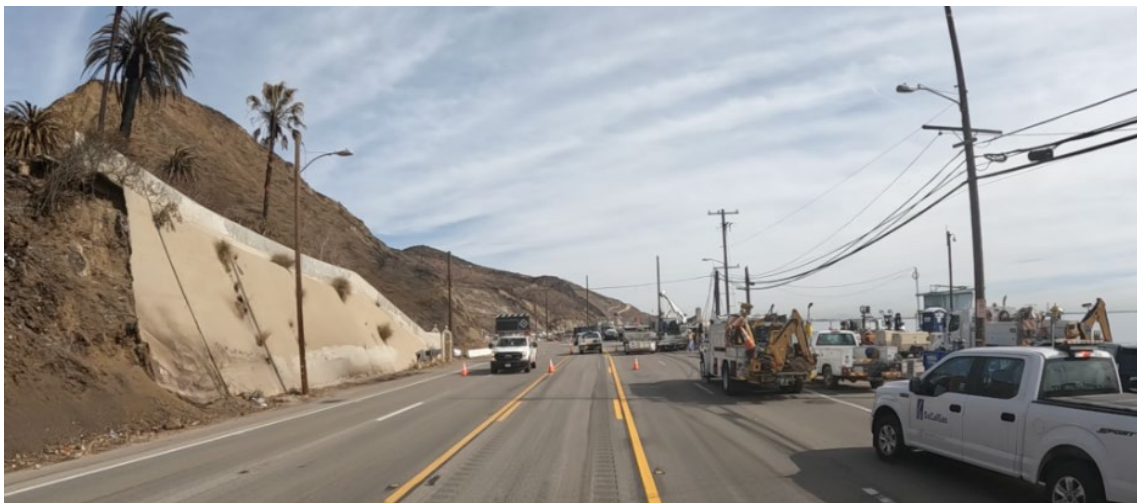
-118.5629706° 34.0409637° 4171100 PACIFIC COAST HY

Shotcrete-treated slopes along the Pacific Coast Highway showed some burn marks but appeared to be undamaged (Fig. 2.58).

Fig. 2.58. Shotcrete-treated slopes along the Pacific Coast Highway remained largely undamaged.

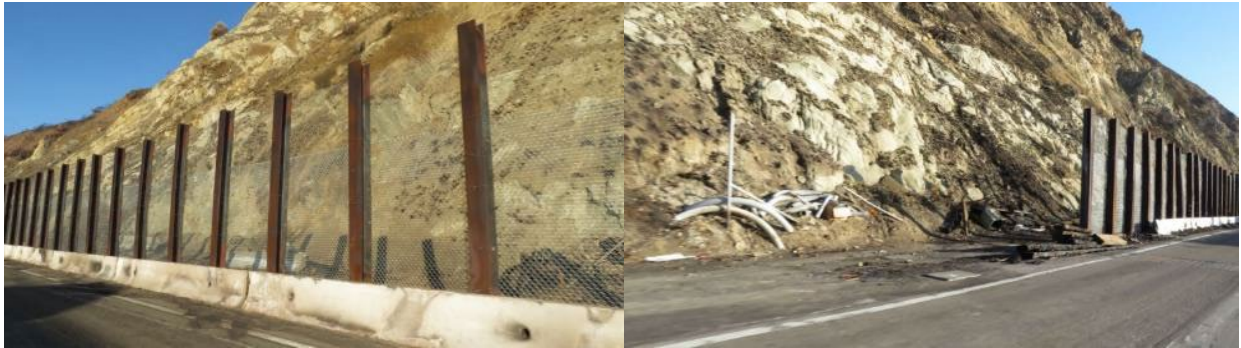
Soldier piles and wood lagging were also used as rockfall barriers along the Pacific Coast Highway in the Malibu area. Fig. 2.59 shows a set of soldier piles that supported wood lagging prior to the

Fig. 2.59. Soldier pile and wood lagging rock barrier wall along the Pacific Coast Highway in Malibu area. The wood lagging completely burned out and was replaced with chain link fencing soon after the fire. The photo on right shows remaining evidence of the burned out wood lagging (February 4, 2025).

fire. The lagging burned and was replaced with chain link fencing soon after the fire to protect the highway.

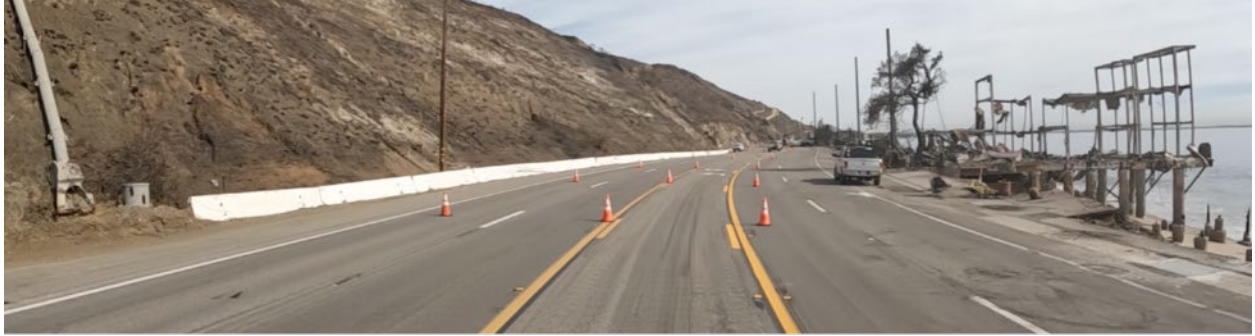
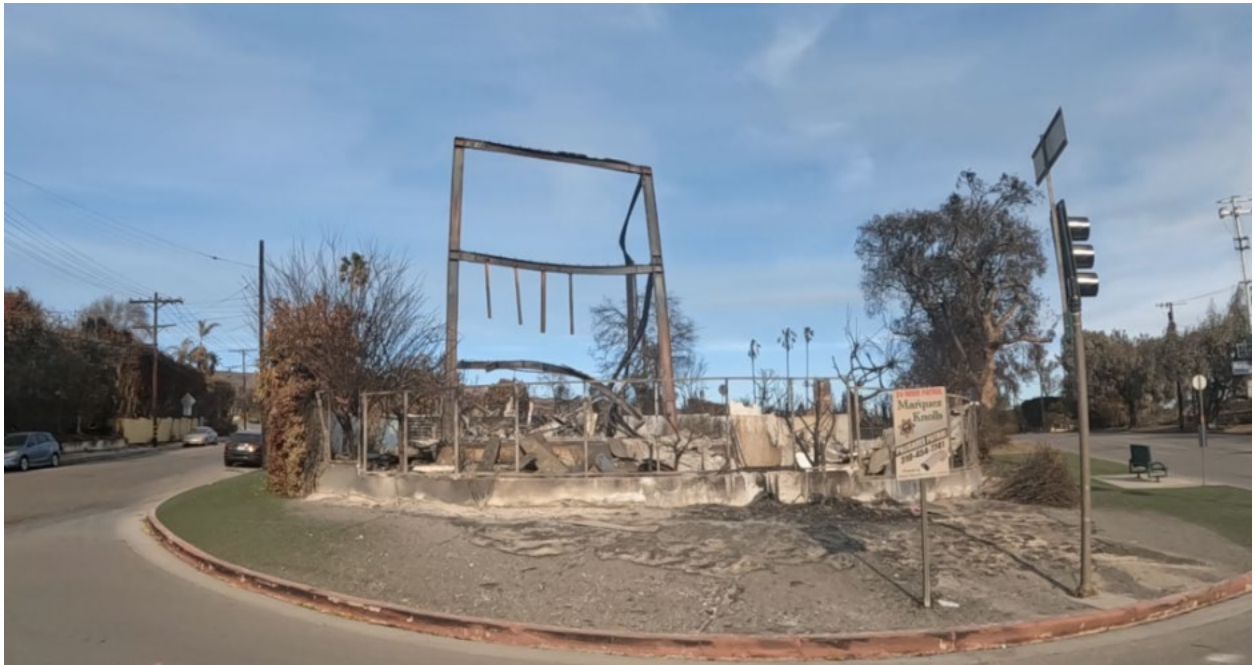
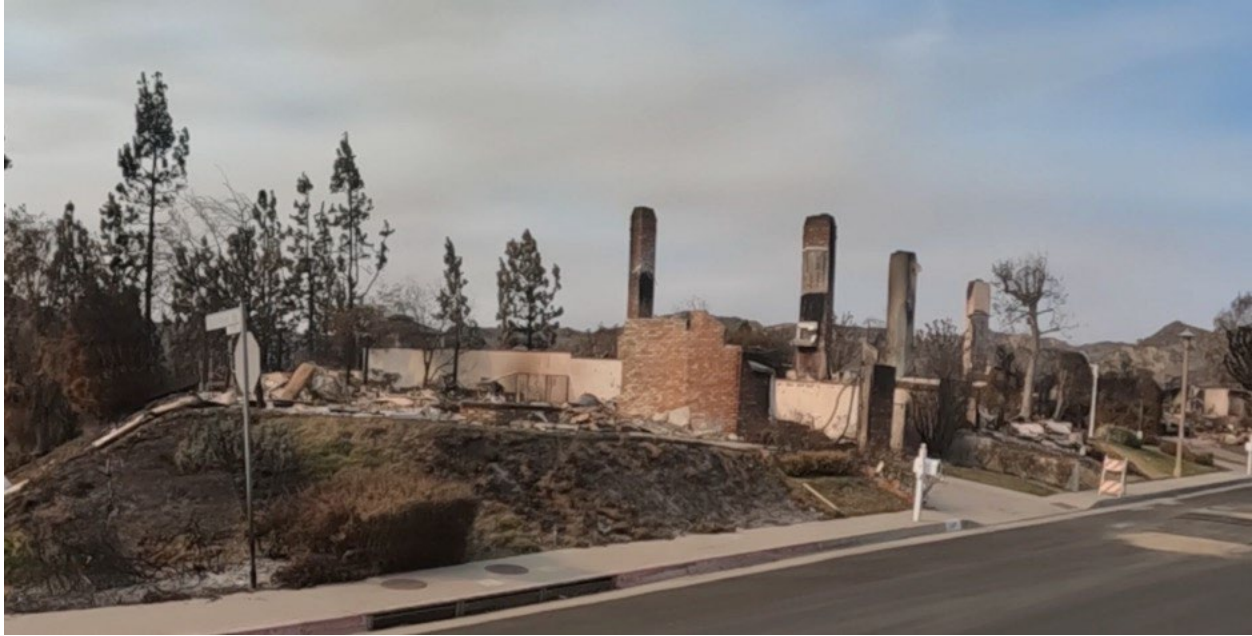
Widespread destruction to both coastal and hillside structures was observed. In several locations, most combustible materials—including wood framing, insulation, roofing, and interior contents—were completely consumed. In Fig. 2.60a, a coastal structure along the Pacific Coast Highway has been reduced to its steel frame, while nearby slope-side infrastructure, such as utility poles, also shows signs of damage. Debris from the burned structure and adjacent hillside is scattered near the road, where barriers have been placed. Fig. 2.60b shows another structure with only a steel skeleton remaining—no cladding or roofing remains, and the frame exhibits signs of heat deformation, indicating prolonged exposure to intense fire. In Fig. 2.60c, remnants of multiple residential buildings show only vertical masonry elements such as chimneys and partial wall sections still standing, highlighting the vulnerability of timber-framed construction in high-intensity wildfire zones.

Fig. 2.60: Structural damage in Pacific Palisades. a) Coastal structure along Pacific Coast Highway reduced to a steel frame, with nearby utility infrastructure impacted and debris scattered near the slope. (b) Freestanding steel skeleton remains of a building, with all combustible materials consumed by intense fire. (c) Burned residential neighborhood showing only masonry chimneys and partial walls left standing amidst widespread structural loss.

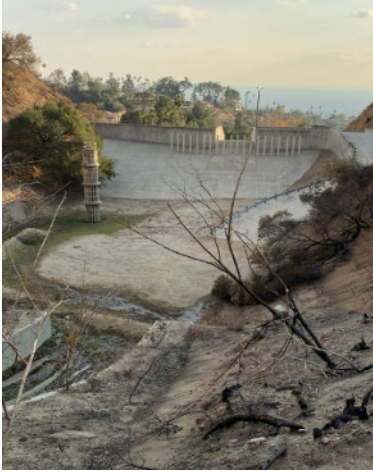
<p>Debris Basin - typically composed of a drainage standpipe and an emergency spillway with debris barrier. Typically designed to accommodate the Design Debris Event. Photos is of the Kinneloa West debris basin. (34.1835°; -118.0858°)</p>

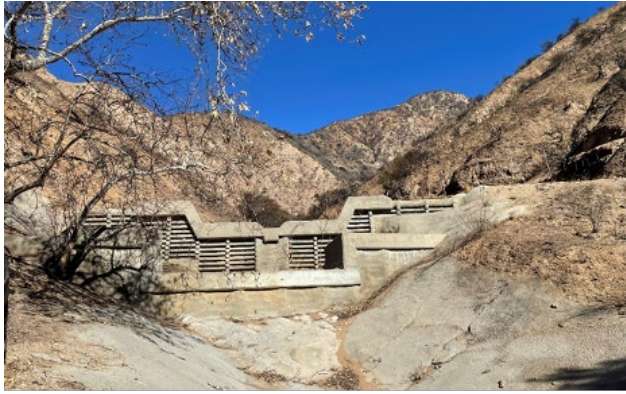
<p>Crib Dam Structure - intended to trap sediment, reduce channel gradient, and promote deposition upstream. Note intended to contain the Design Debris Event. (34.19831°; -118.11786°)</p>

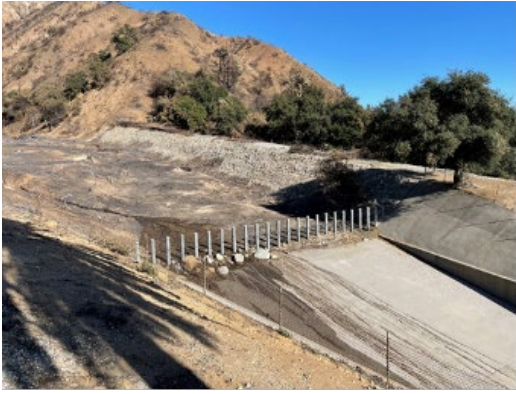
<p>Debris Barrier - typically used to trap large material composed of boulders and woody debris while allowing fine-grained material to pass. (34.17586°; -118.07206°)</p>

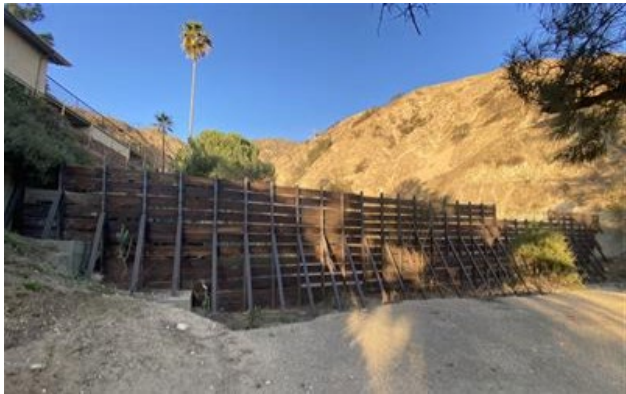
<p>Rail and Timber Structure - intended to trap sediment and debris while allowing water to pass. Not designed to contain the Design Debris Event. (34.19588°; -118.11459°)</p>

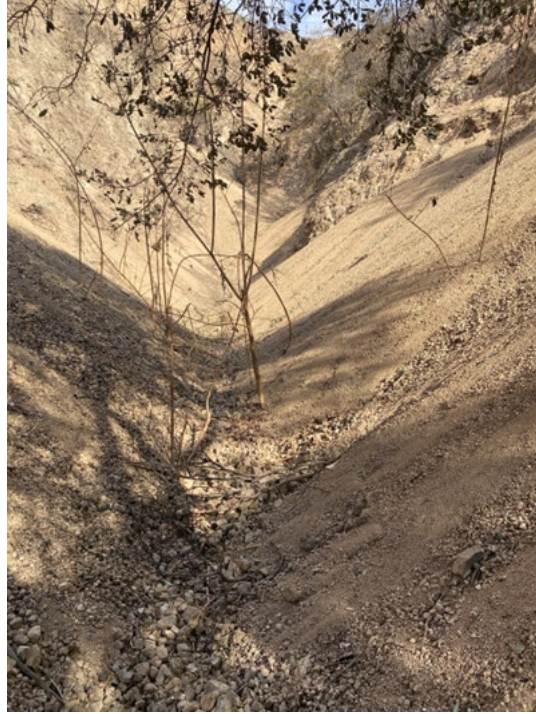
Dry raveling immediately following the Eaton fire was observed throughout the burn area. Ravel cones were observed infilling low order channels with up to several meters of mostly coarse, cohesionless sand material (Fig. 3.9). Due to the mostly granitic bedrock underlying the Eaton Fire and the corresponding supply of friable sand-rich material, the presence of dry ravel, both spatially and volumetrically, appeared greater in the Eaton Fire compared to the Palisades Fire.

Fig. 3.9. Typical post-fire dry-ravel deposit within first order drainage. Date 1-17-2025. (34.19523°, -118.11264°).

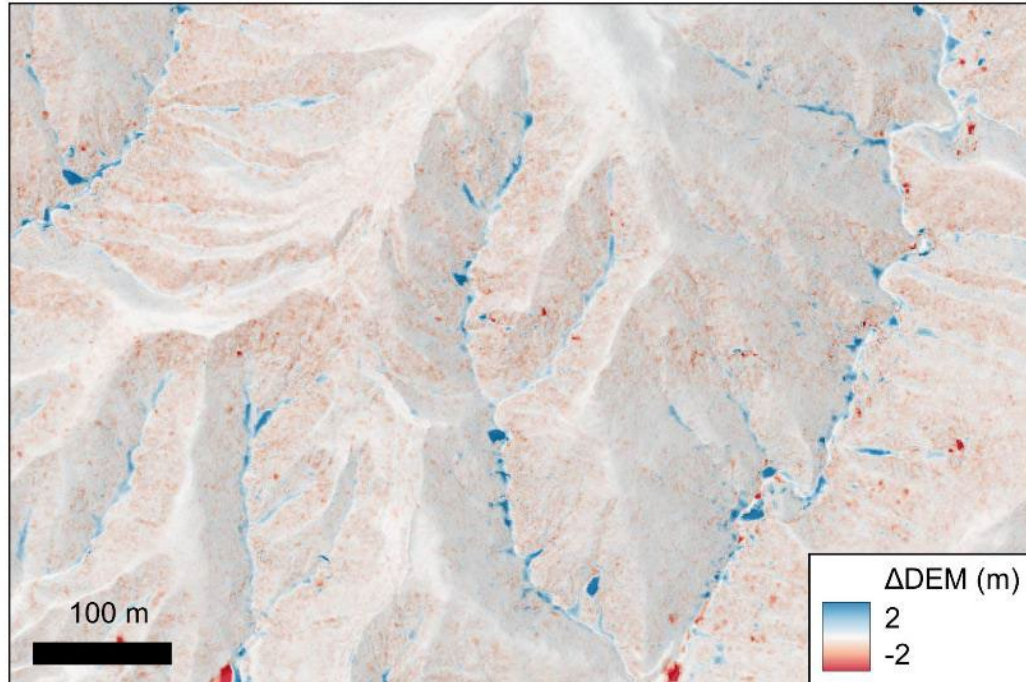
Using two Digital Elevation Models (DEMs) surveyed before (2016) and after the fire (January 22, 2025) with a spatial resolution of 1 m per pixel, Brigham et al. (2025) calculated a differential Digital Elevation Model (dDEM, Fig. 3.10). The resulting dDEM highlights areas with decreased elevation caused by erosion (red), and the ravel sediment deposits (blue).

Fig. 3.10. Digital elevation map differences (dDEM) in and immediately west of Bailey Canyon from airborne lidar DEM difference from 2016 to January 22, 2025, before and after the Eaton Fire (data from Brigham et al., 2025). Note that 0-2 m of postfire dry ravel was deposited in the channels.

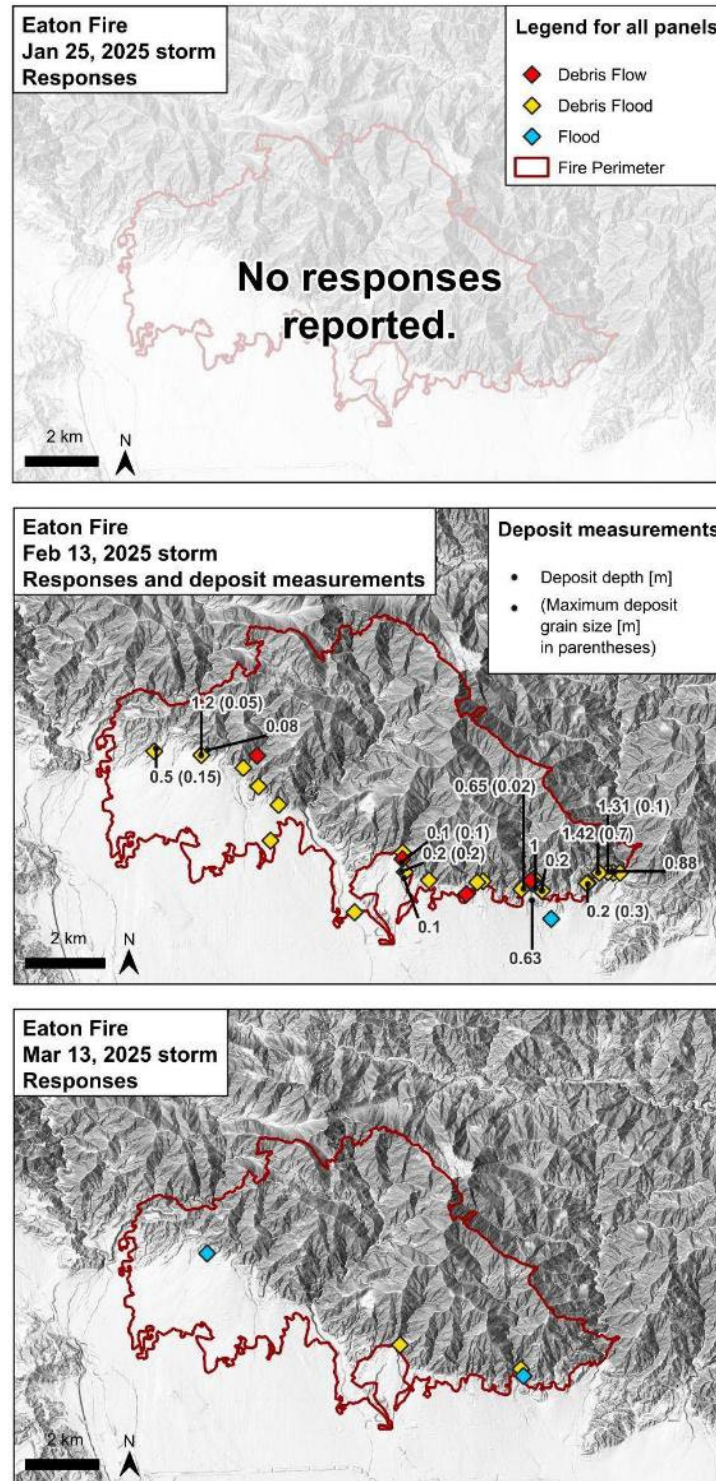
Fig. 3.12. Observed flow responses at the Eaton Fire for the January 25, February 13, and March 13 storms. Points are colored by flow type and located at the basin outlet where the observation was made. The February 13 response map also includes several measurements of deposit depth and maximum grain size observed in the deposit.

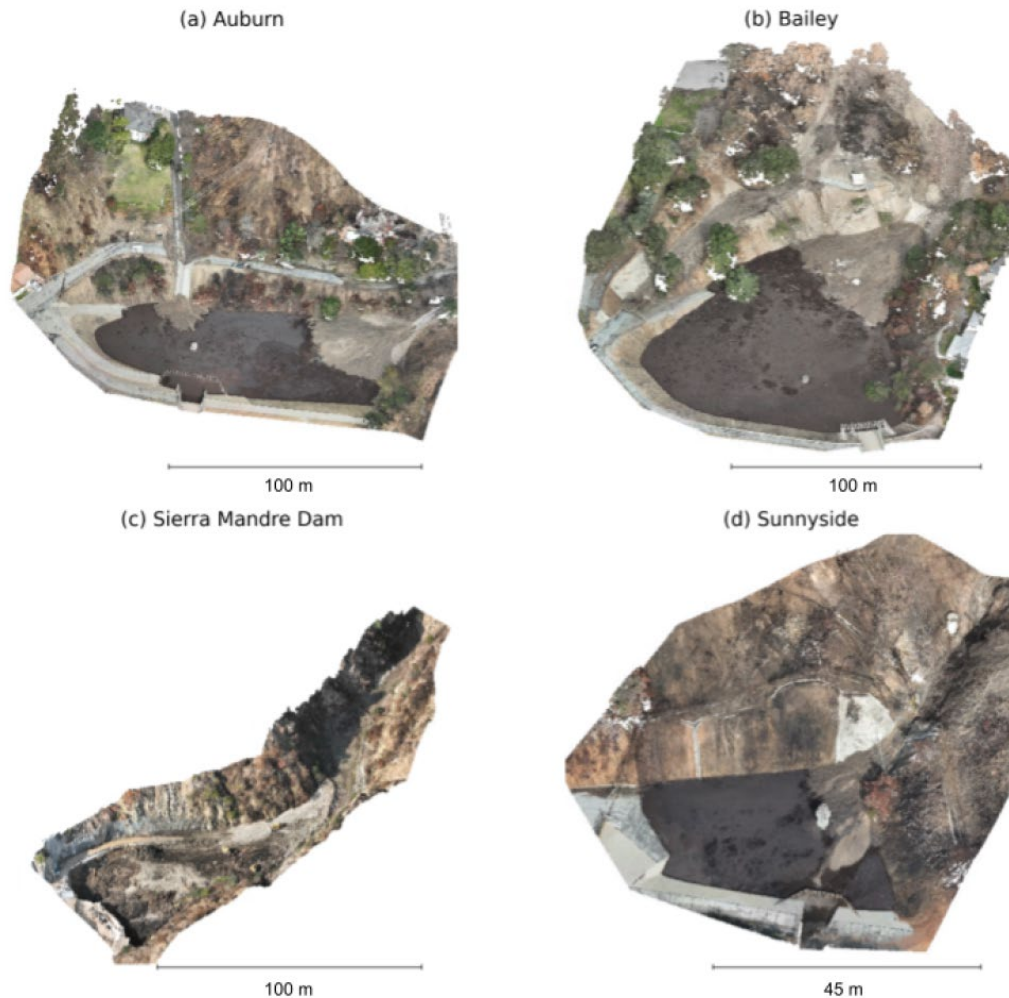
Fig. 3.13. Example point clouds from UAV lidar surveys of debris basins: Auburn, Bailey, Sierra Madre Dam and Sunnyside.

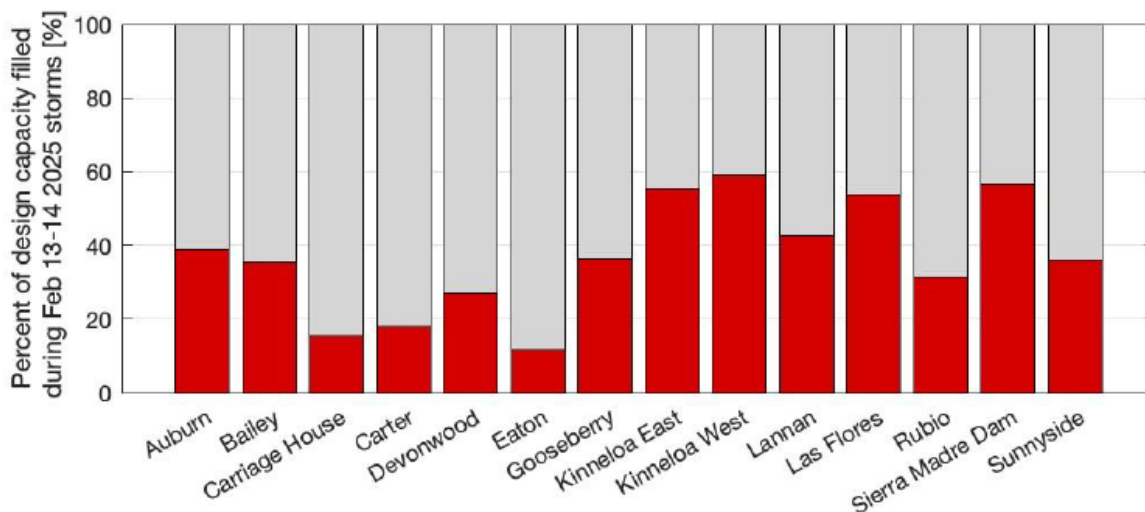
For some basins, repeat surveys were conducted following a single storm to assess if significant dewatering had occurred (i.e., to better measure debris volumes vs. water volumes). We found that the Feb 13-15, 2025 storm event delivered approximately 480,000 cubic yards of debris to the 14 surveyed basins, filling the basins to amounts ranging from 12 to 59% of their design capacities (Fig. 3.14). Preliminary results description and data from this study can be found in Chen et al. (2025) [see “data_description.pdf” therein for a summary report”].

Fig. 3.14. Measured debris volumes delivered to each basin during the Feb. 13-14 storm event, plotted as a percent of each basin’s total design capacity.

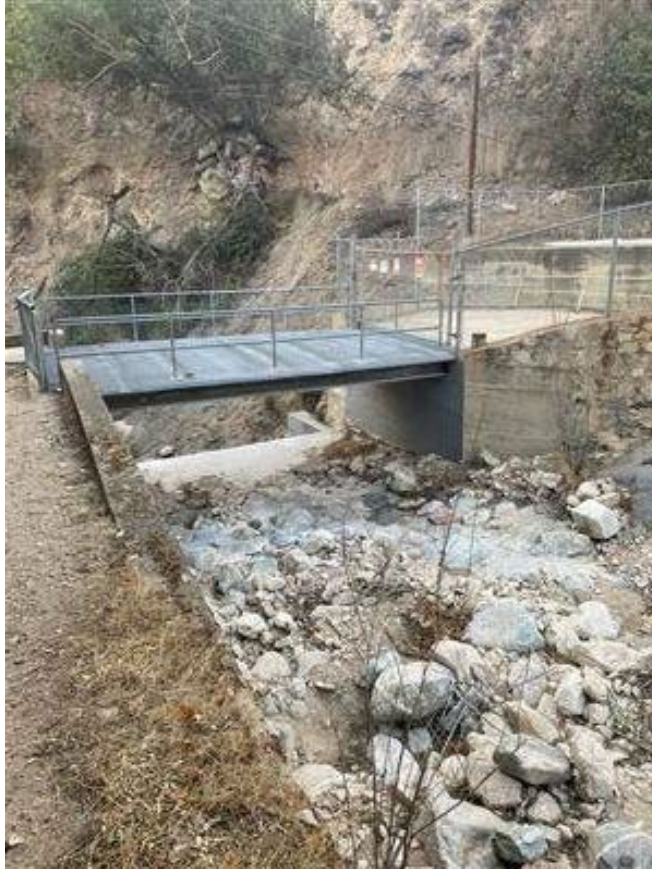
Damage to Kinneloa Irrigation District water supply lines and infrastructure was observed including, damaged well heads, fencing and access roads, was observed in several locations, such as in Pasadena Glen and Rubio Canyon (Fig. 3.15-3.17).

Fig. 3.15. A bridge across Rubio Canyon that accesses a Kinneloa Irrigation District well head. (1/18/25, 34.18385°, 118.12288°).

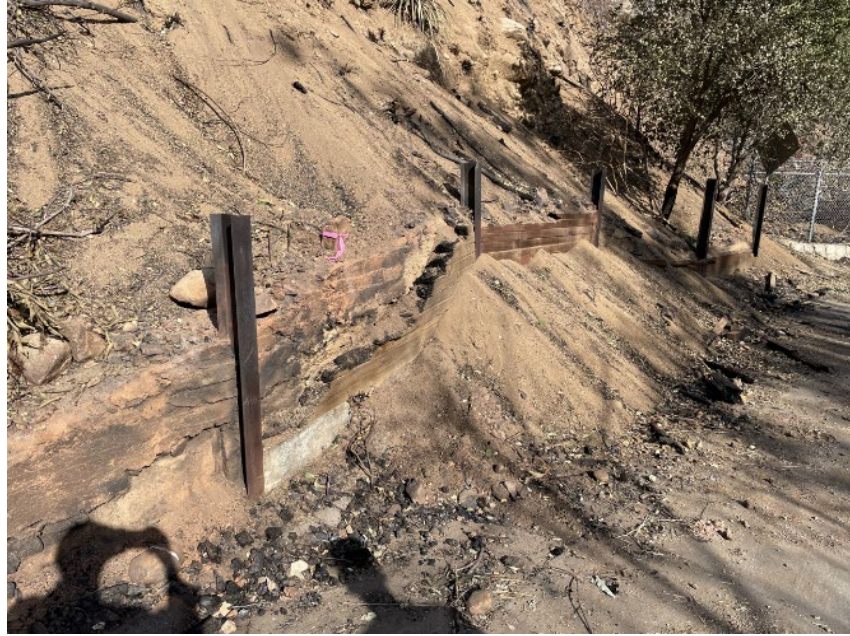
(a)

Similar to the Palisades Fire, several forms of retention or drainage structures were damaged by the Eaton Fire, which may reduce their effectiveness. Burnt soldier pile retaining walls were observed across the fire at the foot of natural slopes (Fig. 3.18a), below roadways (Fig. 3.18b), and along a channel adjacent to a residential property (Fig. 3.18c).

Fig. 3.18. Evidence of burnt soldier pile retaining walls at the Eaton Fire a) at the foot of a natural slope, b) below a roadway, and c) adjacent to a residential property. (Top: 34.176998°, -118.019583°; lower left: 34.176234°, -118.030142°; lower right: 34.194497°, -118.112748°)
