Reconnaissance of the Geotechnical and Infrastructure Impacts of Los Angeles Area Wildfires and Subsequent Storms

A report of the NSF-Sponsored Geotechnical Extreme Event Reconnaissance Association

Report GEER-085: <https://doi.org/10.18118/G6X37N>

June 13, 2025

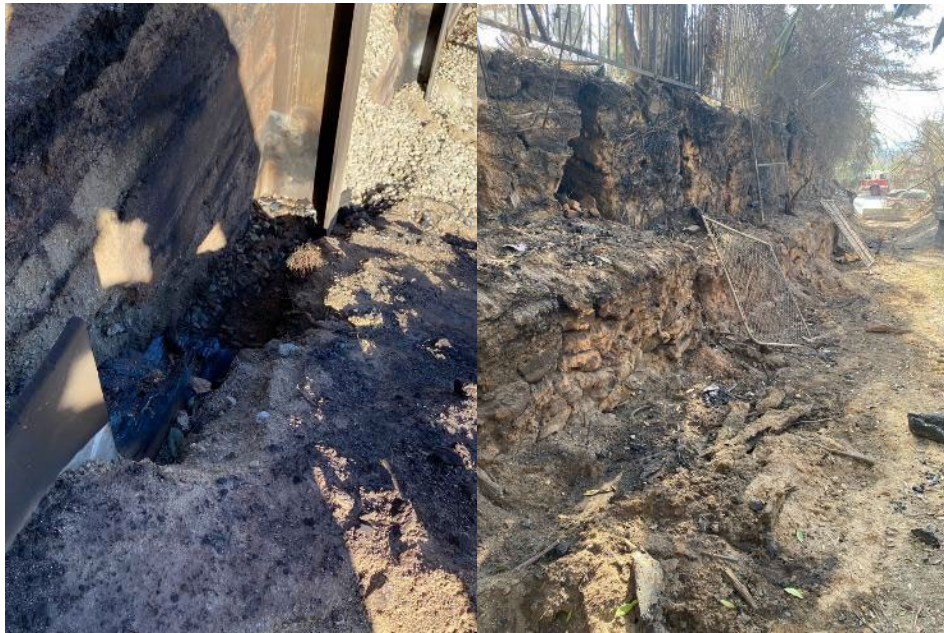
(b)

Similar to the Palisades Fire, several forms of retention or drainage structures were damaged by the Eaton Fire, which may reduce their effectiveness. Burnt soldier pile retaining walls were observed across the fire at the foot of natural slopes (Fig. 3.18a), below roadways (Fig. 3.18b), and along a channel adjacent to a residential property (Fig. 3.18c).

Fig. 3.18. Evidence of burnt soldier pile retaining walls at the Eaton Fire a) at the foot of a natural slope, b) below a roadway, and c) adjacent to a residential property. (Top: 34.176998°, -118.019583°; lower left: 34.176234°, -118.030142°; lower right: 34.194497°, -118.112748°)

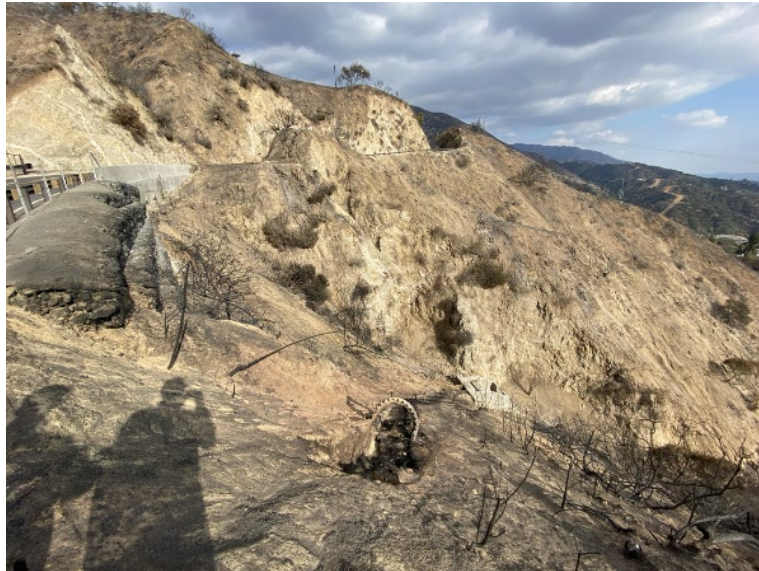
Along Santa Anita Canyon Road, a plastic culvert running under the road and into a steep channel below the road had fully melted, leaving an unlined tunnel of exposed soil below the road (Fig. 3.19a). At this same location, heat from the burning culvert and surrounding fire was directed through the culvert and out of the upstream end, causing substantial spalling of the concrete

Fig. 3.19. (a) Melted culvert and (b) subsequent spalling of concrete debris retention structure along Santa Anita Canyon Rd. (34.177282°, -118.029274°).

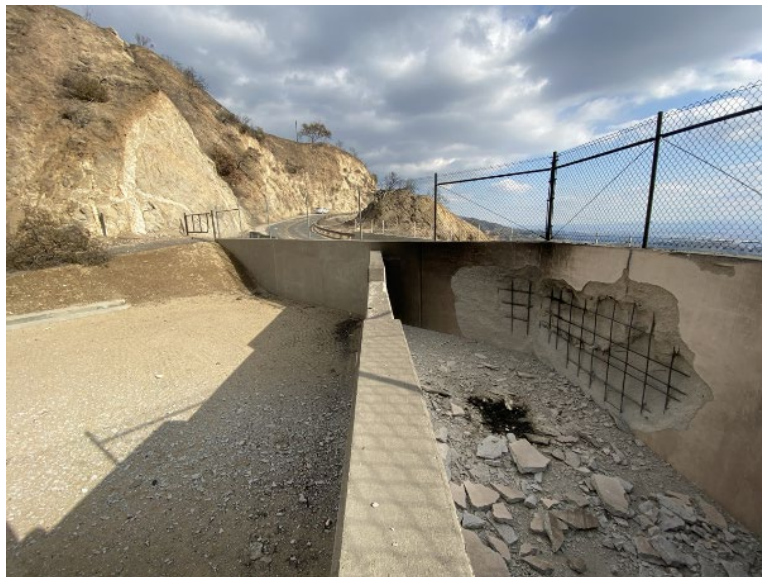
(b)

debris retention structure. The quantity of spalled material was enough to almost completely block the drain grate (Fig. 3.19b), potentially reducing the flow capacity of the culvert.

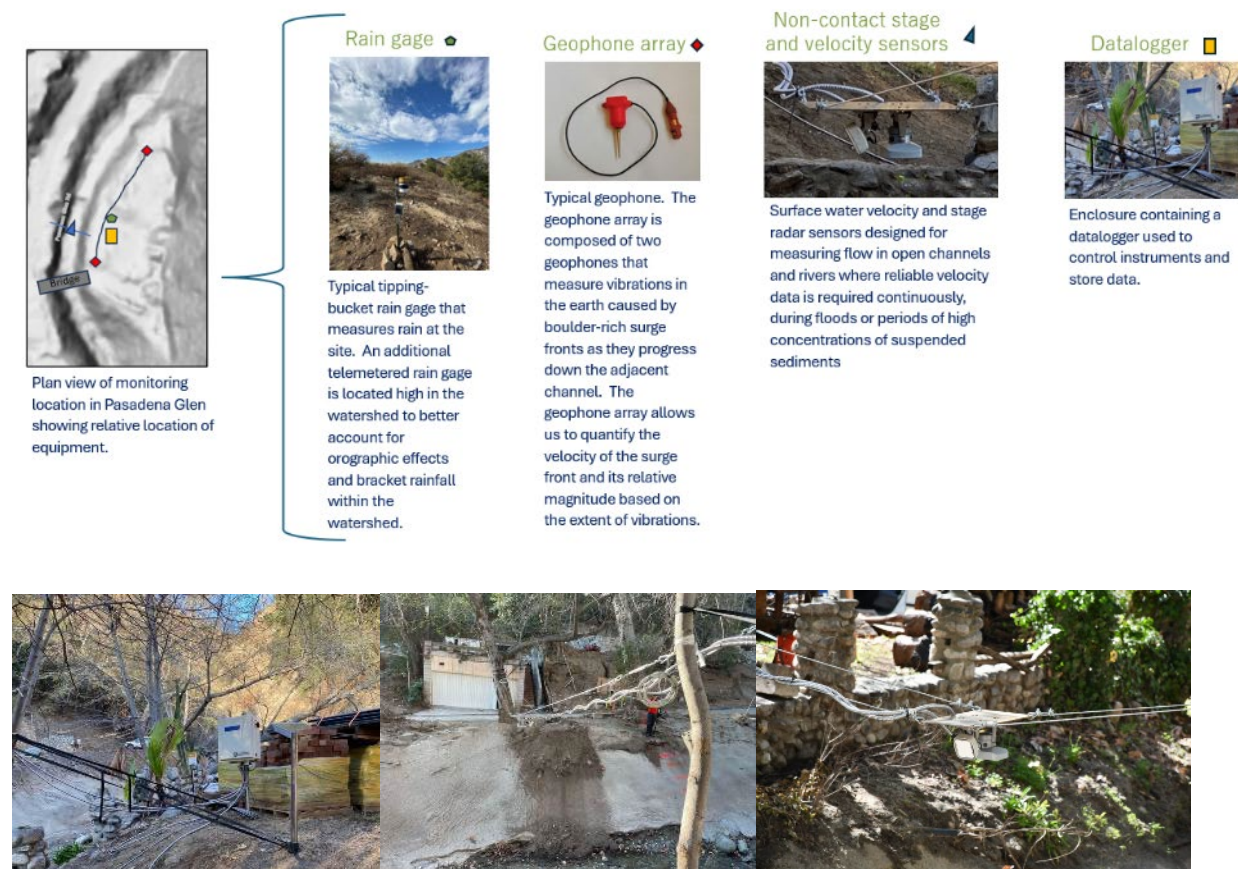
One telemetered rain gauge and three debris flow monitoring stations were installed for the Eaton Fire (locations provided in Fig. 1.4). These instruments will continuously record data over the duration of the study, capturing real-time information on ground movement, precipitation patterns, and flow events, similar to installations deployed by the USGS (Rengers et al. 2023, Fig. 2.61). The main monitoring site at Pasadena Glen (Fig. 3.20), operated by CGS consists of geophones, radar-based non-contact stream stage and velocity sensors, in-channel pressure transducers, camera, and tipping-bucket rain gauges at the outlet and headwaters of the basin. Another monitoring station at Stonehill operated by CGS and USGS consists of geophones, a non-contact stage sensor, video camera, and a tipping-bucket rain gauge. A video camera and tipping-bucket rain gauge were also installed at Rubio Canyon by USGS.

Fig. 3.20. Overview of equipment installed at the Pasadena Glen monitoring site.

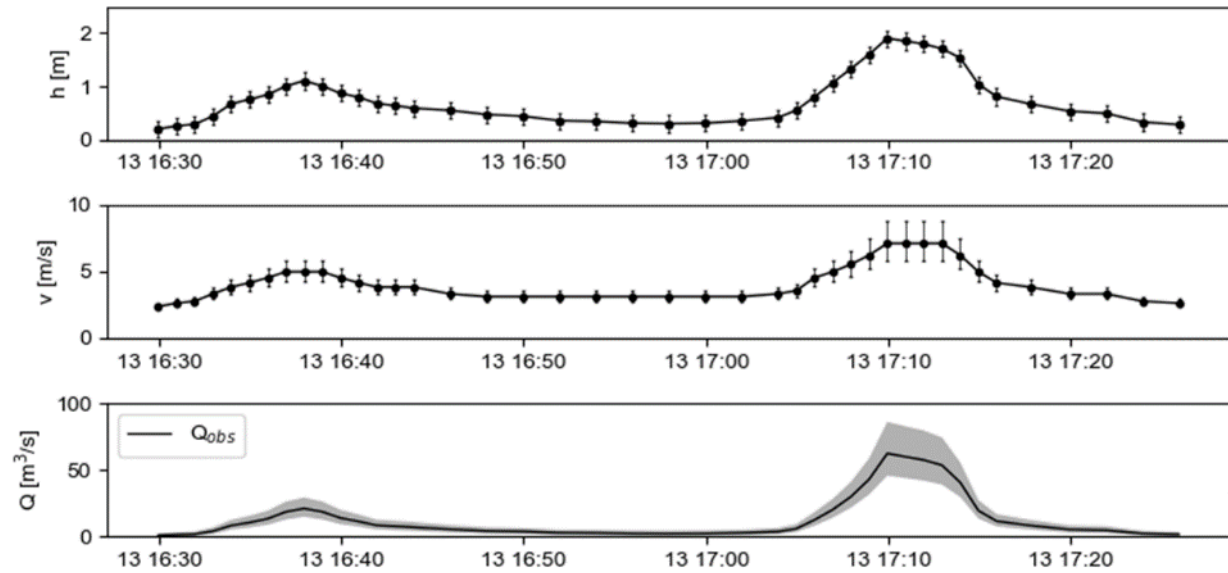
Because the equipment was installed the week of February 18, CGS estimated flow data for the February 13 storm using video analysis methods. At Pasadena Glen, several video cameras were installed by a resident and flow velocity and stage were estimated from the video, and a hydrograph (Fig. 3.21) was constructed based on the surveyed channel cross-section.

Fig. 3.21. Flow data (stream stage h , surface velocity v , and discharge Q) at Pasadena Glen during the peak of the February 13 flow event, estimated from video of channel.

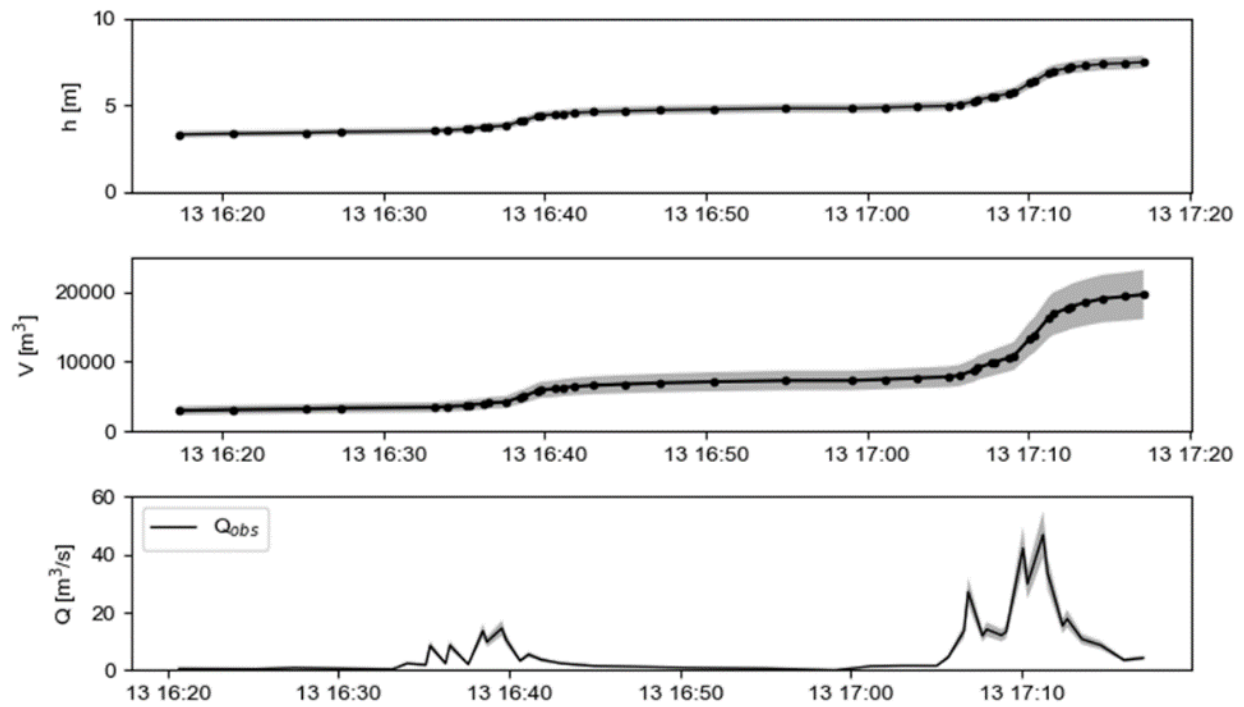
At the Bailey debris basin, a video camera installed by AlertCalifornia (<https://alertcalifornia.org/>) captured the rapid filling of the basin. The Bailey debris basin is composed of an earthen dam with a concrete-lined spillway and a vertical drainage standpipe. Assuming the standpipe was plugged during the runoff event, a hydrograph (Fig. 3.22) was constructed by estimating the elevation of the water surface through time, using this water surface elevation and the basin's hypsometry to estimate the stored volume in the basin, and computing the derivative of stored volume with respect to time to estimate discharge. The assumption that the drainage rate through the standpipe was negligible appeared reasonable, based on subsequent field observations indicating the presence of standing water remaining in the basin after flows entering the basin stopped and evidence in the video.

Fig. 3.22. Flow data (water surface elevation h , stored volume V , and discharge Q) at Bailey Canyon during the peak of the February 13 flow event, estimated from video of debris basin.

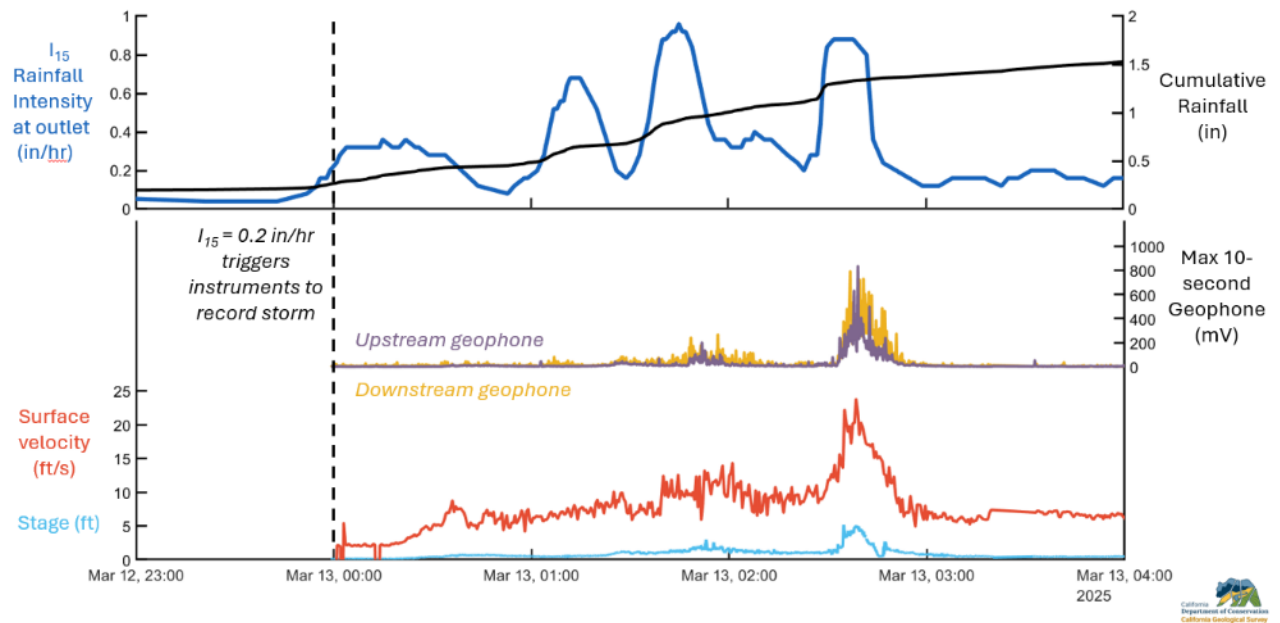
For the March 13 storm, data was directly measured at Pasadena Glen (Fig. 3.23) and Stonehill (Fig. 3.25) by the installed non-contact monitoring equipment. At Pasadena Glen, the equipment recorded rainfall, presented as cumulative rainfall and rainfall intensity over a 15-minute duration, seismic shaking (mV), stream stage, and stream surface water velocity (Fig. 3.23). To estimate discharge at different stream stages, the wetted cross-sectional area at each stage was multiplied by the average stream velocity at the same stage. The average stream velocity was approximated by multiplying the average surface water velocity recorded at the corresponding stage by 0.85 (Fig. 3.24).

Fig. 3.23. Raw rainfall, seismic shaking, and stream stage and velocity data at Pasadena Glen during the March 13 flow event, as measured by the equipment.

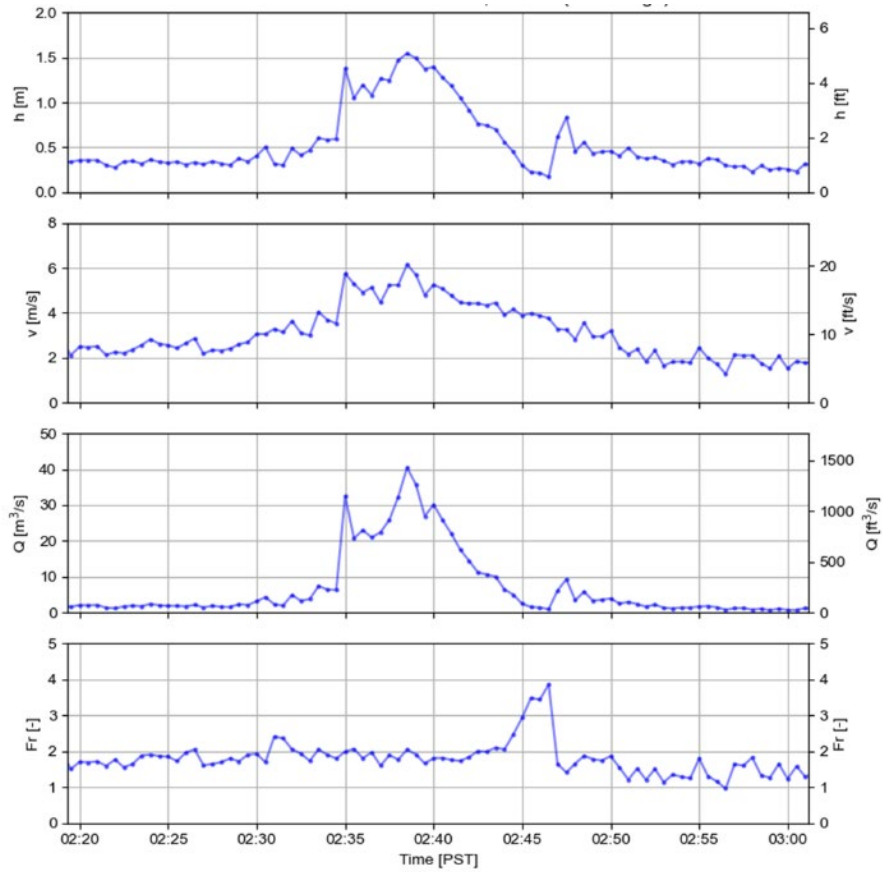
Fig. 3.24. Flow data (stream stage h , surface velocity v , discharge Q , and Froude number Fr) at Pasadena Glen during the peak of the March 13 flow event, as derived based on the channel wetted cross-sectional area and average flow velocity.

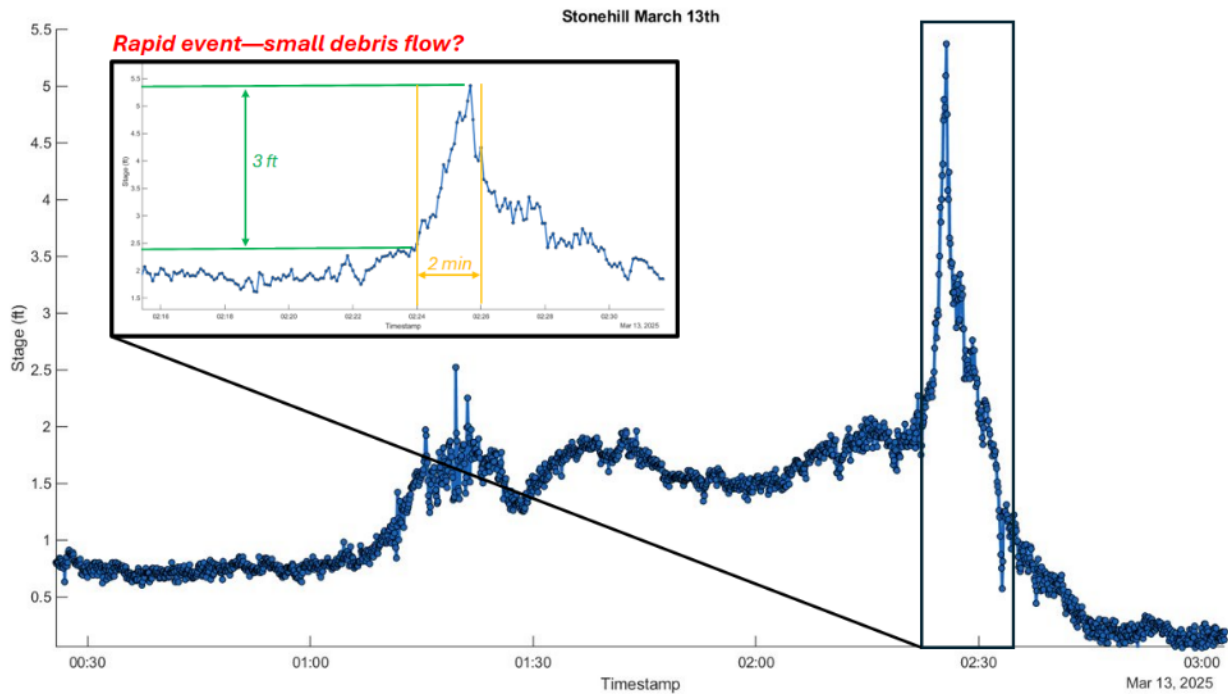
At Stonehill, the equipment recorded rainfall, seismic shaking (mV), and stream stage (Fig. 3.25). Stage data showed a rapid rise in flow over a short duration (Fig. 3.25), indicating the presence of a dilated flow front passing the monitoring station. This type of flow response is common in small to moderate-sized basins burned at moderate and high soil burn severity (Kean et al. 2011)

Fig. 3.25. Stream stage data at Stonehill during the March 13 flow event, as measured by the equipment.
