GEOTECHNICAL IMPACTS OF AUGUST 2018 FLOODS OF KERALA, INDIA

Event: August 2018

Geotechnical Extreme Events Reconnaissance
Turning Disaster into Knowledge
Sponsored by the National Science Foundation
GEER Association Report NO - 058

Date: 10-17-2018

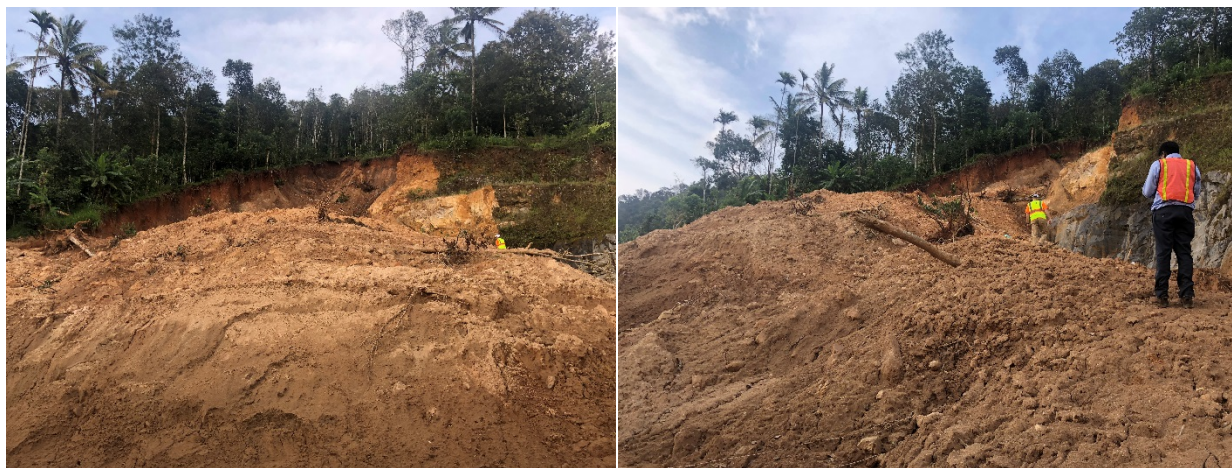
The Kattappana Landslide was encountered while in transit from the Idukki Landslide (Latitude=9.79655°, Longitude=77.0685°) to the collapsed house in Mavady (Latitude=9.8747°, Longitude=77.1194°). Time was limited on this site because the GEER team and Indian counterparts were expected to meet a news crew at the location of the collapsed house prior to sunset. The team was on site at this location for approximately 10 minutes from 4:40-4:50pm on the afternoon of September 6, 2018 (Figure 2.9). While onsite Dr. Coffman took several photographs from different vantage points. These photographs were used to develop a three-dimensional reconstruction of the landslide (Figure 2.10). It would have been nice to spend more time at this landslide because the landslide 1) occurred at a location of terracing, 2) appears to be the result of undercutting of the toe of the landslide and 3) failed along a predetermined failure plane that starts at the soil/rock interface that is shown in the photographs in Figure 2.9. As documented in a Twitter post shown in Figure 2.11 (ANI, 2018), the Kattappana Landslide blocked the Thodupuzha-Puliyamanmala roadway (also referred to as Highway 33 or National Highway 185) preventing traffic from Kumily to Idukki.

Figure 2.9: Photographs of the Kattappana Landslide located at (notice Dr. Coffman within the slide extents preparing to take photographs, Latitude=9.79655°, Longitude=77.0685°).

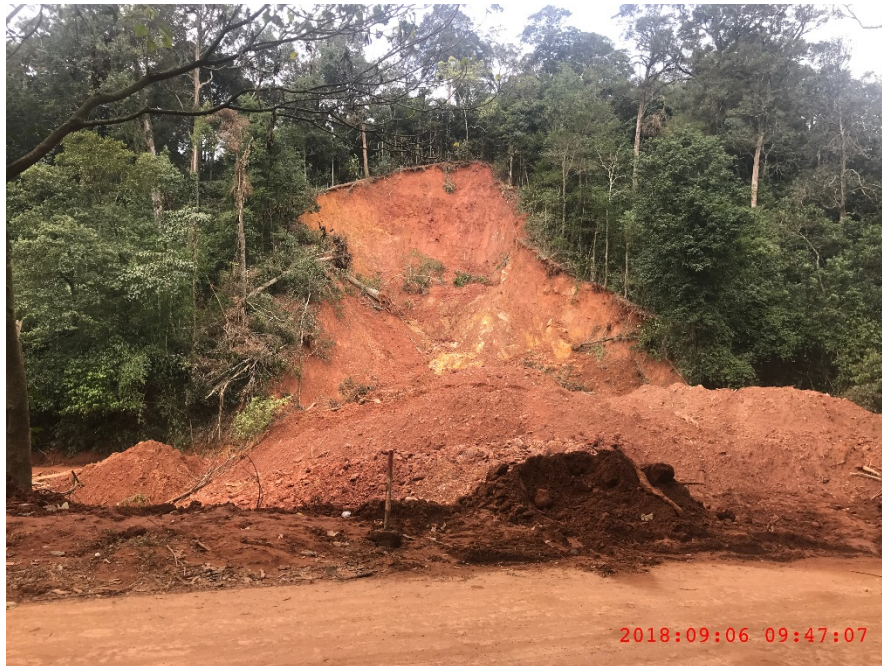
Figure A-1: Landslide that blocked the road @ 9.8263274° N 76.9197930° E

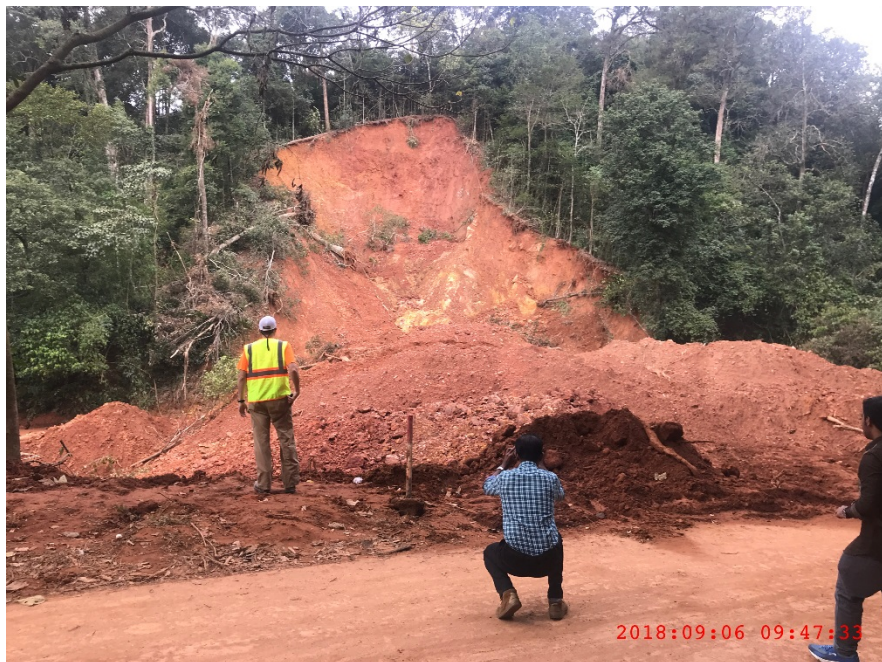
Figure A-2: Landslide that blocked the road @ 9.8263274° N 76.9197930° E

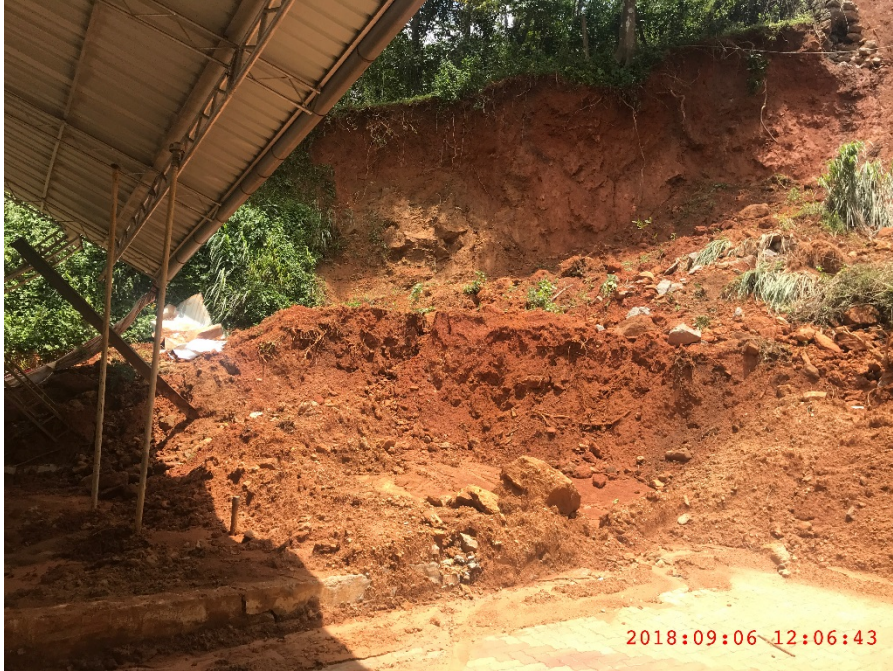
Figure A-3: Landslide near a gas station @ 9.8549653° N 76.9619187° E

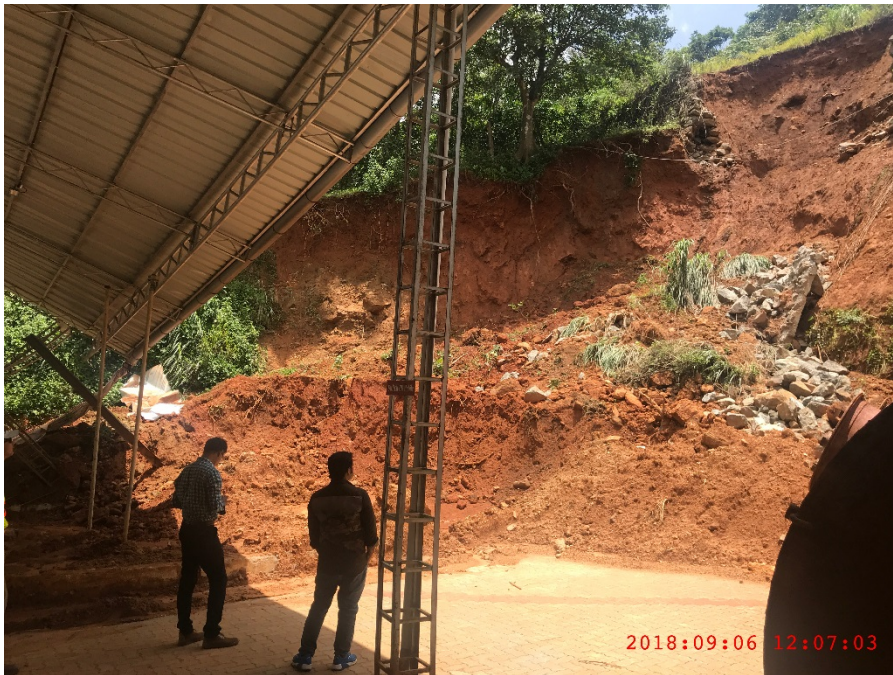
Figure A-4: Landslide near a gas station @ 9.8549653° N 76.9619187° E

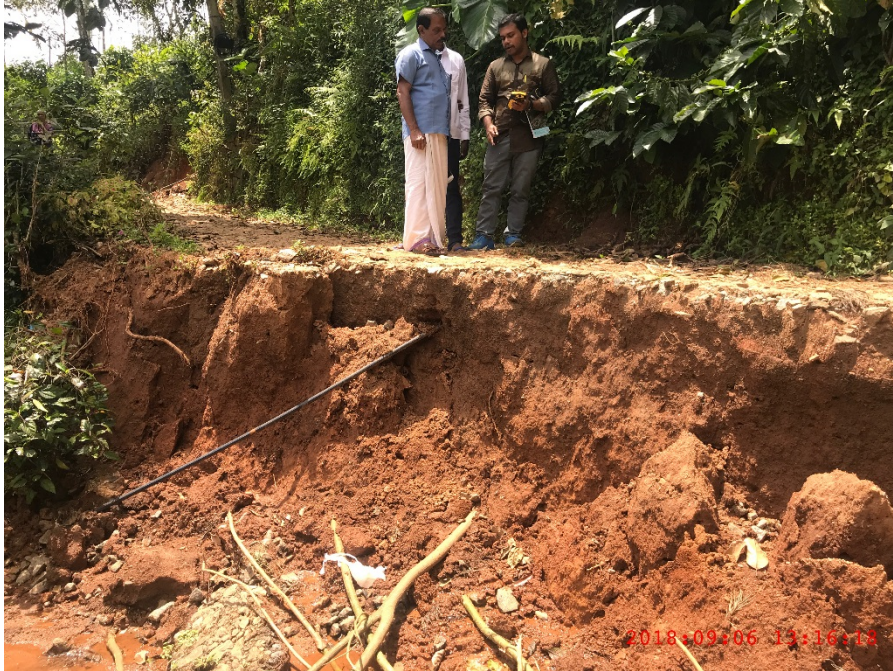
Figure A-5: Landslide scarp @ 9.7968694° N 77.0675658° E

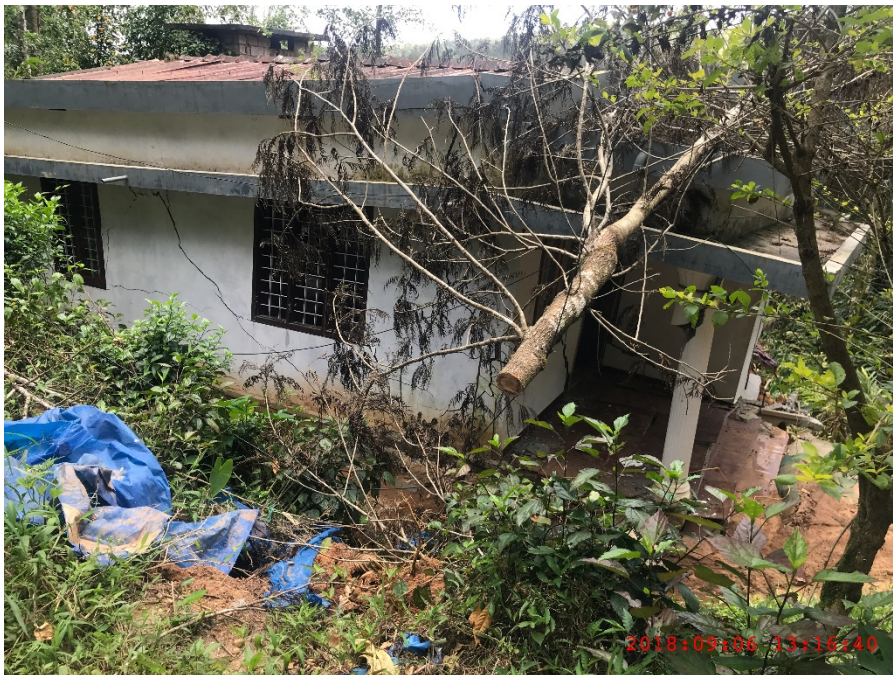
Figure A-6: House destroyed in the landslide @ 9.7968694° N 77.0675658° E

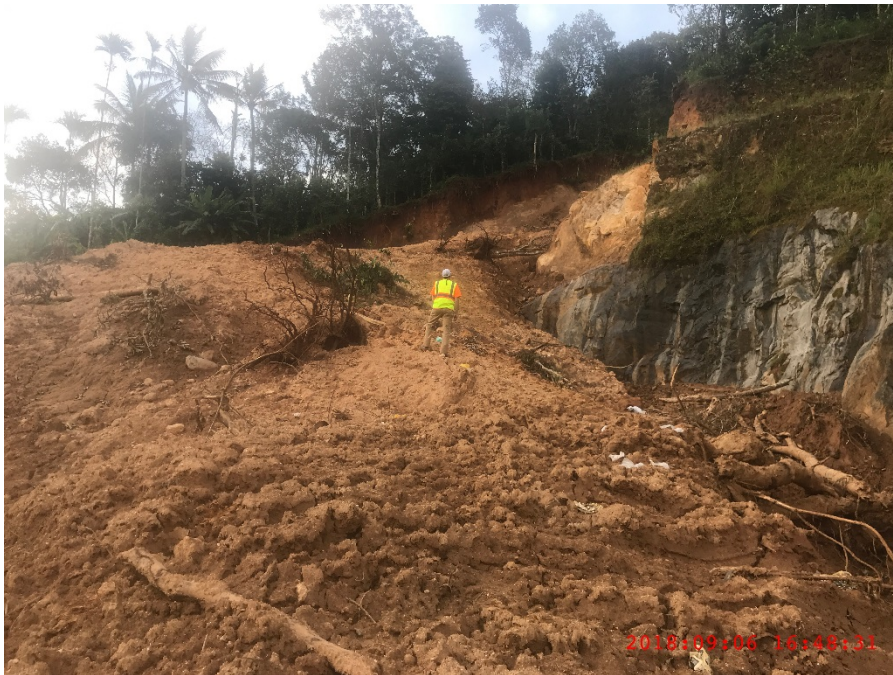
Figure A-14: Major landslide that buried a two storey building that was in construction @ 9.7644641^o N 77.1096940^o E

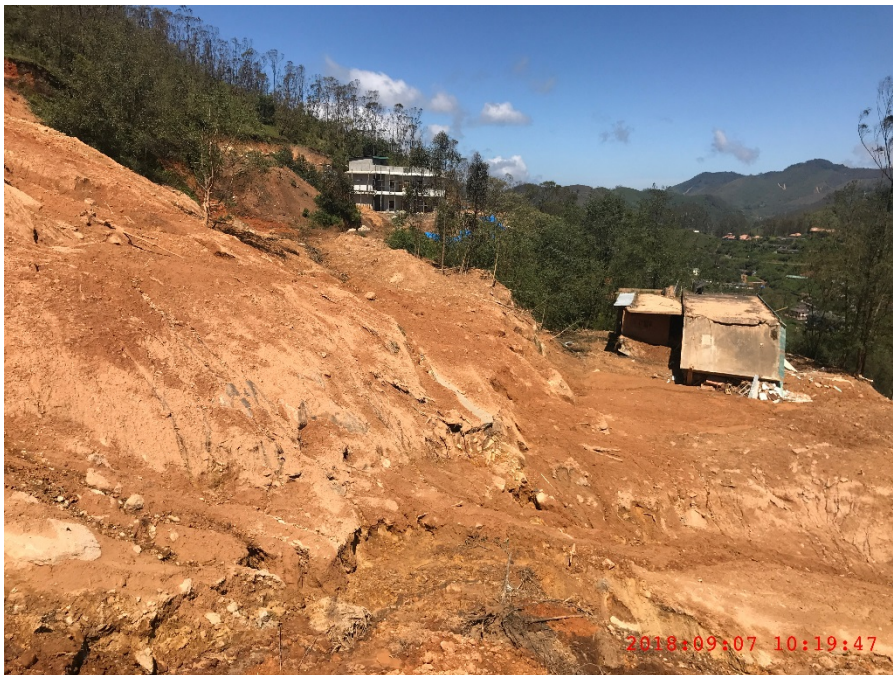
Figure A-17: Munnar college landslide showing the destroyed college building @ 10.0822577° N 77.0734317° E

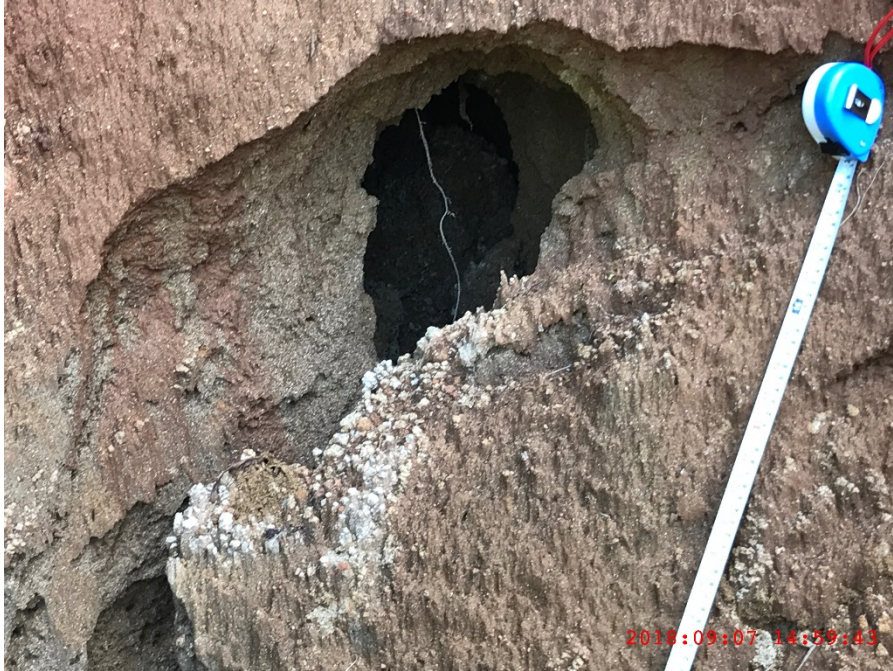
Figure A-20: Example of soil pipping @ 10.0088136° N 77.0257626° E

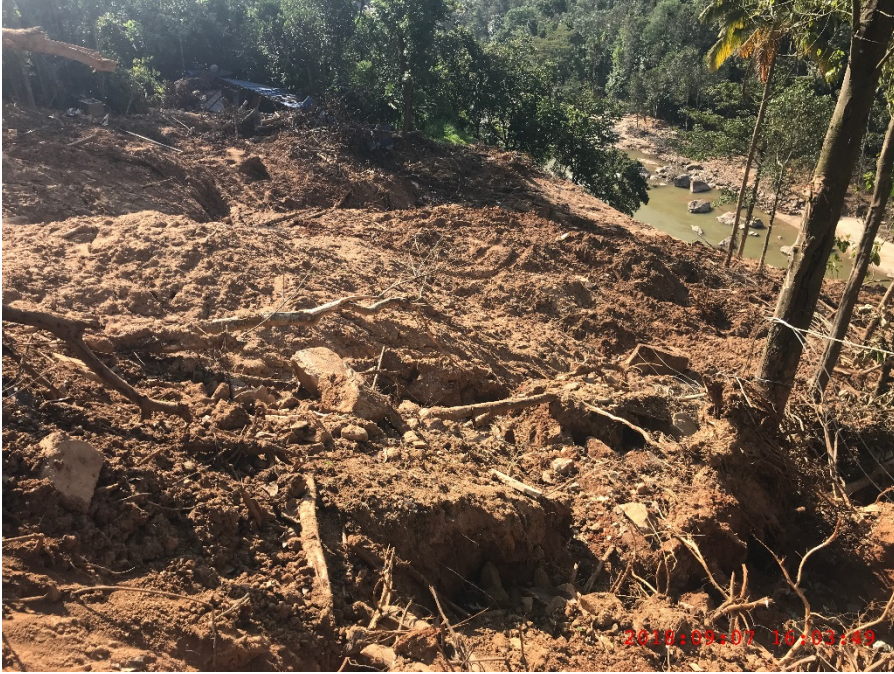
Figure A-25: Panniyarkutty landslide that destroyed three houses and killed five people @ 9.9749966° N 77.0429146° E

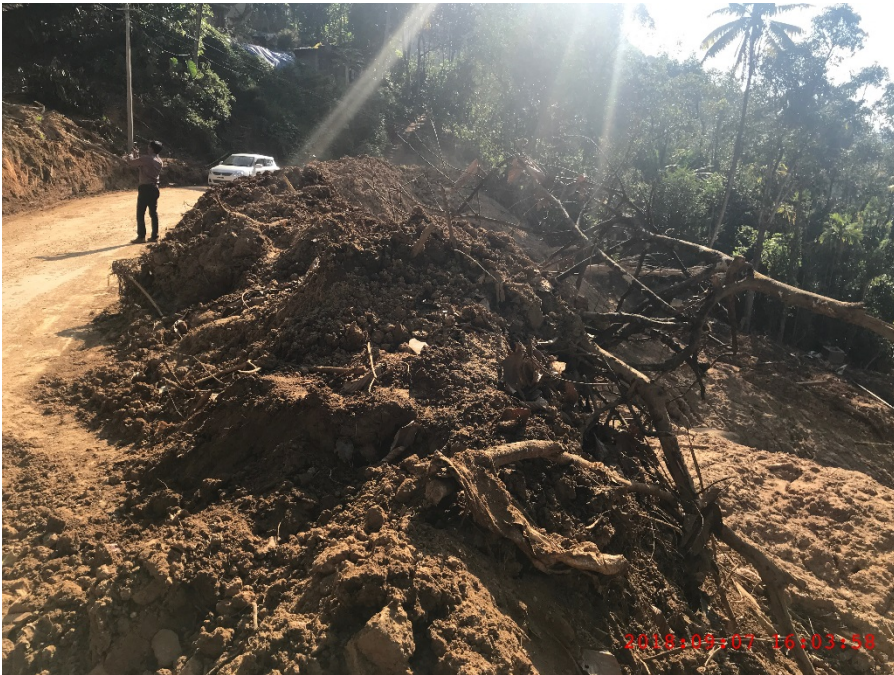
Figure A-26: Panniyarkutty landslide @ 9.9749966° N 77.0429146° E

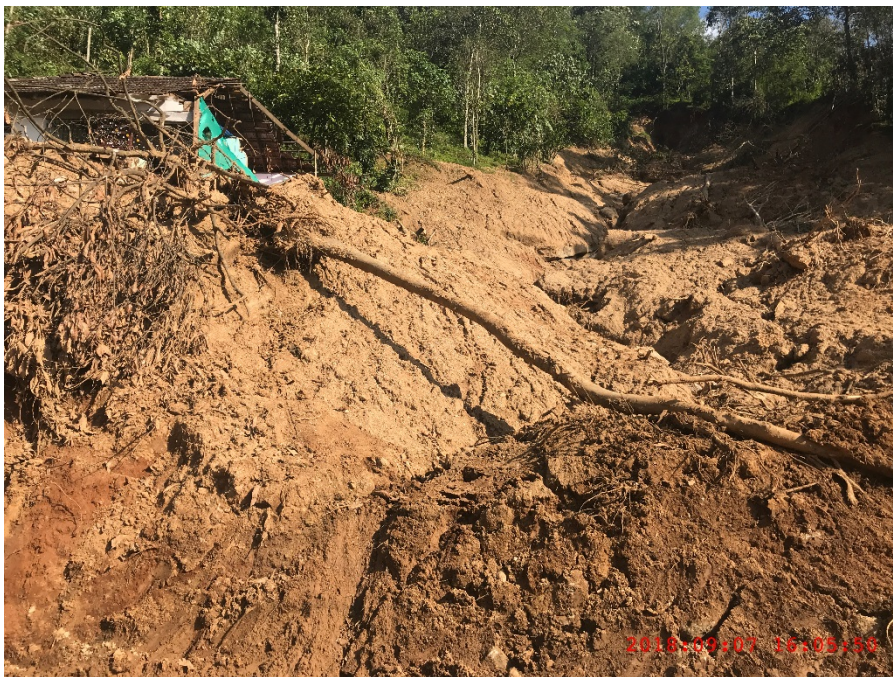
Figure A-28: Seen on the left is a house that has been destroyed in Panniyarkutty landslide @ 9.9748956° N 77.0427662° E

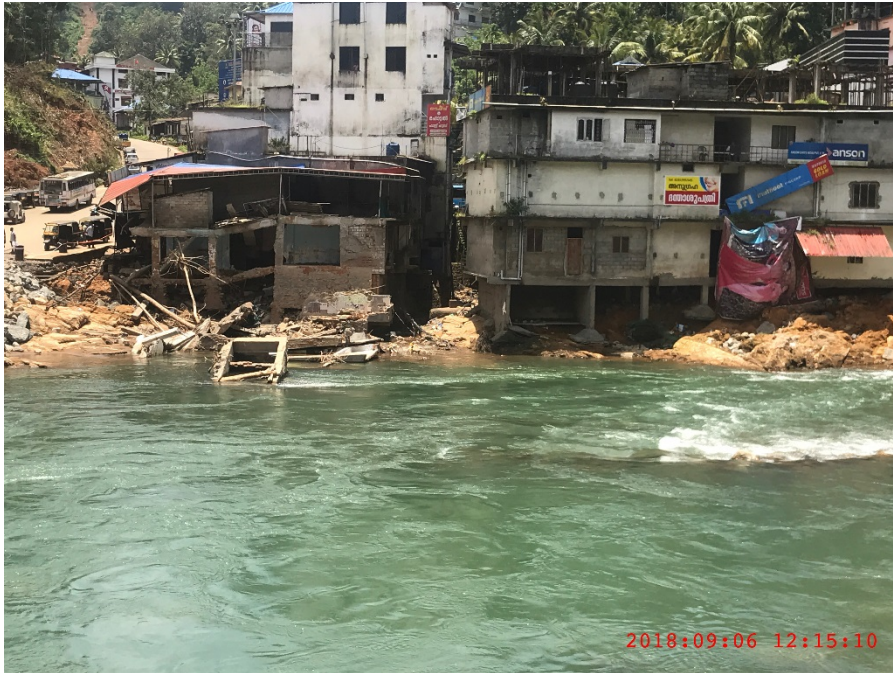
Figure B-2: River erosion @ 9.8575868° N 76.9636007° E

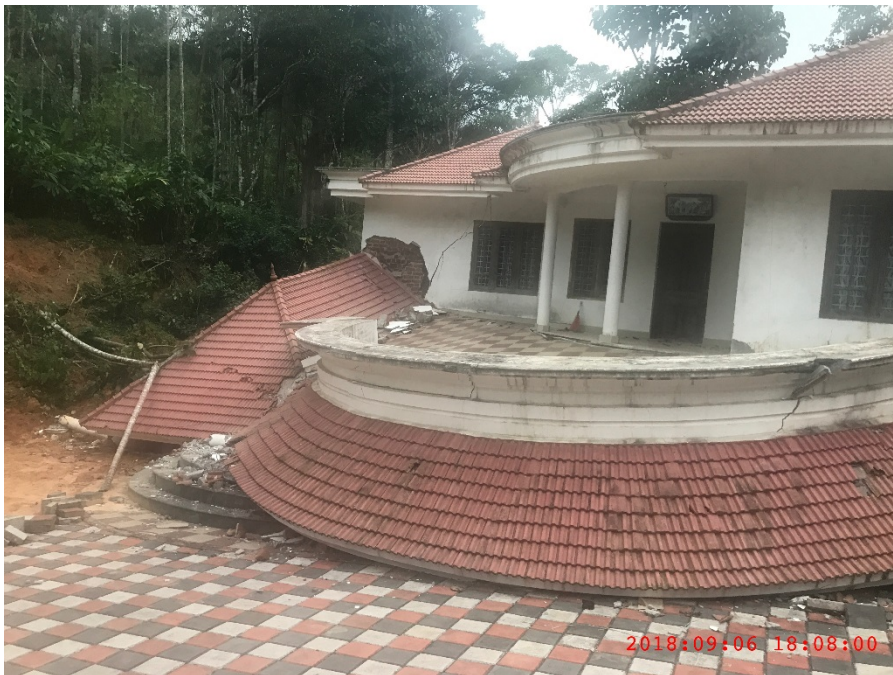
Figure C-5: Building destroyed due to ground movement. An entire floor has been subsided @ 9.8747156° N 77.1193791° E

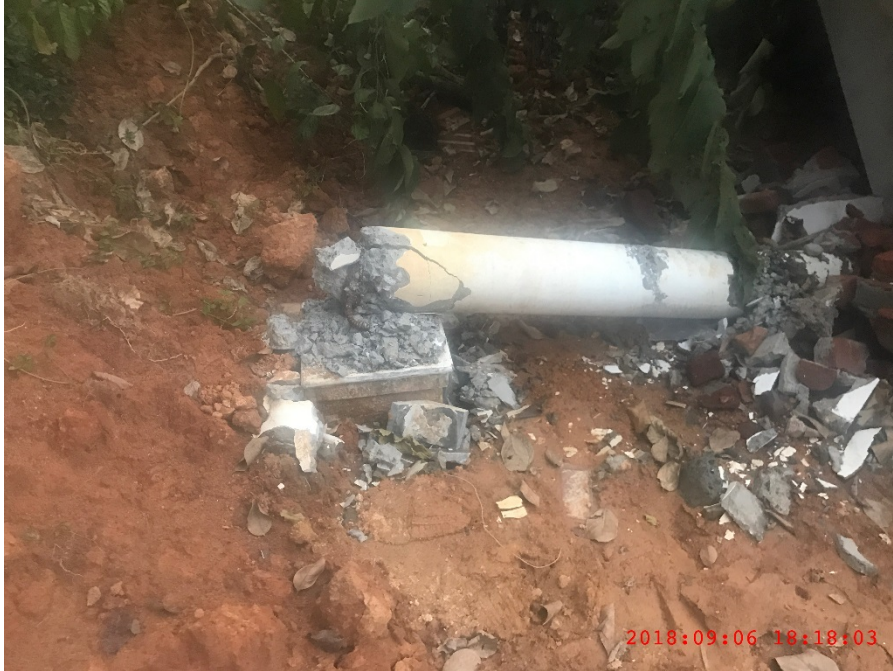
Figure C-6: Column of the building destroyed due to ground movement @ 9.8746397° N 77.1193175° E
