GEOTECHNICAL EXTREME EVENTS RECONNAISSANCE (GEER) ASSOCIATION

Geotechnical Aspects of the August 29, 2021, Hurricane Ida in LA, PA, NJ and NY

Report of the NSF Sponsored GEER and NEER Association Teams

GEER/NEER Association Report No. GEER-077

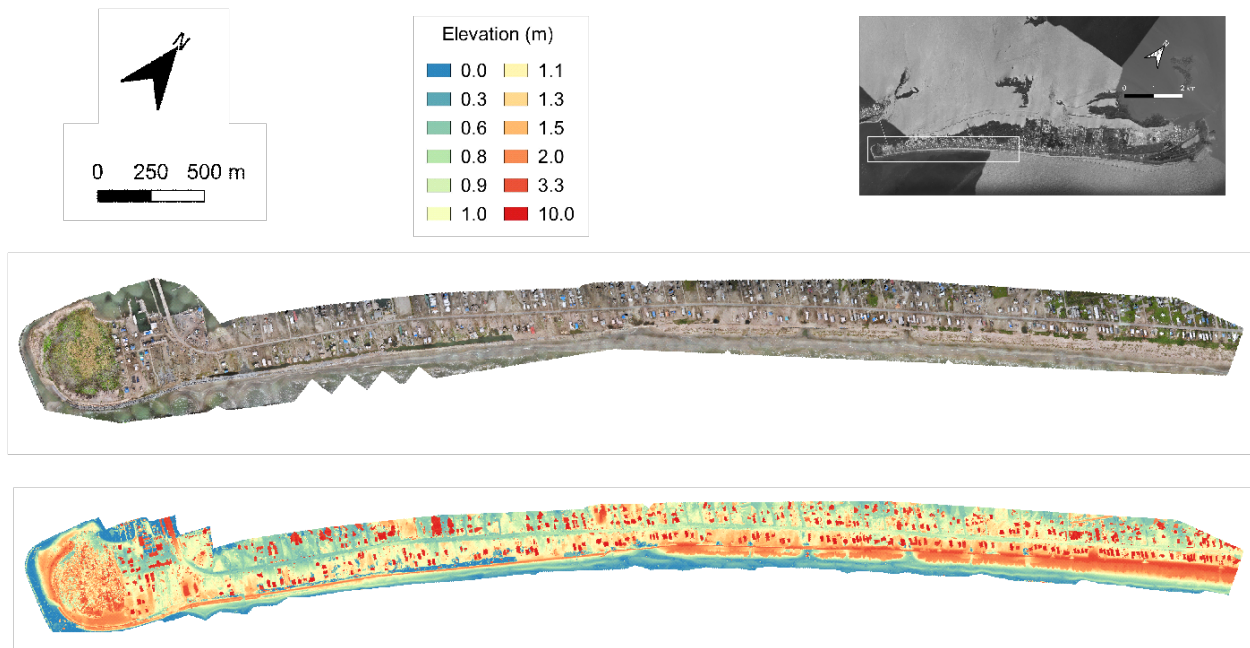
Figure 3.3. Ebee fixed wing drone imagery and digital elevation model (DEM) of the western half of Grand Isle. Drone imagery was supported by NHERI RAPID facility.

Figure 3.3 shows the Ebee fixed wing drone imagery of the western half of Grand Isle. The digital elevation model can be compared with aerial imagery from the Ebee. Several observations are evident from Figure 3.3. For example, the width of beach in front of the levee increases from west to east. Concomitantly, the degree of damage of the levee decreased in this direction. In sections along the western end, the geotube was exposed. There are two geotube designs present at Grand Isle, with one made of a geotextile tube where sand is pumped inside (Figure 3.4A) and another where compacted fine-grained sediment is encapsulated with a geotextile (Figure 3.4B). The clay geotube experienced significant damage across the western section of Grand Isle. Figure 3.4B shows how the geotextile was torn along the leeside. While the geotextile seam strength was overcome during the hurricane, the clay was not eroded.

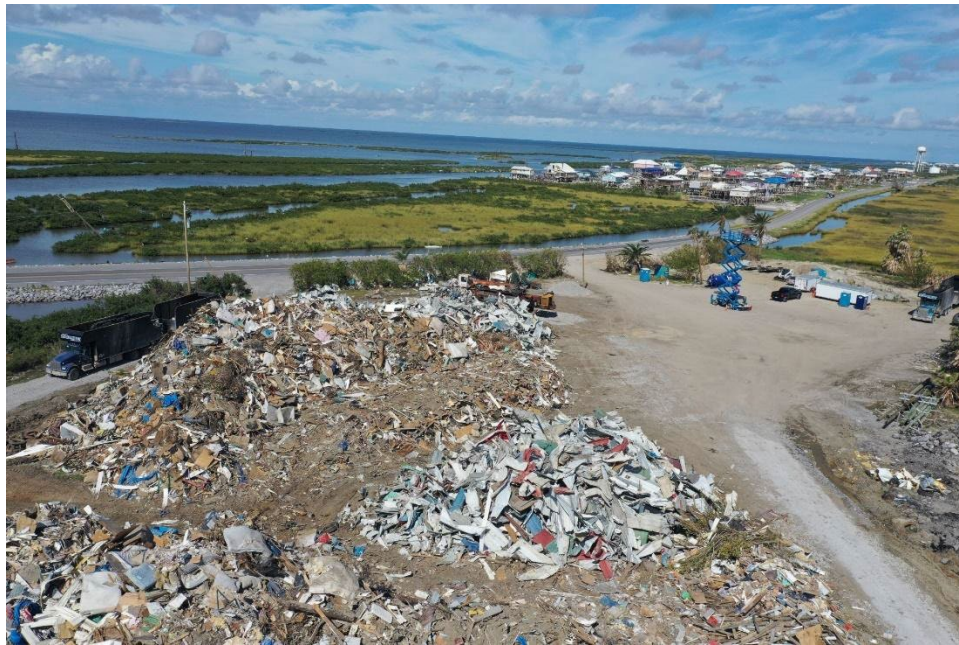
Figure 3.7. Drone image of disaster debris from Grand Isle (29.1892583, -90.0818028). (Photo: J. Bekkaye).

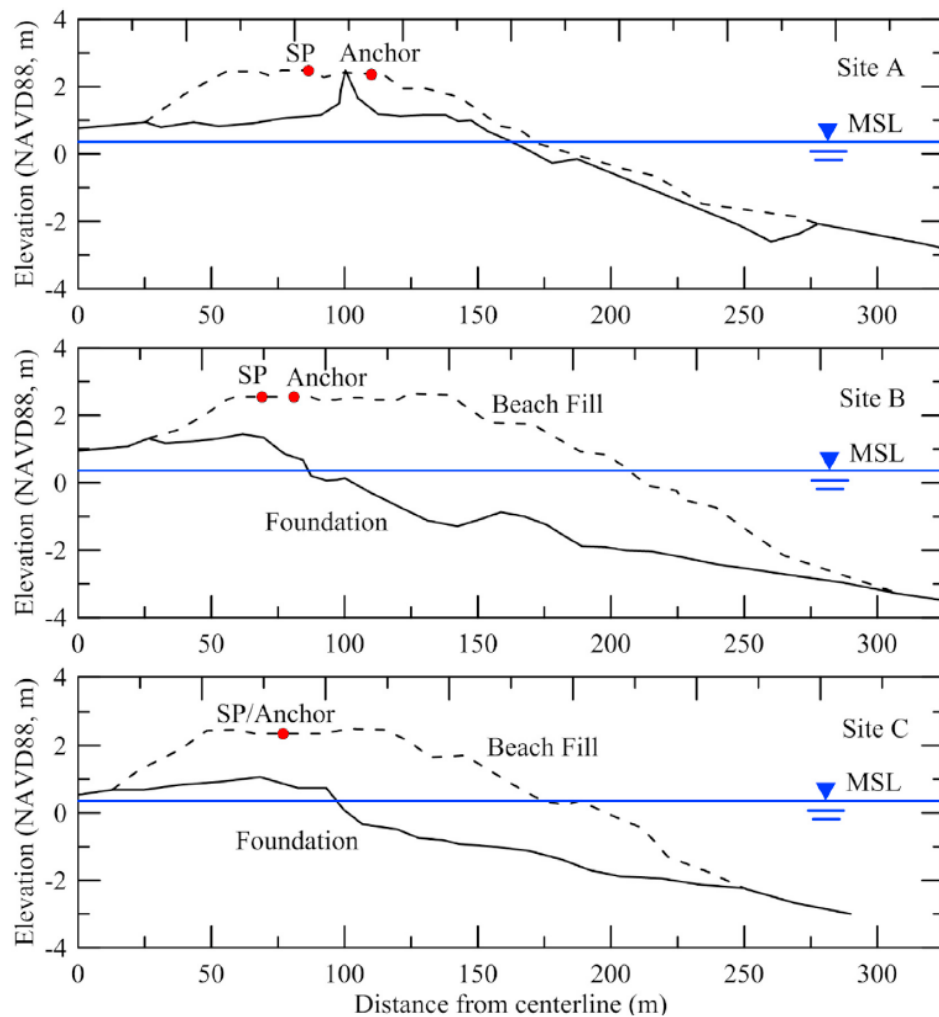
Figure 3.9 shows the as-built cross-sections for three locations along the restored Caminada Headlands beach and dune system. It demonstrates that the elevation of the dune was increased from 1 m (3.3 ft) NAVD88 to about 2.5 m (8.2 ft) NAVD88. However, the beach fill added new loading to the underlying compressible soils, which was found to be about 30 cm (1 ft) after about 2 years (Jafari et al. 2019). This restored dune and beach was immediately tested in 2020 by Hurricane Zeta, which caused overtopping and washover of the dune sediment. This caused a lowering of the dune elevation and inland migration. Then, Hurricane Ida again caused overtopping and washover of the dune. The effect was that the dune was completely lowered to the pre-existing conditions before restoration. Louisiana CPRA conducted aerial LiDAR surveys after Zeta and Ida. Figure 3.10A and 3.10B shows Caminada after restoration (April 2016) and after Hurricane Ida (September 2021). A qualitative comparison of both imagery show the transport of dune into the back barrier marsh and shoreline erosion. Even with this landward migration of sand sediment, Caminada provided storm surge and wave protection to Port Fourchon and Louisiana Highway 1, which is the only evacuation route for Grand Isle.

Figure 3.9. As-built cross-sections of restored Caminada Headlands dune and beach system (Site A: 29.1048083, -90.1940556, Site B: 29.1119083, -90.1780389, and Site C: 29.1191806, -90.1692639) (Jafari et al. 2018).

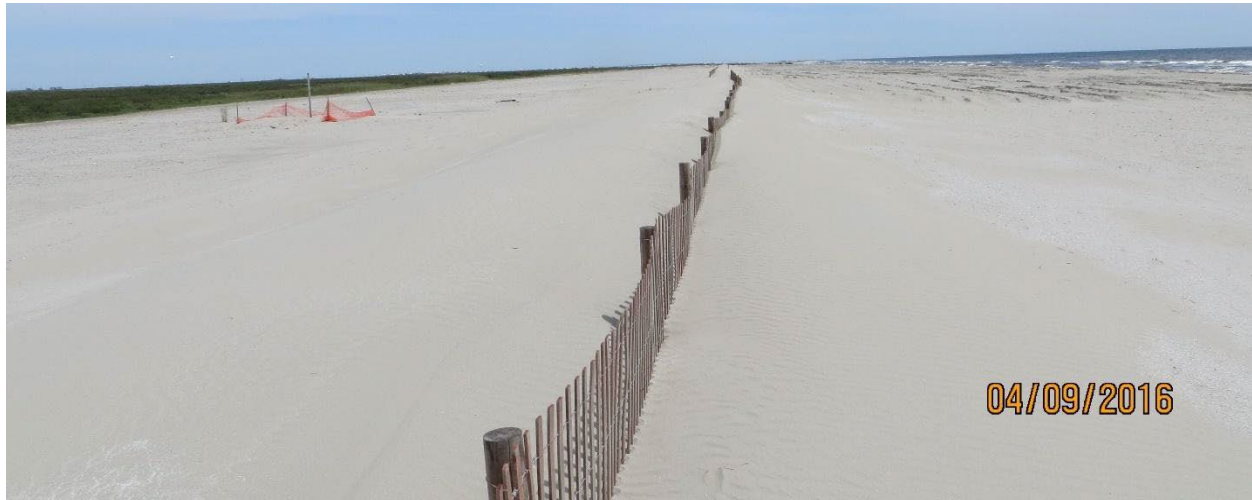
Figure 3.10. Comparison of Caminada Headlands dune and beach system: (A) after restoration in 2016 (29.1772722, -90.0729361), and (B) after Hurricane Ida in September 2021 (29.1754278, -90.0747278) (Photos: N.H. Jafari).

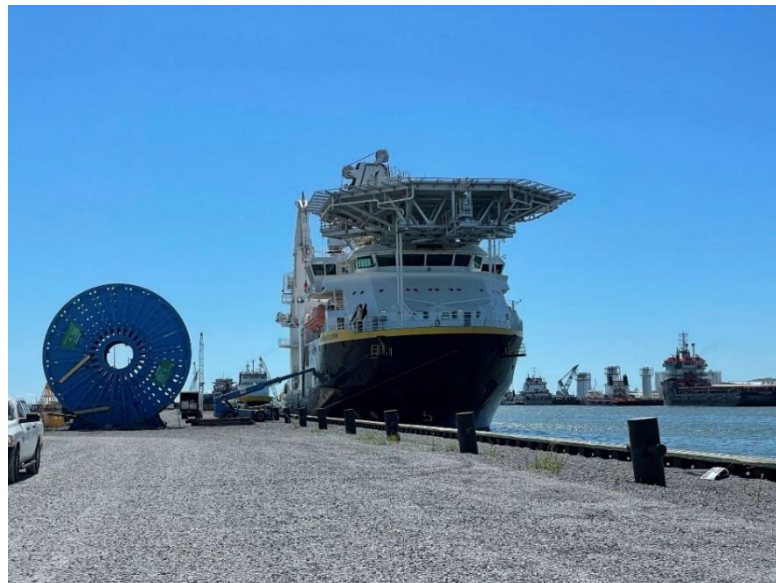
Ida, and the future plans for the Port with regards to flood risk management. Despite the Port's wind gauges registering up to 175 mph during Hurricane Ida, the majority of the Port structures that were constructed after Hurricane Katrina performed well with minor damage. This includes water loading up to 10 ft up the side of structures. Structures that were constructed prior to Hurricane Katrina appeared to have performed worse, with significant wind and water damage. The Port also observed sediment deposition from Hurricane Ida, which was resuspended from the Gulf of Mexico.

Figure 3.11. Site visit to Port Fouchon: (A) Presentation and discussion at the command center, and (B) Investigation of retaining structures.

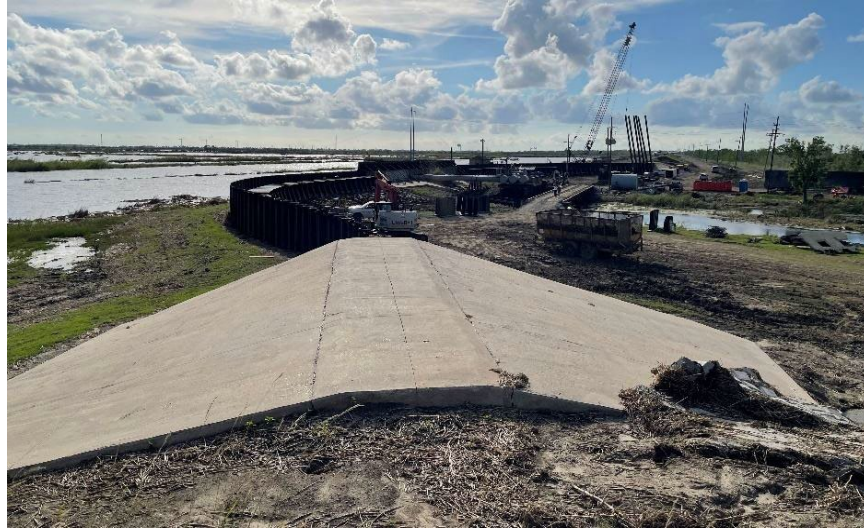
Figure 3.13. Crawfish Ponds area at SLLD: (A) Scour around sheetpile and concrete transition (29.3950944, -90.2306583), and (B) Erosion of grass and soil from levee embankment (29.3950888, -90.2361583) and (29.3950722, -90.2348333) (Photos in B: N.H. Jafari).

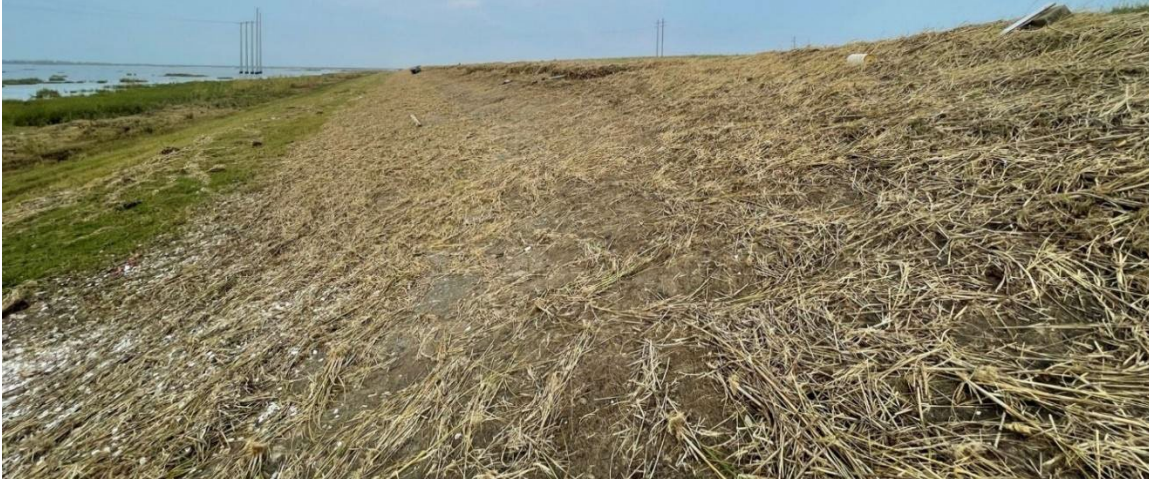
Figure 3.14. SLLD at Highway 1: (A) Grass turf and soil erosion at levee embankment (29.3426333, -90.2489389), and (B) Localized scour around pipelines penetrating levee embankment (29.3425833, -90.2488944) (Photos: N.H. Jafari).

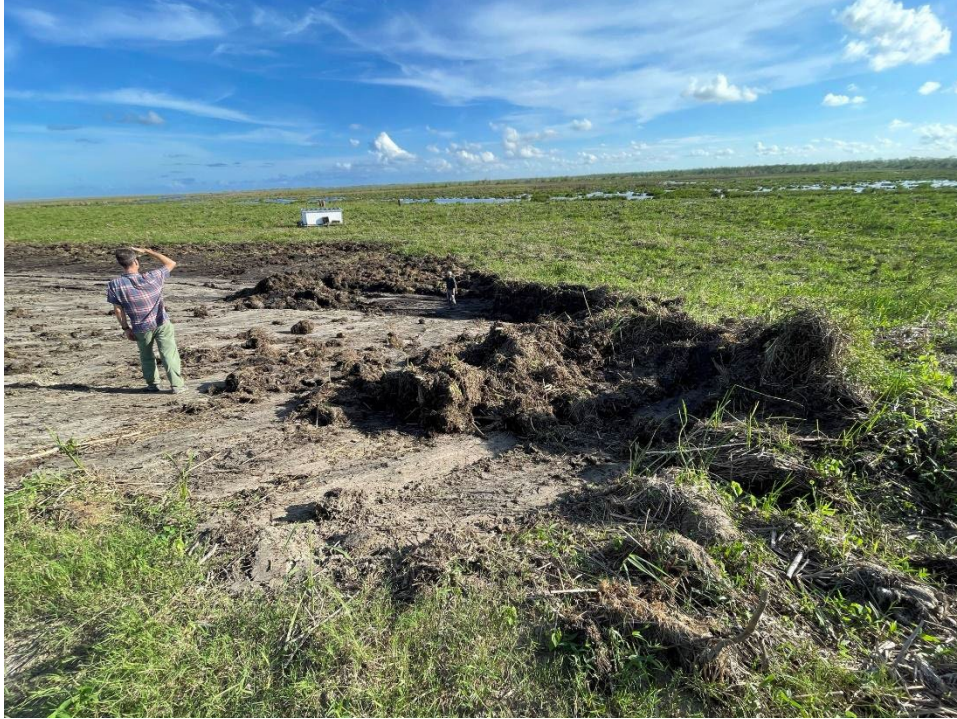
In addition to the overtopping that occurred at the “Crawfish Ponds” area, a small amount of overtopping occurred at the northeast corner of the system, where the levee height is only elevation 11 ft NAVD88. In conjunction with the overtopping that occurred, Figure 3.15 shows large amounts of marsh that were deposited on the levee embankment (up to 5 ft thick) and in the borrow canal directly adjacent to the levee embankment (the marsh filled in the borrow canal, which was previously 15 ft deep and approximately 20 to 30 ft wide). These marsh deposits not only must be removed from the embankment to perform necessary levee improvement construction, but they also have killed the existing embankment turf, which will need to be replaced following the levee

repairs. These deposits also highlight the loss of approximately 60 square miles of marsh, which plays a critical role in attenuating the effects of hurricanes in southern Louisiana.

Figure 3.15. Marsh deposits on levee embankment near Larose, Louisiana (29.5247111, -90.2868417) (Photos: N.H. Jafari).

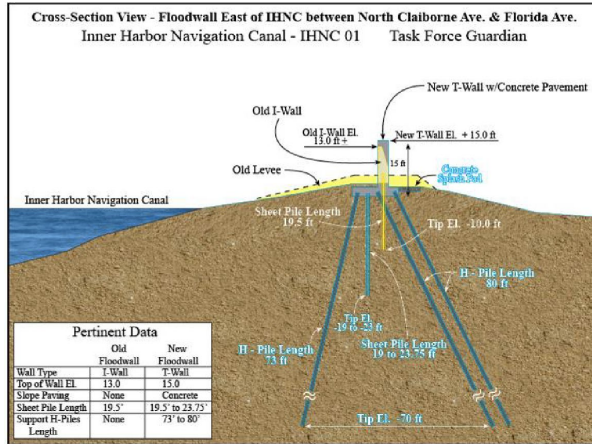
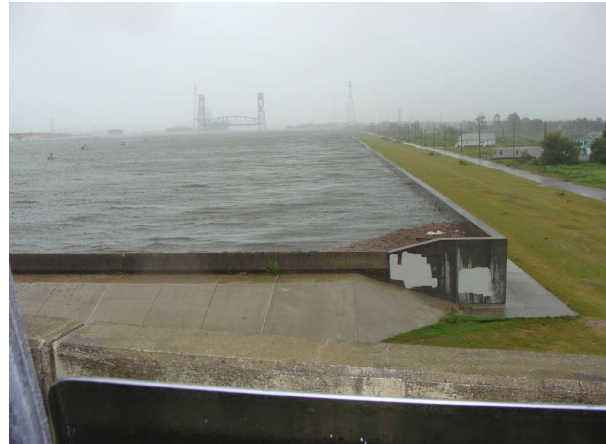
Figure 4.10. IHNC Floodwall cross-section following reinforcement (left), IHNC lower 9th ward floodwall during Hurricane Gustave (right) (lat: 29.978591, long: -90.020675) (GEER Report, Gilbert et al. 2009).

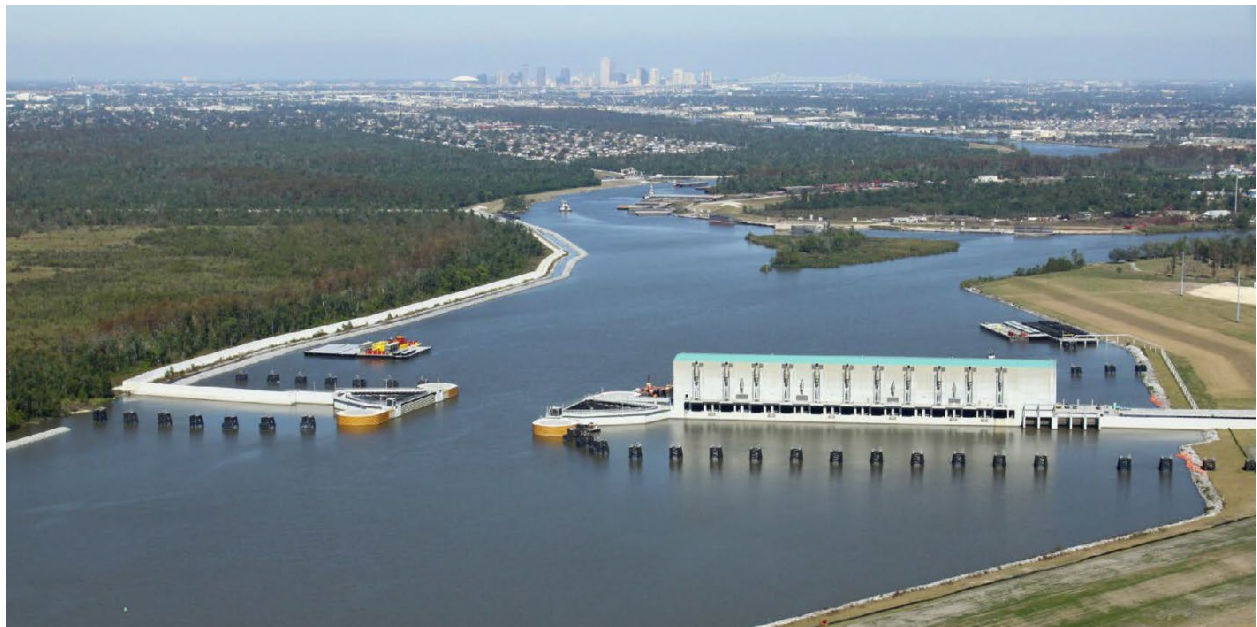
During Hurricane Ida, the Complex experienced the highest level of surge since its construction following Hurricane Katrina, with peak surge reaching EL 6.8 ft. The structure is designed for surge up to EL 16 ft, so no overtopping occurred; however, there were waves that resulted in a small amount of water splashing over the sector gate.

Furthermore, one of the 11 pumps lost capacity due to a coolant leak leading to a small fire at the pump. Although this pump was temporarily offline, the remaining 10 pumps had more than enough pumping capacity to keep up with the needed outflow of water during the event.

Figure 4.13. The Gulf Intracoastal Waterway - West Closure Complex (USACE). (lat: 29.771008, long: -90.074640)

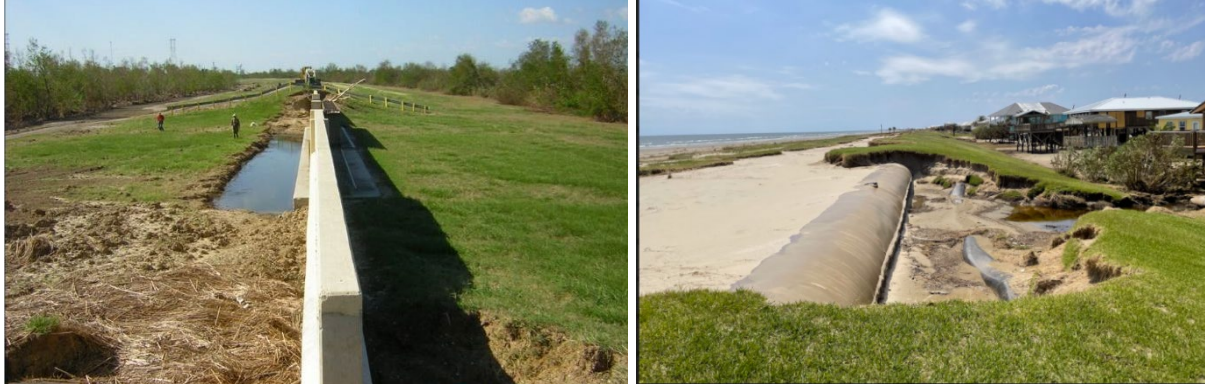
An area that created many problems during Hurricane Katrina was the transition zones between different types of levees and floodwalls, as well as connections between the flood protection system and other infrastructure. Prior to Hurricane Ida, as part of further reinforcements, armoring had been constructed and placed at several of these transition locations. This resulted in a much better performance even at locations that did overtop and experienced significant water flow.

Figure 4.14. Scouring and erosion as a result of a transition zone between different type of levees following Hurricane Katrina (left), scour along a levee section in Grand Isle following Hurricane Ida (right) (lat: 29.244278, long: -89.977038) (photos by A. Athanasopoulos-Zekkos).

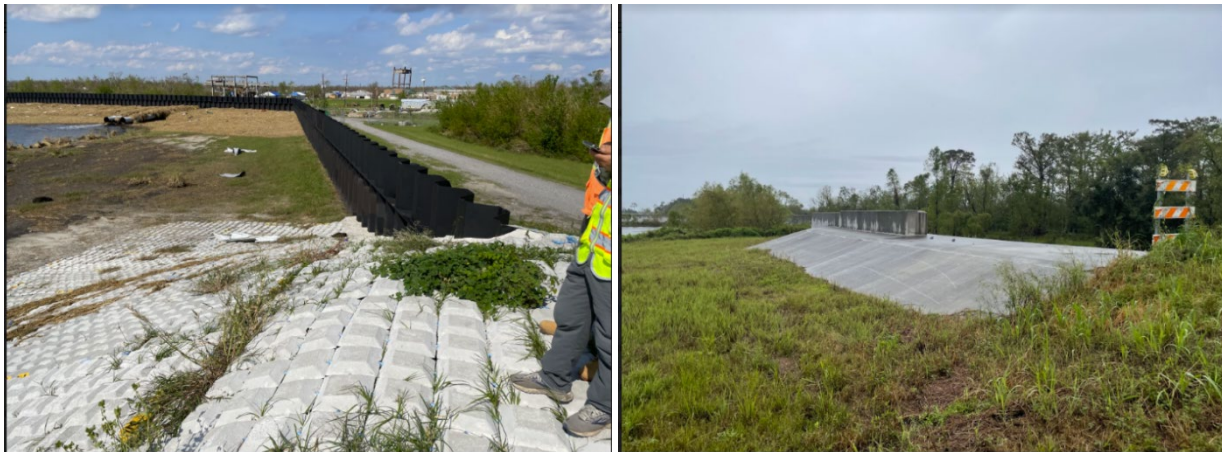
Figure 4.15. Examples of armorings along levee and floodwall transitions prior to Hurricane Ida (lat: 29.244278, long: -89.977038) (photos by A. Athanasopoulos-Zekkos).

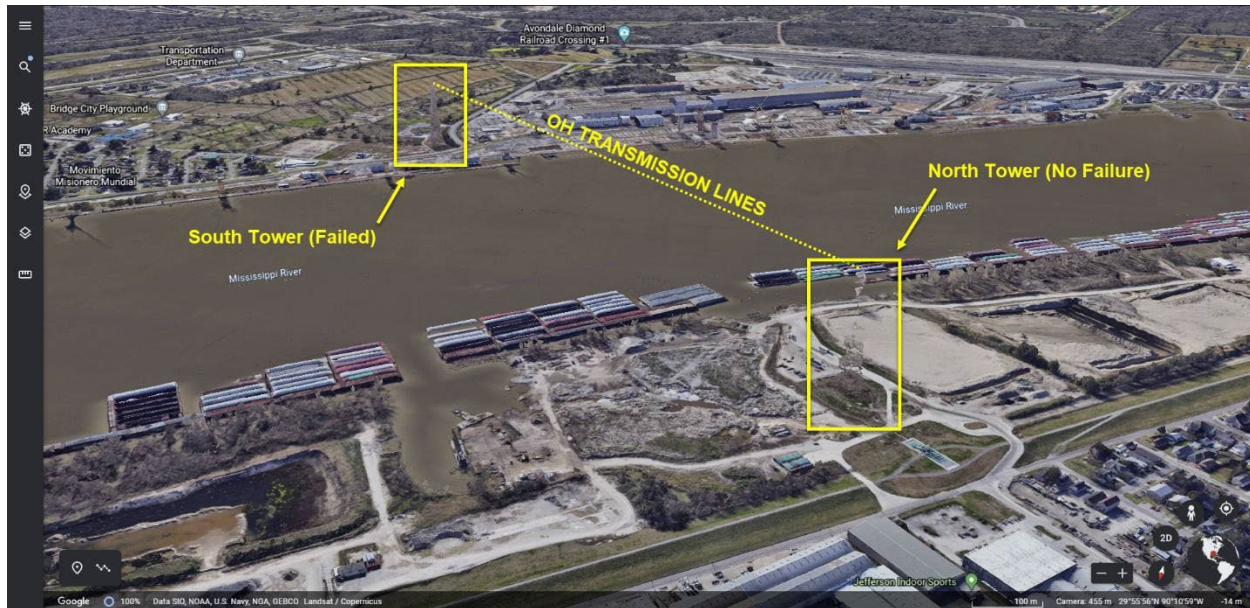
- Location “A” - **Failure** - (29.928702, -90.1790472) – This is an overhead AC bulk power transmission river crossing, where the south tower experienced a structural failure with no observed associated foundation failure. This tower failed in the evening of Sunday, August 29, 2021. The northern tower (on the other side of the Mississippi River) was not documented as being damaged. Figure 5.2 shows a view of the remnant foundations at the time of the GEER reconnaissance. Figure 5.3 shows an aerial oblique view of the downed southern tower as posted on the website “DailyMail.com.” Figure 5.4 shows an image of the northern tower during the GEER reconnaissance, with no observable foundation or structural distress. Figure 5.5 shows an aerial oblique view prior to Hurricane Ida (from Google Earth) looking southwest. The two tower locations have been highlighted in the yellow box and a dashed yellow line added to indicate the alignment of the electric transmission lines.

Figure 5.5. Aerial oblique view from Google Earth showing the overhead transmission line crossing over the Mississippi River. The North Tower did not fail. The South Tower did fail.

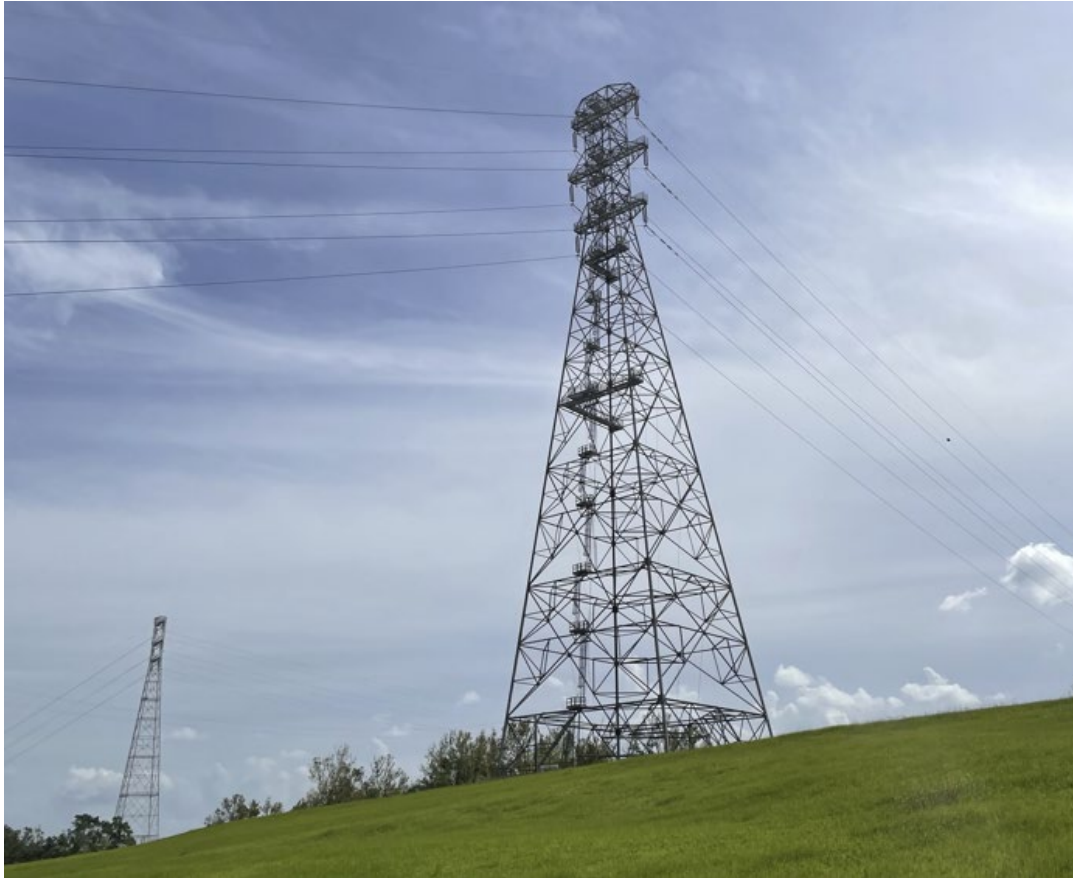
- Location “B” - **No Failure** - (29.95475, -90.138175) – This is an overhead AC bulk power transmission river crossing. There are four lines in total, two on each tower set. No structural or foundation failures were observed at this location as a result of Hurricane Ida. Figure 5.6 shows an image of the northern tower during the GEER reconnaissance. shows an aerial oblique view prior to Hurricane Ida (from Google Earth) looking northwest. The tower locations have been highlighted in the yellow box and a dashed yellow line added to indicate the alignment of the electric transmission lines. Location “A” can be seen in the upper left.

Figure 5.6. Southerly view of the east towers conveying transmission lines across the Mississippi River from Nine Mile Point. (29.955778, -90.138367). (Photo by: A. Athanasopoulos-Zekkos)

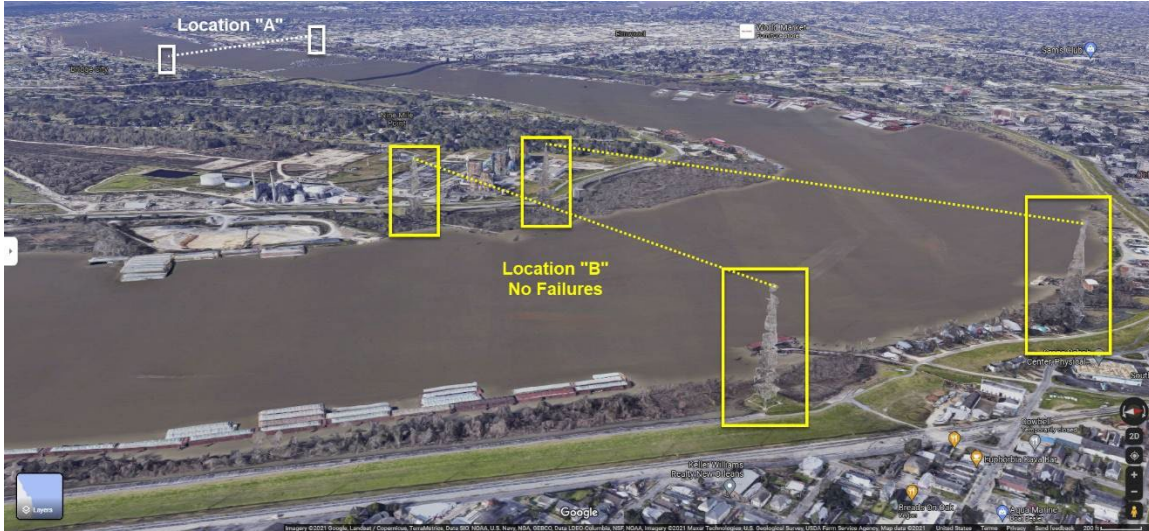
Figure 5.7. Aerial oblique view from Google Earth showing the overhead transmission line crossing over the Mississippi River. All four towers remained in service and no observable structural, or foundation damage was found during the GEER reconnaissance.

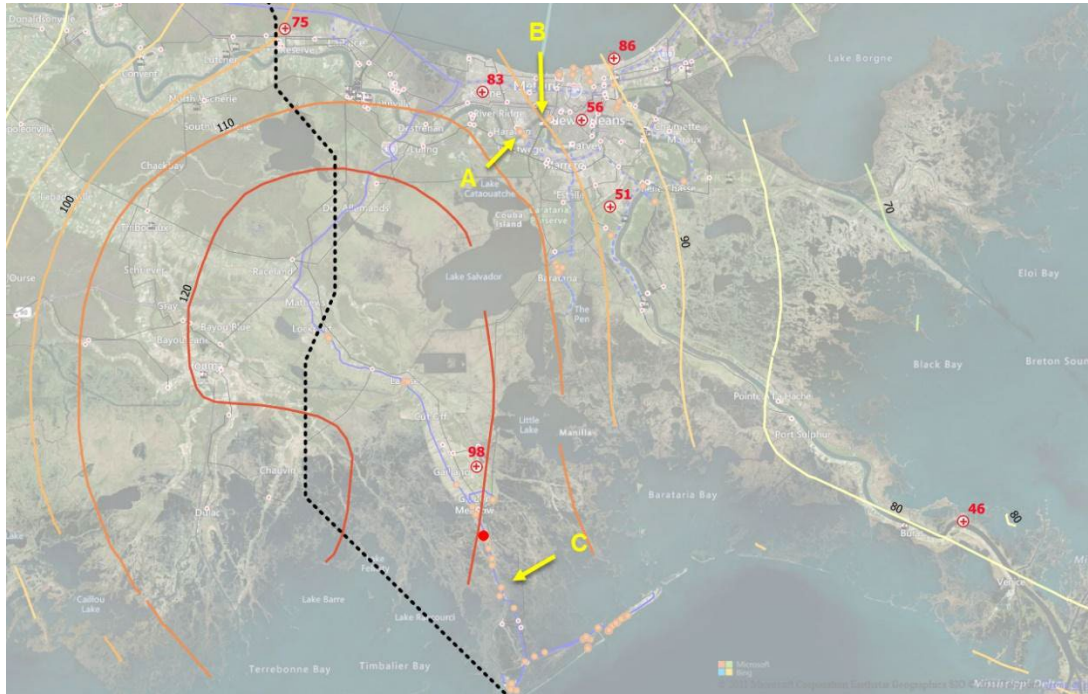
The documented wind speeds and gusts largely fall below 120 mph in the greater New Orleans area. The failed tower at Location “A” had documented maximum gusts below 100 mph. The design wind speeds (per ASCE 74-10, 2010) were on the order of 130 mph (Figure 5.1).

Figure 5.9. Overview of storm track (dashed black line) and predicted wind gust contours with reported maximum gusts (red) relative to Locations A, B, and C.

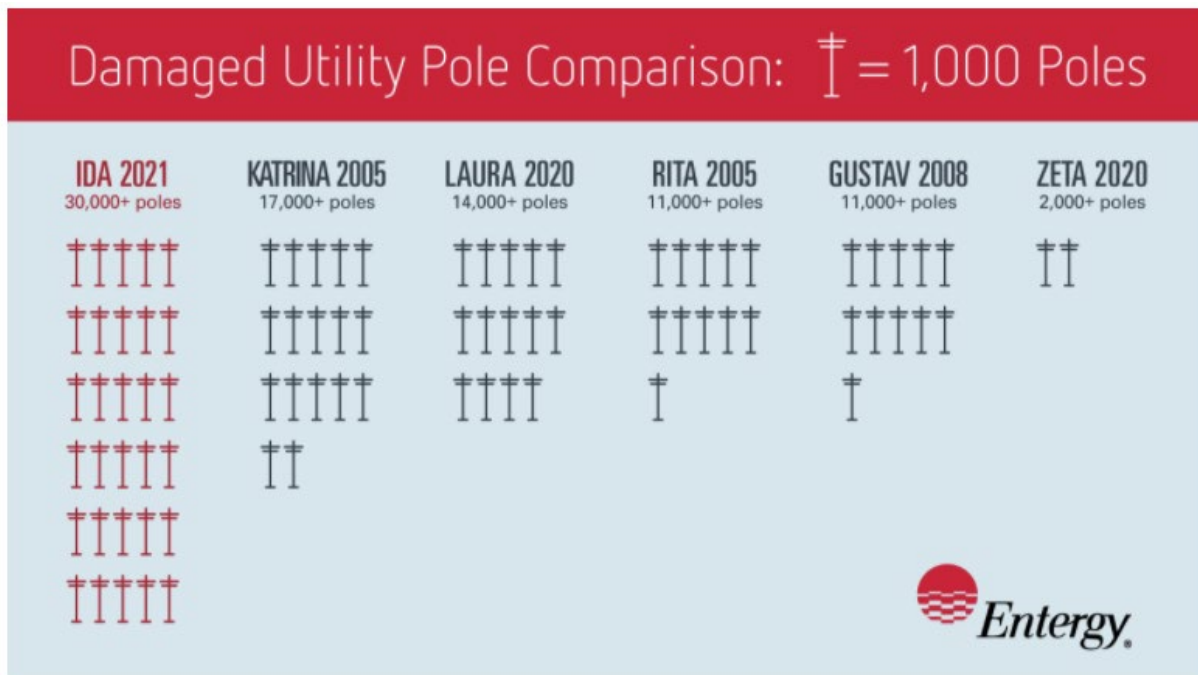
Hurricane Ida had a dramatic impact on the electric grid serving the greater New Orleans area and southern Louisiana. Figure 5.11 shows an evening satellite image from August 9, 2021 of the greater New Orleans area. Figure 5.12 shows a similar view, but on August 31, 2021 after Hurricane Ida. Entergy estimated²³ that the total damage experienced during Hurricane Ida resulted in damage to 30,679 poles (Figure 5.13), 36,469 spans of wire and 5,959 transformers. In total, the number of damaged or destroyed poles from Ida is more than hurricanes Katrina, Ike, Delta and Zeta combined.

Figure 5.13. Over 30,000 utility poles were reported damaged or destroyed by Energy. Source: <https://www.entergy.com/hurricaneida/etr/>.

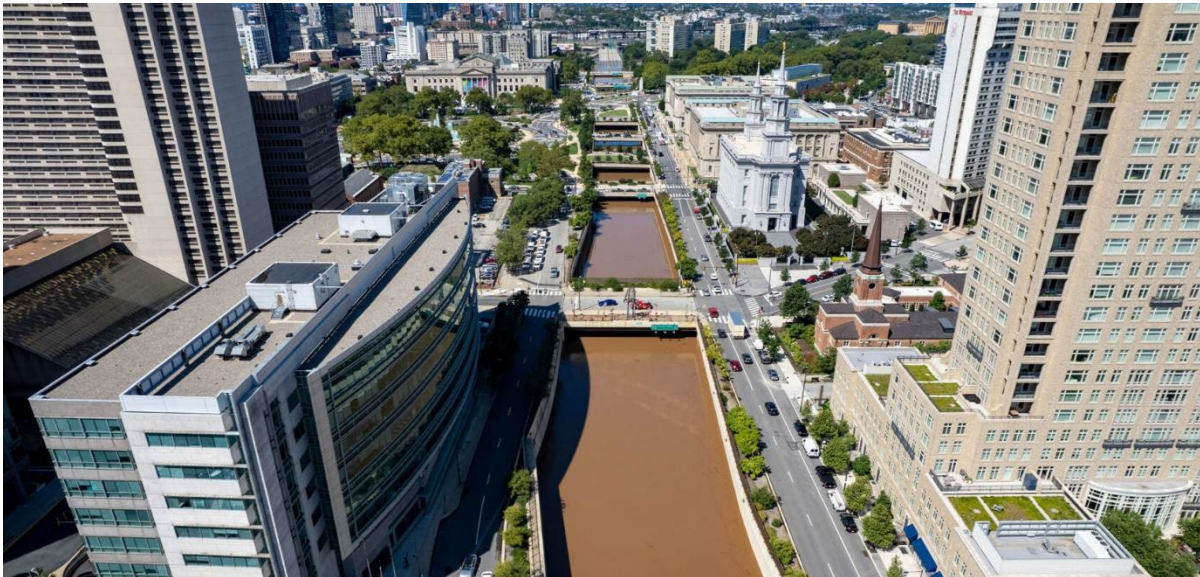
The resulting levels of flooding were historic, as shown in Figure 6.5, where the Vine Street Expressway, a major throughfare through downtown Philadelphia, completely filled with water and remained this way until it could be pumped out several days later. Reports stated that pumping stations along the Vine Street Expressway failed and drains were potentially clogged by tree debris. Flooding was caused by historic flood levels observed in the Schuylkill River. The flood level reached 16.35 feet at a stream gauge in Philadelphia (near the Art Museum), which neared the record of 17.0 feet from 1869 (National Weather Service, 2020). Further upstream severe flooding was observed in Manayunk as shown in Figures 6.6 and 6.7, which show flooding on Main Street and the Green Lane Bridge, respectively. For perspective, Figure 6.7 shows the Green Lane Bridge under normal flow conditions and during flooding caused by Ida. Images across the region were similar. Many popular trails along the river were closed following the event due to damage and excessive debris according to the Philadelphia Parks and Recreation Department.

Figure 6.5. Observed Flooding of the Vine Street Expressway in Downtown Philadelphia, PA (Source: Mark Henninger/Imagic Digital).

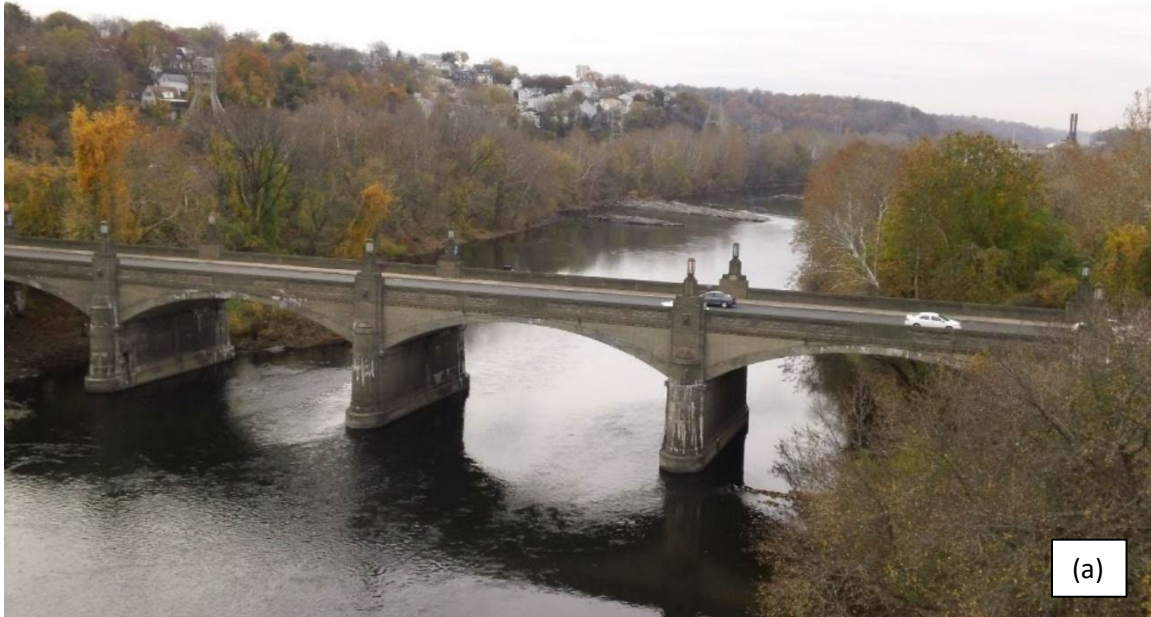
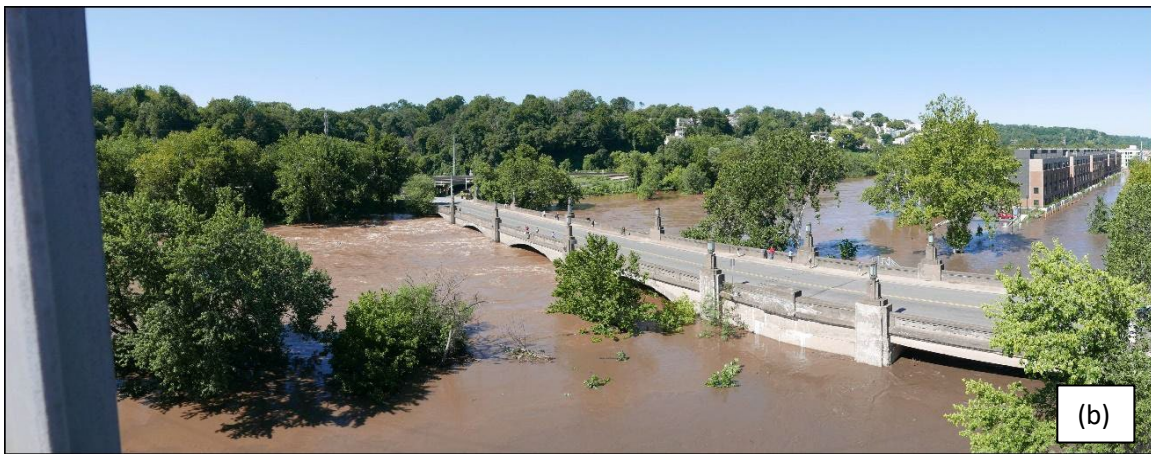
Figure 6.7. Green Lane Bridge across the Schuylkill River in Manayunk neighborhood of Philadelphia, PA. Bridge shown under (a) normal conditions (Source: Historic Bridges of Philadelphia) (b) flood conditions during Ida (Source: Manayunk Council).

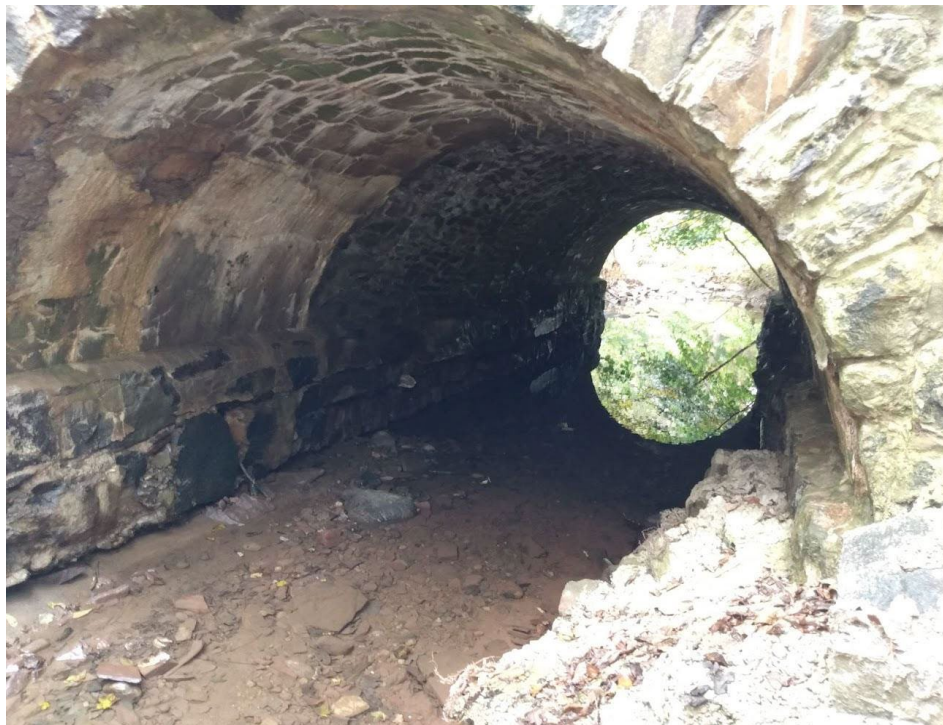
The River Rd Segment 300 Bridge is located near Washington Crossing, PA and is shown in Figures 20 -22. The stone arch bridge was built in 1870 and is 12 ft long and 28 ft wide. The bridge carries approximately 6,370 vehicles per day. Due to flooding in the small creek that runs beneath the bridge, significant scour was observed. Scour lowered the streambed elevation by 2 ft as shown in Figure 20, and 97% of the abutment length was undermined due to the scour.

Figure 6.21. River Rd Segment 300 Bridge Scour and Undermining view from through bridge (40.323972, -74.9275).

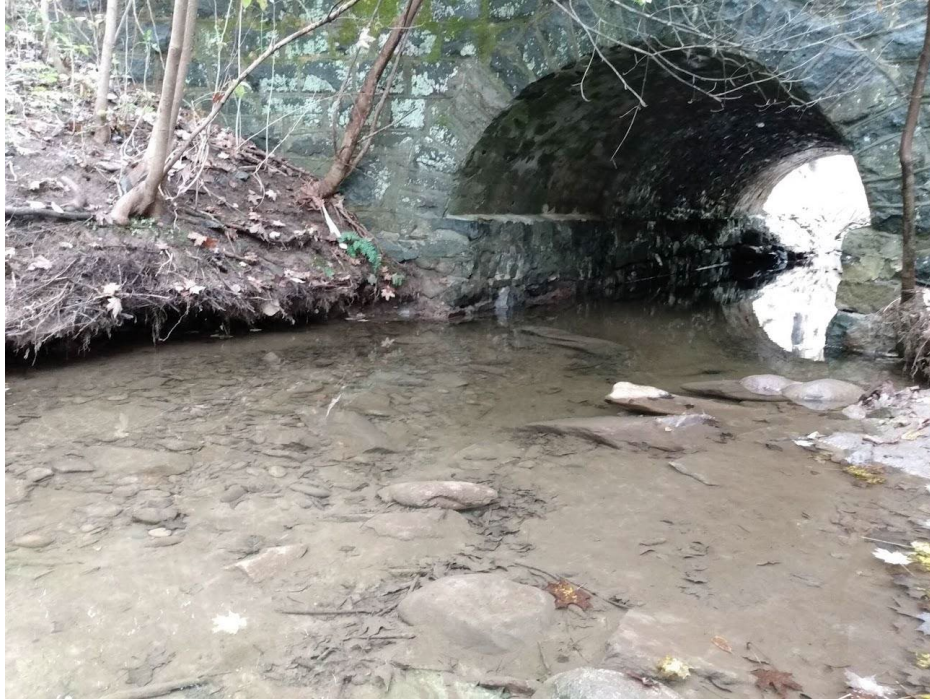
Figure 6.22. River Rd Segment 300 Bridge Scour and Undermining view from downstream (40.323972, -74.9275).

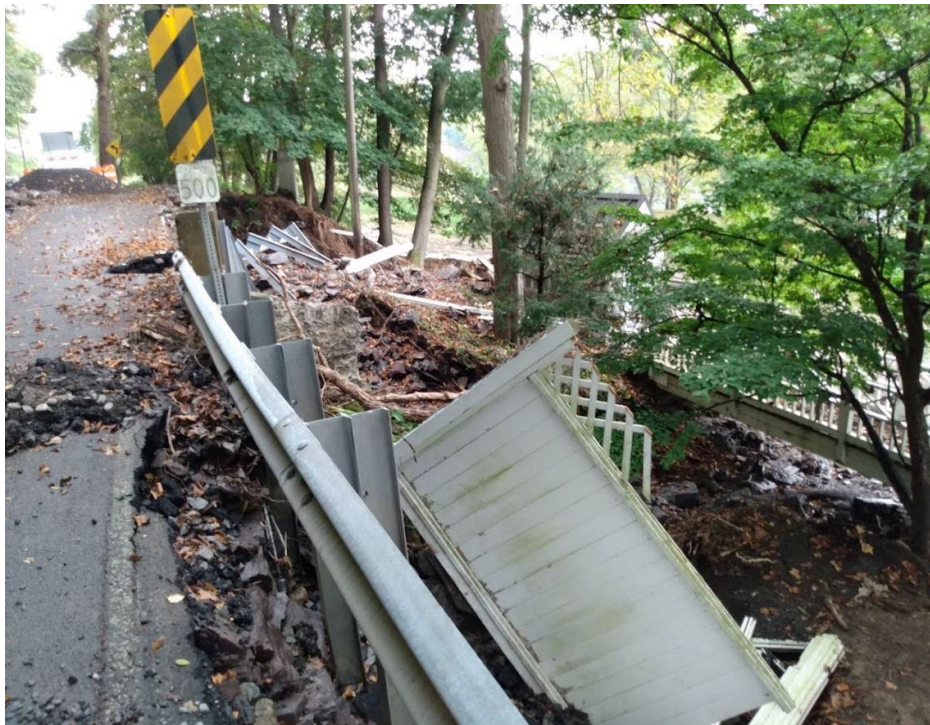
The River Rd Segment 500 Bridge is located in Lumberville, PA and is shown in Figures 6.23 – 6.28. The bridge is adjacent to the Delaware River and has a steep rock slope above the road. A rock slide filled the upstream channel and overtopped the bridge, leading to roadway failure and washout of the bridge abutment.

Figure 6.23. River Rd Segment 500 Bridge Washout and Slope Instability (40.413111, -75.047389).

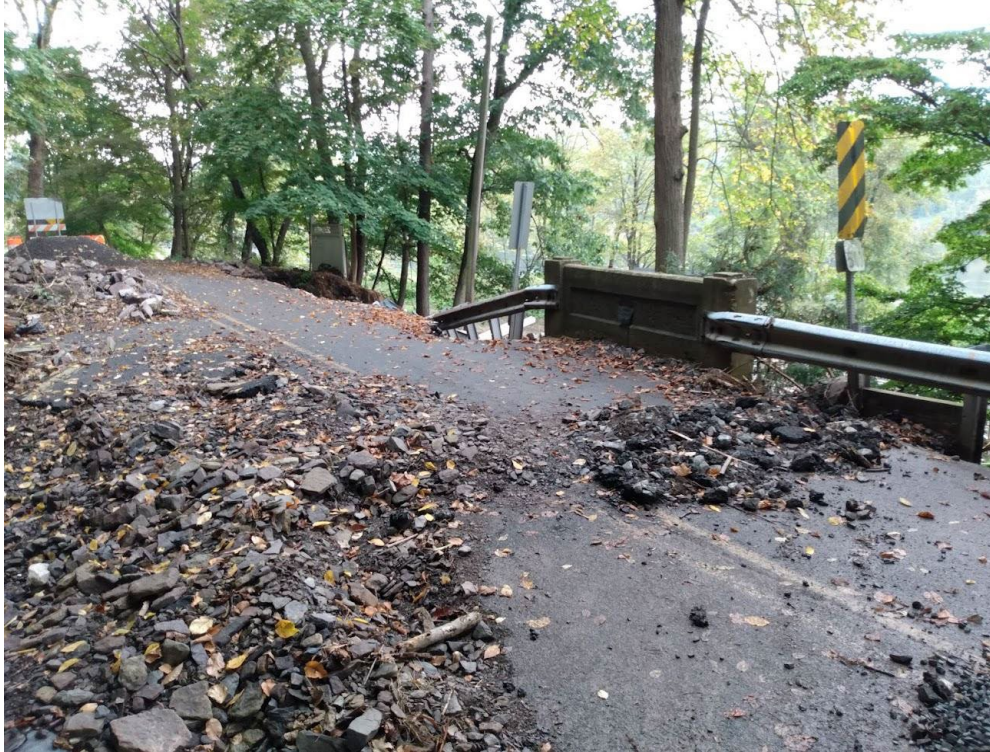
Figure 6.24. River Rd Segment 500 Bridge Roadway View with rock slide materials (40.413111, -75.047389).

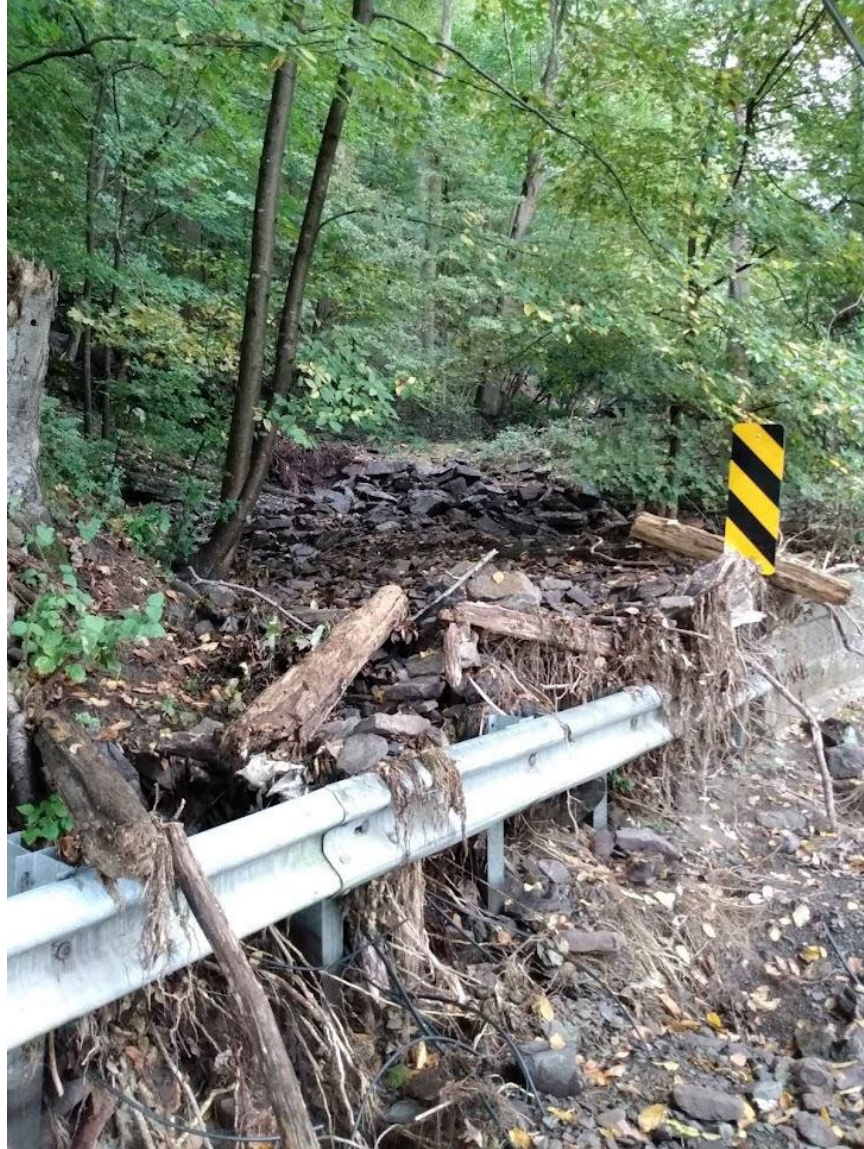
Figure 6.25. River Rd Segment 500 Bridge View above Roadway of Rock Slide (40.413111, -75.047389).

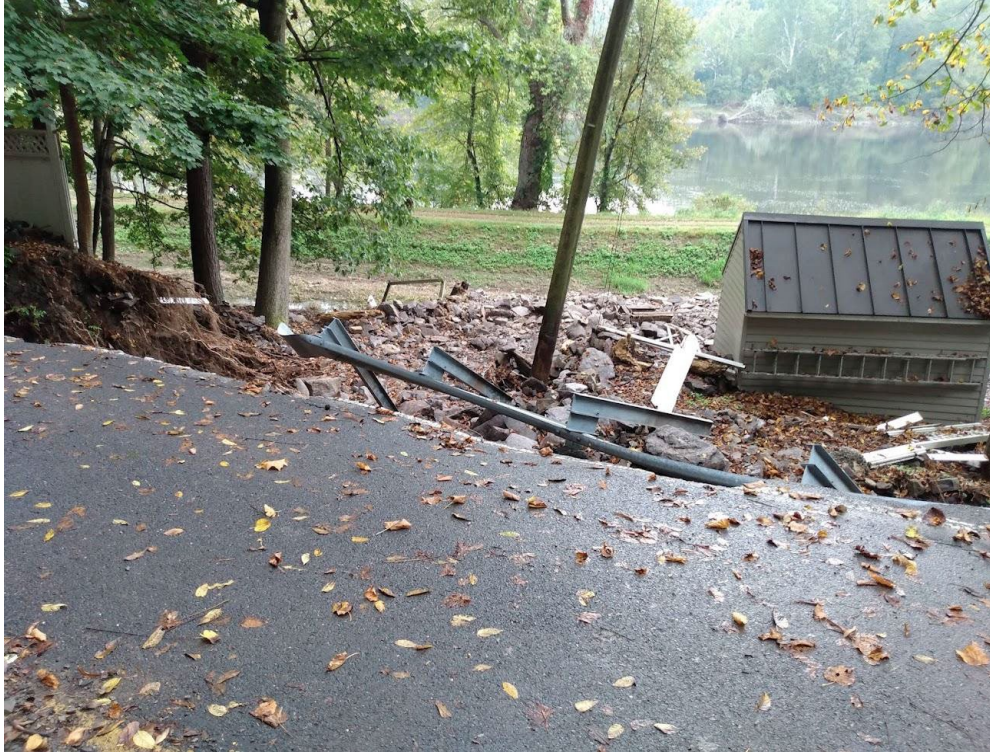
Figure 6.26. River Rd Segment 500 Bridge Washout and Slope Instability with view of Delaware River in Background (40.413111, -75.047389).

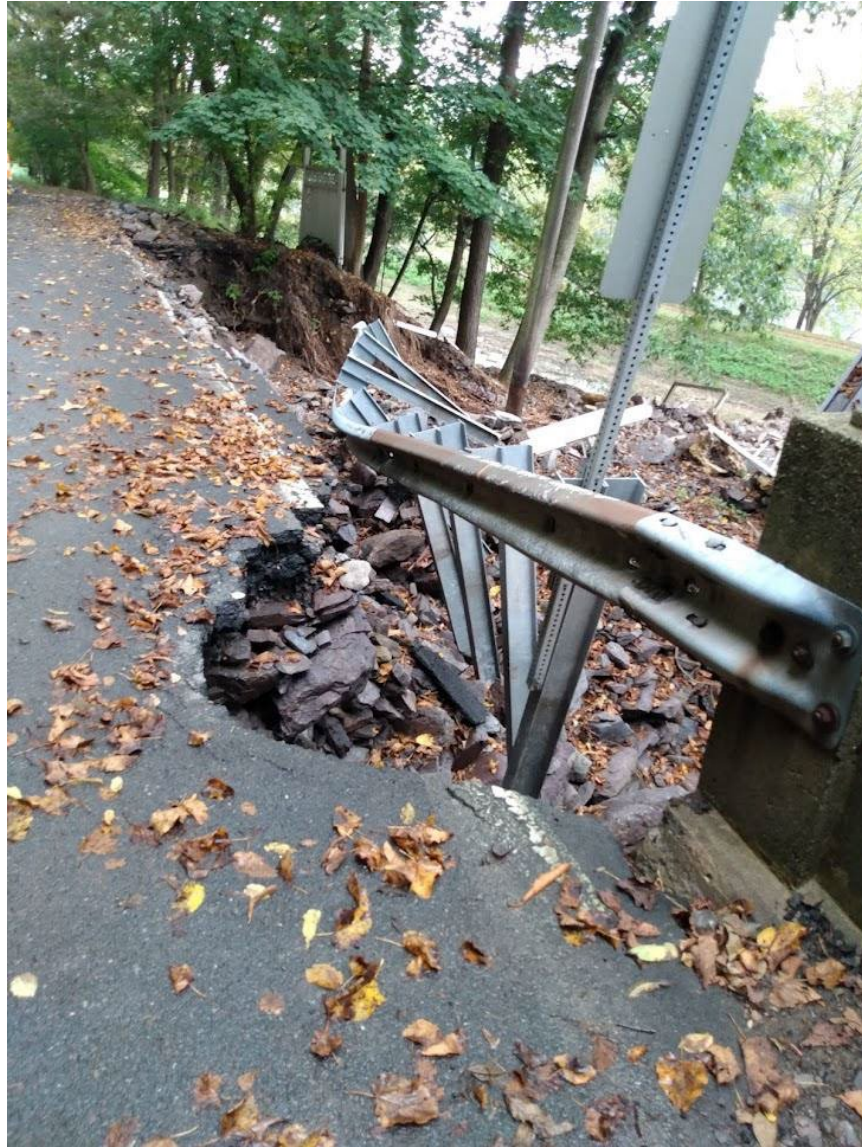
Figure 6.27. River Rd Segment 500 Bridge Washout and Slope Instability on Downstream side (40.413111, -75.047389).
