GEOTECHNICAL EXTREME EVENTS RECONNAISSANCE (GEER) ASSOCIATION

Geotechnical Aspects of the August 29, 2021, Hurricane Ida in LA, PA, NJ and NY

Report of the NSF Sponsored GEER and NEER Association Teams

GEER/NEER Association Report No. GEER-077

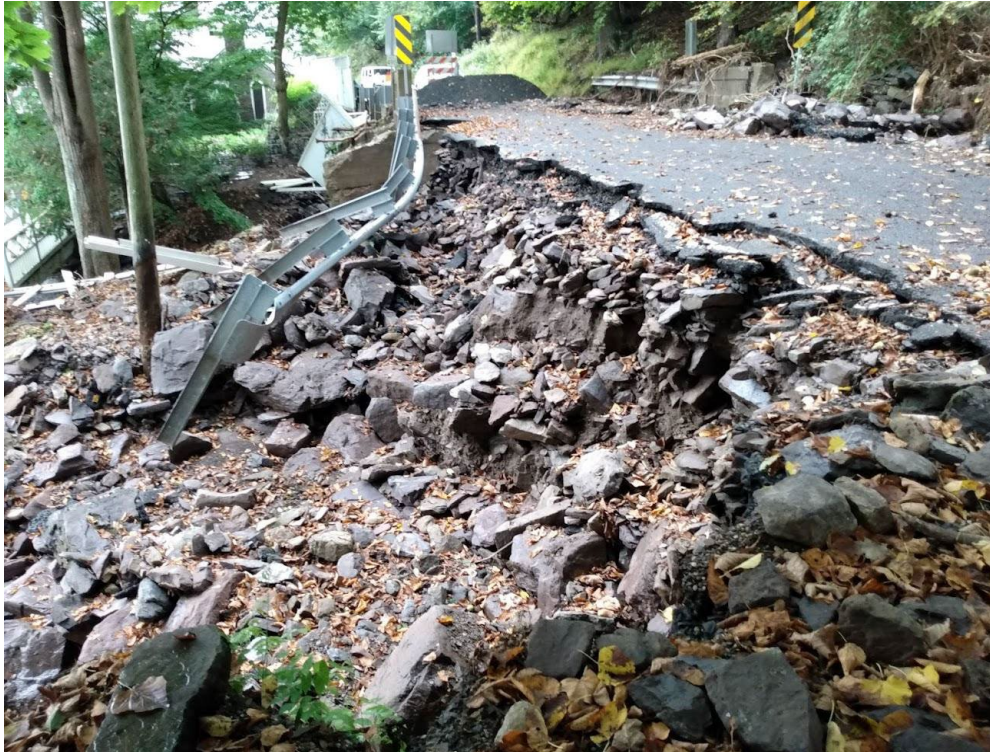
The River Rd Segment 500 Bridge is located in Lumberville, PA and is shown in Figures 6.23 – 6.28. The bridge is adjacent to the Delaware River and has a steep rock slope above the road. A rock slide filled the upstream channel and overtopped the bridge, leading to roadway failure and washout of the bridge abutment.

Figure 6.28. Alternative View of River Rd Segment 500 Bridge Washout and Slope Instability on Downstream side (40.413111, -75.047389).

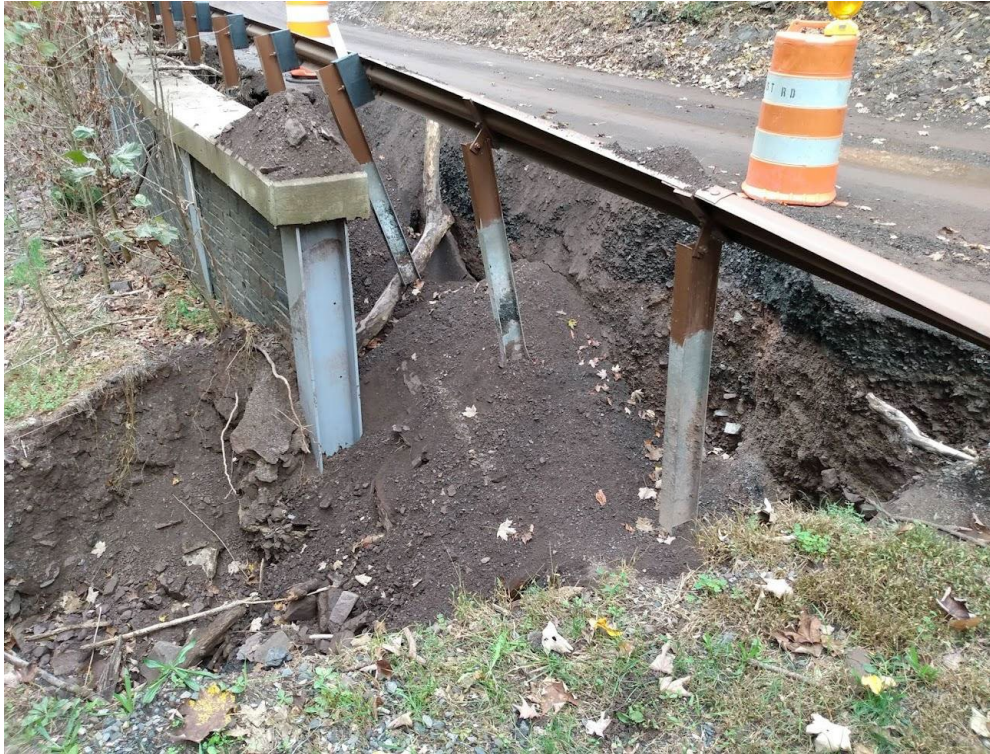
The Fleecy Dale Rd Soldier Pile Wall is located near the River Rd Segment 500 Bridge in Lumberville, PA and is shown in Figures 6.29 – 6.39. There was significant erosion on both sides of the soldier pile wall. Similar to the Segment 500 Bridge, there was a steep slope above the roadway, leading to potential runoff at high velocities and volumes. There was significant washout of the roadway and behind the wall with settlement of the roadway in a few locations. The guide rail was no longer supported for long distances along the wall. Figure 6.39 shows some HDPE drainage pipes and geotextiles that were utilized in wall construction. Figures 6.40 and 6.41 show slope/roadway washout in several locations along Fleecy Dale Rd, not far from the soldier pile wall.

Figure 6.31. Alternative View of Fleecy Dale Rd Erosion behind Soldier Pile Wall (40.397806, -75.05525).

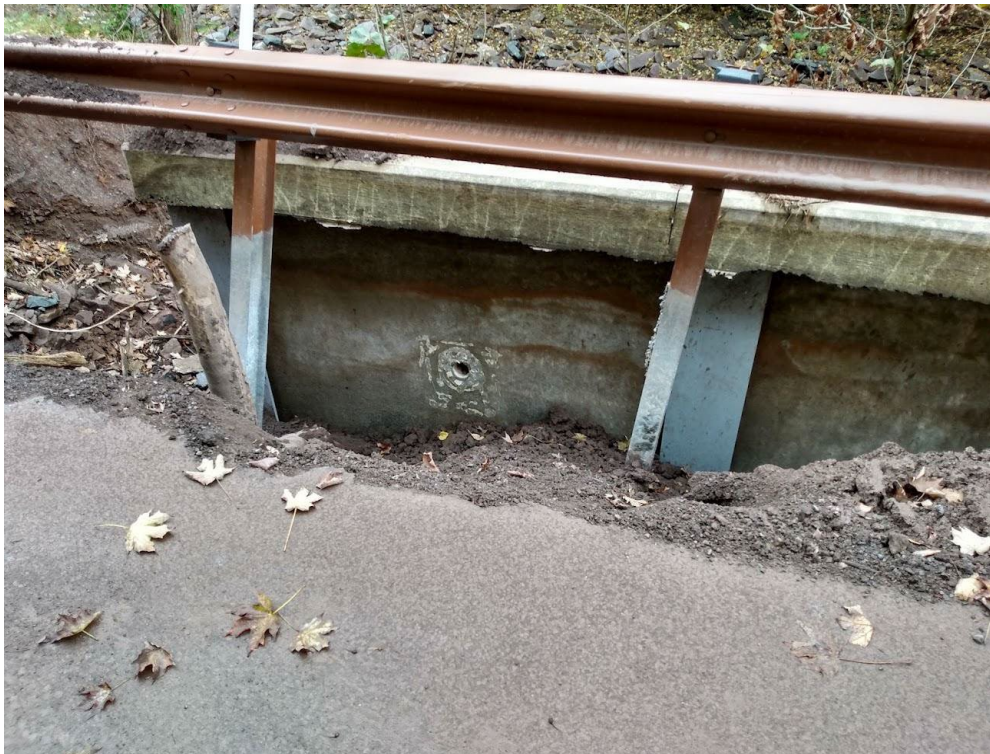
Figure 6.32. Location of Drainage Holes in Wall (40.397806, -75.05525).

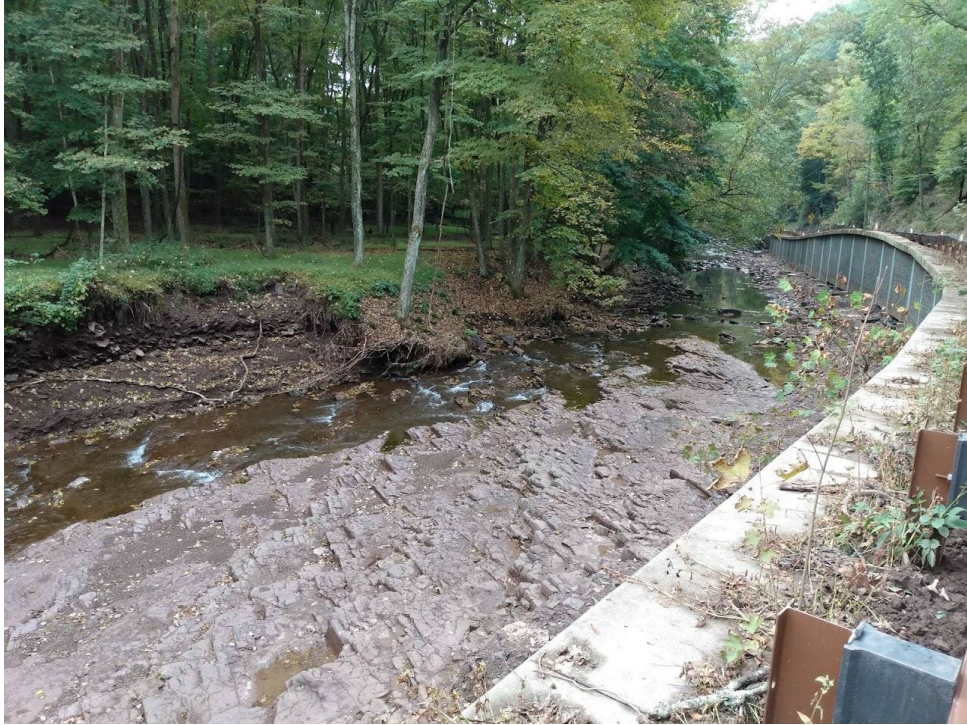
Figure 6.33. View of Paunnacussing Creek with Soldier Pile Wall (40.397806, -75.05525).

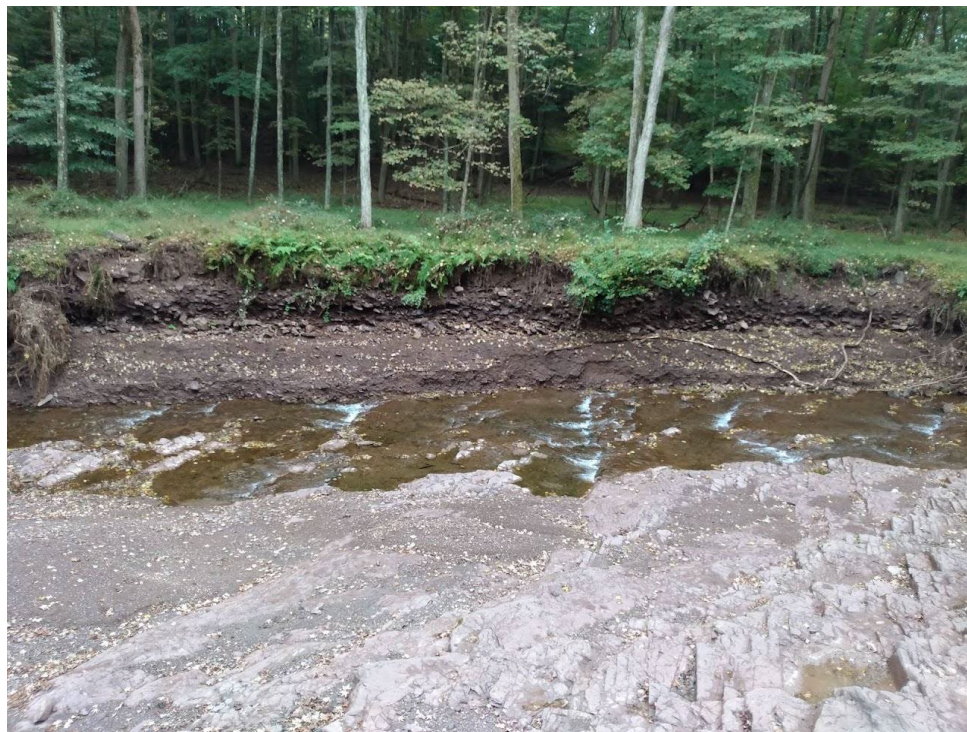
Figure 6.34. View of Streambank Erosion on Bank Opposite of Solider Pile Wall (40.397806, -75.05525).

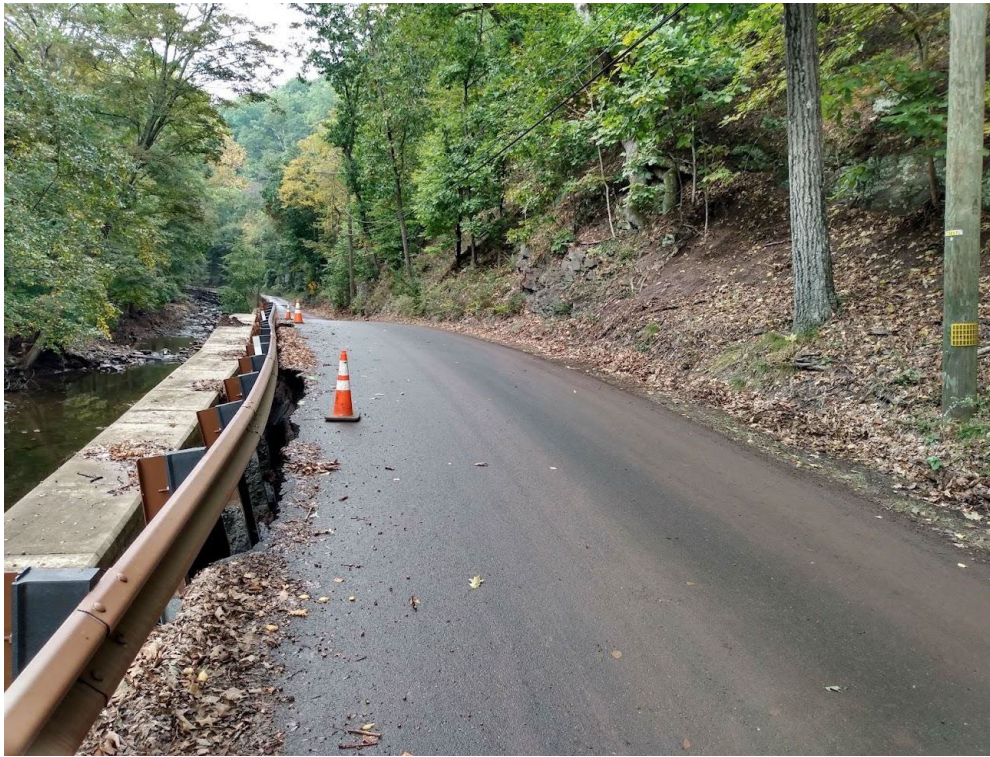
Figure 6.35. Roadway Erosion Behind Wall. Note steep slope above the roadway (40.397806, -75.05525).

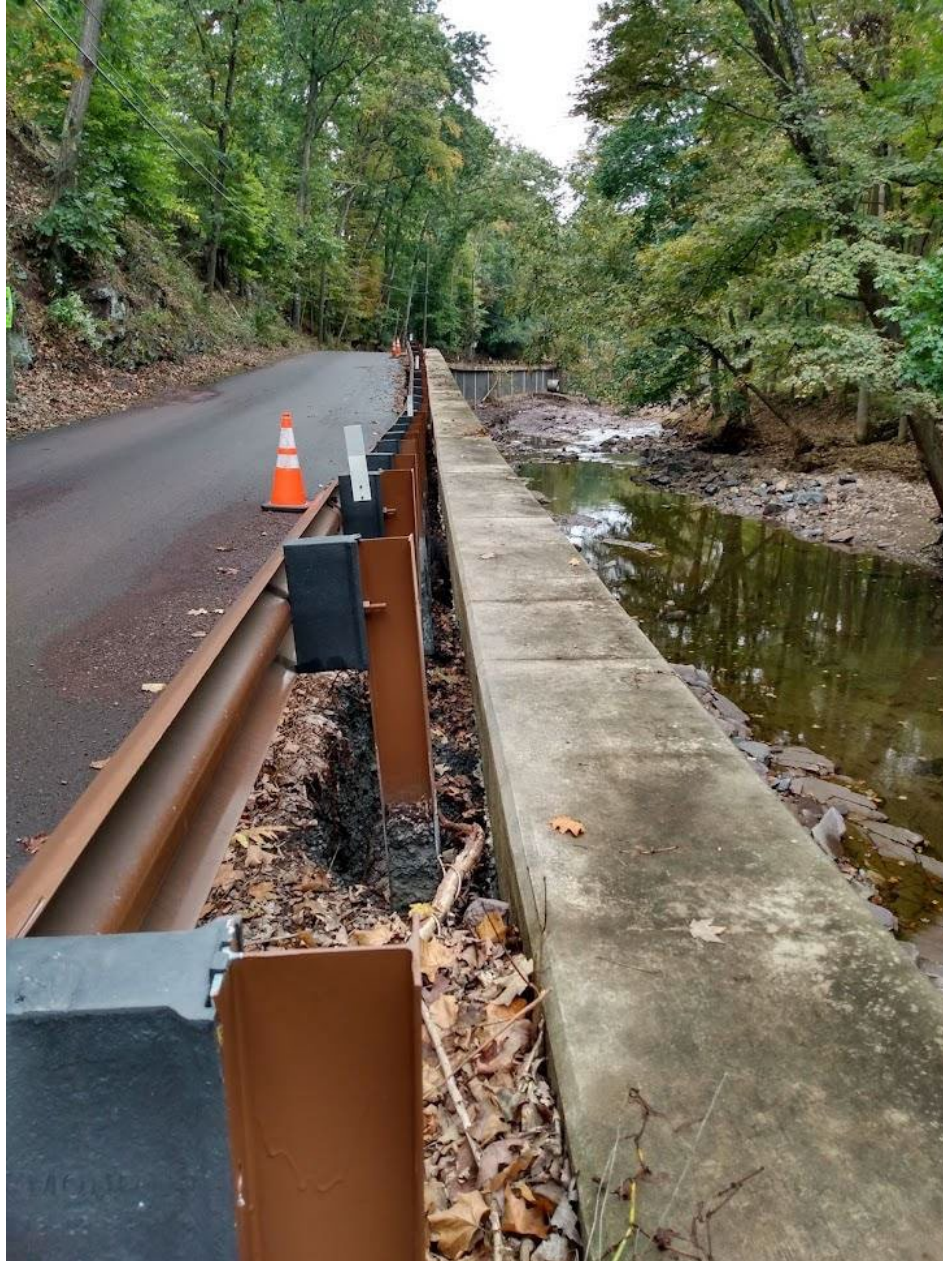
Figure 6.38. View of Soldier Pile Wall looking Downstream (40.397806, -75.05525).

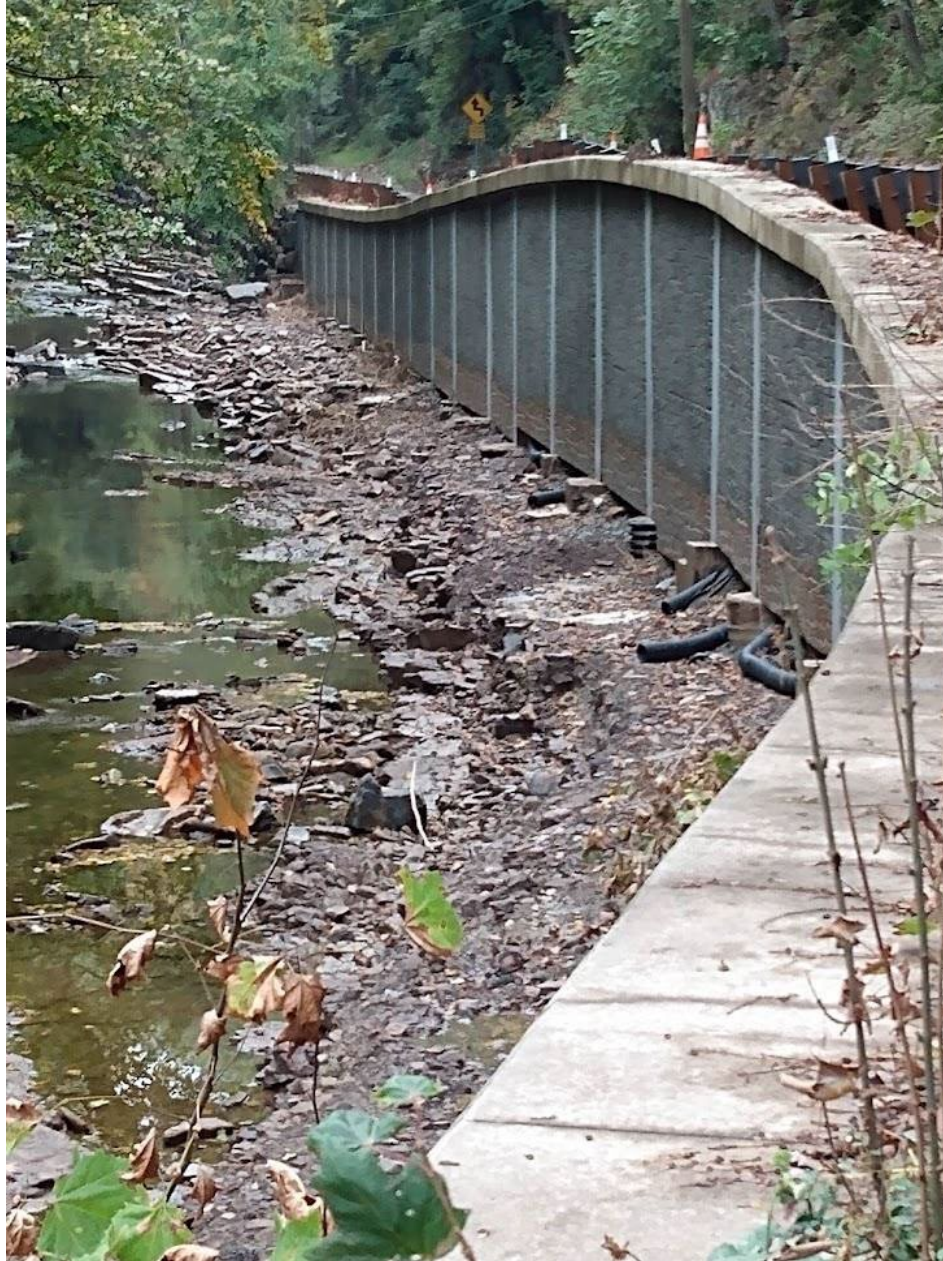
Figure 6.39. View of Soldier Pile Wall looking Upstream. Note the discoloration at the bottom of the wall showing potential scour depth as well exposed drainage pipes (40.397806, -75.05525).

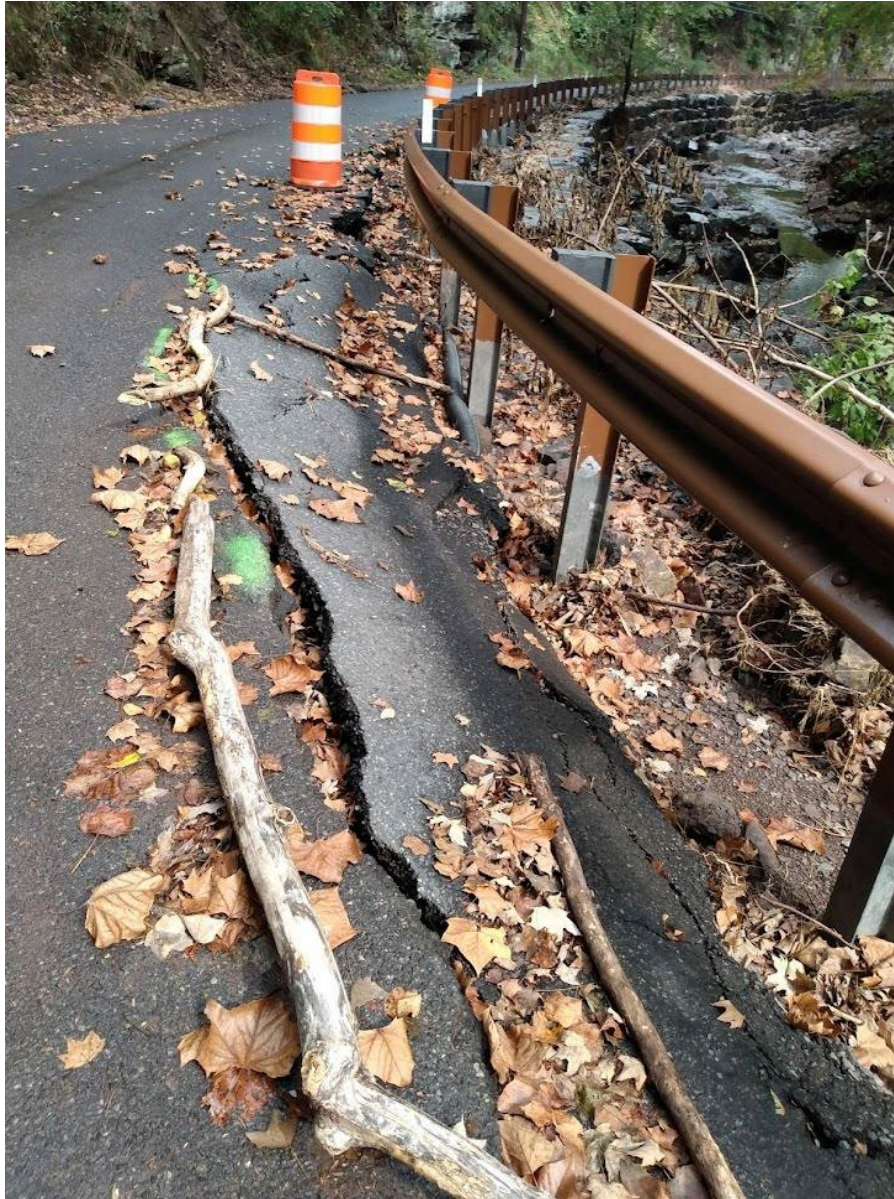
**Figure 6.40. Roadway Washout Upstream of Soldier Pile Wall on Fleecy Dale Rd
(40.396747, -75.056316).**

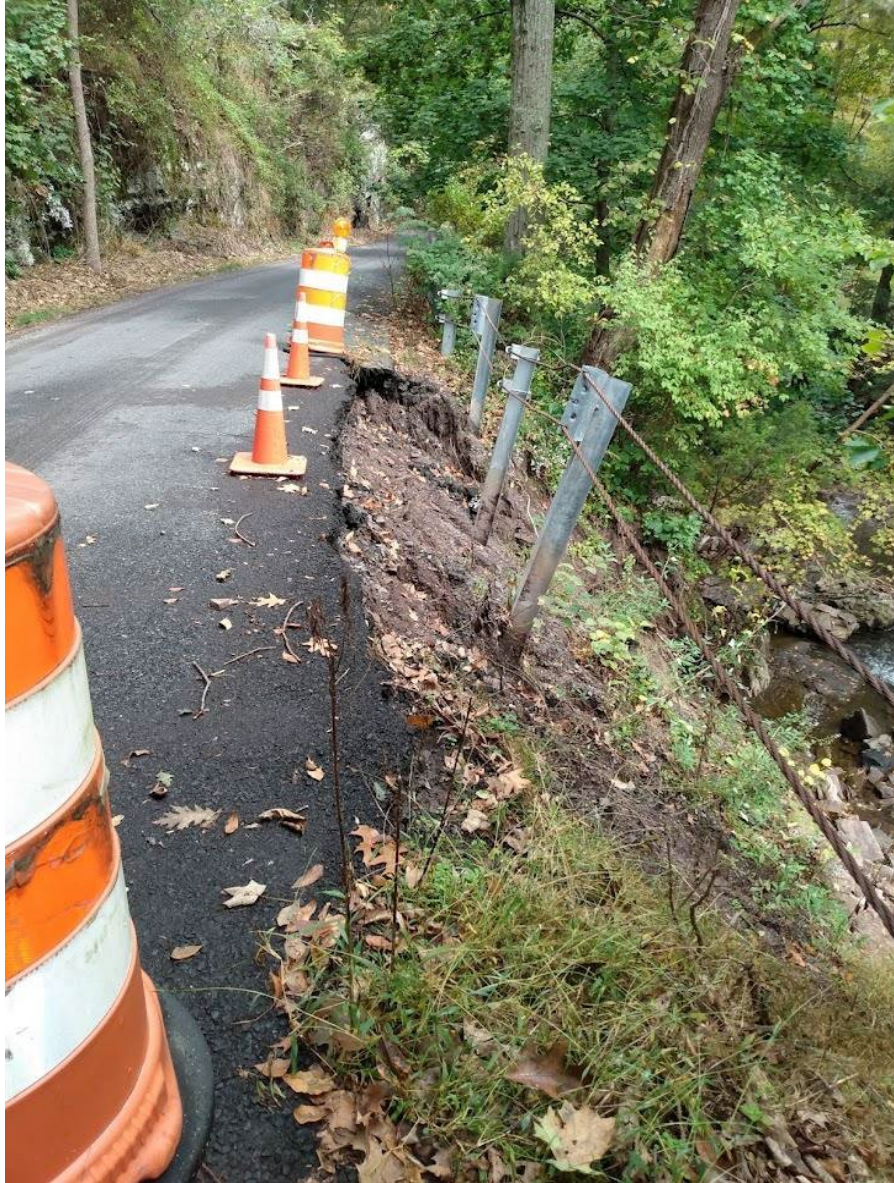
Figure 6.41. Roadway Washout and Slope Instability Upstream of Solder Pile Wall on Fleecy Dale Rd. Note exposed rock above roadway (40.393912, -75.057270).

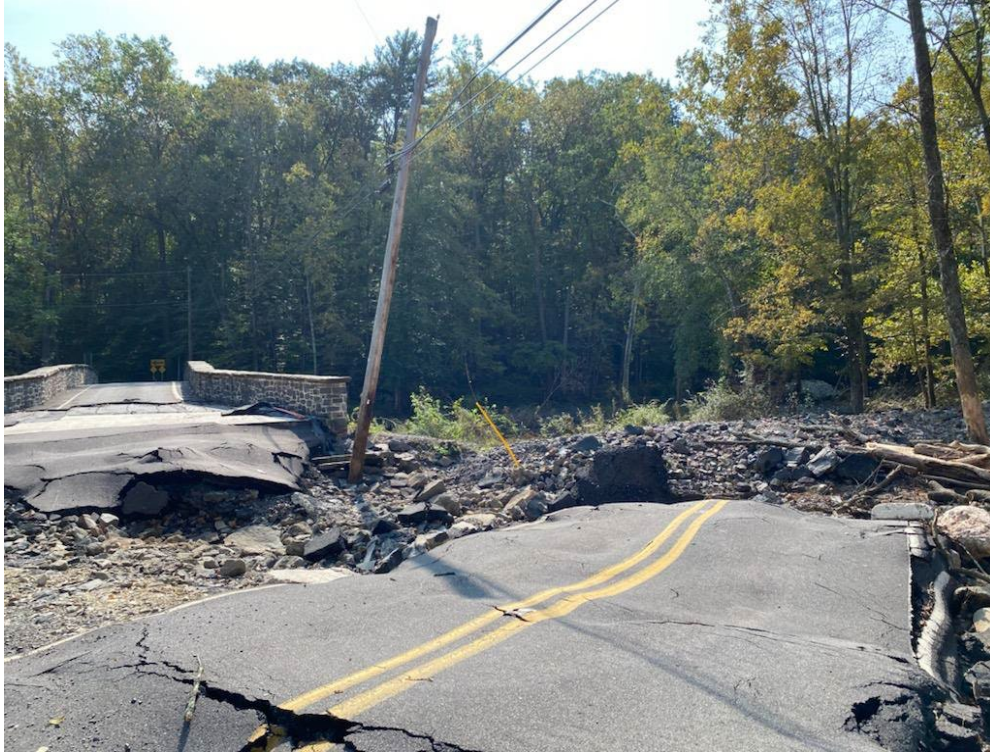
Additional photographs of damage for Swamp Creek Rd and Price Rd Bridges were taken by David Ebling. Figure 6.42 and 6.43 show the Swamp Creek Rd Bridge, which suffered significant washout of the approach roadway. Figure 6.43 shows that there was a geosynthetic beneath the roadway. Figures 6.44 – 6.46 shows the Price Rd Bridge which was damaged and suffered a loss of some of the stone arch bridge and the parapet wall. Figure 6.47 shows the Swamp Creek Bridge 2 which had damage to the parapet wall.

Figure 6.42. Swamp Creek Rd Bridge Roadway Washout (40.334567, -75.449707).

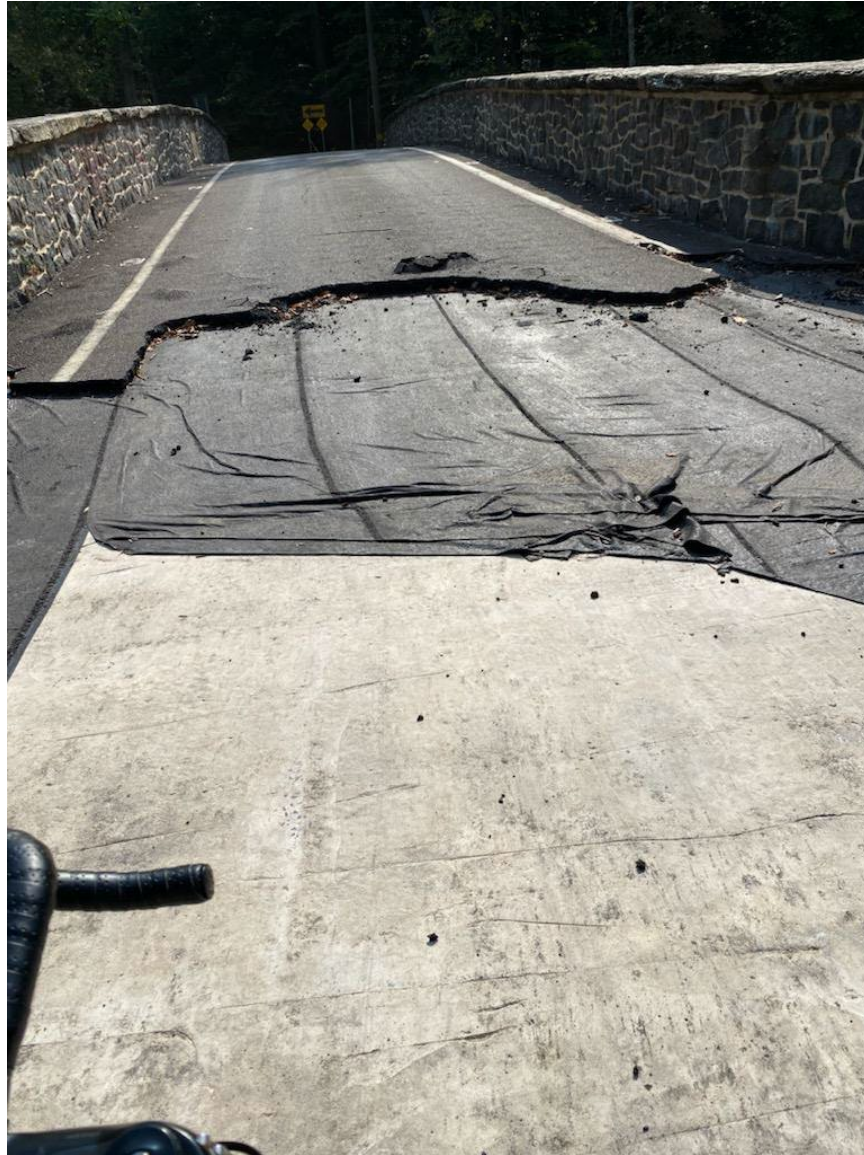
Figure 6.43. Swamp Creek Rd Bridge Asphalt Pavement Washout and Exposed Geosynthetic (40.334567, -75.449707).

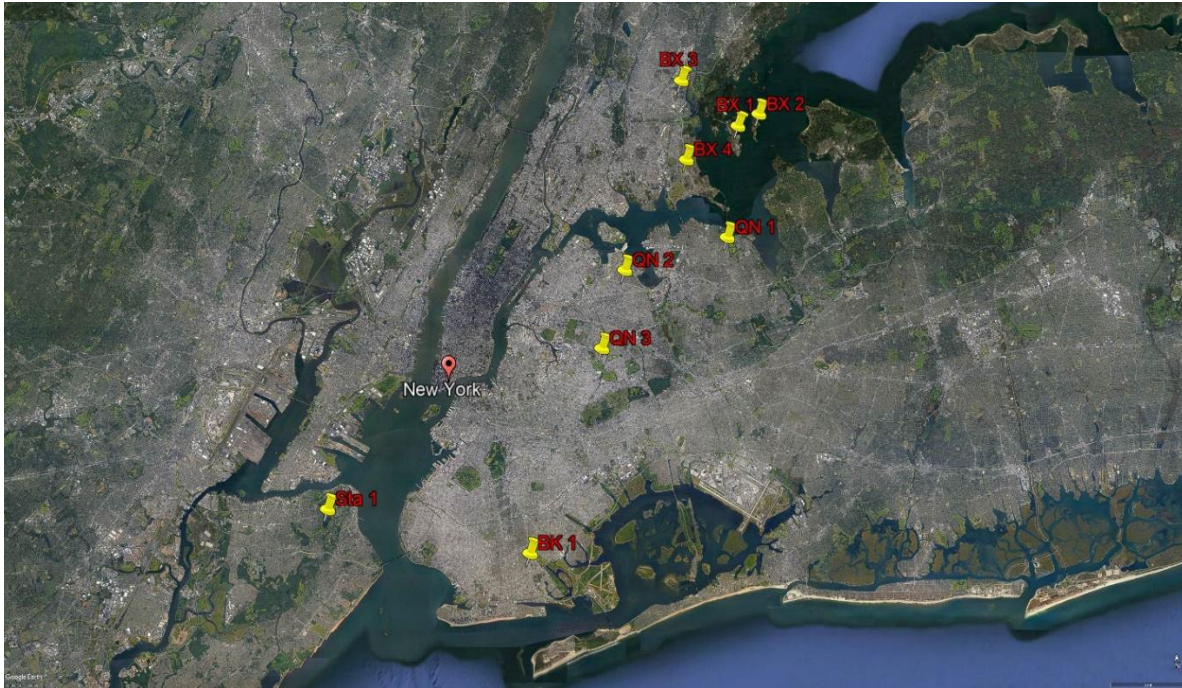
Figure 6.49. Location of severe flooding in New York City (QN= Queens, Sta: Staten Island, BK:Brooklyn, BX: Bronx).

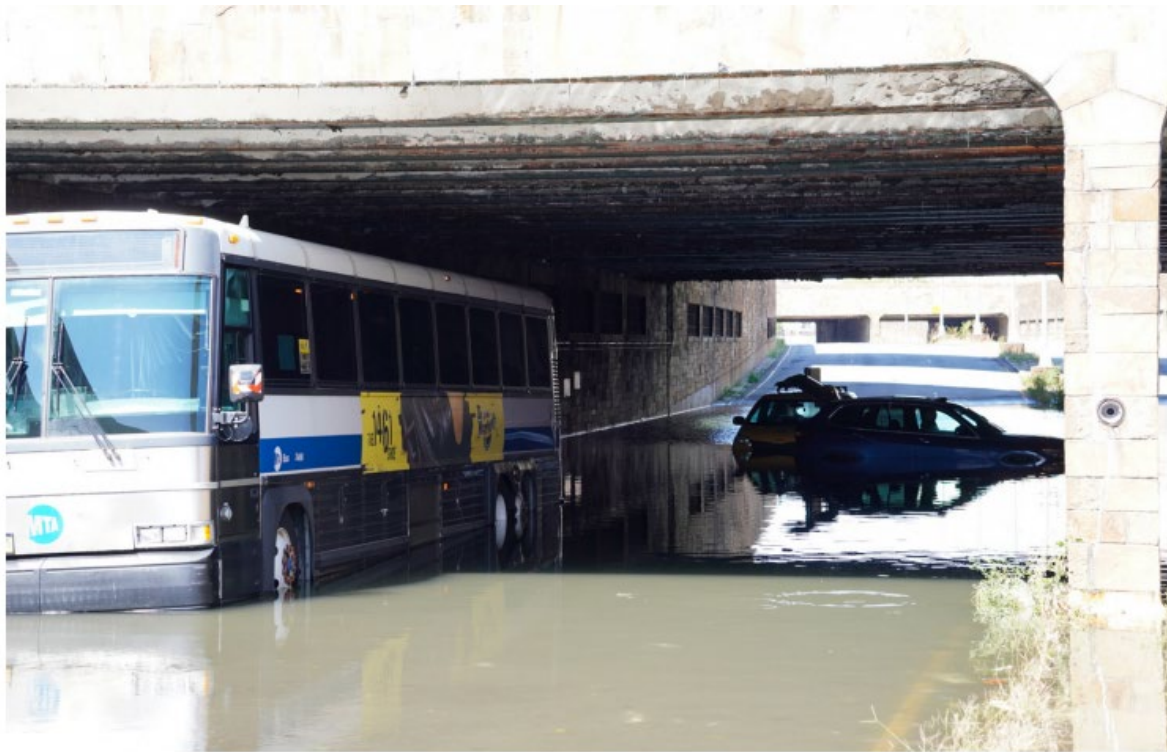
Figure 6.50. Streets flooding due to heavy rainfall in NYC (Image Courtesy: NYC, 2021).

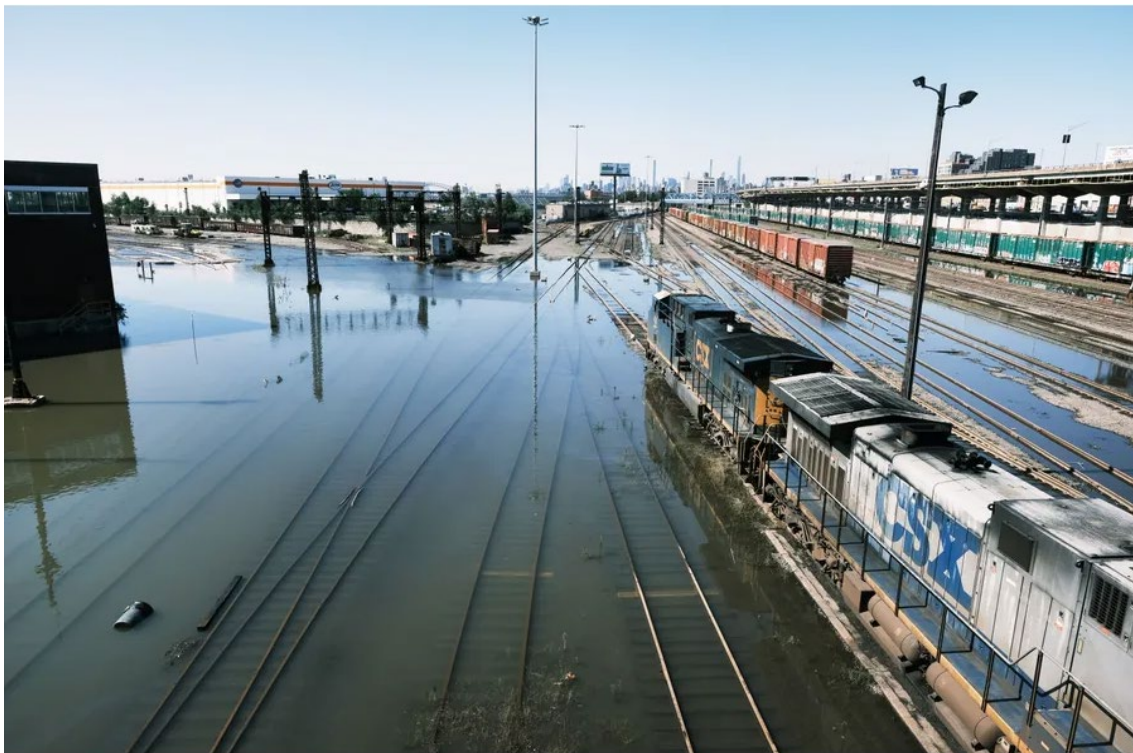
Figure 6.52. Flooded rail track in Bronx, NY (Image Courtesy: NYTimes).

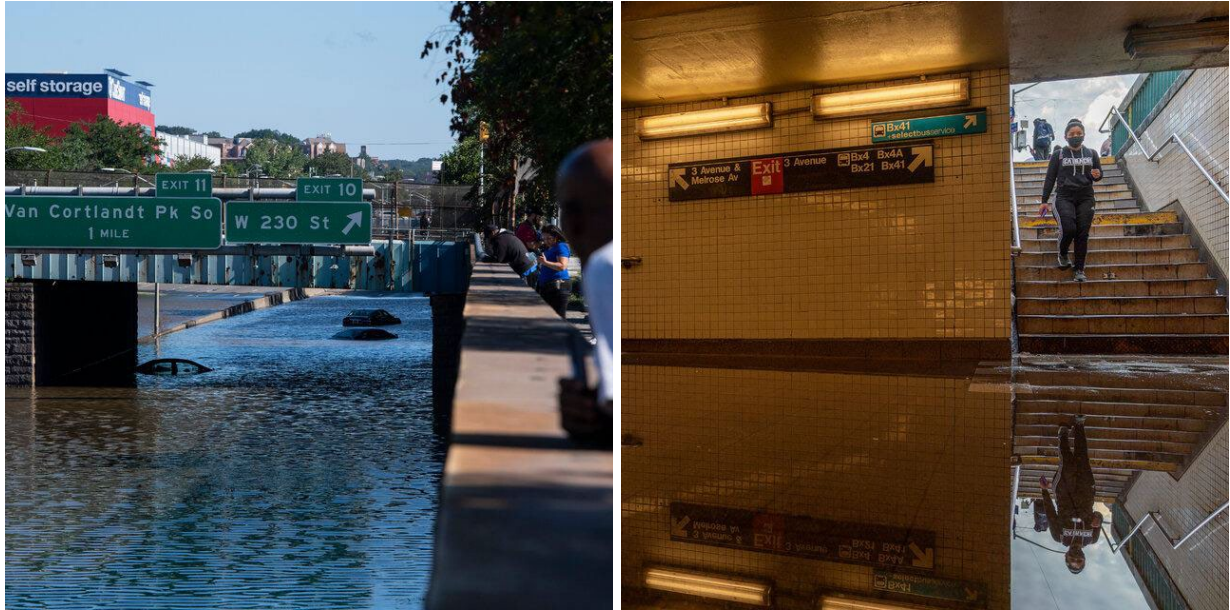
Figure 6.53. Flooded highway (left) and inundated subway (right) in NYC (Image Courtesy: NYTimes).

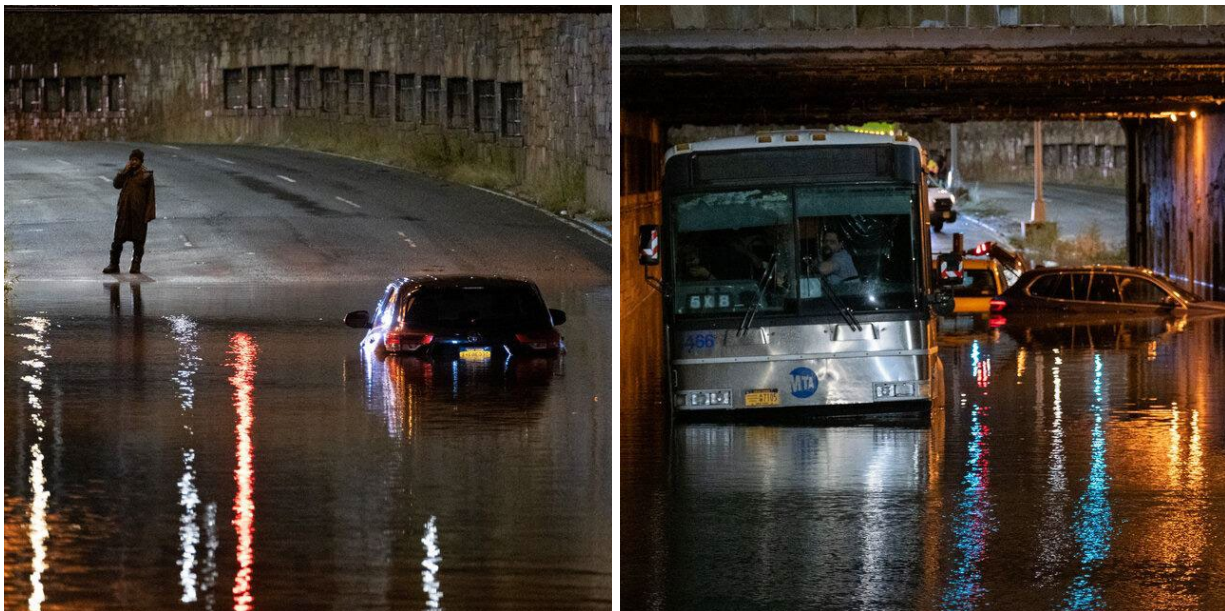
Figure 6.54. Flooded highway with stranded vehicles in NYC (Image Courtesy: Reuters).

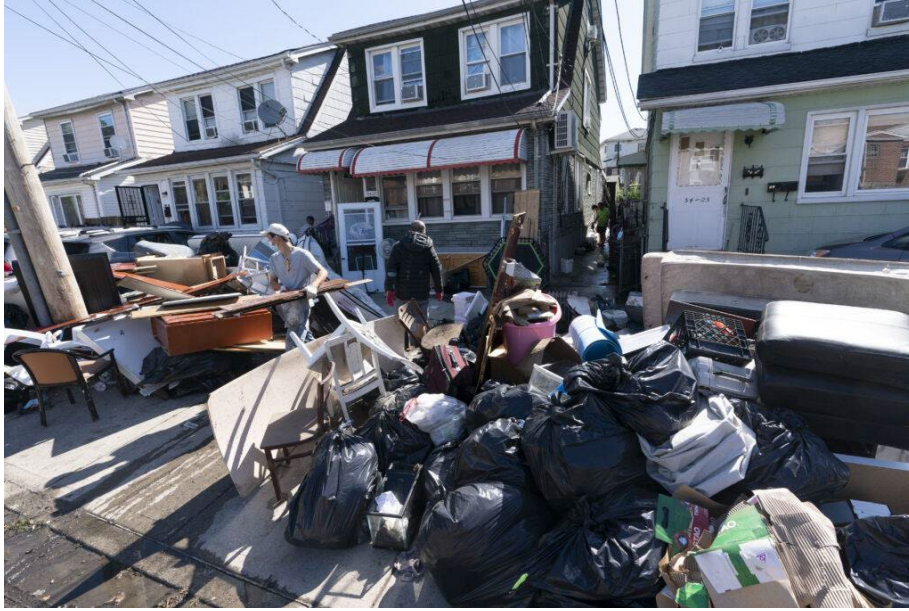
Figure 6.55. Debris piled up at street of Queens (Image Courtesy: Reuters).

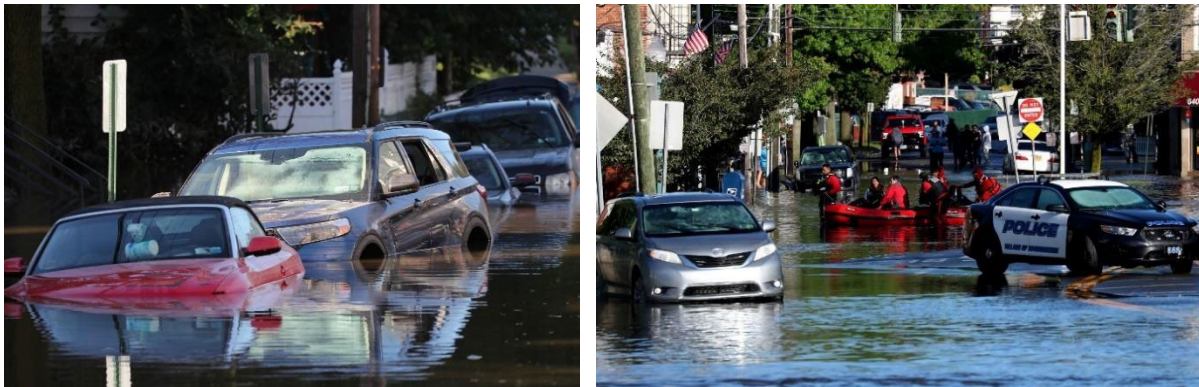
Figure 6.56. Flooded vehicles (left) and rescue operation (right) at NYC (Courtesy: nymag).
