Geotechnical Extreme Events Reconnaissance

July 22, 2014

The 22 March 2014 Oso Landslide, Snohomish County, Washington

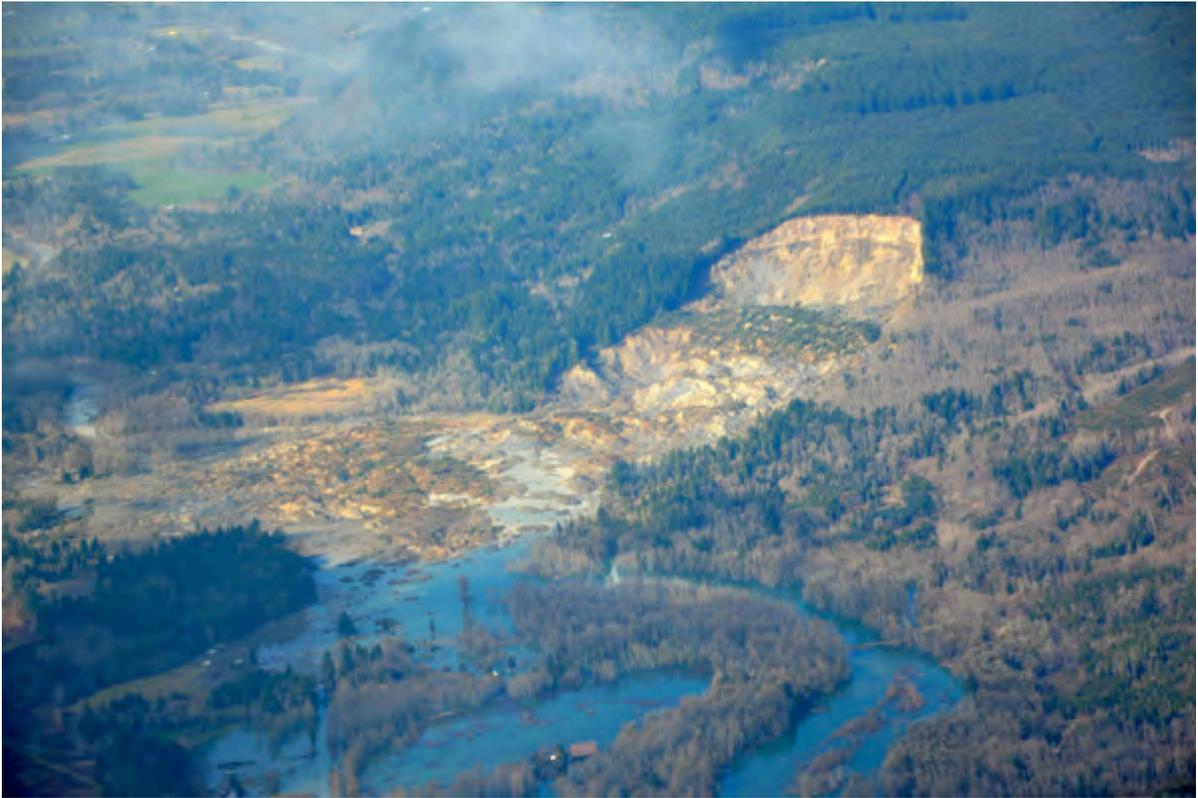
Figure 1.2 The 22 March 2014 Oso, Washington Landslide (photograph courtesy of the Washington Dept. of Transportation)

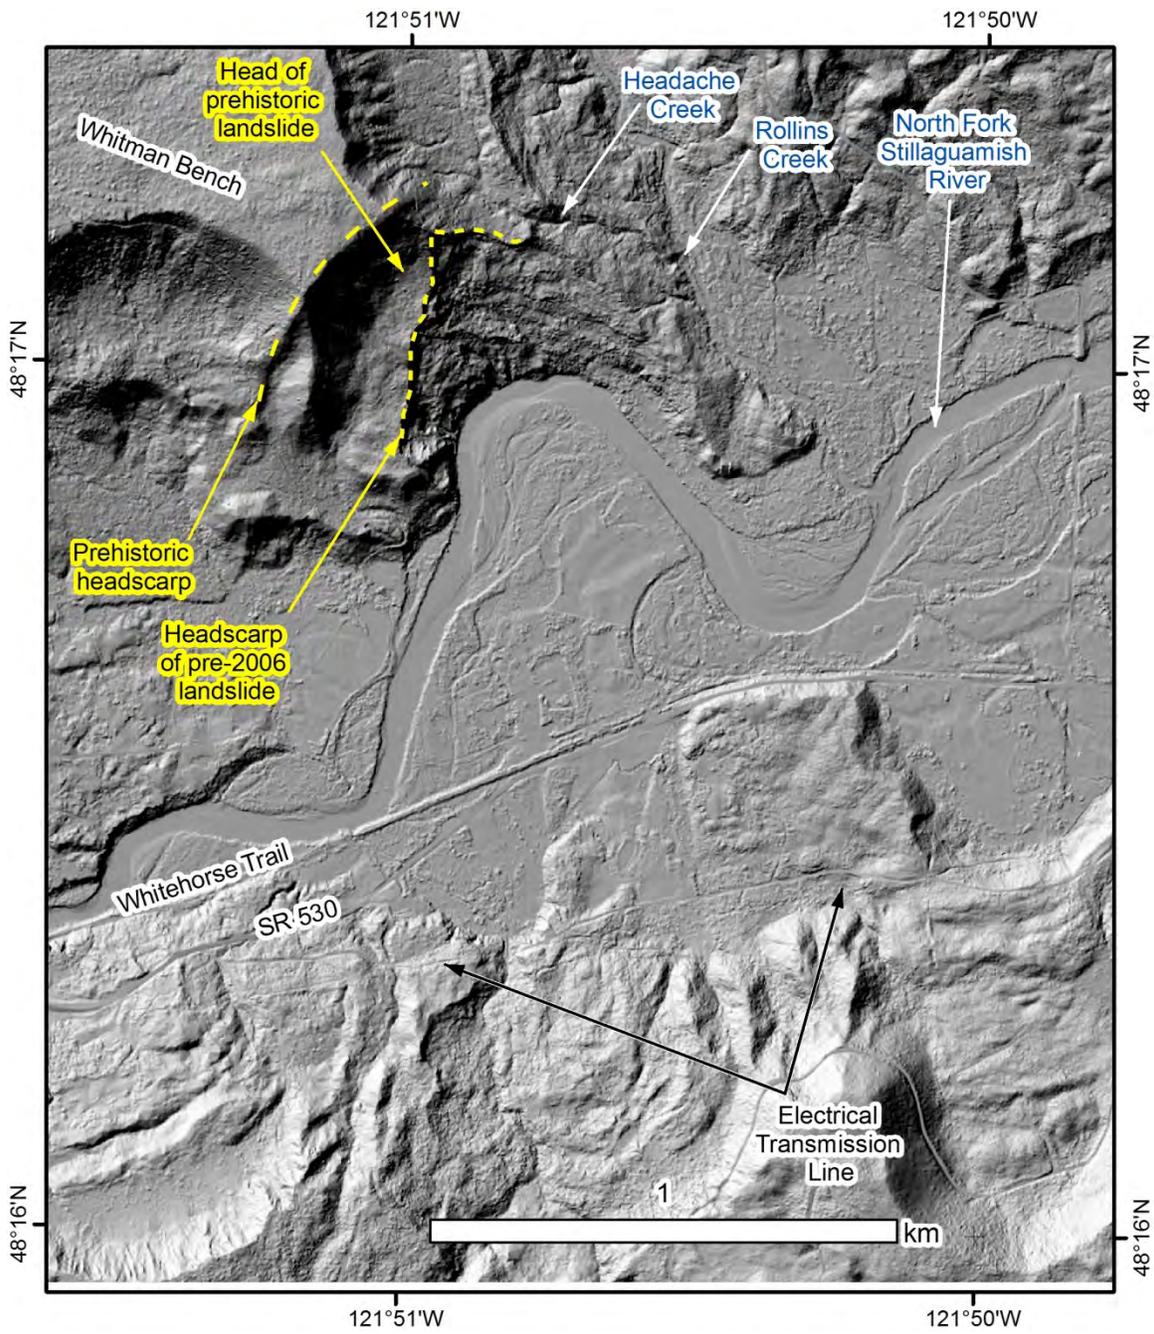
The stratigraphy of the landslide site is disrupted below the elevation of the “ancient headscarp” apparent on the 2003 hillshade image (Figure 2.2.2). But the undisturbed section now exposed in the 2014 landslide headscarp (Figure 2.2.3), together with exposures on the landslide lateral margins, indicates that the site geology consists of deposits that are typical of the sequence found throughout the Puget Lowland. [Note that “headscarp” in this report would be called “main scarp” by Cruden and Varnes (1996).]

Figure 2.2.2 Hillshade map of 2003 ground conditions. Base image from 2003 lidar data.

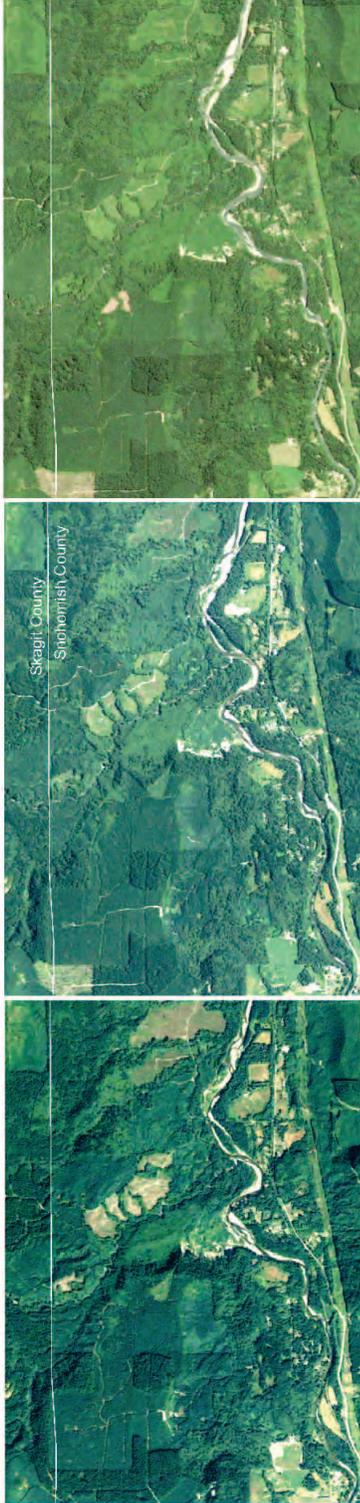
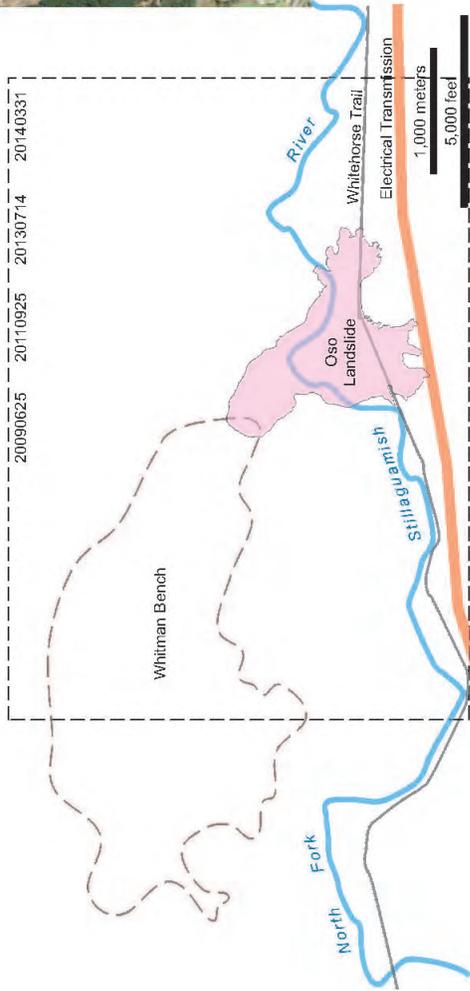
A photograph taken on 25 June 2009 (Figure 2.4.2F) shows little change relative to the 2007 image in Figure 2.4.2E). A photograph taken on 25 September 2011 (Figure 2.4.2F) shows clearcutting northwest of the Hazel landslide on the west edge of the photograph straddling the Snohomish-Skagit County boundary. Two small areas of clearcutting are visible in a photograph taken on 14 July 2013 (Figure 2.4.2F) north of the triangle-shaped area of clearcutting that was visible on Whitman Bench in the aerial photograph taken on 31 July 2005 (Figure 2.4.2E) northwest of the Oso Landslide location. The photograph taken on 31 March 2014 (Figure 2.4.2E) was after the Oso Landslide occurred; vegetation changes are not apparent between the 2013 and 2014 photographs. The head of the Oso Landslide intersects the southeast tip of the triangle-shaped area of clearcutting that was first visible in the 2005 photograph. A correlation between clearcutting timber and landslide activity does not appear to be indicated by the aerial photographs presented in the Figure 2.4.2 series. Conversely, it is clear that large landslides mapped by Dragovitch et al. (2003) in the vicinity of the Oso Landslide and shown in Figure 2.2.1 pre-date logging activities in this region.

Figure 2.4.2F. Images showing features indicating forest harvest (2009, 2011, 2013, 2014)

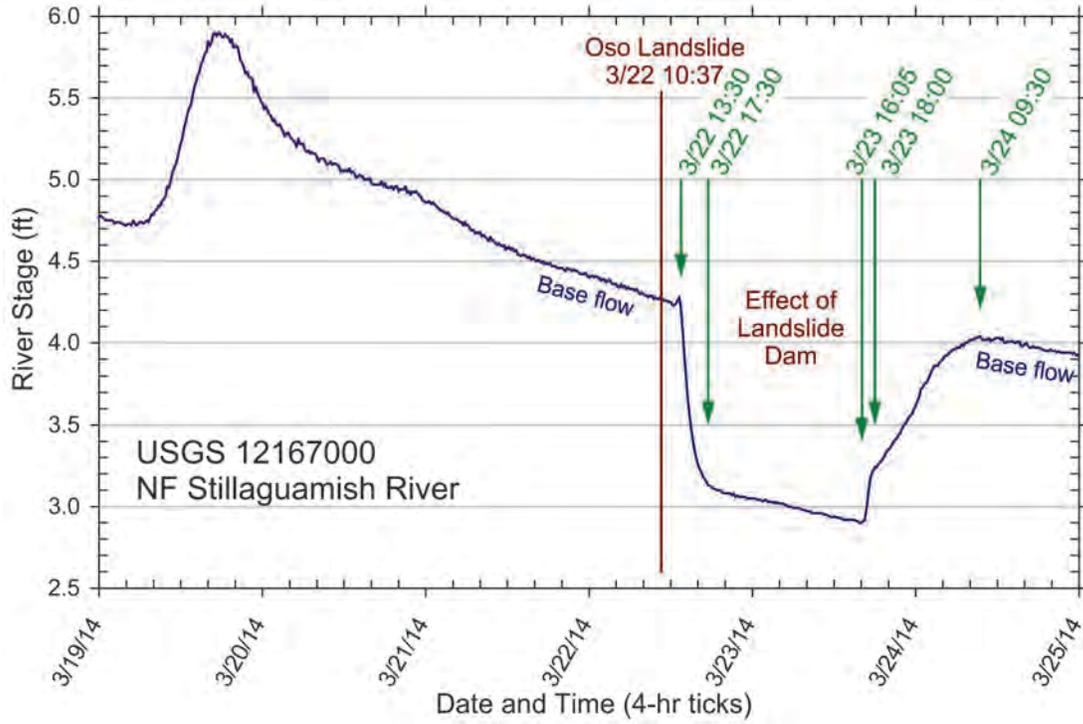
The detailed times associated with changes in river stage listed in Figure 3.3.3 show that a base flow condition returned albeit at a lower stage, at about 5:30 PM on 22 March and persisted for nearly 23 hours before an abrupt rise in river stage occurred. The abrupt rise in stage moderated at 6:00 PM on 23 March. Flow across the landslide appears to have been essentially recovered by

Figure 3.3.3 North Fork Stillaguamish River stage showing effects of Oso Landslide dam. Plotted from data obtained from USGS website http://waterdata.usgs.gov/wa/nwis/uv/?site_no=12167000

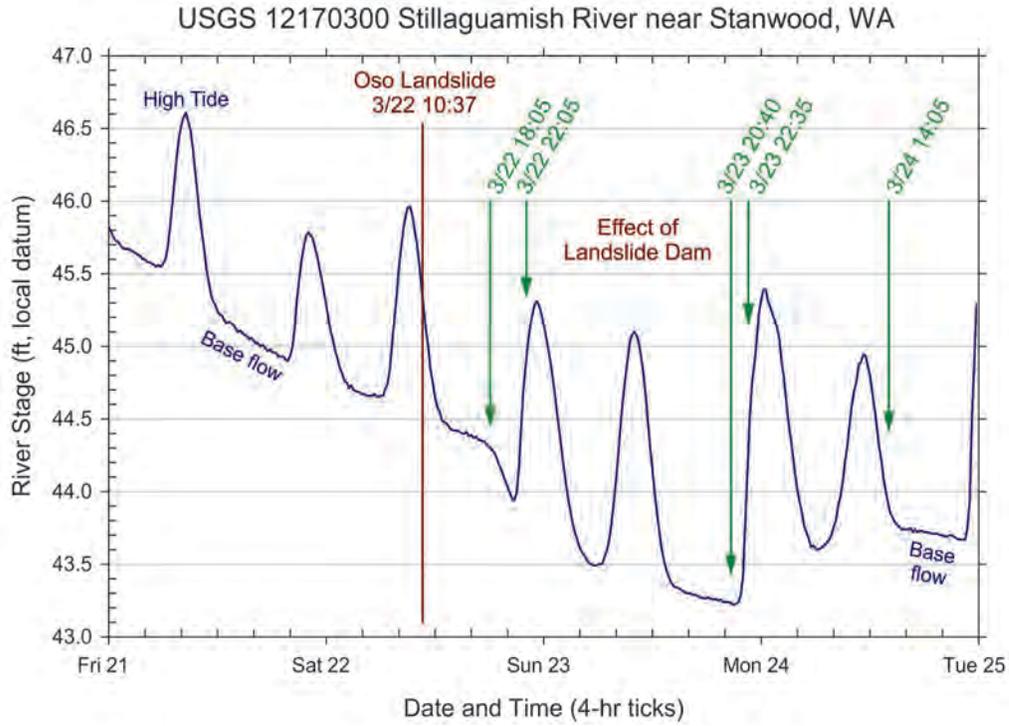
9:30 AM on 24 March. The USGS reported that the drop in river stage amounted to a reduction in discharge of about 34 cms (1200 cfs) (online report at http://www.usgs.gov/blogs/features/usgs_top_story/landslide-in-washington-state/). A stream gauge downstream from Arlington on the Stillaguamish River (USGS 12170300) in the range of tidal influence also recorded the effect of the Oso Landslide dam (Figure 3.3.4).

Figure 3.3.4 Stillaguamish River stage showing effects of Oso Landslide dam and tidal influence from Puget Sound. Plotted from data obtained from USGS website http://waterdata.usgs.gov/wa/nwis/uv/?site_no=12170300.

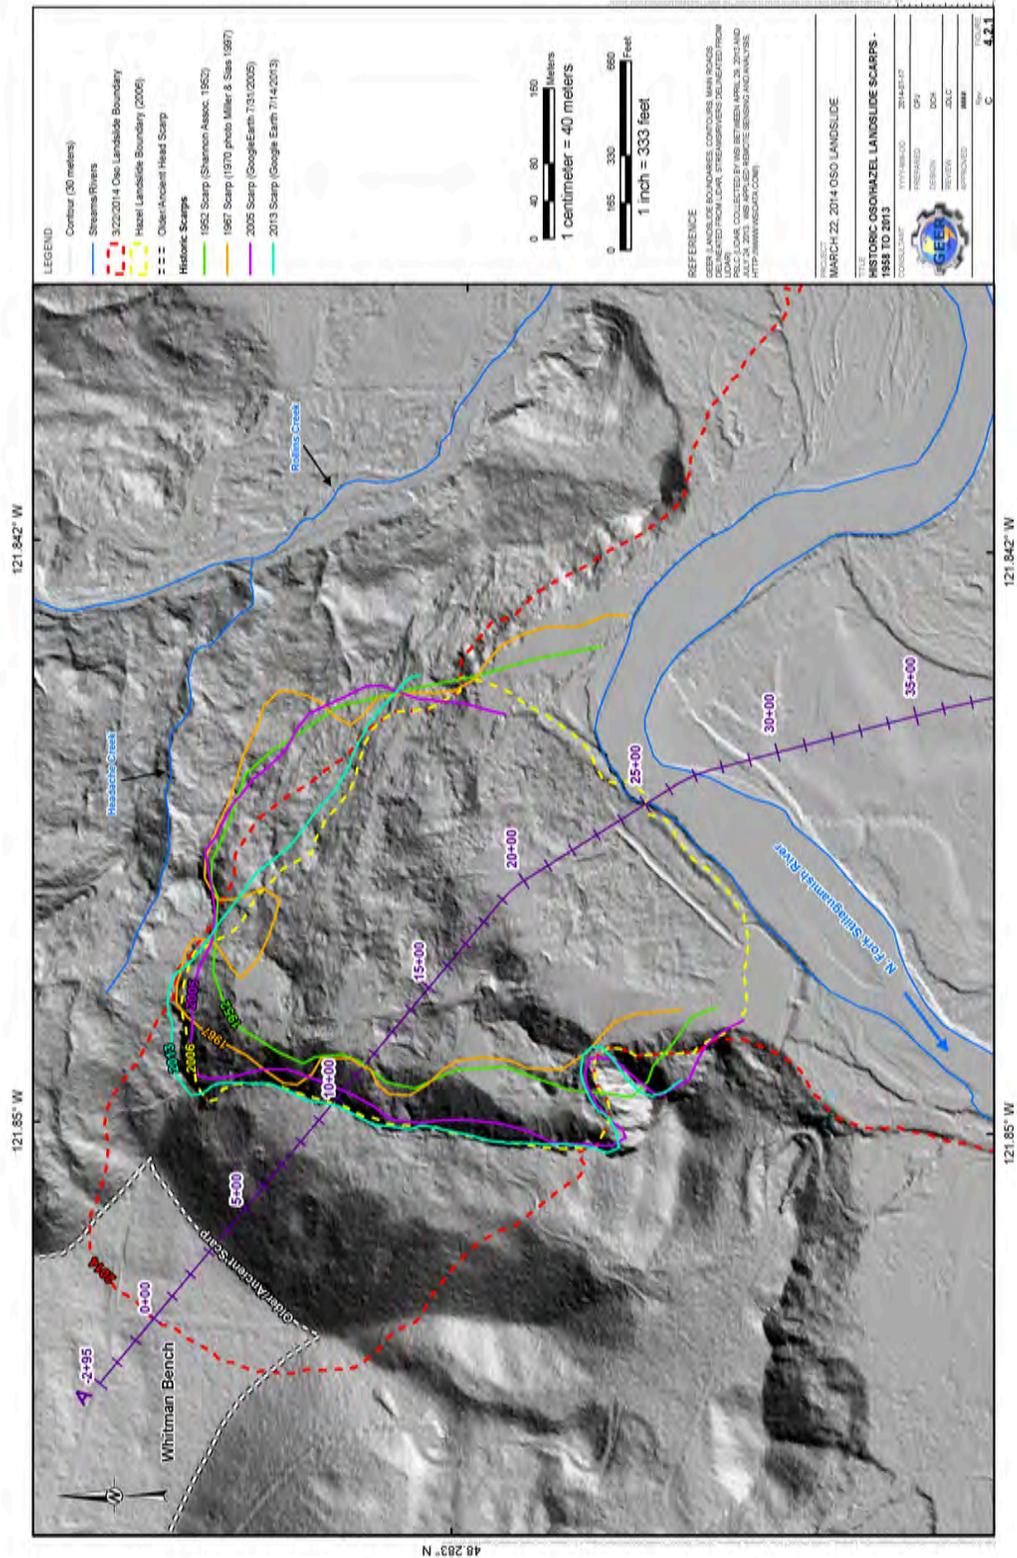
Episodes of prior movement of the Oso (Hazel) slide have been described in a number of studies dating back to the 1950s (Shannon and Associates, 1952; Thorsen, 1969; Benda et al., 1988; Miller and Sias, 1997; 1998). The observed historic activity appears to be episodic with the headscarp advancing headward between 1952 and 2006, but with the main slide mass constrained to approximately the same portion of the slope where the 2006 landslide failed (see Figure 4.2.1 for historic Oso/Hazel Landslide disturbances and scarps from 1952 to 2013).

Georeferencing and compiling the various versions of mapped positions of the active headscarp into a single map reveals evidence of minor episodic headward growth (Figure 4.2.1), until the slide expanded greatly in 2006 and again, this time catastrophically, in 2014.

Figure 4.2.1 Historic Oso/Hazel Landslide disturbances and scarps from 1958 to 2013.

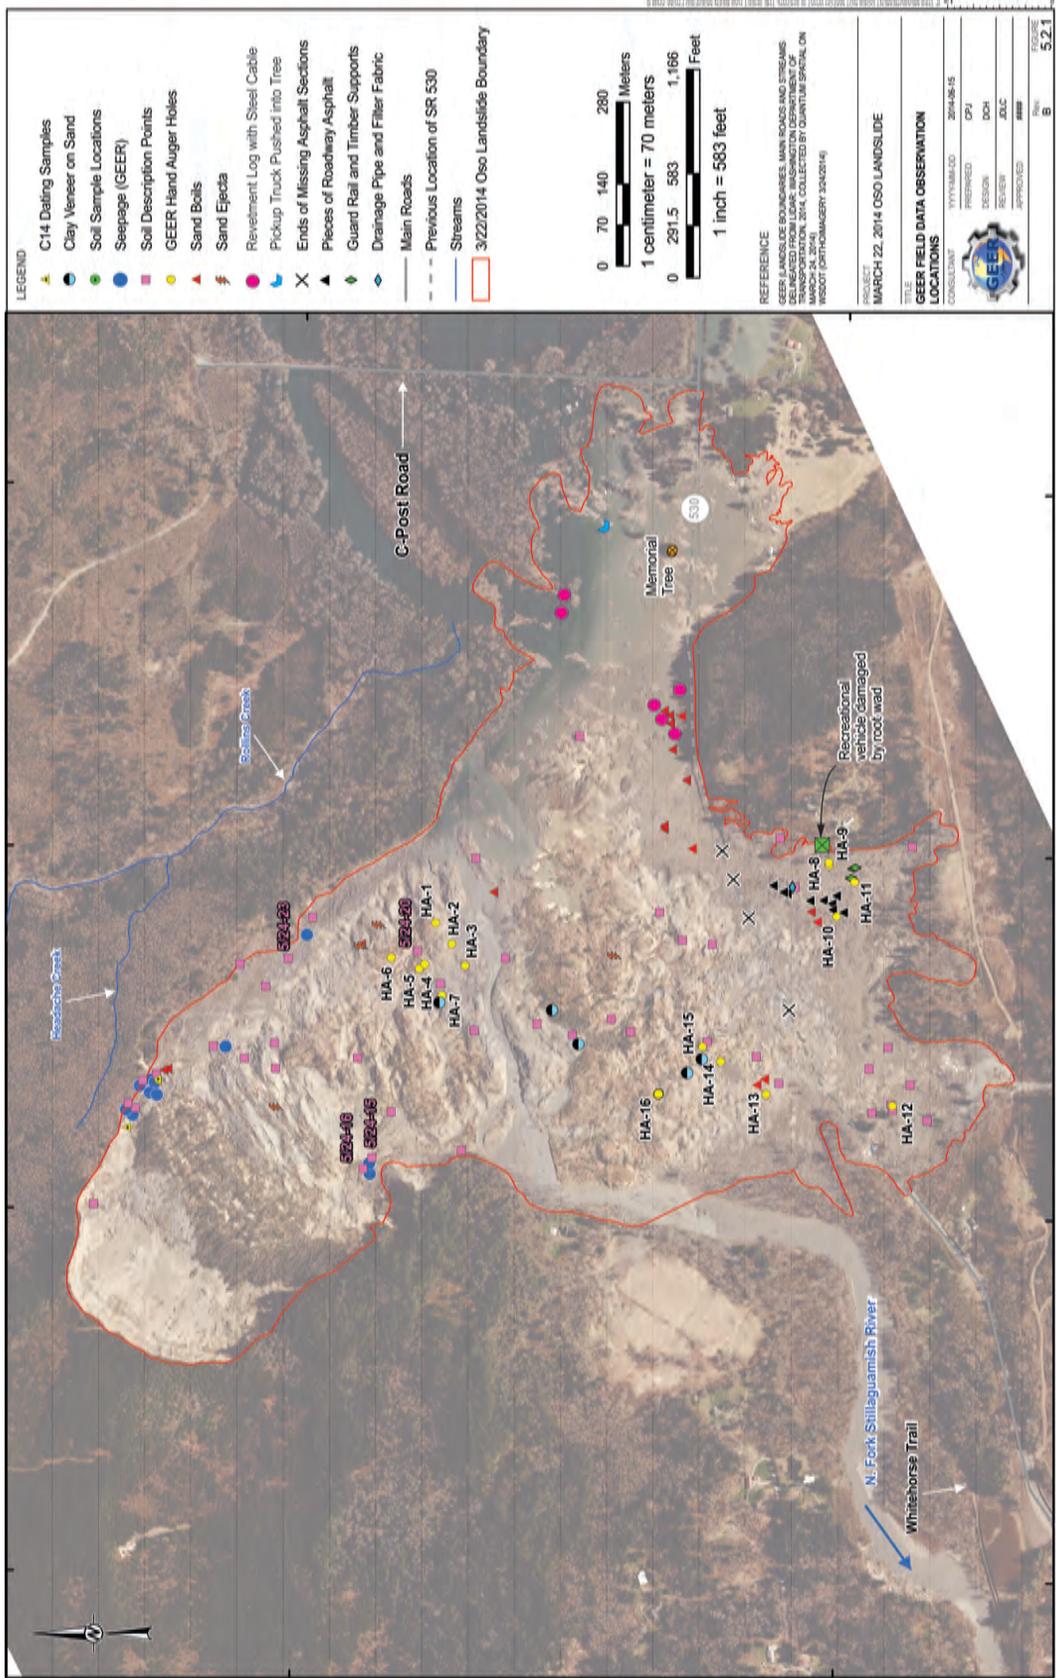
Observations on the morphology of the landslide include how the existing landforms provide evidence of rotation, extension, localized compression, discrete headscarp failures, post-failure talus formations, superposition, debris flow, and liquefaction. Evidence of all of these processes were observed in parts of the landslide and recognized by their morphology, structure, and deposits. Understanding of the stratification of the landslide deposit was augmented by 16 hand auger probe holes. Aerial imagery shows quite well where brown, oxidized material (recessional outwash and colluvium) is on the surface. We used the hand auger primarily to probe the thickness of this cover and to determine if this material could be found underneath a cover of the gray lacustrine deposits mobilized by the landslide. The locations of these probe holes are shown in Figure 5.2.1 (labeled HA-1 to HA-16).

An exposure of relatively flat-lying gray lacustrine sediments, consisting of silty fine sand and a zone of ≈ 10 mm thick clay layers with silt partings (Point 5/24-23 on Figure 5.2.1), is similar to an exposure in ravine on west side of slide (Points 5/24-15&16 on Figure 5.2.1), suggesting that lacustrine deposits were originally continuous across the area that is now the landslide. Fallen, small deciduous trees were observed along the margin in Zone C but not to great enough extent to be mapped or analyzed as part of this effort.

Figure 5.2.1 Locations of key observations of GEER team during site reconnaissance.

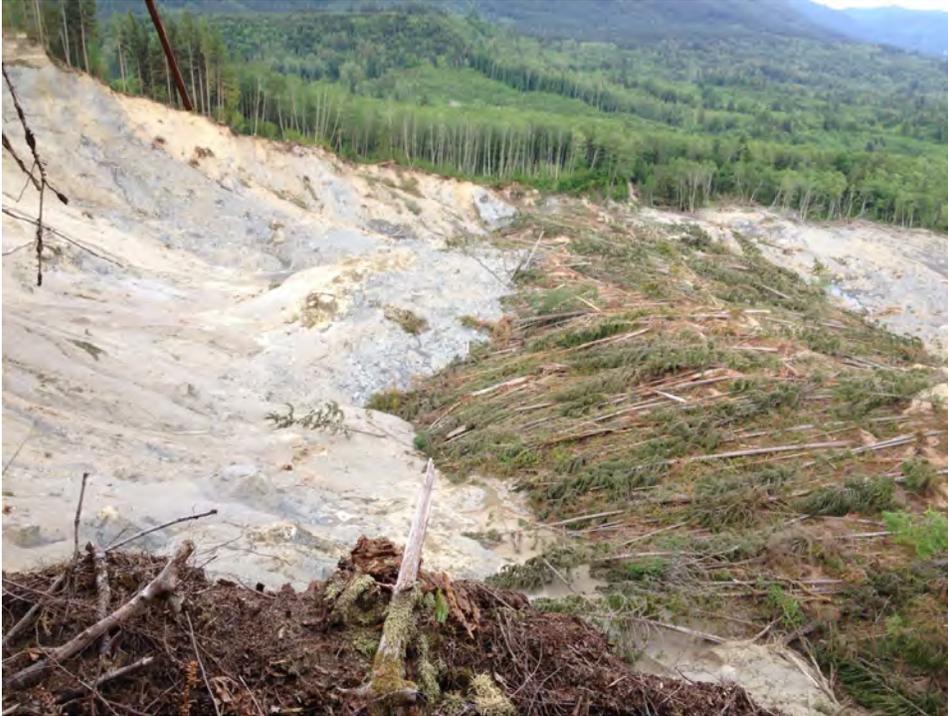
Zone A4 consists of a scarp-face failure in which till fragments and overlying recessional outwash material collapsed onto and over-rode a portion of the slump block that forms Zone A2 (Figure 5.2.6). Other failures off the headscarp have started to infill the closed depression (moat or graben) on the upslope side of Zone A2 at the base of Zone A1 with loose debris eroded from the over-steepened scarp face, rapidly smoothing the sharp, angular features of the headscarp as the moat fills with talus.

Figure 5.2.6 Onlap of gray till in Zone A4 over eastern portion of the downed-tree-covered slump block of Zone A2 (back-rotated slump block); view east from 48.27073, -121.84038.

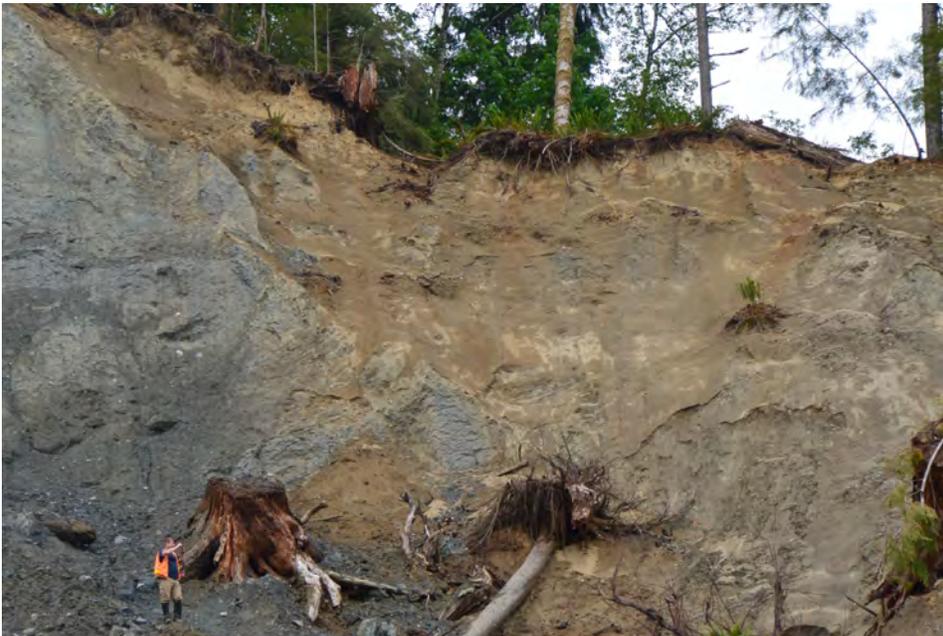
Figure 5.2.7 Photograph of the eastern margin of Zone A; view toward northeast. Note exposure of in-place till (gray at left) with steep contact (prehistoric landslide scarp) running from upper left corner of photo to lower middle. Sandy oxidized talus in middle and upper right buries log sampled for 14C dating (see Table 5.3.1, sample Oso3).

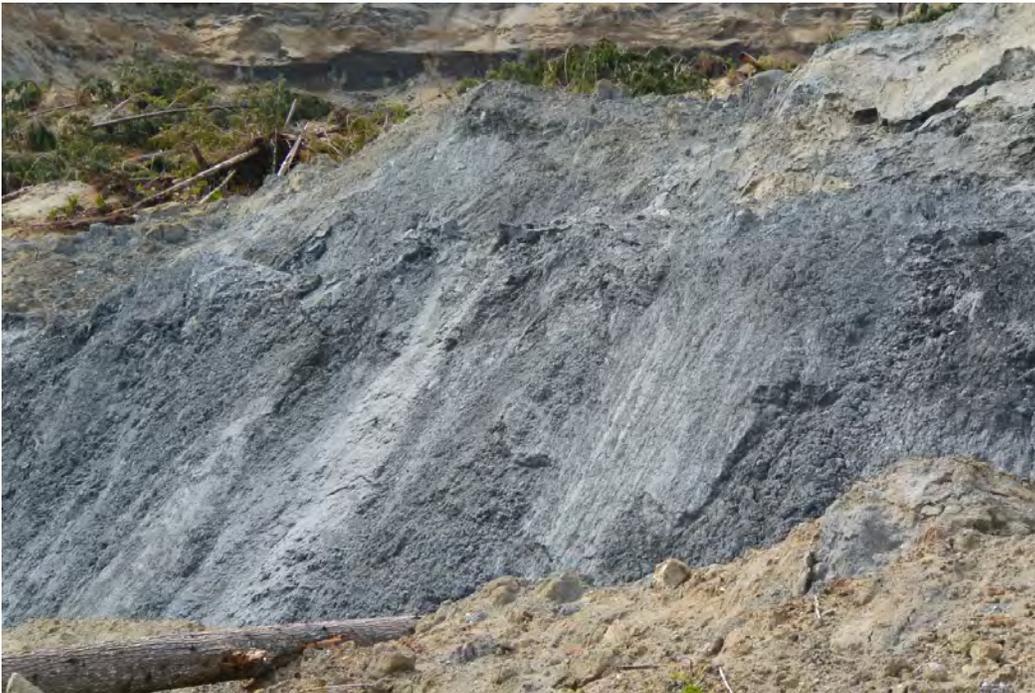
Figure 5.2.9: Zone B slickensides in lacustrine clay.

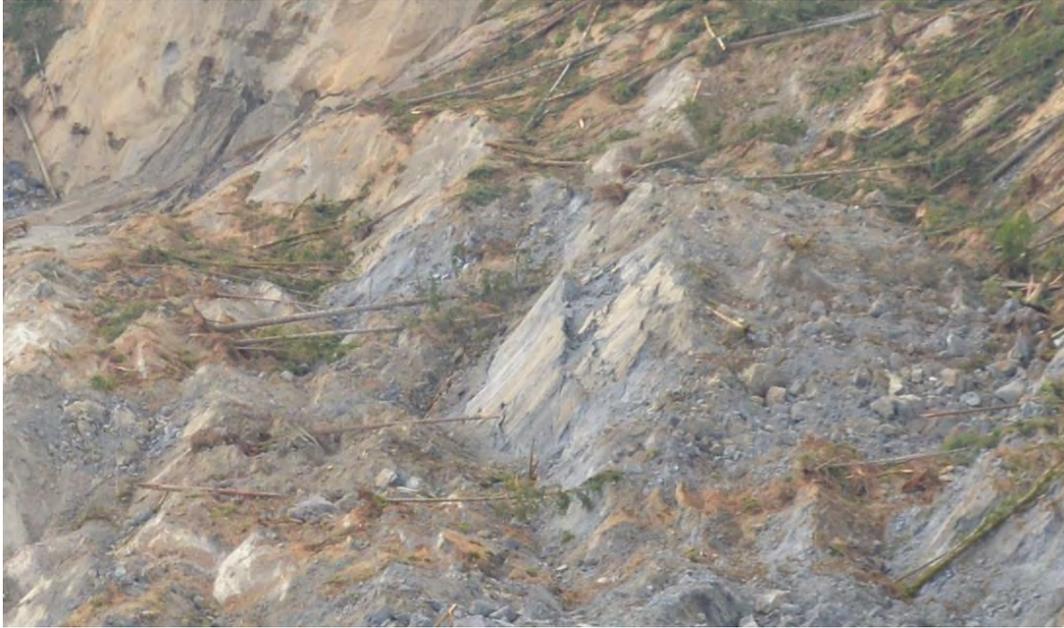
Figure 5.2.10a. Oblique view of two approximately 100-ft-long (30 m) fallen trees (near the center of the image) that have been dragged downslope after they were felled. They indicate the extension in this part of the slide mass. Photo by Eric Jensen, King County Sheriff Department, photo date 3/24/2014.

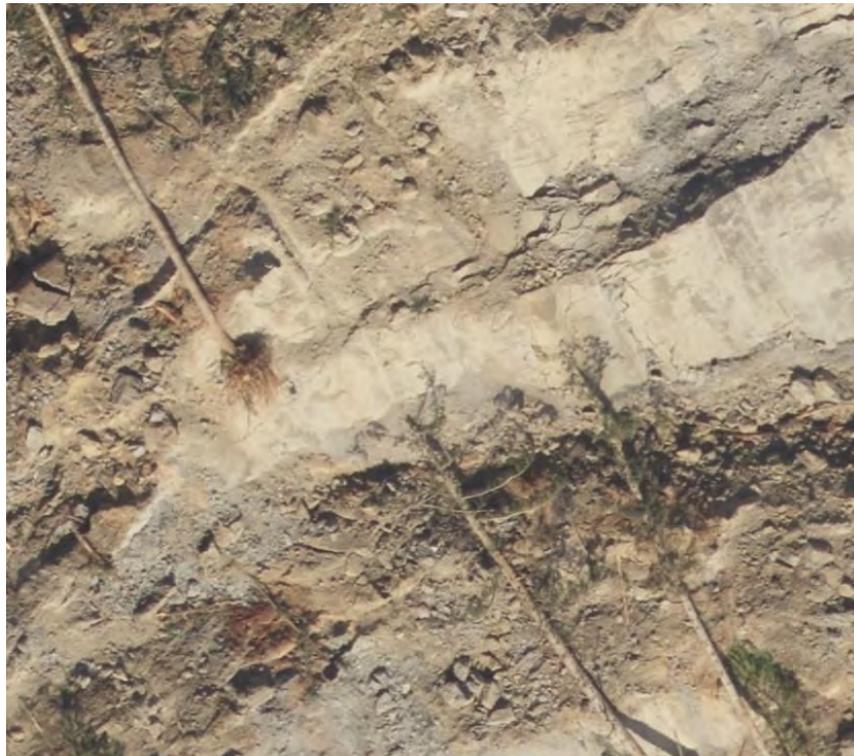
Figure 5.2.10b. Aerial view of indicator trees showing trails at least (45 m) 150 ft long showing skid marks from dragging. Location 48.28332, -121.84838. Aerial image dated 3/24/14 was provided by WSDOT GeoMetrix Office.

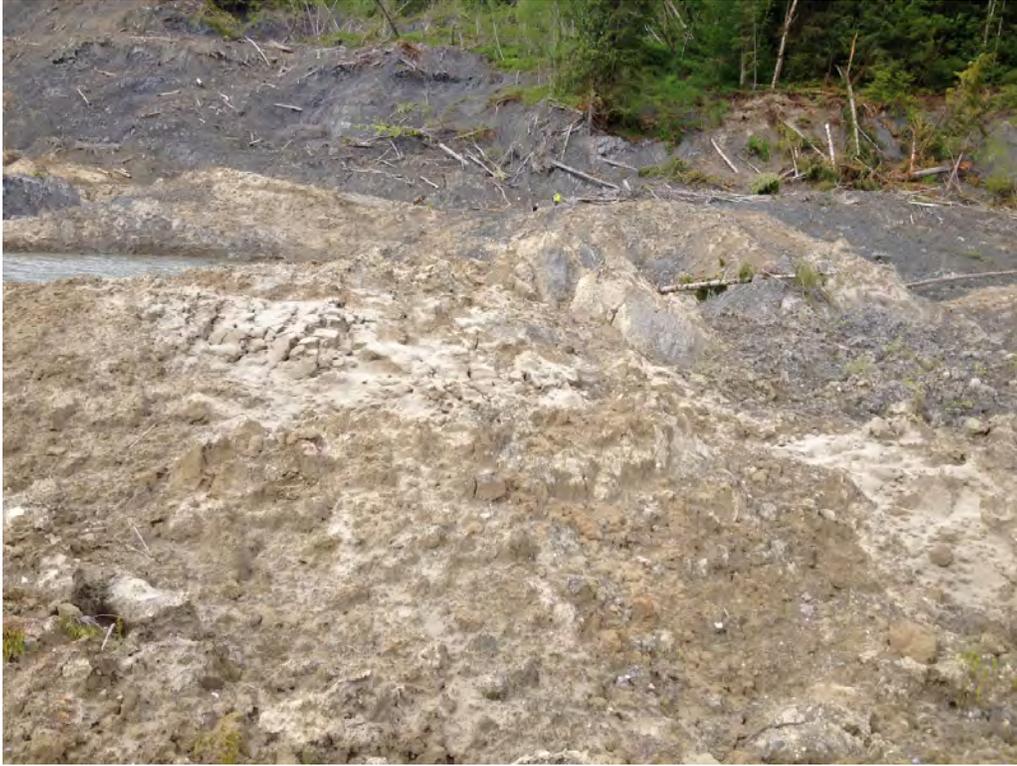
Deposits that are herein called sand ejecta (Figure 5.2.12) were observed in Zone B (and in Zone E). Sand ejecta deposits may be another expression of the same phenomenon as a sand boil (see

Zones E and F) – confined elevated water pressure and liquefaction of susceptible soils at depth. The sand ejecta deposits were not observed in low spots, but rather in what appear to be compression ridges. They appear to represent ejection by water of sand from cracks as the mass was emplaced. Sand ejecta deposits are not typically associated with earthquake-induced liquefaction and their mechanism of origin on the Oso Landslide is not as confidently understood as the sand boils. The fact that they were generally observed on higher ridges suggests that they could be associated with the thrusting upward of the ridges. Sand ejecta deposits were observed near the Zone B-Zone C interface.

Figure 5.2.12 View looking northeast at sand ejecta deposits in Zone B near the Zone C interface. Camera position: 48.28238, -121.84391.

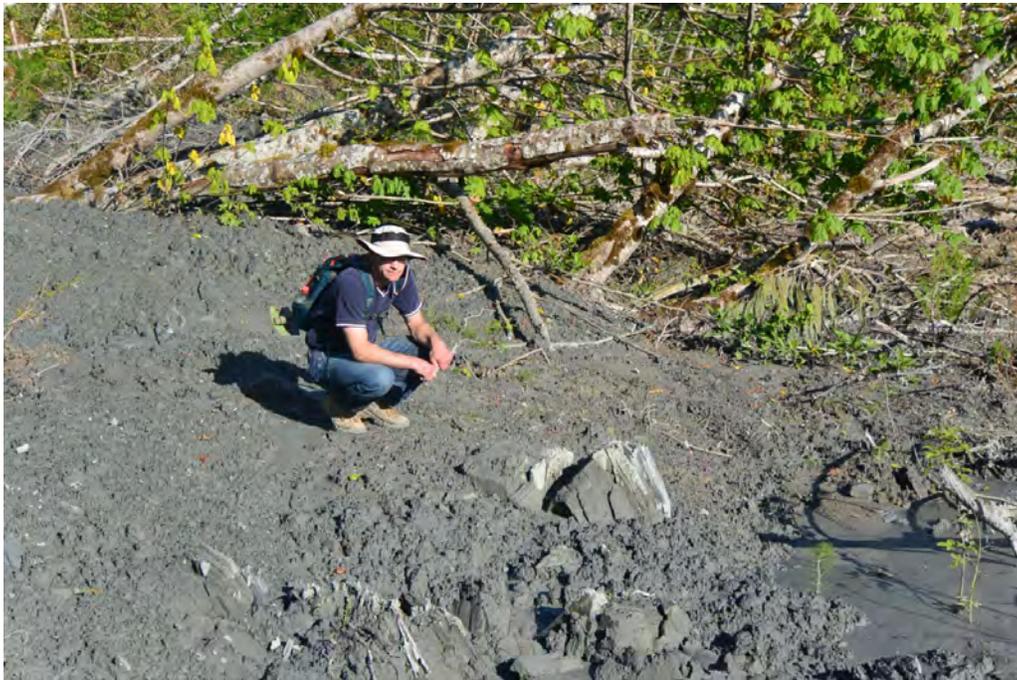
Figure 5.2.13A Liquefied lacustrine sediments in Zone C. Note rafted block of material set in flow matrix.

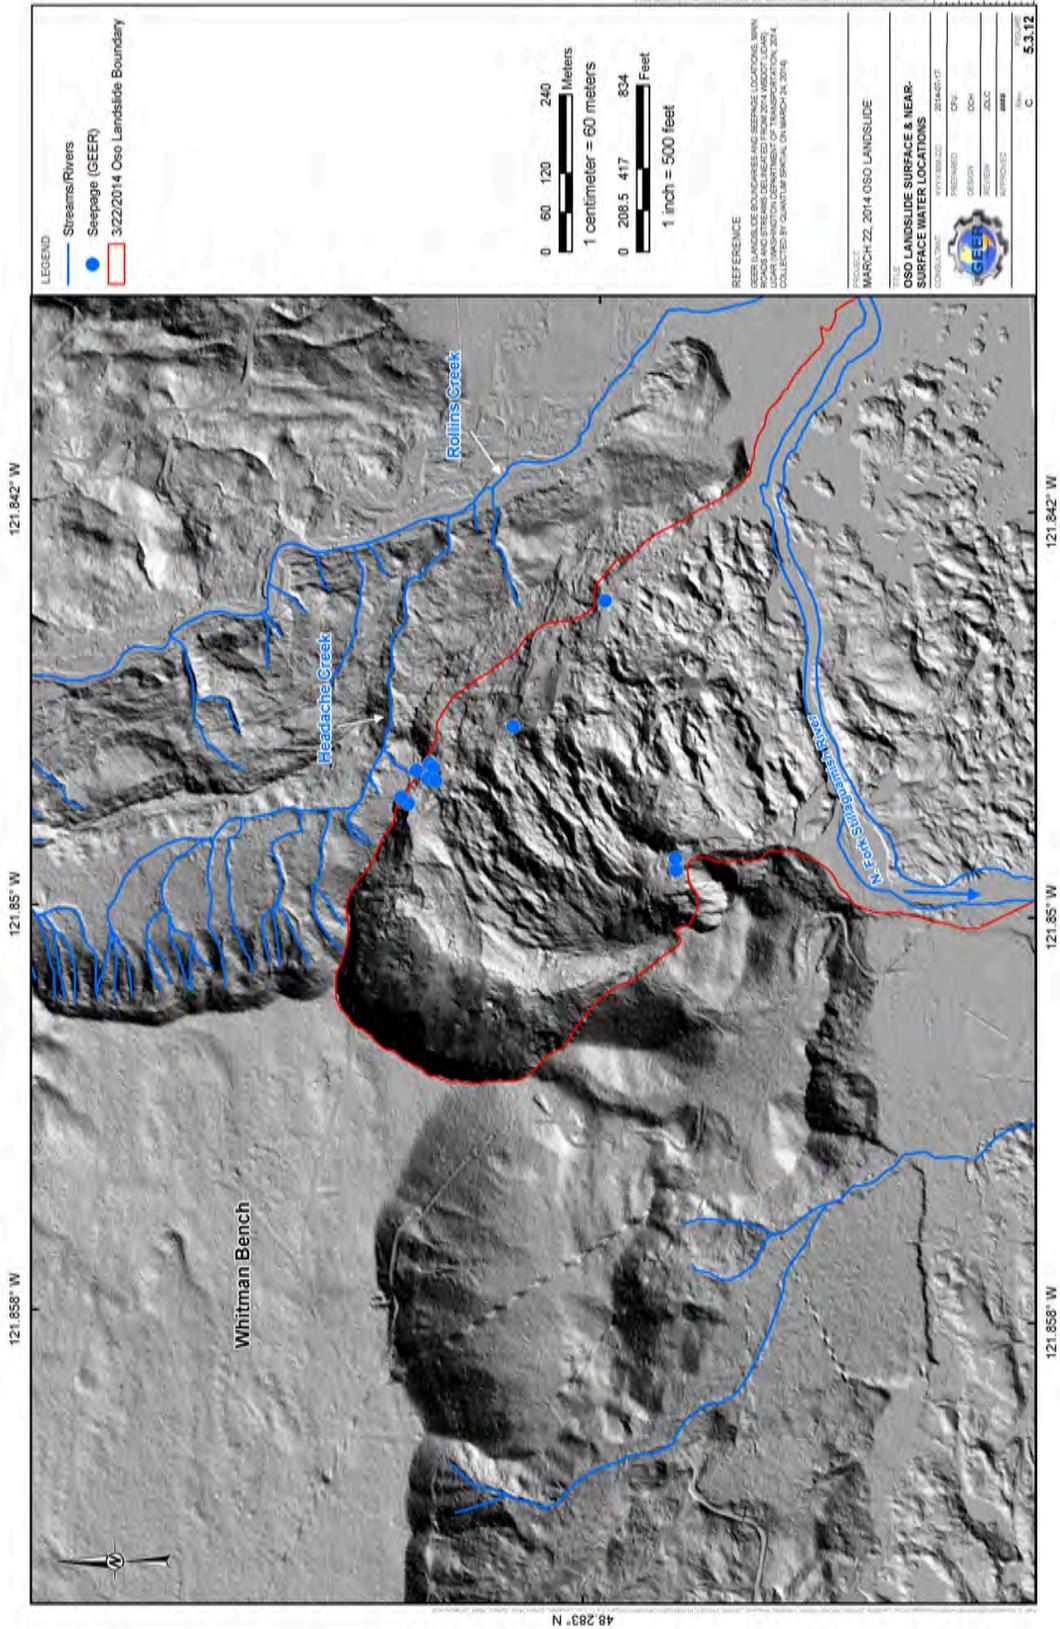
Figure 5.2.13B Map showing locations where several actively flowing seeps along the eastern margin of the landslide correspond to the uppermost areas of Zone C.

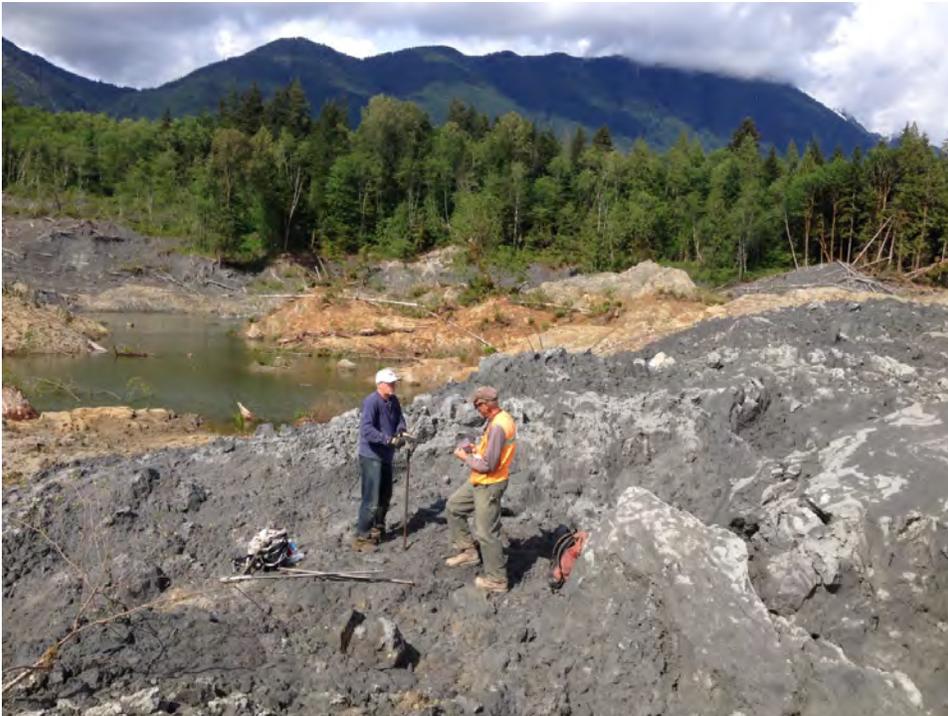
Figure 5.2.15: Hand auger boring (HA-3) into lacustrine material on the northern margin of Zone D. Camera location: 48.28118, -121.84519; view to northeast.

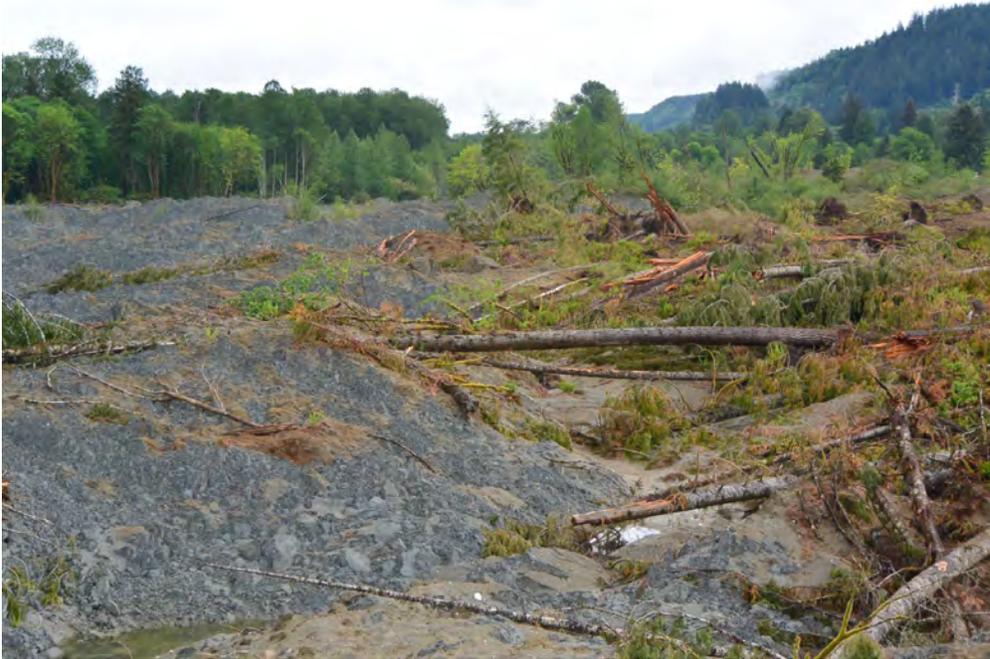
Figure 5.2.16: Southern margin of Zone D (gray on left) overriding northern trailing margin of Zone E debris (brown on right); view is to the east.

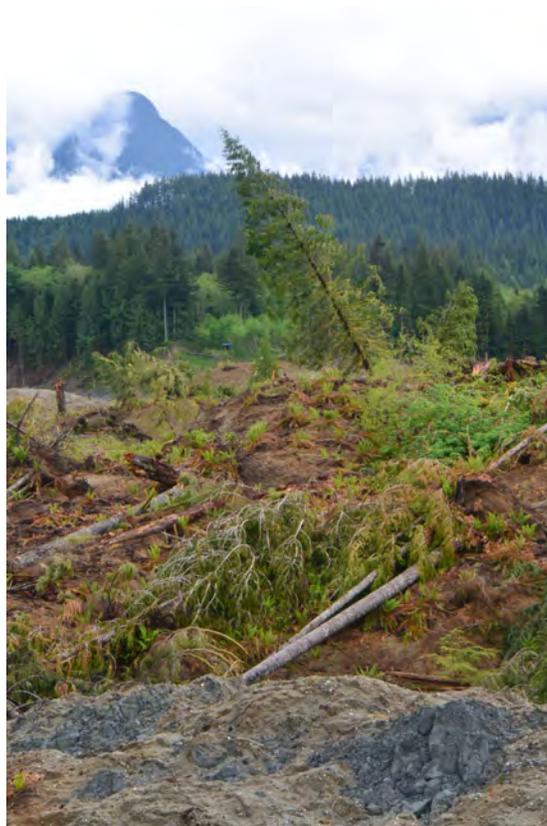
Trees on the surface of Zone E are both coniferous and deciduous. The coniferous trees are at the northern part of the zone and are dropped in various orientations, with some remaining subvertical (Figure 5.2.19). Large trees, with one observed to be >1.5 m in diameter, occur along the northern margin of the western portion of Zone E. Along this edge of Zone E (the northern

Figure 5.2.19 Tilted subvertical trees in Zone E.

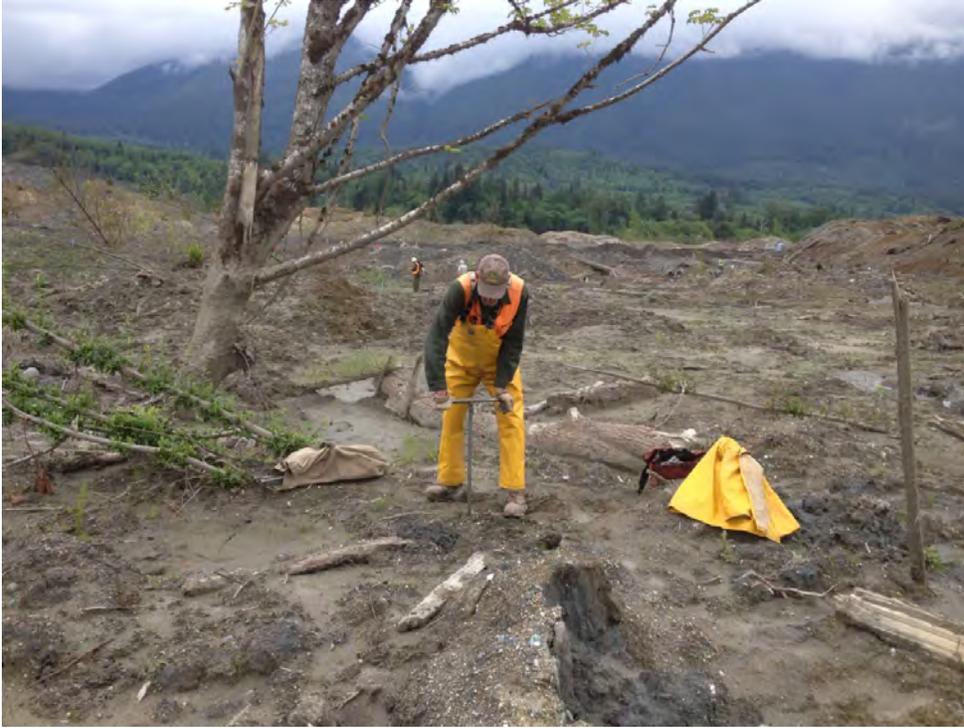
Figure 5.2.23 Sub-vertical tree rafted into current location near HA-10. Camera position: 48.27503, -121.84315, view northeast.

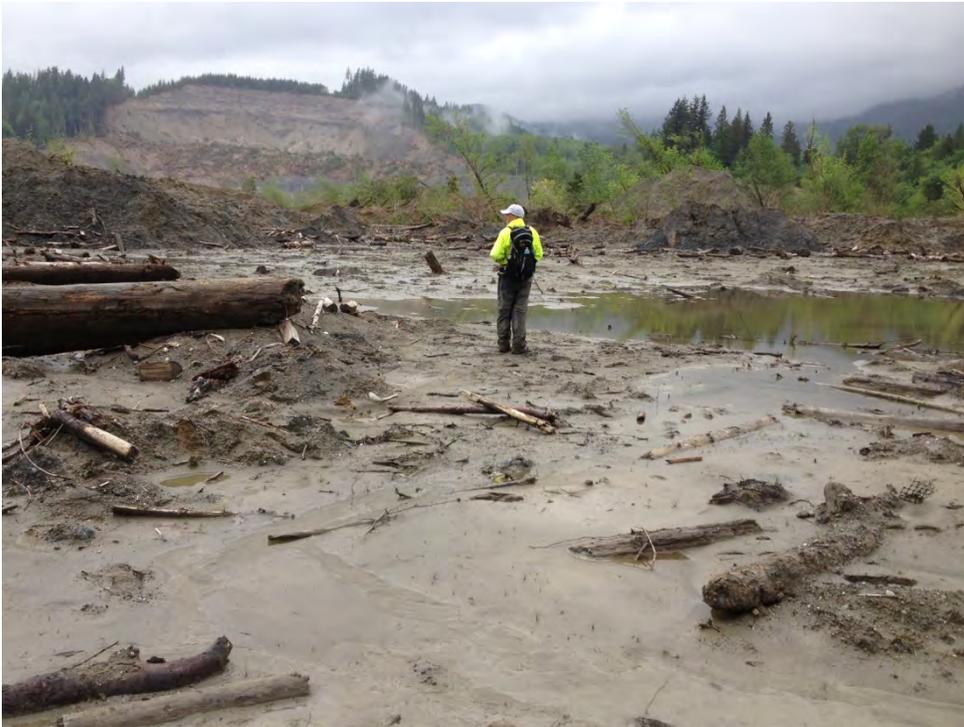
Figure 5.2.24 View from north end of Zone F toward rafted deciduous trees in Zone E, in background. Camera position: 48.27781, -121.83851.

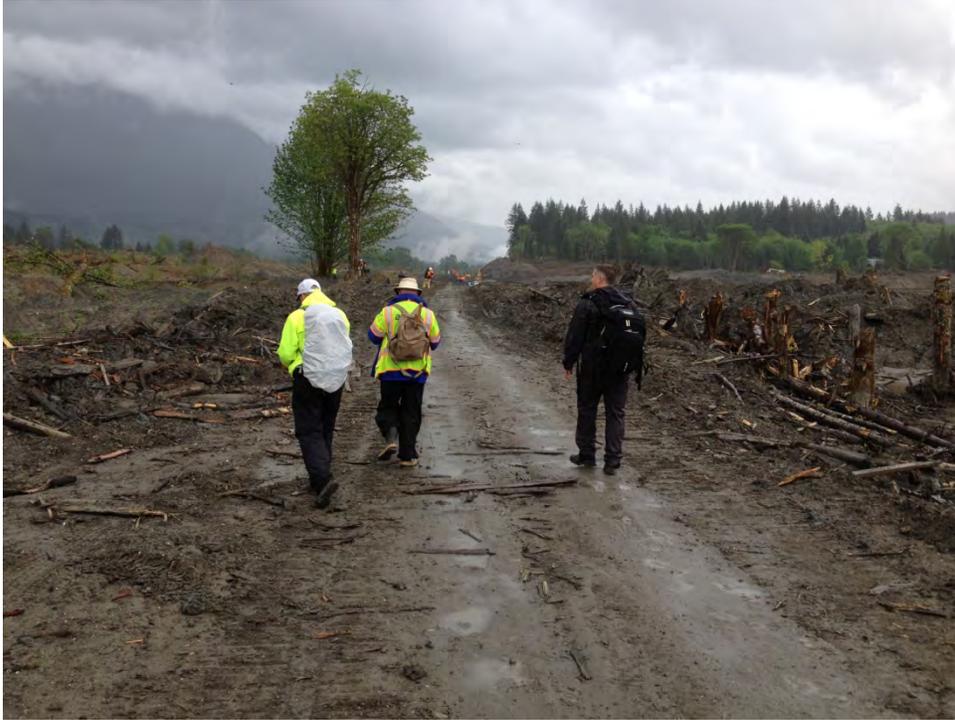
Figure 5.2.25 Maple trees north of SR 530 that appear to be in place. Camera position: 48.27521, -121.84814.

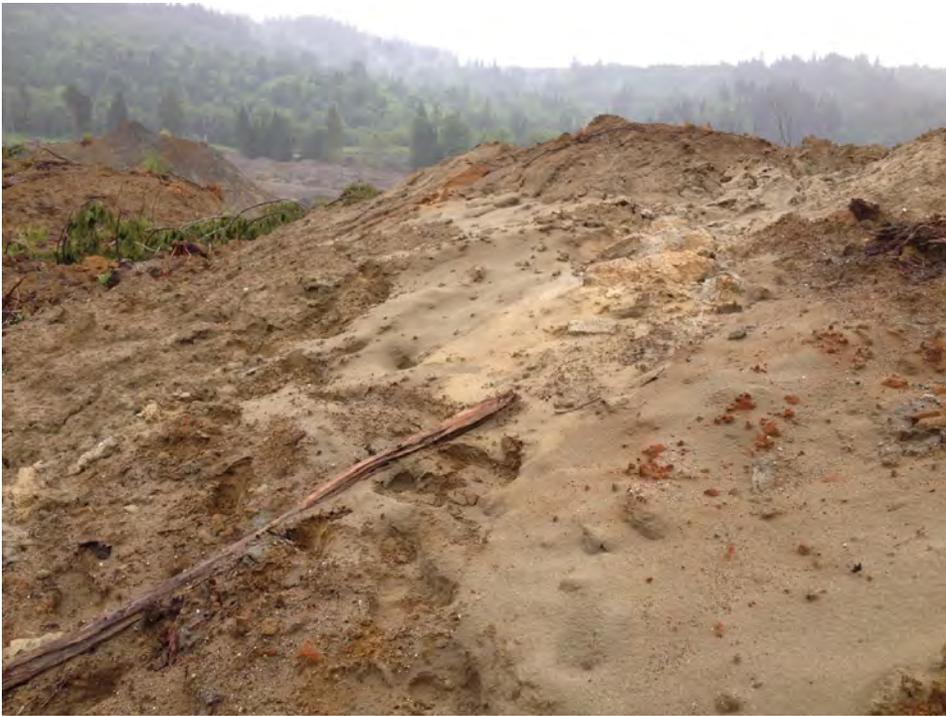
Sand ejecta were observed in Zone E (Figure 5.2.26). As in Zone B, the sand ejecta deposits were not observed in low spots, but rather in compression ridges where they appear to represent ejection by water of sand from cracks as the mass was emplaced. Sand ejecta were observed in the northern part of Zone E near the contact with Zone D. Sand boils (Figure 5.2.27) were also observed in the Zone E. Sand boils are a common observation when liquefaction has occurred from earthquakes. They indicate that at some depth below the ground surface the water pressure in the soil reached or exceeded the total overburden pressure, causing the soil to lose essentially all of its strength and flow like a liquid. Some of the flow then escapes to the ground surface, carrying the liquefied material with it, and creates the sand boils. The soil that forms the mound on the surface generally represents the soil that liquefied, but other material can also be entrained and deposited, or could have been washed away in the two months between the landslide and our observation of the boils. Without excavation it is not possible to tell from what depth the material has come, but sand boils from earthquakes most often indicate liquefaction in the upper 50 feet (15 m). Sand boils from earthquakes typically occur soon after the shaking has stopped and it is expected that these sand boils and ejecta formed soon (within seconds to minutes) after the slide came to rest.

Figure 5.2.26 Typical sand ejecta deposit. Camera position: 48.27849, -121.84406.
